# Dutchtown South Community Corporation Dutchtown South Neighborhood Survey

Lynn Josse and NiNi Harris  
8/5/2010

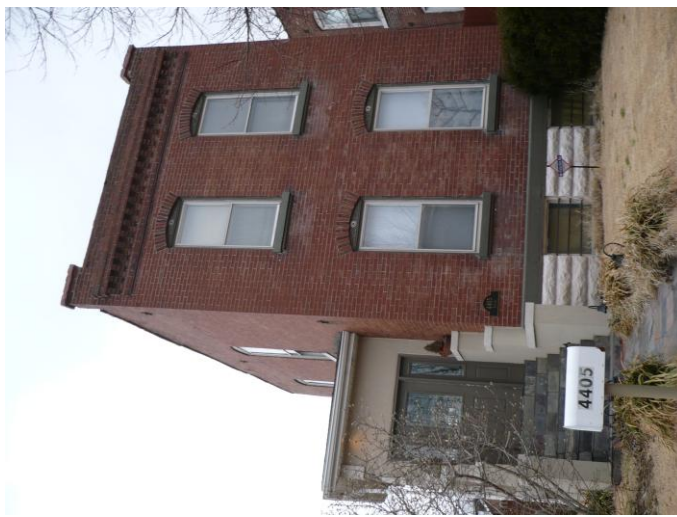
This red brick two-family building has a rock-faced limestone foundation at the façade. Above, there are two windows in segmental arched openings at both the first and the second story. The cornice is corbelled brick. The side porch is toward the front of the left (south) elevation; this porch was added post-1951.

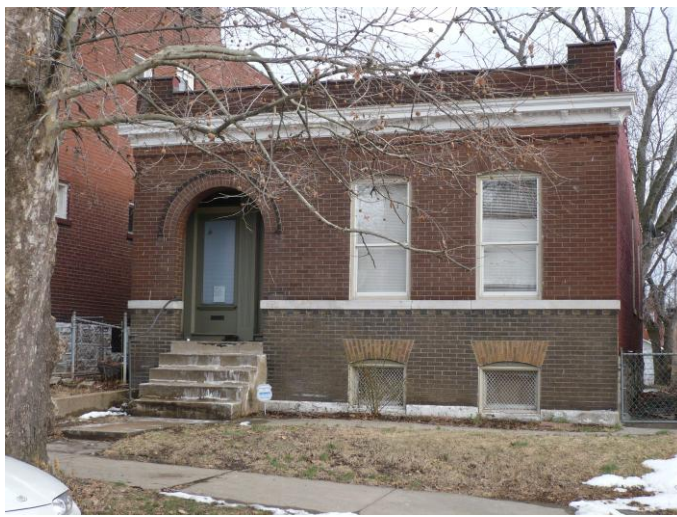
The original front door and door-shaped sidelight are recessed behind a round-arched opening at the left bay. To the right are two replacement windows in segmental arched openings. The basement windows' voussoirs are contrasting tan brick

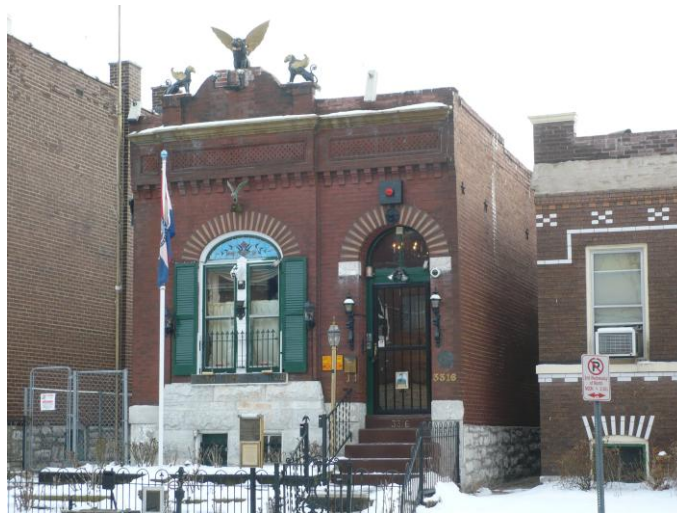
This narrow single story house has a limestone foundation at the façade. The front door, transom and paneling are at the right bay behind a narrow round-arched opening. The window bay to the left projects about one with; the paired 1/1 windows are under an irregular (3-centered) arch an art glass transom. Both arches feature Roman brick voussoirs in alternating red and tan. The entry has stone imposts; the sides of the window are obscured by applied shutters. Molded brick corbels are under slightly projecting panels of square Celtic knot terra cotta/brick pieces, which are in turn below the metal cornice. The front parapet wall has a moderately rebuilt center arch over the projecting bay. Various griffons, birds, lamps, shutters, alarms and cameras are applied to the façade and parapet but do not detract significantly from the house's integrity. An informational sign dates the house to 1886 and offers information about the house's history. The 1896 date is from a building division certificate.

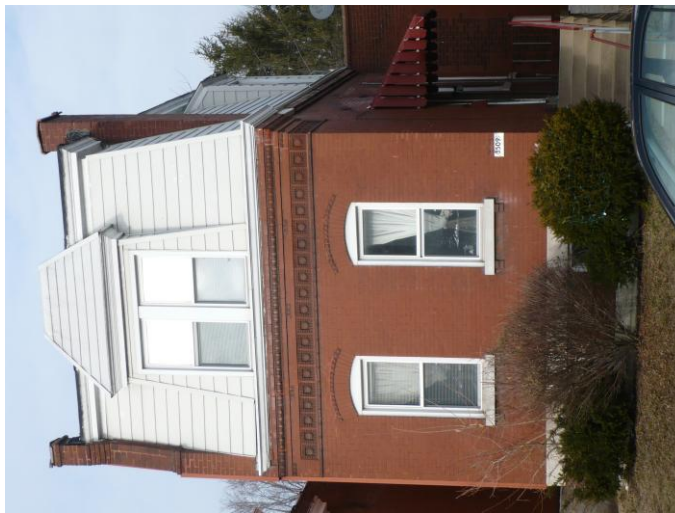
The second story of this brick house is a full-height mansard roof, steeply sloped at the front a right (east) elevations, an supported by a brick parapet wall at the left (west) elevation. At the façade, the base is coursed limestone and the two windows are in segmental arched openings. The windows themselves are contemporary replacements. There is a cornice of pressed brick and red terra cotta bricks. The front dormer has a hipped roof with the ridge running parallel to the façade. Its two windows are also replacements. The porch (a concrete stoop and metal awning) is at the right (east) elevation. The door appears to be an early Craftsman-era replacement. The back section of the house is a single story and includes an el at the right side. Its door opening has been bricked in. A certificate dates this house to 1900 (which seems late for the style and detailing, although not impossible); no permit has been found that correlates with that date.
