ARCHITECTURAL/HISTORIC INVENTORY FORM - Cultural Resources Office
St. Louis Planning and Urban Design

1. Survey no. SLC-AS-053-0195	2. Survey name: Thematic Survey of Flounder Houses in St. Louis City	3. County: St. Louis [Independent City]
4. Address: (from City GEO database) 908 MORRISON AV		5. City/State: St. Louis, Missouri
Alternate address: 908 Morrison Avenue		Property Zip Code: 63104
Latitude: 38.614945		6. UTM Easting: 743839.02
Longitude: -90.199405		UTM Northing: 42277768.84
8. Historic Name (if known): N/A	11a. Historic Use (if known): Domestic	City Block 466.03
9. Present/other name (if known): Domestic	7. Township-Range-Section: N/A	City Ward 7
10. Ownership: Private		Neighborhood Number: 34

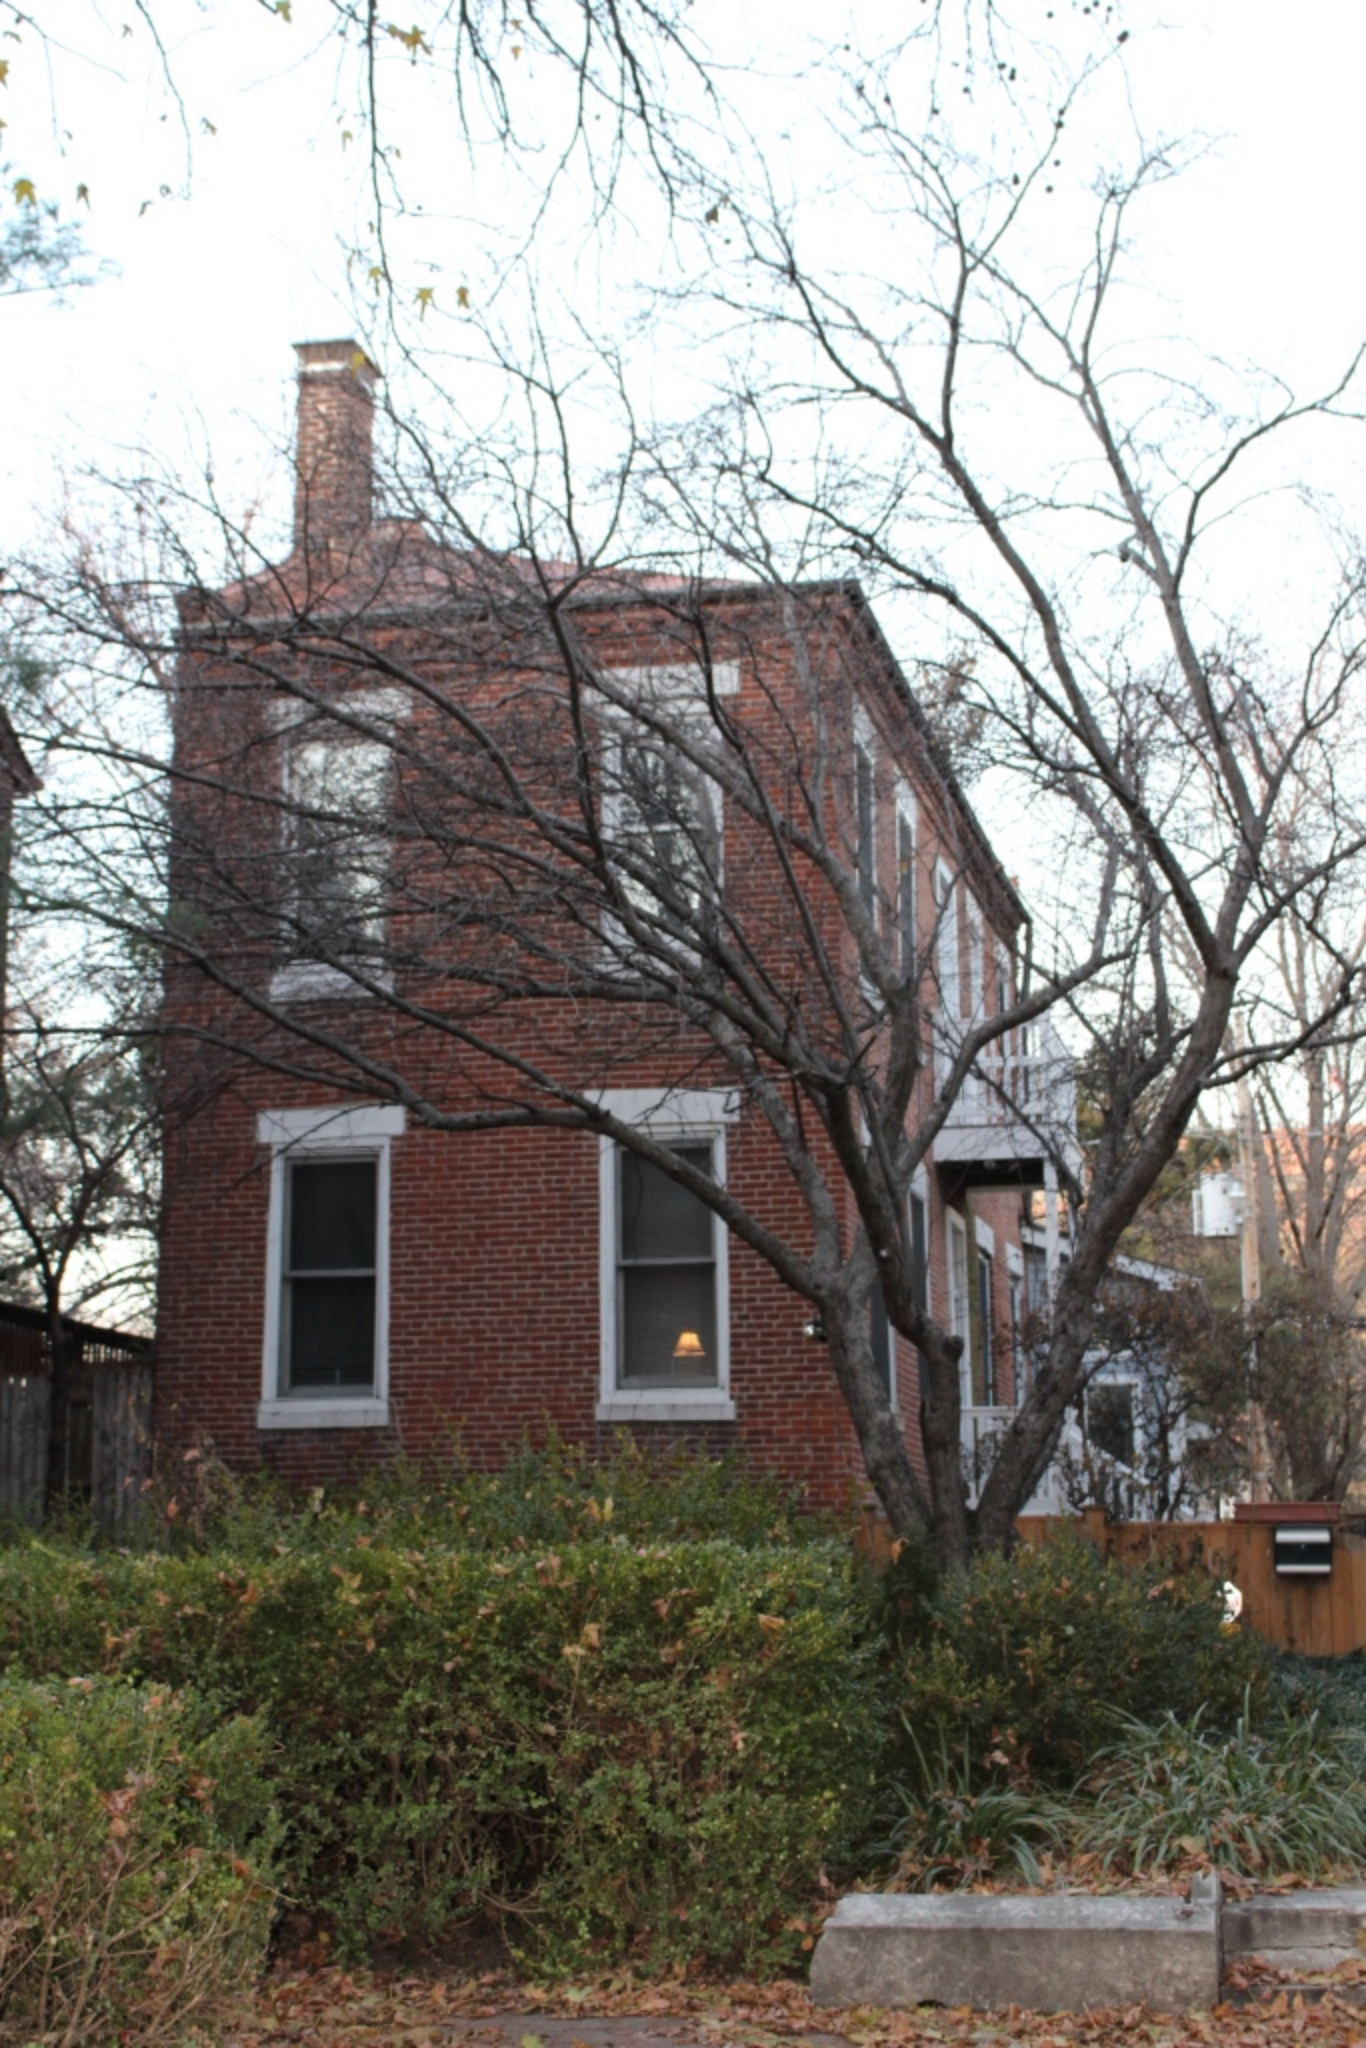
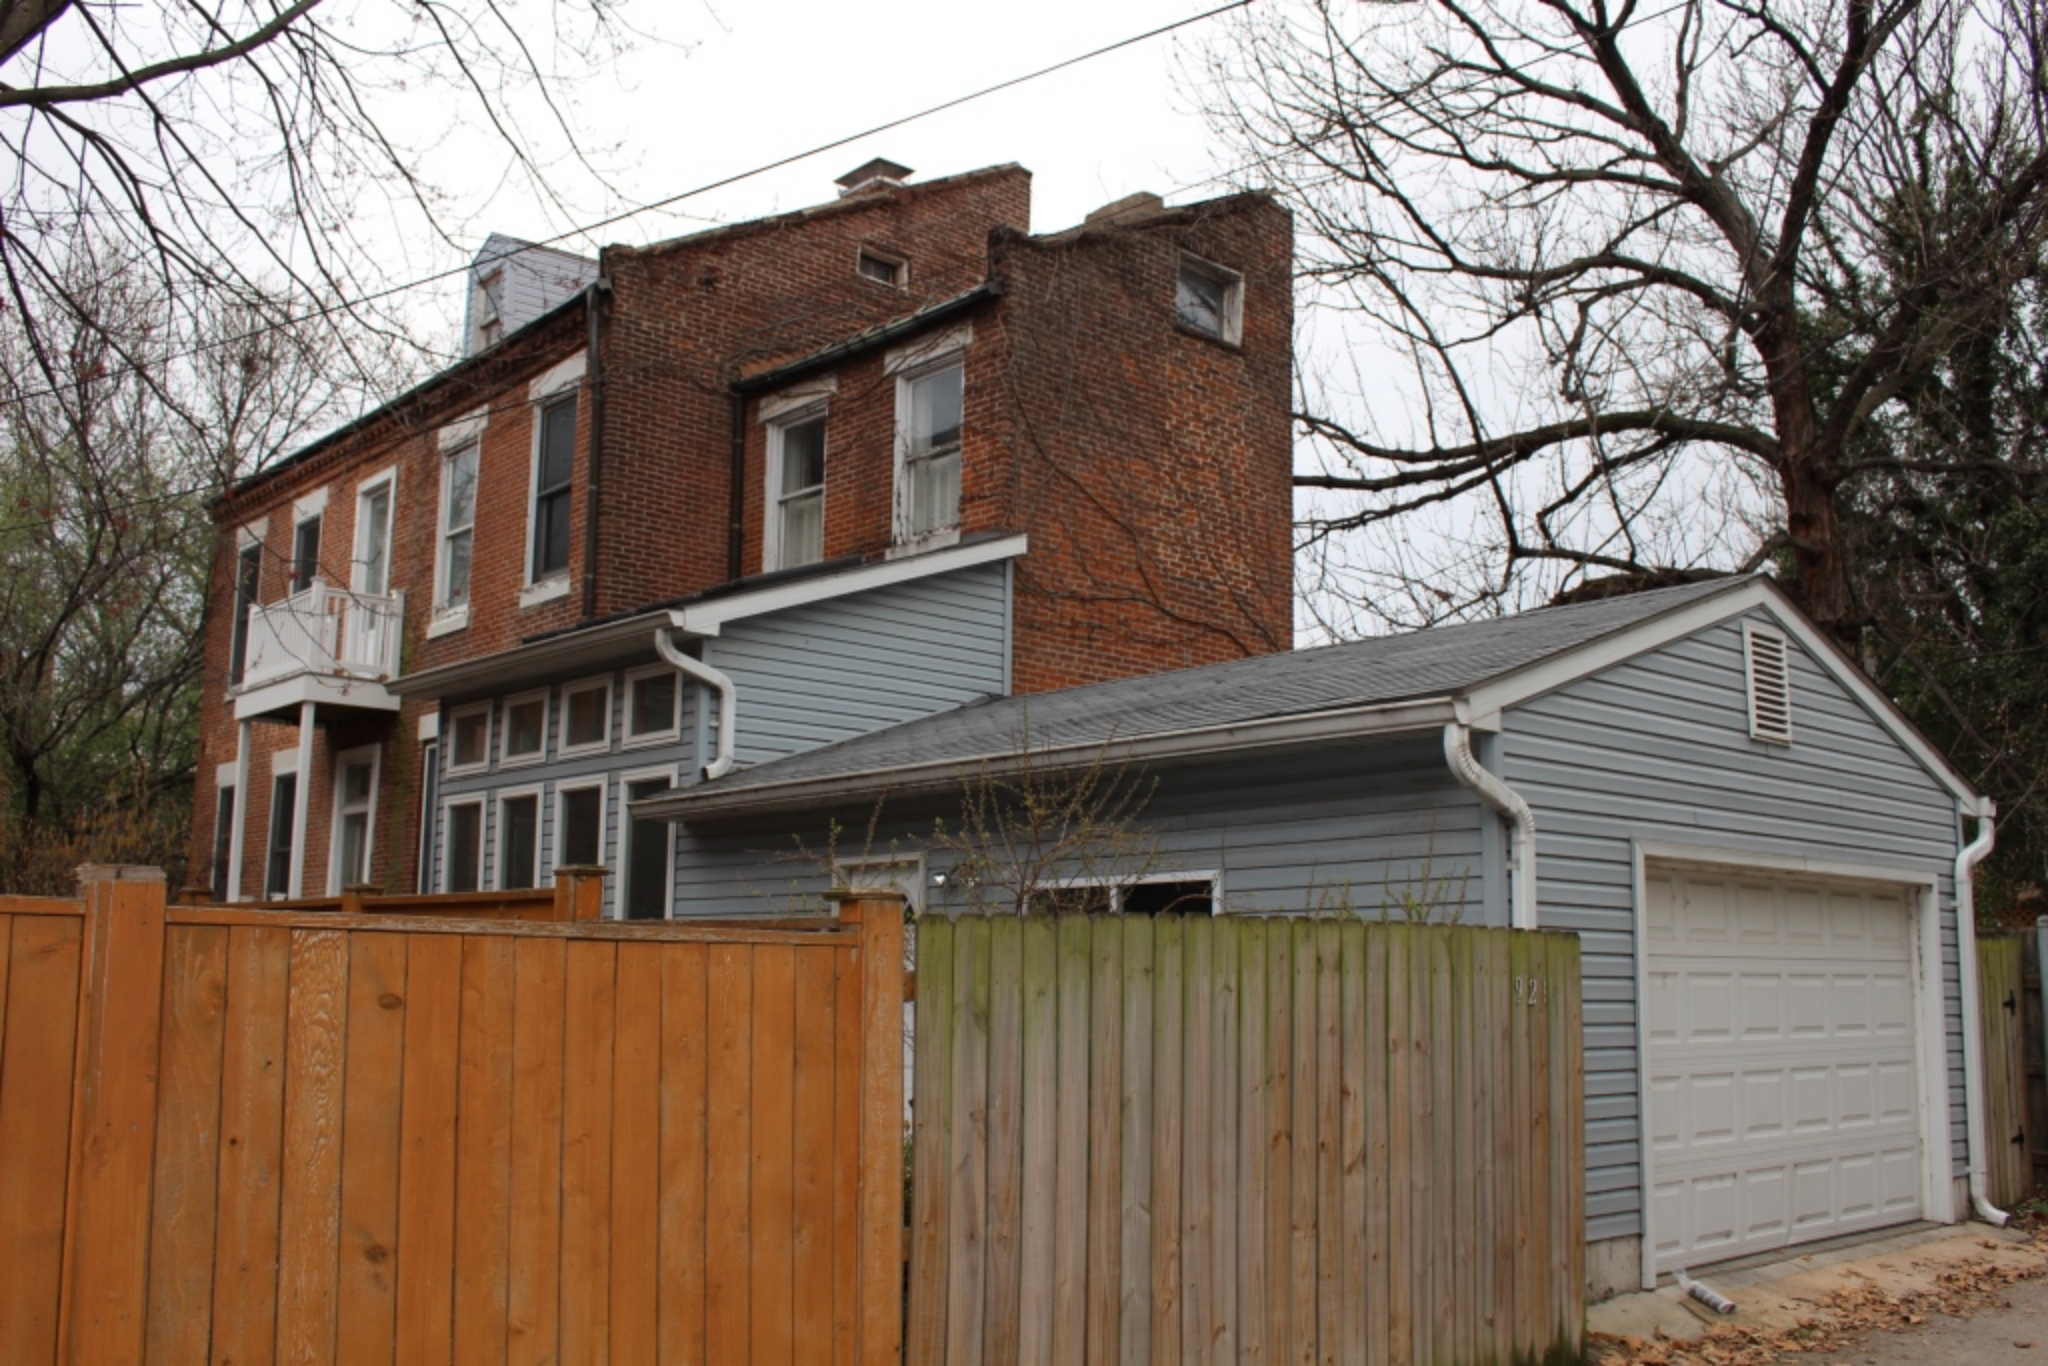
Two-story side entry with simple brick corbelled cornice extending length of south and east facades. Windows on south and east side have trapiated cut stone lintels and sills. Windows are replacement and have been wrapped. The main entry is centered on the east façade and is accessed by a small wooden two-story porch. The second floor, east façade has a central door that enters out on to the porch. The is a east facing dormer centered on the main roof of the house. The rear has a two-story flat roof brick additon and is accompanied by a newer one-strory frame addition of the north-east corner of the house.

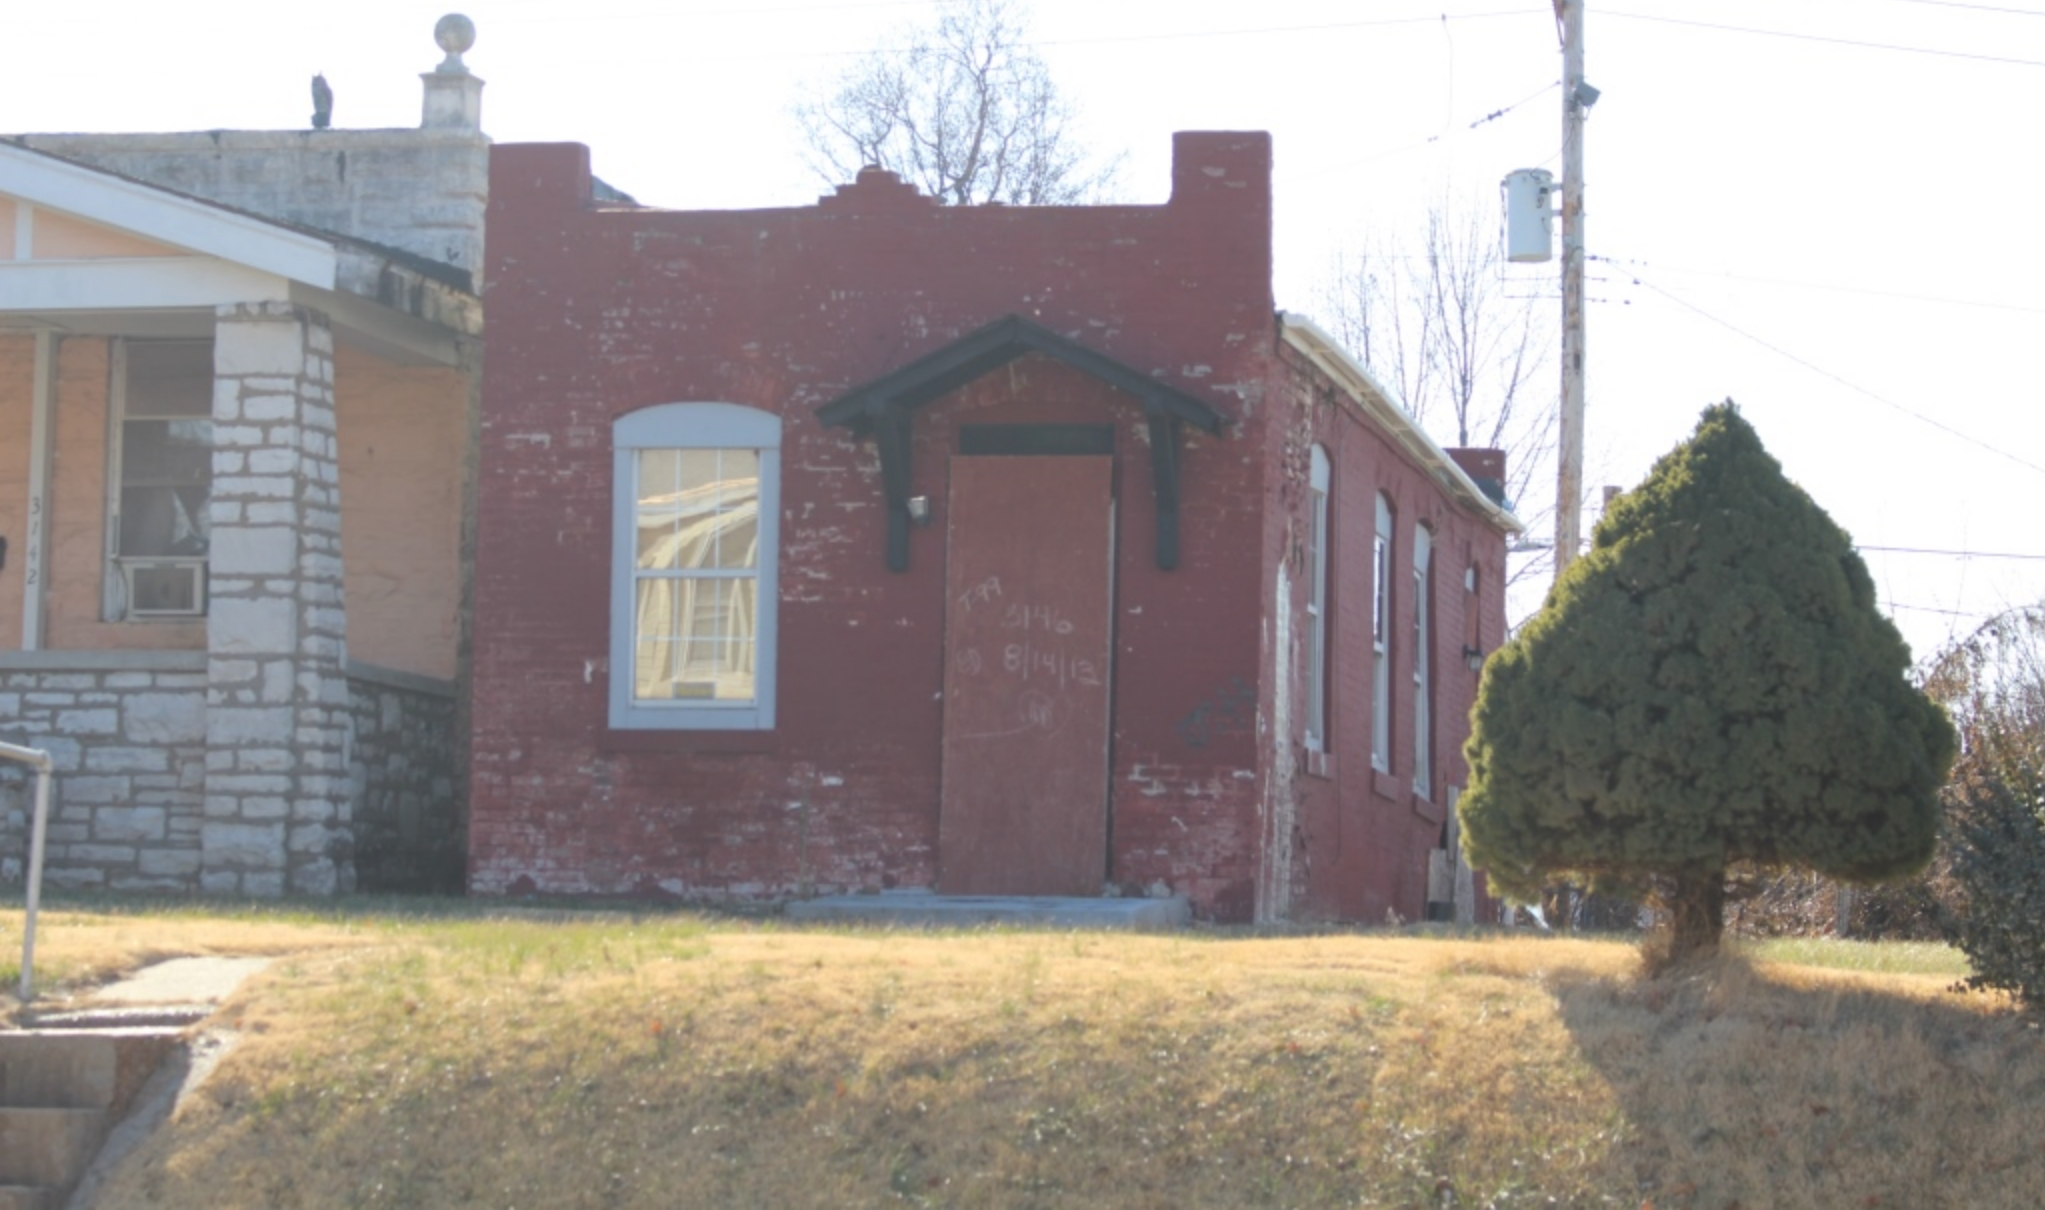
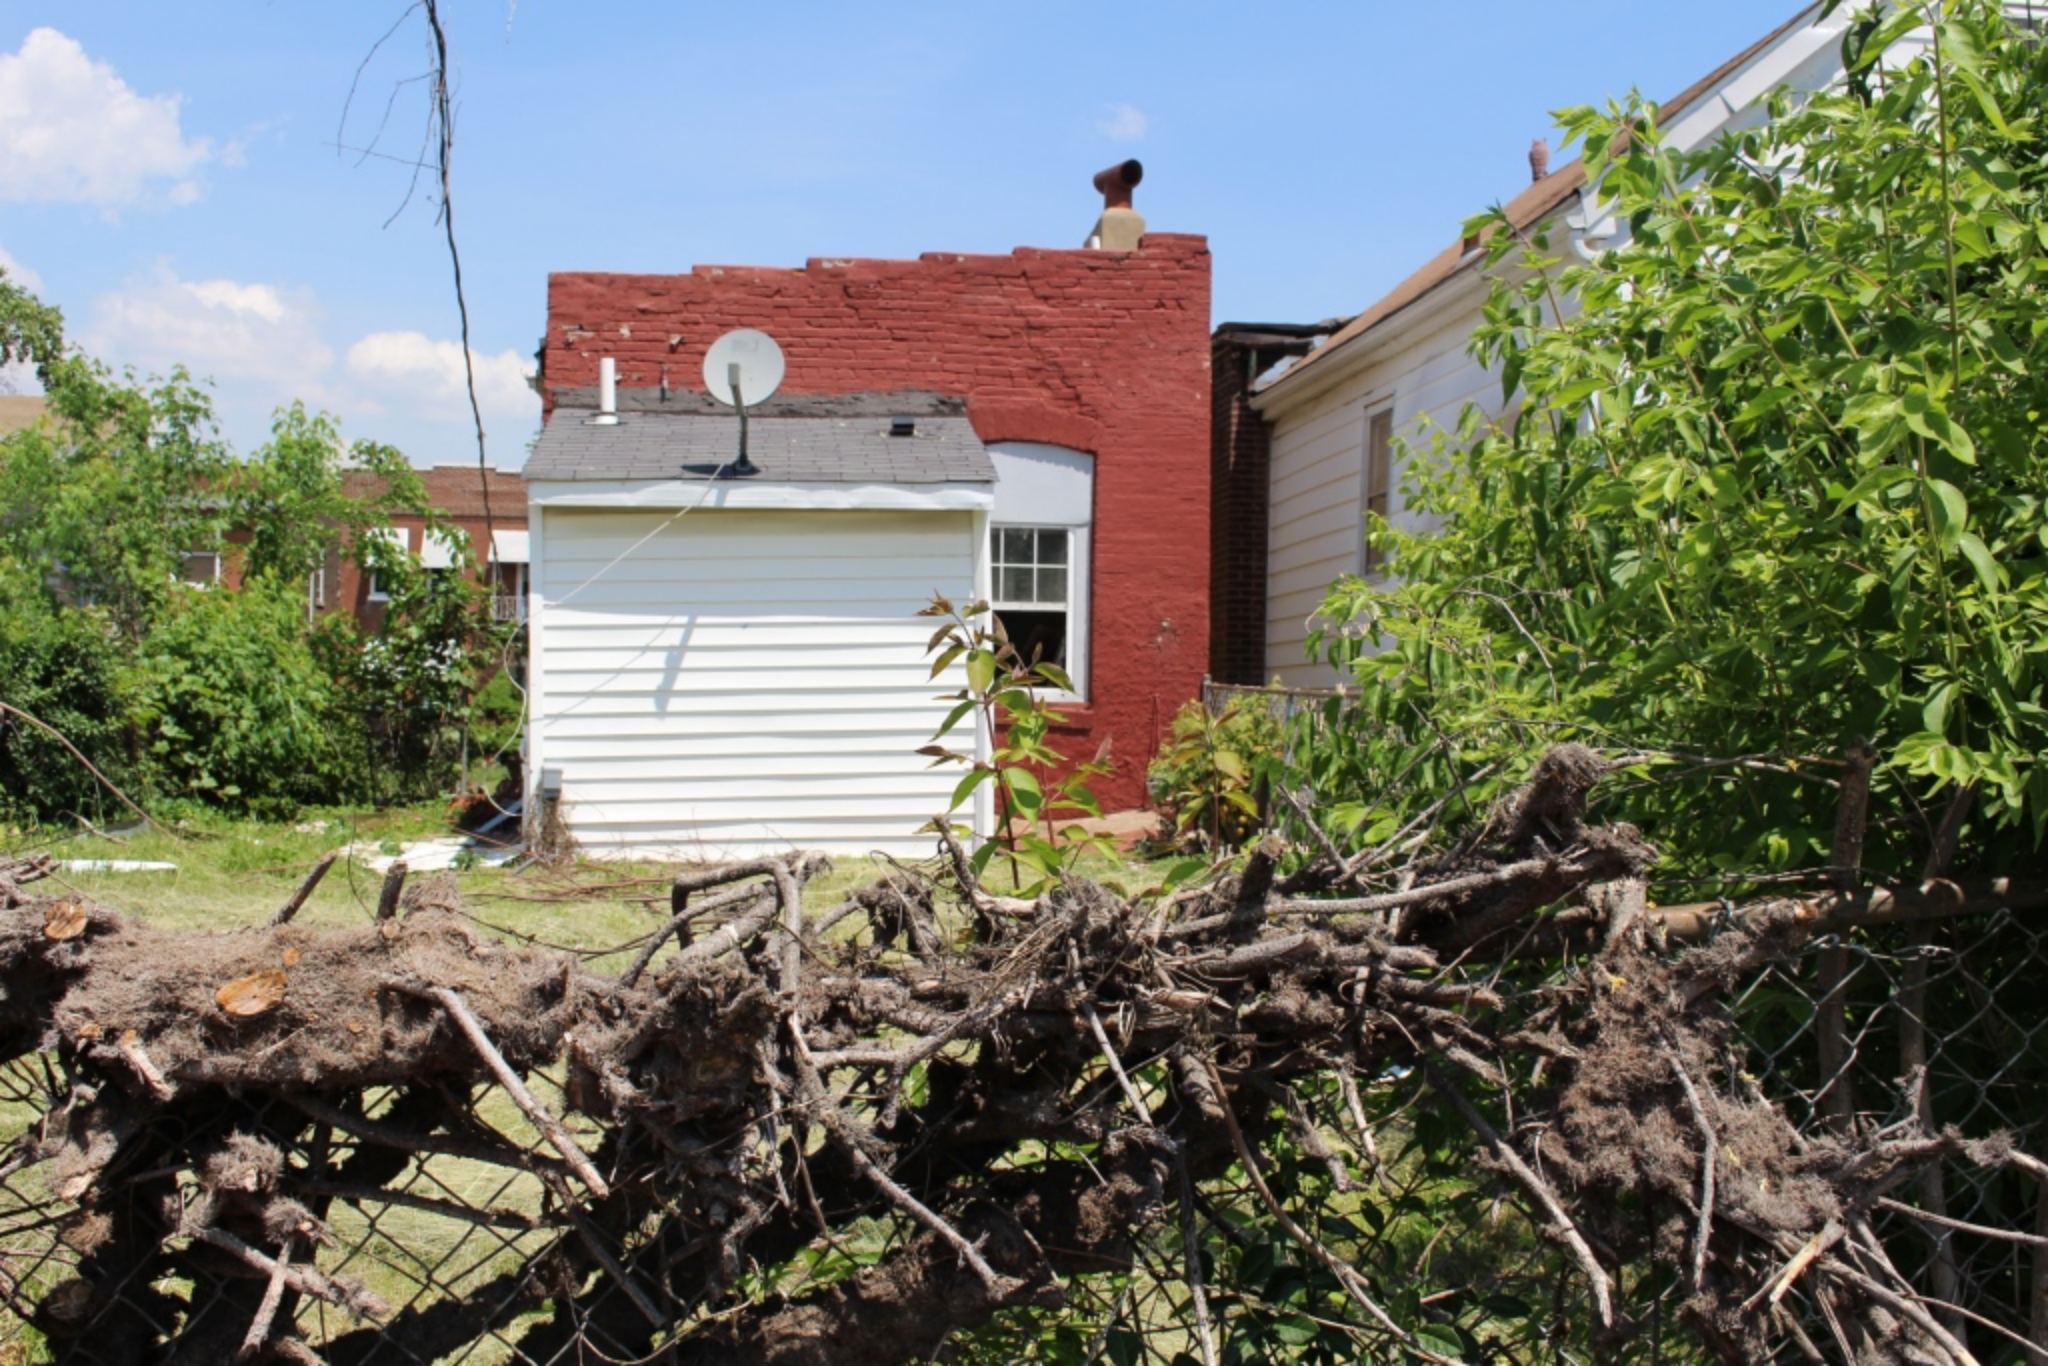
Matching flounder next door. Damage from a leaking gutter has affected the masonry of the west façade and one bay has collapsed to the foundation.

One-story brick flounder featuring a front facing stepped parapet, which may be a later alteration. Flounder roof is concealed behind the parapet. The brick has been painted red. All the windows on the house have been replaced with vinyl and wrapped. All window and doors have segmental soldier arches and limestone sills. One bay of the west façade has collapsed, exposing the interior.

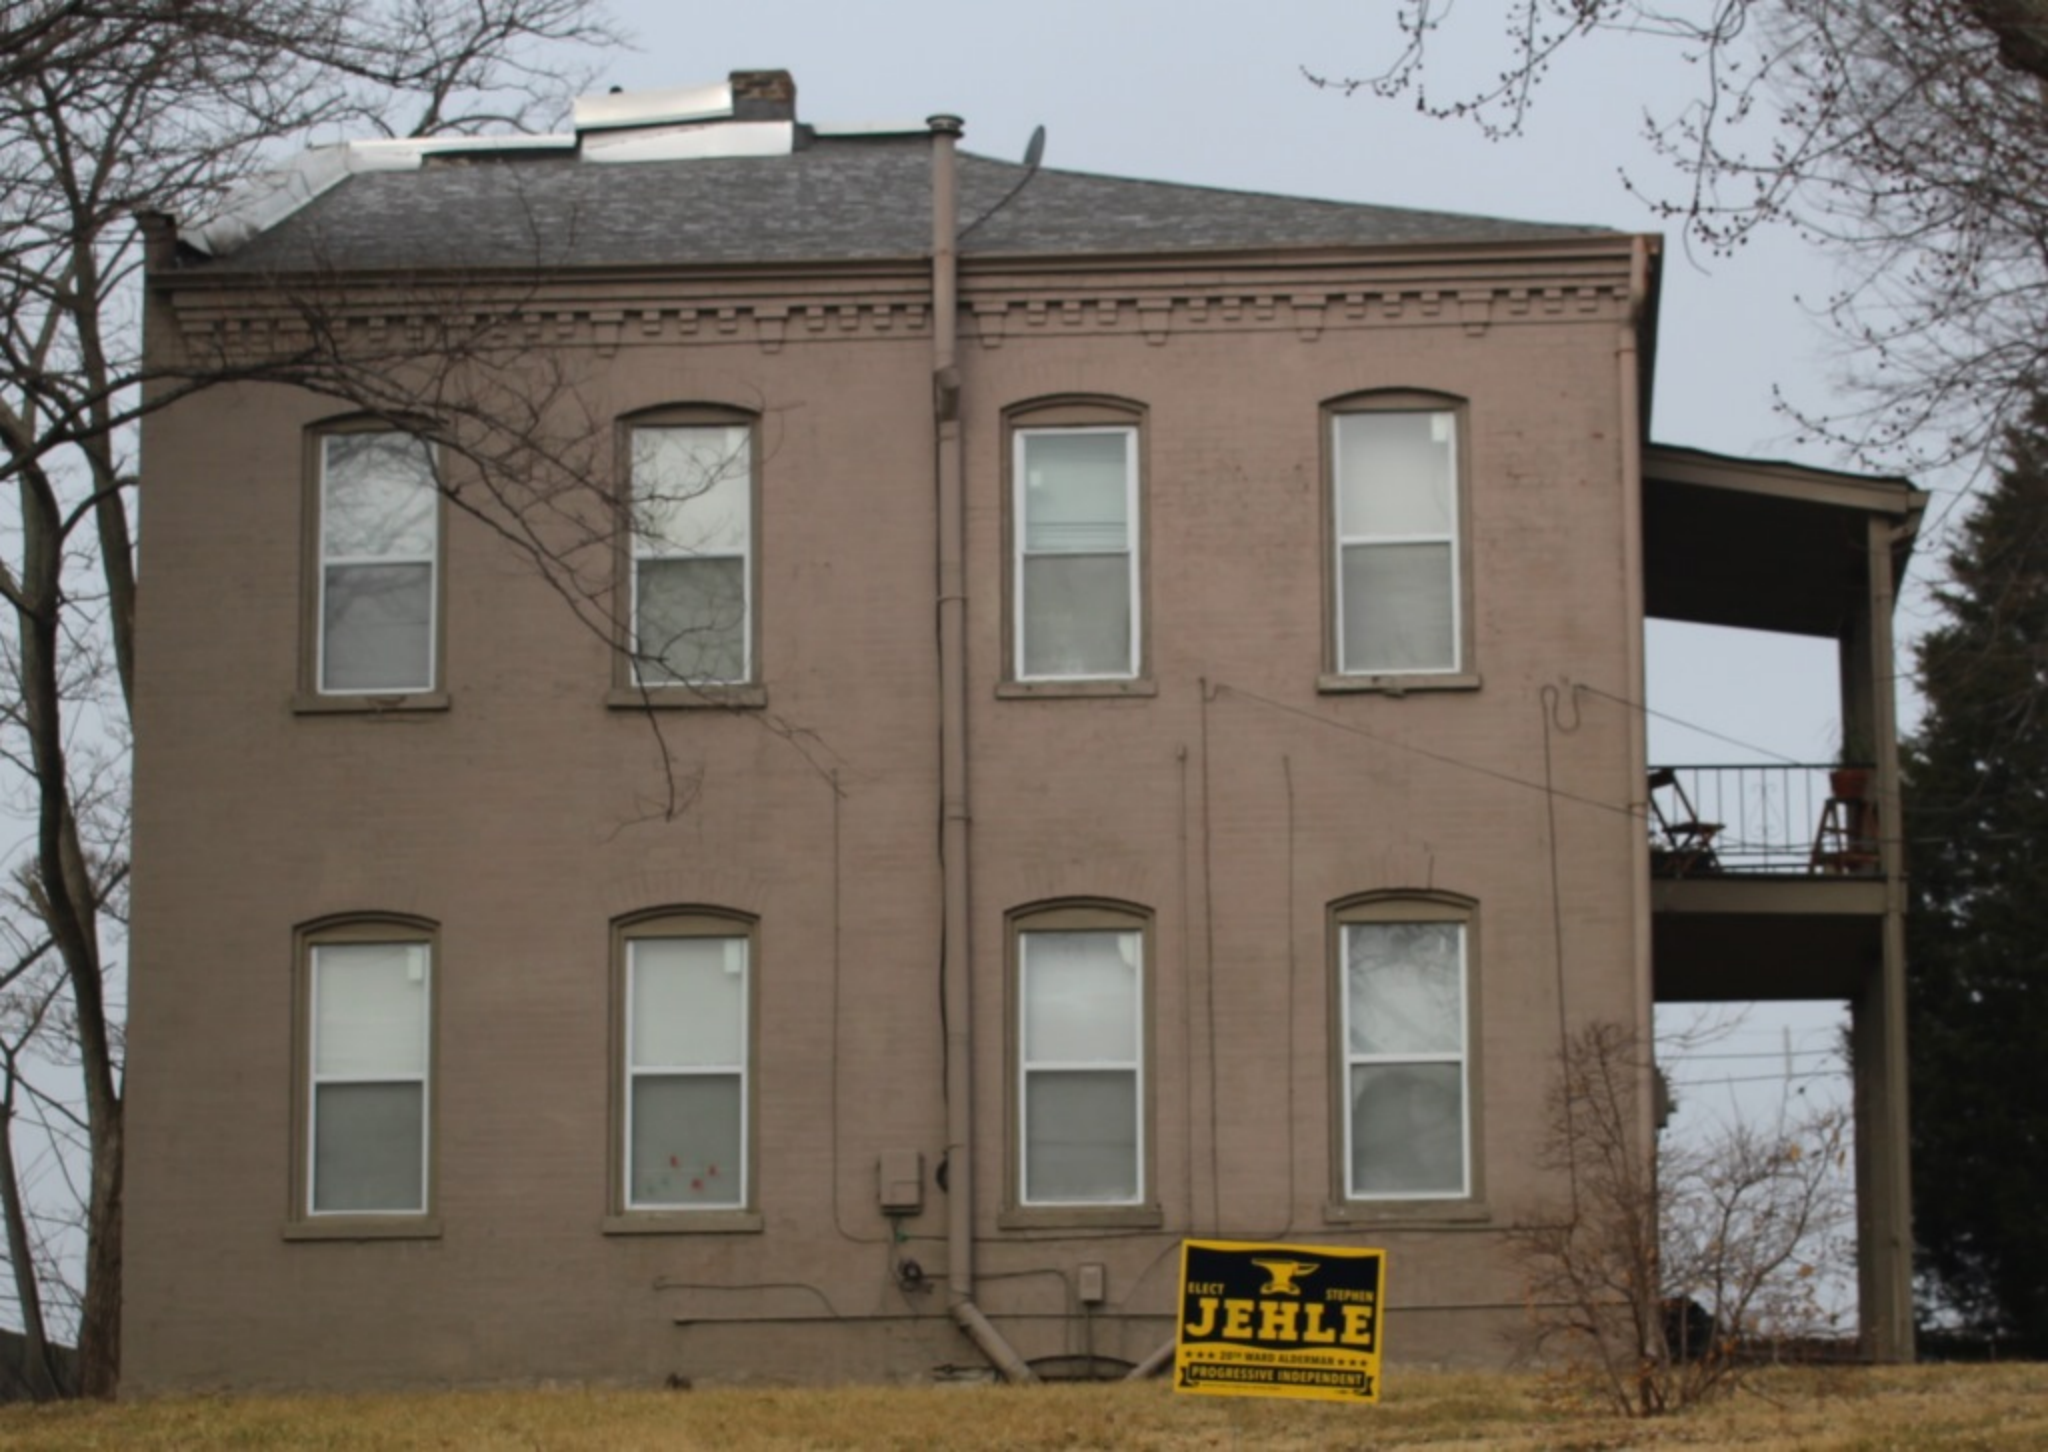
This 2-story, 4-bay building was built as a hipped front 2-bay wide flounder with side entry and taller south wall. The front façade has a denticulated brick cornice with brick consoles; a simpler cornice of dentils returns along the north wall. The low foundation is coursed rough-faced rubble limestone. The side elevation presented 4-bays with 2 center doors flanked by single windows. Currently the westernmost door is blocked in and sided. The second story duplicates the pattern with 2 single doors centered between two windows. All door transoms have been blocked in and sided. A 2-story replacement wood porch shelters the doors and a wood bulkhead covers a cellar entrance under the easternmost window. All openings have segmental soldier arches, windows are replacement 1/1 doublehung metal sash and brickmold.

Another 2-story flounder form consisting of one room at each story was added before 1903 at the southeast corner to create a 4-bay front façade; its tall wall faces west toward the rear of the property and has a high casement window set just below the parapet - a later insertion with a rowlock sill. The addition's details, including cornice, openings and foundation, duplicate that of the original flounder. Another 2-story addition was made before 1903 - perhaps at the same time - at the northwest corner of the main building. This has two bays, with a single door (transom blocked) on the east and a window on the west, and two windows at the second story. Between this addition and the main building was once a wide opening under a flat header arch> It has been bricked-in to to accommodate a window (now blocked and boarded); this may once have been a mousehole allowing entry to the interior of the site. As with the front addition, this addition duplicates the original simplified side cornice and window details.

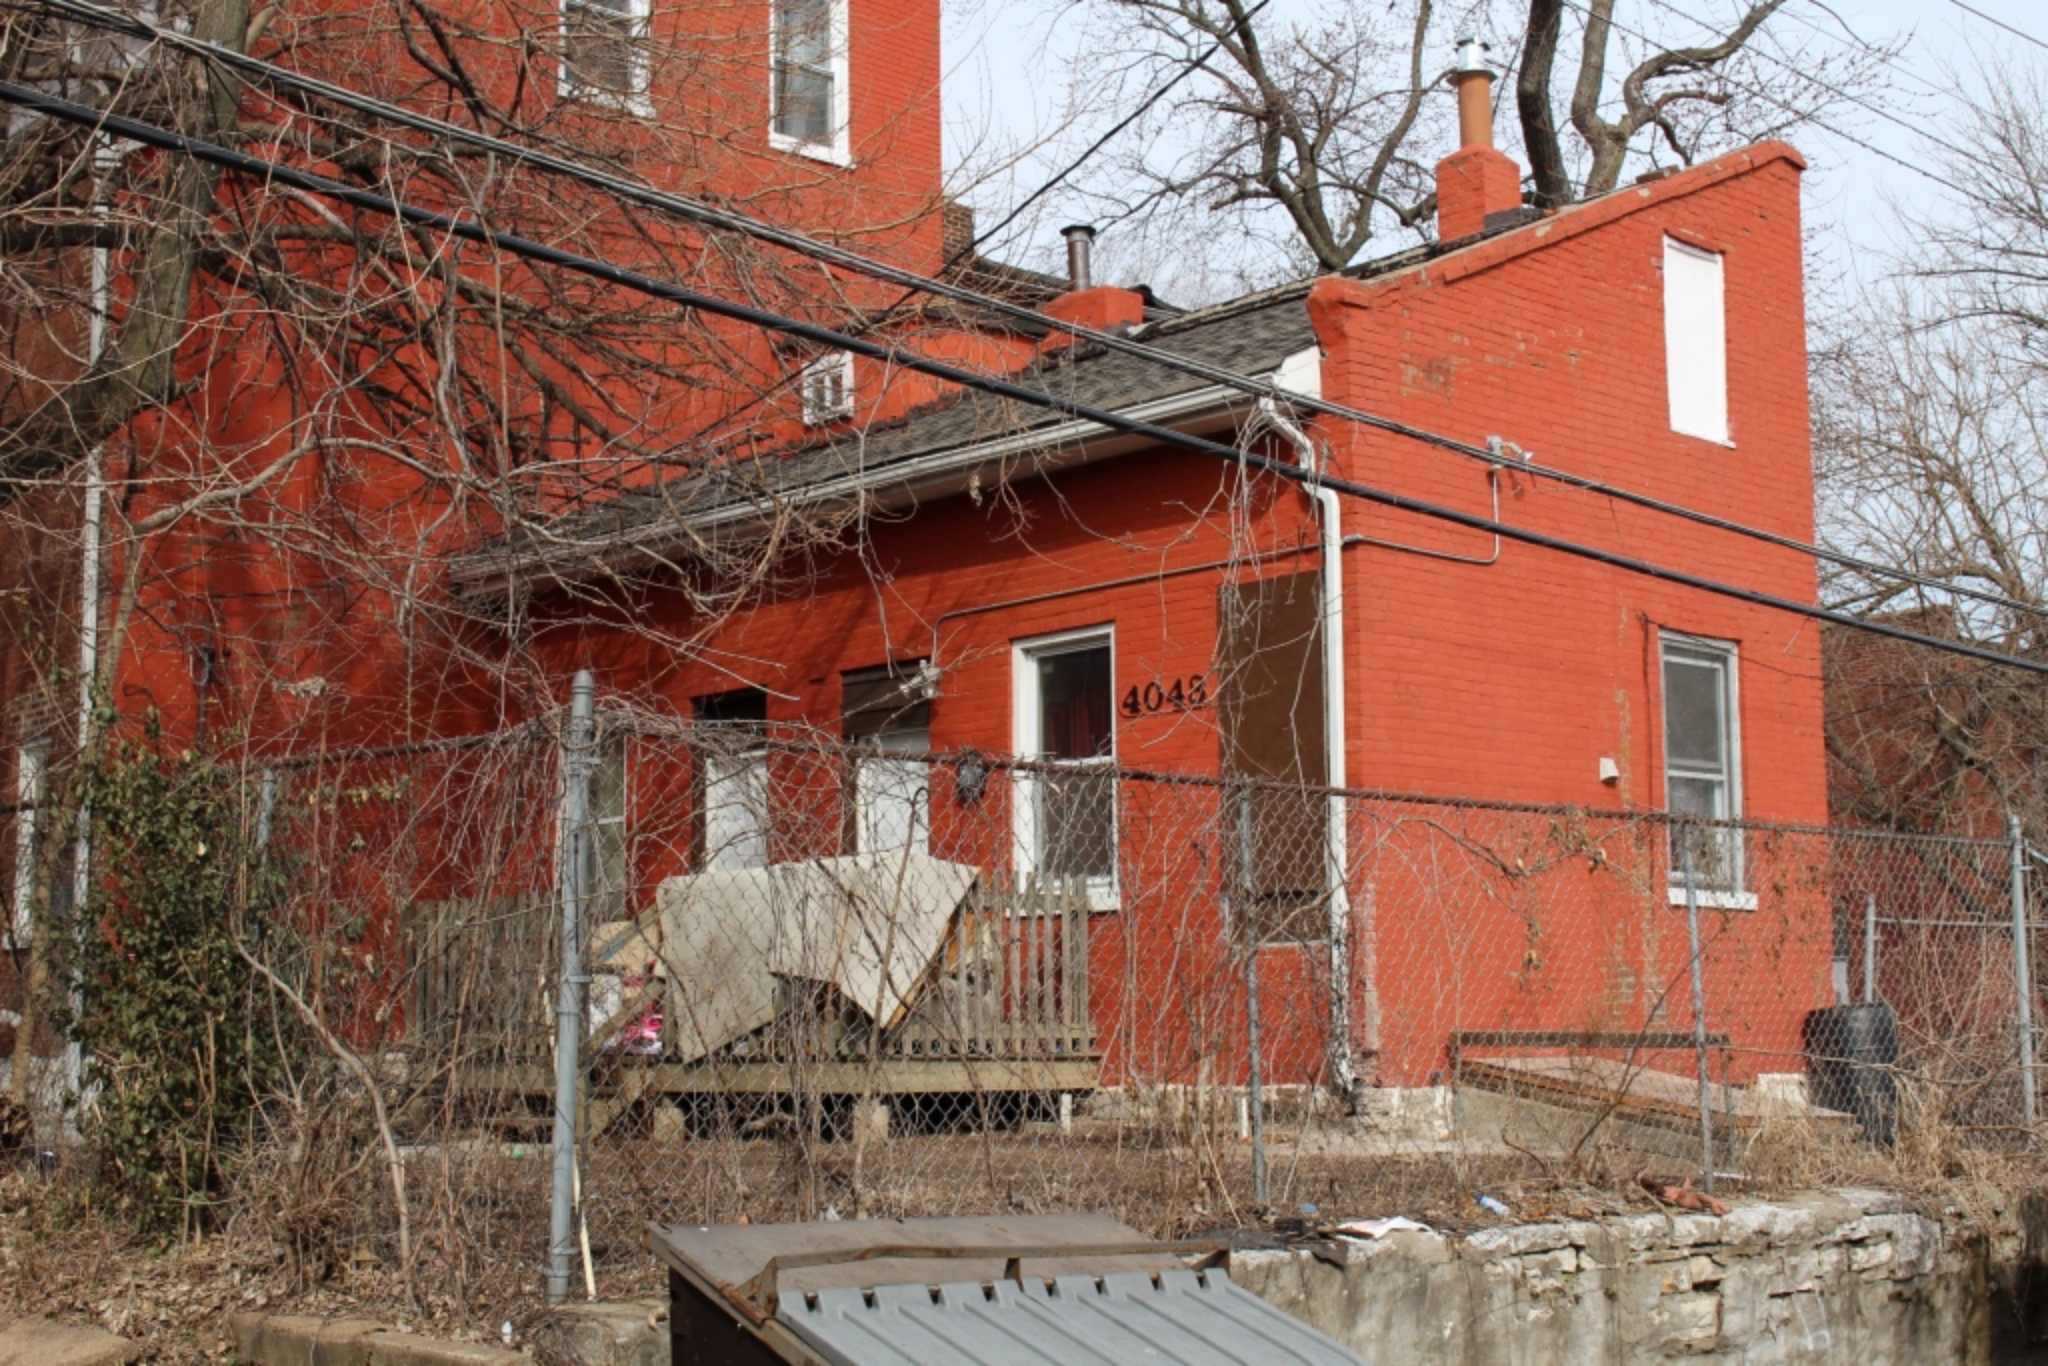
Front house has mansard as third story (height wrong in NRHP description). Joint in brick on north wall and different heights and quality of limestone foundations suggest that the flounder was on site prior to main house.

This flounder is an example of a rear, alley flounder being built first and a larger main house later constructed in front. The brick one-and-one-half story flounder with shed roof and higher north wall has flat-arched openings at doors and windows. A pair of doors in the south wall is flanked by windows. The doors are replacement units set below blocked transoms; the 1/1 double-hung sash is vinyl and the brickmold is wrapped. The coursed rubble limestone foundation is low in height and lower than that of the main house; exterior basement door and steps outside the east wall give access to basement. The attic window is blocked.
