ARCHITECTURAL/HISTORIC INVENTORY FORM - Cultural Resources Office
St. Louis Planning and Urban Design

1. Survey no. SLC-AS-053-0195	2. Survey name: Thematic Survey of Flounder Houses in St. Louis City	3. County: St. Louis [Independent City]
4. Address: (from City GEO database) 908 MORRISON AV		5. City/State: St. Louis, Missouri
Alternate address: 908 Morrison Avenue		Property Zip Code: 63104
Latitude: 38.614945		6. UTM Easting: 743839.02
Longitude: -90.199405		UTM Northing: 42277768.84
8. Historic Name (if known): N/A	11a. Historic Use (if known): Domestic	City Block 466.03
9. Present/other name (if known): Domestic	7. Township-Range-Section: N/A	City Ward 7
10. Ownership: Private		Neighborhood Number: 34

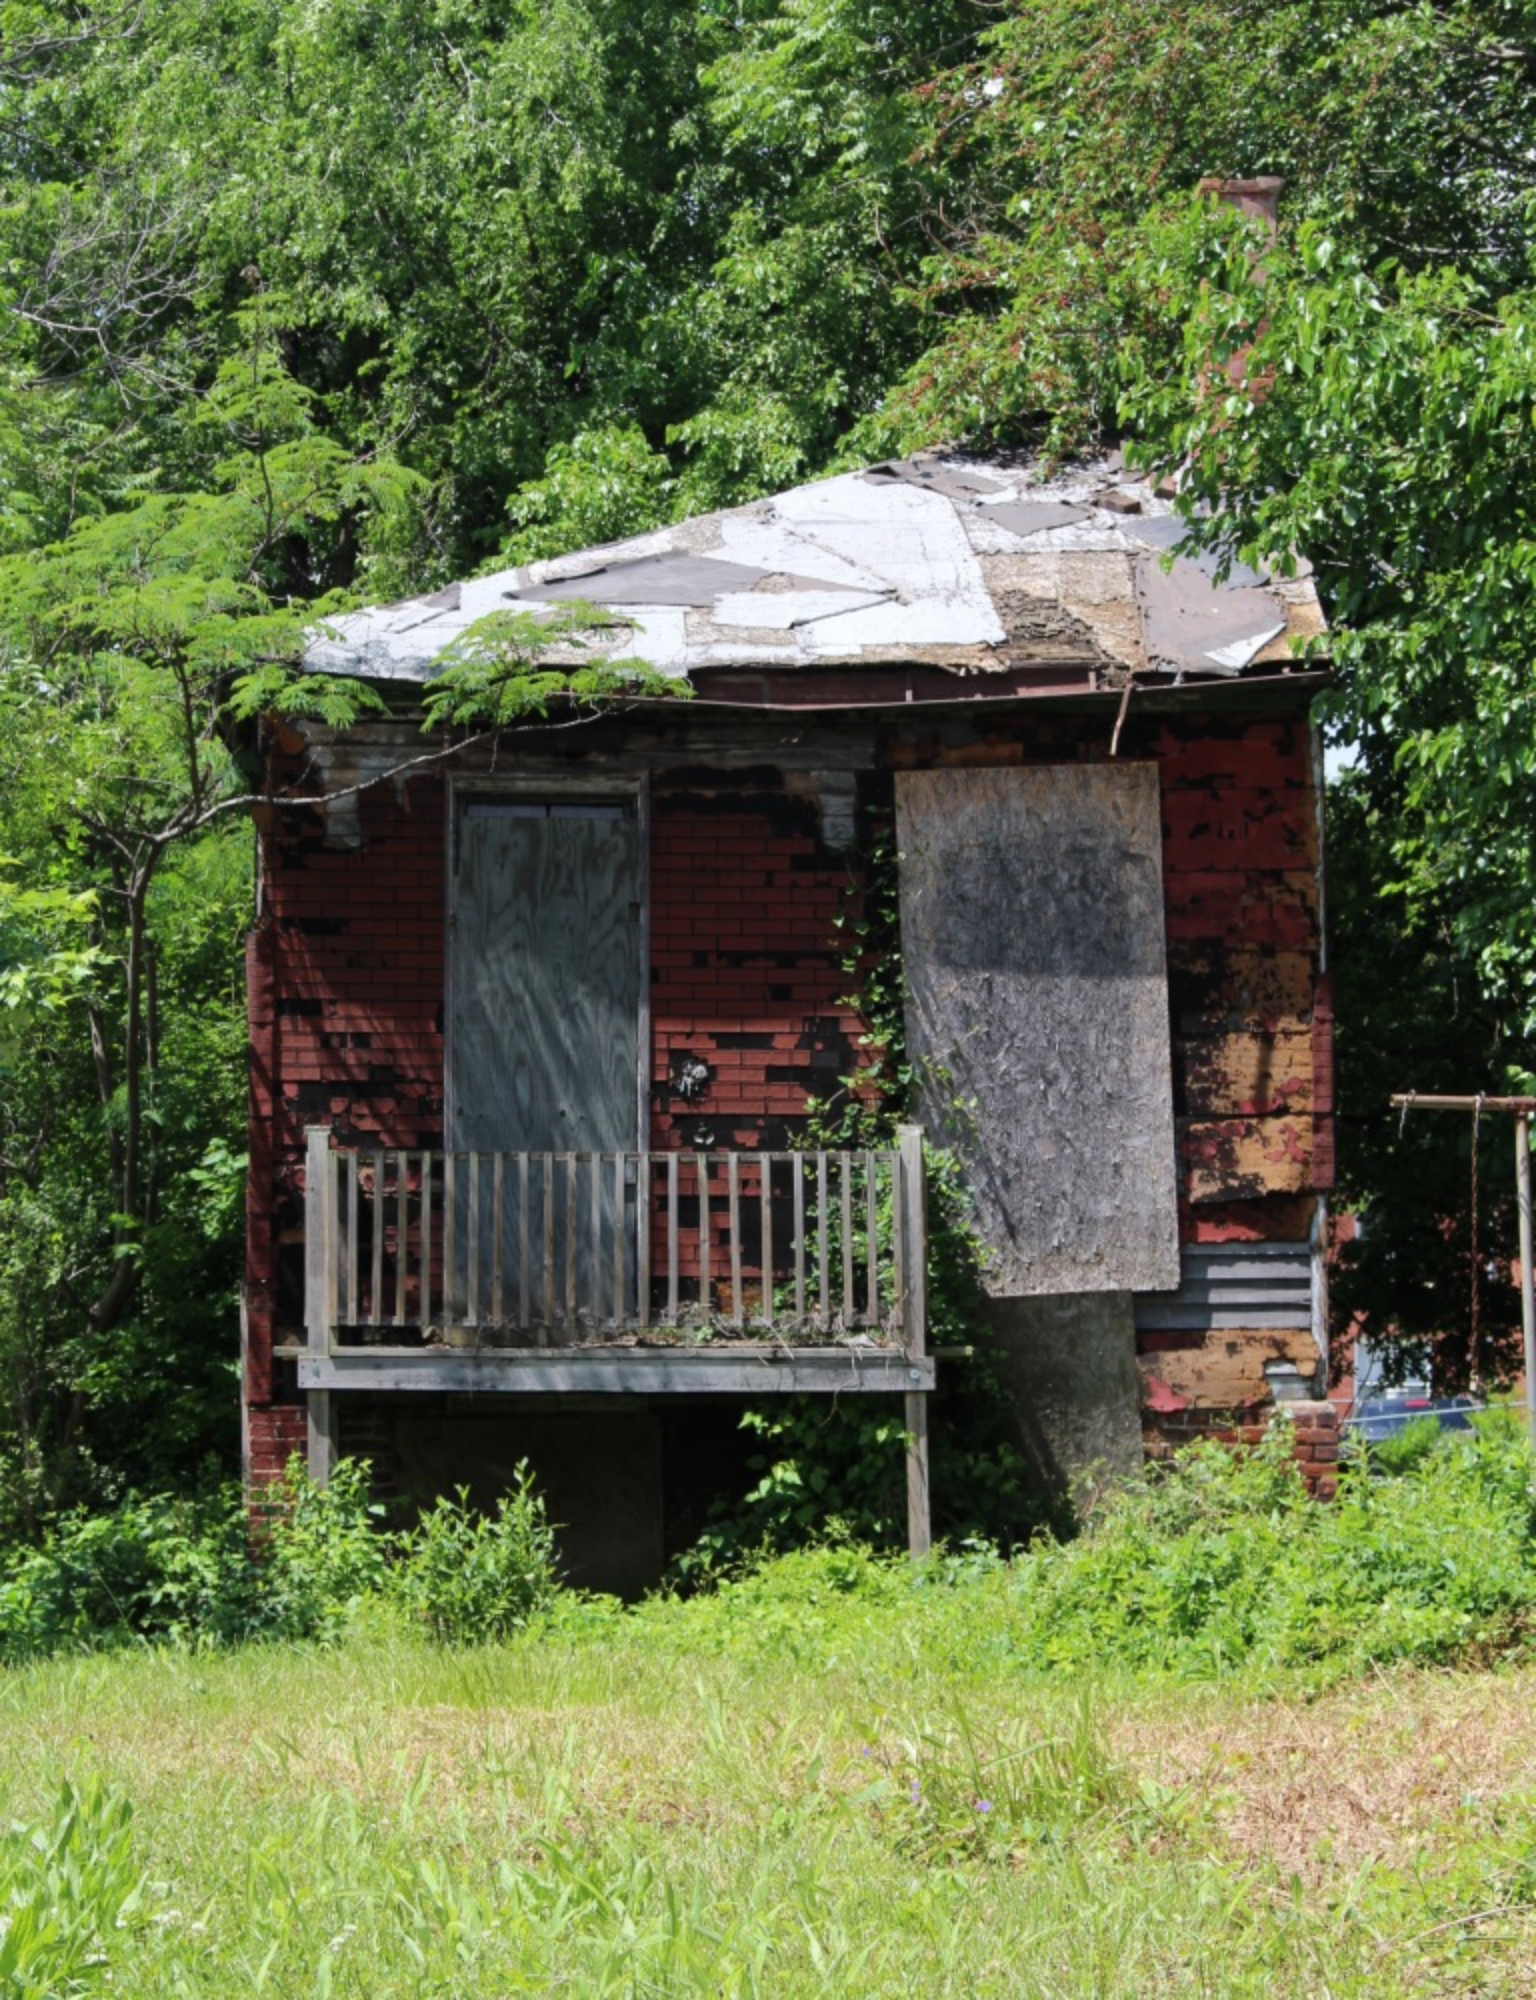
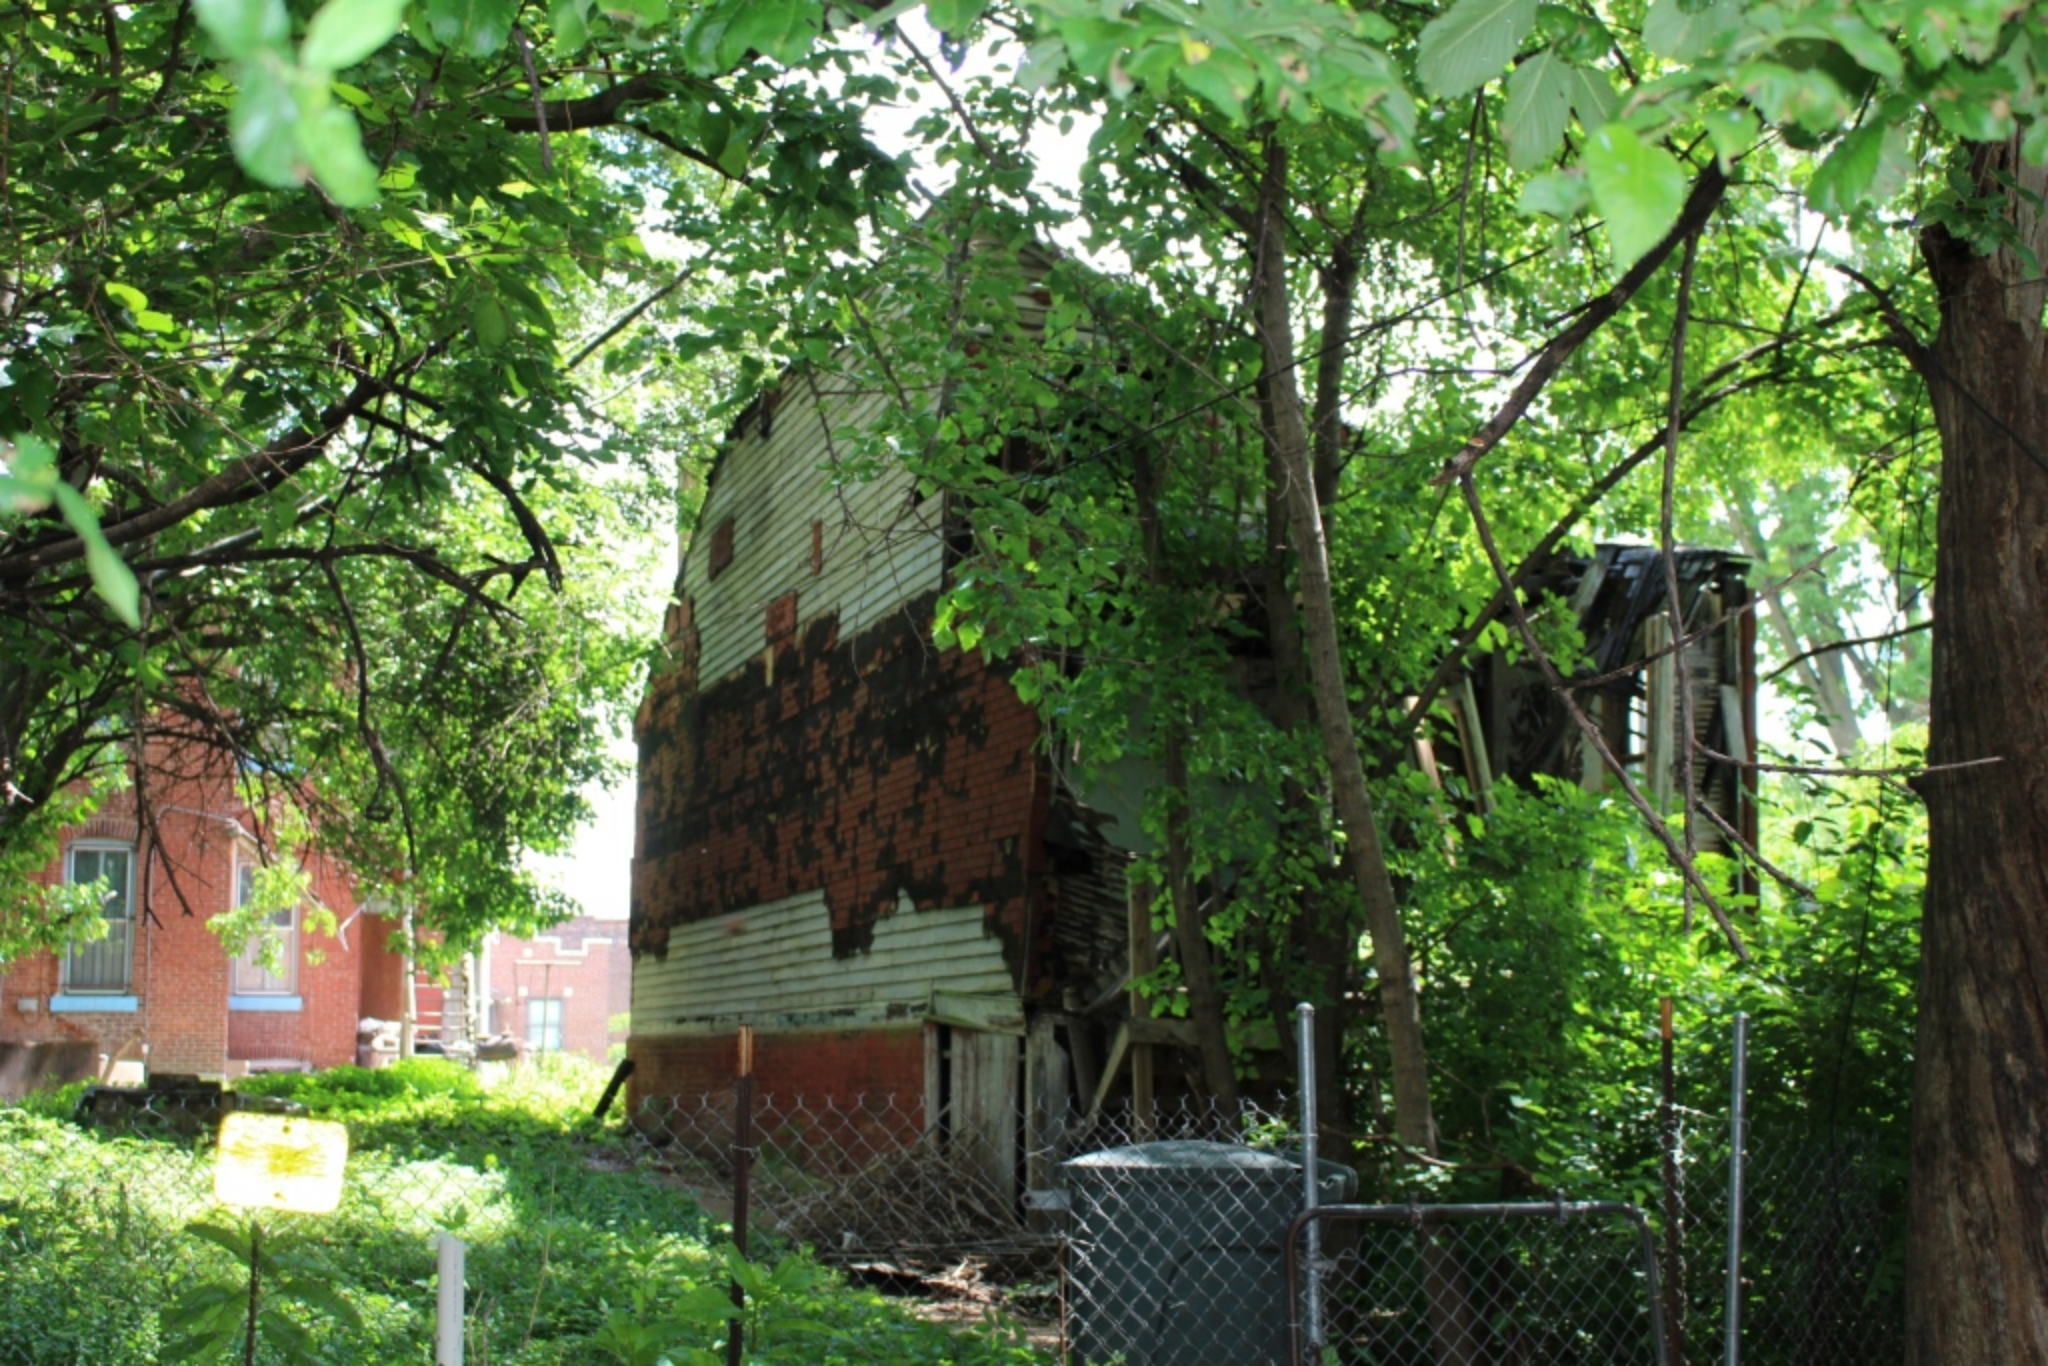
This one-story frame founder is set back in the middle of the lot. Rolled asphalt material covers the clapboard siding. All windows and doors are boarded. A shed-roofed porch extends from the rear. The porch on the façade is a replacement wood one. The shed roof is hipped in the front and the taller wall rises on the north.

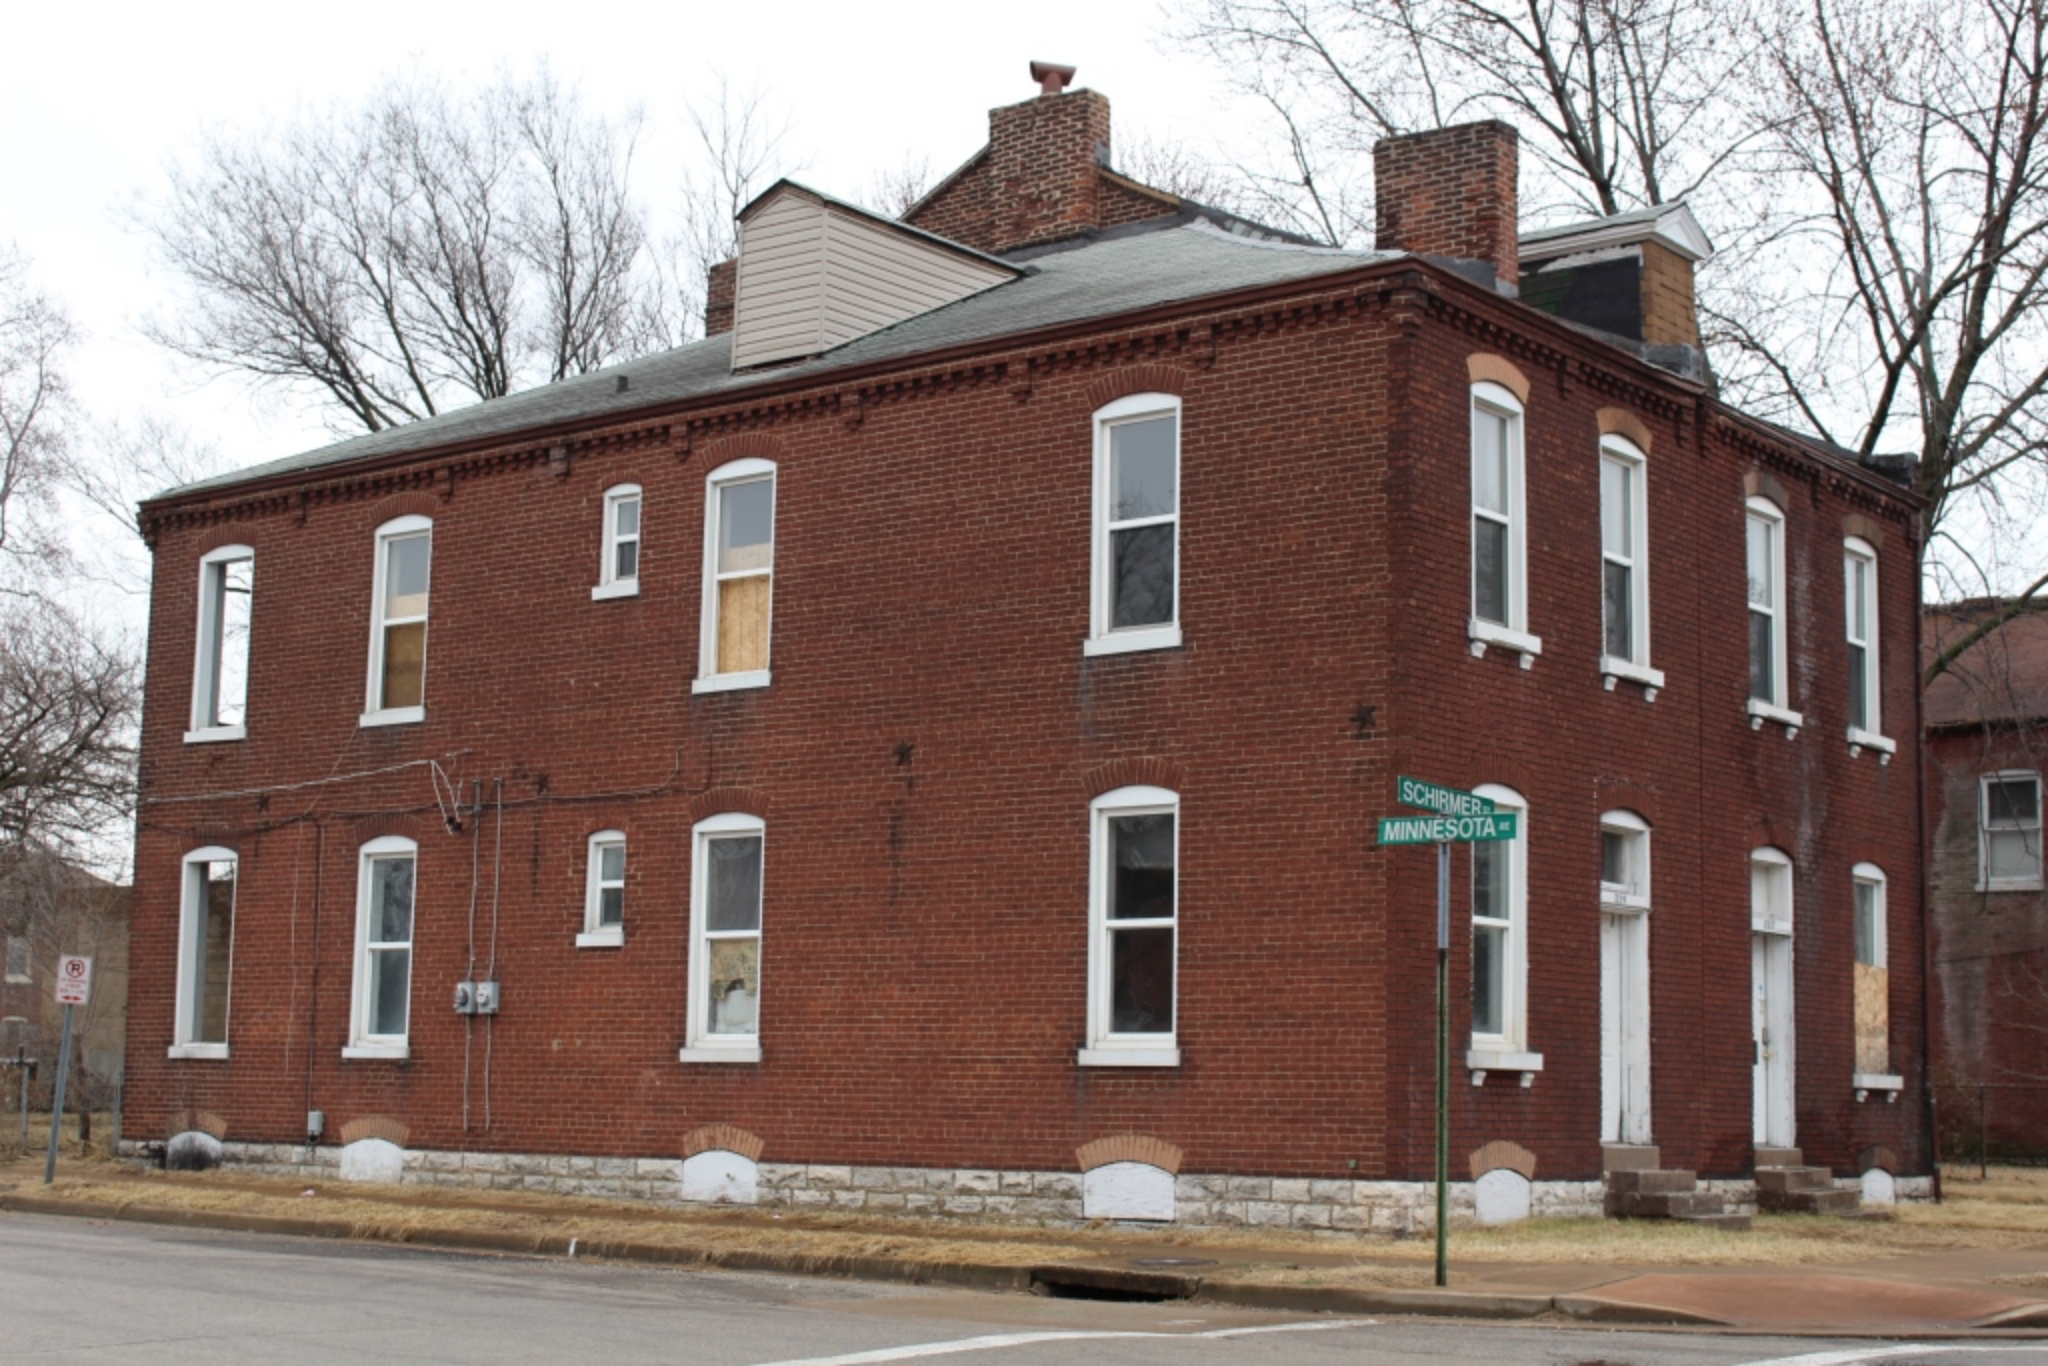
The taller wall of this 2-story, common bond brick flounder property is attached to the adjacent house at 227 W Schirmer, which is not a flounder. Materials and details of both properties are similar and they appear to have been constructed at the same time. The rubble stone foundation on both street frontages is veneered with rough-faced coursed ashlar. All openings throughout the building are placed under segmental soldier arches. The first story of the primary façade presents a single-leaf entry door (the door has been replaced) under a 1-light transom in the eastern bay, with a single doublehung window in the western bay and doublehung windows at each bay of the second story. Windows on the front façade have bracketed lugsills. A corbelled brick cornice with dentils and pendants extends across the front façade and returns the length of the 5-bay west façade. A small dormer is centered on this elevation; its window has been blocked in. A window is placed at the first and second story of each bay, with the central bay windows considerably smaller than the rest. The openings of the northernmost bay have no sash and mark the position of a 2-story recessed porch with brick wing walls that extends across the 4-bay rear elevation. All basement windows have been boarded, and the rear masonry wall painted.

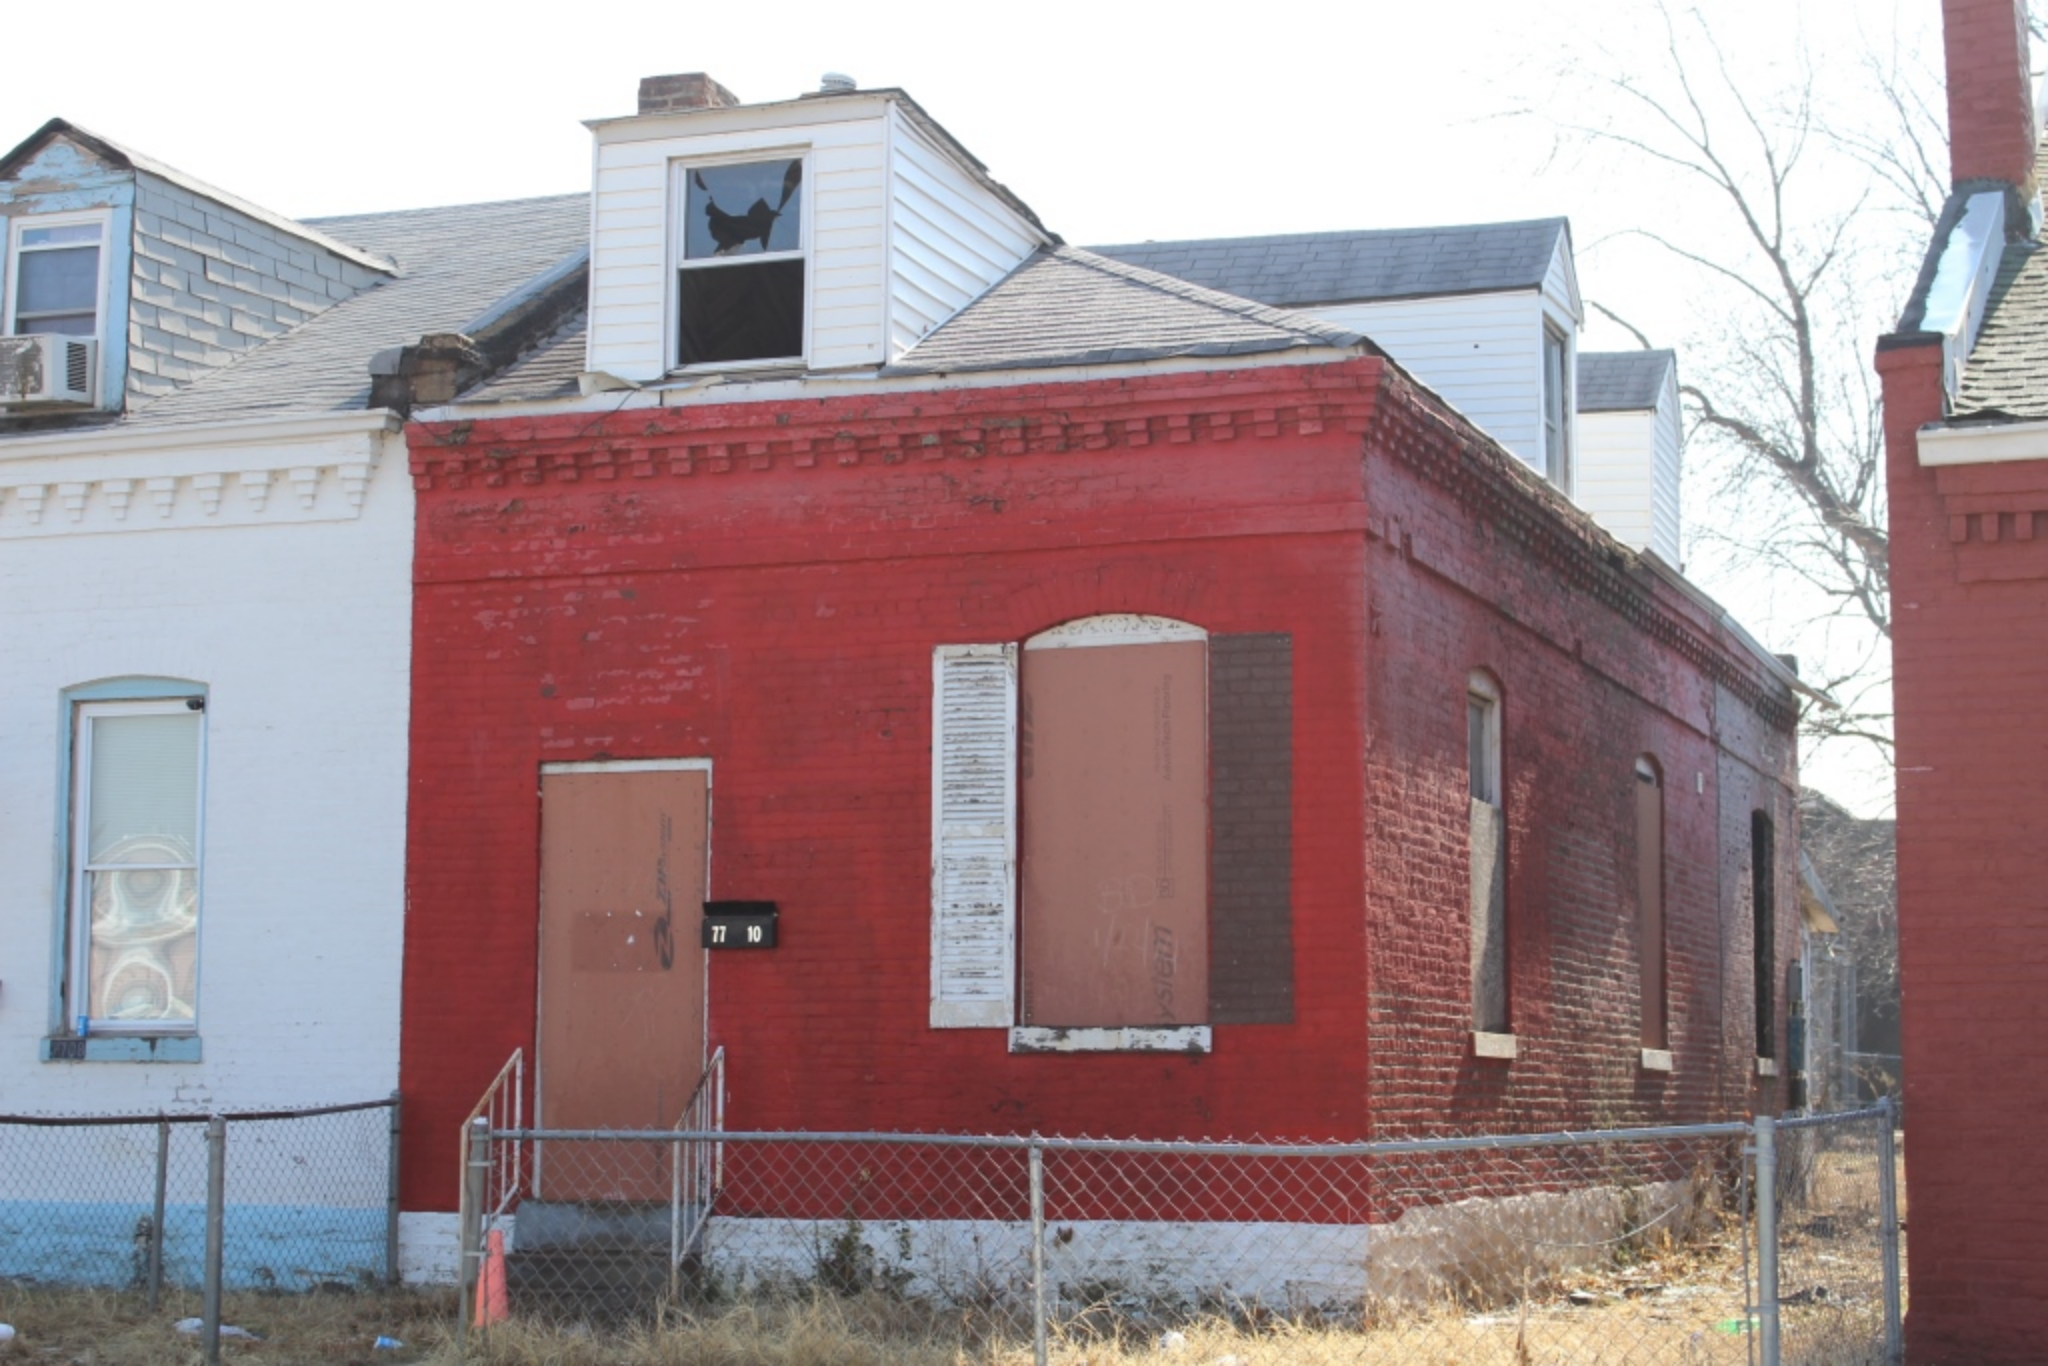
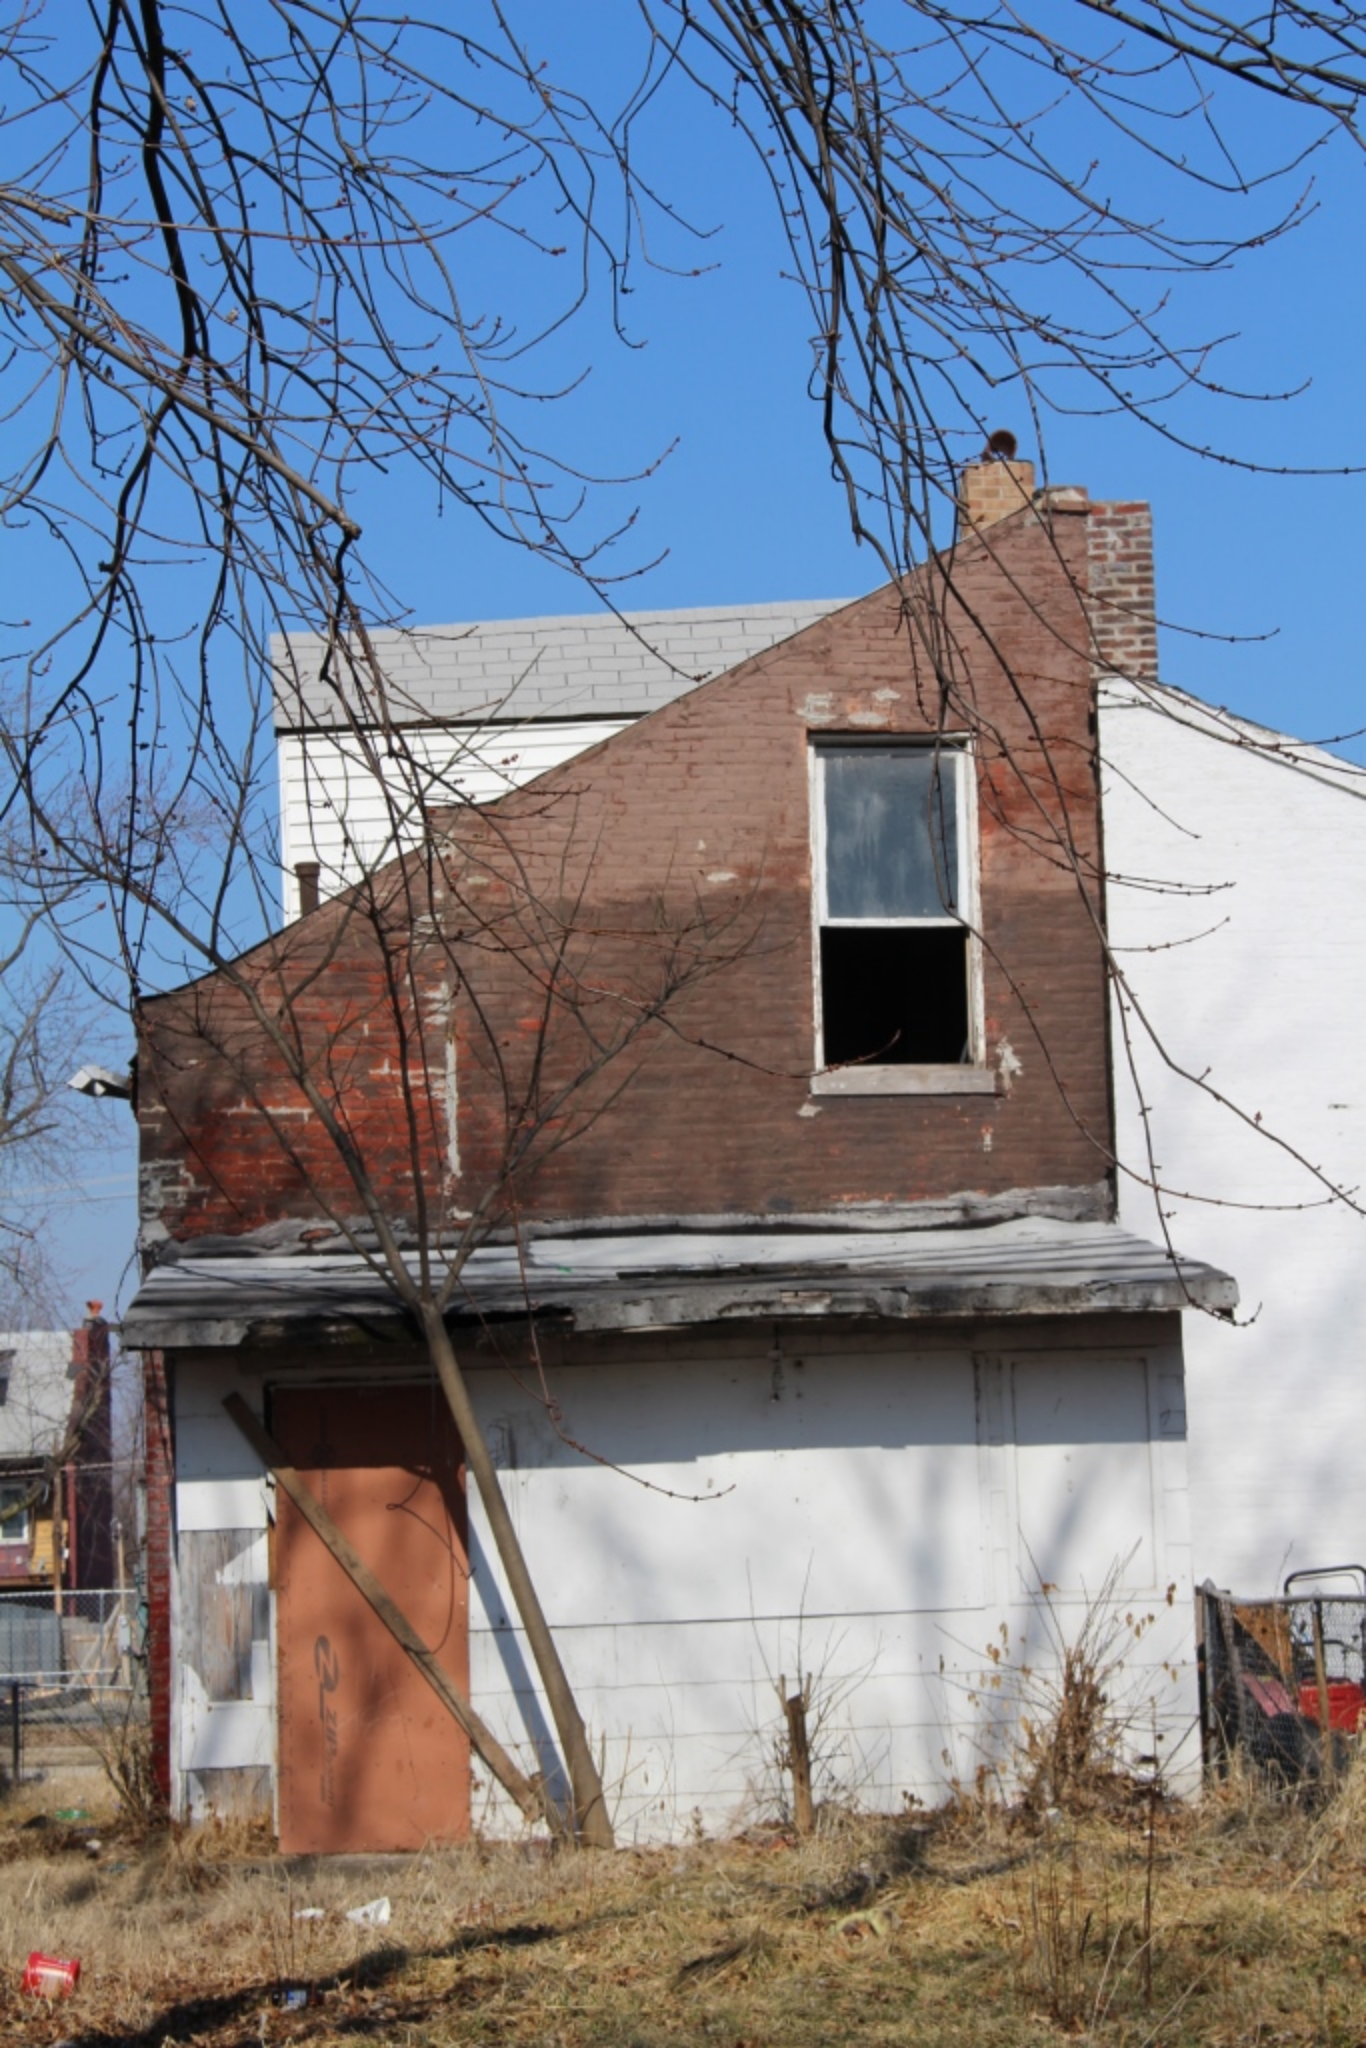
This is a 1-1/2 story brick flounder, with its tall blind wall sited at the north property line and directly adjacent to the neighboring house. The shed roof is hipped at the front: the original dormer, placed asymmetrically near the north parapet has been replaced by a larger, shed-roofed dormer with single doublehung window. The 2-bay front elevation is distinguished by a cornice that is more detailed than most of the small vernacular flounders in the area: it displays a corbelled brick cornice with dentils at the parapet; five courses below the corbelling, a 2-course stringcourse projects slightly, creating the appearance of a frieze. The same cornice design returns along the south elevation. The front façade presents a singleleaf entry door in its northern bay; the head of the door has been rebuilt and the original transom eliminated. In the southern bay, a single doublehung window with decorative wood eyebrow, is set below a segmental soldier arch, with a wood lugsill. Windows of the south elevation are similar, but without decorative eyebrows. The 4-bay south façade had originally only 2 bays, as shown on the October 1908 Sanborn map. It retains its original narrow pedimented dormers, although the window of the rear dormer has been closed. The side gallery porch of the 1-1/2 story flounder ell at the rear of the house was replaced some time after 1908 with a brick addition that extended the south façade 2 additional bays. Details of the original building were replicated in the addition. Currently the first story of the rear elevation has been obscured with a 1-story frame addition; the original window opening on the second story appears to have been increased in height, the original segmental arch being replaced by a steel lintel. The building has been painted.
