Land-Use and Building Survey Inventory Form

SURVEY NO. BU-AS-005-LUBC-018		
TOTAL SCORE OF OVERALL INTERIOR BUILDING CONDITION:		LOCATION: L1 – 1 ST FLOOR; L2- 2 ND FLOOR; L3 -3 RD FLOOR
12- EXCELLENT	6-8 – FAIR	0-4 - DILAPIDATED
9-11 – GOOD	1-3 - POOR

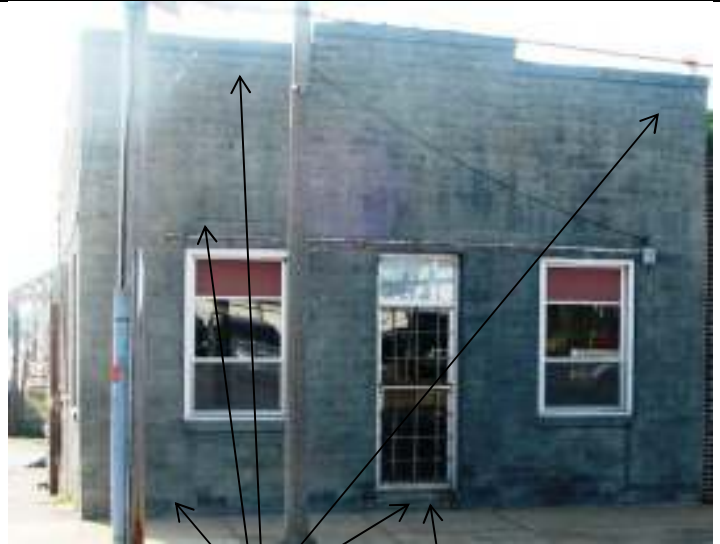
Façade, showing mortar issues, missing step and damaged screens.

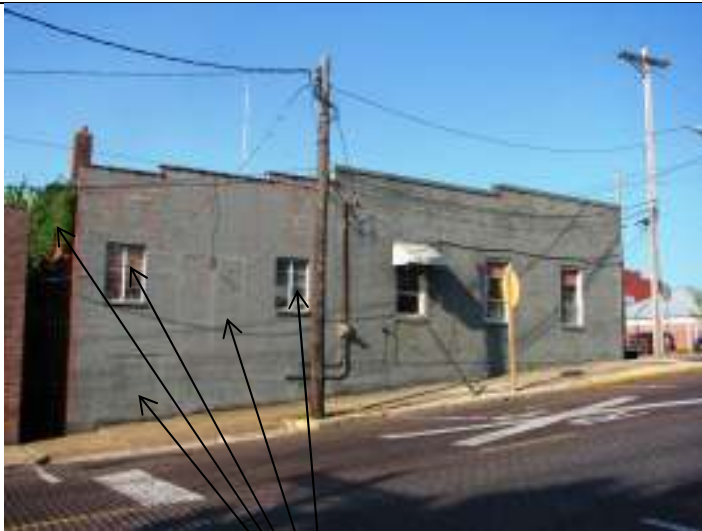
North elevation, showing infilled openings, and broken windows; vegetation on east wall surface

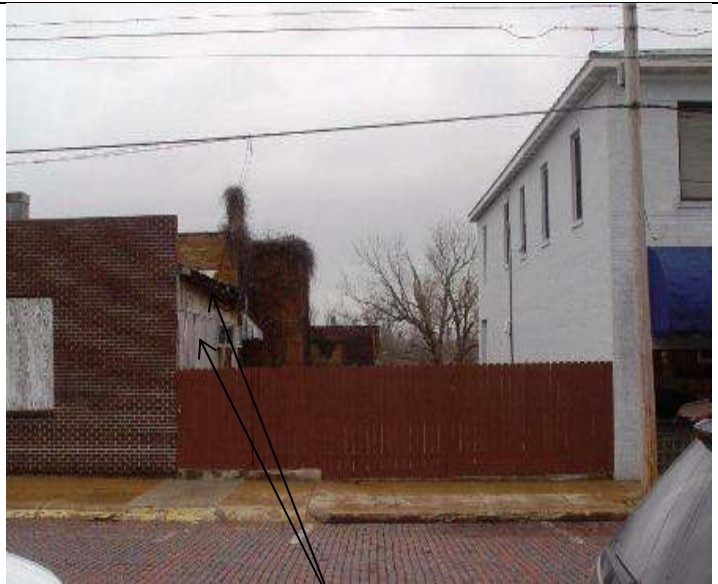
South elevation, deterioration of wood siding and roof rafters.

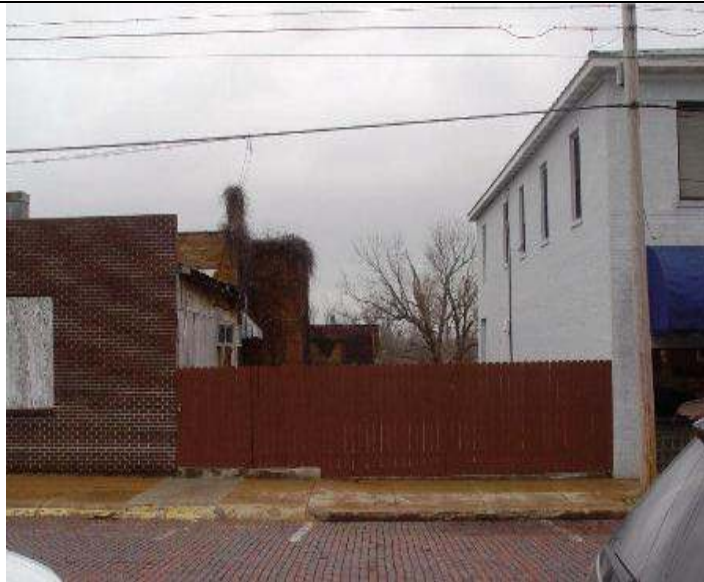
Showing lot where building once stood

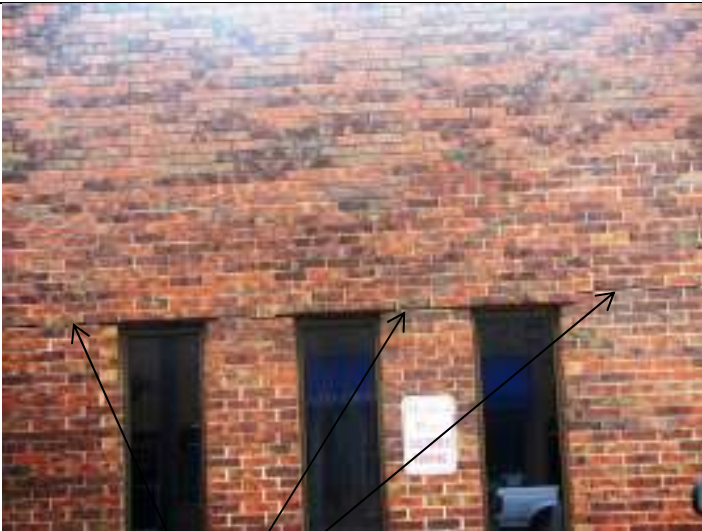
Showing missing mortar

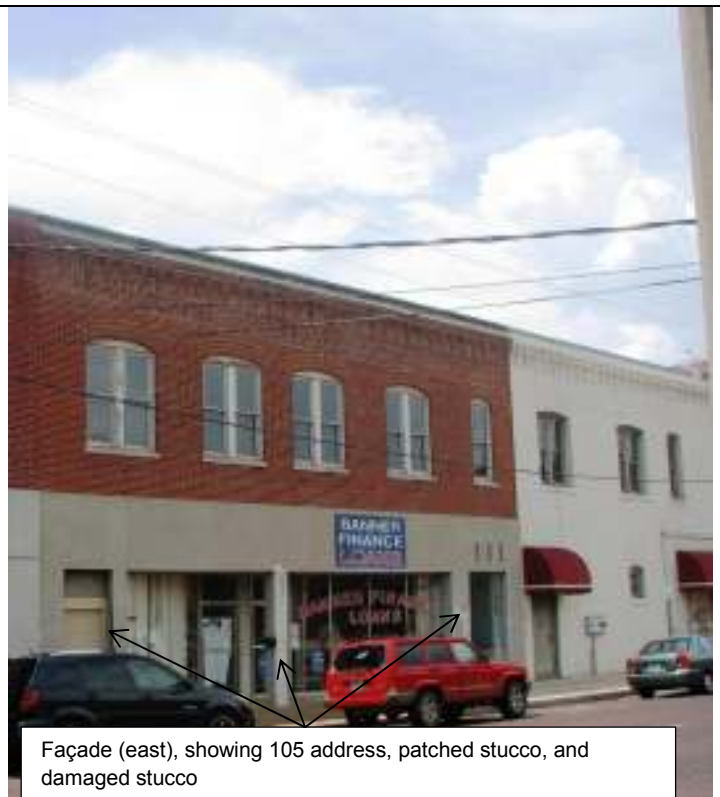
Façade (east), showing 105 address, patched stucco, and damaged stucco

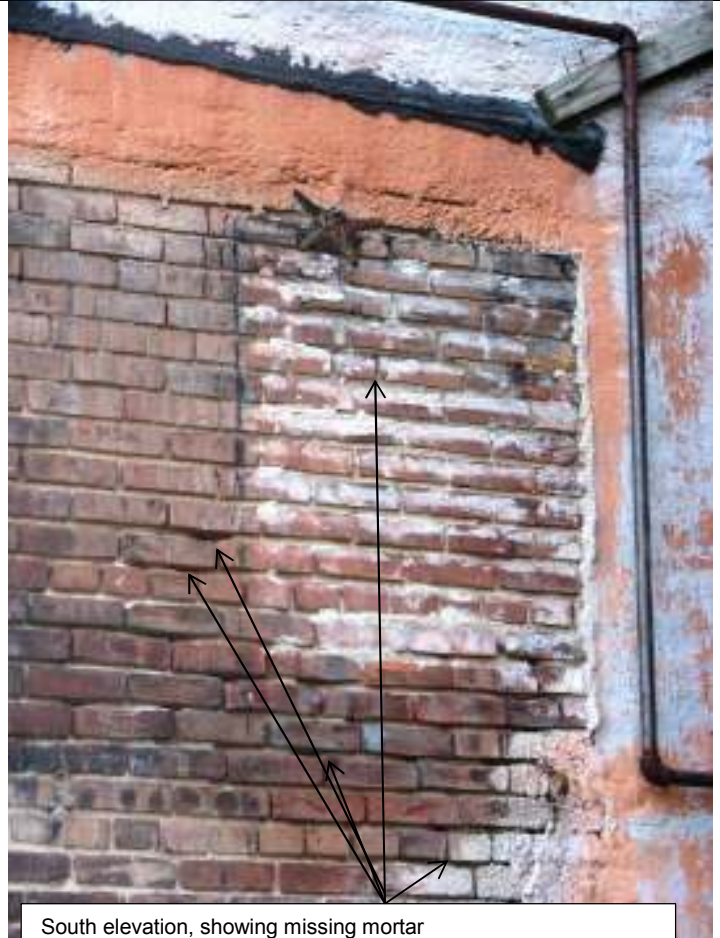
South elevation, showing missing mortar

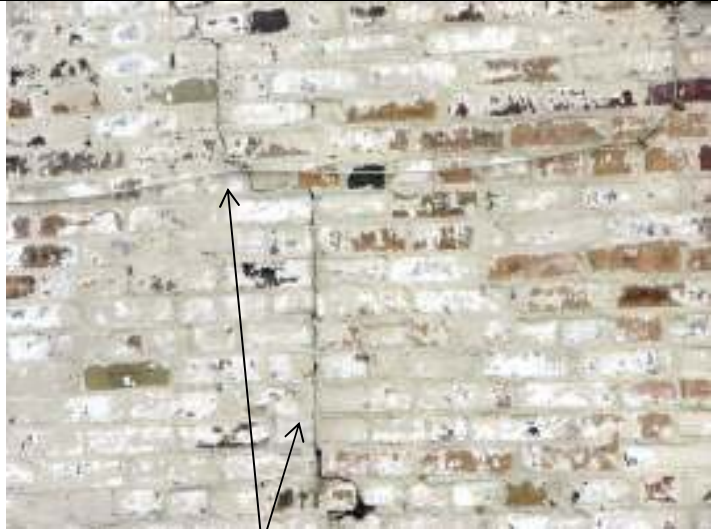
West elevation, showing crack in brick wall surface

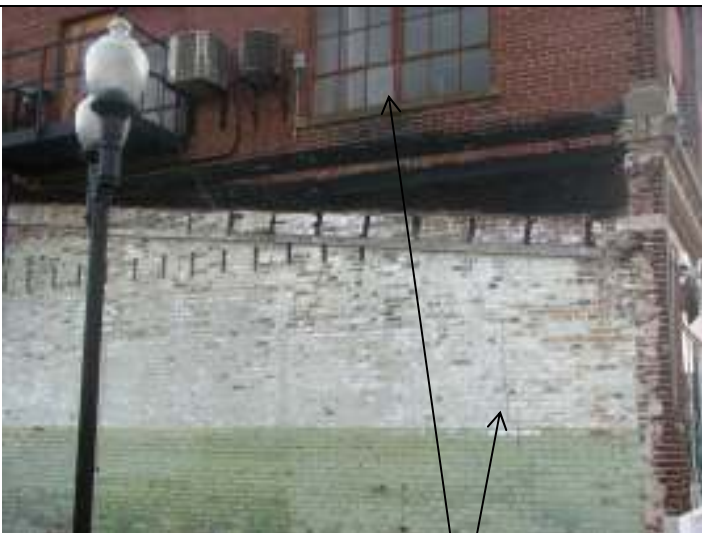
West elevation, showing area of crack, and worn/weathered metal window frame

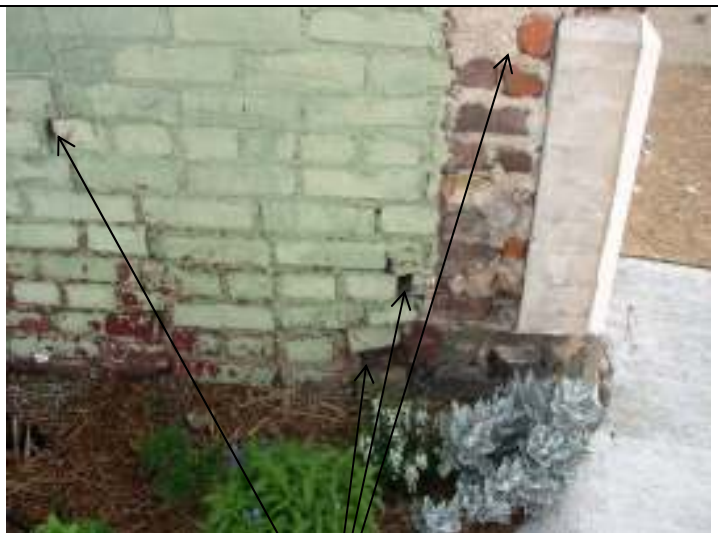
Southwest corner, showing missing and loose brick, improper mortar repair

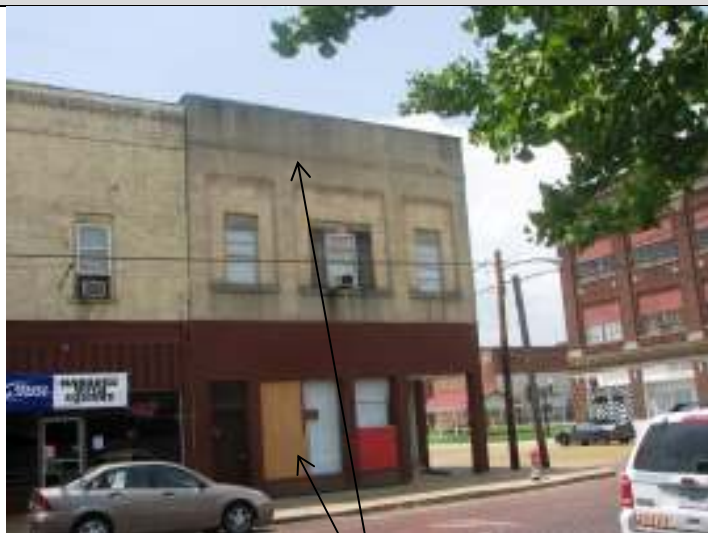
Façade (east), showing weathered stucco, and missing windows

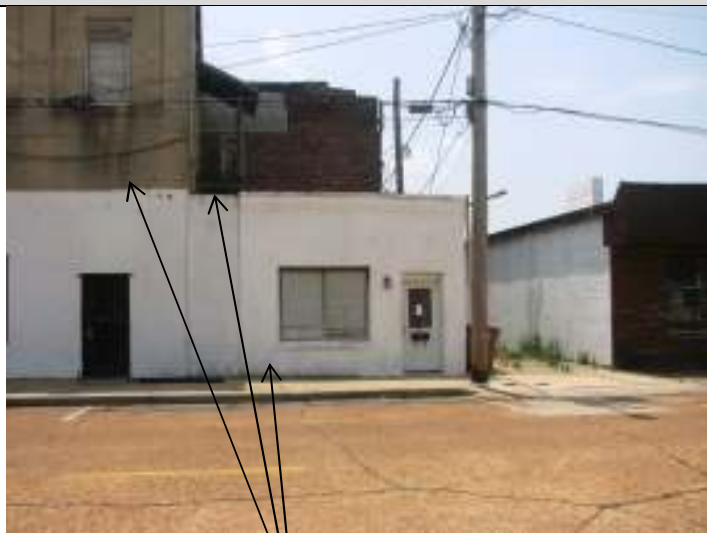
North and west elevation, showing weathered stucco and porch;
attached building with address of 408 Poplar St.

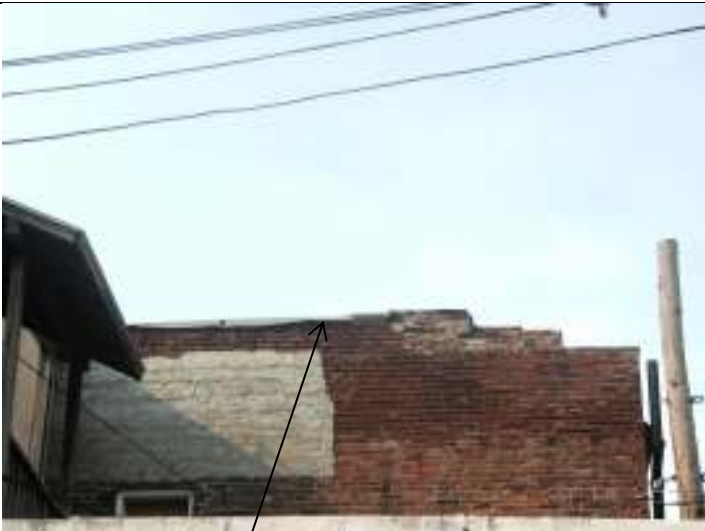
North, showing bend and loose metal coping

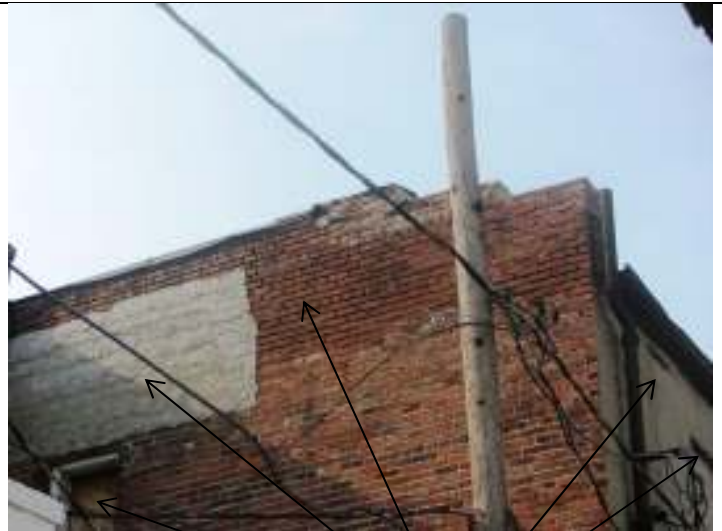
North and west elevation, showing missing mortar, missing window, infilled window, repair of brick with concrete and missing brick

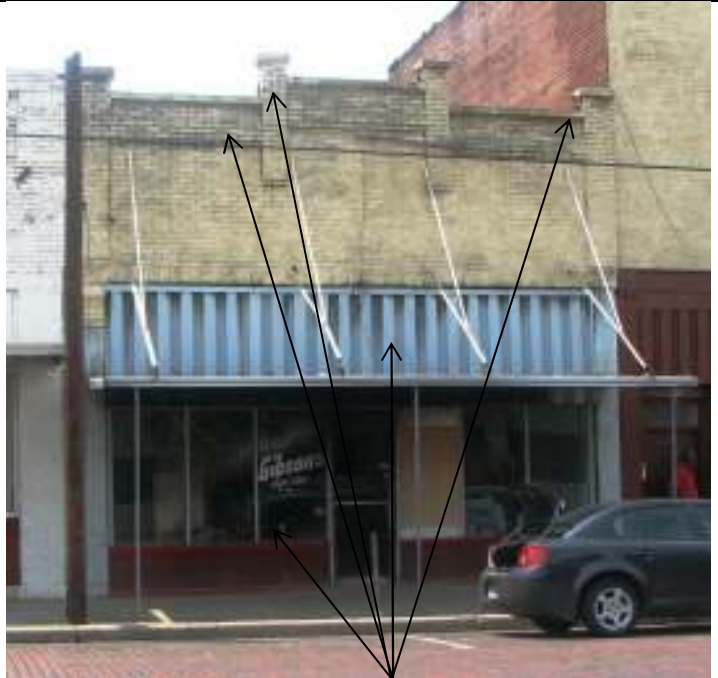
Façade, showing cracked window, missing mortar, and loose wires

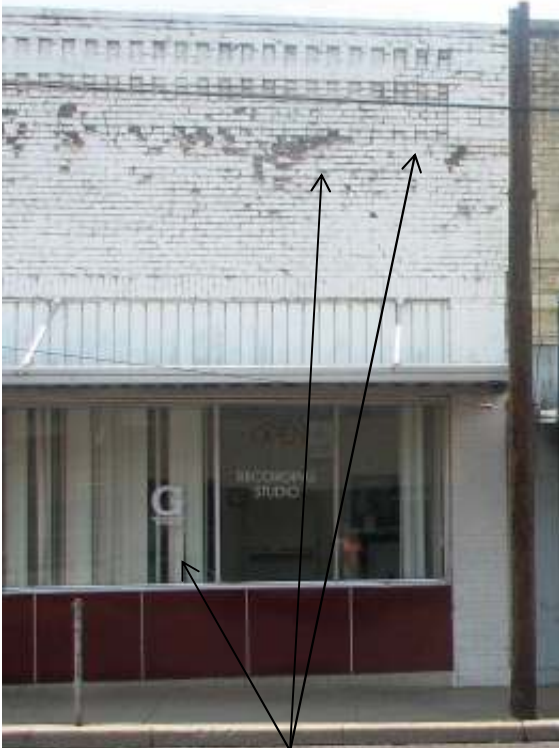
Façade (207) showing cracked window, peeling paint and mortar issues

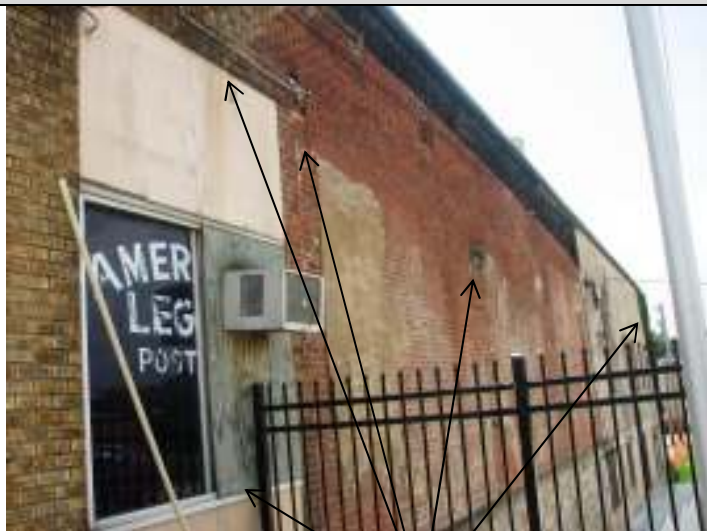
North elevation, showing crack in brick wall, boarded window, mortar issues, and vegetation on wall surface

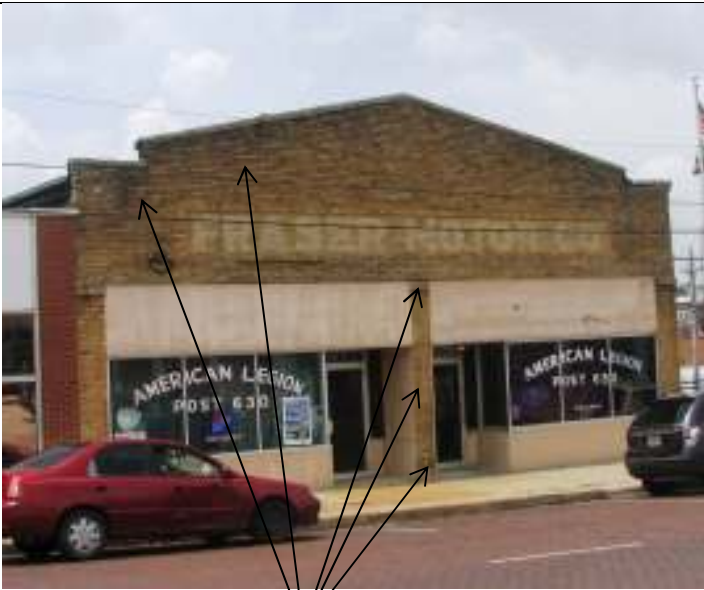
Façade, showing mortar issues

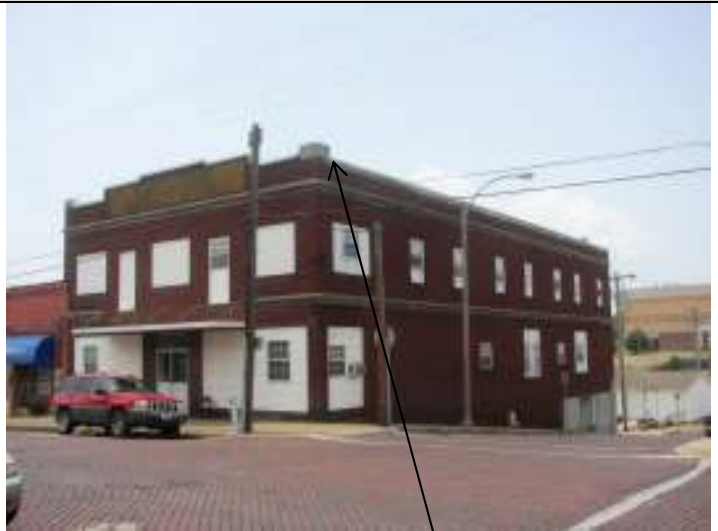
Façade and north elevation, showing improper re-pointing of brick and infill of windows

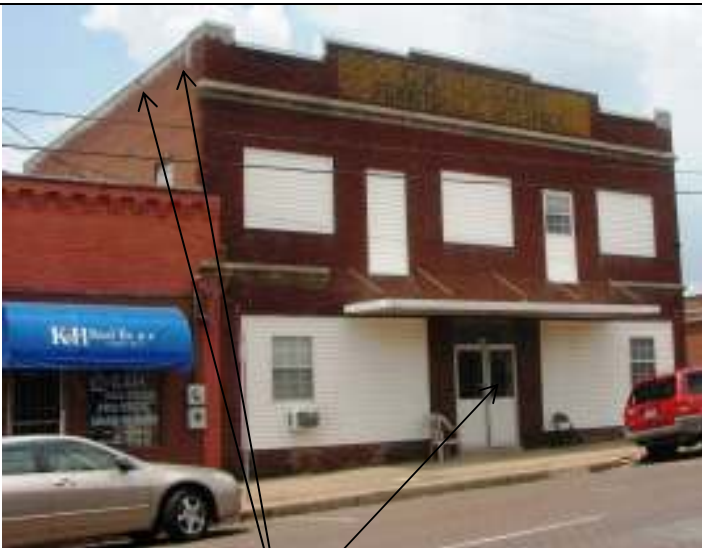
Façade and south elevation, showing improper re-pointing of the brick, missing brick, broken window in door, and enclosed window openings

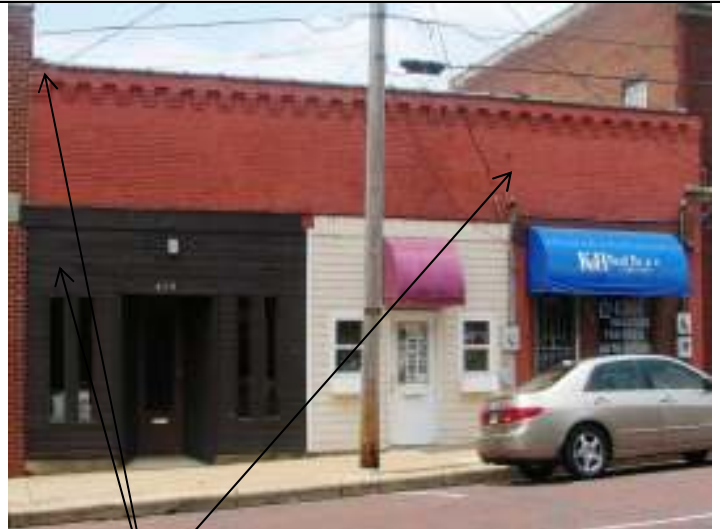
Façade, showing loose wood siding, loose (trim) coping, and areas of cracks in mortar

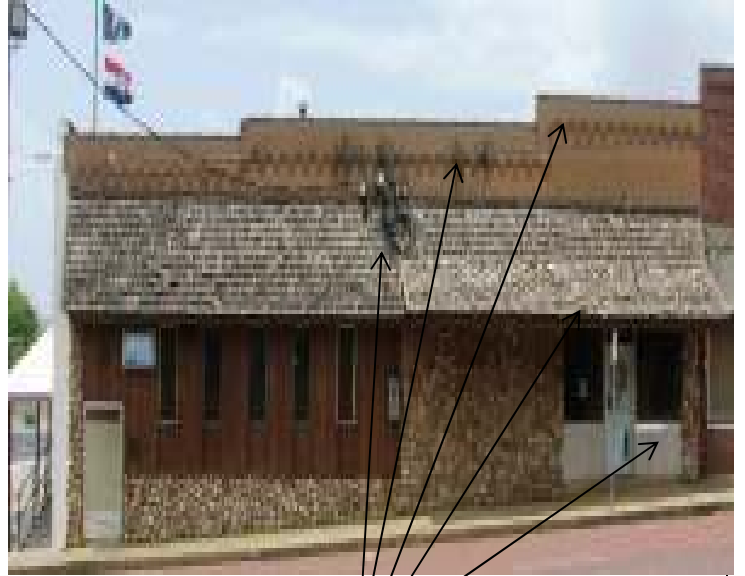
Façade, showing dent in bulkhead, loose/missing shingles, discolored bricks, wires/cables and cracks in brick wall surface.

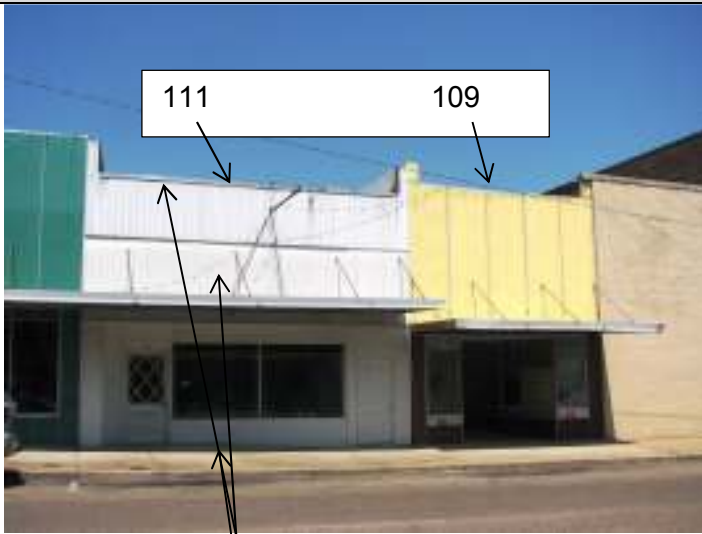
Façade (east), showing weathered wood siding, bent metal coping, loose hanging lights

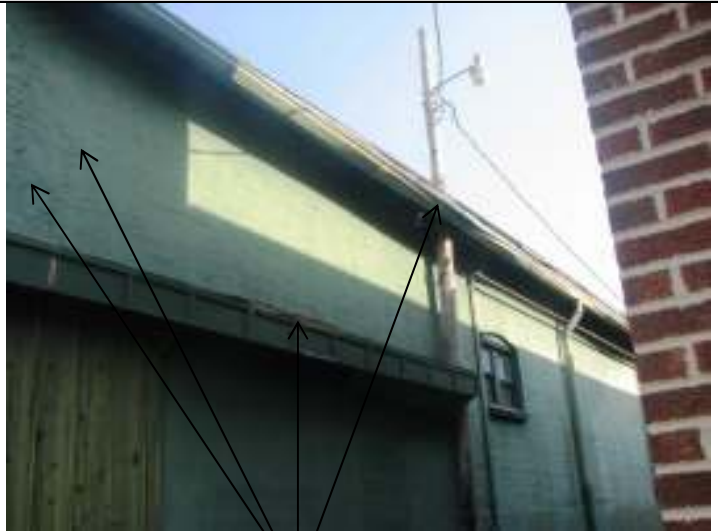
East elevation, showing bent gutter, deteriorated trim, and cracked brick wall surface

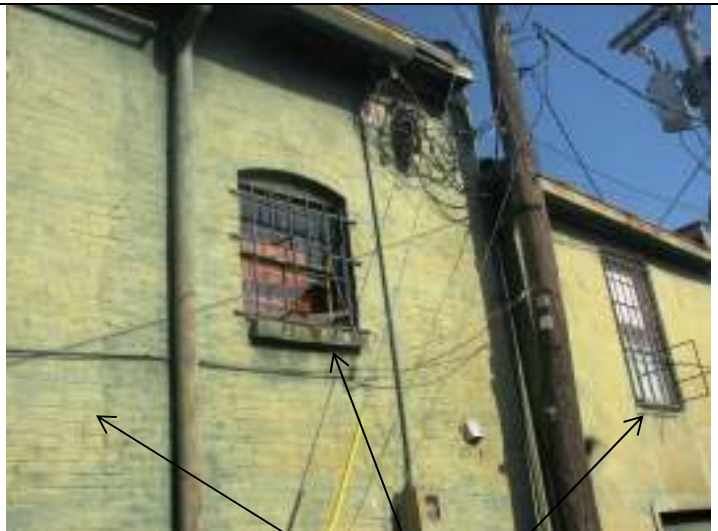
South elevation, showing security bars, and cracks in the mortar

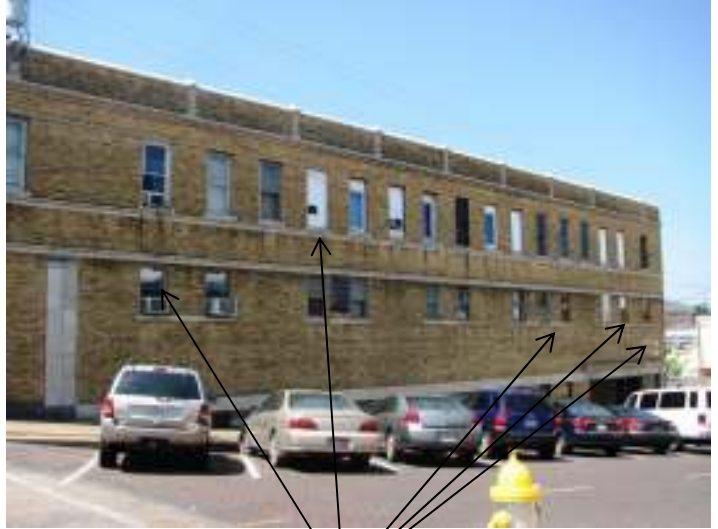
North elevation, showing boarded up windows, and missing windows, and vacant sign frame

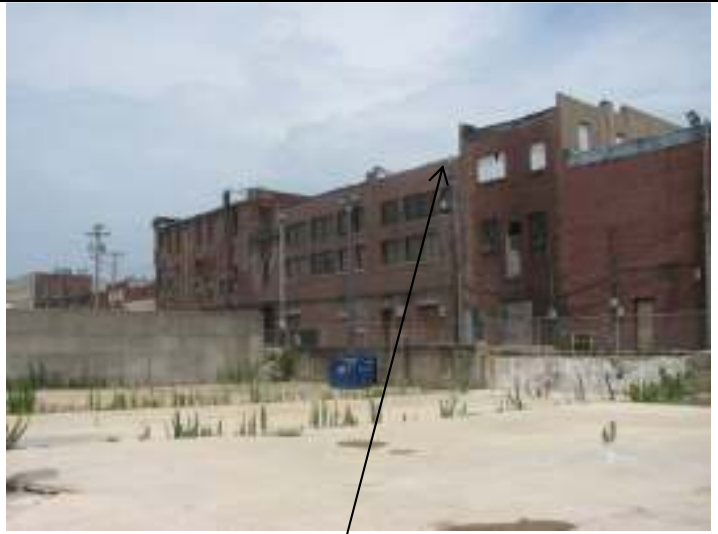
West elevation, showing previous brick work repair

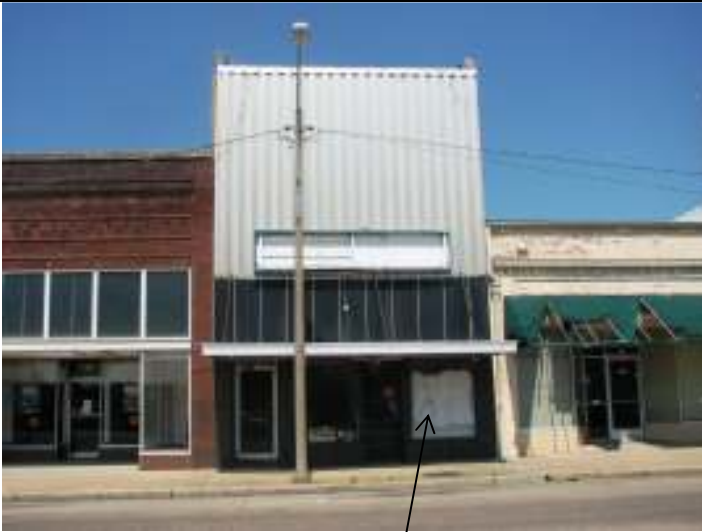
Façade (east), showing cracked storefront window

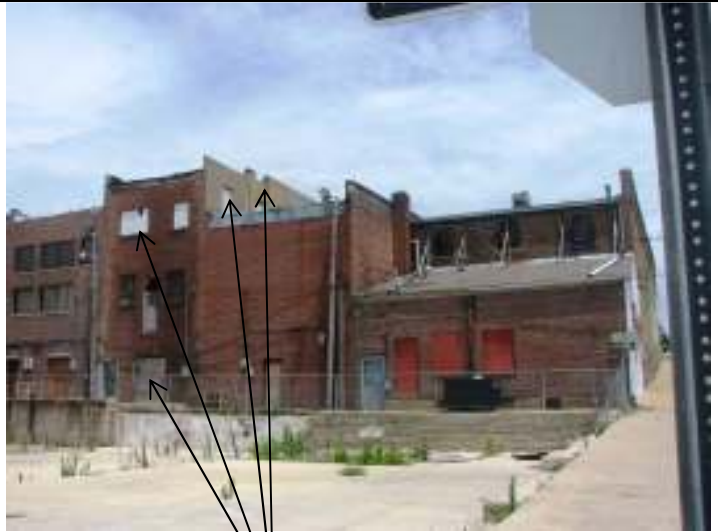
West and south elevations, showing boarded up windows and doors, and cracked stucco

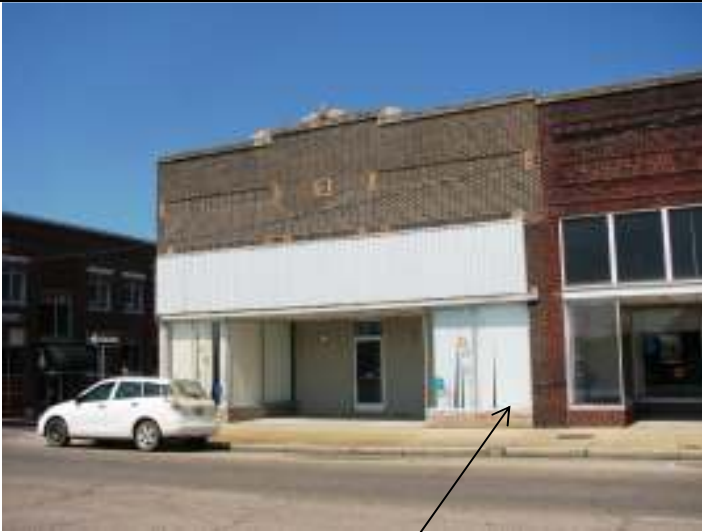
Façade (east), showing cracked window

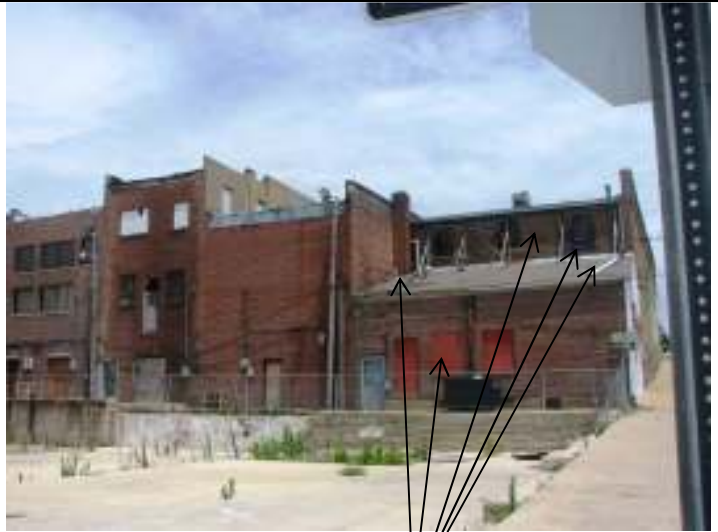
West elevation, showing boarded up windows, gutters but no downspouts, and mortar issues

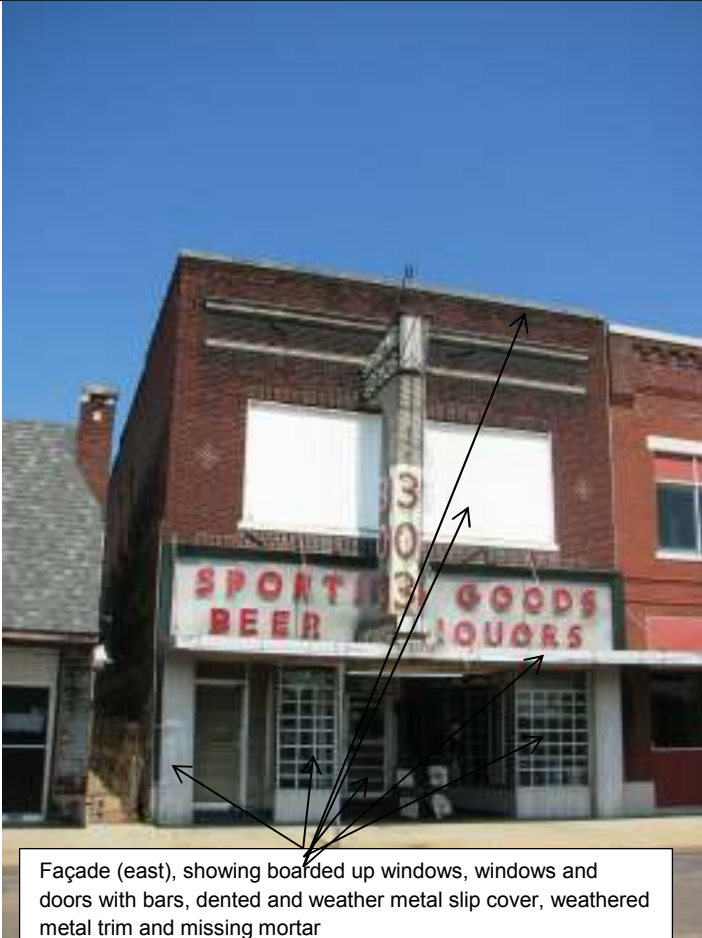
Façade (east), showing boarded up windows, windows and doors with bars, dented and weather metal slip cover, weathered metal trim and missing mortar

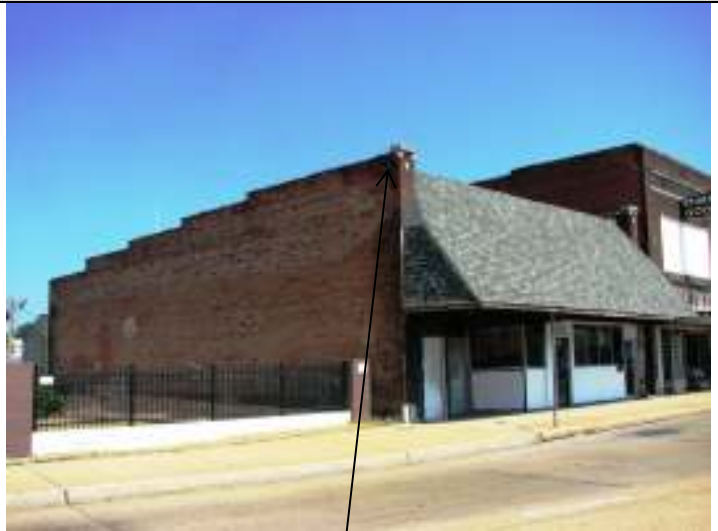
South elevation, showing loose brick

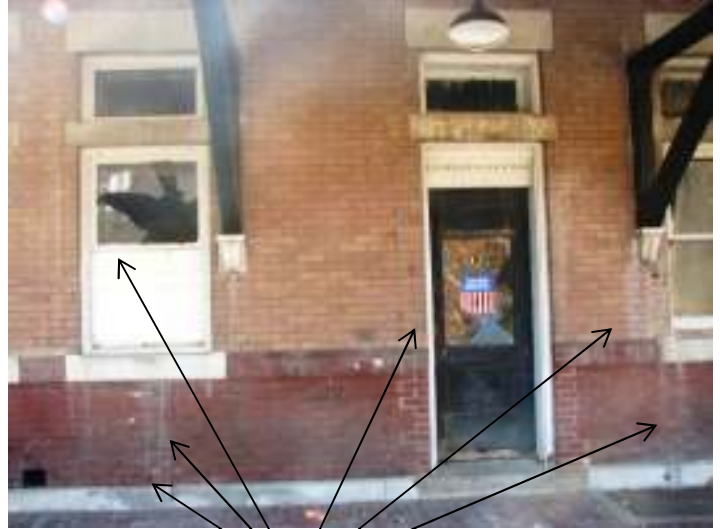
Façade (west), showing broken windows/glass, boarded up windows, missing mortar, and water damage to wall surface.

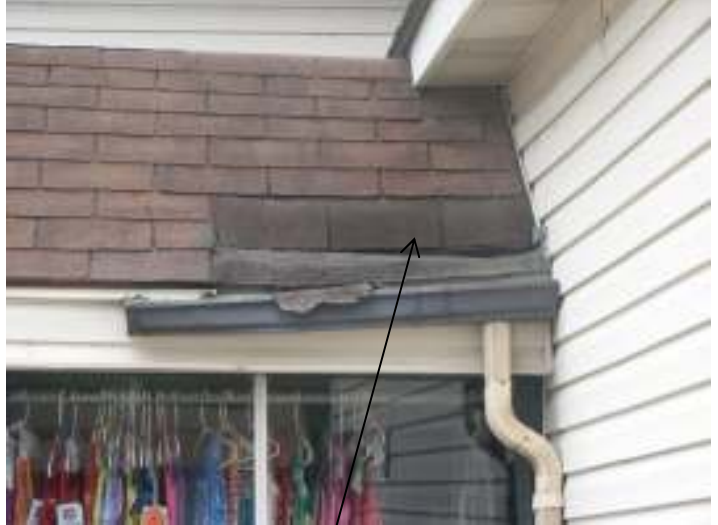
Façade; showing damaged roof

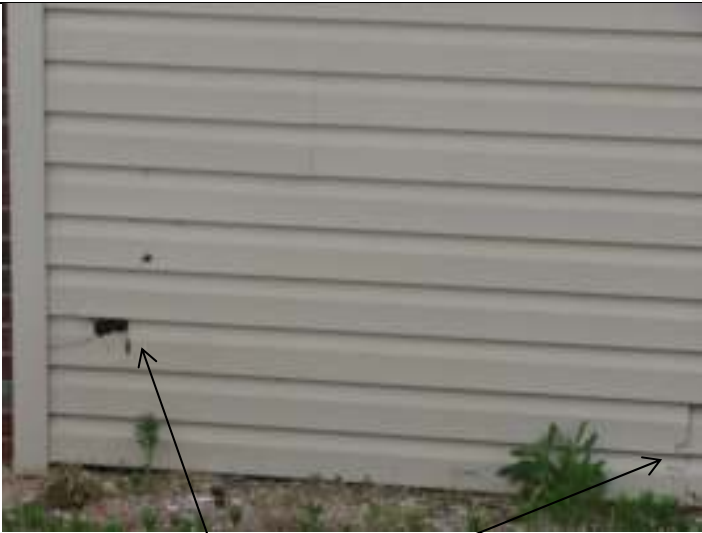
West elevation; showing hole in siding

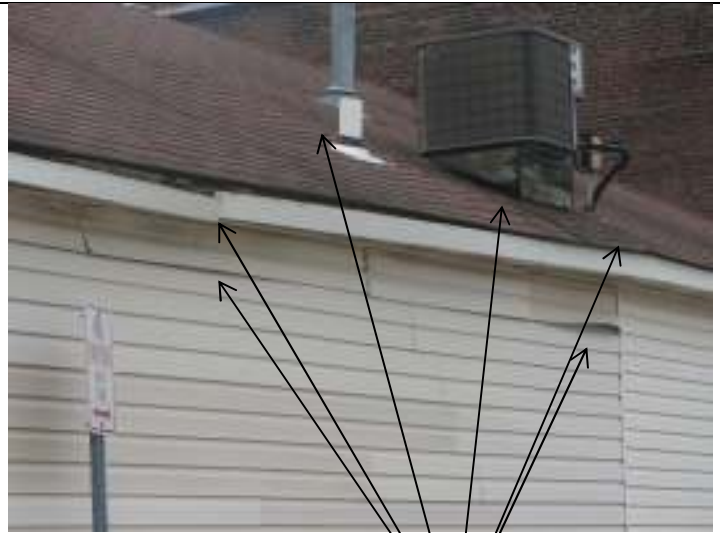
West elevation; showing loose and buckled siding, loose trim, and worn roof appears to have some buckling

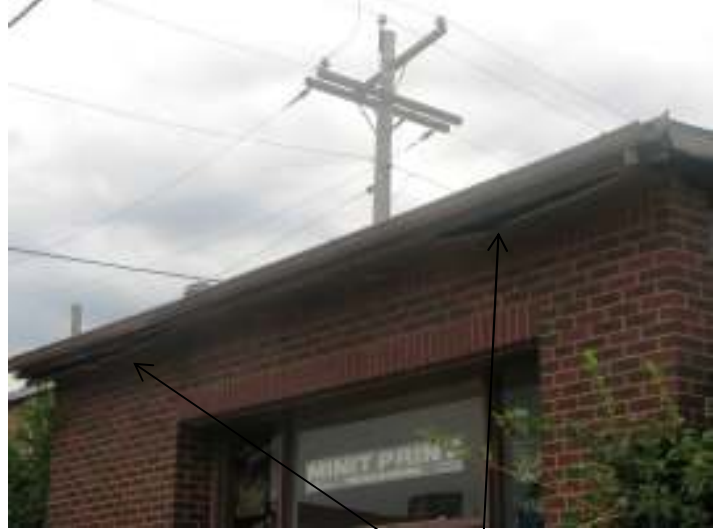
Façade, showing loose trim on the northeast and northwest corner of roofline

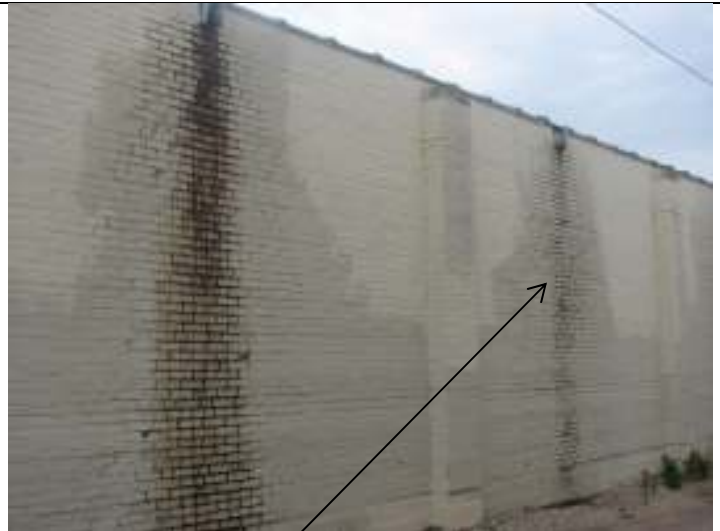
East elevation, showing water damage caused by missing downspouts.

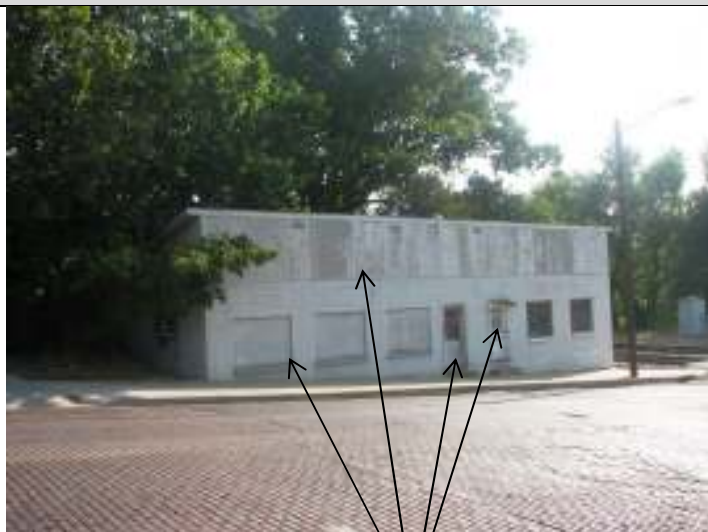
Façade and south elevation, showing boarded windows, missing glass panels in doors, and worn metal slip cover.

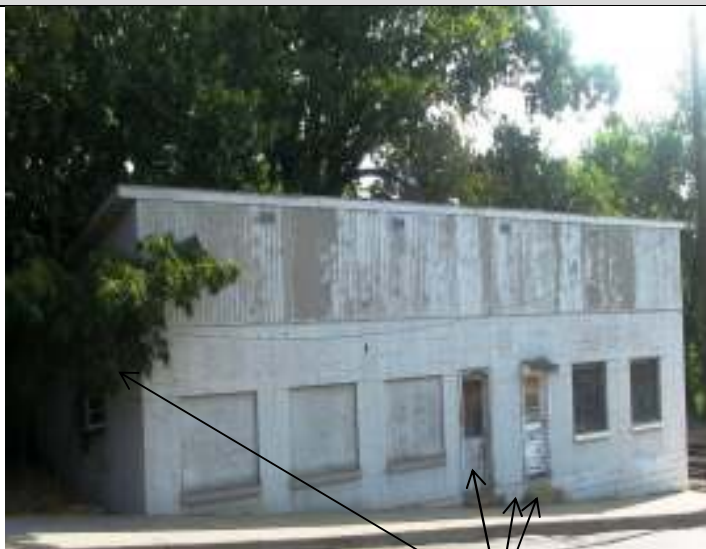
Façade, showing missing step, crack in foundation, deteriorated doors and overgrown vegetation

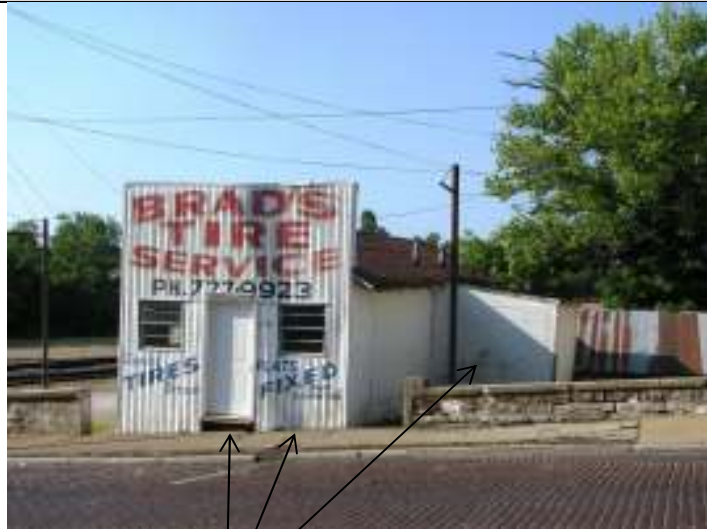
Façade (north) and west elevation, showing missing entrance step, worn siding, and metal slip cover

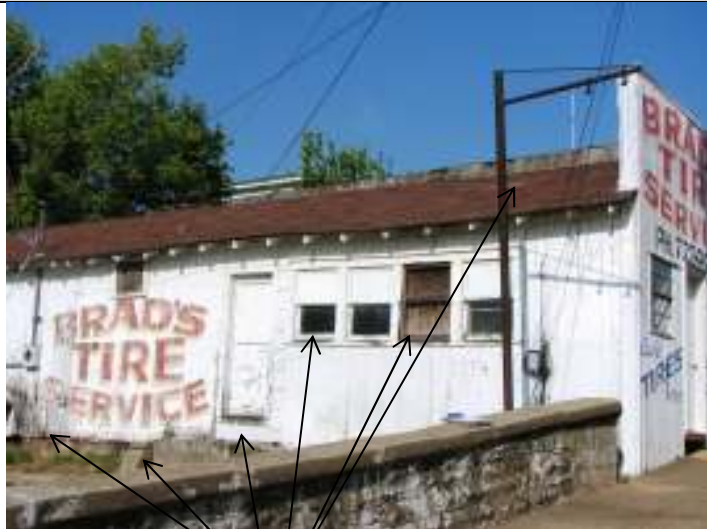
East elevation, showing boarded window, missing entrance step, loose siding and missing shingles

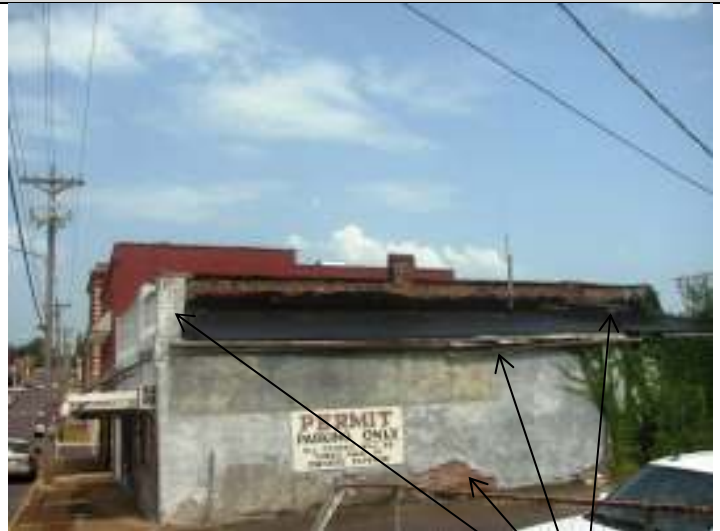
East elevation, showing missing stucco, leaning parapet, sagging roof, loose gutter, and cracks in brick roof ridge

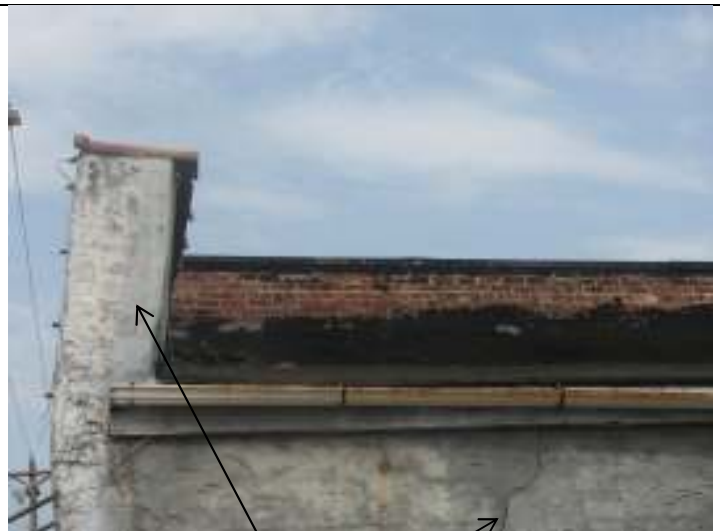
East elevation showing leaning parapet and cracks in stucco

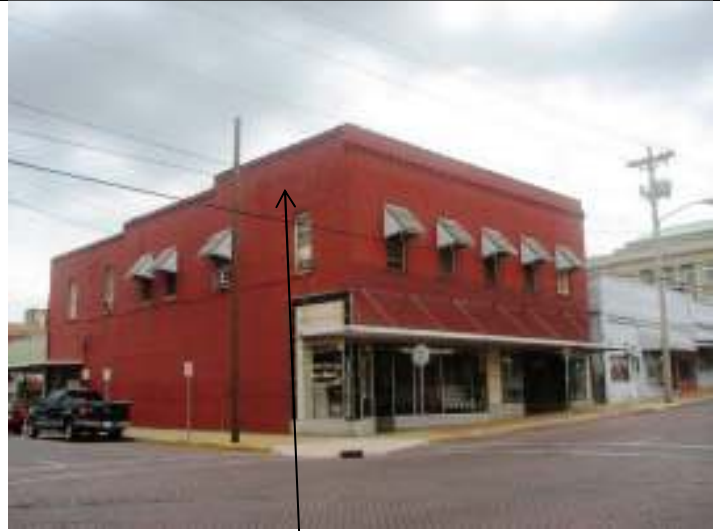
West elevation and façade, showing some peeling painting and spalling of brick

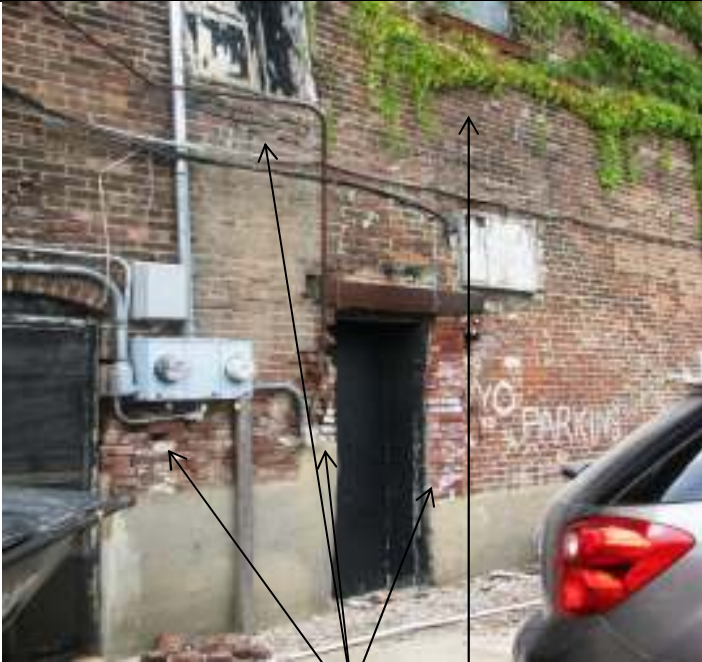
Rear (north) elevation, showing loose and fallen bricks, mortar issues, and vegetation on wall surface.

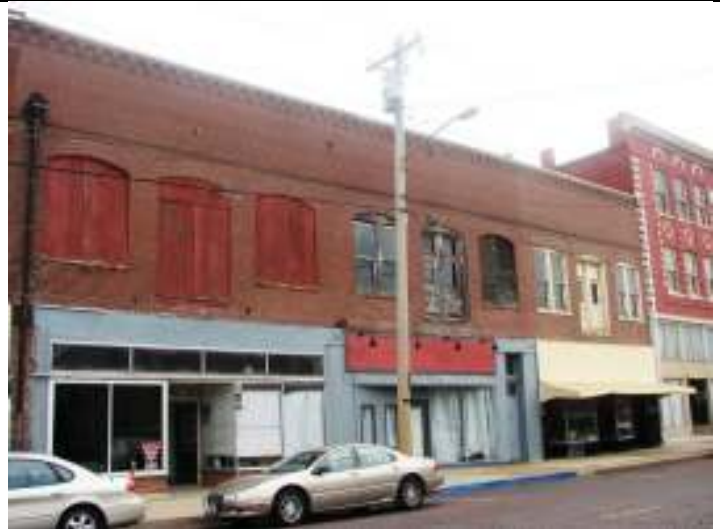
403-405 Vine St. has the light yellow awning. Photo shows the weathered windows and doors on the second level.

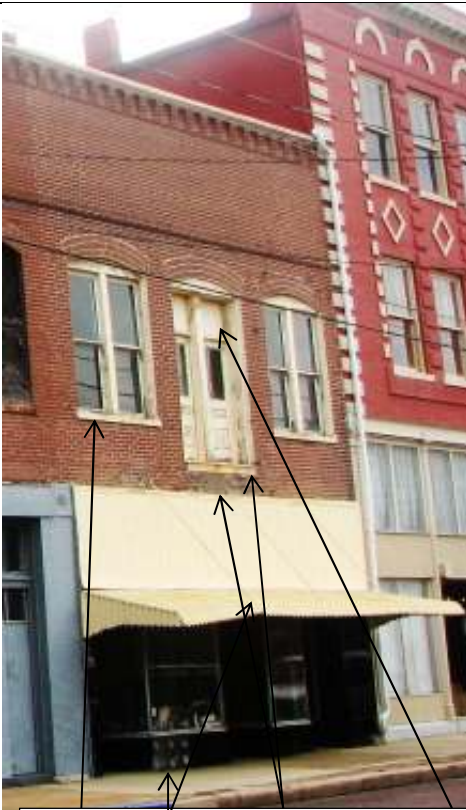
Façade, showing missing Carrara glass panels, bent awning, deteriorated brick/mortar, and doors/windows

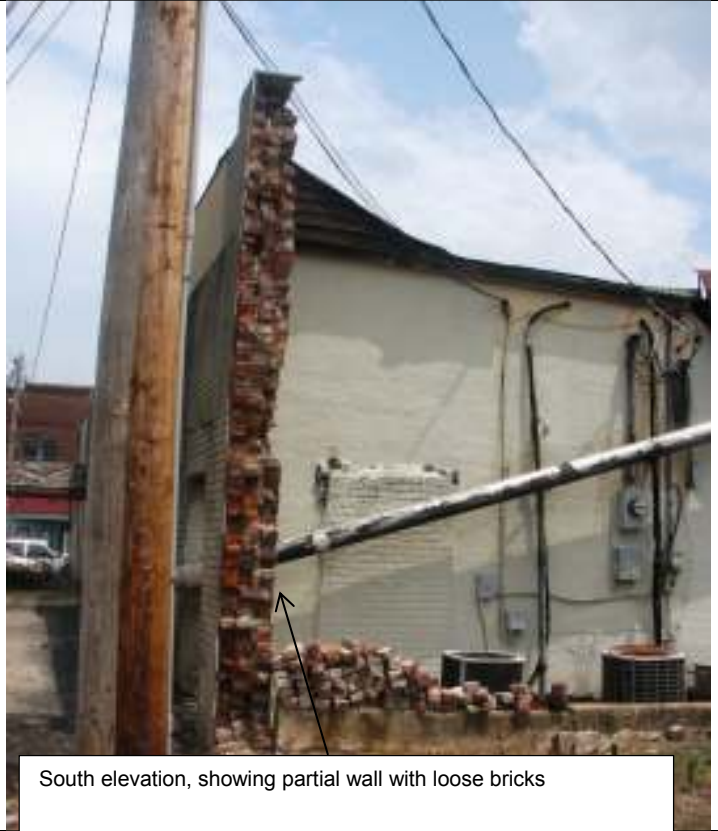
South elevation, showing partial wall with loose bricks

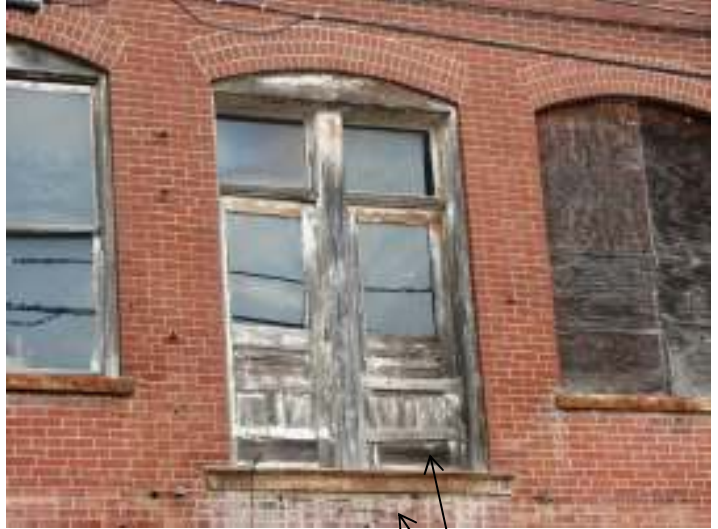
Upper level doors on façade and water damaged brick/mortar bellows doors

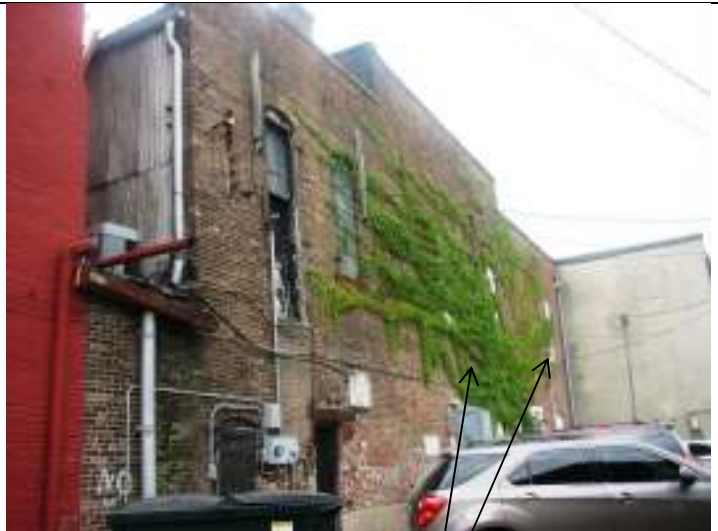
Rear (north) elevation showing vine covered wall surface and covered over window openings

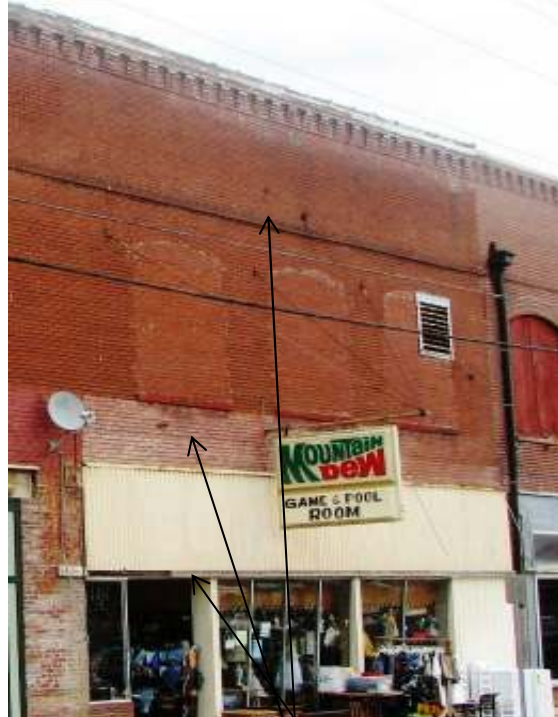
Façade – showing cracks in mortar, missing trim from metal slip cover and mortar issues

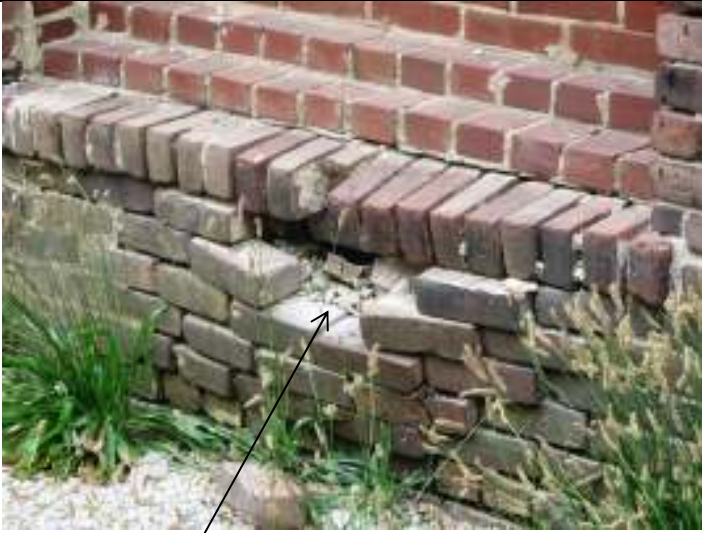
Loose and fallen brick on rear (north) elevation
