Land-Use and Building Survey Inventory Form

SURVEY NO. BU-AS-005-LUBC-018		
TOTAL SCORE OF OVERALL INTERIOR BUILDING CONDITION:		LOCATION: L1 – 1 ST FLOOR; L2- 2 ND FLOOR; L3 -3 RD FLOOR
12- EXCELLENT	6-8 – FAIR	0-4 - DILAPIDATED
9-11 – GOOD	1-3 - POOR

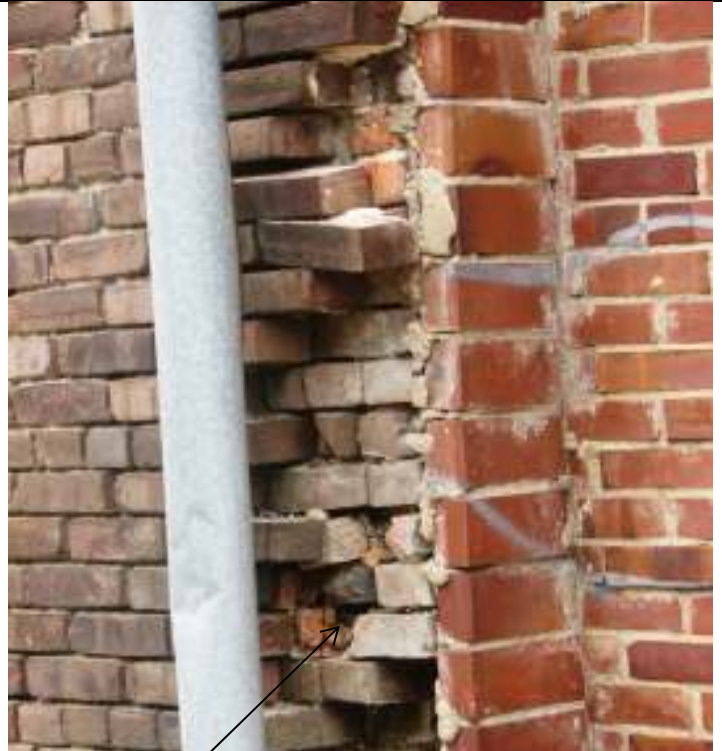
Loose and fallen brick on rear (north) elevation

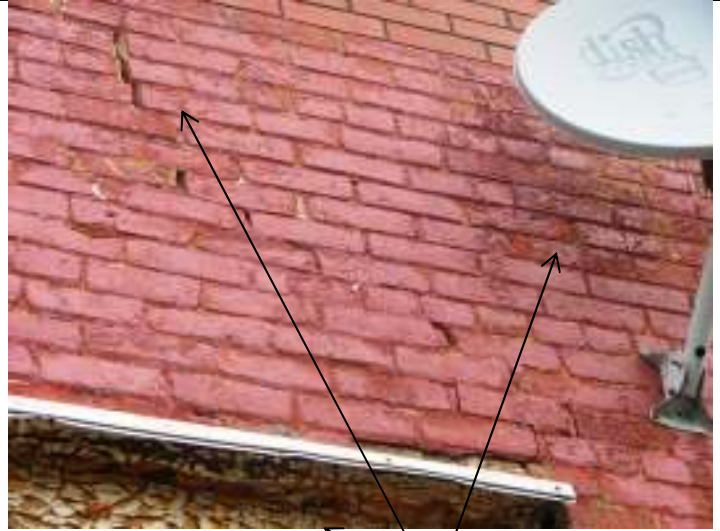
Upper façade, showing cracked brick and missing mortar, peeling paint

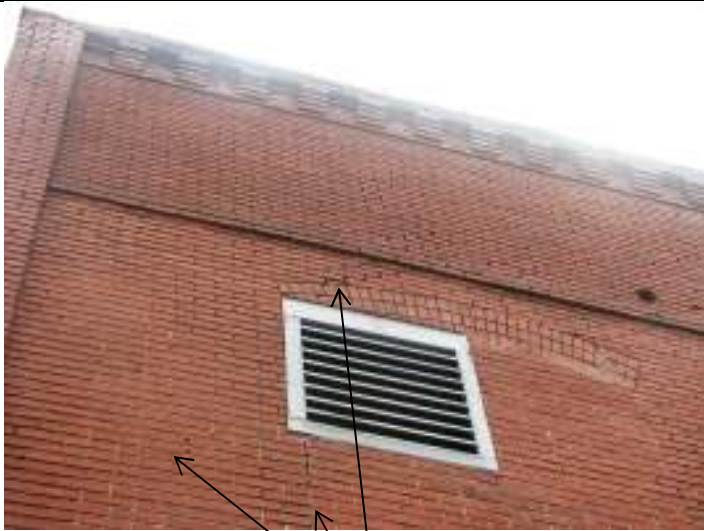
Upper façade showing cracked brick and missing mortar

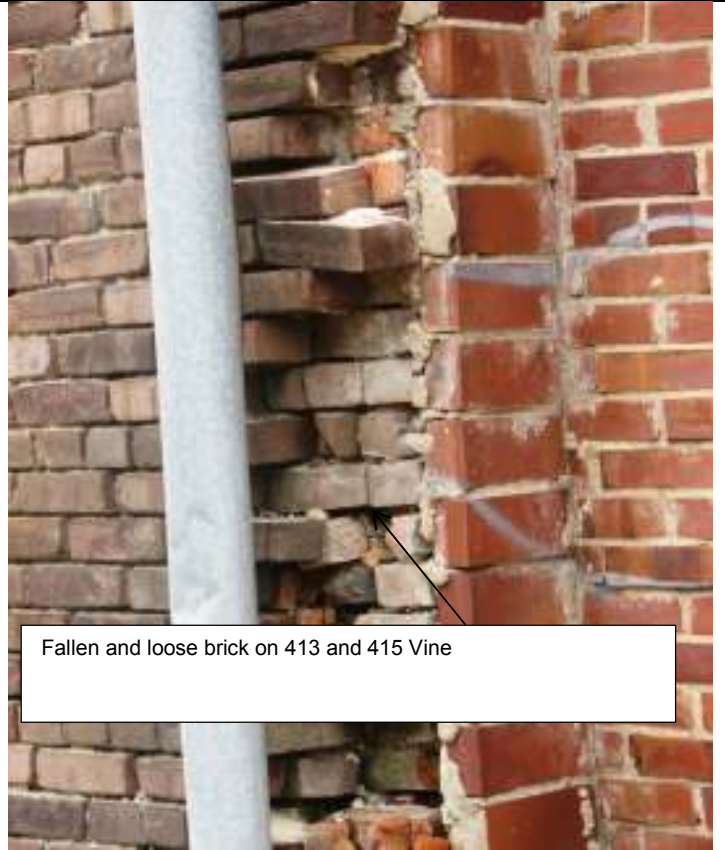
Fallen and loose brick on 413 and 415 Vine
