City of St. Louis Cultural Resources Office

Holly Hills Neighborhood Survey

Lynn Josse and NiNi Harris
3/1/2010

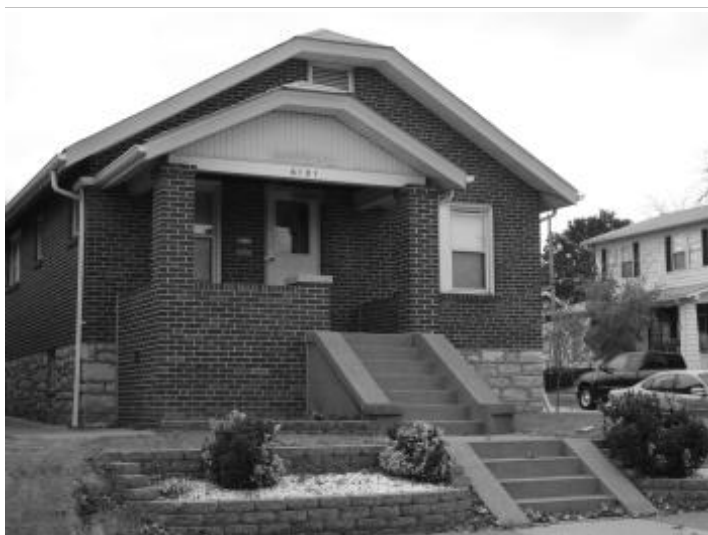
Replacement windows.

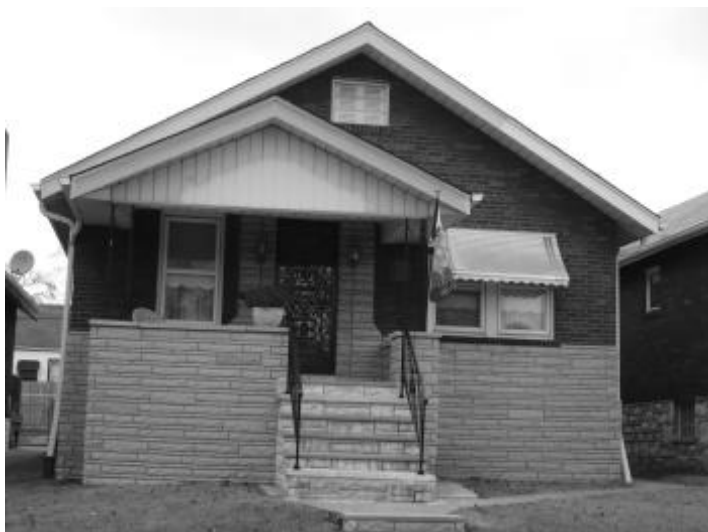
Imitation stone veneer below the first story sill level at façade and porch, and around the front door. Porch piers replaced with metal trellis-style supports. Full window replacement.

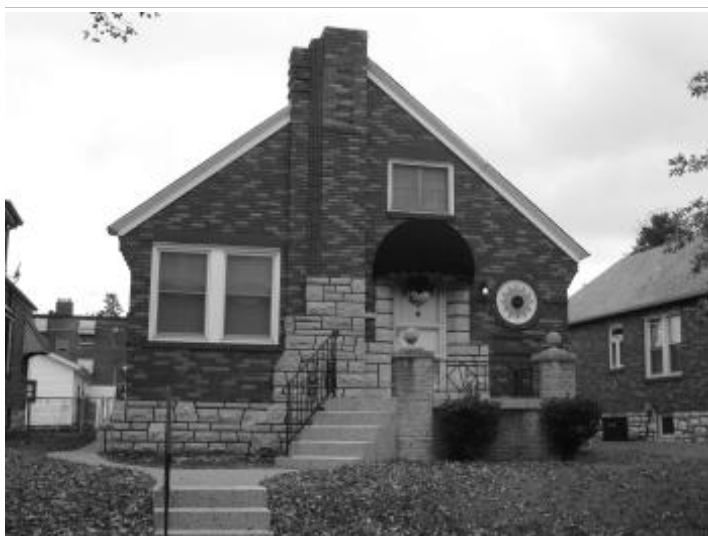
Replacement window pair, left. Trim wrapped at eaves.

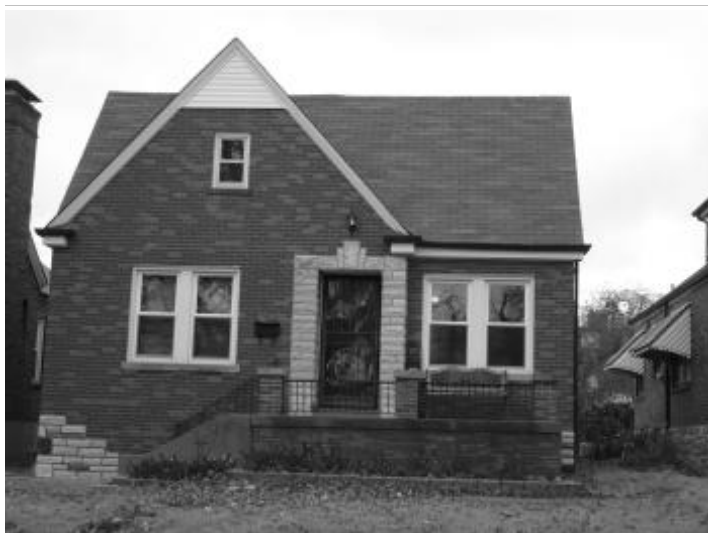
2 replacement window pair at either side of the front door.

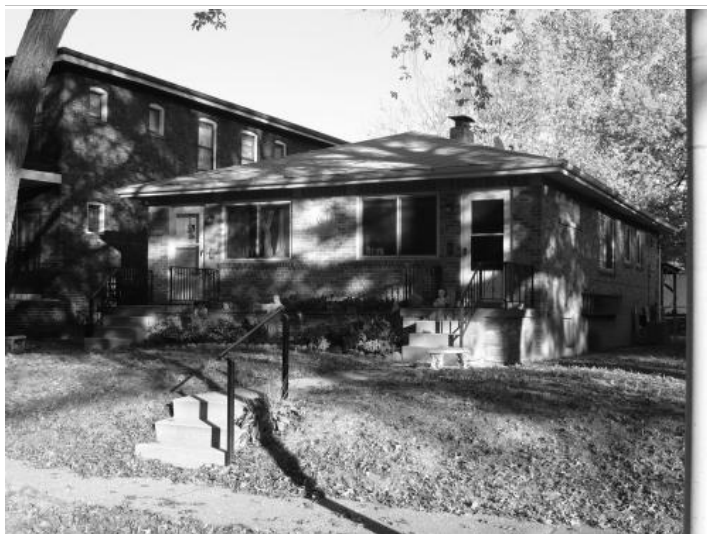
Replacement windows

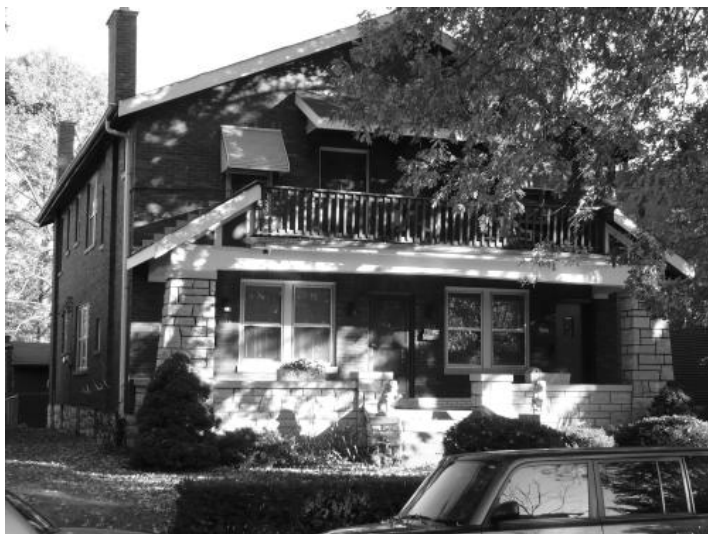
Some wood trim is wrapped. Replacement balcony railing.

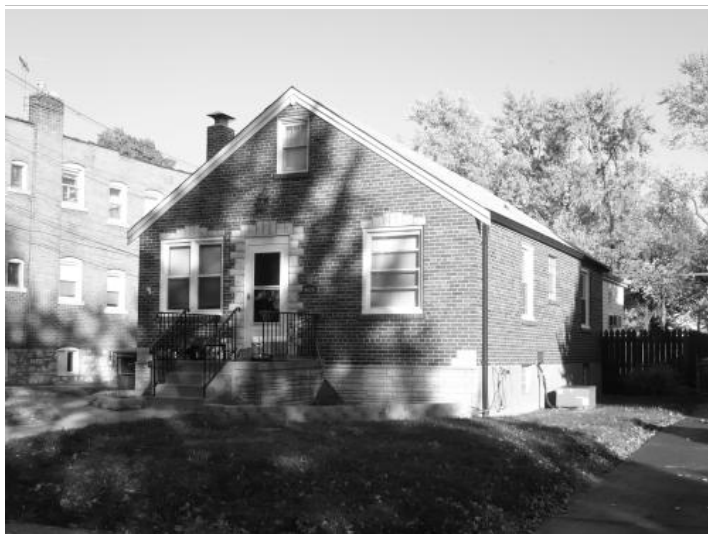
The windows are contemporary vinyl replacements.

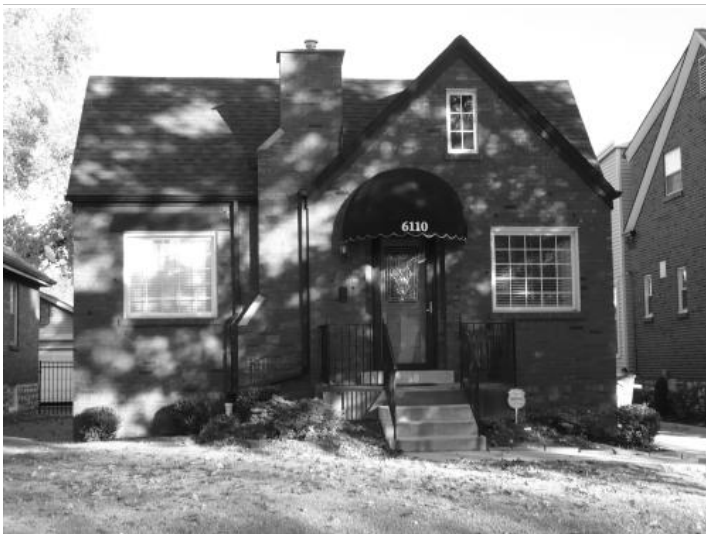
Vinyl windows; replacement door.

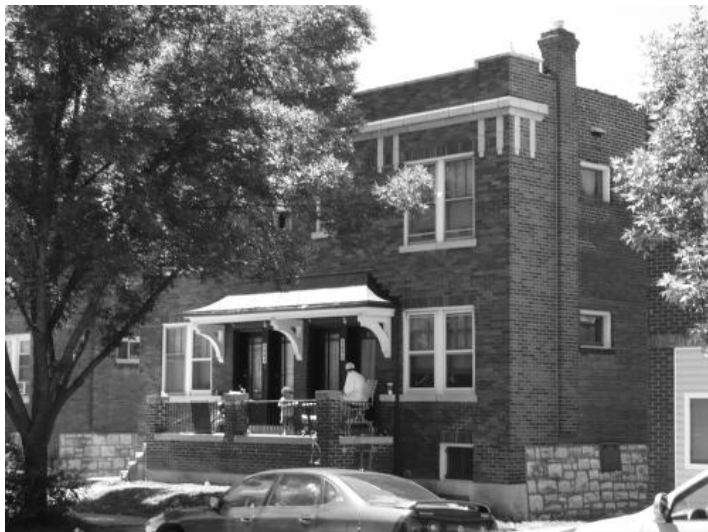
First floor windows and doors are replacements.

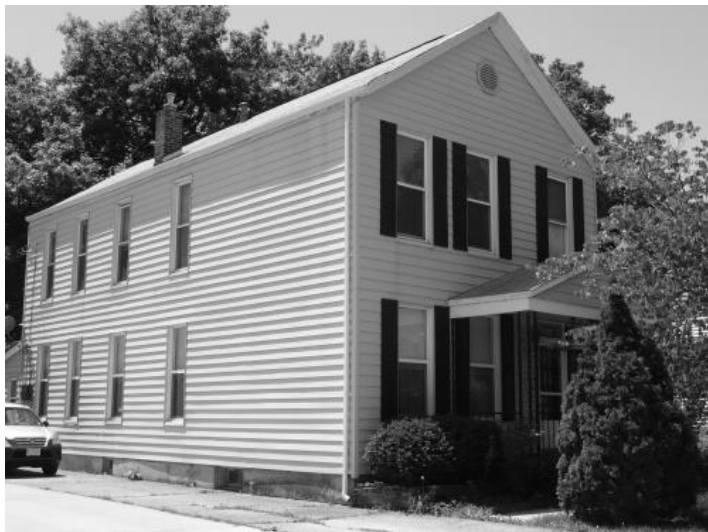
Concrete slab porch has trellis-style metal supports under a gabled roof (at the right 2/3 of the façade). Windows are replaced, and their trim lost under the vinyl siding.

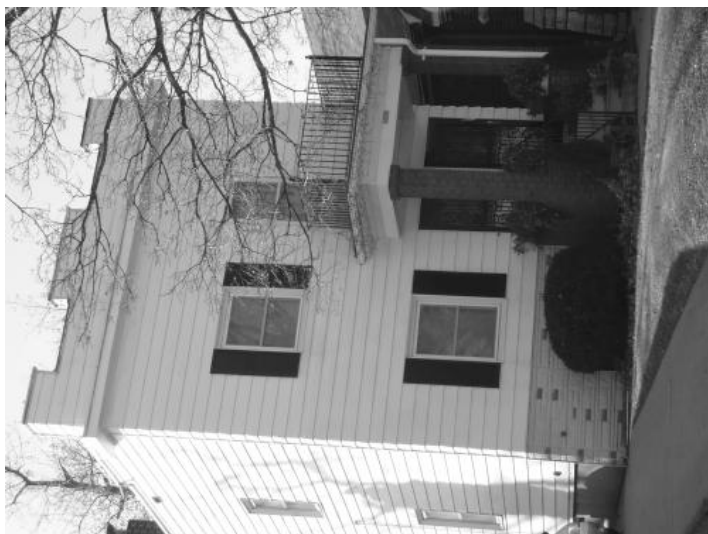
Window openings and vinyl replacements at left bay are shorter than historic windows, and their trim is obscured by the vinyl siding and inoperable applied shutters. Base of façade is covered with imitation stone veneer.

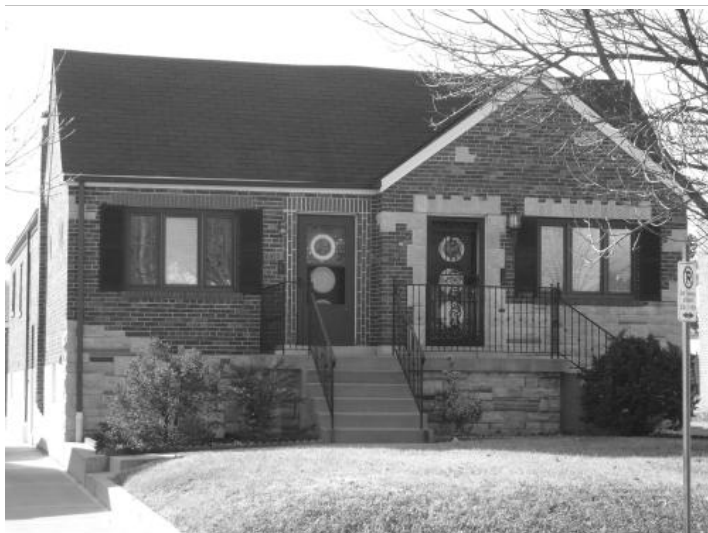
Windows are replacements.

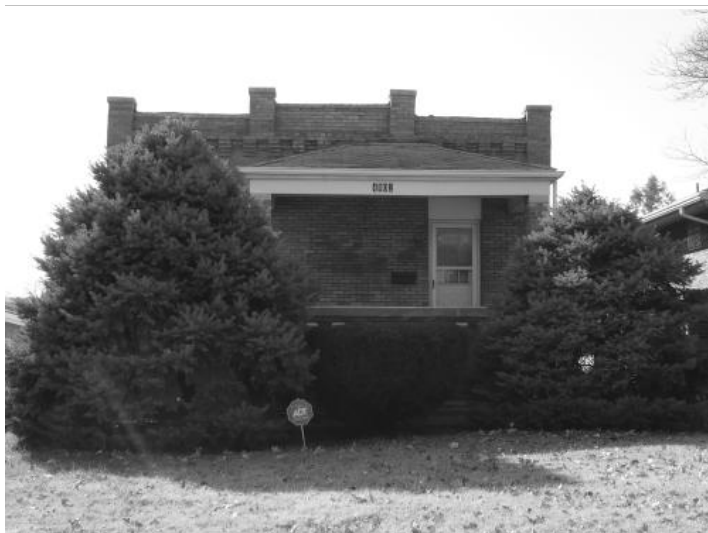
Replacement door with covered transom. Replacement windows.

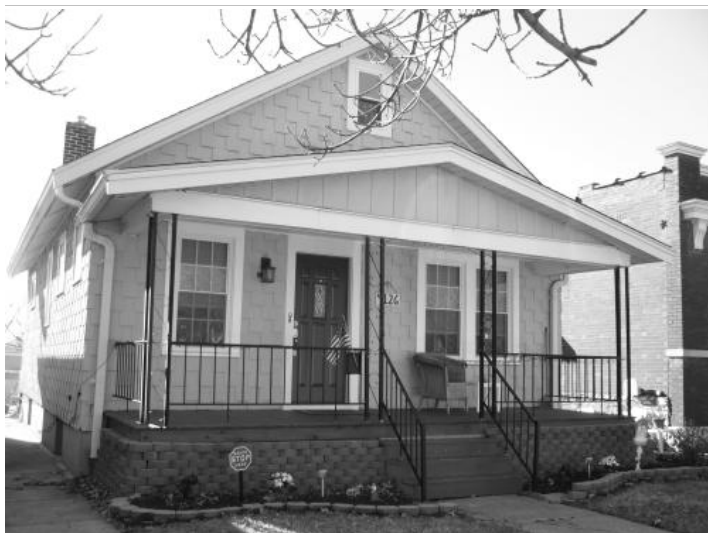
Replacement piers and railings at porch; replacement windows with their frames obscured by siding; replacement door.

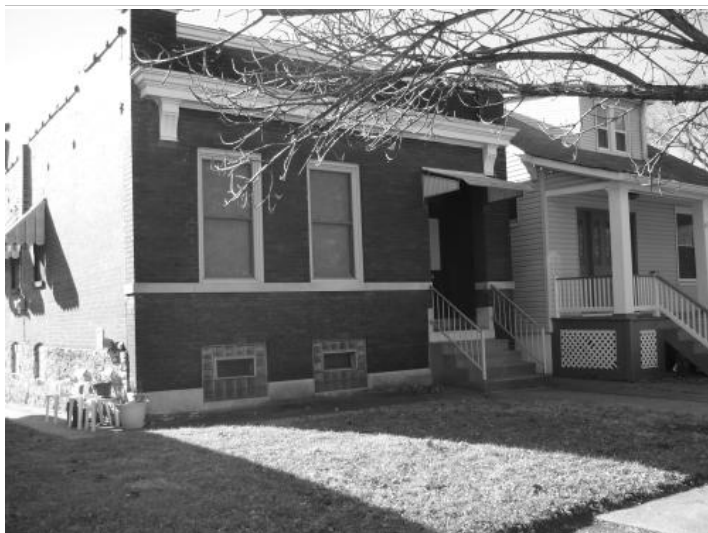
Replacement windows and glass block in basement windows.

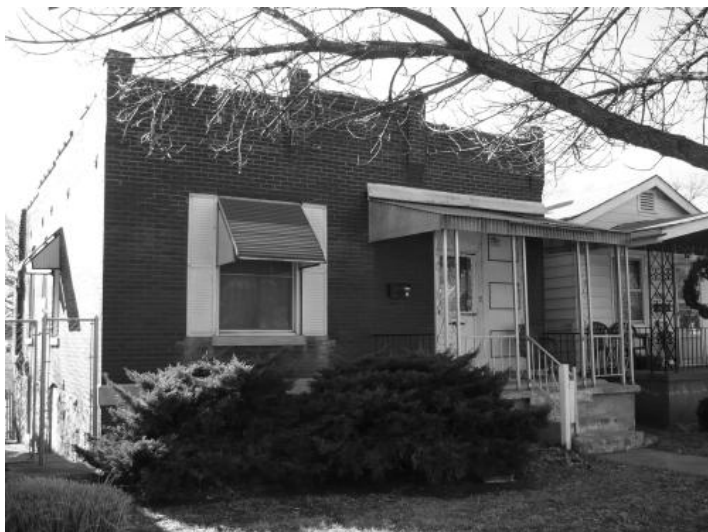
The front porch's fiberglass awning and metal supports and railings replace the original. Front door is a replacement, its sidelight covered with wood. Shutters and fiberglass awning added at window.

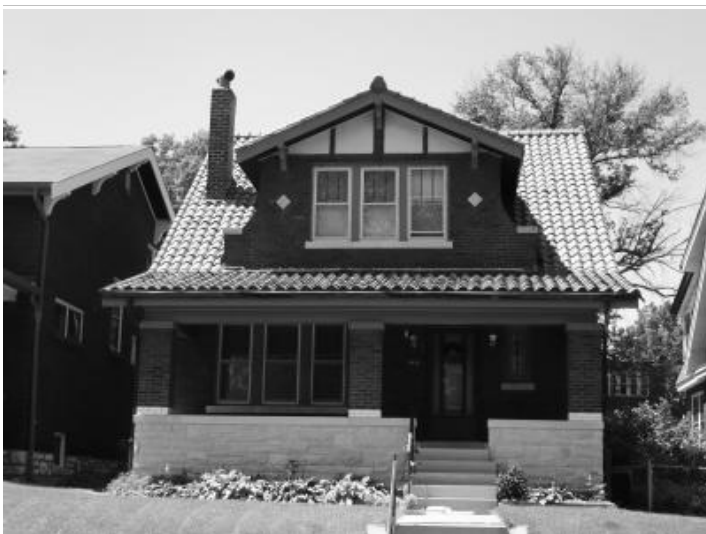
Replacement windows

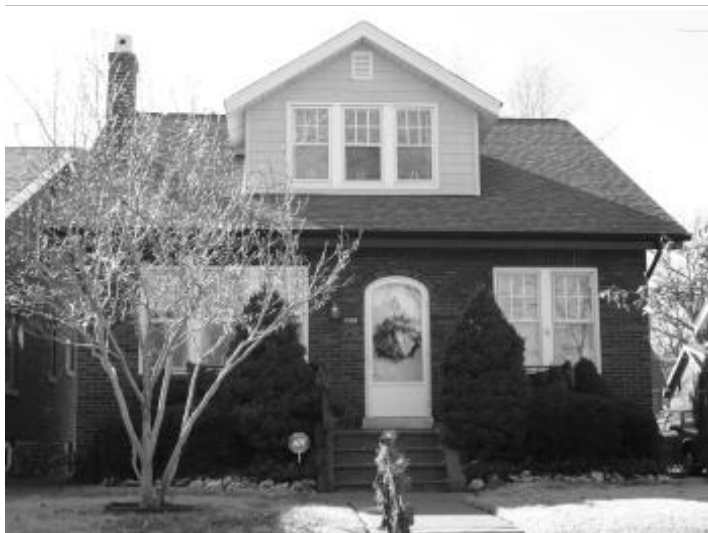
Some wood trim covered/replaced with modern materials.

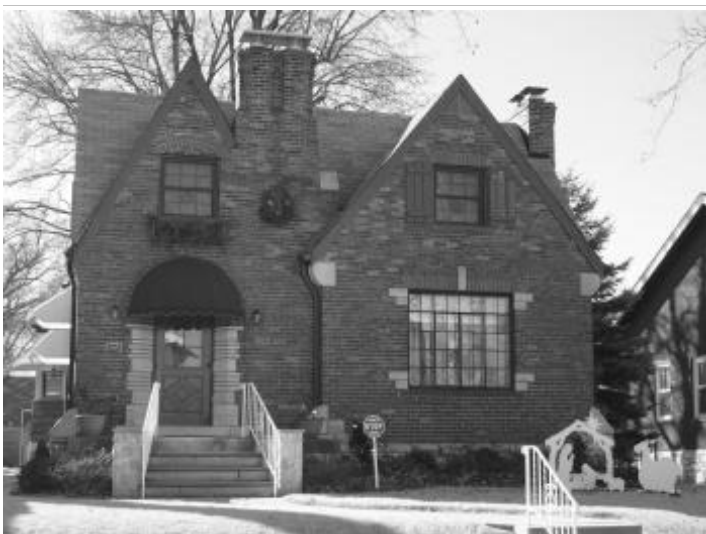
replacement windows at second story.

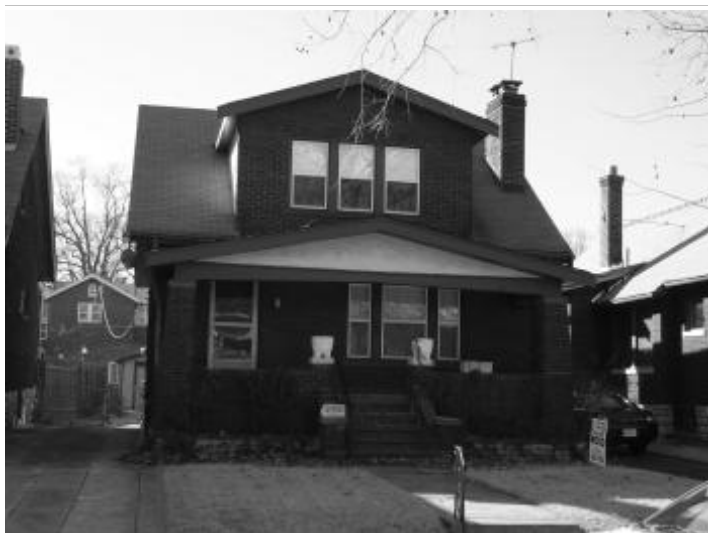
Replacement door and windows.

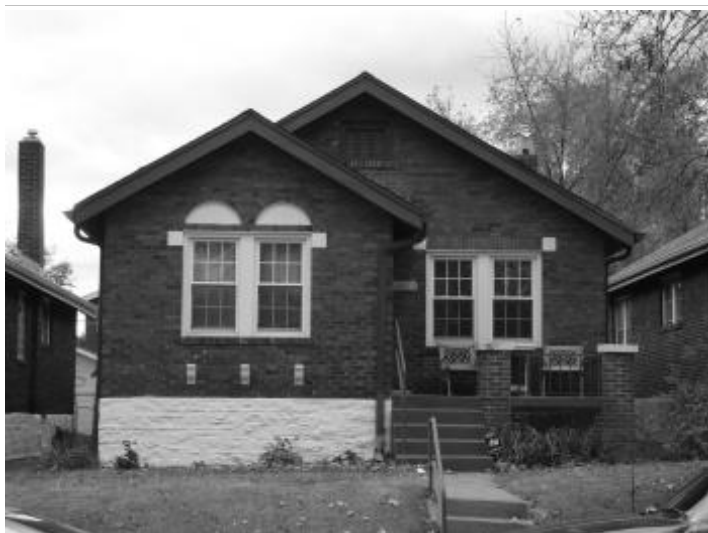
Front door and both pairs of façade windows are replacements.

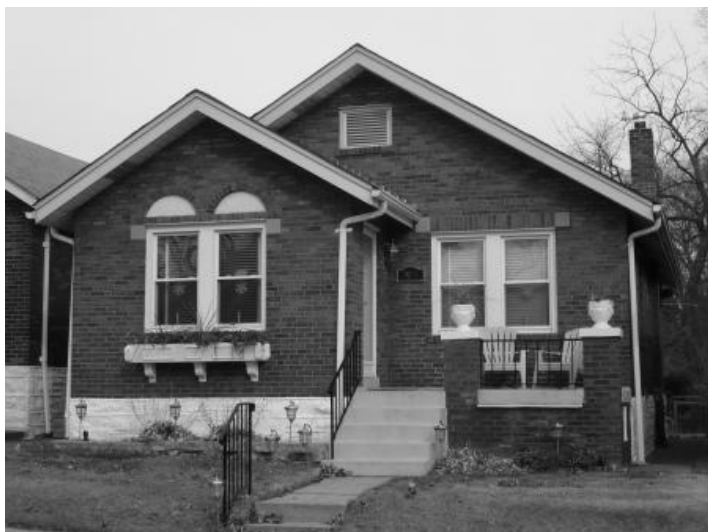
Both pairs of windows at the façade are vinyl replacements, and the door is replaced. Some wood elements (eaves and vergeboard) are sided.

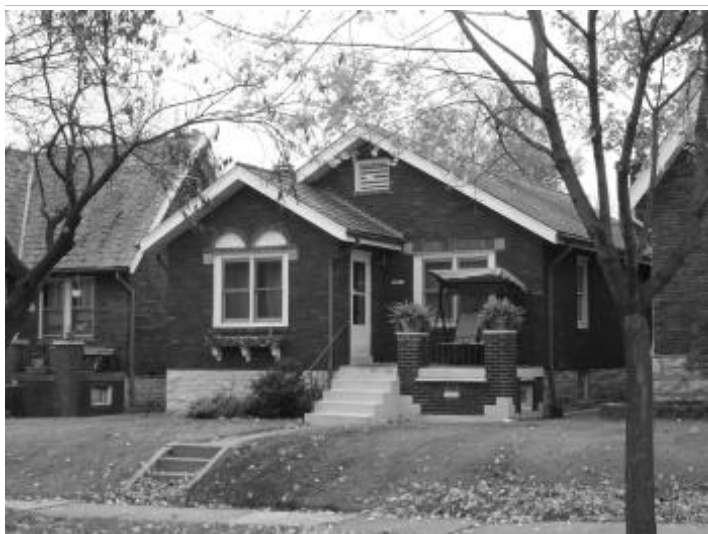
Replacement windows.

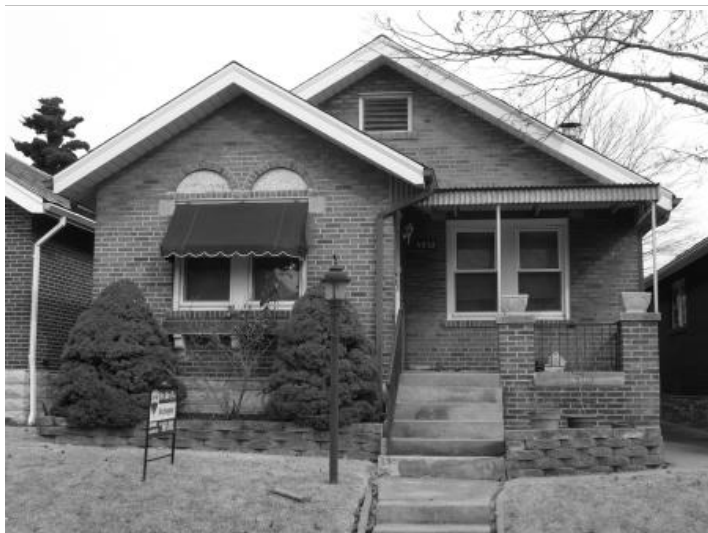
Front door is a replacement; vinyl covers some wood elements (eaves); windows are replacements.

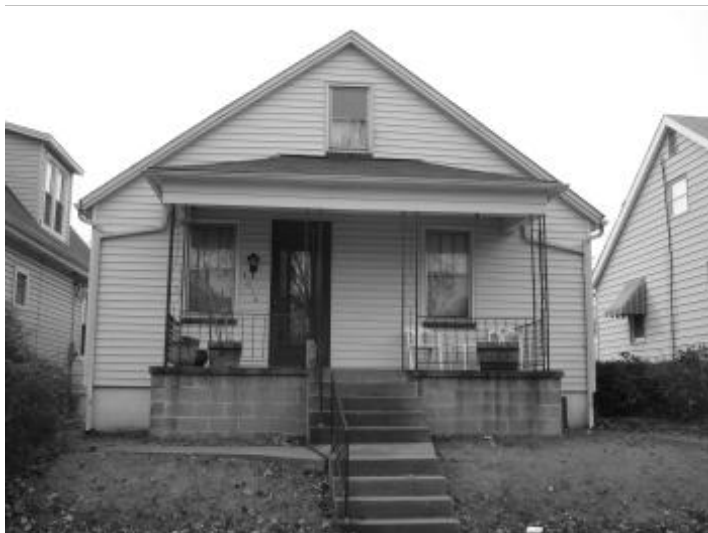
All porch elements except roof are replacements. Brick sills at windows. Siding covers character-defining wood trim.

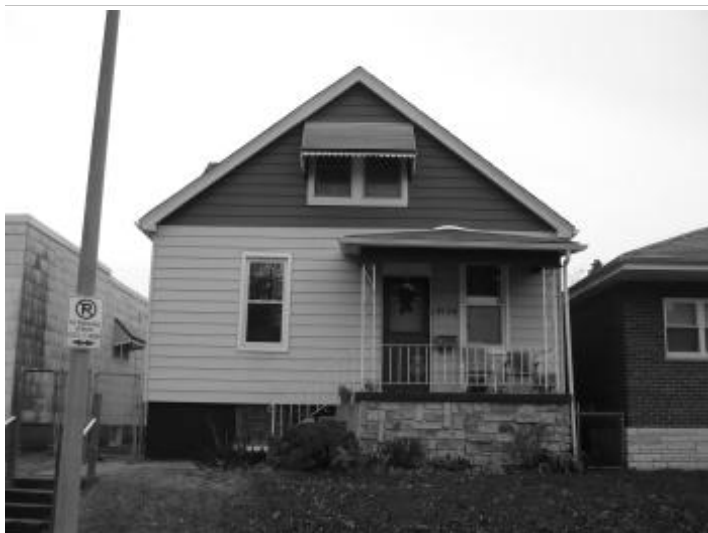
Porch is on an imitation stone faced base, and has metal supports. Replacement windows and door.

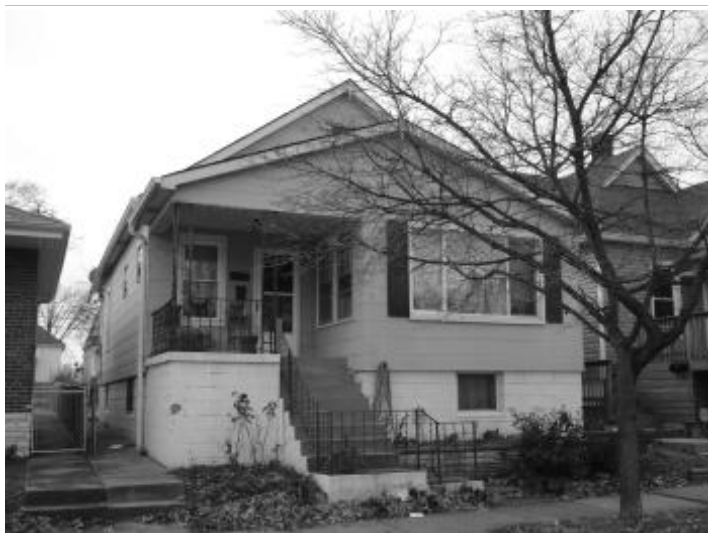
Some windows are replaced. Replacement front door.

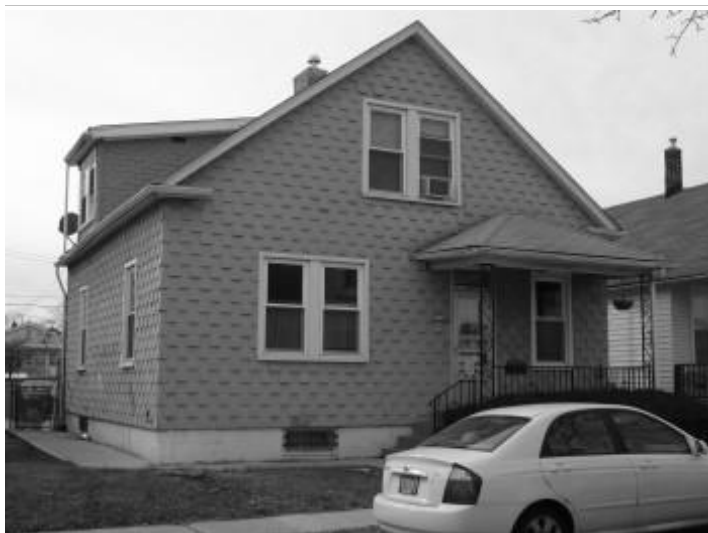
The porch roof is held up by metal trellis-style supports. Windows are replacements.

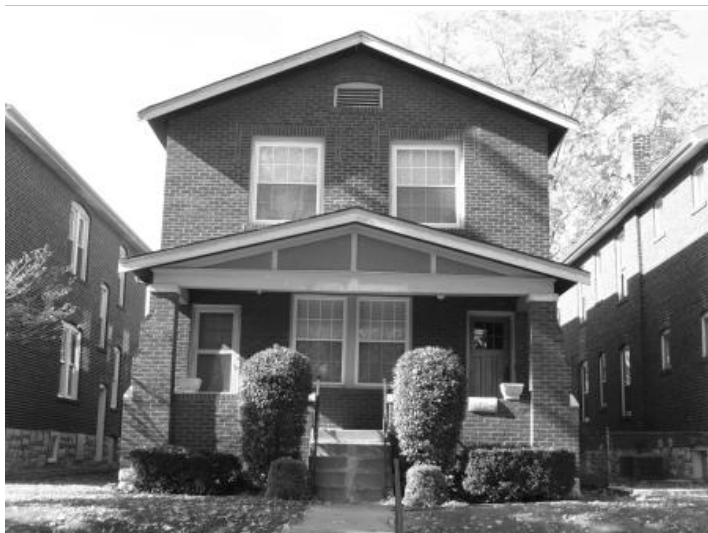
Replacement windows.

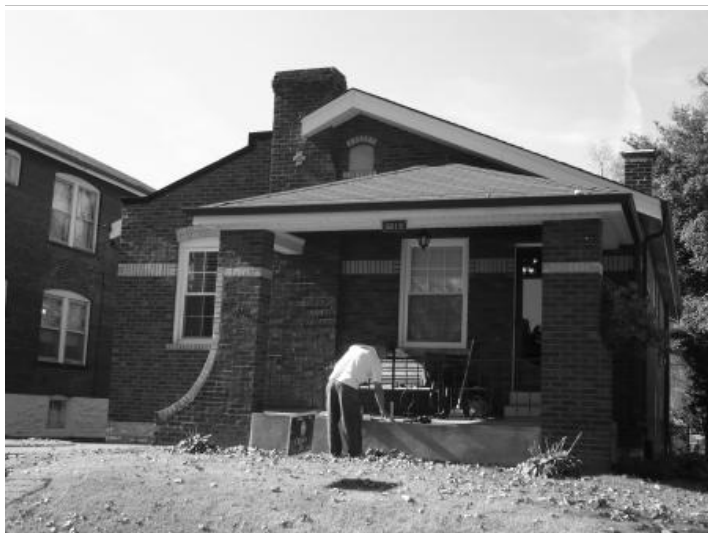
Replacement door and windows.

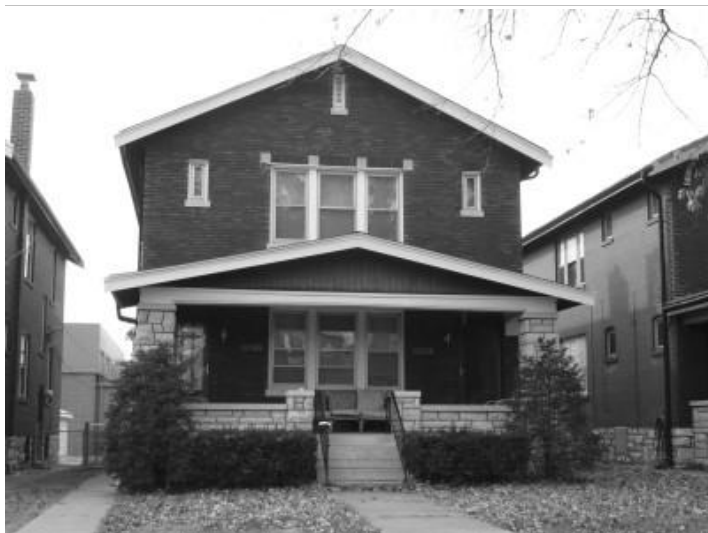
The triple window sets centering both stories have been replaced.

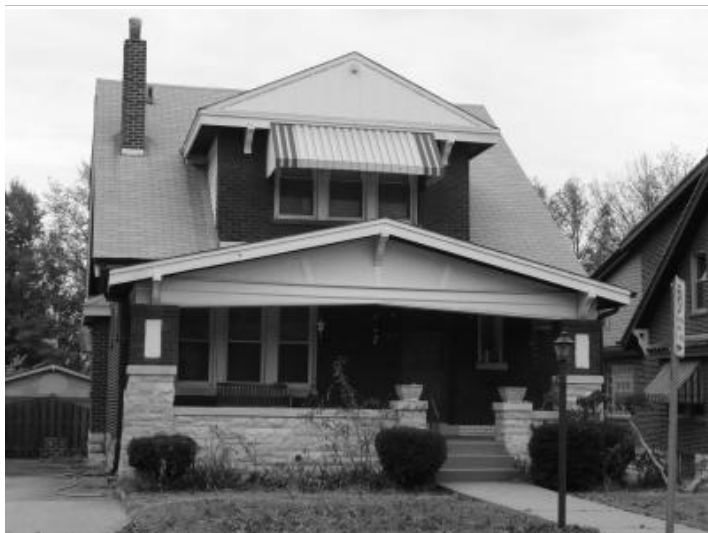
Replacement façade windows; awning over dormer windows; gable dormer has vertical metal siding over gable end.

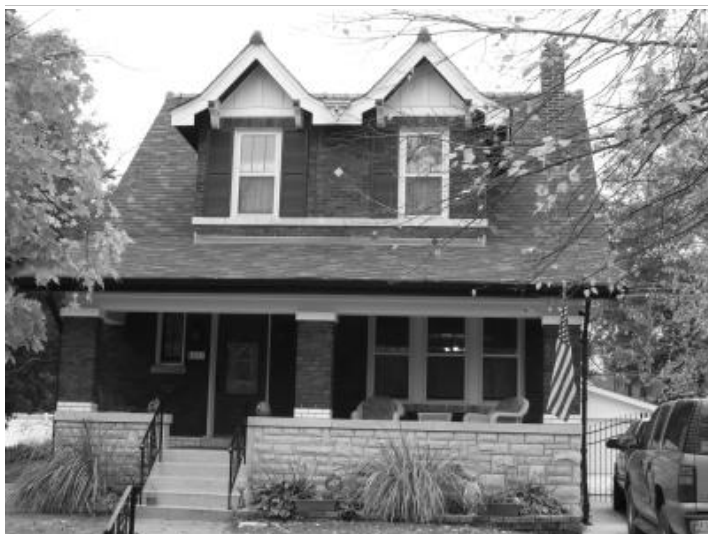
Replacement front door.

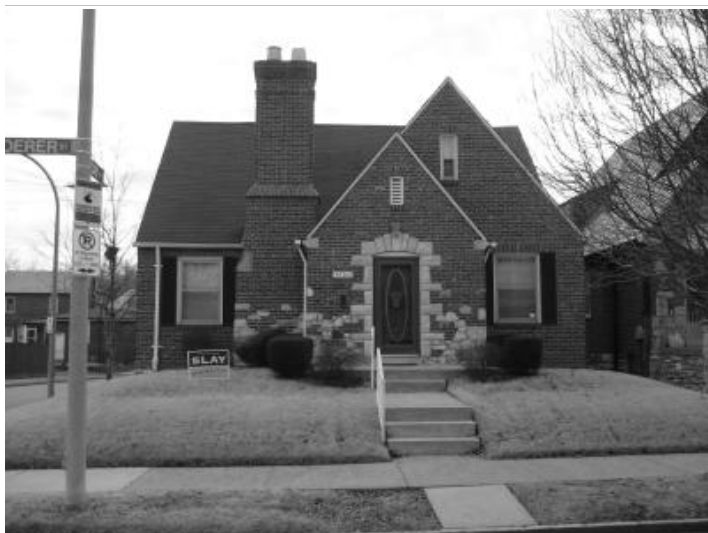
Replacement windows at outer bays.

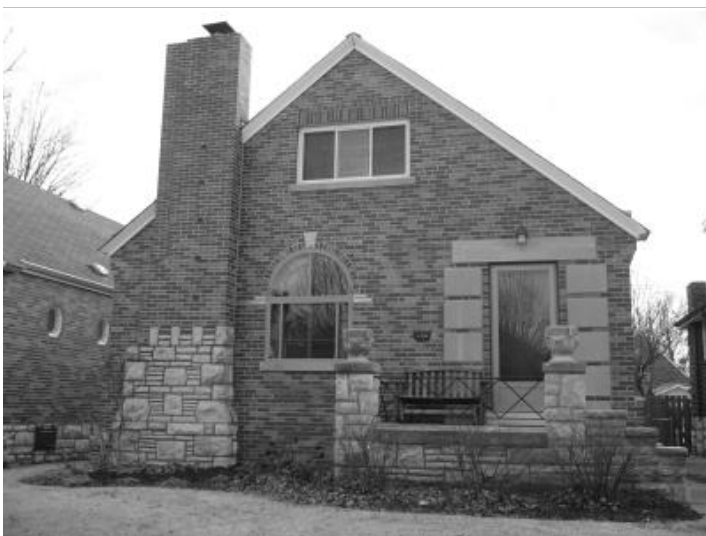
Replacement windows in gable end.

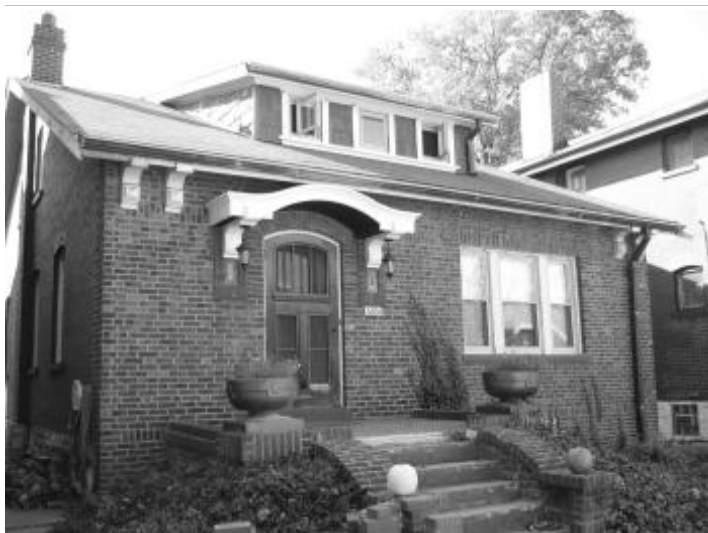
Replacement windows.

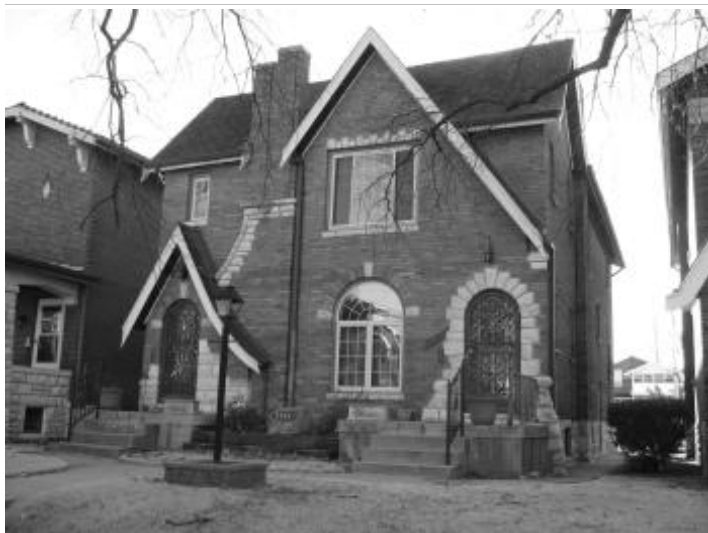
Façade windows are replacements.

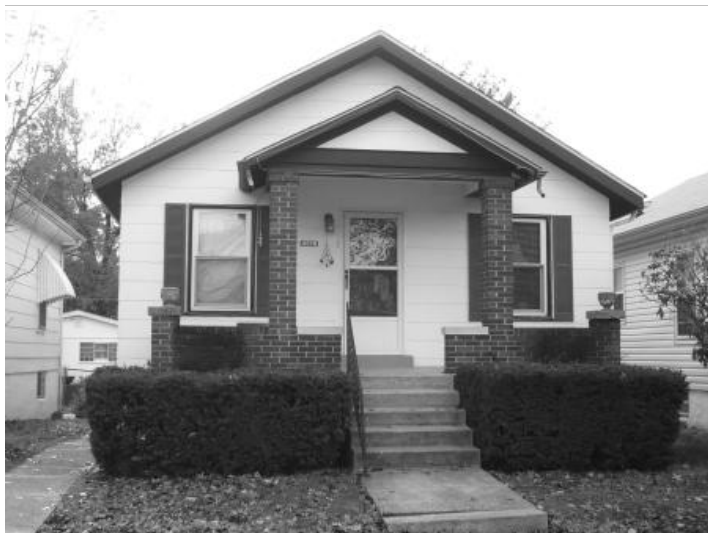
Shutters added; original window trim missing.

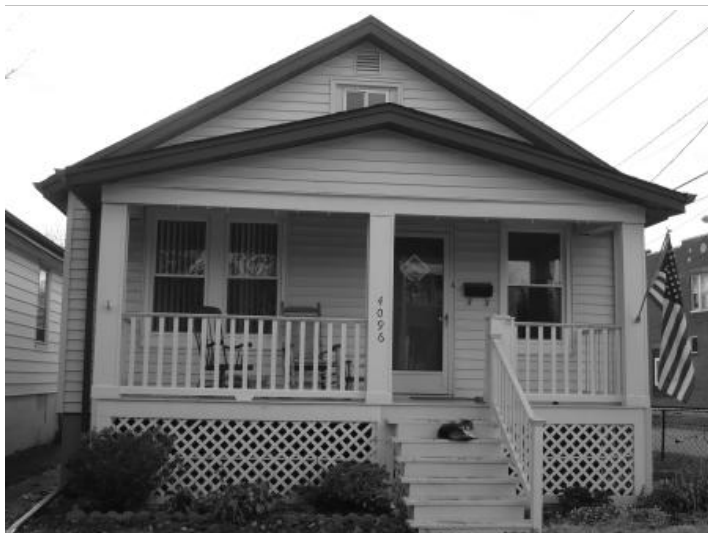
Replacement windows and front door.

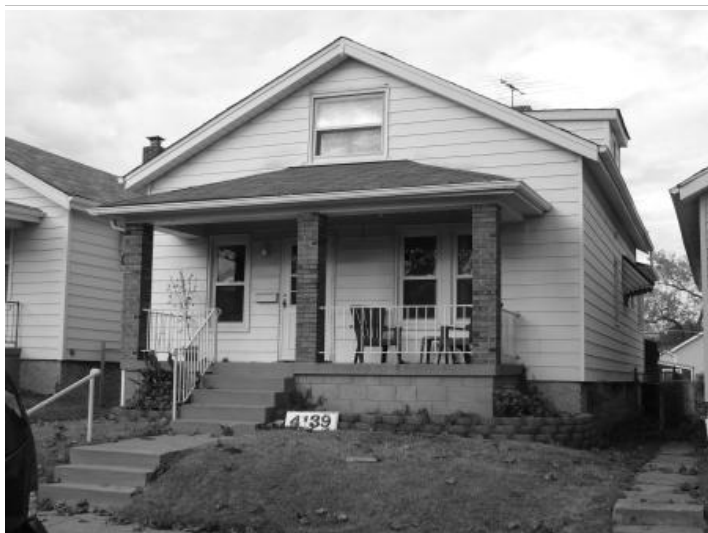
Replacement windows and front door.

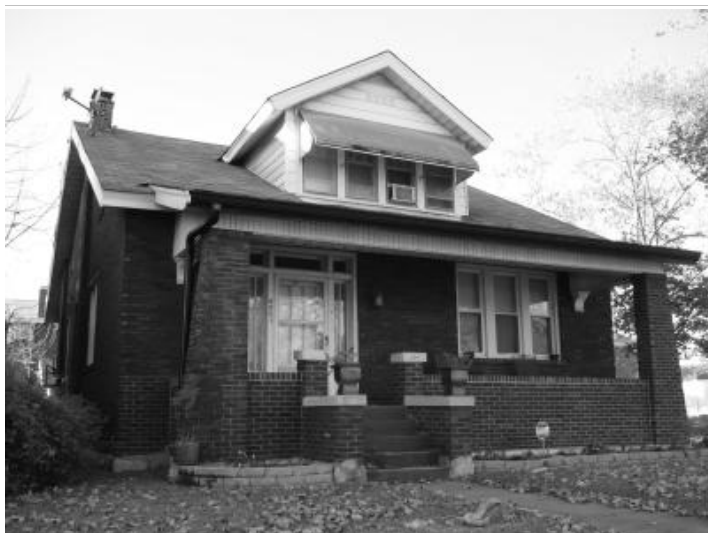
First story windows are replacements. Eaves, soffits, gable end and dormer walls covered with siding.

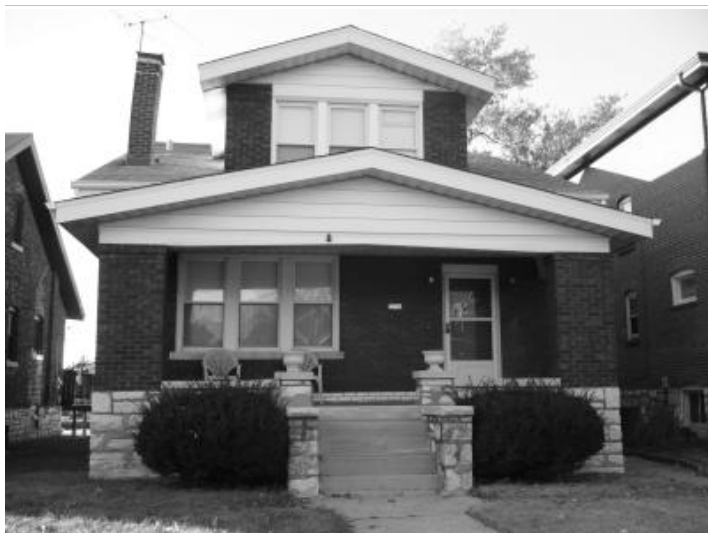
Replacement door and windows. Siding at porch and dormer gable ends.

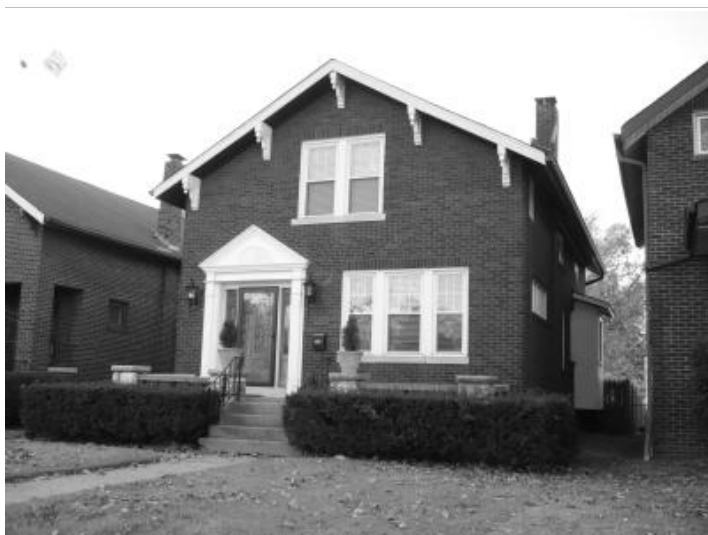
Replacement door, sidelights, architrave. Replacement windows

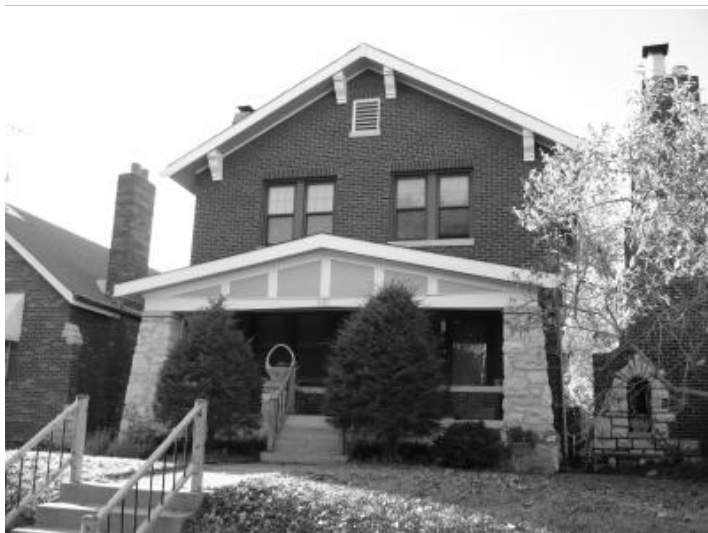
Front door and windows are replaced.

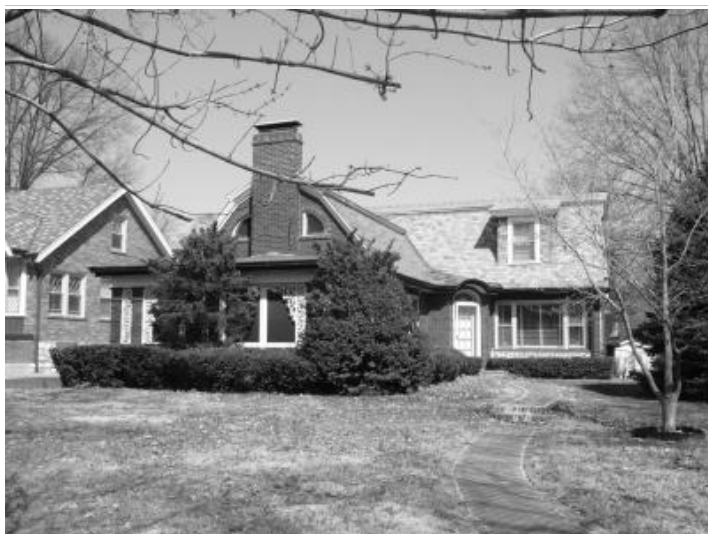
It appears that the right wing's picture window replaces smaller original windows.

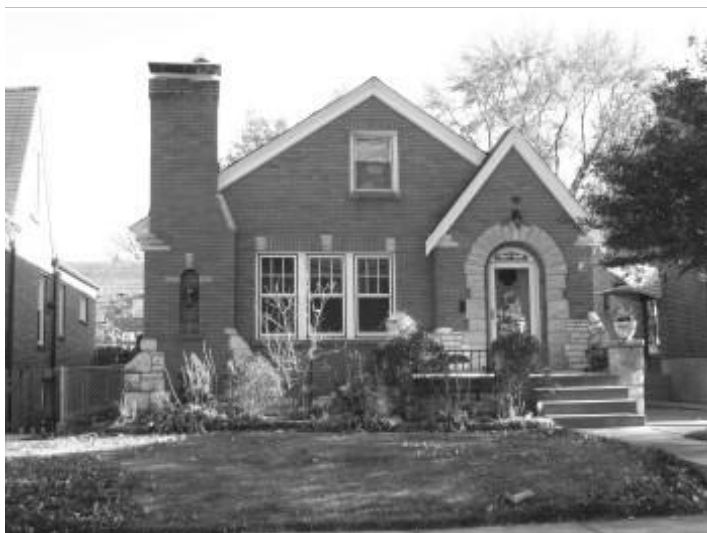
replacement attic window

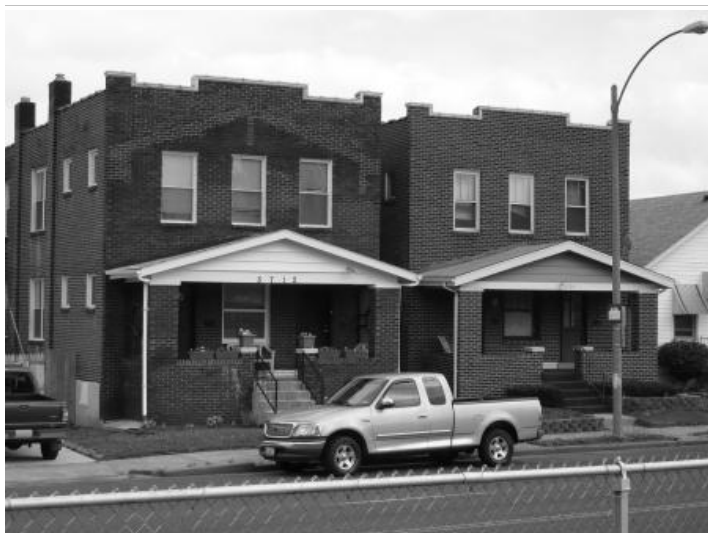
Replacement doors and windows; porch gable end is covered with modern siding; applied gable removed at upper façade.

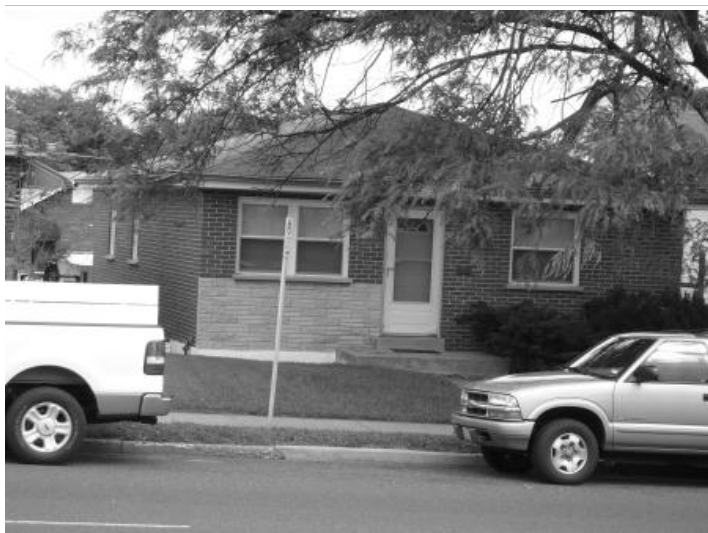
replacement windows

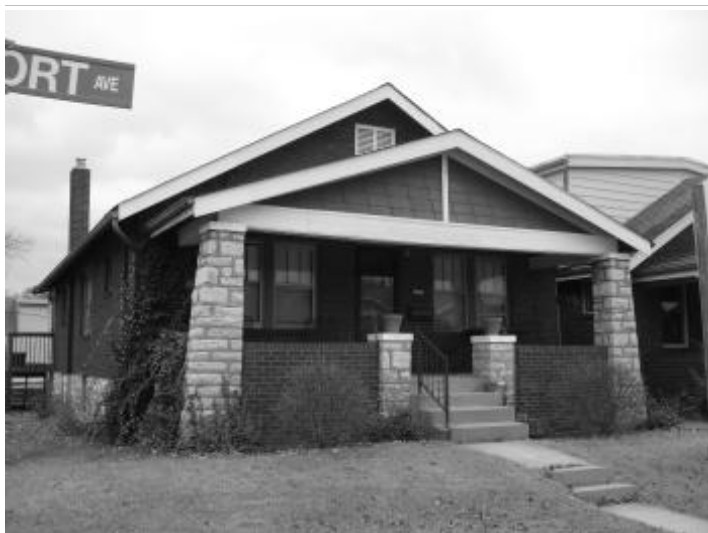
Replacement front door. Vinyl siding over vergeboards; porch gable end is shingled.

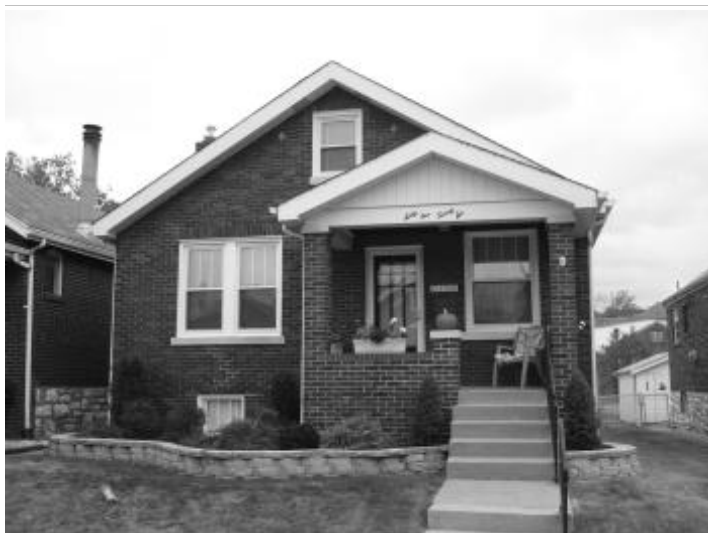
Replacement windows; gable end of front porch is sided over.

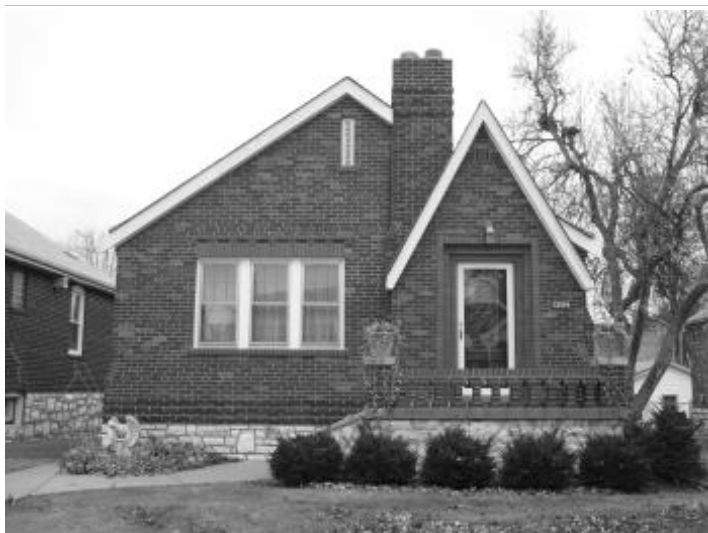
replacement door.

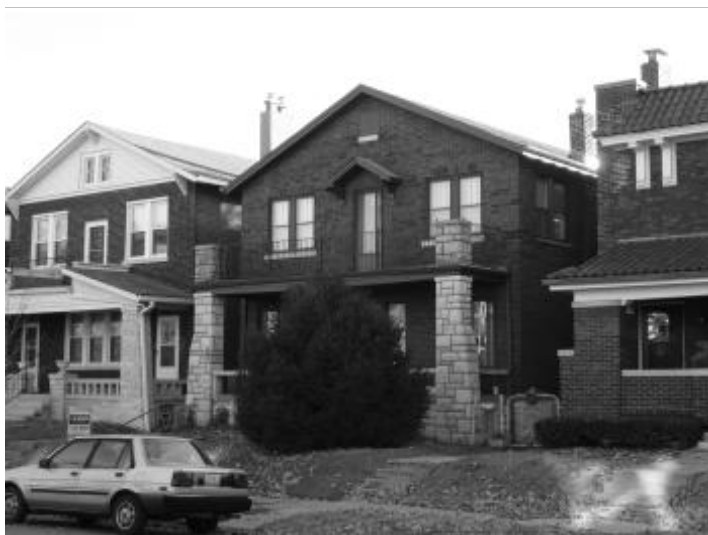
All three doors and first story windows are replacements. Soffits, eaves and bracketed hood at balcony all sided over.

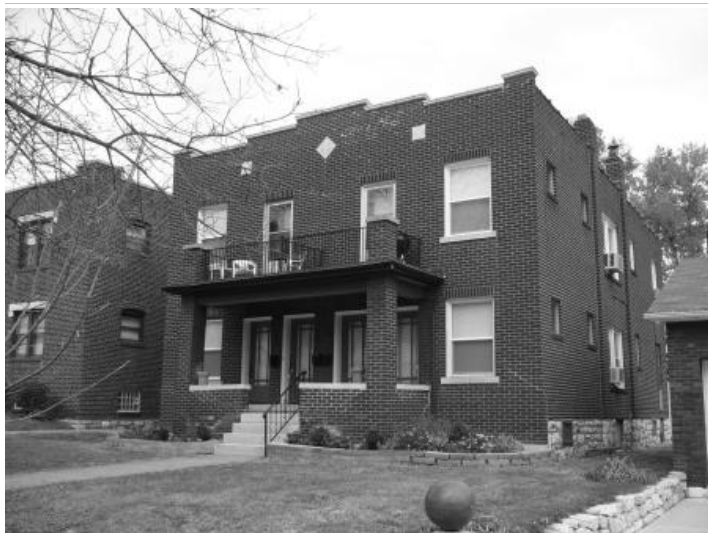
Replacement windows at outer bays, both stories.

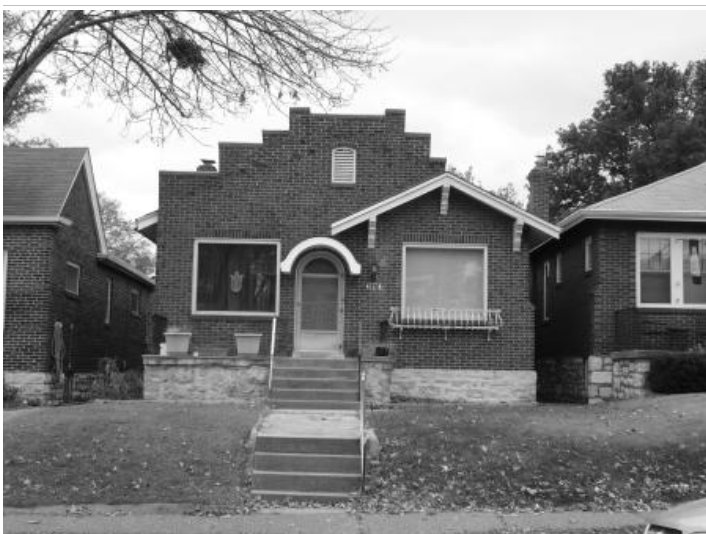
Front windows replaced by wide fixed panes.

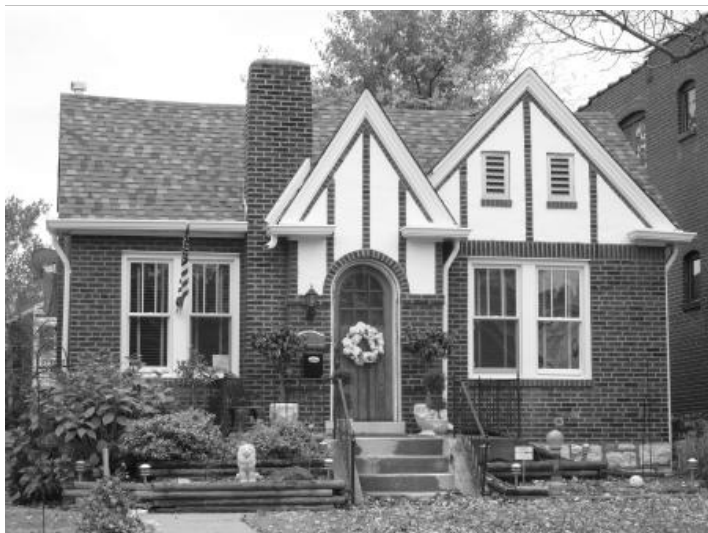
Some wood trim replaced or wrapped with siding.

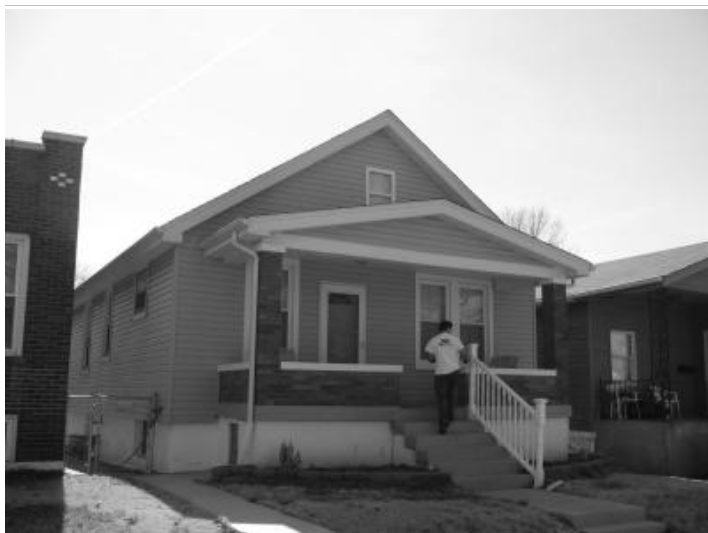
The front door is a replacement, the single window to its left and pair to the right are also replacements.

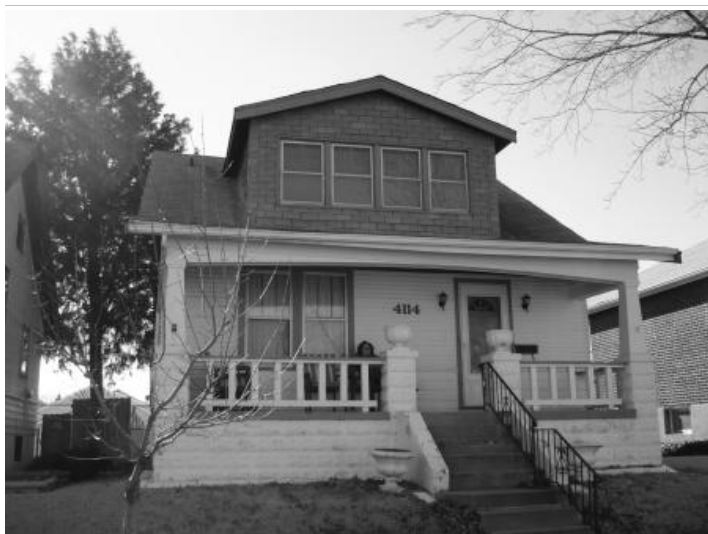
Replacement door.

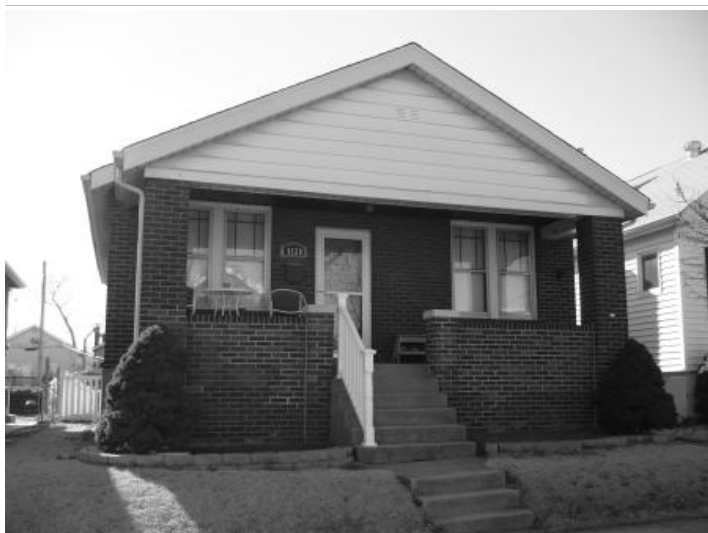
Replacement front door. Vinyl siding at gable end.
