1. Survey No.			2. Survey name:		
JA-AS-091-240		Fairmount Phase I Survey			
3. County:			4. Address (Street No.)	reet No.) Street (name)	
			, , ,	. ,	
JA			104	S. Home Avenue	
5.City: Vicinity:		6. Geographical Reference:		7. Township/Range/Section:	
Independence			39.109917, -94.459124	1	T: 50N R: 32W 32
8.Historic name (if k	nown):	•		9. Present/other	name (if known):
10. Ownership:			11a. Historic use (if know	/n):	11b. Current use:
Private	Public		Domestic		Domestic

21. (cont.) History and significance. Expand box as necessary, or add continuation pages.

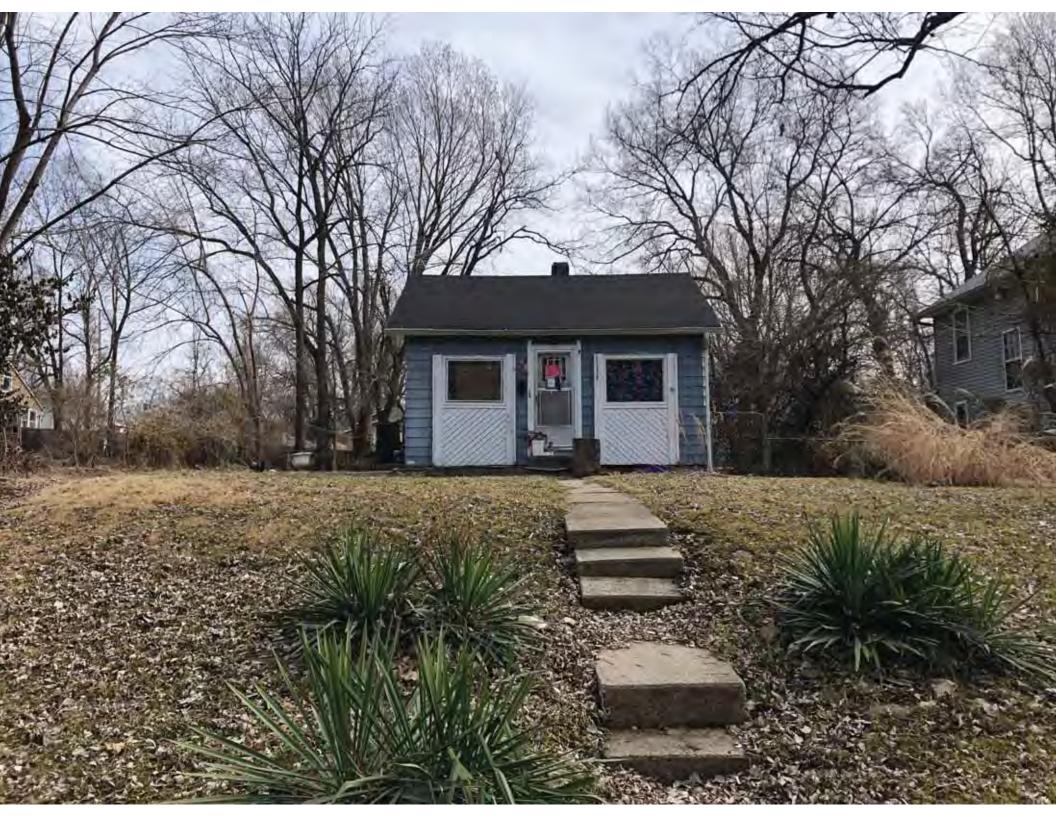
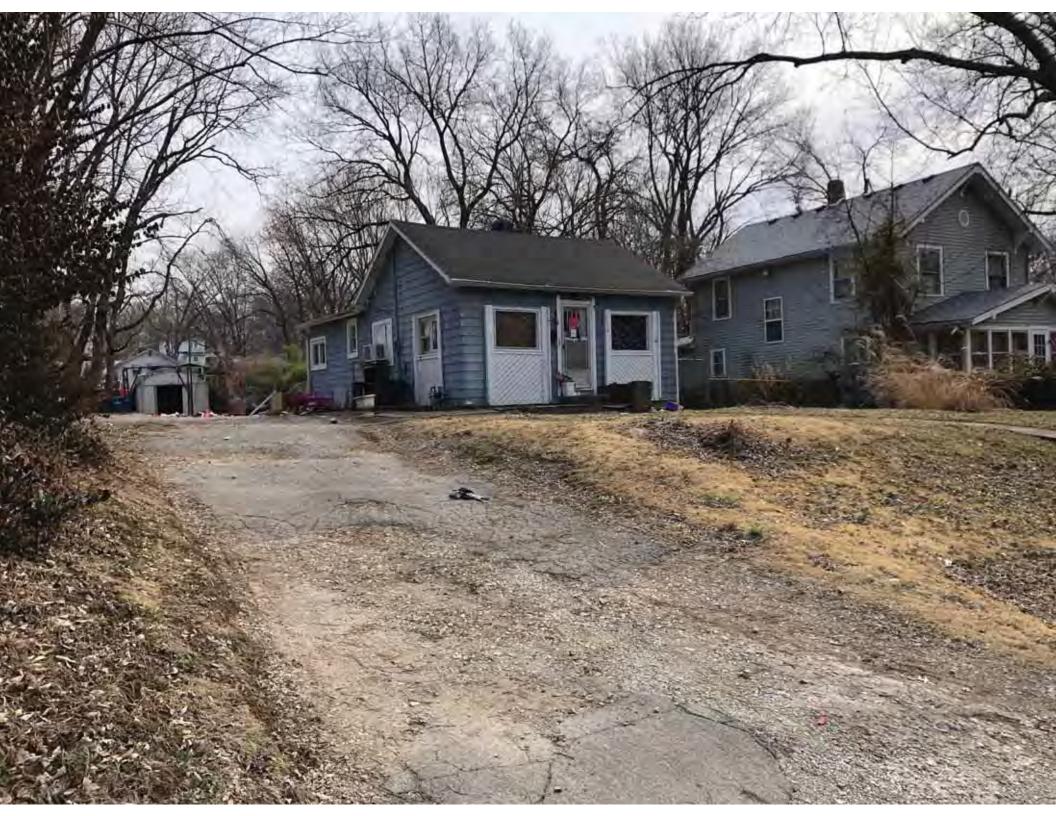
The main façade of this modest, side-gabled house faces west. The centrally placed main entry is flanked by two fixed pane windows. Wood paneling under the fixed pane windows has a diagonal plank pattern and extends from the window sill to the foundation line. A similar window and paneling pairing can be seen at the western bay of the north façade. A brick chimney is placed at the rear (east) slope of the roof. Windows on secondary façades are varied and feature fixed and one-over-one sash; several windows have been obscured by plywood paneling or are missing. A two-bay addition to the east façade features a flat roof and was constructed at an unknown date. This building is a common example of its type that lacks distinction and therefore historical significance. Additionally, due to some loss of original materials, including siding, this building has diminished integrity of materials and workmanship.

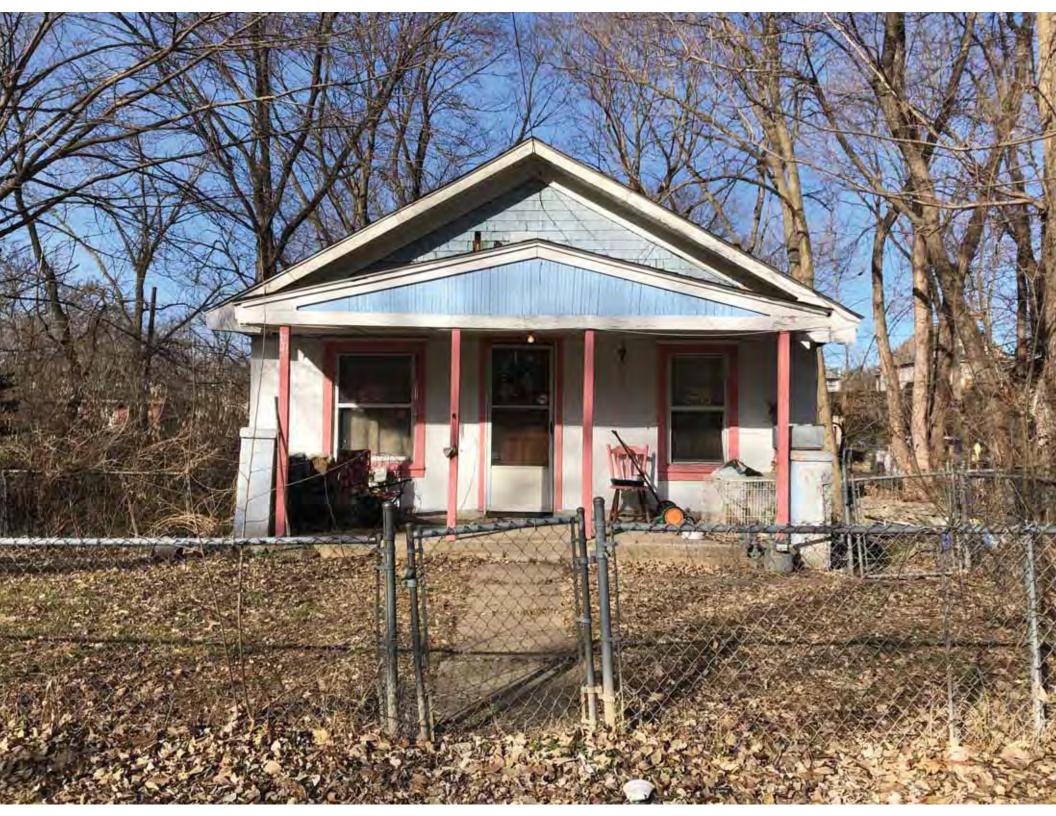
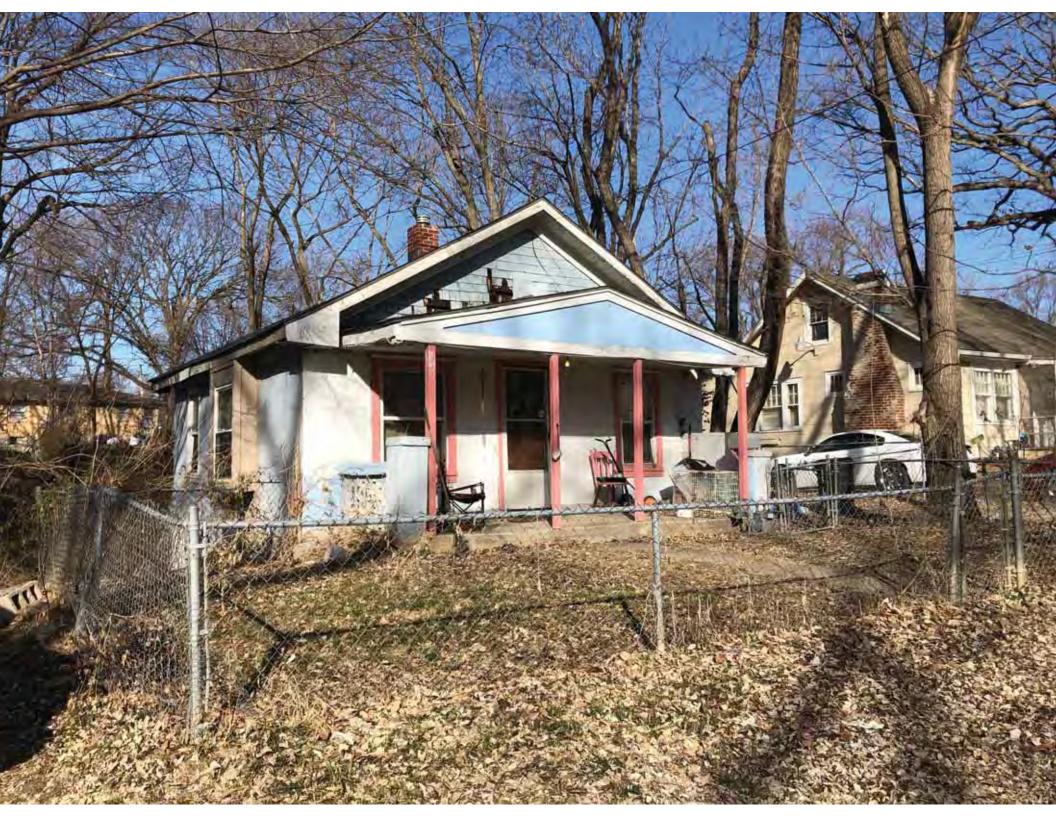
The main façade faces west. A centrally placed main entrance door is flanked by two one-over-one vinyl sash windows with wood surrounds. The gable end features wood shingles. A brick chimney is placed at the south slope of the roof. A full-width porch features a gable roof supported by four replacement wood posts. Two plinths for original porch columns, no longer in use, are extant at the north and south ends of the porch. Additional features of this house include a stucco exterior and a banked basement. This residence likely was Craftsman in style with a front-gabled roof form; however, modifications, alterations, and loss of original building materials have significantly impacted the integrity of this residence. Due to loss of original materials, changes to form, and other alterations, this building lacks sufficient integrity of design, materials and workmanship to be considered eligible for listing in the NRHP.

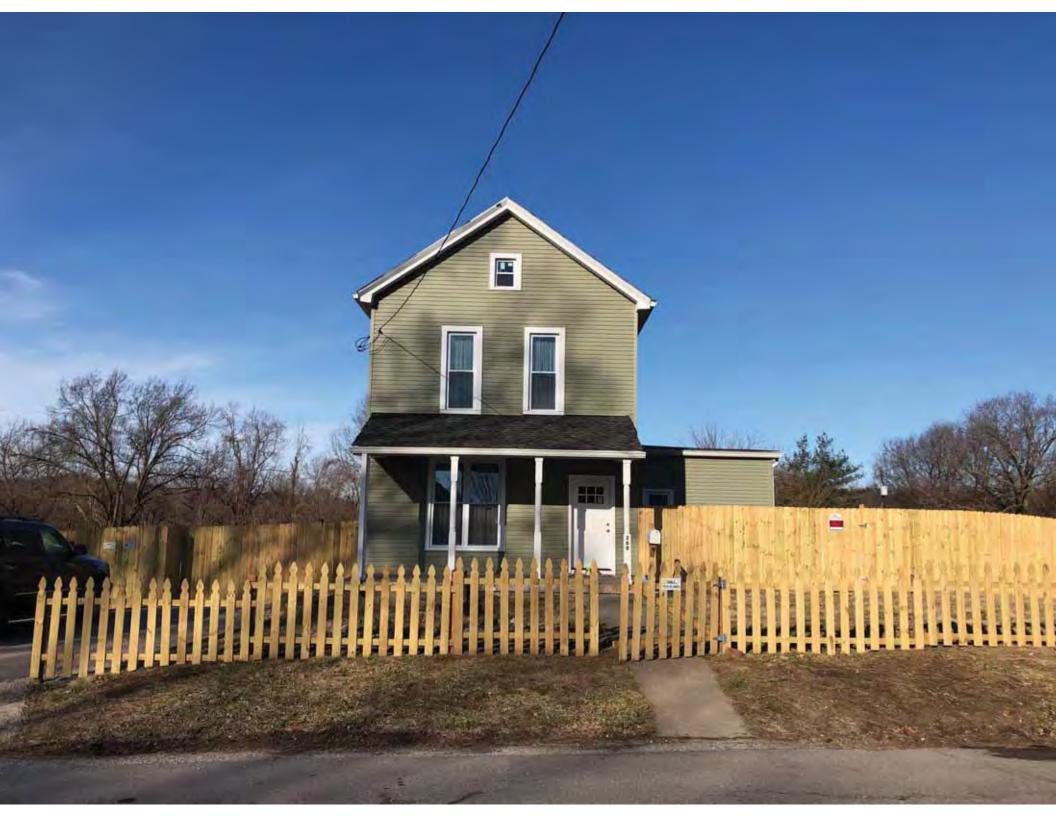
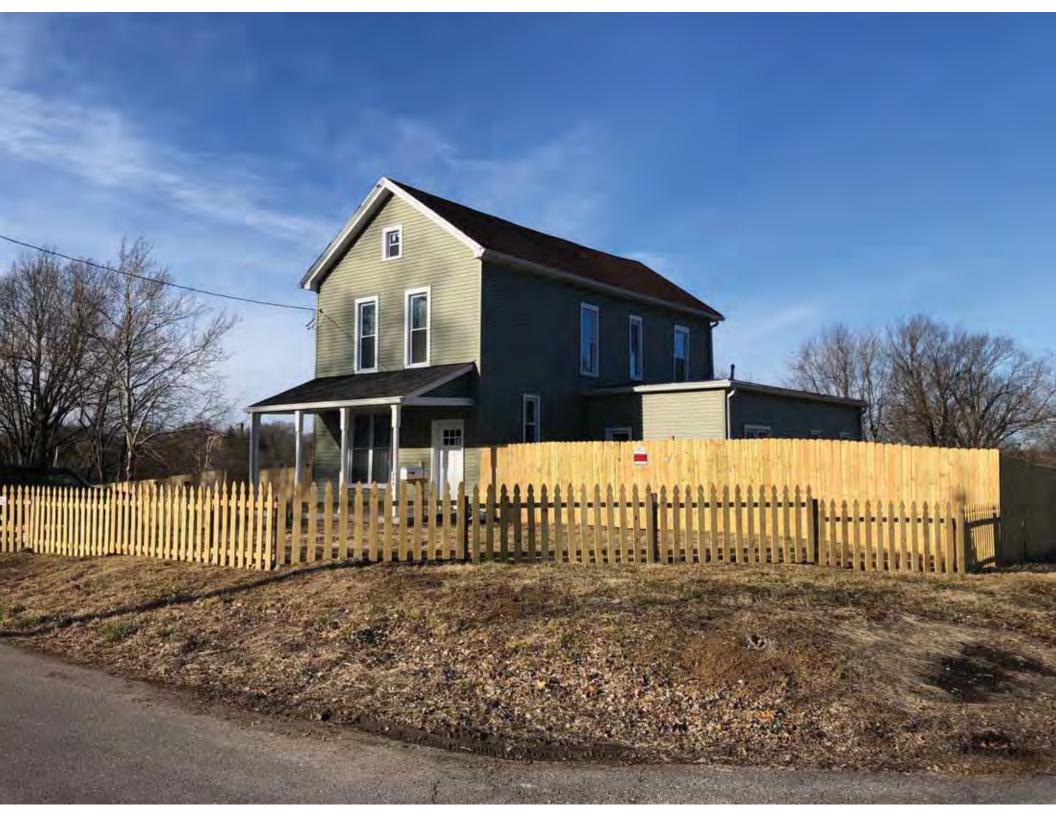
The main façade faces east. The main entry is placed to the north of paired replacement one-over-one vinyl sash windows. A full-width porch with a shed roof is supported by four turned wood posts. The second story at this façade features two one-over-one vinyl sash replacement windows and a smaller, one-over-one vinyl sash window in the gable end at the attic level. An addition at the first story level, constructed at an unknown date, wraps from the north to a portion of the west façade and has a flat roof. Secondary entrances are located at the west bay of the south façade and the south bay of the west façade, the latter underneath a flat-roofed partial-width porch. A 2018 property photo accessed on the Jackson County Parcel Viewer website shows the house once featured a brick chimney on the north side slope of the roof. The photo also indicates that porch supports have been replaced since the photo was taken. Due to loss of original materials, changes to form, and other alterations, this building lacks sufficient integrity of design, materials and workmanship to be considered eligible for listing in the NRHP.

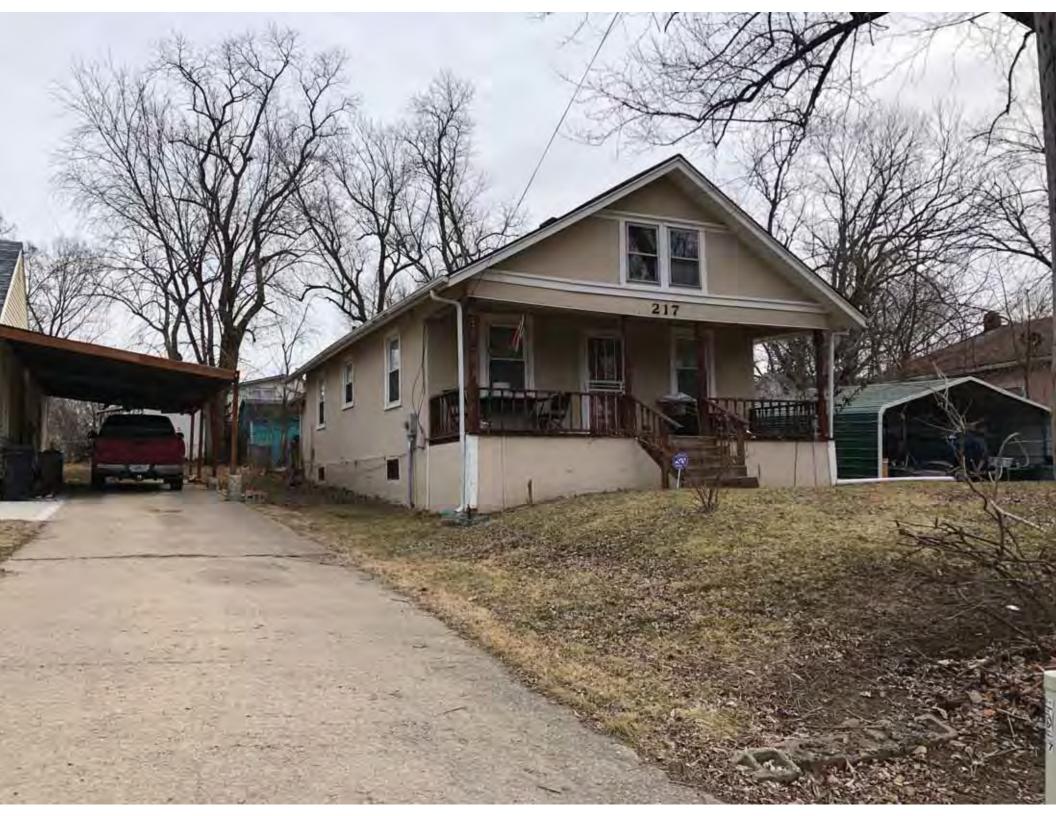
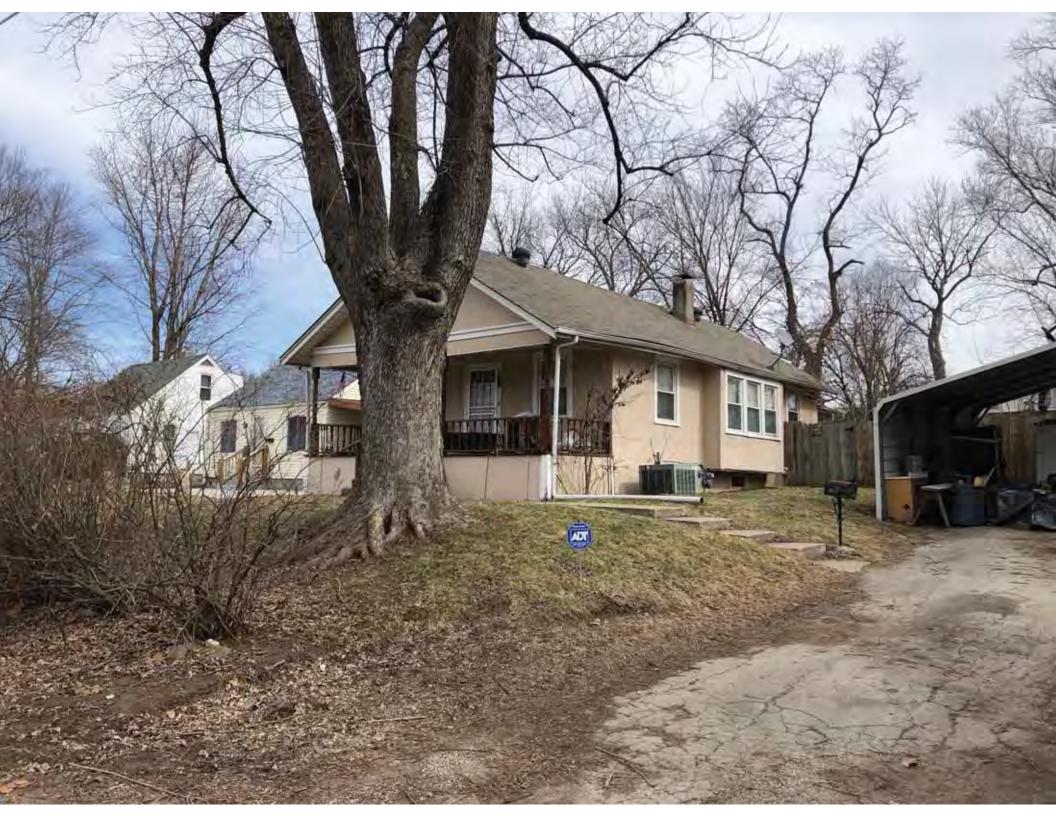
The main façade faces west. A centrally placed main entry is flanked by replacement, one-over-one vinyl sash windows with wood surrounds, which repeat at the secondary façades. A pair of replacement one-over-one vinyl sash windows are placed centrally at the front gable end withdecorative trim at the head and sill of the windows extending the full width of the gable end. The full-width, open porch features four, non-original, equally spaced wood spindle columns with wood spindle railing. Additional features include a bay window centered at the south façade with three one-over-one vinyl sash windows, a brick chimney at the south side slope, and a partial-width, shed roofed addition to the rear, constructed at an unknown date. Although the date of construction and form of this house point to a likely original Craftsman styling, few character defining features remain due to loss of original building materials, alterations, and subsequent modifications. Due to loss of original materials and other alterations, this building lacks sufficient integrity of design, materials and workmanship to be considered eligible for listing in the NRHP.

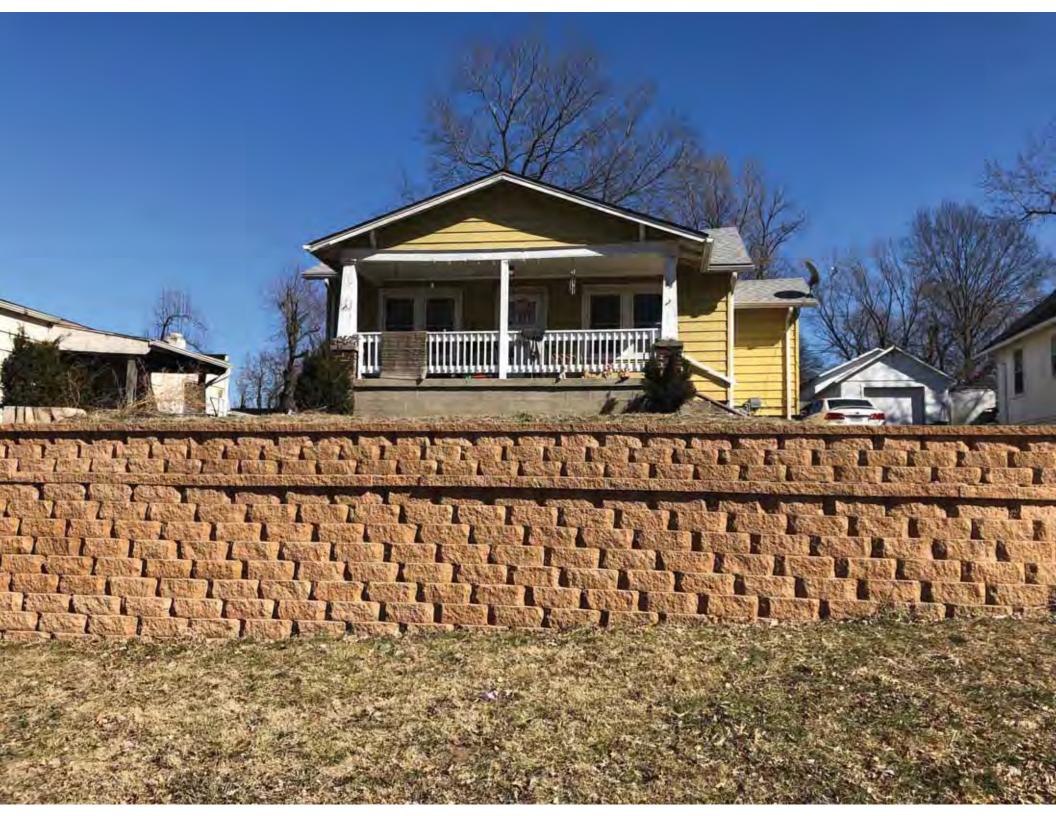
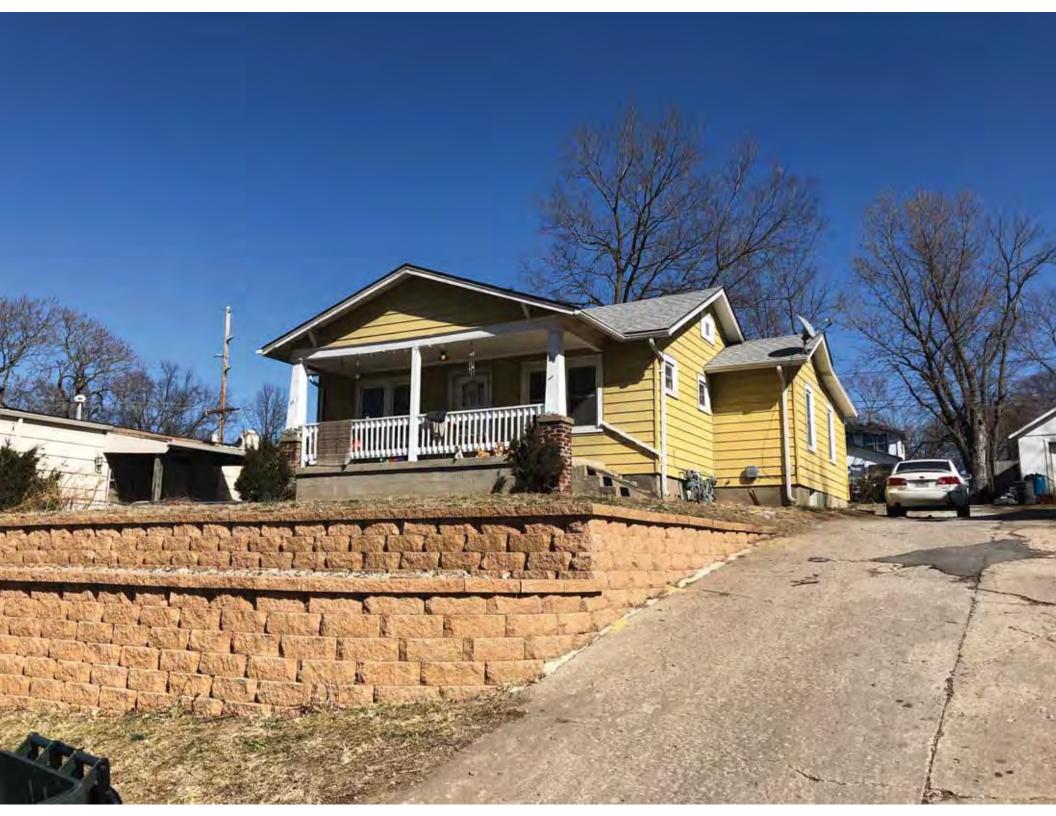
The main façade faces west. A central main entry is flanked by paired, replacement, one-over-one vinyl sash windows with aluminum storms and wood surrounds, which repeat at the secondary façades. The full-width, gabled, open porch features two battered wood columns, supported by brick plinths witha central square post and a simple timber batten railing. The porch also features two knee braces. Additional house features include partial-length, south façade ell addition and a c. 1960 shed roof, enclosed porch addition to the rear, as observed on aerial imagery. This building is a common example of its type that lacks distinction and therefore historical significance. Additionally, due to loss of original materials, including windows and siding, this building lacks sufficient integrity of materials and workmanship to be considered eligible for listing in the NRHP.

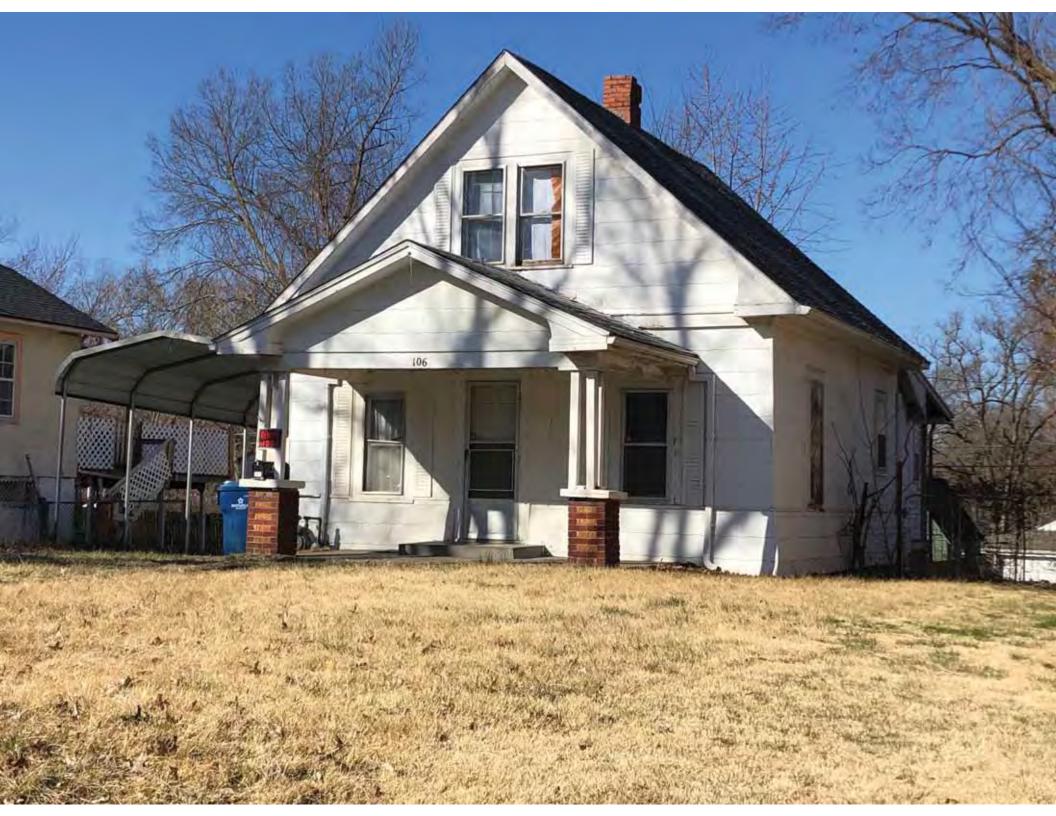
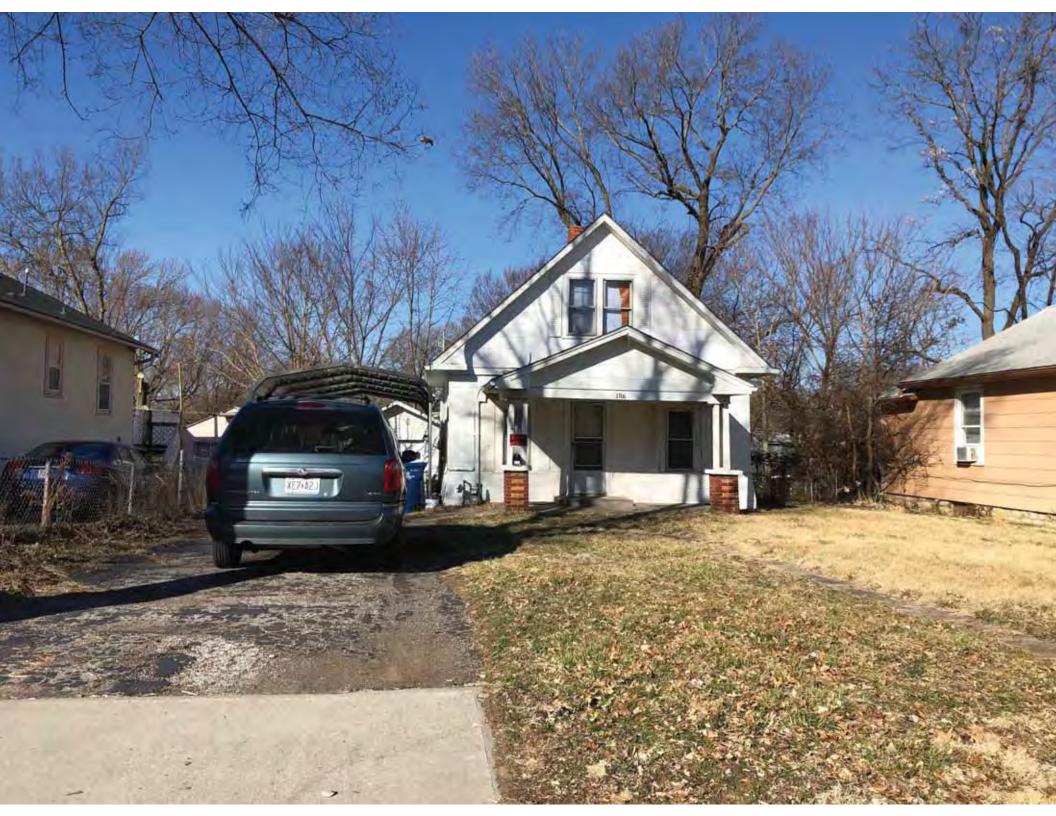
The main façade faces east. An asymmetrically-placed main entry is flanked by replacement, one-over-one vinyl sash windows with aluminum storms and wood surrounds, which repeat at the secondary façades. The main entry consists of a six-panel wood door with wood surround and full-glass storm door. The partial width, gable porch is centered at the main façade and features two groupings of three wood posts, supported by brick plinths. The second story features paired, one-over-one vinyl sash windows with wood surrounds centered at the gable end. Additional features include a brick ridge chimney and a full-width shed roof addition to the rear (constructed at an unknown date). Foundation materials could not be determined, as the foundation has been covered with asbestos siding. This building is a common example of its type that lacks distinction and therefore historical significance. Additionally, due to loss of original materials, this building lacks sufficient integrity of materials and workmanship to be considered eligible for listing in the NRHP.

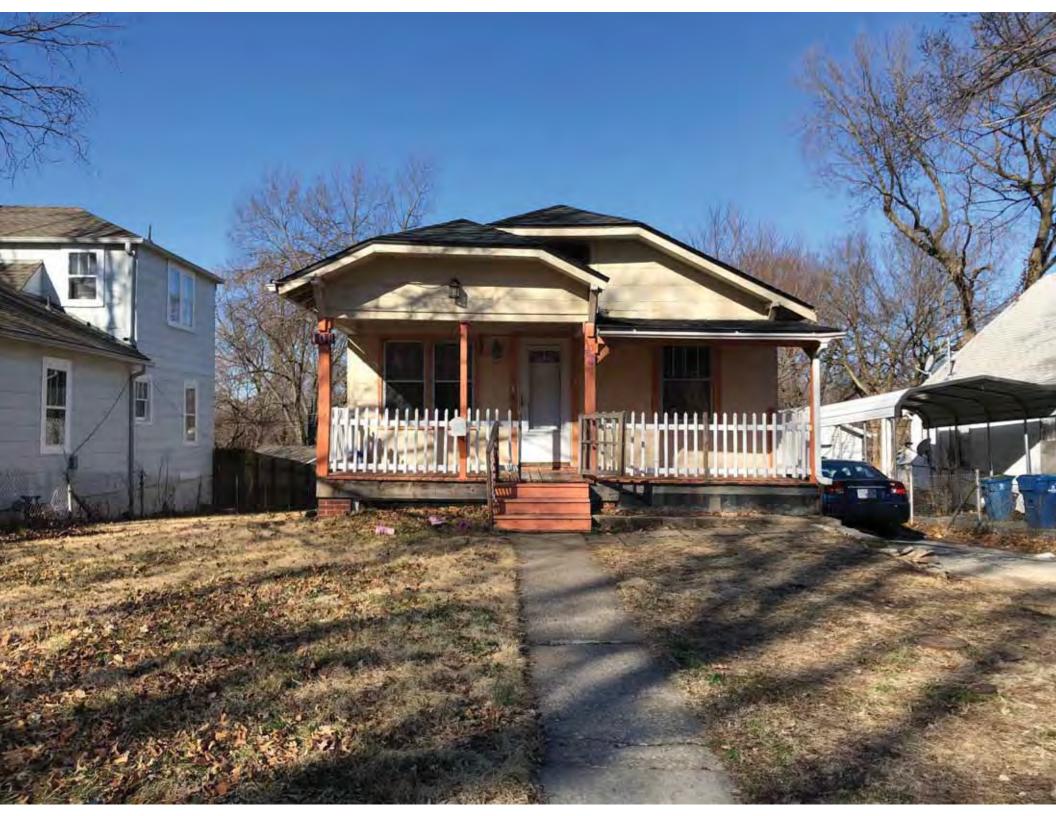
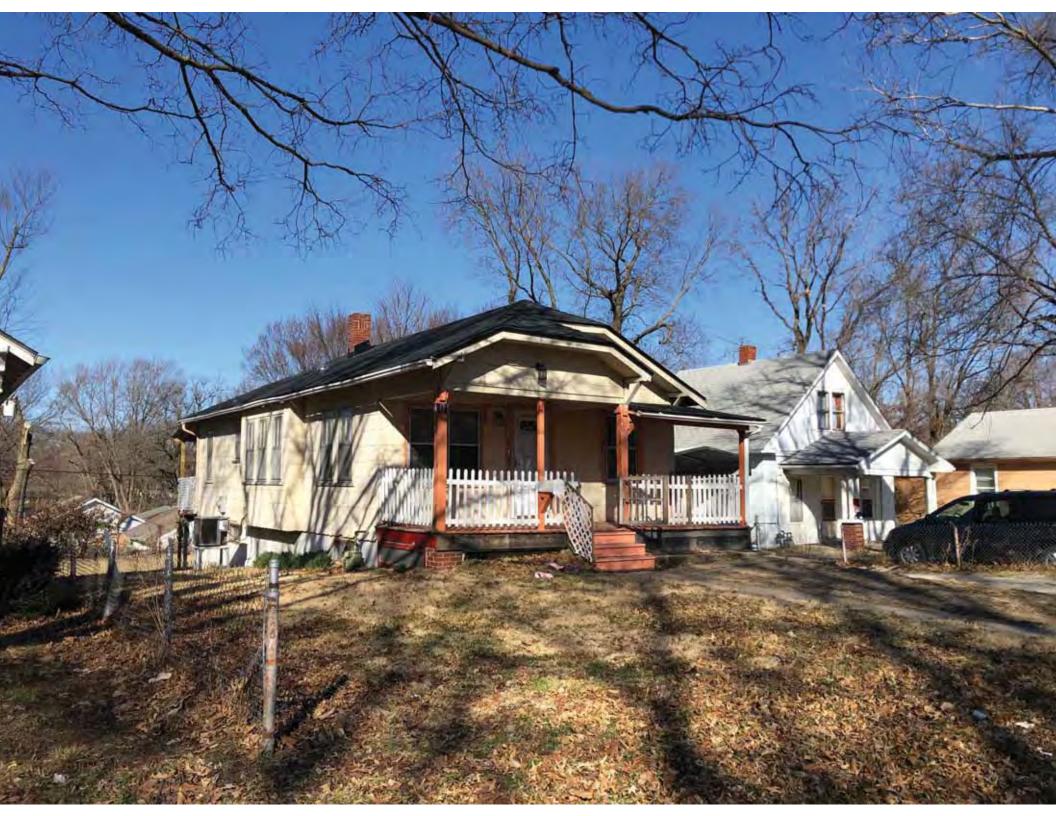
The main façade faces east. An asymmetrically-placed main entry is flanked by an original, four-over-one wood sash window to the north and replacement, paired one-over-one vinyl sash windows to the south. The main entry consists of a single-leaf, four-panel door with upper fan light. The partial-width, hipped gable porch shelters the central and southern bays and features three square wood posts set on brick piers. A partial-width, shed roof porch fills the northern bay. A non-original timber batten railing spans the full width of the east façade. Additional features include knee bracing, a brick chimney placed at the south side slope of the roof, and a bay window placed centrally at the south façade. A partial-width, open porch extends from the south bay at the rear façade. This building is a common example of its type that lacks distinction and therefore historical significance. Additionally, due to some loss of original materials, including siding, this building has diminished integrity of materials and workmanship.

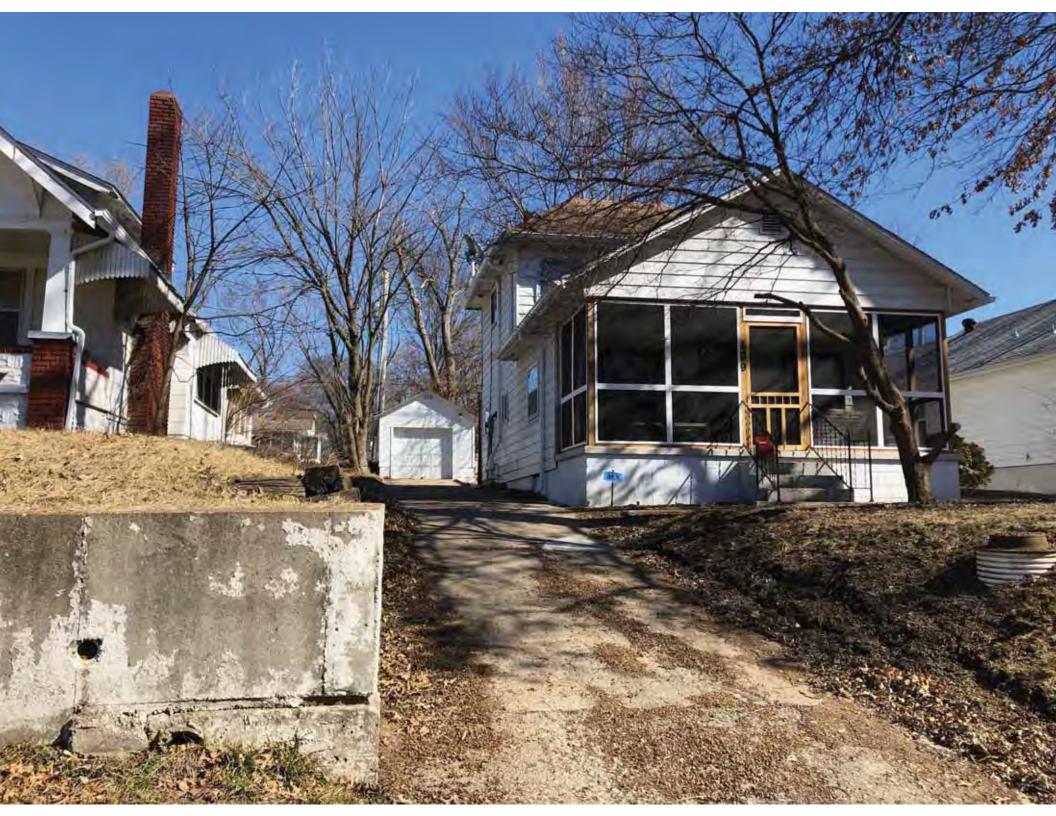
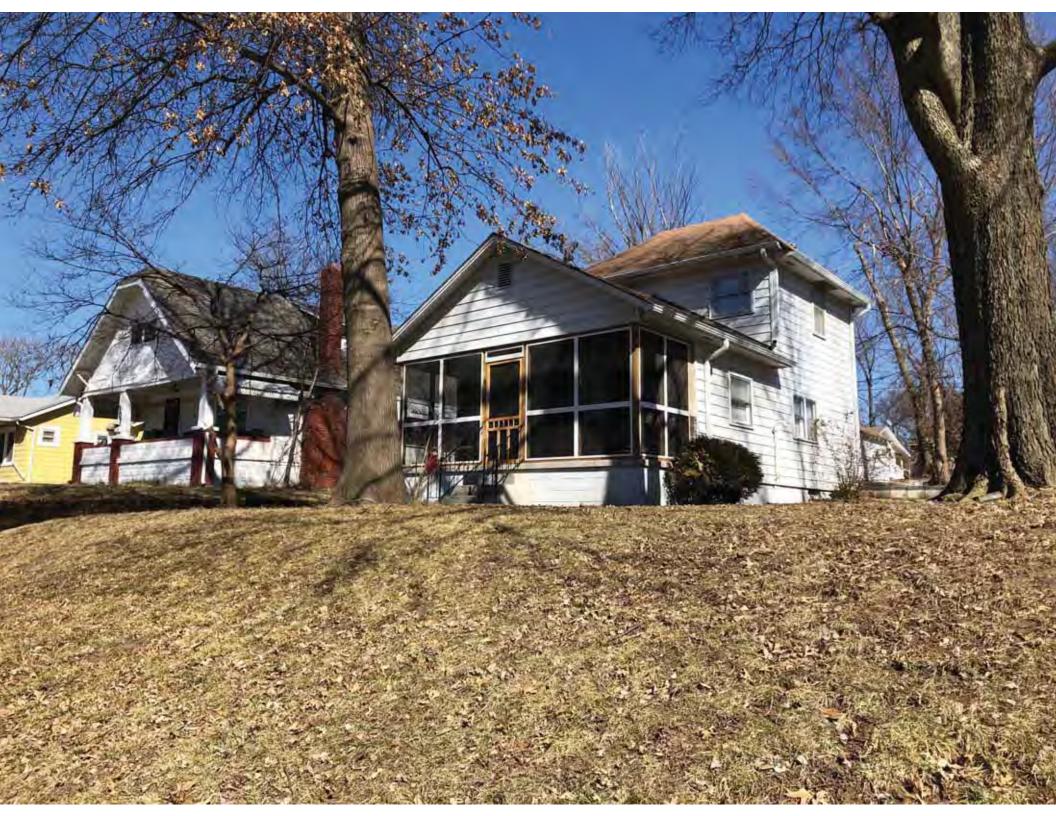
The main façade faces west. An asymmetrically-placed main entry door is flanked by square, diamond-paned windows with wood surrounds that surmount a coursed brick skirting at the main façade. A small rectangular louvered vent is placed centrally at the gable end. The full-width, screen-enclosed porch features wood posts set on a concrete block foundation. This porch configuration replaced wrought iron columns and railing in 2019, as seen on a Google Street View image capture of the property. A two-story, hipped addition to the rear was constructed c. 1965 (as observed on historic aerial imagery) and features one-over-one vinyl sash windows with aluminum storms as well as some sliding windows at the north façade. A small rear entry porch was likely constructed at the same time as the hipped addition. Although the construction date and form of this house indicate a likely Craftsman original styling, loss of original building materials and alterations have compromised the character-defining features of this residence. Due to loss of original materials, changes to form, and other alterations, this building lacks sufficient integrity of design, materials and workmanship to be considered eligible for listing in the NRHP.

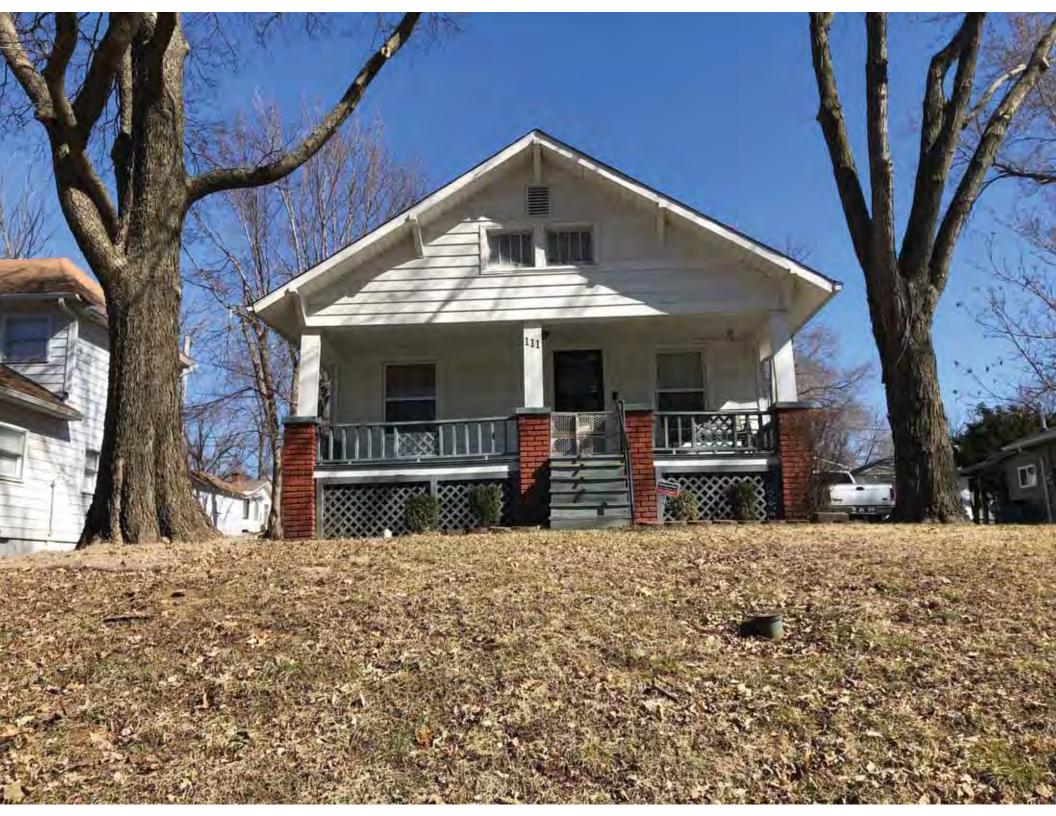
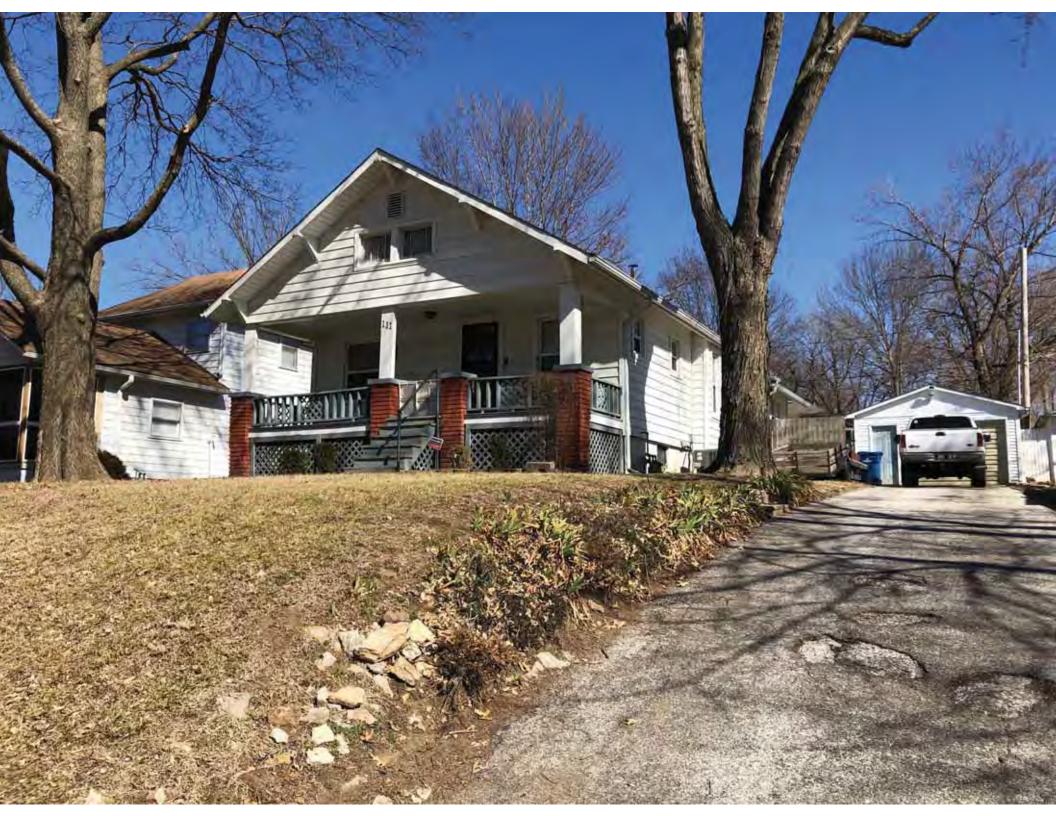
The main façade faces west. An asymmetrically-placed main entry is flanked by replacement, one-over-one vinyl sash windows with wood surrounds, which repeat at the secondary façades. Paired, fixed wood windows with four vertical panes are placed centrally at the gable end, which features knee bracing. The full-width, open porch features three square wood columns supported by brick plinths (a fourth plinth lacks a column), and a simple, wood railing. Additional features include a bay window centered at the south façade, a metal stack chimney at the south side slope, and a full-width, gabled addition to the rear, constructed at an unknown date. This building is a common example of its type that lacks distinction and therefore historical significance. Additionally, due to some loss of original materials, including siding, this building has diminished integrity of materials and workmanship.

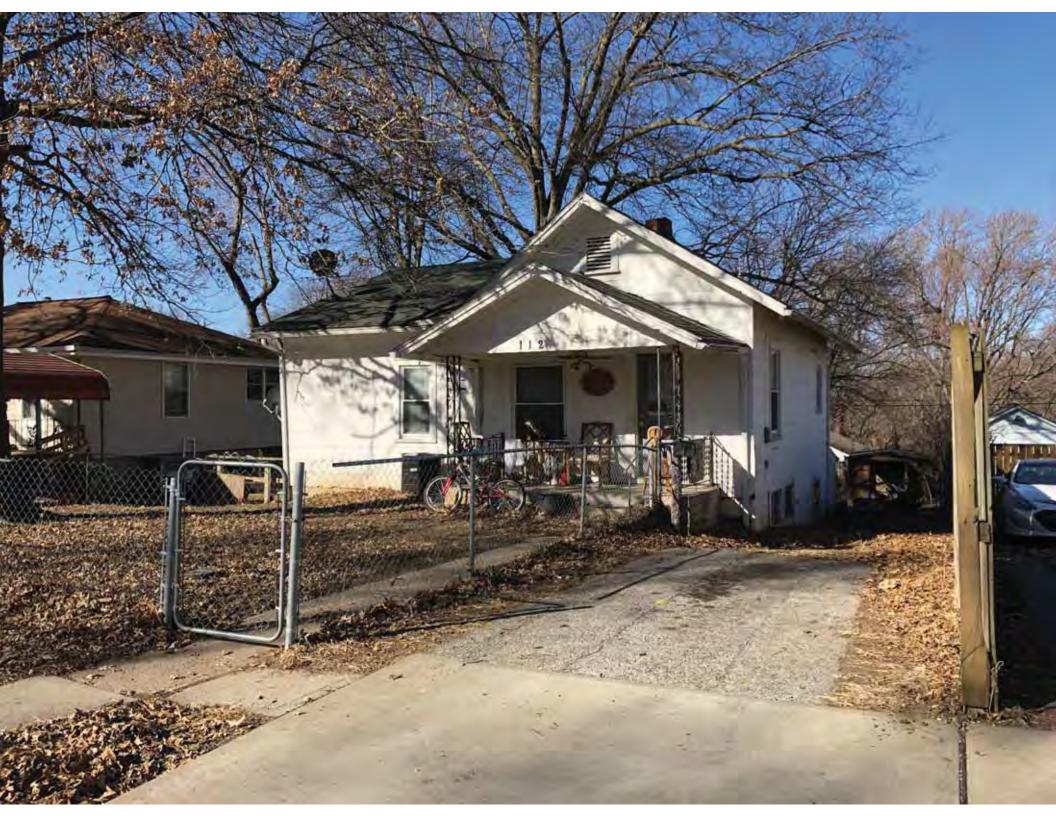
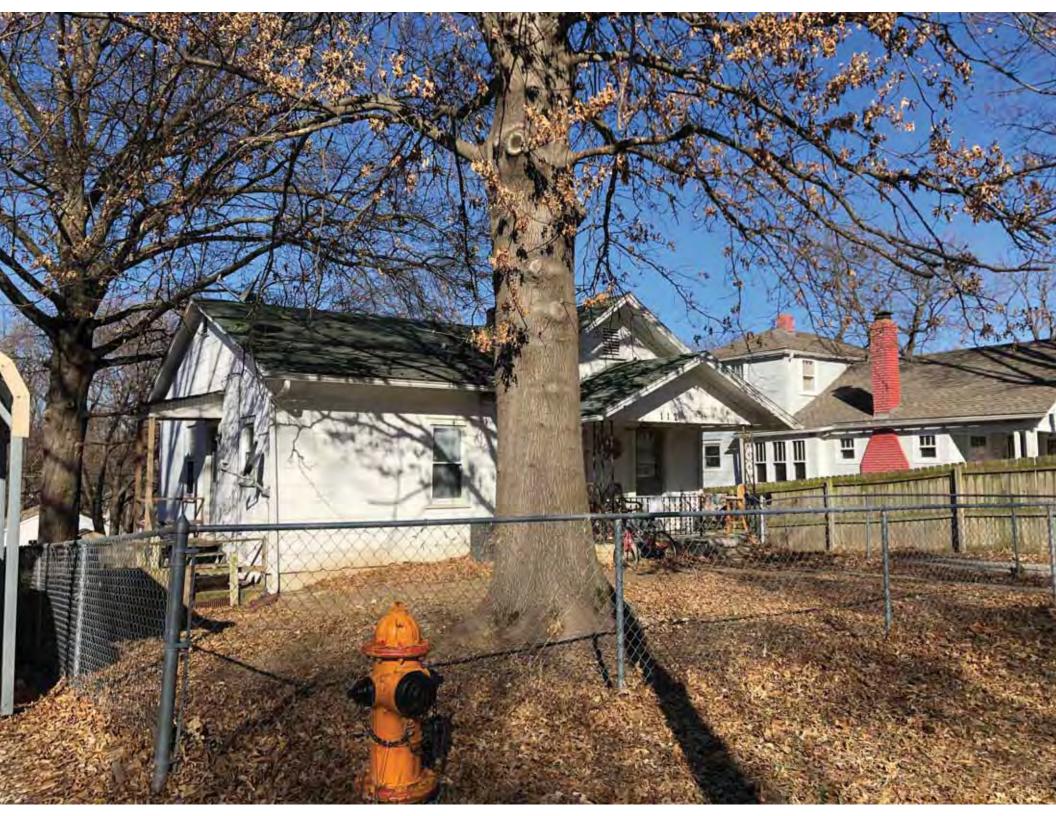
The main façade faces east. This one-story house features a gable front, rectangular plan, modified c. 1955 with a full-width, gabled wing addition, as observed on historic aerial imagery. The front-facing gable contains a gabled, open porch supported by non-original, wrought iron columns and railing. The porch shelters a single-leaf main entry door placed north of a replacement, one-over-one vinyl sash window. A second window is placed at the main façade of the wing addition. The south façade features a secondary entry withshed roof entry porch, flanked by small sash windows. A brick ridge chimney is placed at the intersection of the gabled wing. A partial-width, rear porch was enclosed at an unknown date. Due to loss of original materials, changes to form, and other alterations, this building lacks sufficient integrity of design, materials and workmanship to be considered eligible for listing in the NRHP.

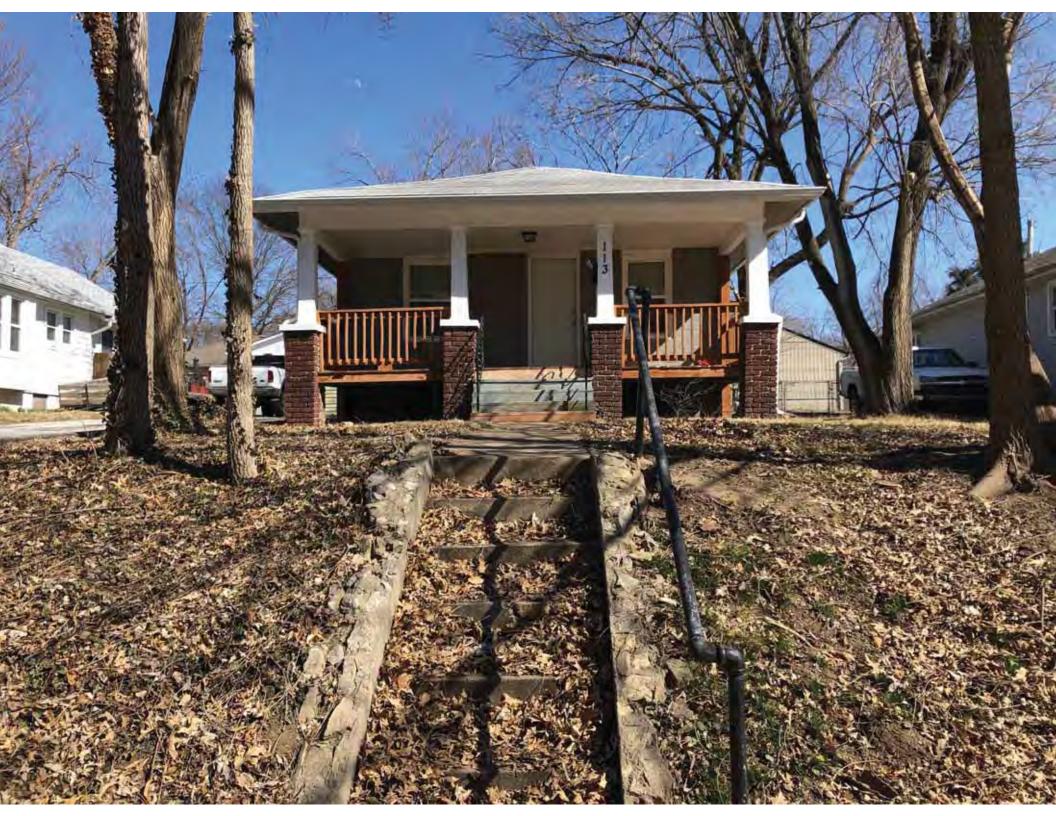
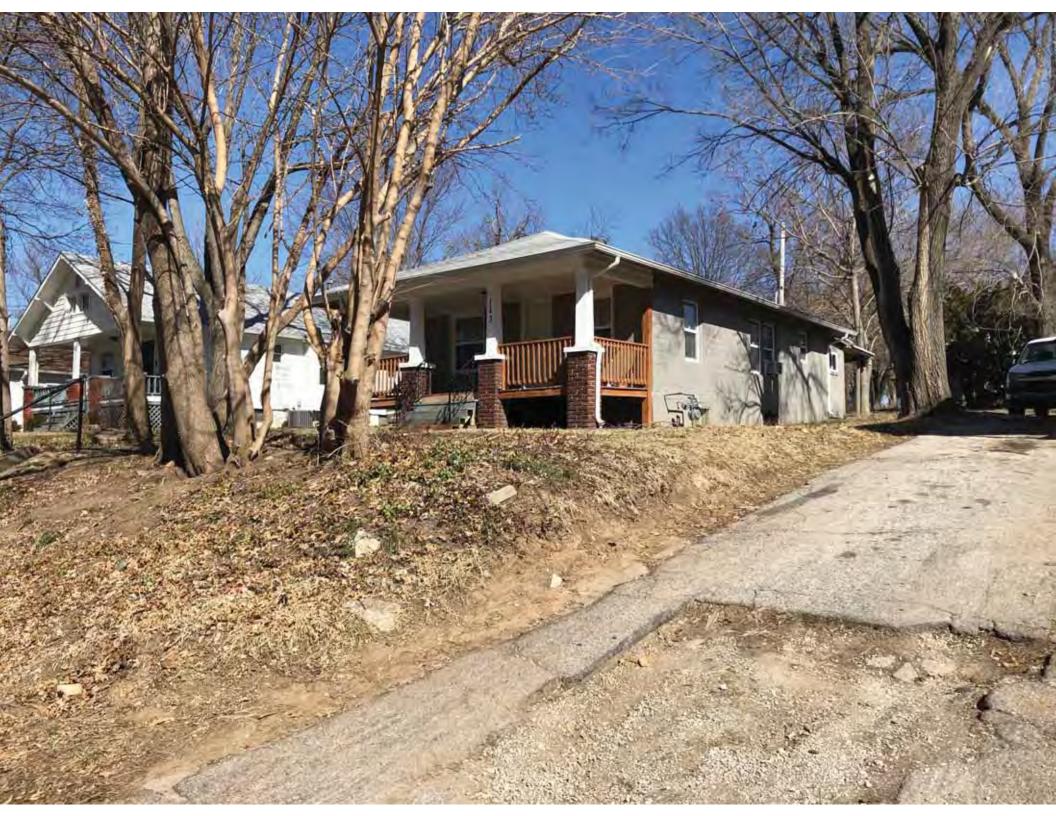
The main façade faces west. This house is characterized by its brick tile wall cladding and Craftsman detailing. An asymmetricallyplaced main entry is flanked by replacement, one-over-one vinyl sash windows with wood surrounds, which repeat at the secondary façades. The main entry consists of a single-leaf, six-panel wood door. The full-width, open front porch features four, equally spaced, battered wood columns, supported by brick plinths and a timber batten railing with central staircase. Additional features include a concrete block chimney placed at the north side of the hipped roof and a partially enclosed porch addition to the rear, constructed at an unknown date. This building retains a sufficient level of integrity to be considered for NRHP eligibility; however, it is a common example of its type that lacks distinction and therefore historical significance.
