1. Survey No.			2. Survey name:		
JA-AS-091-240		Fairmount Phase I Survey			
3. County:			4. Address (Street No.)	reet No.) Street (name)	
			, , ,	. ,	
JA			104	S. Home Avenue	
5.City: Vicinity:		6. Geographical Reference:		7. Township/Range/Section:	
Independence			39.109917, -94.459124	1	T: 50N R: 32W 32
8.Historic name (if k	nown):	•		9. Present/other	name (if known):
10. Ownership:			11a. Historic use (if know	/n):	11b. Current use:
Private	Public		Domestic		Domestic

21. (cont.) History and significance. Expand box as necessary, or add continuation pages.

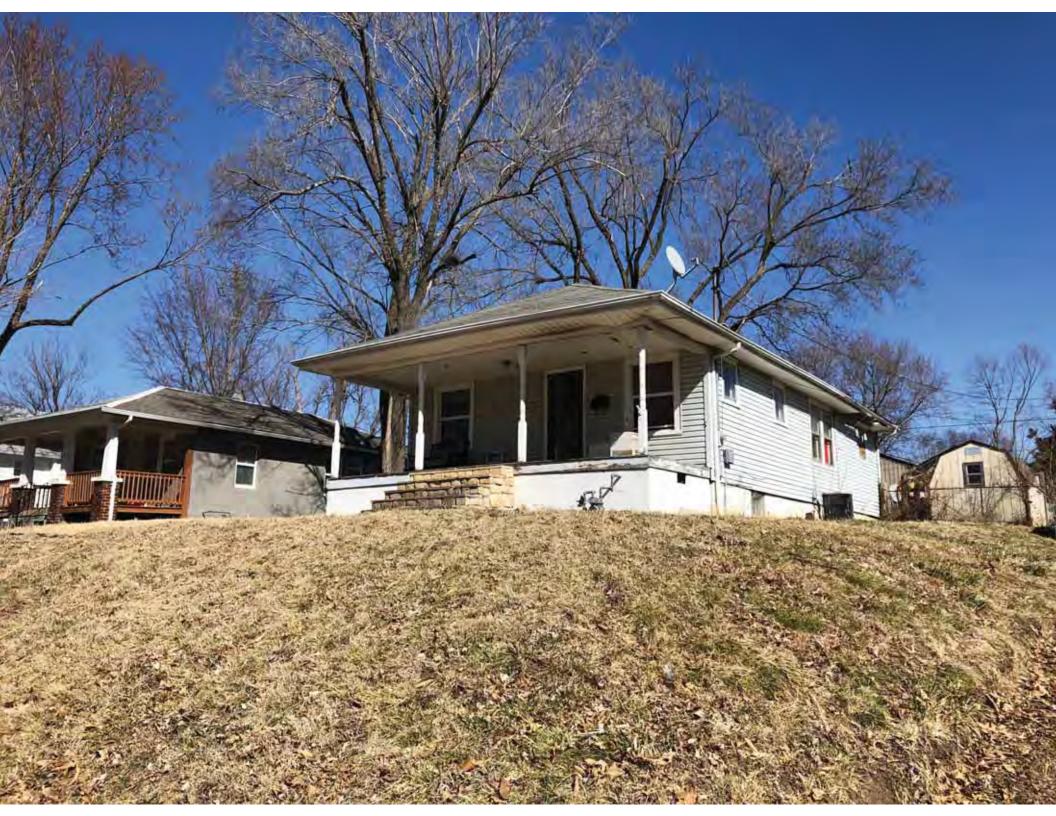
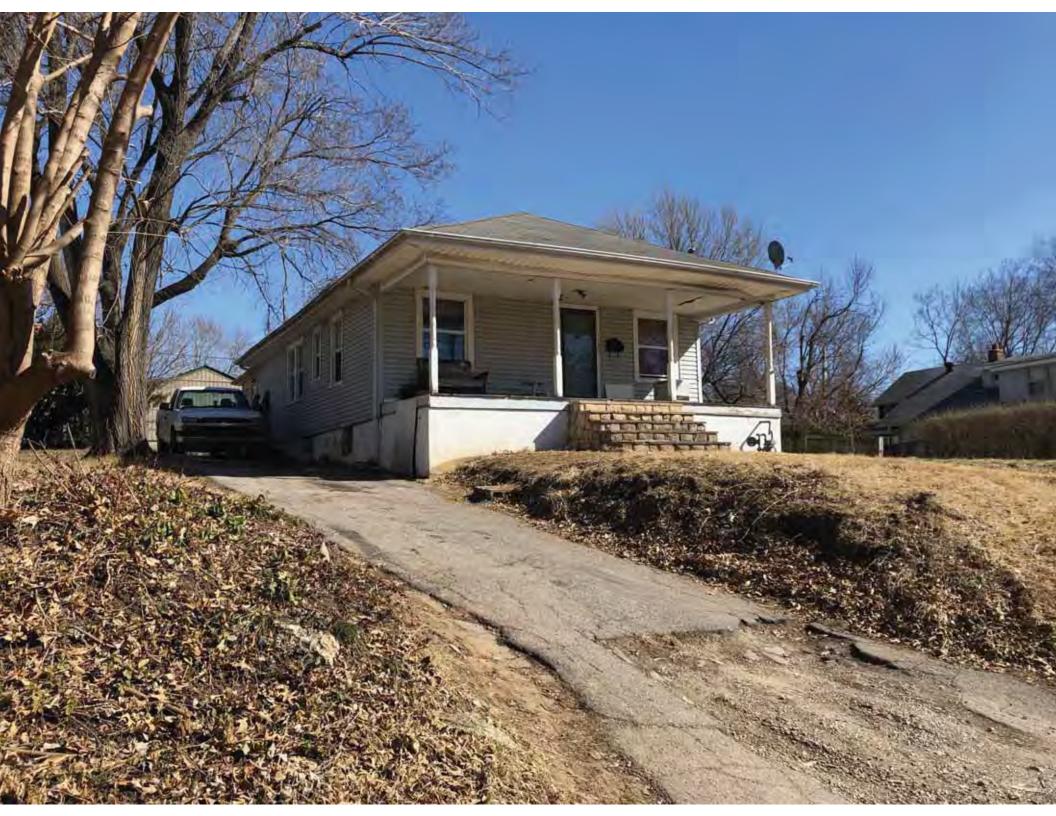
The main façade faces west. An asymmetrically-placed main entry is flanked by replacement, one-over-one vinyl sash windows with wood surrounds. The main entry consists of a single-leaf, wood-paneled door with diamond-shaped window. The full-width, open porch features four, non-original, turned spindle supports set on a concrete block foundation with central stone staircase. The secondary façades feature paired and single window units, including two square windows at the south façade. Additional features include a concrete block chimney placed at the rear slope of the hipped roof and a partial-width, hipped addition to the rear. Although the construction date and form of this house indicate a likely Craftsman original styling, loss of original building materials and alterations have compromised the character-defining features of this residence. Due to loss of original materials and other alterations, this building lacks sufficient integrity of design, materials and workmanship to be considered eligible for listing in the NRHP.

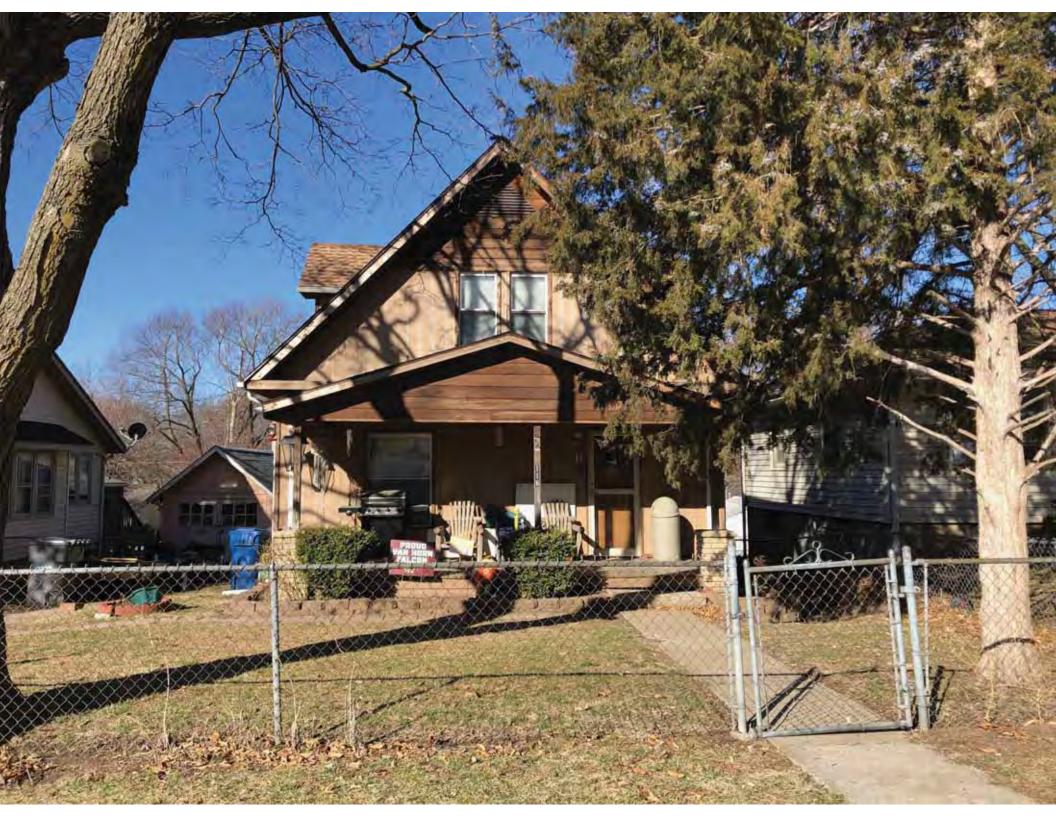
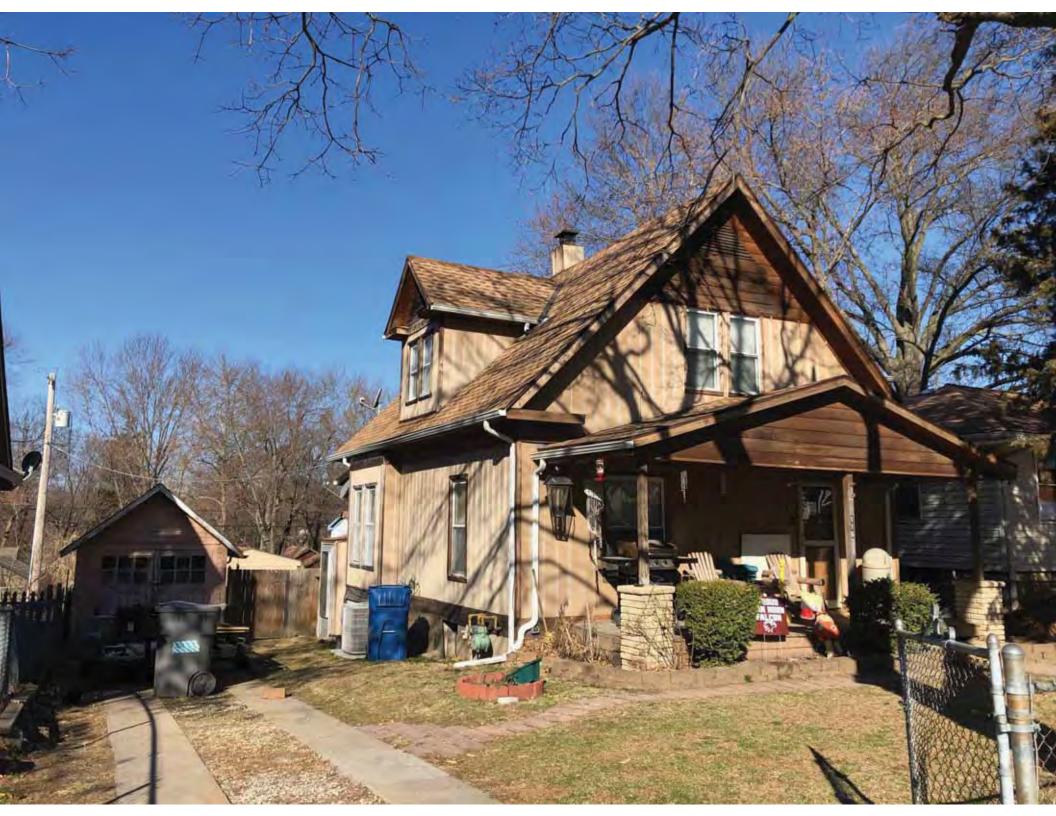
The main façade faces east. This gable-front house is clad in wood board and batten siding; however, it appears to be missing the battens. A single-leaf main entry door is placed north of a one-over-one vinyl sash window, which repeat in pairs and single units at the secondary façades. The full width, gabled porch features three square wood posts; the two outer posts are supported by brick plinths. The second story features paired one-over-one vinyl sash windows centered at the gable end and surmounted by wood shiplap cladding in the gable peak. Additional features include centered gabled dormers at each side slope of the roof, a bay window at the south façade, and a concrete block chimney at the north side slope of the roof. Rear porch additions, featuring shed roofs, were enclosed at an unknown date. This building is a common example of its type that lacks distinction and therefore historical significance. Additionally, due to loss of original materials, this building lacks sufficient integrity of materials and workmanship to be considered eligible for listing in the NRHP.

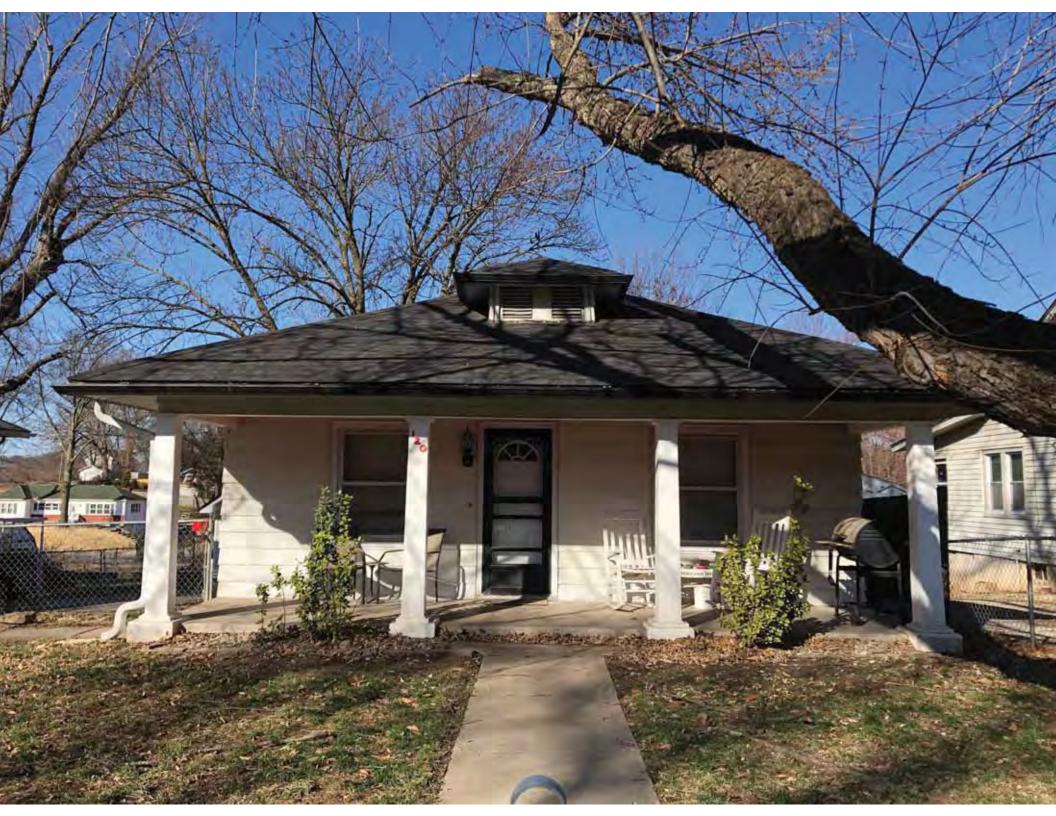
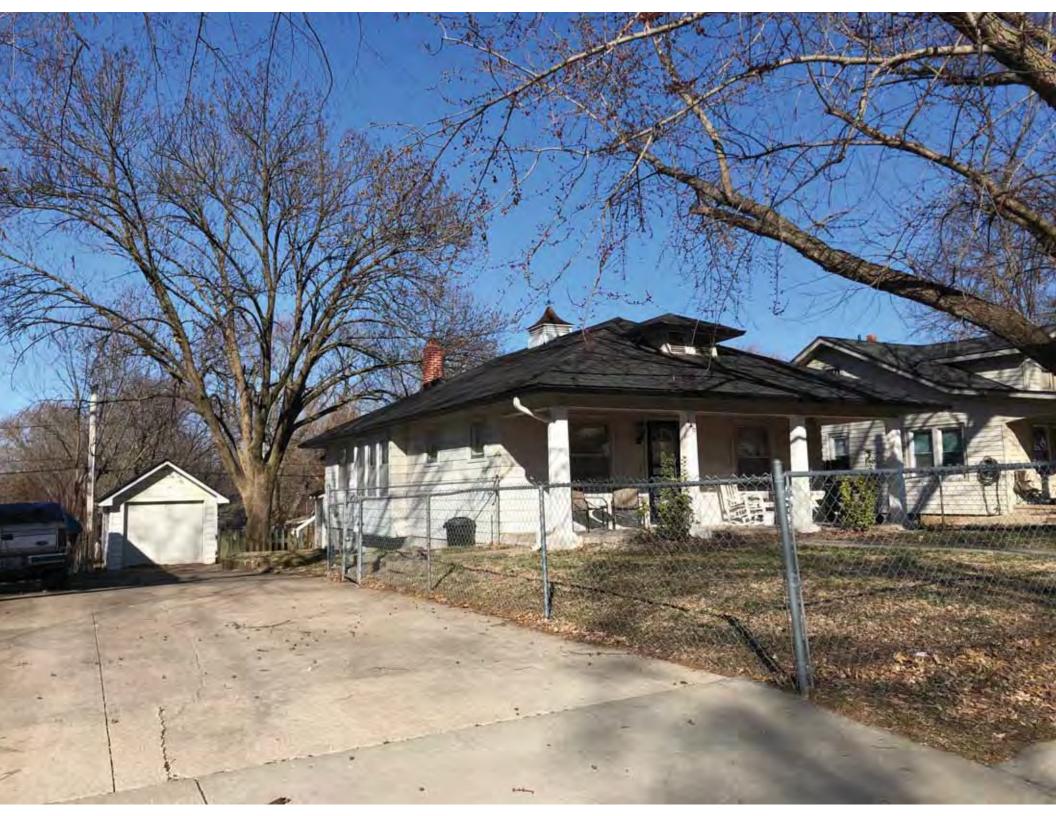
The main façade faces east. An asymmetrically-placed main entry is flanked by replacement, one-over-one vinyl sash windows with aluminum storms and wood surrounds, which repeat at the secondary façades. The main entry consists of a single-leaf, four-panel wood door with upper fan light. The full-width, open porch features four battered wood columns. A hipped dormer with two squared louvered vents is centrally located at the main façade. The south façade features a bay window at the central bay and a brick chimney at the south slope of the roof. A small wood frame cupola is placed centrally along the ridge line. The rear porch was enclosed at an unknown date. This building is a common example of its type that lacks distinction and therefore historical significance. Additionally, due to loss of original materials, this building lacks sufficient integrity of materials and workmanship to be considered eligible for listing in the NRHP.

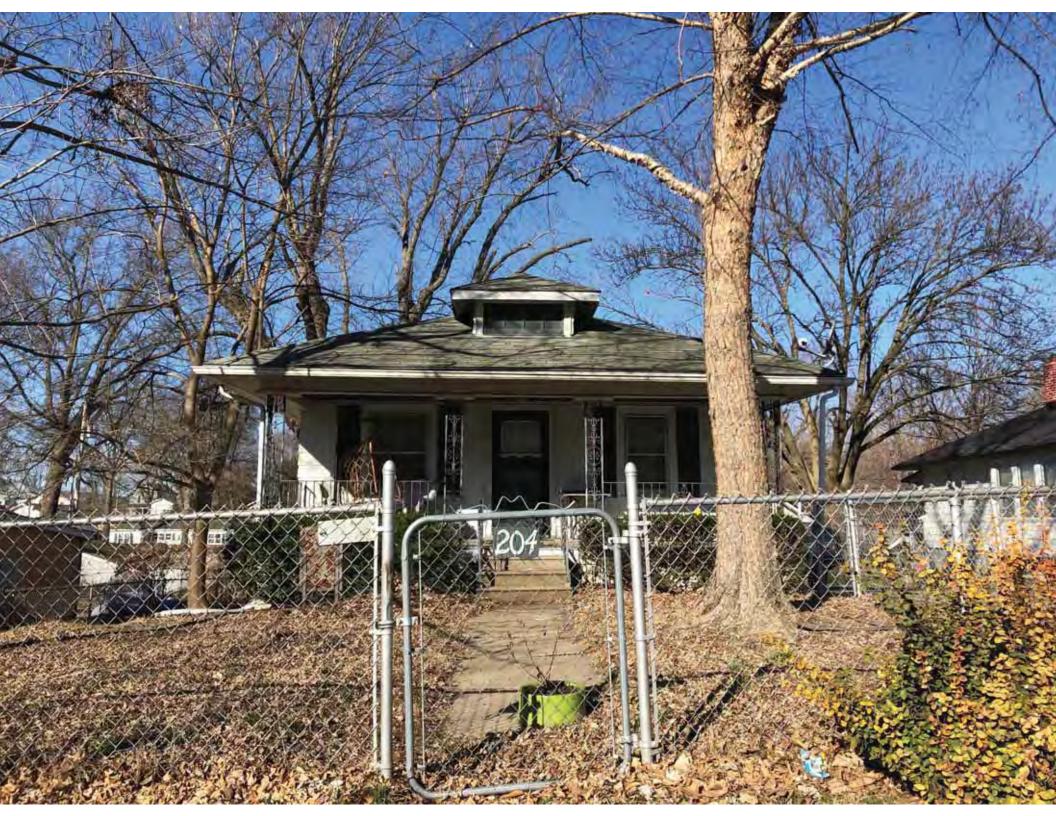
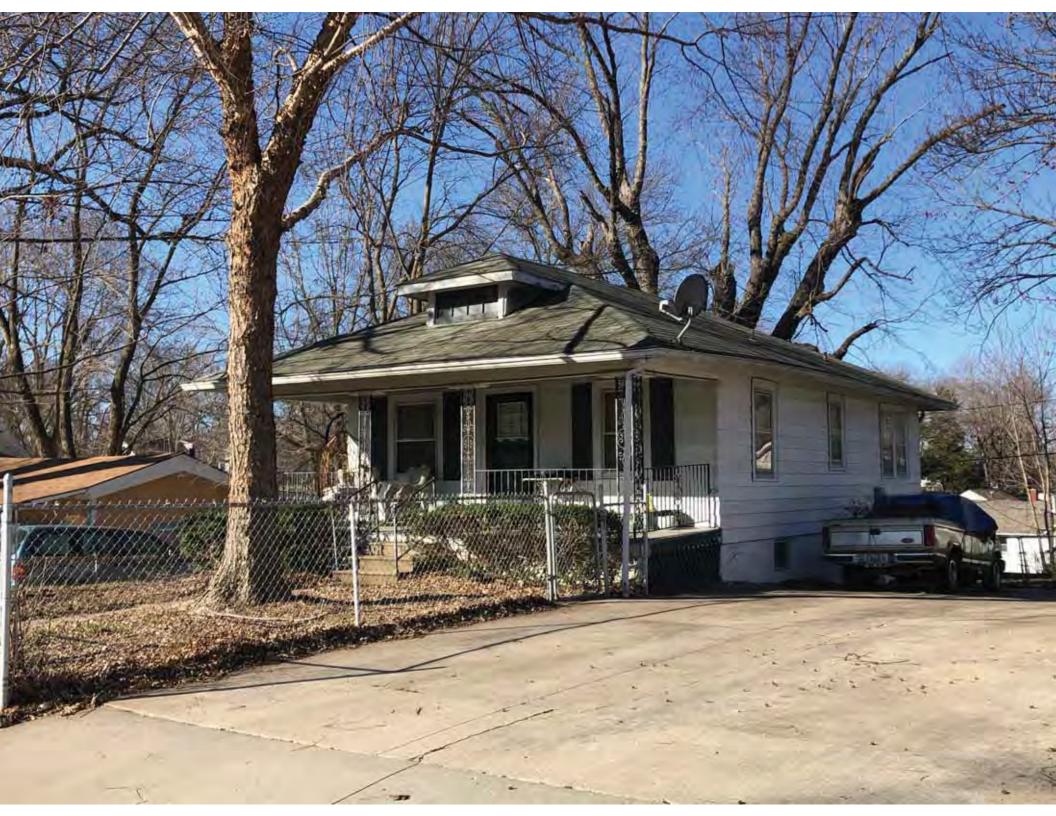
The main façade faces east. An asymmetrically-placed main entry is flanked by replacement, one-over-one vinyl sash windows with aluminum storms and wood surrounds, which repeat at the secondary façades. The full-width, open porch features four non-original wrought iron columns and railing with a central staircase. A hipped dormer is centrally located at the main façade. The south façade features a bay window at the central bay and a brick chimney at the south slope. The rear porch was enclosed at an unknown date. This building is a common example of its type that lacks distinction and therefore historical significance. Additionally, due to loss of original materials, this building lacks sufficient integrity of materials and workmanship to be considered eligible for listing in the NRHP.

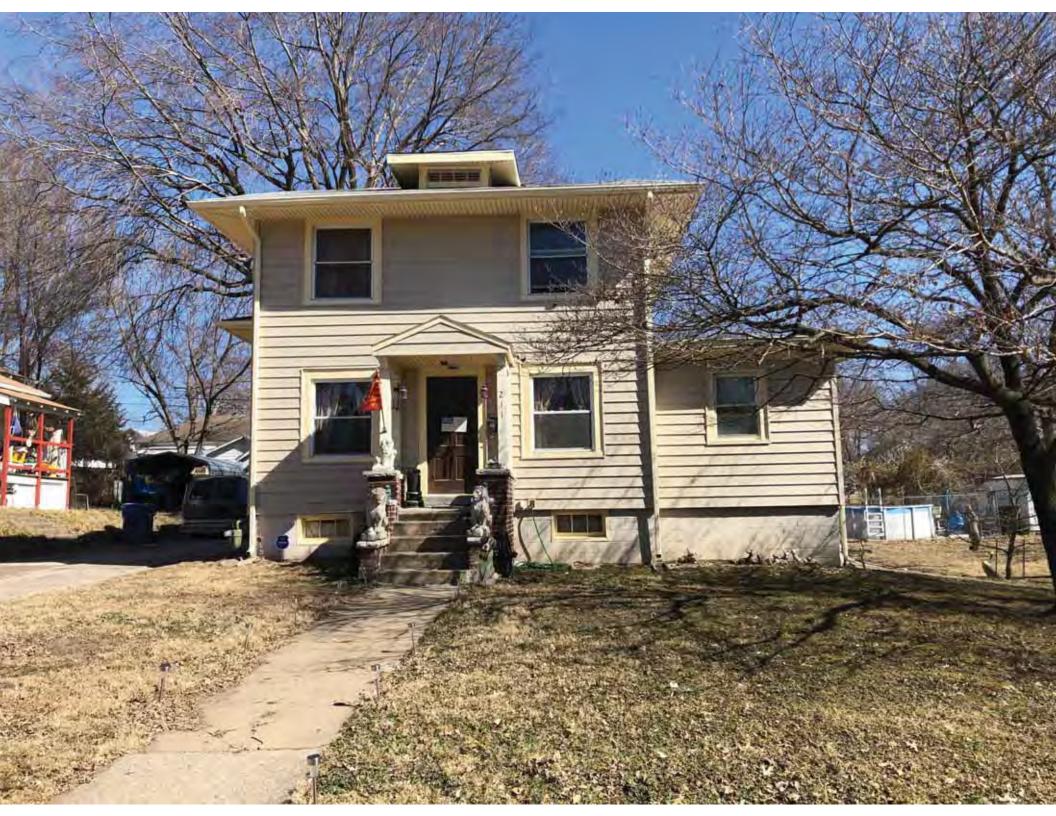
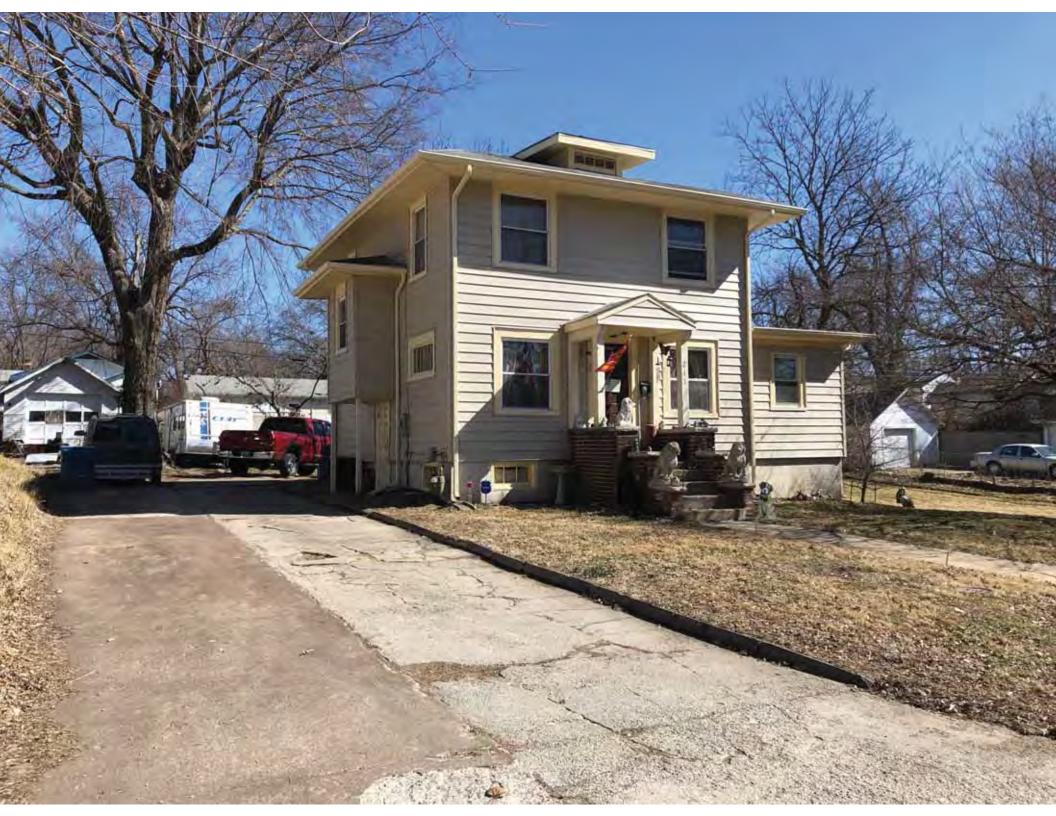
The main façade faces west. This hipped roof, square plan, house differs slightly from an American Four-Square in form with its central hall and lack of a full width porch. A central, six-panel, wood door with wood surround is flanked by replacement, one-over-one vinyl sash windows with wood surrounds, which repeat at the second story and secondary façades. The entry porch portico features a gable pediment roof with two squared posts and two pilasters supported by solid brick walls witha concrete staircase. A shallow, hipped dormer with divided lite wood window is placed centrally at the front roof slope. Additional house features include a single-story, hipped, side addition and a hipped bay window supported by two square posts, centered at the north façade, surmounting a six-panel wood entry door. Wood clapboard siding was replaced with vinyl siding at some date after February 2019, as seen on a Google Street View image capture of the property, and a handful of original multi-lite wood windows are retained at the basement level and north façade. Although the construction date and form of this house indicate a possible Prairie original style, many of the character-defining features of this residence have been lost due to modifications, additions, and loss of original materials. Due to loss of original materials, changes to form, and other alterations, this building lacks sufficient integrity of design, materials and workmanship to be considered eligible for listing in the NRHP.

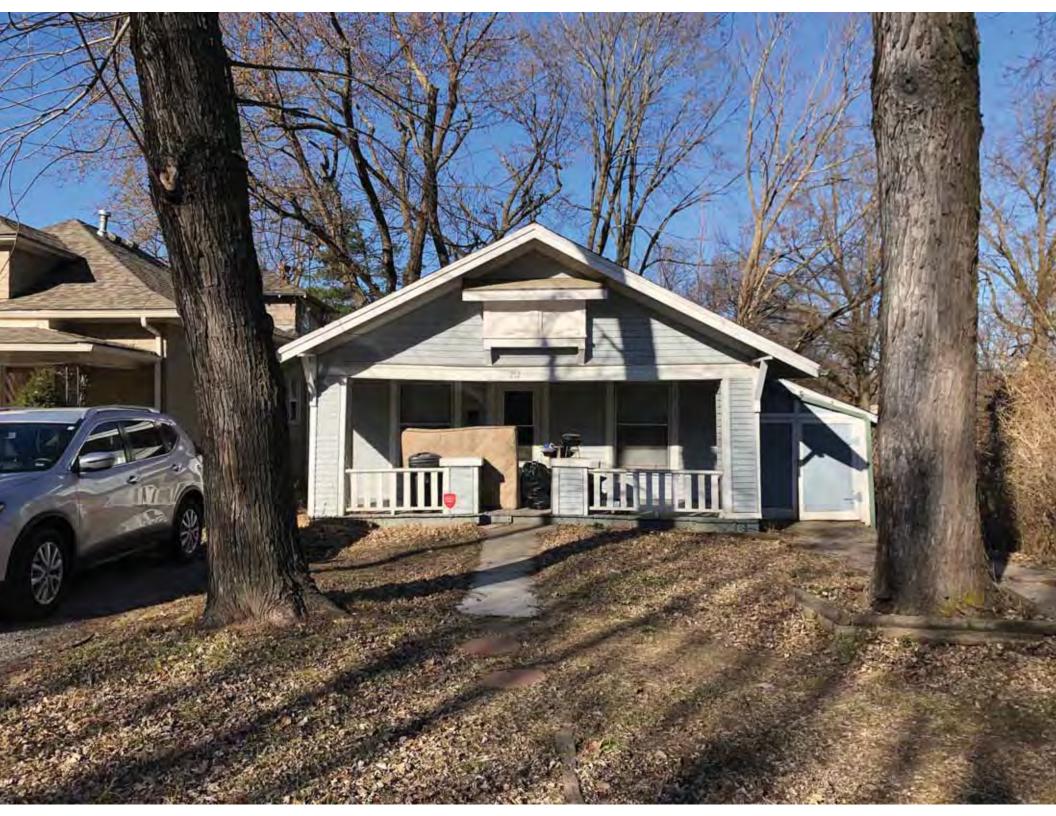
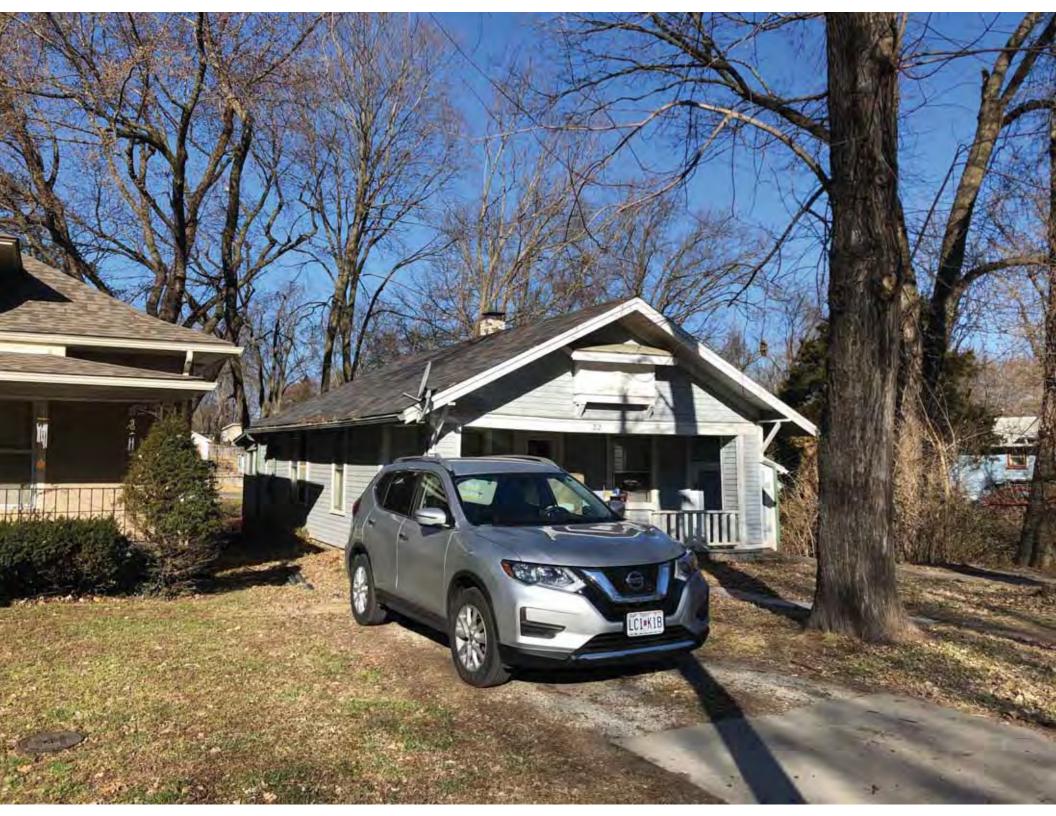
The main façade faces east. An asymmetrically-placed main entry is flanked by replacement, one-over-one vinyl sash windows with aluminum storms and wood surrounds, which repeat at the secondary façades. The main entry consists of a single-leaf, four-panel door with upper fan light. The full-width open porch features two full columns clad in non-original vinyl siding with two inner piers flanking a central entryway. Original porch railing has been replaced with vinyl balusters and rail. Original porch supports and piers have been covered with vinyl siding. The gable end features knee braces and a central pent roof with boarded windows. Additional features include a brick chimney placed at the north roof slope, a shed roof addition at the north façade, and a porch addition to the rear (constructed at an unknown date). Although the construction date and form point to a likely original Craftsman styling, few character-defining features remain due to loss of original materials, alterations, and subsequent modifications. Due to loss of original materials, changes to form, and other alterations, this building lacks sufficient integrity of design, materials and workmanship to be considered eligible for listing in the NRHP.

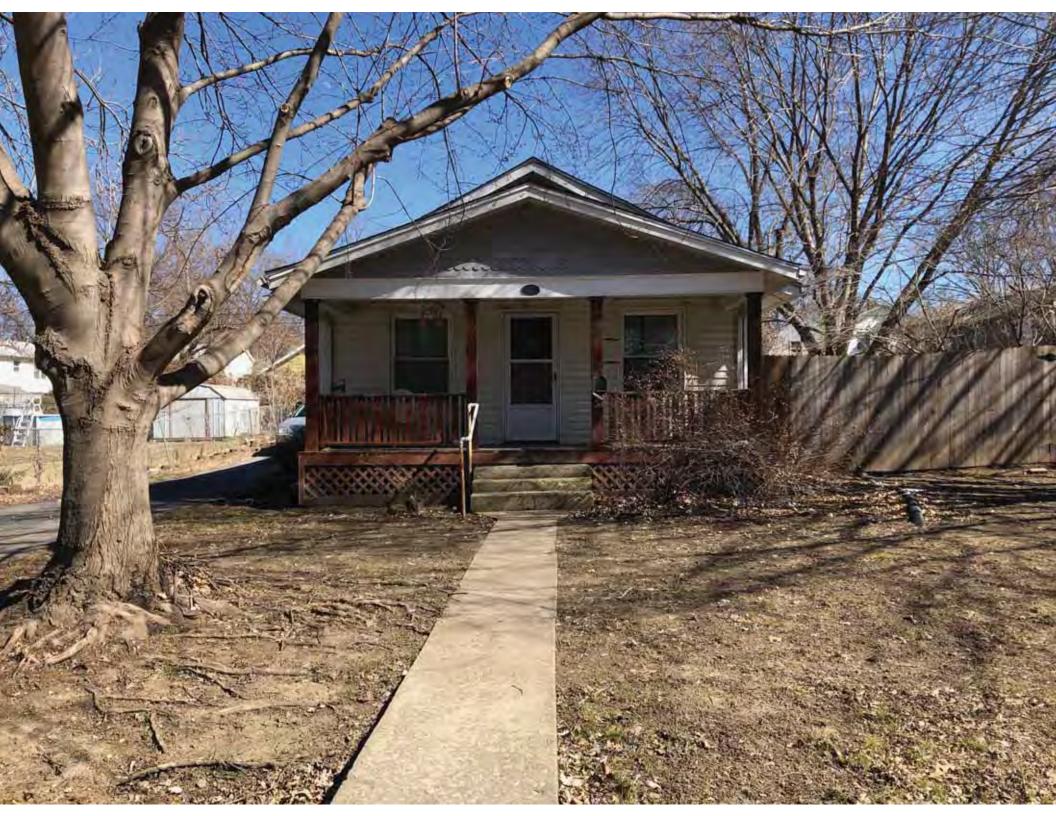
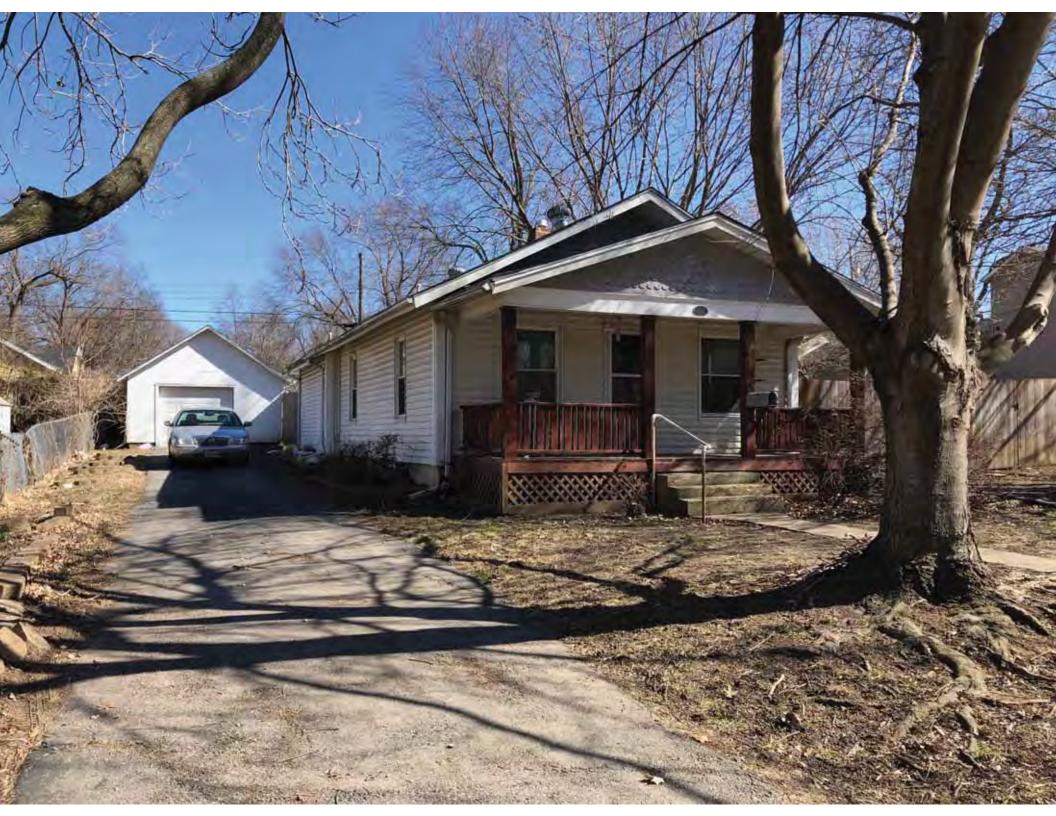
The main façade faces west. A central main entry is flanked by replacement, one-over-one vinyl sash windows with aluminum surrounds, which repeat in pairs and single units at the secondary façades. The main entry consists of a single-leaf, six-panel wood door. The full-width, gabled, open porch features four, square wood posts, non-original wood railing, and scalloped shingles at the gable end. Additional features include a brick chimney placed near the ridge at the south side of the gable roof and a rear porch enclosed at an unknown date. Although the construction date and form of this house indicate a likely Craftsman original styling, loss of original building materials and alterations have compromised the character-defining features of this residence. This building is a common example of its type that lacks distinction and therefore historical significance. Additionally, due to loss of original materials, this building lacks sufficient integrity of materials and workmanship to be considered eligible for listing in the NRHP.

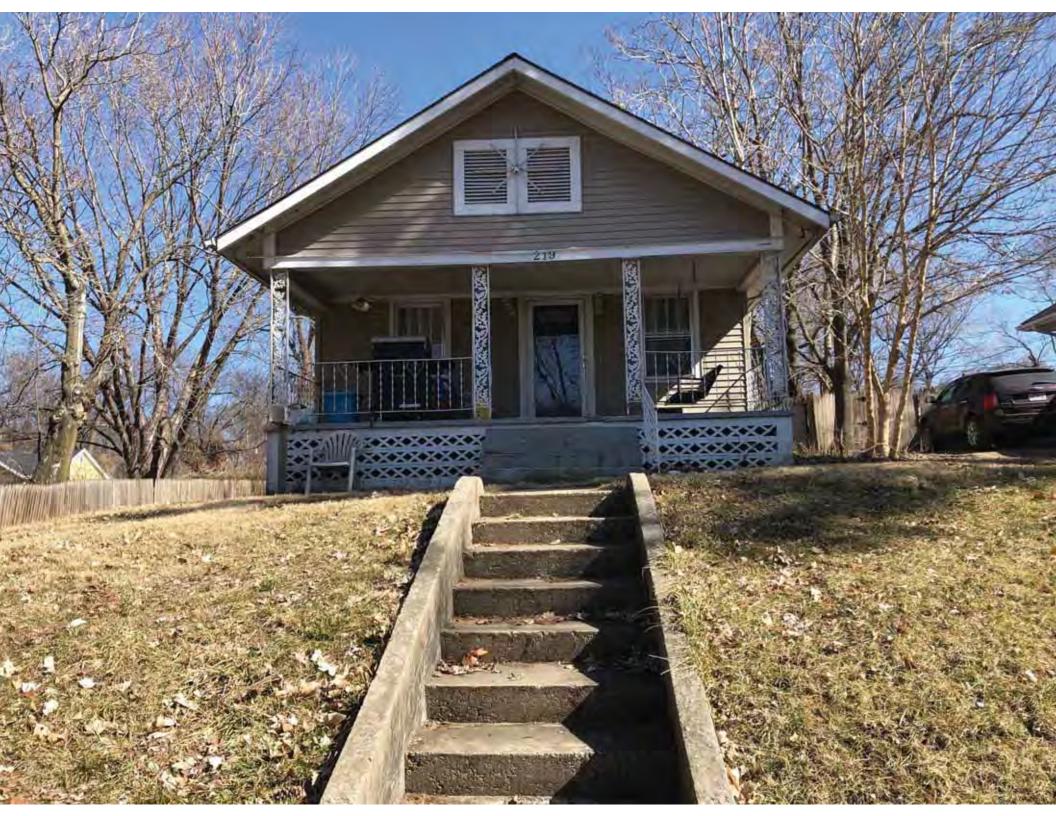
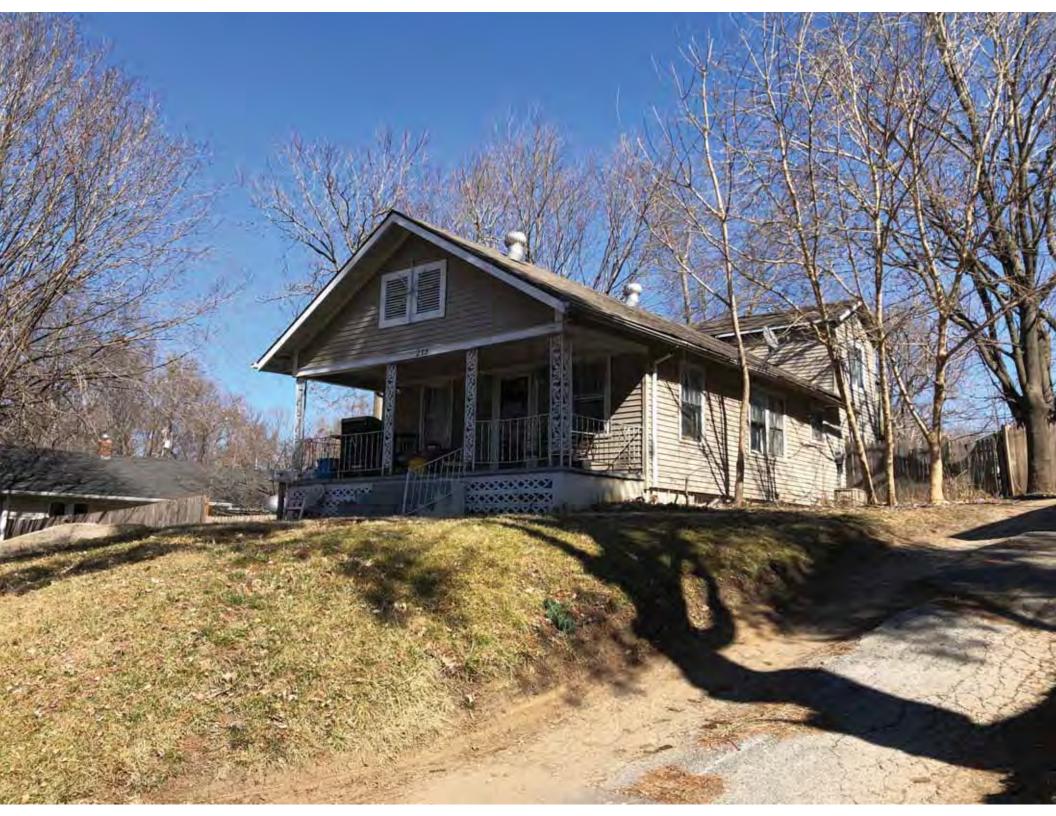
The main façade faces west. An asymmetrically-placed main entry is flanked by original, four-over-one wood sash windows with aluminum storms and wood surrounds, which repeat in pairs and single units at the secondary façades. A pair of louvered vents is placed centrally at the gable end. The full-width, open porch features four non-original wrought iron columns and railing witha central concrete staircase. Additional features include two metal stack chimney vents near the ridge at the south side slope and a two-story, gabled addition to the rear (c. 1960, as observed on historic aerial imagery). Although the construction date and form of this house indicate a likely Craftsman original styling, loss of original building materials and alterations have compromised the character-defining features of this residence. Due to loss of original materials, changes to form, and other alterations, this building lacks sufficient integrity of design, materials and workmanship to be considered eligible for listing in the NRHP.

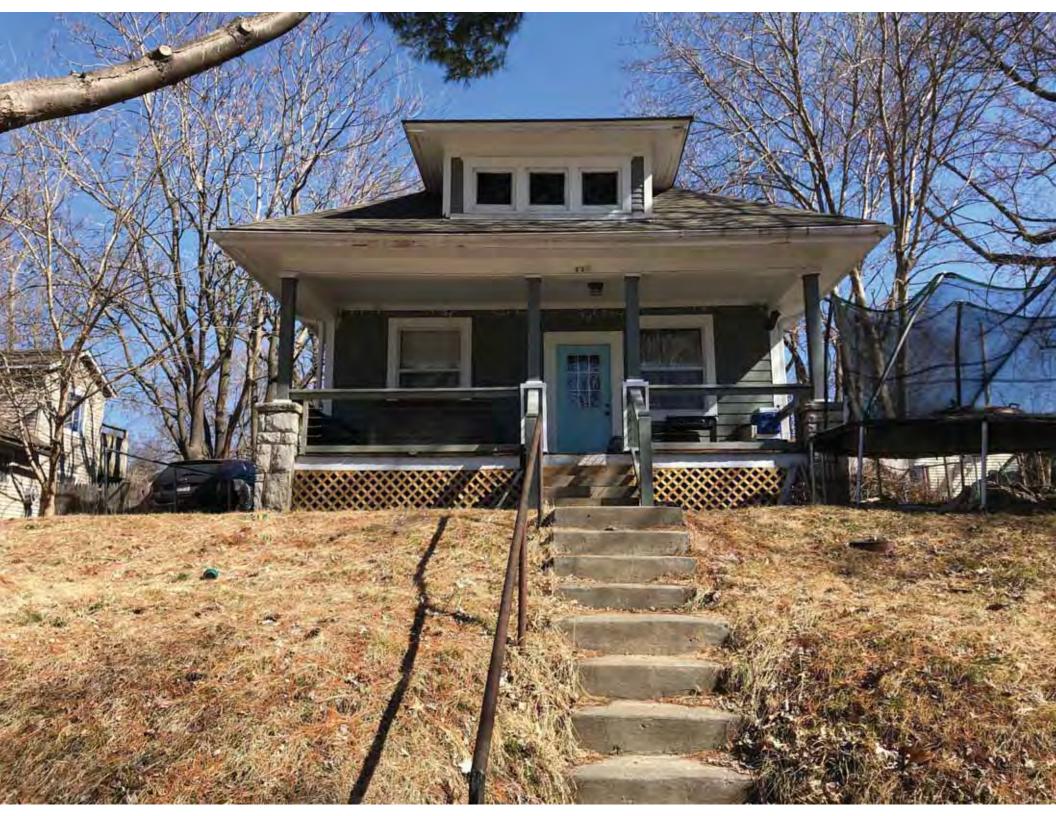
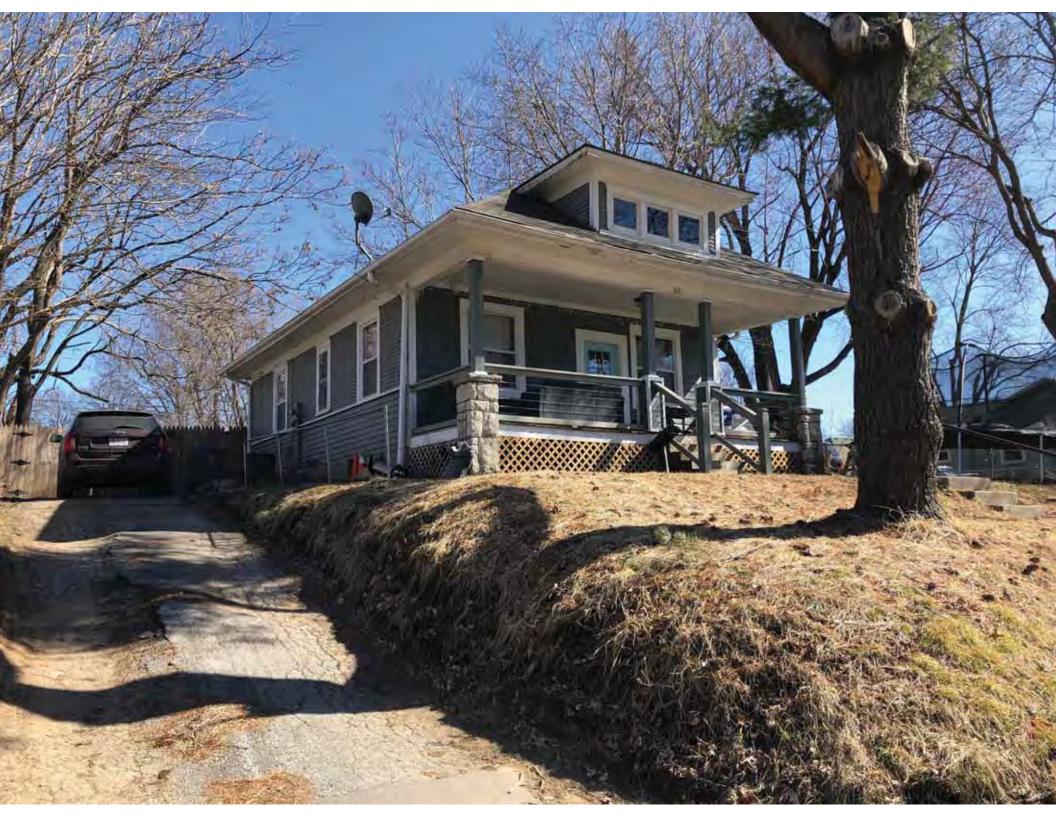
The main façade faces west. The main façade and lower third of the secondary façades of this house are clad in wood shiplap, while the upper two thirds of the secondary façades are clad in narrow wood clapboard. An asymmetrically-placed main entry is flanked by replacement, one-over-one vinyl sash windows with wood surrounds, which repeat at the secondary façades. A hipped dormer with three, square wood windows and a wide eave overhang, is placed centrally at the front roof slope. The full-width, open porch features four, square wood columns, supported by stone plinths at each end and two low, wood clad piers flanking the staircase. The porch railing was replaced with wire cables in 2019 (as seen on Google Street View). Additional features include a brick chimney placed at the rear roof slope, a bay window with tripartite fenestration at the eastern bay of the south façade, and a partial width, hipped, addition to the rear. This house retains few of its original Craftsman-style details. This building is a common example of its type that lacks distinction and therefore historical significance. Additionally, due to some loss of original materials, including windows, this building has diminished integrity of materials and workmanship.

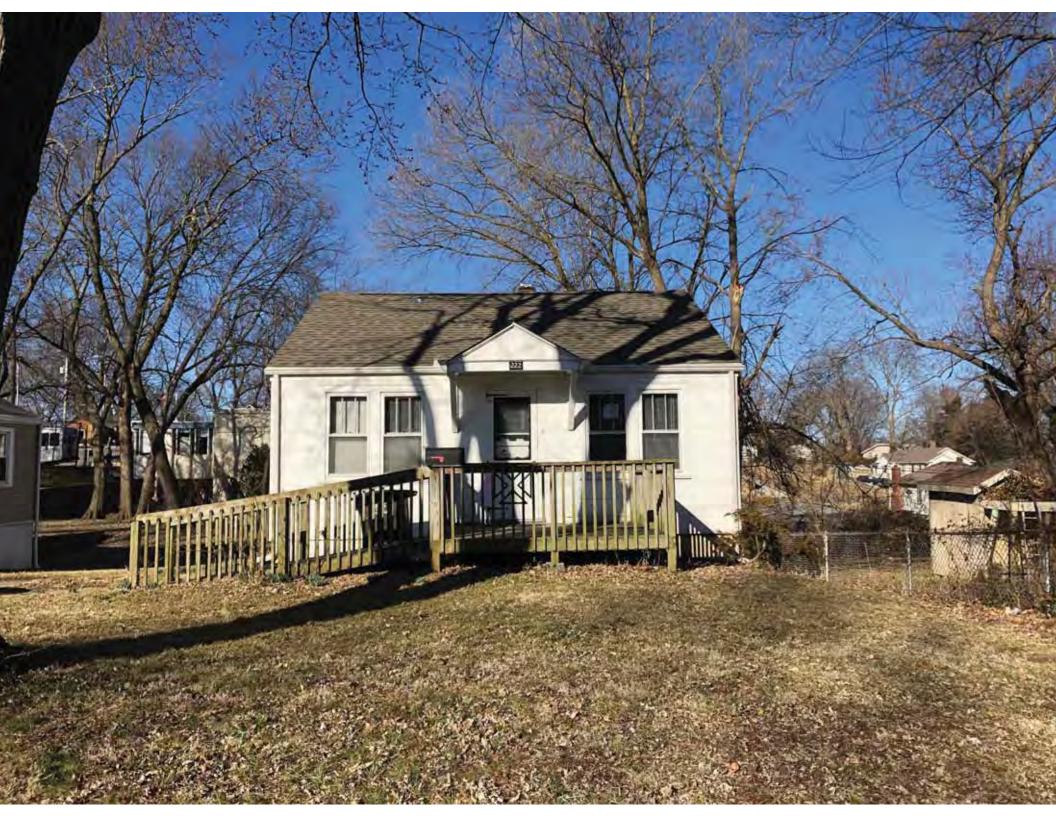
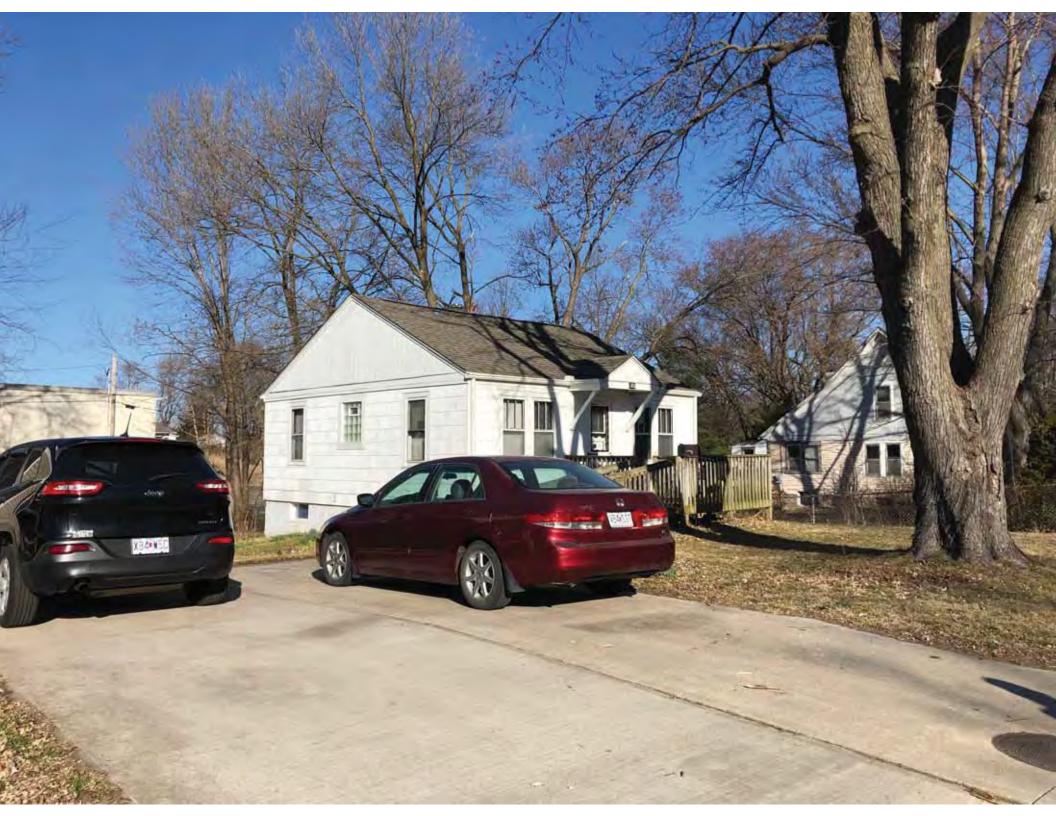
The main façade faces east. A central main entry is flanked by paired, three-over-one wood windows with wood surrounds. Replacement sash windows are featured at the secondary façades. The central entry consists of a single-leaf apron door withdentil details, sheltered by a bracketed, gabled hood and accessed by a wood ramp with deck. A brick chimney is placed centrally at the rear slope. This building is a common example of its type that lacks distinction and therefore historical significance. Additionally, due to some loss of original materials, including siding, this building has diminished integrity of materials and workmanship.

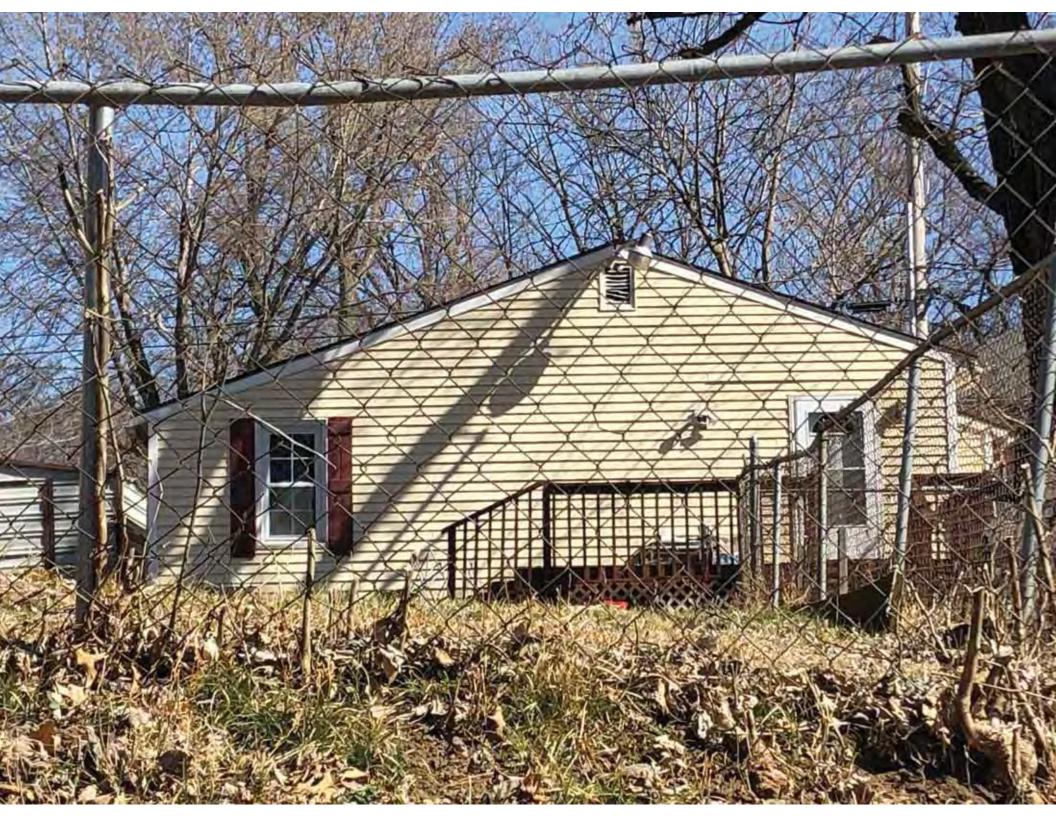
The main façade faces west. As depicted on 1945 and 1957 Sanborn maps, this house featured a front gable, square plan, altered with a shed roof extension to the north at an unknown date. The asymmetrical façade features a single-leaf, four-panel, vinyl entry door with upper fan light placed at the far southern bay and a replacement, four-over-four, vinyl sash window at the far northern bay (within the shed roof extension). A partial-width, wooden deck is appended to the main façade at the south side. The remaining façades are not visible from the public right-of-way. The existing entry door replaced a sliding door entrance and the existing window replaced a one-over-one sash window within the last 15 years, as observed on a 2011 Google Street View image capture of the property. Due to loss of original materials, changes to form, and other alterations, this building lacks sufficient integrity of design, materials and workmanship to be considered eligible for listing in the NRHP.
