1. Survey No.			2. Survey name:		
JA-AS-091-240		Fairmount Phase I Survey			
3. County:			4. Address (Street No.)	reet No.) Street (name)	
			, , ,	. ,	
JA			104	S. Home Avenue	
5.City: Vicinity:		6. Geographical Reference:		7. Township/Range/Section:	
Independence			39.109917, -94.459124	1	T: 50N R: 32W 32
8.Historic name (if k	nown):	•		9. Present/other	name (if known):
10. Ownership:			11a. Historic use (if know	/n):	11b. Current use:
Private	Public		Domestic		Domestic

21. (cont.) History and significance. Expand box as necessary, or add continuation pages.

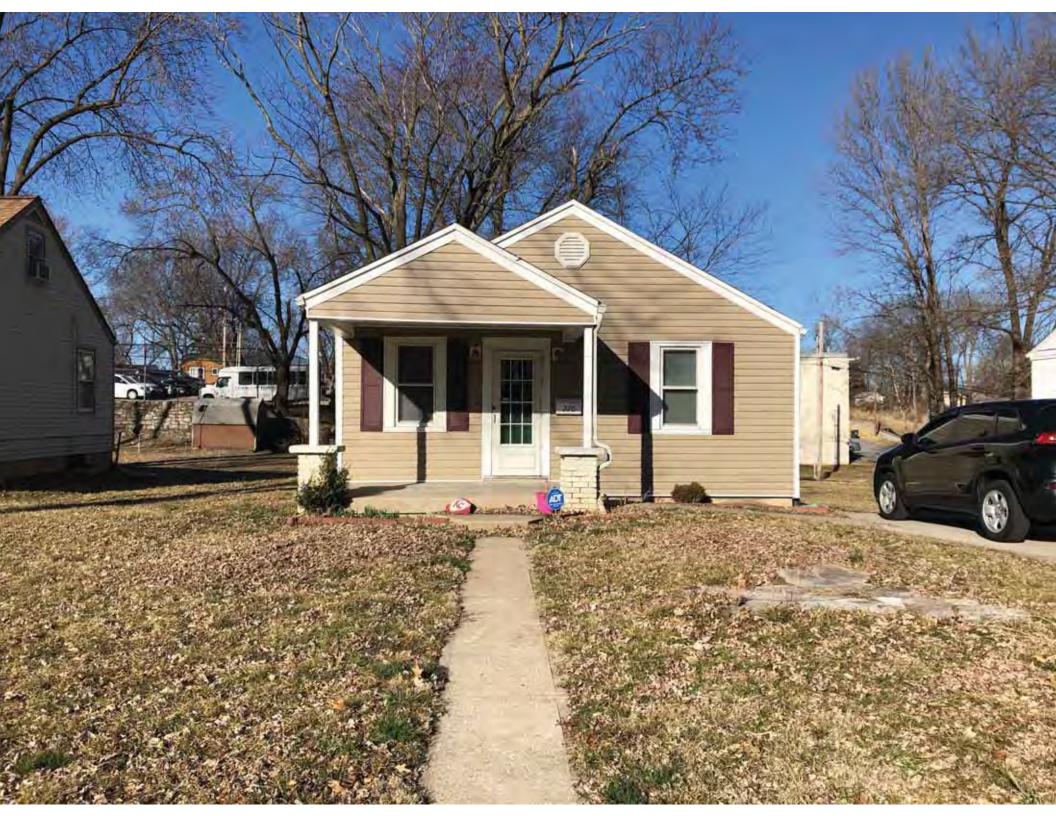
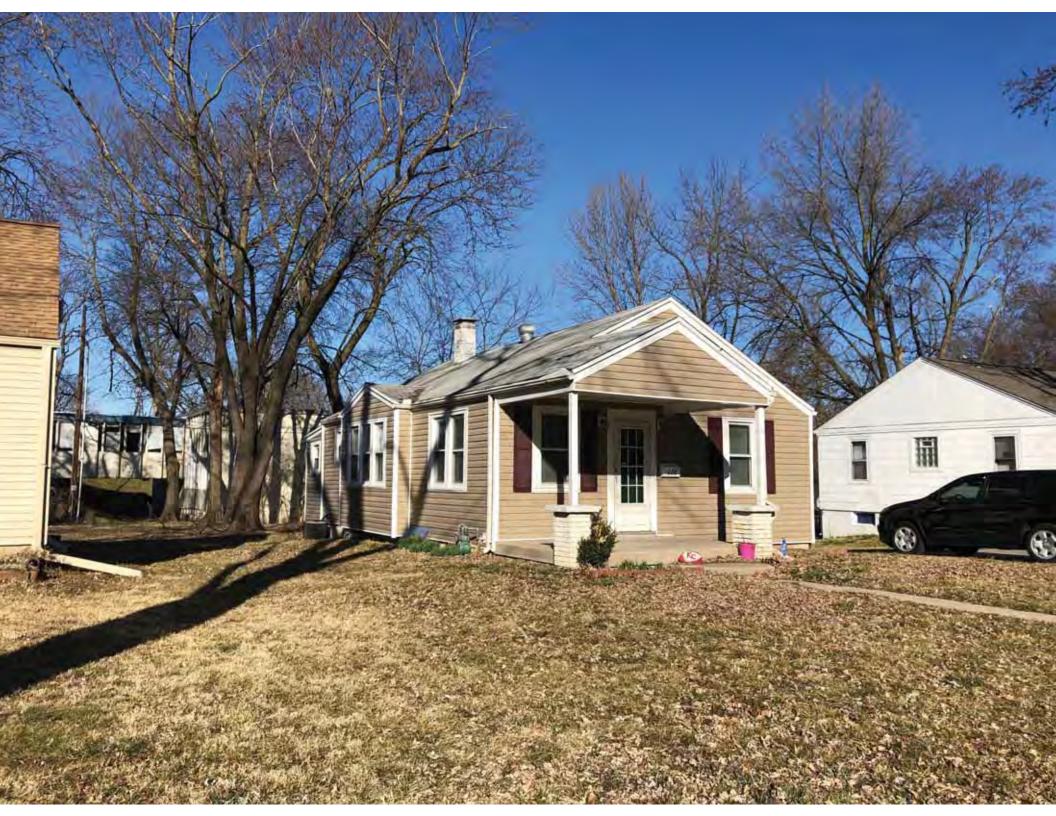
The main façade faces east. An asymmetrically-placed main entry is flanked by replacement, one-over-one vinyl sash windows with wood surrounds, which repeat at the secondary façades. These windows replaced three-over-one wood sash windows within the last fifteen years, as seen on a 2011 Google Street View image capture of the house. A partial-width, gabled, open porch features two square posts supported by brick plinths and shelters the central and southern bays at the main façade. Additional features include a gabled bay window that breaks the roof line, centered at the south façade and a brick chimney placed at the south roof slope. This building is a common example of its type that lacks distinction and therefore historical significance. Additionally, due to loss of original materials, this building lacks sufficient integrity of materials and workmanship to be considered eligible for listing in the NRHP.

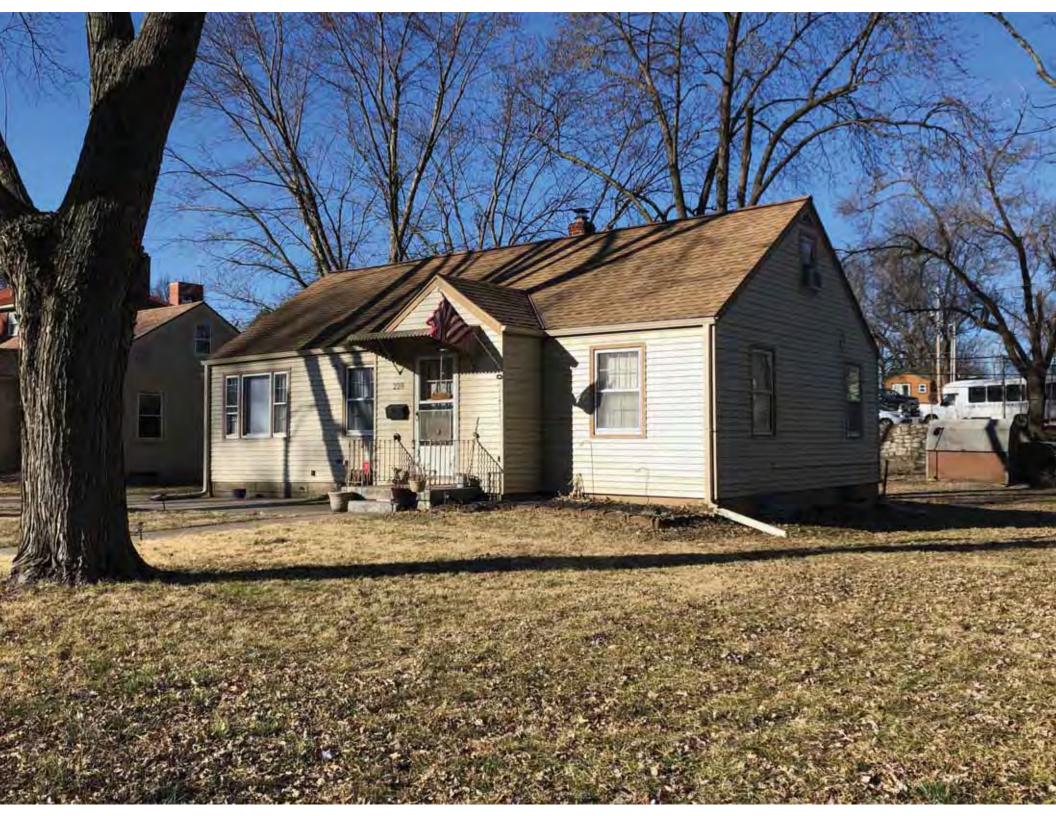
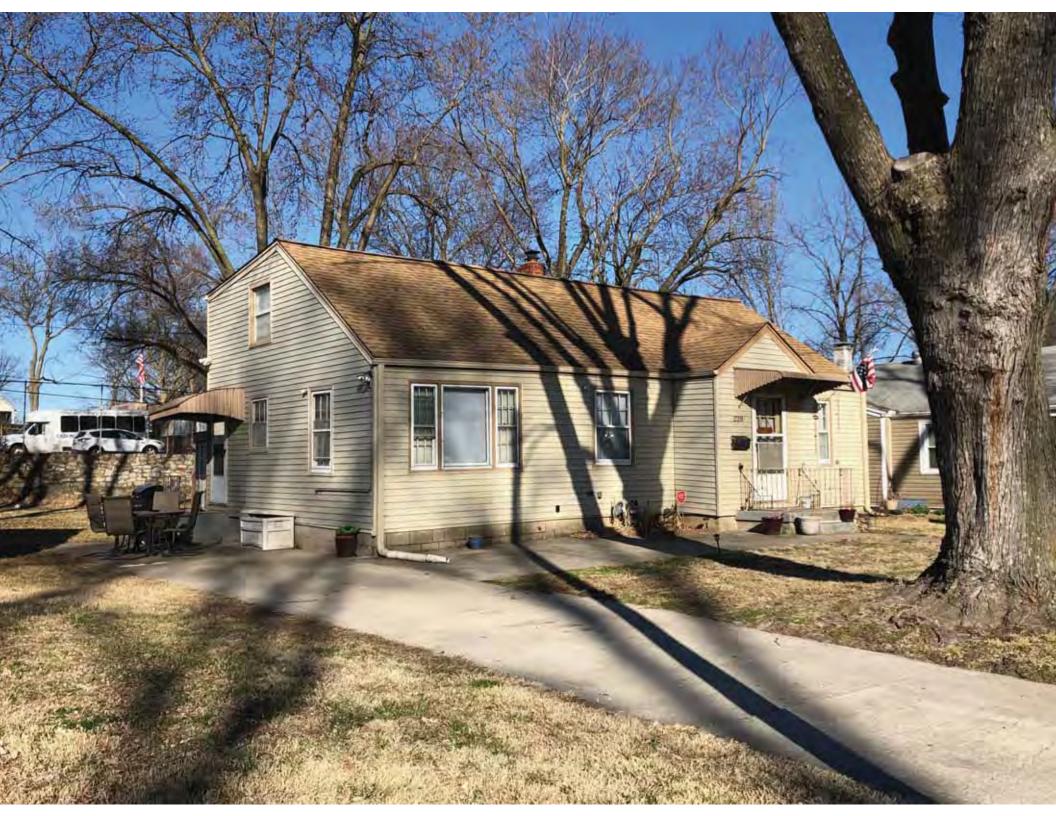
The main façade faces east. This side gable Minimal Traditional house features an original, three-bay wide, symmetrical block with a side gable extension (constructed c.1965, as observed on historic aerial imagery) to the south adding a fourth main façade bay. A gabled entrance vestibule is flanked by eight-over-eight wood sash windows. Multi-lite sash windows repeat at the secondary façades. A three-part picture window withsix-over-six sash windows flanking a large central pane, is placed at the far southern bay at the main façade. The c. 1965 addition features a shed roof second story to the rear. A brick chimney is placed centrally at the rear slope. The subject of this form was a identical in plan to 230 S. Huttig (JA-AS-091-301) before additions/alterations. Due to loss of original materials, changes to form, and other alterations, this building lacks sufficient integrity of design, materials and workmanship to be considered eligible for listing in the NRHP.

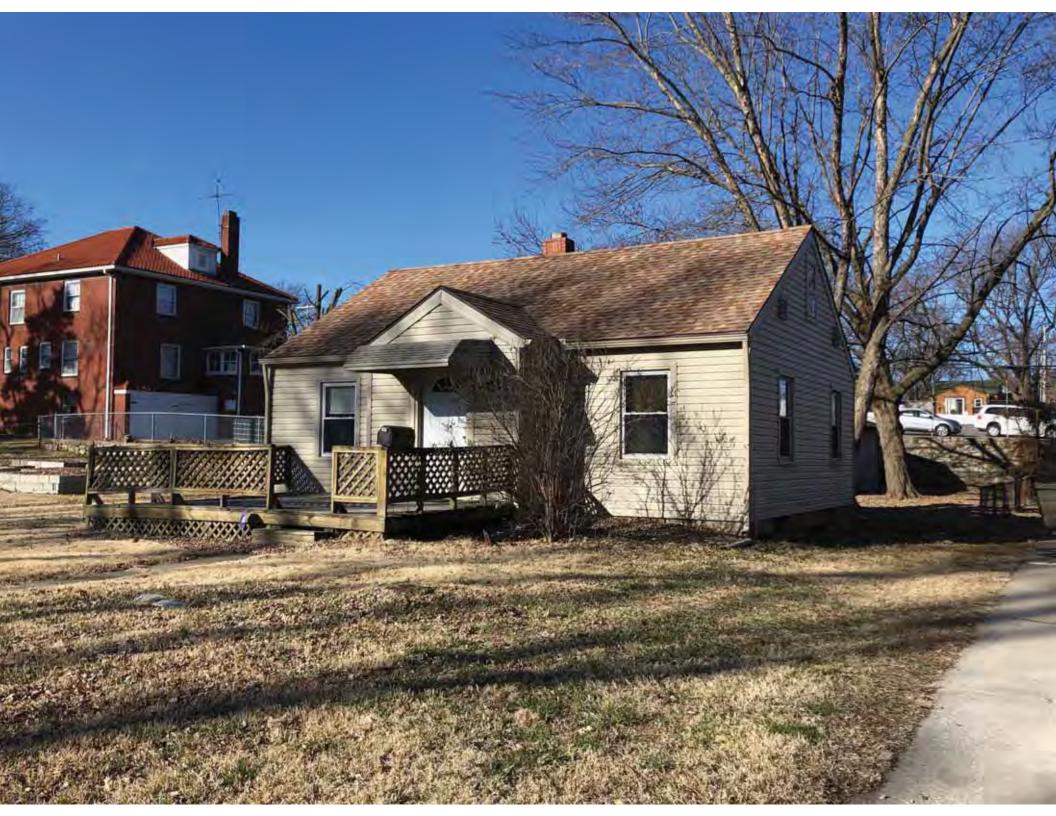
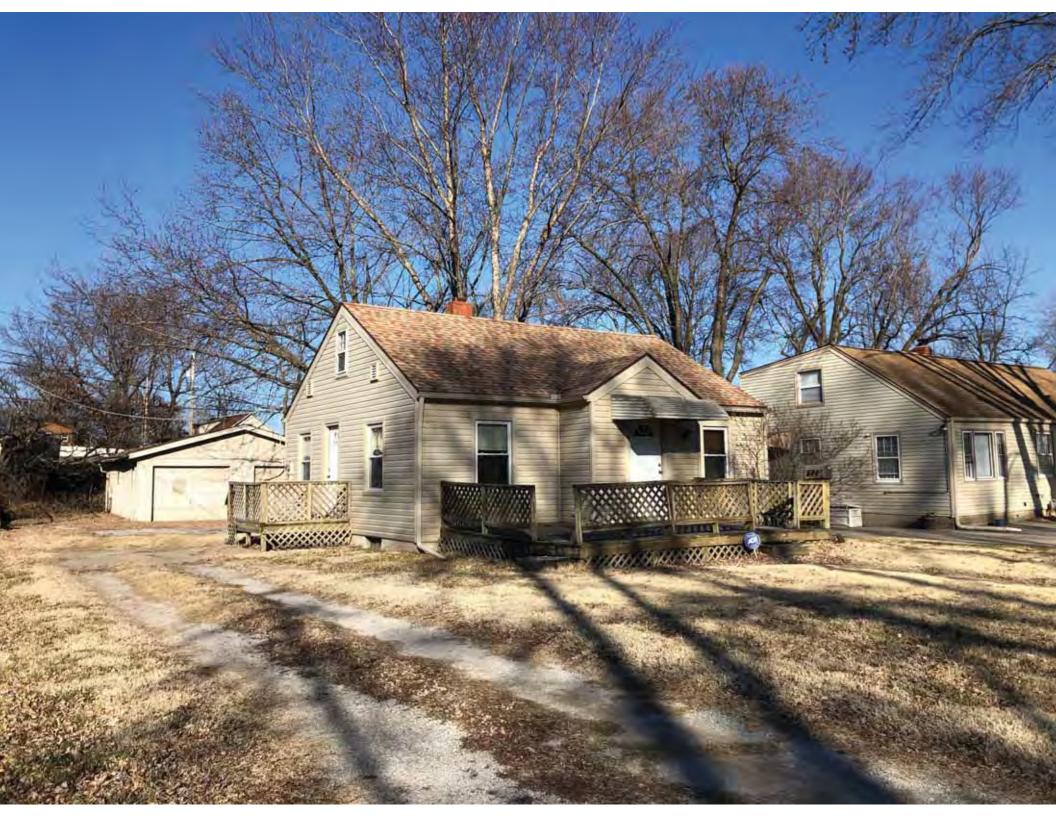
The main façade faces east. A central, gabled entrance vestibule withsingle-leaf, vinyl paneled entry door, is flanked by replacement, one-over-one vinyl sash windows, which repeat at the secondary façades. The south façade features a secondary entry consisting of a central single-leaf entry door flanked by single, one-over-one window units and reached by a wooden deck. A wooden deck also spans three-quarters of the main façade. A brick chimney is placed centrally at the rear slope of the roof. The subject of this form and 528 S. Huttig (JA-AS-091-301) were identical in plan before additions/alterations. This building is a common example of its type that lacks distinction and therefore historical significance. Additionally, due to loss of original materials, this building lacks sufficient integrity of materials and workmanship to be considered eligible for listing in the NRHP.

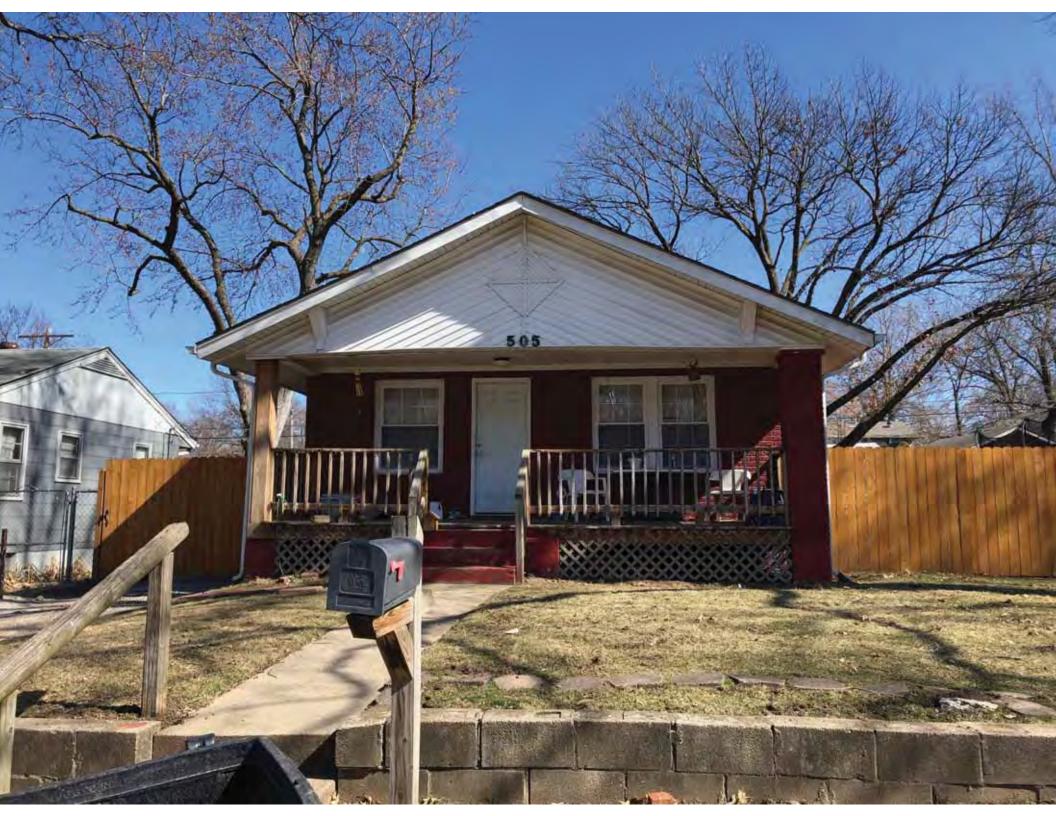
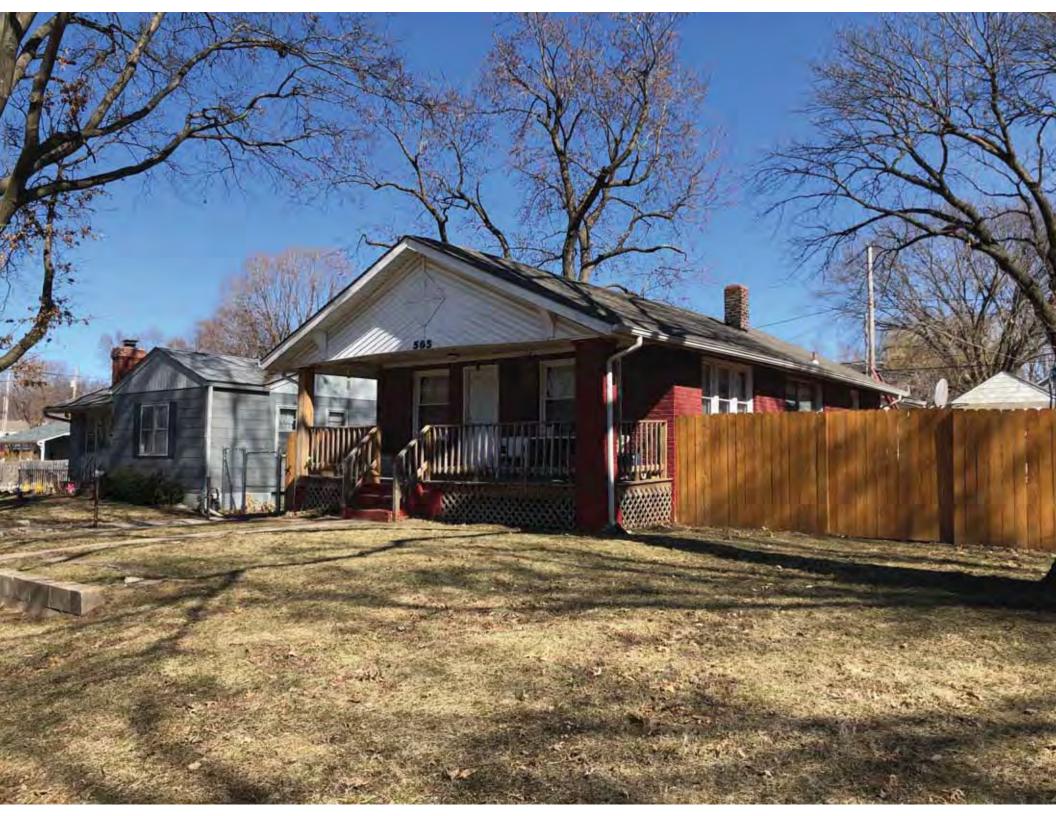
The main façade faces west. An asymmetrically-placed main entry is flanked by a single, replacement, one-over-one vinyl sash window with wood surround to the north and paired replacement windows to the south. Google Street View image captures of this house revealed three-over-one wood windows were replaced at all façades after February 2019. The main entry consists of a single-leaf, six-panel vinyl door. The full-width, open porch features a full brick column at the south end and a replacement wood post set on a brick pier at the north end. The gable end is clad in replacement diagonal patterned vinyl siding and features two knee braces at the corners. Additional features include a brick chimney placed at the south side of the gable roof and a c. 1960 full-width, addition to the rear, as seen on aerial imagery. A brick exterior chimney at the north facade has been shortened at an unknown date and no longer extends beyond the roofline. Little remains of the original Craftsman-style detailing due to replacement of original materials, modifications, and additions. Due to loss of original materials, changes to form, and other alterations, this building lacks sufficient integrity of design, materials and workmanship to be considered eligible for listing in the NRHP.

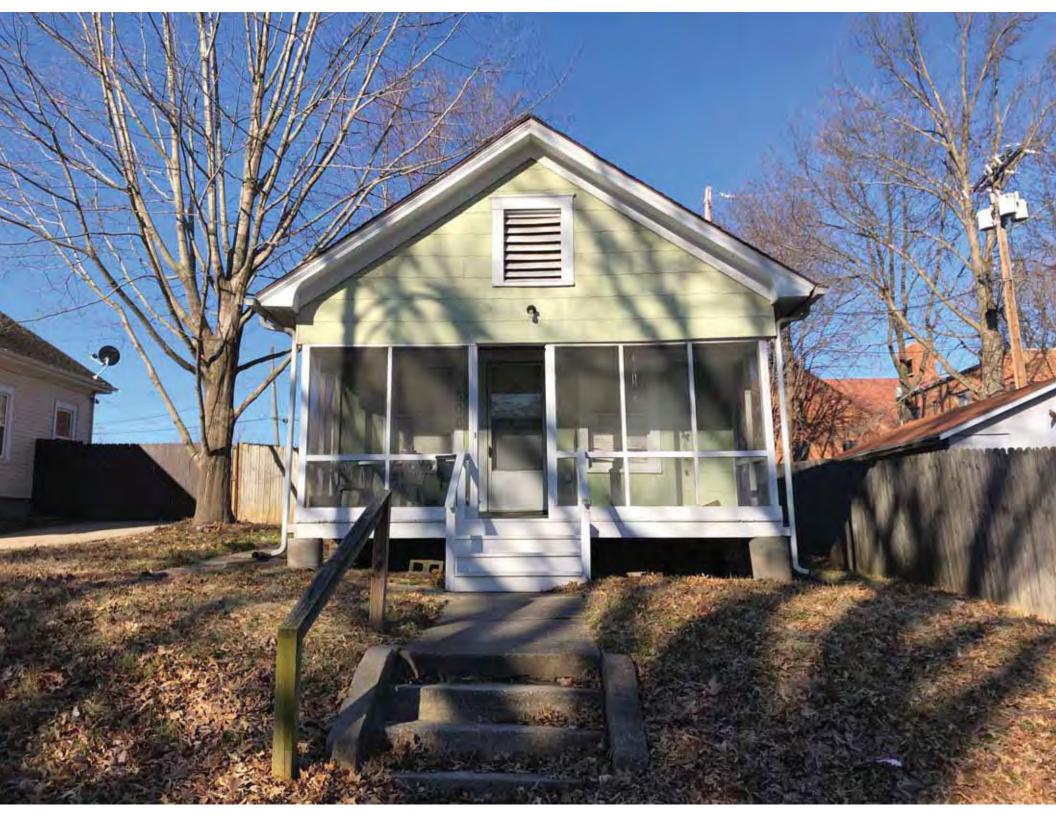
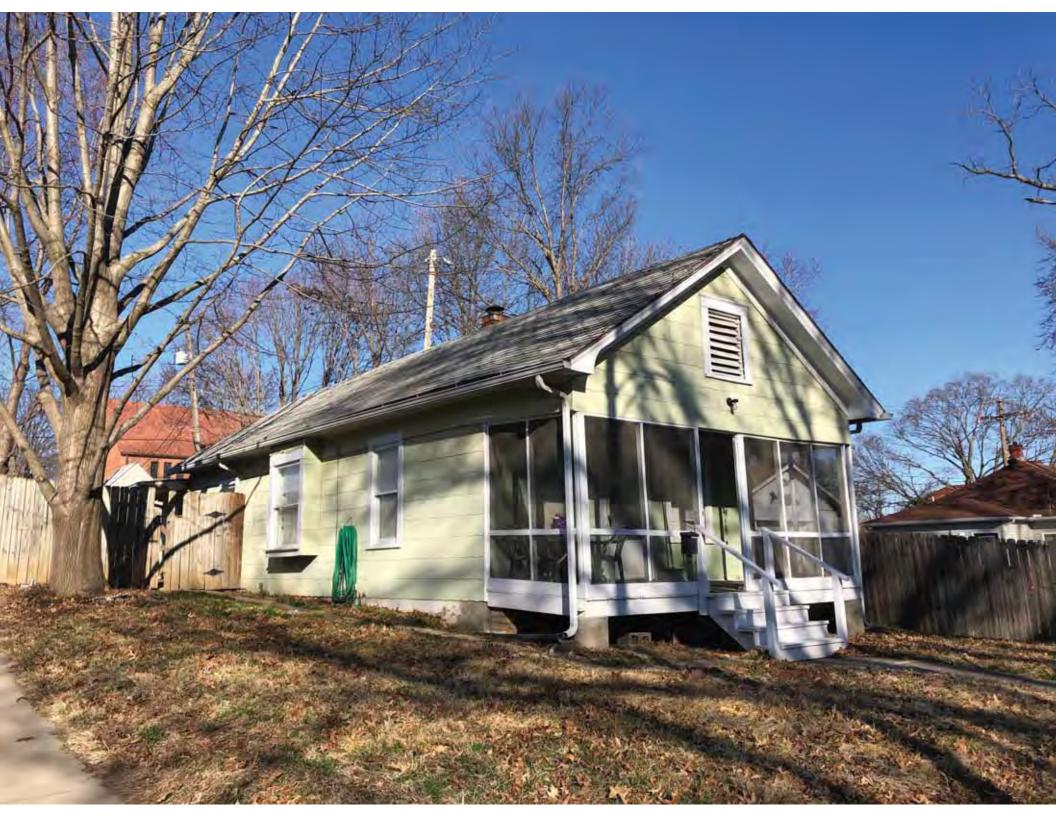
The main façade faces east. An asymmetrically-placed main entry is flanked by replacement, one-over-one vinyl sash windows with wood surrounds, which repeat at the secondary façades. The full-width, screen-enclosed porch features three wood posts, concrete piers, and a central staircase. A louvered vent is placed centrally at the gable end. Additional features include a brick chimney placed at the north side of the gable roof and a projecting window opening at the south façade. A rear porch has been enclosed at an unknown date. This building is a common example of its type that lacks distinction and therefore historical significance. Additionally, due to loss of original materials, this building lacks sufficient integrity of materials and workmanship to be considered eligible for listing in the NRHP.

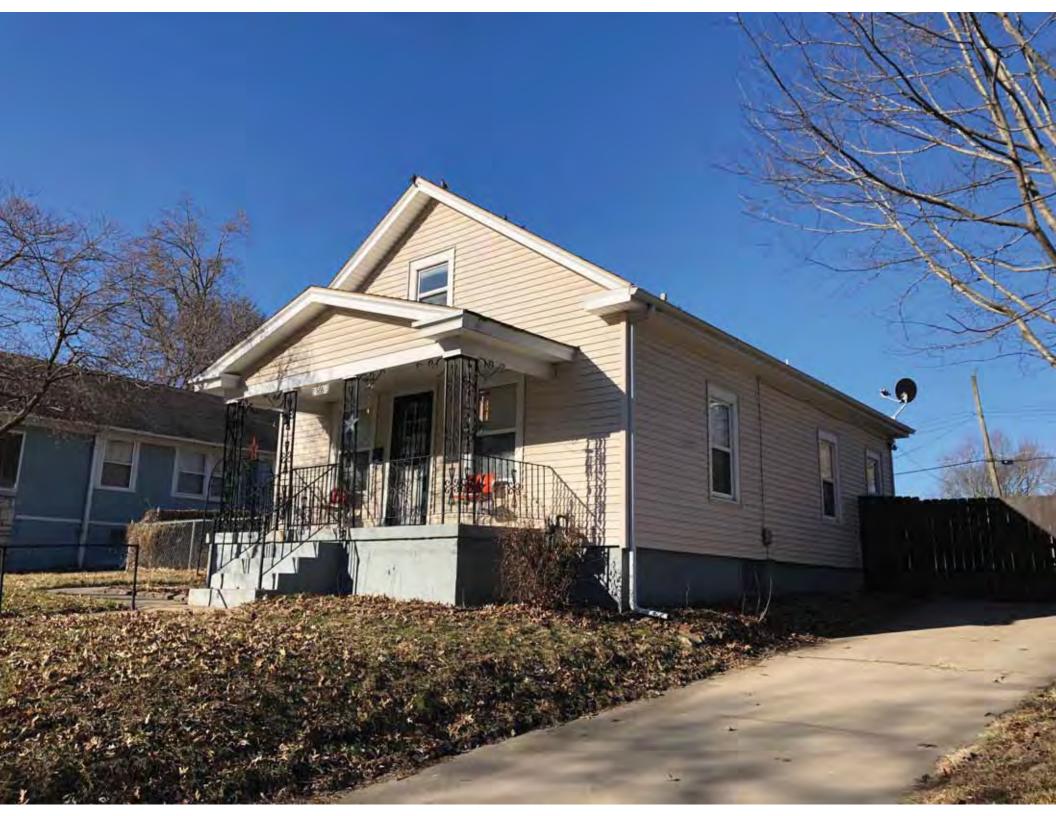
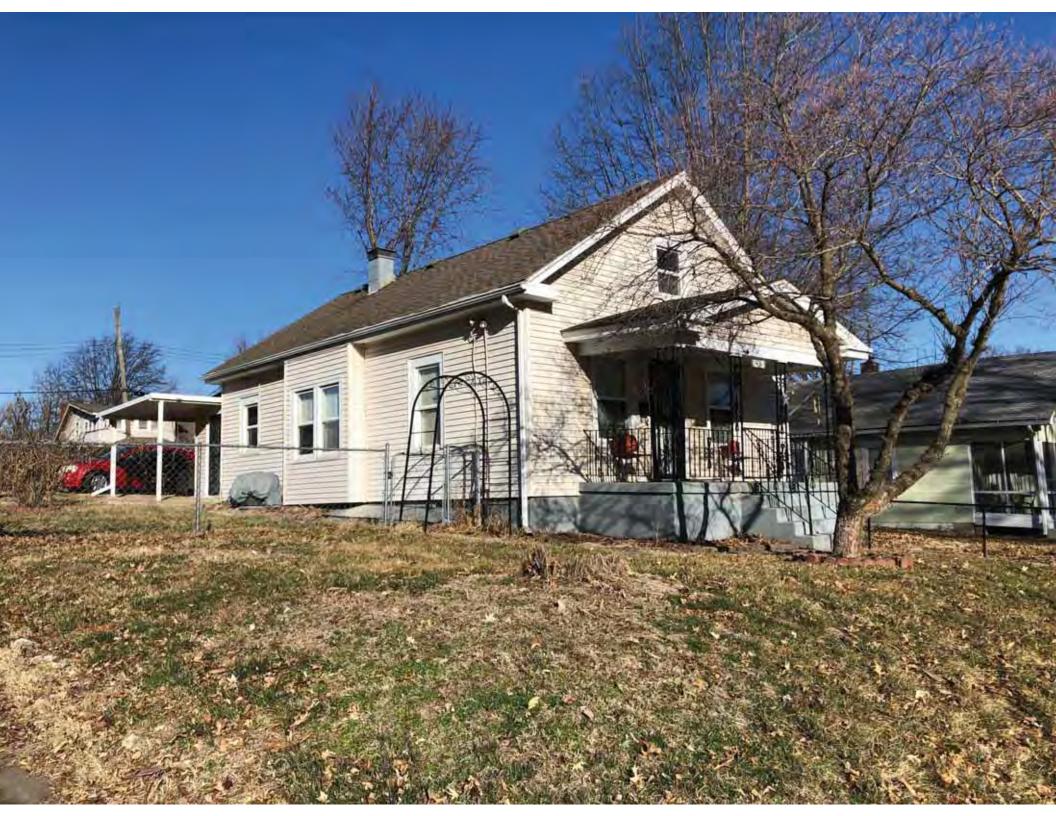
The main façade faces east. A slightly offset (to the north) main entry is flanked by replacement, one-over-one vinyl sash windows with wood surrounds, which repeat at the secondary façades. The full-width, gabled, open porch features four, non-original, wrought iron columns, set on a concrete foundation wall. The second story features a one-over-one vinyl sash window centered at the gable end. Additional features include a concrete block chimney placed at the south side of the gable roof, a bay window with paired one-over-one sash windows centered at the south façade, and a rear porch, which was enclosed at an unknown date. This building is a common example of its type that lacks distinction and therefore historical significance. Additionally, due to loss of original materials, this building lacks sufficient integrity of materials and workmanship to be considered eligible for listing in the NRHP.

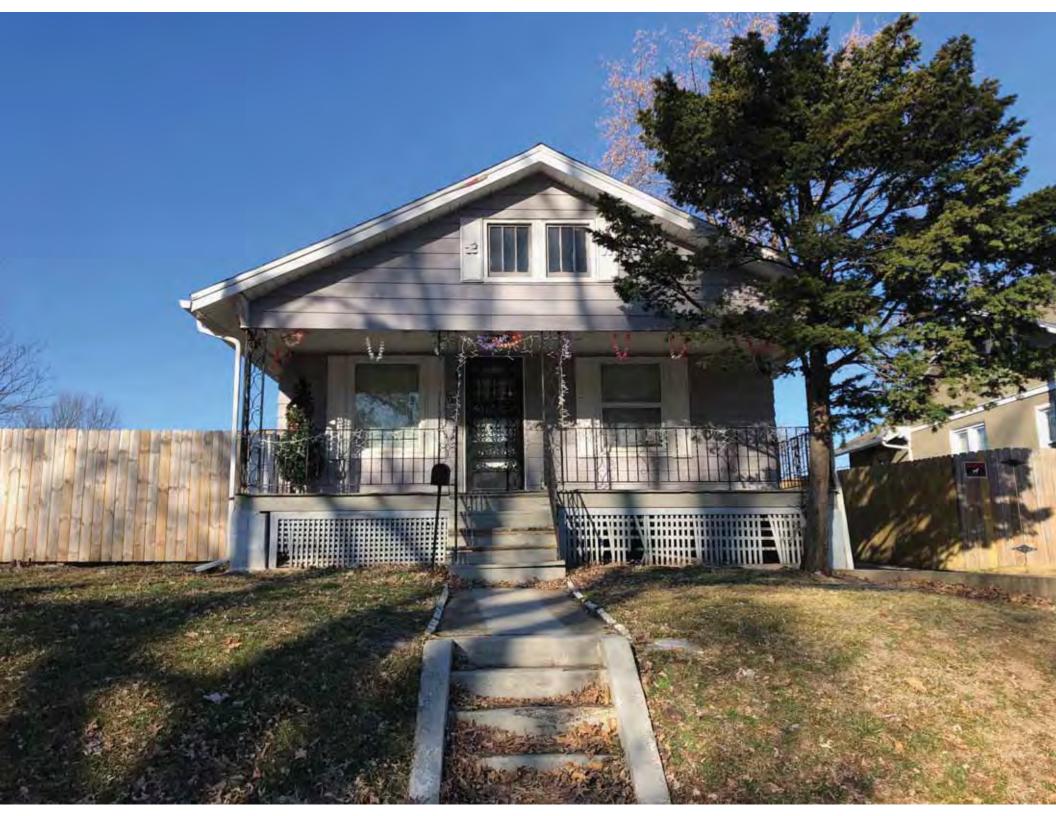
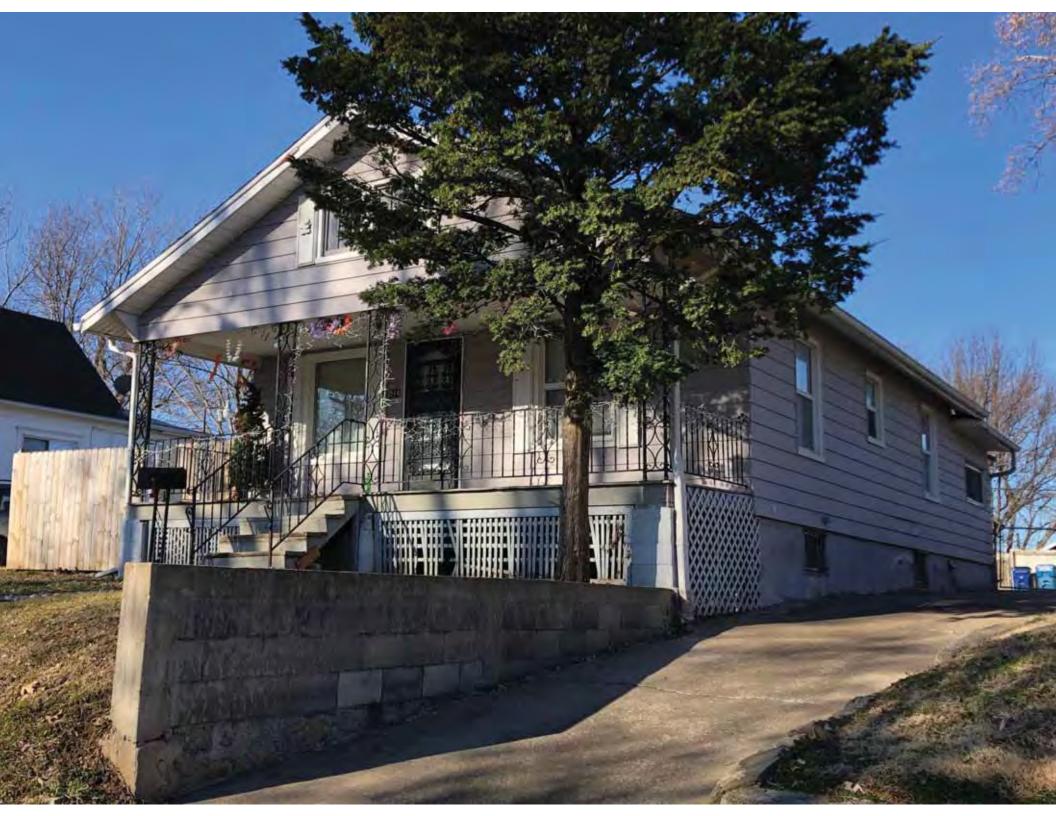
The main façade faces east. An asymmetrically-placed main entry is flanked by a replacement, one-over-one vinyl sash window to the north and a replacement, single-lite fixed window to the south. Two, original, three-lite, fixed wood windows are placed centrally at the gable end. One-over-one vinyl sash windows are placed at the north facade. The full-width open porch features four, non-original, wrought iron columns, supported by concrete block piers and a wrought iron railing. A full-width gabled rear addition was constructed at an unknown date. Little remains of the original Craftsman-style detailing due to replacement of original materials, modifications, and additions. Due to loss of original materials, changes to form, and other alterations, this building lacks sufficient integrity of design, materials and workmanship to be considered eligible for listing in the NRHP.

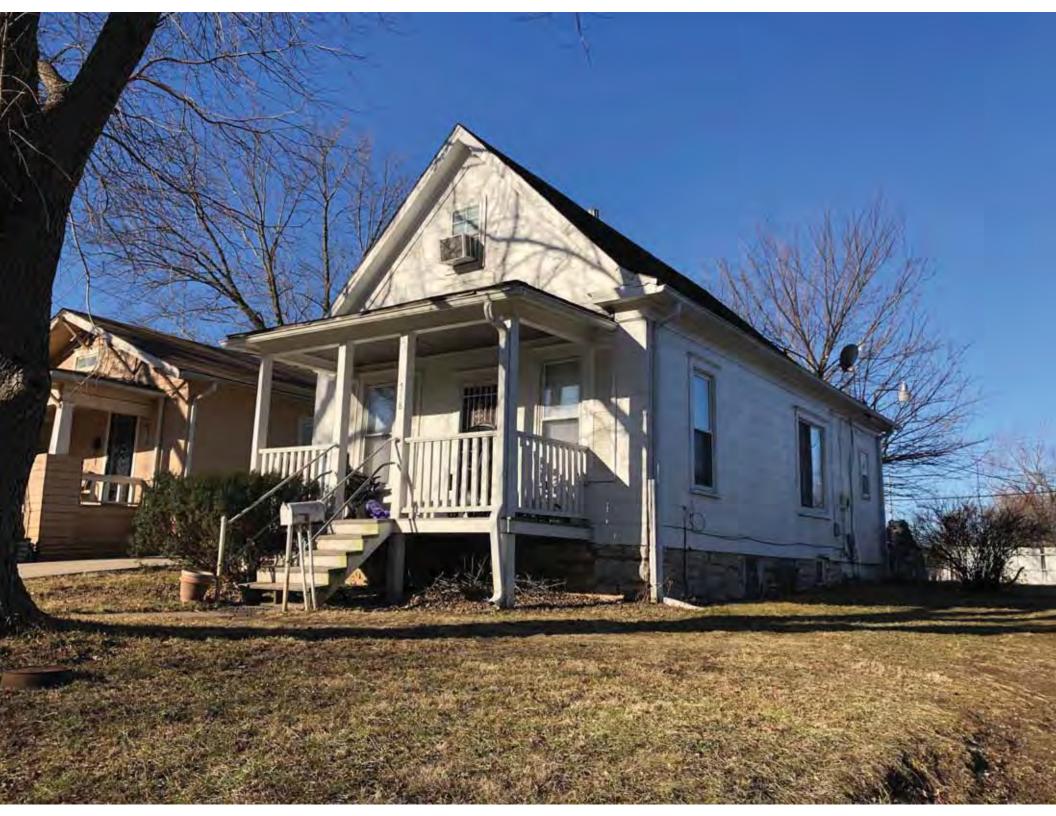
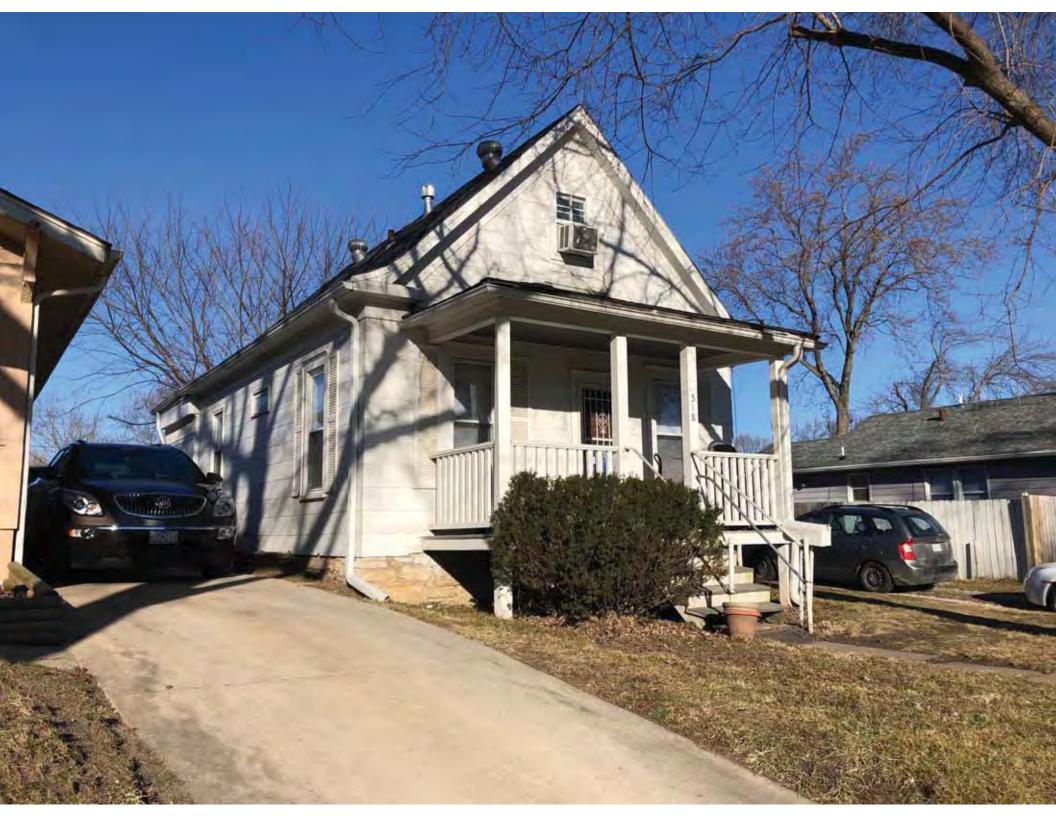
The main façade faces east. The first story is characterized by asbestos siding (which covers the original wood clapboard or wood shingle siding) and features an asymmetrically-placed main entry flanked by replacement, one-over-one vinyl sash windows with wood surrounds, which repeat at the secondary façades. The full-width, open porch features a hipped roof supported by four, square wood posts. A simple squared railing and central staircase are additional features of the porch. The second story features wood shiplap cladding and a one-over-one vinyl sash window at the gable end. A rear porch was enclosed at an unknown date. This building is a common example of its type that lacks distinction and therefore historical significance. Additionally, due to loss of original materials, this building lacks sufficient integrity of materials and workmanship to be considered eligible for listing in the NRHP.

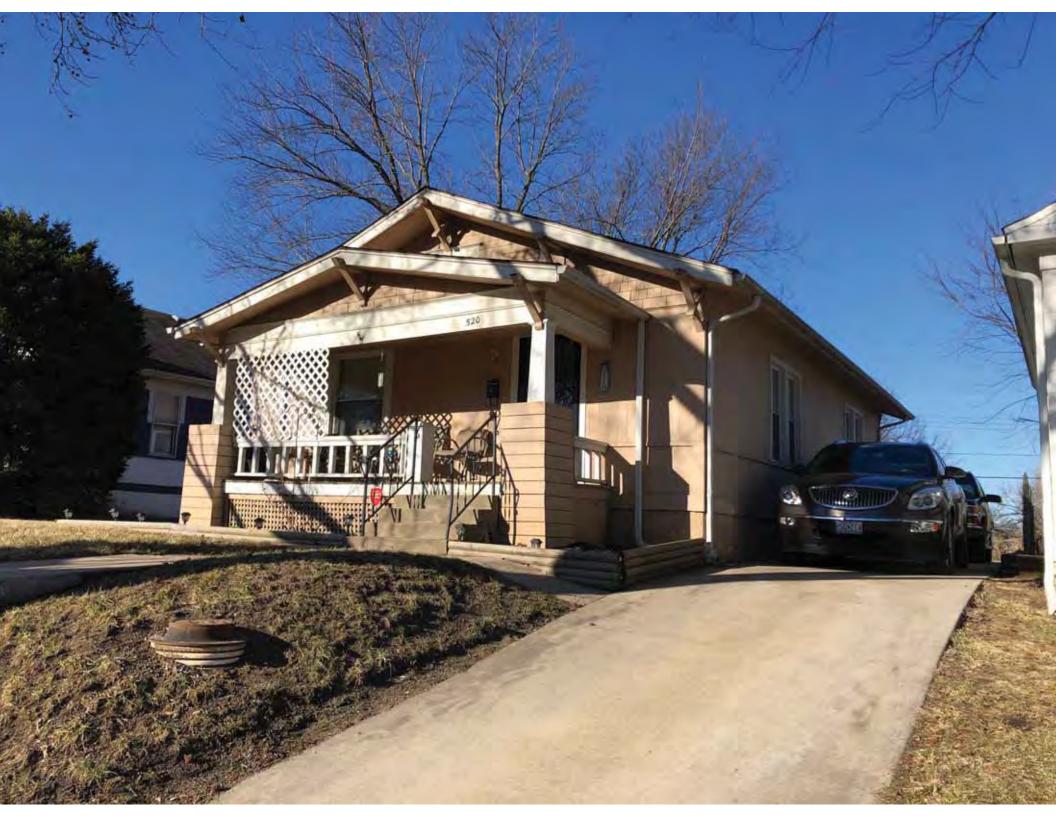
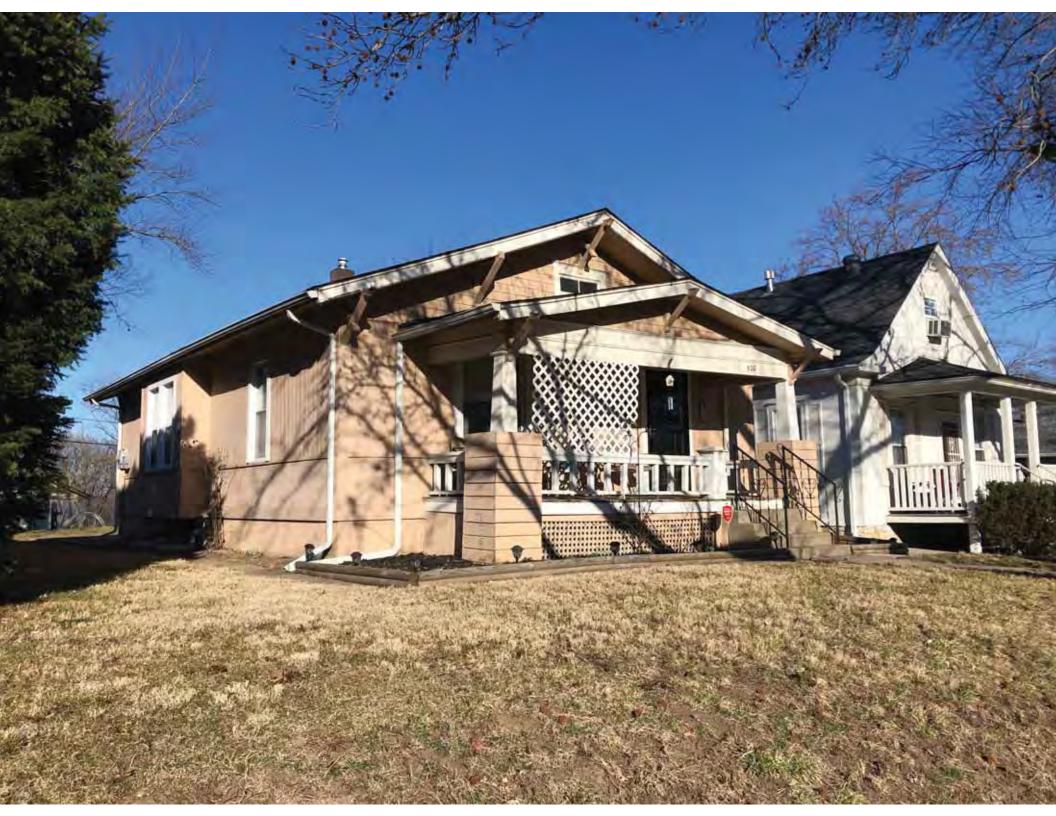
The main façade faces east. A single-leaf, wood-paneled, entry door is placed north of a replacement, one-over-one vinyl sash window withwood surround. These windows repeat at the secondary façades in paired and single units. A small, two-lite fixed wood window is placed centrally at the gable end of the house. The full-width, gabled, open porch features two battered wood columns supported by plinths that have been covered in vinyl siding. Both the house and porch gable ends are clad in wood shingles and feature knee bracing. Additional features include a concrete block chimney at the south side slope of the roof and a bay window centered at the south façade with a pair of one-over-one vinyl sash windows. This house features stucco and vertical plank siding exterior cladding. This house retains few of its original Craftsman-style details. This building is a common example of its type that lacks distinction and therefore historical significance. Additionally, due to loss of original materials, this building lacks sufficient integrity of materials and workmanship to be considered eligible for listing in the NRHP.

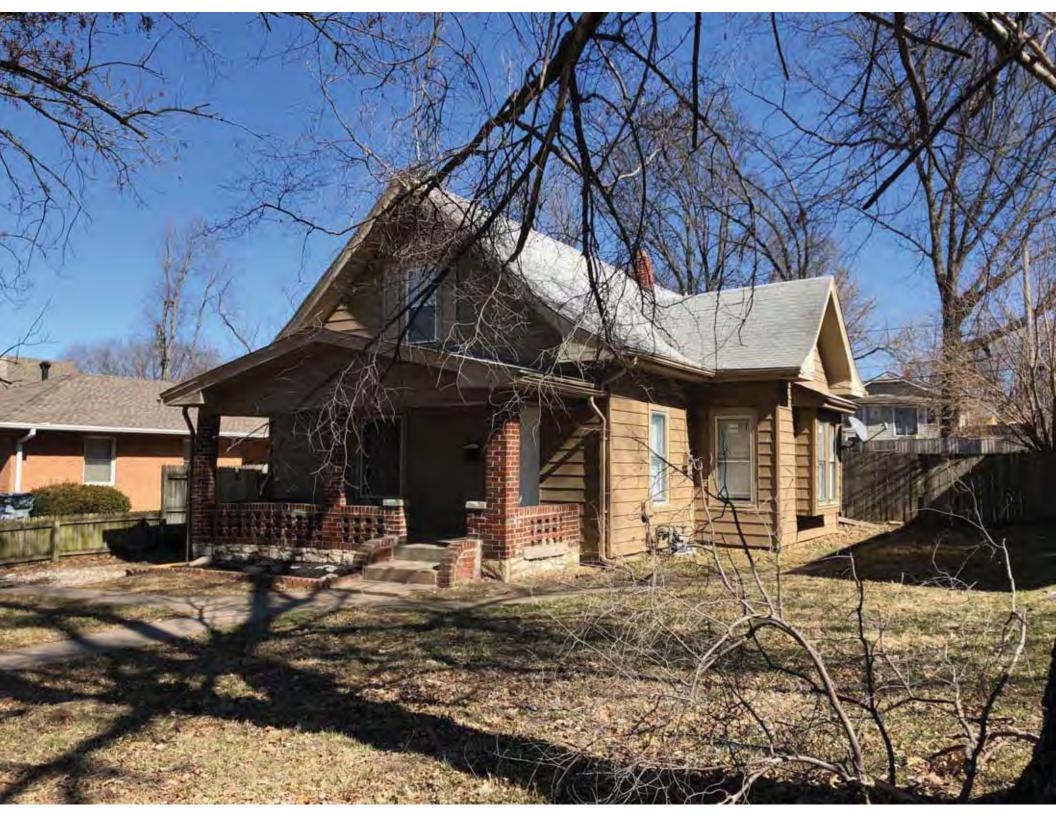
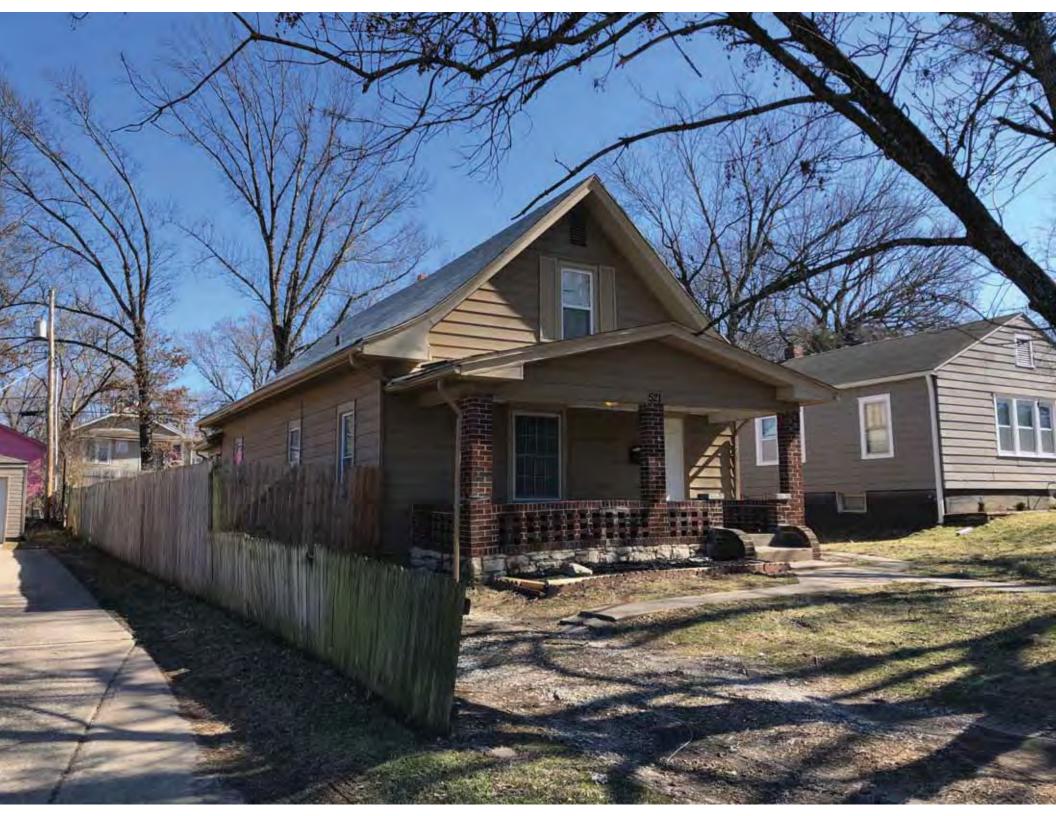
The main façade faces west. A single-leaf, six-panel, entry door is placed south of a replacement nine-over-nine vinyl sash window with wood surround. The full width, gable porch features three brick columns and a decorative brick rail set on a stone foundation. Two brick piers, without porch supports, flank an offset staircase. The second story features a one-over-one vinyl sash window centered at the gable end. A cross-gable wing extends from the central bay at the south façade and features a shed roof bay window at its south façade. Additional features include a brick chimney placed at the south side of the gable roof and a rear, hipped addition, constructed at an unknown date. This building is a common example of its type that lacks distinction and therefore historical significance. Additionally, due to some loss of original materials, including windows, this building has diminished integrity of materials and workmanship.

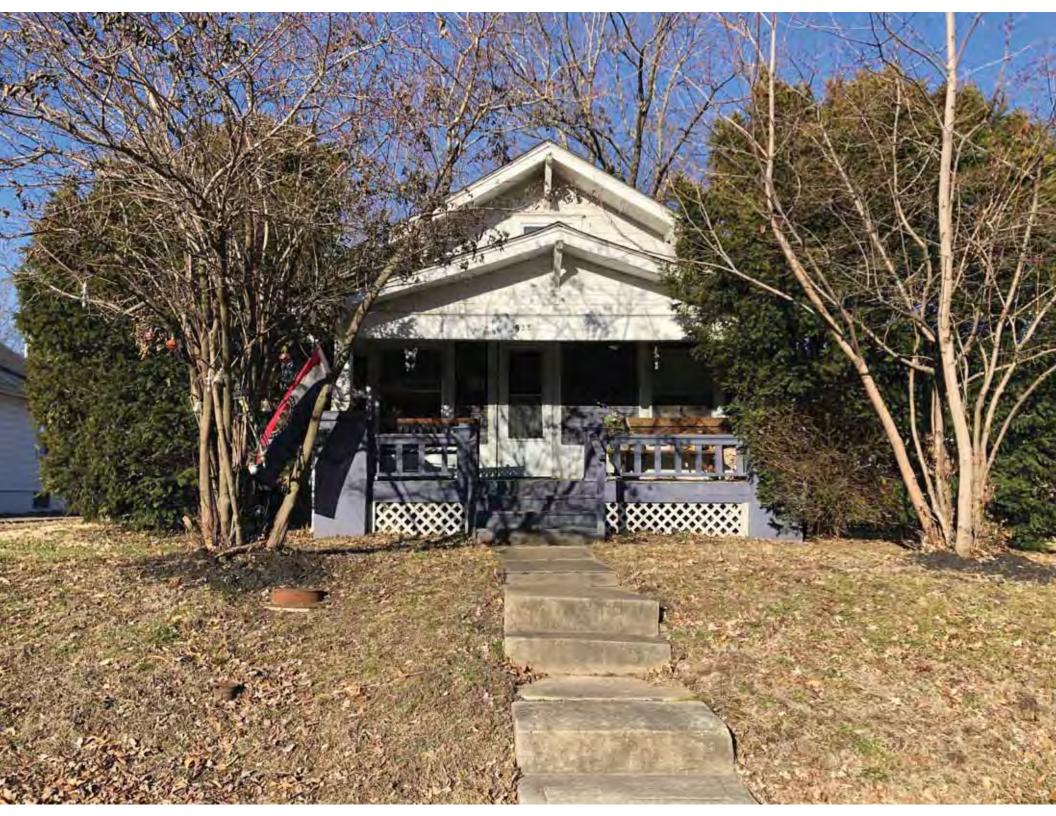
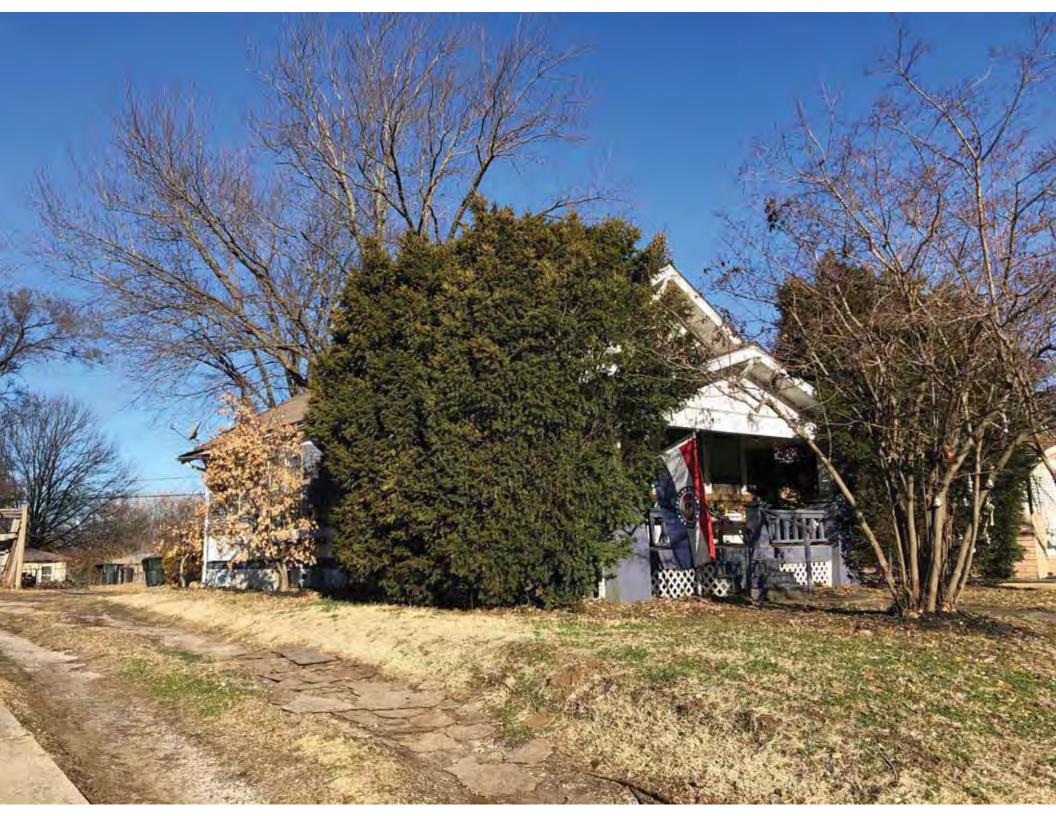
The main façade faces east. An asymmetrically-placed main entry is flanked by replacement, one-over-one vinyl sash windows with aluminum storms and wood surrounds. The north façade contains similar fenestration. The south façade is obscured by vegetation. A sash window with wood surround is placed centrally at the gable end of the house. The full-width, gabled, open porch features two battered wood columns with brick plinths, a simple squared railing, and a centrally-located staircase. Additional features include wood shingle gable ends with knee bracing and a wide band of wood clapboard located near the foundation line at all facades. This building is a common example of its type that lacks distinction and therefore historical significance. Additionally, due to some loss of original materials, including windows, this building has diminished integrity of materials and workmanship.
