1. Survey No.			2. Survey name:		
JA-AS-091-240		Fairmount Phase I Survey			
3. County:			4. Address (Street No.)	reet No.) Street (name)	
			, , ,	. ,	
JA			104	S. Home Avenue	
5.City: Vicinity:		6. Geographical Reference:		7. Township/Range/Section:	
Independence			39.109917, -94.459124	1	T: 50N R: 32W 32
8.Historic name (if k	nown):	•		9. Present/other	name (if known):
10. Ownership:			11a. Historic use (if know	/n):	11b. Current use:
Private	Public		Domestic		Domestic

21. (cont.) History and significance. Expand box as necessary, or add continuation pages.

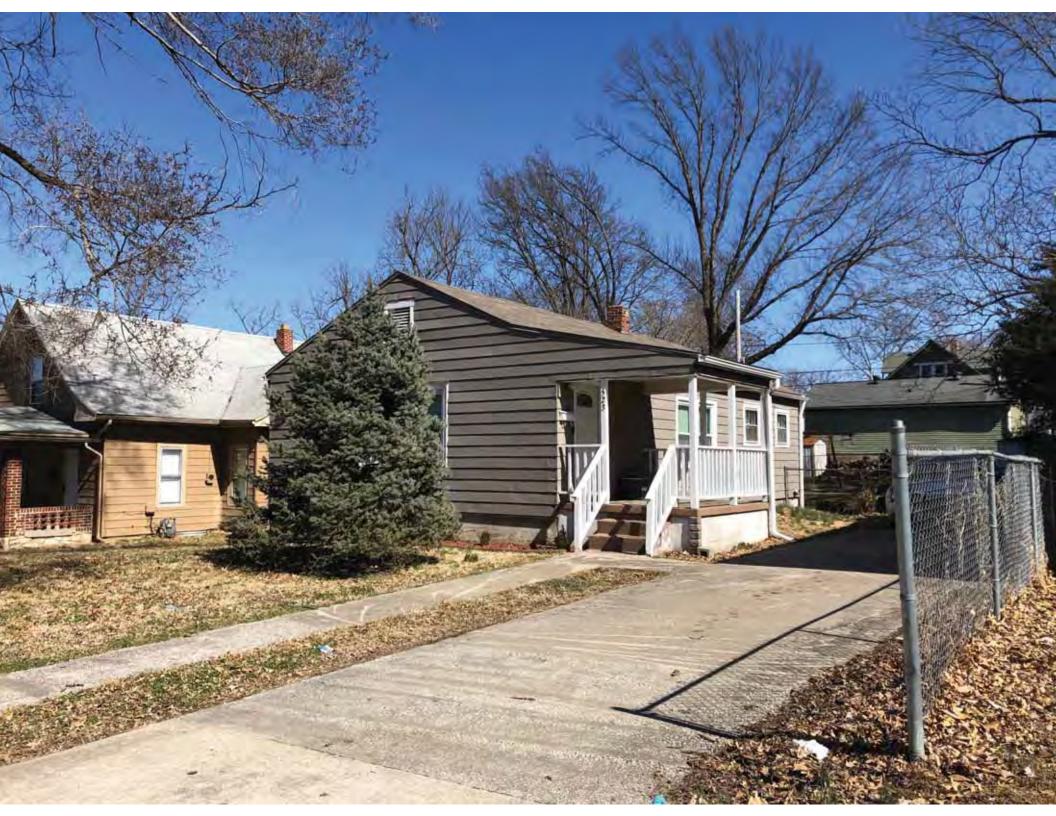
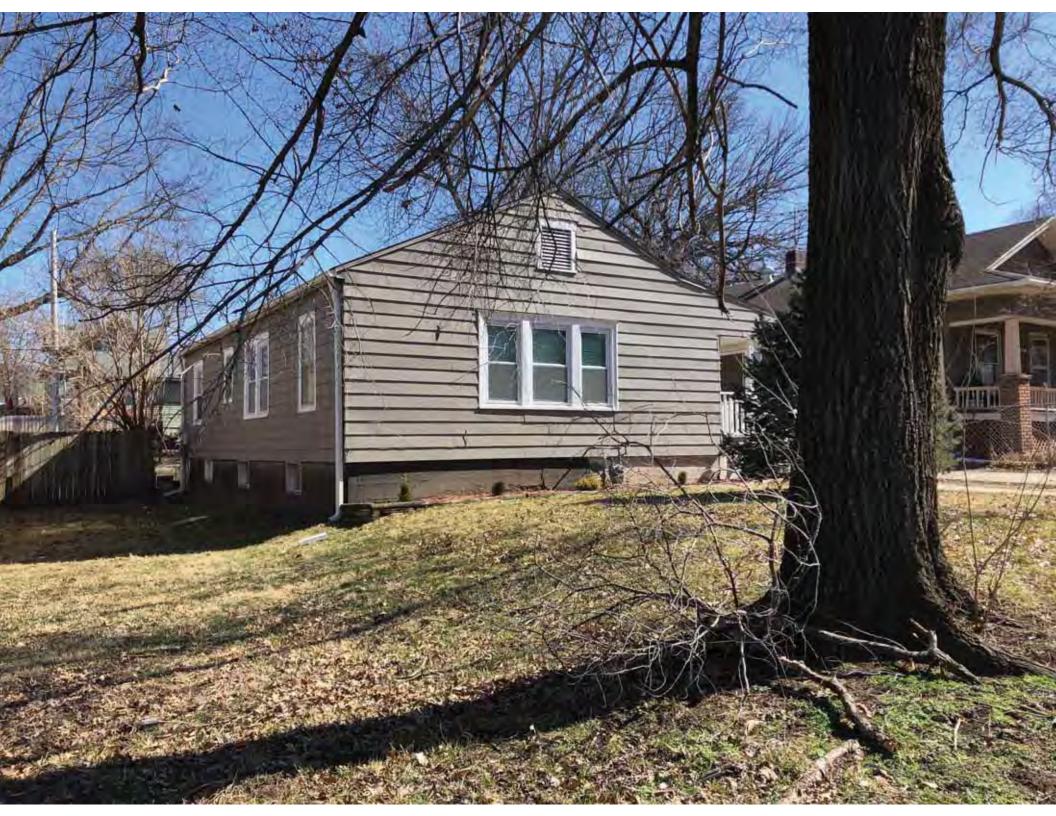
The main façade faces south. This house has been significantly altered from its original front-gabled form, as seen on a 1917 Sanborn map. A single-leaf, four-panel entry door with upper arched window, is placed at the far western bay of the main (south) façade. A set of paired, replacement, one-over-one vinyl sash windows are placed in the central bay and two, original, four-over-one wood sash windows are placed at the east bay. A non-original, partial-width, shed roof entry porch shelters the entry door and features square wood posts, a simple squared railing, and west elevation staircase entrance. The west gable end features three, grouped, one-over-one vinyl sash windows at the central bay and a gable end square louvered vent. Original window openings and placement are extant at the north facade; however, original windows have been replaced with one-over-one vinyl sash units. A brick chimney is placed at the front roof slope. A 1917 Sanborn map indicates a front-gabled form with a full-width, open front porch and partial-width, open, rear porch; by 1945, as reflected on a 1945 Sanborn map, the front porch has been enclosed to form an addition and a south side entry has been added. Due to loss of original materials, changes to form, and other alterations, this building lacks sufficient integrity of design, materials and workmanship to be considered eligible for listing in the NRHP.

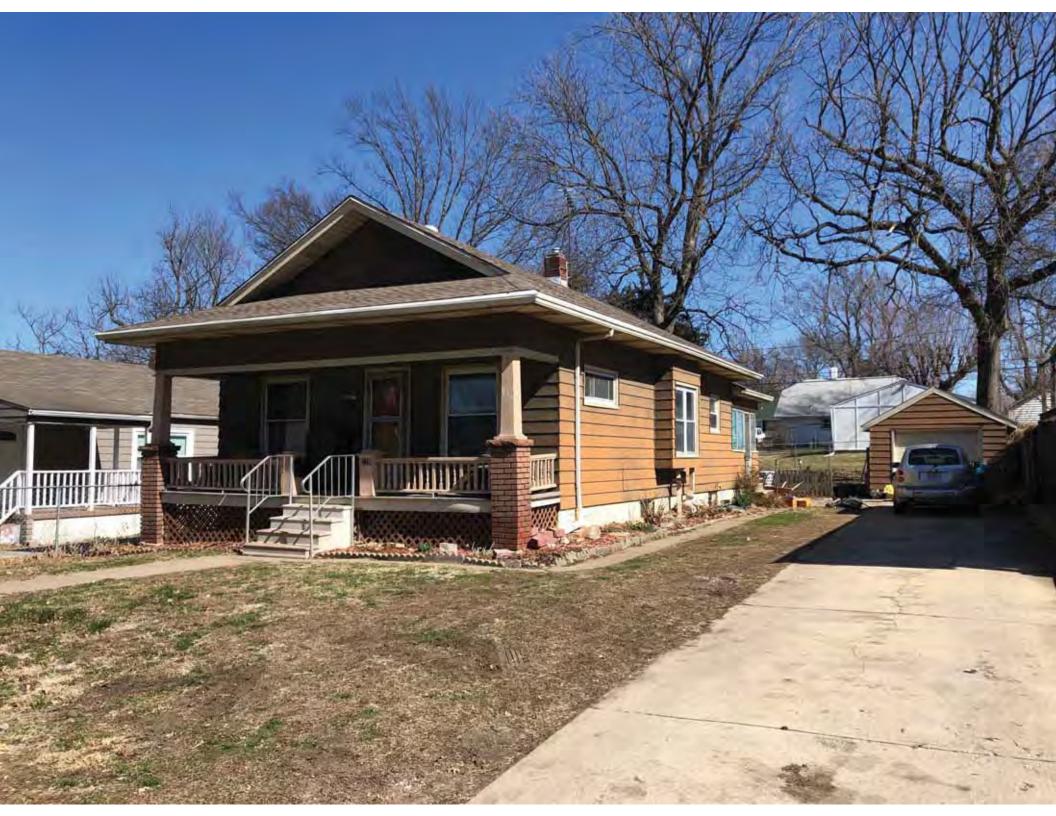
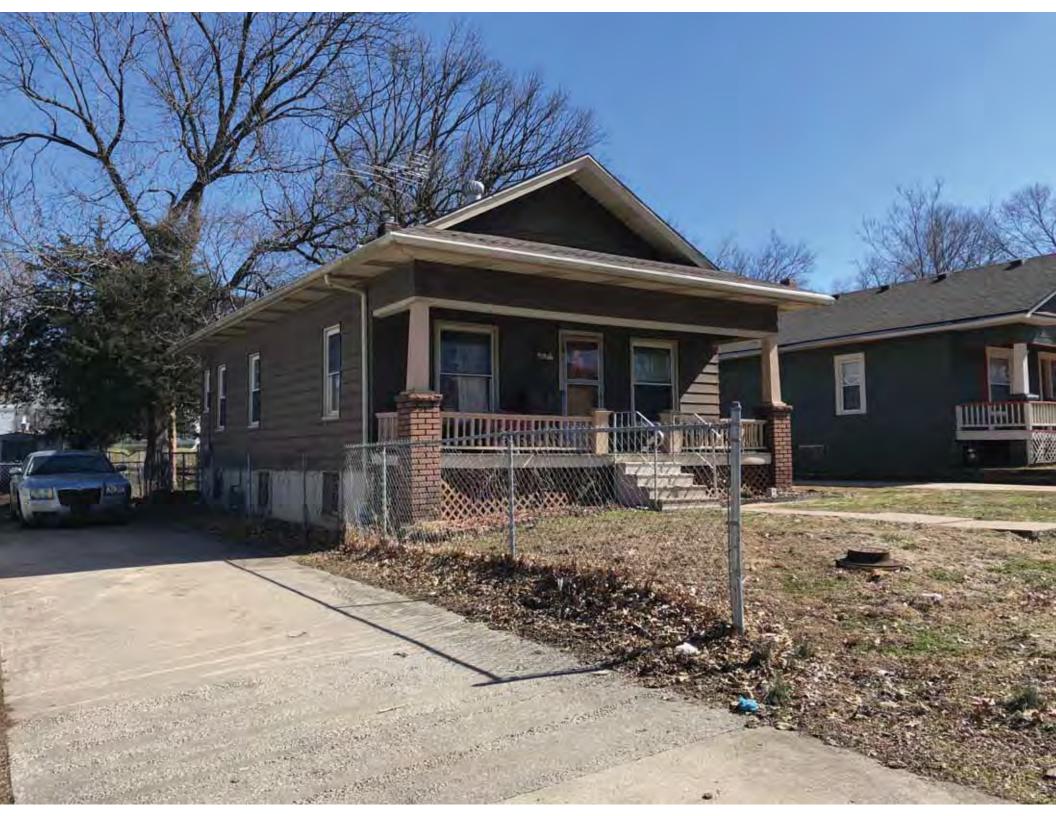
The main façade faces west. An asymmetrically-placed main entry is flanked by replacement, one-over-one vinyl sash windows with aluminum storms, which repeat at the secondary façades. The full-width, hipped porch features two battered wood columns, supported by brick plinths, and two inner piers lacking columns that flank the staircase entrance. The porch also features a turned spindle wood railing. Additional features include a brick chimney placed at the south side of the gable roof, a bay window centered at the south façade, and a partial-width, enclosed porch addition to the rear (constructed at an unknown date). This house retains few of its original Craftsman-style details. This building is a common example of its type that lacks distinction and therefore historical significance. Additionally, due to some loss of original materials, including windows, this building has diminished integrity of materials and workmanship.

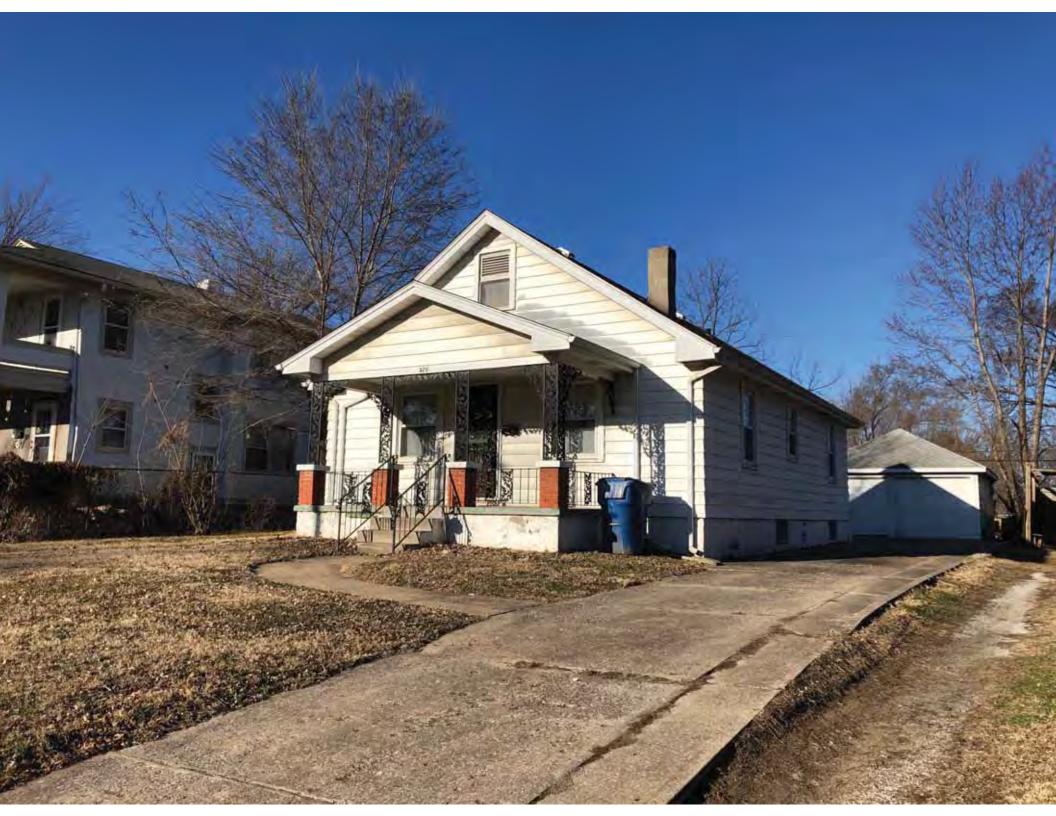
The main façade faces east. An asymmetrically-placed main entry is flanked by replacement, one-over-one vinyl sash windows, which repeat at the secondary façades. The gable end of the house features a one-over-one sash window; the upper window pane has been replaced with a louvered vent. The full-width, gabled, open porch features four, wrought iron columns supported by brick plinths. The south facade features a bay window with a group of three, one-over-one units, placed within a cross gable at the center bay. A concrete block chimney is placed near the ridge at the north side of the gable roof. This building is a common example of its type that lacks distinction and therefore historical significance. Additionally, due to loss of original materials, this building lacks sufficient integrity of materials and workmanship to be considered eligible for listing in the NRHP.
