National Register of Historic Places Registration Form

historic name Beins, Henry, House

Beins, Henry, House
Franklin County, Missouri
Historic Resources of Washington, Missouri

Summary: The Henry Beins house at 620 Locust Street in Washington, Missouri is a one and one-half story brick hall and parlor house with a brick foundation, a side facing gable roof, and a dentiled cornice. It has a symmetrical three-bay facade, with segmental arched door and window openings. The central front door is sheltered by an open frame porch which has simple Victorian style ornamentation. The house is representative of Property Type B. Vernacular Missouri-German, Subtype: Hall and Parlor, and meets the registration requirements set forth in the MPS Cover document "Historic Resources of Washington, Missouri." The two-room front part of the house was built ca. 1868; it was extended to the rear ca. 1900 and again several decades later. The porch appears to have been added about the time the first addition was made. Nearly all of the windows in the house have early two-over-two wooden sash, which were probably installed in the late 1800s. The period of significance runs from the time the original ho

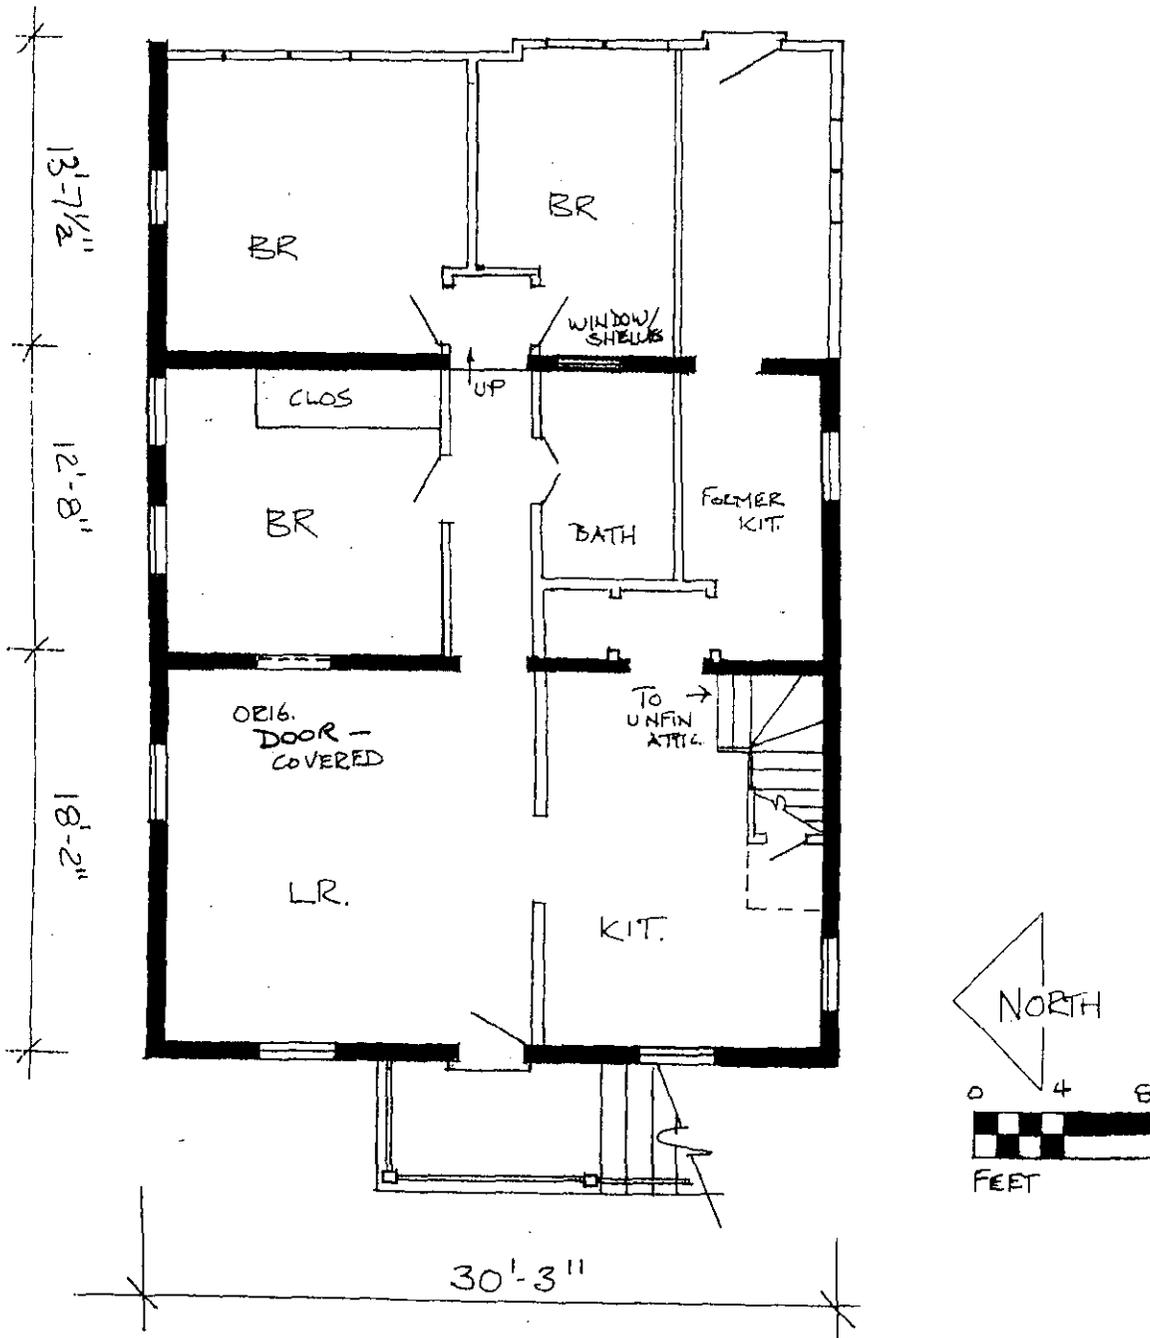
Figure One. Floorplan. Drawn by Debbie Sheals.

The interior of the house has had much the same layout for the last century. The front door opens to the living room, which is on the north side of the house. (See Figure One.) The current kitchen is on the south. A small corner stair in the kitchen leads up to the unfinished attic space. The stair is partly enclosed, and has a door on one end which leads to the basement stairs. (See photo 9.) The basement was originally accessed from outside via a flight of brick steps on the east. The steps were covered by the early addition, but are still visible from the basement.

There are doors from both front rooms into the early addition. The door in the kitchen leads to a small narrow room which once served as a kitchen; the plastered south wall still bears the marks of wall cabinets and a large sink. That room also has a door into the modern rear addition. The east door in the living room leads to a hallway, off of which is a bedroom and a bathroom. The hall continues to the back of the house and two more bedrooms which flank the hallway. (See photo 7.)
