NATIONAL REGISTER OF HISTORIC PLACES REGISTRATION FORM

historic name Block Unit #1 Historic District

street & number 4100-4191 Enright Avenue not for publication N/A
city or town St. Louis vicinity N/A
state Missouri code MO county St. Louis [Independent City] code 510
zip code 63108

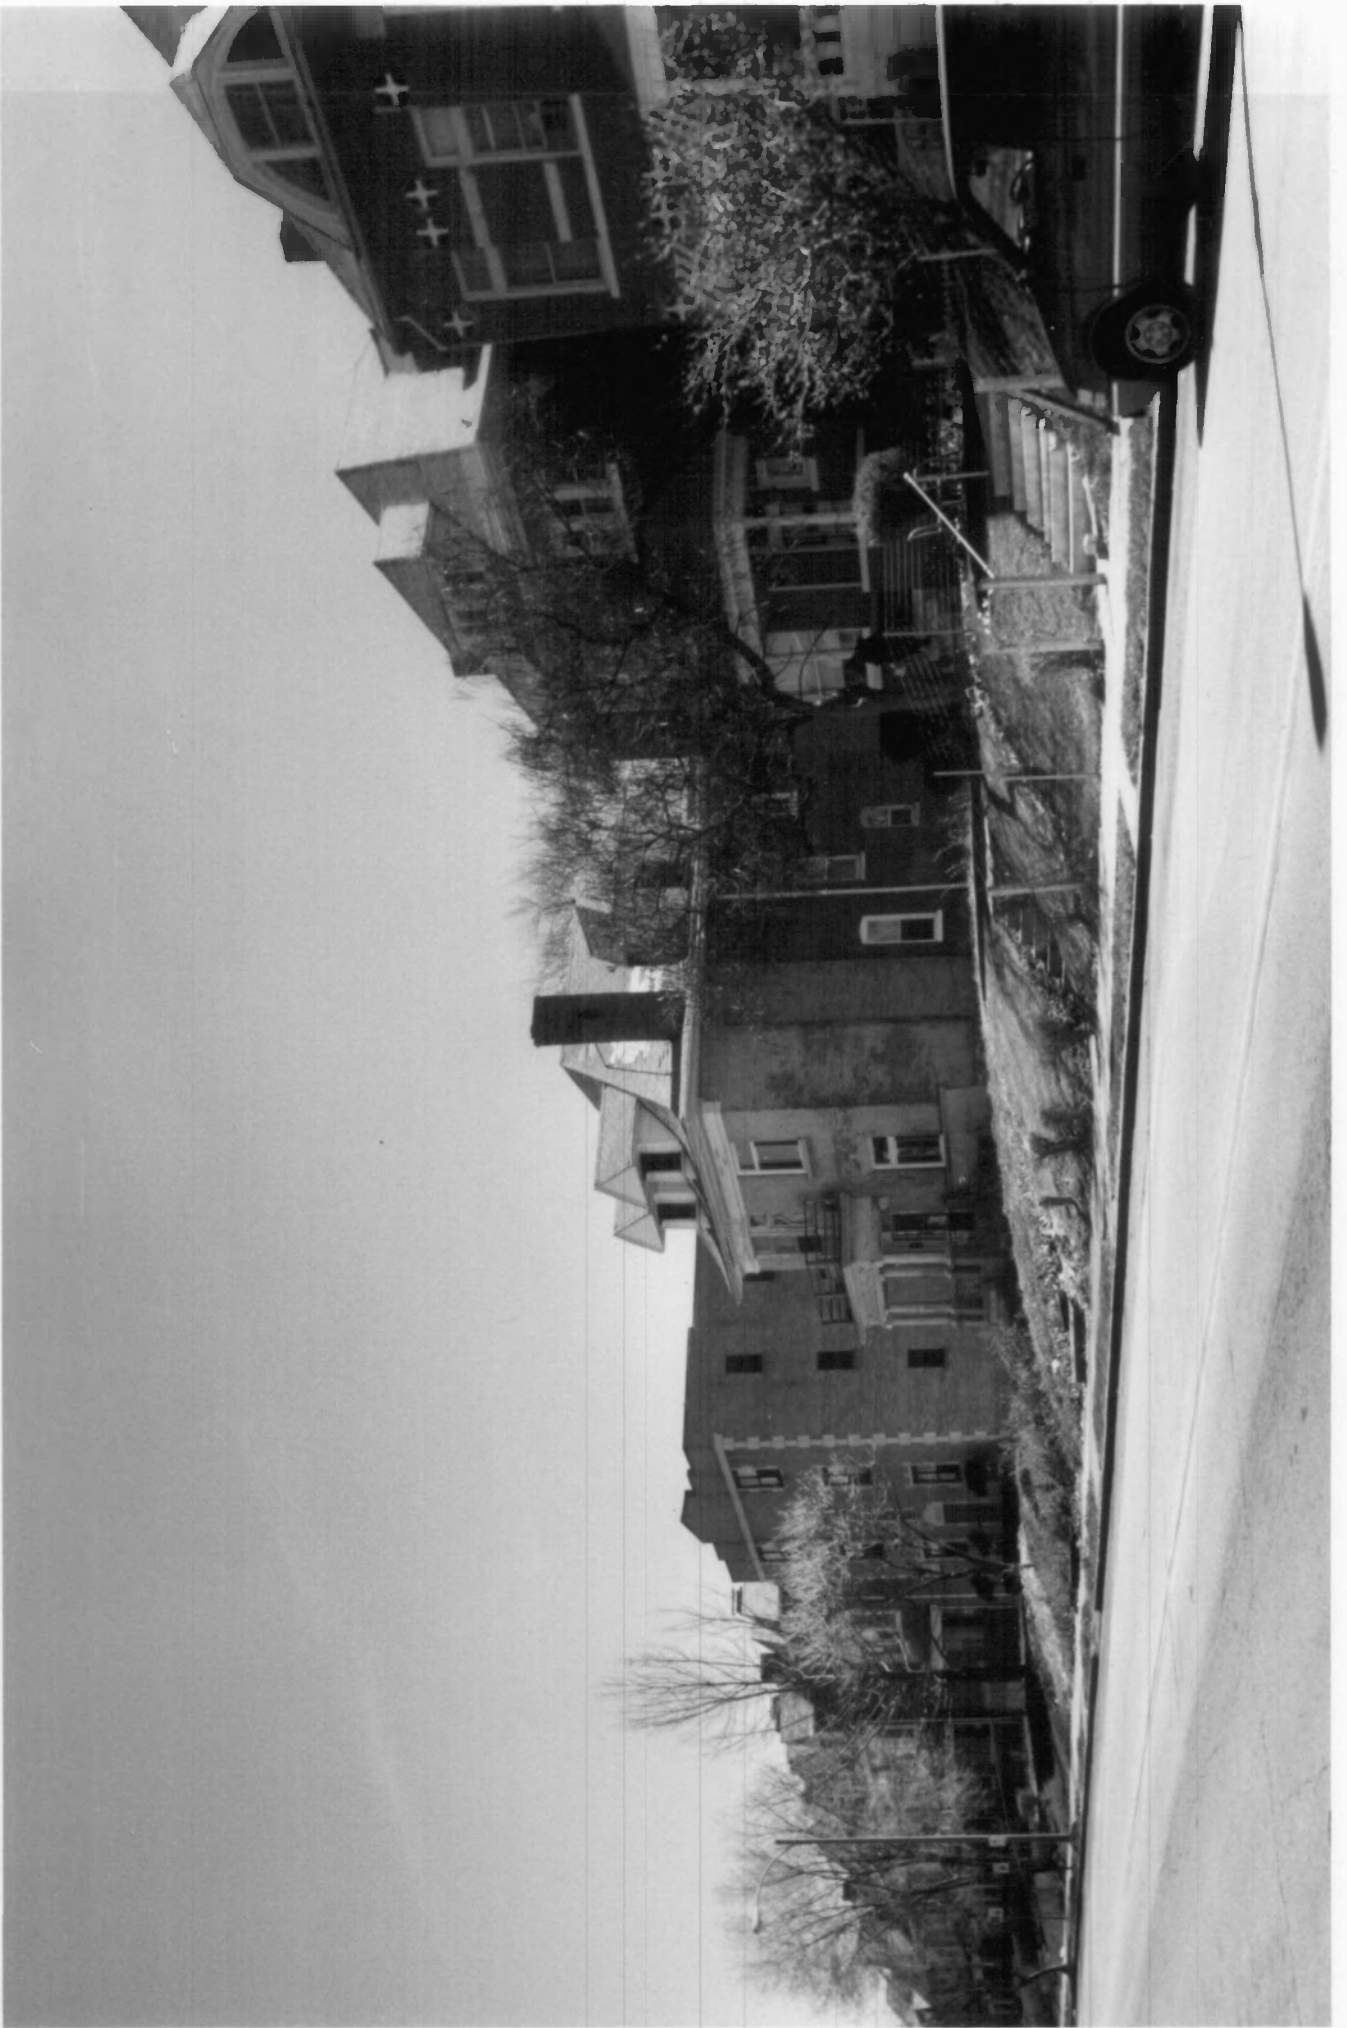
Photo #1

Block Unit #1 Historic District
4187 - 4183 Enright (L→R)

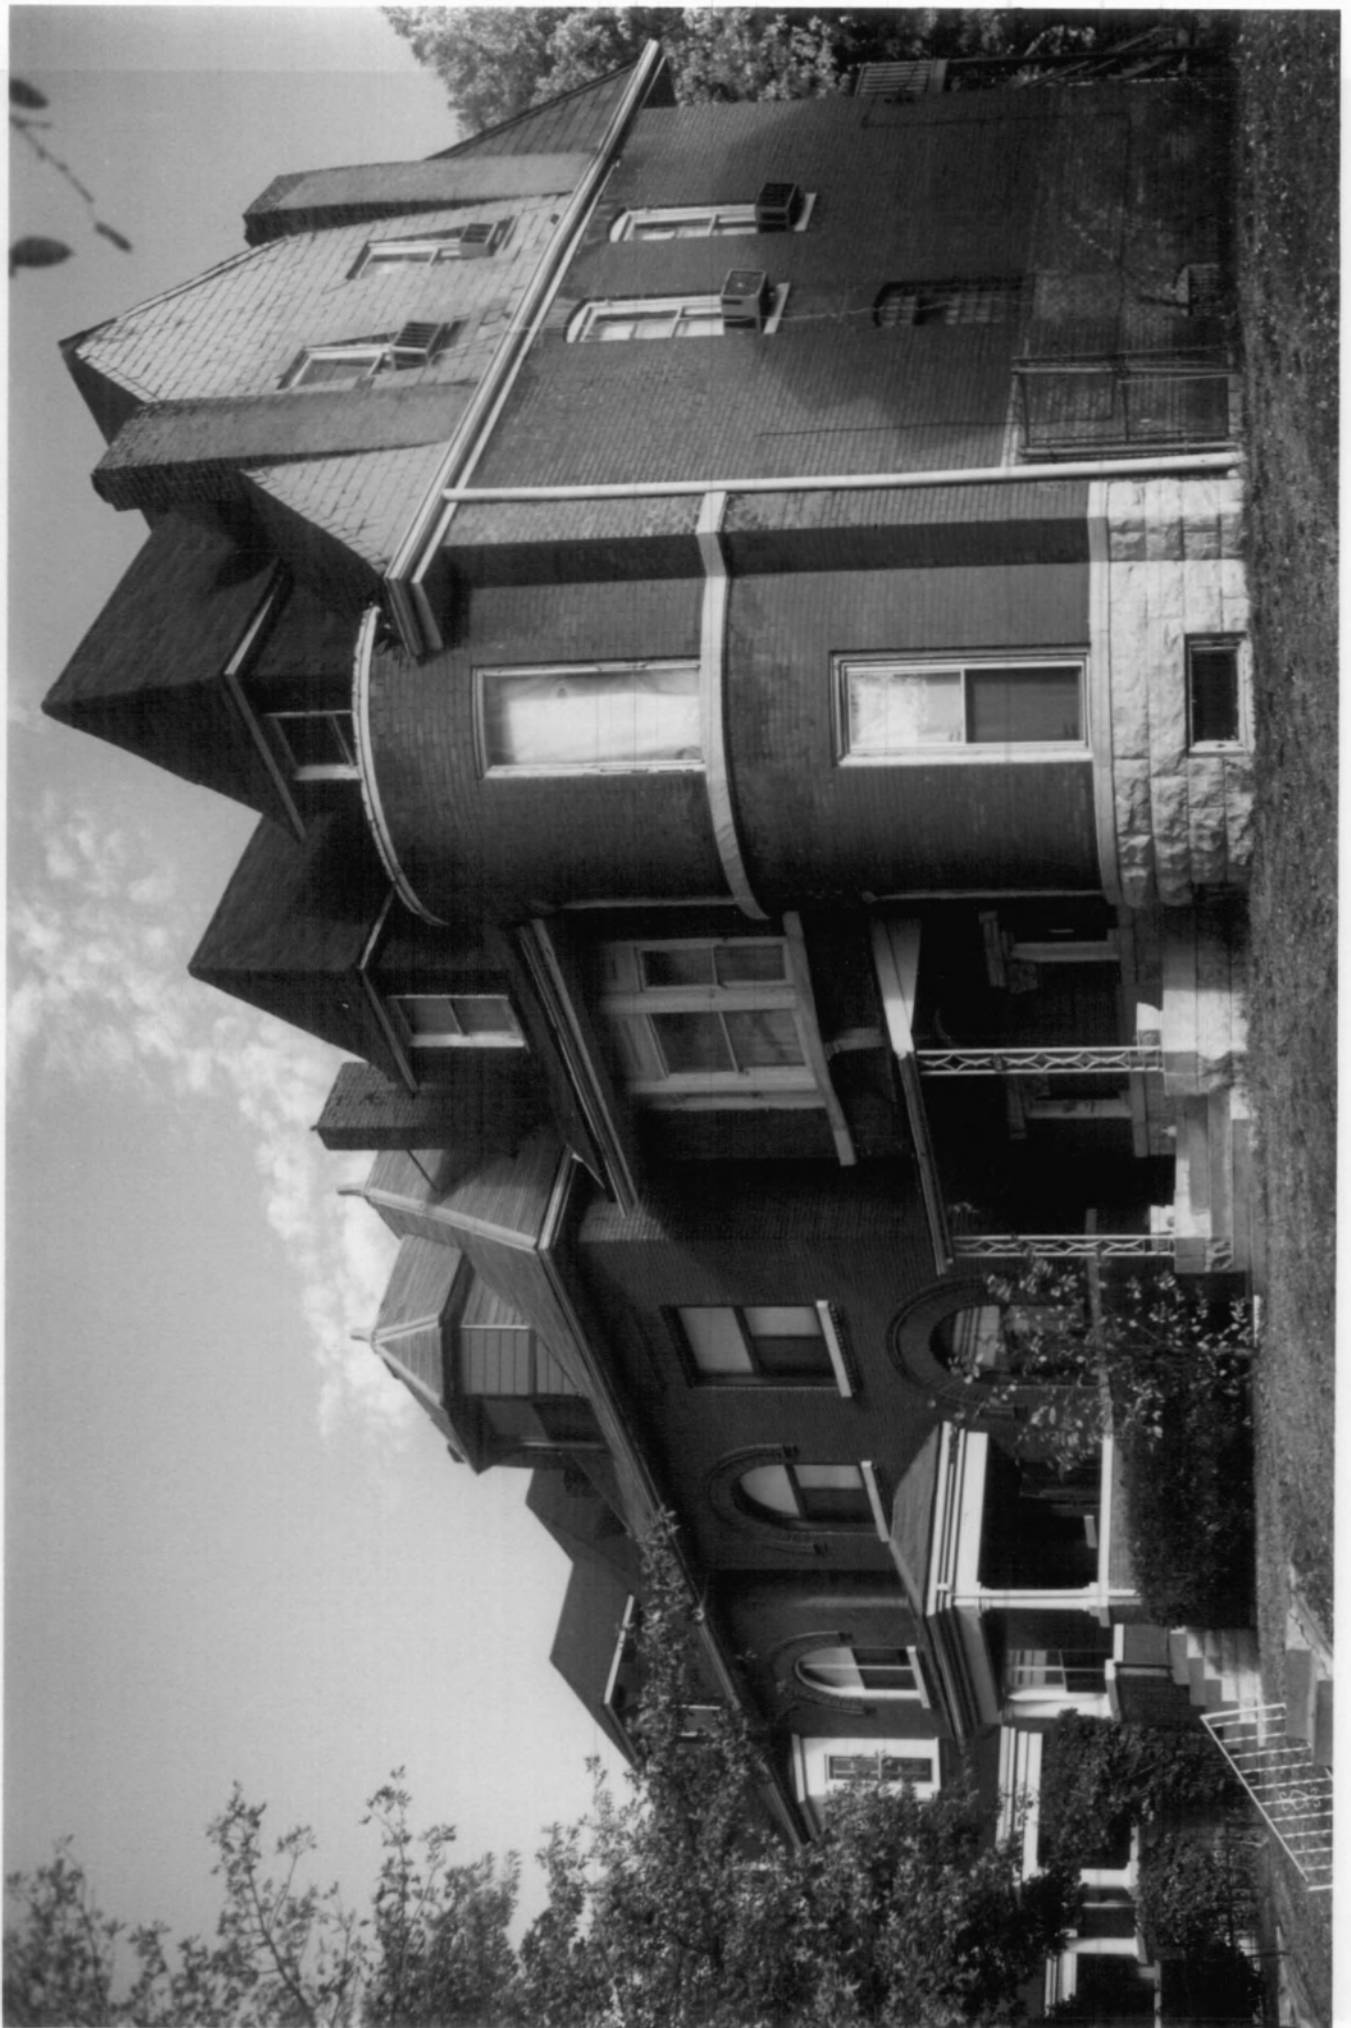
Photo # 3

4169, 4167, 4163 Enright (L→R)
St. Louis [Independent City], MO

The most notable grouping of foursquares is found at the western end of the north side of the block. The original house on this section of the block (**4183 Enright**) was an imposing Queen Anne built for owner Robert Grant in 1887. In 1892-93, he built eight speculative foursquares on his property. The seven extant foursquares from this group have similar facades, although each is individualized through variations in window shape and trim. (See Photos 2, 3 and 10.)

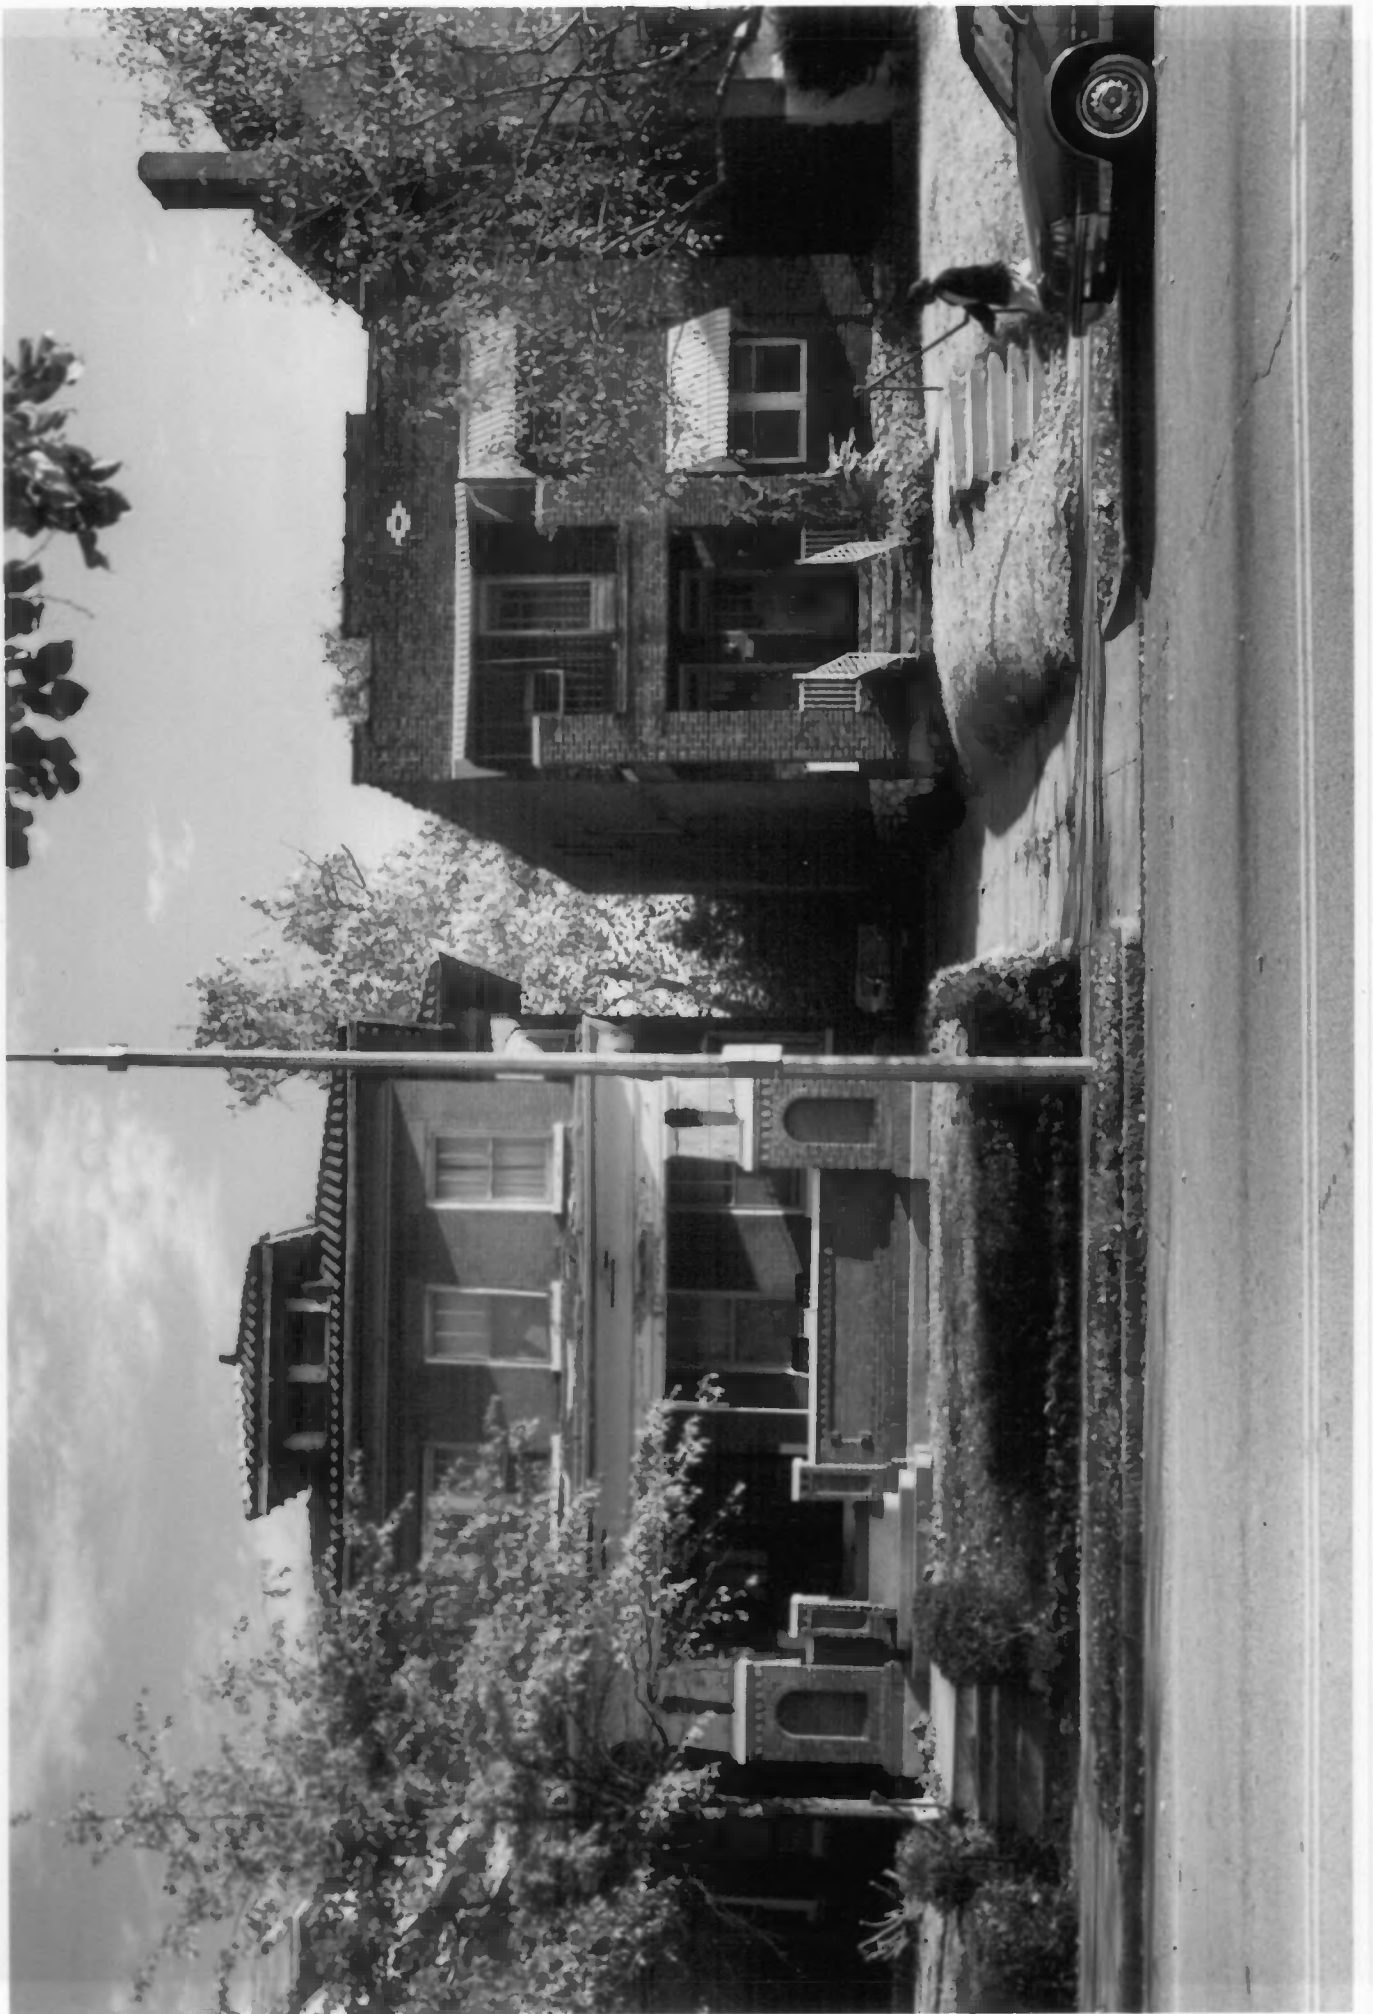
Photo #4

Block Unit #1 Historic District

4133-4119 Enright

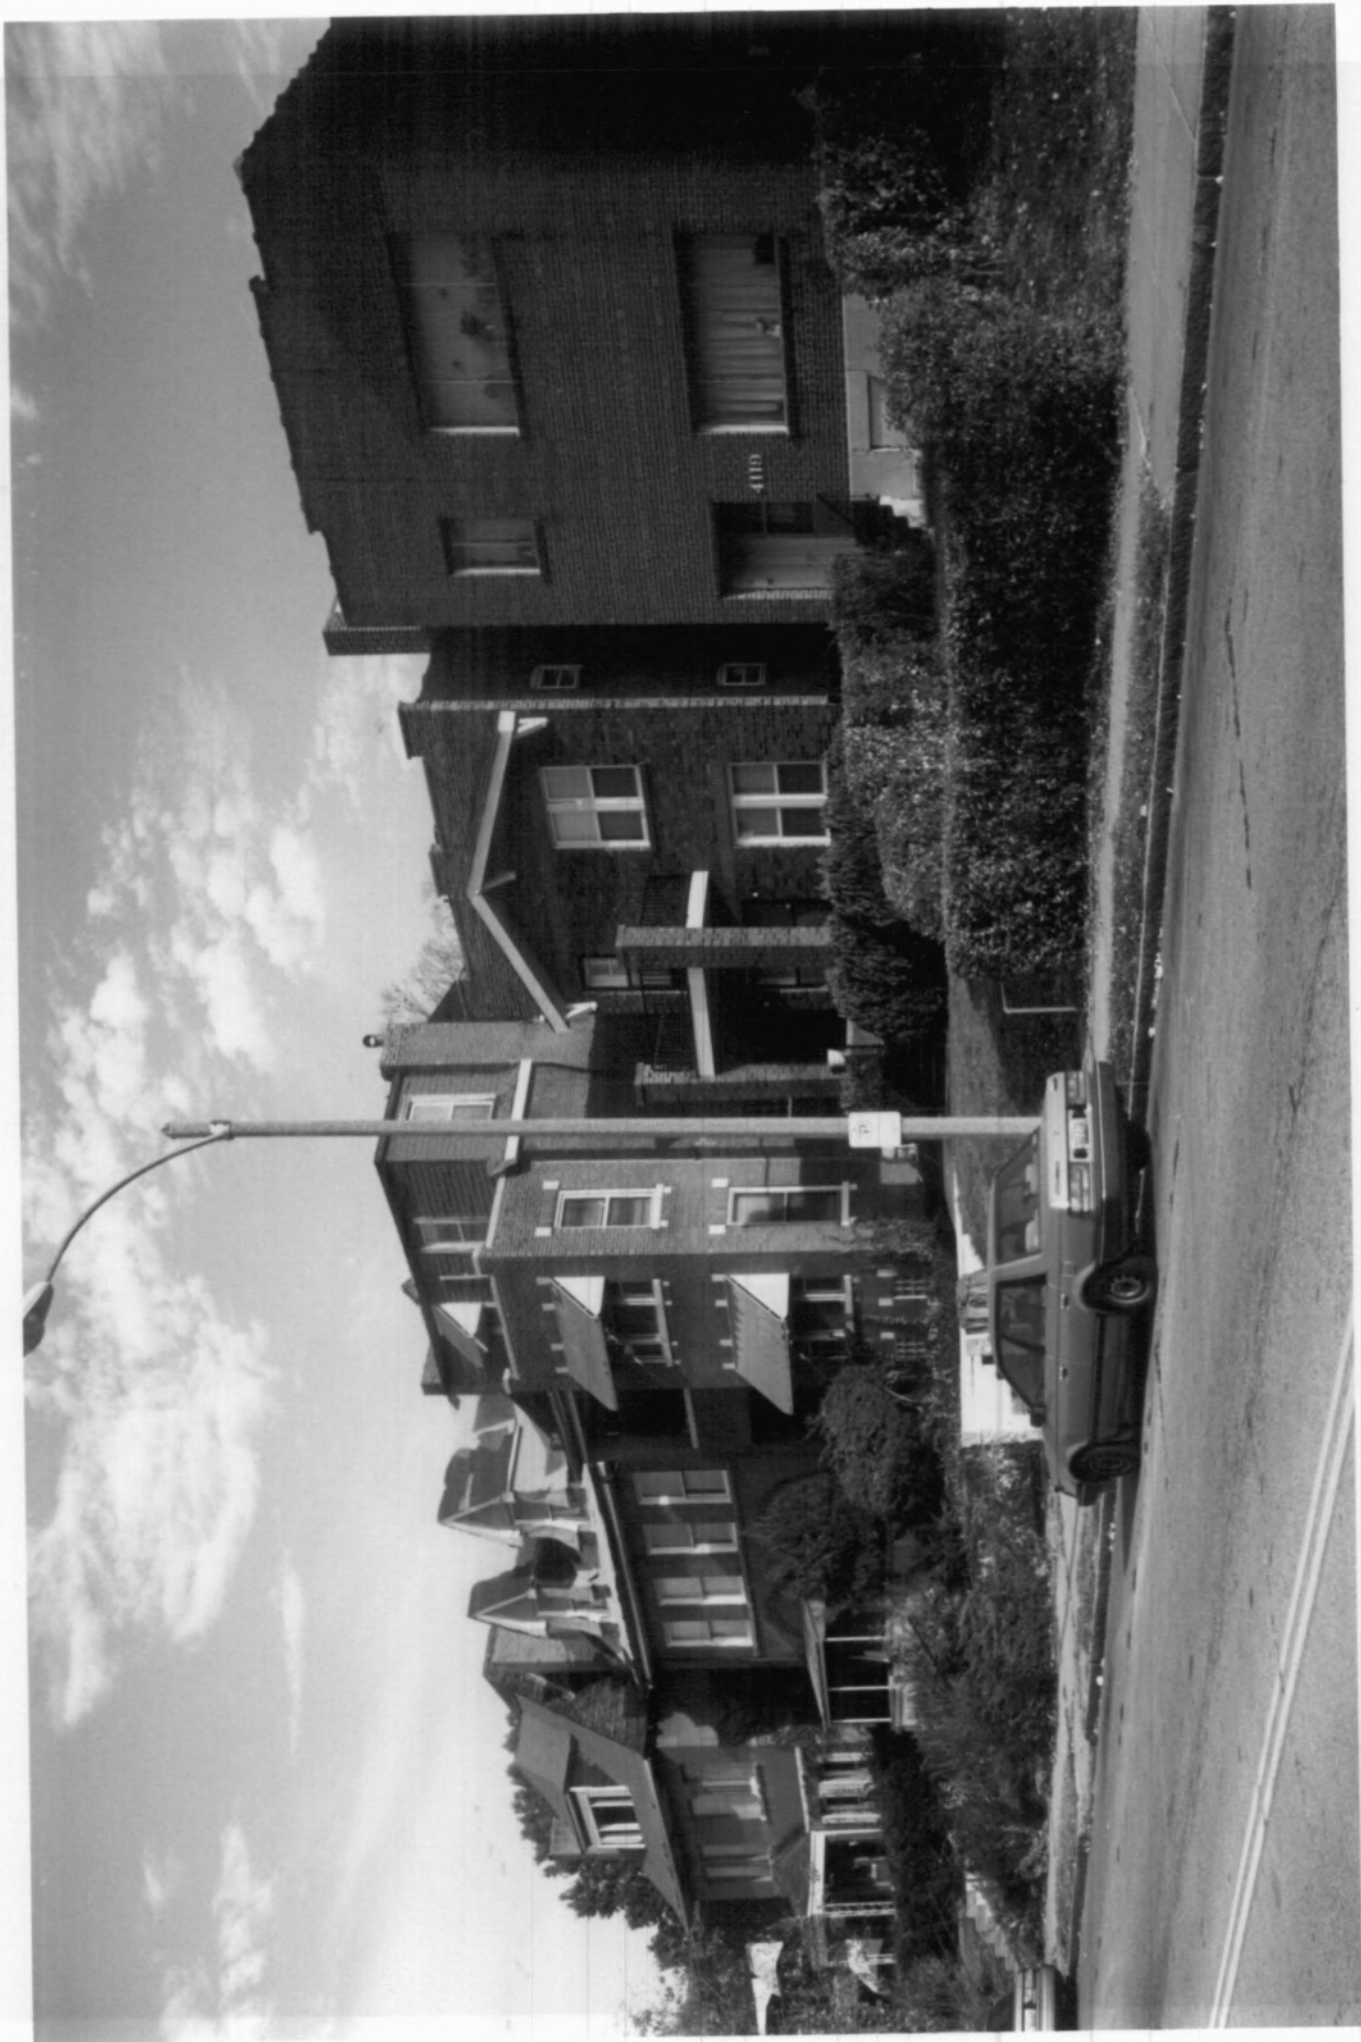
Photo #5

4106 - 4110 Enright

4106-10 Enright (Photo 6)
1927

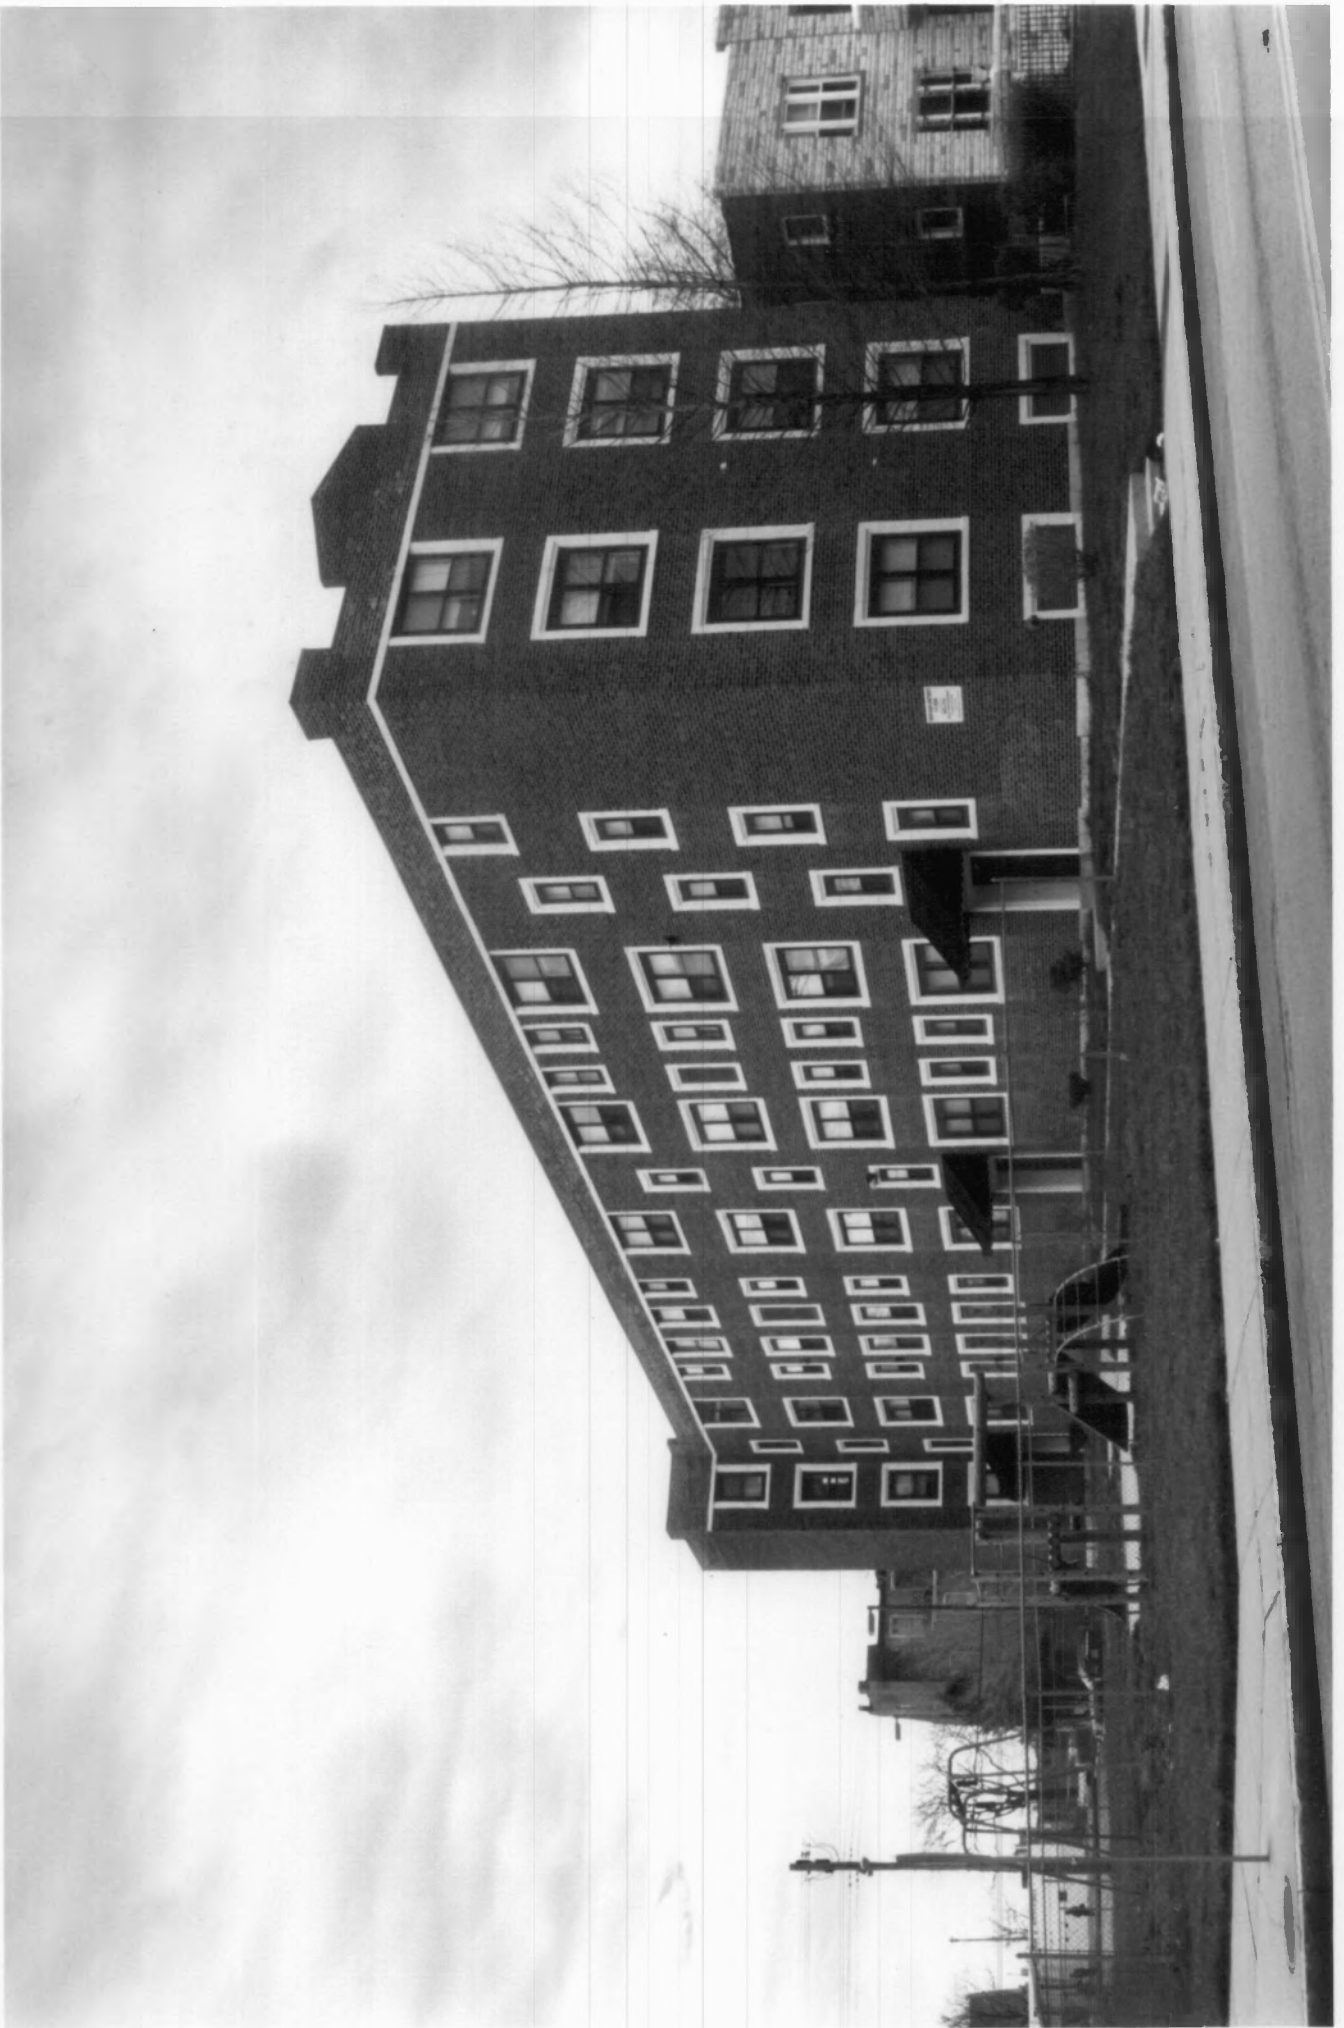
Photo 6

Block Unit # 1 Historic District
4112, 4114 Enright (L to R)
St. Louis [Independent City], MO

4112 Enright (non-contributing) (Photo 7)
1928; 1959

There are two non-contributing residential buildings, both described above. The first is located at **4112 Enright (Photo 7)** Although it is an interesting example of the "Modern Movements" category, the foursquare's permastone veneer and porch configuration almost certainly date to 1959, after the close of the period of significance. The second non-contributing residence is located at **4119 Enright (Photo 5, right)**. This is actually the oldest building in the district, dating to 1886; however, its plain brick facade was added in 1959.

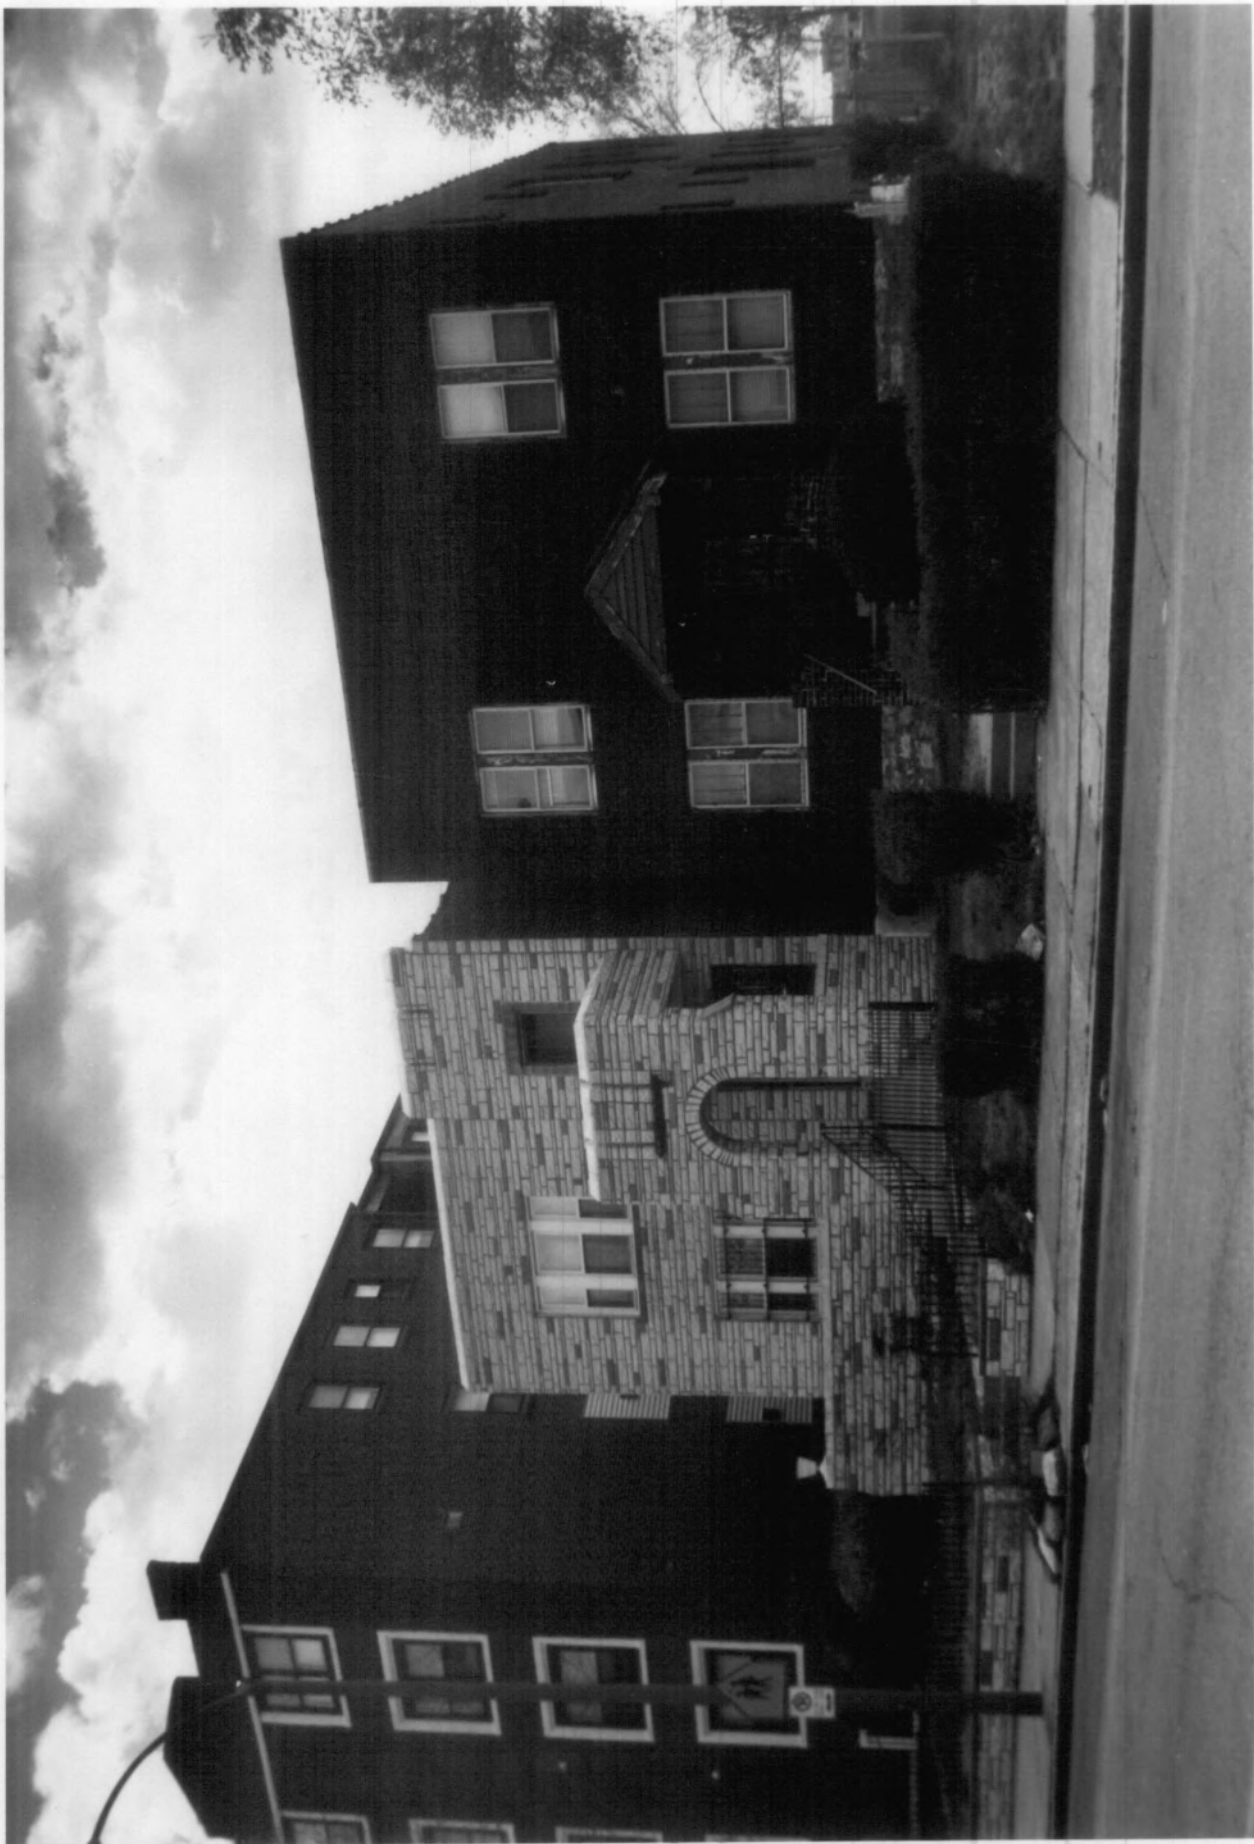
Photo 7

4122-24, 4128, 4132, 4134, 4136 Enright (L to R)

4122-24 Enright (Photo 8)

4128 Enright (Photo 8)

4132 Enright (Photo 8)

4134 Enright (Photo 8)

4136 Enright (Photo 8)

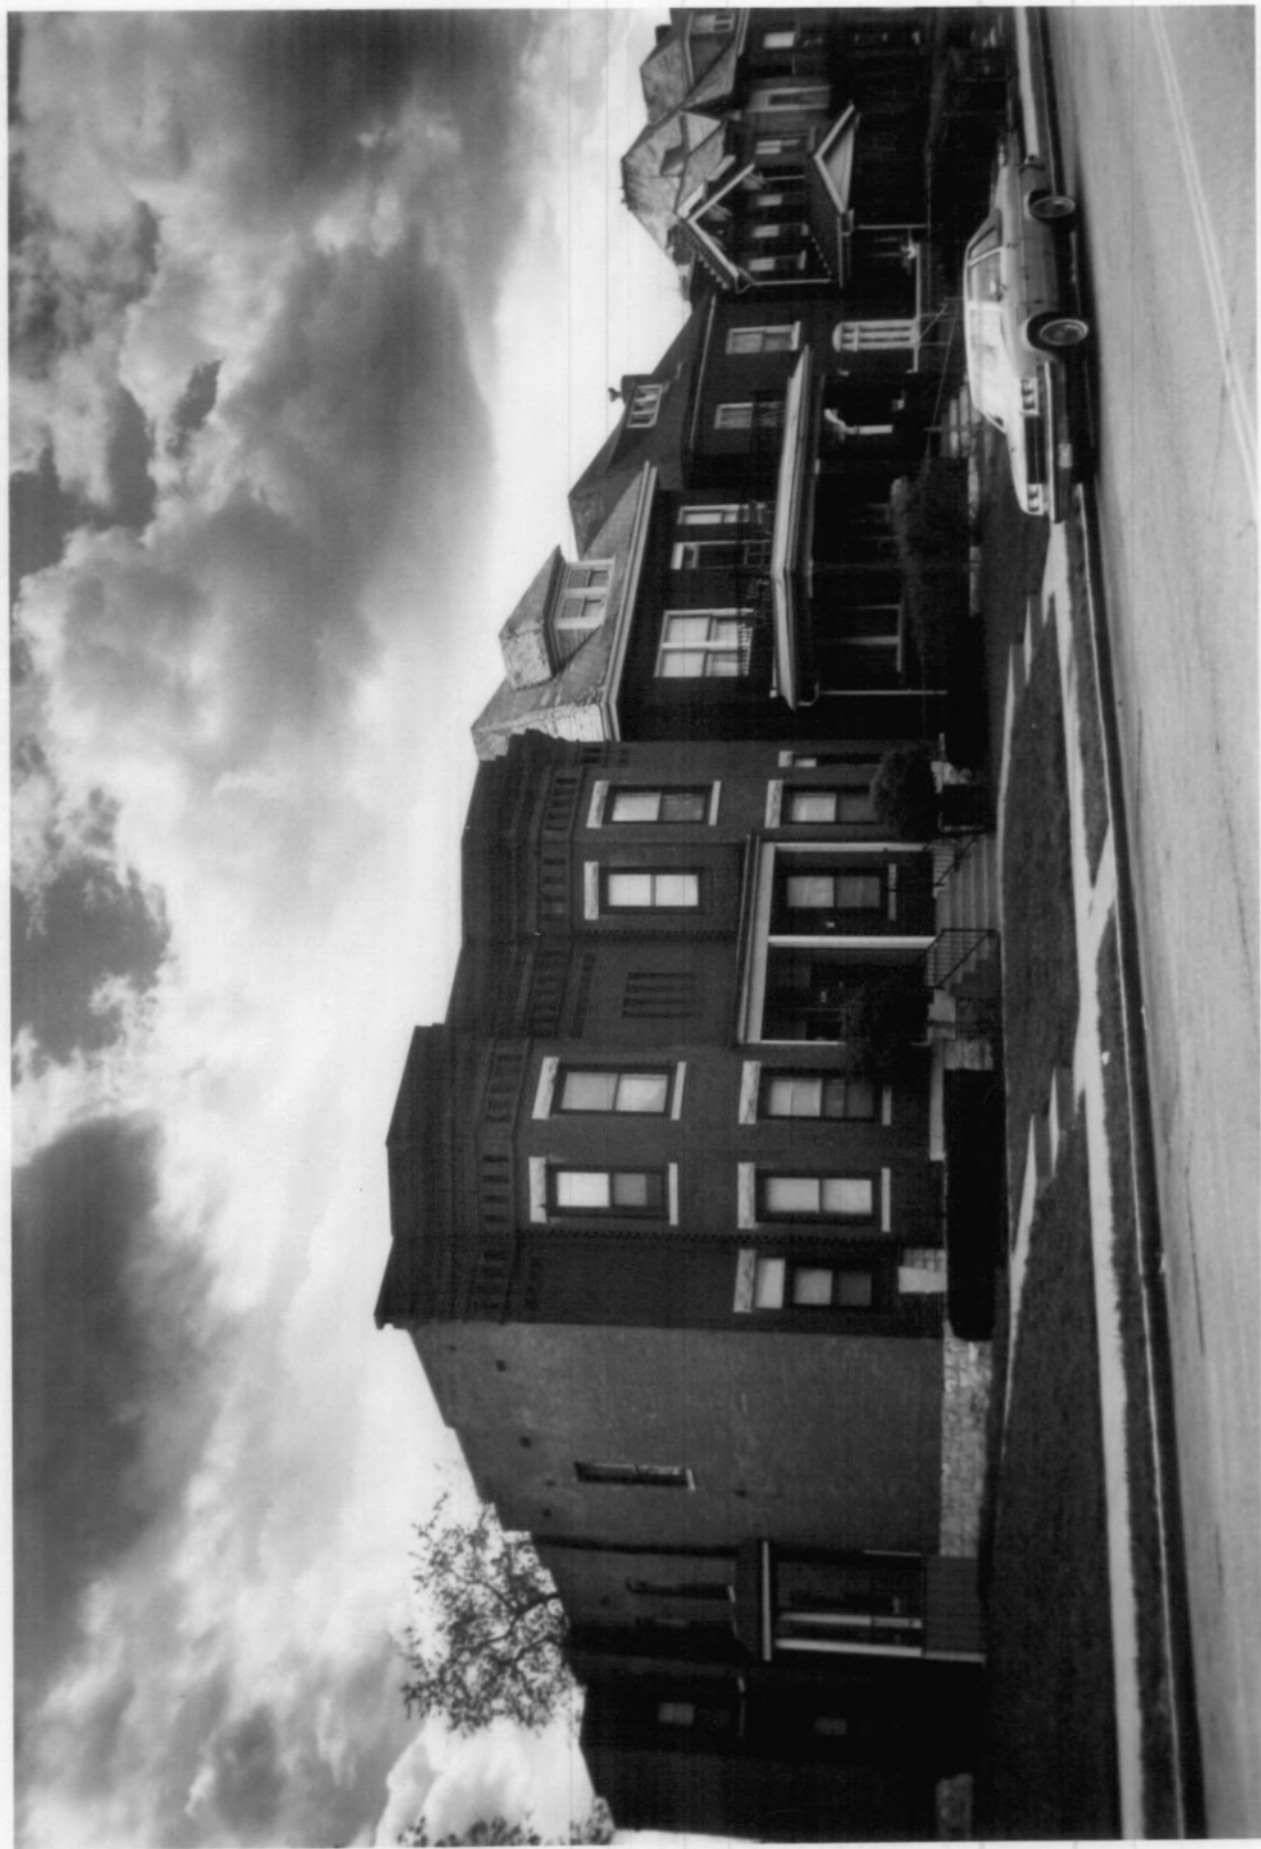
Photo 8

4142, 4146, 4148, 4150, 4154 Enright (L to R)

4142 Enright (Photo 9)

4146 Enright (Photo 9)

4148 Enright (Photo 9)

4150 Enright (Photo 9)

4154 Enright (Photo 9)

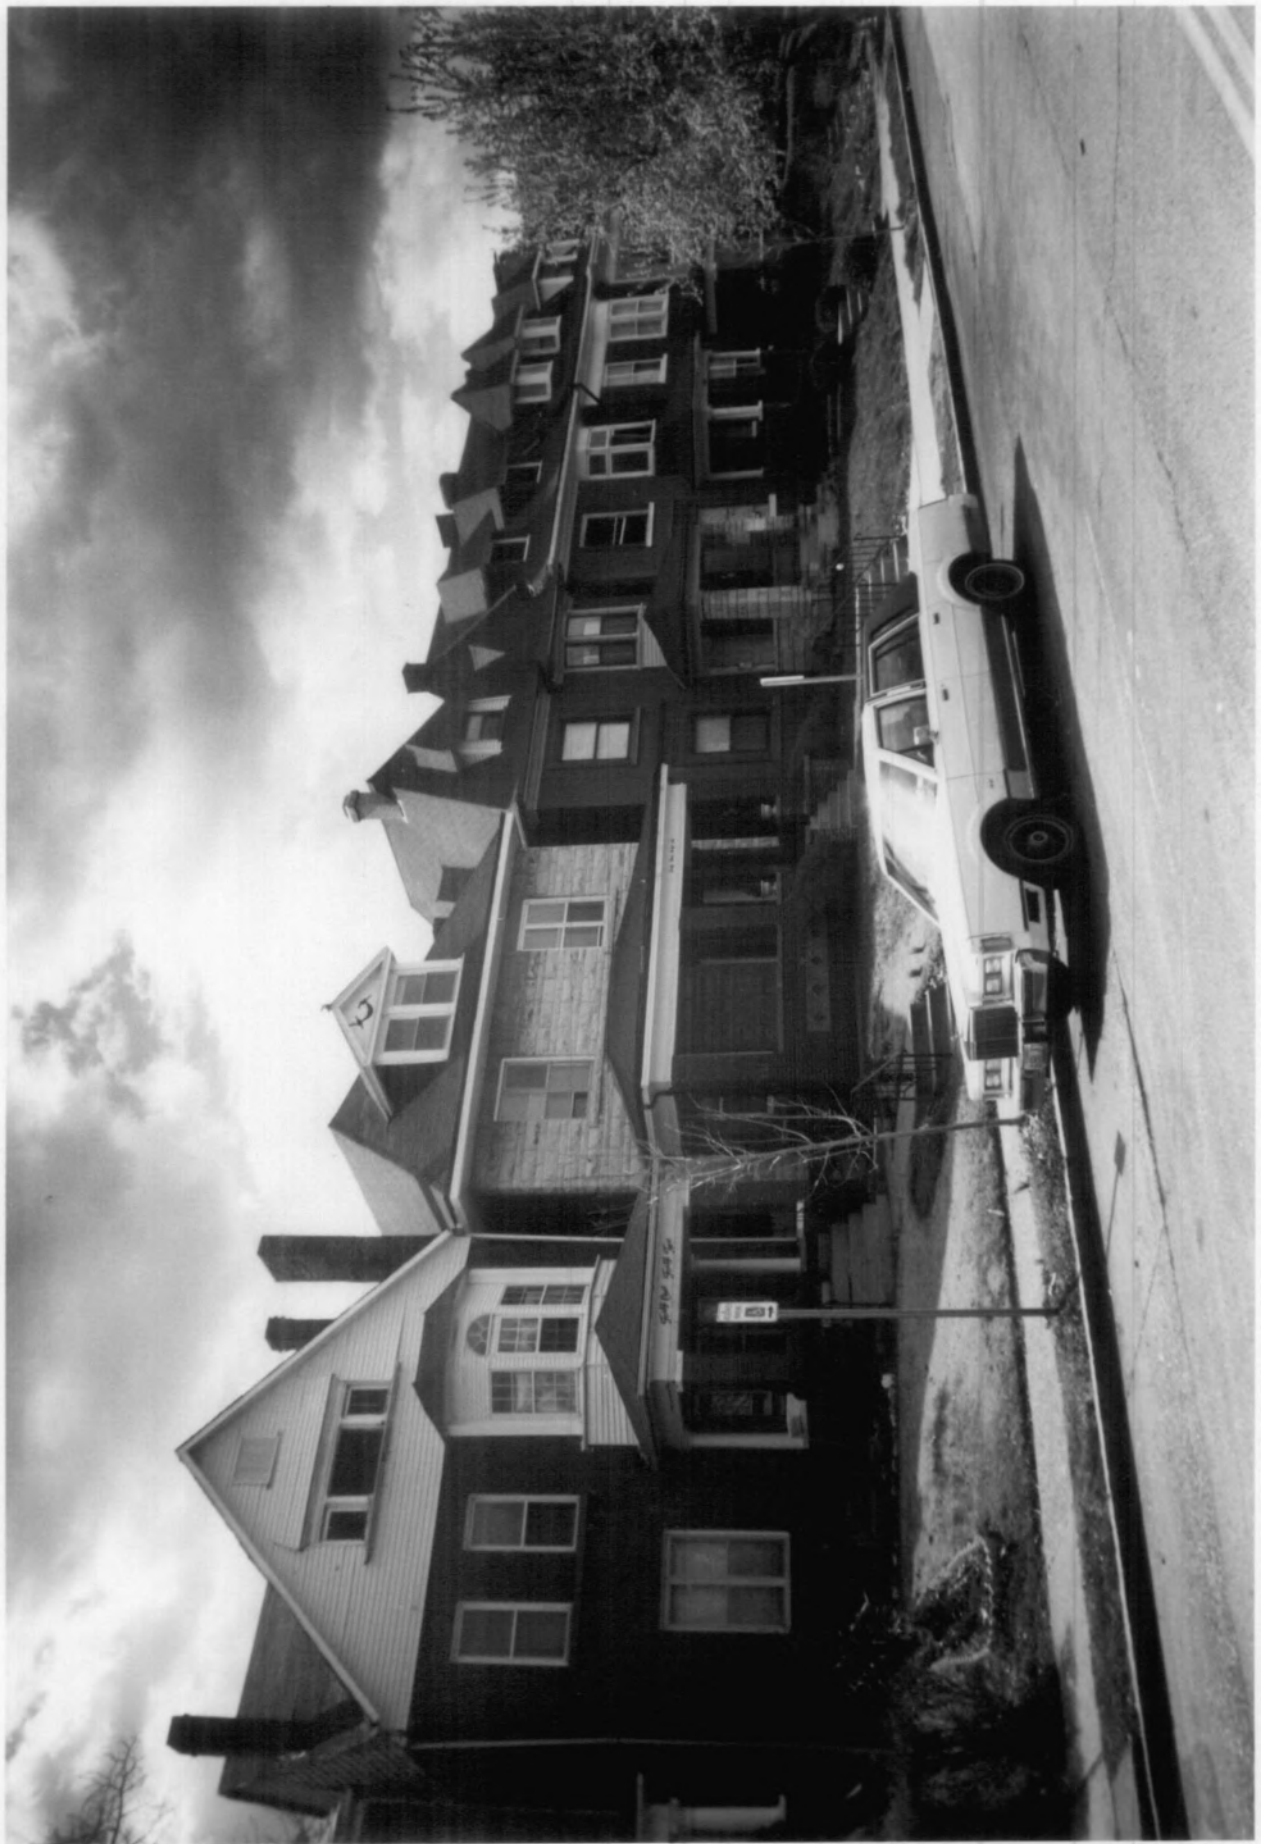
Photo 9

Block Unit #1 Historic District
4179, 4175, 4173, 4169 Enright (L to R)
St. Louis [Independent City], Mo
Lynn Josse
