NATIONAL REGISTER OF HISTORIC PLACES REGISTRATION FORM

historic name Block Unit #1 Historic District

street & number 4100-4191 Enright Avenue not for publication N/A
city or town St. Louis vicinity N/A
state Missouri code MO county St. Louis [Independent City] code 510
zip code 63108

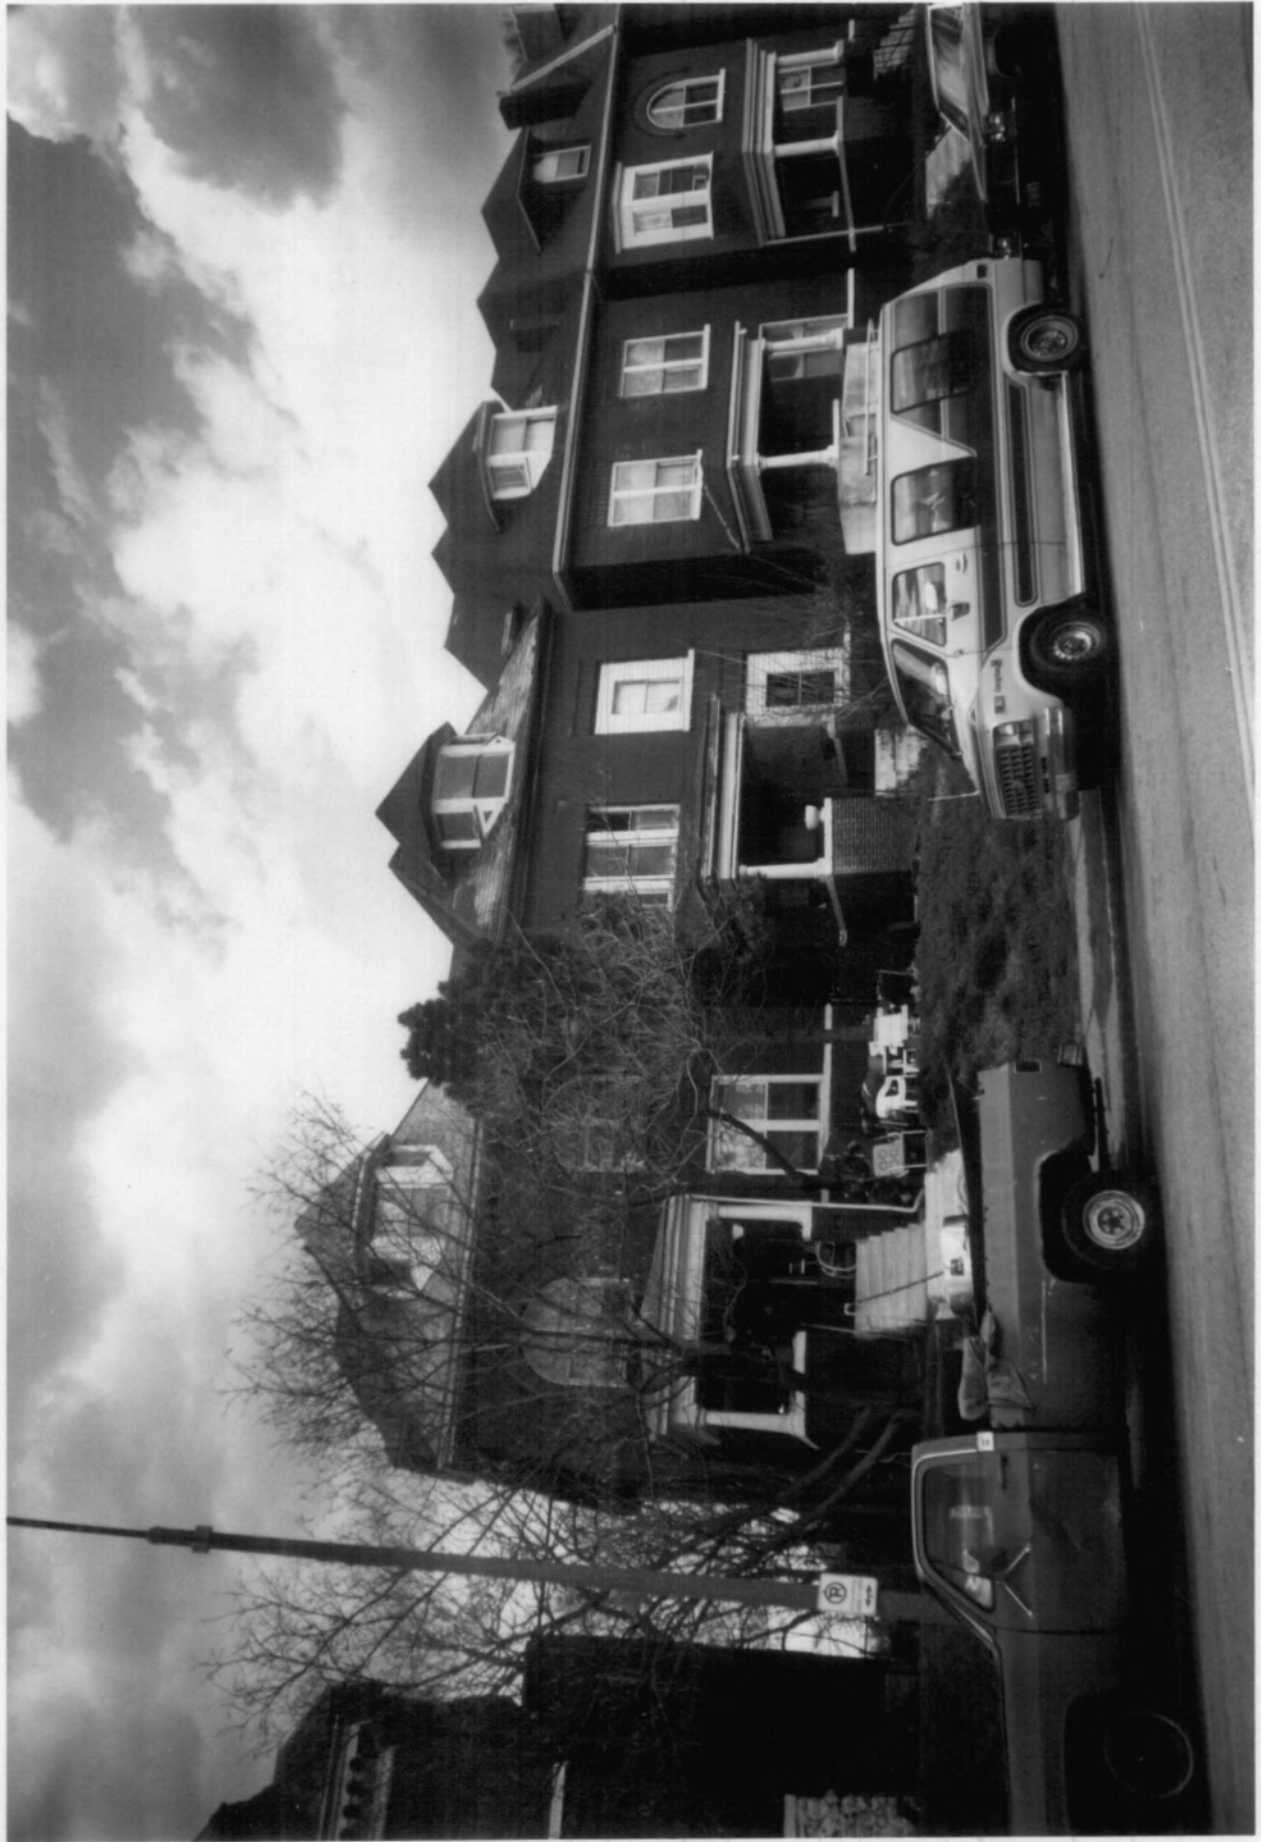
Photo 10

Block Unit #1 Historic District
4179, 4175, 4173, 4169 Enright (L to R)
St. Louis [Independent City], Mo
Lynn Josse

The most notable grouping of foursquares is found at the western end of the north side of the block. The original house on this section of the block (**4183 Enright**) was an imposing Queen Anne built for owner Robert Grant in 1887. In 1892-93, he built eight speculative foursquares on his property. The seven extant foursquares from this group have similar facades, although each is individualized through variations in window shape and trim. (See Photos 2, 3 and 10.)

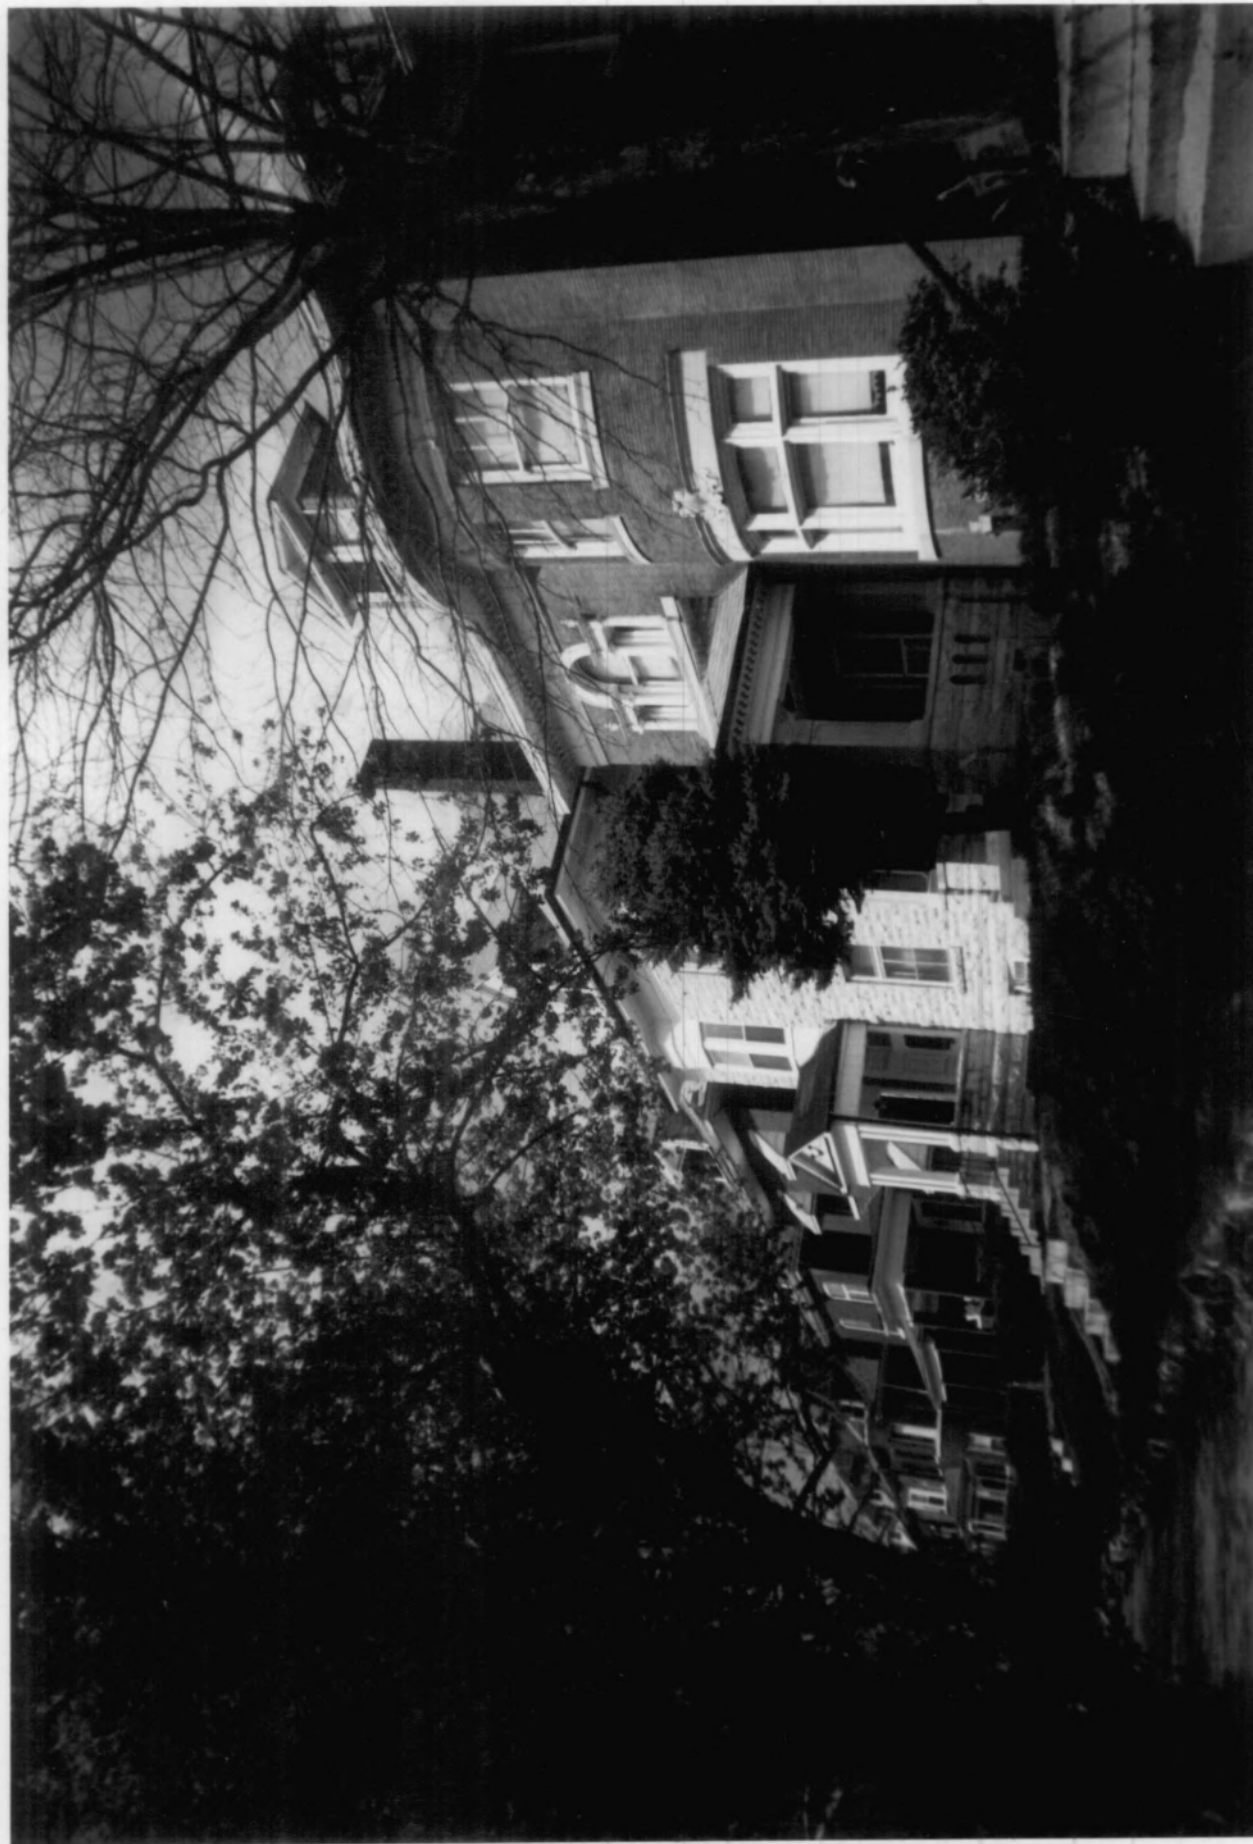
Photo 11

4109.17 Enright

The three low-rise apartment buildings in the district have all been altered to varying extents. At **4109-17 Enright**, doors and stair windows facing the street have been closed over and windows are replaced with modern dark vinyl sashes. A three-story tower has been built at the entrance to the courtyard, closing the U shape; its peaked parapet line is built to resemble the cross gables of the original building. The new main entrance is at the parking lot to the east. The Beverly at **4166-70 Enright** (Photo 1, 4th from right) has similar modifications: the front door and two windows at both floors above it have been filled in with what appears to be louvered venting. **4106-10 Enright** (Photo 6) has been rehabilitated with modern windows and awnings but appears otherwise intact.
