MISSOURI OFFICE OF HISTORIC PRESERVATION

Architectural/Historic Inventory Survey Form

Community of Bonnots Mill Survey

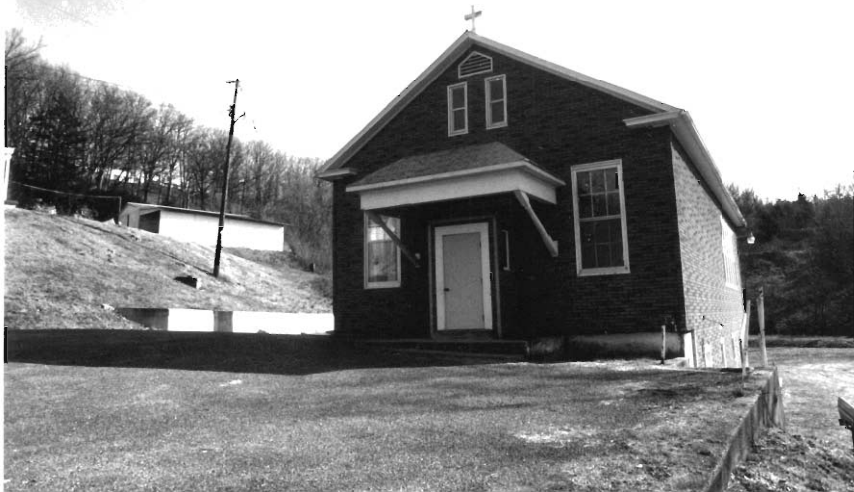
OS-AS-602-001

Exterior condition: Good Endangered/by what?: No

Modern solid door off-center to left of facade (northwest) in front projection with horizontal 1/1 window above. Oversized hip roof door hood with wide wood frieze supported by turned posts set as angled braces; concrete stoop slightly above grade. 6/6 sash to south of front entrance and 4/4 sash to north with aluminum frame storm sash. Gable with two narrow 1/1 sash and louvered vent in apex; small wood cross on ridge. Narrow overhanging eaves return on front gable. Southwest elevation with exposed at-grade basement with pedestrian door at west end and sash to east. First story with four grouped sash at east end. Interior brick chimney on northeast elevation toward rear. Eight adjoining 4/4 windows on northeast elevation toward front of building with stepped wing toward rear. 3/1 window faces southeast in wing of rear elevation with two paired 4/4 windows on first floor of main building block. Boarded window and gable returns in rear gable. 2/2 window in basement off center to left with basement door off center to right.

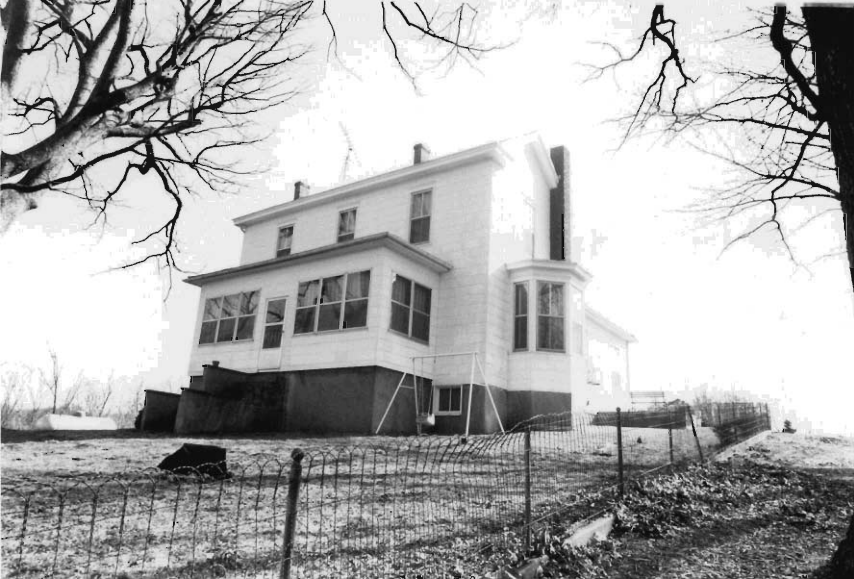
OS-AS-012-082

No. of stories: 2 Basement?: Yes Foundation material: Limestone
Wall construction: Frame (brick-nogging) Roof type and material: Gable; Metal (standing seam)
No. of bays: Front, 3 Wall treatment: Asbestos shingle
Plan shape: Rectangular Changes (Addition or Altered?): Yes
Exterior condition: Good Endangered/by what?: No

Pre-Classical (three bay) I-House. Rectangular plan dwelling with standing seam metal, gable roof. Gable extension with shed wing at rear. All gables have returns. Symmetrical facade (northwest). Broad, central enclosed porch with metal roof, an early twentieth century alteration. Front entrance in center of facade, with sets of 1/1 storm sash on either side. Three 2/2 windows with drip molds on second floor of facade. Main block of building has 2/2 windows with plain drip molds. Semi-octagonal bay with 2/2 windows on southwest elevation. Toward rear of dwelling on southwest elevation, exterior end brick chimney. Rear gable extension has brick chimney at center of ridge, 2/2 window in gable, and two northeast facing windows. Shed wing with rear entrance and 1/1 window facing southeast and four windows facing northeast.

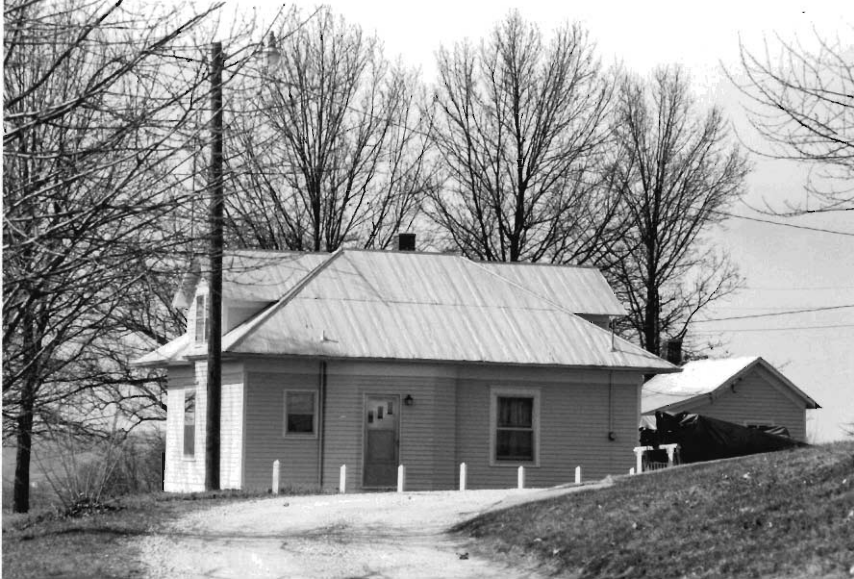
OS-AS-002-003

Exterior condition: Good Endangered/by what?: No

Square floor plan. Hipped, corrugated metal roof. Frame construction with artificial siding. Gable front, wall dormers with pairs of 1/1 windows face northeast and southwest. Front entrance faces southeast in semi-hexagonal "bay", off center to the left of the facade. Smooth wood cornice band below eave of roof and dormers.

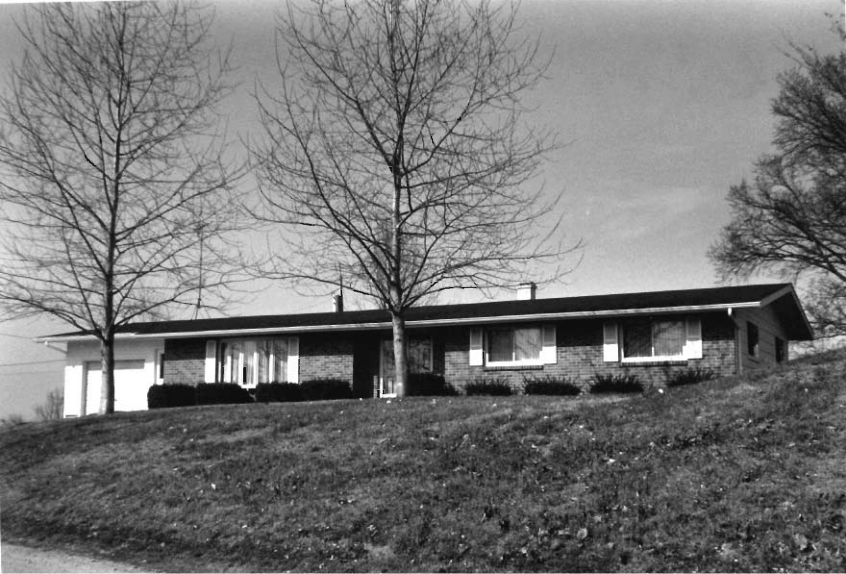
OS-AS-002-004

No. of stories: 1	Basement?: Yes	Foundation material:
Wall construction: Frame	Roof type and material: Gable; Asphalt shingle	
No. of bays:	Wall treatment: Artificial siding/Brick veneer	
Plan shape: Rectangular	Changes (Addition or Altered?): Yes	
Exterior condition: Excellent	Endangered/by what?: No

Ranch house with rectangular floor plan. Low pitch, asphalt shingle, gable roof. Two adjoining front doors in recess off center to the left. Two 2-light sliding sash windows in right bay of facade (south) and a 5-light casement bay window in the left bay. Shutters on all facade fenestration. Garage addition to west elevation. Accommodates one car and has modern overhead car door. A pedestrian door also faces south in the garage addition. Two windows face east and one faces west. Stuccoed chimney to right of facade center at roof ridge.

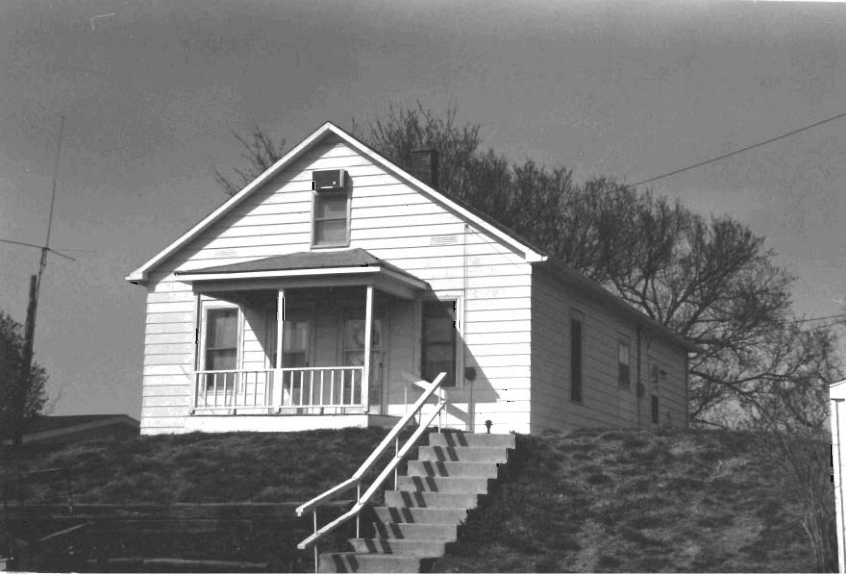
OS-AS-002-005

Exterior condition: Good Endangered/by what?: No

Rectangular floor plan. Gable roof with asphalt shingle. Front entrances to right and left of facade center. 1/1 window below narrow vent in gable facing front (south). Three simple wooden posts extending from wooden porch base support asphalt shingle, hipped, porch roof. Plain wooden balustrade. 1/1 windows on all elevations. Door on east elevation at rear. Similar to building #18.

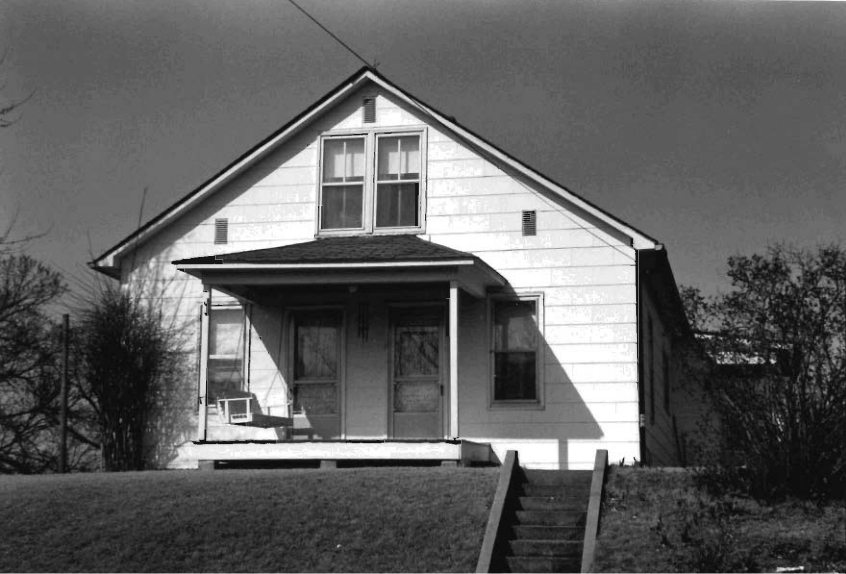
65-16-a2-006

Exterior condition: Good Endangered/by what?: No

Retains a high degree of integrity. Good example of an early twentieth century Open Gable house type. This building would contribute to a potential National Register historic district (1C).

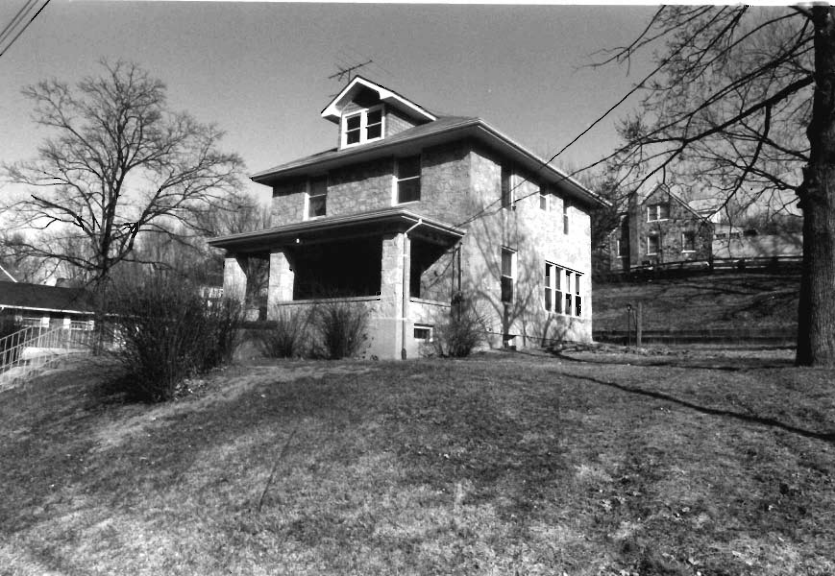
The house was constructed in 1923 by the Schill Construction Company. Henry Samson was the first occupant. Al and Josephine Samson later lived in the dwelling.

An excellent example of the Four Square house type with the Craftsman stylistic influence of Native Rock wall treatment. This building would contribute to a potential National Register historic district (1C).

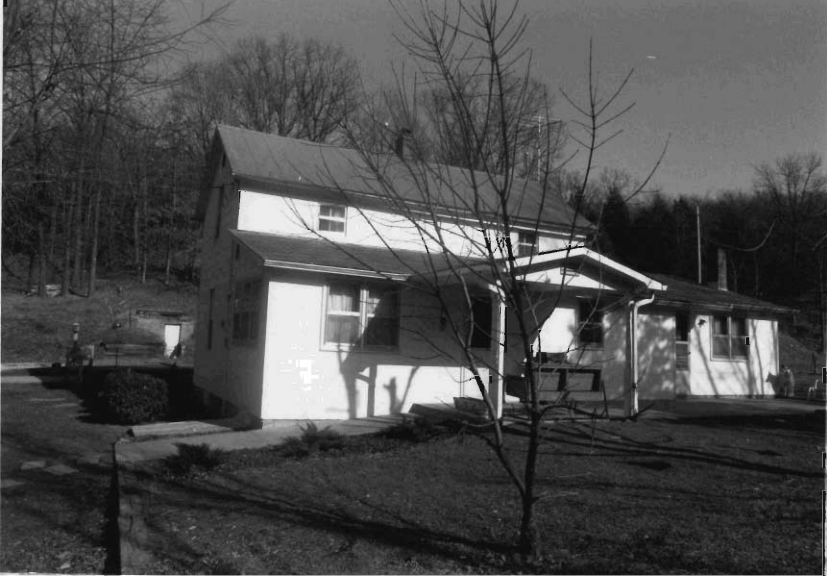
Perhaps an I-House (3 bay) or a New England One and a Half house type, but enclosed porch interferes with complete evaluation. Even though this house would not contribute to a national Register historic district, its four outbuildings would be contributing (1NC; 4C).

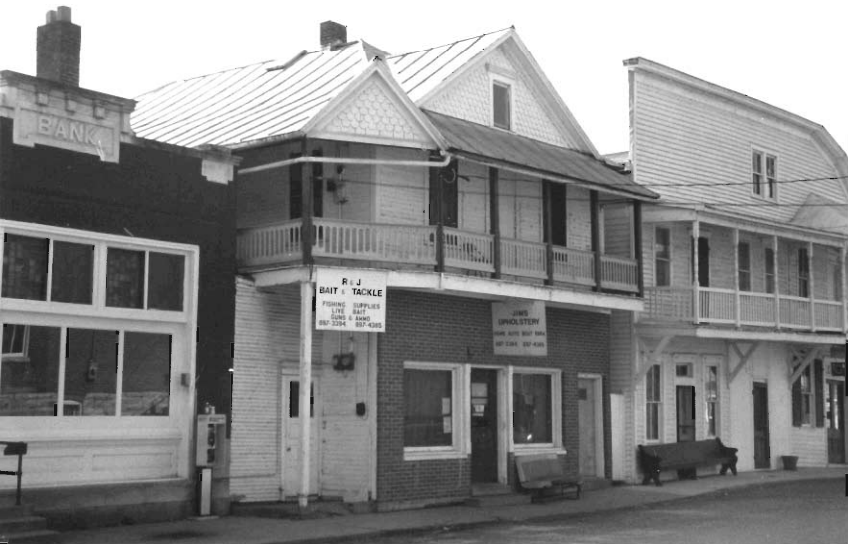
An excellent late 19th century commercial building, an important component of this small Main Street commercial grouping. The building retains a fairly high degree of integrity despite the unfortunate alteration of the main section of the facade.

This building would contribute to a potential National Register historic district (1C).

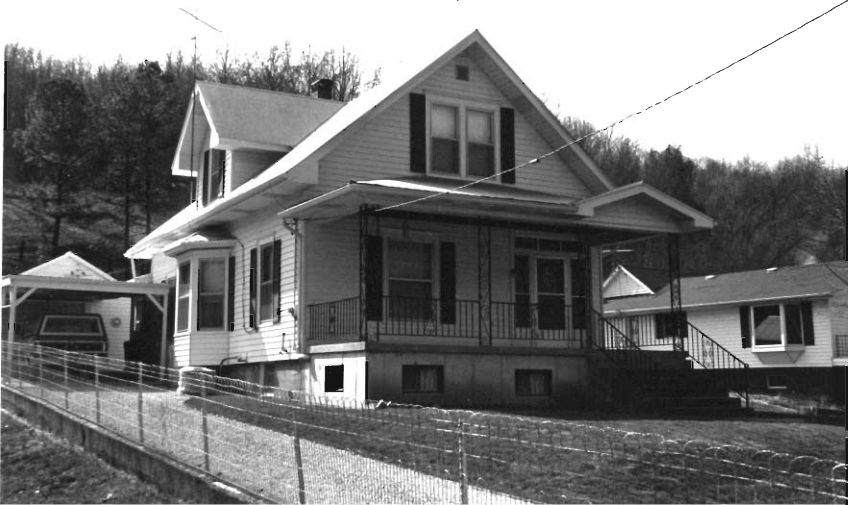
A good example of an early twentieth century vernacular house type, despite the artificial siding and minor porch alterations. The first occupants were Mr. and Mrs. Gus Dieckriede. Mr. & Mrs. Leo L. and Mary Catherine Rotter purchased the house in May 1945 and currently reside here.

This building and its garage would contribute to a potential National Register historic district (1C; 1C).

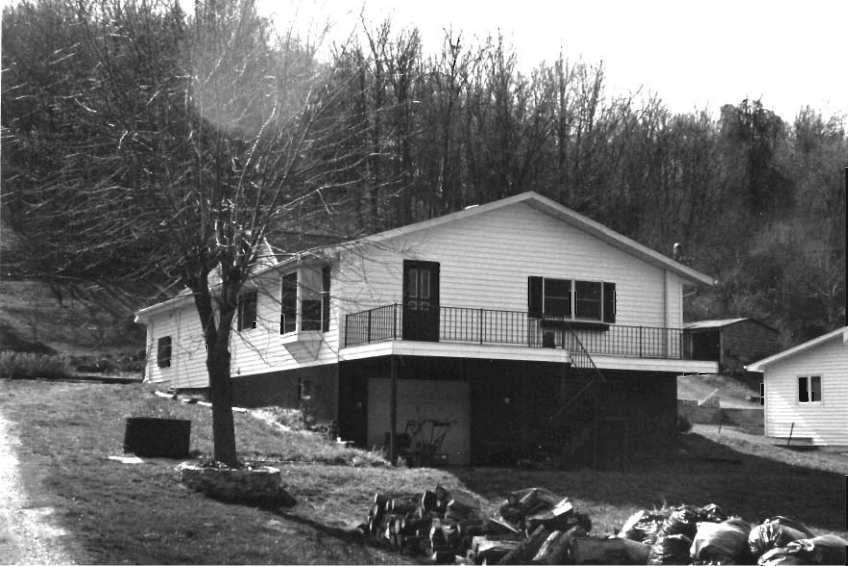
While the core of this house dates to 1878, the original plan and materials of the house are totally obscured by modern alterations and additions.

The two buildings would be within the boundaries of a potential National Register historic district, but would be non-contributing (1NC; 1NC).

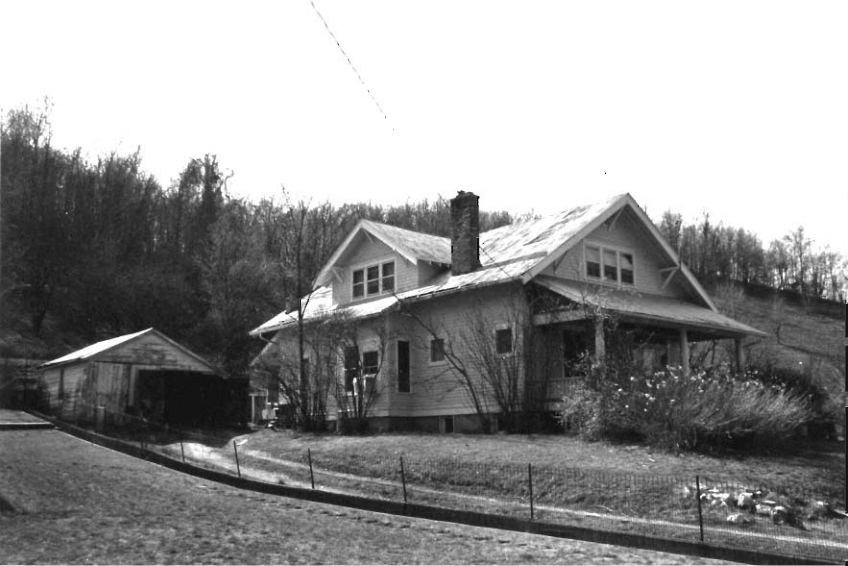
A good example of a Craftsman style influenced Bungalow, with a front gable roof, wide gable roof dormers to the sides, full-facade porch, and angular brackets under wide eaves. Built c. 1915. The first occupant of this dwelling was Henry Dieckriede, a German immigrant who became an important businessman in Bonnots Mill. His general store in Bonnots Mill was, at one time, one of the largest in the county. Locally, the house is also known as the Elmer Perry House although John Channer is the current resident.

This building and its garage would contribute to a potential National Register historic district. The wood shed is not of sufficient size to be counted (1C; 1C).

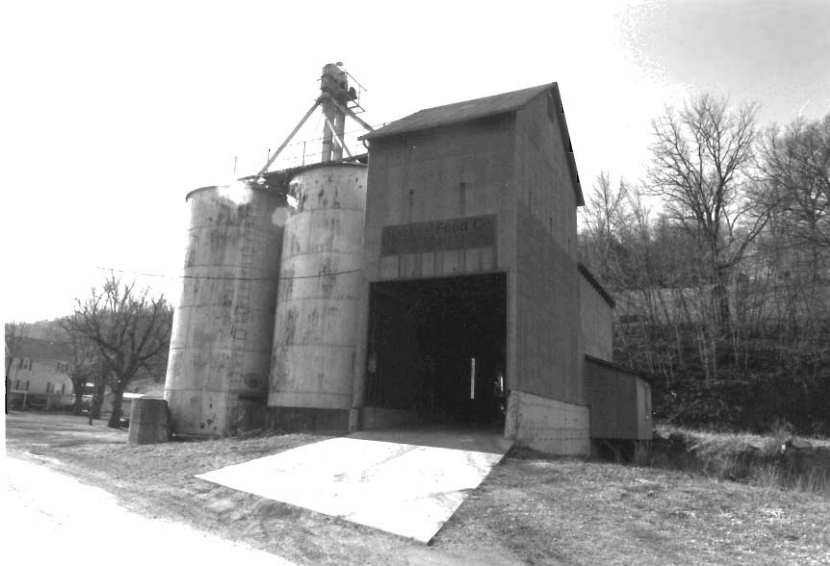
No. of stories: 2 (in height) Basement?: No Foundation material: Concrete?
Wall construction: Frame/concrete Roof type and material: Side gable/metal
No. of bays: N/A Wall treatment: Metal/concrete
Plan shape: Irregular Changes (Addition or Altered?): Yes
Exterior condition: Fair-good Endangered/by what?: No

Side gable, oversized (basically 2-story) delivery building set on concrete foundation. Two silos to southeast with modern loading equipment on top. Rear with lower, corrugated metal shed roof section; small, corrugated metal, shed roof appendage supported on posts attached to north elevation of rear section. Two 2/2 windows on southeast elevation and one 2/2 window on first floor. Double, wood swing doors in basement of northwest elevation on shed appendage.

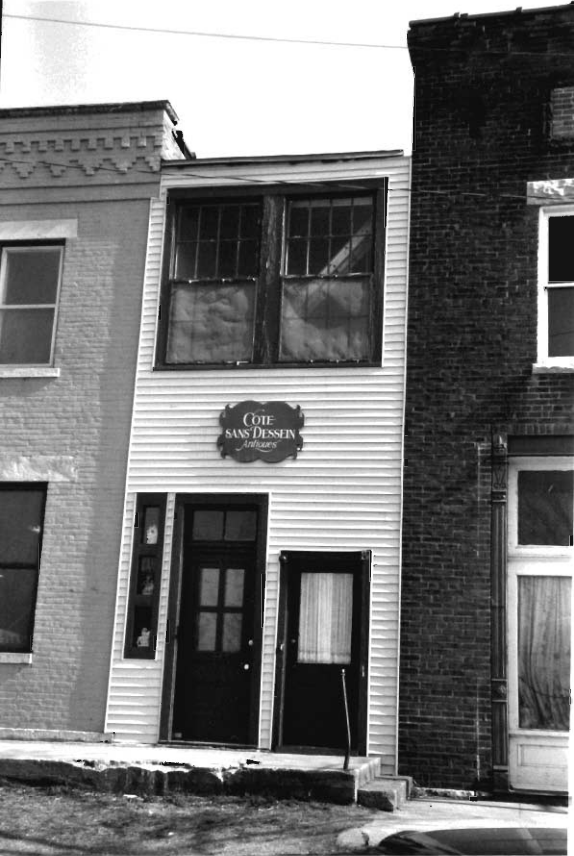
Early example of infill construction as building is "squeezed" between two late nineteenth century commercial buildings. Apparently it was "closed in" in the early 1900s. Building is located in intact row of early commercial buildings and contributes to this fine grouping. It is important to the commercial development of the village.

Current antique shop name reflects the name of one of the early French settlements which preceded Bonnots Mill. This building would contribute to a potential National Register historic district (1C).

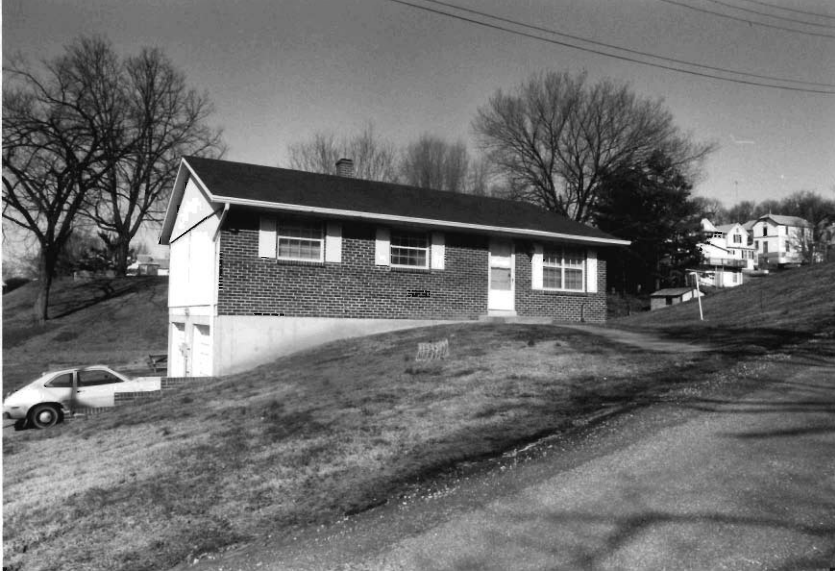
Modern in construction. This building is within the boundaries of a potential National Register historic district, but would be non-contributing (1NC).

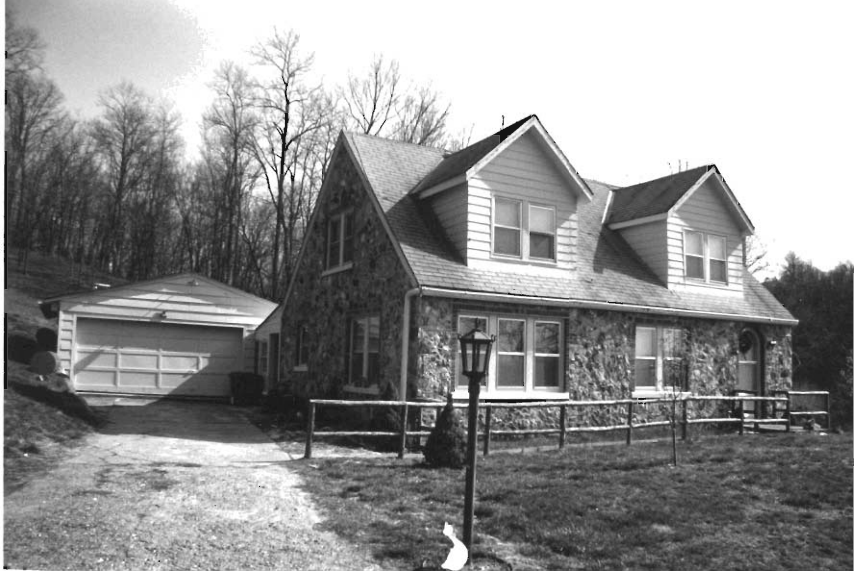
The building was constructed in 1949, with B. Cain as the builder and Mr. Scheppers as the mason for the Native Rock masonry wall treatment. Harold and Betty Drekman currently reside here.

A good example of late Craftsman influence and Native Rock treatment. While the house retains a high degree of integrity, neither the house nor the garage meet the fifty-year rule to contribute to a potential National Register historic district (1NC; 1NC).
