National Register of Historic Places Registration Form

historic name Broeker, John H., House

street & number 605 Locust Street [N/A] not for publication

Broeker, John H., House
Franklin County, Missouri
Historic Resources of Washington, Missouri

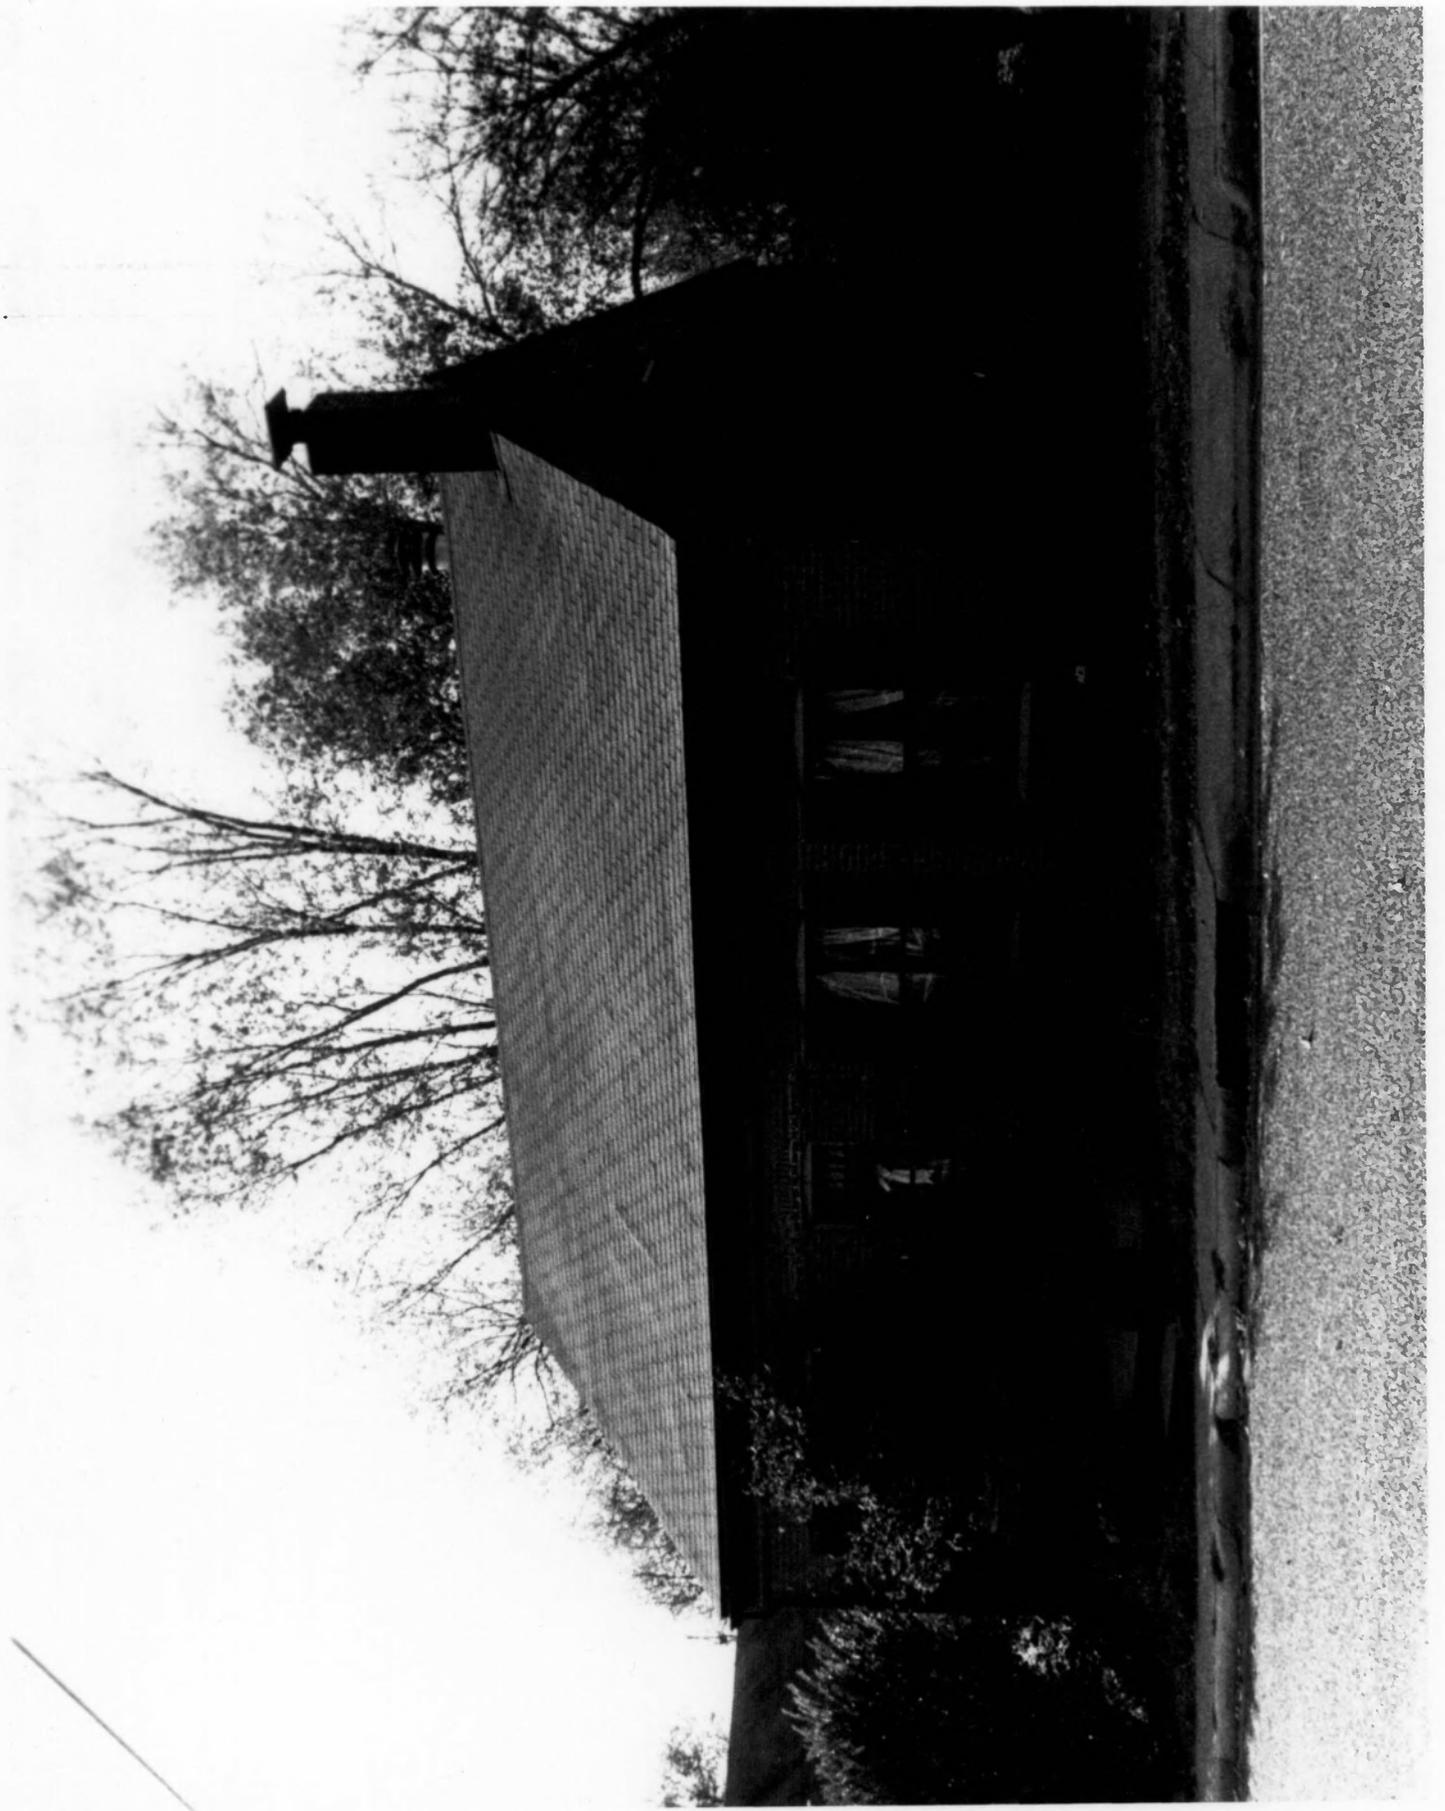
The facade is ornamented with a dentiled cornice. The cornice consists of five courses which are stepped back from the eaveline, with dentils which are composed of bricks set with the short end in a vertical orientation (sailors). The dentils end about eight inches from the edges of the walls. The walls have a common bond pattern of six rows of stretchers to one of headers. The roof of the house does not appear to be original, as it overhangs the sidewalls just slightly. Most early roofs in the area have no side overhangs, and many of this age have, or had, small parapet walls at the gable ends. The roof change is a notable alteration, but does not seriously affect the historic appearance of the house. It is also entirely possible that the change was done within the period of significance. A small exterior chimney on the north wall may also be a later addition.

The five-bay facade features a central entrance flanked by pairs of evenly spaced double-hung windows. The one-over-one windows, which are early but not original, have four light exterior wooden storm windows, and louvered wooden shutters. The door and all windows are topped with shallow segmental arches which are composed of soldier course bricks. The side walls of the main house contain windows of various ages and configurations. The second floor windows, which are set high in the gable ends, are topped with brick jack arches. They have six-over-six sash which are early or original. The south ground floor wall is blank; the north wall of the house has two sets of windows on the first floor. One double-hung window near the front is early, but has neither jack nor segmental arch; it does not appear to be original. A pair of windows near the back corner are obviously newer; it is likely they were installed when the ca. 1940 addition was made. (See photo 2.)

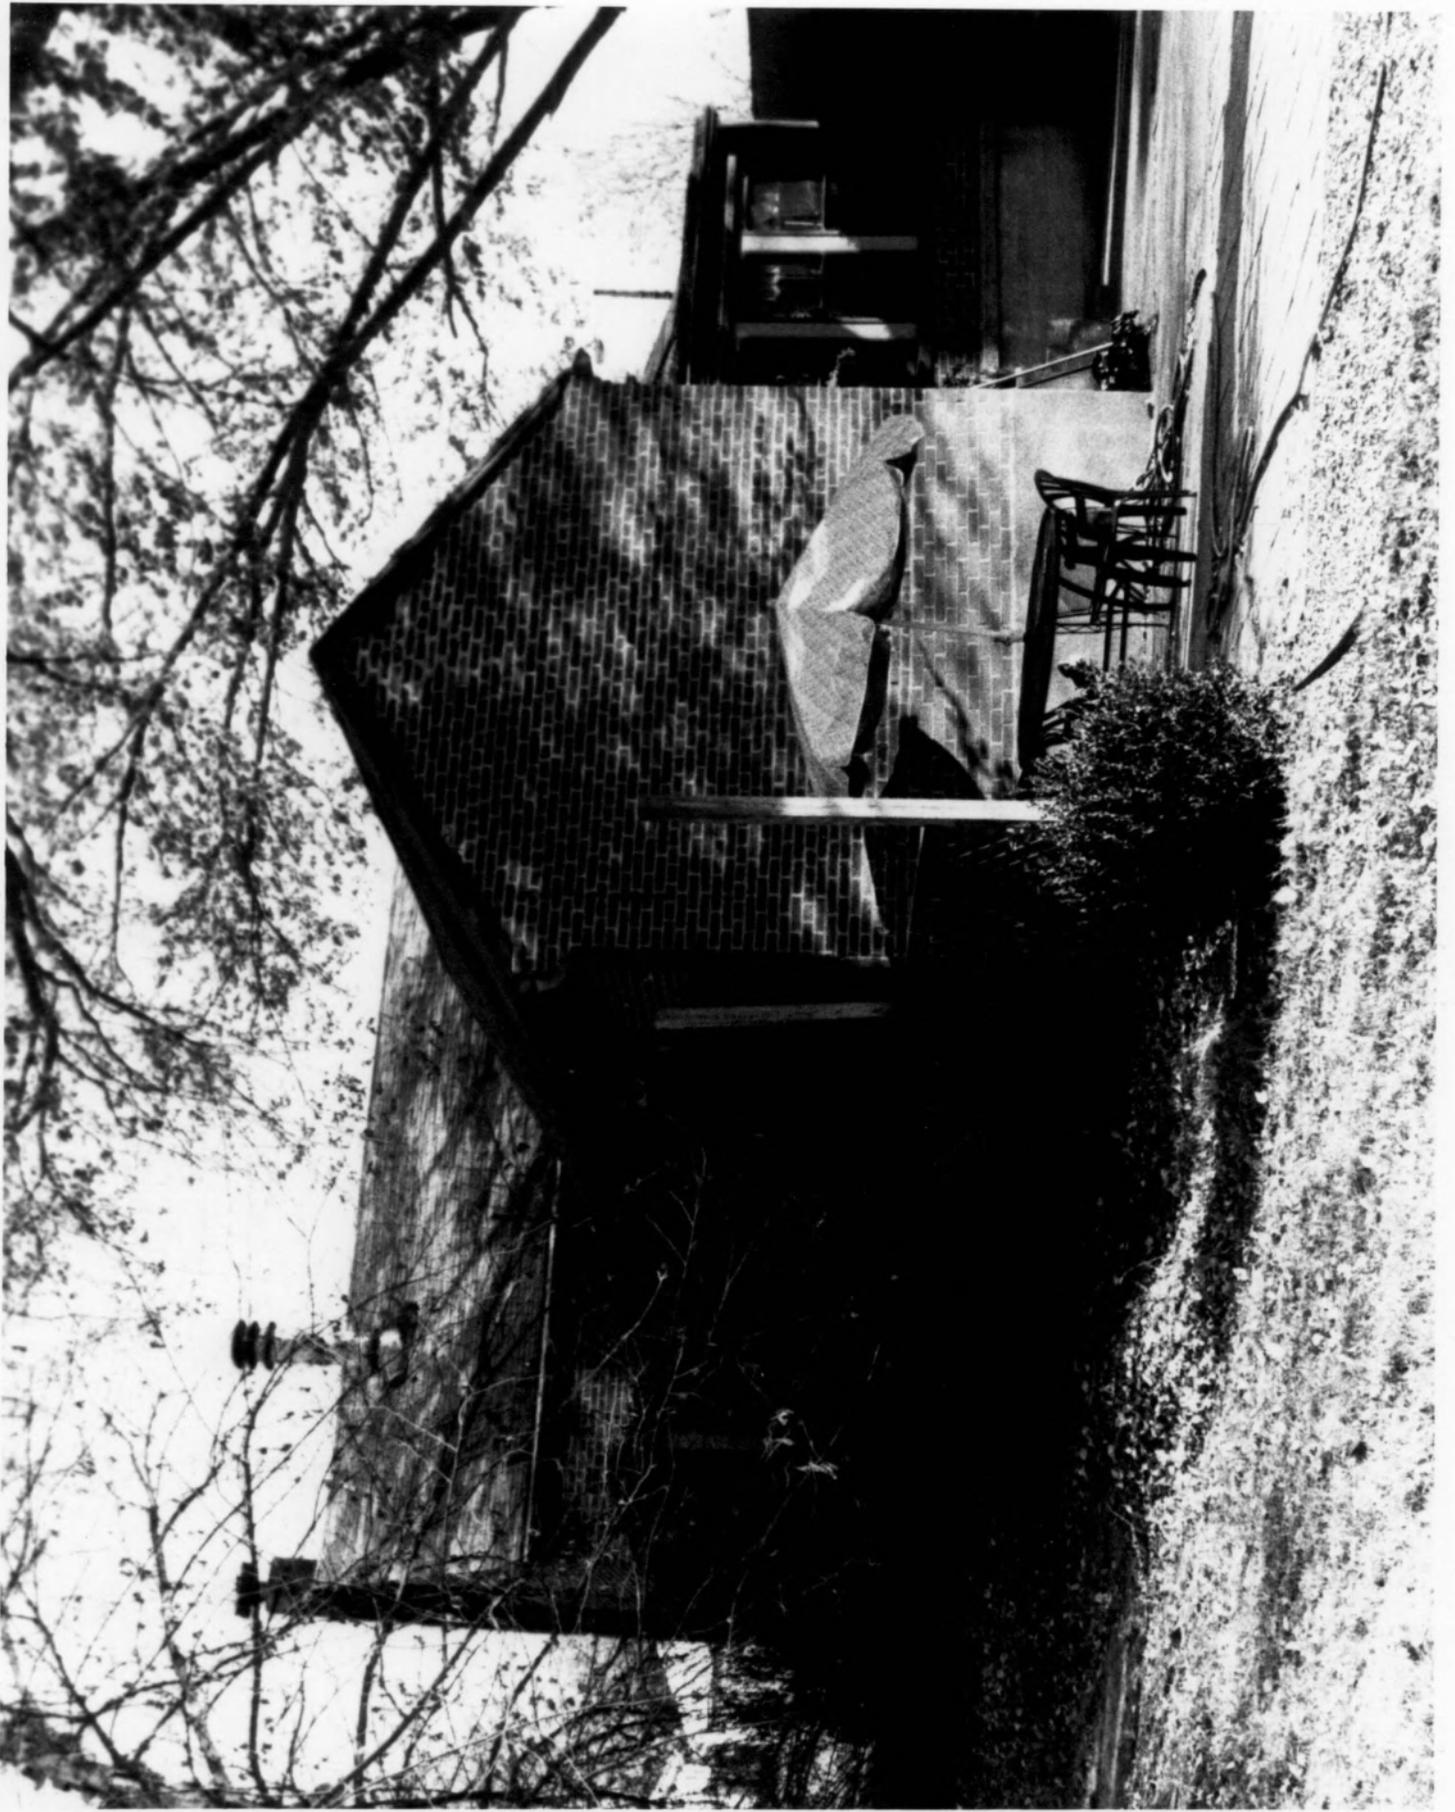
The second oldest part of the house appears to have started out as a separate building. It is rectangular, with the short end set about six feet from the main part of the house. It has a tin-covered gable roof that is separate from, and perpendicular to, the main roof. (See photos 2 and 3.) It has brick walls and dentiled cornices on both long walls, and appears to be close to the original house in age. There are, however, differences in construction details which indicate that the two parts of the building were built at different times. The cornices are slightly different, as are the windows. Each dentil on the rear building is made up of two header bricks stacked together, while each of the front dentils consist of a single brick. The windows of the rear ell also differ from those at the front of

The ca. 1940 part of the house is a narrow, shed-roofed addition which runs along the back of the original house to connect the two early buildings. That addition also has brick walls; the bricks are notably harder and newer than those of the other walls, and appear to be veneer, as there is no bond pattern. The last change to occur to the form of the house was the addition of a small sun porch on the back. That addition is modern, but several decades old. It has a shed roof and newer brick walls. Most of the walls of the porch are taken up by one-over-one wood windows.
