**National Register of Historic Places
Registration Form**

historic name Cass Bank and Trust Company

street & town 1450 N. 13th Street N/A not for publication

**Cass Bank and Trust Building
St. Louis (Independent City), MO**

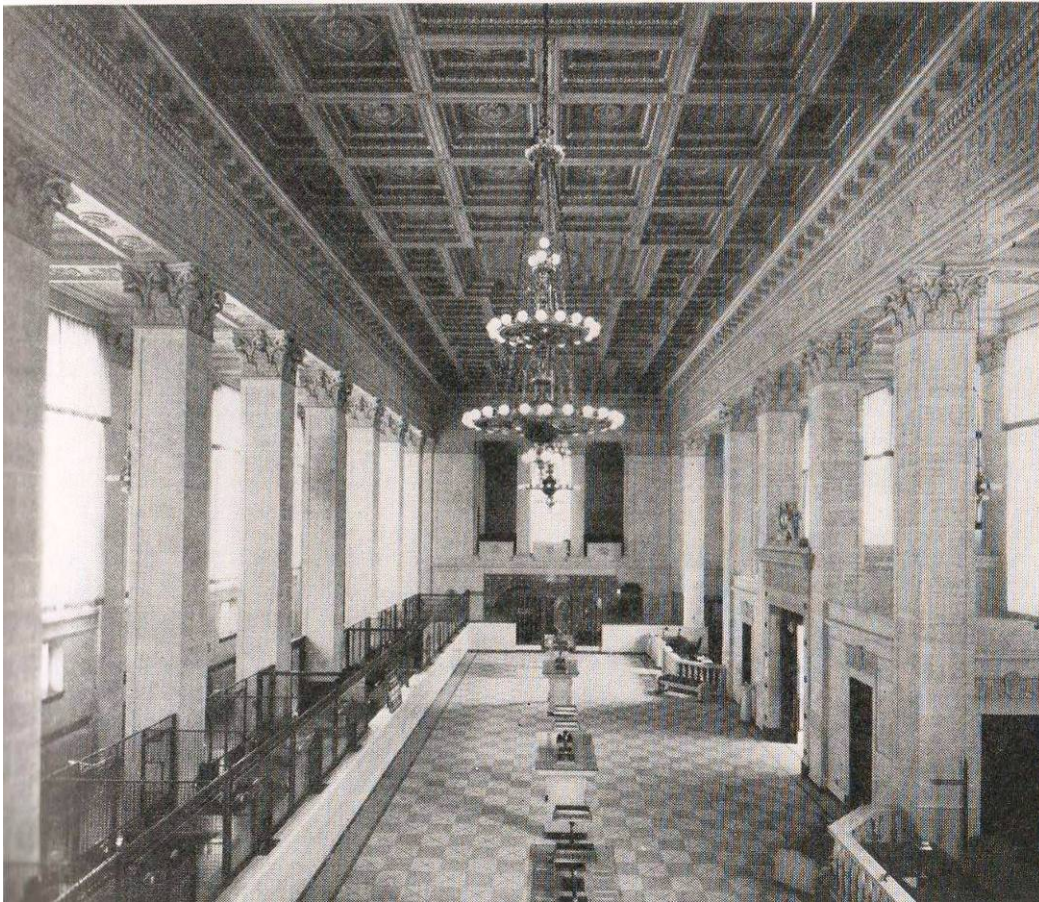
Figure 9: Historic Photo- 1927

checkerboard granite floor of contrasting tans. The most impressive architectural feature in the lobby is the ceiling, divided into three sections with massive Greek cross panels centered in each section surrounded by smaller coffers. Each square is embellished with spiral and floral motifs. (Figure #9 and #10)

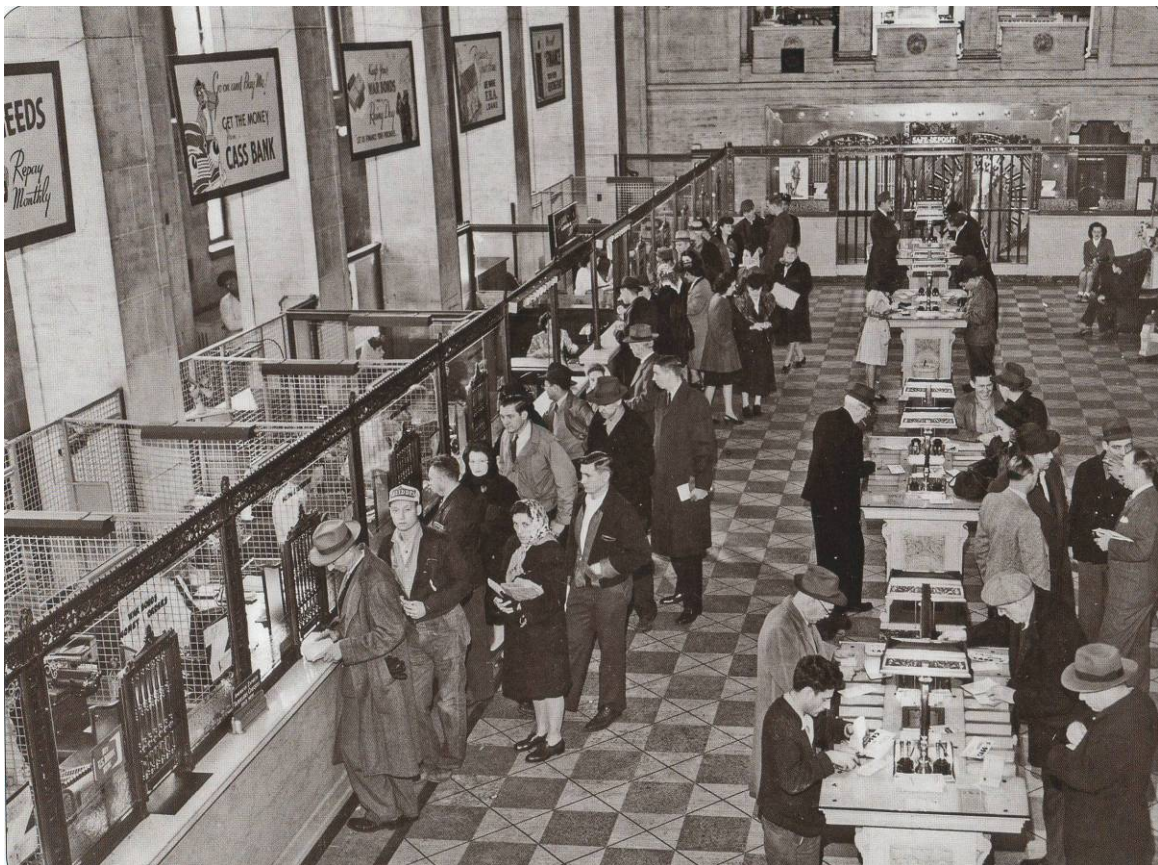
Figure 11: Historic Photo- 1942
**Source: Courtesy of- Cass Commercial Bank
Company Literature**

The arrangement of the bank interior fits the criteria as listed in *The Bankers Magazine* by J. H. Griffith. He suggested that the desks of the executive officers be separated from the public by only a neat rail instead of heavy partitions. In Cass Bank and Trust, they were located just to each side of the main entrance divided by a polished marble banister. Griffith also outlined that the different type of tellers' windows should be separated as not to mix up the lines during the rush hour. At Cass, the new accounts teller and the informational teller were located at the north end of the bank opposite the vault and the receiving tellers were along the east wall welcoming the patrons as they came into the bank. Public conveniences were listed as very important in bank arrangement. Handsome desks, plentiful chairs and tables with plenty of writing utensils were paramount. Cass Bank had islands constructed of marble with glass tops symmetrically placed down the center of the bank and sitting areas scattered at each end.¹⁷ (Figure #11)
