State Historical Survey and Planning Office, State Capitol Building, Room B-25,
HISTORIC INVENTORY Jefferson City, Missouri 65101

1. No.		4. Present Name(s)	
2. County St. Louis		5. Other Name(s)	
3. Location of Negatives Community Development Agency			
6. Specific Location 2711 Accomac		16. Thematic Category Residential	28. No. of Stories 2

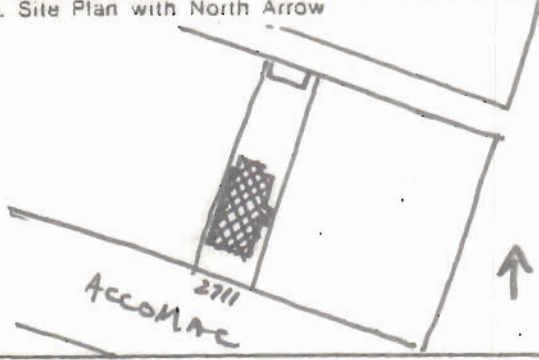
8. Site Plan with North Arrow

9. Coordinates UTM Lat. 15/741900/4276700 Long. 15/740315/4276880 15/740400/4277680		25. Open to Public? Yes <input type="checkbox"/> No <input checked="" type="checkbox"/>	37. Condition Interior Poor Exterior Fair

43. History and Significance Significant for cast iron cornice.			
44. Description of Environment and Outbuildings At least the top half of the building is vacant - perhaps all of it. 2nd floor windows are missing. In grave danger.

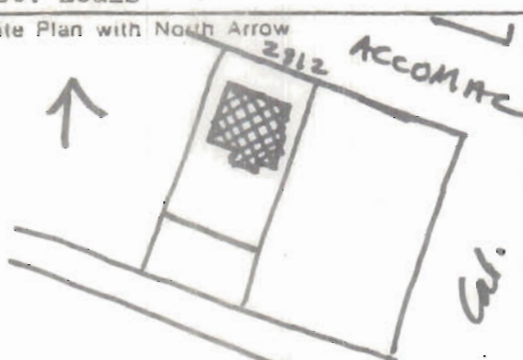
8. Site Plan with North Arrow

19. Architect or Engineer	31. Wall Construction Masonry
		20. Contractor or Builder	32. Roof Type & Material Gable/Slate

9. Coordinates UTM Lat. 15/741900/4276700 Long. 15/740315/4276880 15/740400/4277680		25. Open to Public? Yes <input type="checkbox"/> No <input checked="" type="checkbox"/>	37. Condition Interior _____ Exterior Good

15. Name of Established District			41. Distance from and Frontage on Road 20'/40'
42. Further Description of Important Features This late Victorian house is a hybrid combining features of several styles. The foundation is the rough cut limestone common to St. Louis structures. In this case, however, it extends all the way to the sill level on the front. The entrance is placed in the center of the building recessed within a large Romanesque arch. The facade is reddish brown brick. The glazing is one over one. The first floor windows are topped with jack arches with keystone. The keystone and end blocks are limestone. The simple cornice is painted yellow ochre, so is the window frames. The gable roof on this building is unusual. The common roof to this style building would be a hipped roof. Two large dormers finish the building.

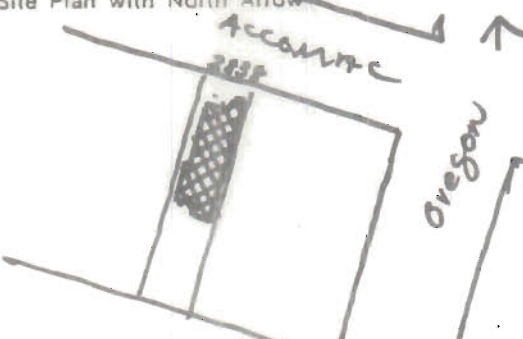
7. City or Town If Rural, Township & Vicinity St. Louis		17. Date(s) or Period C. 1915-1920	
8. Site Plan with North Arrow

15. Name of Established District		26. Local Contact Person or Organization Community Development Agency	
42. Further Description of Important Features A Victorian townhouse treated in brick - buff brick on the front, red on the sides and front. The porch is classical - it has the usual classical detailing. A walk-out is above the porch. A large 2nd floor bay window is another good feature. The roof appears to be a fake mansard in gray asphalt shingles broken by a stepped gable.		27. Other Surveys in Which Included

37. Condition Interior Good Exterior Good	
		38. Preservation Underway? Yes No	
		39. Endangered? By What? Yes No <input checked="" type="checkbox"/>	
		40. Visible from Public Road? Yes <input checked="" type="checkbox"/> No <input type="checkbox"/>

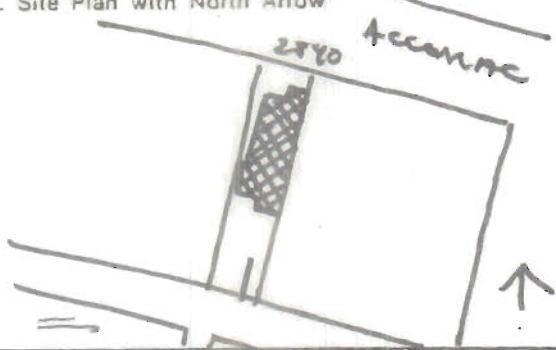
7. City or Town If Rural, Township & Vicinity St. Louis		17. Date(s) or Period C. 1920	
8. Site Plan with North Arrow

36. Changes (Explain in #42) Addition Altered Moved	
		37. Condition Interior Good Exterior Good	
		38. Preservation Underway? Yes No	
		39. Endangered? By What? Yes No <input checked="" type="checkbox"/>

42. Further Description of Important Features A Victorian townhouse with a fake mansard roof in gray slate. The roof is broken by a small dormer (probably just show) and a strongly vertical gable. The porch is classical and has the usual classical detailing. Above it is a second floor walkout. Another important feature is a large second floor bay window. The facade are all red brick but the brick on the front facade is a better quality brick with a darker color.

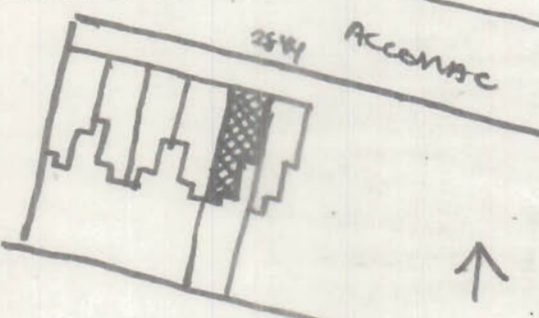
17. Date(s) or Period C. 1900-1905	
7. City or Town If Rural, Township & Vicinity St. Louis		18. Style or Design Eclectic / Second Empire	
8. Site Plan with North Arrow

39. Endangered? By What? Yes I: No X	
		40. Visible from Public Road? Yes X: No I:	
		41. Distance from and Frontage on Road	
42. Further Description of Important Features This is a row of eclectic style row-houses used as multi-family residential. The row is in very good condition. The facade is treated in buff brick and features the lavish use of terra cotta. Strong Beaux Arts influences in the decoration but also features the Second Empire style mansard roof and the repeated use of Romanesque arches. Second Empire is as good a name as any to put on this structure.

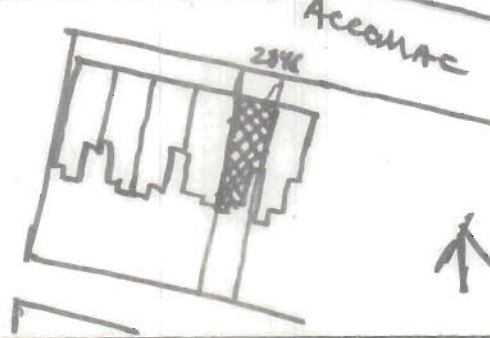
7. City or Town If Rural, Township & Vicinity St. Louis		17. Date(s) or Period C. 1900-1905	
8. Site Plan with North Arrow

42. Further Description of Important Features This is a row of eclectic style row-houses used as multi-family residential. The row is in very good condition. The facade is treated in buff brick and features the lavish use of terra cotta. Strong Beaux Arts influences in the decoration but also features the Second Empire style mansard roof and the repeated use of Romanesque arches. Second Empire is as good a name as any to put on this structure.

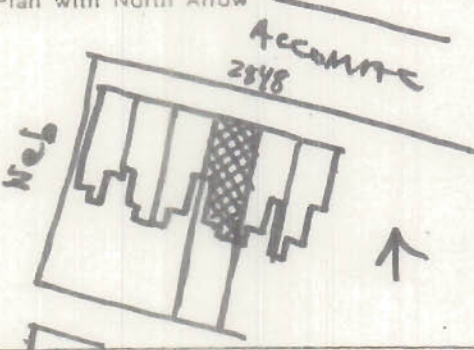
7. City or Town If Rural, Township & Vicinity St. Louis		17. Date(s) or Period C. 1900-1905	
8. Site Plan with North Arrow

42. Further Description of Important Features This is a row of eclectic style row-houses used as multi-family residential. The row is in very good condition. The facade is treated in buff brick and features the lavish use of terra cotta. Strong Beaux Arts influences in the decoration but also features the Second Empire style mansard roof and the repeated use of Romanesque arches. Second Empire is as good a name as any to put on this structure.

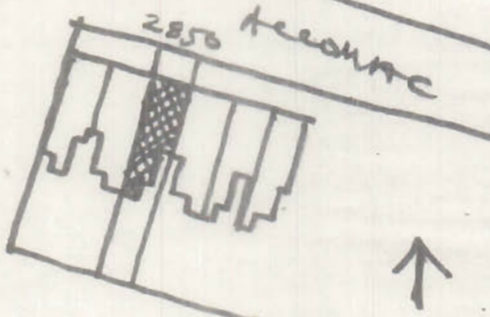
8. Site Plan with North Arrow

42. Further Description of Important Features This is a row of eclectic style row-houses used as multi-family residential. The row is in very good condition. The facade is treated in buff brick and features the lavish use of terra cotta. Strong Beaux Arts influences in the decoration but also features the Second Empire style mansard roof and the repeated use of Romanesque arches. Second Empire is as good a name as any to put on this structure.

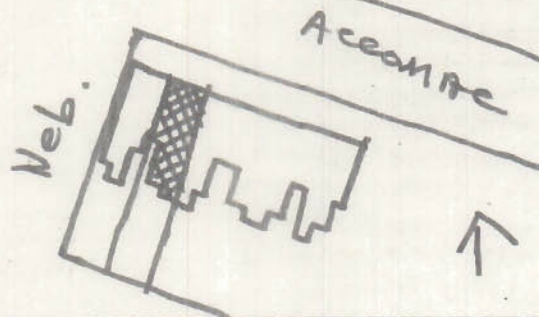
8. Site Plan with North Arrow

18. Style or Design Eclectic 2nd Empire	30. Foundation Material Masonry
		19. Architect or Engineer	31. Wall Construction Masonry

9. Coordinates UTM Lat. 15/741900/4276700 Long. 15/740315/4276880		25. Open to Public? Yes <input type="checkbox"/> No <input checked="" type="checkbox"/>	37. Condition Interior _____ Exterior <u>Good</u>

42. Further Description of Important Features This is a row of eclectic style row-houses used as multi-family residential. The row is in very good condition. The facade is treated in buff brick and features the lavish use of terra cotta. Strong Beaux Arts influences in the decoration but also features the Second Empire style mansard roof and the repeated use of Romanesque arches. Second Empire is as good a name as any to put on this structure.

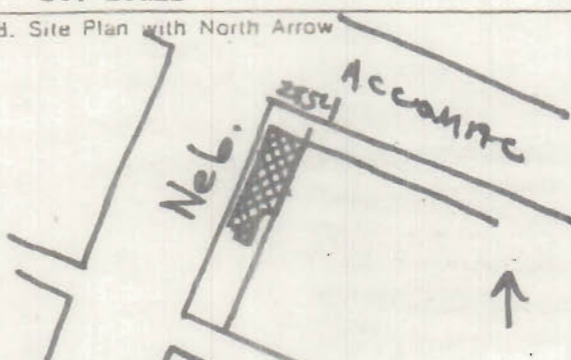
8. Site Plan with North Arrow

18. Style or Design Eclectic / 2nd Empire	30. Foundation Material Masonry
9. Coordinates UTM Lat. 15/741900/4276700 Long. 15/740315/4276880		19. Architect or Engineer	31. Wall Construction Masonry

15. Name of Established District		25. Open to Public? Yes <input type="checkbox"/> No <input checked="" type="checkbox"/>	37. Condition Interior Exterior Good

42. Further Description of Important Features This is a row of eclectic style row-houses used as multi-family residential. The row is in very good condition. The facade is treated in buff brick and features the lavish use of terra cotta. Strong Beaux Arts influences in the decoration but also features the Second Empire style mansard roof and the repeated use of Romanesque arches. Second Empire is as good a name as any to put on this structure.

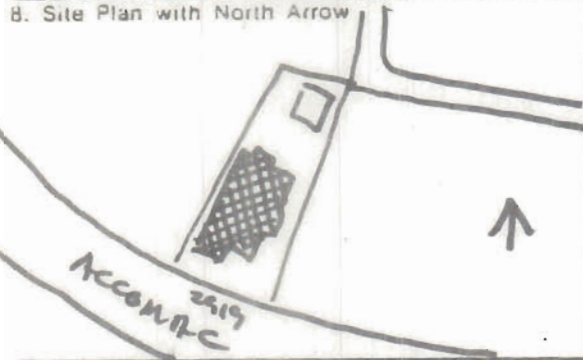
7. City or Town If Rural, Township & Vicinity St. Louis		17. Date(s) or Period C. 1910 Feb 19, 1906 (bld Permit)	
8. Site Plan with North Arrow

42. Further Description of Important Features A modified version of the usual St. Louis Victorian home. The roof is hipped and treated with varigated gray slate shingles. The foundation is masonry - rough on the sides and at the rear. Dressed on the front and goind all the way to the 1st floor sill level. The porch is classical with a bay window above it. The lintels are all limestone blocks forming flat arches with keystone and wings on the 2nd floor and Romanesque arches with keystone and wings on the 1st floor. Copper flashing on the roof.

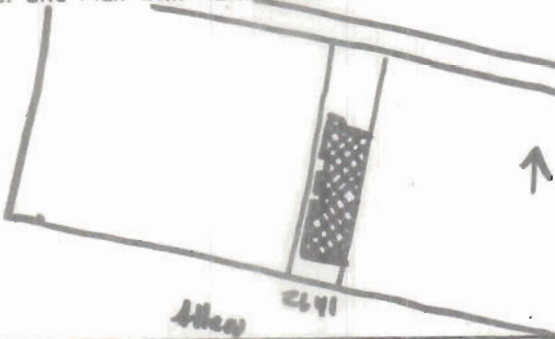
7. City or Town If Rural, Township & Vicinity St. Louis		17. Date(s) or Period C. 1885	
		18. Style or Design Second Empire Townhouse	
8. Site Plan with North Arrow

15. Name of Established District		29. Basement? Yes <input type="checkbox"/> No <input checked="" type="checkbox"/>	
42. Further Description of Important Features A 2nd Empire townhouse. Red brick facade. Mansard roof treated in gray slate pierced by 2 dormers. Cornice is cast iron over lavish pressed brick. Foundation is dressed limestone with wrought iron grills over the windows (front) undressed limestone side and rear.		30. Foundation Material Masonry

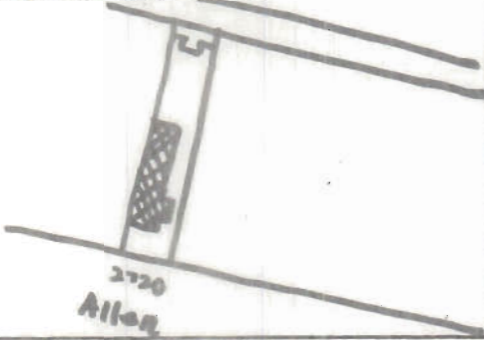
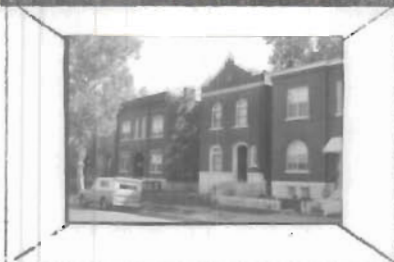
8. Site Plan with North Arrow

42. Further Description of Important Features A red brick vernacular building with brick foundation painted white (front) and limestone (sides and rear). Pressed brick around all front windows which are circular headed and also painted white. The building's important feature is its cast iron cornice.

43. History and Significance City Significance:
Good example of the use of cast iron cornices.

44. Description of Environment and Outbuildings
Narrow well-kept lot; enclosed by a very good cast iron fence.

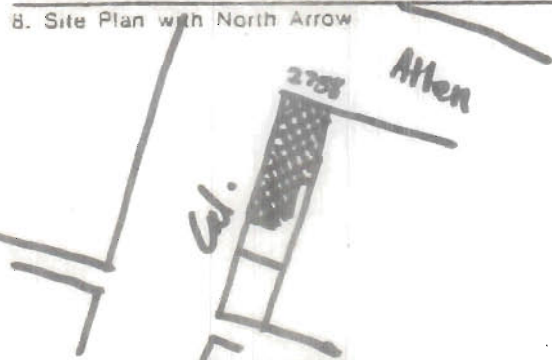
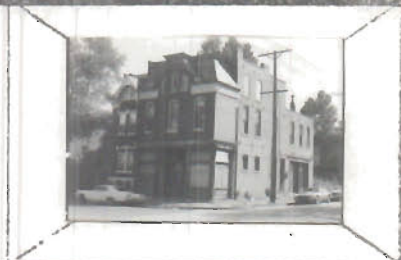
7. City or Town If Rural, Township & Vicinity St. Louis		17. Date(s) or Period C. 1905	
8. Site Plan with North Arrow

43. History and Significance City Significance: A good example of this St. Louis style as well as cast iron cornices and storefronts.			
44. Description of Environment and Outbuildings Located on the corner of Allen and California. A reasonably intact neighborhood showing signs of decline.

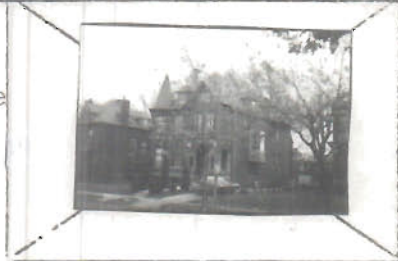
42. Further Description of Important Features The building has some elaborate stone-work. The heavy cut stone foundation is painted red. Six granite steps lead to a porch with solid brick rail. Short Richardsonian columns frame the entranceway. They are topped with large Romanesque arches. The play of the stone string courses is another St. Louis brick derivation of the Richardsonian Romanesque style. An unusual feature is 2 white stone medallions with figures in an animal head motif. Also interesting is the copper weather vane atop the building's conical tower. Elaborate wrought iron grills cover the basement windows. In a side bay window, is a handsome stained glass window. The foundation is 18 inches thick. The brick walls: 13".

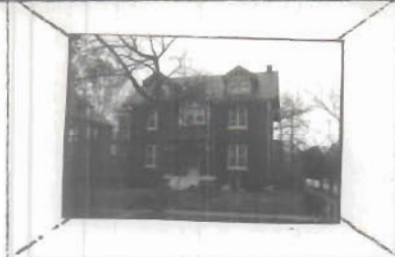
42. Further Description of Important Features A gray brick structure with half timbering on the dormer. Large brackets. The roof is gable with gray slate. Two symmetrical dormers and the central pavilion break the roof line. Porte cochere on the side of the house.

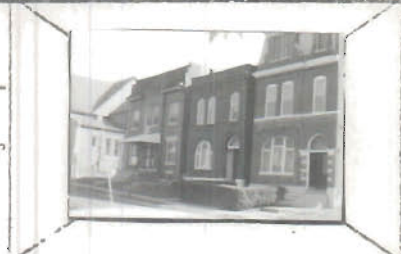
42. Further Description of Important Features The building is typical of St. Louis vernacular architecture during the years of strong Richardsonian Romanesque influences. The house probably could be called Richardsonian row house. These influences are apparent in the entrance set in a large Richardsonian arch supported by short, double columns, another Richardsonian feature. The large arch of the entrance is repeated with an identical arch to the left, divided into 3 windows. On the 2nd floor the arches are again repeated - a single window on the right and a pair joined by coupled arches (again a Richardson feature) on the left. The building's best feature is its brick work, particularly on the cornice. Six different types of brick are used on the front of the building.

44. Description of Environment and Outbuildings
The neighborhood here is shaky. The house itself is vacant and is a city board up. It's probably a shambles inside.

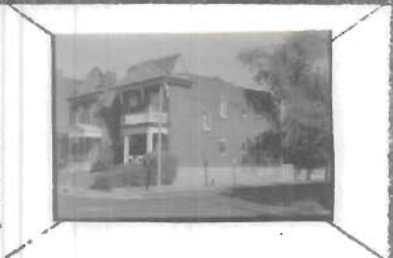
42. Further Description of Important Features An eclectic building whose prominent features include some very good brickwork and unusual cornice and roof. Equalitus - verticality fights the wide horizontal cornice (Chicago School influences). Front windows are one over one sash with flat heads while those on the side are two over two. Porch to the right (east) side of the house contains double entry - walkout above. The roof has false gable front hiding a flat asphalt roof. Alterations include the porch railings & aluminum. Storm doors. The building badly needs tuckpointing. Noticable lean to the chimney.

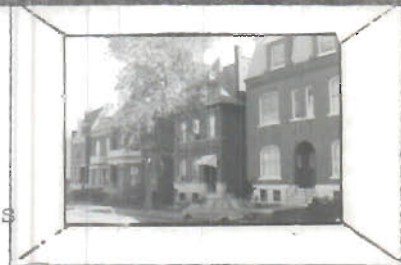
43. History and Significance: City Significance			
44. Description of Environment and Outbuildings Alterations to the house include the shingles and a large aluminum awning. Garage in rear.

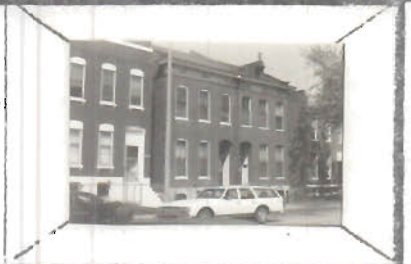
42. Further Description of Important Features The 2 structures, 2005 & 2007 California together form a 4-family flat. They are identical other than that the plan of one is the opposite of the other. Both have limestone foundations (dressed in the front). Red brick facades. All of the windows are 2 over 2 sash with stone sills and are set into segmental arches. The 2 entries are together in the center of the buildings, recessed with 2 doors off of each entry. The cornice is restrained with little decoration. Chimneys on either side both lean. 2005 has a dormer while 2007 does not. Neither structure is in good repair.

43. History and Significance City Significance:
 These are 2 of the older structures in the city.

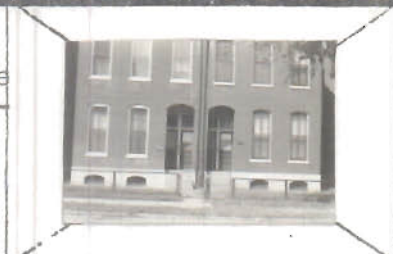
15. Name of Established District			41. Distance from and Frontage on Road 20' / 30'
42. Further Description of Important Features The two structures 2005 & 2007 California together form a 4-family flat. They are identical other than that the plan of one is the opposite of the other. Both have limestone foundations (dressed in the front). Red brick facades. All of the windows are 2 over 2 sash with stone sills and are set into segmental arches. The 2 entries are together in the center of the buildings, recessed with 2 doors off of each entry. The cornice is restrained with little decoration. Chimneys on either side both lean. 2005 has a dormer while 2007 does not. Neither structure is in good repair.

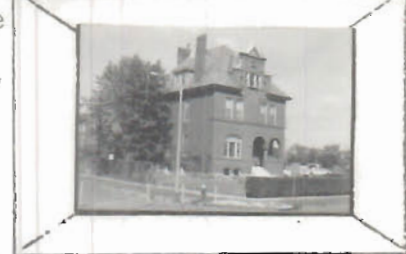
42. Further Description of Important Features This is an exceptionally good example of the St. Louis style Victorian homes being built after the 1904 World's Fair. The structure has a hipped roof of variegated gray slate. A large Dutch dormer on the front. A more common dormer sheathed in slate is on the side. A very tall chimney is a good design feature - it has, however, a pronounced lean. This and minor tuckpointing are the only noticable outside problems. Hoopengabers top the roof and dormers. The porch is recessed under the northeast corner behind paired Richardsonian arches. The short column is twisted - an unusual feature. To the left of the entrance is a large set of windows set into a basket arch - good stained glass. A modified Palladian window set into the Dutch dormer is another good feature. The brickwork is good, yet restrained. Pressed brick in egg and dart motif and sandstone blocks form a string course at the second floor sill level.

43. History and Significance State Significance:
A very good example of St. Louis style architecture in the early 1900's.

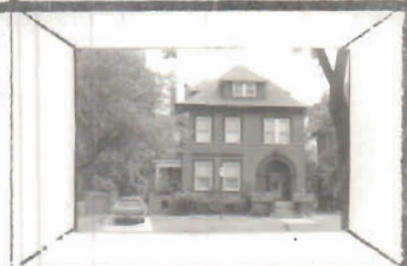
42. Further Description of Important Features A variation of asymmetrical end front. Variegated gray slate hipped roof with Richardsonian dormers on front and sides. The entry is set into a Romanesque arch with keystone. This and trim around windows is terra cotta painted black. Art glass fan light and side lights. Variegated red brick facade.

43. History and Significance City Significance:
 The building permit is to Andrew Fruth and is dated May 5, 1896. One interesting feature of the house is the construction of the roof. The 1896 tornado passed through the area while the house was under construction, so Mr. Fruth had the contractor use an unusual method of pinning on the roof with spikes extended four feet down into the walls.

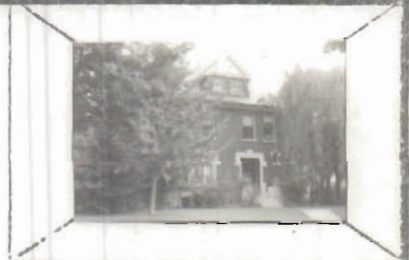
42. Further Description of Important Features A St. Louis vernacular building with end gables toward the front. Hipped gray slate roof. Red brick facade. Wide cornice. Dressed limestone foundation. Limestone also frames the first floor front entry and windows, with keystone and end blocks.

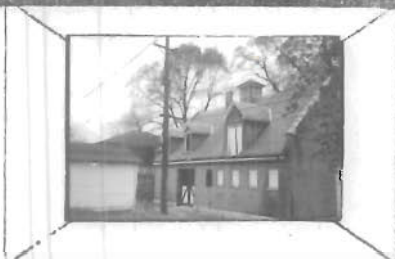
42. Further Description of Important Features A red brick stable with a slate gable roof crowned with a small cupola. Three dormers break the roof on the alley side. An excellent building in the picturesque manner.

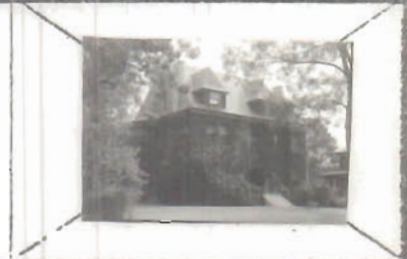
42. Further Description of Important Features A late Victorian building with a strong Richardson flavor. Features include a suppressed tower with conical roof. A pair of Richardsonian dormers sheathed in slate. Slate is also on the side gable. Strong wrap-around cornice. The entry is recessed under a Romanesque arch. Heavy limestone construction.

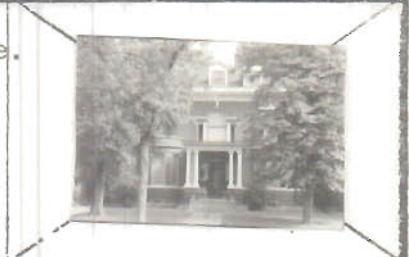
42. Further Description of Important Features The structure is close to Colonial in tradition. The Palladian window is the building's dominant feature. The entry is set into a Richardsonian arch. Projecting front porch is supported by paired Ionic columns. The roof is hipped with 3 front dormers - the material is gray slate. The dormers may be an addition.

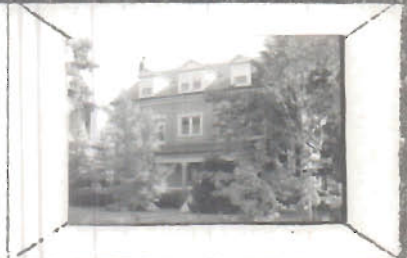
42. Further Description of Important Features The building's winged lintels say Georgian, but the liberties in the porch do not reinforce this. American Colonial Revival. The roof is hipped - broken by 3 dormers, double windows in the center dormer, single windows on the ends. The double window is repeated on the 2nd floor. Brick quoins.

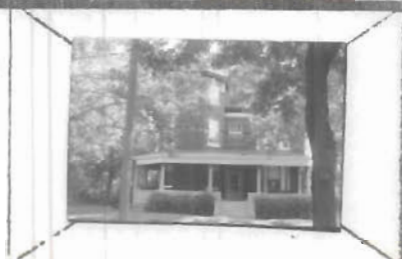
42. Further Description of Important Features An interesting Victorian structure with an inviting wrap-around porch. The roof is hipped and treated in varigated gray slate. Facade red brick. Horizontal/vertical play in proch and roof.

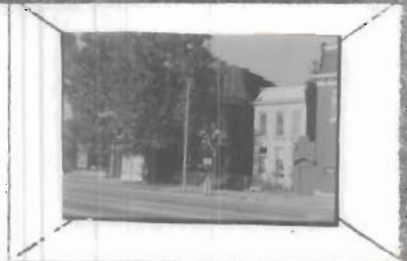
42. Further Description of Important Features A red brick residential building with a gray, fish scale, slate mansard roof. Rusticated limestone base-ment/foundation. The building has a heavy bracketed cornice. Very good wood carving on cornice and above windows and doors.

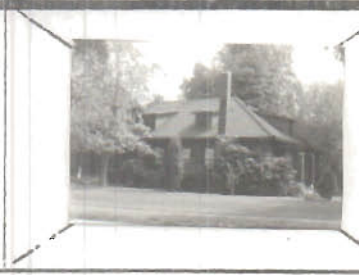
40. Visible from Public Road? Yes <input checked="" type="checkbox"/> No <input type="checkbox"/>	
		41. Distance from and Frontage on Road 35'/90'	
42. Further Description of Important Features A low 1½ story brick home with tile roof. The only house of its low height on Longfellow. The roof is gable with low slope. California style in its symmetry. It is in the Green Bros. tradition. The green tile triangular decoration on the side of the house is Arts and Crafts. Arts and Crafts with California influences would be a good description of the style.

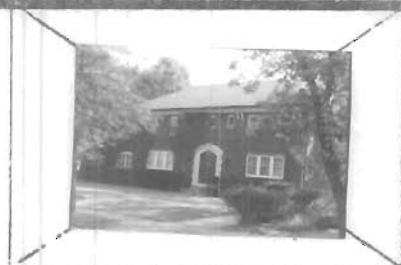
42. Further Description of Important Features A two-story red brick building. Simple, restrained entrance. Heavy wooden brackets, in pairs, hold up the slate roof. A group of 3 one over one windows on either side of the entrance. Good brickwork. Strong Chicago School influences.

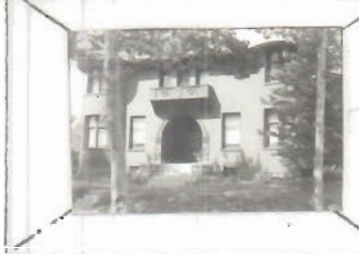
15. Name of Established District			
42. Further Description of Important Features A very interesting building. It has strong Chicago School influences. The architecture is straight Richardsonian with classical decoration. A simple building - pure geometry. The architect is unknown but the sophistication of design suggests Ittner as a possible architect.

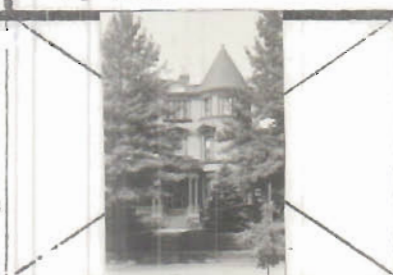
15. Name of Established District			41. Distance from and Frontage on Road 25' / 80'
42. Further Description of Important Features The handsome interior features include painted ceilings. A man named Plache was the artist. He did quite a bit of work in the Compton Heights area. Significant alterations in 1911. George Mueller and Co. was the builder. A nationally significant building with a wide range of influences. The predominant form and geometry is Victorian. The porches, however, have classical French influences. The overhangs are unusually wide. Palladian windows on the gable. The gable roof is treated in red slate. Buff brick facade. Bay window directly over the entry.

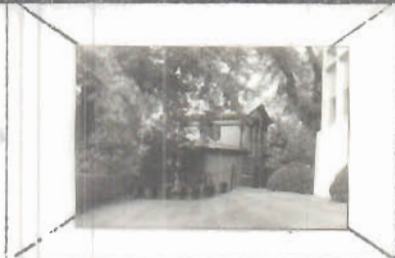
42. Further Description of Important Features Link did relatively few of the Compton Heights homes. The building is much more restrained compared to the flamboyant exuberance of many of the homes of Longfellow and Hawthorne. The building is a hybrid - illegitimate ancestry. A classical entrance tacked on medieval form. The front gable intersects with the side gable. Parapet wall. The roof lines are the building's dominant feature. An eclectic combination of classical, medieval and modern.

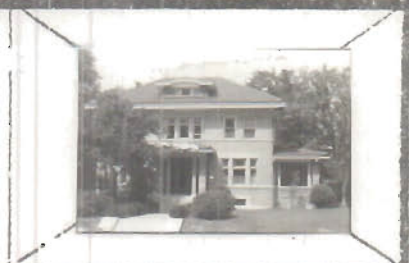
42. Further Description of Important Features A structure of national importance. Chicago School. It's major features are a wide overhanging hipped roof with horizontal dormers. It shows influences from both Wright and Sullivan. Closely related to the developments of the Prairie School movement. Wide horizontal cornice. Cornice window mullions painted yellow ochre (painting in process). The roof is treated with red Spanish tiles. The tile roof repeats on the entry and porch on the east side of the house.

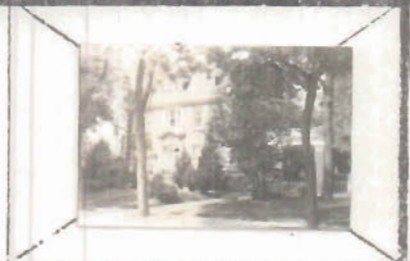
42. Further Description of Important Features This is an early 1900 version of the earliest Georgian style. The quoins, etc. are all common to the Beaux Arts Revival of the Georgian style. Treated in gray brick with lime-stone quoins and trim. Terra cotta panels bearing swag motif below 2nd floor windows. Three dormers to the front, one each on either side. Pediment over entry. Limestone balustrade on porch runs the length of the house. Porte cochere on the east side of the house. Red tile on roof.

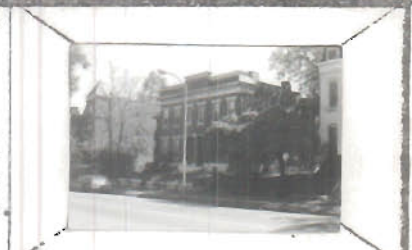
42. Further Description of Important Features The building is a tenement - in the old use of the word not the modern connotation. The foundation is masonry. Segmental arches top all windows. The frames above windows and doors bear decorative carving. The entrances are recessed (two double entrances in the center of the building). The doors of the right entrance appear original while those of the left are modern. The facade is red brick. On the front, it appears to have been painted red at some time. The cornice is heavily ornamented and supported by large brackets. The mansard roof is in gray slate; there are no dormers.

43. History and Significance City Significance:
 A good example of a St. Louis tenement; the roof is an unusual feature. The mansard is too short to be used as another floor.

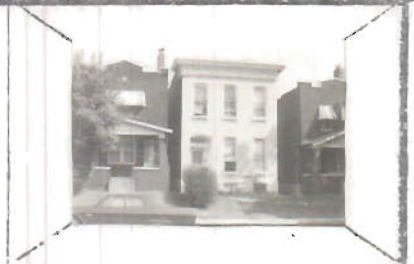
42. Further Description of Important Features This is a common St. Louis style building. It is identical to the Second Empire style buildings being built at the time - except that it lacks the mansard roof, perhaps because of cost or perhaps the additional space just was not needed. The basement as usual is coarse, unfinished limestone. Windows are one over one capped with segmental arches. The red brick front has been painted gray. The building's best feature is an exceptionally good cornice, highly carved and ornamented.

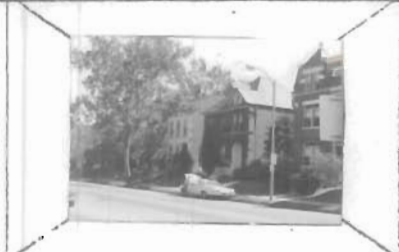
42. Further Description of Important Features The building is typical of St. Louis middle class housing at the turn of the century. It does have some Richardsonian influences. Round arches over the windows on the second floor, two arches are joined. A brick string course passes through each floor. The roof is hipped with gray slate, but above the doorway it becomes a gable roof framing a Palladian window. Two large dormers pierce the roof. They are also treated with gray slate - not just on the roof but sides and front also. The doorway is recessed. The door appears original.

43. History and Significance City Significance:
A good example of a widespread local style.

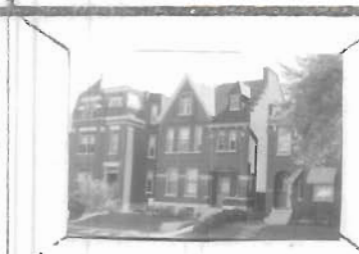
15. Name of Established District			
42. Further Description of Important Features This building bears the mansard roof hallmark of the 2nd Empire style, but it shows late Victorian influences. The structure has a strong vertical feel to it. The door is recessed. (The doors are original). The transom of the door as well as the top panel of all windows are in artglass. The pair of windows to the left of the doorway are topped with a basket arch. The roof is gray slate in the fish scale pattern. The Mansard roof is pierced by two dormers; one large and sharply vertical, the other small.

43. History and Significance City Significance: Although the structure is a hybrid with several different styles, it is still a handsome building.			
44. Description of Environment and Outbuildings A well kept house fronting on Russell Avenue.

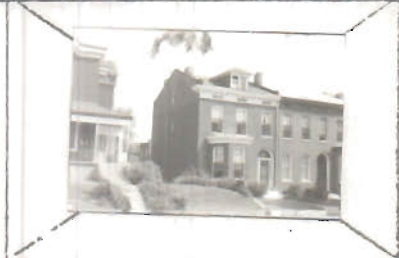
42. Further Description of Important Features A red brick, vernacular style building with gable roof. The roof is pierced by a single dormer. The windows are set into brick segmental arches. Glazing is 2 over 2. Large 1st floor projecting bay. Rectangular windows in the frieze are an unusual feature. Entry is a major feature with large fanlight and sidelights. Badly needs tuckpointing - missing top half of chimney. Dormer windows are boarded.

44. Description of Environment and Outbuildings
This building obviously needs major work. Its adjoining neighbor has been boarded.

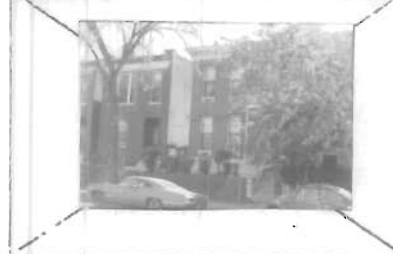
40. Visible from Public Road? Yes <input checked="" type="checkbox"/> No <input type="checkbox"/>	
		41. Distance from and Frontage on Road 15'/35'	
42. Further Description of Important Features A good St. Louis style building. Features include a good cornice with large brackets. Red brick is the primary feature of the facade. The building's best feature, however, is its excellent terra cotta. The terra cotta serves as segmental arches over the windows and as string courses slightly lower. The foundation is the usual limestone.

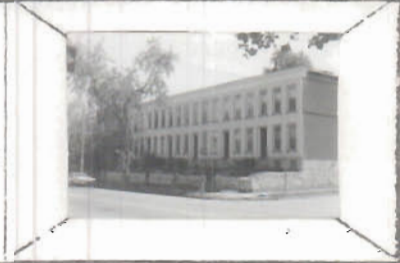
42. Further Description of Important Features The building is part of a row of Residential buildings, a very good example of a rapidly disappearing street scape. The roof is flat, perhaps with parapet. The cornice is a strong design element. The building is brick; the front is dressed limestone, painted gray. Framing of the windows and doors are dark gray as is the foundation. Basement windows are covered with cast iron grills in an arrow motif. The glazing is an adaptation of the usual one over one. In this instance the upper section of the windows and doors is in art glass. The art glass is simple, not particularly a good effort. All of the doors appear to be original.

44. Description of Environment and Outbuildings
 Part of an exceptional row. The front yard (not well maintained) slopes rapidly. A limestone (unfinished) wall with crenelation fronts against the sidewalk. The walls all lean toward the sidewalk.

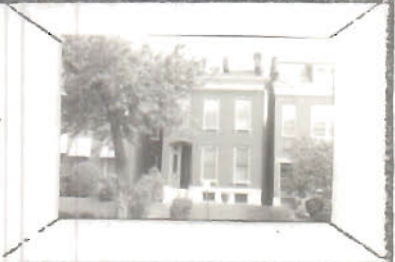
42. Further Description of Important Features The building would be at home in Souard. It follows the style of the city's older ethnic neighborhoods which developed a vernacular architecture similar to that of the European areas the emigrants had left. In this case this building probably is not that old. Most likely as this area was developed, it was probably built by someone with a foundness for the earlier architecture. The doors are recessed and appear to be the original golden oak. The base-ment is limestone with cast iron grills. The windows are all double hung sash. The cornice is large and heavily bracketed. A single narrow dormer in the Souard fashion pierces the roof.

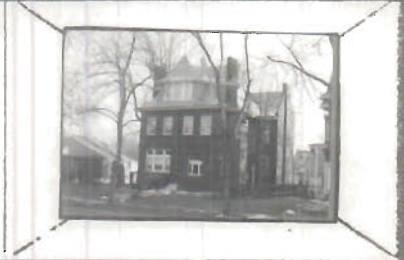
42. Further Description of Important Features A handsome Victorian building in the late St. Louis Victorian style. The roof is hipped, treated in gray slate with large dormers, front and side. The chimney passes through the east and west side dormers, an unusual feature. Copper finials on peaks of roof and dormers. Also copper flashing. Walkout on top of east side bay. The railing has disappeared. Brick construction - good pressed brick outlining front lower windows and entry. Entry set into circular headed arch. Fanlights in entry. Lower art glass window on west side (stairway).

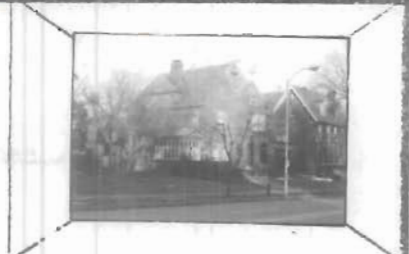
42. Further Description of Important Features A handsome picturesque structure treated in red brick. The roof is hipped, in gray green slate. Copper flashing. Small dormer in front with large dormers on west side. Large brackets support side dormers. Broad cornice. Excellent brick detailing on 1st and 2nd floor windows. The entry is recessed into the house under 2 large Romanesque arches. A large bay window also under the arches is in art glass. A pair of coupled Romanesque windows also has art glass in the circular head. A large bay window is above the entry. It is treated in leaded glass. Porte cochere to the east side of the house. A stepped gable is a major design element. Sandstone sills under many of the windows. The porte cochere has been rebuilt; if the work is completed it is unfortunate but that isn't certain.

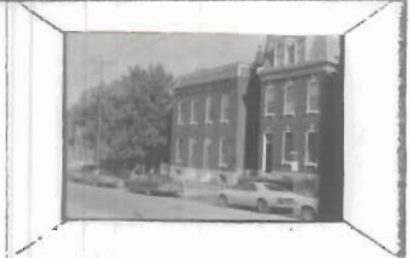
42. Further Description of Important Features The only alteration of the building is aluminum screen doors on both entrance. The building is a 2 story red brick 2-family flat. Rusticated limestone foundation. The glazing is one over one. The frame above the windows and doors are carved then topped with brick segmental arches. A very good brick cornice. The roof is flat, made to appear as a mansard from the front. The materials are gray slate in the fish scale pattern.

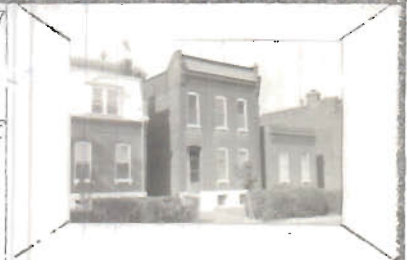
42. Further Description of Important Features This building is very similar to 2727 and 2729 Shenandoah. Again an attempt to dress up a simple building by adding a fake mansard roof to the front. The mansard is in gray slate, the rest of the roof is flat with parapet. The front facade is also dressed up with excellent brick work particularly in the cornice. A half dozen brick styles are used. Pressed brick also forms an eyebrow above the segmental arches over the entrance and windows. The glazing is one over one. No decoration on the frames. The sills are limestone.

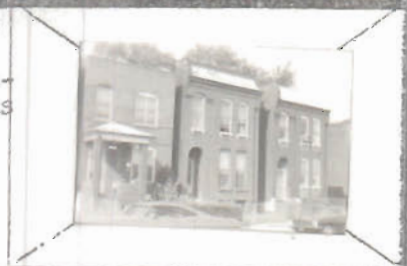
42. Further Description of Important Features The building is supposed to look like the usual St. Louis Second Empire style building. The mansard roof, however, is fake with a flat roof with parapet behind it. The fake mansard is sheathed in gray slate. The building is almost identical to its neighbor. The entrance is recessed into a Romanesque arch. The doorway is original. Two windows complete the symmetry of the first floor, 3 are on the 2nd. All are topped with segmental arches. The glazing is one over one. The building's best feature is a good brick cornice.

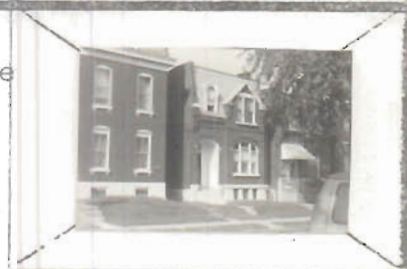
42. Further Description of Important Features A fairly unusual house. Most Second Empire style houses are 2 1/2 stories although there are several 1 1/2 story structures on this block. It bears the distinctive mansard roof but the 2nd Empire style label is somewhat misleading. The building's other Victorian features put this structure later than the 2nd Empire heyday. The entrance is recessed with a modern door. To the right of the entrance is a group of 3, 3 over 3 windows set into a basket arch. At either end of the arch is a carved sandstone or terra cotta ornament in a leaf motif. Above this is a brick cornice (excellent). A large late Victorian dormer rises up through the roof as does a smaller wooden dormer to the left. This is a very good building, good scale. An excellent example of the state of the art in St. Louis brick work at the turn of the century. The building contains at least 8 different types of pressed brick.

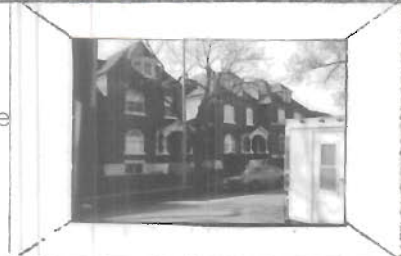
42. Further Description of Important Features This building is very similar to its neighbors, on either side. The brick, however, in this case is a darker shade of brown. It was recently tuckpointed. Again, the original roof has been replaced with asphalt shingles. A good cornice in pressed brick and the ornamented ~~cornice~~ front porch are the building's best features.
Victorian

43. History and Significance City Significance:
 A good example of the St. Louis Vernacular architecture at the turn of the century. The brick cornice is an exceptional feature.

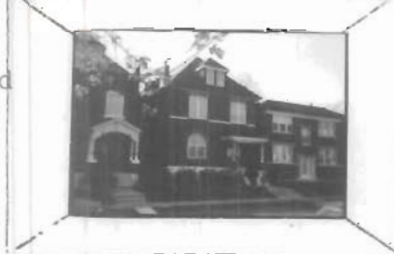
15. Name of Established District			
42. Further Description of Important Features Another example of St. Louis. Vernacular architecture around 1900-1910. A red brick structure with a hipped roof (the original slate roof still exists). Exceptional pressed brick window sills. The lintels are red sandstone. The porch is classical in design and detailing.

43. History and Significance City Significance: A good example of its architectural period.			
44. Description of Environment and Outbuildings Well kept property. Part of a very good blockface. There is a garage on the rear alley.

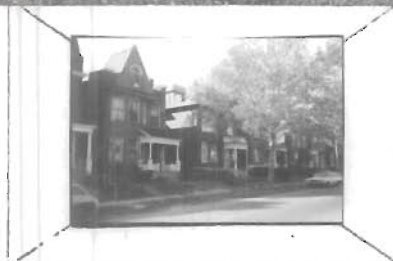
42. Further Description of Important Features Again the structure closely follows the St. Louis style at the turn of the century. The roof is hipped and is now in green asphalt shingles rather than the original slate. The facade is red brick - the front gable projects slightly as does the ornamented Victorian porch. Another first floor feature is a pair of coupled Romanesque arched windows outlined in pressed brick. Directly above them is a bay window bracketed out. The only alterations are the roof and an aluminum storm door.

43. History and Significance City Significance:
 A good but typical example of both style and period.

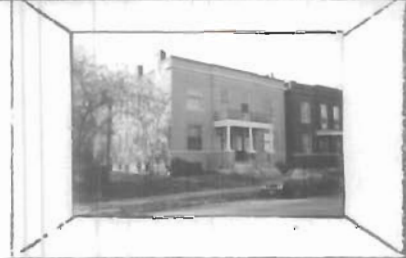
42. Further Description of Important Features The variegated gray/green slate roof is broken by 2 decorative dormers topped with copper hoopengabers. The roof is a gable roof. The bricks are almost pink in color. The cornice is wide - sweeps around the house. The entry and porch is to the right (east) side of the front facade while a curving bay rises on the left and continues through the 2nd floor. A limestone string course is at the 2nd floor sill level. All glazing is onve over one sash. The front porch is ruined with aluminum awnings and modern wrought iron. The foundation continues up to the 1st floor sill level alternating rough cut limestone with smooth faced limestone.

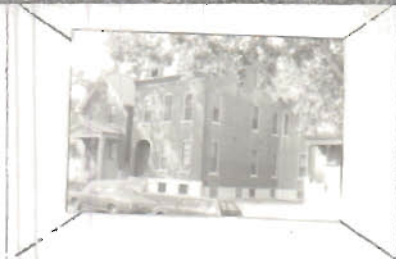
42. Further Description of Important Features The building's best feature is its lavish use of pressed brick in a variety of styles (five). Other features include a gray slate mansard roof broken with 2 decorative dormers. The double entry is recessed into the house under a basket arch. The foundation is unfaced limestone. Wrought iron grills are on the windows.

43. History and Significance City Significance:
A good example of St. Louis brick construction.

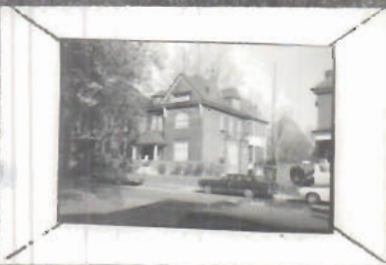
42. Further Description of Important Features This is a vernacular structure with some interesting features. The most unusual of these is the frieze which is completely covered with swirling ornament. The 2nd floor at one time opened to a walk out over the porch. This is gone; replaced by a poorly done porch. The walkout doors (one for each unit and 2 windows on either side) are circular headed and have pressed brick hoods with keystones. On the lower floor the windows are flat arch with stone sills. All glazing is one over one. There is more pressed brick in a diamond pattern separating the 1st and 2nd floors. Wrought iron window grills on the basement.

The neighboring building has been torn down leaving a vacant lot and this building does not appear to be kept in proper condition

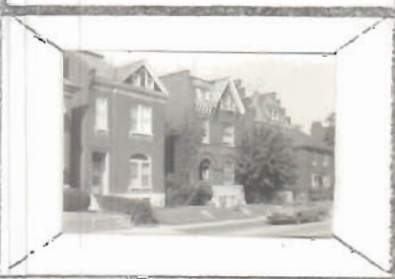
42. Further Description of Important Features A very good bldg. - made particularly outstanding by the lavish use of pressed brick. Richardson's influence shows in the small Richardsonian dormer and 2 large 1st floor Romanesque arches. One serving as the double entry and the other as a large window. Pressed brick outlines the Romanesque arches. There is also a pressed brick string course as the 2nd floor sill level and an exceptional brick cornice. The large brackets on the cornice are an unusual feature. Also important is the Palladian window set into the gable. The foundation is limestone alternating in row between faced stone and coarse. The tops of 2 chimneys have been removed.

43. History and Significance State Significance:
 An exceptional example of St. Louis brick work.

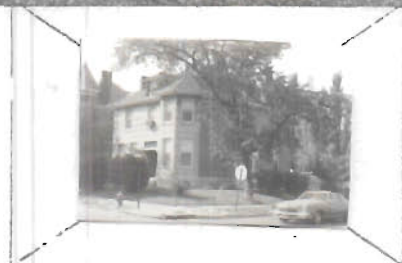
42. Further Description of Important Features The building has a strong horizontal feeling that is only partially dispelled by a large combination bay tower. The front of the building is treated in stone - alternating between wide finished stone and rough, undressed narrow stone. The entrance is recessed and altered with a new door. The sides and rear of the house are in buff brick.

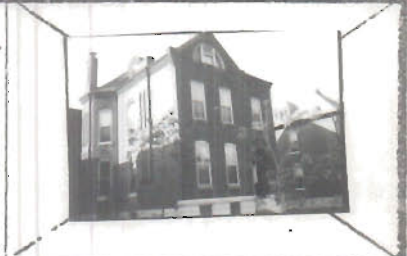
42. Further Description of Important Features The roof is a combination hipped/gabled and is treated with variegated gray slate. Despite its date, Richardson's influence is strong. The entrance is recessed under a large Romanesque arch with terra cotta keystone. The entrance features its original woodwork and beveled glass doors. Jack arches with terra cotta keystones top all windows. All of the glazing is one over one sash. The basement/foundation is limestone - faced on the front of the house and left rough on the sides and back. The projecting gable and thermal window is an interesting feature, as is the excellent brick cornice.

43. History and Significance City Significance:
A good example of St. Louis brickwork.
