National Register of Historic Places Registration Form

historic name Degen, Henry, House

street & number 112 W. Fourth Street [N/A] not for publication

city or town Washington [N/A] vicinity

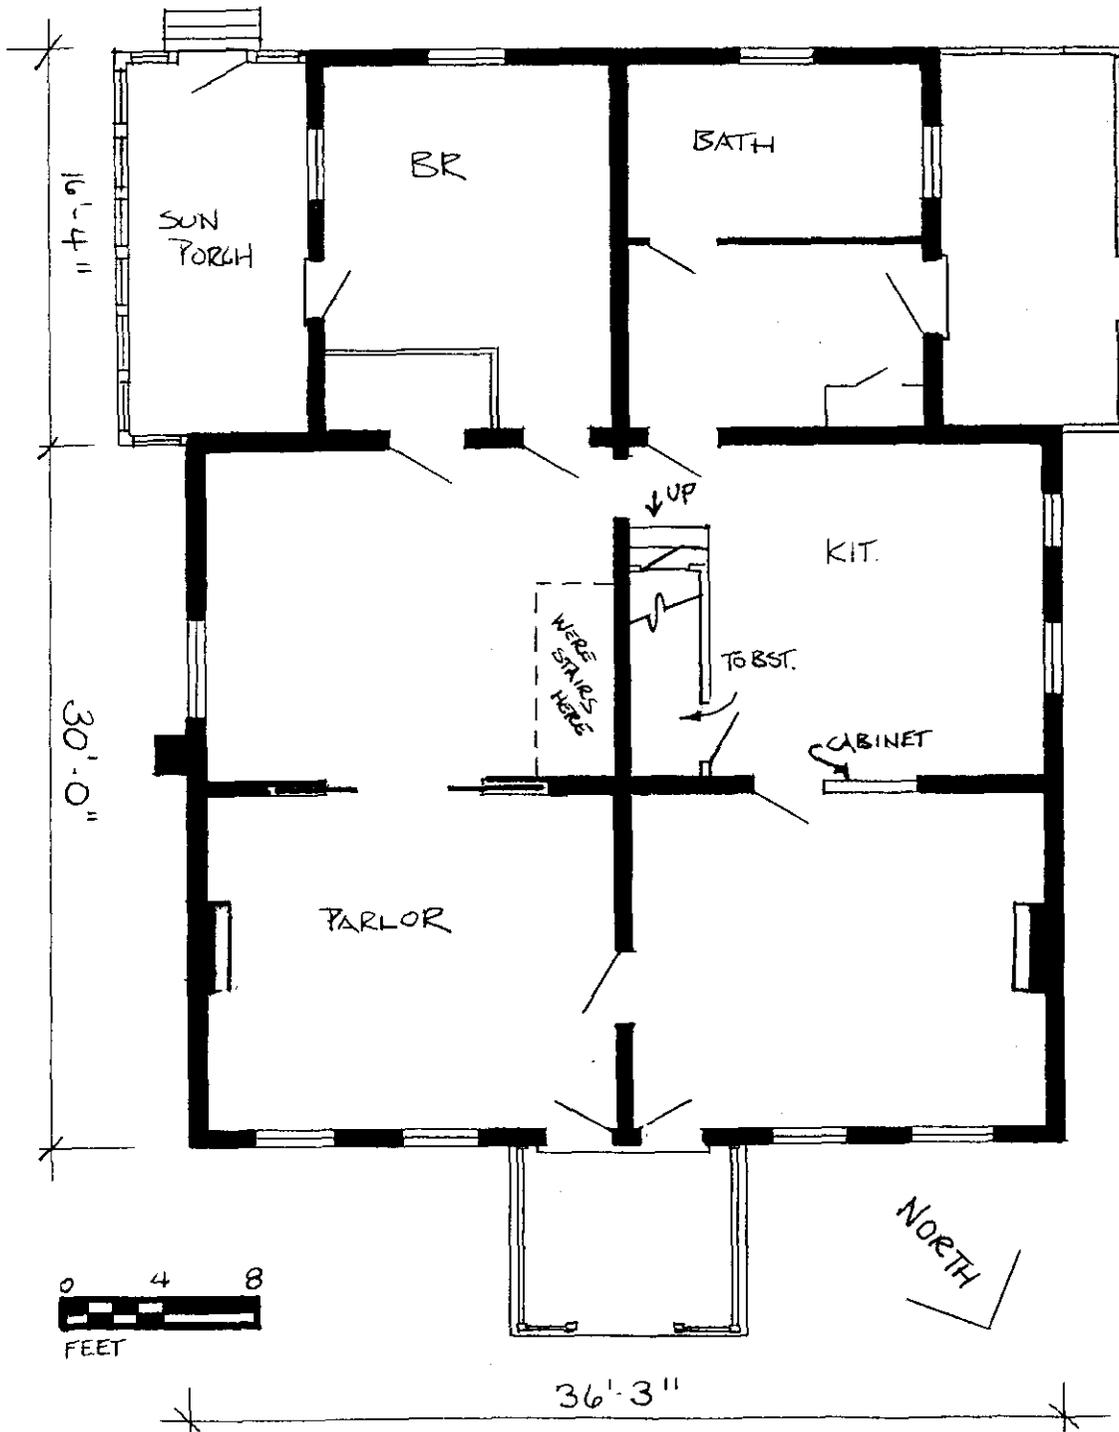
Figure One. First Floor Plan, Drawn by Debbie Sheals.

The interior of the building is highly intact and relatively ornate. The main part of the house contains four rooms which are roughly the same size. Each front door opens into a parlor, and each parlor has a wide doorway leading to the room behind it. Each side of the house is nearly a mirror image of the other, and it is possible that they were at one time separate apartments. If they were originally separate, however, they were joined at a very early date. Sanborn maps show this as a single family dwelling from 1893 on, and there are doorways which link the two sides of the house which have exactly the same trim as the rooms they join.

The front rooms have formal, highly molded door and window trim, while the back rooms have simpler pedimented trim, which is more common to modest houses in the area. A doorway between the two front rooms has the same type of molded trim, and appears to be original. Each front room also has a small fireplace and mantel on the side wall. (The original internal chimneys have been removed at the roofline.)

The doorway between the two east rooms has large paneled pocket doors which are operable and in very good condition. The doorway between the west rooms is the same size, but contains a regular swinging door, and a cabinet. (See photo 6.) The cabinet appears to date to the early 20th century; the door is original, or nearly so. That passageway was probably an open double doorway to start with, and converted to its present form early in the twentieth century. The change may have happened when the southwest room became a kitchen.

Each of the rear rooms has a door to the rear ell. Both doors, which were originally exterior doors, has a three light transom, and pedimented trim. A doorway between the two rear rooms has the same type of pedimented trim. The rear ell contains a bedroom and a modern bathroom, as well as doors to the side porches. (See Figure One.)

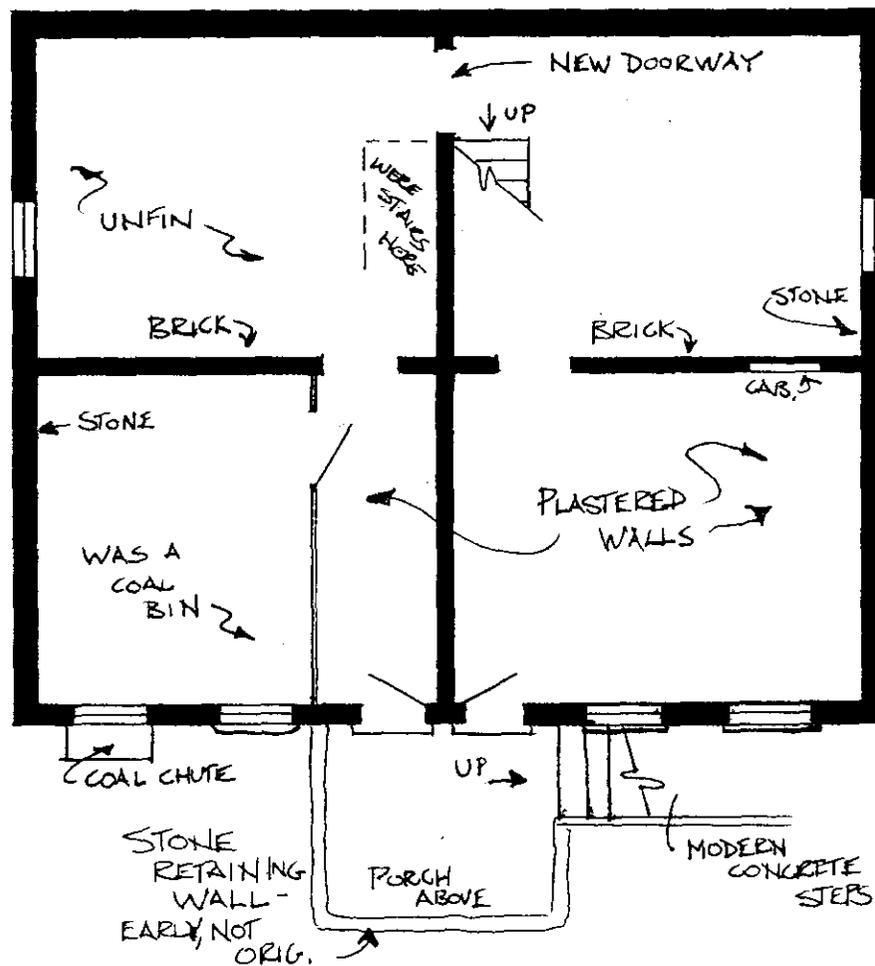
Figure Two. Basement Plan. Drawn by Debbie Sheals.

The two front rooms of the basement appear to have been finished when the house was built. They both have plastered walls and ceilings, and woodwork which is similar to that of the back rooms upstairs. Each room has a full-height, six-over-six window, and a four-panel door which leads outside. The doors and windows have wide flat trim and pedimented lintel pieces. The lintel pieces are simpler than those of the main floor; the trim of the main floor has a band of molding along the top of the lintel piece which is absent on the basement woodwork. The west front room has the added refinement of a small built-in cupboard on one wall. (See photo 8.) The east room was converted to a coal bin at some point; there is now a thin frame wall next to the door, and one window opening holds a coal chute. The rear two rooms of the basement are unfinished, and were originally not connected. The only doorway between the east and west sides of the basement has been installed in the last few years. (See Figure Two.)

beneath the front porch, and the front basement windows are nearly as large as those on the main part of the facade. A stone retaining wall, which allows access to the doors beneath the porch, appears to have been added after the main foundation walls were built. Also, the basement windows, which are now largely below grade, appear to have been fully exposed when new. They now have stone and concrete walls in front of them to create very shallow wells.

The front basement windows are topped with segmental arches of cut stone. The easternmost window has been converted to a coal chute; the other windows still contain early or original six-over-six windows. (See photos 1 and 8, and Figure Two.) A modern set of concrete steps along the west side of the facade leads down to the area in front of the basement doors. The stone front wall of the basement has large, uniformly shaped blocks with fairly smooth surfaces.
