Survey number: CL-AS-014-001		2. SURVEY NAME: Downtown Smithville Historic Resource Inventory			
3. COUNTY: CLAY		4. ADDRESS (STREET NO. 104		STREET (NAME) N BRIDGE ST	
5. CITY: SMITHVILLE	Vicinity <input type="checkbox"/>	6. UTM	OR	LAT: 39.387405	7. TOWNSHIP/RANGE/SECTION
				LONG: -94.581164	T: R: S:
8. HISTORIC NAME (IF KNOWN):			9. PRESENT/OTHER NAME (IF KNOWN):		
10. OWNERSHIP: <input checked="" type="checkbox"/> PRIVATE <input type="checkbox"/> PUBLIC		11A HISTORIC USE (IF KNOWN): Commerce: Specialty Store		11B CURRENT USE Commerce/Trade: Business

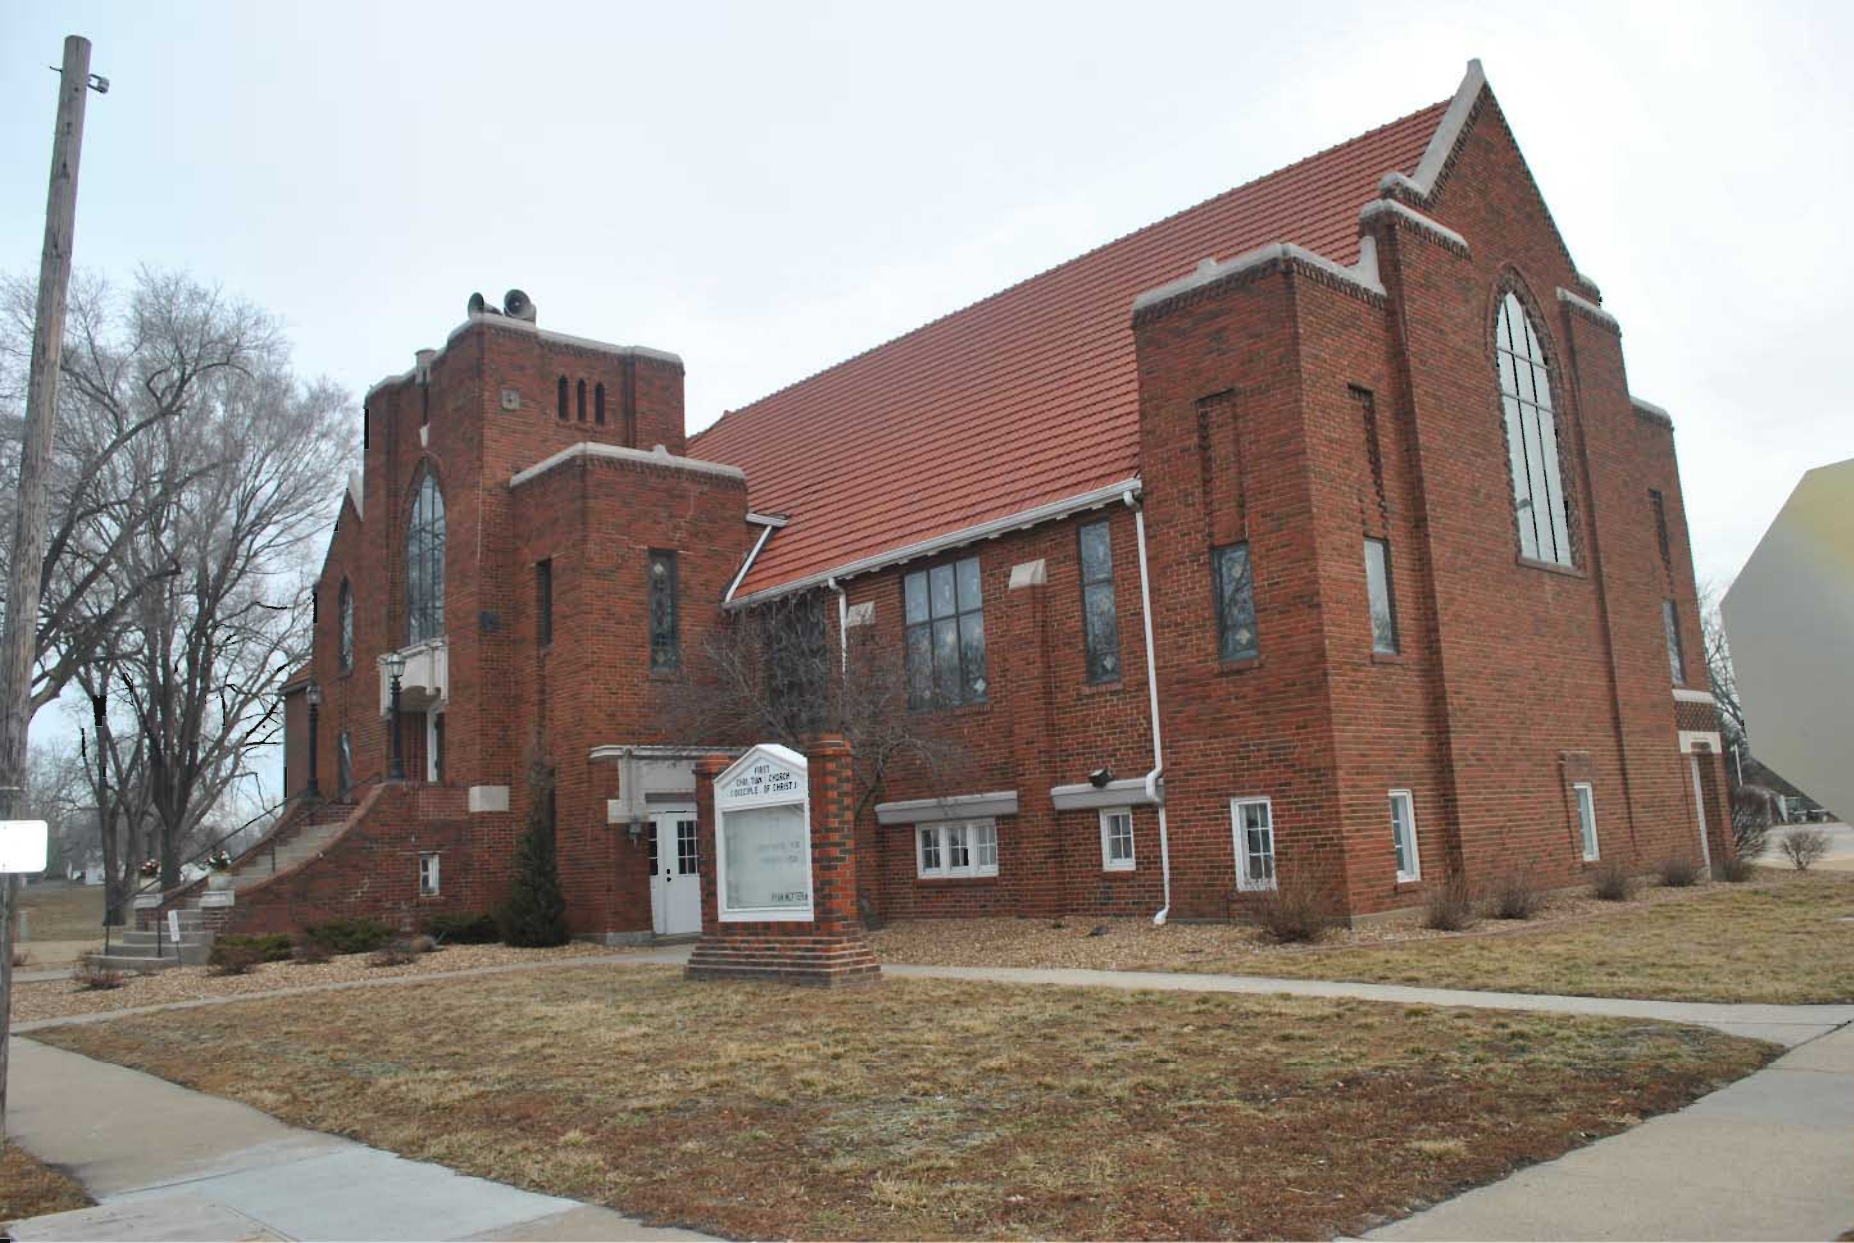
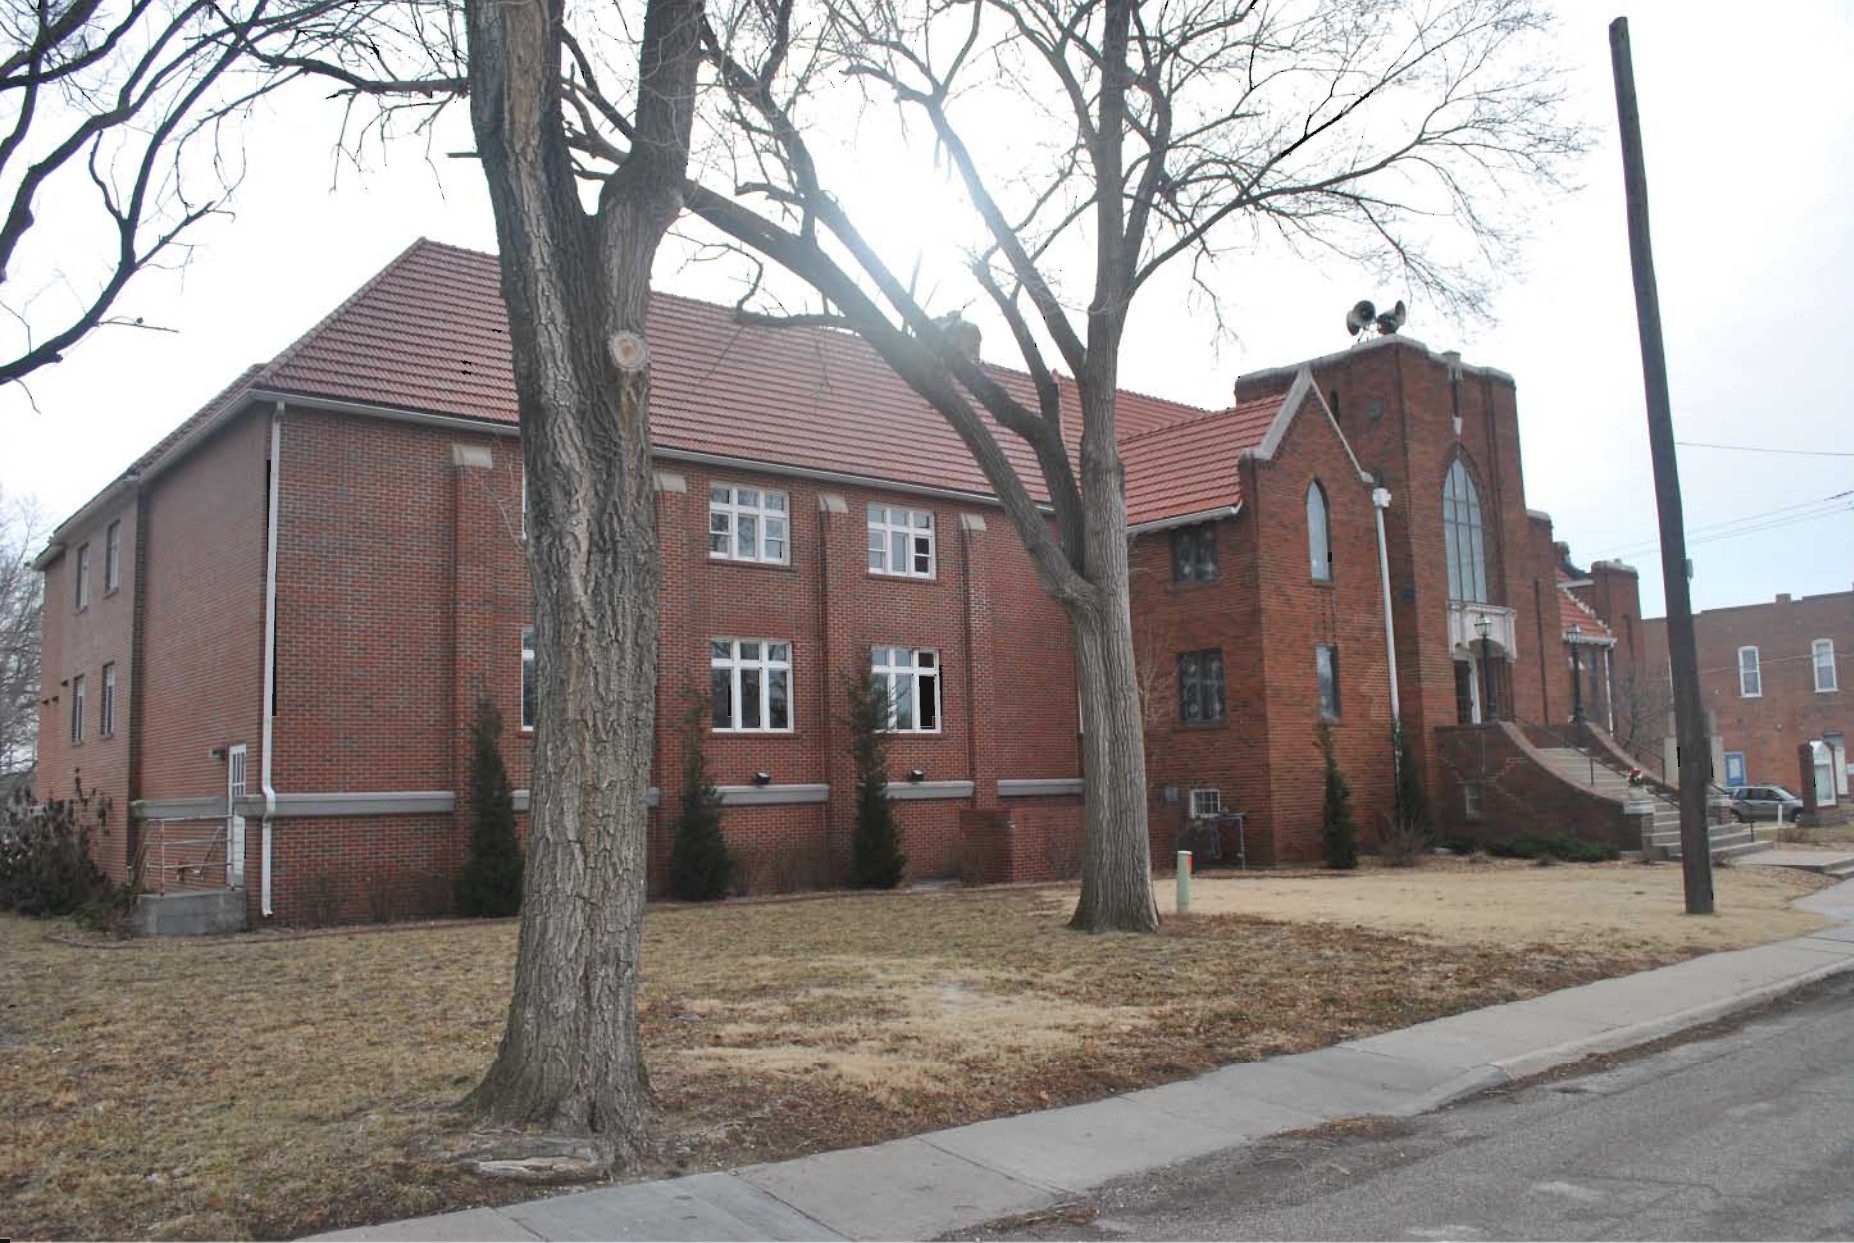
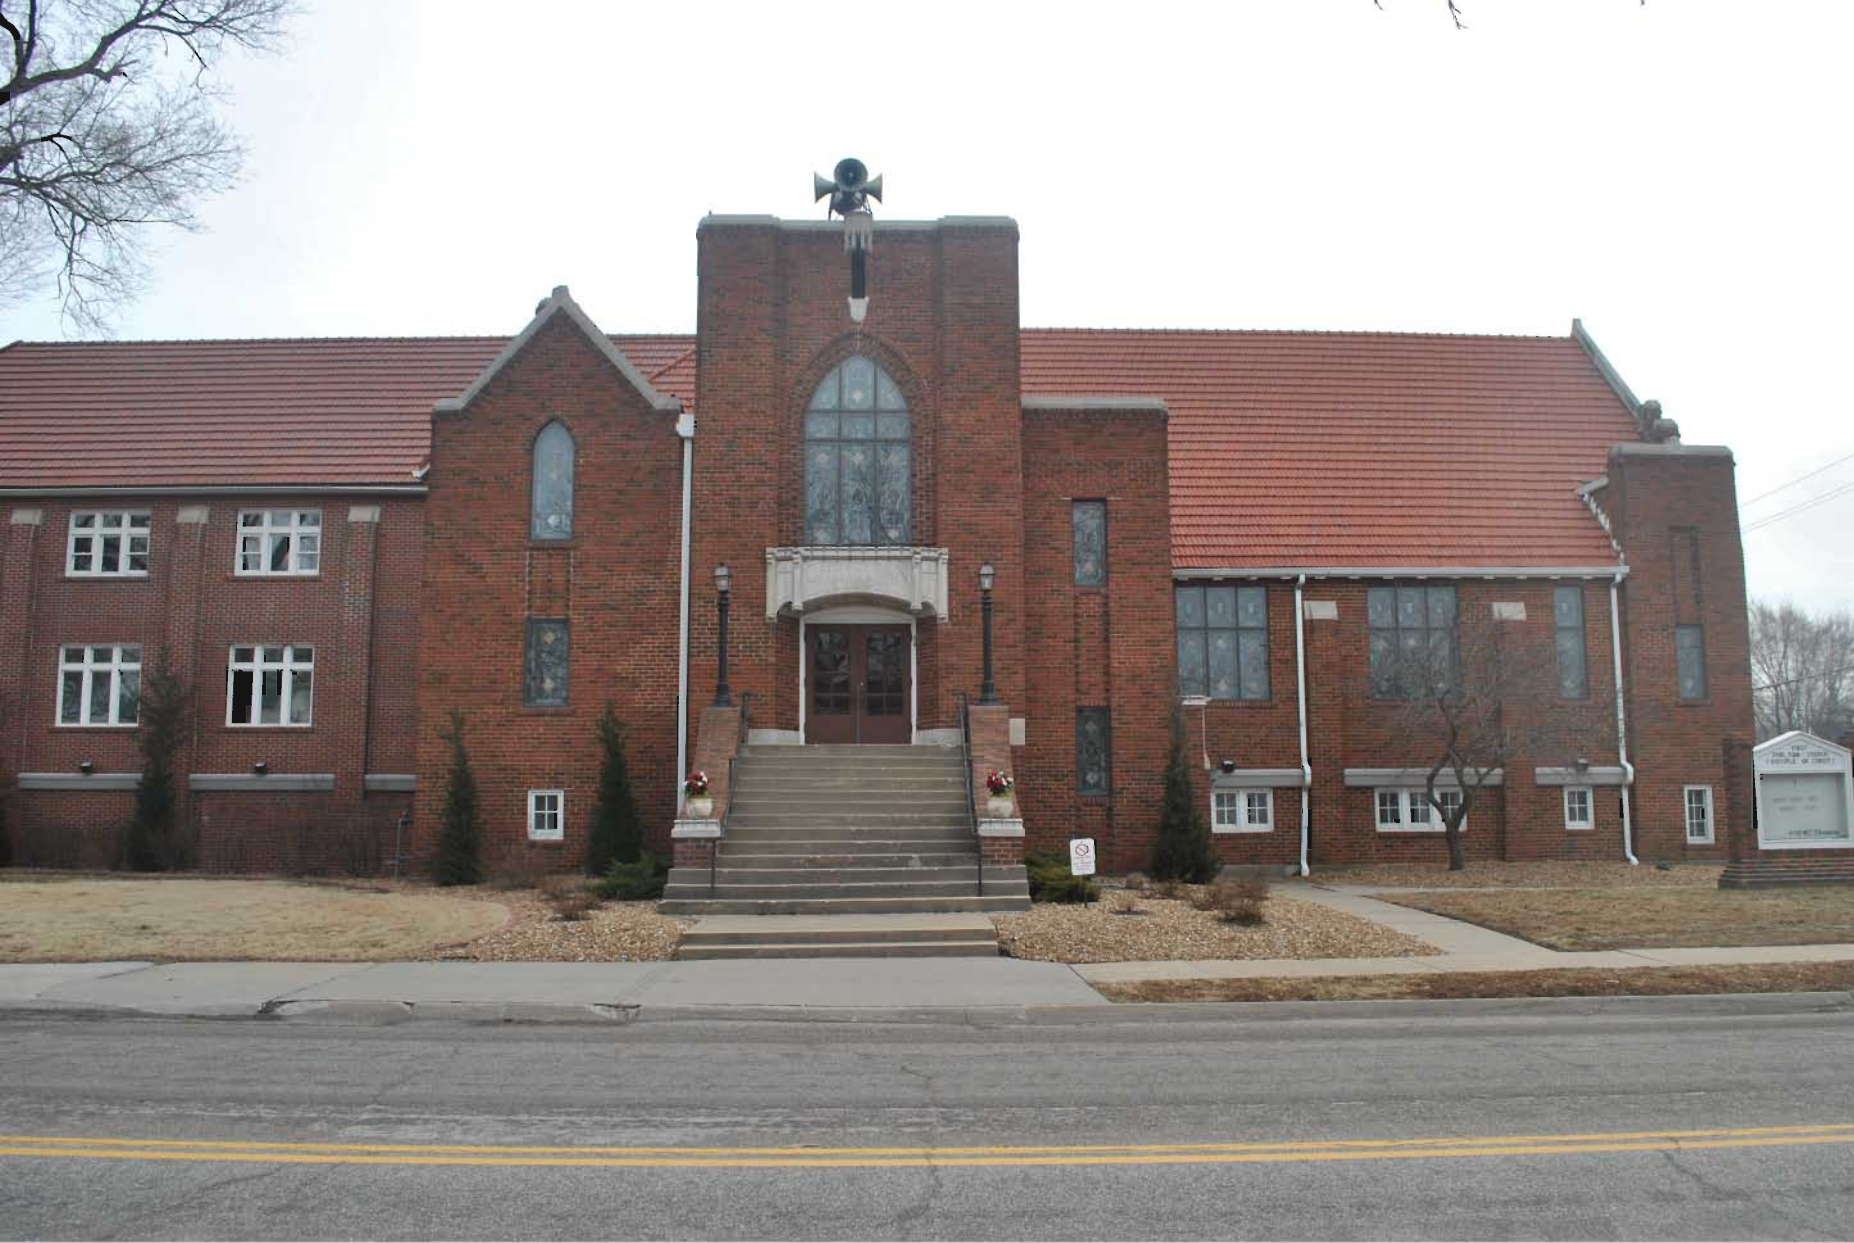
The 2.5 story brick church has a rectangular plan. Limestone trim (copings, beltcourse, washes atop pilasters) accents the red brick. A decorative brick pattern ornaments the parapet walls just below the copings. A clay-tile-clad gable roof tops the building. A tower block projects from the rectangular mass at the north end of the west elevation. The main entrance is located at the base of the tower, at the top of a flight of 13 wide steps flanked by brick cheek walls. Historic multi-light wood doors fill the doorway. A large lancet window filled with stained glass pierces the wall above the entry. A large stained glass lancet window also pierces the south elevation. Smaller, rectangular stained glass windows pierce the side (east and west) elevations, the south elevation and the tower.

The First Christian Church is a contributing resource to a potential NR district and could be individually listed in the NR. It has excellent integrity and is in excellent condition. It continues its historic function as a church.

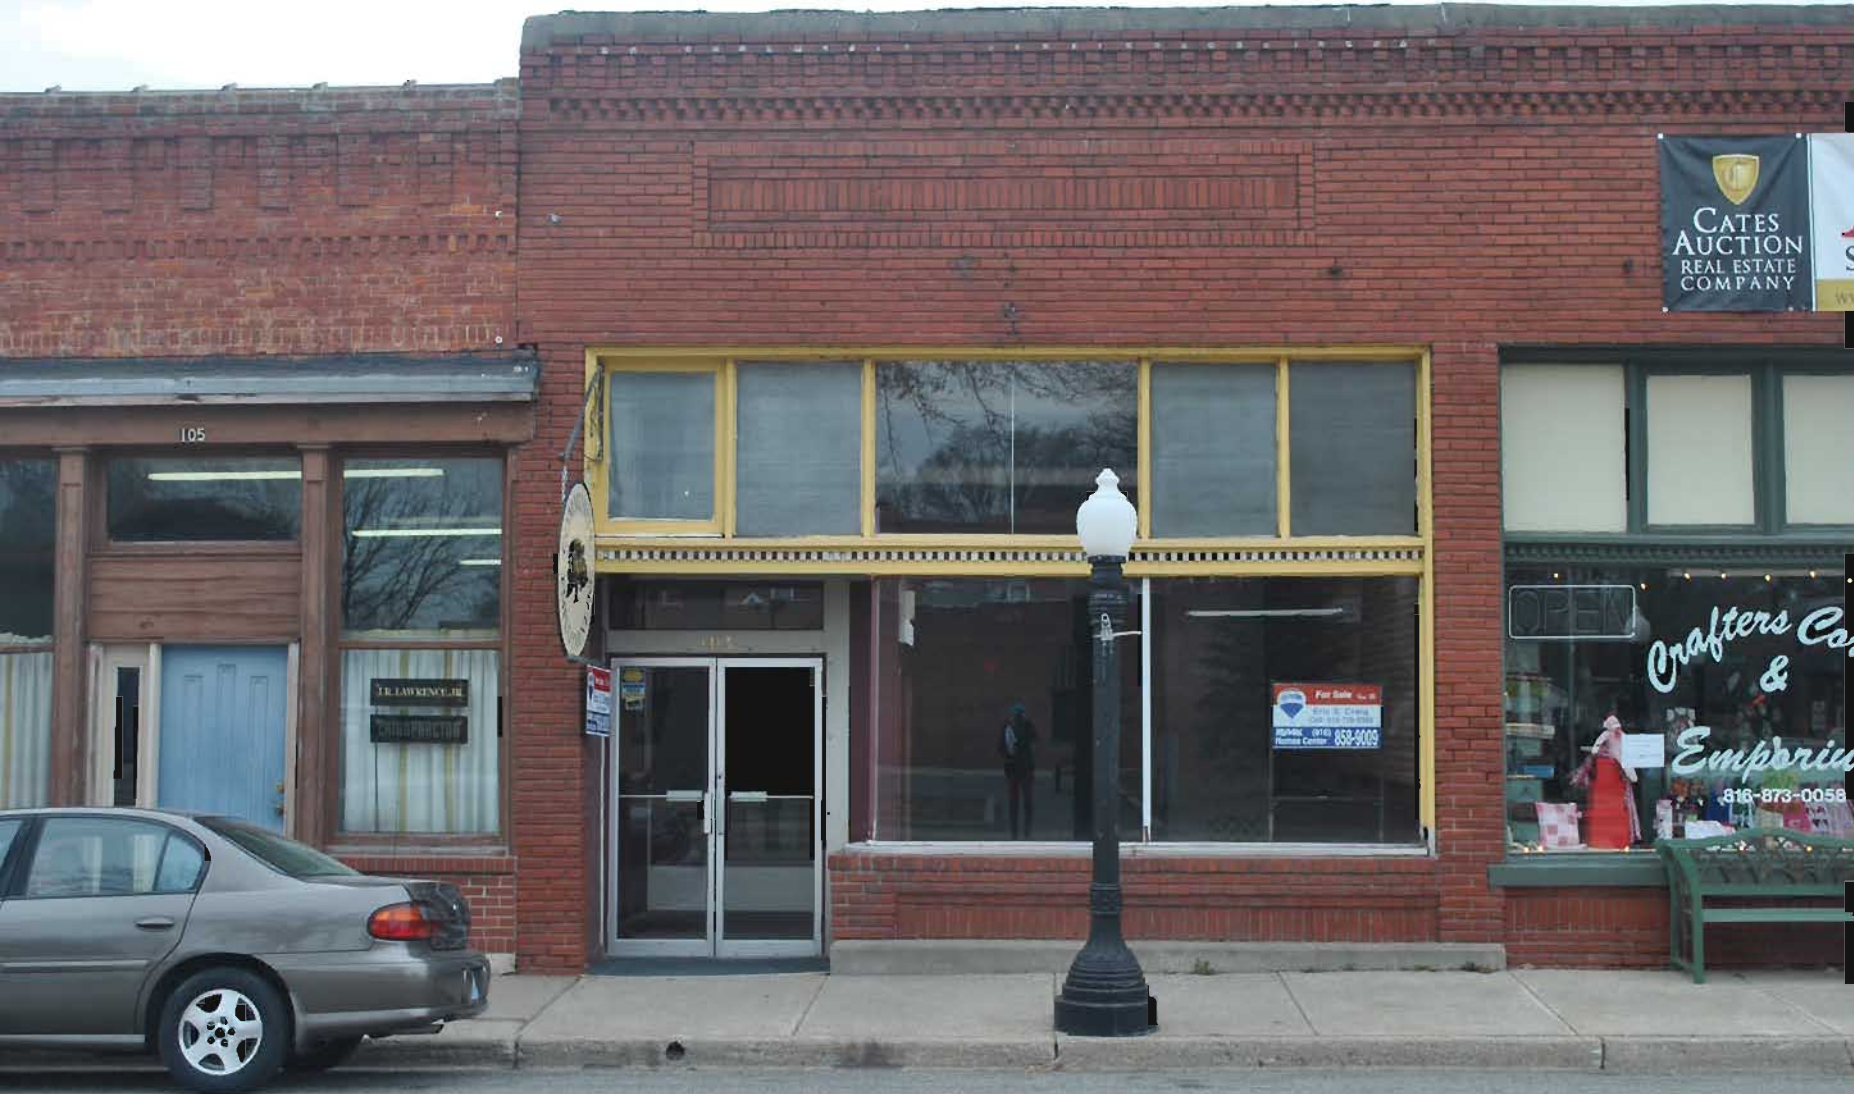
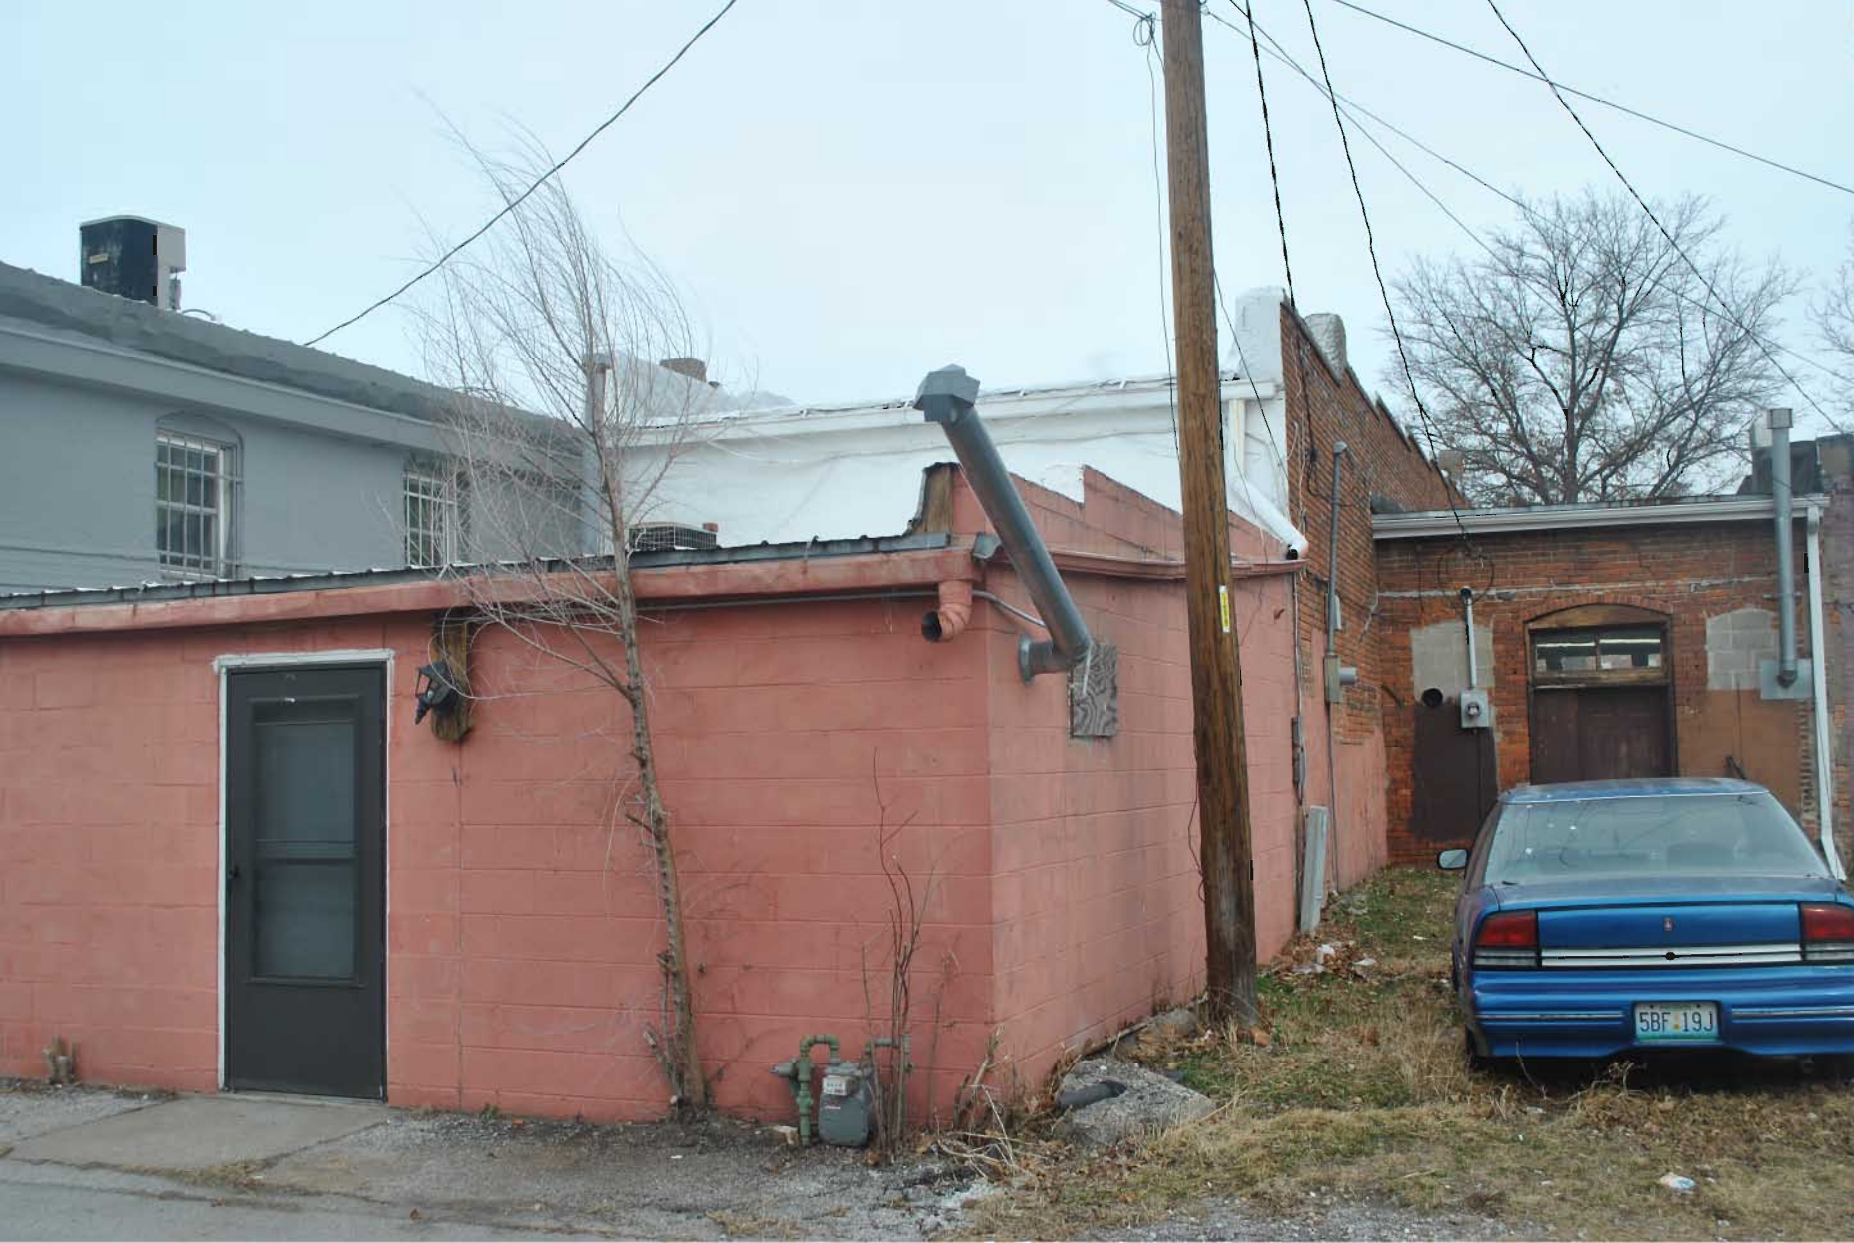
The building has good to fair integrity. Although the historic storefront is gone, the historic wood-framed transom remains. The parapet retains its historic decorative brickwork and is in good condition. It is a contributing building to a potential National Register district.

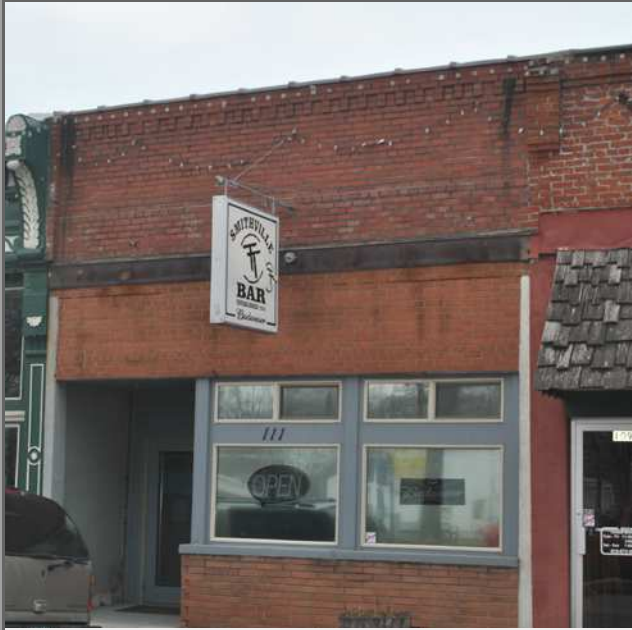
The one-story one-part commercial block has a plain façade clad with red brick. The historic storefront assembly has been replaced with non-historic infill. Three bays are defined by window and door openings in the former storefront. The doorway is recessed in the east bay. The central and west bays each have a non-historic single-light fixed windows topped by long, rectangular two-light windows. They are all set in wood frames. Non-historic brick clads the knee wall and the transom. A steel lintel spans the width of the building above the storefront. Historic brick clads the parapet above the lintel. A simple dentiled brick cornice spanning the top of the parapet provides the only ornament on this simple building.

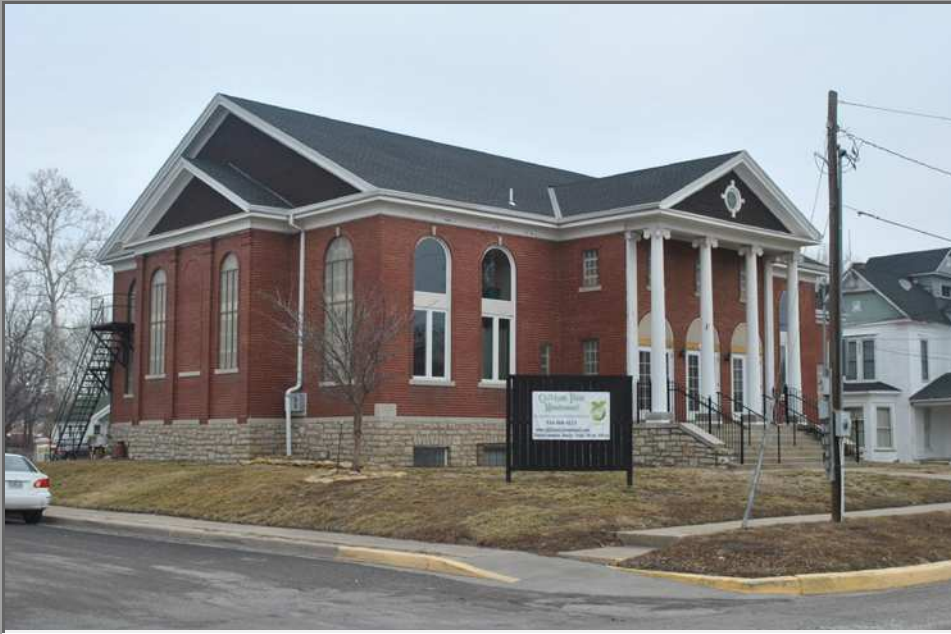
This 2-story former church is now used as a school. An asphalt shingle-clad side-gabled roof tops the building. The symmetrical façade is comprised of 7 bays defined by arched window and door openings. The central 3 bays project from the center of the façade. Four fluted ionic columns support the 2-story front-gabled portico that spans the center 3 bays. The stairs rising to the portico span the width of the portico. Red brick clads the 2-story walls. Limestone clads the raised foundation walls. Non-historic windows fill historic window openings. The 2-story arched windows pierce the S, W, and N elevations. Historic multi-light windows with storm glazing fill the arched openings on the west and the 2 W openings on the north elevation. Non-historic windows fill the arched windows on the front (south) elevation and the 4 east openings on the north elevation. They have single-light fixed sashes in the 2nd story arch and paired casement sashes in the 1st story. Historic multi-light shashes with storm glazing fill a few 1-story squared window openings on the 1st and 2nd stories on the S and E elevations. Three doorways at the front portico provide entry into the building. Non-historic paired multi-light french doors fill the openings. The transoms have non-historic infill.

Many of the building's historic materials and its form are intact. It retains good integrity despite the replacement of historic windows and doors in many of the openings. It is a contributing resource to a potential National Register district.

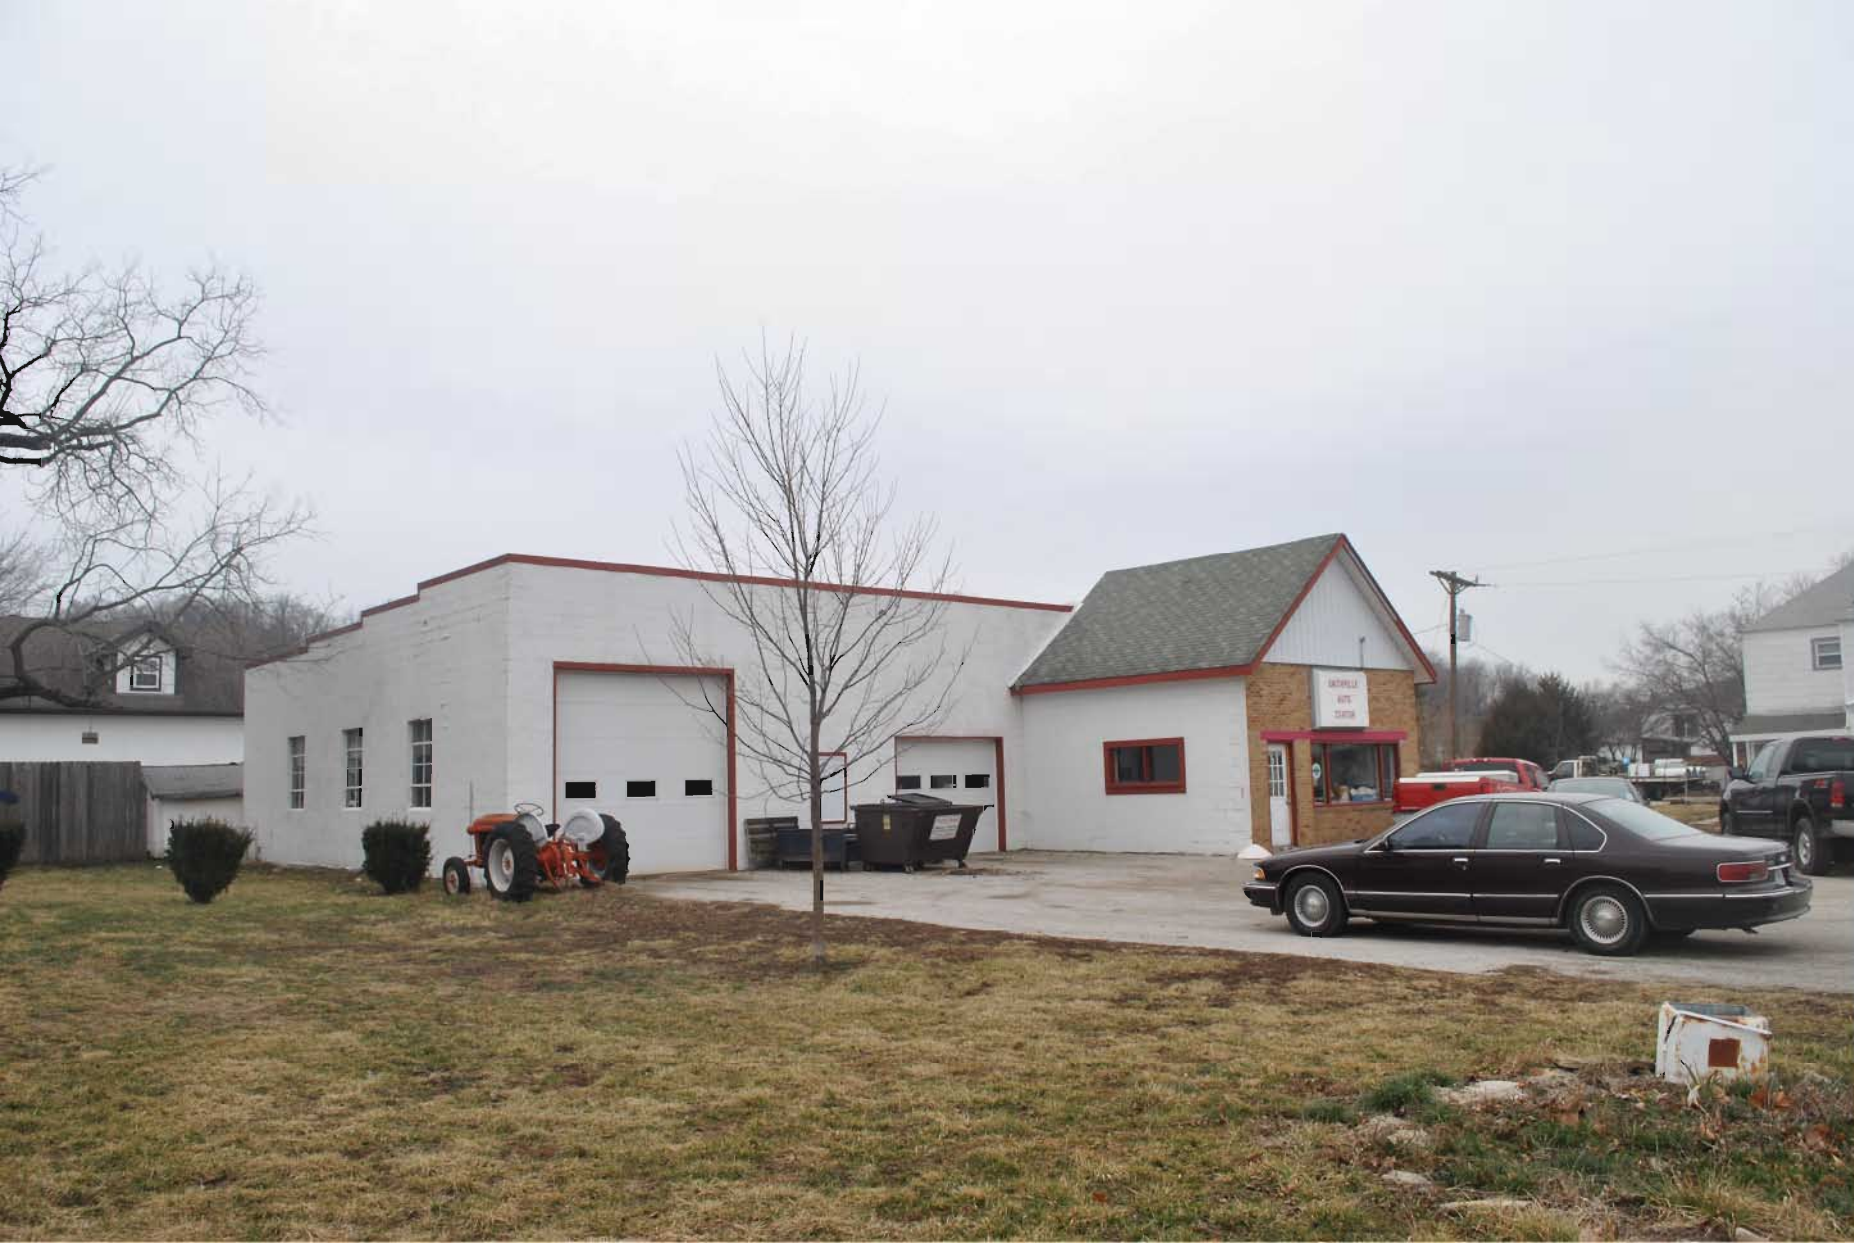
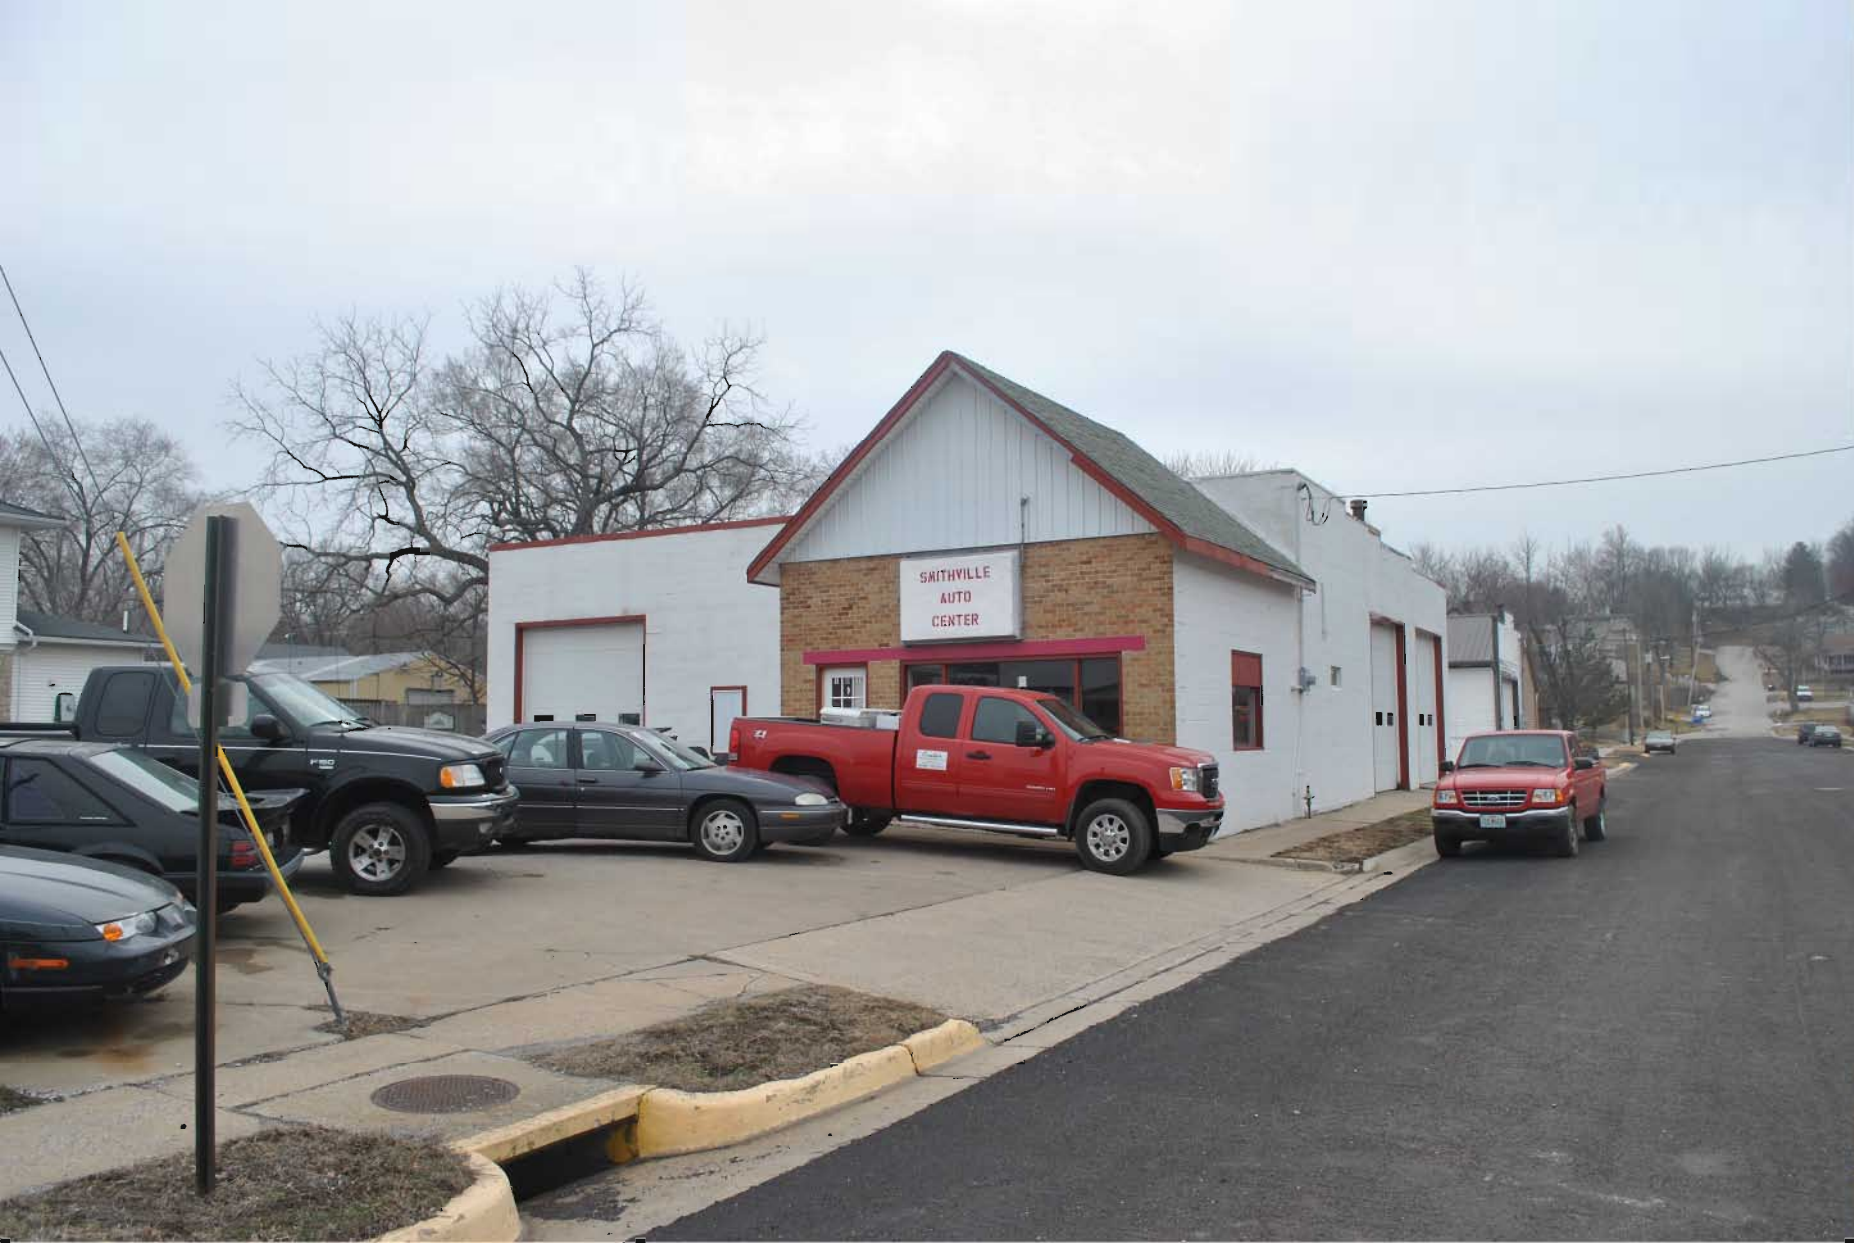
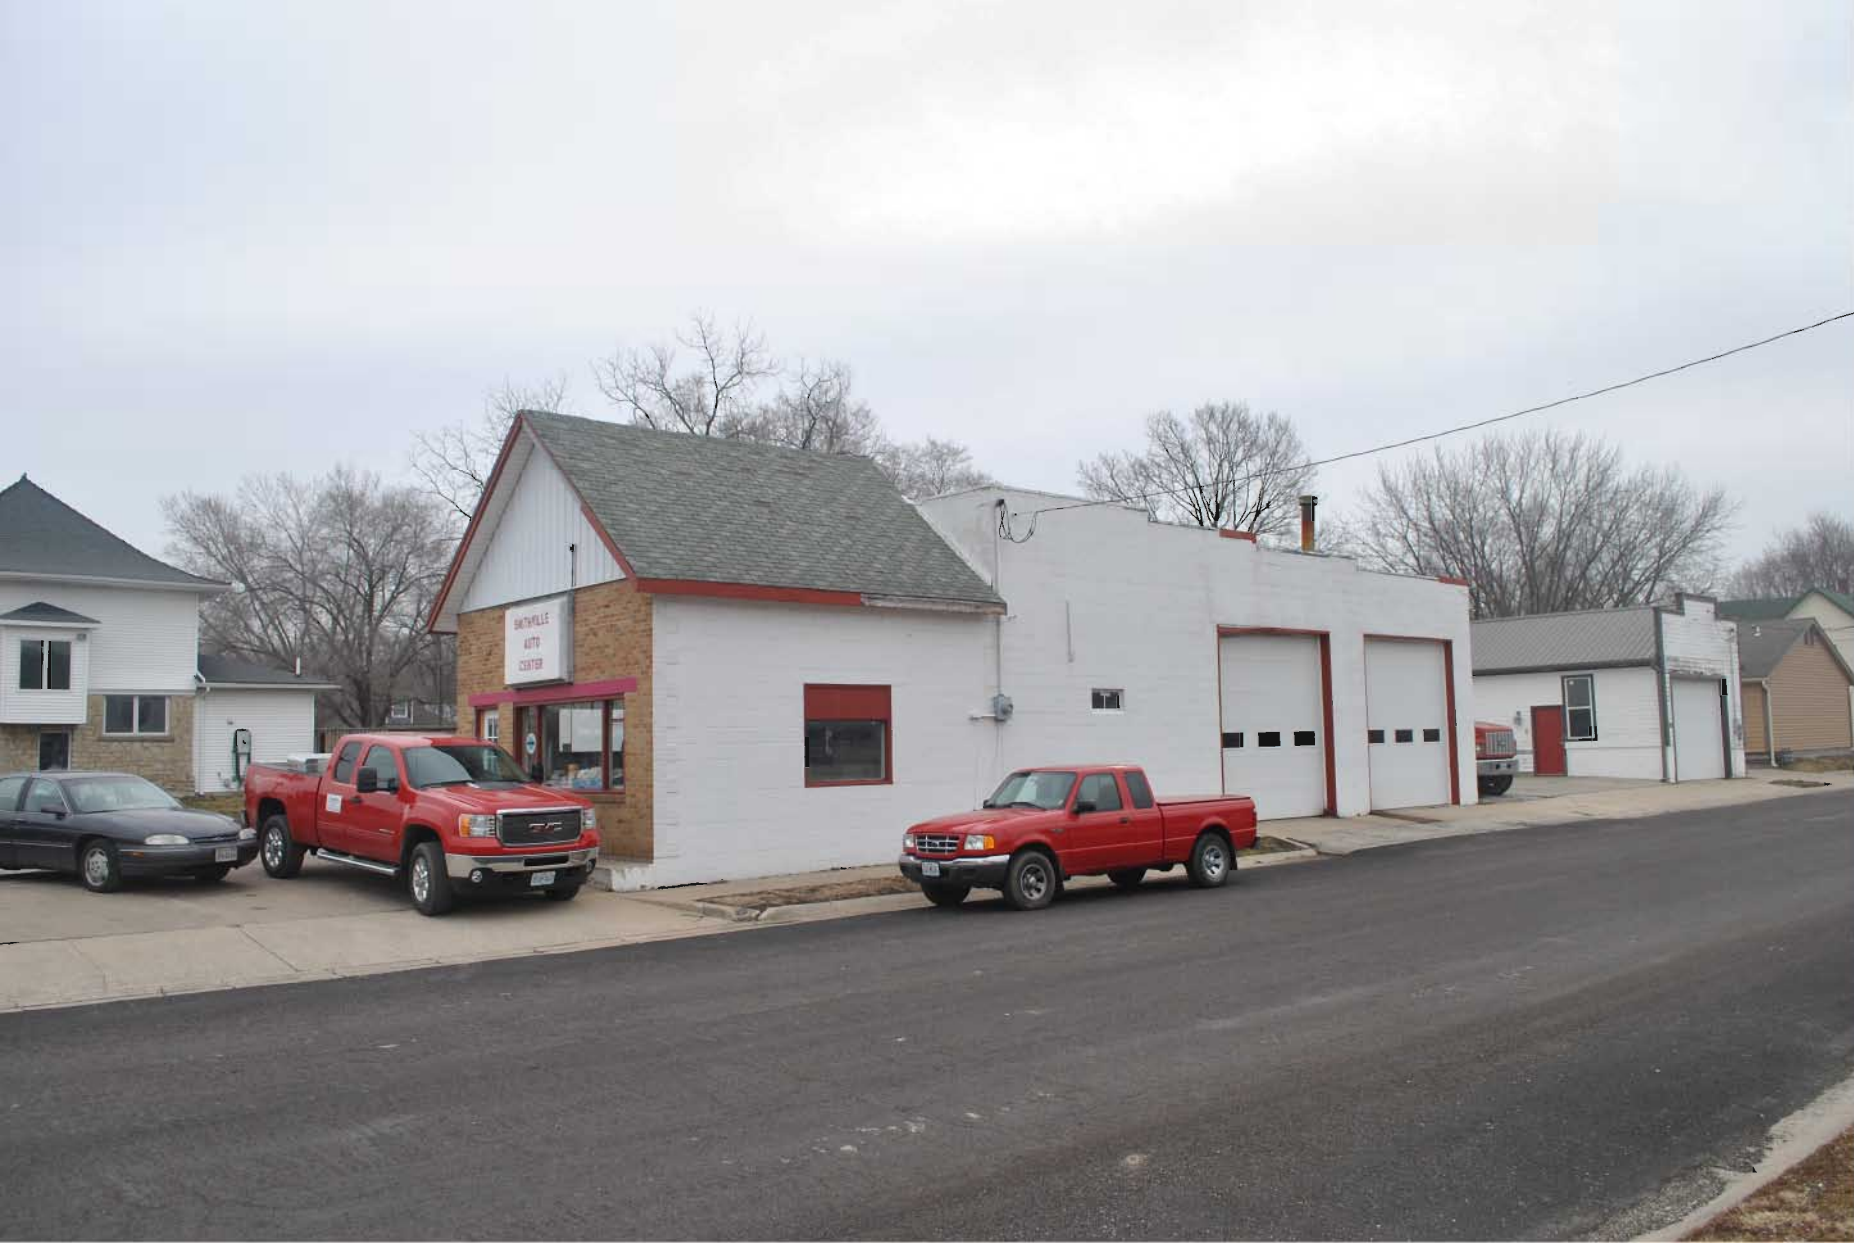
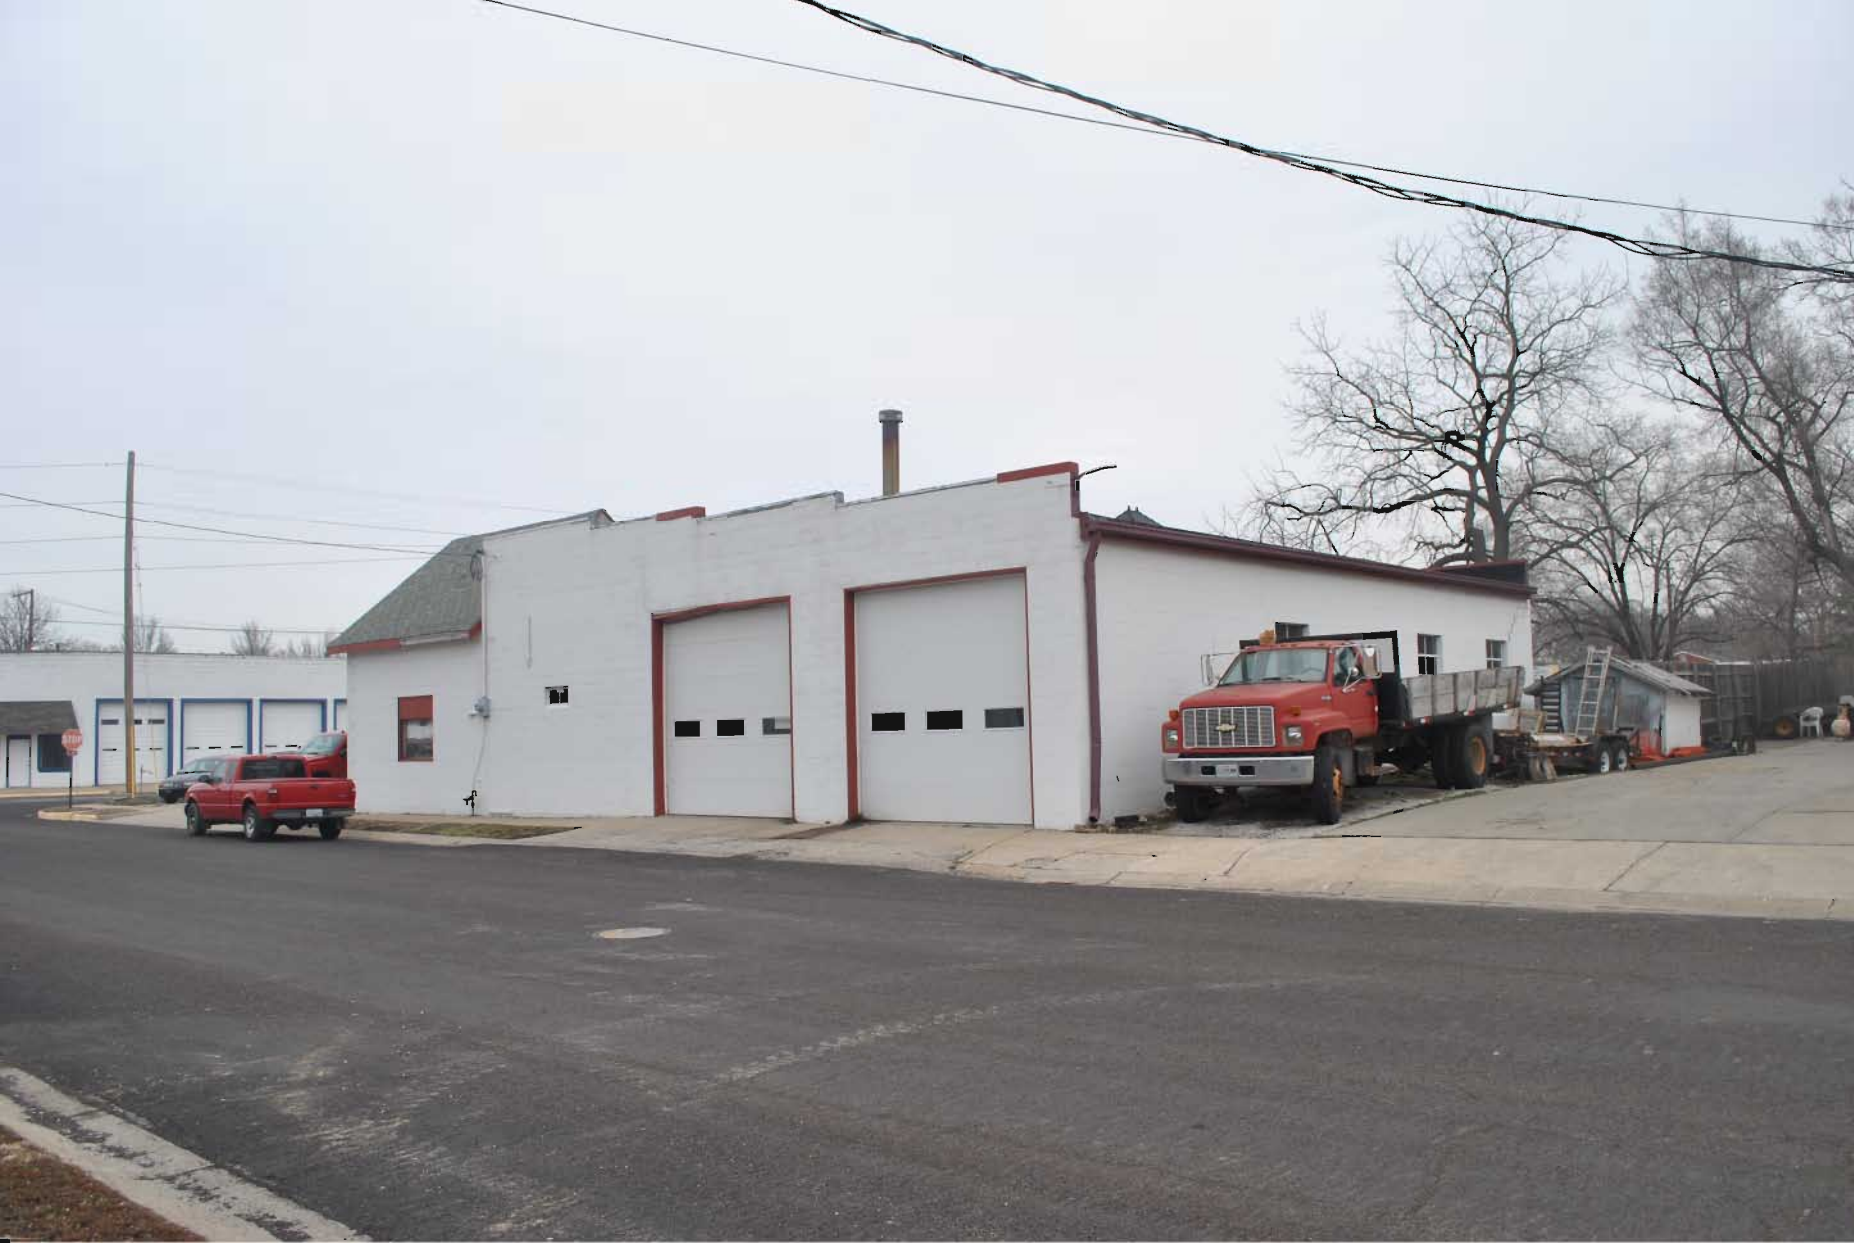
This one-story building has a rectangular plan with a small block that projects from the west end of the north elevation. The main area houses a garage for vehicular servicing and repair and has a flat roof. The smaller block houses the office and has a front-gable roof. The front elevation faces north and consists of three bays. The first bay (west) consists of the projecting block which has a pedestrian door flanked by a display window to the west. The two bays on the main block are defined by vehicular openings filled with non-historic metal overhead doors. The west elevation also has three bays consisting of a picture window on the north end and two vehicular bays in the center/south end. Historic wood-framed picture windows fill the window openings in the office block. Multi-light steel windows fill the openings in the garage block.
