**ARCHITECTURAL/HISTORIC INVENTORY FORM - Cultural Resources Office**  
**St. Louis Planning and Urban Design**

1. Survey no. SLC-AS-053-0001	2. Survey name: Thematic Survey of Flounder Houses in St. Louis City	3. County: St. Louis [Independent City]
4. Address: (from City GEO database) <b>1812 S 8TH ST</b>		5. City/State: St. Louis, Missouri
Alternate address: 1812 S 8th		Property Zip Code: 63104
Latitude: 38.608949		6. UTM Easting: 743586.48
Longitude: -90.202538		UTM Northing: 4277095.00
8. Historic Name (if known): N/A	11a. Historic Use (if known): Domestic	City Block: 372 City Ward: 7
9. Present/other name (if known):	7. Township-Range-Section: N/A	10. Ownership: Private
11b. Current Use: Domestic		Neighborhood Number: 21

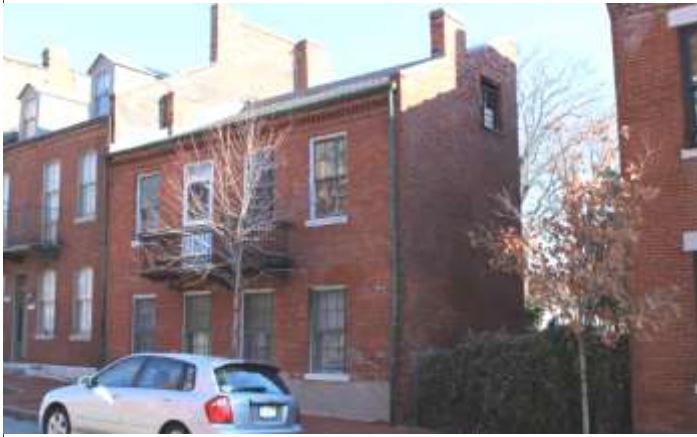
Two and a half story brick Flounder with long side fronting on to street. Dentiled cornice along the street facing side. Seven historic windows that face the street have trabiated lintels with stone sills. A second floor door with modern screen door enters out onto a cast iron bracketted central porch. There is a concrete parging over the front facing foundation. On the south side of the house there is only one small window, which is located in the attic portion of the house. There are three chimneys, two on the north side and one on the south. The rear has a partial two-story brick section that encompasses less than half the front massing of the house. A wooden deck projects off of that rear portion.

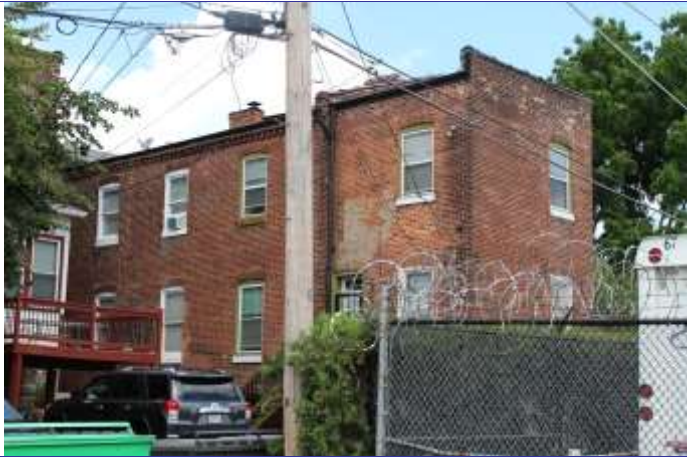
**1222 S 9TH ST**

The building was recently rehabbed and in excellent condition in a stable area of Soulard.

This 2-story brick flounder is an alley house. Its main entrance faces the street. There is a corbelled cornice on the façade at the horizontal eaves of the hipped front roof. The two-story, two-bay brick building has a main entry on the front (west) façade and secondary entry on the south. A simple brick dentiled cornice runs the length of the front and south facades. The first story of front elevation presents a singleleaf entry with replacement door and transom. Cast concrete steps with decorative stairwalls, also a recent addition, lead to a small stoop with wrought-iron railings. The entry is flanked on the north by a single window with 2/2 replacement sash. The two second-story windows have been replaced with vinyl 6/6 sash. Openings are placed under segmental arches of two header rows. The windows have wood sills that have been wrapped with aluminum. All windows and doors have been replaced. The building has a two-story rear addition with a flat roof. A flat-roofed two-story wing at the alley has a second entrance. The tall blind wall rises on the north side of the free-standing building.

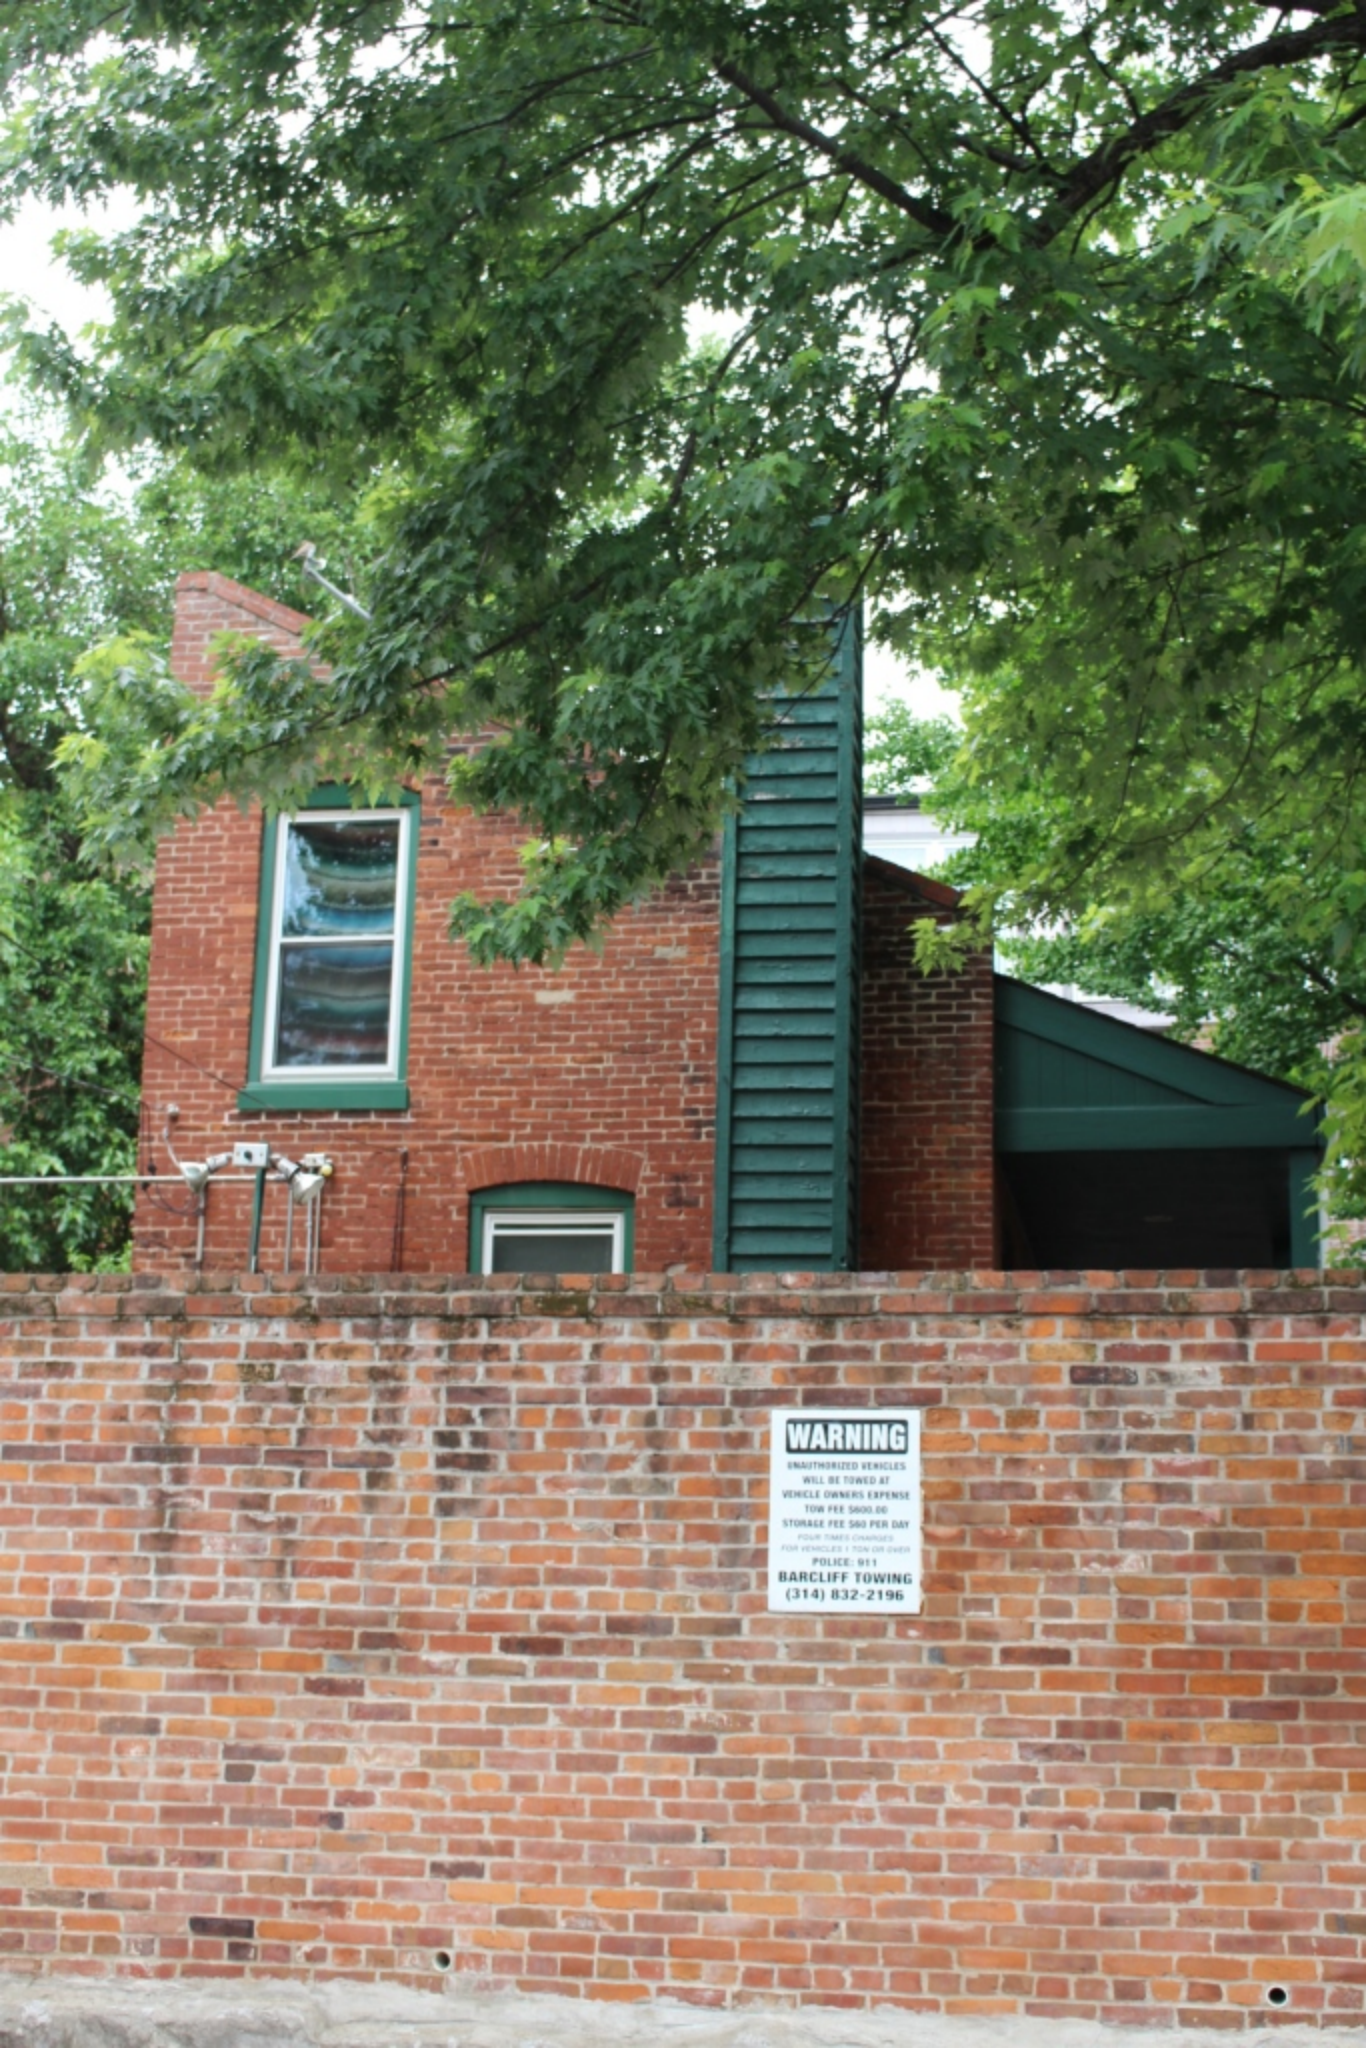
**1818R S 9TH ST**

One and a half story brick house located in alley. Windows have segmented soldier course arches with wood sills. Roofline extends down over full length side porch. Side parapets have brick coping.

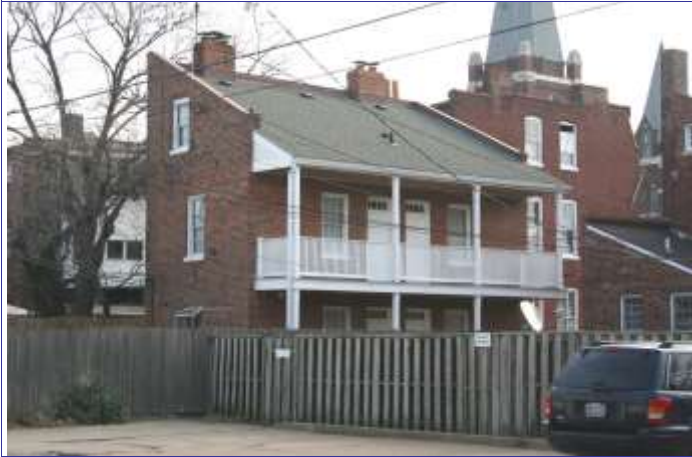
**1825 S 9TH ST**

Two and a half story brick flounder with full length two-story side porch. Entrance to the house is located on the south side. Windows have flat segmented arched soldier course lintels with stone sills. The two transomed front doors have been replaced. The roof line extends to form the roof of the porch. There is a projecting two course run of brick that acts as the coping for the side parapets. The exposed stone foundation has a concrete parging.

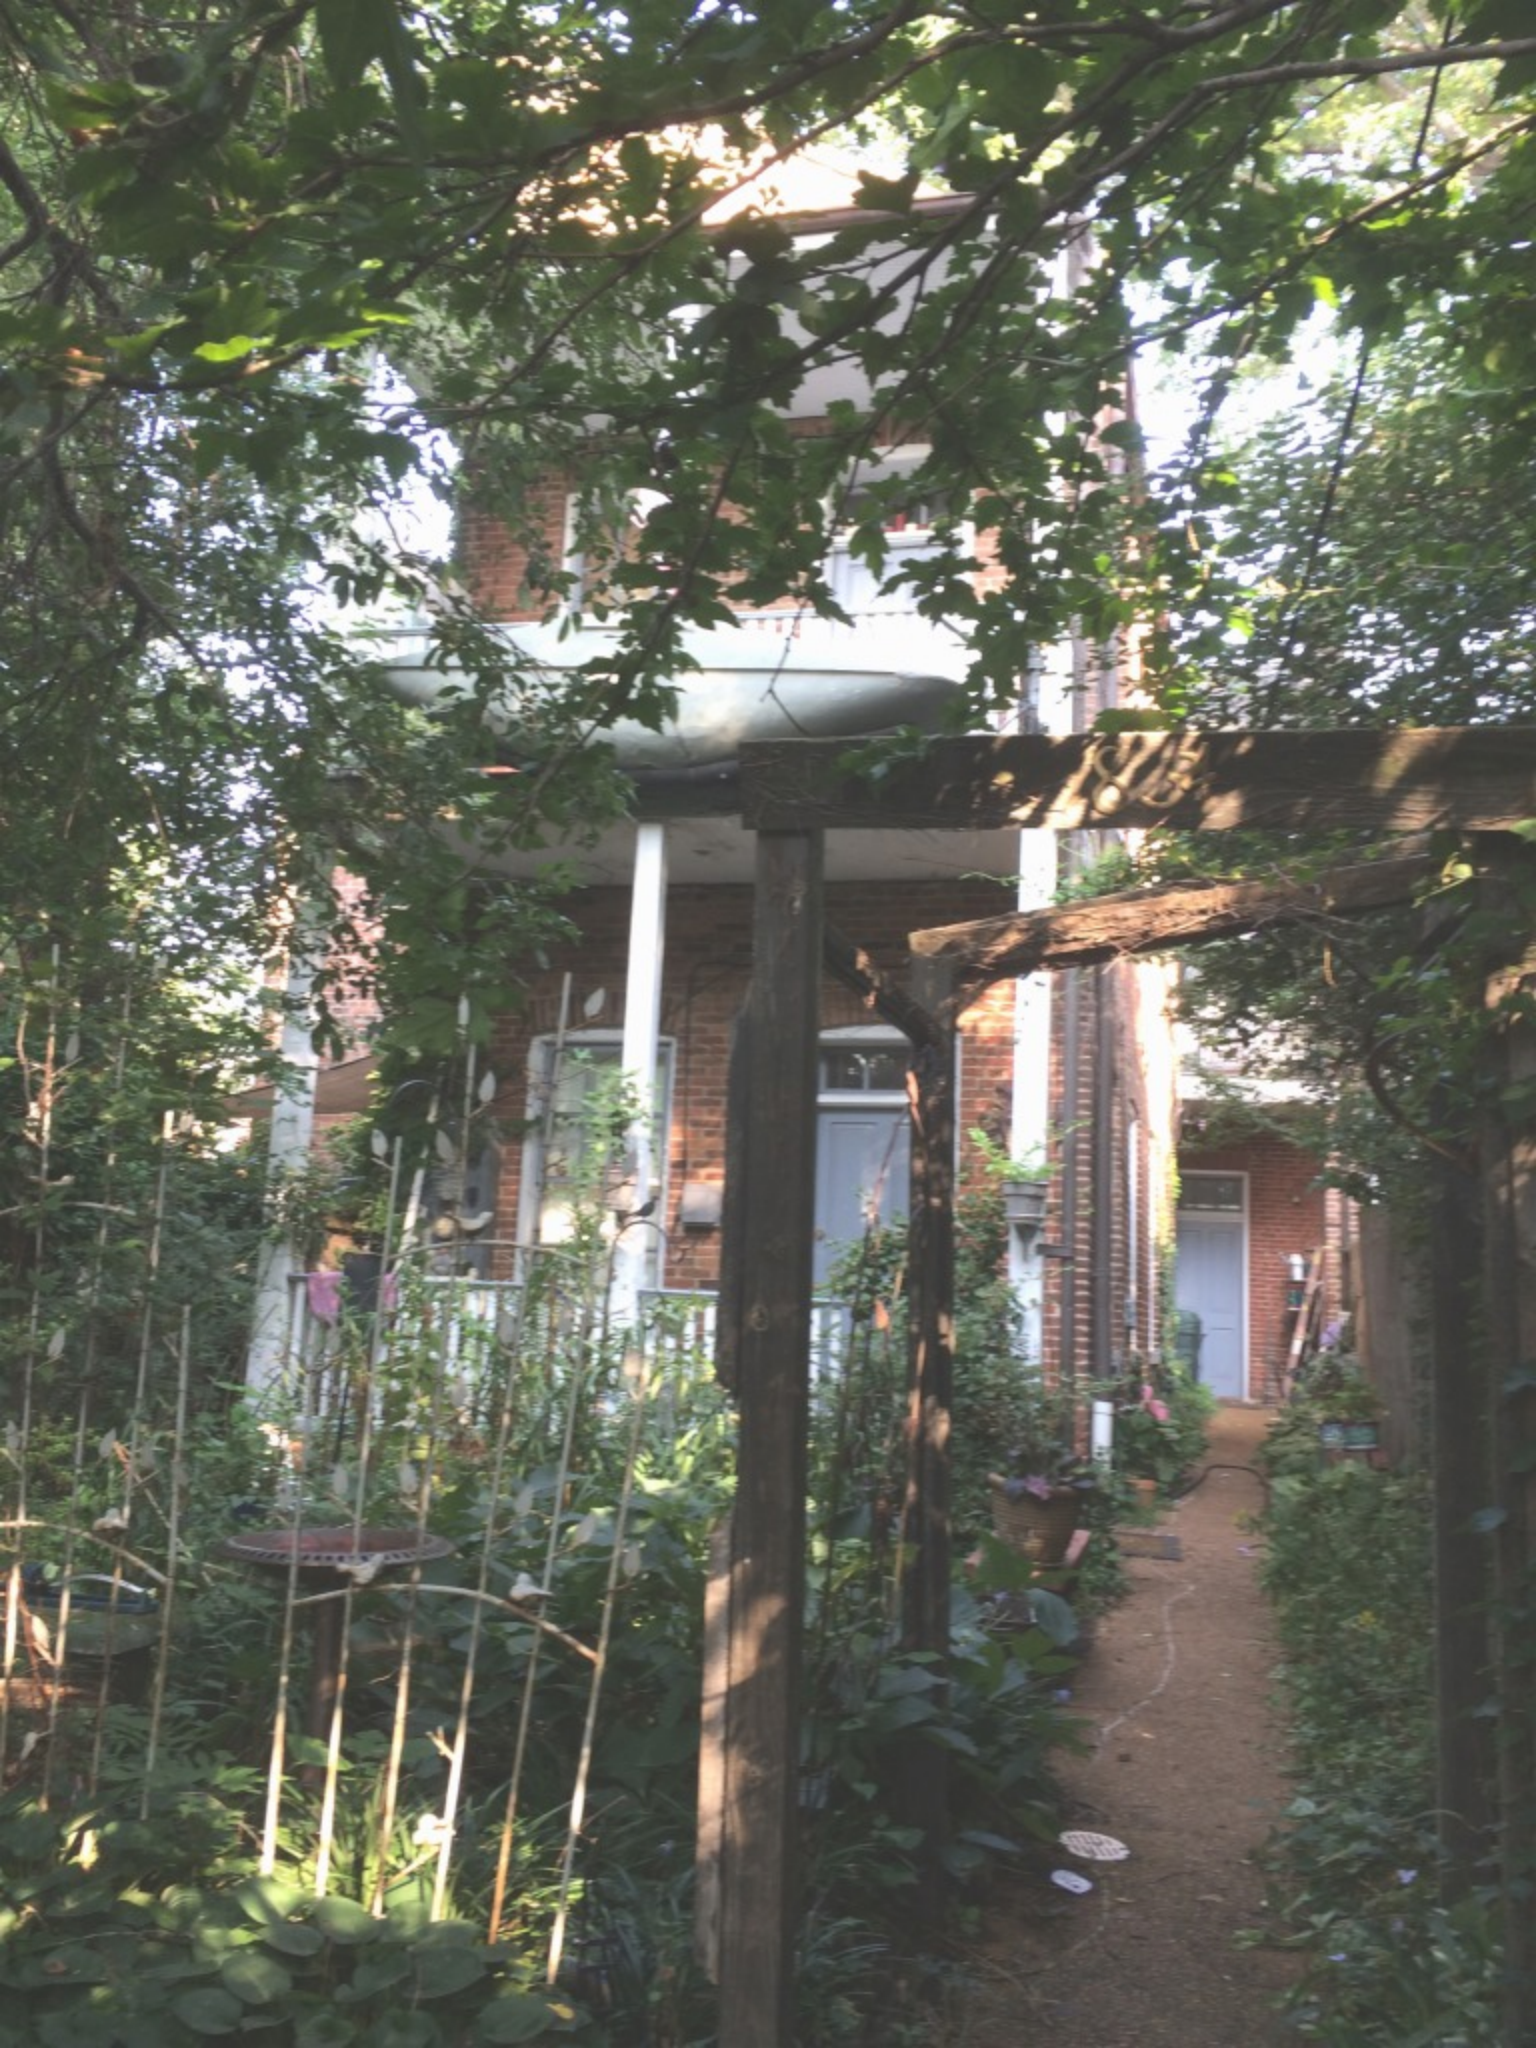
**1834 S 9TH ST**

Attached to the rear of 1834 S 9th by wood gallery. Clearly a separate flounder visible from Bing Maps Birdseye. Inaccessible for photography and inspection.

The taller windowless wall rises on the south side, from the proprty line. The north side of the building has four bays on each floor. The rear of the building has a two-story wood porch. There are no dormers.

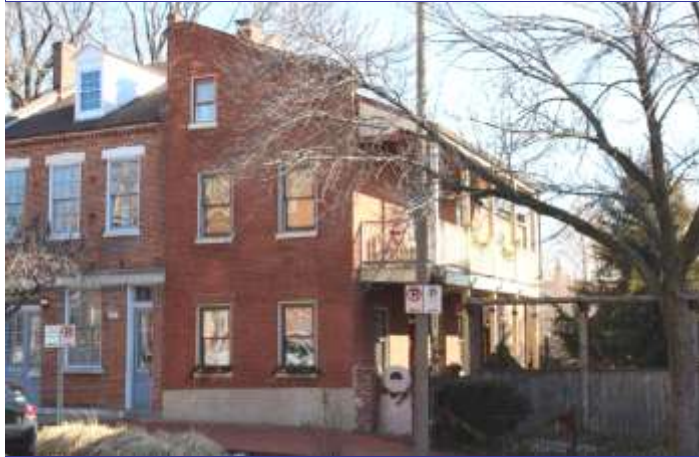
**1836 S 9TH ST**

Two and a half story brick flounder full length two-story side porch. Entrance to the house is located on the south side. Windows have brick jack arches, an unusual detail. The side entry door has been replaced with a modern door and altered transom. The main roof extends on the south side to cover a two-story wood porch running the length of the façade. The exposed stone foundation has a concrete parging. There is a two-story frame flounder addition at the rear of the building.

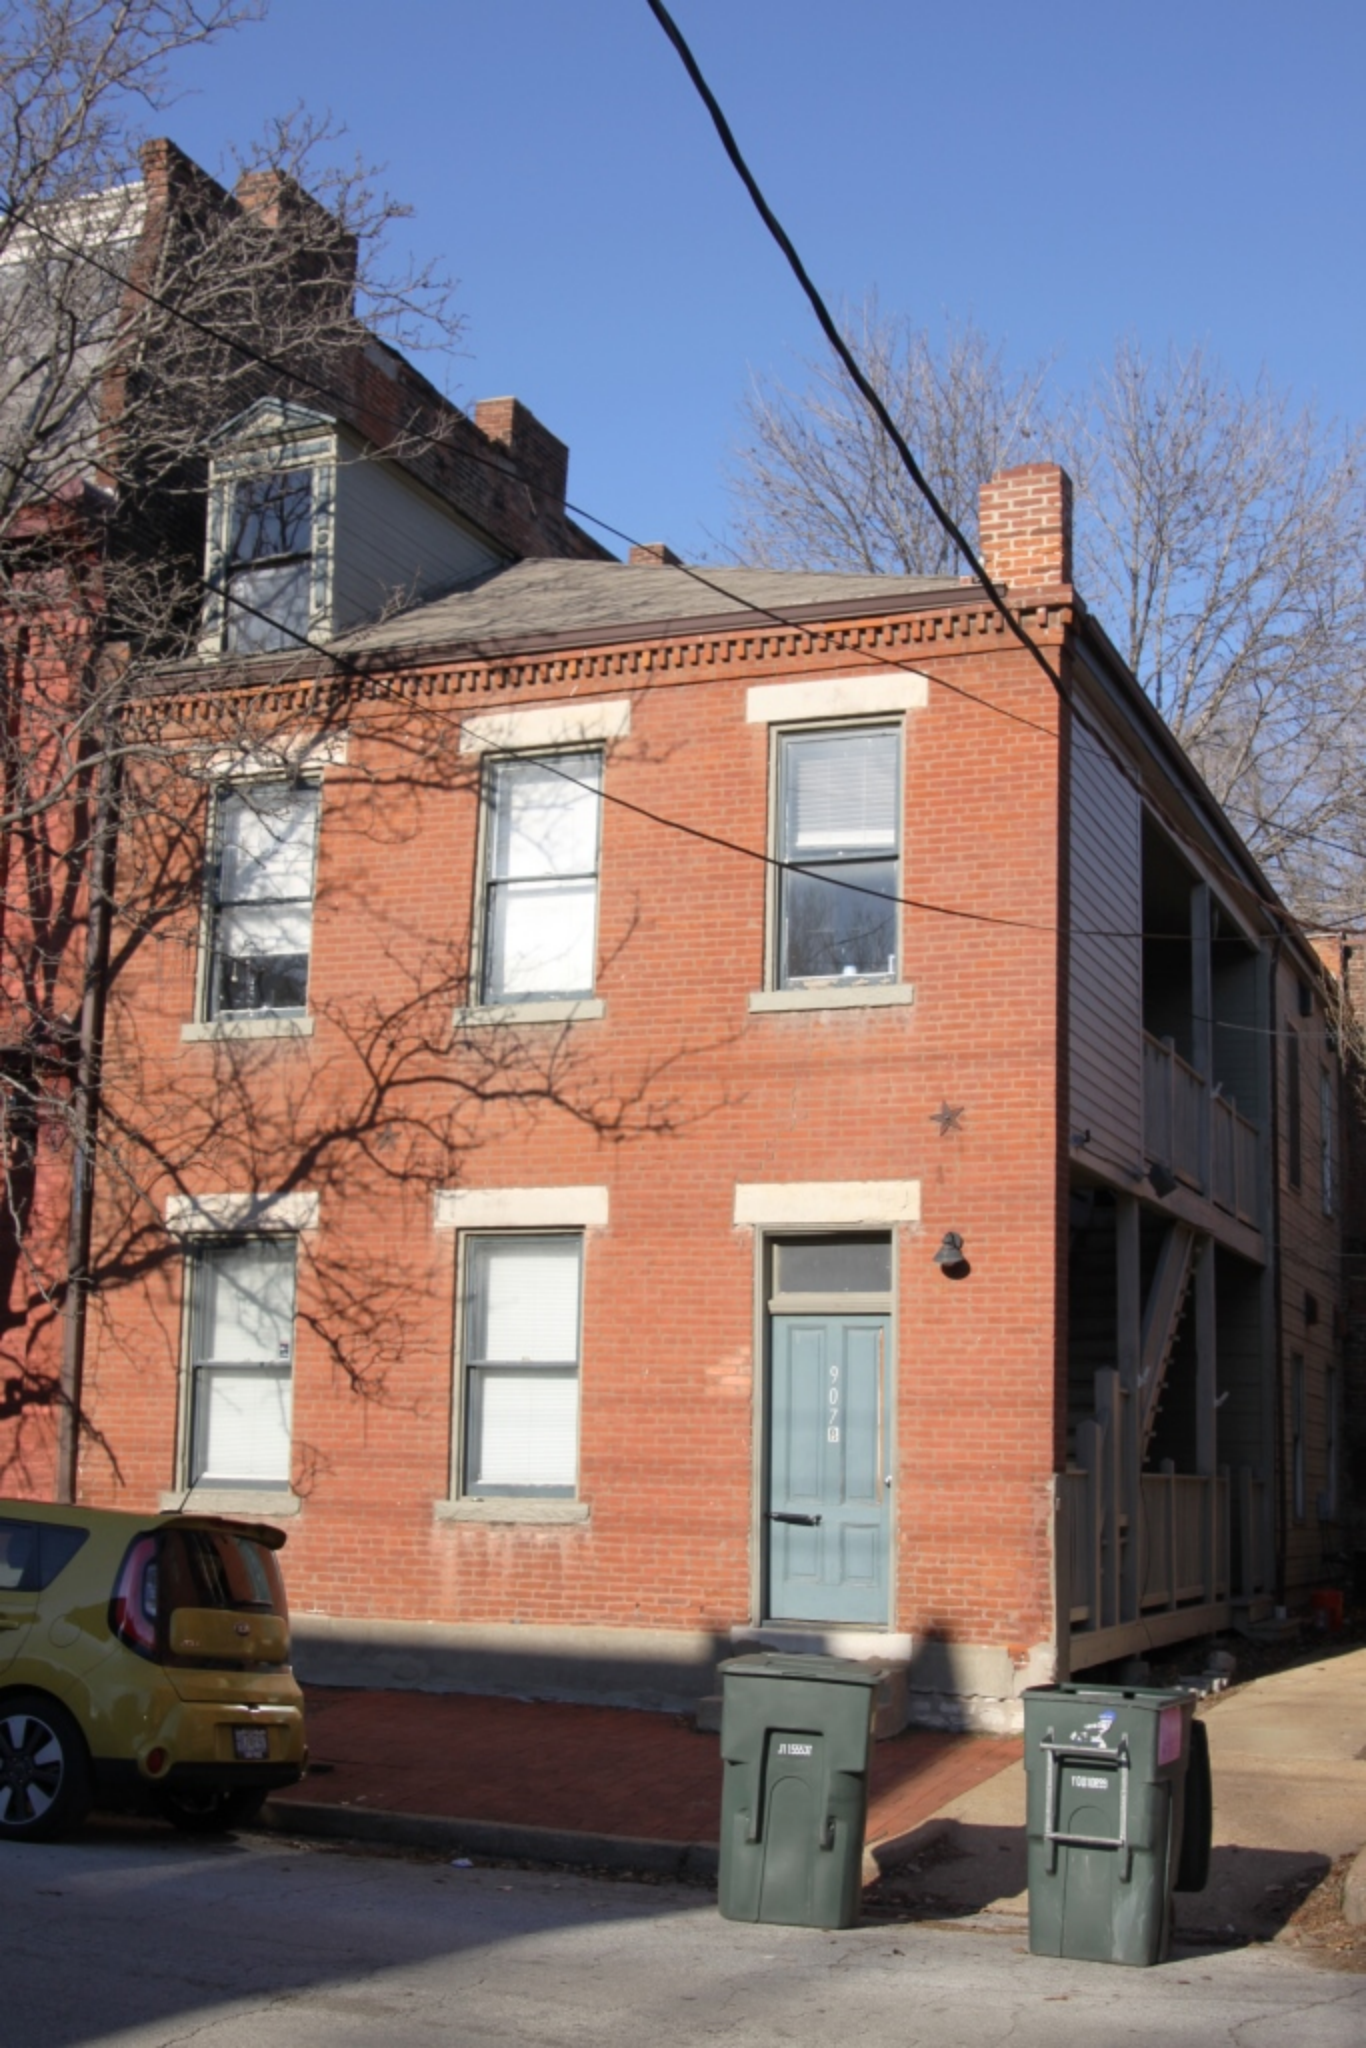
This two-story with loft brick flounder stands at the sidewalk. The east bay, where the entrance is located, is the brick wing wall of the wood gallery along the front portion of the east side wall. The windows in the three bays are flat-headed and have stone heads and sills. They all have replacement wood 1/1 doublehung sash. A denticulated brick cornice edges the façade eaves. A small dormer filled with a window projects from the low-pitched front hip roof; another dormer projects from the shed roof slanting from the taller windowless wall on the west side. The wood-framed gallery is open the entire length on the ground story; stairs rise within it towards the rear of the gallery; the front bay of the second story is enclosed with wood siding.

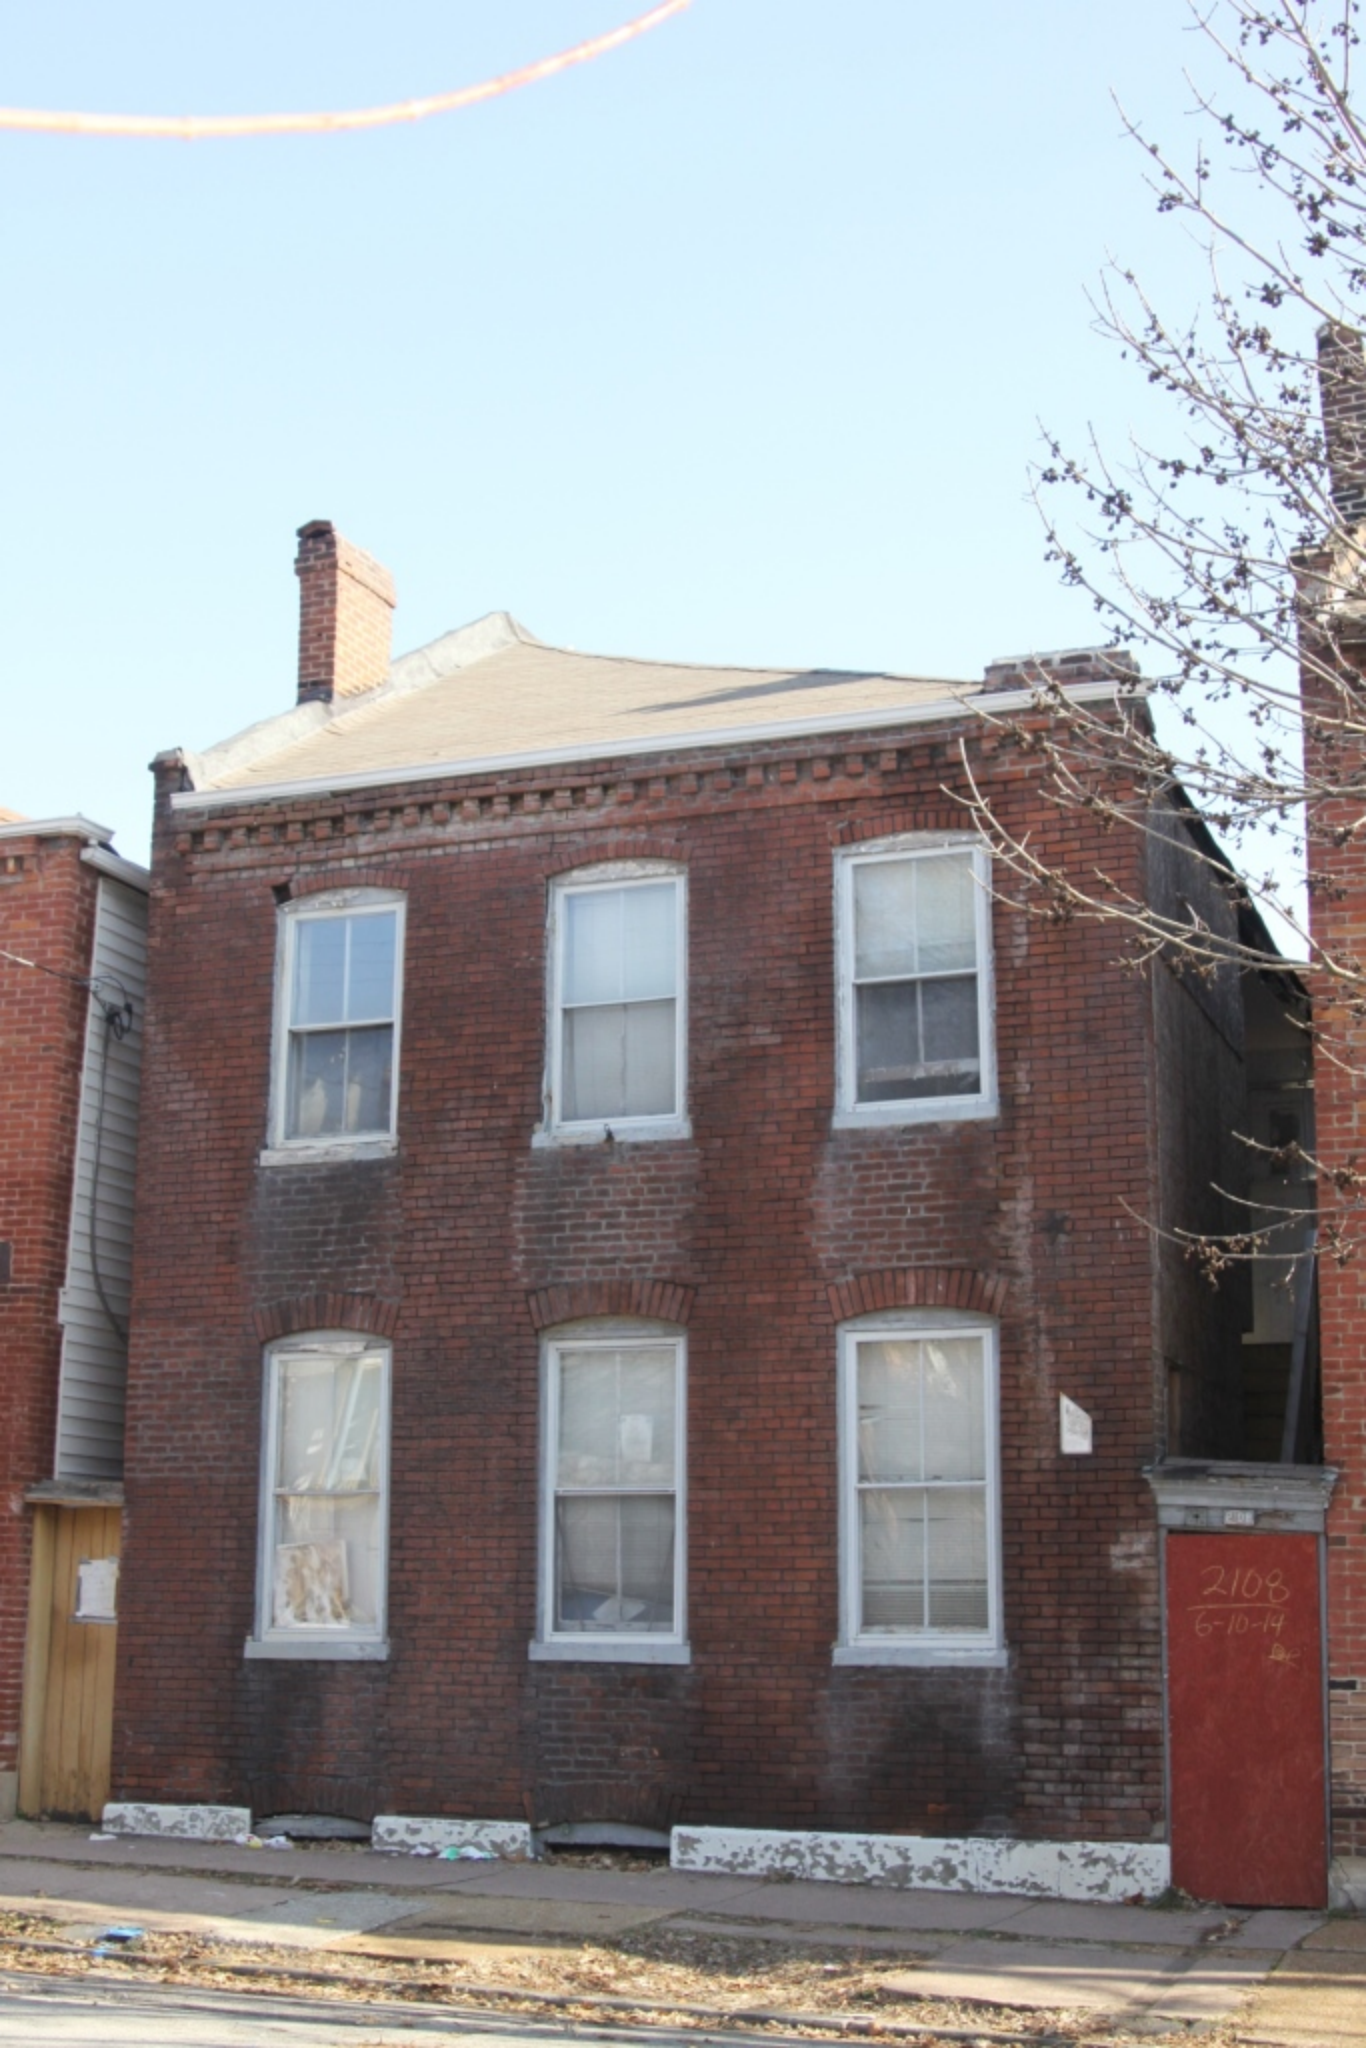
Change of street level has buried front basement windows. Leaking front gutter endangers brick cornice and has already led to loss of 2 brick rowlocks at second story window head. Building is vacant and boarded by City.

Two-story building with dentiled brick cornice. Side gallery type with a wing wall at street. The front façade features six double-hung windows with segmented arches, wood eyebrows, and wood sills. Arches of the first story are soldiers; those of the second, rowlocks. A finished stone sill runs the length of the front façade. Two basement windows are partially visible at the sidewalk level. Entance to the building is on the south side of the building where the gangway displays an original wood enclosure, showing deterioration. The south side originally had open side porches but has been enclosed at some point with wooden frame. There is a small one-story brick addition off of the rear of the building with a flat roof.

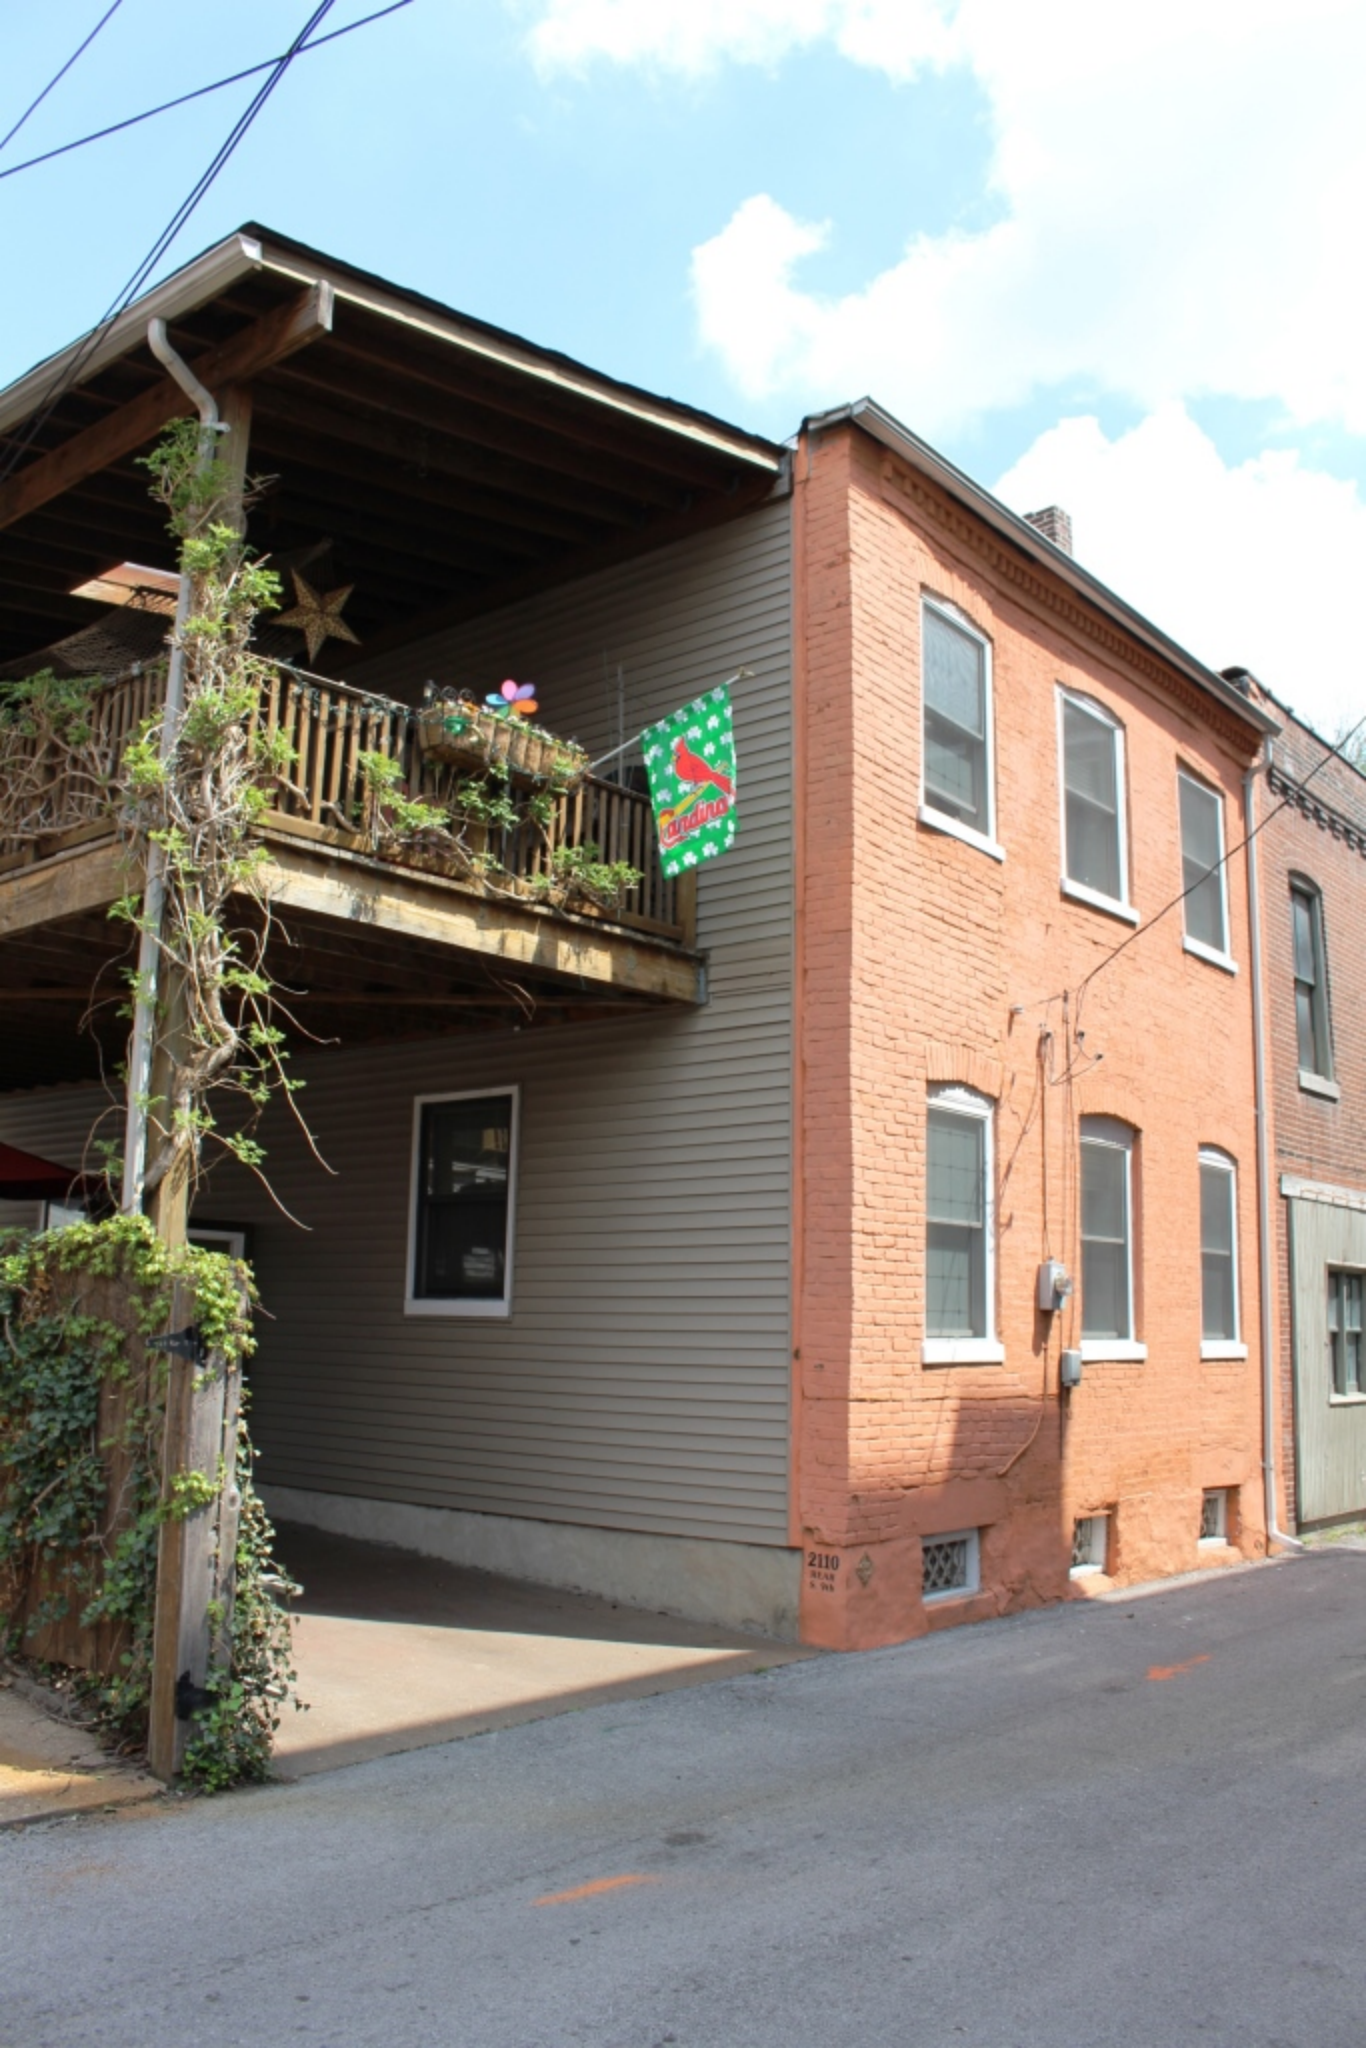
Two-story brick flounder alley house with hipped front and denticulated brick cornice. The front (alley-facing) wall has three windows at both the 1st and 2nd story. The windows have segmental arches, soldier course lintels and painted wood sills. The easternmost lintel at the 2nd story has been altered to a flat arch with a rowlock lintel. The windows have been replaced with vinyl windows with wood eyebrows. There are 3 front basement windows with the center window being smaller than the others and having no lintel visible. The other two have large painted stone lintels. The windows themselves have been boarded within the window frames. The building abuts the neighboring building on the right. There are two chimneys at the right side, one on the front slope and one further back. The original left side gallery has been enclosed and is now covered in vinyl siding. There are three bays at each level under a contemporary, very deep 2-story porch with a shed roof. The front façade of the building has been painted.

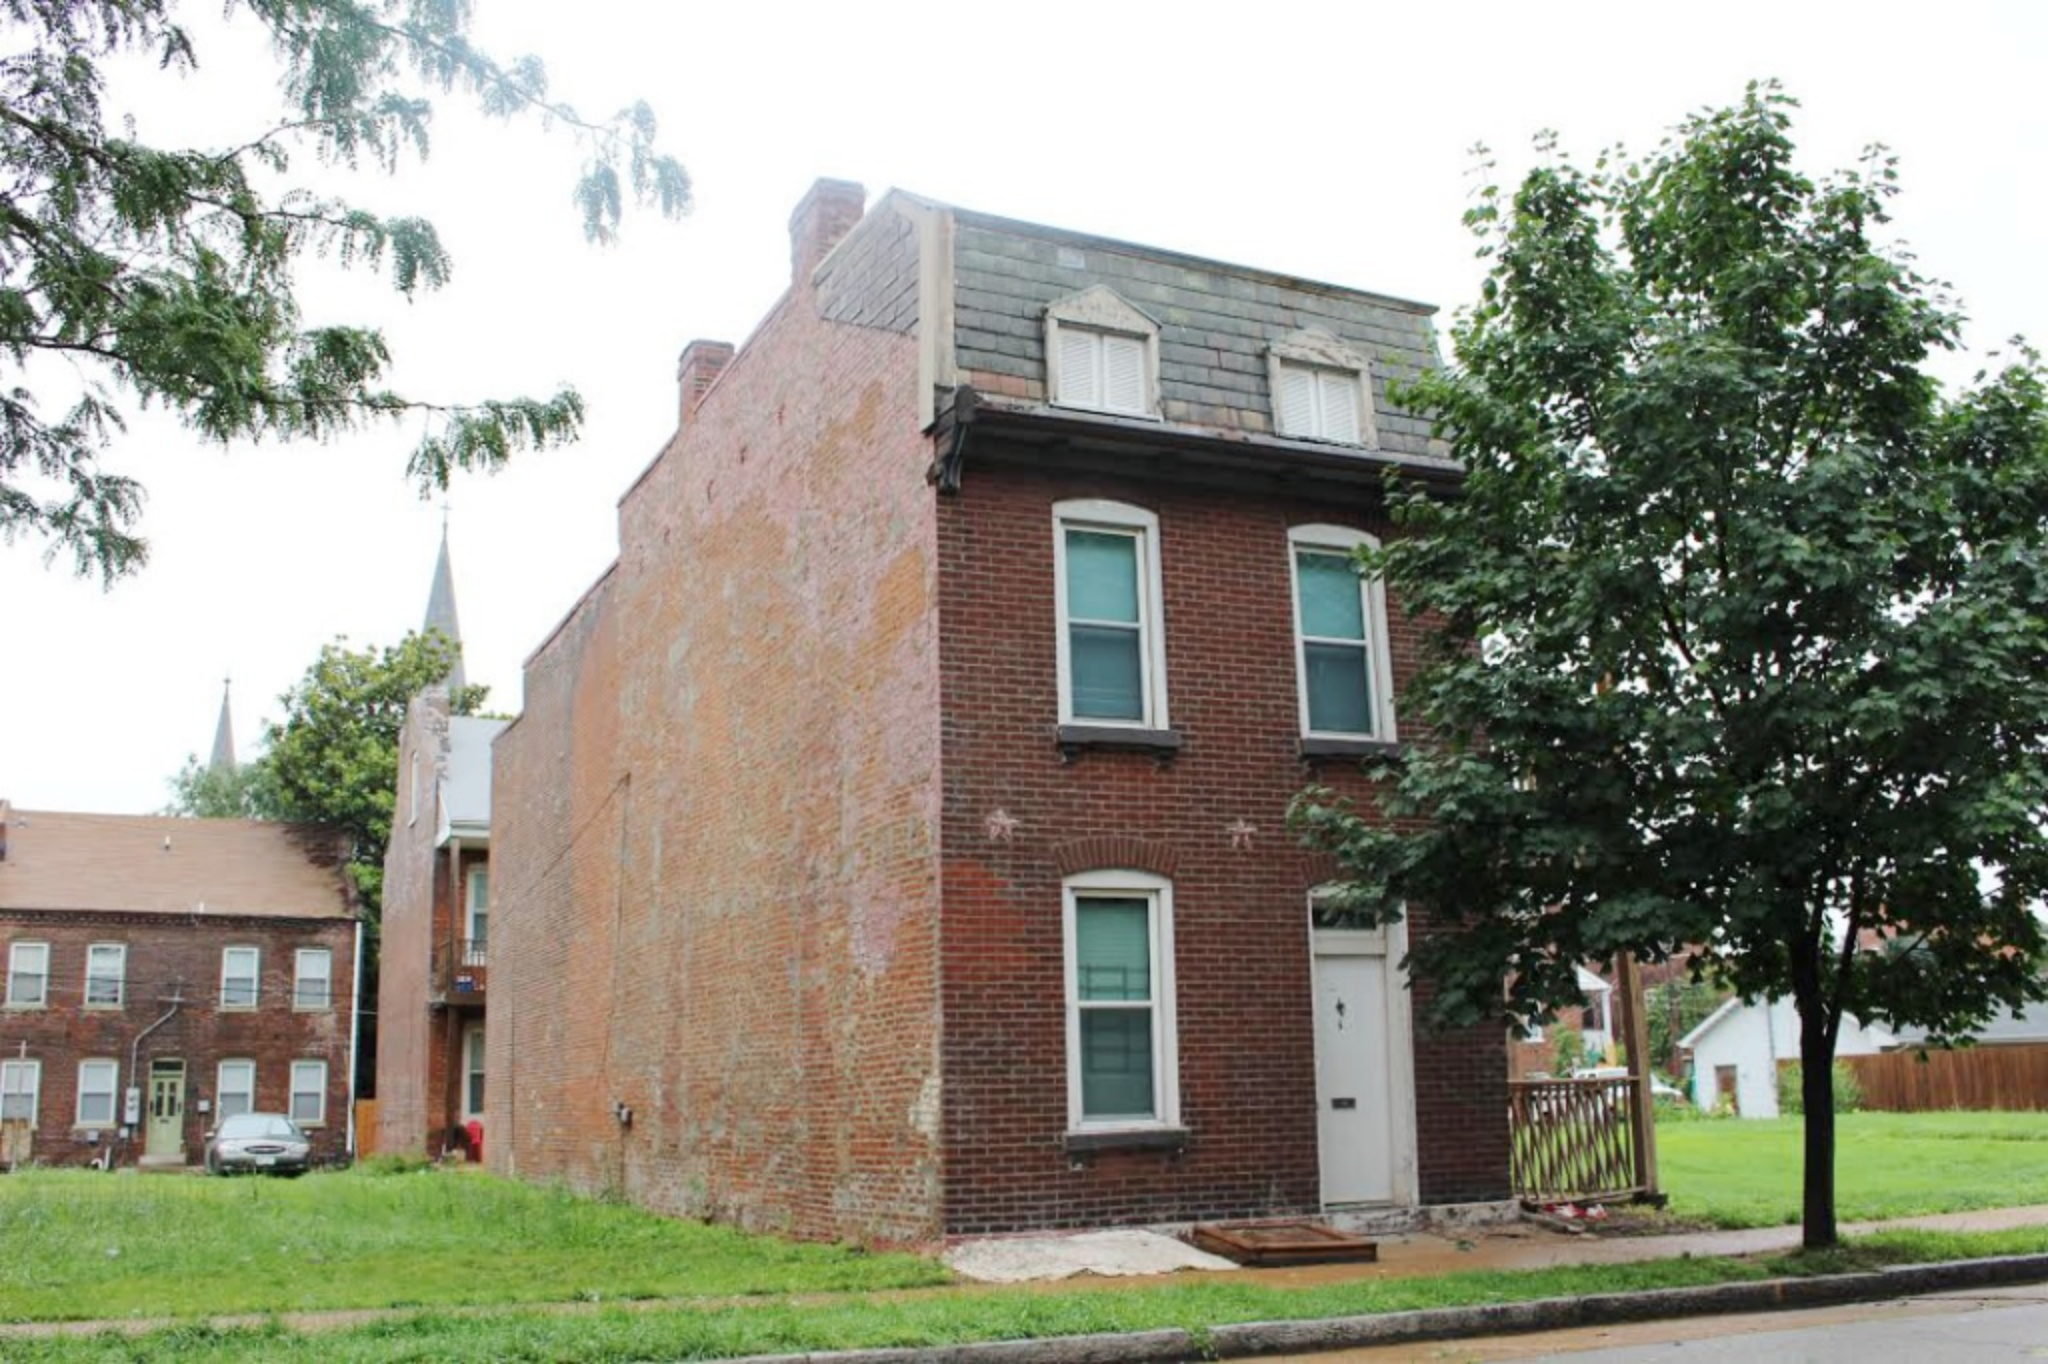
**1808-12 S 10TH ST**

Two and a half story flounder with side gallery. Two-bay front façade; openings are placed under segmental arches with bracketed stone sills. Door and transom have been replaced. Basement windows appear to be below current street grade. At some point a false mansard with bracketed cornice was installed; it retains its slate shingles and two gabled dormers, closed with shutters. The mansard does not appear on the Compton and Dry illustration. Cellar access is at the front of the house at the sidewalk level. The original two-story gallery porch has been replaced with a porch half the size; the remainder of the façade is filled with a two-story framed, sided addition at the rear. There are two progressively smaller brick additions to the rear of the house. Both additions appear to be historic although they have new windows and siding. The north side of the building was once a party wall' it has been parged.
