**ARCHITECTURAL/HISTORIC INVENTORY FORM - Cultural Resources Office**  
**St. Louis Planning and Urban Design**

1. Survey no. SLC-AS-053-0001	2. Survey name: Thematic Survey of Flounder Houses in St. Louis City	3. County: St. Louis [Independent City]
4. Address: (from City GEO database) <b>1812 S 8TH ST</b>		5. City/State: St. Louis, Missouri
Alternate address: 1812 S 8th		Property Zip Code: 63104
Latitude: 38.608949		6. UTM Easting: 743586.48
Longitude: -90.202538		UTM Northing: 4277095.00
8. Historic Name (if known): N/A	11a. Historic Use (if known): Domestic	City Block: 372 City Ward: 7
9. Present/other name (if known):	7. Township-Range-Section: N/A	10. Ownership: Private
11b. Current Use: Domestic		Neighborhood Number: 21

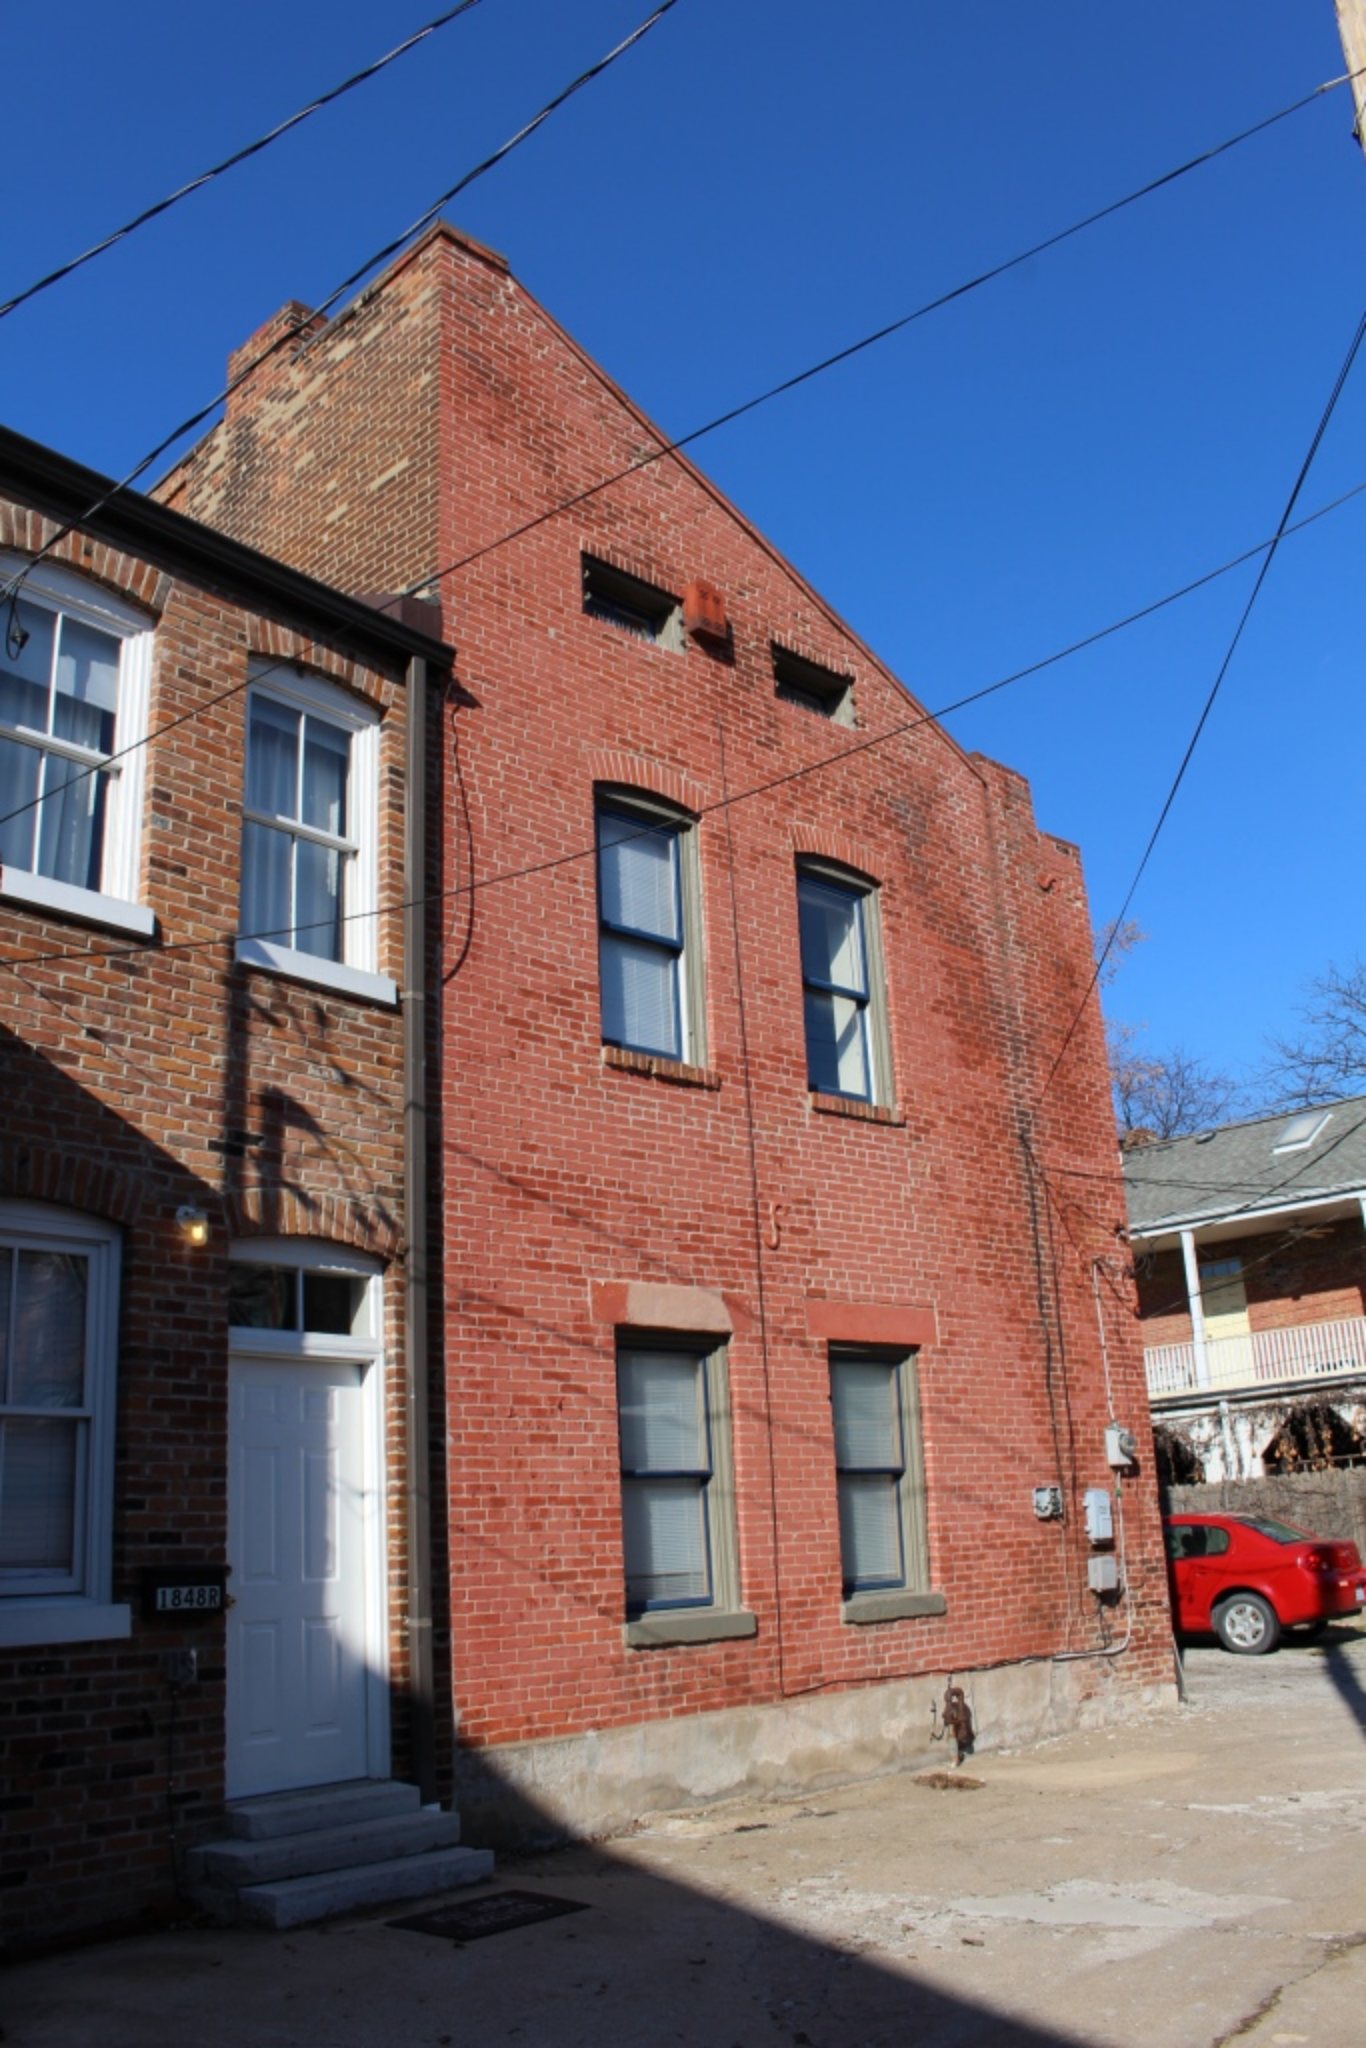
Two-story, traditional brick flounder with side entry. Brick wing wall screening 2-story side gallery porch is not original, but an early addition. Windows have ashlar limestone lintels and sills (painted) at first story; segmental soldier arches on second with rowlock sills, an early alteration. 2 rectangular vents have been added to the attic story. The foundation has been parged. Approximately one-third of the second story gallery has been enclosed.

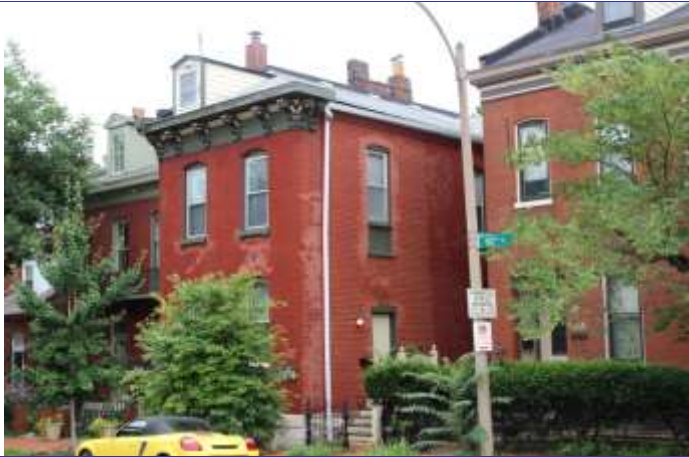
**2354 S 10TH ST**

Building is in good condition, but needs minor maintenance such as painting. There is a rear building on a separate parcel behind the flounder. Because of this it was difficult to get a photo of the rear of the building.

The two-story hipped roof brick flounder has a large bracketed wood cornice which returns slightly along the south elevation. The cornice has been slightly altered. There is a simple gabled dormer toward the north side. A chimney sits on the north side slightly behind the dormer. The first and second stories have two bays with 1-over-1 windows. The second story windows have been replaced and no longer have segmental arch sashes. The first story retains its segmental arch double-hung wood windows. All of the front windows have soldier brick lintels and painted bracketed stone sills. There is a smooth ashlar limestone watertable with a tooled, coursed ashlar foundation below. There are two windows at the basement level, one is a two-light French casement and the other has been boarded. The south elevation has a corbeled brick cornice which extends from the bracketed wood cornice. There is an entry close to the front of the building on this elevation with a small wood stoop having an historic handrail. A door at the 2nd story has been converted to a window. There is a second entry closer to a rear ell section. A two-story porch sits at the corner where the ell meets the main section of the house. The porch has simple wood posts and an historic handrail. A small dormer sits on the ell roof above the porch. Two openings on the ell face the street. The two-story rear ell has a side gable roof and appear from the rear to resemble an I-house, being one room deep with a center entry. There are three bays at the rear with one-over-one double-hung windows.

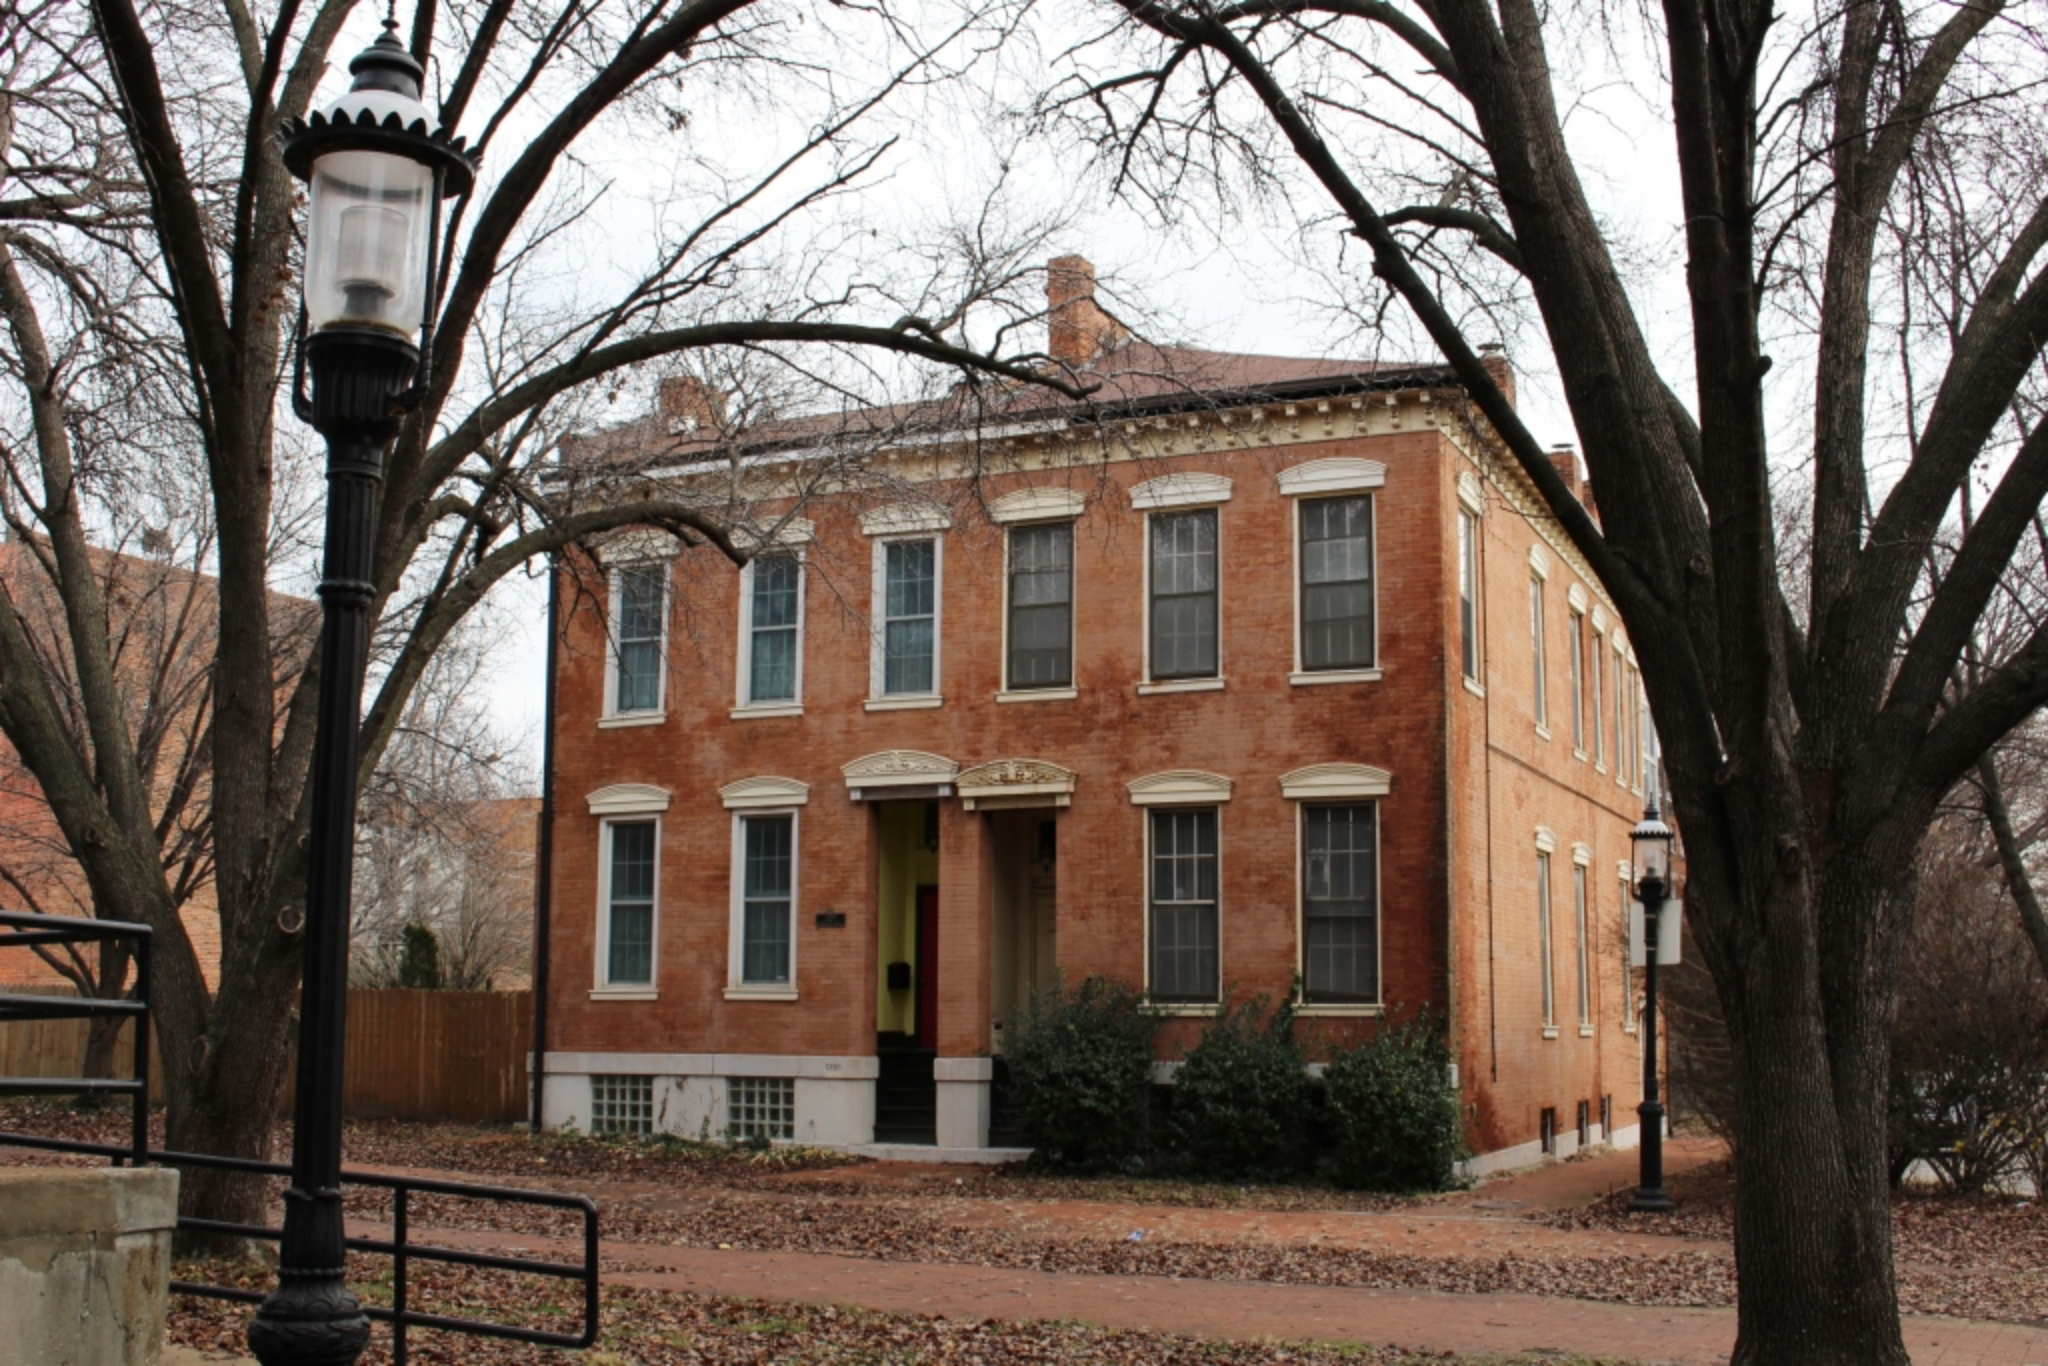
semi-detached to non-flounder, building is generally good condition, some maintenance at cornice needed.

This 2-story brick flounder located at a corner shares a party wall with the very similar building to its north. The two street façades have foundations of ashlar stone. The entrance has a recessed entrance with steps. The door and window bays of the two street façades have square heads accented with projecting curved pediment heads; the one above the door bears ornamental carving. The long side street façade has bays of various widths and includes an entrance at street level. Projecting from the rear of the building is a with with an angled bay termination on the steet side with windows in both stories. A bracked wood cornice edges the horizontal eaves at the two street walls.

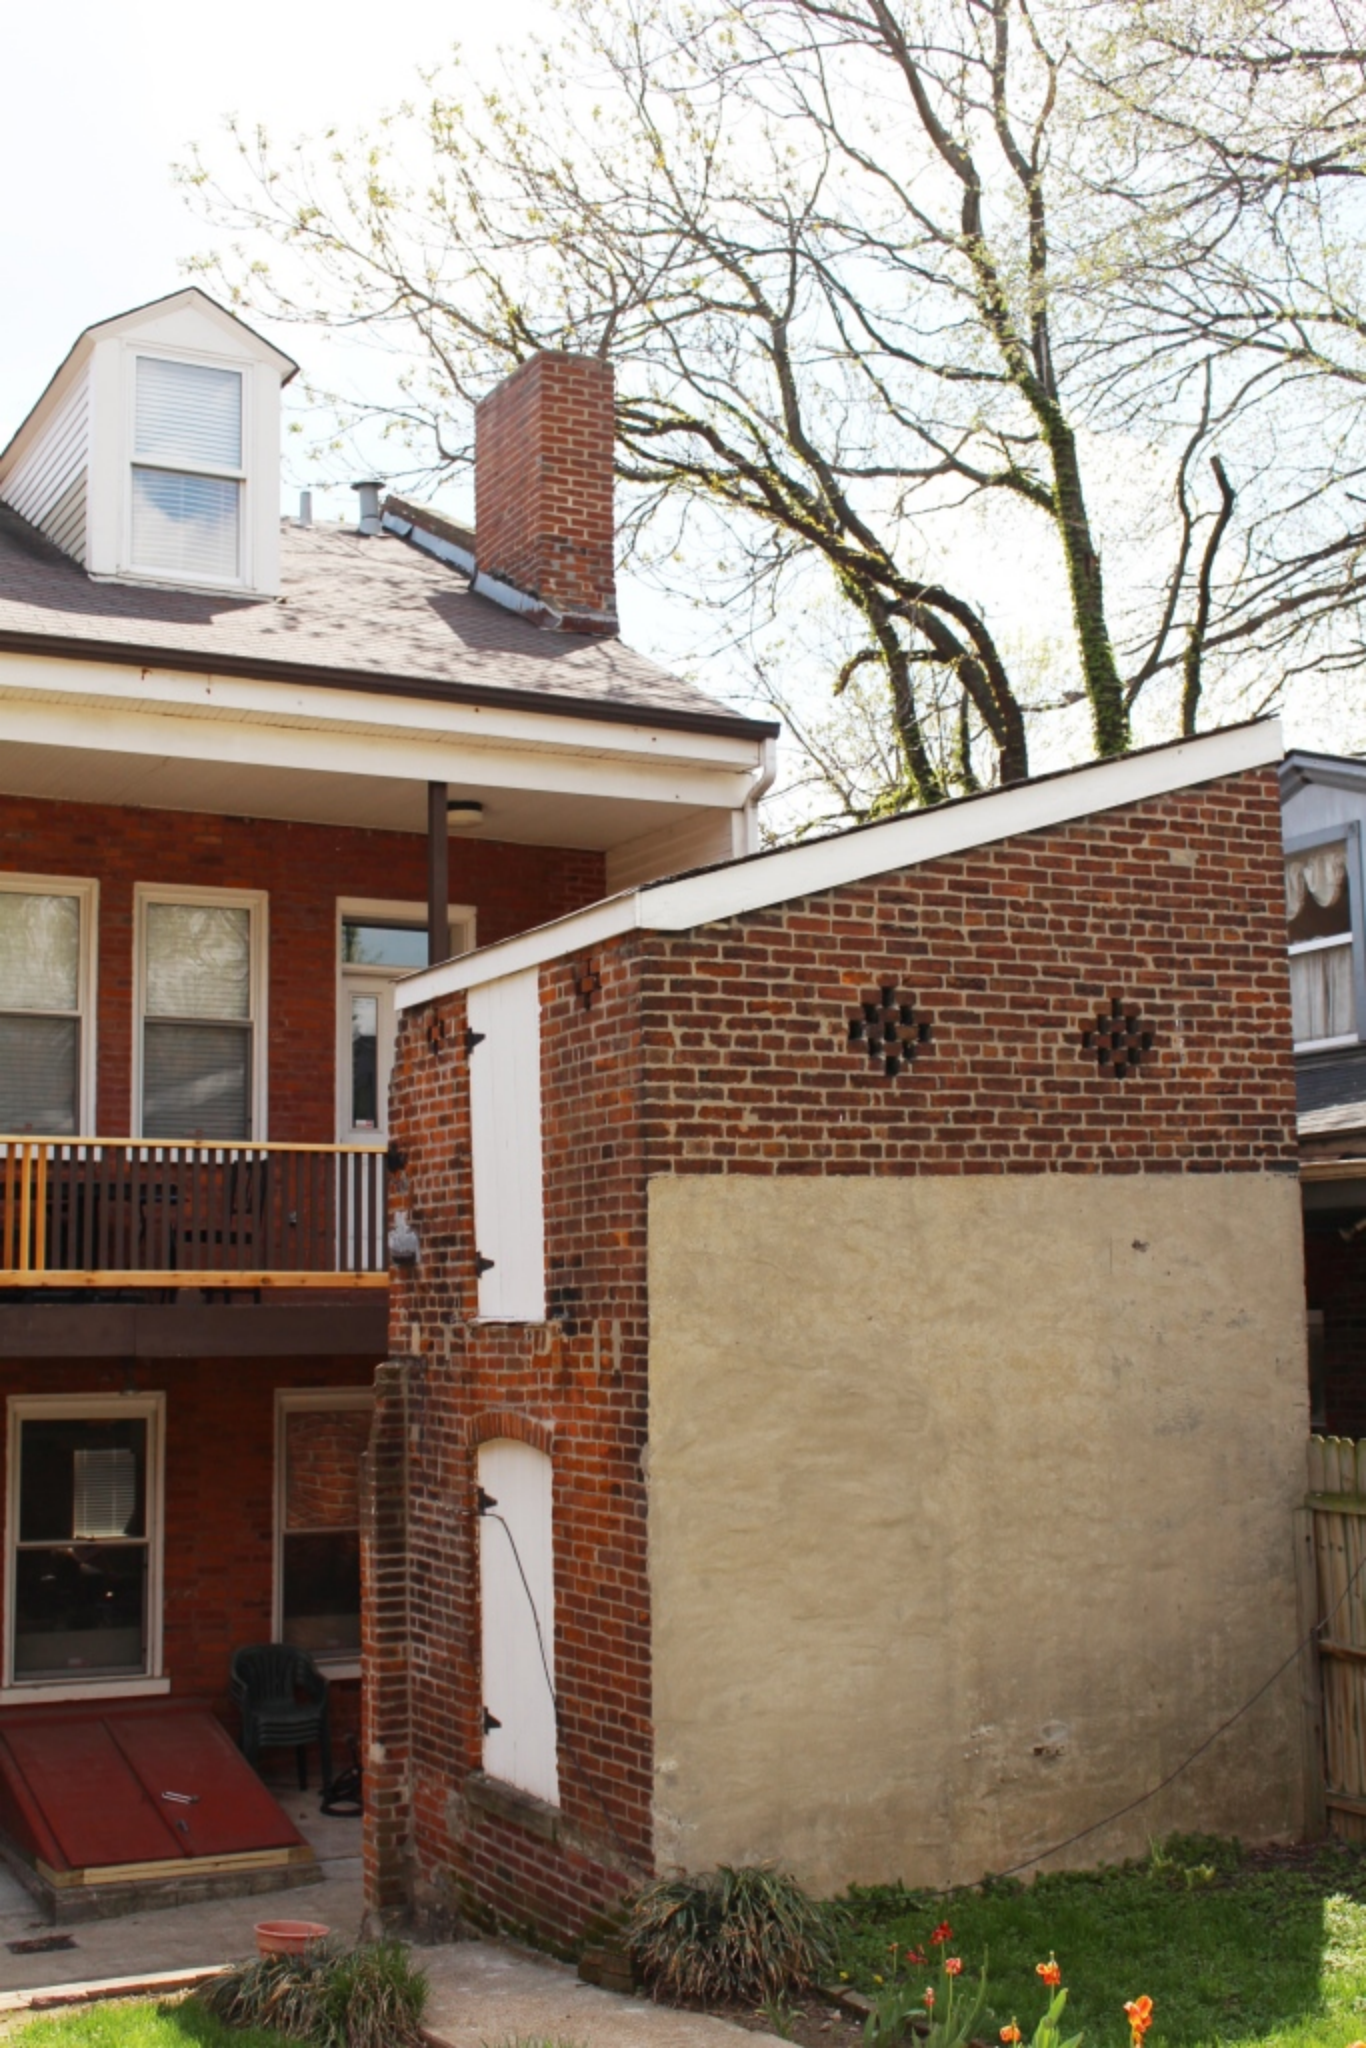
## 1917 S 11TH ST

A small, two-story brick outbuilding. The facade facing the alley has been parged about two-thirds of the way up the wall. Above the parging are two decorative diamond shaped vents created by rowlock bricks. The left side has one bay at each level, both vertical board doors, with the 2nd story door being much smaller. The 1st story door is segmentally-arched with a rowlock lintel. The second story door is rectangular with the lintel hidden by a fascia board. Between the 1st & 2nd story are infilled beam pockets. A one story stretcher-wide brick extension projects from the rear of the left side.

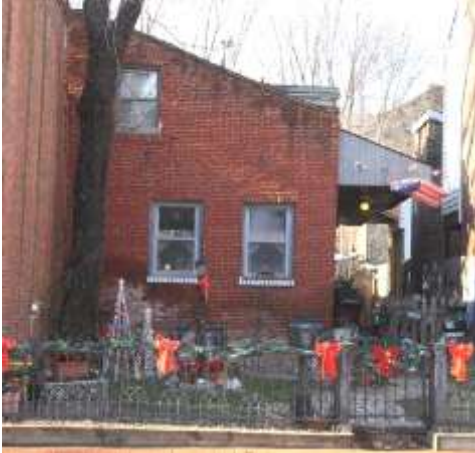
Front façade

Building is set back off the street & is very close to the building on the left. There is an historic hoop-and-spear wrought iron fence at the front of the property.

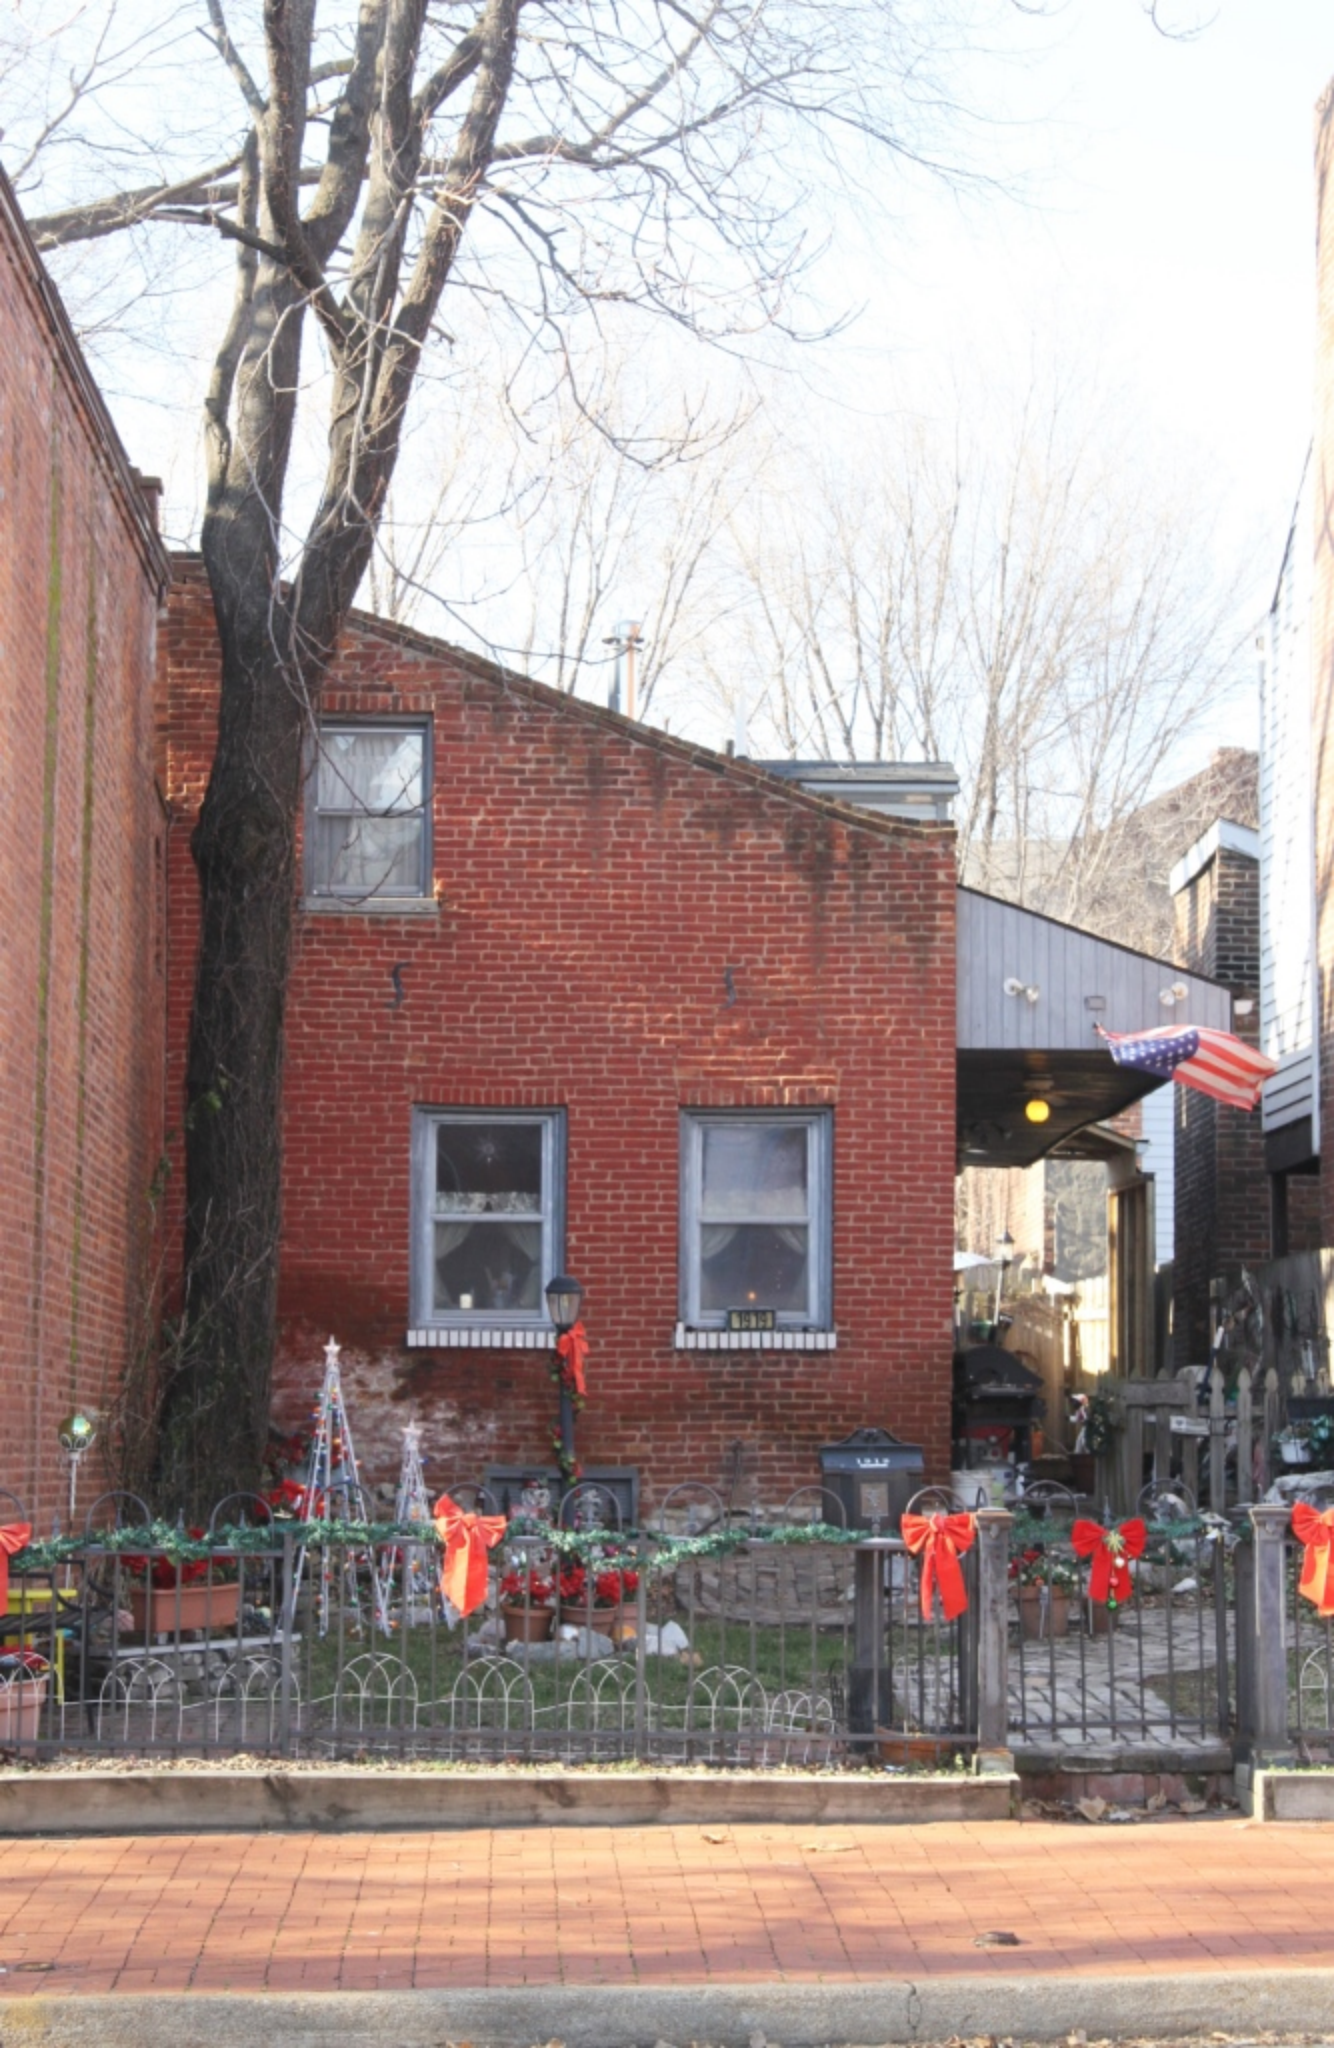
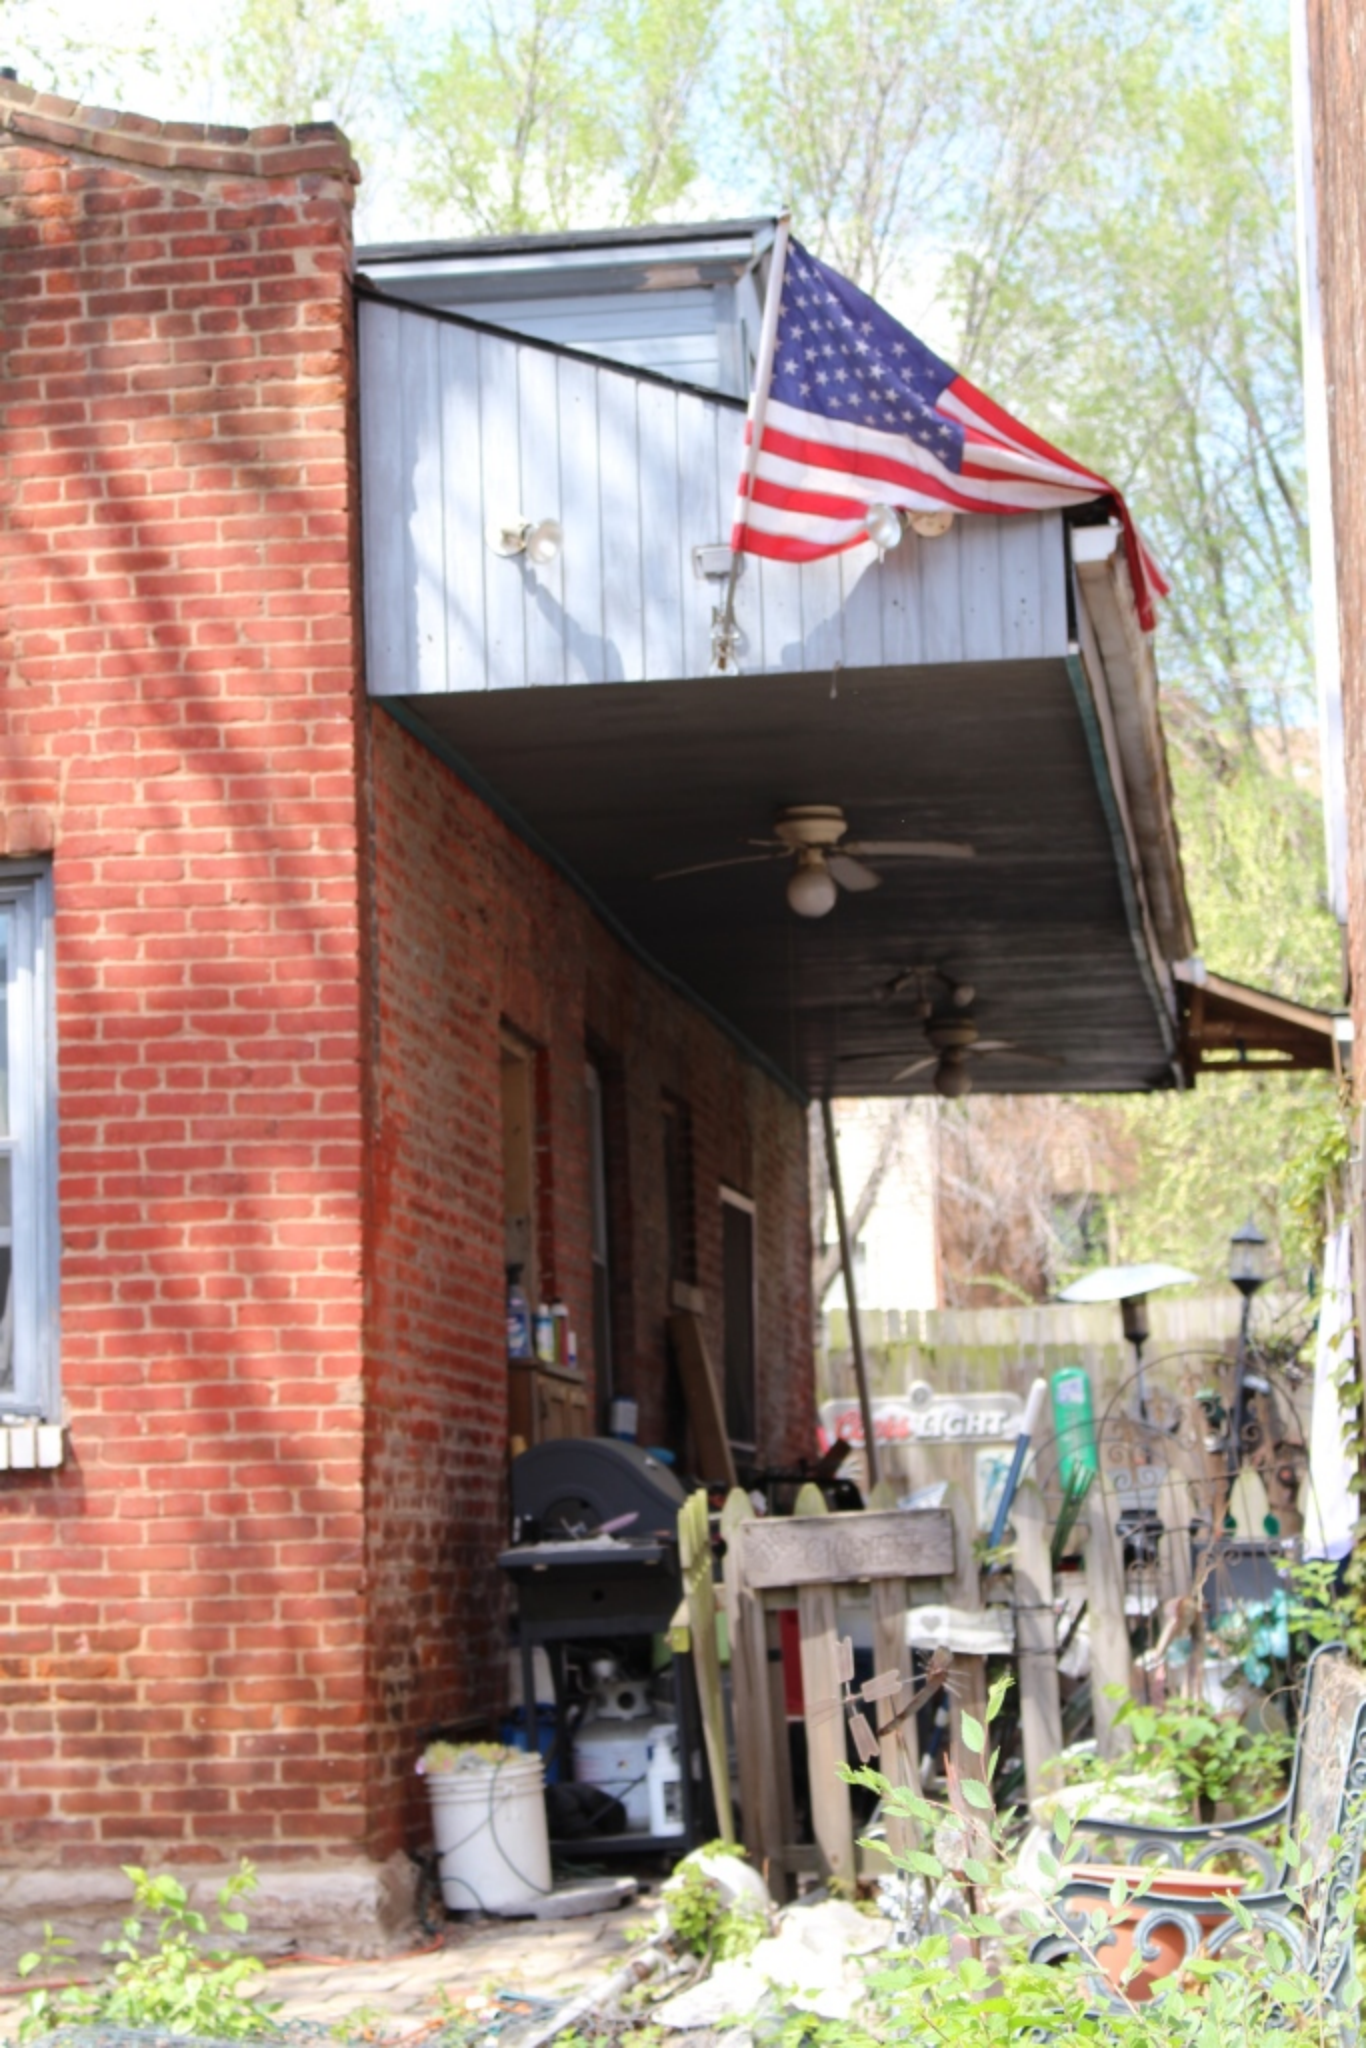
## 1919 S 11TH ST

Two story brick flounder with corbelled course at top of wall. Two windows on the 1st story, one on the 2nd. The 1st story window openings appear to have been altered at some point in the past. They have rowlock flat arches, and glazed rowlock brick sills. The second story window retains its original wood sill. A small amount of the rubblestone foundation is visible at the front. A center basement window has been covered. A gabled dormer is present about halfway back on the right side. A shed roof projects from the right side, although there are no supporting posts until a separate rear portion. This portion of the porch is on a small one-story flounder addition at the rear of the building. A side window and door are present, with another window on the addition. The chimneys are not visible from the street.

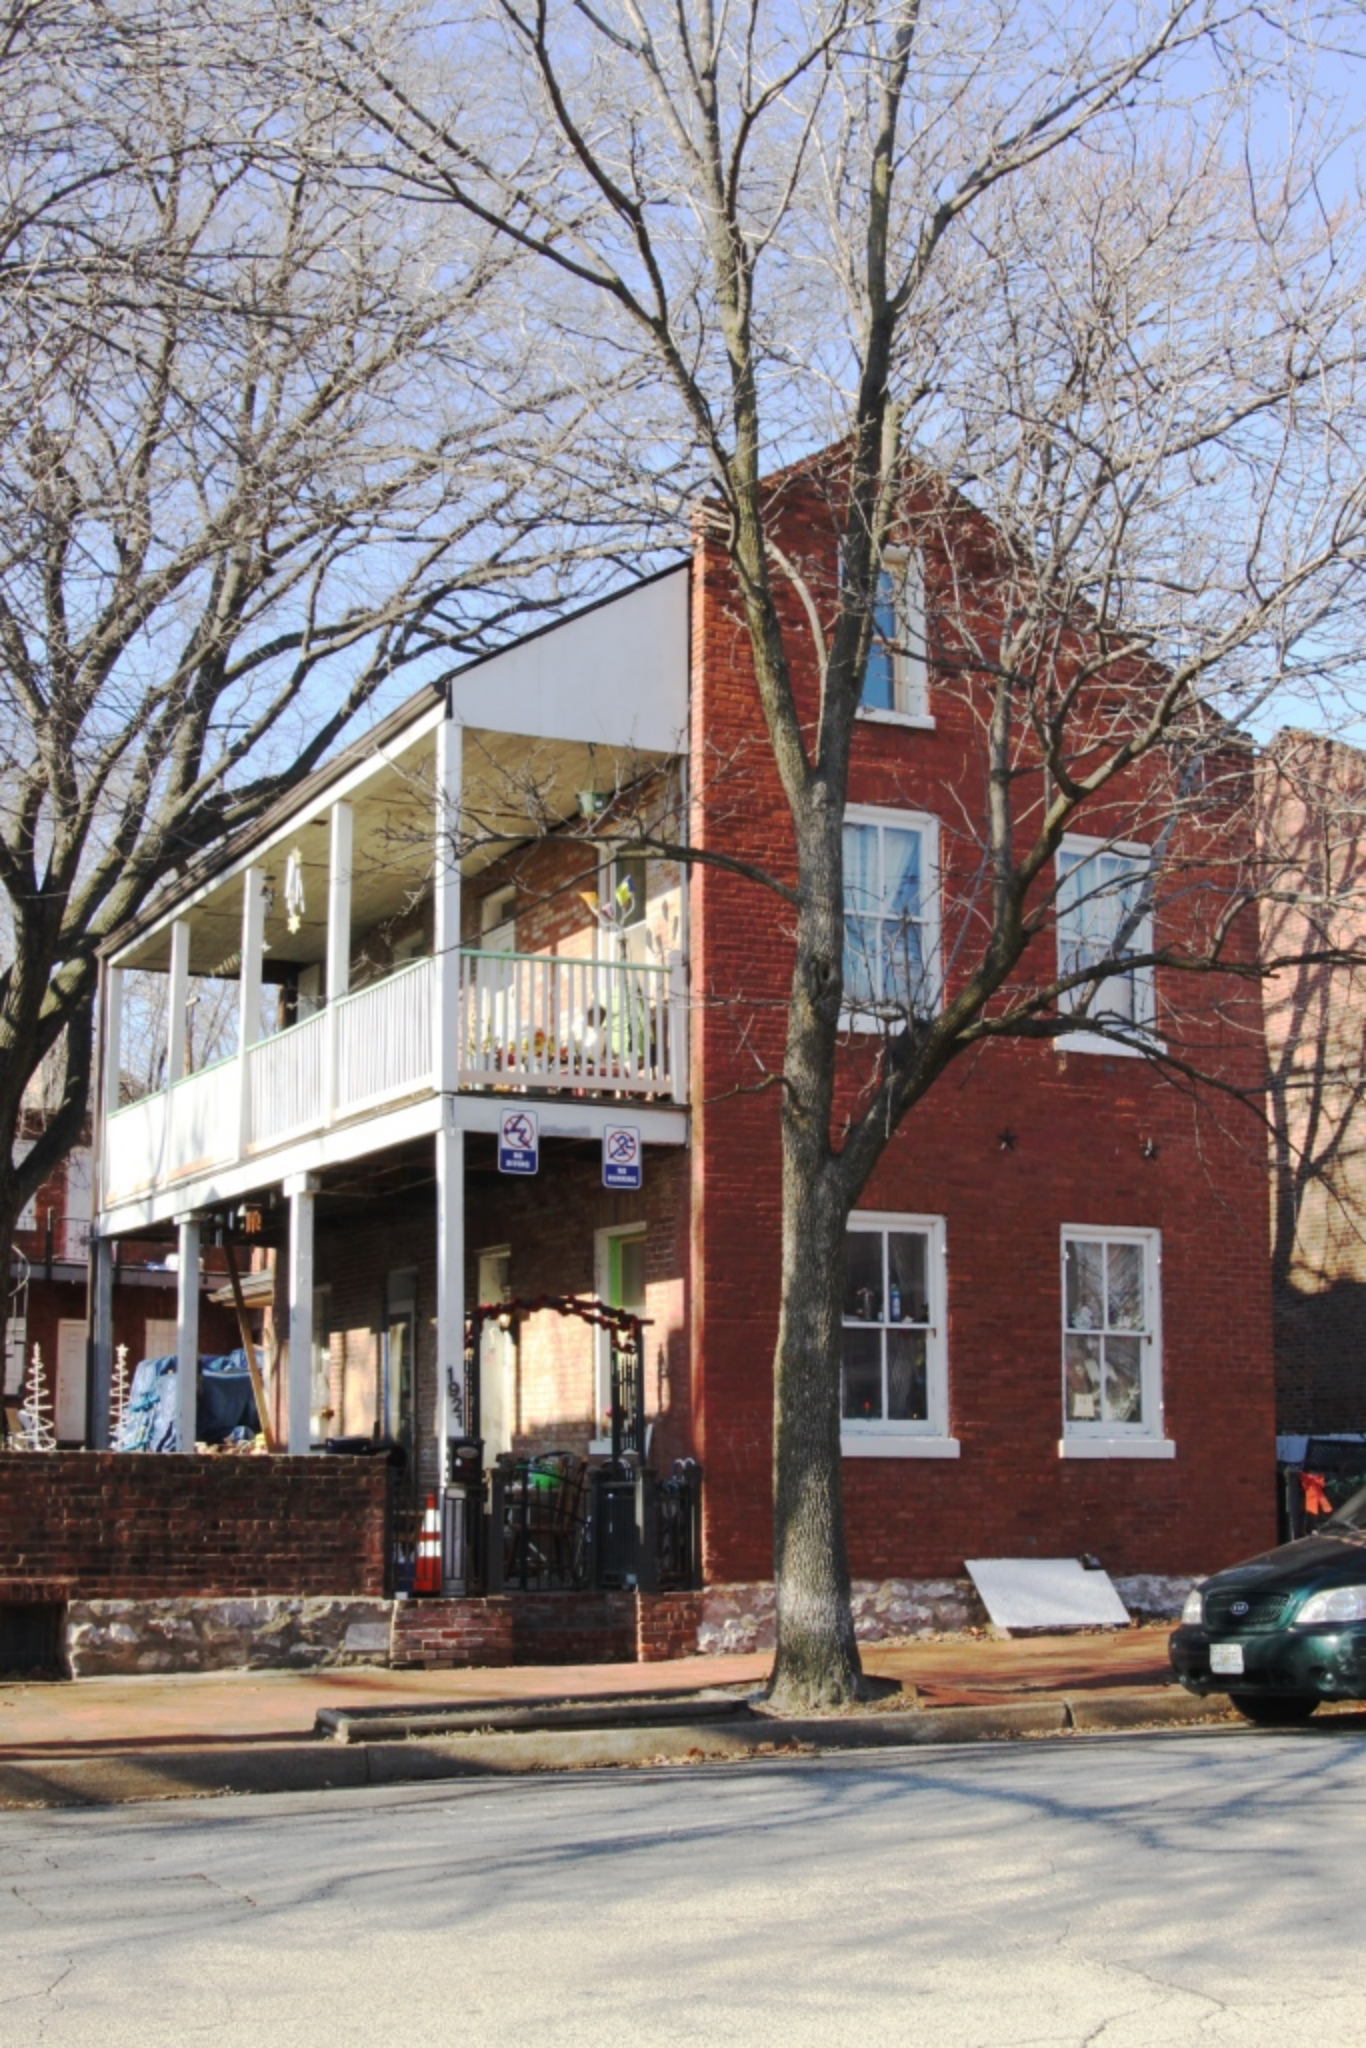
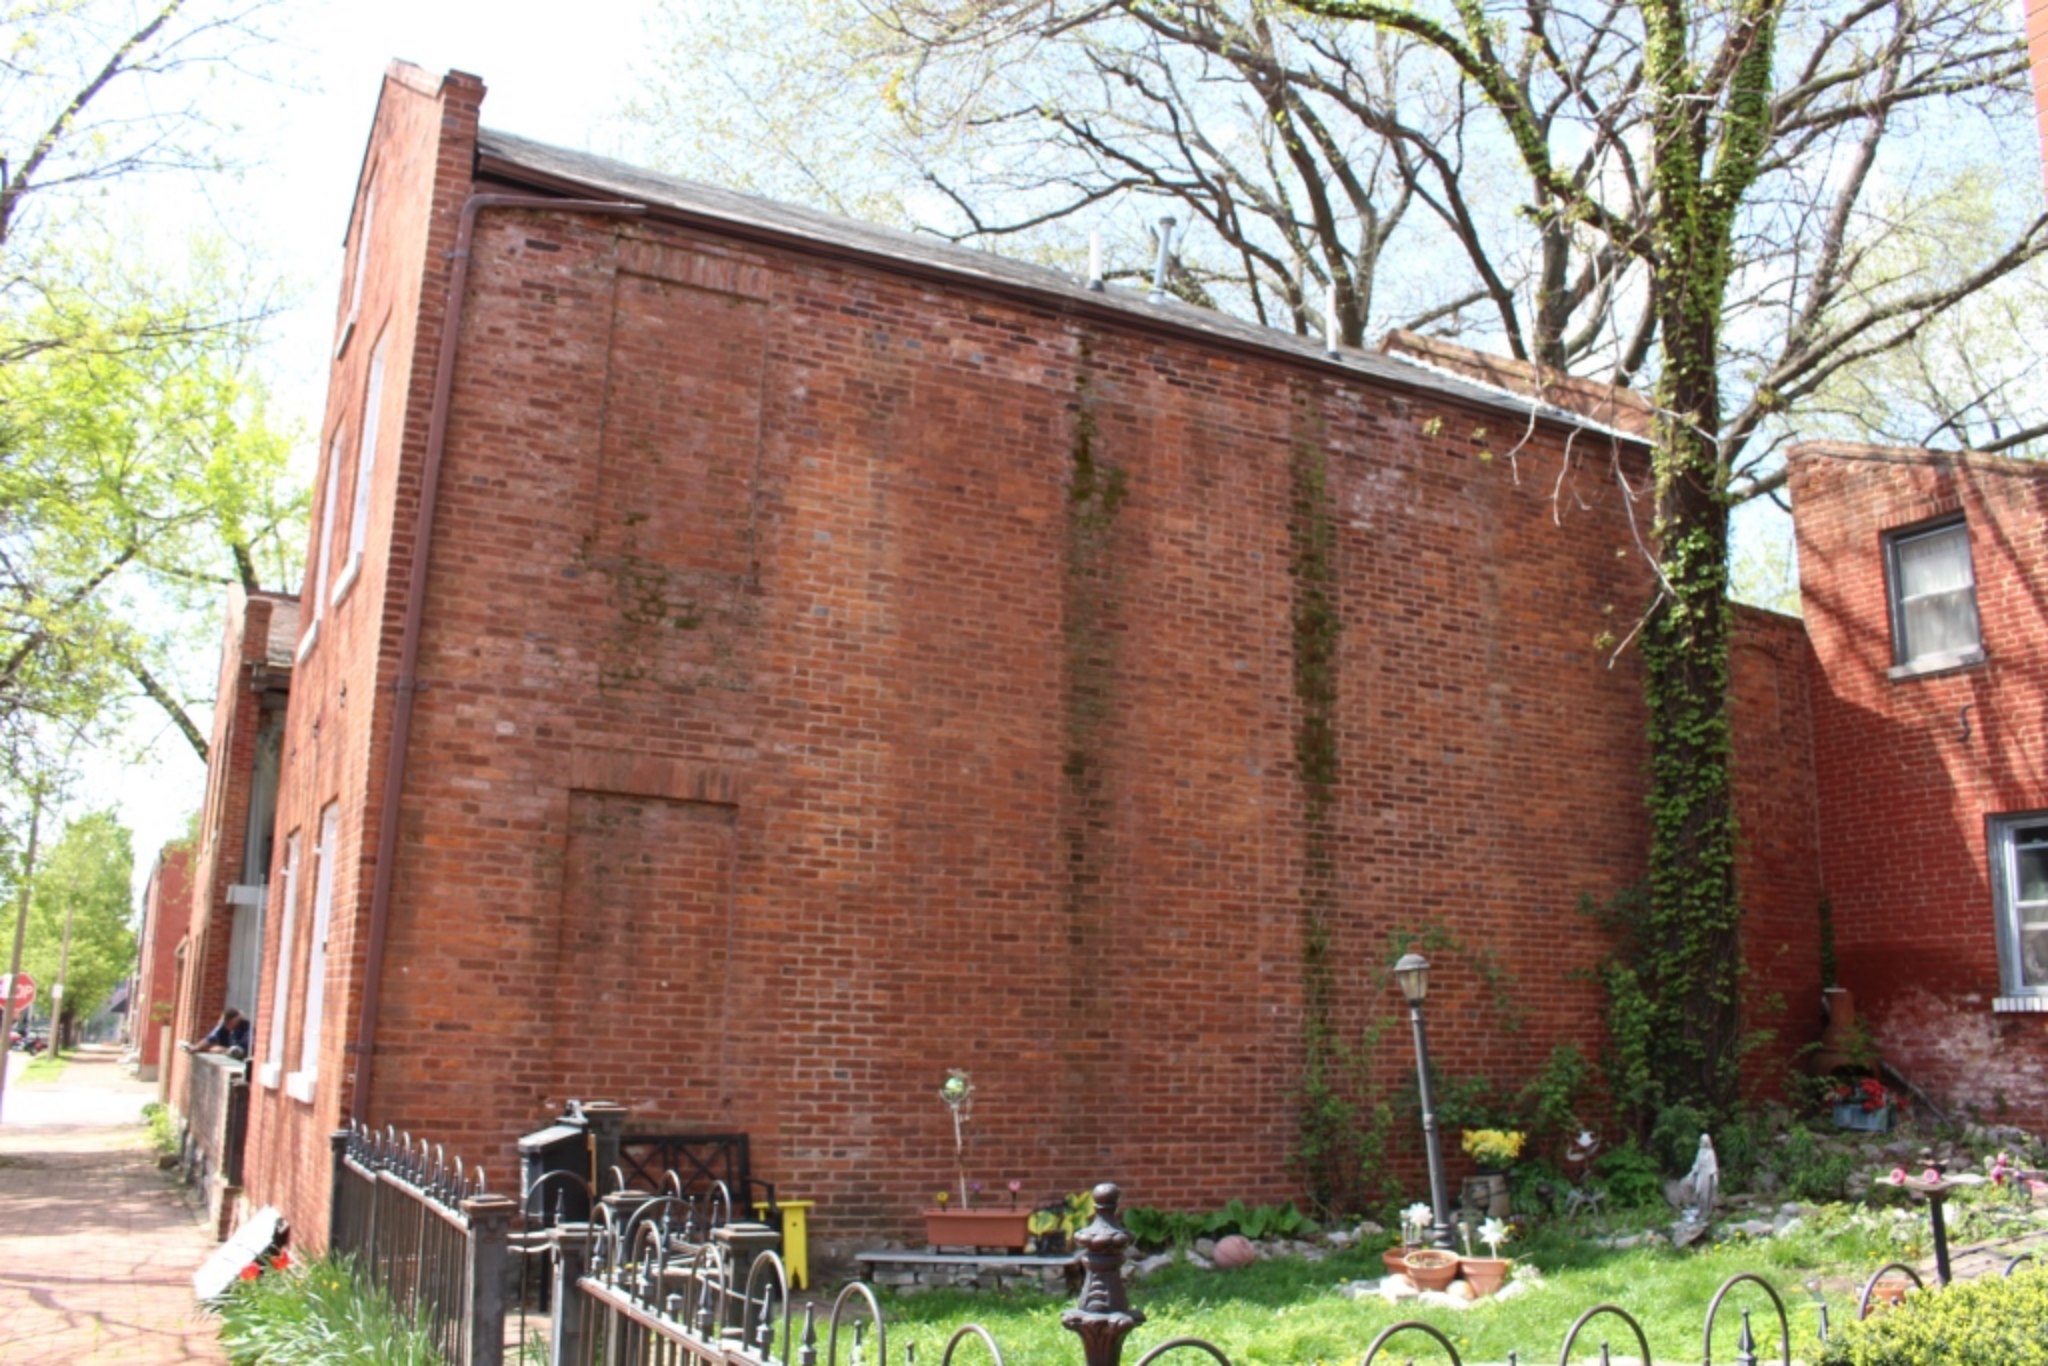
Three story brick gablet flounder with a two story, shed roof gallery porch along the left side. The front has two bays at the 1st & 2nd stories, and one at the 3rd. The windows are 2-over-2 with stone sills and flat soldier course lintels at the 1st & 2nd stories. The 3rd story window is 1-over-1 with a wood sill and a rowlock lintel. A small amount of the rubblestone foundation is visible at the front of the buidling with a central covered basement window in a small window well. There are no windows on the right side of the building although it appears that there was originally a window opening at both the 1st and 2nd story towards the very front of this side. The openings have been infilled, with the brick slightly recessed. The opposite side has four openings at both the 1st and 2nd story, with the two center bays being doors with transoms above. There is a one story flounder addition at the rear of the building with 3 side bays.
