**ARCHITECTURAL/HISTORIC INVENTORY FORM - Cultural Resources Office**  
**St. Louis Planning and Urban Design**

1. Survey no. SLC-AS-053-0001	2. Survey name: Thematic Survey of Flounder Houses in St. Louis City	3. County: St. Louis [Independent City]
4. Address: (from City GEO database) <b>1812 S 8TH ST</b>		5. City/State: St. Louis, Missouri
Alternate address: 1812 S 8th		Property Zip Code: 63104
Latitude: 38.608949		6. UTM Easting: 743586.48
Longitude: -90.202538		UTM Northing: 4277095.00
8. Historic Name (if known): N/A	11a. Historic Use (if known): Domestic	City Block: 372 City Ward: 7
9. Present/other name (if known):	7. Township-Range-Section: N/A	10. Ownership: Private
11b. Current Use: Domestic		Neighborhood Number: 21

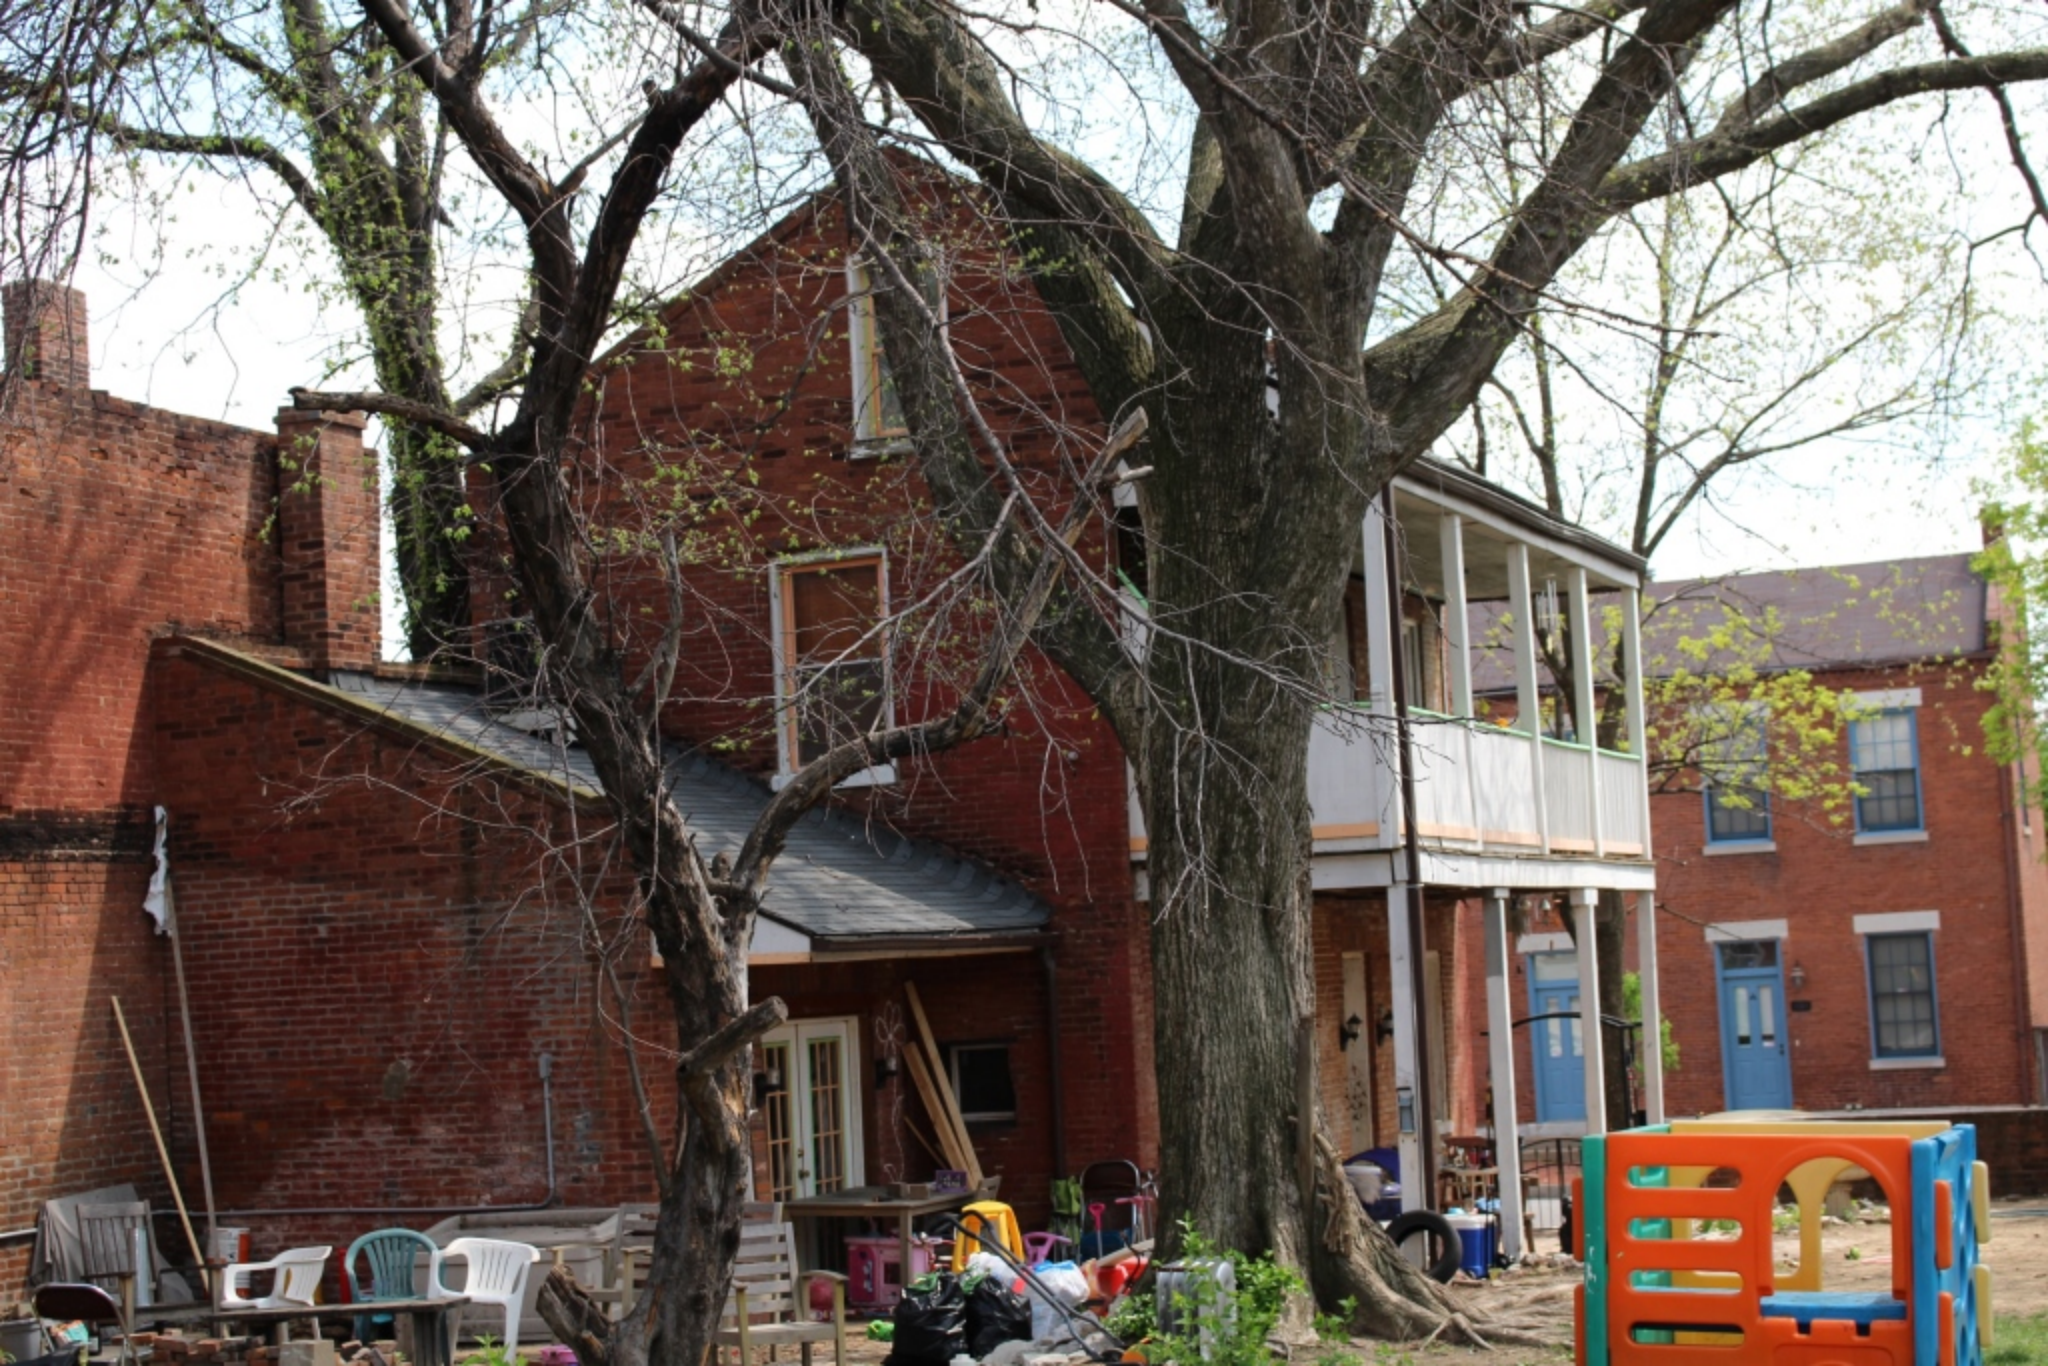
**1921 S 11TH ST**

Three story brick gablet flounder with a two story, shed roof gallery porch along the left side. The front has two bays at the 1st & 2nd stories, and one at the 3rd. The windows are 2-over-2 with stone sills and flat soldier course lintels at the 1st & 2nd stories. The 3rd story window is 1-over-1 with a wood sill and a rowlock lintel. A small amount of the rubblestone foundation is visible at the front of the buidling with a central covered basement window in a small window well. There are no windows on the right side of the building although it appears that there was originally a window opening at both the 1st and 2nd story towards the very front of this side. The openings have been infilled, with the brick slightly recessed. The opposite side has four openings at both the 1st and 2nd story, with the two center bays being doors with transoms above. There is a one story flounder addition at the rear of the building with 3 side bays.

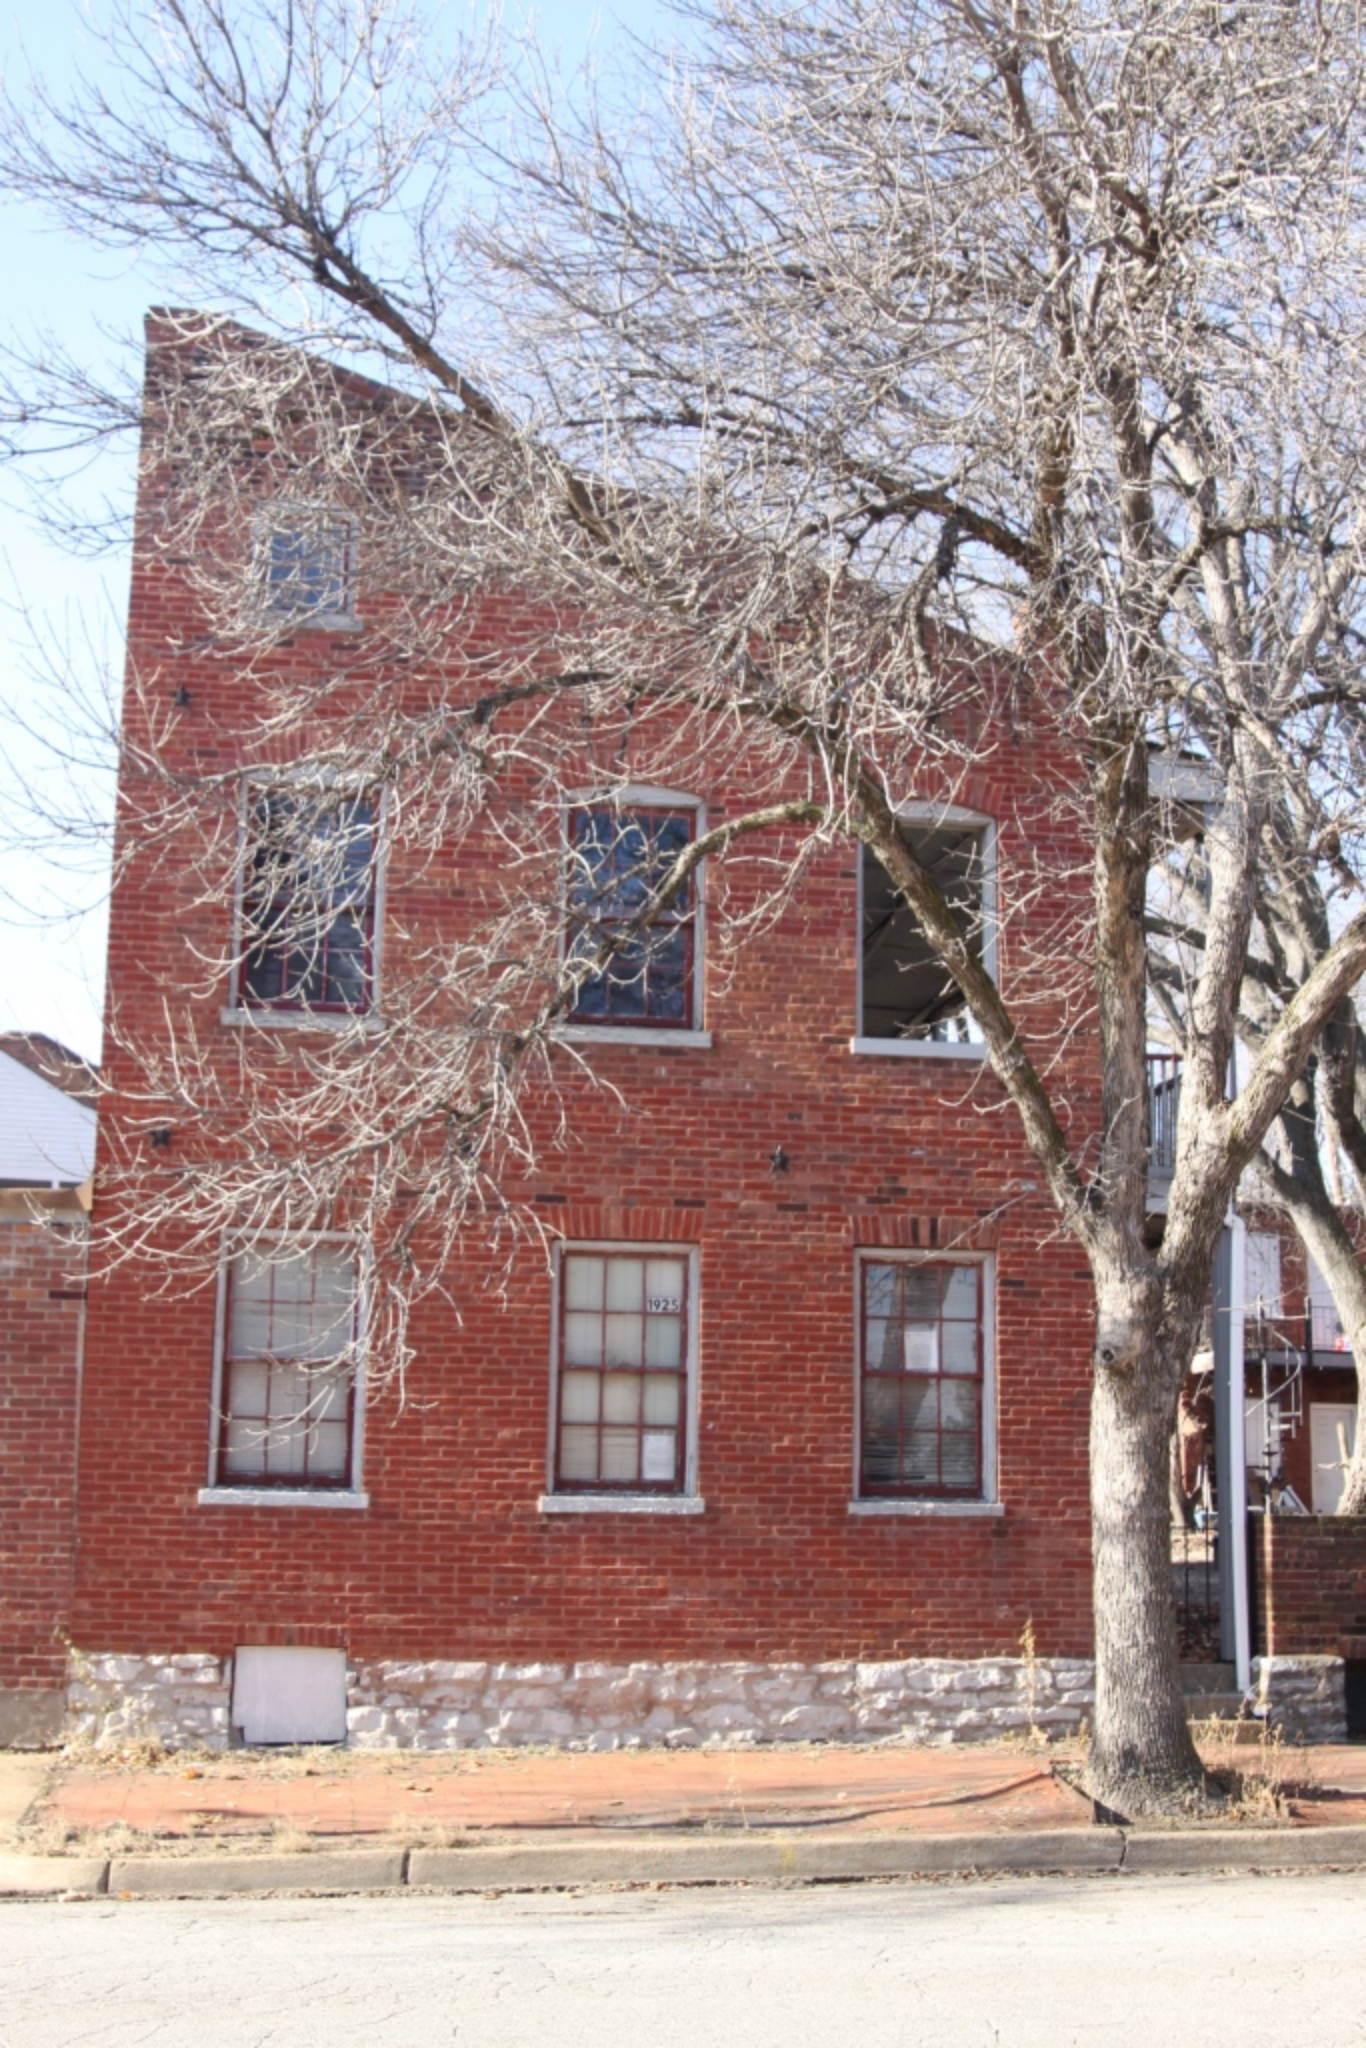
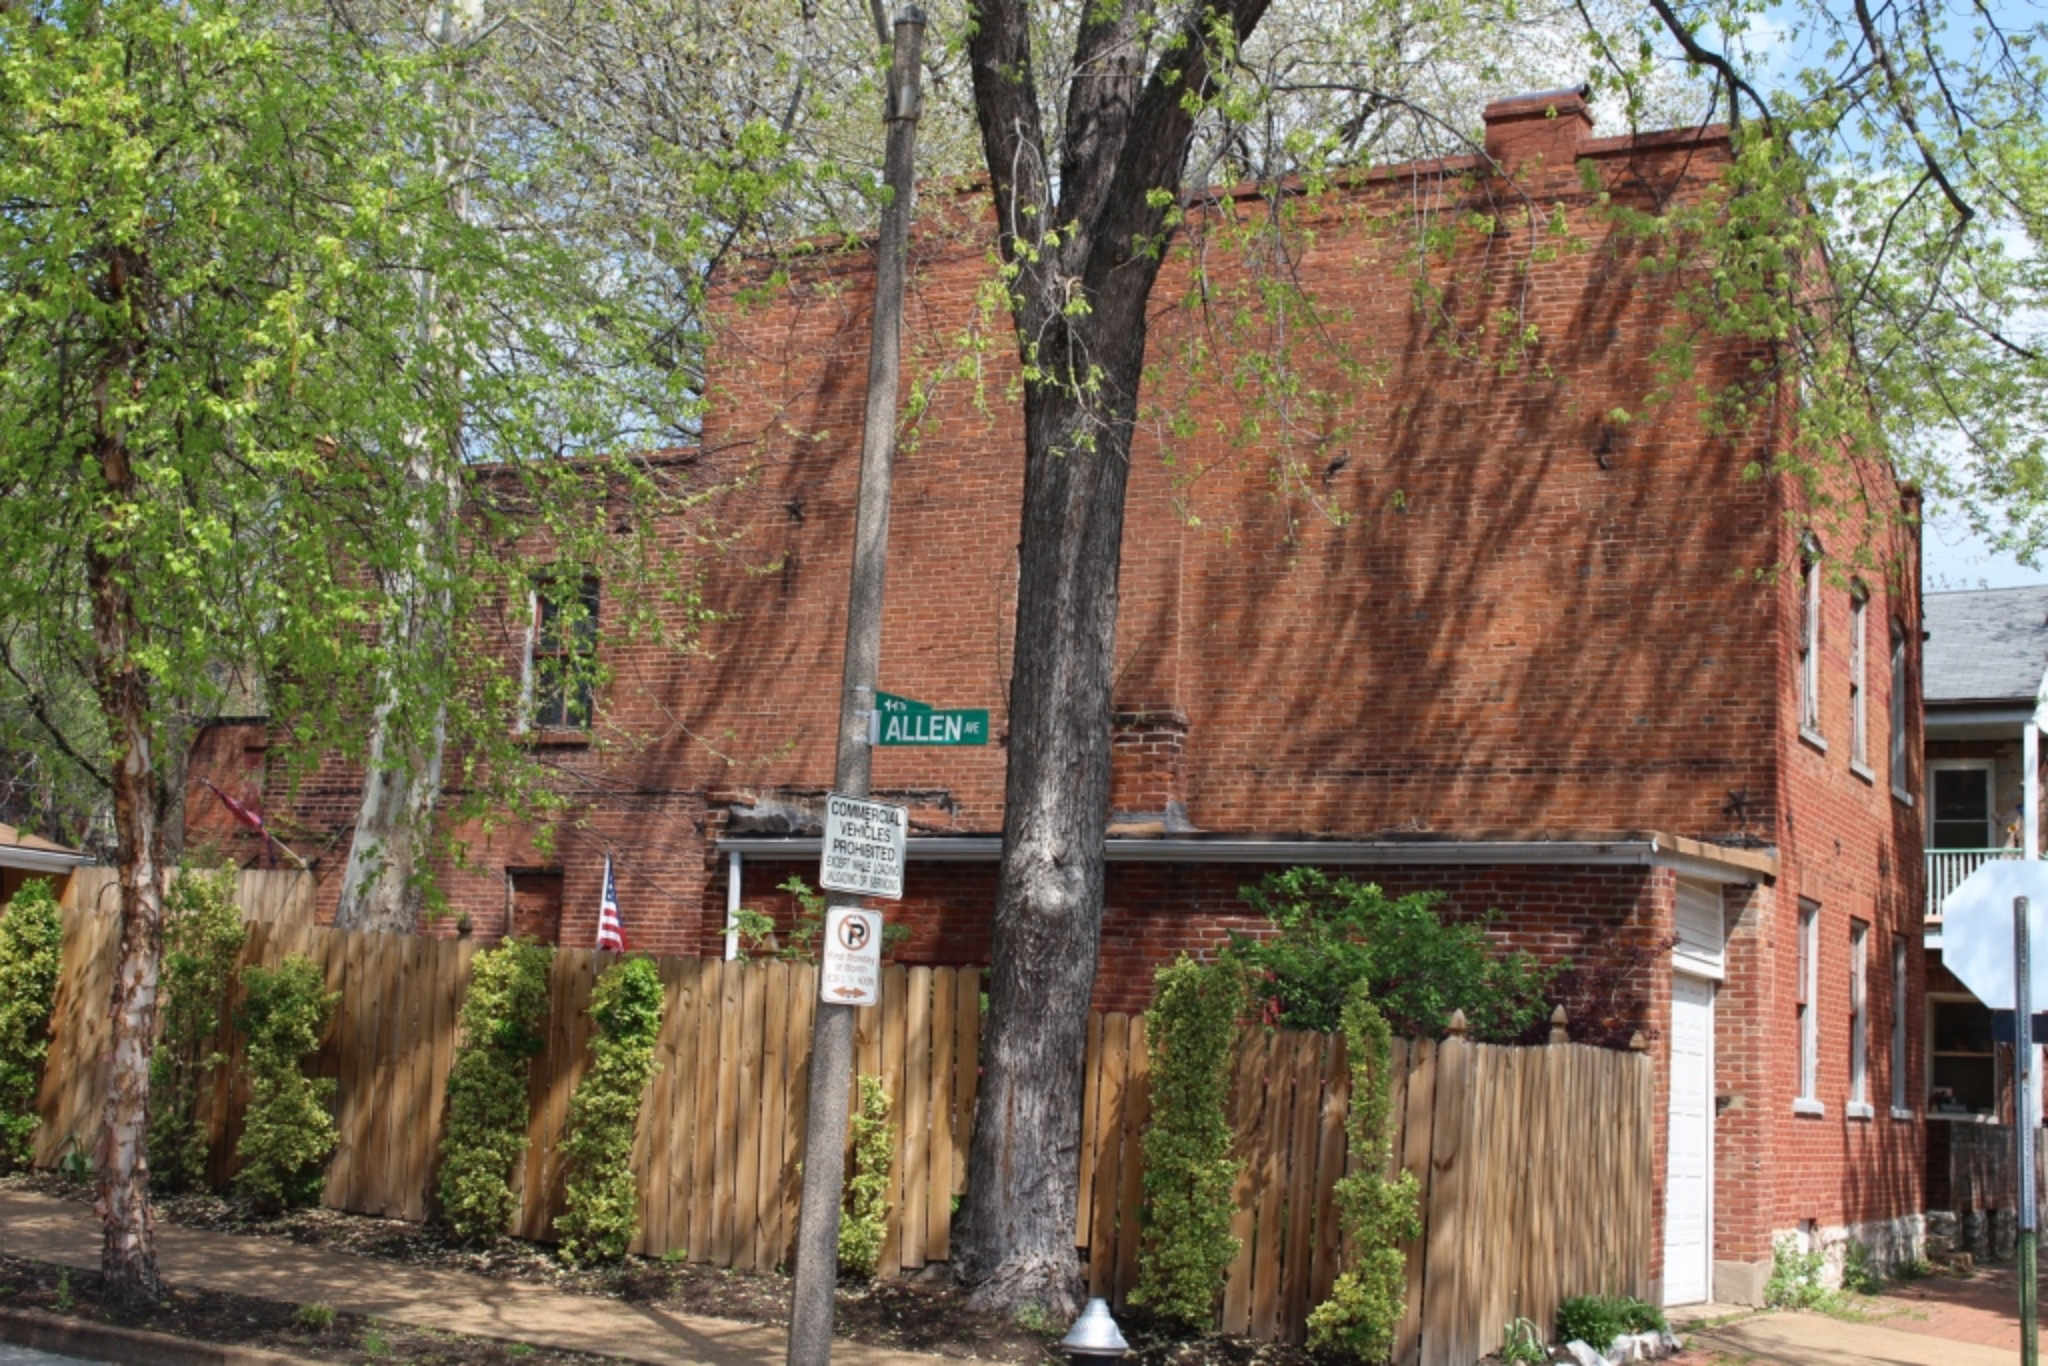
**1925 S 11TH ST**

Two-story w/ loft brick flounder with corbelled course near top of wall. The three bays at the first two stories are 6-over-6 windows, except for the rightmost 2nd story window which is open. All front windows have wood sills. Loft window has segmental rowlock lintel, 2nd story has segmental arch soldier brick lintels and the 1st story has jack arch soldier brick lintels. The loft window is a fixed 4-light window. There is a small covered basement window under the leftmost window, with a rowlock lintel and stone sill. The right side of the building is frame. The first story is enclosed close to the edge of the front façade. Covered in plywood, it has one window and one door w/transsom opening, although the window opening appears to have originally been a door. On the 2nd story, the wall is set back one bay resulting in the open front window and a deeper porch. The two-story, shed roof gallery porch projects only a few feet past the edge of the building. The two 2nd story openings are both doors with transoms. There are two additional windows at the 1st story and one at the 2nd story on this side of the two story brick rear flounder ell. On the left side of the building there are two 2nd story window openings , one on the main building and one on the ell. These 2-over-2 windows have segmental arch soldier brick lintels, brick rowlock sills. There is one small retangular fixed window on the 1st story of the ell on this side. These windows may have been added at a later date. There are three chimneys on the left side of the building, 2 on the main structure and one at the rear of the ell.

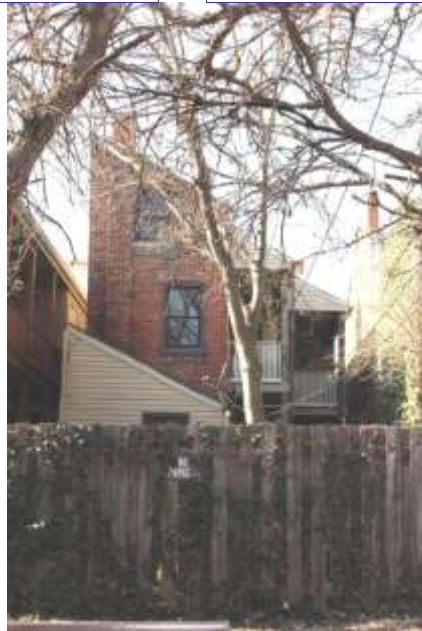
Rear façade

Good condition and well-maintained.

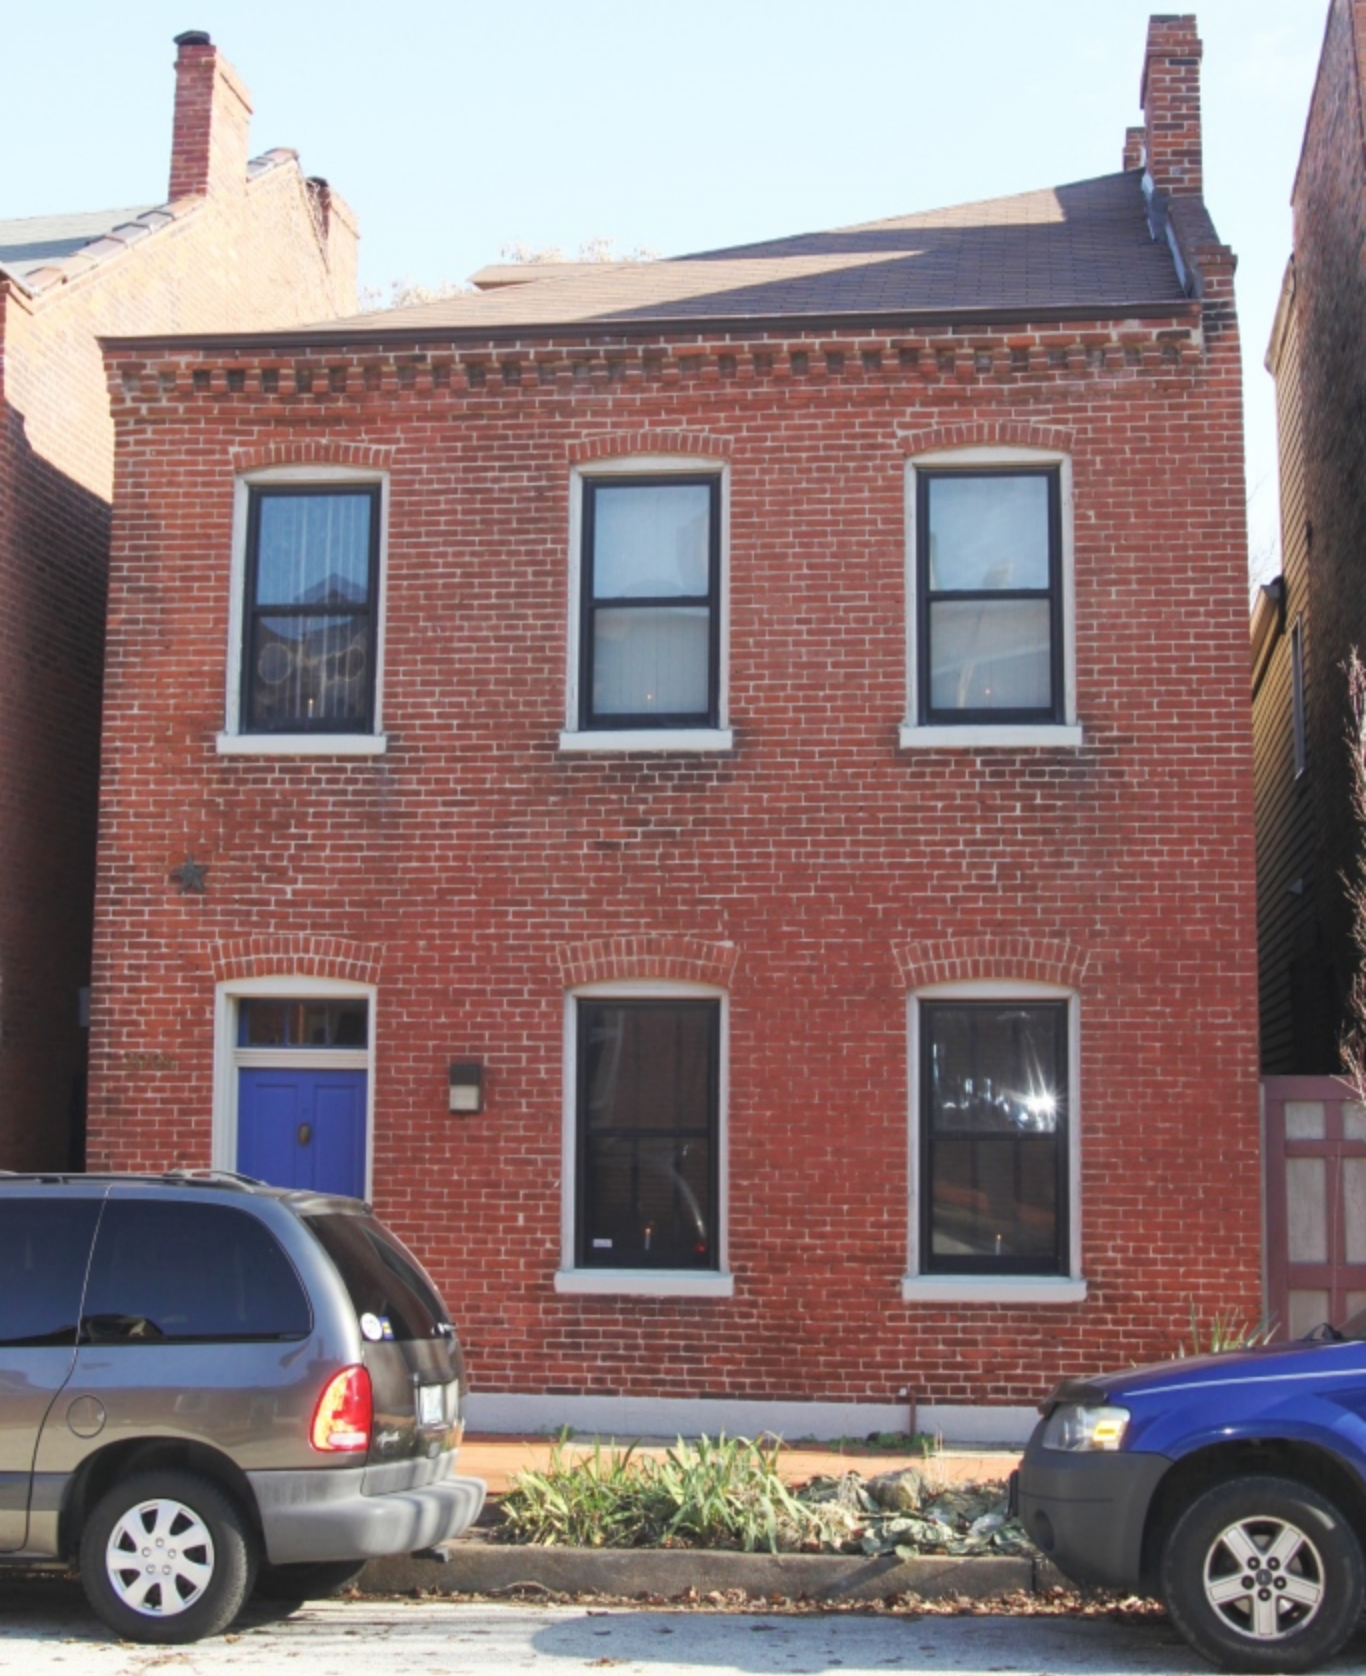
Two-and-a-half story brick, hipped front flounder with a gabled side dormer and denticulated brick cornice. There are three front bays on the 1st and 2nd stories, with a front entry to the left side. The entry has a four-panel door with a 3-light transom above. The windows have stone sills with double-rowlock lintels on the first story and single-rowlock lintels on the second story. The limestone foundation is smooth and has been painted. The left side of the building is frame with vinyl siding. A small, two-story recessed porch is present at the rear corner. There is a Baltimore chimney at the right side. A thinner, two-and-a-half story rear flounder el at the rear has a two-story side gallery porch and a rear chimney. A one-story frame flounder el sheathed in vinyl siding, constructed before 1908, is located at the rear.

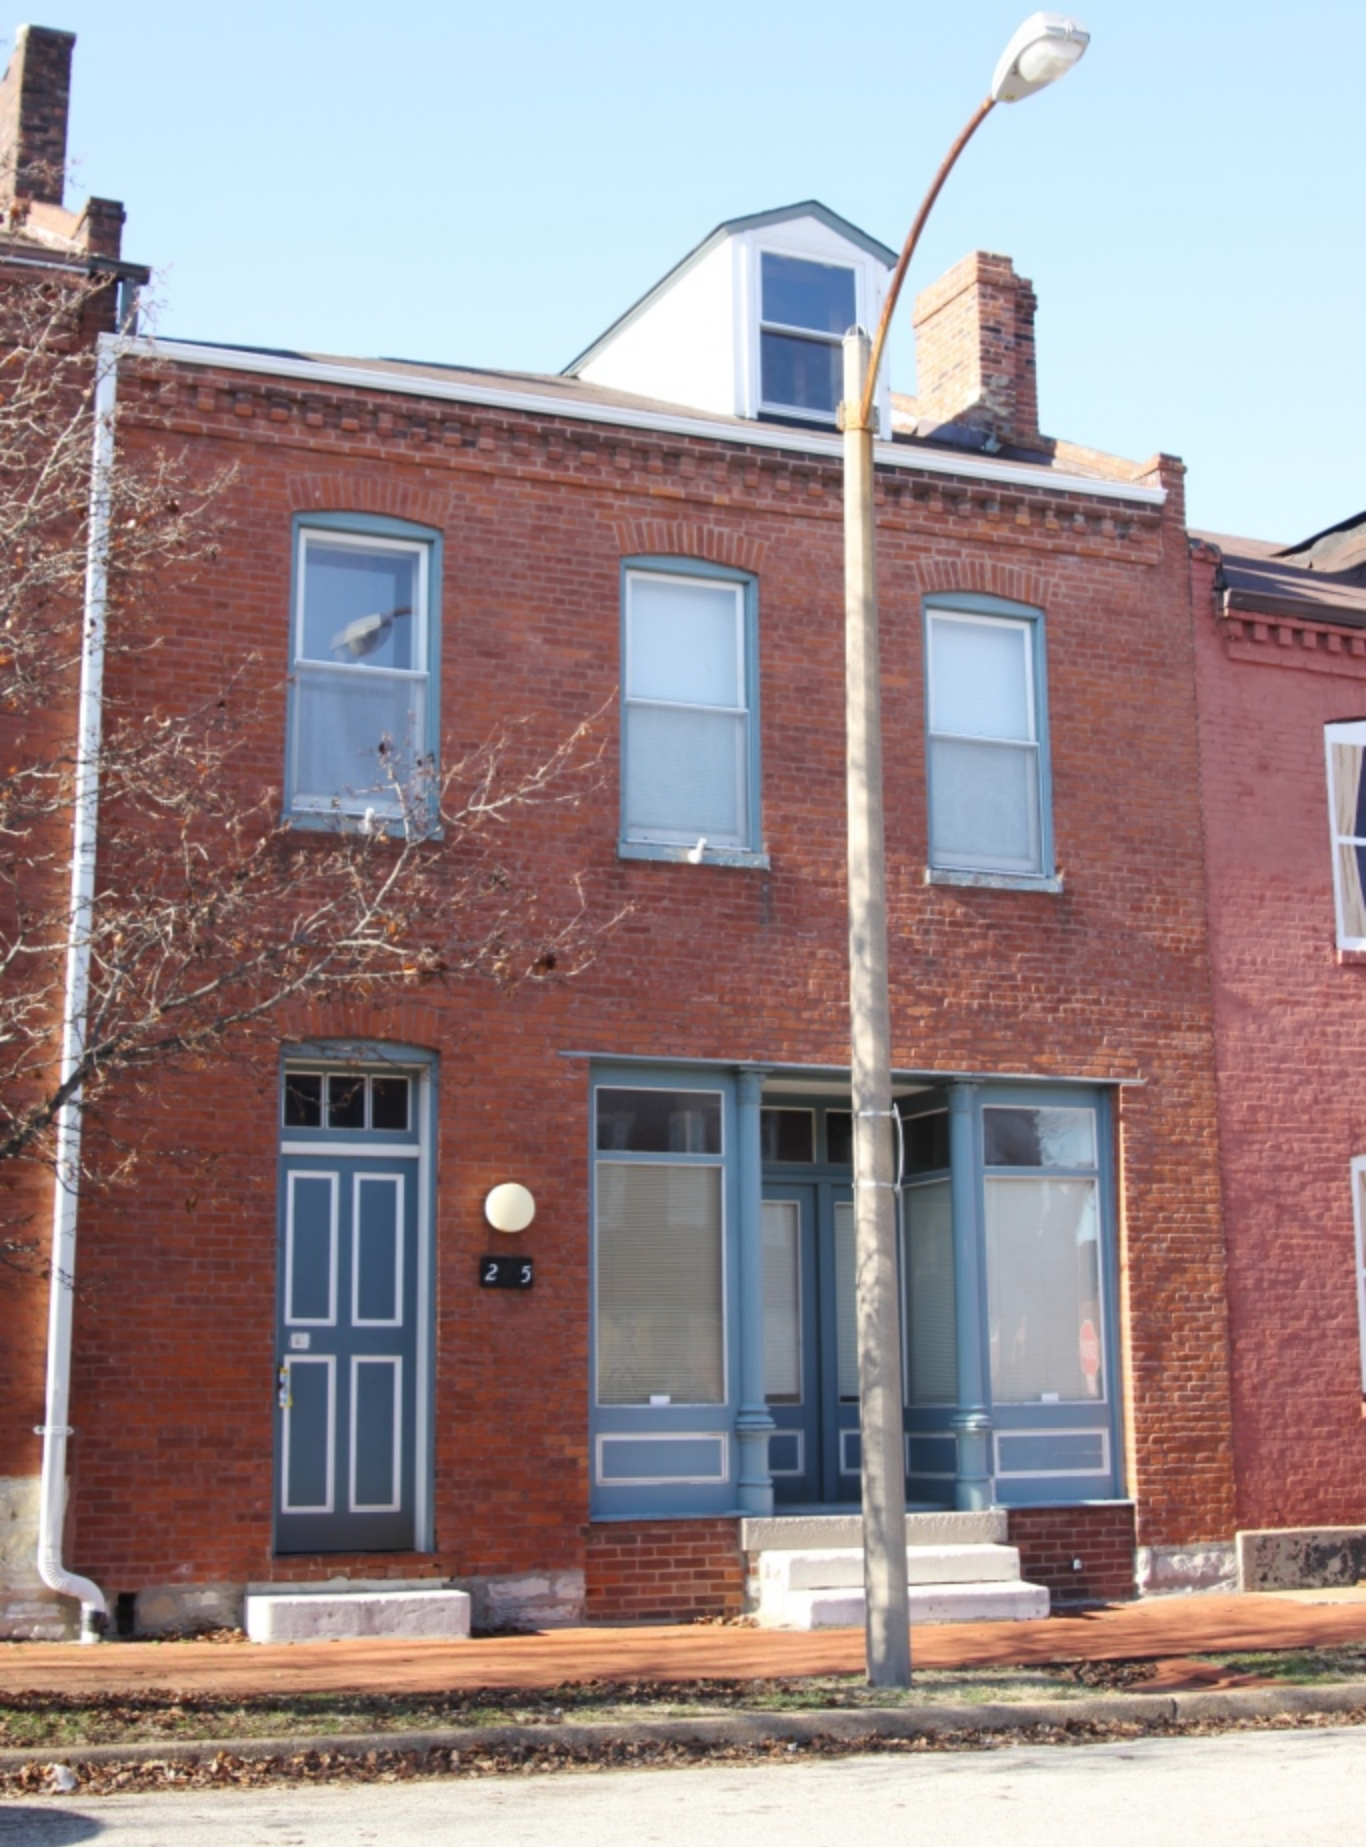
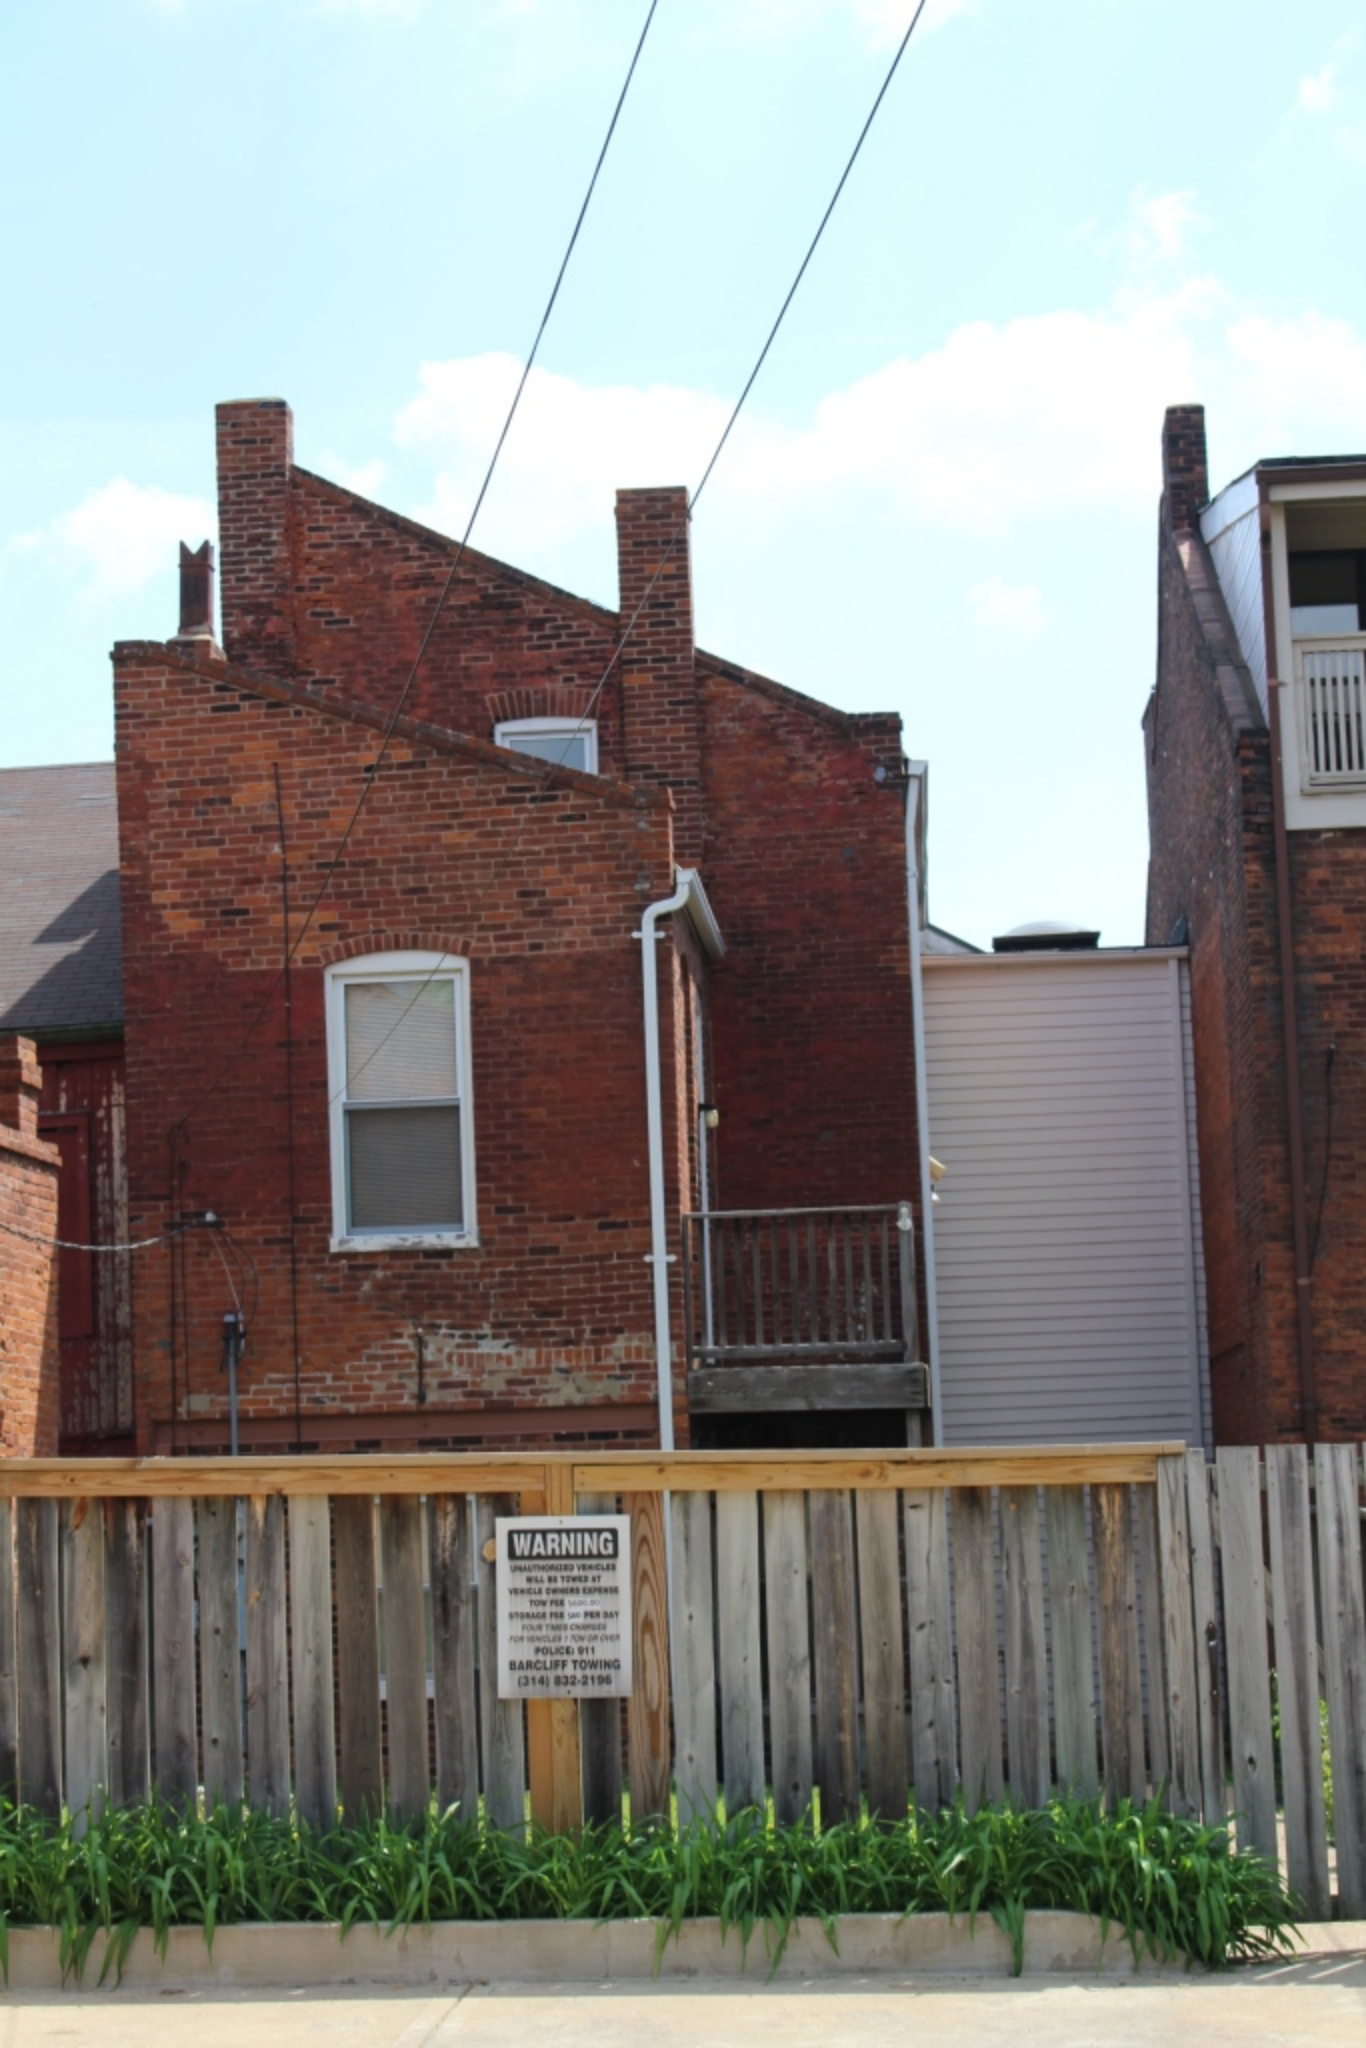
**2005 S 11TH ST**

Two-story hipped front brick flounder with a front dormer. Originally a residence, a storefront with simplified Corinthian castiron columns and a central recessed entry was added before 1909. The original residential entry remains at the left side of the front façade, allowing access to a side gallery porch and the rear of the property. The building has a denticulated brick cornice. The window and residential door openings have segmental arch soldier brick lintels and the windows have stone sills. The window in the gabled dormer and the 2nd story windows are all 1-over-1. The residential door is four-panel with a 3-light transom above. The storefront has wood panel bulkheads, transoms and a 2/3rds glass door. Three steps lead up to the storefront entry, while only 1 step to the residential door. Brick has been used to infill below the storefront. The residential entry which was likely originally a wing wall has been enclosed behind that point with a vinyl sided wall at the rear. The building also has an original two-story brick flounder ell at the rear. There is a small two-story wood deck at the rear corner where the building meets the ell. There are three chimneys on the right side of the building, one chimney at the rear of the main building and one on the right side of the ell.

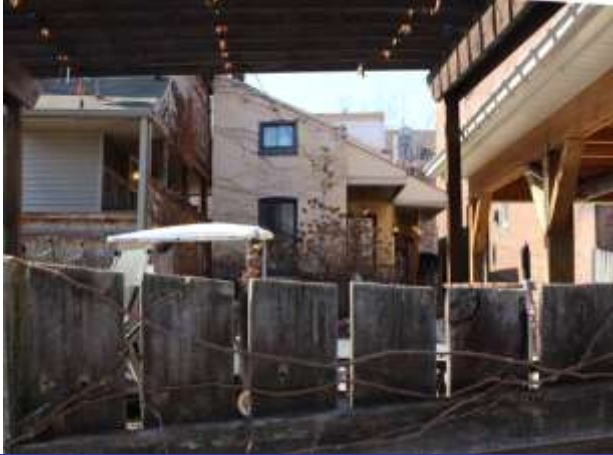
Rear façade

One-and-a-half story brick flounder. Three bay front façade w/ furthest left bay being a wing wall hiding a side gallery porch and entry to the building. Front double-hung 2-over-2 windows with eyebrows and segmental arch, double rowlock lintels and painted stone sills. Second story window to the left side is smaller, but in the same configuration as the 1st story windows. The stone foundation has been parged and painted. The original gallery porch on the north wall of the building has been enclosed and now is frame with lap siding. There are no openings in the south wall, with an integral chimney at the very rear. A one story historic brick addition is at the rear of the building.

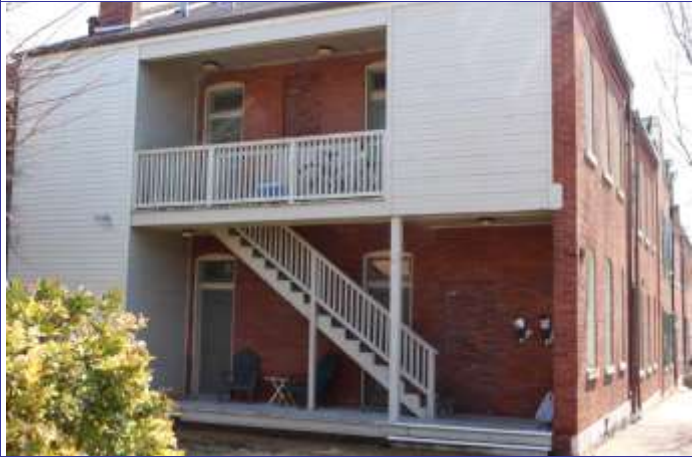
North elevation

Building is in good condition and is well-maintained.

Two-and-a-half story hipped front brick flounder with a denticulated brick cornice and front gabled dormer. All of the front windows are 2-over-2 with segmental-arch top sashes. The first and second story windows have soldier brick lintels and stone sills. There is a chimney located at the front left corner of the building with two corbelled courses near the top. There are two additional chimneys on the main structure, on at the left side and one near the rear on the right slope. There is an ashlar limestone watertable near grade with some rubblestone visible below. The left side of the building has a recessed gallery with enclosures at the first bay of the 2nd story and on both stories towards the rear. There are three door openings at each story, with on of these on each floor having been infilled. The three existing doors have transoms. There is a large two-and-a-half story flounder building at the rear of the property that is now attached by a frame addition.
