**ARCHITECTURAL/HISTORIC INVENTORY FORM - Cultural Resources Office**  
**St. Louis Planning and Urban Design**

1. Survey no. SLC-AS-053-0001	2. Survey name: Thematic Survey of Flounder Houses in St. Louis City	3. County: St. Louis [Independent City]
4. Address: (from City GEO database) <b>1812 S 8TH ST</b>		5. City/State: St. Louis, Missouri
Alternate address: 1812 S 8th		Property Zip Code: 63104
Latitude: 38.608949		6. UTM Easting: 743586.48
Longitude: -90.202538		UTM Northing: 4277095.00
8. Historic Name (if known): N/A	11a. Historic Use (if known): Domestic	City Block: 372 City Ward: 7
9. Present/other name (if known):	7. Township-Range-Section: N/A	10. Ownership: Private
11b. Current Use: Domestic		Neighborhood Number: 21

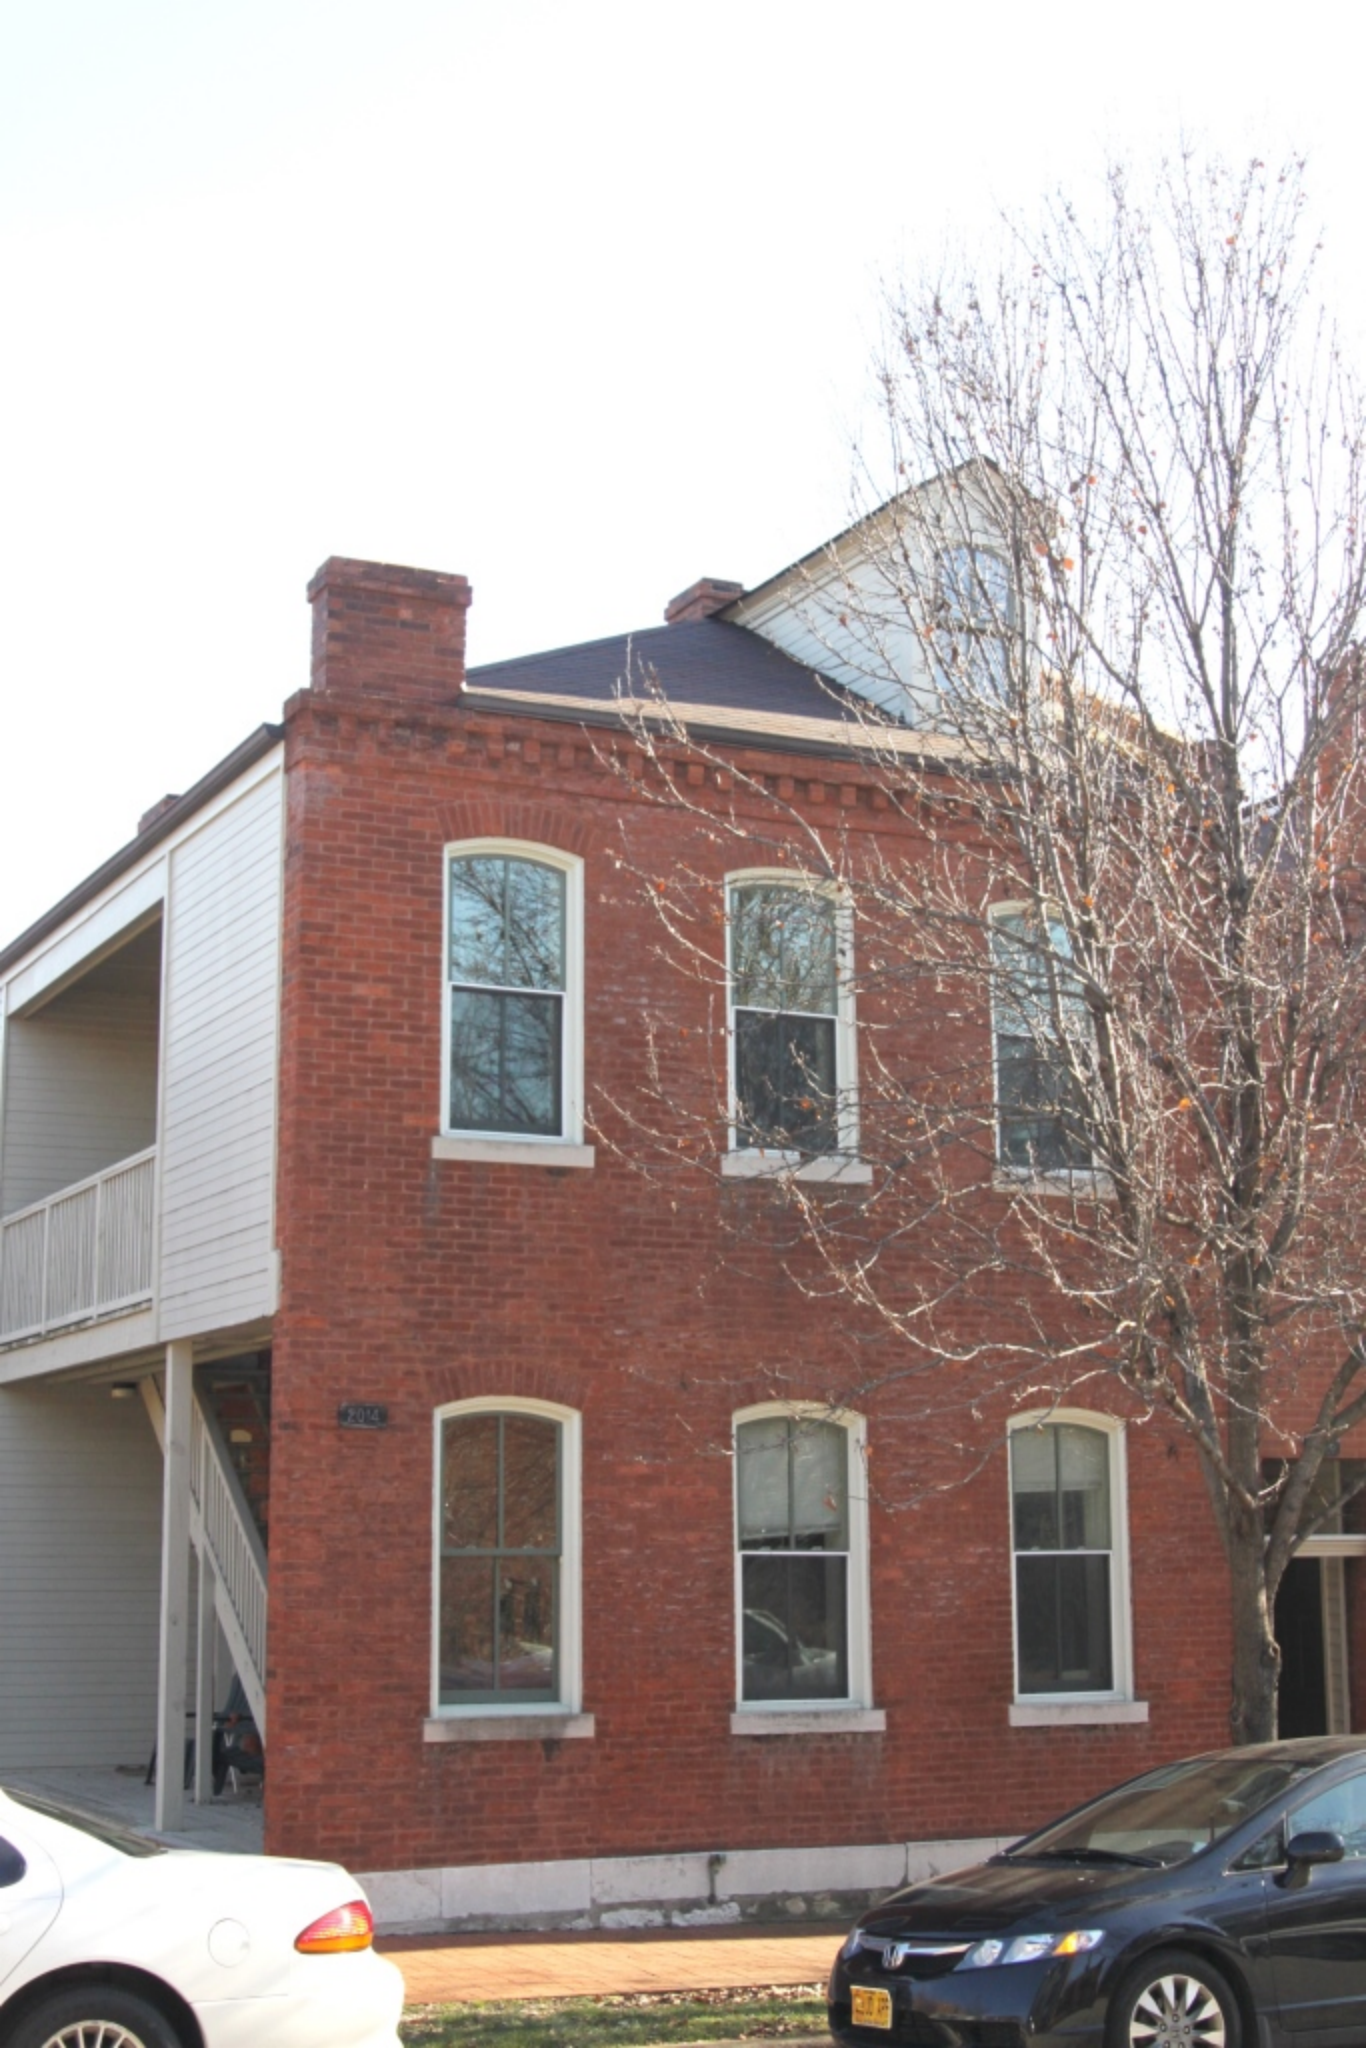
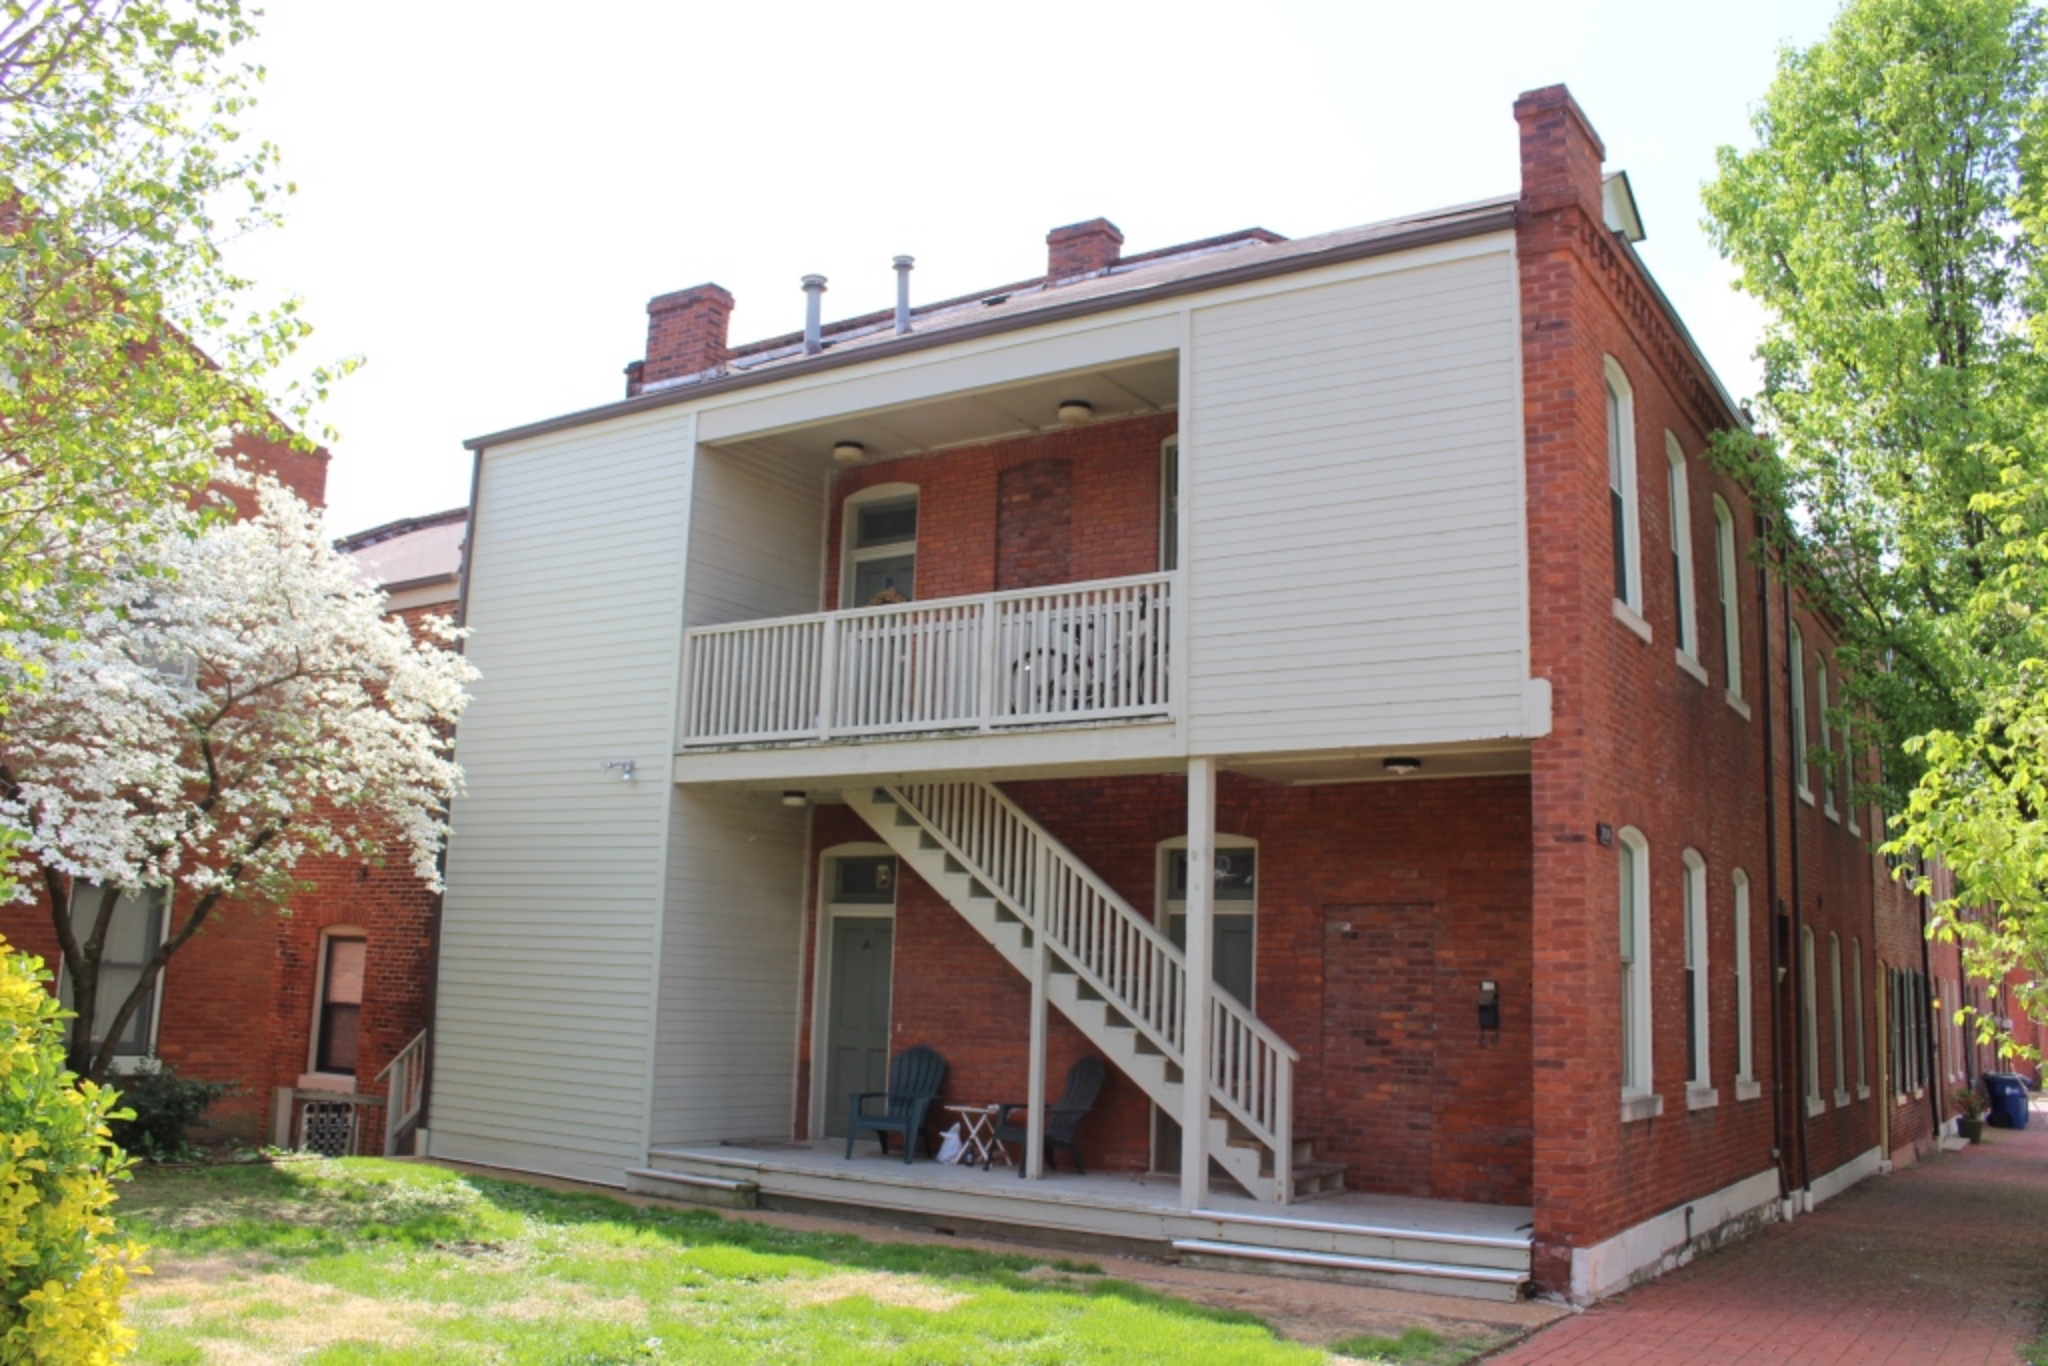
**2014 S 11TH ST**

Two-and-a-half story hipped front brick flounder with a denticulated brick cornice and front gabled dormer. All of the front windows are 2-over-2 with segmental-arch top sashes. The first and second story windows have soldier brick lintels and stone sills. There is a chimney located at the front left corner of the building with two corbelled courses near the top. There are two additional chimneys on the main structure, on at the left side and one near the rear on the right slope. There is an ashlar limestone watertable near grade with some rubblestone visible below. The left side of the building has a recessed gallery with enclosures at the first bay of the 2nd story and on both stories towards the rear. There are three door openings at each story, with on of these on each floor having been infilled. The three existing doors have transoms. There is a large two-and-a-half story flounder building at the rear of the property that is now attached by a frame addition.

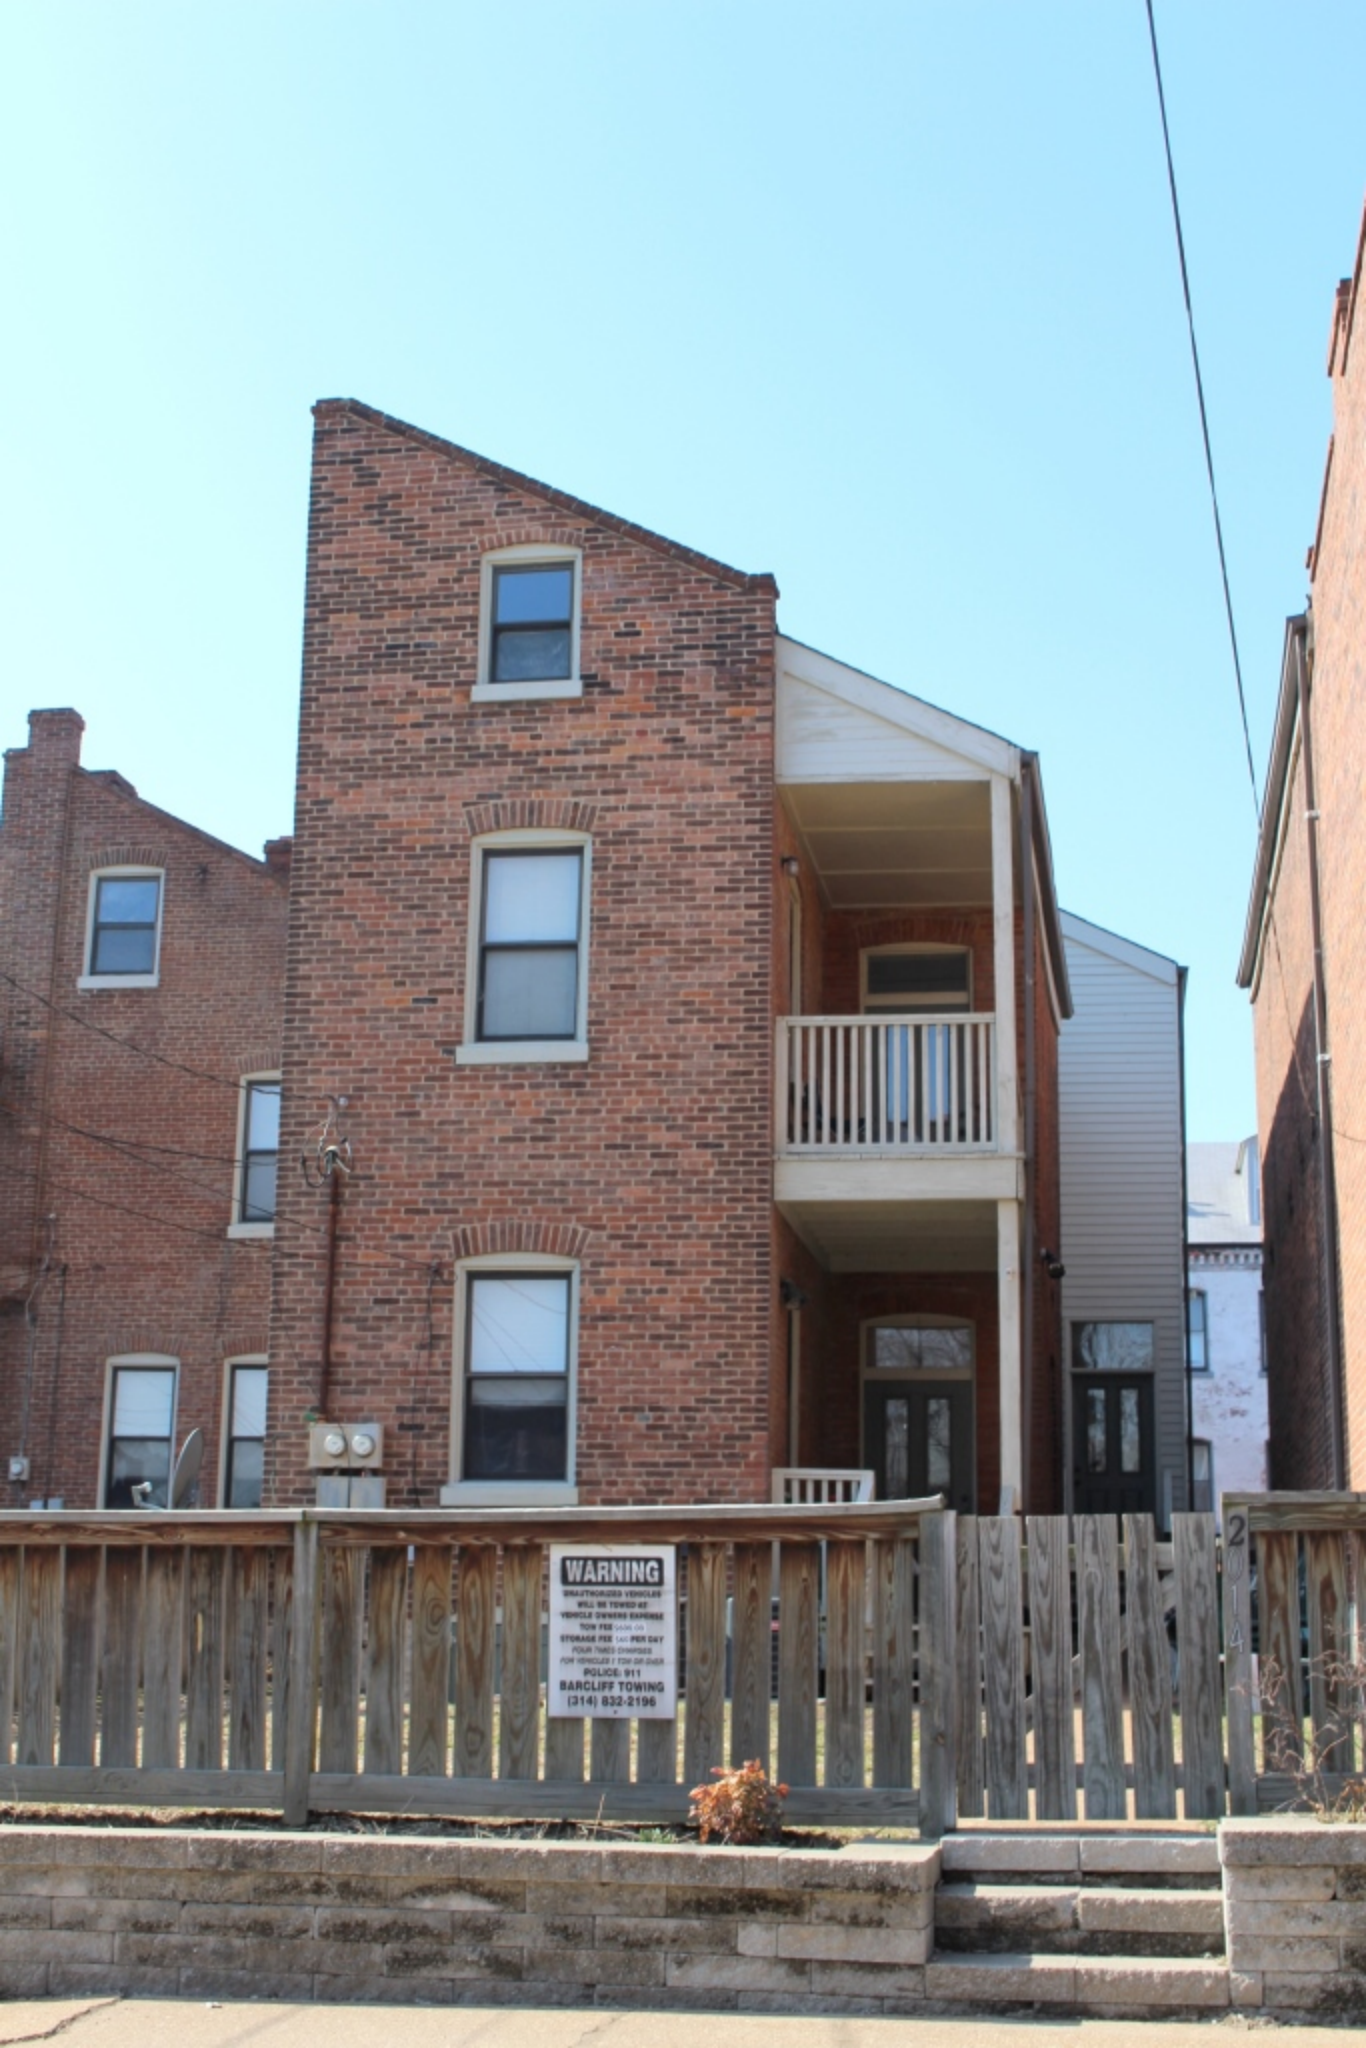
The two-and-a-half story brick flounder is at the rear of the front building of the property and was attached to the front property by a frame addition aft. 1908, likely much later. The building has one bay facing the alley with a window at each story, the top being smaller. The windows have segmental-arch soldier brick lintels and painted stone sills. The windows have simple eyebrows and are one-over-one. There appears to be a coal door at the basement level of the building with a segmental-arch rowlock lintel. The foundation is of rubble limeston. There is a corbeled course near the top of the front parapet wall. There is a two-story shed roof porch on the right side. This porch gives access to the recessed portion of the front façade which holds a two-light, two-panel door with two-light transom at each level. There is one sided window on each story of the right side. There are no openings on the left side of the building, but there are two chimneys.

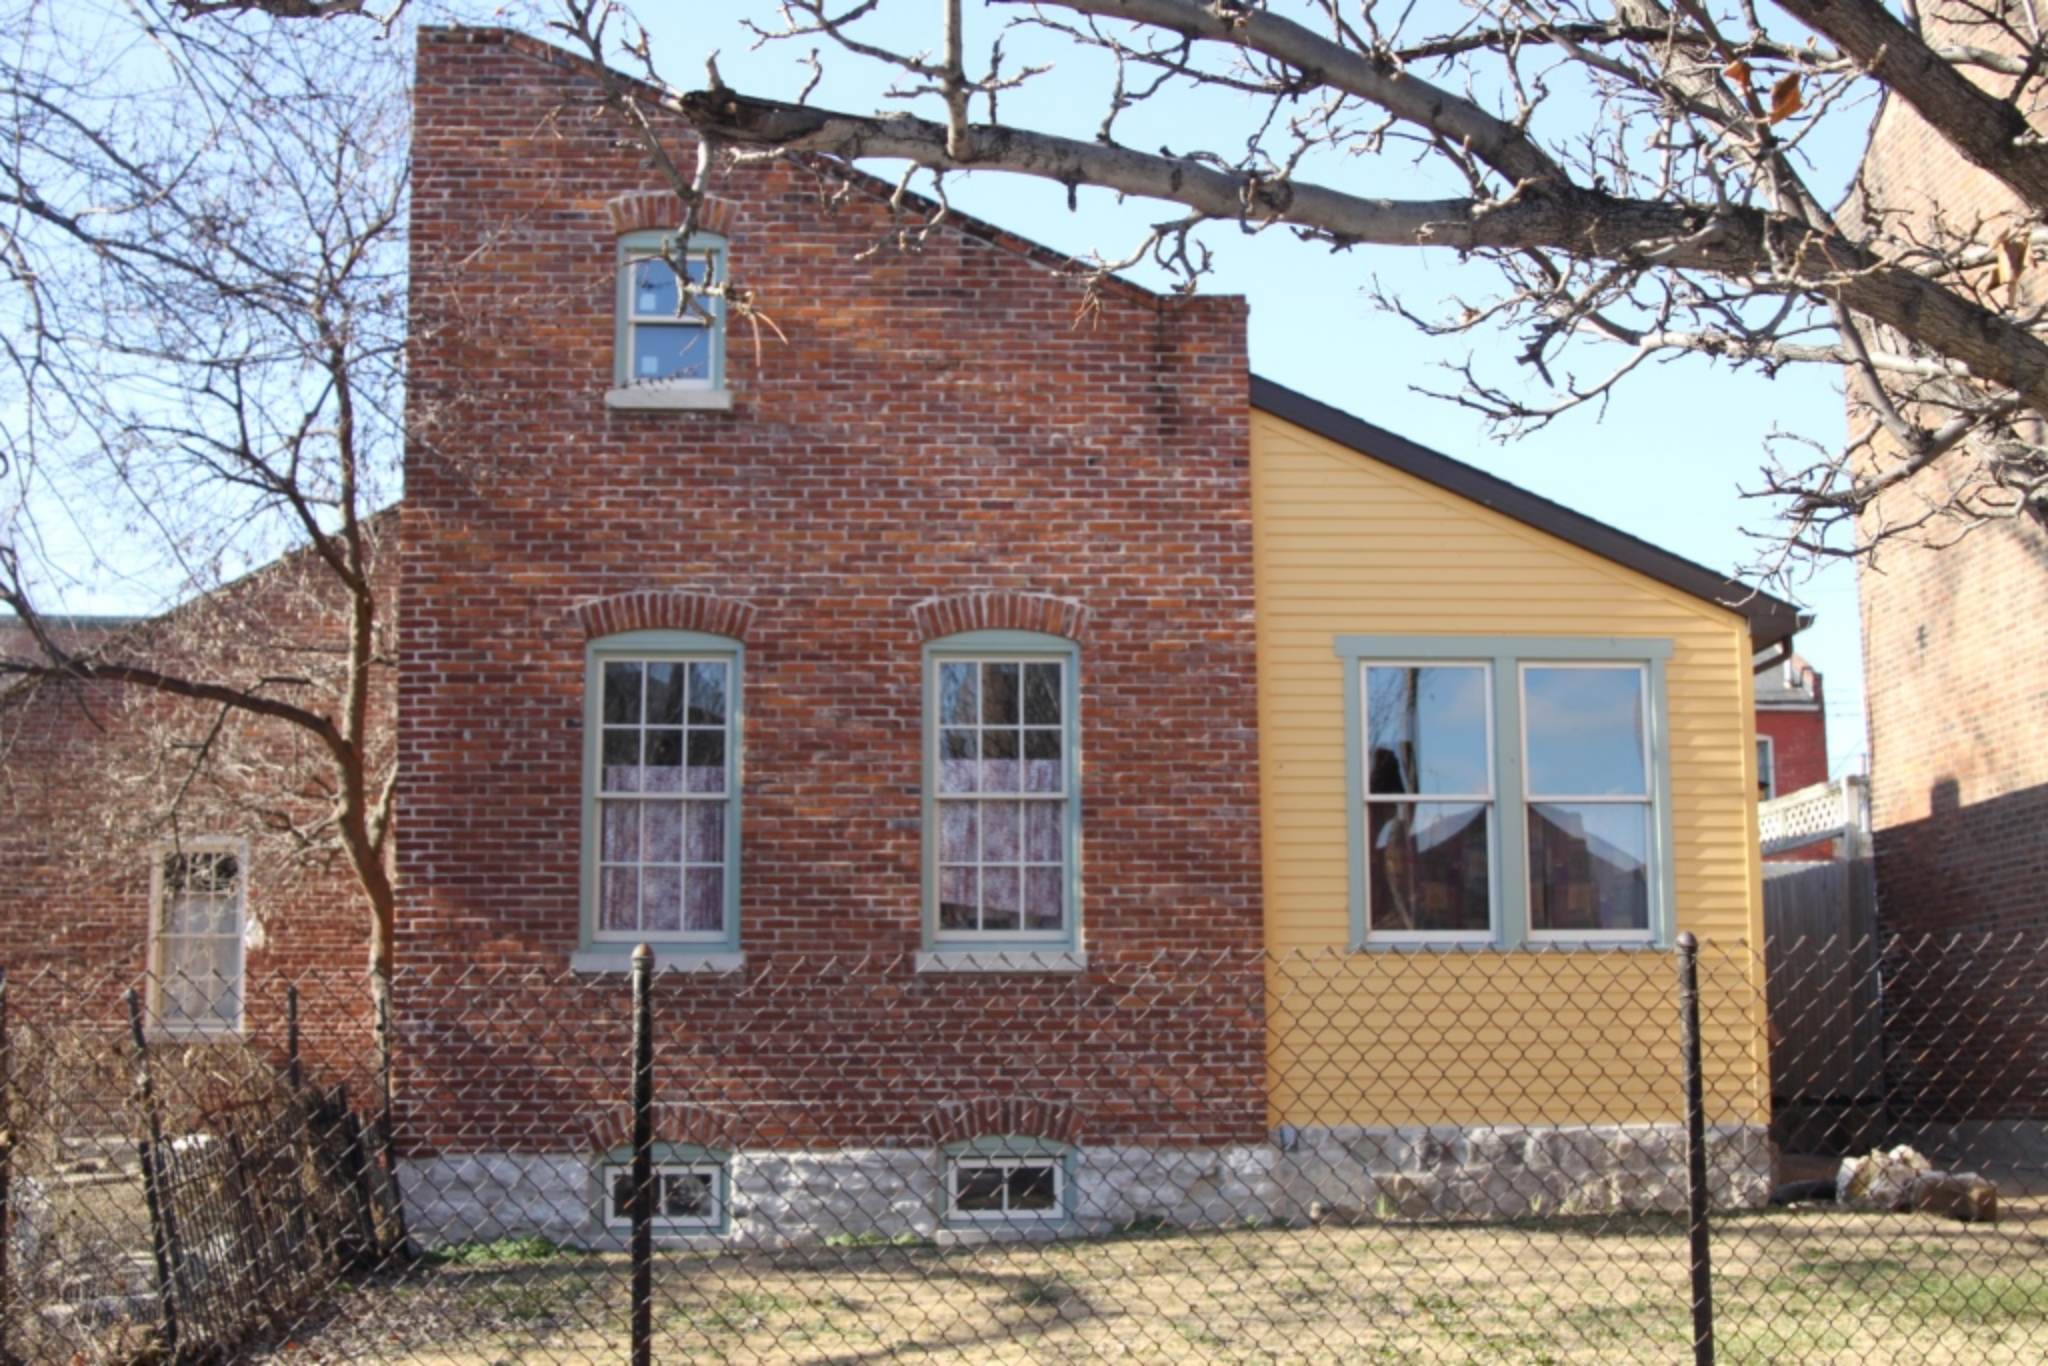
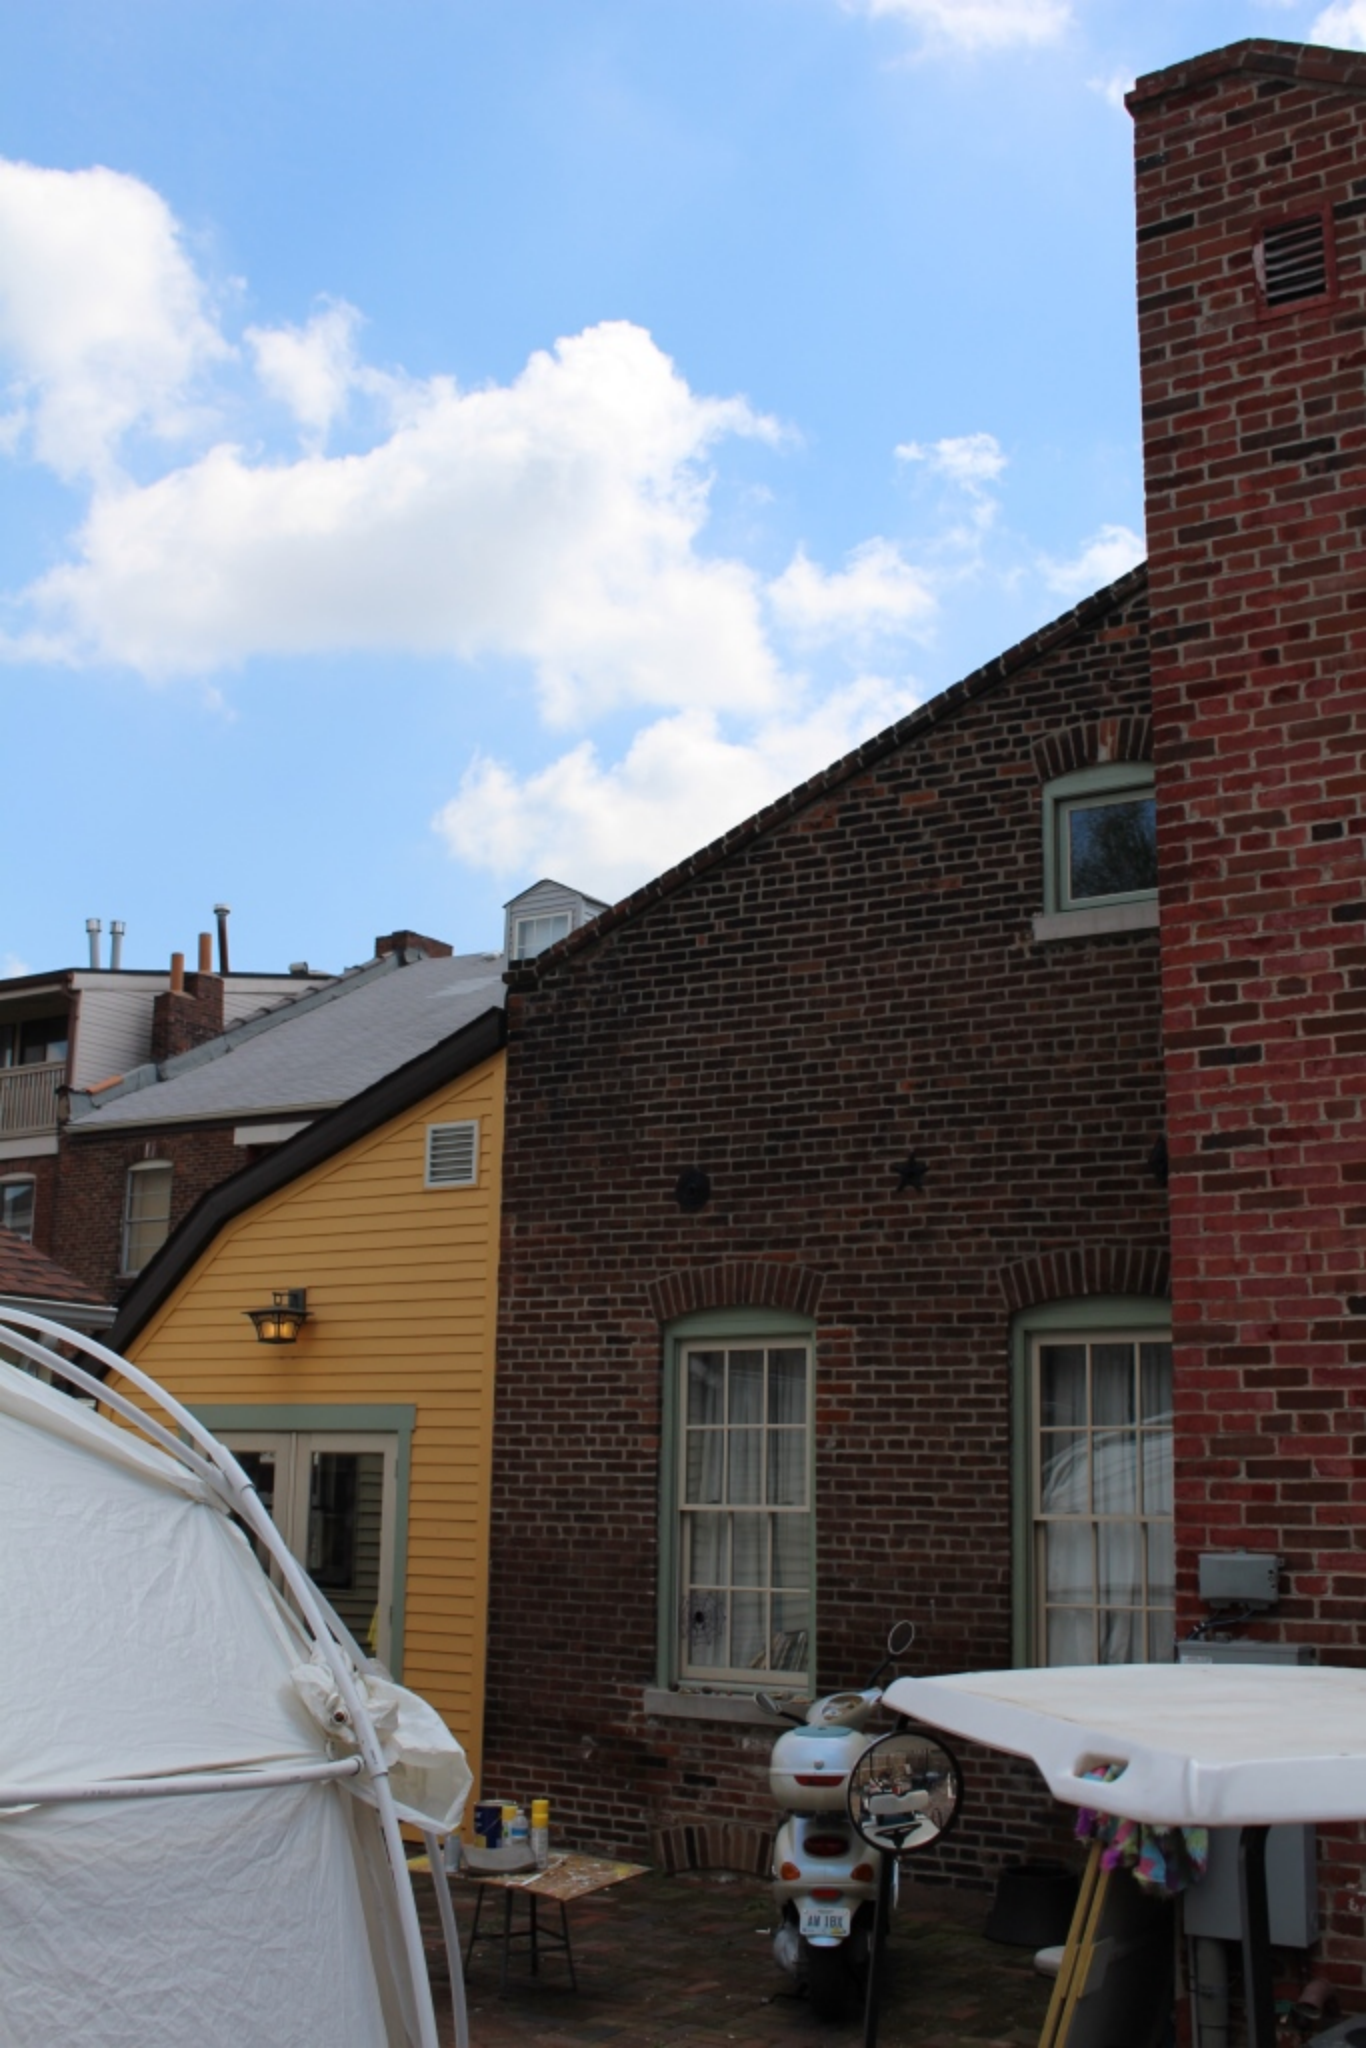
**2015 S 11TH ST**

The brick flounder is a one-story with a loft. There is a corbeled course near the top of the front parapet. The wall has been at least partially rebuilt at some point. The highest and lowest points on the parapet are flat instead of angled. The house has two bays at the first story, with the windows having segmental-arch soldier brick lintels and limestone sills. The windows are square head 6-over-6. The very small loft window has the same lintel and sill, but is a one-over-one window. The basement windows also have the same lintels and sills but are two-light awning windows. There is a single one-over-one window on the left side of the building which may have been added. The gallery porch on the right side of the building has been enclosed to make a frame addition. The addition is sheathed in clapboards and there is a uncoursed stone foundation, and paired one-over-one windows on the front. The house has a small gabled dormer on the right side. And a small shed roof porch extending from the addition. There are two chimneys along the left side of the building.

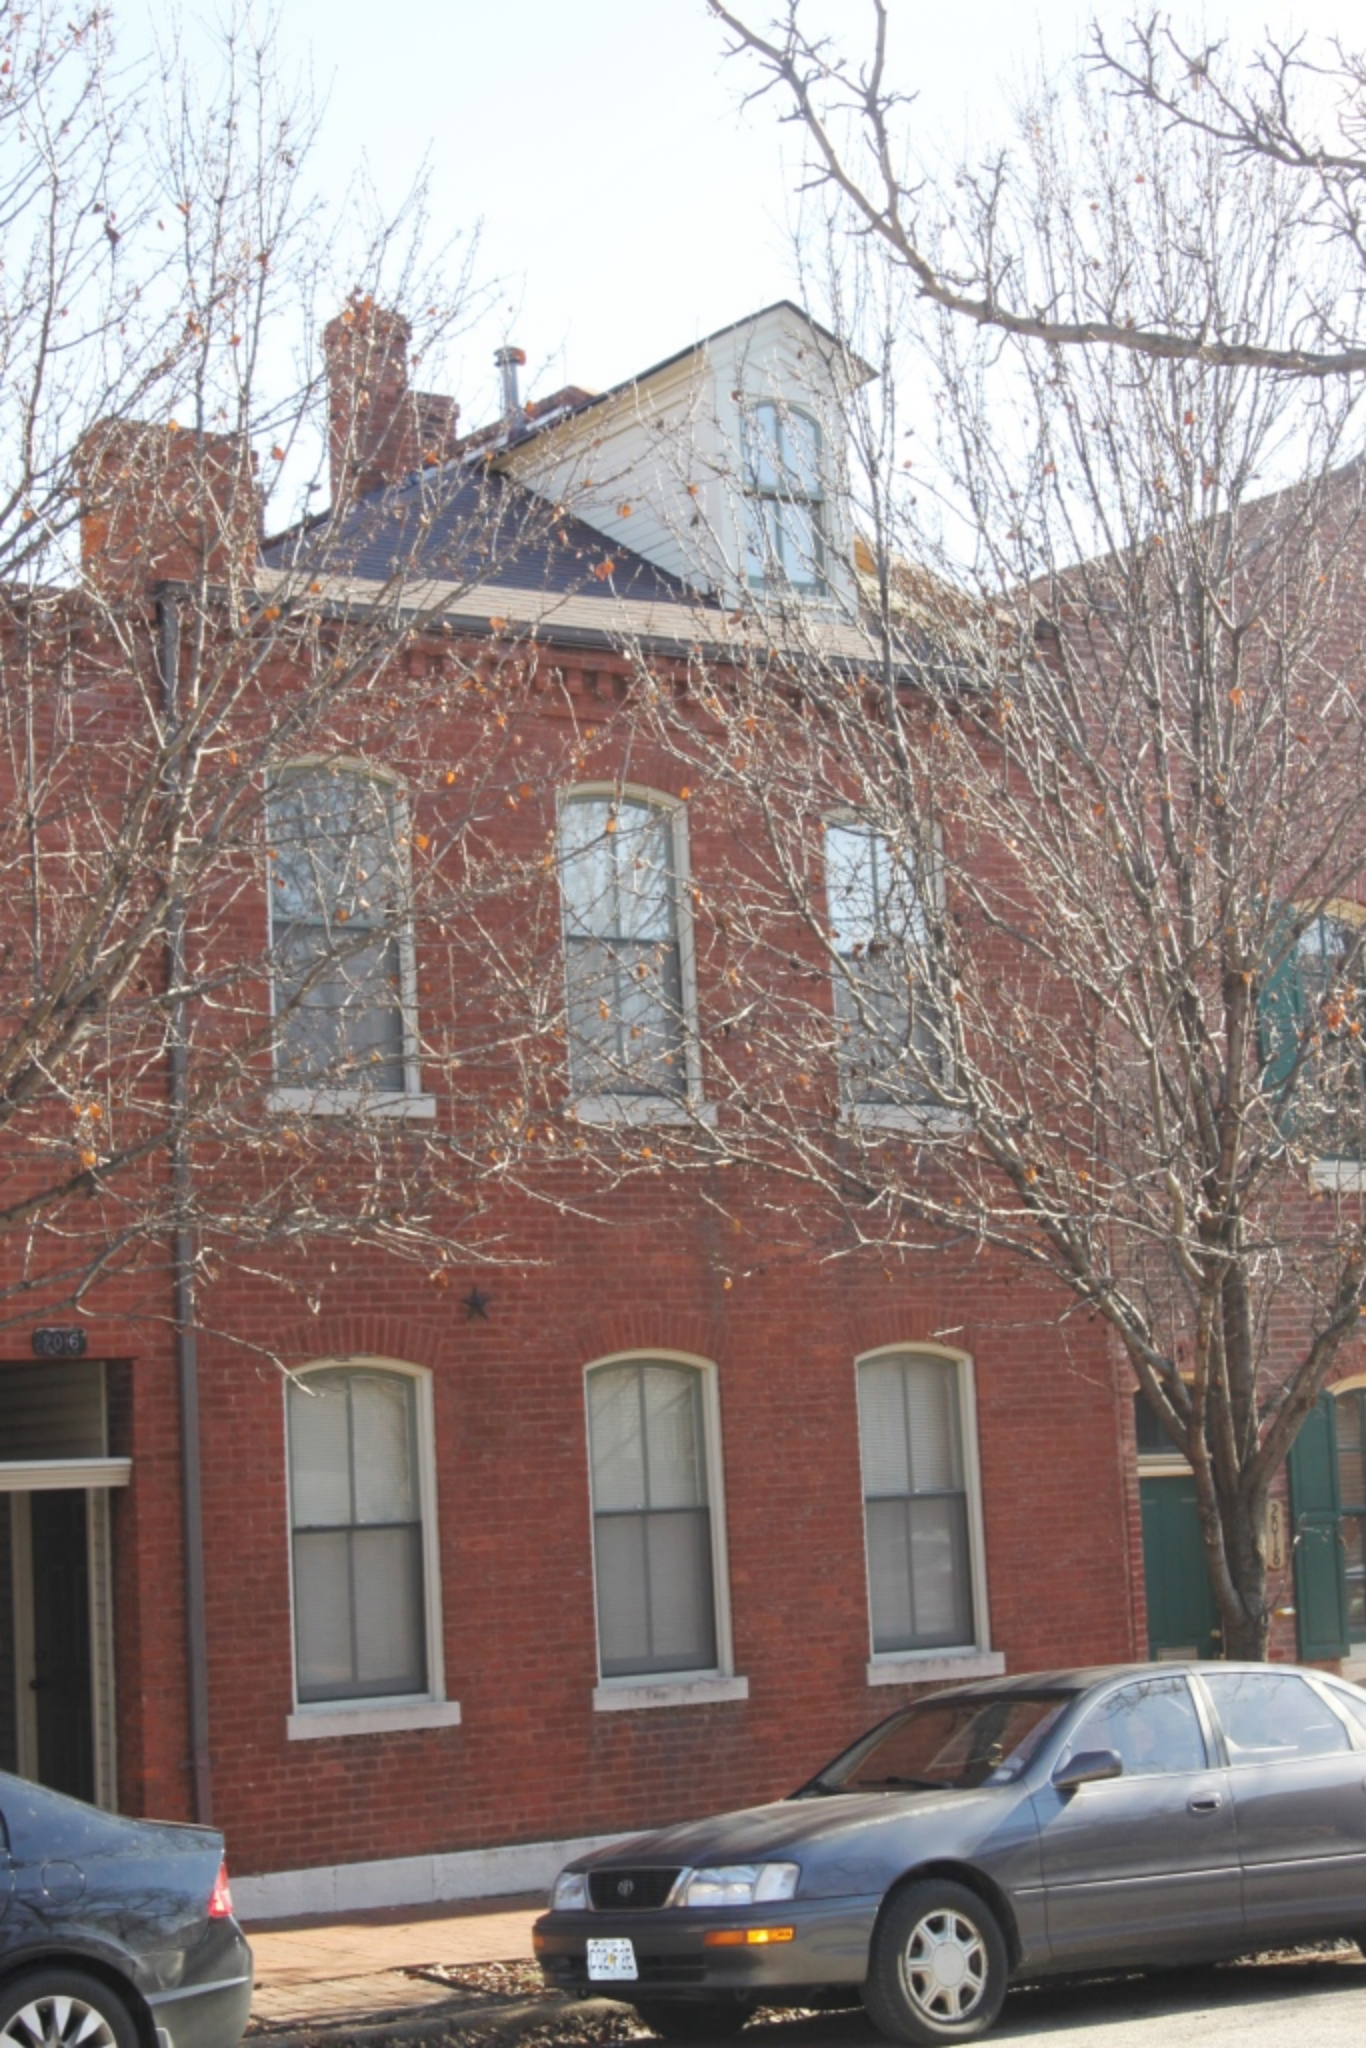
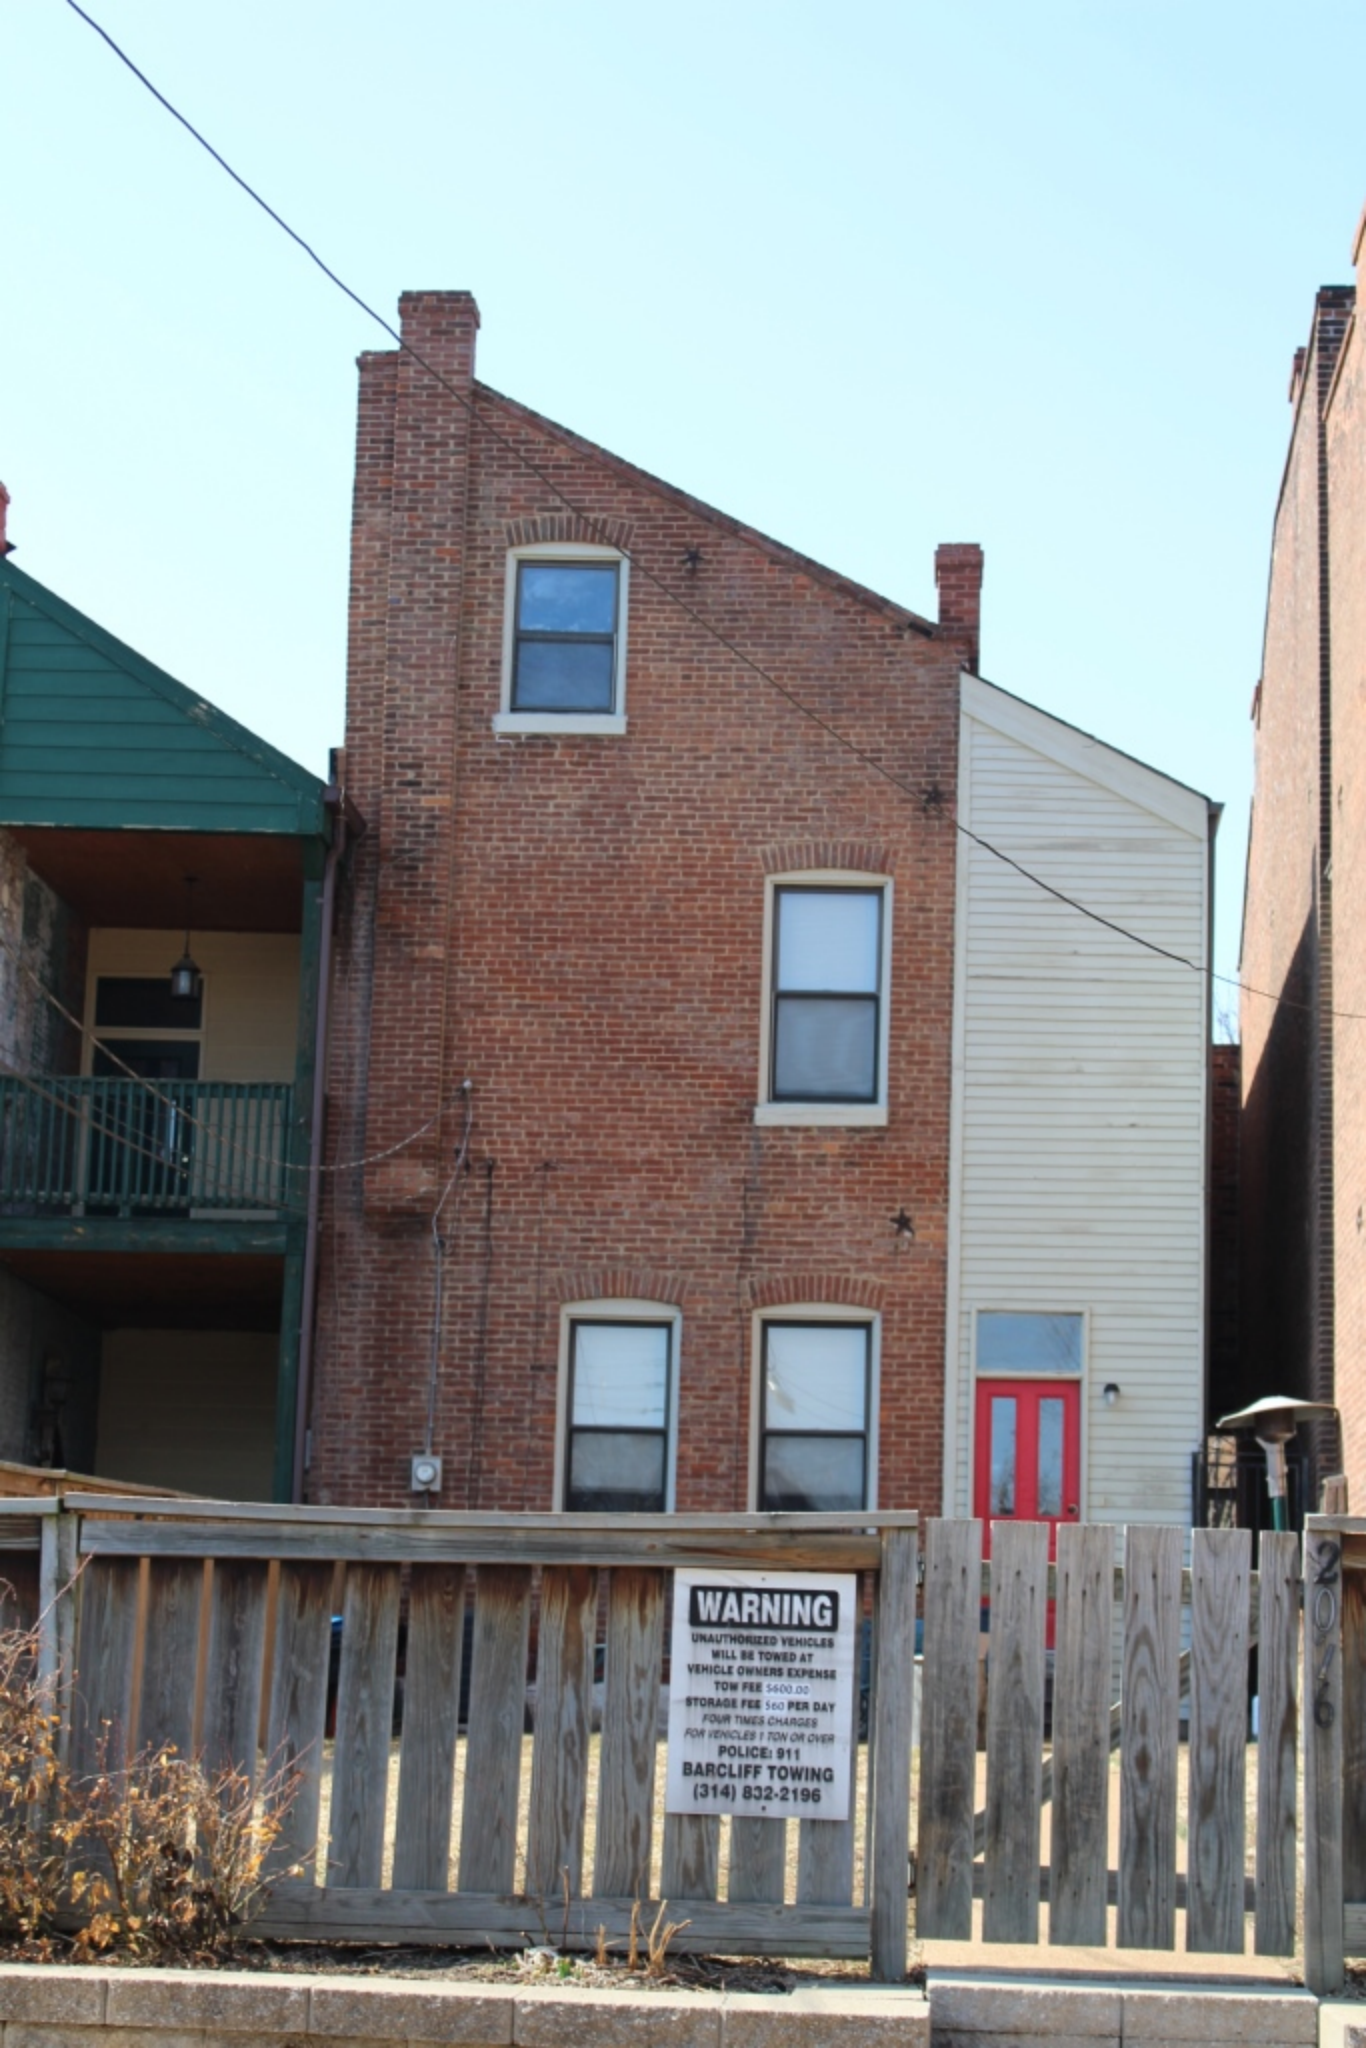
The two-and-a-half story brick hipped-front flounder has gabled wood dormer on the south side of the roof. The dormer is sheathed in wood clapboards, has crown molding along the roofline and a 2-over-2 segmental arch window. There is a chimney at the north edge of the front façade. The corbelled brick cornice has large dentils. There are three bays at both the first and second stories with 2-over-2 segmental arch double-hung windows with soldier brick lintels and limestone sills. There is one iron star tie rod anchor between the stories. An ashlar limestone foundation is visible above the sidewalk. A mousehole was created by the addition of a brick wall at the second story between 2016 and 2014 S. 11th. This wall shows up on the 1909 Sanborn map. There is a molded wood beam at the transom level. The north side of the building contains the entry. The gallery porch along this wall has been enclosed and sheathed with wood clapboards. The rear has a more classic flounder appearance with the clapboard sided enclosed gallery holding a rear door with transom. The windows on this elevation are 1-over-1 double-hungs.

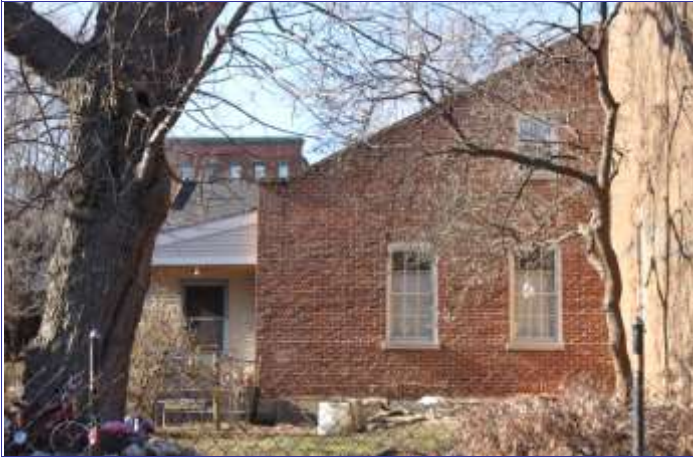
2021 S. 11th - Front

The one-and-a-half story brick flounder sits back off the street and it's north wall is attached to the neighboring flounder building. The front wall has a brick coping and a corbelled course near the top of the parapet. There area two six-over-six windows at the first story with segmental arch lintels and stone sills. There is a single small one-over-one window at the attic level with a segmental arch lintel and stone sill. The rubblestone foundation has been partially parged and the two small windows at the basement level have been boarded. The basement windows have segmental arch lintels. The original side-gallery porch has been enclosed behind a small recessed porch. The addition is sided in vinyl and the entry door is at the side near the front of the building, accessed from the recessed porch. There are three one-over-one windows on the south side of the building.
