**ARCHITECTURAL/HISTORIC INVENTORY FORM - Cultural Resources Office**  
**St. Louis Planning and Urban Design**

1. Survey no. SLC-AS-053-0001	2. Survey name: Thematic Survey of Flounder Houses in St. Louis City	3. County: St. Louis [Independent City]
4. Address: (from City GEO database) <b>1812 S 8TH ST</b>		5. City/State: St. Louis, Missouri
Alternate address: 1812 S 8th		Property Zip Code: 63104
Latitude: 38.608949		6. UTM Easting: 743586.48
Longitude: -90.202538		UTM Northing: 4277095.00
8. Historic Name (if known): N/A	11a. Historic Use (if known): Domestic	City Block: 372 City Ward: 7
9. Present/other name (if known):	7. Township-Range-Section: N/A	10. Ownership: Private
11b. Current Use: Domestic		Neighborhood Number: 21

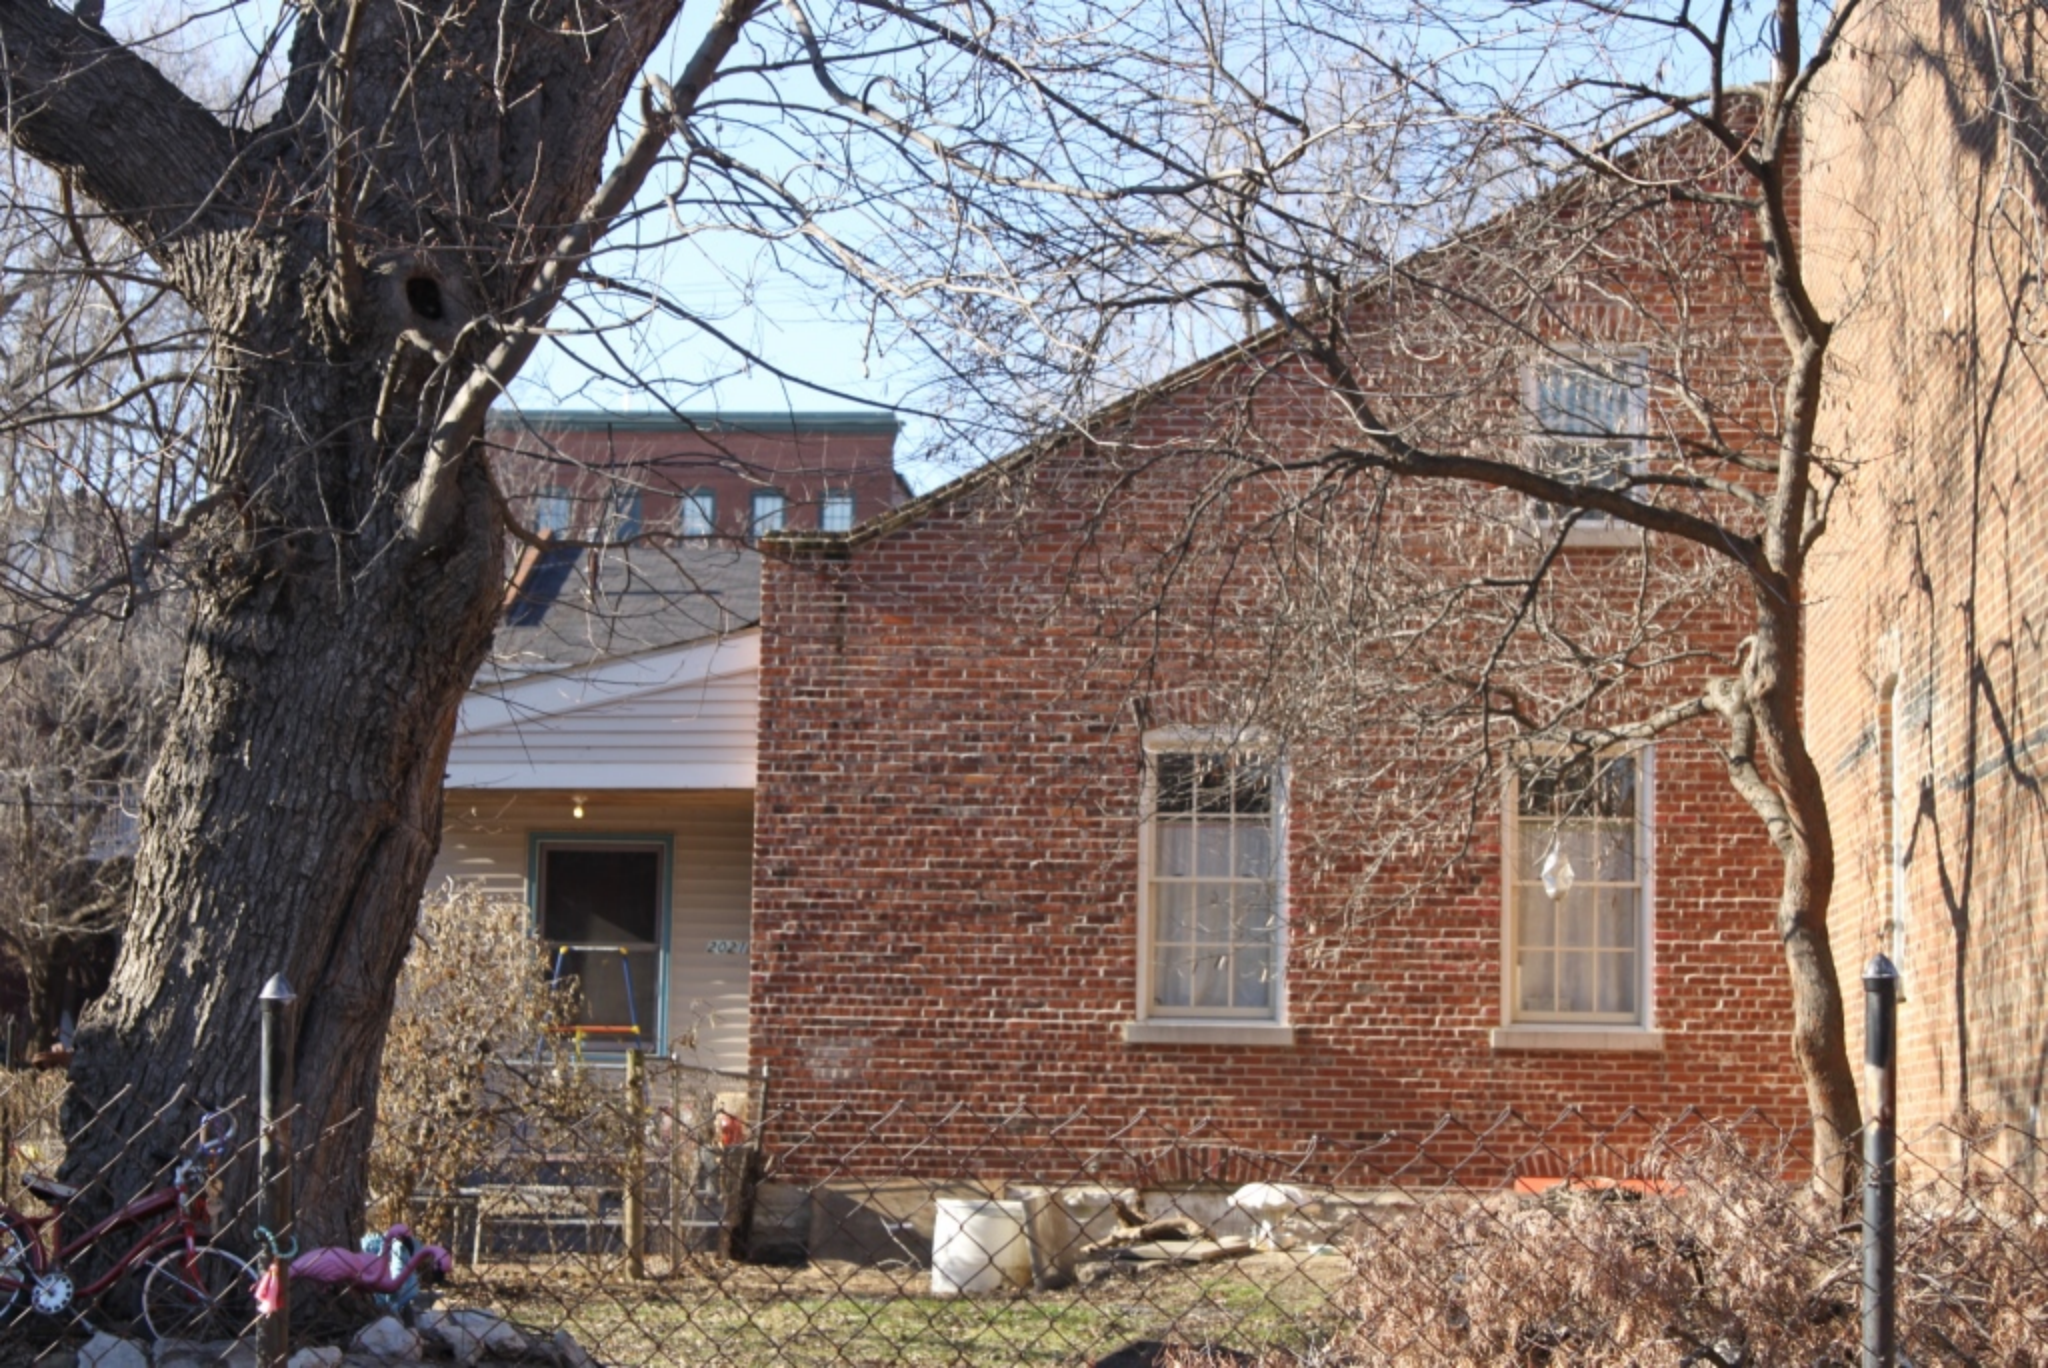
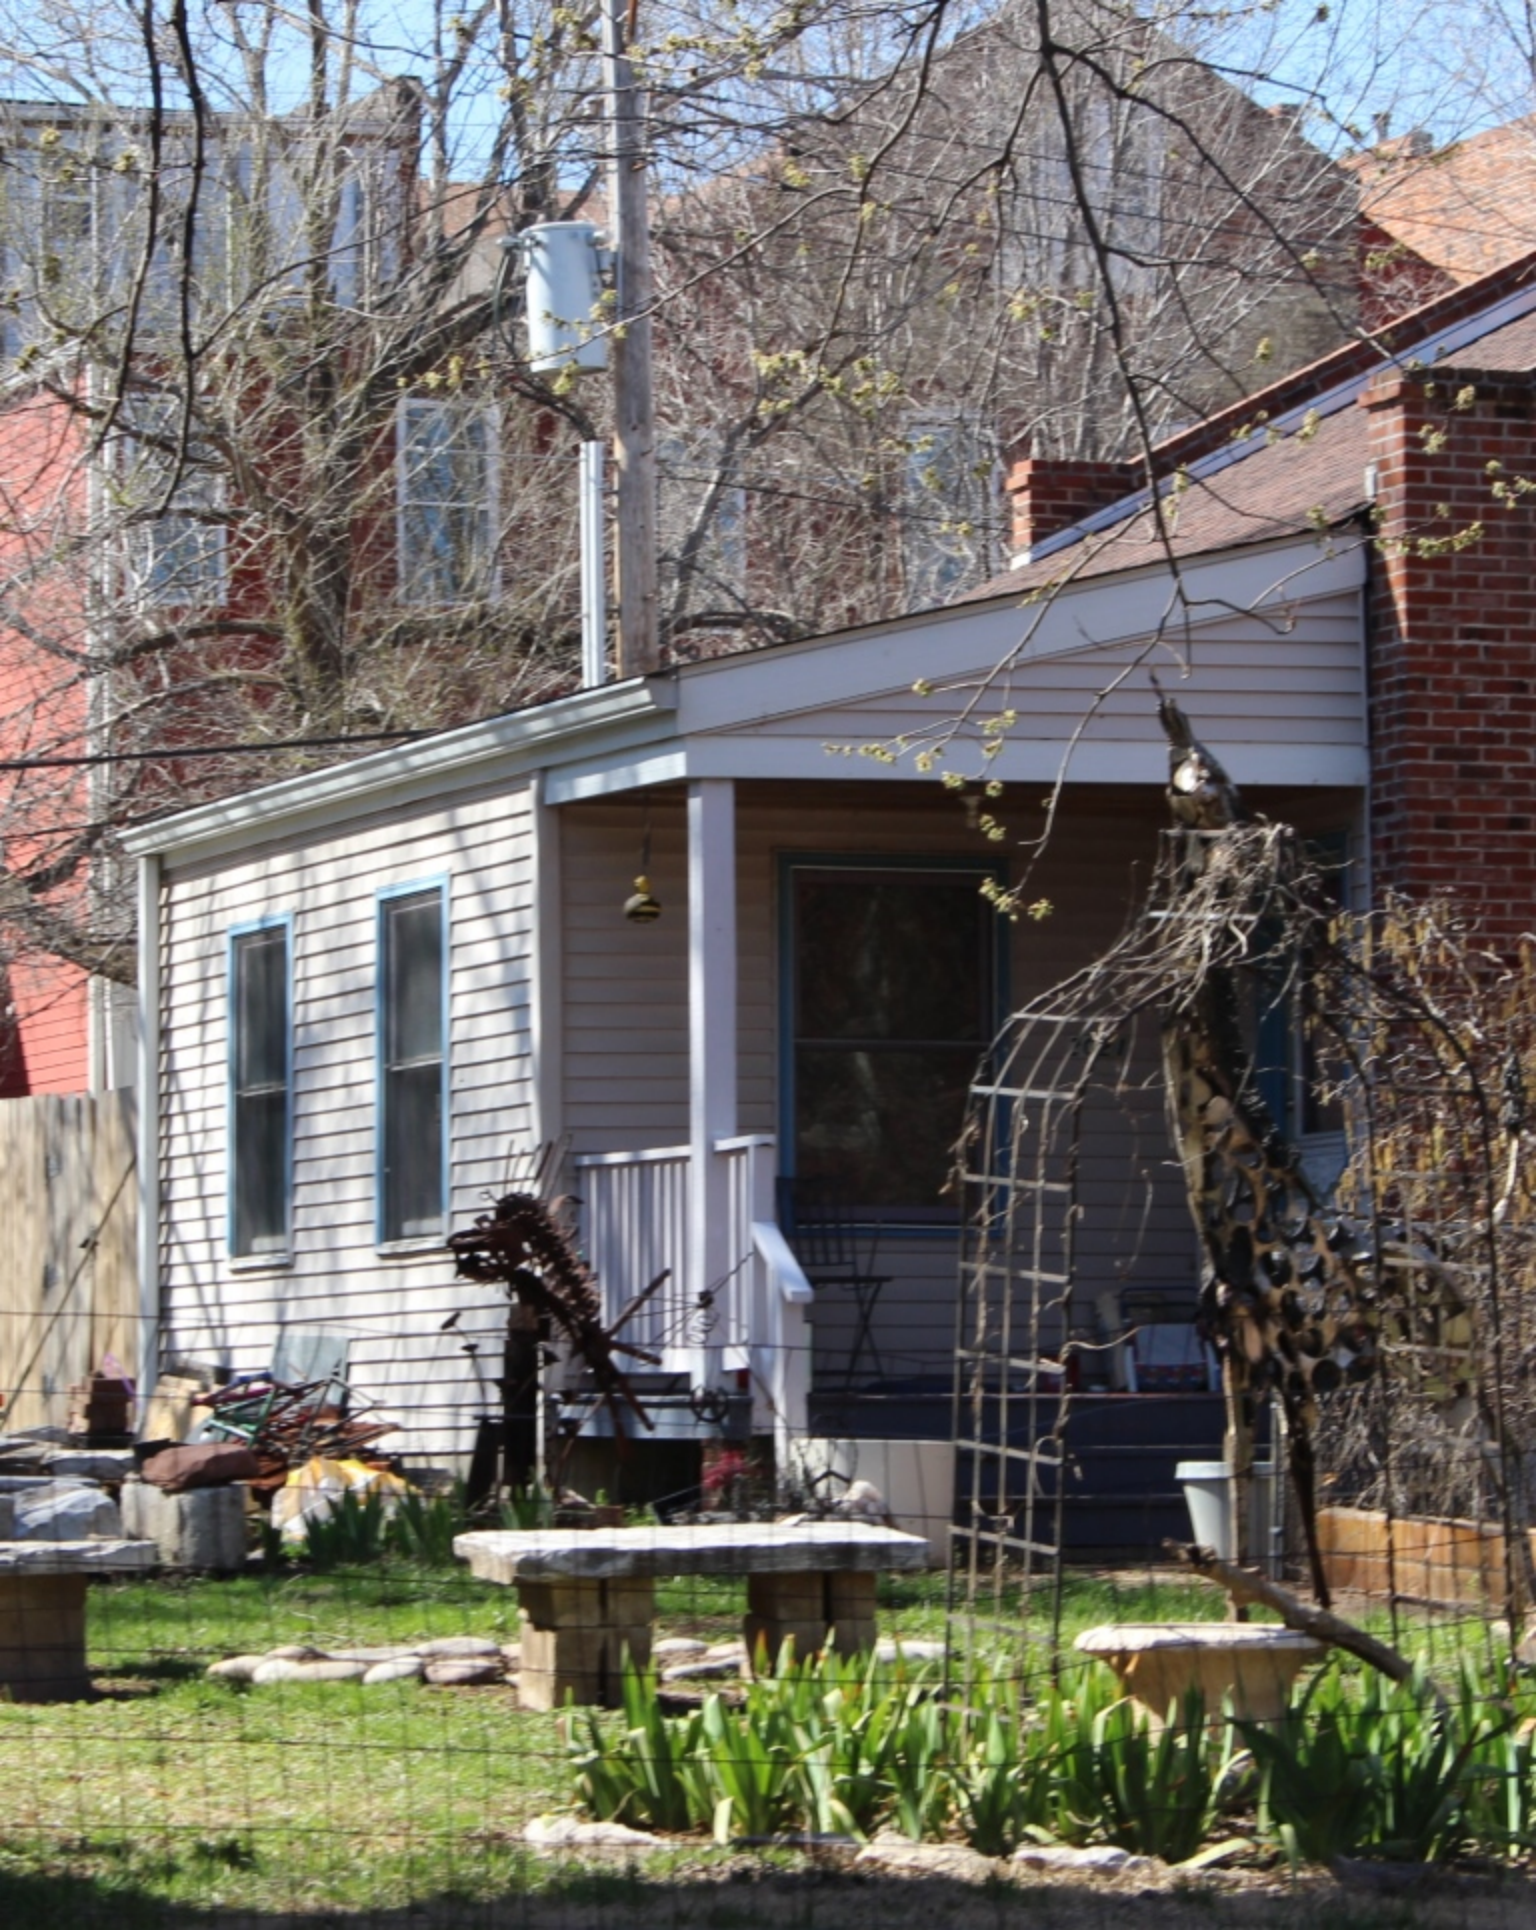
The one-and-a-half story brick flounder sits back off the street and it's north wall is attached to the neighboring flounder building. The front wall has a brick coping and a corbelled course near the top of the parapet. There area two six-over-six windows at the first story with segmental arch lintels and stone sills. There is a single small one-over-one window at the attic level with a segmental arch lintel and stone sill. The rubblestone foundation has been partially parged and the two small windows at the basement level have been boarded. The basement windows have segmental arch lintels. The original side-gallery porch has been enclosed behind a small recessed porch. The addition is sided in vinyl and the entry door is at the side near the front of the building, accessed from the recessed porch. There are three one-over-one windows on the south side of the building.

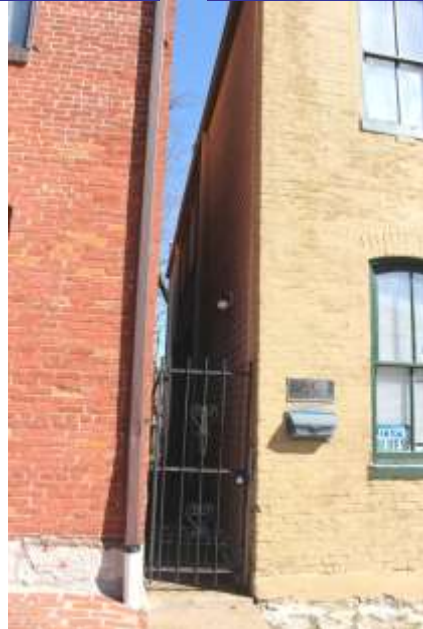
North elevation with gallery

The building is in fair-to-good condition and is fairly well-maintained. There is some minor cracking around the window sills.

The two-and-a-half story painted brick hipped-front flounder has simple gabled wood dormer on south side of the roof. The dormer has a 2-over-2 window and is sheathed in wood & wood clapboards. There is a chimney at the north edge of the front façade. The corbelled brick cornice has large dentils. There is an additional chimney at the south wall next to the dormer. There are three bays at both the first and second stories with 2-over-2 segmental arch double-hung windows with soldier brick lintels and painted stone sills. The rubblestone foundation has been painted at the front façade. Half of one boarded basement window is visible on the southernmost bay. The window has a segmental arch double rowlock lintel. The north side of the building contains the entry. The gallery porch along this wall has been enclosed and sheathed with vinyl siding. The rear has a more classic flounder appearance although slightly wider as it remains 3 bays wide at the rear. The windows on this elevation are 1-over-1 double-hungs.

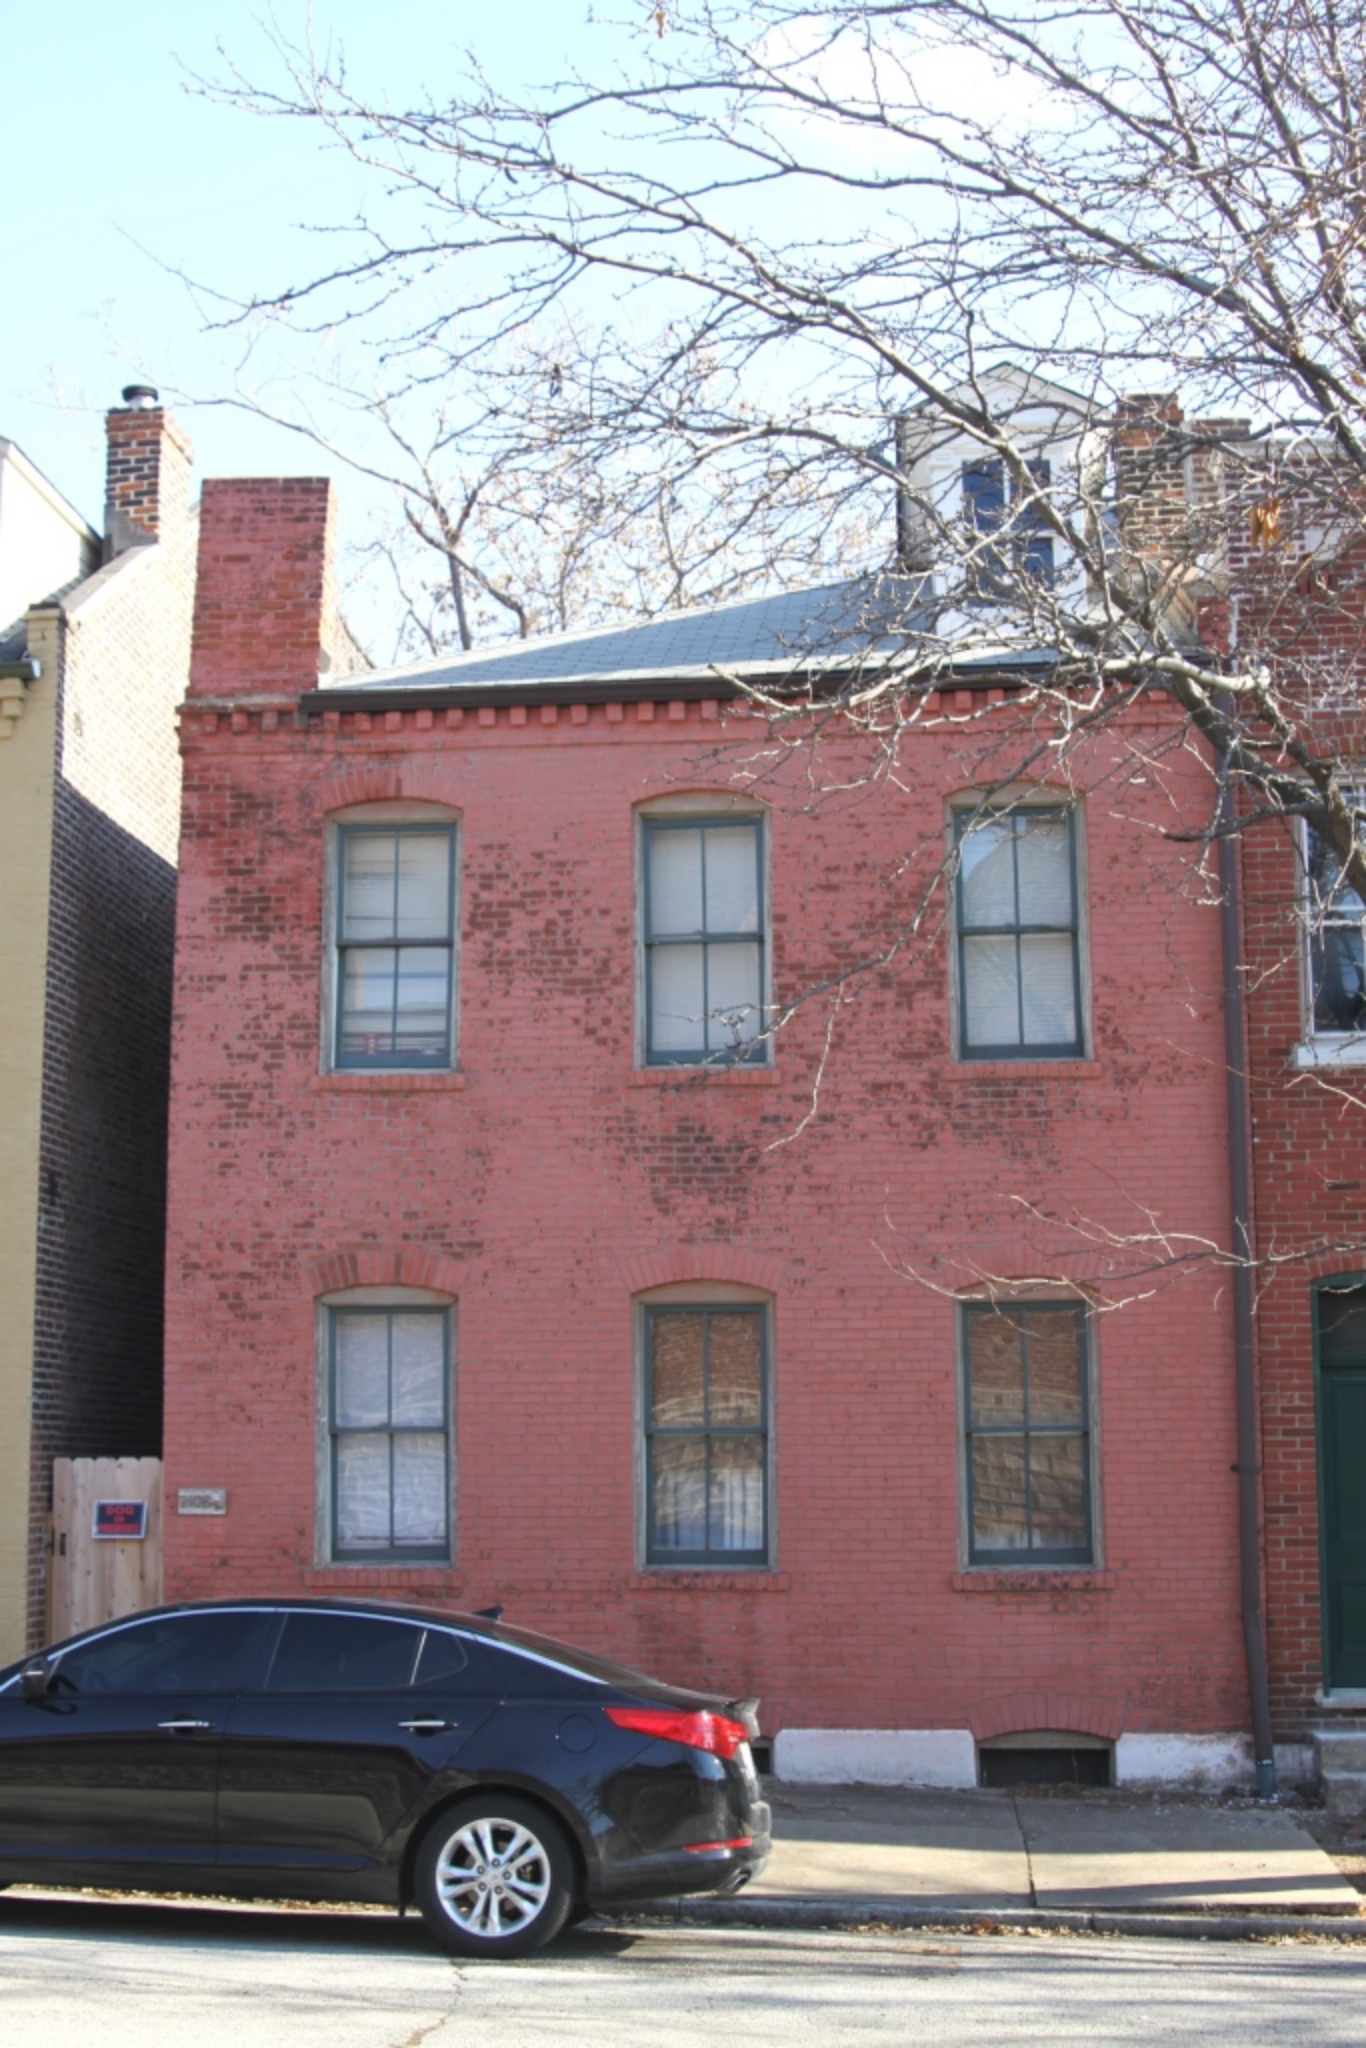
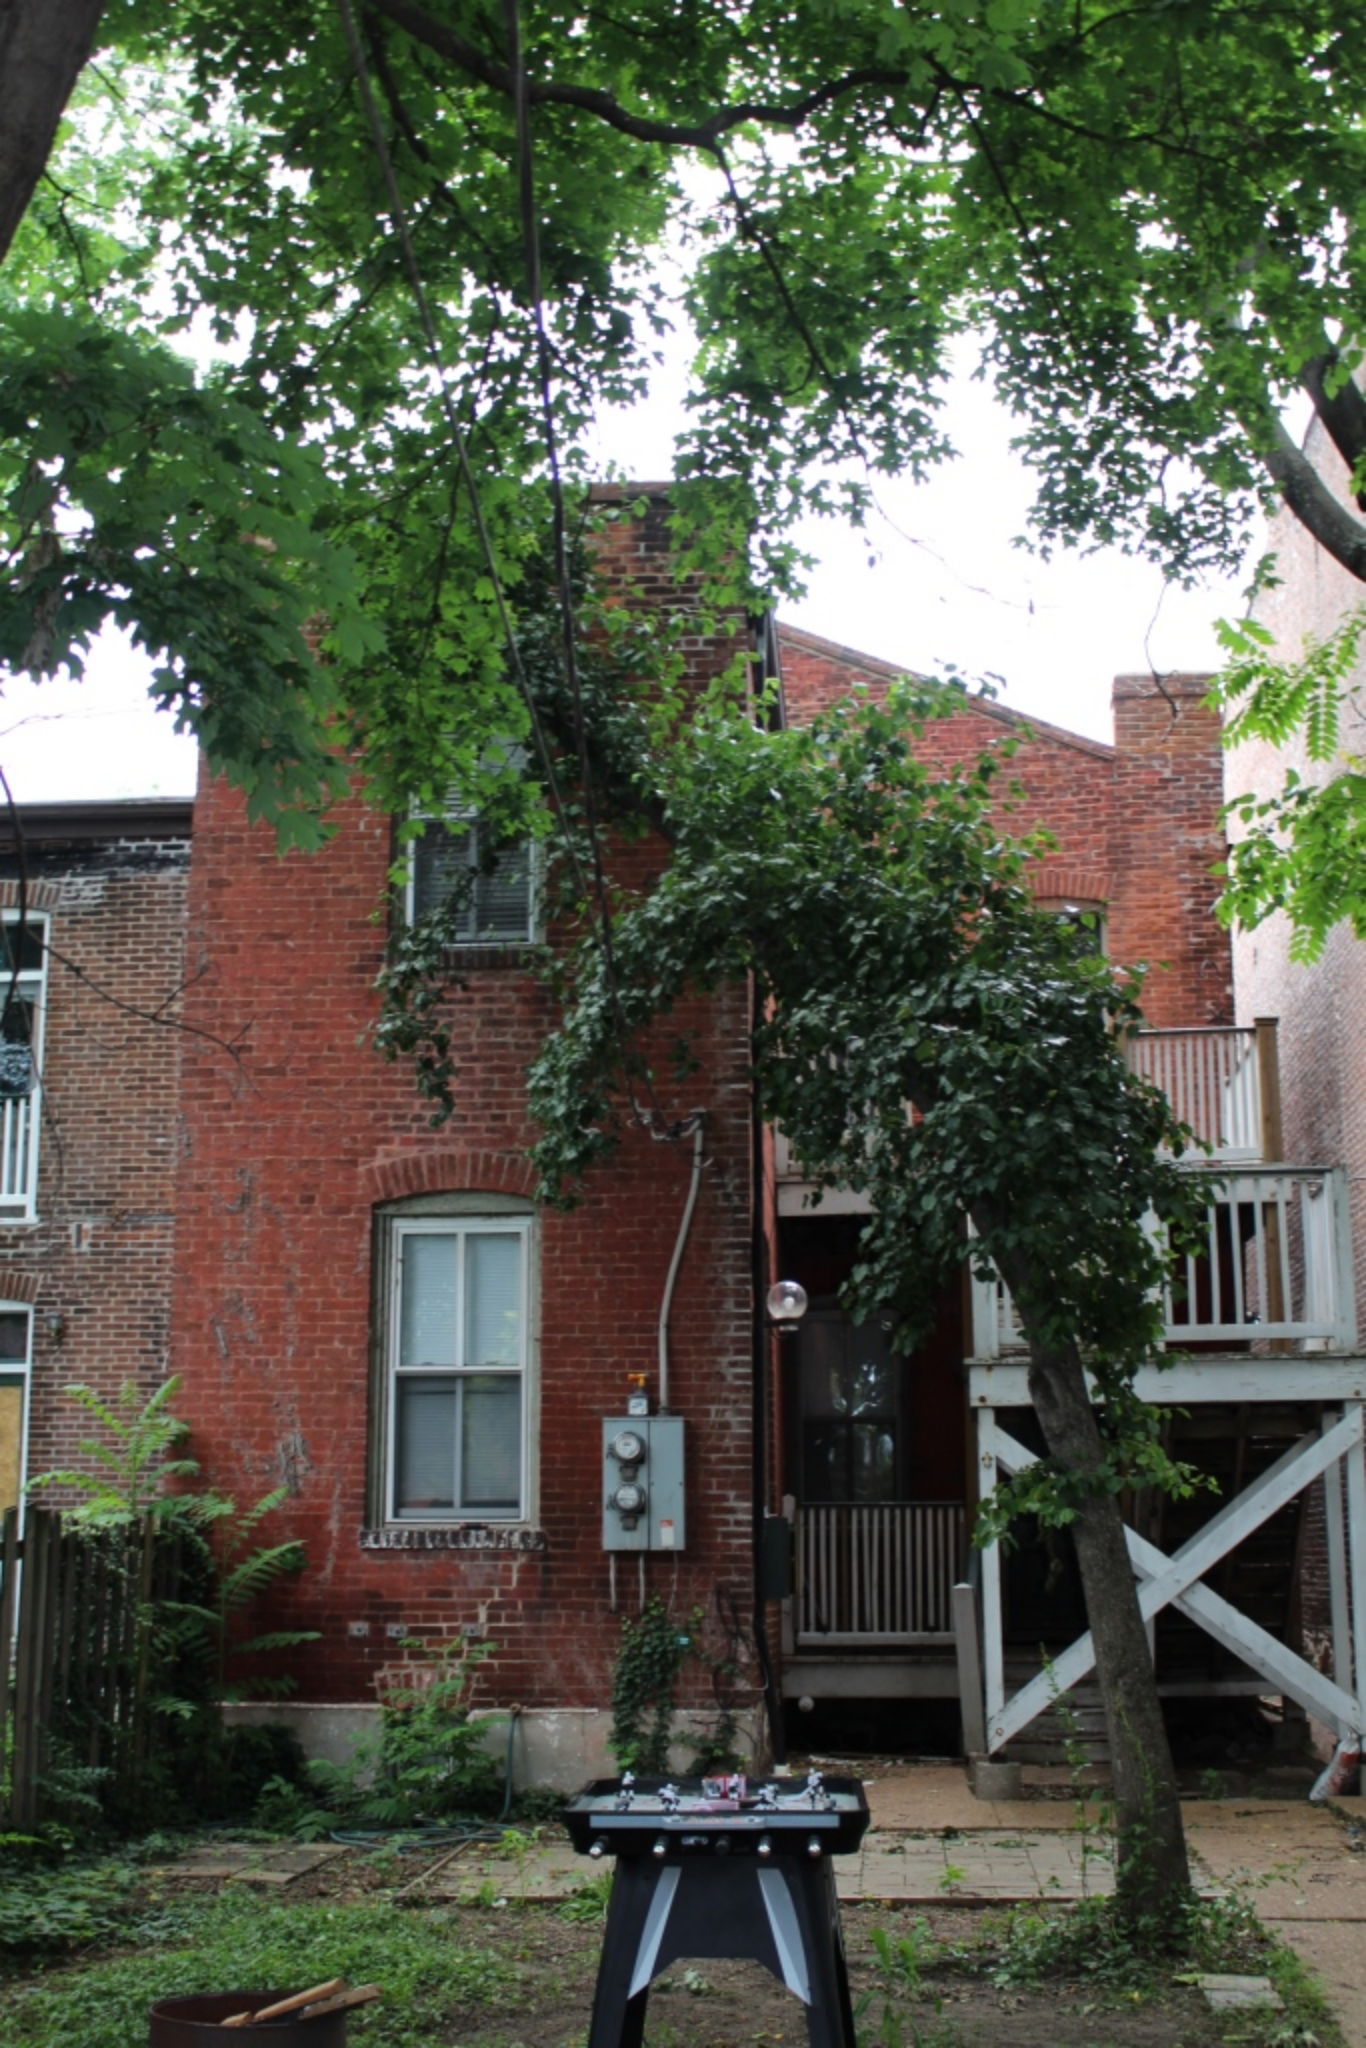
The two-and-a-half story painted brick hipped-front flounder has a decorative gabled wood dormer on south side of the roof. The dormer has a 2-over-2 window and is sheathed in wood & wood clapboards. There is a chimney at the north edge of the front façade. The corbelled brick cornice has large dentils. There is an additional chimney at the south wall next to the dormer. There are three bays at both the first and second stories with 2-over-2 double-hung windows with segmental arch soldier brick lintels and rowlock sills. There is a smooth painted stone finish at the foundation level. Two partial boarded basement windows are visible at the two southernmost bays. The window has a segmental arch double rowlock lintel. The north side of the building contains the entry, towards the rear. The gallery porch along this wall has been enclosed and sheathed with vinyl siding. The rear has a more classic flounder appearance although slightly wider as it remains 3 bays wide at the rear. A two-story flat-roofed brick addition covers one bay of the rear elevation. The windows on this elevation are also 2-over-2 double-hungs.

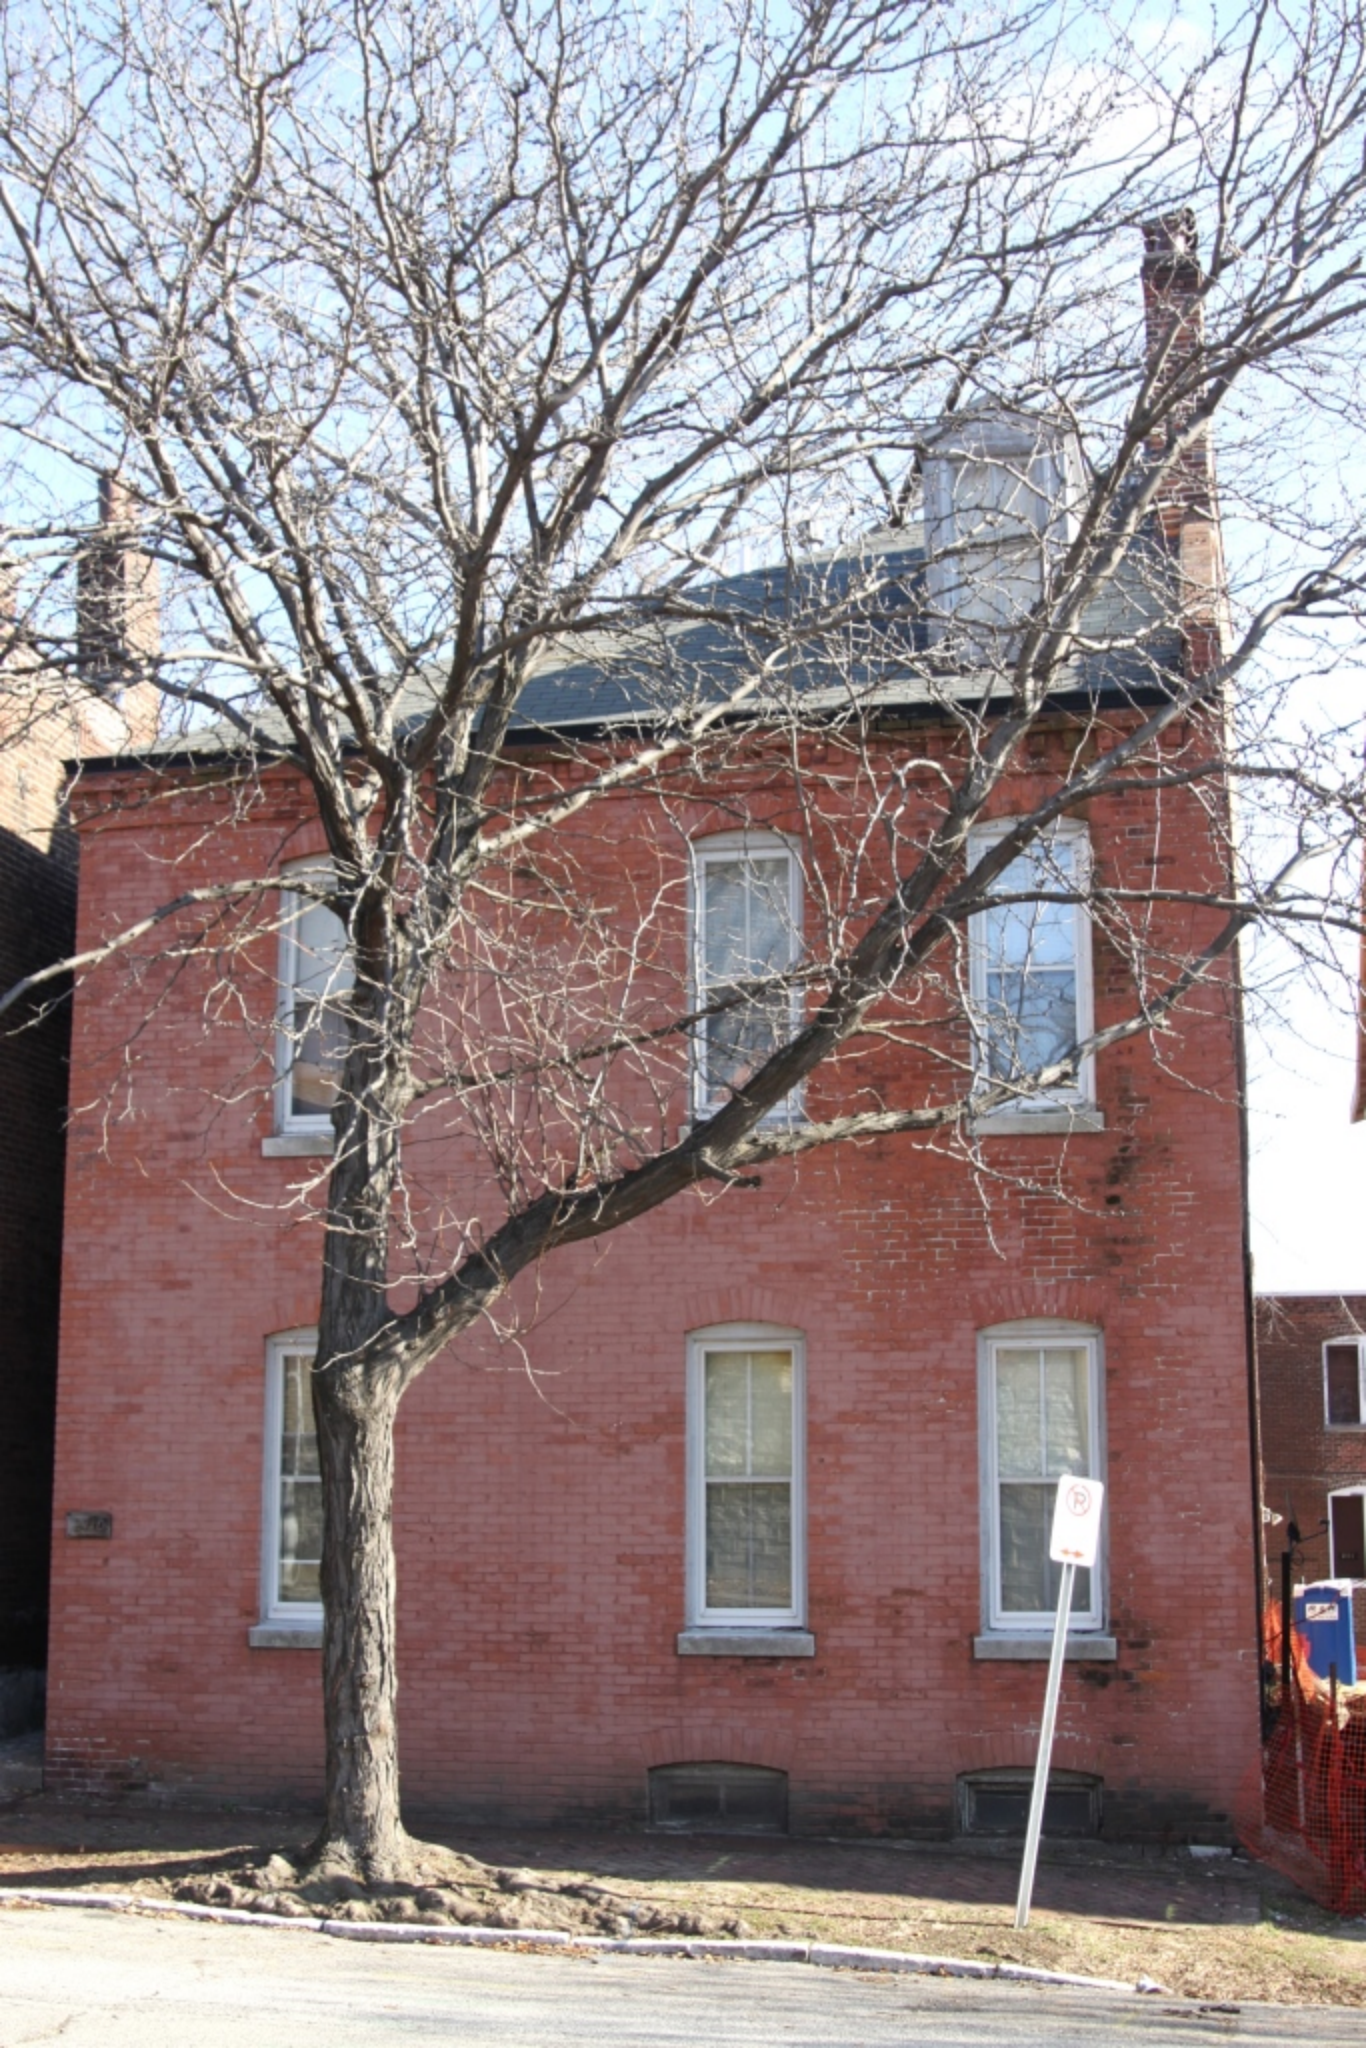
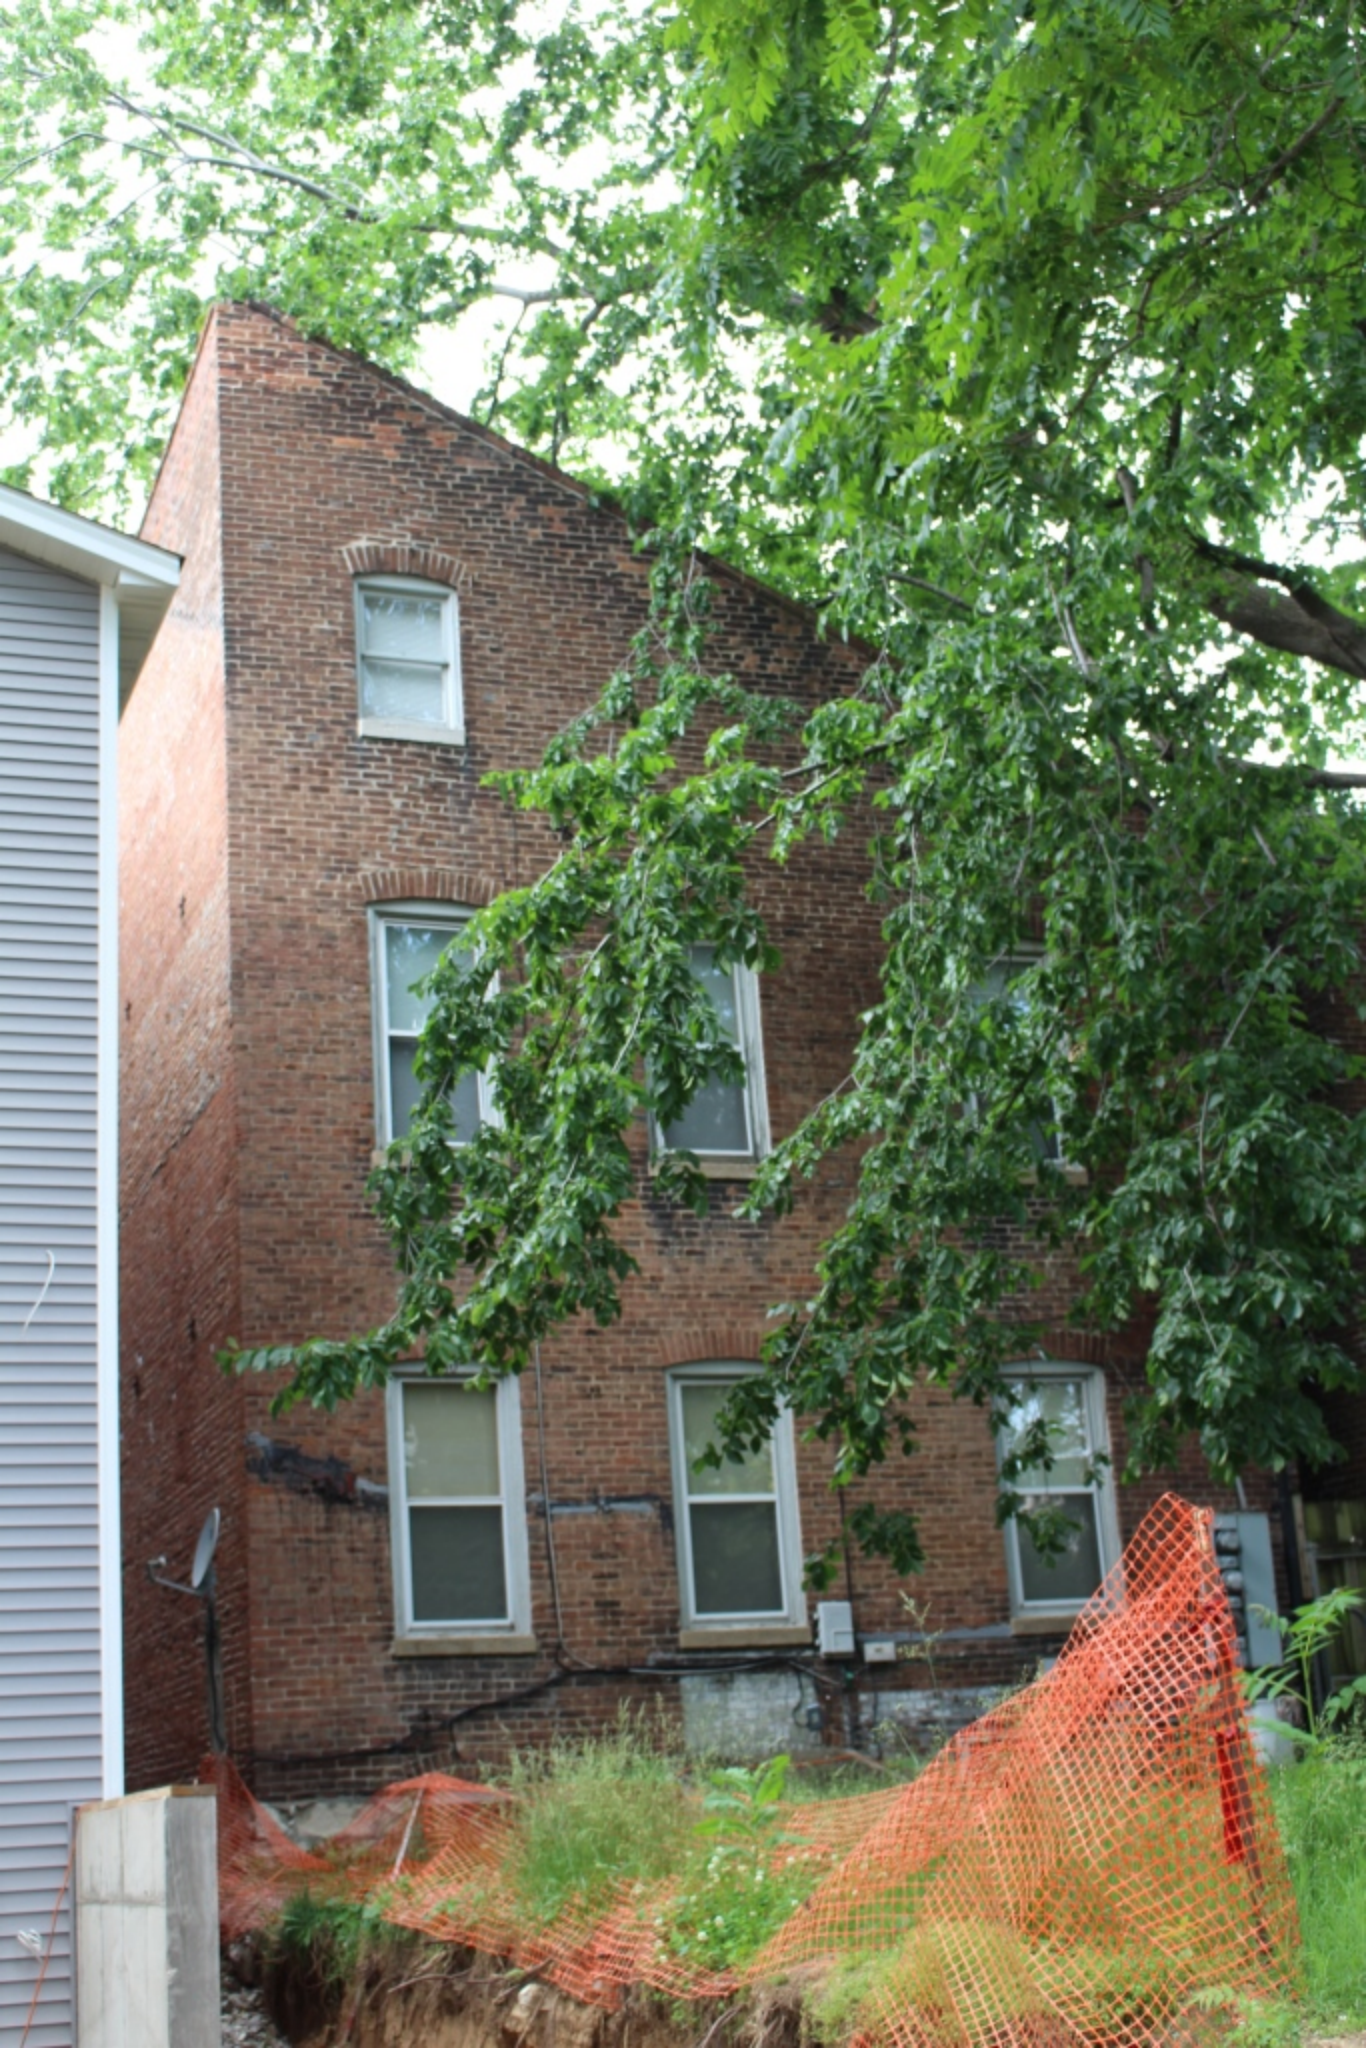
The two-and-a-half story painted brick hipped-front flounder has simple gabled wood dormer on south side of the roof. The dormer has a 2-over-2 window and is sheathed in wood & wood clapboards. The corbelled brick cornice has large dentils. There is a chimney at the south wall next to the dormer. There are three bays at both the first and second stories with 2-over-2 segmental arch double-hung windows with soldier brick lintels and stone sills. The façade is not symmetrical, with the northernmost bay set apart from the other two. The foundation is not visible at the front façade. There are two small basement windows visible at the southernmost bays. The two-light windows have segmental arch soldier brick lintels. The north side of the building contains the entry. The gallery porch along this wall has been partially enclosed and sheathed with beadboard-type siding. The center portion of the gallery remains open. The rear has a more classic flounder appearance although slightly wider as it remains 3 bays wide at the rear. The windows on this elevation are 1-over-1 double-hungs.

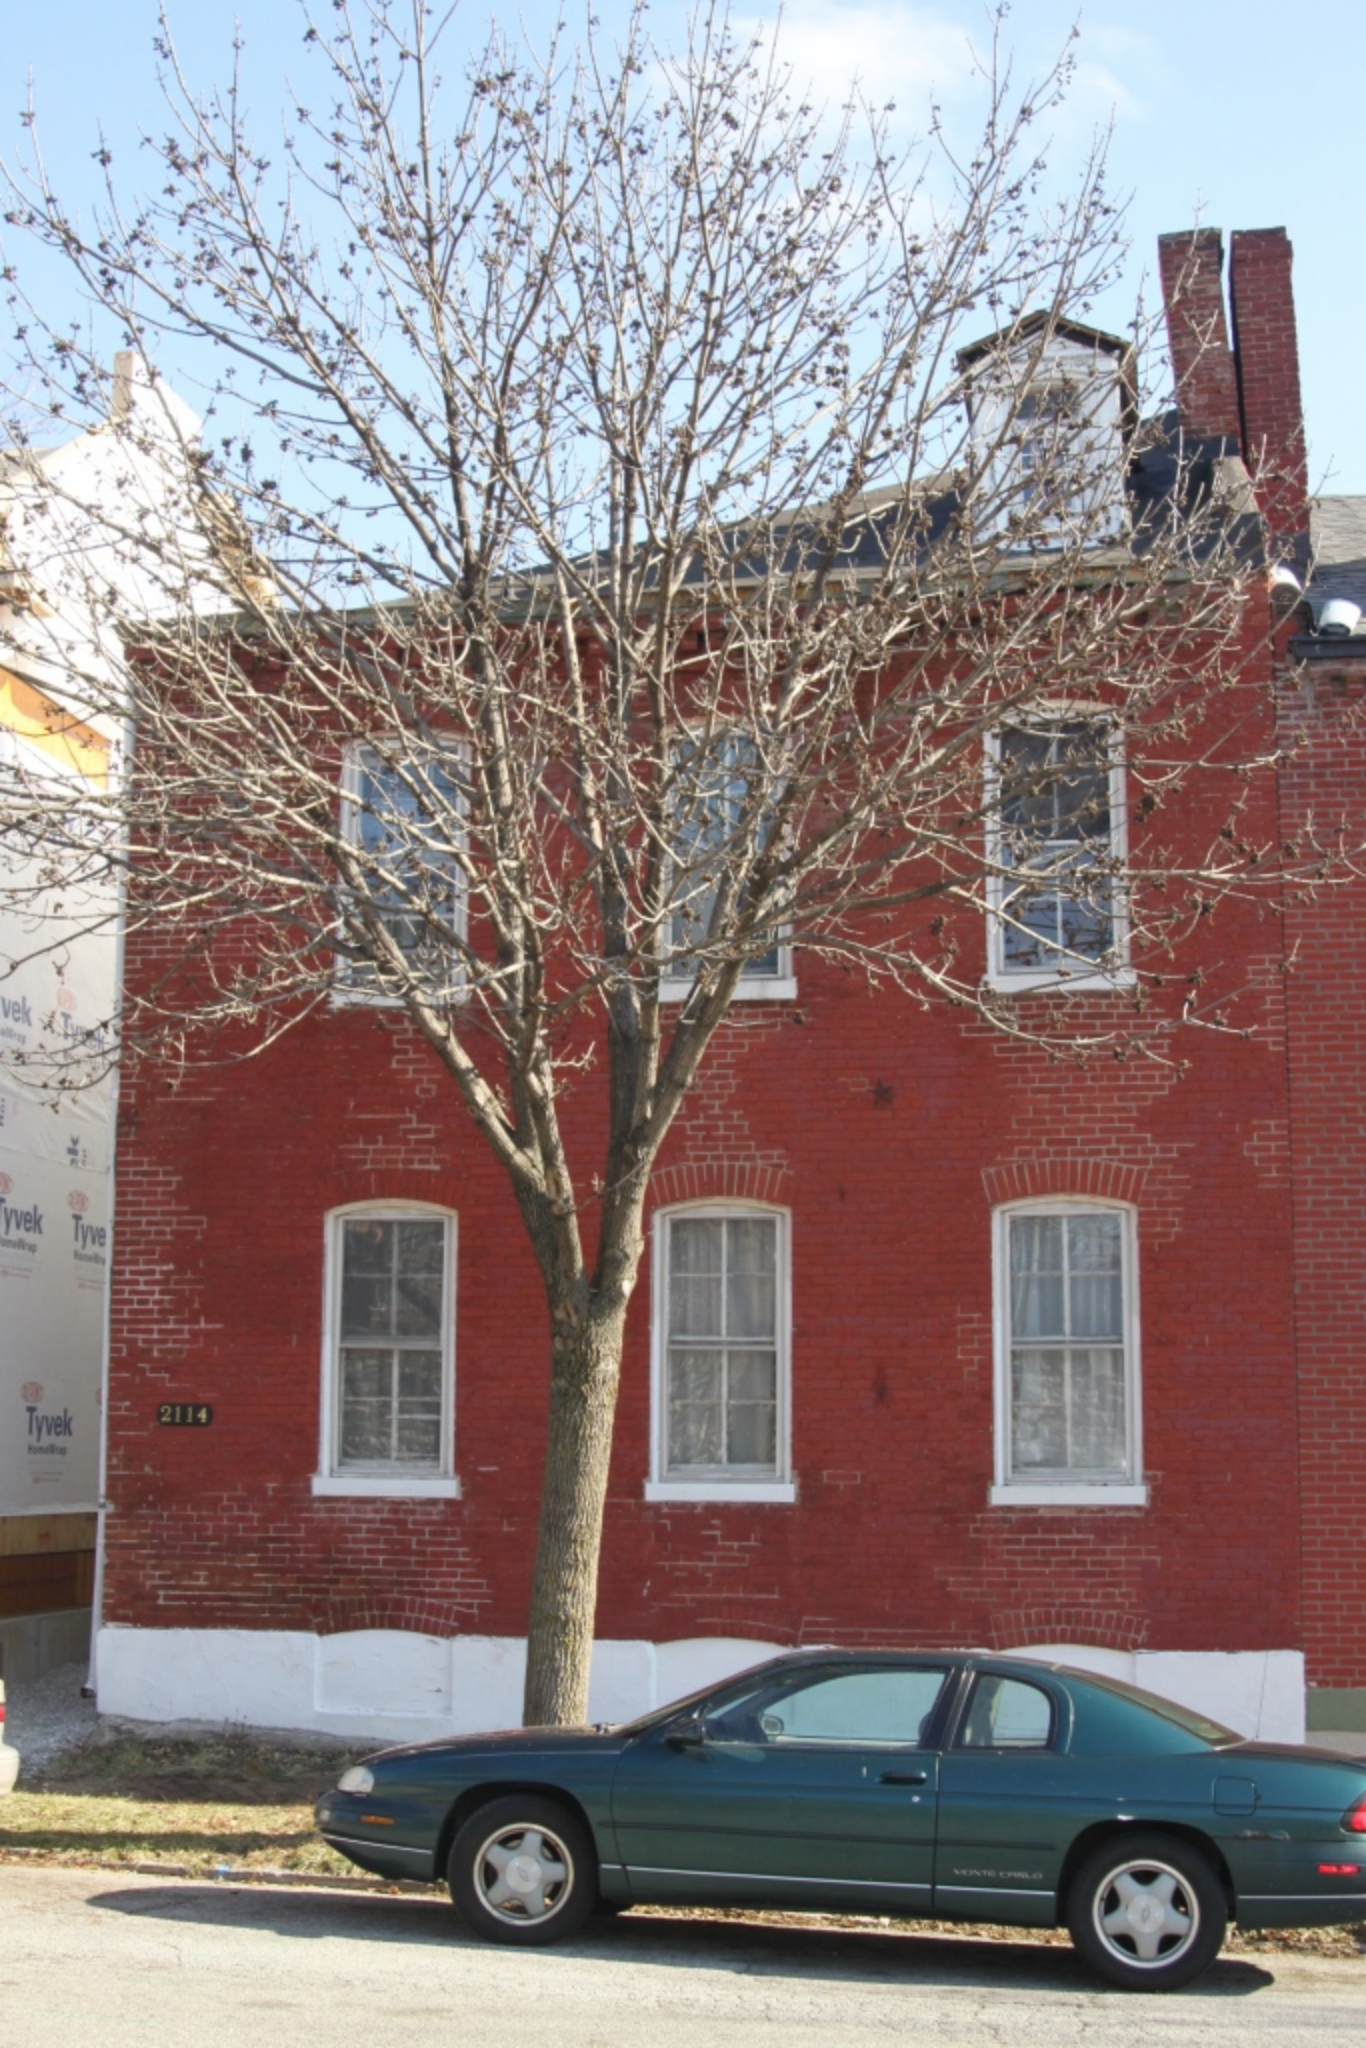
The two-and-a-half story brick hipped-front flounder has simple gabled wood dormer on south side of the roof. The dormer has a small window which has been altered and is sheathed in wood & wood clapboards. The corbelled brick cornice has large dentils. There is a chimney at the south wall next to the dormer. There are three bays at both the first and second stories with 4-over-4 segmental arch double-hung windows with soldier brick lintels and painted stone sills. The ashlar stone foundation has been painted at the front façade. There are three boarded windows at the basement level. The windows have segmental arch double rowlock lintels. The north side of the building contains two entries. The gallery porch along this wall has been enclosed and sheathed with vinyl siding. The rear has a more classic flounder appearance although slightly wider as it remains 3 bays wide at the rear. The windows on the first story of this elevation are 6-over-6double-hungs, while those at the second story are 2-over-2.
