**ARCHITECTURAL/HISTORIC INVENTORY FORM - Cultural Resources Office**  
**St. Louis Planning and Urban Design**

1. Survey no. SLC-AS-053-0001	2. Survey name: Thematic Survey of Flounder Houses in St. Louis City	3. County: St. Louis [Independent City]
4. Address: (from City GEO database) <b>1812 S 8TH ST</b>		5. City/State: St. Louis, Missouri
Alternate address: 1812 S 8th		Property Zip Code: 63104
Latitude: 38.608949		6. UTM Easting: 743586.48
Longitude: -90.202538		UTM Northing: 4277095.00
8. Historic Name (if known): N/A	11a. Historic Use (if known): Domestic	City Block: 372 City Ward: 7
9. Present/other name (if known):	7. Township-Range-Section: N/A	10. Ownership: Private
11b. Current Use: Domestic		Neighborhood Number: 21

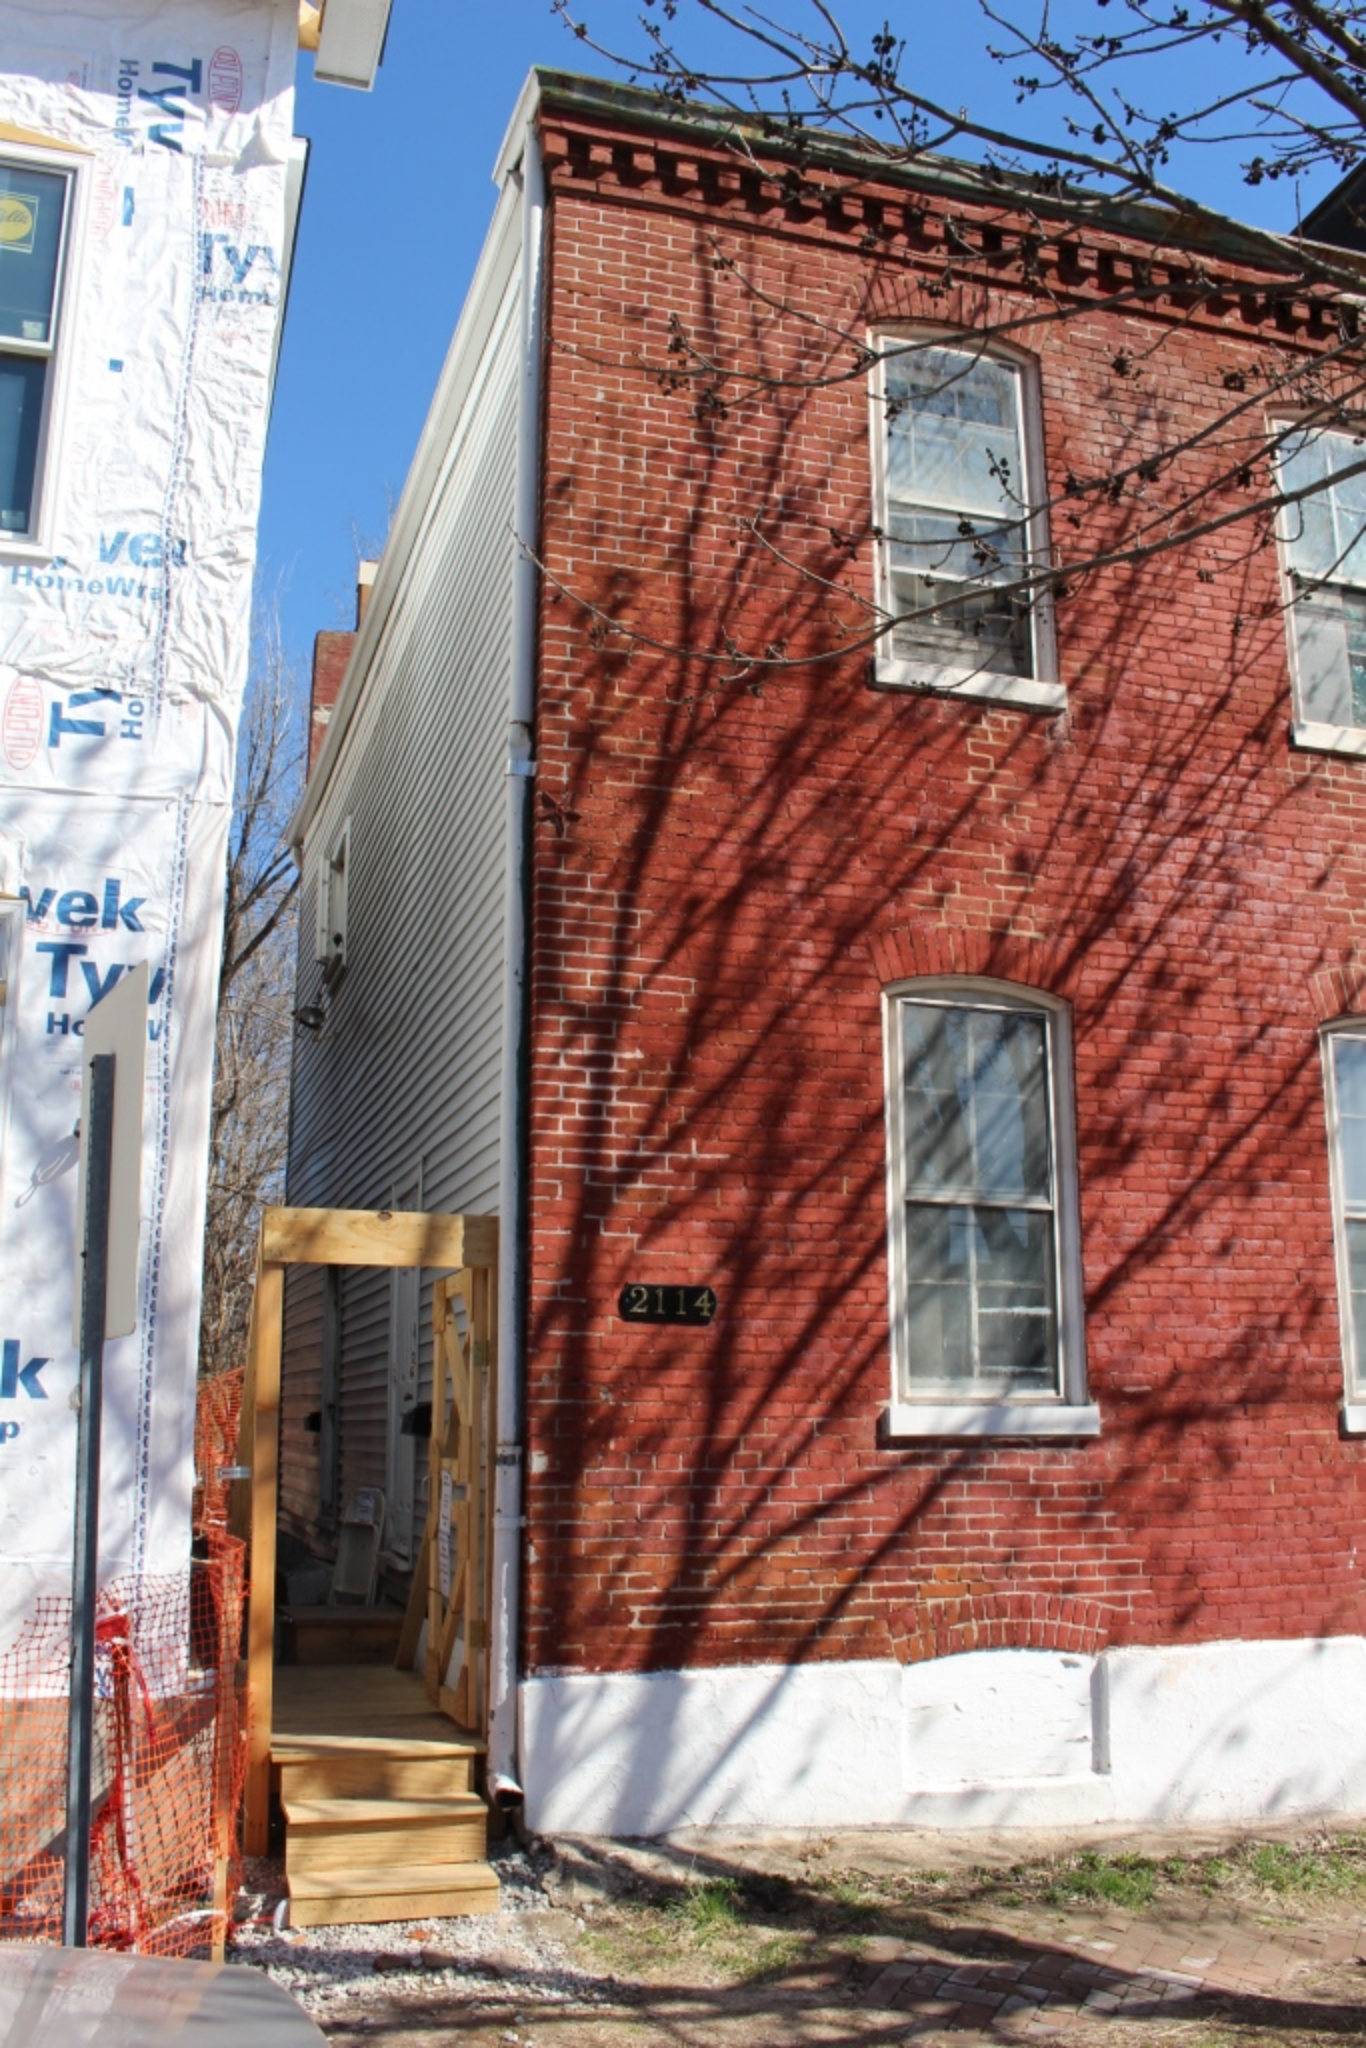
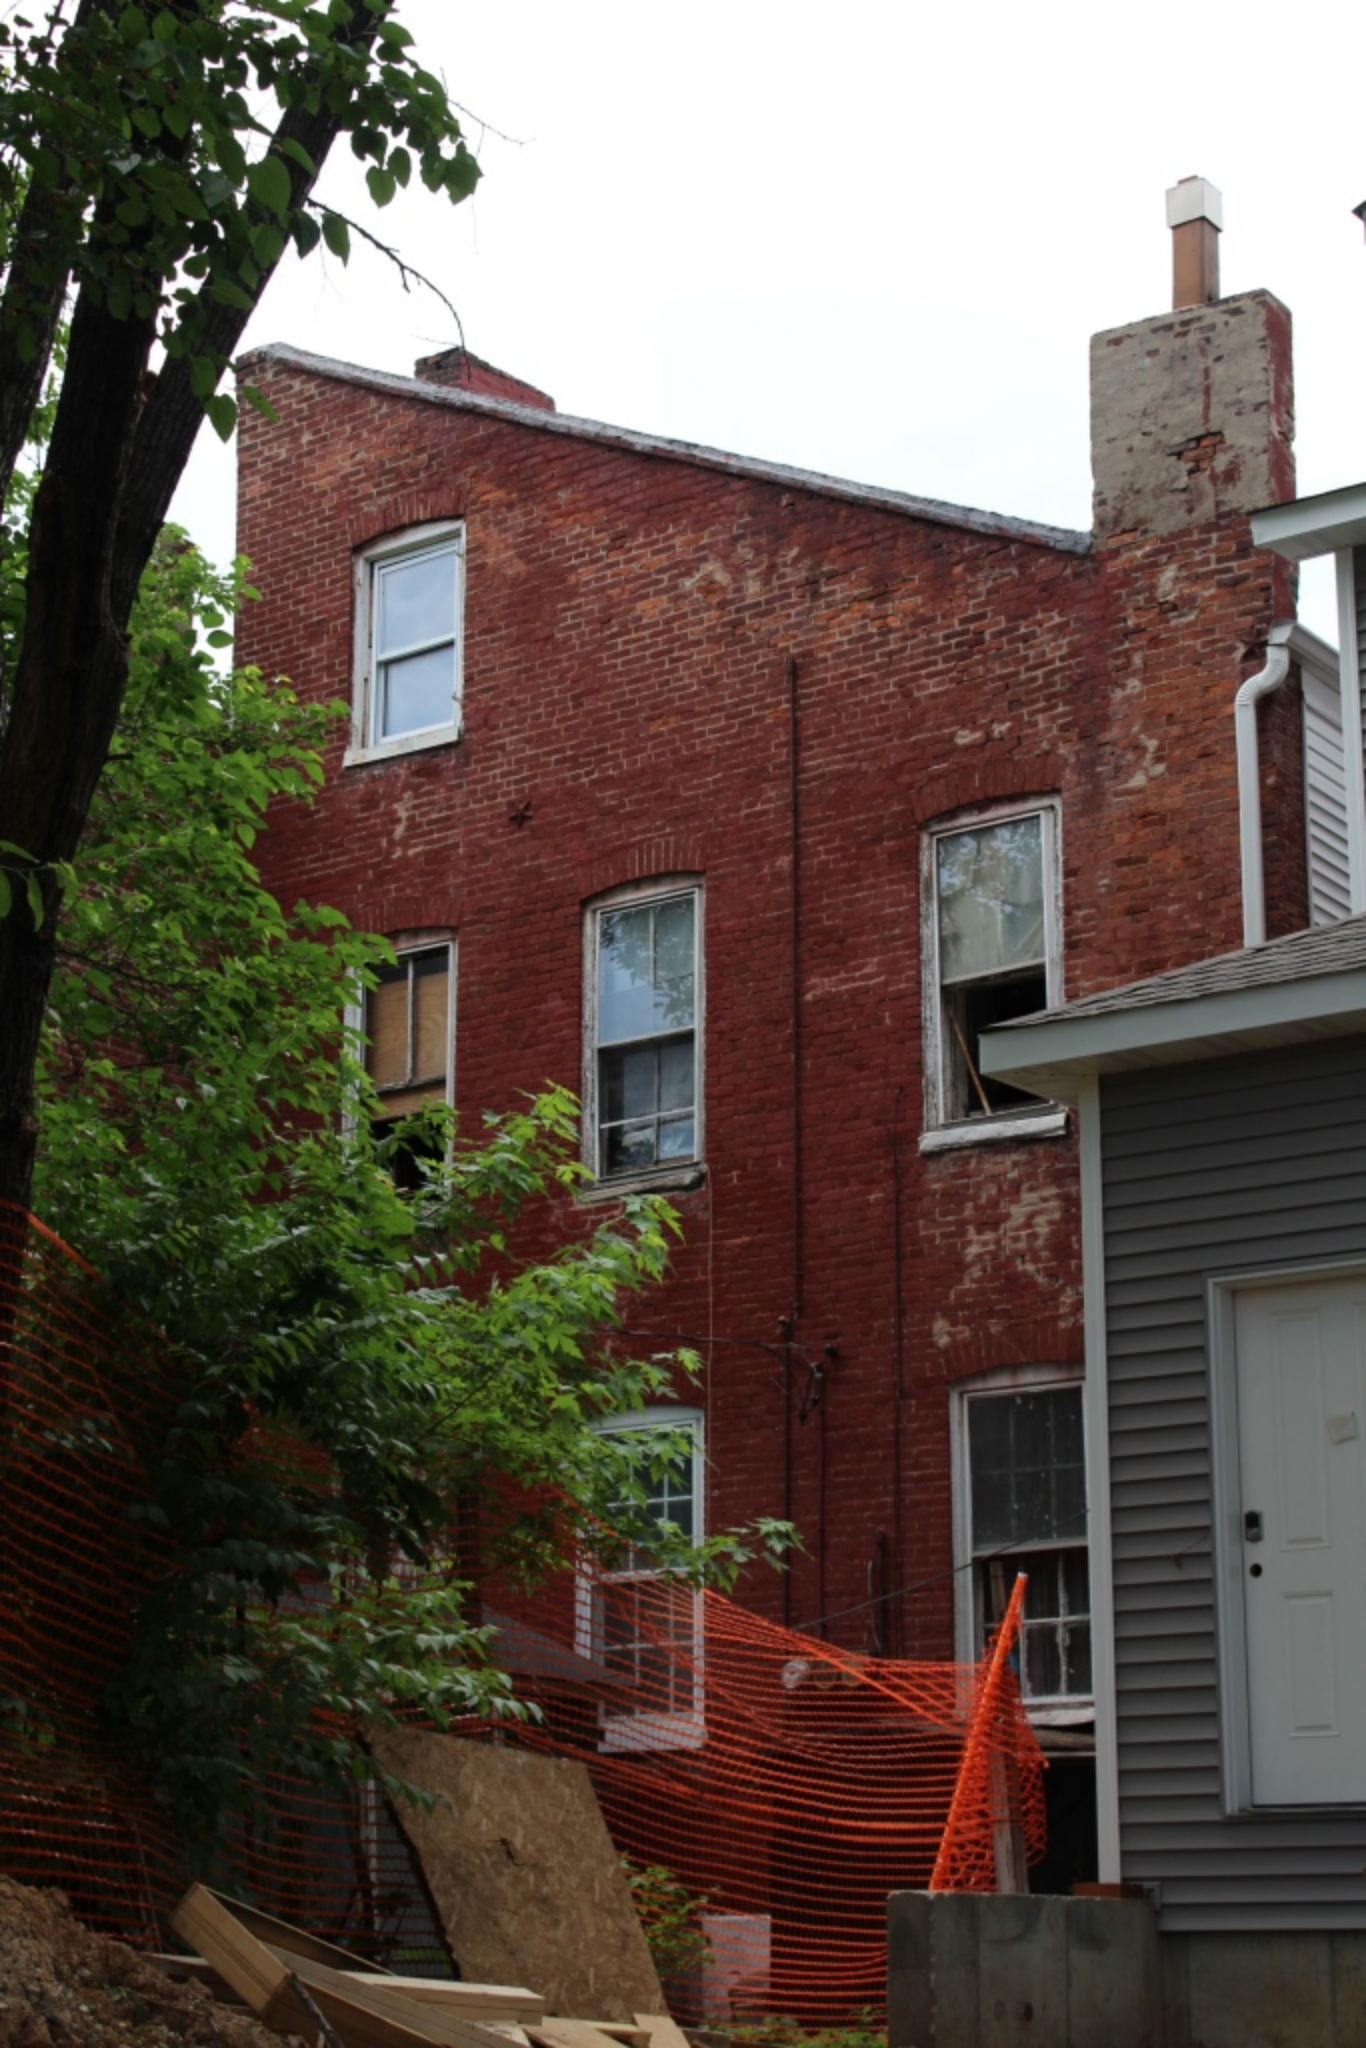
The two-and-a-half story painted brick hipped-front flounder has simple gabled wood dormer on south side of the roof. The dormer has a 2-over-2 window and is sheathed in wood & wood clapboards. The corbelled brick cornice has large dentils. There is a chimney at the south wall next to the dormer. There are three bays at both the first and second stories with 2-over-2 segmental arch double-hung windows with soldier brick lintels and stone sills. The façade is not symmetrical, with the northernmost bay set apart from the other two. The foundation is not visible at the front façade. There are two small basement windows visible at the southernmost bays. The two-light windows have segmental arch soldier brick lintels. The north side of the building contains the entry. The gallery porch along this wall has been partially enclosed and sheathed with beadboard-type siding. The center portion of the gallery remains open. The rear has a more classic flounder appearance although slightly wider as it remains 3 bays wide at the rear. The windows on this elevation are 1-over-1 double-hungs.

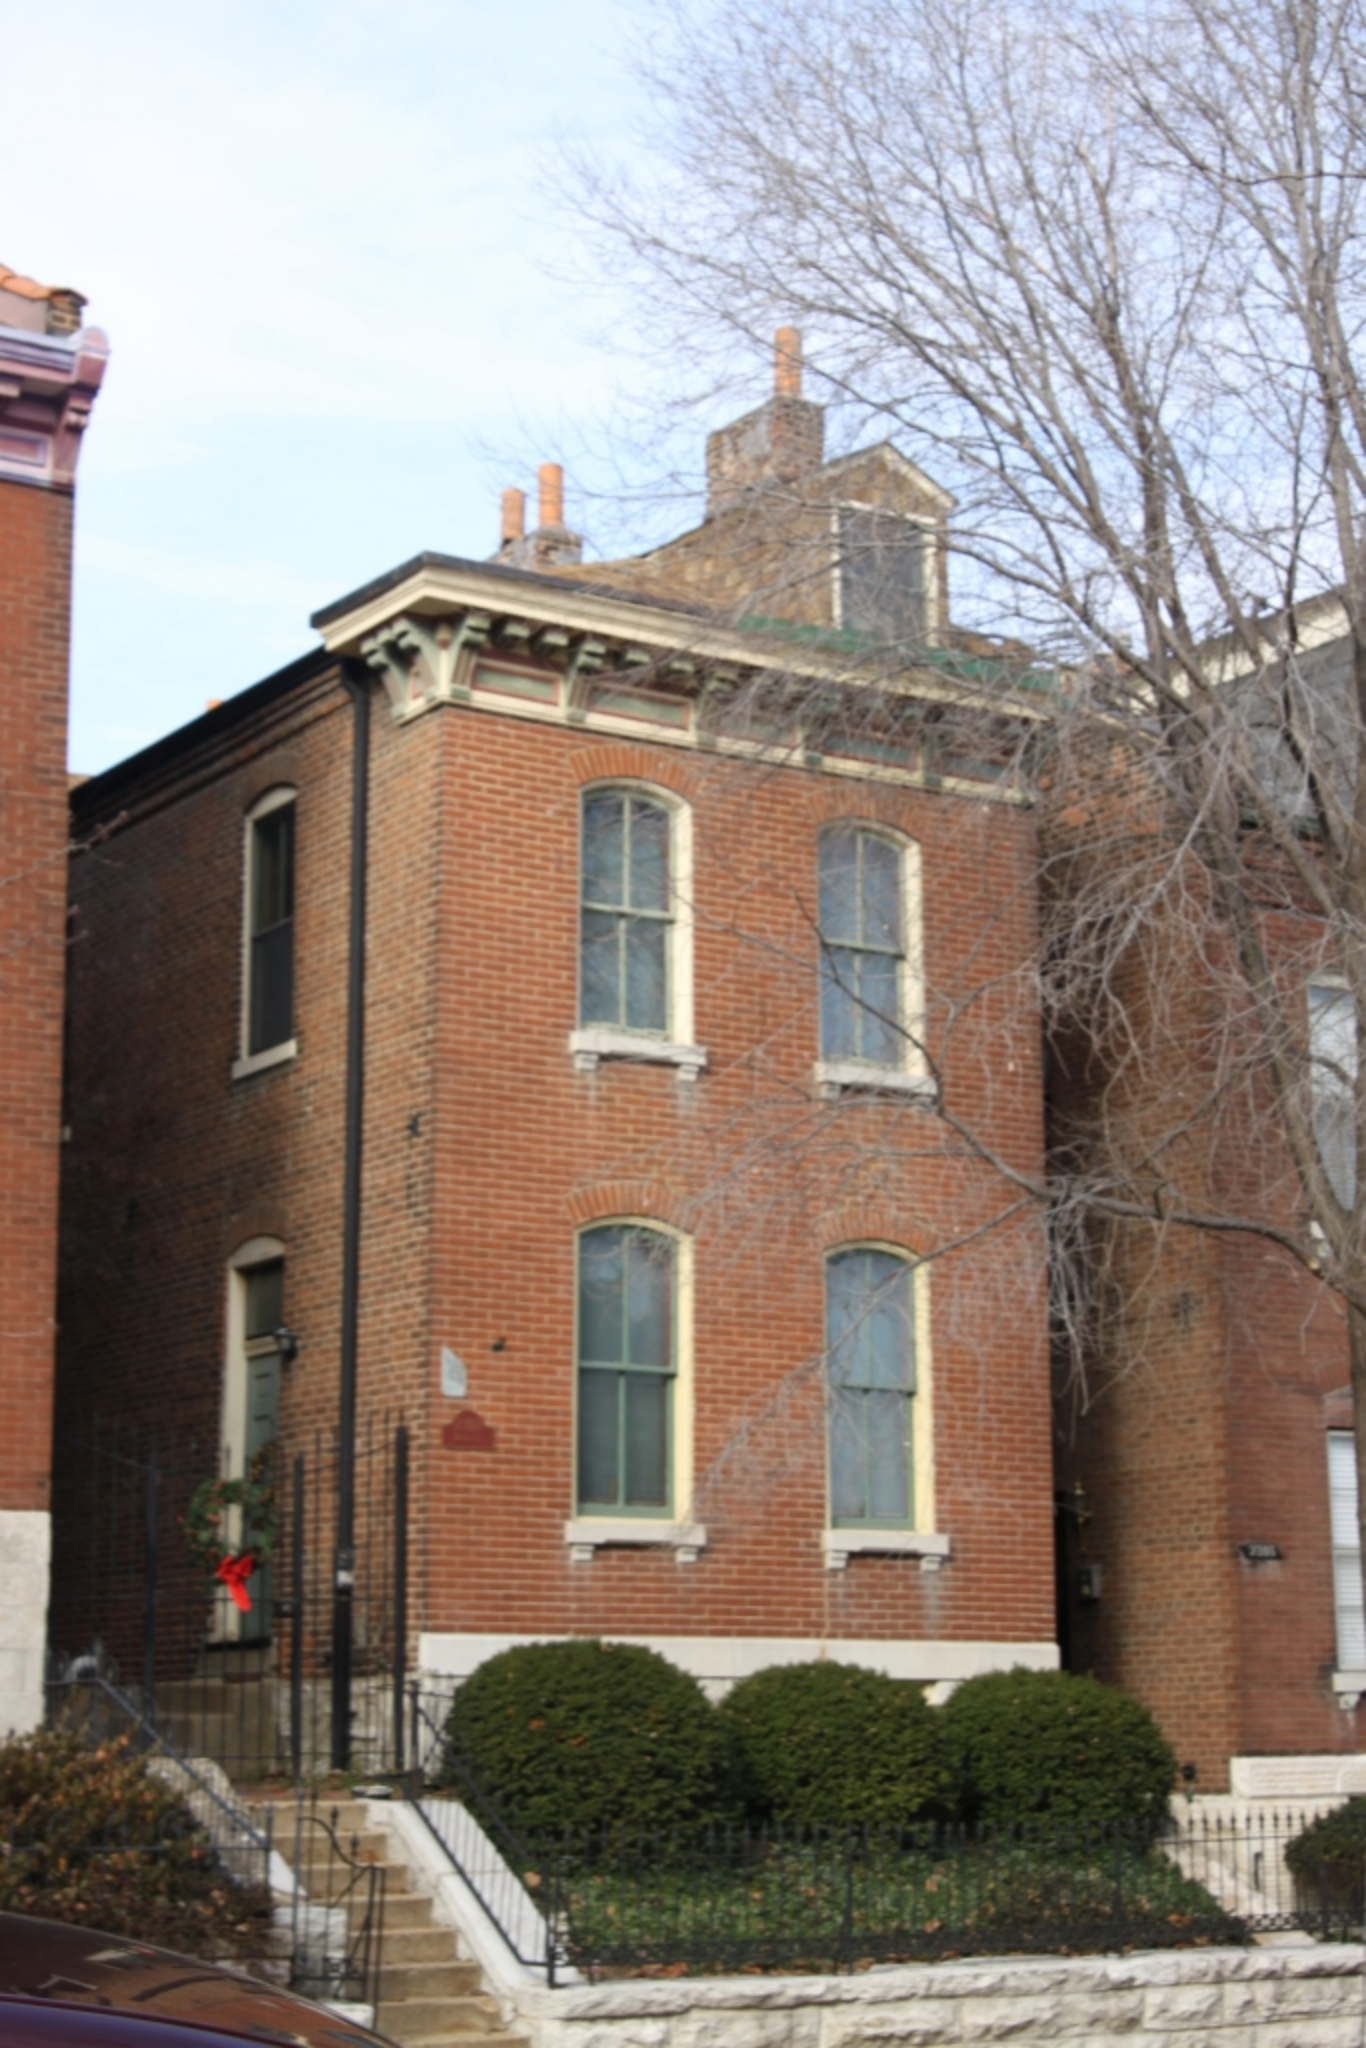
The two-story hipped roof brick flounder has a bracketed wood cornice which returns slightly along the south elevation. There is a simple gabled dormer toward the north side sheathed in asphalt shingles. A chimney sits on the north side slightly behind the dormer. The first and second stories have two bays with 2-over-2 segmental arch double-hung wood windows with soldier brick lintels and bracketed stone sills. There is a smooth ashlar limestone watertable with a tooled, coursed ashlar foundation below. Two two-light french casement windows are present at the basement level. The south elevation has a corbeled brick cornice which extends from the bracketed wood cornice. There is an entry close to the front of this elevation. There is a second entry closer to a rear ell section. What used to be a two-story porch where the ell meets the main section of the house has been enclosed at the second story and sheathed in asphalt-shingle siding. The base of the first story porch has also been removed but the porch column remains. The two-story rear ell has a side gable roof and appear from the rear to resemble and I-house, being one room deep with a center entry. There are three bays at the rear with two-over-two double-hung windows. There is also a chimney on either side of the ell.

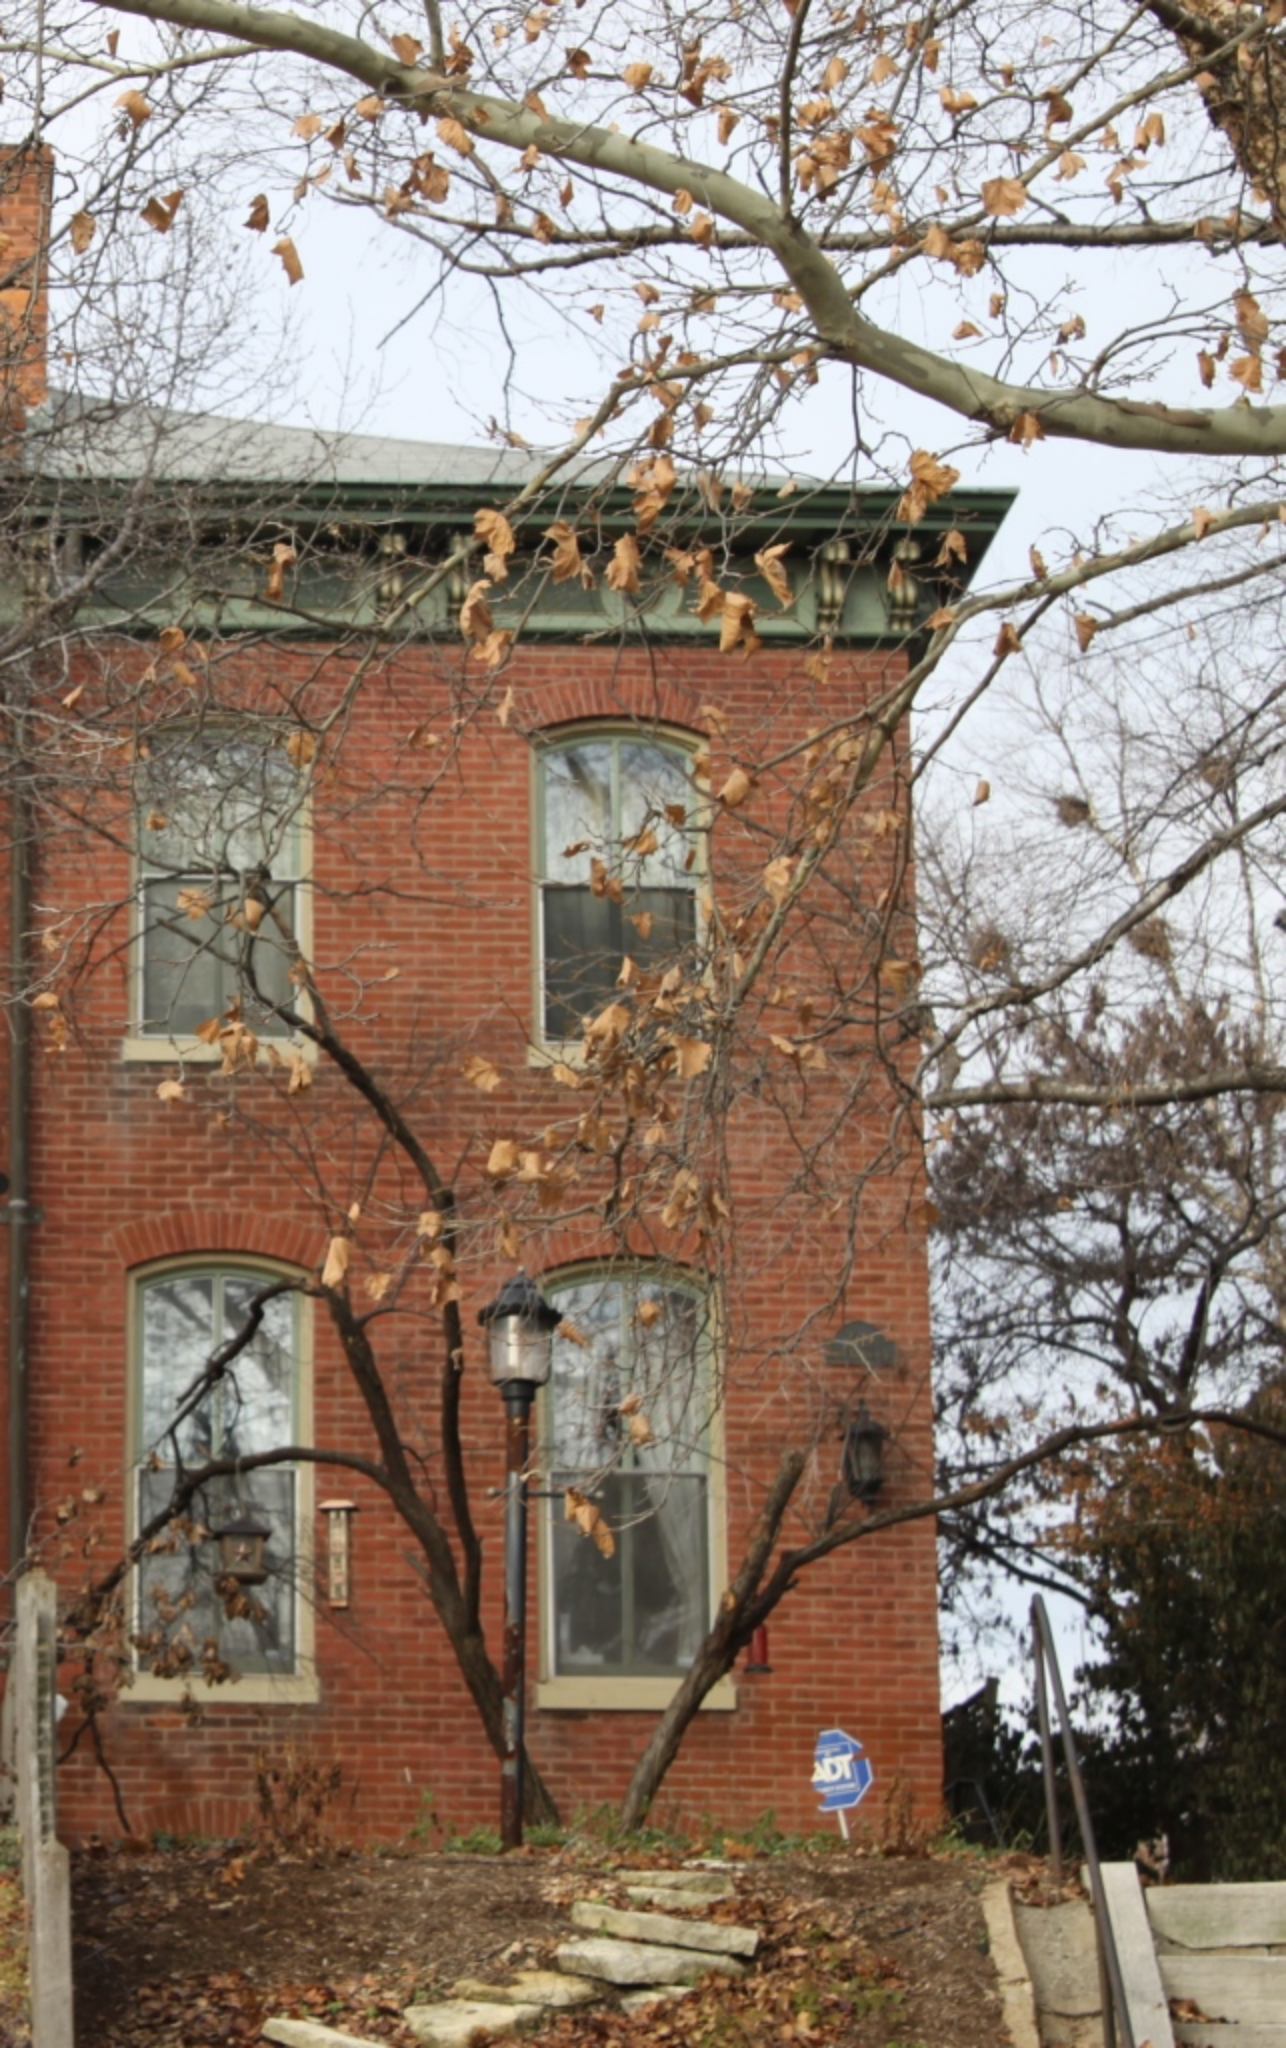
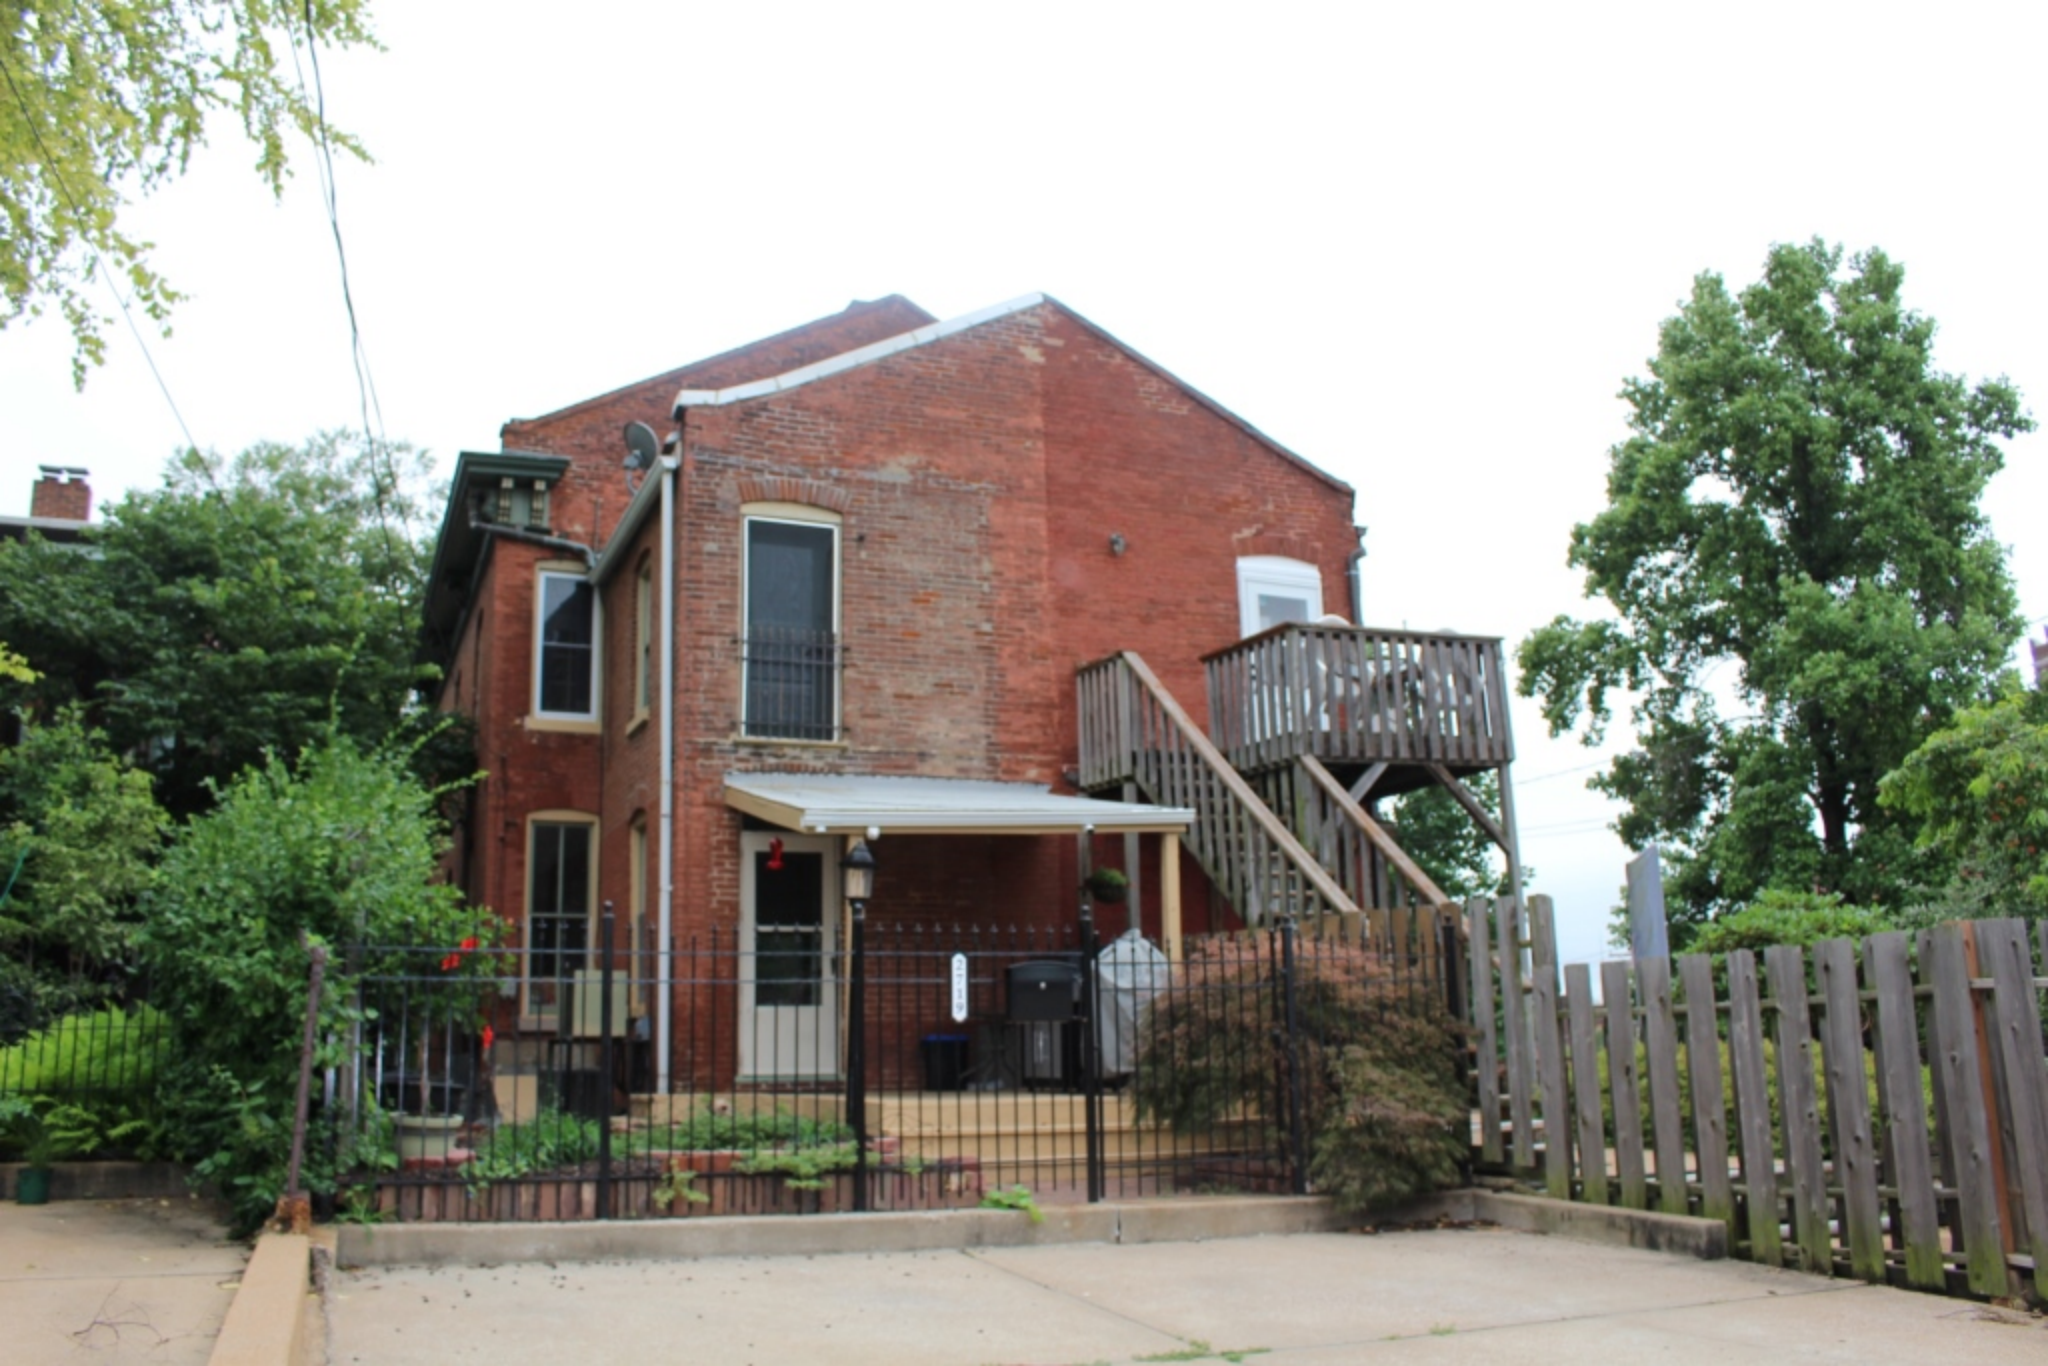
The two-story brick hipped roof founder is semi-detached with an attached chimney on the left side and a wood cornice with decorative brackets which extends along the north side of the building and returns on the rear. The first and second story double-hung windows have segmental arch top sashes and are two-over-two. The windows have soldier brick lintels and limestone sills. Single-light awning windows with soldier brick lintels sit in an ashlar stone foundation. The north elevation has three bays on the main section and an additional bay on a smaller 2-story flounder addition. The windows on the main section are 2-over-2, while the windows on the addition are 1-over-1. The center bay of the north elevation has door openings at both stories, with a small stoop at the first story. The second story door opening has been shortened to a window. There is a small gabled dormer on the north side. The rear has a small French casement window at the attic level. There is a non-historic shed roof porch at the rear, with door openings on both the first and second stories.

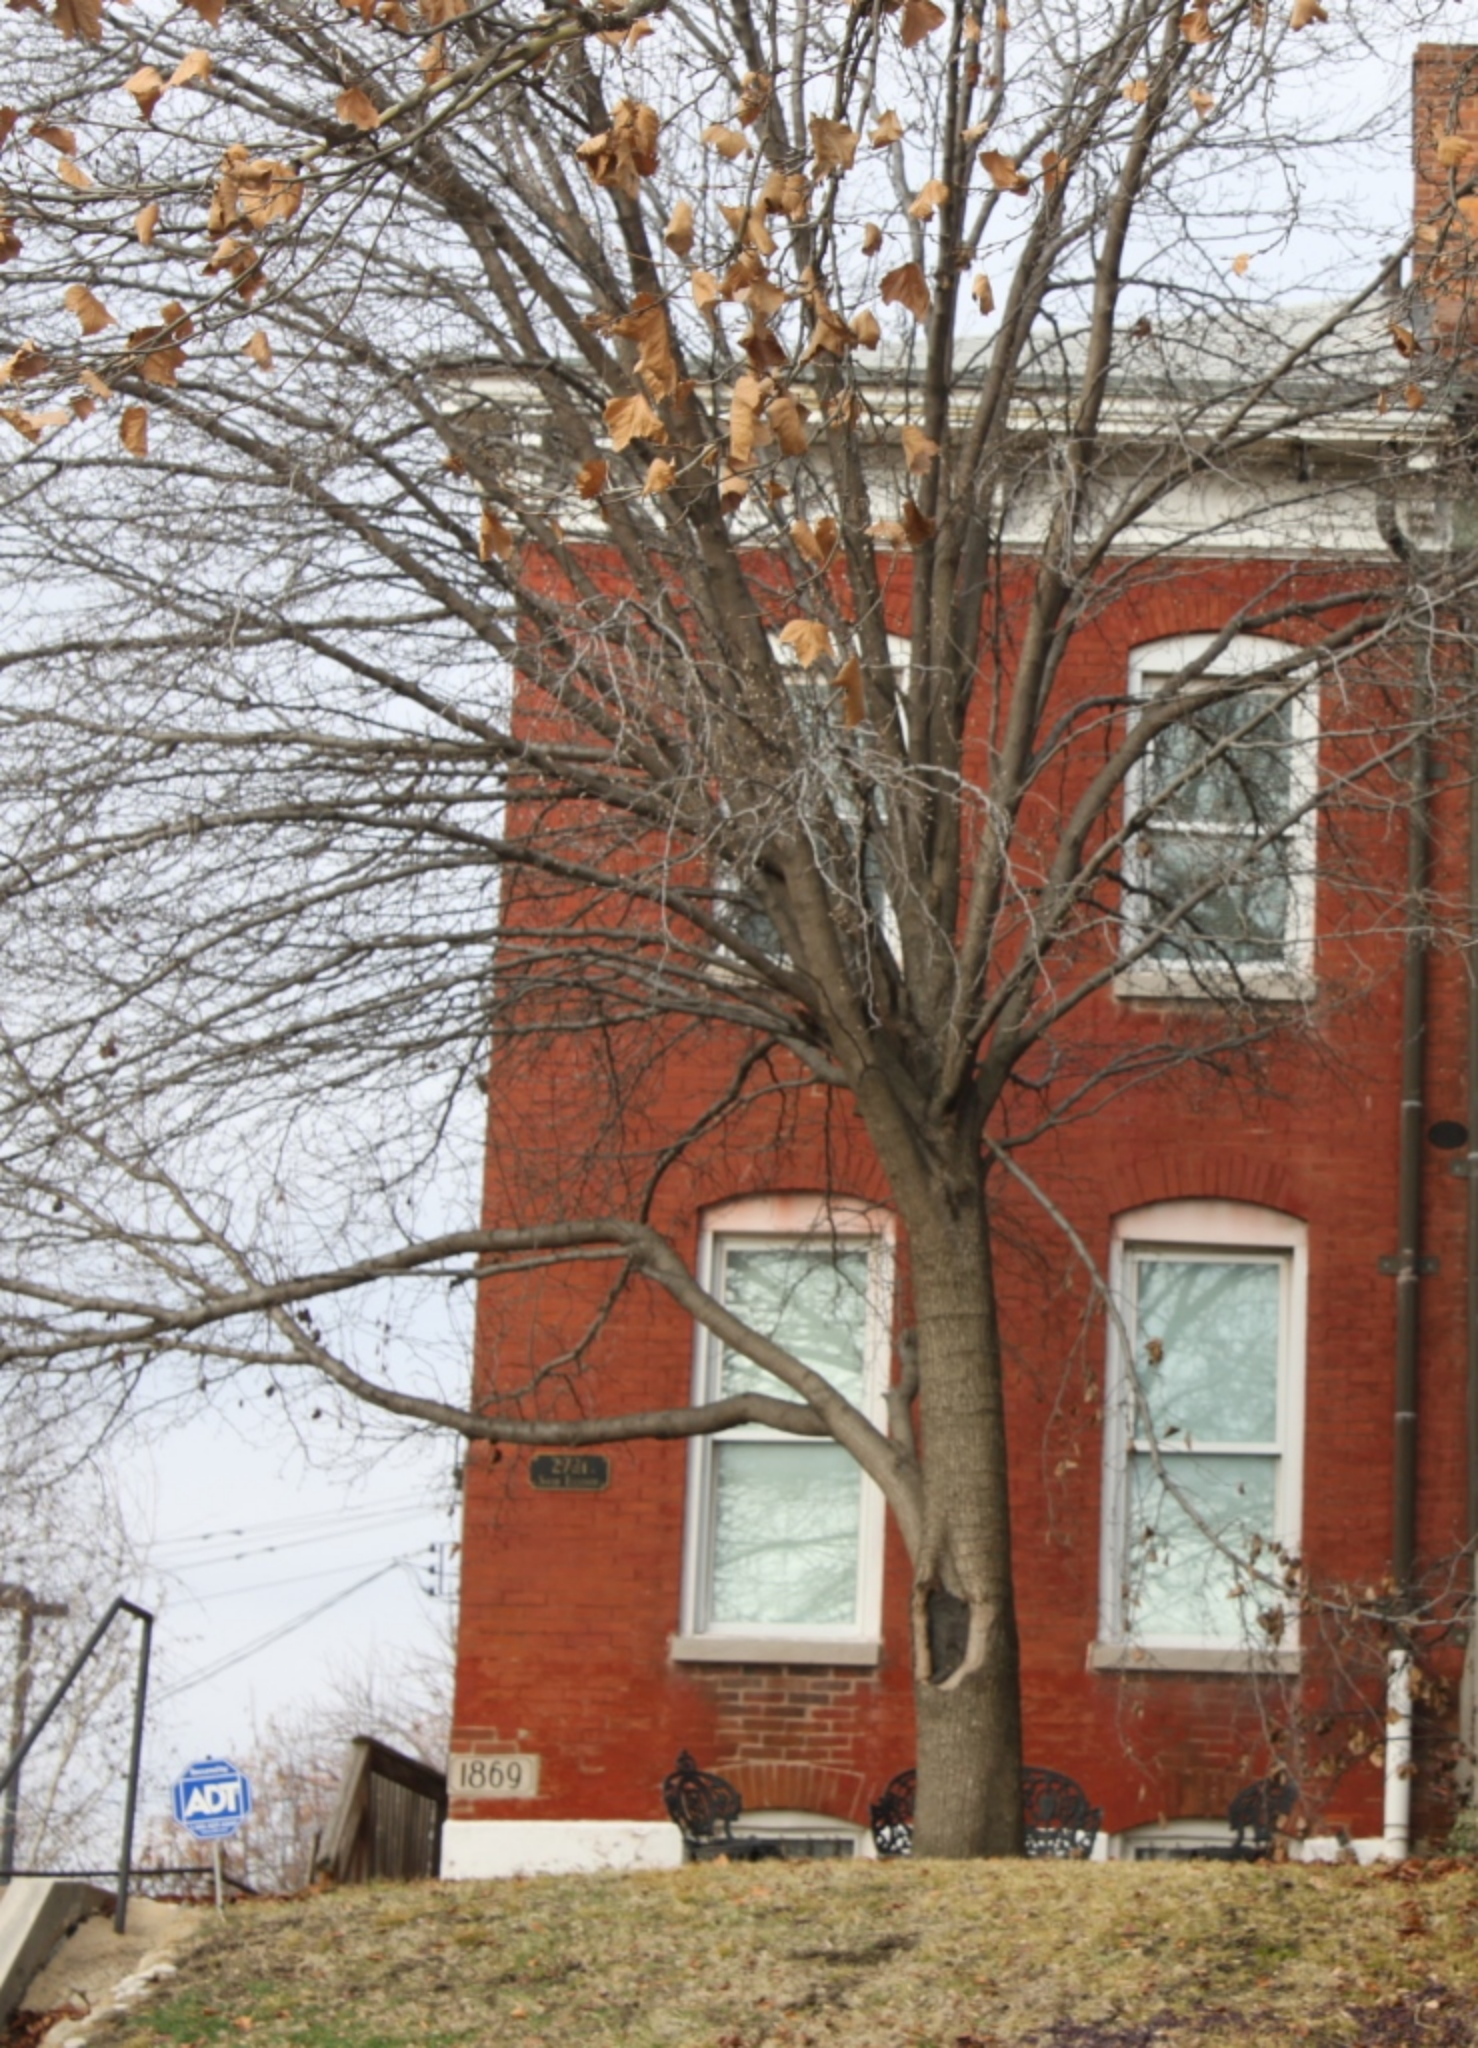
The two-story brick hipped roof founder is semi-detached with an attached chimney on the right side and a wood cornice with decorative brackets which extends along the south side of the building and returns on the rear. The first and second story double-hung windows are two-over-two double-hungs with segmental arch soldier brick lintels and limestone sills. Single-light awning windows with soldier brick lintels sit in an ashlar stone foundation. There is a small stone cornerstone which bears the date, 1869. It is a later addition. The south elevation has three bays on the main section and an additional bay on a smaller 2-story flounder rear addition. The windows on both sections are 1-over-1. The center bay of the south elevation has door openings at both stories, with a small stoop at the first story. The second story door opening has been boarded. The rear has a small French casement window at the attic level. There is a non-historic deck at the rear, with door openings on both the first and second stories.
