**ARCHITECTURAL/HISTORIC INVENTORY FORM - Cultural Resources Office**  
**St. Louis Planning and Urban Design**

1. Survey no. SLC-AS-053-0001	2. Survey name: Thematic Survey of Flounder Houses in St. Louis City	3. County: St. Louis [Independent City]
4. Address: (from City GEO database) <b>1812 S 8TH ST</b>		5. City/State: St. Louis, Missouri
Alternate address: 1812 S 8th		Property Zip Code: 63104
Latitude: 38.608949		6. UTM Easting: 743586.48
Longitude: -90.202538		UTM Northing: 4277095.00
8. Historic Name (if known): N/A	11a. Historic Use (if known): Domestic	City Block: 372 City Ward: 7
9. Present/other name (if known):	7. Township-Range-Section: N/A	10. Ownership: Private
11b. Current Use: Domestic		Neighborhood Number: 21

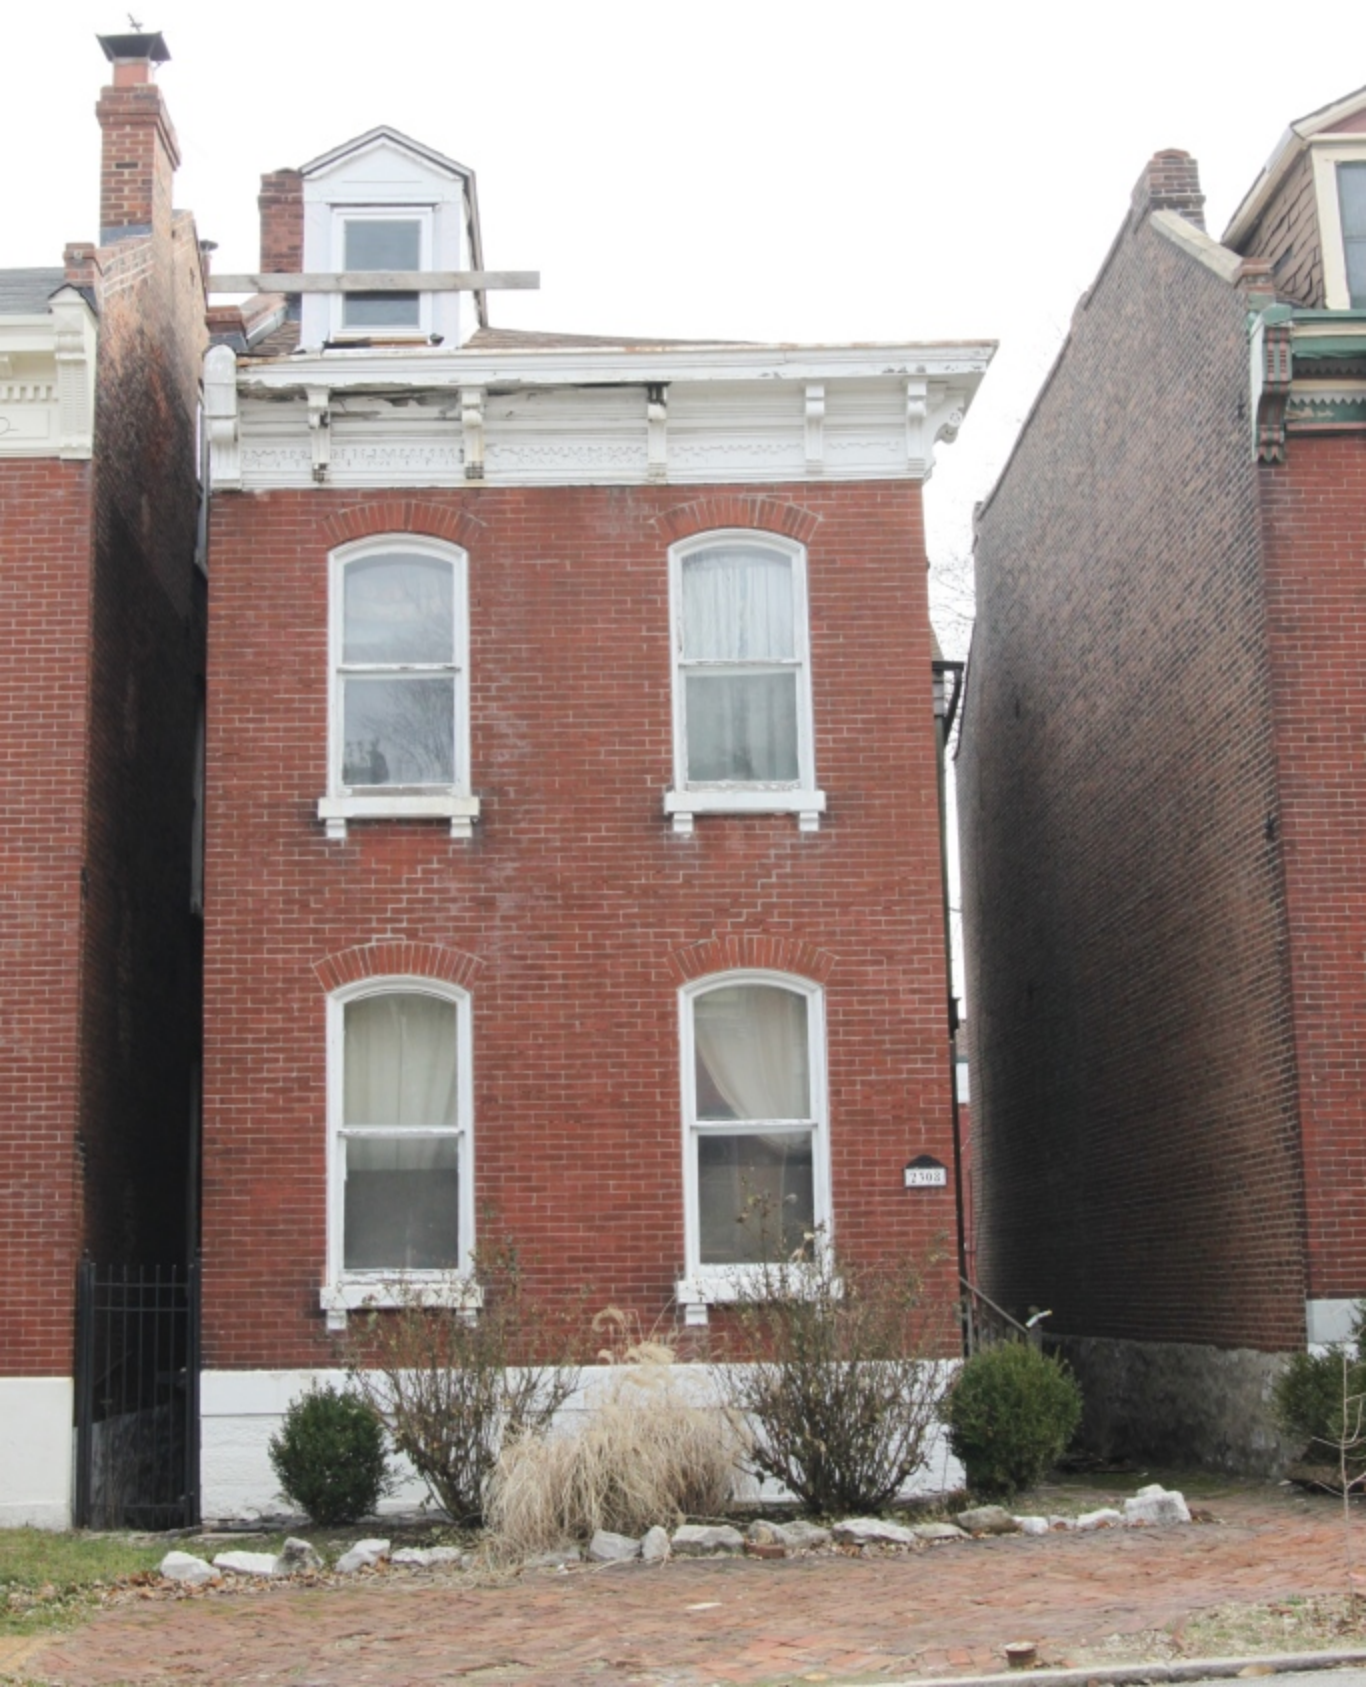
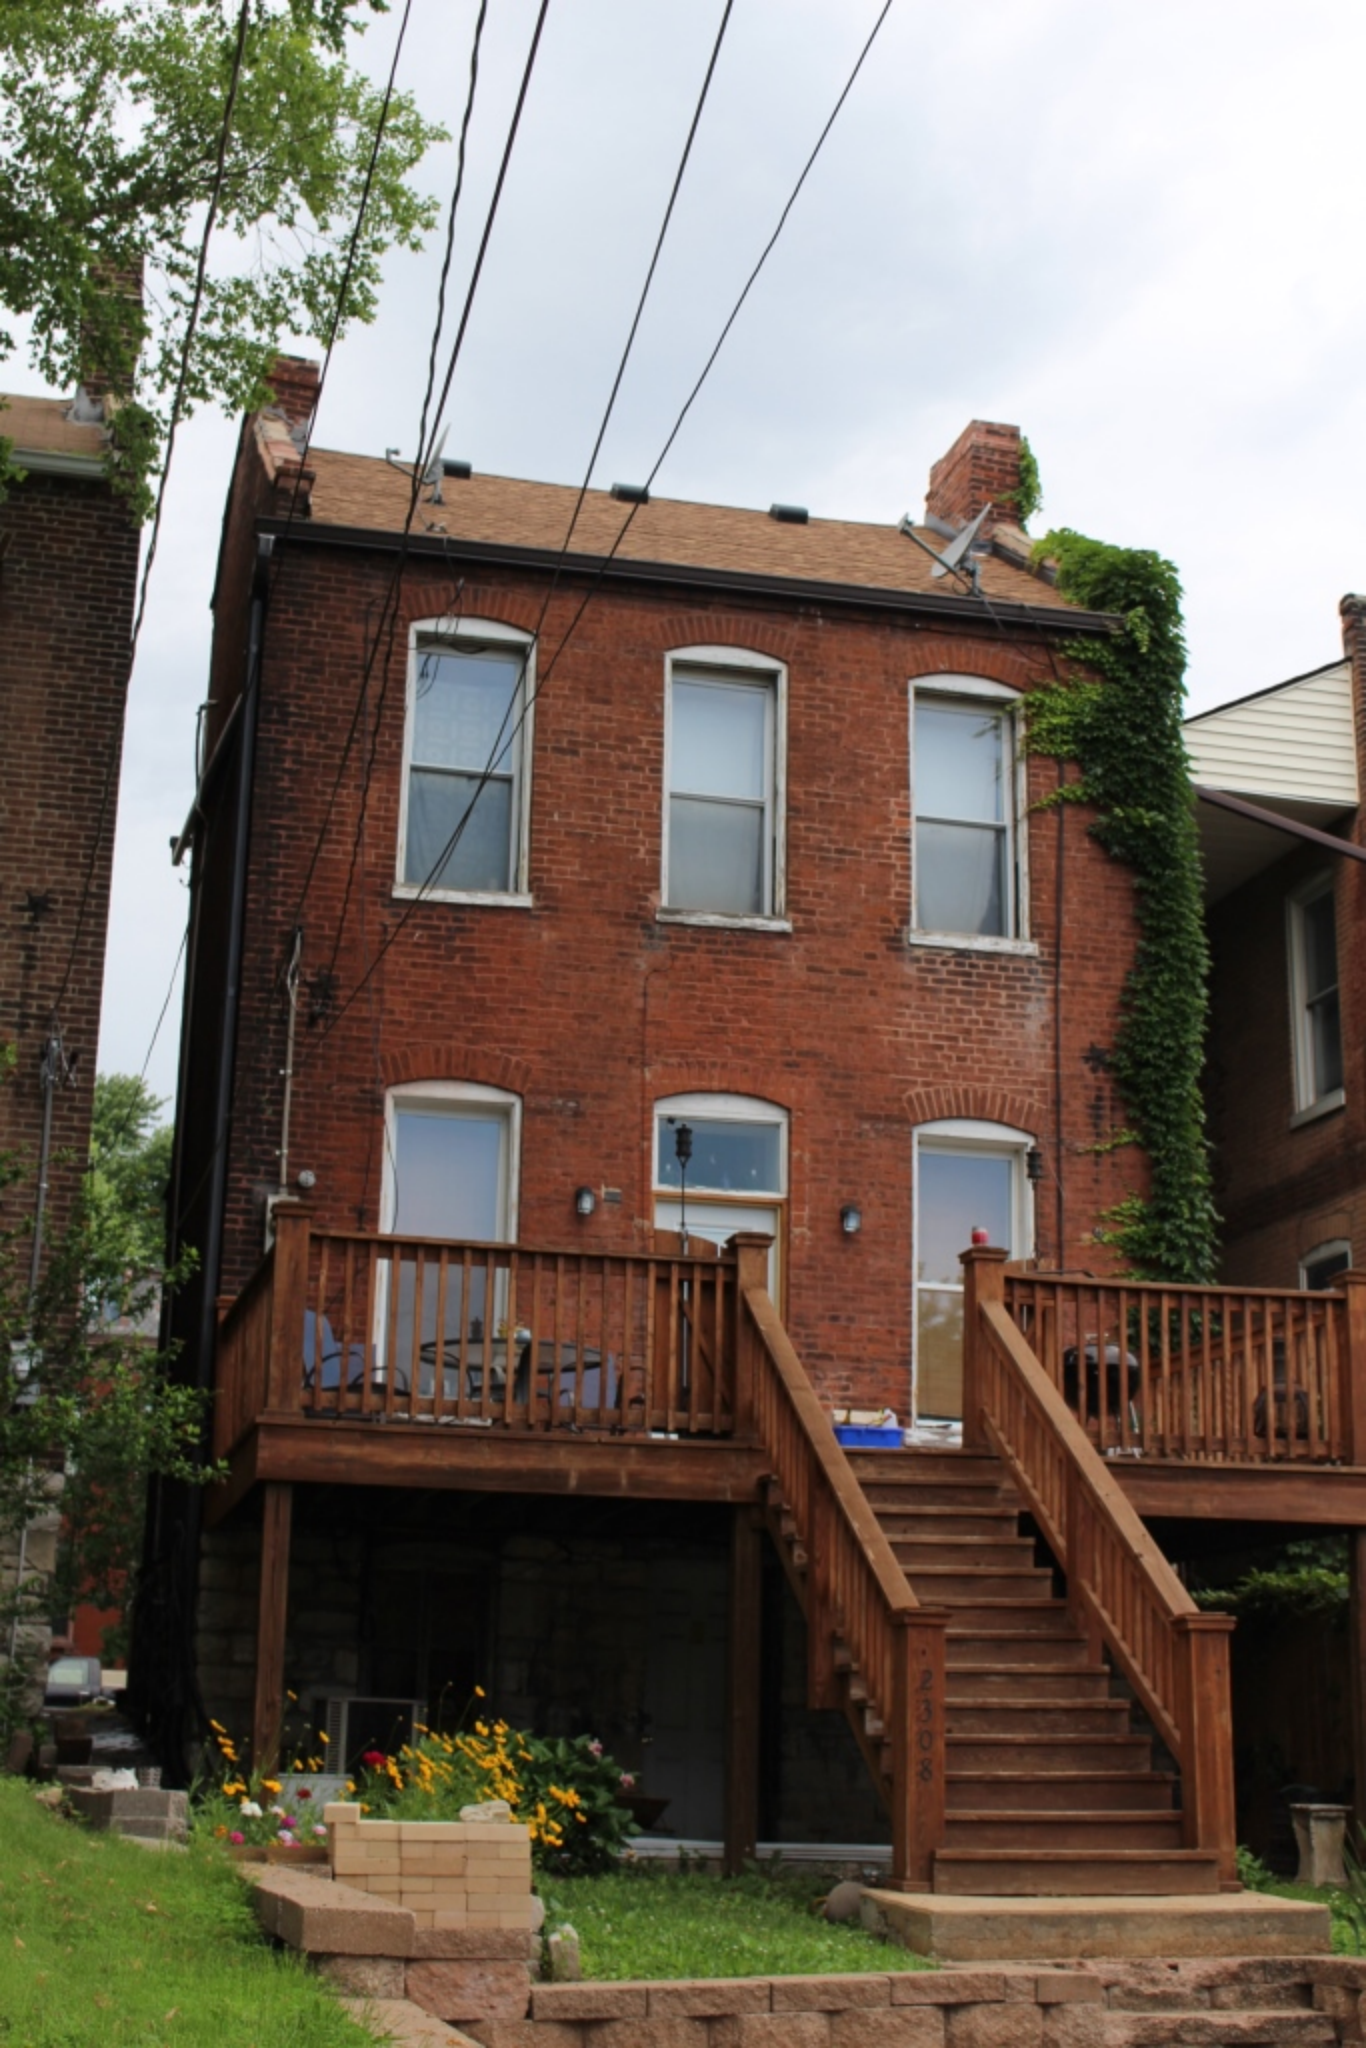
The two-story hipped roof brick flounder has a bracketed wood cornice which returns slightly along the south elevation. There is a simple gabled dormer toward the north side the sheathing has been removed. A chimney sits on the north side slightly behind the dormer. The first and second stories have two bays with 1-over-1 segmental arch double-hung wood windows with soldier brick lintels and bracketed stone sills. There is a smooth ashlar limestone watertable with a tooled, coursed ashlar foundation below. There are two boarded windows at the basement level. The south elevation has a corbeled brick cornice which extends from the bracketed wood cornice. There is an entry close to the front of the building on this elevation. There is a second entry closer to a rear ell section. A two-story porch sits at the corner where the ell meets the main section of the house. The porch has simple wood posts and an historic handrail. A small dormer sits on the ell roof above the porch. Two narrow one-over-one double hung windows on the ell face the street. The two-story rear ell has a side gable roof and appear from the rear to resemble and I-house, being one room deep with a center entry. There are three bays at the rear with one-over-one double-hung windows. There is also a chimney on either side of the ell. The basement is raised at the rear and there are two small double-hung windows at the basement level, as well as the entry.

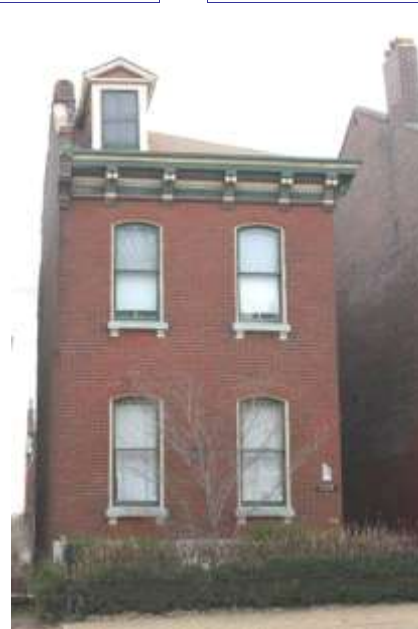
Front façade

Excellent

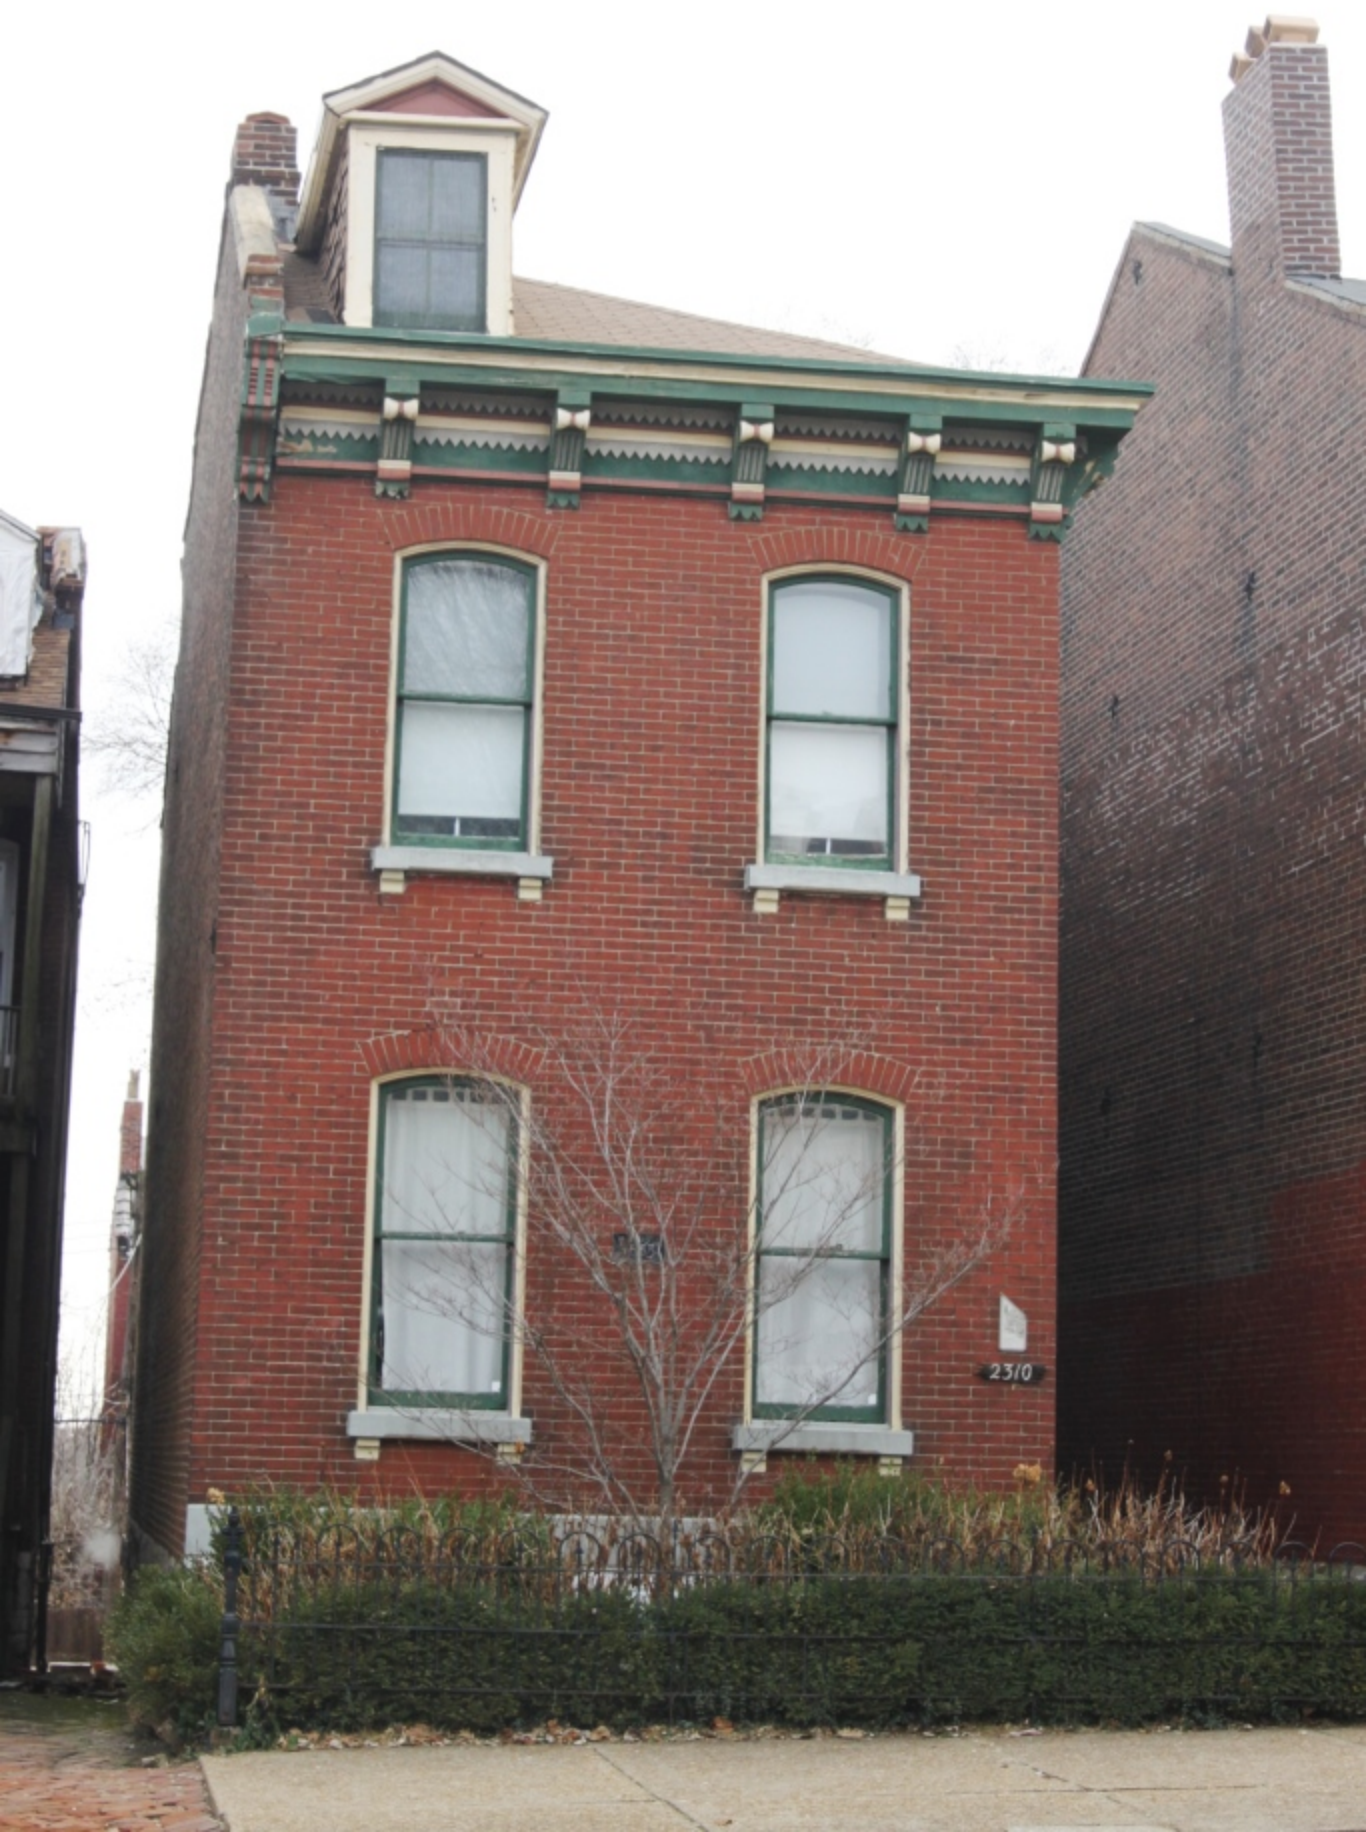
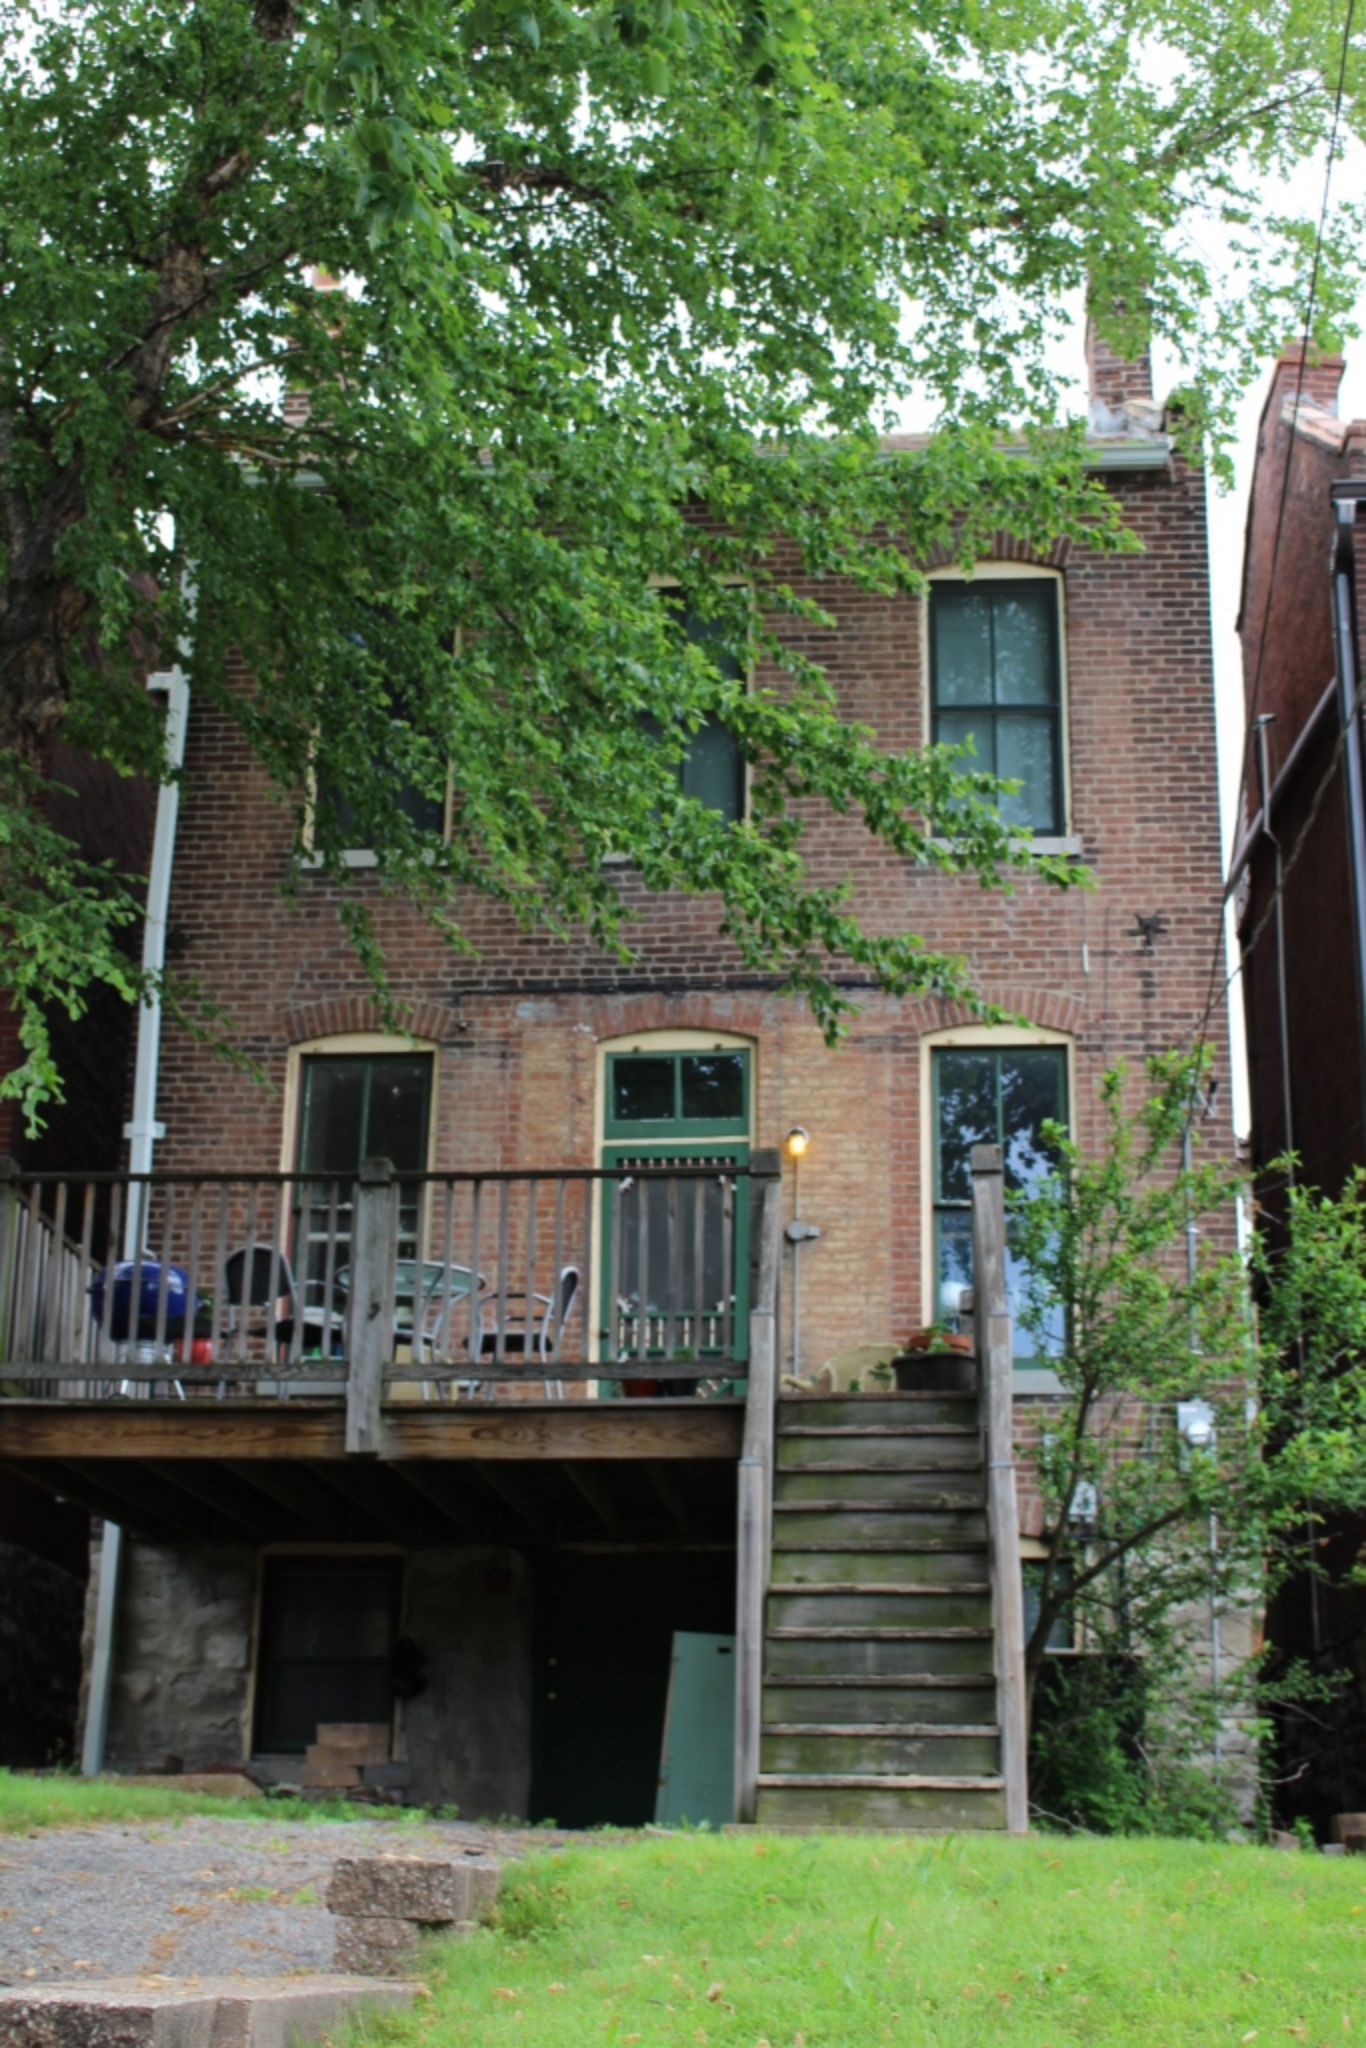
Two-and-a-half story brick hipped flounder. Three chimneys on left side starting at apex of hip roof, shed roof behind. Large side gable brick ell at the rear of the flounder. Simple two-story recessed front porch on the ell section. Another shuttered side entry into the flounder section. Two 1-over-1 segmental arch windows with soldier brick lintels and stone sills with small consoles at both the 1st and 2nd story of the front façade. Coursed limestone foundation at front façade with ashlar limestone watertable. Ornate wood cornice returns slightly around south side, corbelled brick cornice beyond that point. Narrow pedimented dormer to left side of roof on front with 2-over-2 double-hung window.

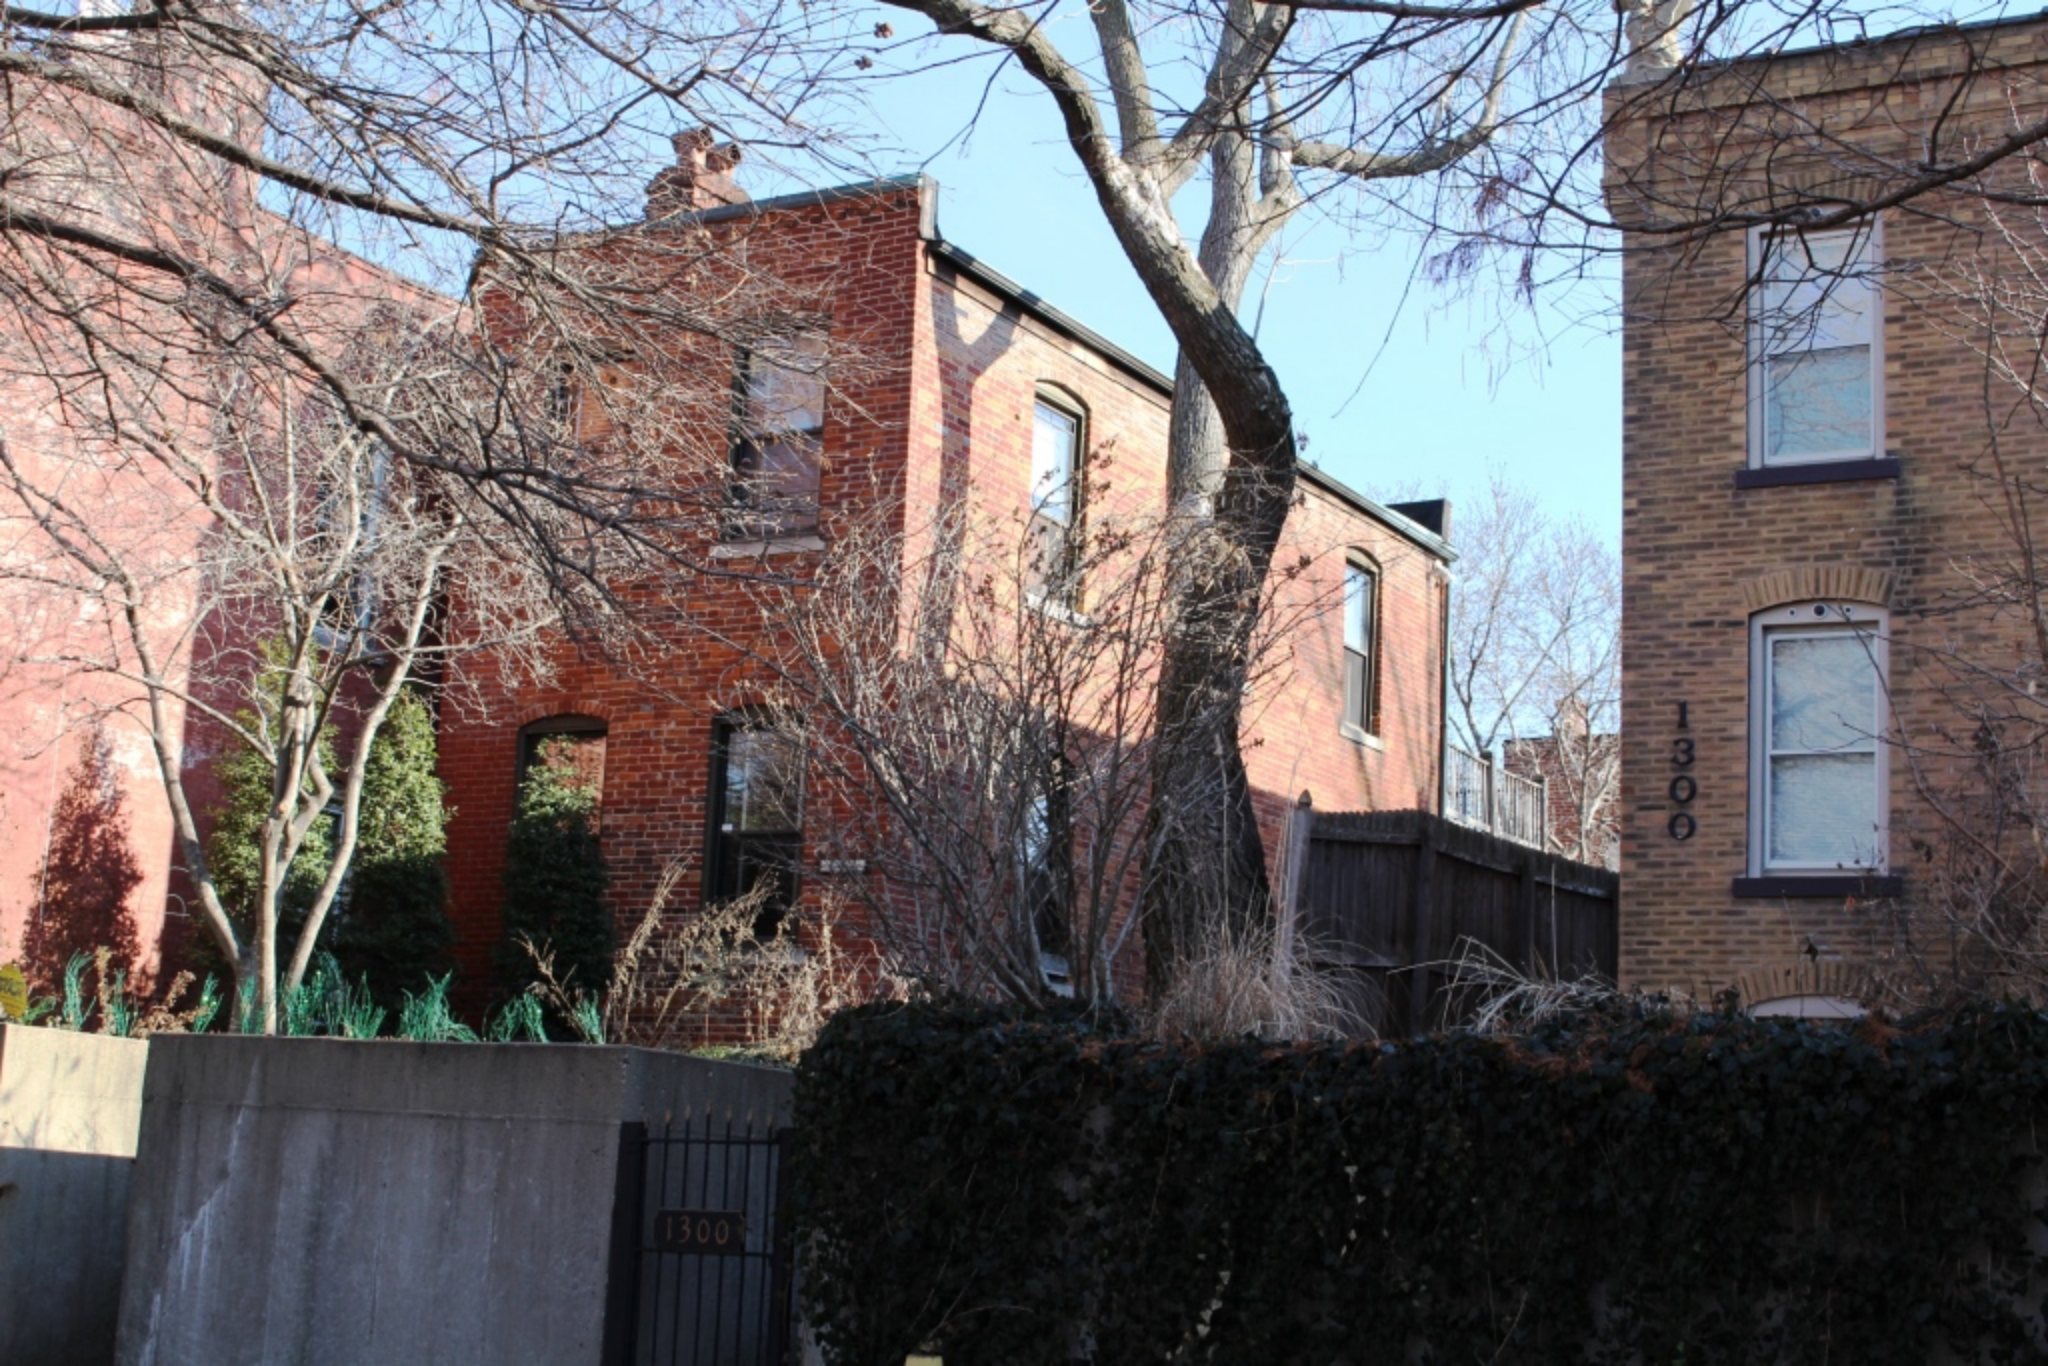
Two-story brick flounder with dentiled cornice on front facing parapet. The building's shed roof has a shallower pitch than is usual for flounder roofs and was likely altered at the time the front parapet was added. The parapet is not shown on the Compton & Dry 1875 Atlas and the 1908 Sanborn map also indicates sloping parapet at the front facade. The four front facing windows have header brick segmented arched lintels with stone sills. The main entrance is on the south side of the building that enters out onto a small wooden side porch. There is a large wooden deck off of the rear of the building. The building itself is set back off of the main building line of the street by at least 15'.

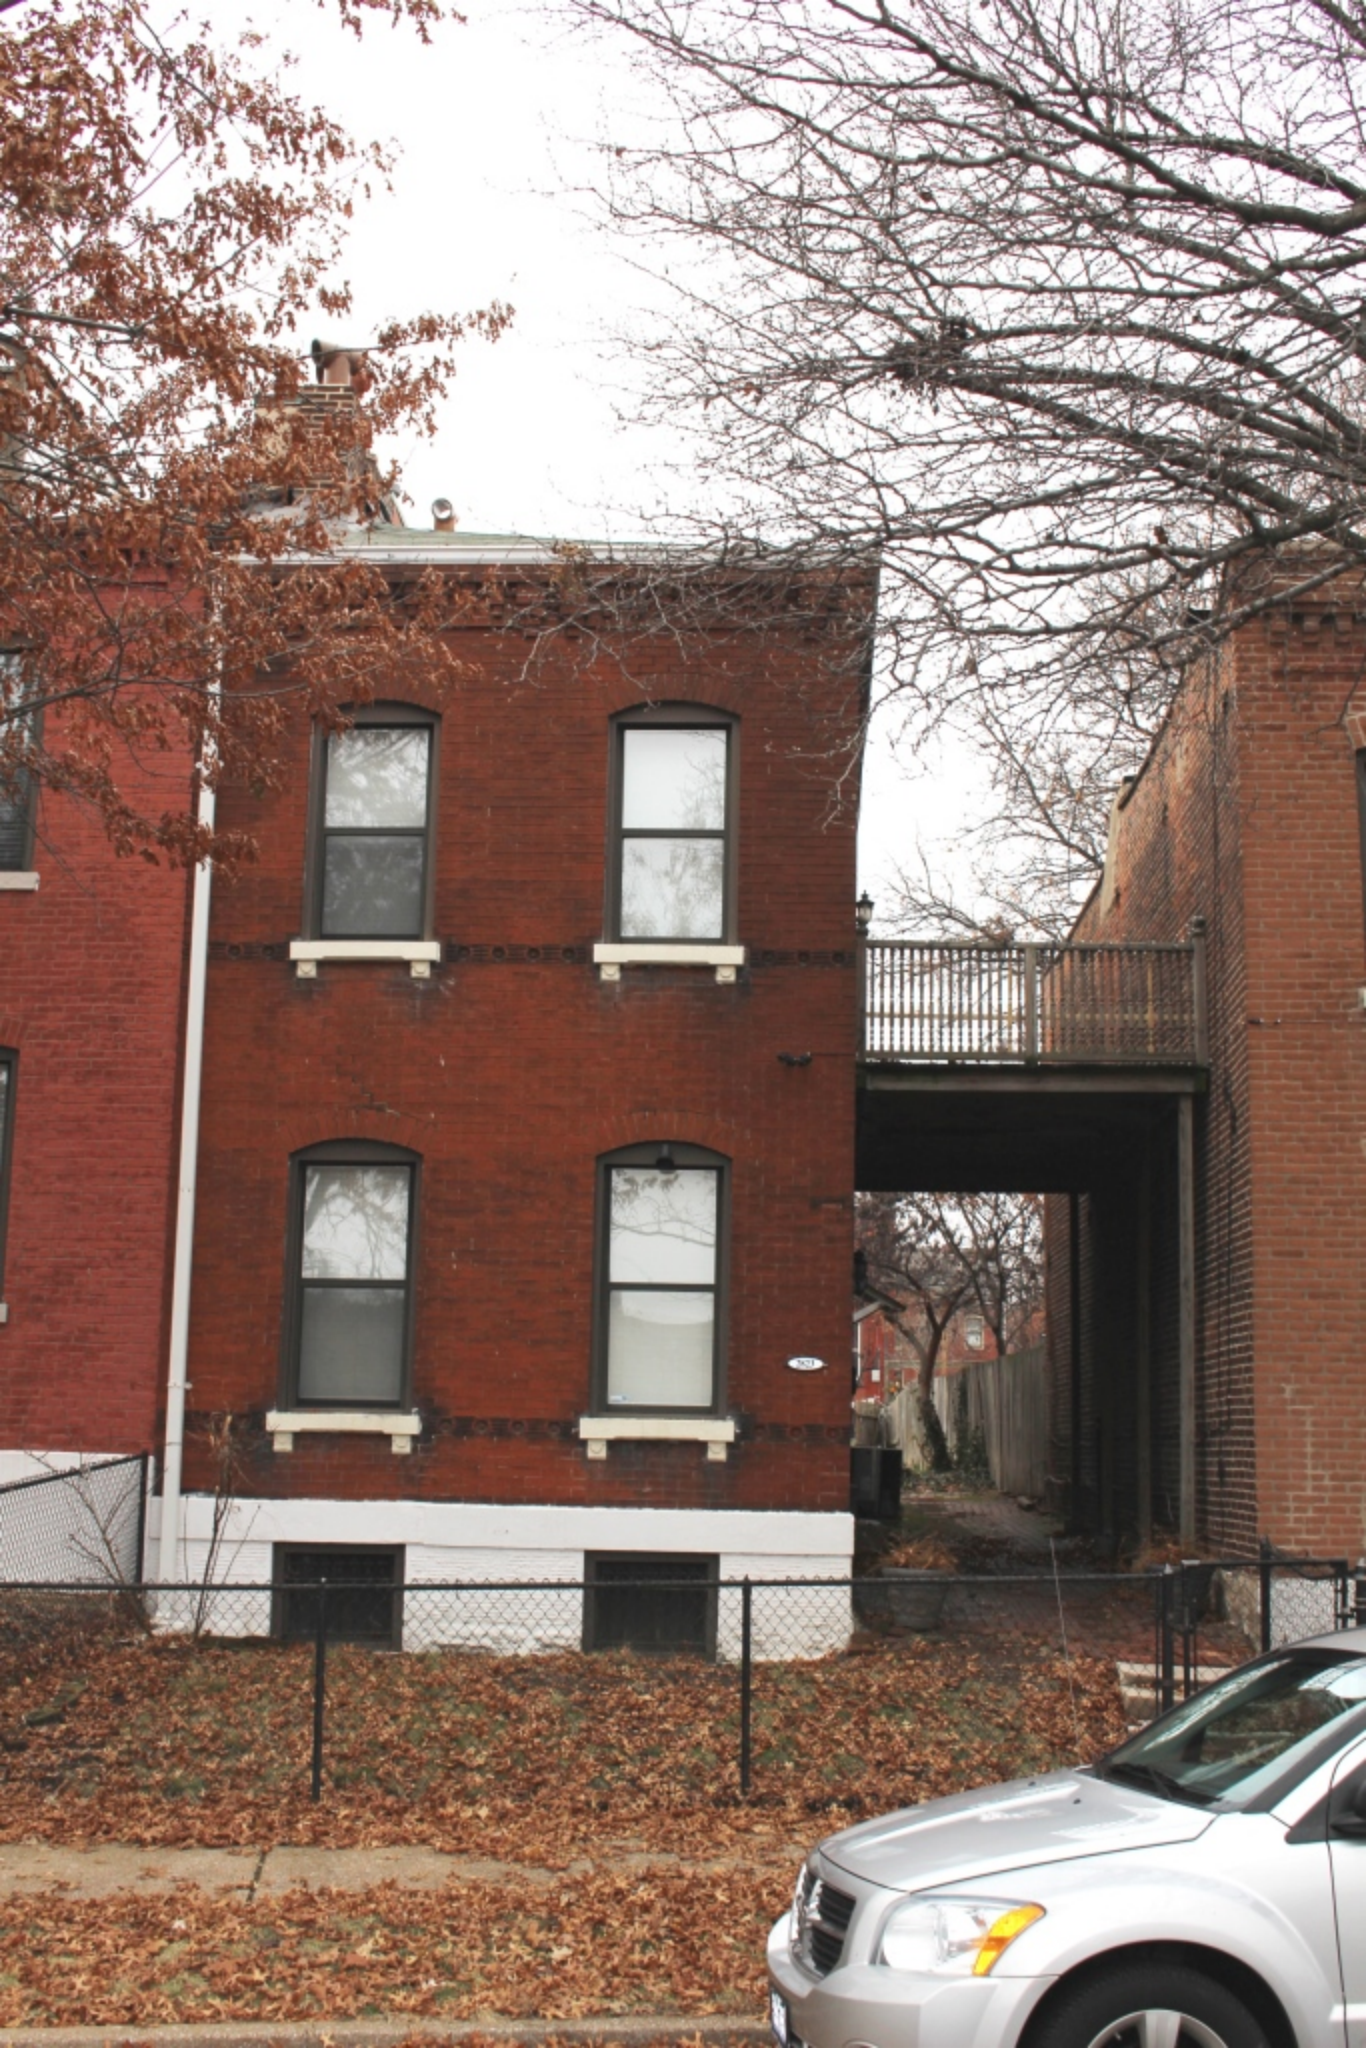
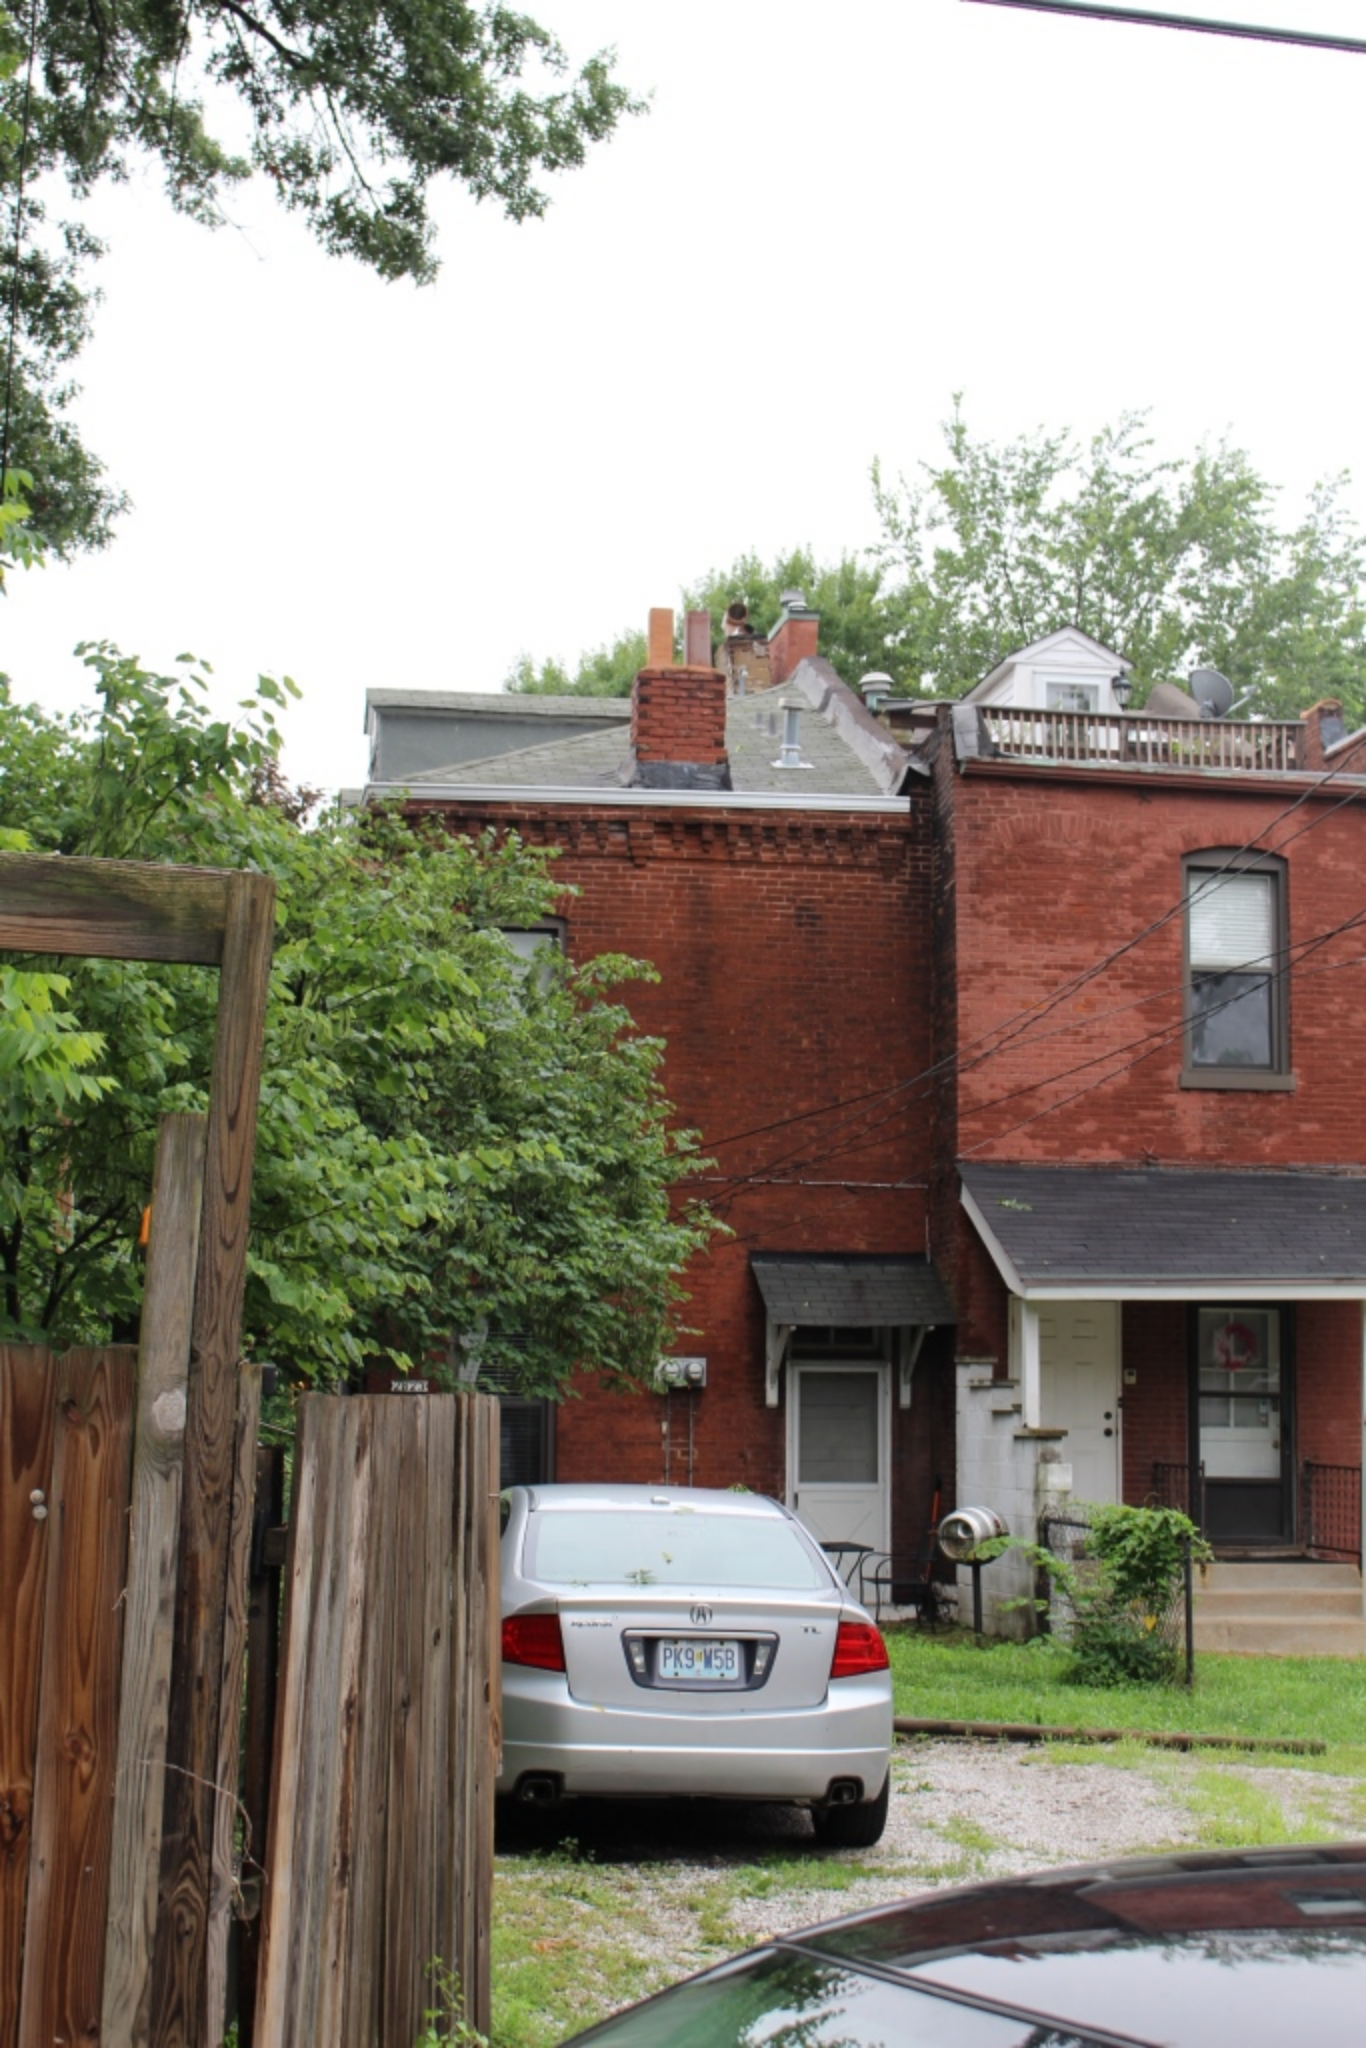
Two-story flounder with dentiled brick cornice and cut-stone veneered front foundation. The foundation stone and watertable have been painted white. There are two terra-cotta belt courses across the front façade with a circular tile motif. Four front windows feature segmented soldier arches and bracked stone sills. The main entrance is on the north side of the building under a modern deck that spans the distance to the neighboring house. There are two original gabled dormers projecting from the roof facing north. Three chimneys appear on the building, two on the south side and one on the west.
