**ARCHITECTURAL/HISTORIC INVENTORY FORM - Cultural Resources Office**  
**St. Louis Planning and Urban Design**

1. Survey no. SLC-AS-053-0001	2. Survey name: Thematic Survey of Flounder Houses in St. Louis City	3. County: St. Louis [Independent City]
4. Address: (from City GEO database) <b>1812 S 8TH ST</b>		5. City/State: St. Louis, Missouri
Alternate address: 1812 S 8th		Property Zip Code: 63104
Latitude: 38.608949		6. UTM Easting: 743586.48
Longitude: -90.202538		UTM Northing: 4277095.00
8. Historic Name (if known): N/A	11a. Historic Use (if known): Domestic	City Block: 372 City Ward: 7
9. Present/other name (if known):	7. Township-Range-Section: N/A	10. Ownership: Private
11b. Current Use: Domestic		Neighborhood Number: 21

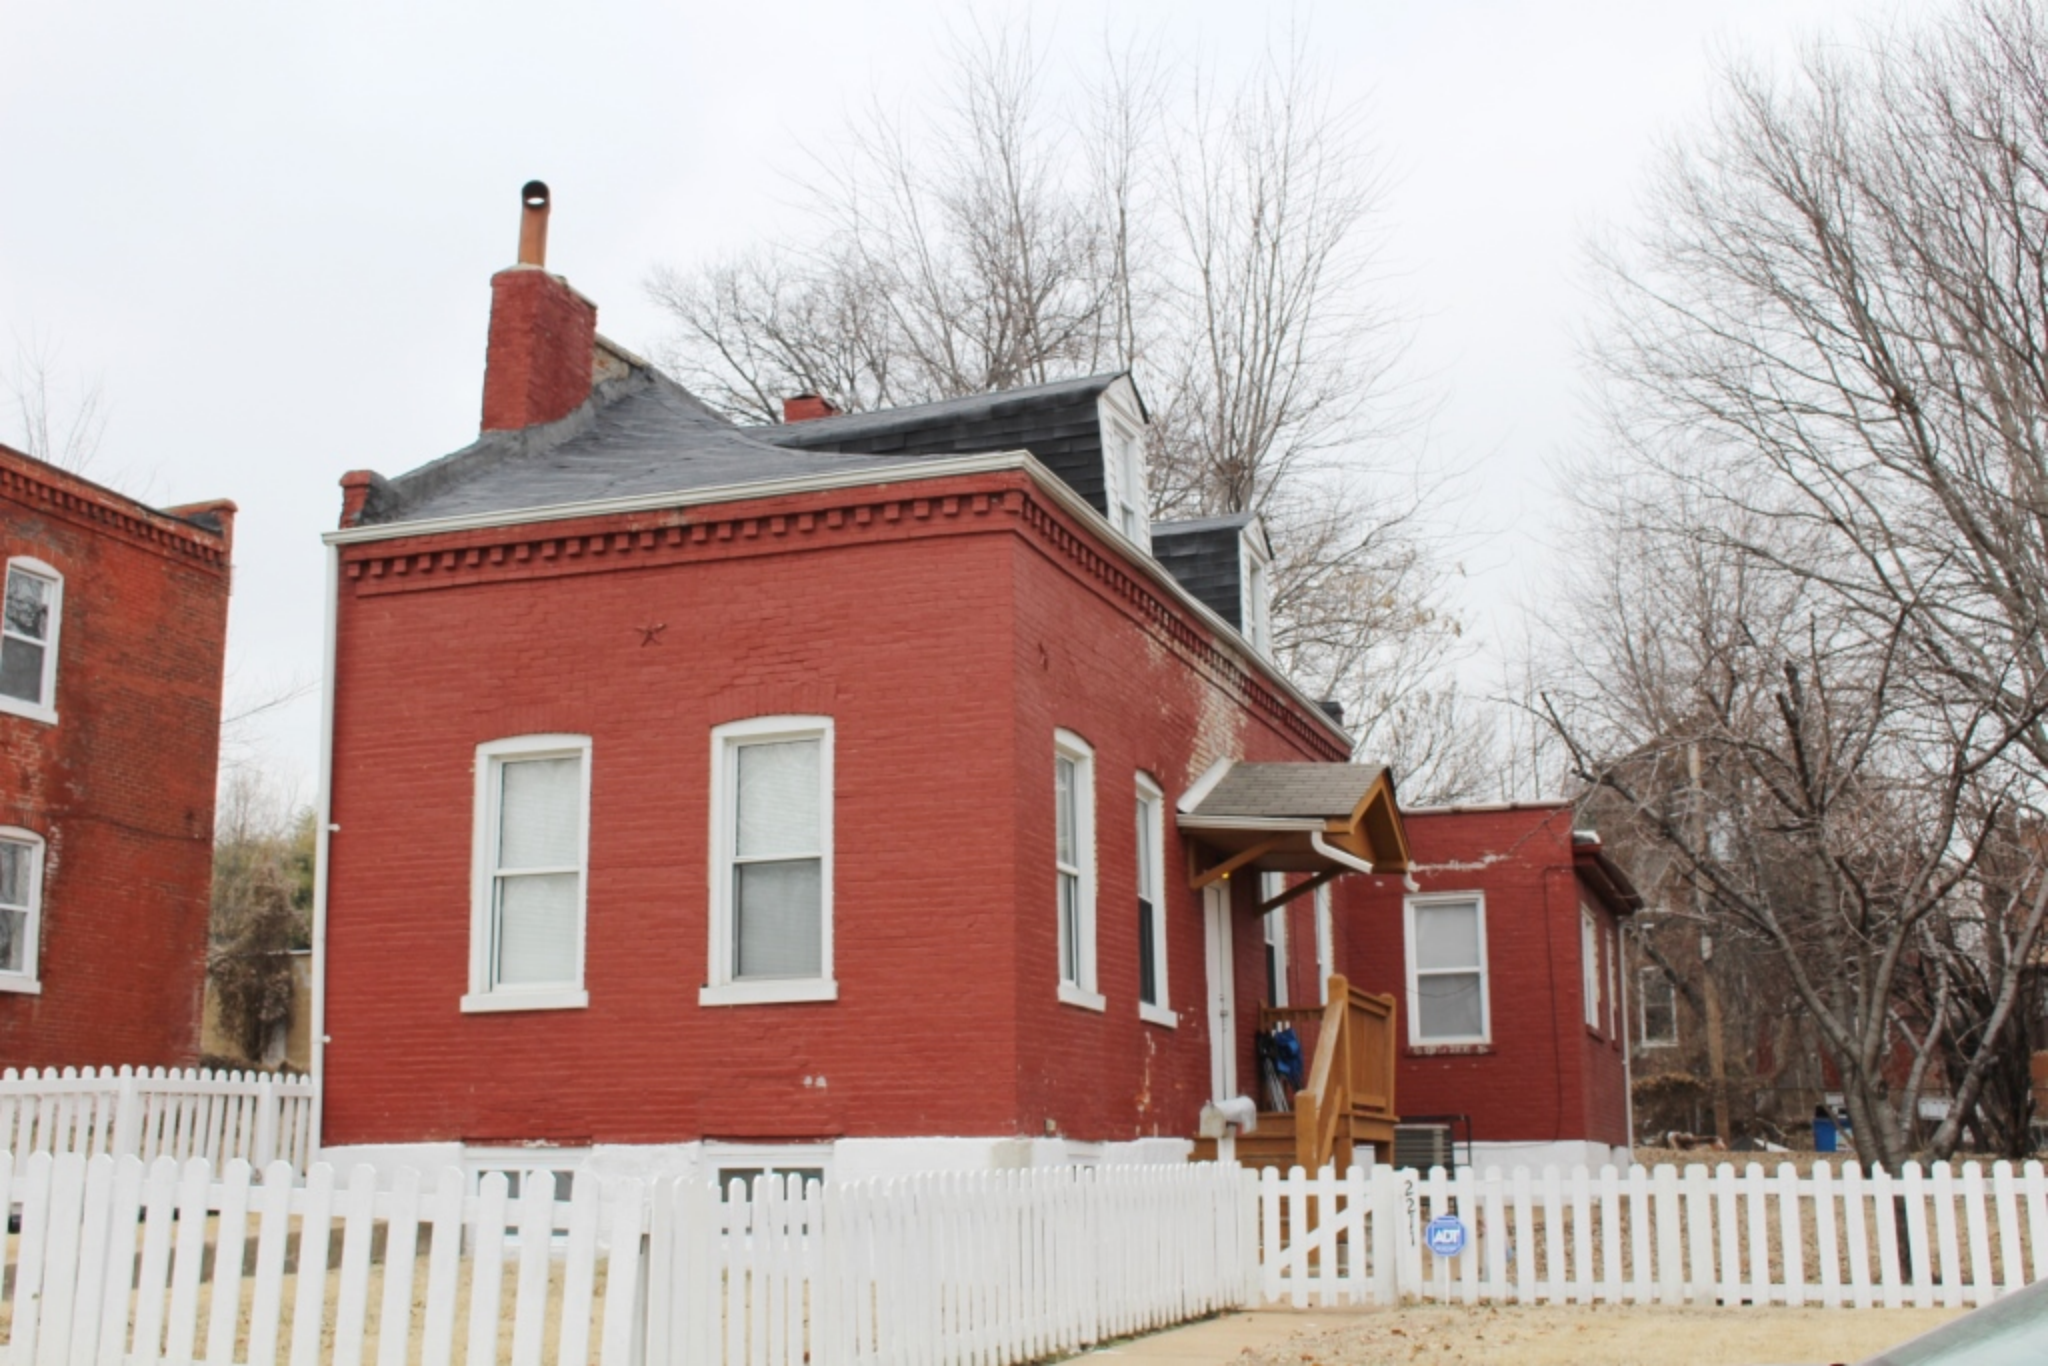
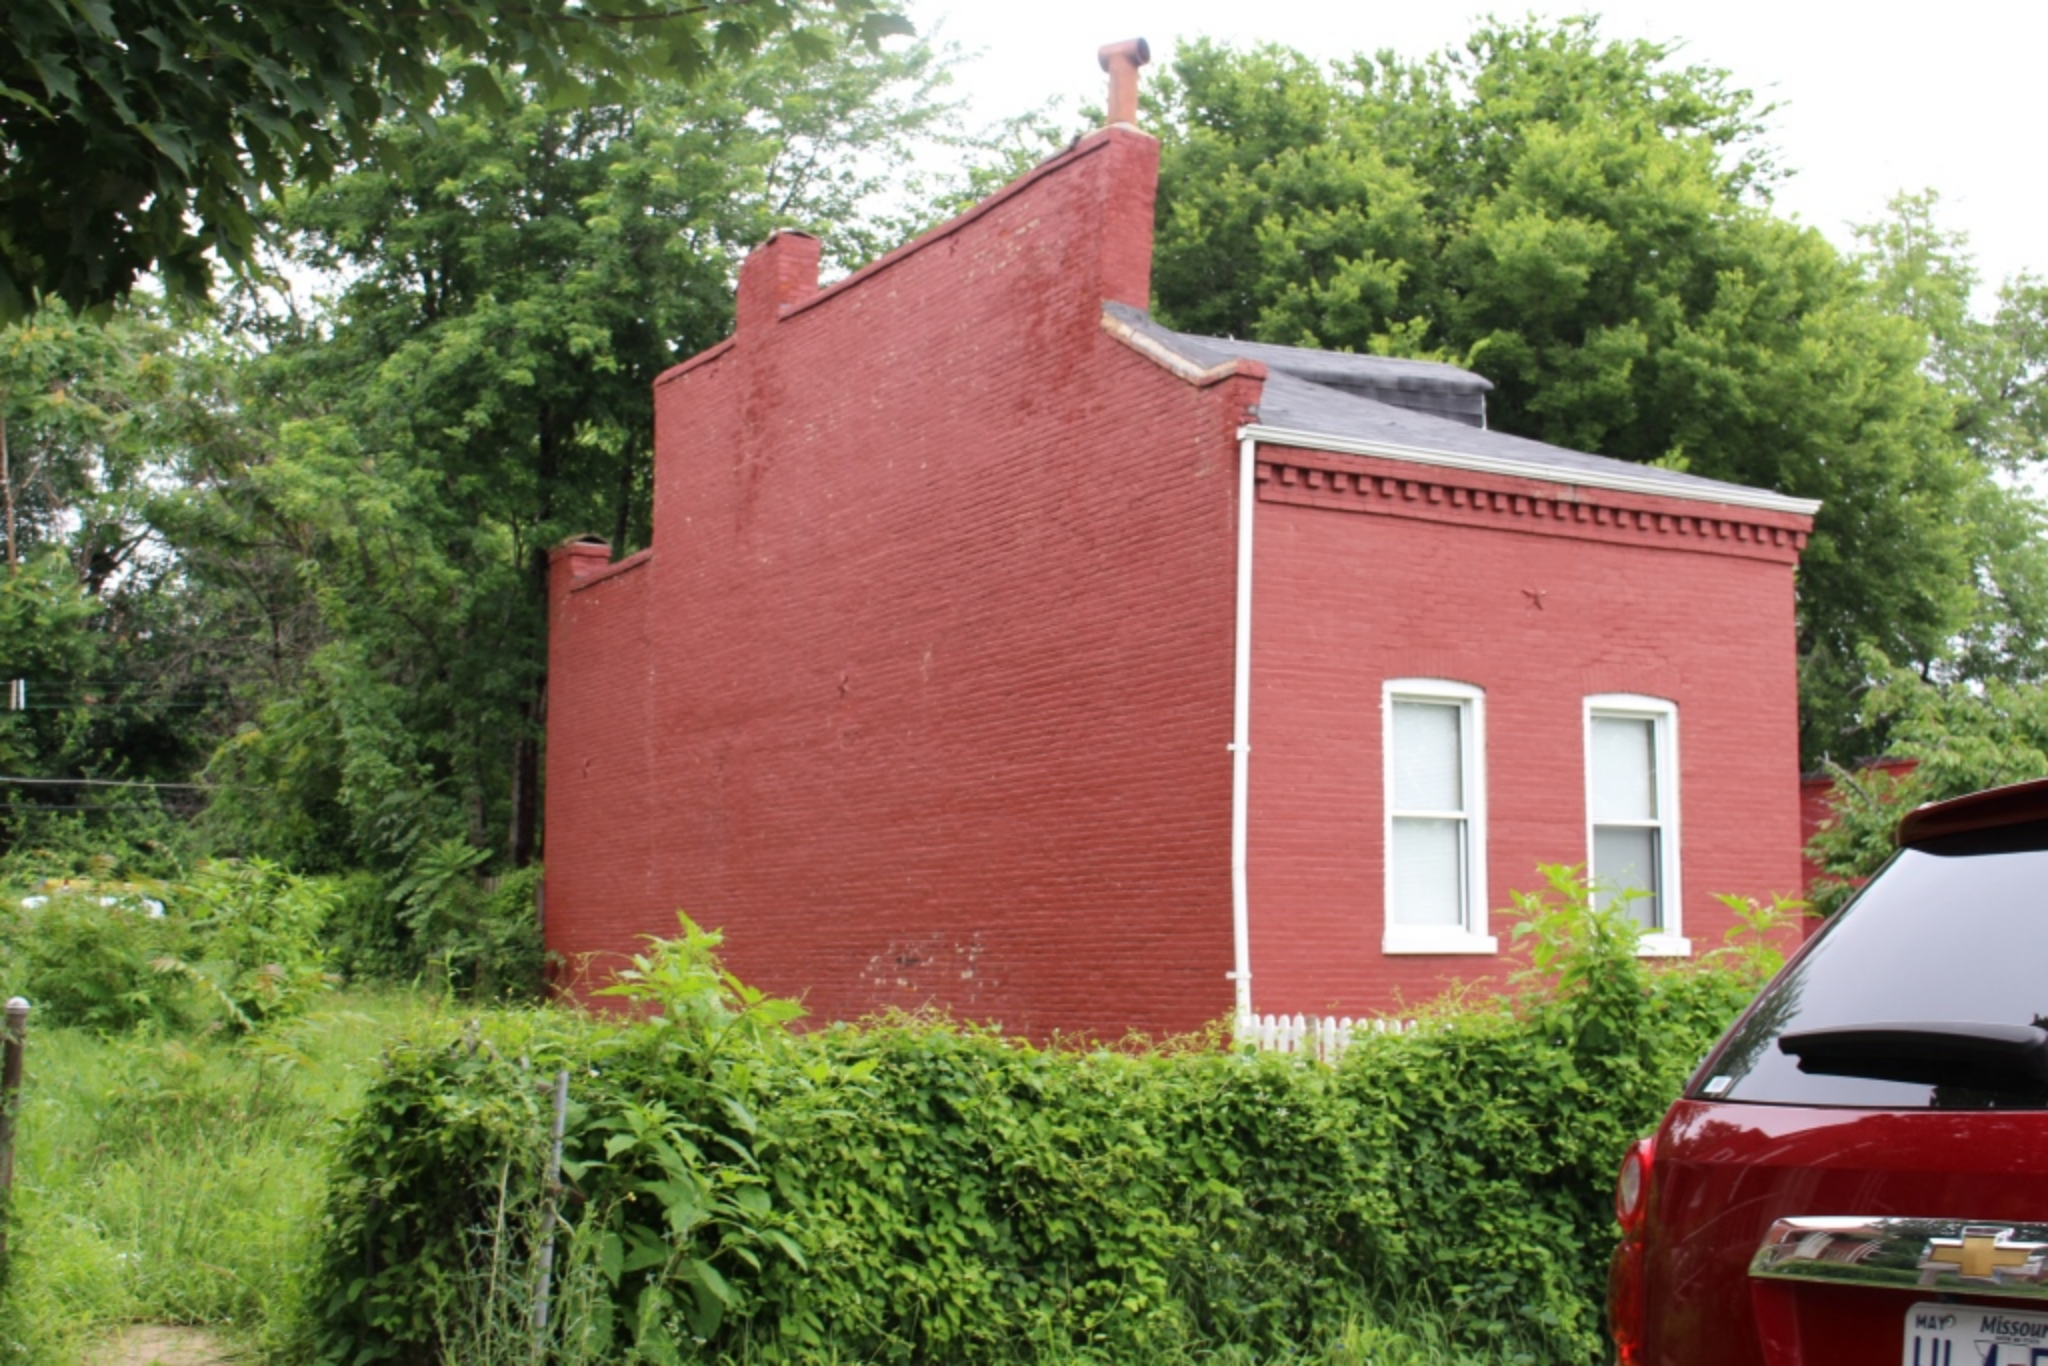
One and a half story brick flounder with dentiled brick cornice that runs the length of the south front and east side of the building.  
All first floor windows have wrapped wooden sills with segmented arched lintels. The west façade of the building lacks any  
fenestration. There are two original gabled dormers that project on the east elevation; they have been sided with roofing shingles  
and aluminum siding. On the the east side of the building, the central entry has been altered with a contemporary door; the  
entry has been covered by a small gabled hood with brackets and a wood porch. A one story brick flat roofed addition has been  
constructed at the rear of this façade. The building has been painted brick red; and the exposed foundation has been parged and  
painted white. The masonry above the 2 front basement windows appears to have been rebuilt.

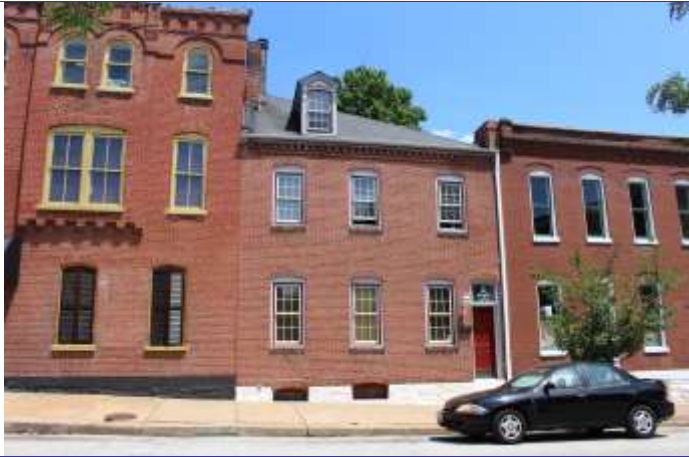
**823 ALLEN AV**

This two-and-one-story brick flounder is at the sidewalk. The façade has two regular bays on the west side, including basement windows. The east portion of the façade has a third window bay on the second story. At the ground level, two openrings are placed closely together: a window beside a narrow entrance into what is likely a gallery and the entrance to the building. A denticulated brick cornice edges the eaves of the façade; a gabled dormer extends from the front slope of the hip front of the roof. Bing bird's eye views indicate that there is a window in the upper half story in the rear wall and that a lower rear brick wing also has the form of a flounder.

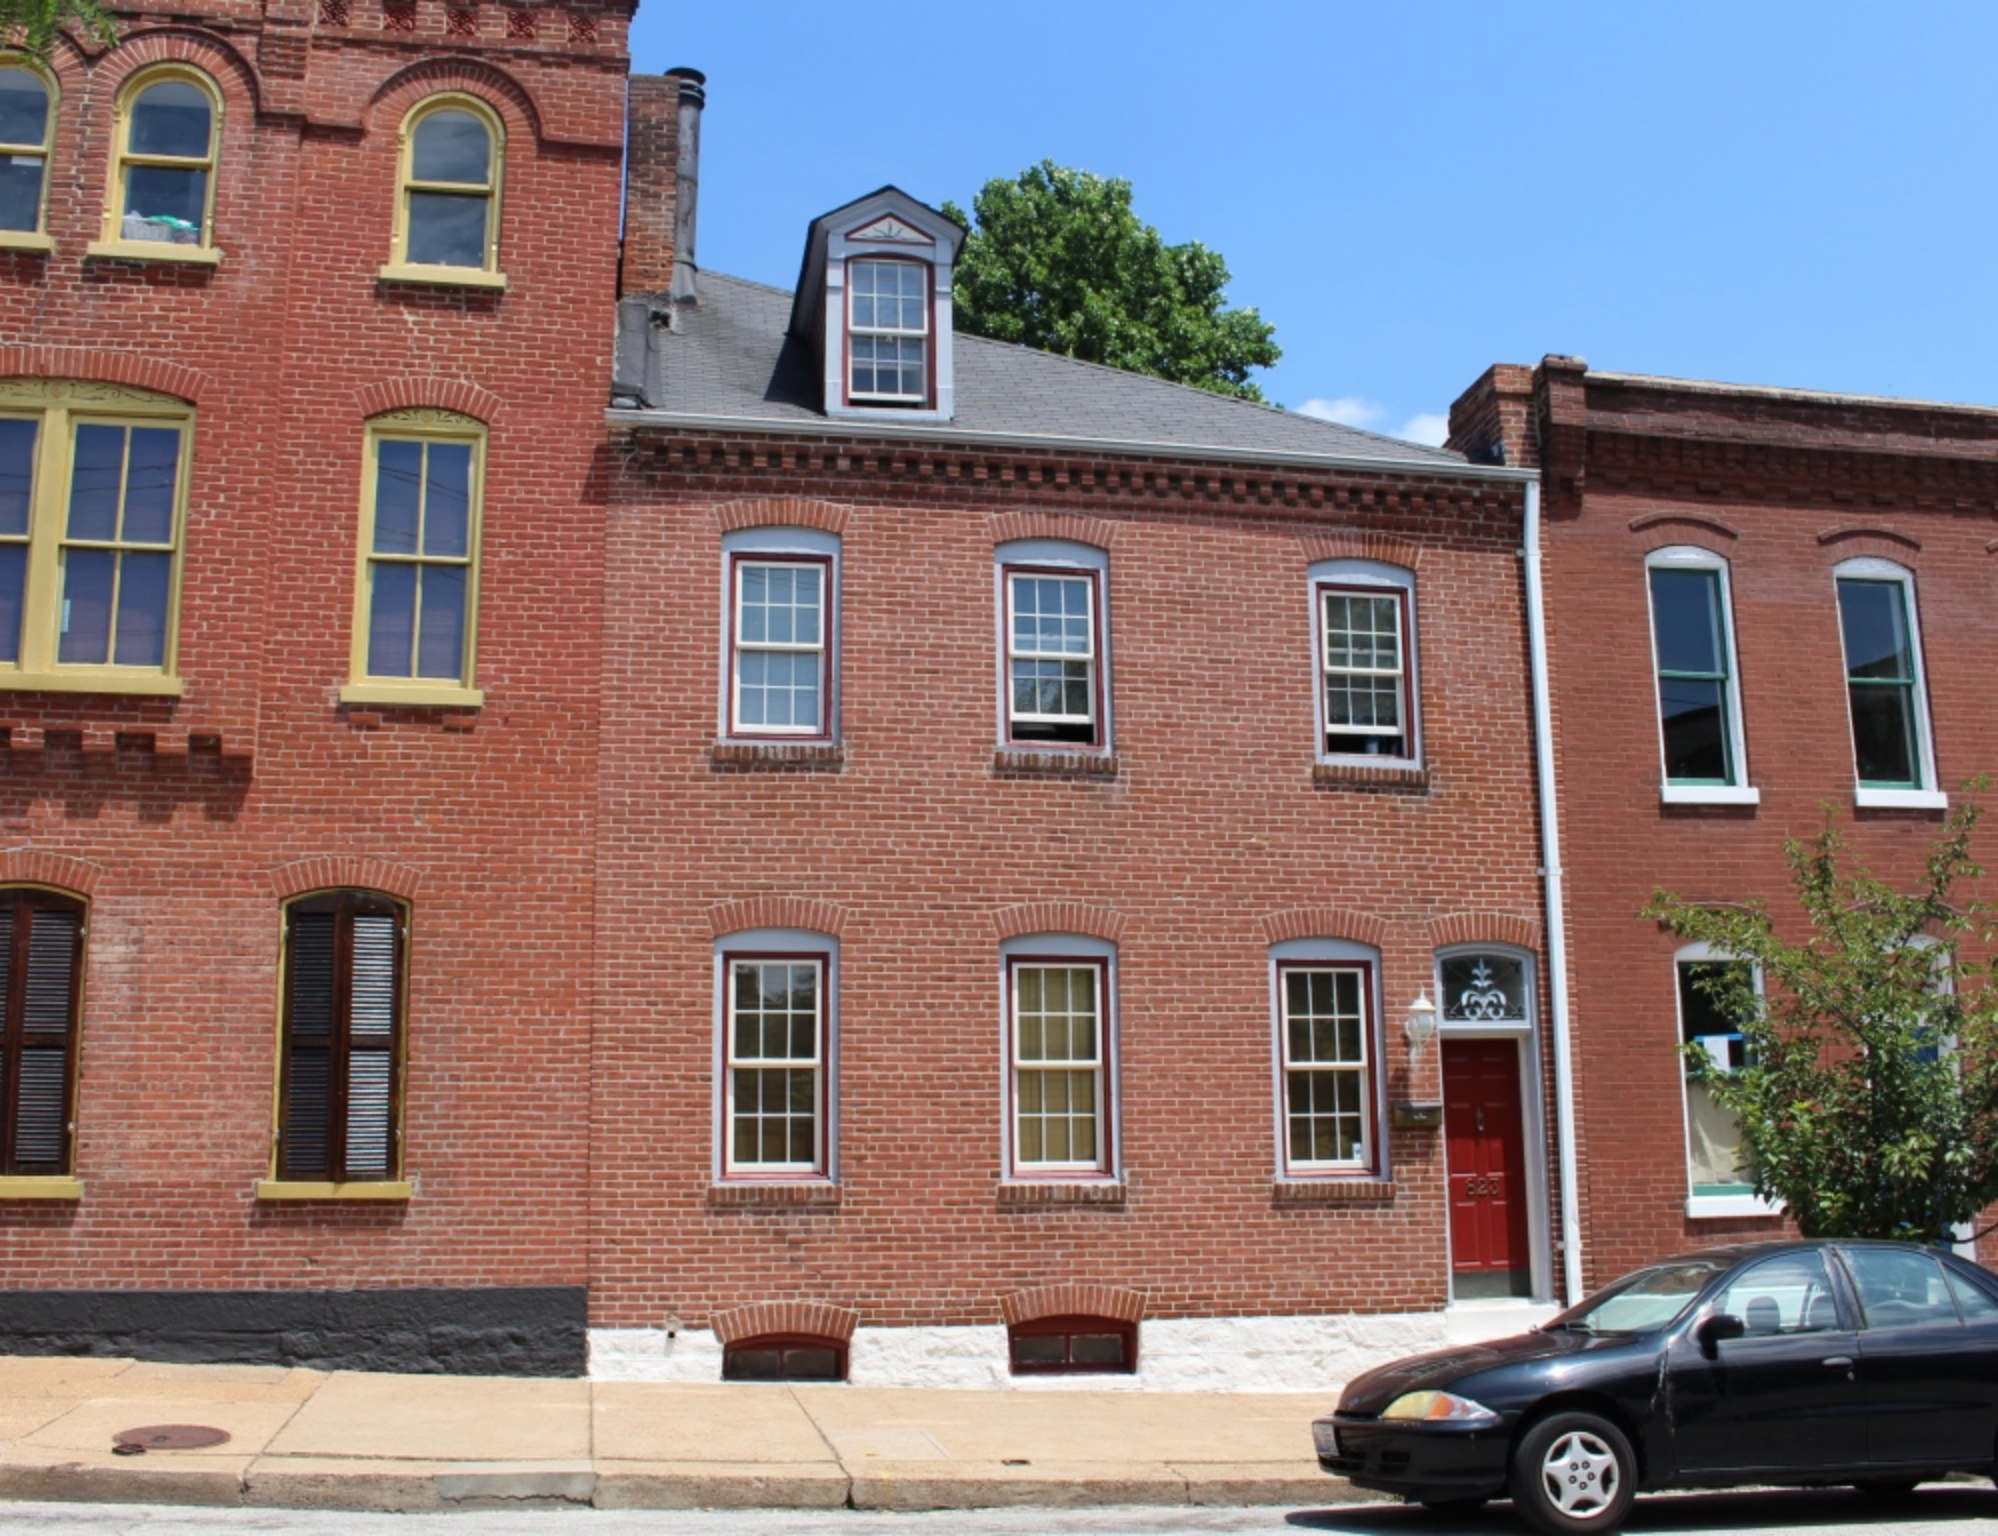
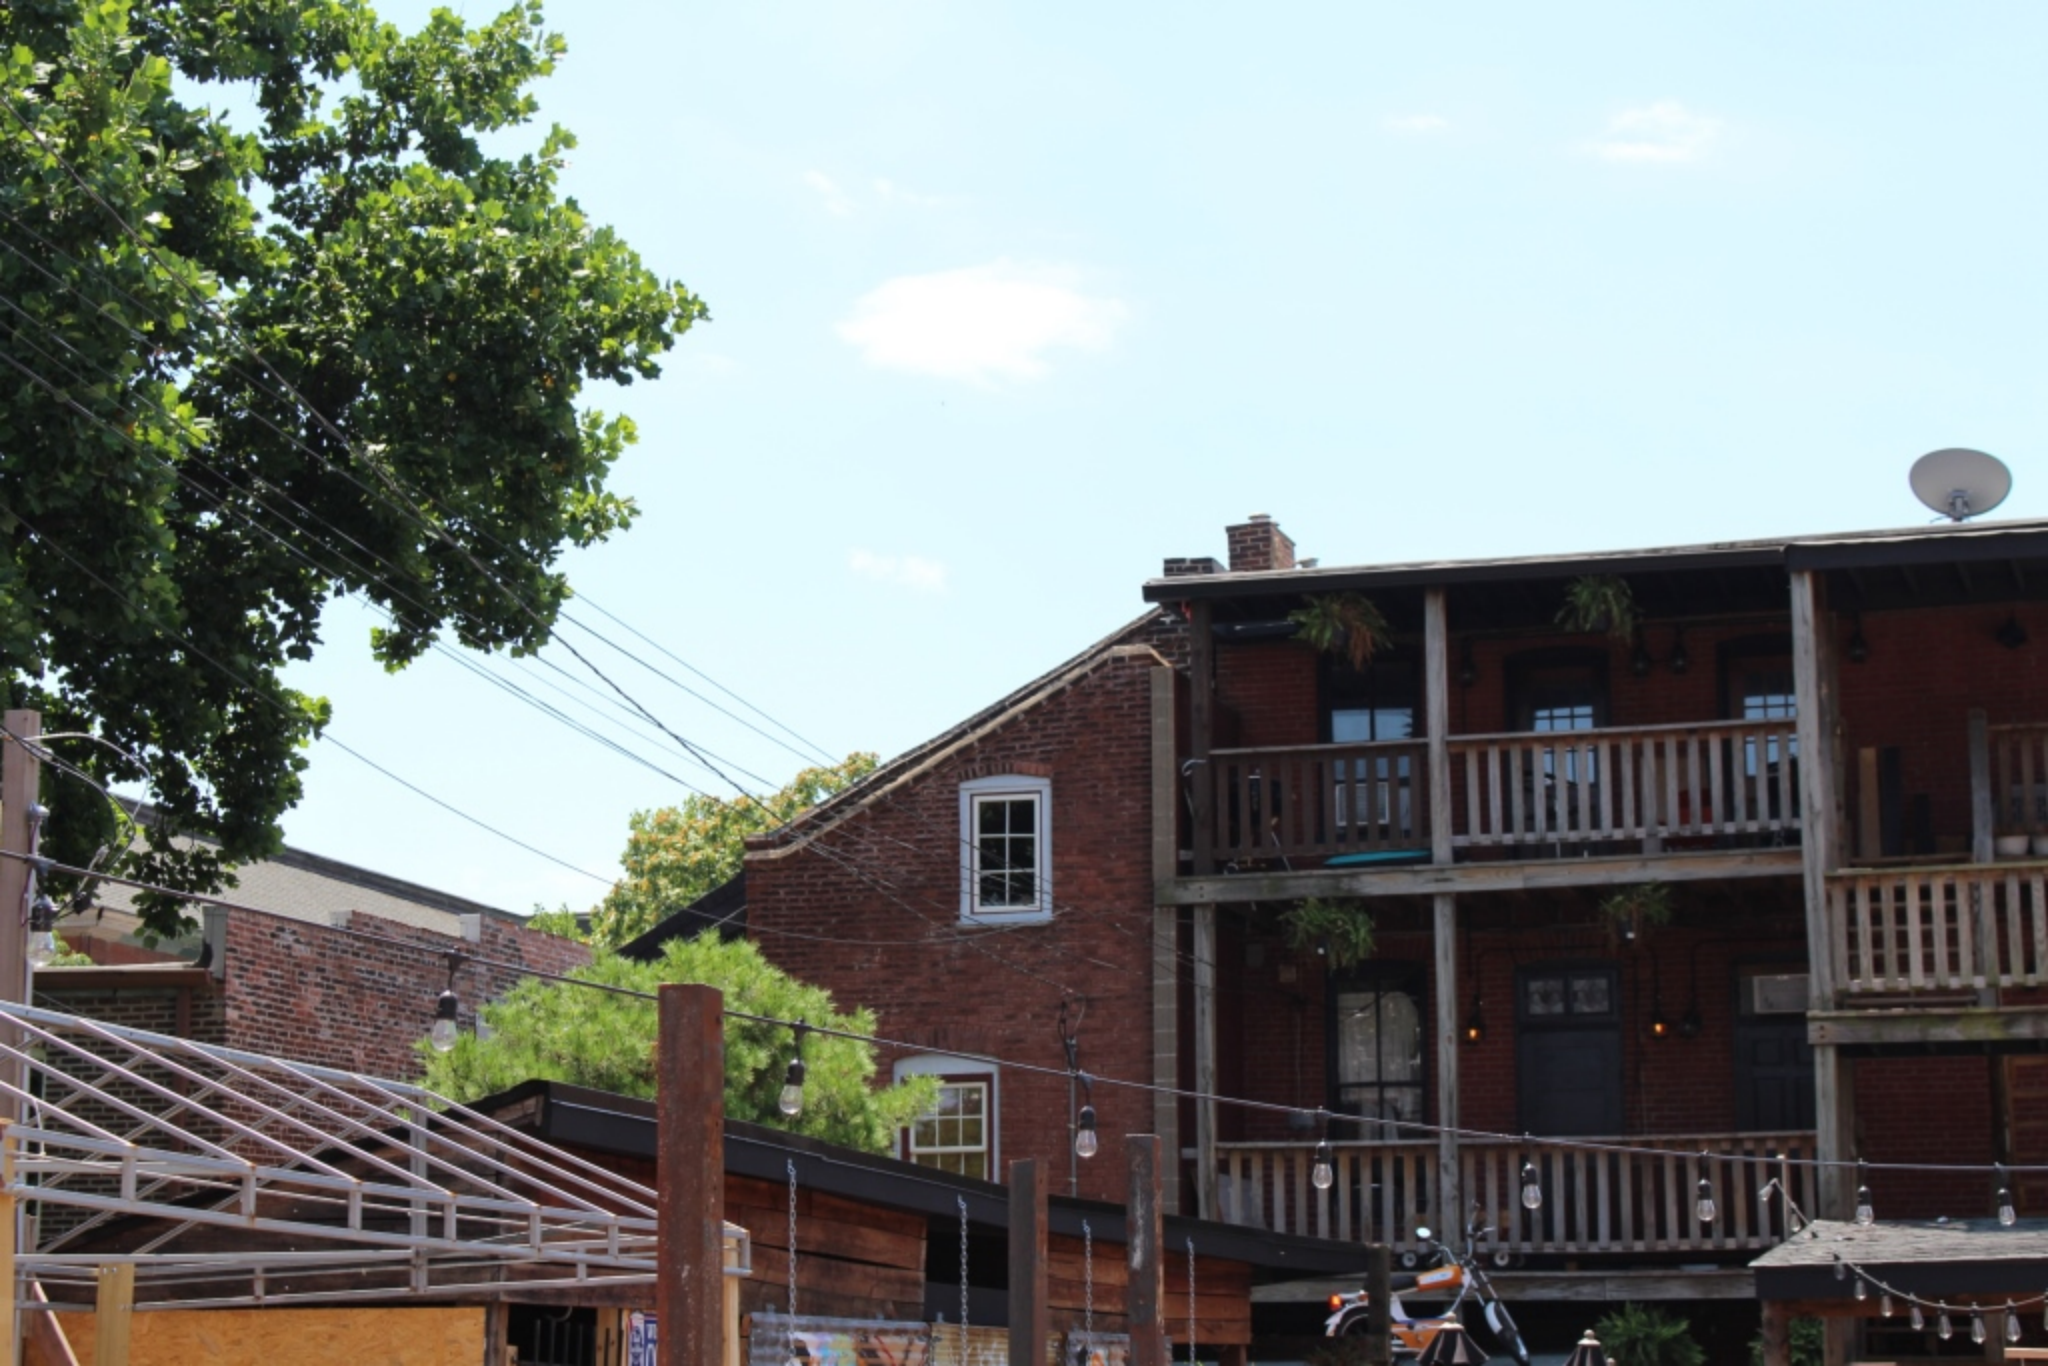
**823 ALLEN AV**

Rear building on lot blocks view of rear of building. Bsement has heavy masonry paint. Hopkins atlas indicates that the adjacent corner bulding was built after the flounder.

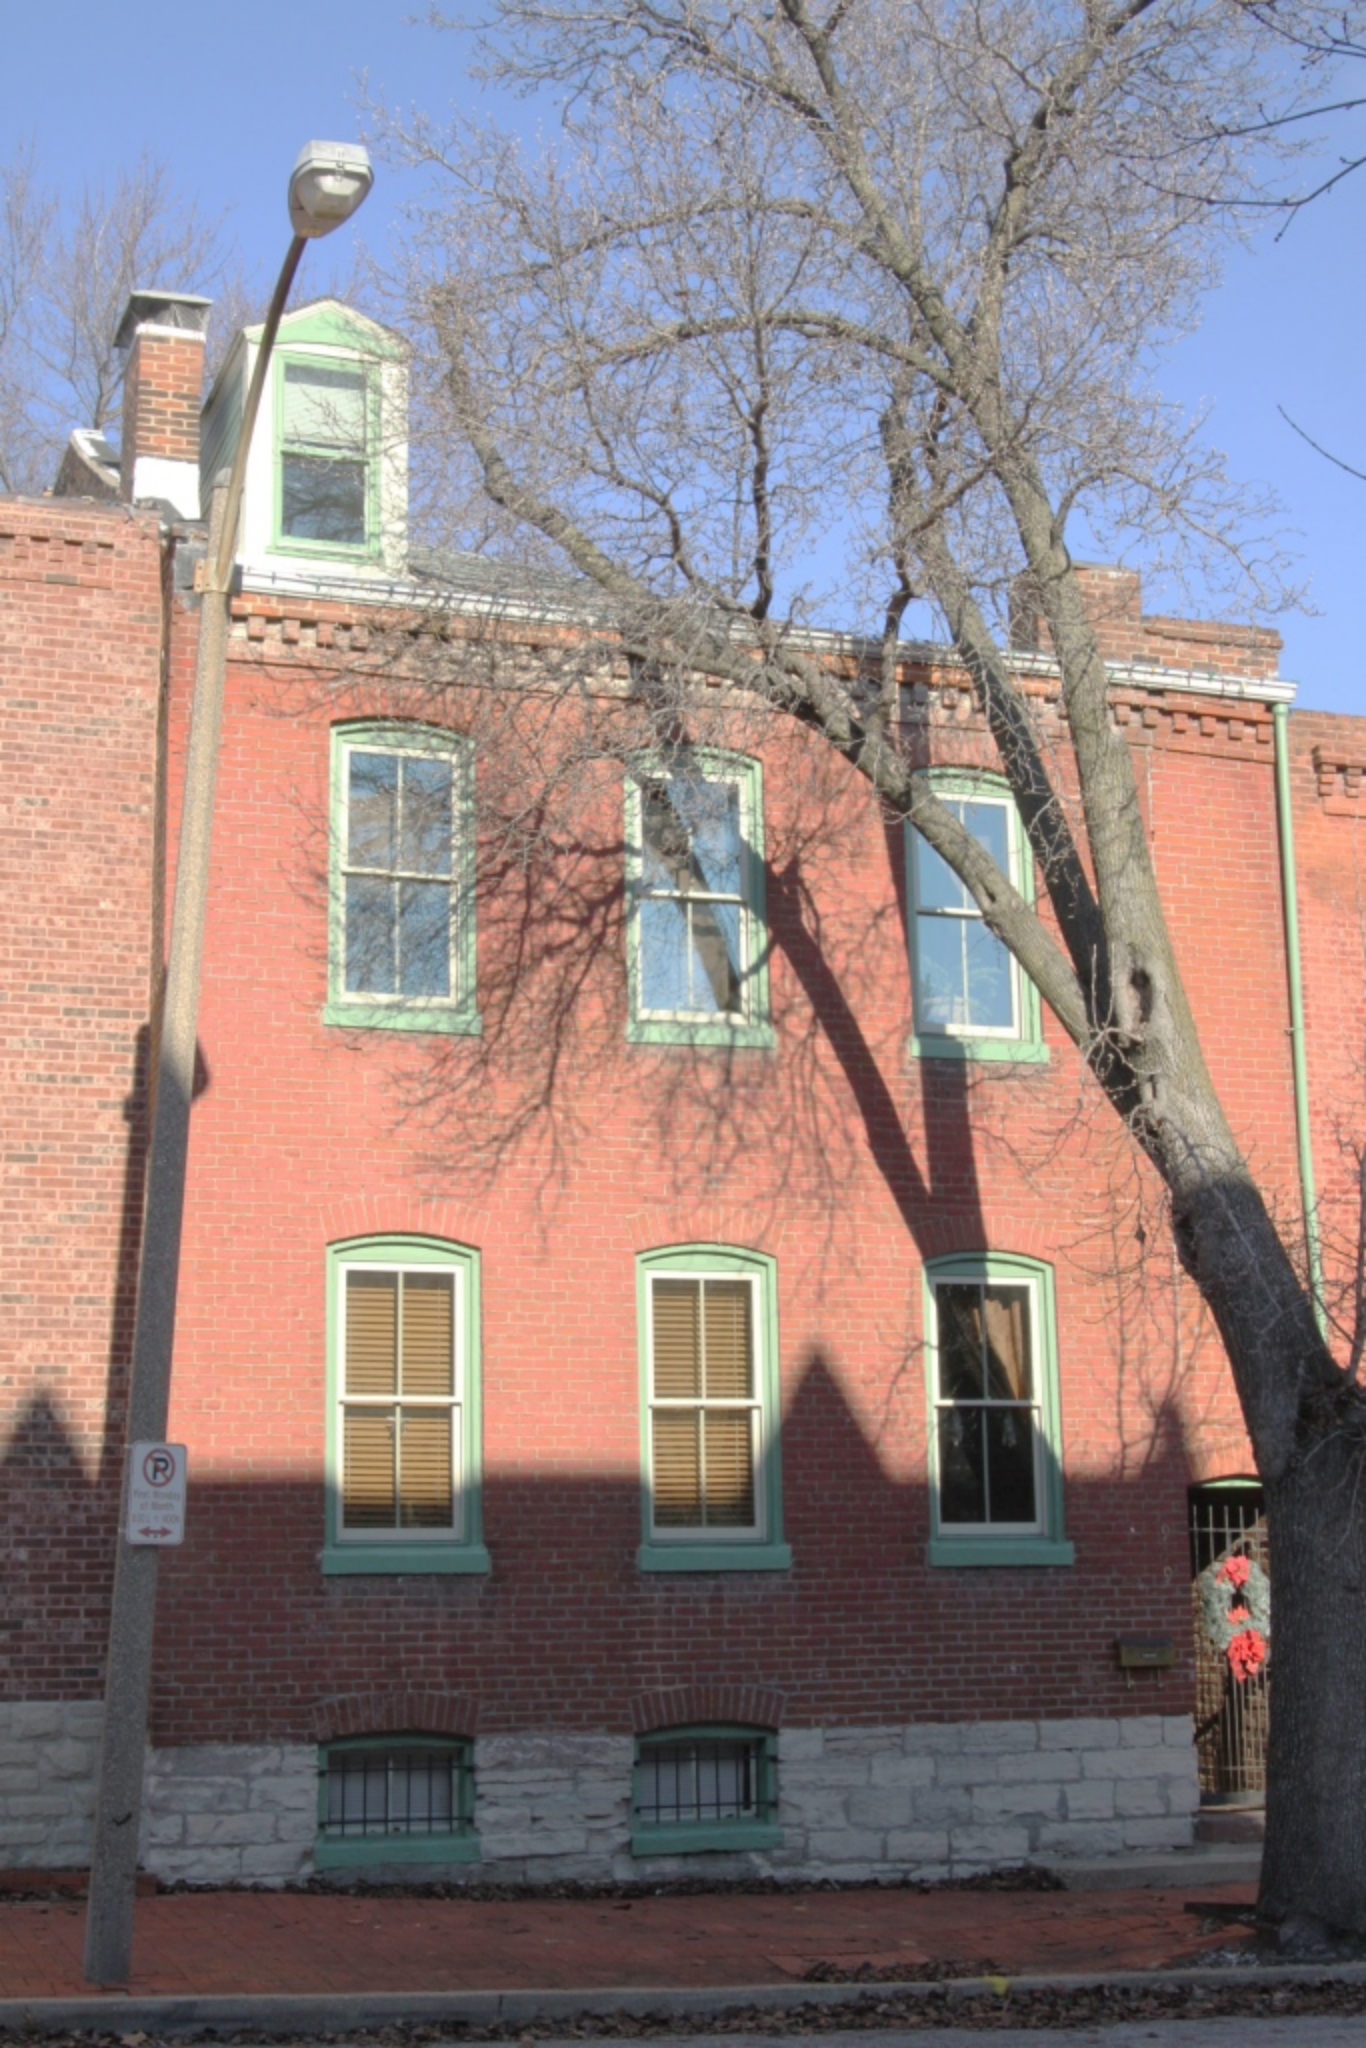
The are three windows on the first and second floor of the building. Each of those windows have segmentally arched lintels with stone window sills. The basement level has two casement windows with the same treatment. The ashlar stone water table projects up to the top of the basement window and runs the length of the front façade. A dentiled brick cornice runs the length of the front façade. There is a frame dormer that projects from the west side of the roof. The gangway between the house to the east has been filled in with a modern addition creating a "mouse hole"

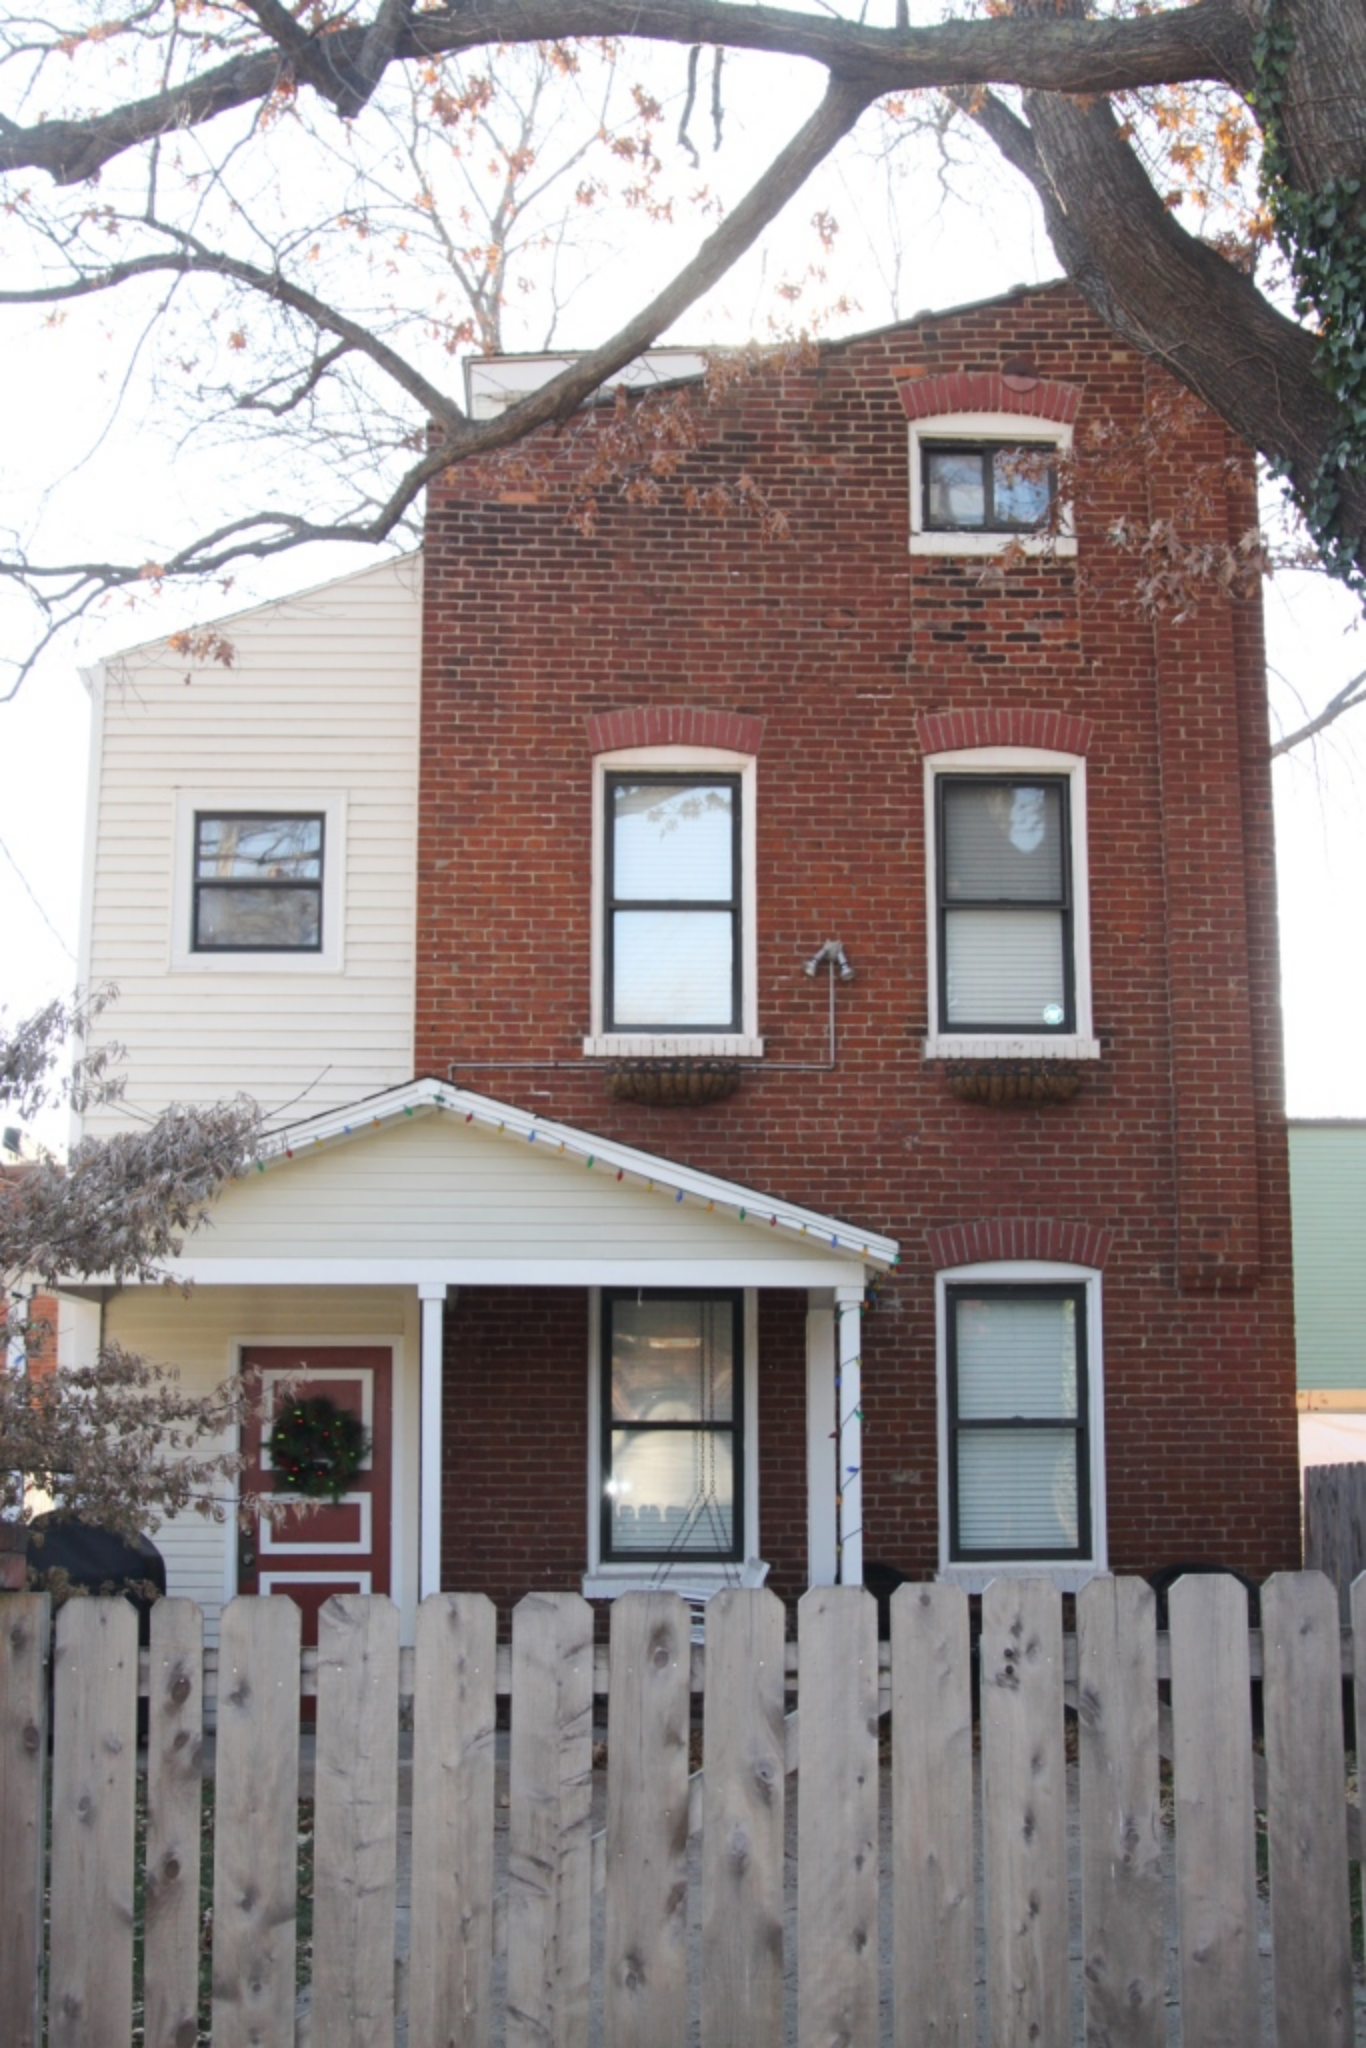
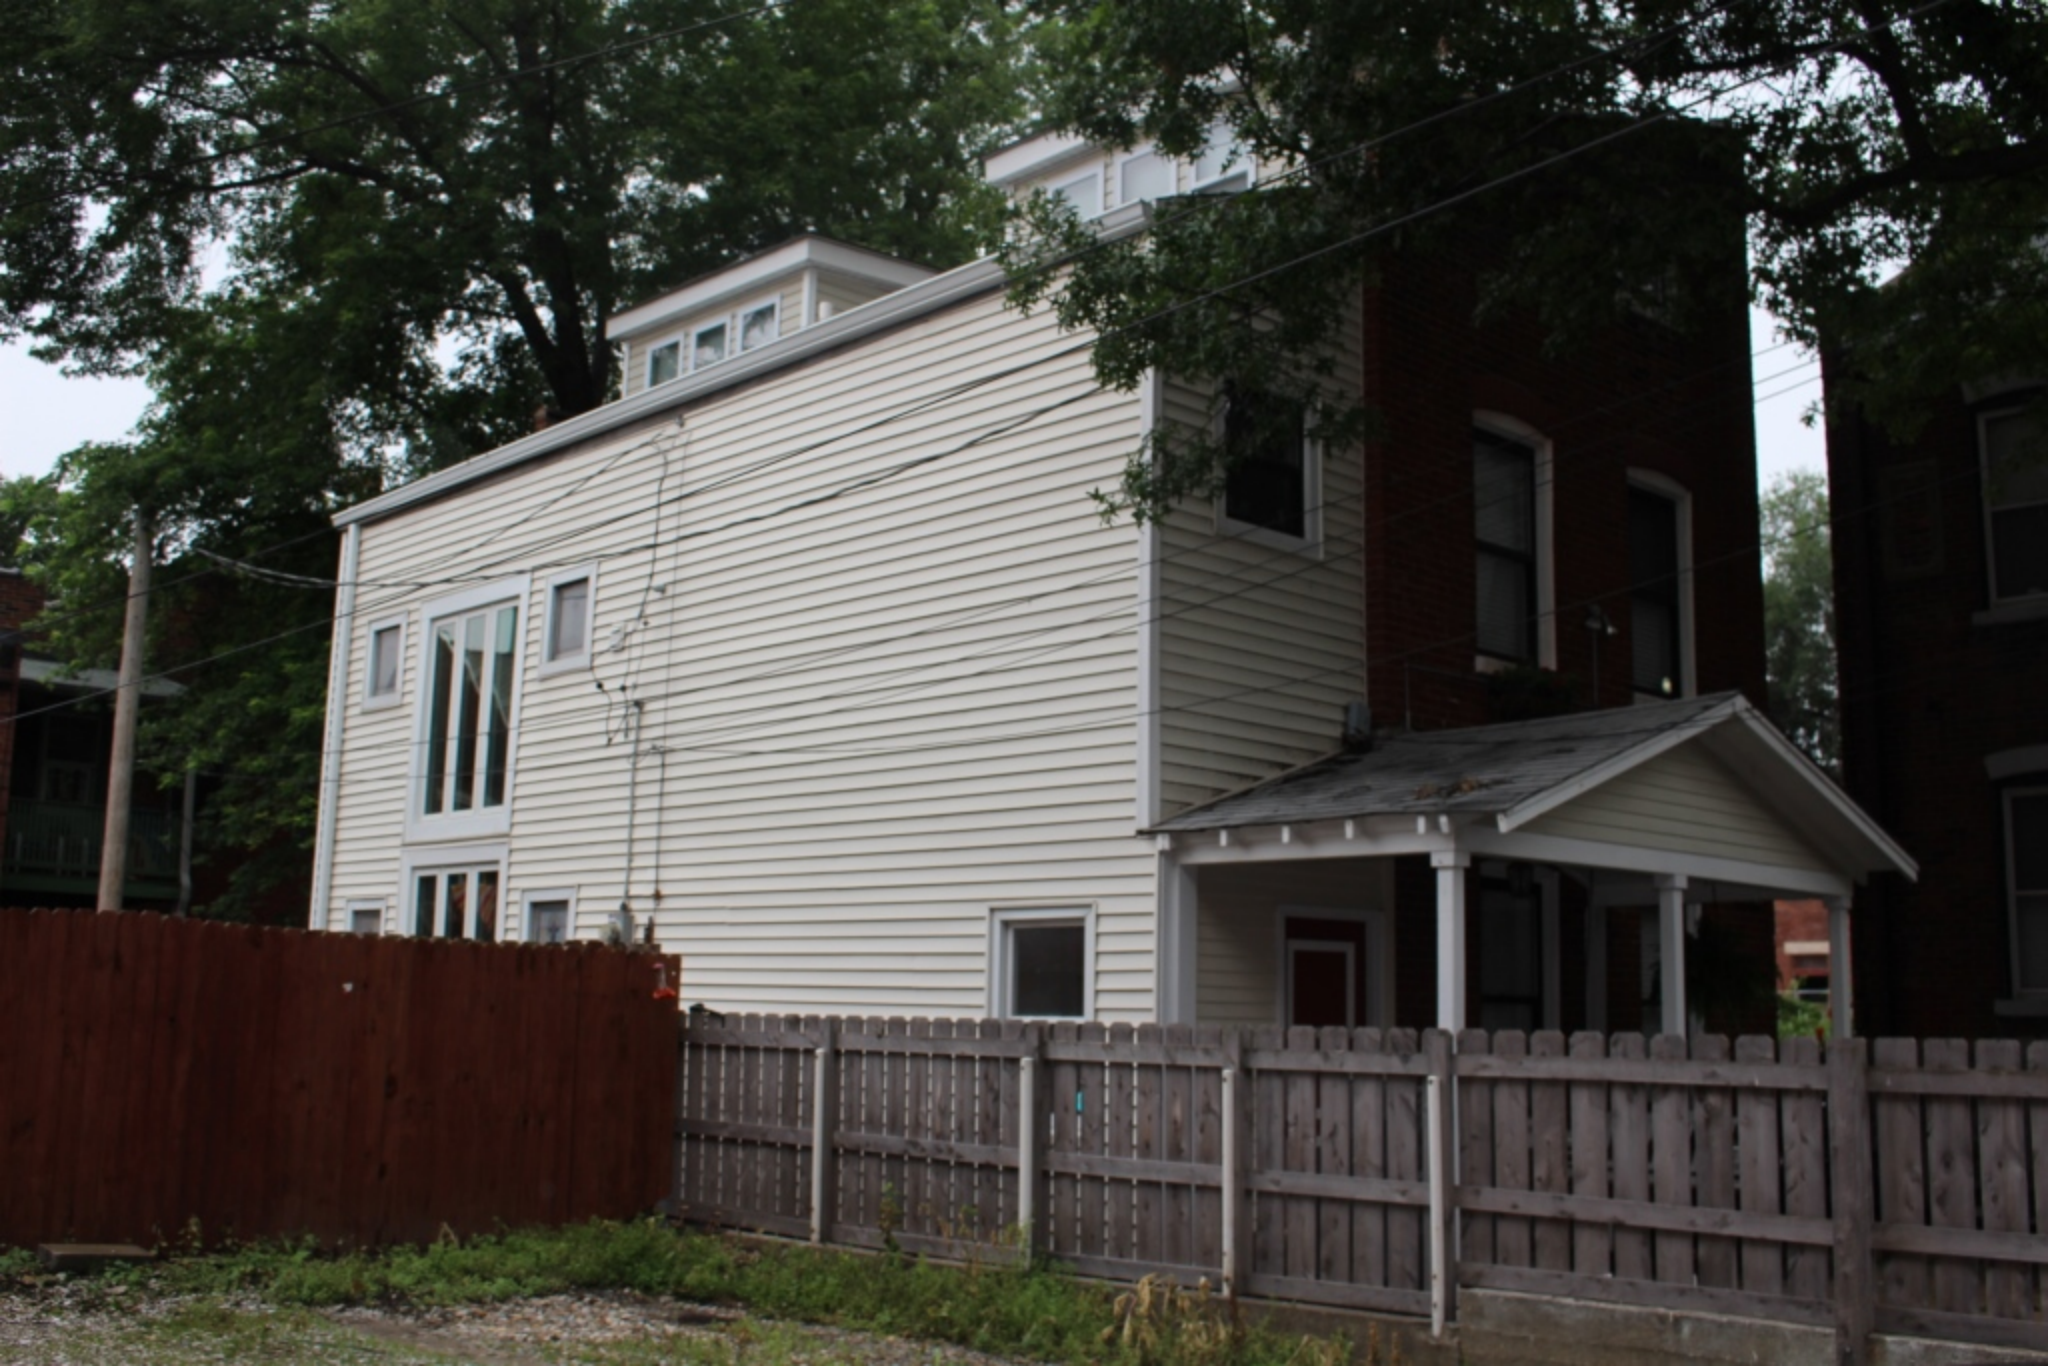
The two-story brick flounder has a loft which is noted by the small two-light fixed window at the attic level. There are two bays on the brick façade and another bay on the enclosed gallery portion of the building. The windows at the first and second stories of the brick portion are one-over-one double-hung windows with segmental arch soldier brick lintels and rowlock sills. The second story window on the frame section is a small one-over-one double-hung. The entry is located in the frame section, a solid three-panel door. A gabled front porch has beewn added to the front of the building, covering about 3/4s of the façade width. The porch is at grade with narrow round columns and vinyl siding at the gable front. On the east elevation there are four bays. There is one one-over-one double-hung window near the front on the first story. The remaining windows a grouped towards the rear and are the same on the first and second stories. There is are long tripartite casements flanked by small, high square windows. Two widen shed roof dormers have been added to the roof at this side. Each dormer has three small single-hung vinyl windows. The rear of the building only has one bay as there are no windows on the frame portion and only one at each level on the brick portion. The windows are similar to those on the front, but the first story window has been shortened.
