**ARCHITECTURAL/HISTORIC INVENTORY FORM - Cultural Resources Office**  
**St. Louis Planning and Urban Design**

1. Survey no. SLC-AS-053-0001	2. Survey name: Thematic Survey of Flounder Houses in St. Louis City	3. County: St. Louis [Independent City]
4. Address: (from City GEO database) <b>1812 S 8TH ST</b>		5. City/State: St. Louis, Missouri
Alternate address: 1812 S 8th		Property Zip Code: 63104
Latitude: 38.608949		6. UTM Easting: 743586.48
Longitude: -90.202538		UTM Northing: 4277095.00
8. Historic Name (if known): N/A	11a. Historic Use (if known): Domestic	City Block: 372 City Ward: 7
9. Present/other name (if known):	7. Township-Range-Section: N/A	10. Ownership: Private
11b. Current Use: Domestic		Neighborhood Number: 21

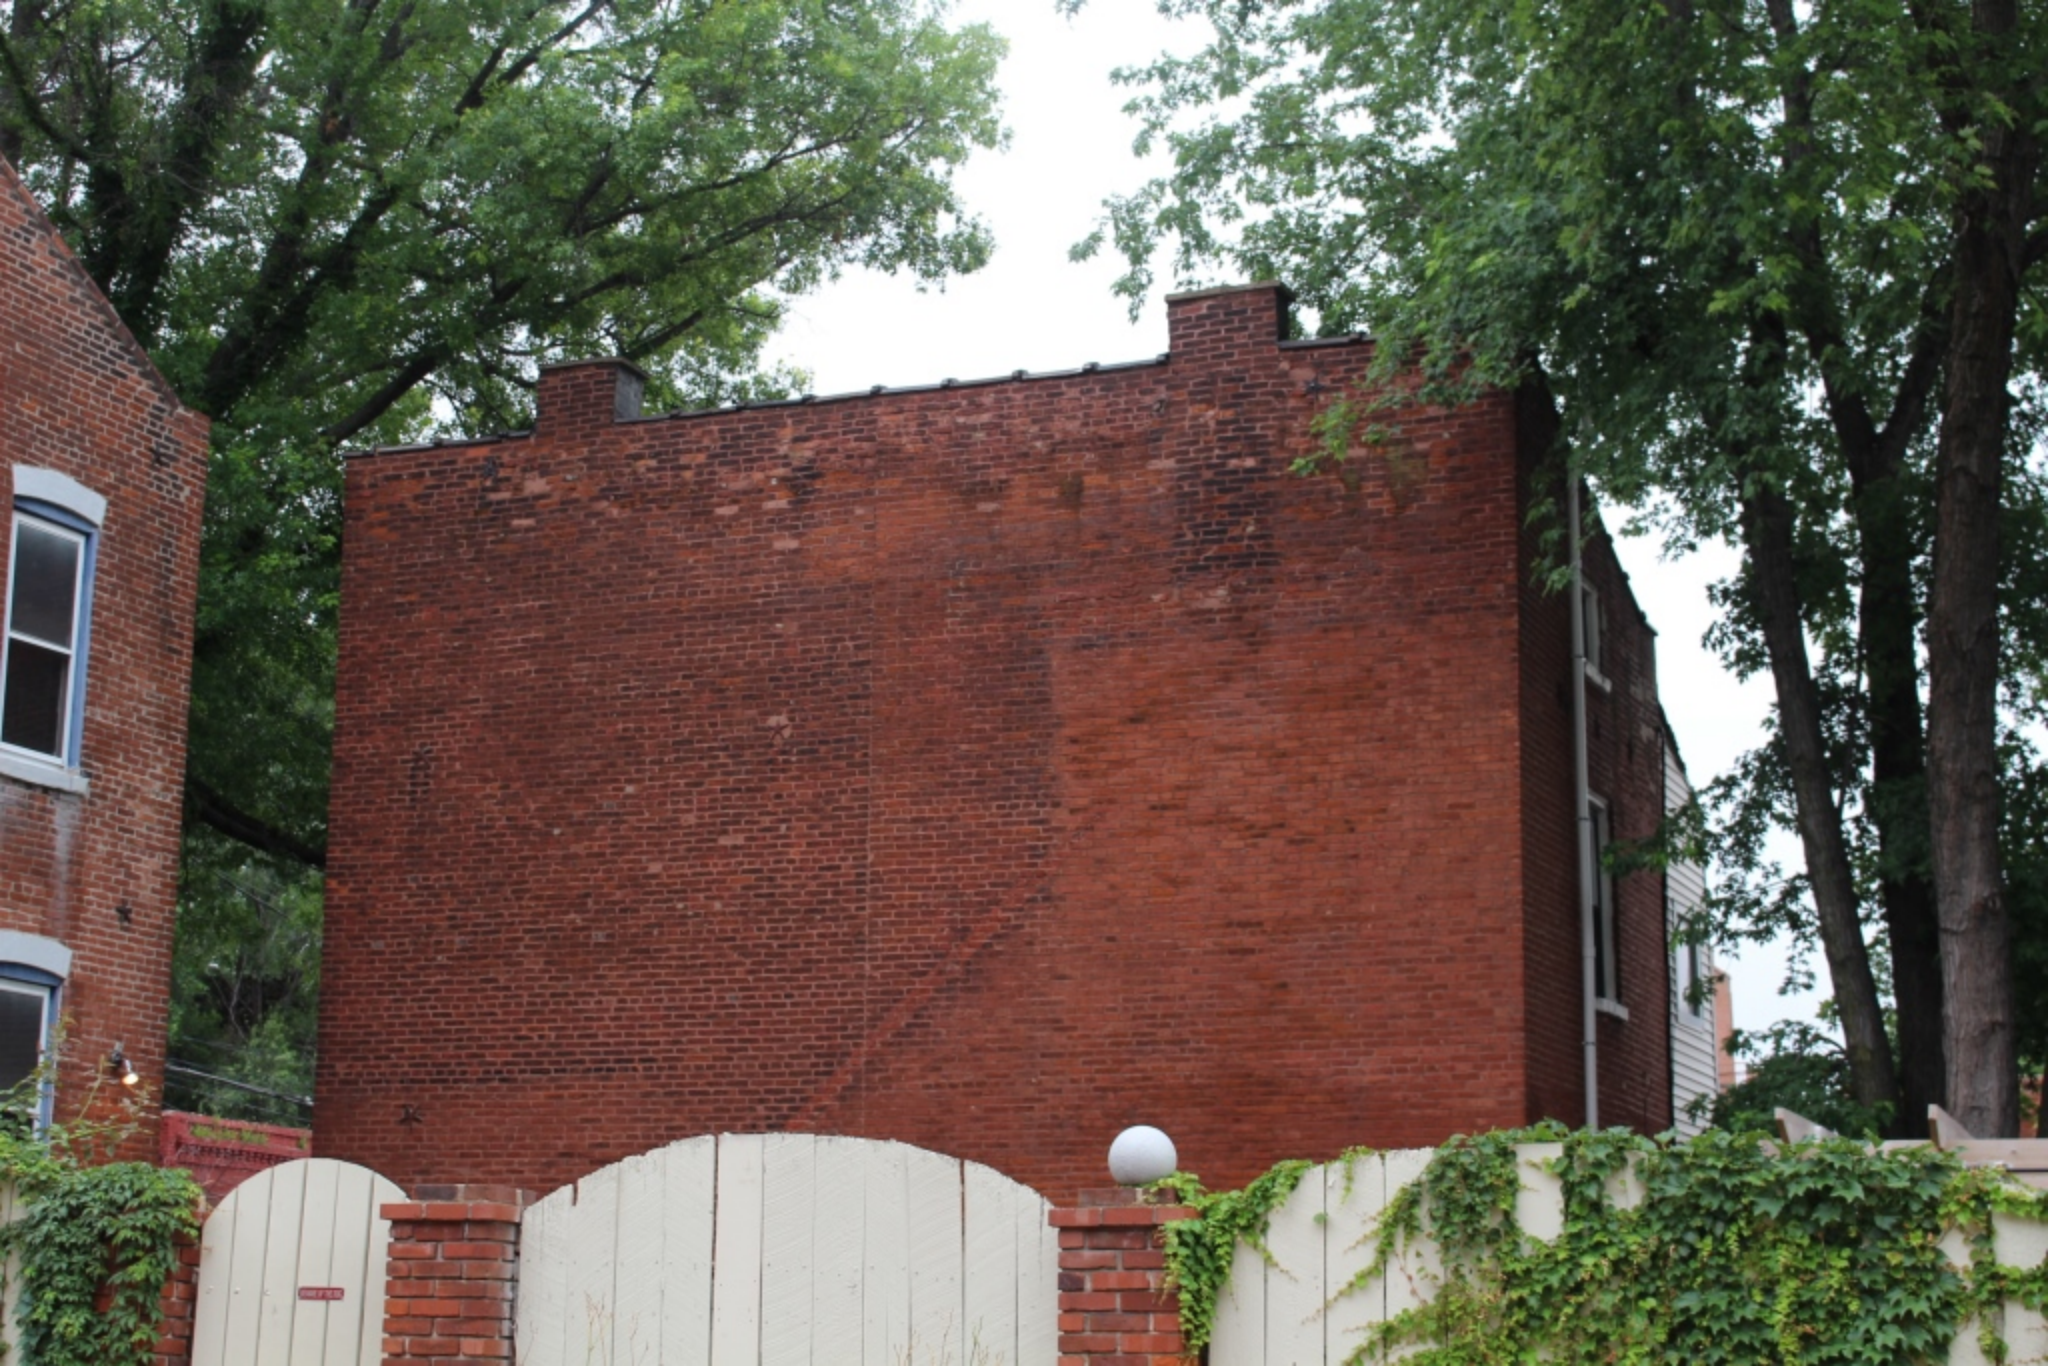
**919R ALLEN AV**

The two-story brick flounder has a loft which is noted by the small two-light fixed window at the attic level. There are two bays on the brick façade and another bay on the enclosed gallery portion of the building. The windows at the first and second stories of the brick portion are one-over-one double-hung windows with segmental arch soldier brick lintels and rowlock sills. The second story window on the frame section is a small one-over-one double-hung. The entry is located in the frame section, a solid three-panel door. A gabled front porch has beewn added to the front of the building, covering about 3/4s of the façade width. The porch is at grade with narrow round columns and vinyl siding at the gable front. On the east elevation there are four bays. There is one one-over-one double-hung window near the front on the first story. The remaining windows a grouped towards the rear and are the same on the first and second stories. There is are long tripartite casements flanked by small, high square windows. Two widen shed roof dormers have been added to the roof at this side. Each dormer has three small single-hung vinyl windows. The rear of the building only has one bay as there are no windows on the frame portion and only one at each level on the brick portion. The windows are similar to those on the front, but the first story window has been shortened.

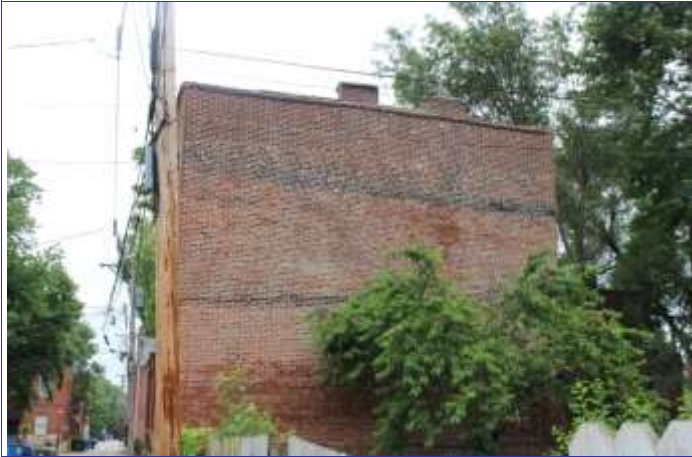
**1007 ALLEN AV**

The subject property is an alley house and only the alley side is visible from inspection.

The two and a half story brick alley building has a single bay facing the alley. A single window is at each floor. The first floor window has a paired areched header brick lintel wit a stone sills. The second and third floor windows have a single header arched lintel and a stone sill. There is a stone foundation that is barely visible above the alley line. The main entrance to the building faces the main house along Allen. There appears to be a two and a half story portion that houses the main entrance.

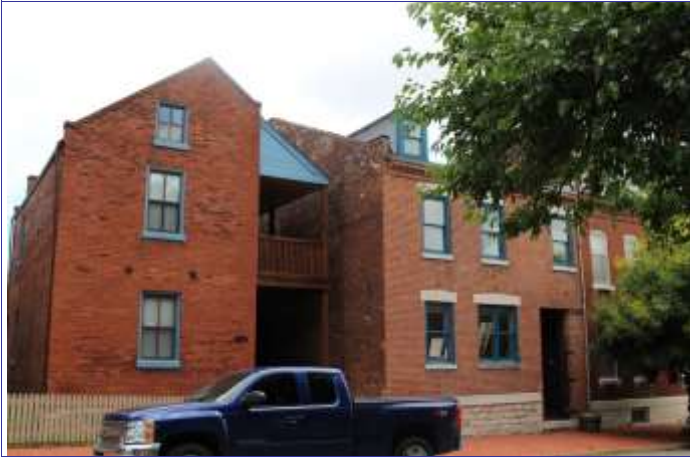
**1041 ALLEN AV**

Building is in good condition and is well-maintained.

This 2-story brick flounder has a hipped roof at the front from which a dormer projects. The limestone foundation has an ashlar watertable and there is a corbelled cornice at the eaves. The eastern of the three bays of the façade has an open square-headed entrance with exposed iron lintel into a passageway and has a gate; the brick returns on the house side of the passage way to the entrance, a few feet. Most of the passageway wall is enclosed with siding. The window above the passageway is offset towards the corner of the building. The flat-headed window openings have flush stone pedimented heads and sills; they hold wood double-hung sash. The taller blind wall is exposed on the west; the gallery-type area on the east abuts the adjacent building. A small gabled dormer projects from the front hipped roof slope.

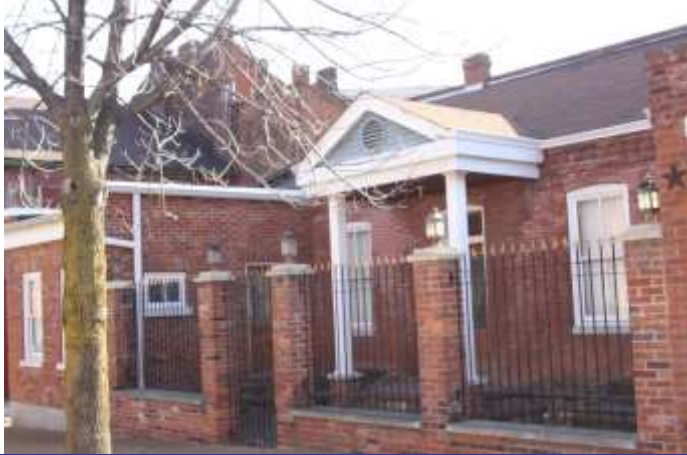
**1104-10 ALLEN AV**

Building is in good condition and is well-maintained.

The 1-story brick flounder, an alley house, is positined so its long side, the shorter wall, faces the street. The four-bay façade has an entrance in one of the center bays that has a modern gabled-roof entrance porch supported by wood posts. The door and window openings have segmentally-arched heads formed of header bricks and stone sills. A denticulated cornice edges the eaves. A flounder-shaped wing slightly lower in height extends from the alley end of the house; a flat-roofed extension to that wing faces the street and has a garage door in the street façade. At the other end of the house, another two-part flat-roofed wing extends towards the street.

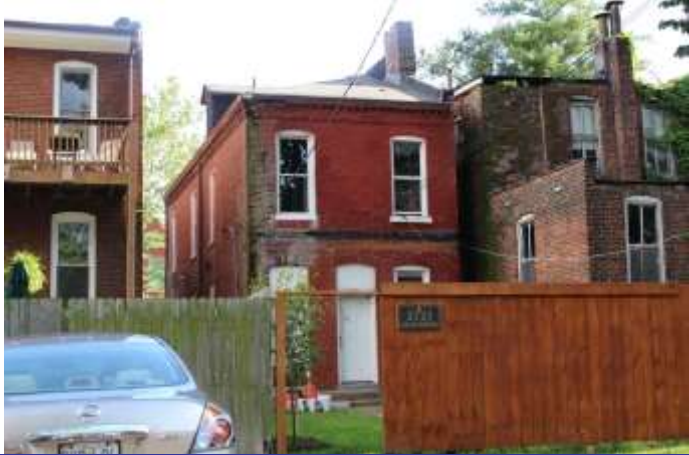
**2721 ALLEN AV**

This 2-story brick flounder has a side entrance in the front bay of the east side. A low-pitched hip roof intersects the main shed roof from which a dormer projects; the taller windowless wall is on the west side. A corbeled brick cornice edges the façade, east side and rear. The two bays of windows have segmentally-arched heads formed of brick stretchers and lugged stone sills.

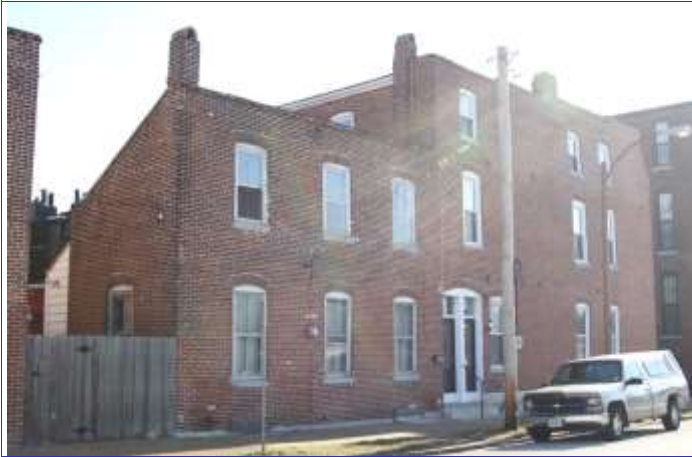
**1229-31 ALLEN MARKET LA**

construction details suggest that the flounder was built first; the corner of the building serves as one of the sides of the entrance at the rear of the side wall of the front building; the break in the brick above is clear; the third story overlaps the top of the flounder wall by about one foot.

This 1 1/2-story brick flounder is positioned behind the front building, facing the street; an adjacent building is at the alley. The taller wall faces the street and has three bays of windows, with openings at both the main and attic story. The window openings have segmentally-arched heads, with those on the attic story flatter than the ones below, formed of stretcher bricks; sills are stone. Aerial views indicate that a dormer projects from the steep slope of the shed roof. The northeast corner of the building is an wood gallery.

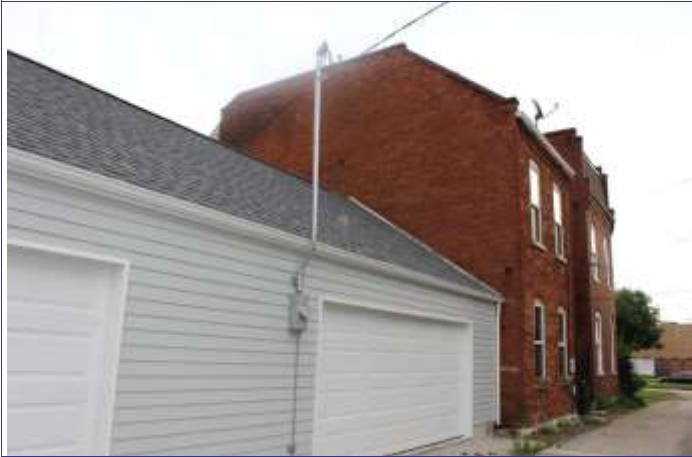
**710 ANN AV**

new garage abuts on blind side; the north side on the interior of the lot is not visible. The Bing Maps bird's-eye view shows the north side and roof forms well.

This 2-story brick flounder positioned at the alley has a hipped roof at both the front and rear. A corbelled brick cornice edges the horizontal eaves of the alley and east sides of the building except for the taller windowless wall on the west side. The main roof extends to cover a two-story gallery on the short side of the building on the interior of the lot. The two bays of windows facing the alley and this in the east wall have segmentally-arched heads formed of stretcher brick and stone sills; window sash is replacement 1/1 doublehung sash. The entrance is in the rear bay of the east wall; A single step gives access to the door set under a transom.

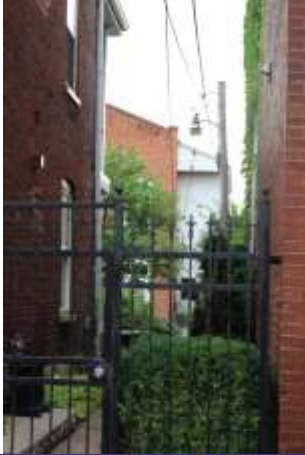
**710 ANN AV**

This 2-story brick flounder has a two-story gallery that includes the entrance. The two-bays facing the street have segmentally-arched openings formed of stretcher bricks. The openings hold 2/2 doublehung sash. The main shed roof has a hipped front and a corbelled brick cornice edges the horizontal eaves. A small gabled dormer projects from the front roof slope near the east side of the taller windowless wall. The 2-story gallery is covered by the main roof slope. The street end of the gallery is open as a two-level porch and the rear portion is enclosed.

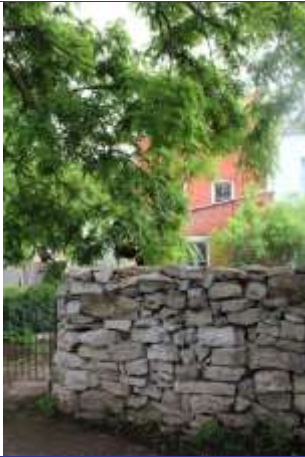
**808 ANN AV**

This 2 1/2 story brick flounder presents three bays to the street, one of which is the wing wall for a side gallery. The openings into the house have segmentally-arched heads of stretcher brick and stone sills; these openings, as well as the square-headed window in the second story of the wing wall, have arched head 2/2 doublehung sash. The entrance in the wing wall has a square head into which a paneled door is set below a transom. The taller windowless wall rises on the east side. The shed roof is hipped in the front where a denticulated brick cornice edges the horizontal eaves; a small gabled dormer projects from the front roof slope and a larger gabled dormer extends from the shed roof. A window at the attic level at the rear lights that space as well. The gallery is an open porch at the ground story and is enclosed with modern siding at the second story where there are two windows. A one-story wing with a flounder form projects from the rear and an exterior staircase rises to the rear end of the gallery.

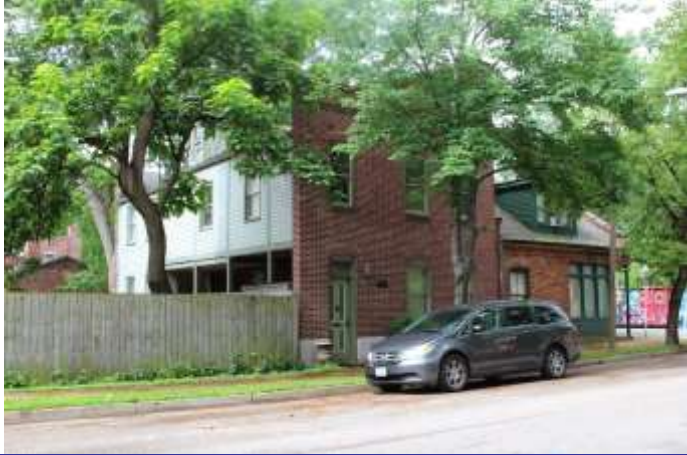
**824 ANN AV**

foundation parged

This 2 1/2-story brick flounder presents three bays to the street, one of which is a gallery wing wall with a flat termination at the lower slope of the dominant shed roof. The entrance through the wing wall into the open gallery is at grade. That opening, as well as the window openings have segmentally-arched heads formed of soldier bricks and brick header sills. The attic window and others have 1/1 doublehung sash. The gallery is enclosed with siding at the second story and has windows in some bays. The open ground story is shielded from view by a privacy fence.

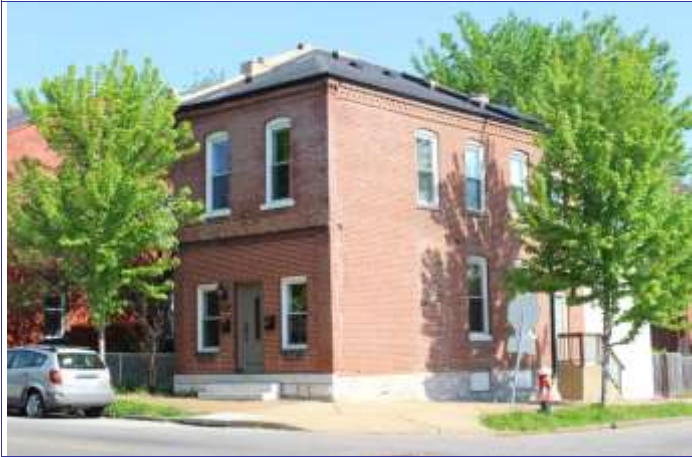
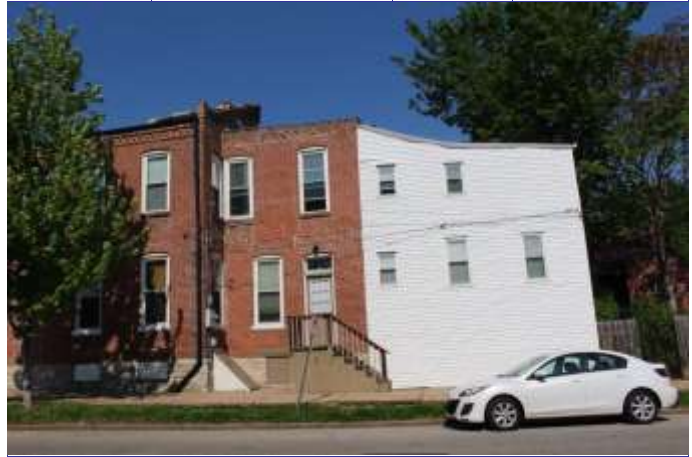
**2733 ARSENAL ST**

The two-story rear wing likely reworking or replacement of historic wood-framed extensions that show on 1909 Sanborn Map; replacement windows set inside brickmold; front storefront filled in with brick. The front entrance is not historic.

This two-story brick flounder, a store and loft building by function, originally had a storefront in the Arsenal street façade, which has since been infilled. The shed roof of the front block angles down to the east from the edge of the taller windowless wall on the west side of the building. The corbelling at the cornice on the Arsenal façade incorporates curved, shaped bricks; the denticulated cornice on the east side of the building (now facing Iowa), is simpler. The three bays on the east side wall consist of narrow window openings and include a blocked one that appears to have been a door; these openings, and the two at the second story of the Arsenal façade have segmentally-arched heads formed of soldier bricks; sills are a mix of stone and header bricks. All windows have replacement sash. The raised limestone basement has two windows aligned with the two northern bays of the front block. The two-story brick rear wing is set back from the east façade of the front block, behind a bay of windows and an exterior access to the basement. The two-bay wide wing has a door facing Iowa approached with a concrete stoop. The door and window openings of this wing are also segmentally-arched and similar in size to those on the front wing. The wood-framed rear wing has vinyl siding that extends to the sidewalk. It has a roof that slopes down from the flat roof of the brick rear wing, and then flattens at the rear.

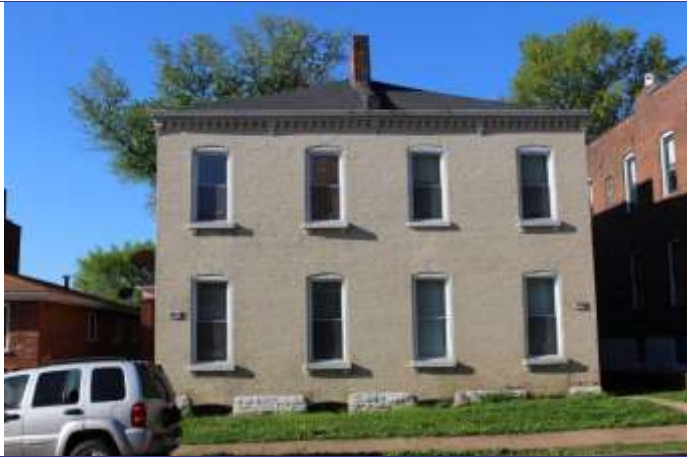
**2814-6 ARSENAL ST**

This 2 1/2 story brick building is a pair of semi-detached flounders with a hipped front roof slope and the rest of the building covered by a shed roof. A fully-developed corbelled brick cornice edges three sides of the building. The entrances in the center bays of the main portion of the side façades consist of a simple step to the west side entrance and a stoop-sized porch with brick columns supporting a hipped roof that shelters the east entance. Windows, including those at the basement level, have semi-elliptical arches formed of headers and the windows on the two stories of the façade have prominent bracketed projecting sills. Gallery porches fill the inset of the brick wall at the rear of the side walls; their shed roofs shelter exterior steps leading to the second-story level where there is a porch with wood railings. Steps lead to the door in each of the rear wings. Attic windows facing the alley have historic two-light casement wood sash. All other windows above the basement have replacement vinyl sash.

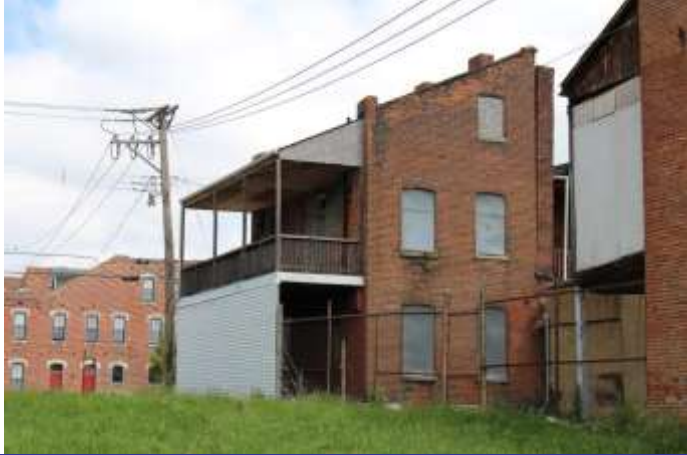
**1407 BENTON ST**

Building is in fair condition and the windows have been boarded.

This 2 1/2 story flounder positioned at the alley has a projecting wood gallery on the west side. It abuts a building on its east side that faces N 14th Street. The basement is notable for its cut and coursed limestone block. Window openings have setmentally-arched heads at all stories; the attic arch is lined with headers, those at lower stories with stretcher bricks.

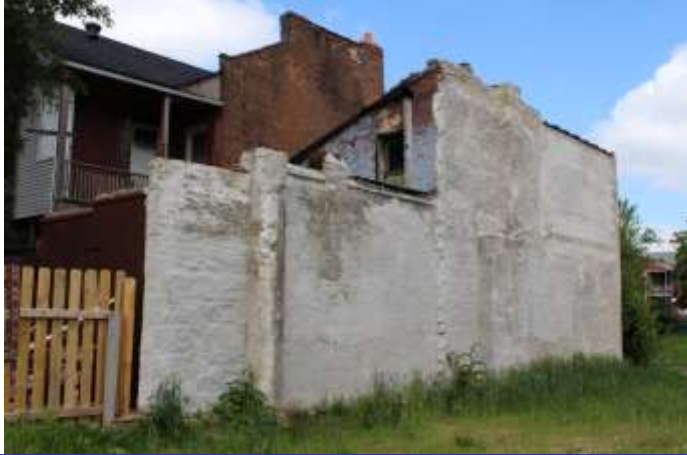
**1410 BENTON ST**

This 1 1/2-story brick flounder has a wood gallery bay on the west side that includes the entrance. The two-bay brick portion of the façade has an attic window in the east bay; the attic window has 3/1 wood sash. The two windows in the ground story have prominent painted stone headers and sills and hold replacement sash. The entrance into the end of the wood gallery has a historic wood enframement with dentil molding. A replacement door is set to the west side of the opening and is flanked by a blocked sidelight. The tall windowless wall, originally a party wall, is now parged. There is an opening at the attic level in the rear wall filled with a glazed wood door. A flat-roofed one-story brick addition extends to the rear.

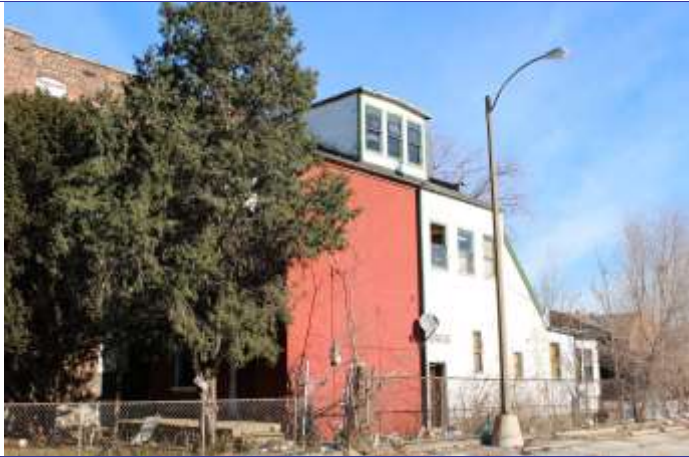
Front and south facades

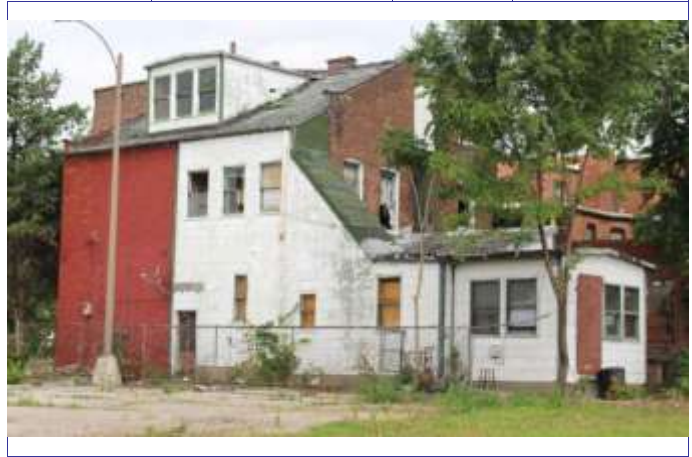
Rear and south facades

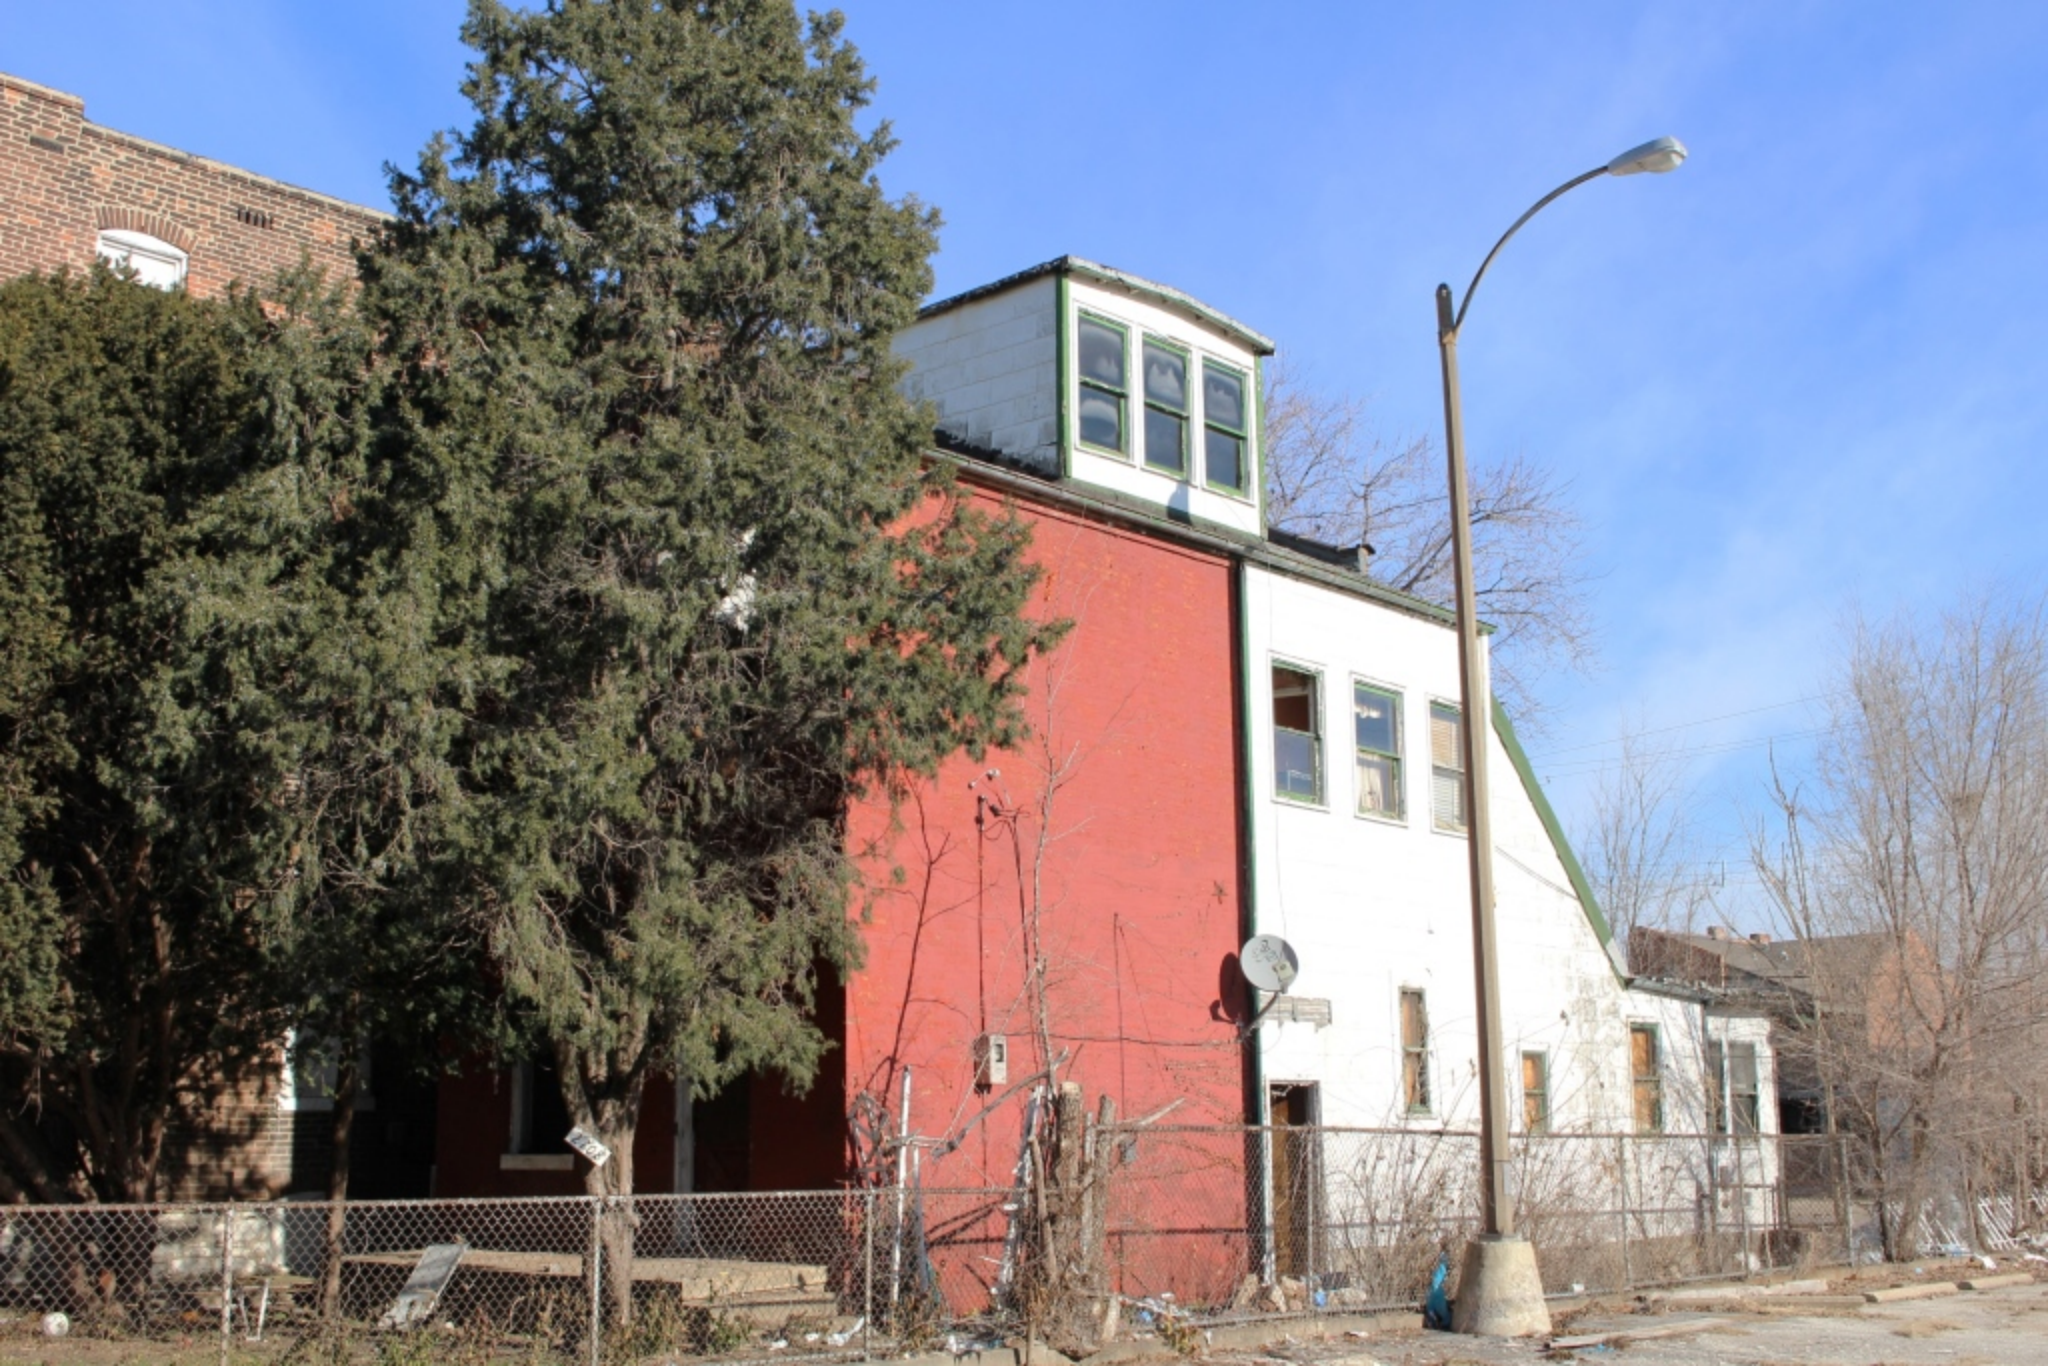
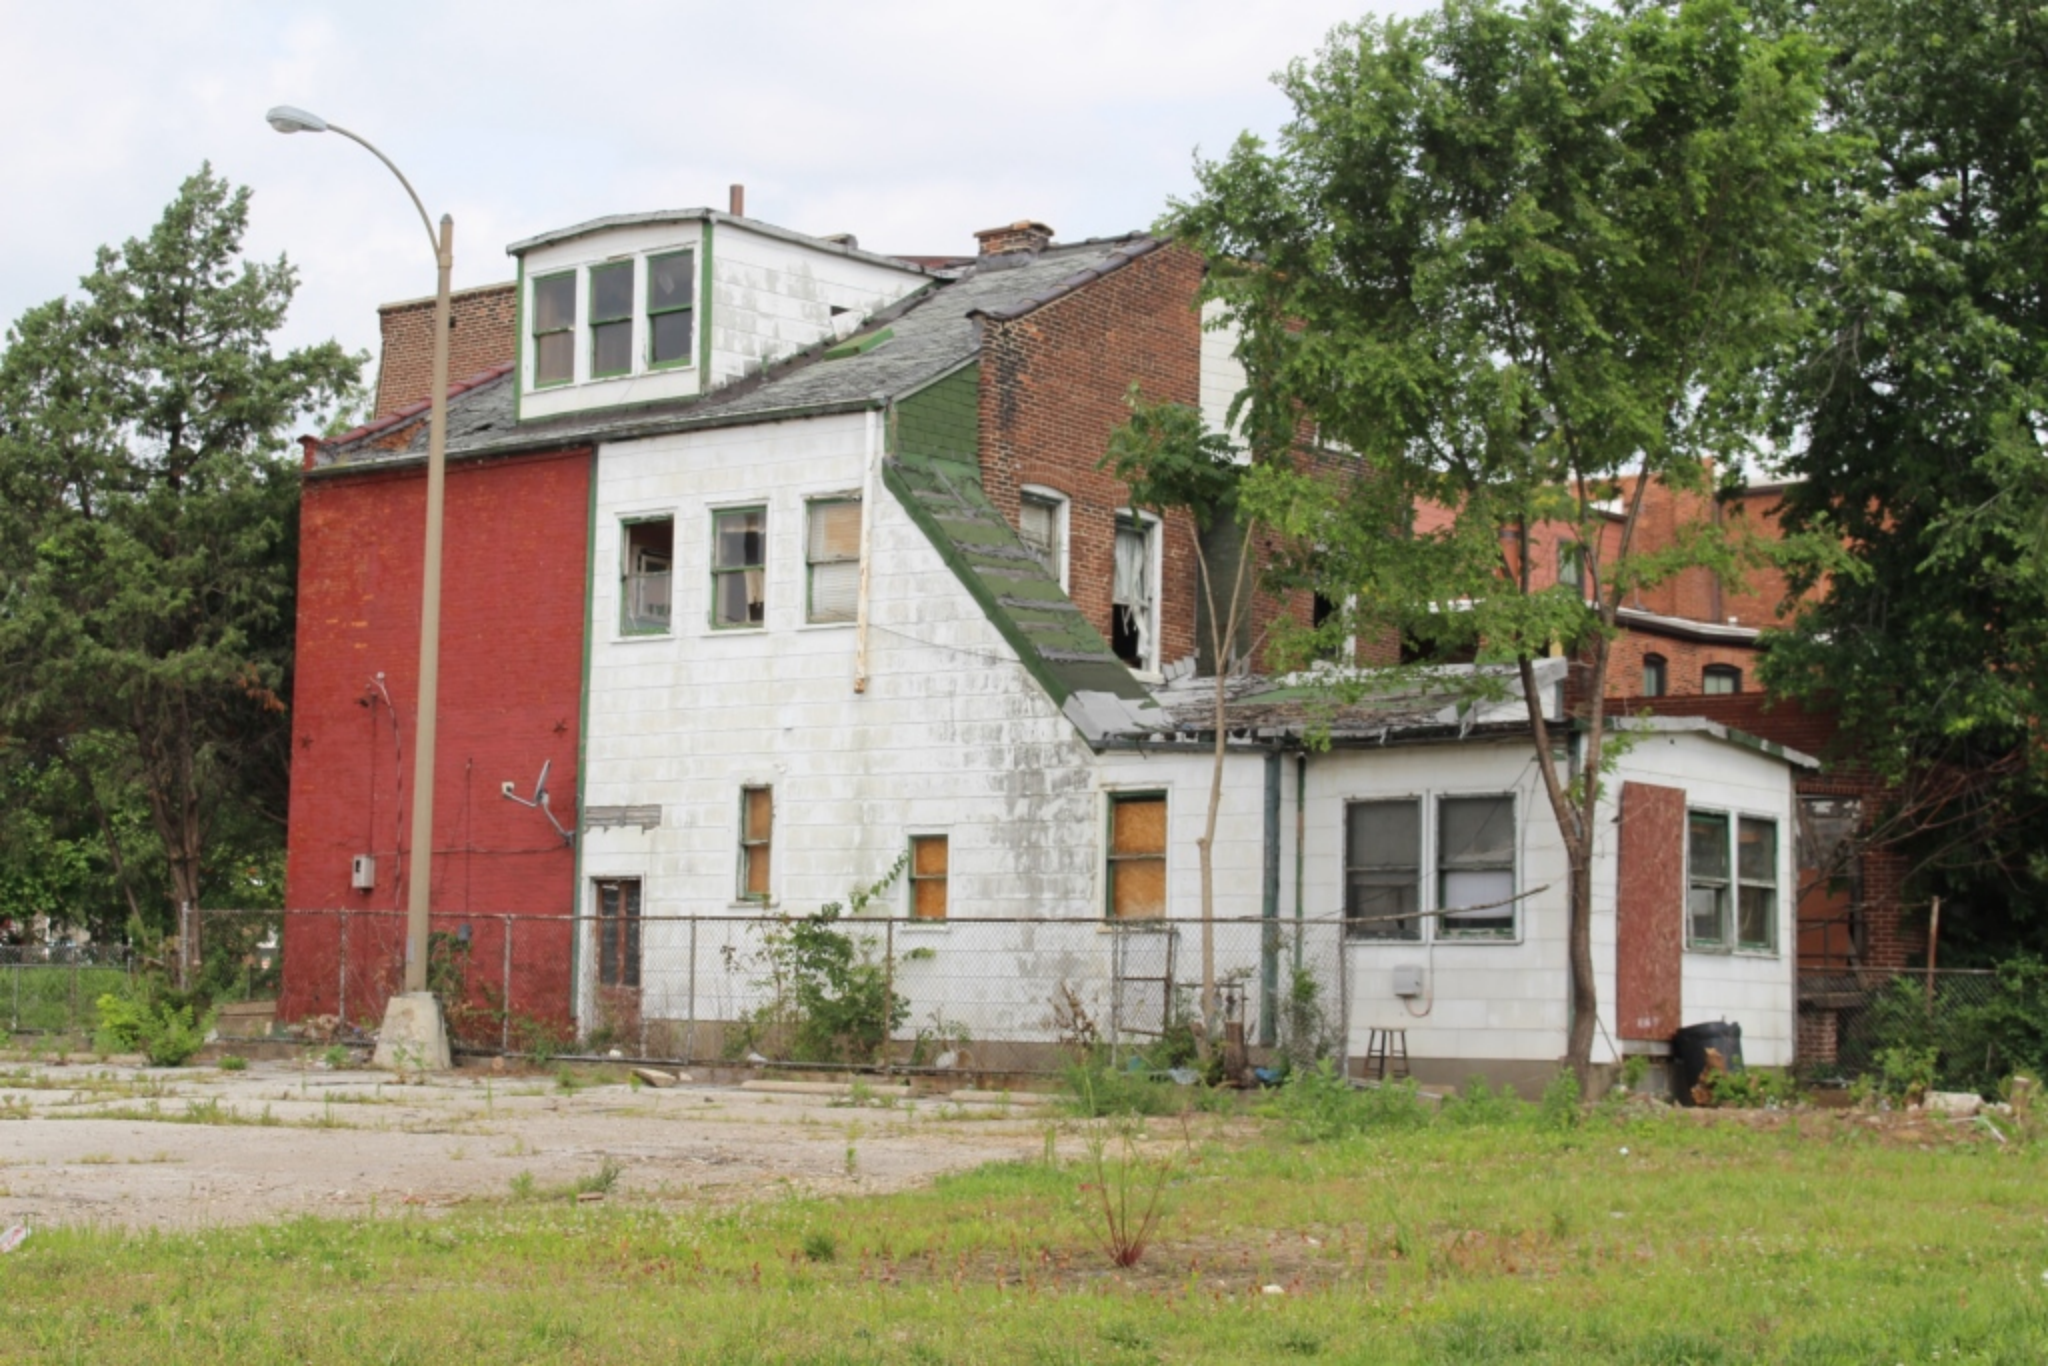
The front portion of this building with additions to the rear is a 2 1/2-story brick flounder set back from the street. Asbestos shingle siding covers the rear portin of the main block where the Sanborn map indicates there was an inset gallery porch. The flounder presents two bays to the street, the right-hand one an entrance. The front portin of the south side wall, as well as the taller north wall are windowless. The rear portion of the south side wall has an entrance and irregular fenestration pattern. A large dormer projecting from the shed roof has a bank of three double-hung windows in its face. An enclosed staircase projects above the one-story rear wing to give access to the second story in the brick flounder portion of the property. This area, and two small porch-size areas are clad with asbestos shingles.

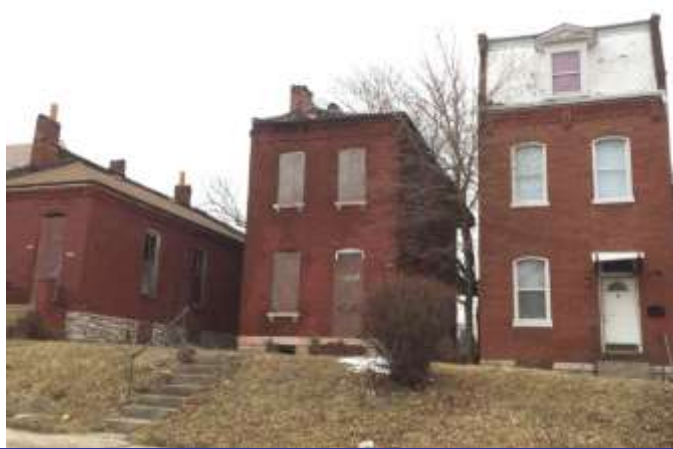
**4406 BLAIR AV**

Two story brick building with exposed stone foundation and heavy, dressed stone water table. The front façade has three windows and single entry door under segmentally arched heads of soldiers. Windows have stone sills with brackets. Windows and the transom of the entry are also segmentally arched. The front entry has a simple stoop consisting of two stone steps. There is a dentiled brick cornice that runs the length of the front façade. All the windows and doors have been boarded.

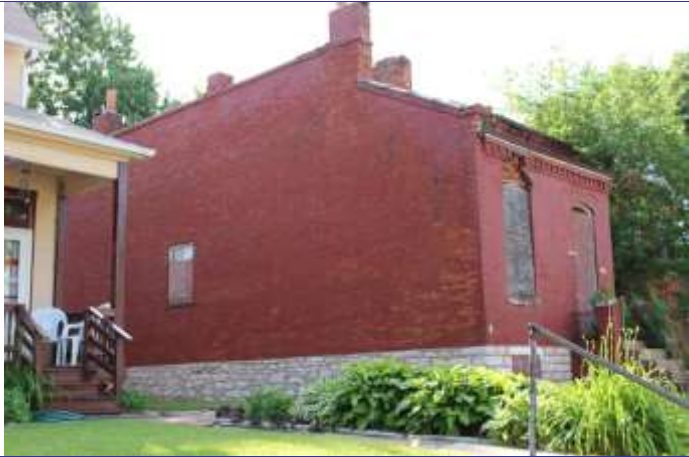
**4408 BLAIR AV**

Rear frame addition covered in artificial siding with a shed roof.  
Structural failure on front elevation at window head; front wall appears unstable, although foundation is in sound condition.

One-story brick building with one window and door on the front façade. All of openings are set under segmental soldier arches; windows and entry transom have segmentally-arched sash and windows have wood sills; the front entry step has been altered with brick rowlocks. All windows and doors on the building have been boarded. Cast concrete entry stair c. 1920 is flanked by two brick columns with cast concrete caps. Exposed limestone foundation on all four sides of the building appears to be in sound condition. A dentiled brick cornice runs the length of the front and east side of the building. Paired chimneys highlight the west side of the Flounder. The parapet that runs along the west side has a standard clay coping tile. The front façade is exhibiting evidence of deterioration from a leaking gutter; the head of the front window has collapse, taking a portion of the cornice with it; failure of the arch over the entry appear imminent.
