**ARCHITECTURAL/HISTORIC INVENTORY FORM - Cultural Resources Office**  
**St. Louis Planning and Urban Design**

1. Survey no. SLC-AS-053-0001	2. Survey name: Thematic Survey of Flounder Houses in St. Louis City	3. County: St. Louis [Independent City]
4. Address: (from City GEO database) <b>1812 S 8TH ST</b>		5. City/State: St. Louis, Missouri
Alternate address: 1812 S 8th		Property Zip Code: 63104
Latitude: 38.608949		6. UTM Easting: 743586.48
Longitude: -90.202538		UTM Northing: 4277095.00
8. Historic Name (if known): N/A	11a. Historic Use (if known): Domestic	City Block: 372 City Ward: 7
9. Present/other name (if known):	7. Township-Range-Section: N/A	10. Ownership: Private
11b. Current Use: Domestic		Neighborhood Number: 21

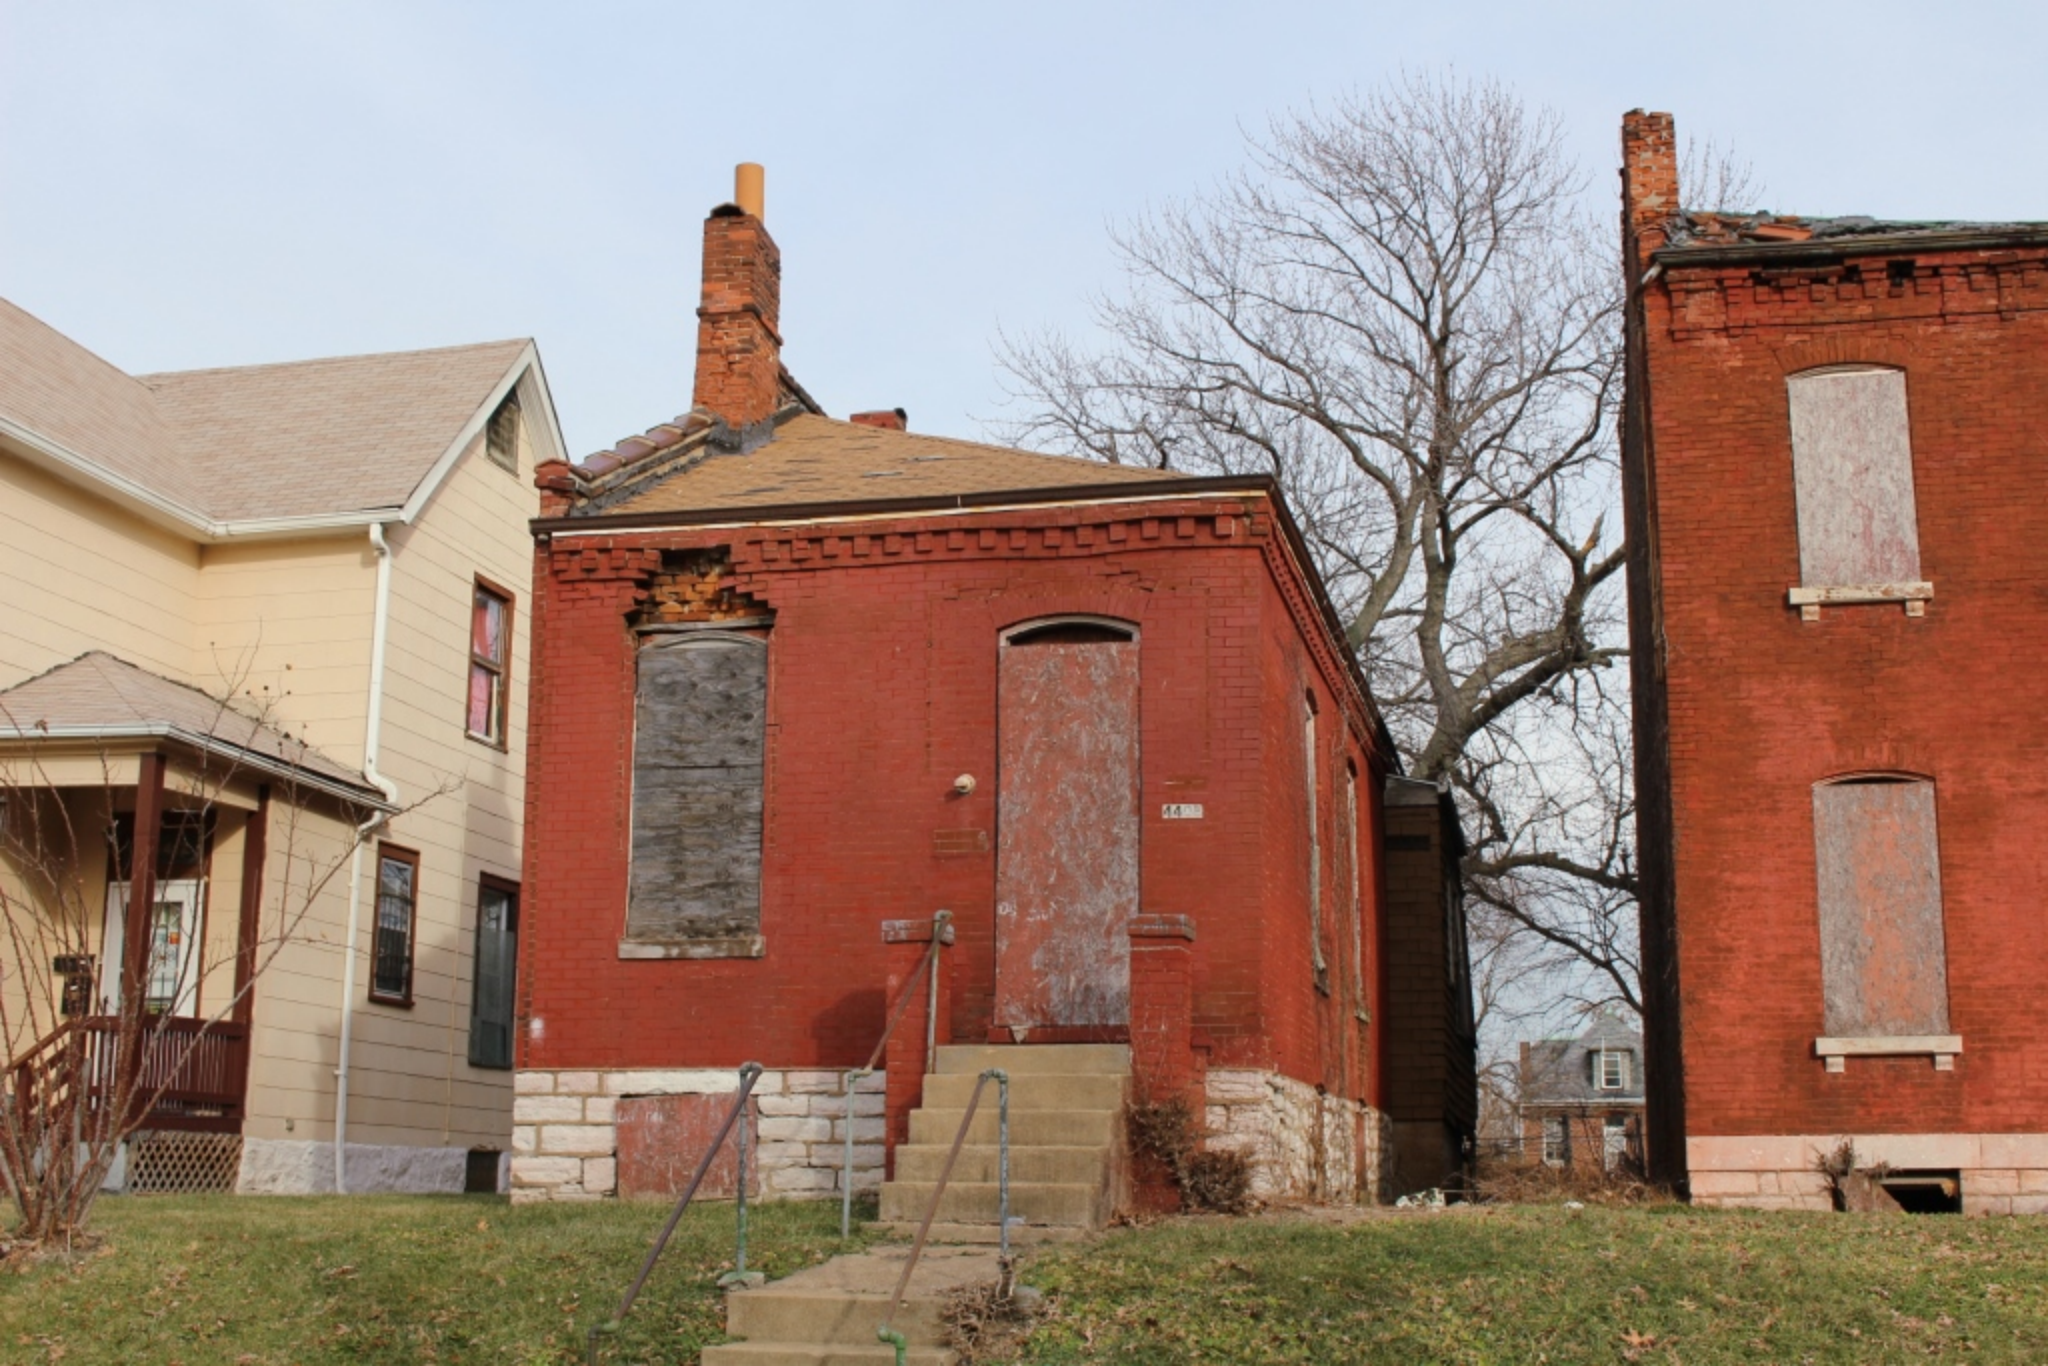
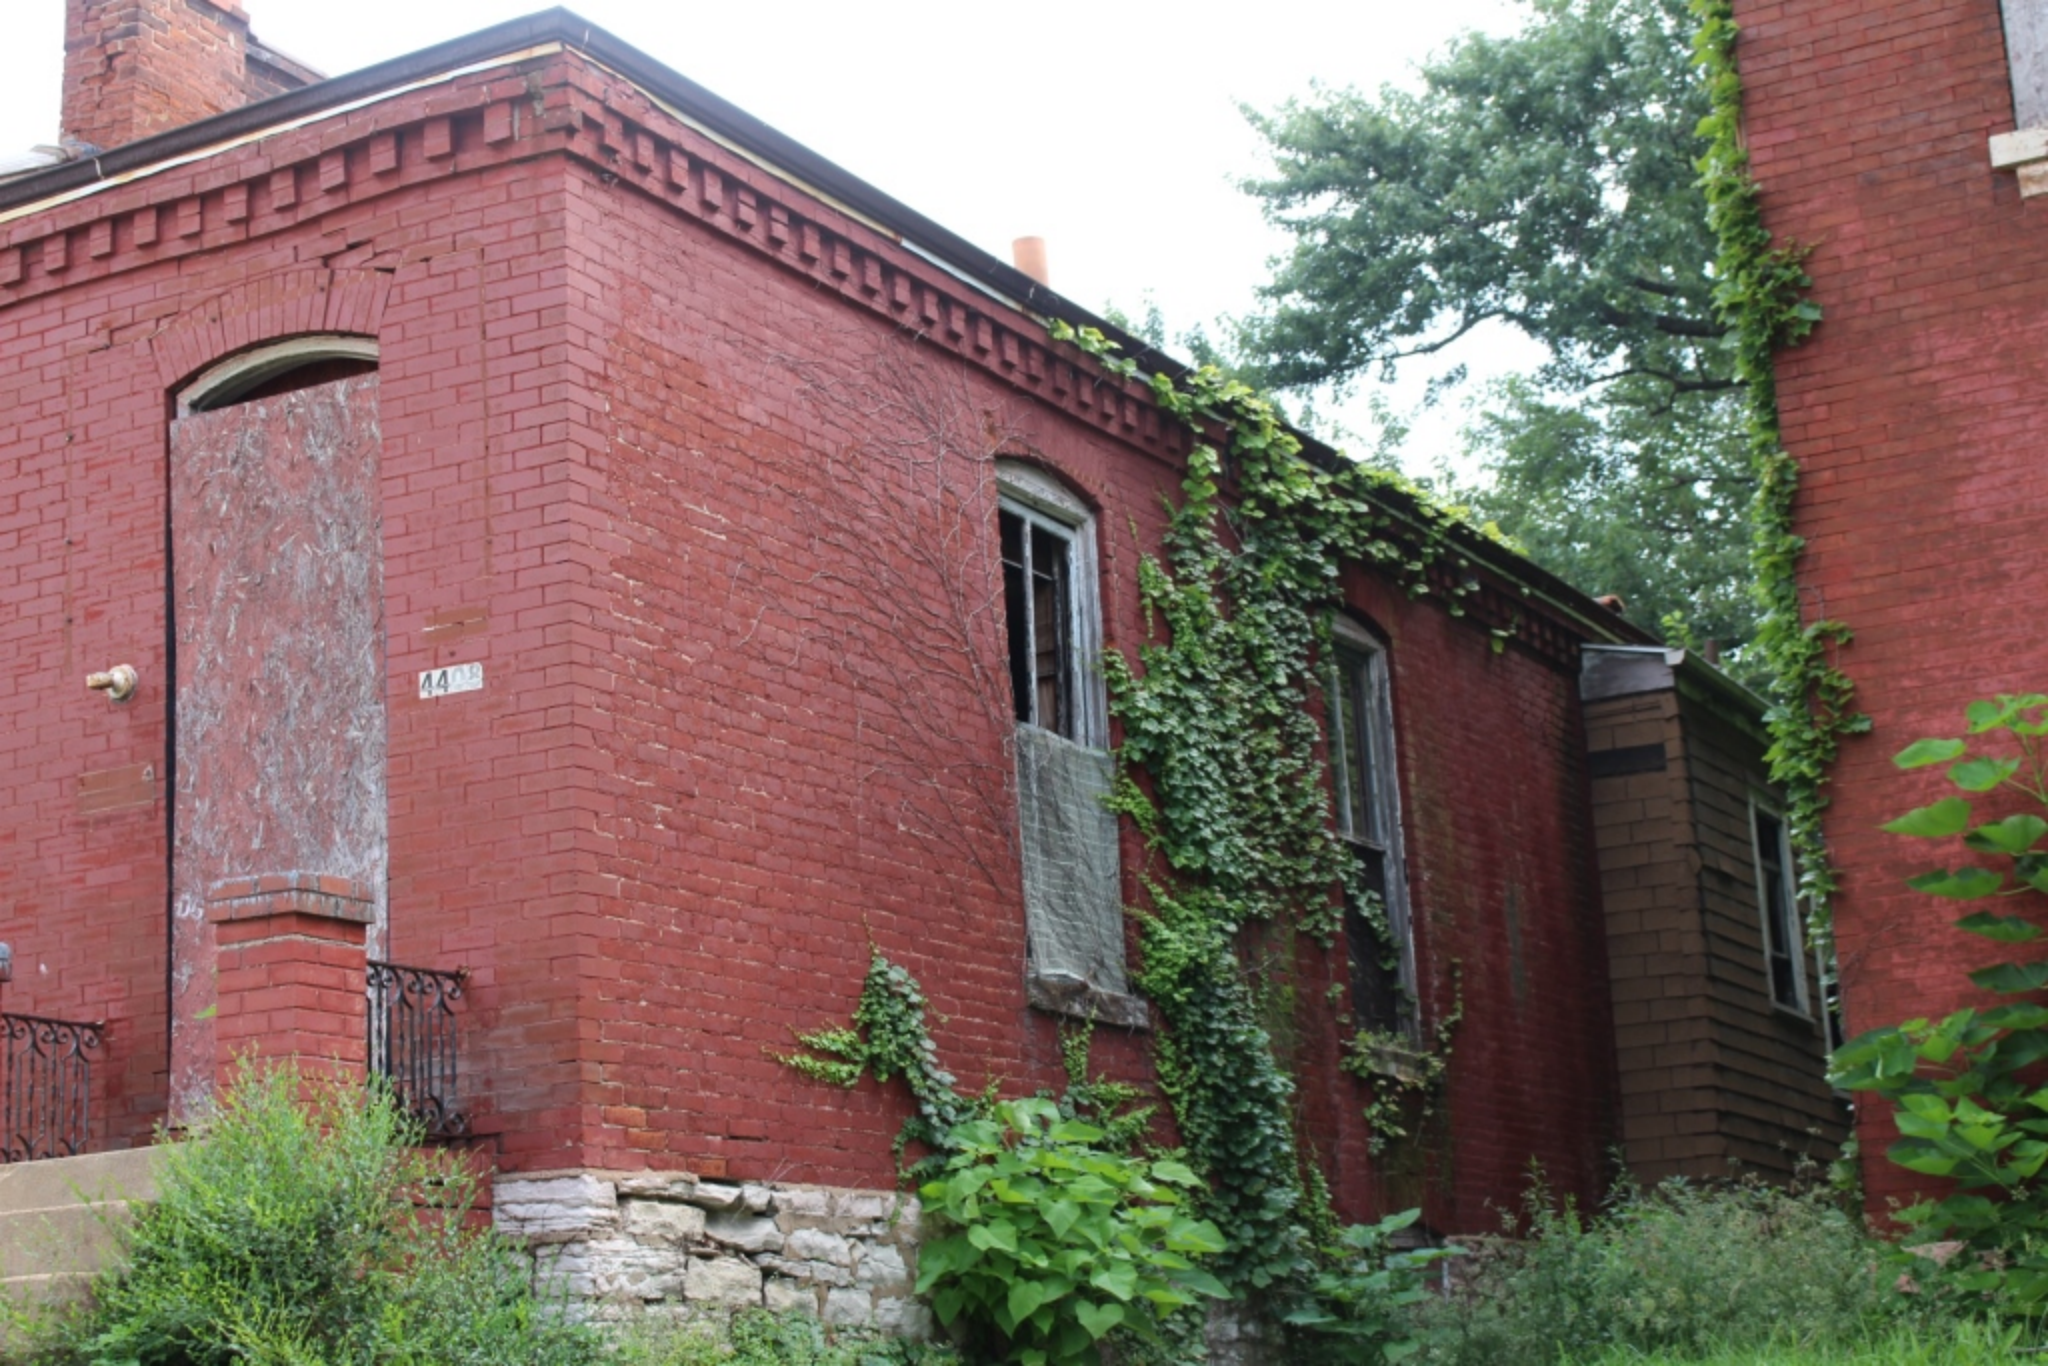
One-story brick building with one window and door on the front façade. All of openings are set under segmental soldier arches; windows and entry transom have segmentally-arched sash and windows have wood sills; the front entry step has been altered with brick rowlocks. All windows and doors on the building have been boarded. Cast concrete entry stair c. 1920 is flanked by two brick columns with cast concrete caps. Exposed limestone foundation on all four sides of the building appears to be in sound condition. A dentiled brick cornice runs the length of the front and east side of the building. Paired chimneys highlight the west side of the Flounder. The parapet that runs along the west side has a standard clay coping tile. The front façade is exhibiting evidence of deterioration from a leaking gutter; the head of the front window has collapse, taking a portion of the cornice with it; failure of the arch over the entry appear imminent.

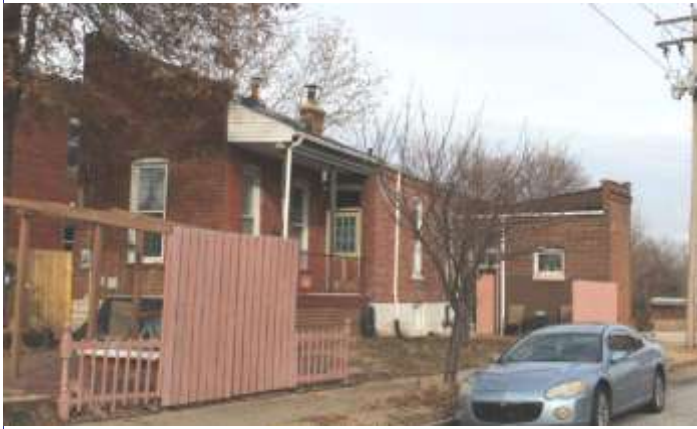
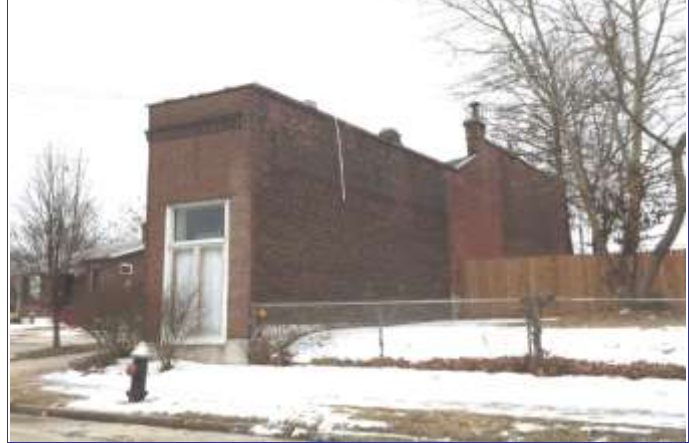
1 story storefront added to street side.

The 1-story brick common bond flounder has a brick one story commercial addition, c. 1900 attached to the front facade. Flounder has Baltimore chimney on the west (blind) elevation and a narrower flounder ell at the rear, the northern bay obscured by the addition. The entrance to the brick flounder residence is now off the side and rear. The exposed east elevation of the original house has a corbelled brick cornice running the length of the façade and two original window openings. The rear ell contains two more windows. All have been replaced with 1/1 aluminum sash. The building has a stone foundation that has been parged on the south side of the building. On the rear, west and north sides the building's rubble stone foundation is exposed.

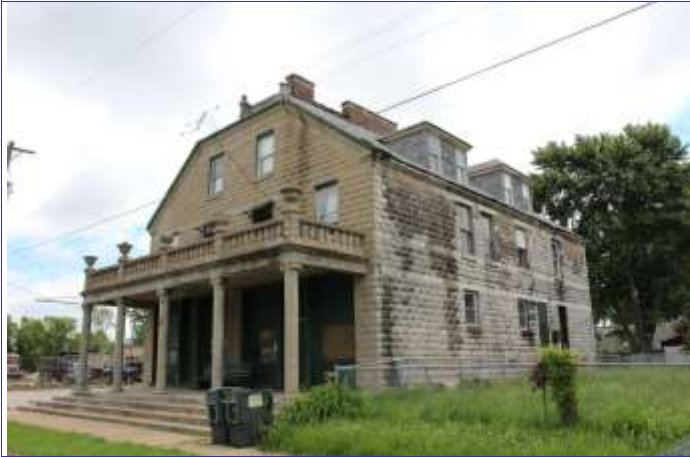
**400 BLASE AV**

This pair of semi-detached flounders built of rock-faced concrete block have a parapet where the shed roofs meet at the ridge line. The hipped front roof is clipped. The front porch and two storefronts suggest a mixed use for the building. There are two entrances near the rear of each side. The fenestration is irregular on the sides. Two hipped-roof dormers project from each side roof slope.

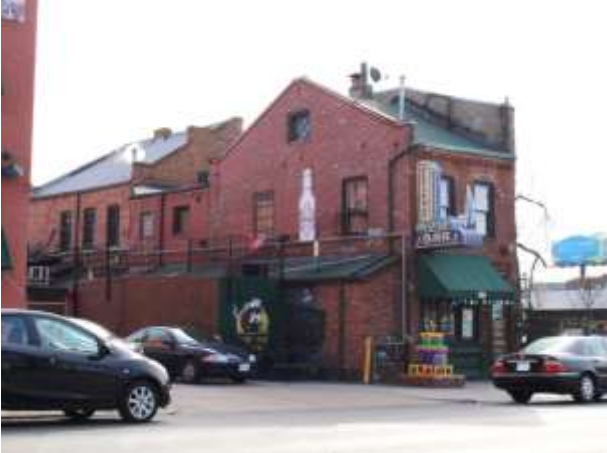
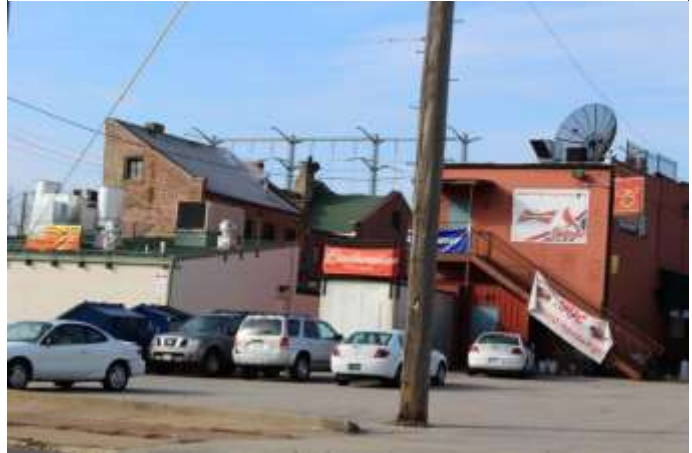
The 2 ½-story brick flounder with a shed roof was built in a mid-lot location. It has window openings on all three walls at the attic level; there is one additional window in the taller, i usually windowless wall. There are two bays of windows on the short wall and three openings at the east portion of the longer wall.

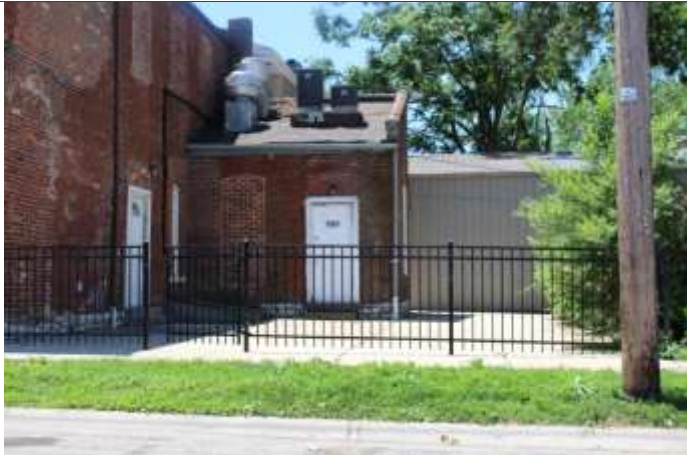
North elevation from Primm Street

This is a small common bond brick flounder with rubble limestone foundation, attached to the rear of the front property at 7901-03 S Broadway. Its entry façade faces Primm Street. The taller, blind wall is set at the south property line and is in close proximity to the adjacent building. The street façade had originally two openings under segmental soldier arches: a relatively large window on the east and a singleleaf door with transom on the west. Both openings have been bricked in, and a contemporary, prehung door inserted. The rear (west) elevation contains a single window; its original window head has been rebuilt with a steel lintel and the opening closed with vinyl siding. The parapets on the south and west walls have brick coping that has been overlaid with parapet tiles. Two large commercial fans and several air conditioning units have been installed on the roof.

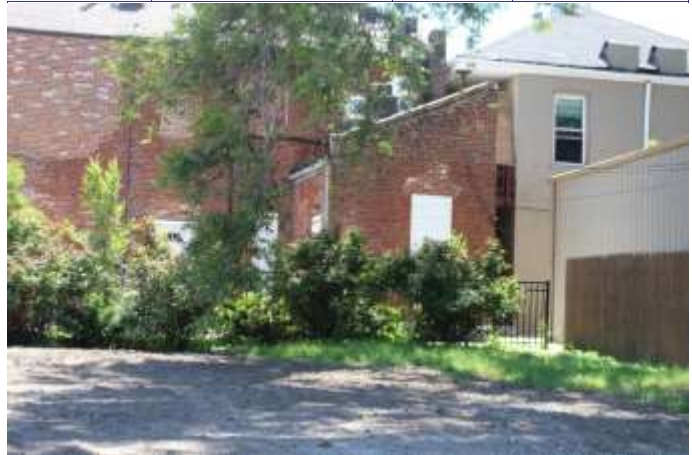
West elevation from alley

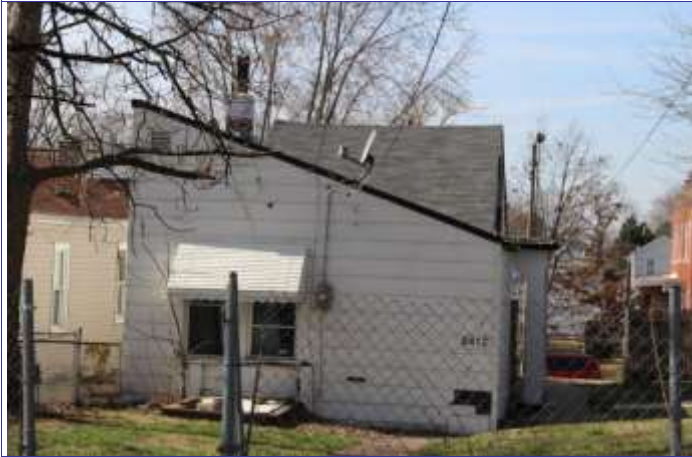
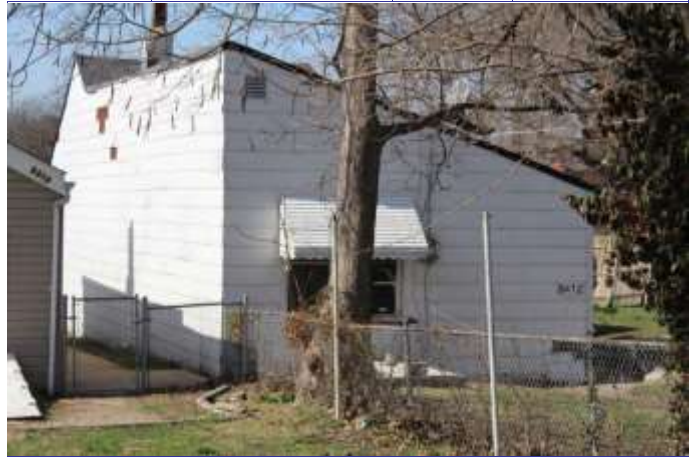
**8412 S BROADWAY**

On major commercial street with a number of similar early vernacular residential properties. Property is set atop a steep grade: a concrete block retaining wall at the property line is a replacement for the original limestone wall that is extant on the property to the west.

A one-story frame flounder with loft. The tall blind wall is set on the south property line. The house has been altered with the addition of aluminum siding over brick-pattern asphalt siding, over original wood clapboards. Paired doublehung windows have been cut in the east façade, not the original openings. The siding obscures the existing foundation, which is only minimally exposed. A likely side gallery may have been enclosed. A two-room house is attached at the western (street-facing) façade. Judging from the flounder's shape and its awkward connection to the front block, the flounder appears to be the earliest building on the site and the front an addition.

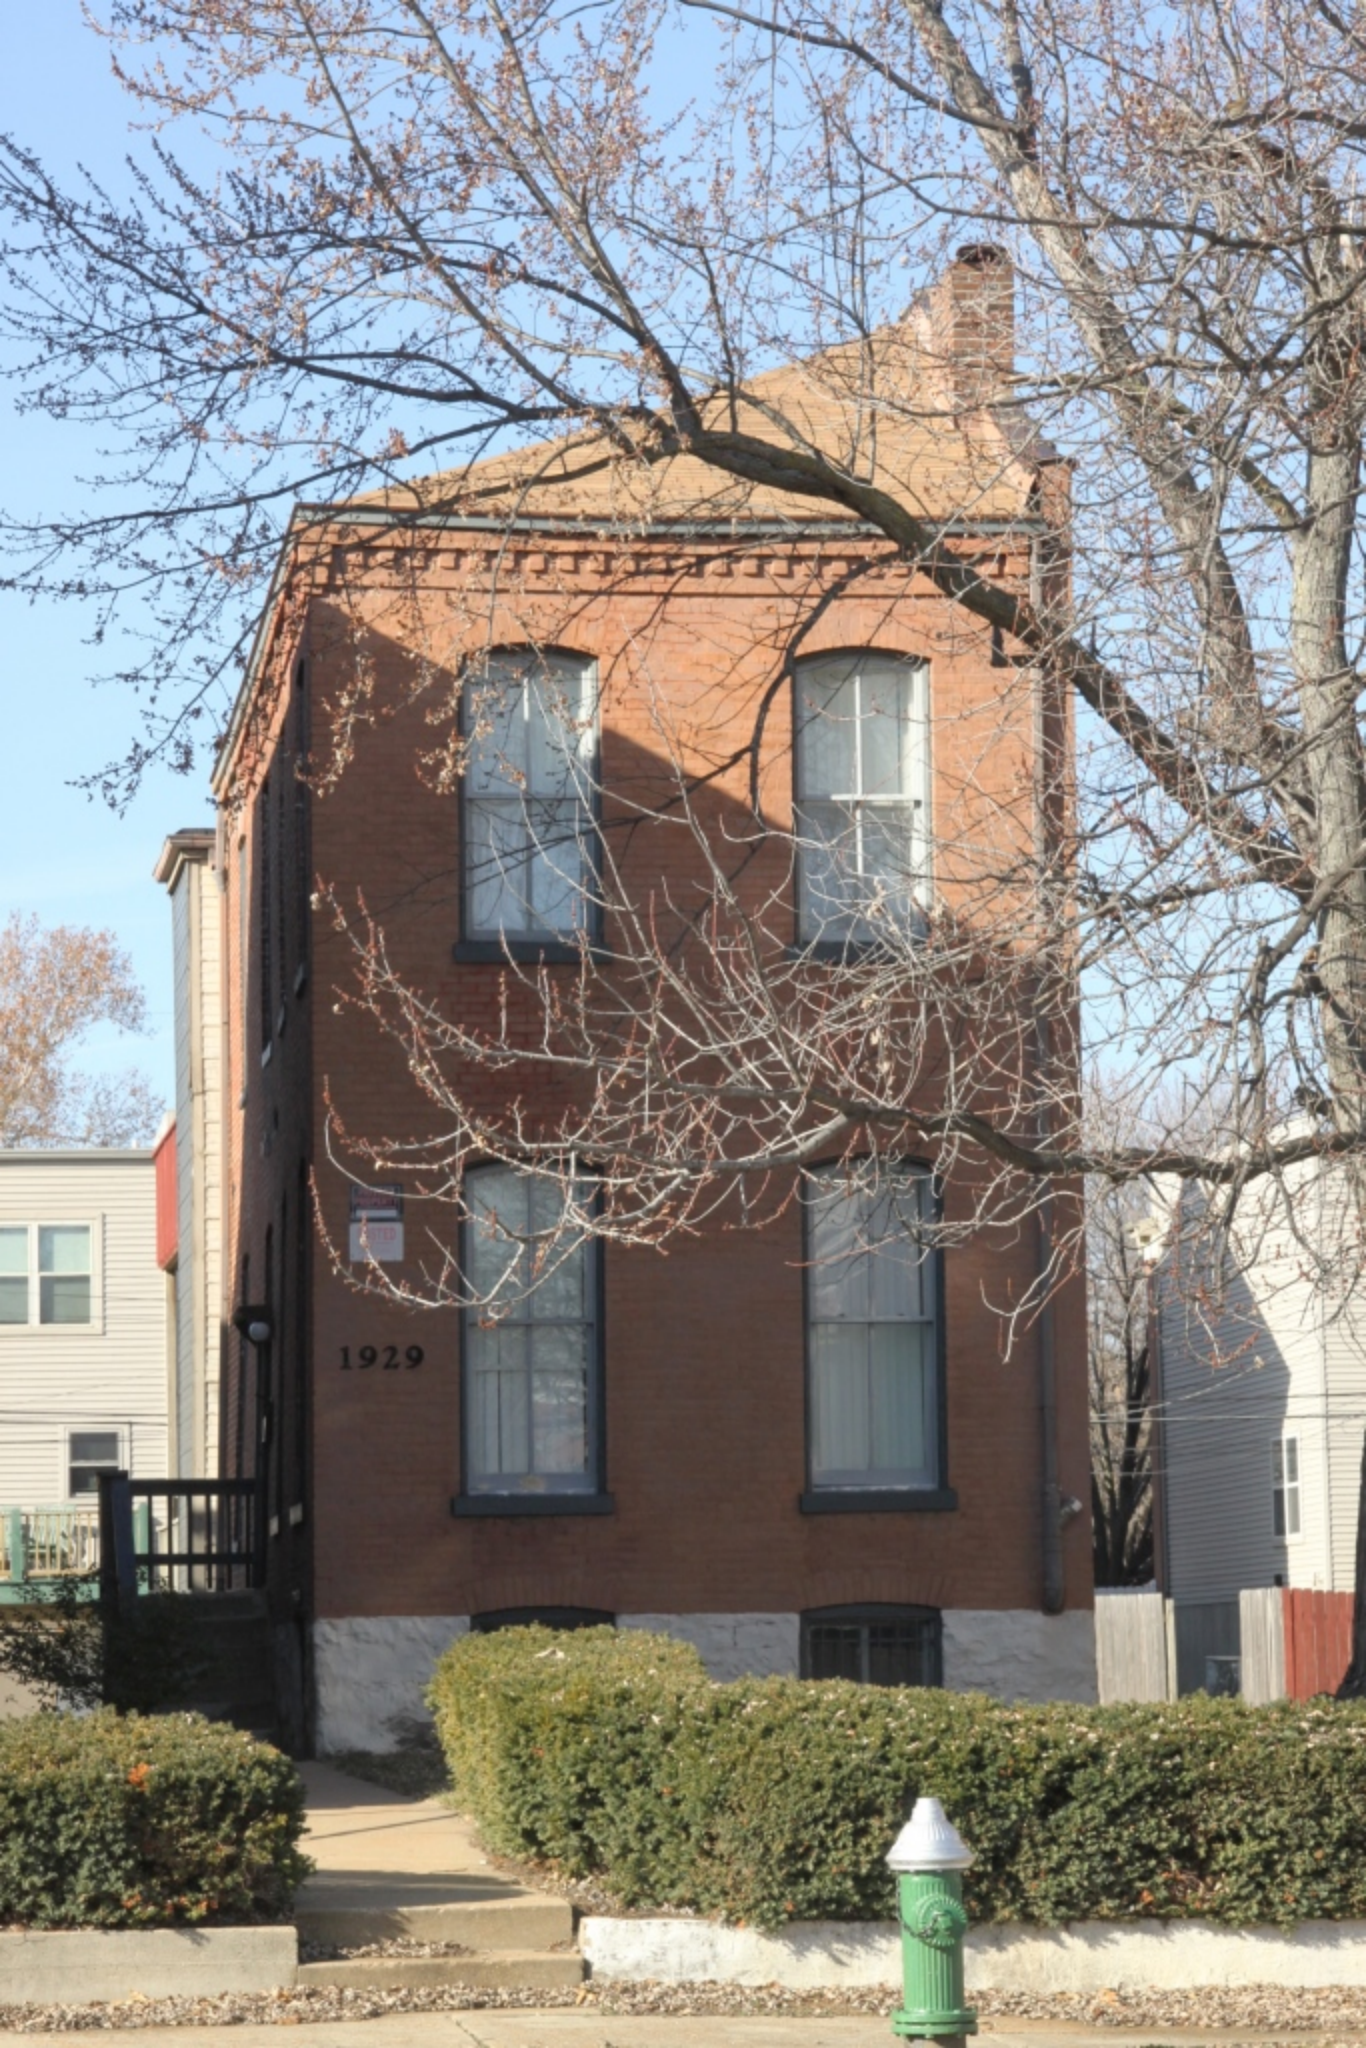
This 2 1/2-story brick flounder has two bays on the façade and a side entrance. Arched basement windows pierce the limestone foundation. Window openings have segmentally-arched heads formed of soldier bricks and stone sills. The windows have arched head 2/2 doublehung wood sash. A denticulated brick cornice edges the façade and south side eaves. The tall, originallay windowless wall, rises on the north side; two flat-headed windows have been cut in a bay very close to the rear corner of the main wing. The entrance is in the third bay back; the stoop is a replacement concrete structure with wood railings. A gallery along the south side of the rear wing has an enclosed bay adjacent to the front wing; the open gallery portion gives access to a door in the enclosed bay, leafing the historic entrance without access. The second story serves as a porch. The main block is set far back on lot, near its center.

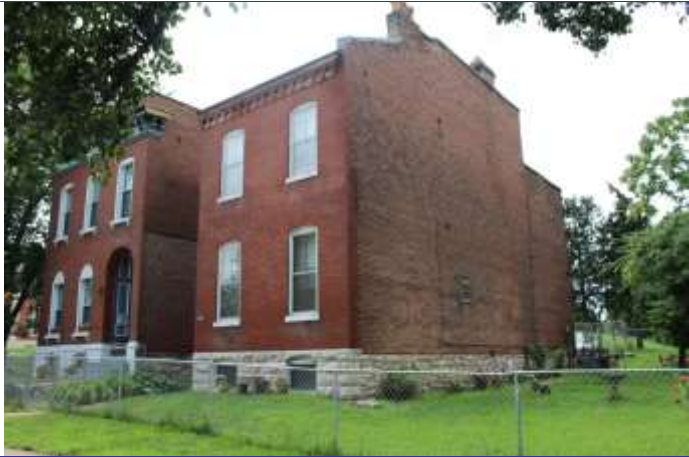
**2608 CAROLINE ST**

This two-story with loft brick flounder has a side entrance and a flat-roofed rear wing. A corbelled brick cornice edges the façade, where there is a hipped front to the shed roof, and the east side wall. The taller west wall is windowless. Window and door openings are segmentally-arched and storm sash protects historic wood sash. Stairs lead to the side door which is sheltered by a modern awning. A two-story wood gallery flanks the narrower rear wing.

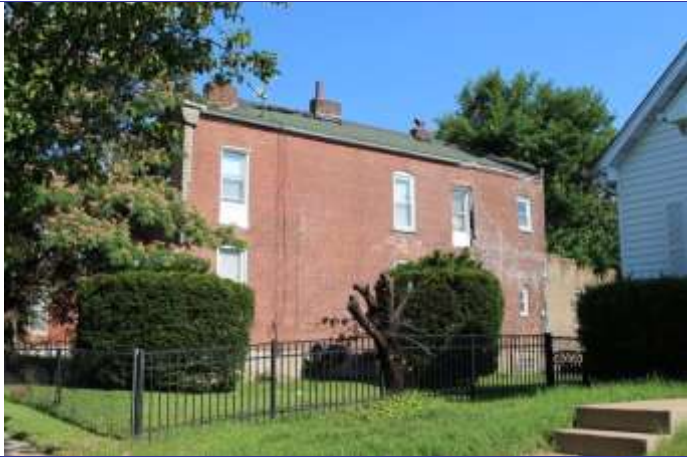
### 3129 CAROLINE ST

foundation parged with concrete; artificial stone veneer added to façade obscures cornice; some window sizes altered. Roof may have old rolled roofing; rear portion of east side has no gutter, exhibits evidence of water moving through brick; exposed door jamb indicates outer wythe of brick pulling away. Doors on side façade suggest that there was a gallery but none is shown on the Sanborn map.

This two-story brick flounder has a low-pitched shed roof with a gable front. A simulated stone veneer on the façade seems to maintain the original openings in the two bays. Window heads are arched and there are slightly projecting sills. Concrete steps lead to a stoop at the main entrance. A plastic awning forms a roof for the porch. The foundation on the east wall has been parged. Two openings on the second story have been altered form doors to windows; there is a side door. Openings have segmentally-arched heads with soldier brick. The slightly-taller west wall is windowless. A one-story rear wing is concrete block construction.

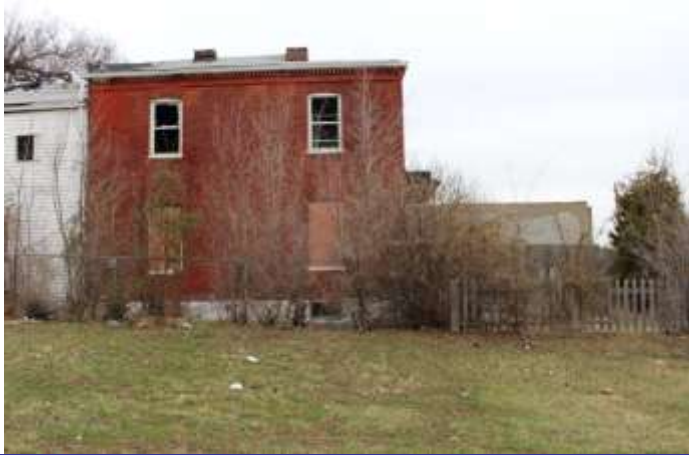
Side elevation looking west

Building is fire damaged; likely occupied prior to fire. First floor boarded.

This two-story brick hipped front flounder is set back from the sidewalk; it has a flounder ell that appears to be constructed at the same time as the main block. The front elevation has two bays, with a single-leaf entry door on the east and a doublehung window on the west. Two windows are placed at the second story. Remnants of a replacement wood porch remain over the entrance, which along with all window openings, is a segmentally-arched opening of soldiers. The foundation of both the front and 2-bay side (east) facades are coursed rubble limestone. The upper parapet of the front elevation has been rebuilt and now lacks the simple denticulated cornice that is extant along the east wall. Window sash is replacement; the building and foundation has been painted. Two chimneys rise from the ridge of the roof. A large crack in the blind taller wall corresponds to where the flounder rear wing connects with the main body of the house. The ell originally had a 2-story gallery porch (shown clearly on Compton & Dry) that is now enclosed with siding, obscuring its east façade. The flounder rear façade is a single bay, with a window at each story and has been stuccoed.

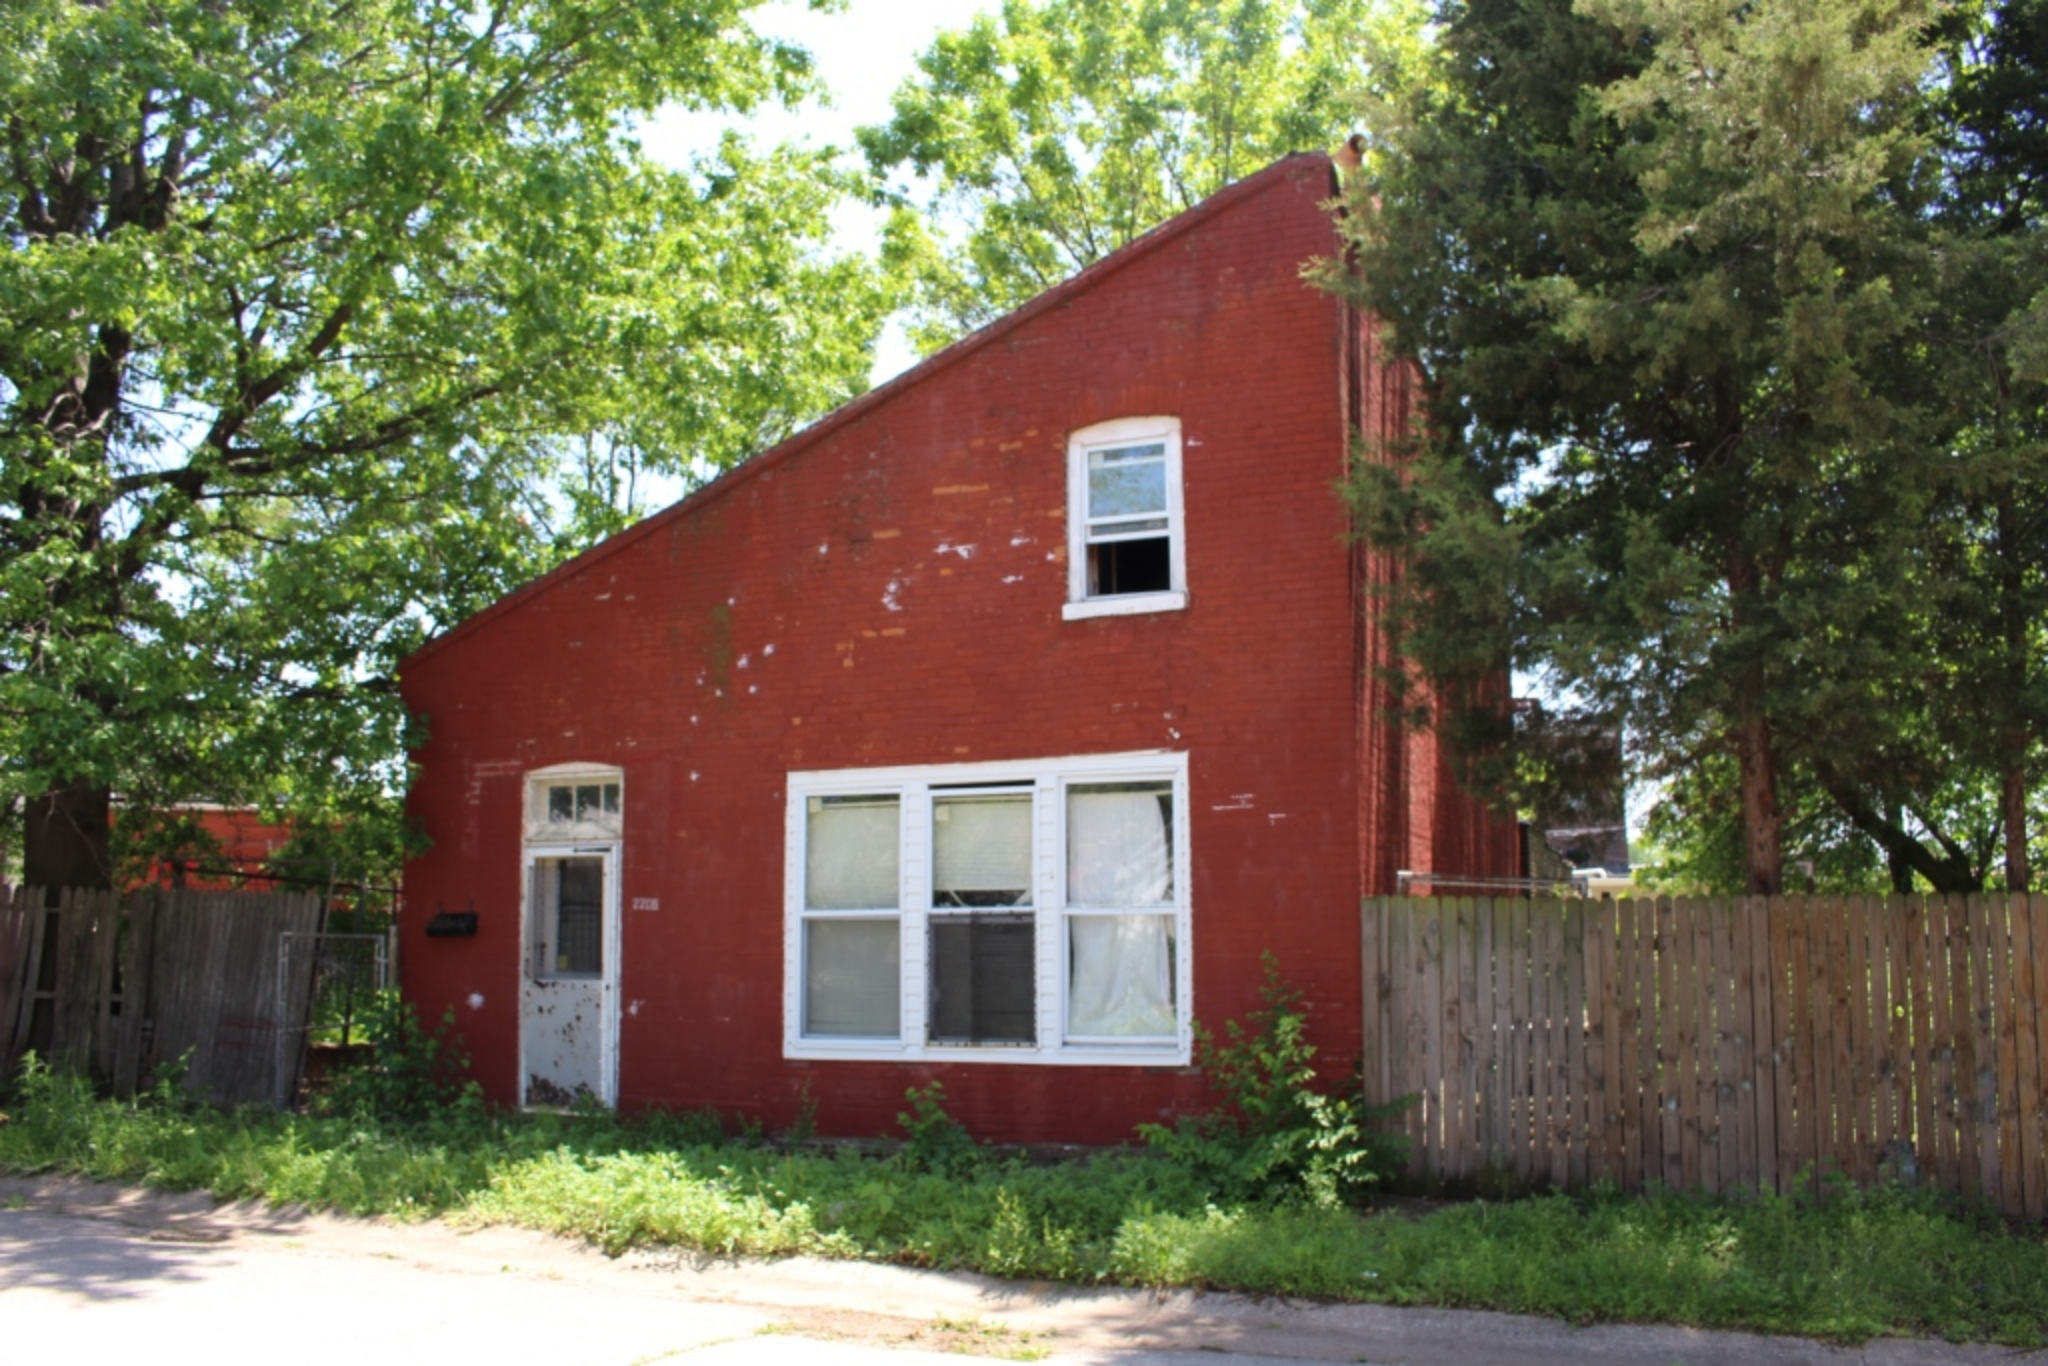
This 1 1/2-story brick flounder has a side gallery with a brick wing wall. The façade, likely originally three bays, has an entrance in the east side bay, through the brick wing wall into the wood-frame gallery. The windows on the ground story of the façade have been altered with a wide opening into which 3 doublehung vinyl windows. The historic window openings at the attic level have replacement 1/1 doublehung sash. The gallery enclosed with wide siding has an entrance in the bay second from the façade sheltered by a shed roof. Another set of three windows is located in the south end of the gallery. A polygonal brick addition with a very low-pitched roof extends from the south end of the house. A free-standing brick garage is positioned very close to the house on the alley.

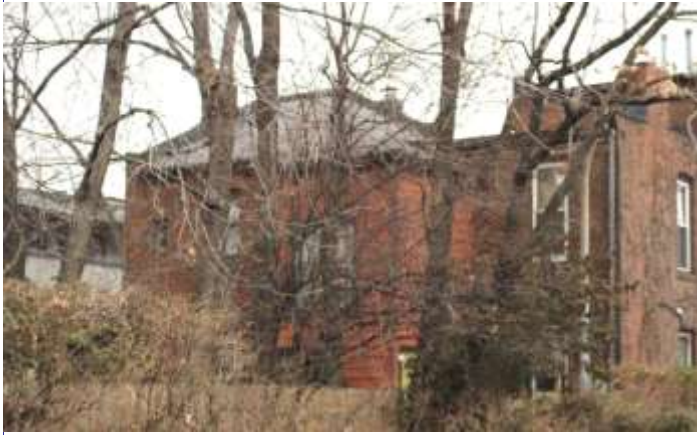
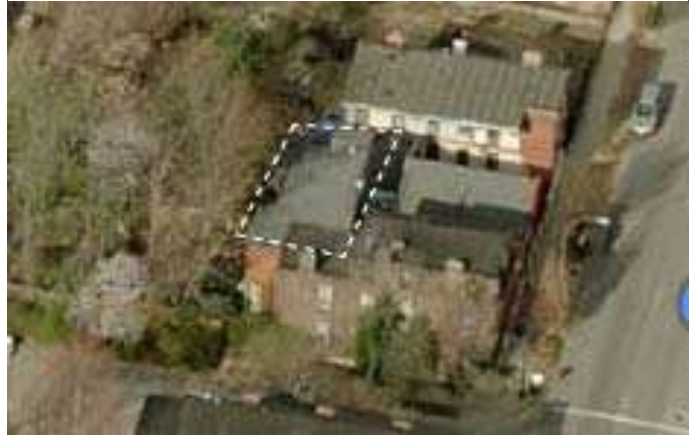
**1934-6 CHEROKEE ST**

Difficult to photograph; property is surrounded by a high privacy fence and many trees.

Originally, 1934 Rear Cherokee had a two-bay hipped front façade facing Salena. It predates construction of the corner commercial building, whose rear wing now obscures half of what was once the flounder's primary façade. A two-story frame addition covered with aluminum siding has been added on the south bay, containing a new entry. The original south elevation is perceivable behind the addition; it had 2 bays, with windows at each story. Some have been blocked down. The remaining walls, including the taller north wall, are blind.

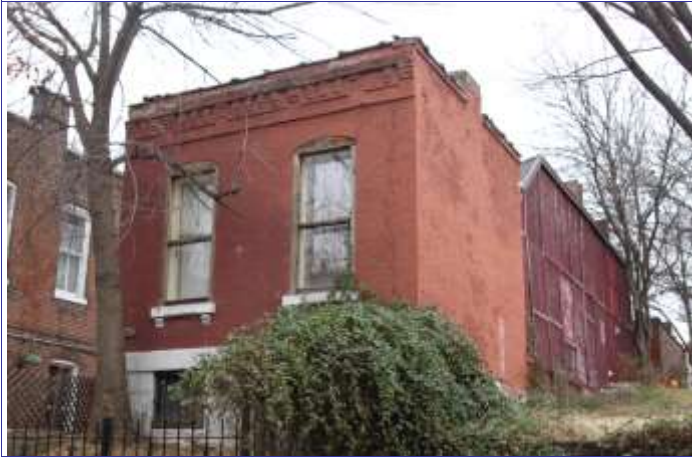
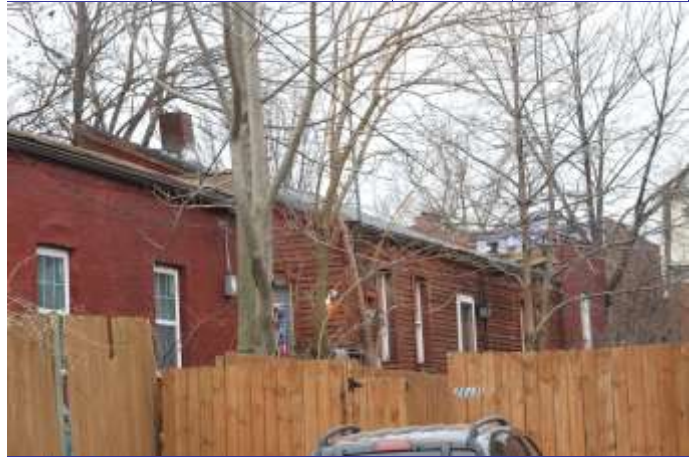
**2109 CHEROKEE ST**

The wood-framed shed-roofed flounder is the center portion of this property. Its tall, windowless wall rises on the east; it appears to be clad with plywood and battens. An entrance is located in the east wall and is flanked by two windows on each side. A flat-roofed small brick house fronts the flounder on the Cherokee side. A slightly longer flat-roofed addition extnds from the rear of the flounder almost to the alley.

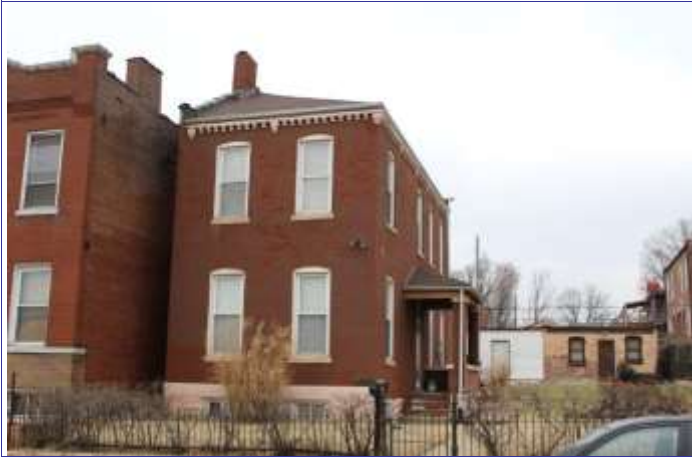
**2013 CHIPPEWA ST**

Two story brick, side entry flounder. The brick and cast concrete entry porch on east side have the characteristics of 1920's Craftsman design. All windows have segmentally arched soldier course brick lintels and stone sills. The windows and doors on the building have been replaced. The street facing façade has a finished ashlar foundation with a cast stone, or parged water table. A dentiled cornice runs the length of the south and east facades. Corbelled drops decorative elements occur at regular intervals the length of the cornice. There is a newer one story brick addition on the back, north side of the building.
