**ARCHITECTURAL/HISTORIC INVENTORY FORM - Cultural Resources Office**  
**St. Louis Planning and Urban Design**

1. Survey no. SLC-AS-053-0001	2. Survey name: Thematic Survey of Flounder Houses in St. Louis City	3. County: St. Louis [Independent City]
4. Address: (from City GEO database) <b>1812 S 8TH ST</b>		5. City/State: St. Louis, Missouri
Alternate address: 1812 S 8th		Property Zip Code: 63104
Latitude: 38.608949		6. UTM Easting: 743586.48
Longitude: -90.202538		UTM Northing: 4277095.00
8. Historic Name (if known): N/A	11a. Historic Use (if known): Domestic	City Block: 372 City Ward: 7
9. Present/other name (if known):	7. Township-Range-Section: N/A	10. Ownership: Private
11b. Current Use: Domestic		Neighborhood Number: 21

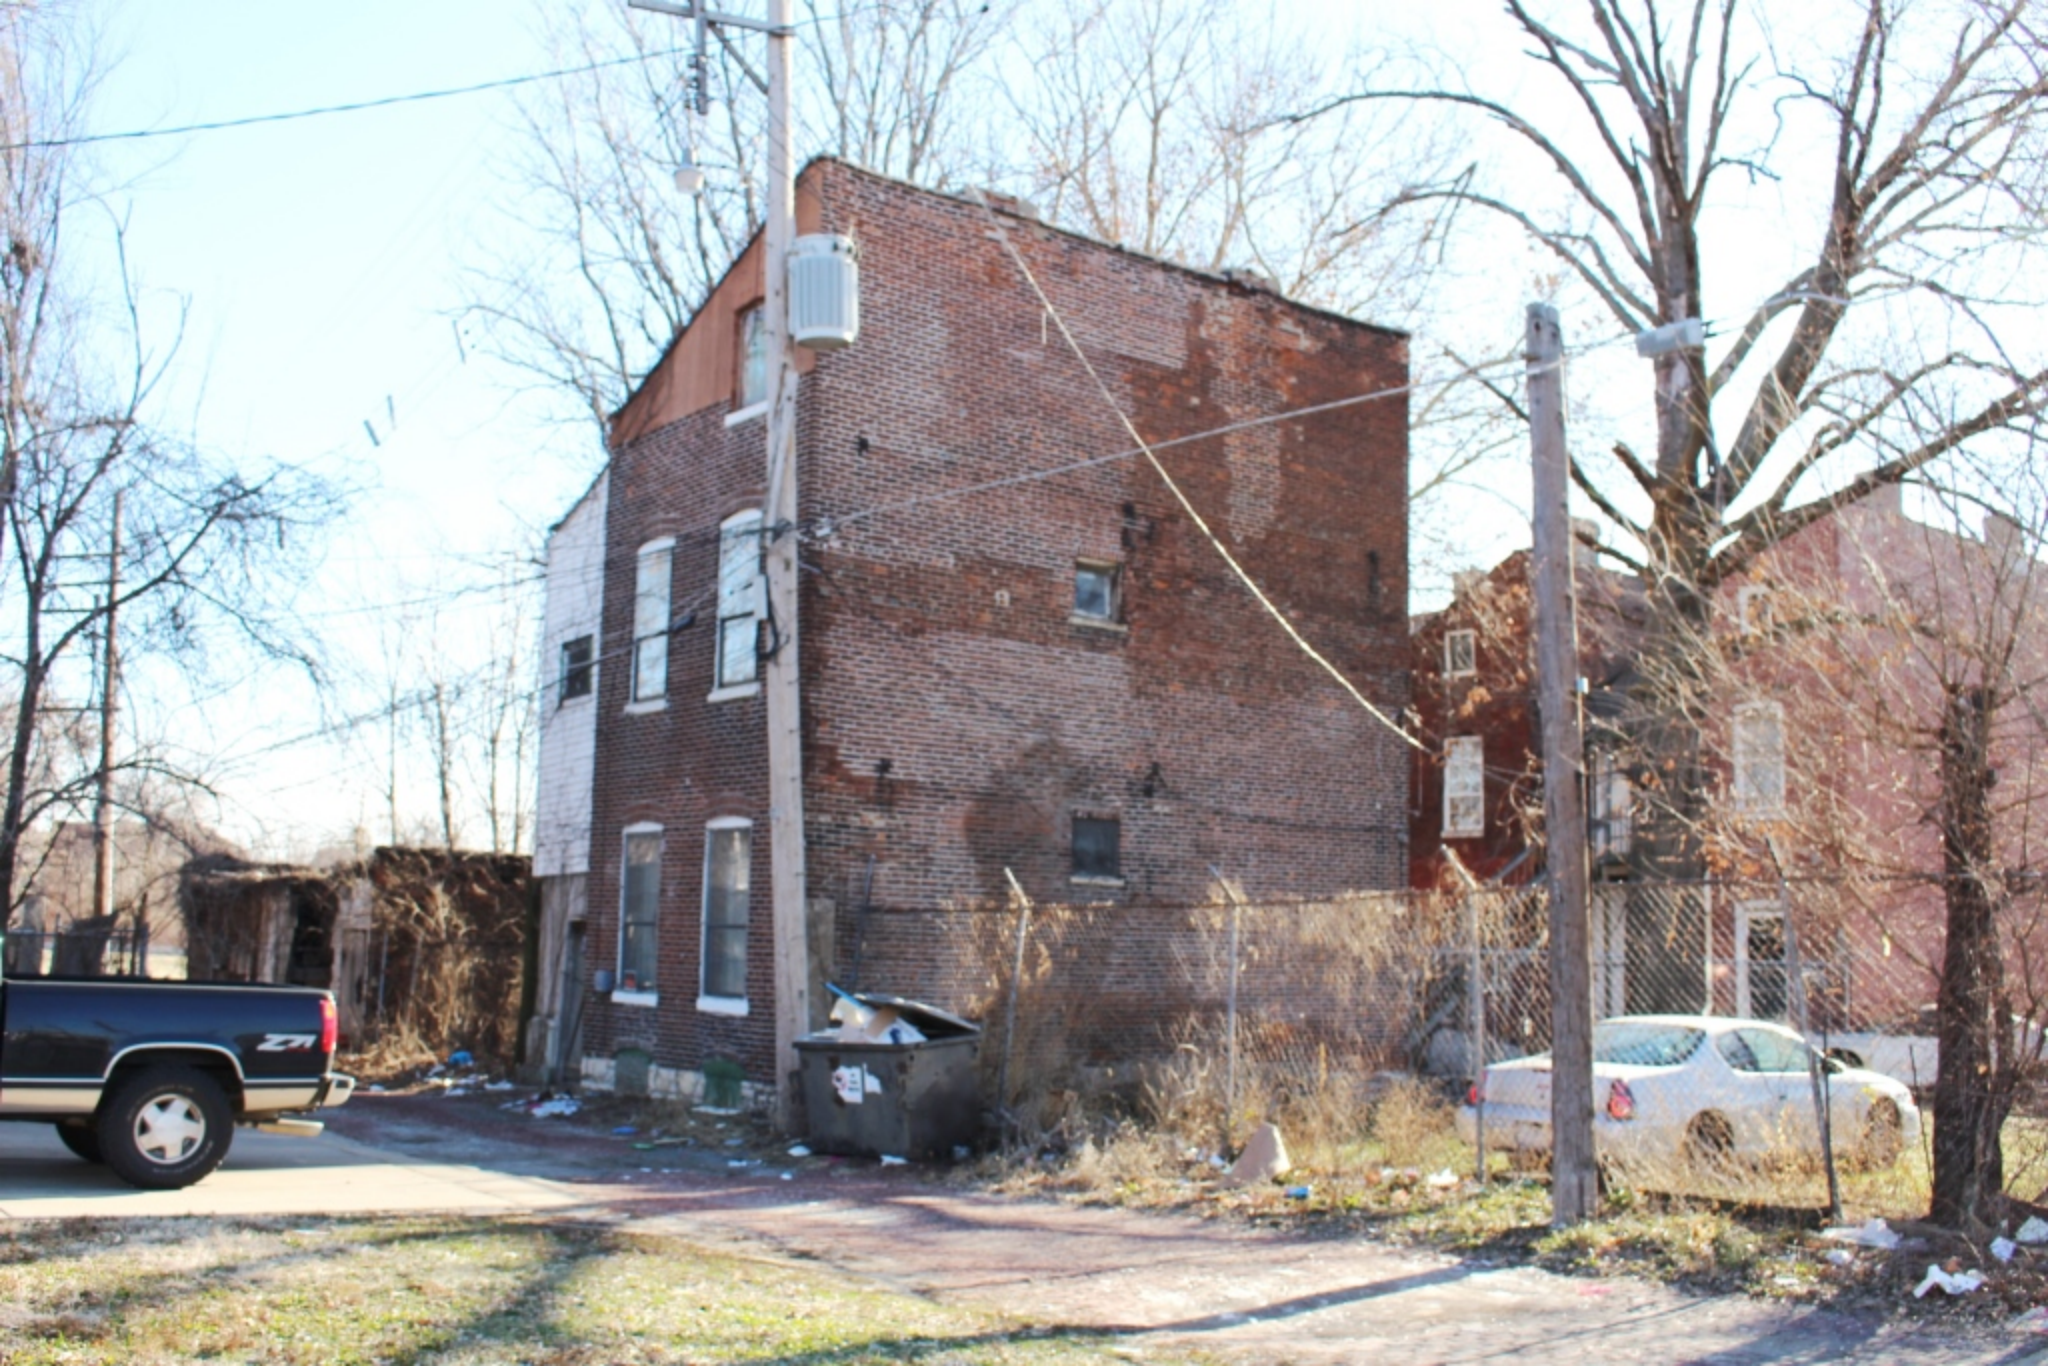
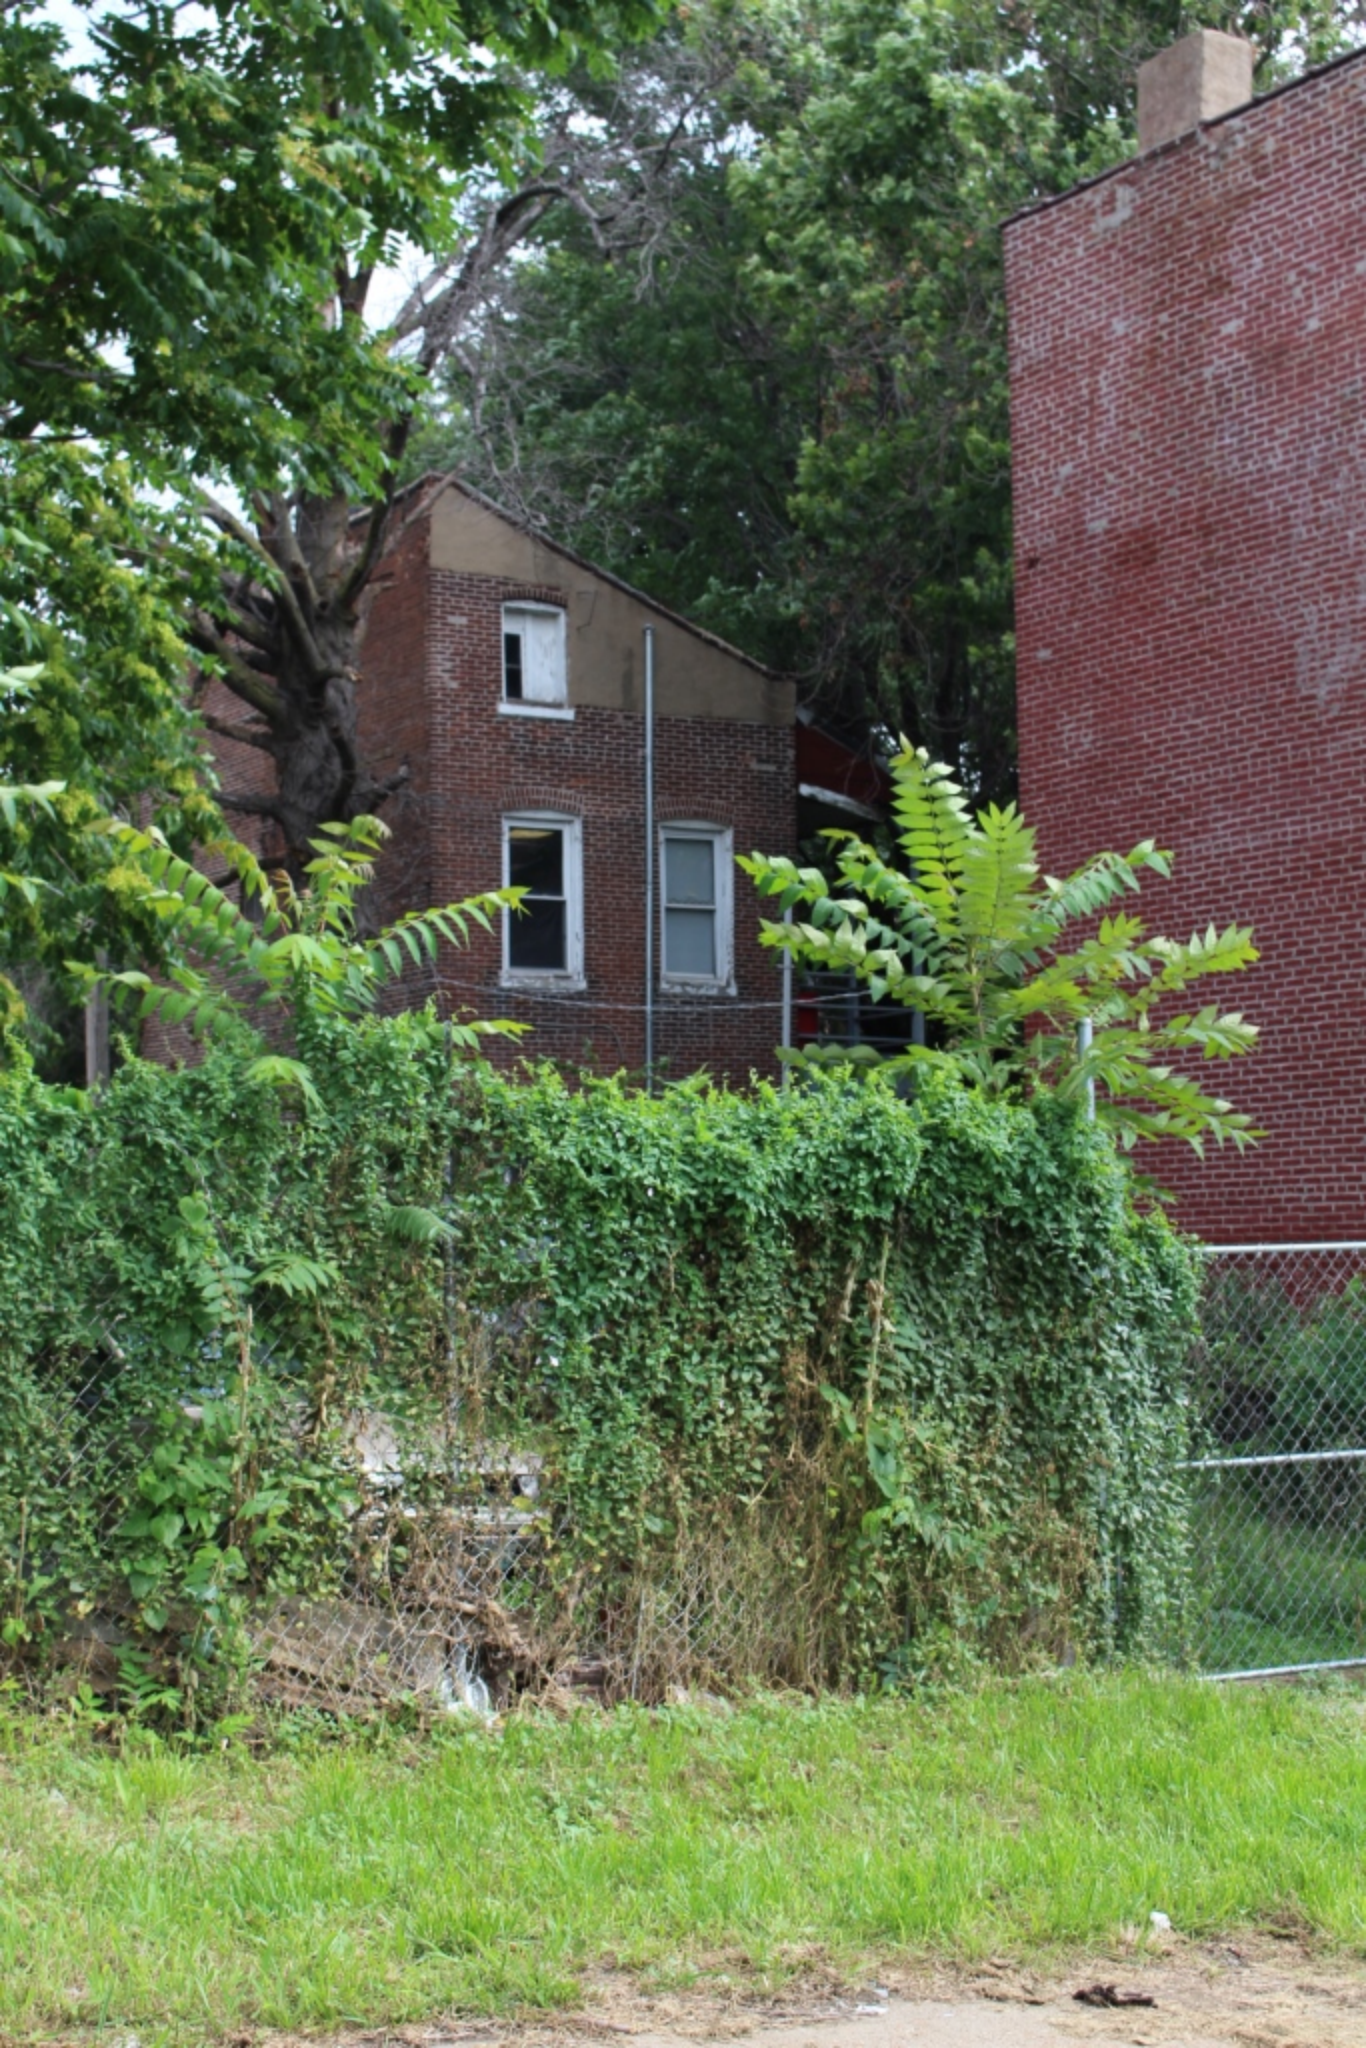
1455 Rear Clinton Street is a 2-1/2 story brick flounder with coursed rubble limestone foundation. It is located at the alley behind 1455 Clinton Street. Its tall blind wall is sited at the property line on the west. It was originally blind, but small square casement windows have been cut at the first and second floor, probably for the installation of bathrooms. Two brick chimneys are placed at the roof ridge; they have been lowered and capped. The narrow north (alley) and south facades are identical: both 2 bays with doublehung windows under double rowlock arches and wood sills at first and second stories. A smaller doublehung window opens at the attic story. The building originally had a 2-story gallery porch on its east façade that sheltered the entries and the stair to the second floor unit; the northern half of this has been enclosed, but the original shed roof is extant on the south end.

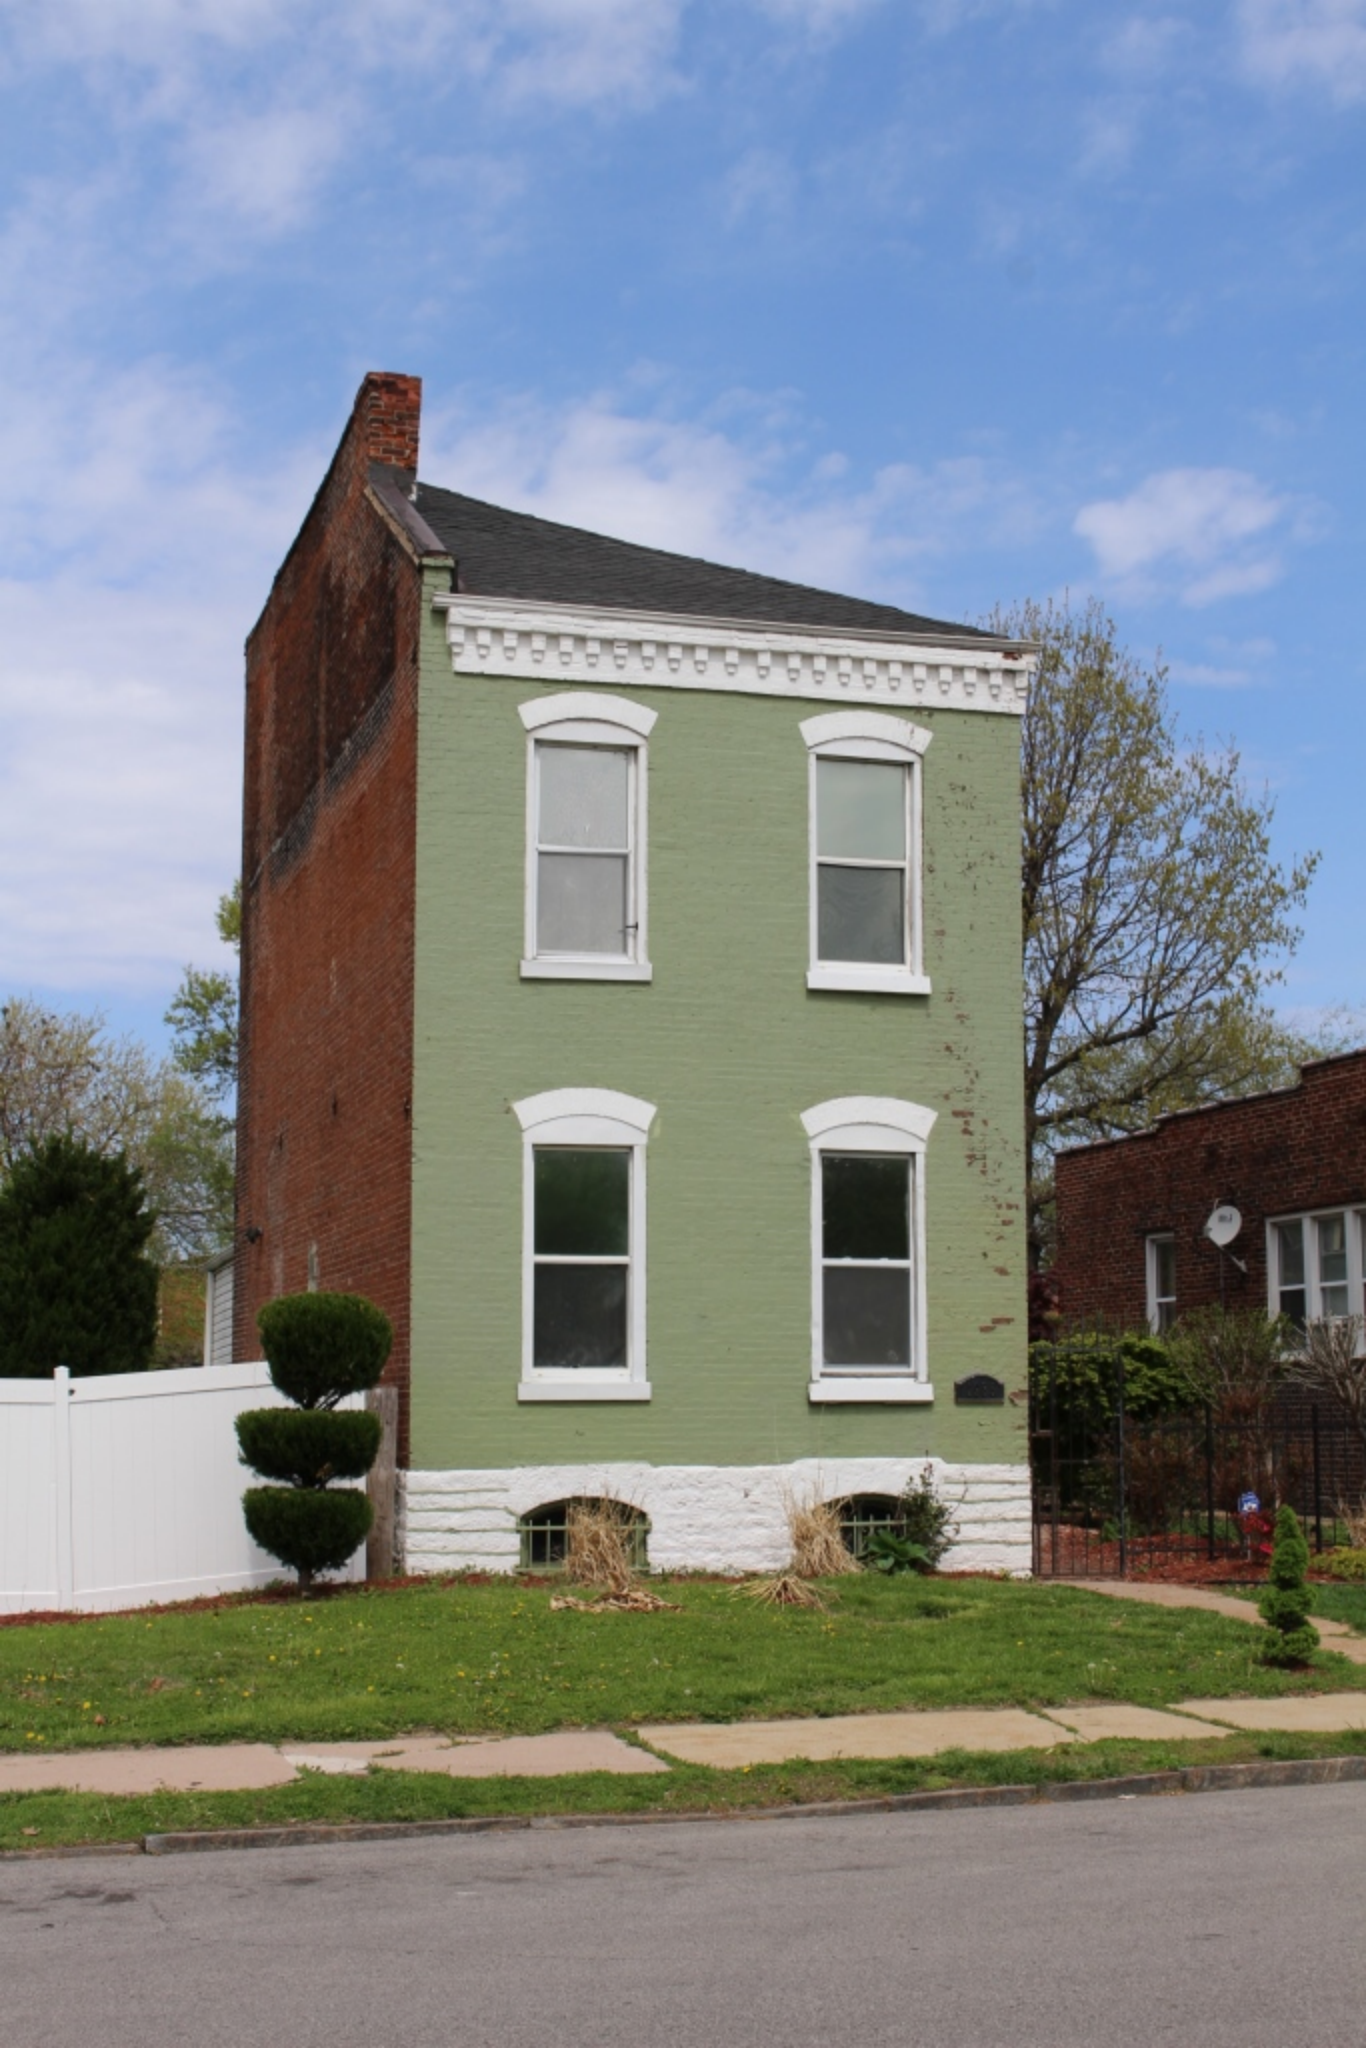
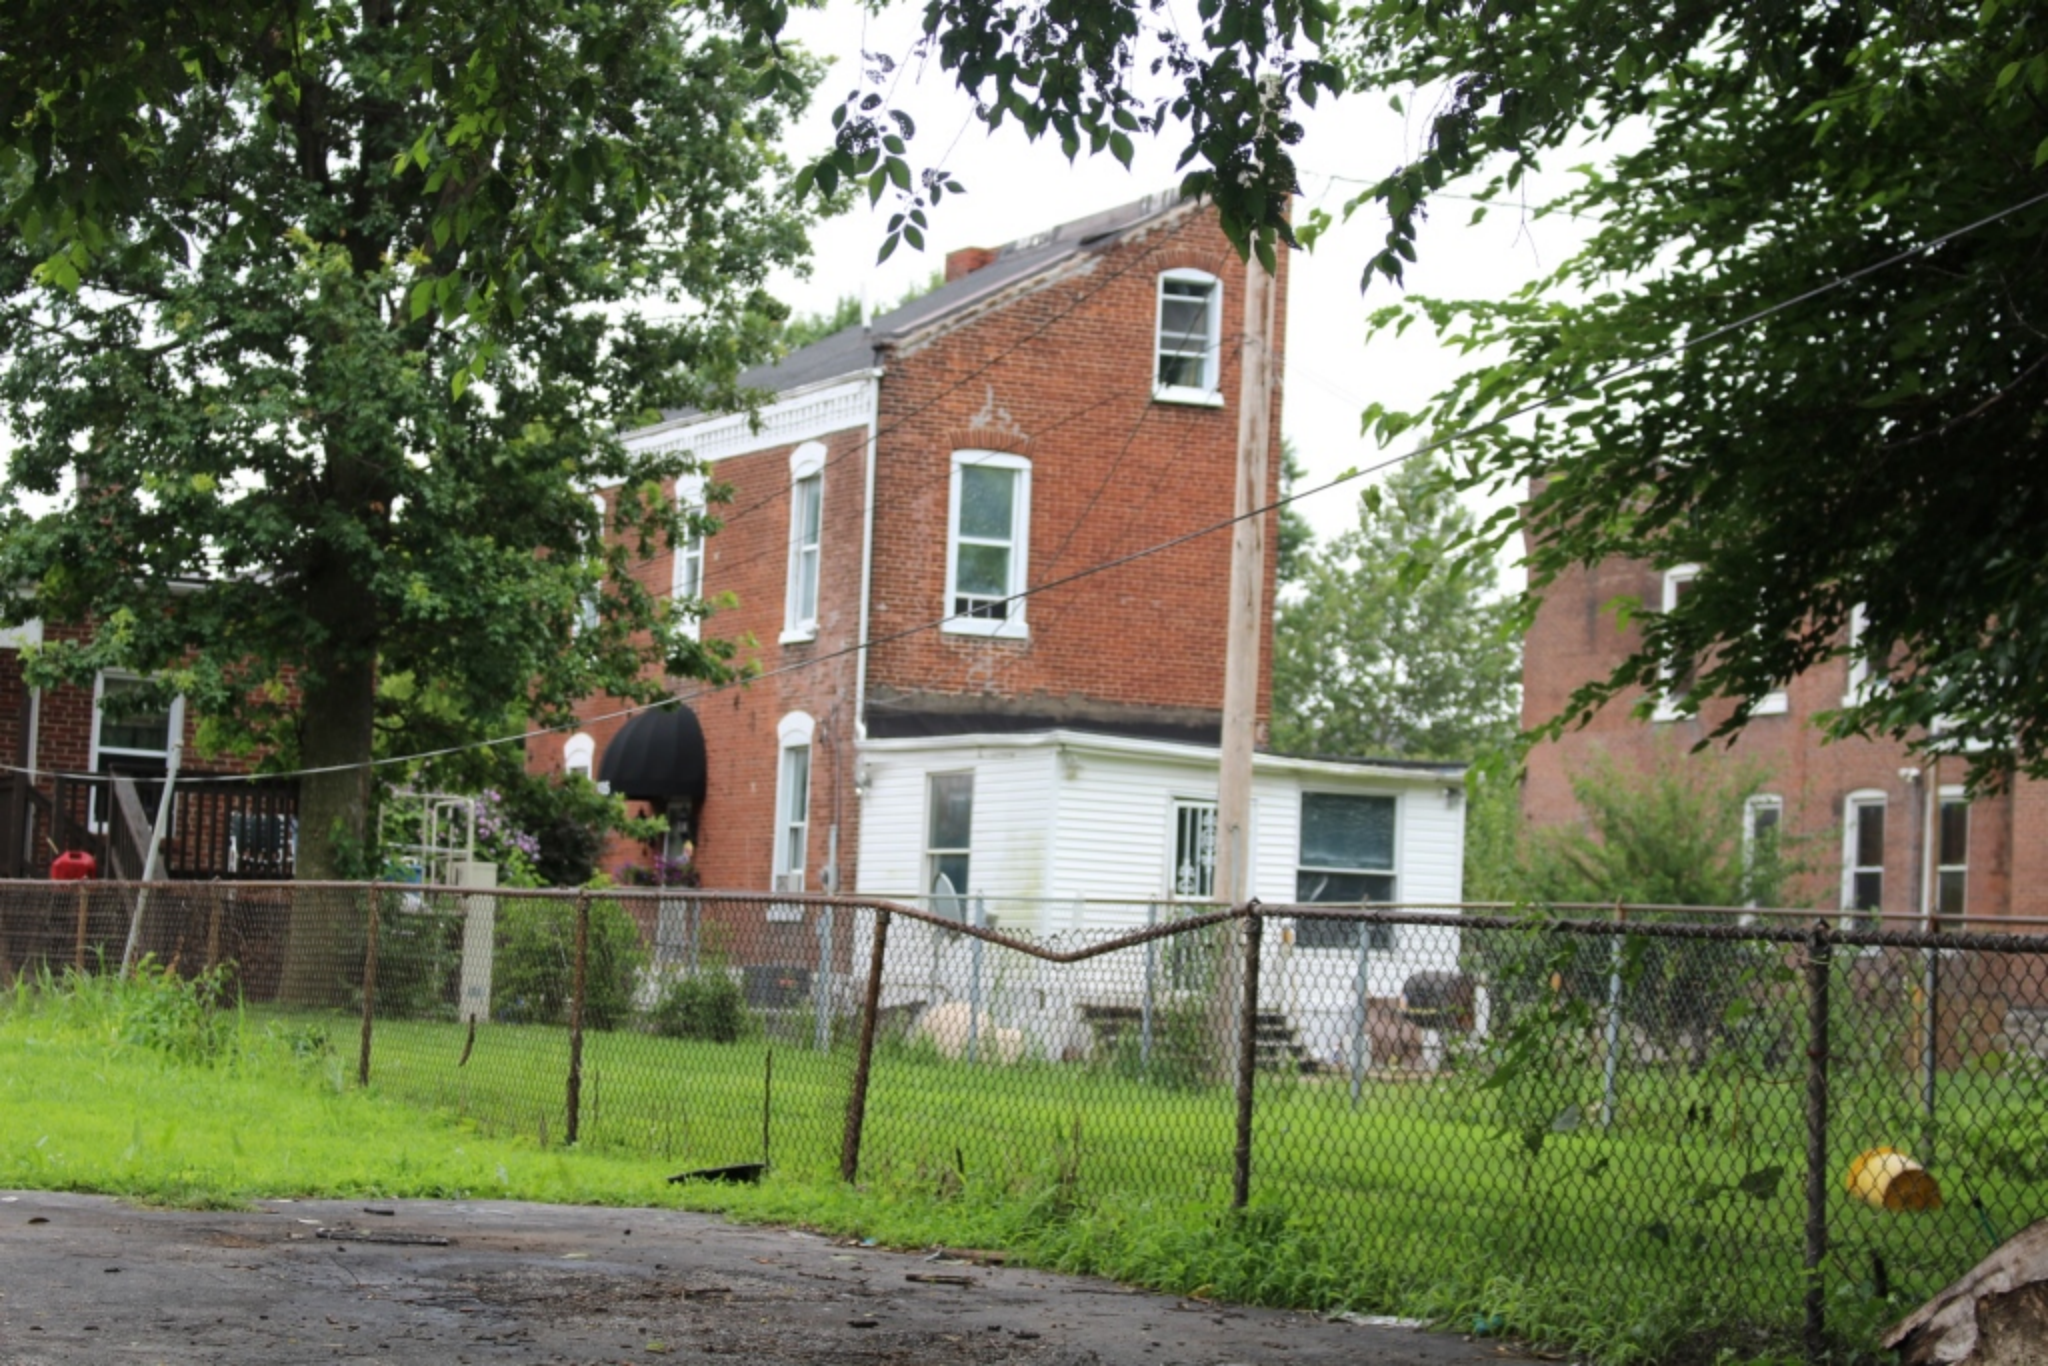
This two-stry brick flounder presents a narrow façade to the street with two bays of windows; the entrance is in the center of the east wall. The dwelling has a high coursed rubble limestone foundation, openings with segmental arches formed of headers, and is terminated with a corbelled brick cornice on the façade and east side. Steps lead to the entrance in the east side. The one-story wood-framed extension from the rear appears to be a historic element with replacement siding. All windows have replacement 1/1 aluminum sash; one opening on the side of the entrance has been blocked down. The tall windowless flounder wall rises on the west, unaltered.

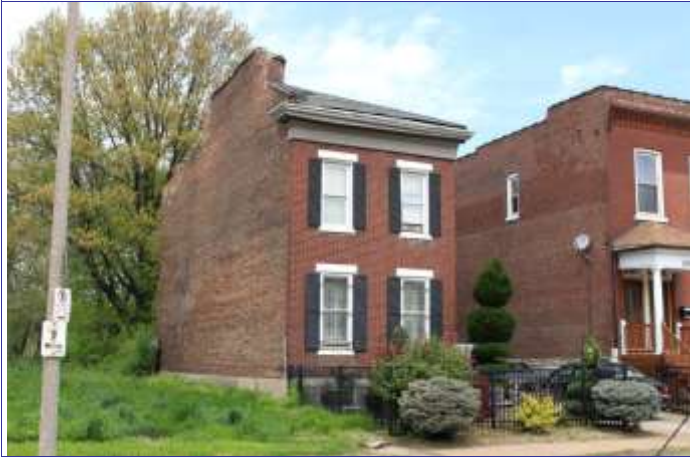
**2007 E COLLEGE AV**

This two-story brick flounder is a relatively high-style Federal expression for the building type. The roof -- hipped at the front and rear -- has a intersecting gable that accentuates the middle bay of the side façade where the entrance is located. A molded wood cornice has a deep fascia board and molded consoles at the eaves on the east side. An oval oriel window pierces the brick wall under the intersecting gable. The five bays on the side façade and two on the front façade have square-headed openings with prominent limestone sills and headers; windows consistently have replacement vinyl 1/1 doublehung sash. The entrance in the center bay is protected by a single-bay porch with turned wood posts supporting a gable roof perpendicular to the building; it has been altered over time. Concrete conceals the raised foundation, presumed to be limestone. The taller windowless brick wall on the west is unaltered. A two-story wood extension clad with vinyl siding extends to the north and east of the brick portion of the flounder.

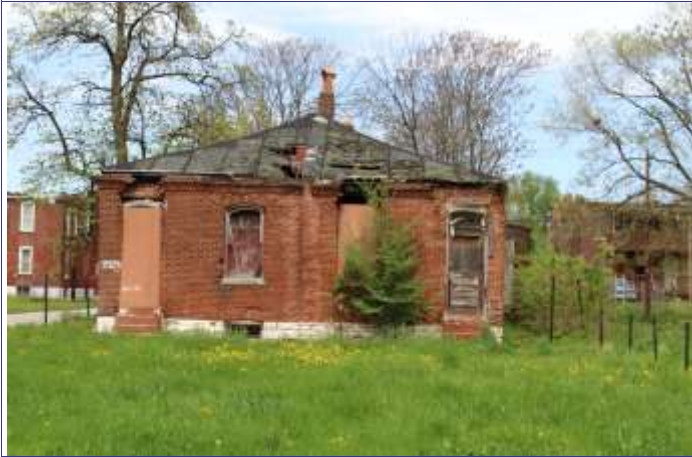
**2127-9 E COLLEGE AV**

roof collapsed on 2129; missing rolled roofing material on both units; collapses in corbelled brick cornices on front and southeast corner; other loss of brick

This pair of semi-detached flounders are side-by-side units set back on the rear half of the lot. The two-bay façade of each unit has a door near the corner, and a window bay closer to the party wall. The foundations have different size and coursing of the roughly cut limestone; 2129 has a basement window in the façade and two in the west wall, below two windows with segmentally-arched heads formed of header bricks. A corbelled brick cornice edges the front and side walls of both units. The east unit, 2127, has a deeper rear extension than the one on 2129. An opening boarded behind the remnants of window sash indicates that the top sash had an arched head; the door transoms also had arched heads.

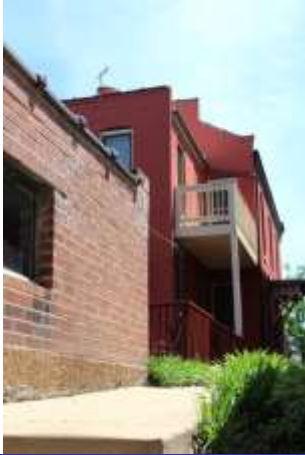
## 1923 S COMPTON AV

This 2-story brick flounder has an angled bay window of brick on the ground story. The bay has a paneled and bracketed wood cornice. Above the bay, there are two bays of windows. These openings and the three in the bay windows have segmentally-arched heads with decorative eyebrows. A bracketed wood cornice edges the façade and a simpler version extends along the south side. The entrance in the second bay from the façade is sheltered by a decorative wood roof with large braces supporting a bracketed fascia. The taller windowless wall rises on the north side. A shorter narrower rear wing with a flt roof extends from the north side of the main block; a two-story gallery extends along its south side, a replacement form that connects with a deck to the rear on the ground story and is a wood porch at the second story.

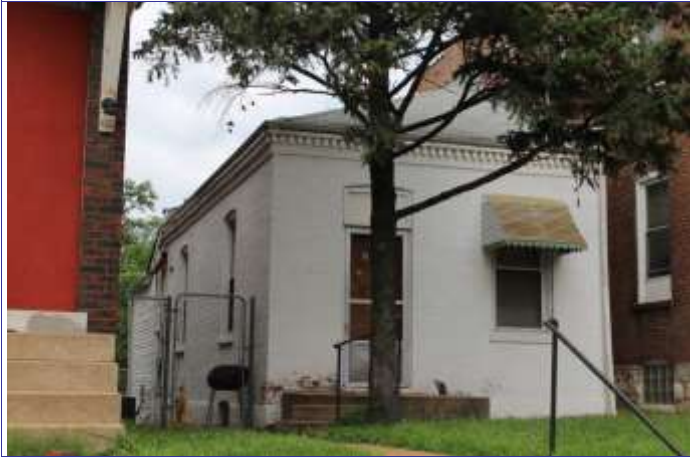
**3841 S COMPTON AV**

foundation parged; likely limestone; façade and other portions painted.

This one-and-one-half story brick flounder has a hipped front shed roof. It presents two bays to the street; these openings, and others have segmentally-arched heads of soldier bricks and stone sills. A replacement concrete stoop provides access to the front entrance in the south bay of the façade. A wood-framed rear portion of the house is clad in vinyl siding.

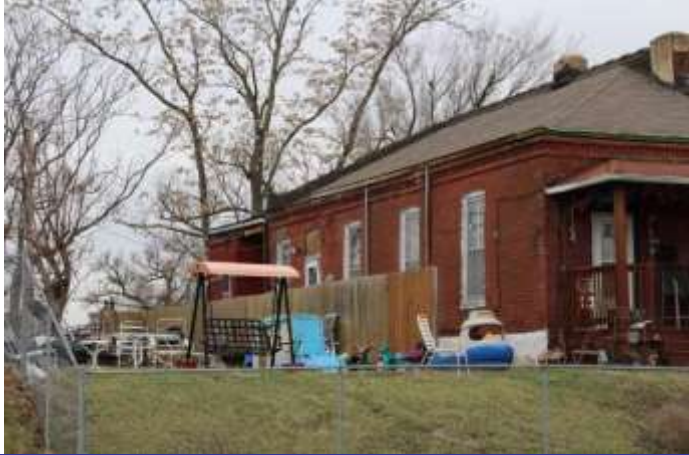
**3626 COTE BRILLIANTE AV**

This one-story brick flounder has a low hipped roof front. The original full-width porch with low-pitched hipped roof has been altered with replacement posts and a poured concrete base. A denticulated brick cornice edges the façade and continues the length of the east wall. Window openings have segmentally-arched openings with soldier heads and most retain the original 2/2 doublehung wood sash. One window with replacement sash has been inserted at the second story of the original blind wall. The building has been painted. A rear frame ell has a flat roof.

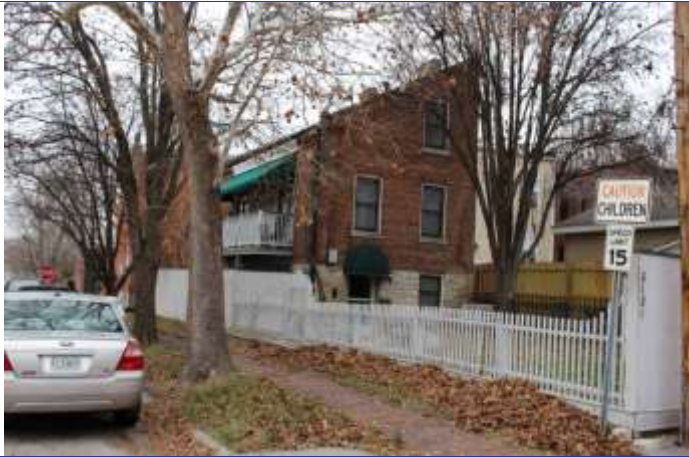
**2121 CRITTENDEN ST**

A privacy fence obscures lower level facing street.

This 2 1/2 story brick flounder has a less common orientation, with its long side to the street. The building features a raised exposed rubble stone basement that incorporates the entrance to the house on the east façade. All windows have flat arches of soldiers and stone sills. A full size window lights the attic at both side walls under a steeply-pitched shed roof. The street facing side of the house has been altered. The center portion sustained a collapse which has been infilled with a frame wall sheathed with clapboard and sliding doors that lead out onto a wooden deck. A simple brick dentilled cornice runs the length of the south façade.

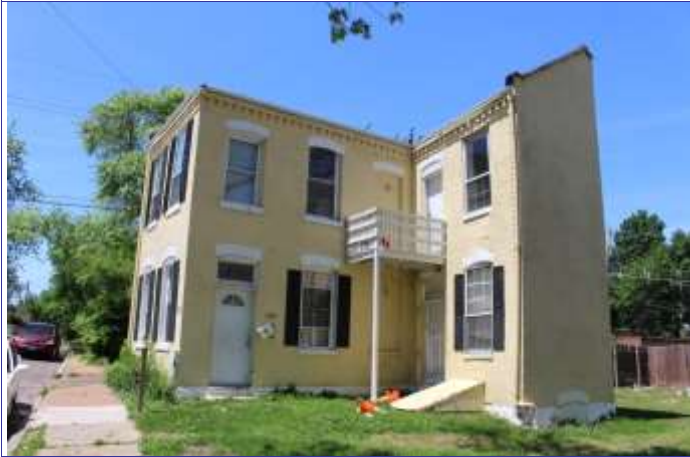
**2907 CRITTENDEN ST**

Painted.

This flounder has an unusual L-shaped form with the side-wing extending to the side from the rear of the main block that has its short side to the street. The roof of the west wing is a high hipped shed roof that intersects with the shed roof of the east wing; the taller wall on the west side is windowless; the taller wall on the north side has two bays of regular sized windows at both stories, and a bay on the west of quite small windows. There are entrances in the front side bay of the main block and the bay adjacent to the main block of the side wing. Many door and window openings have segmentally-arched heads formed of header bricks; some seconnd-story openings have flat heads and are positioned just below the cornice. Most window openings hold replacement 1/1 double-hung sash; two windows are blocked. The corbelled brick cornice extends along the eaves of all of the lower edges of the roof. The two entrances have transoms above the doors. A small wood-framed porch shelters the entrance in the side wing and a door at the second floor has access to the flat roof edged with a wood railing. The foundation is low; an exterior cellar access door extends from the side wing. The east wall of the side wing is at less than a right angle to the wall facing the street, and at the corner bricks project slightly indicating this form. The brick reveals that the corner is not square at the northwest rear corner as well.

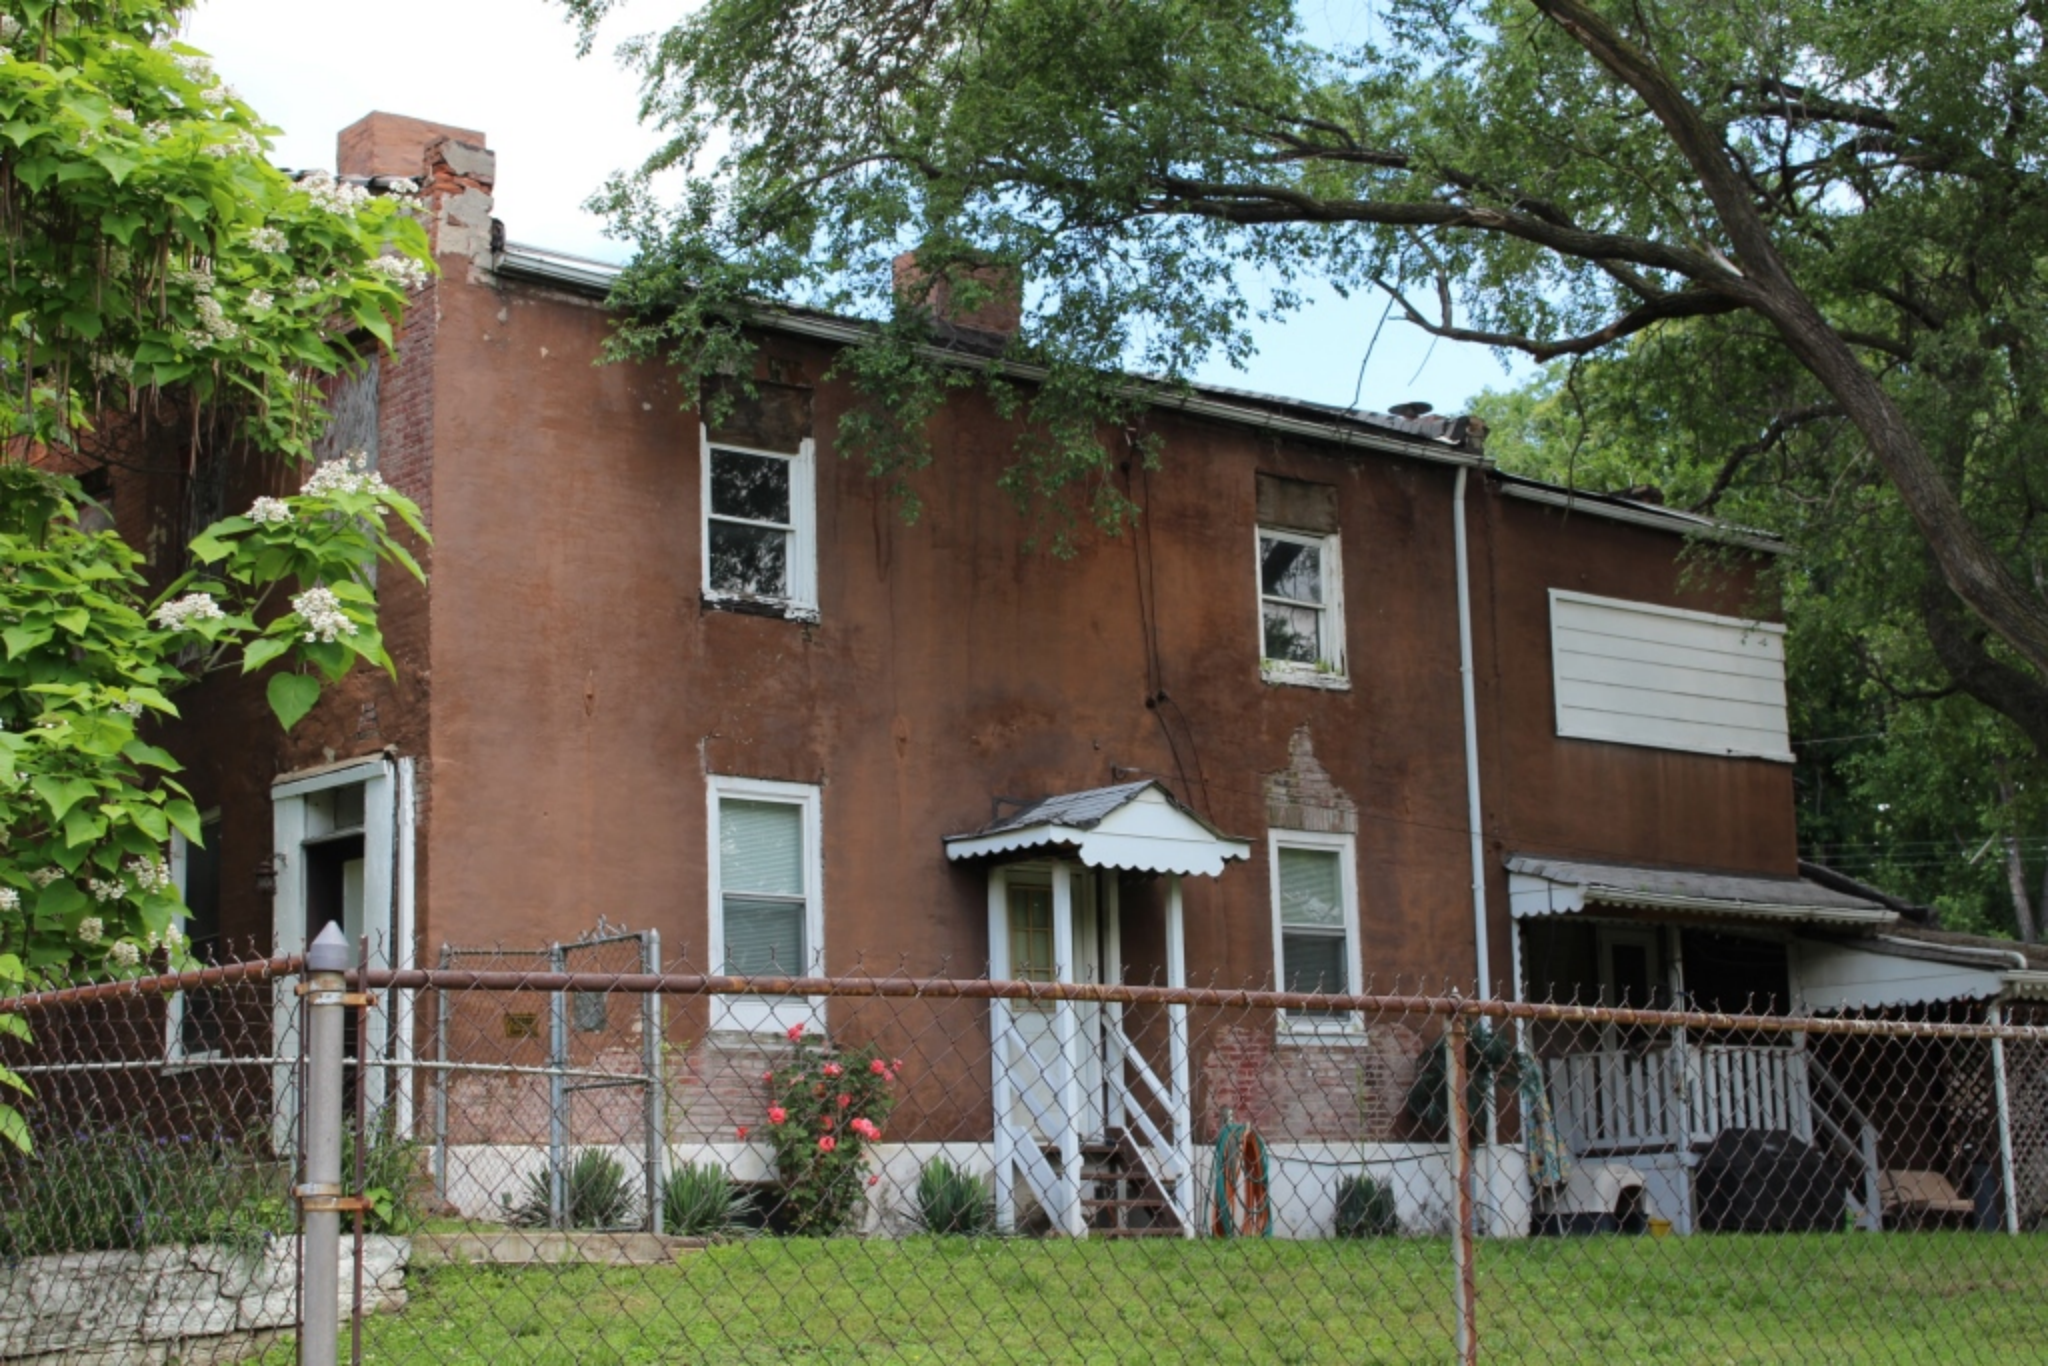
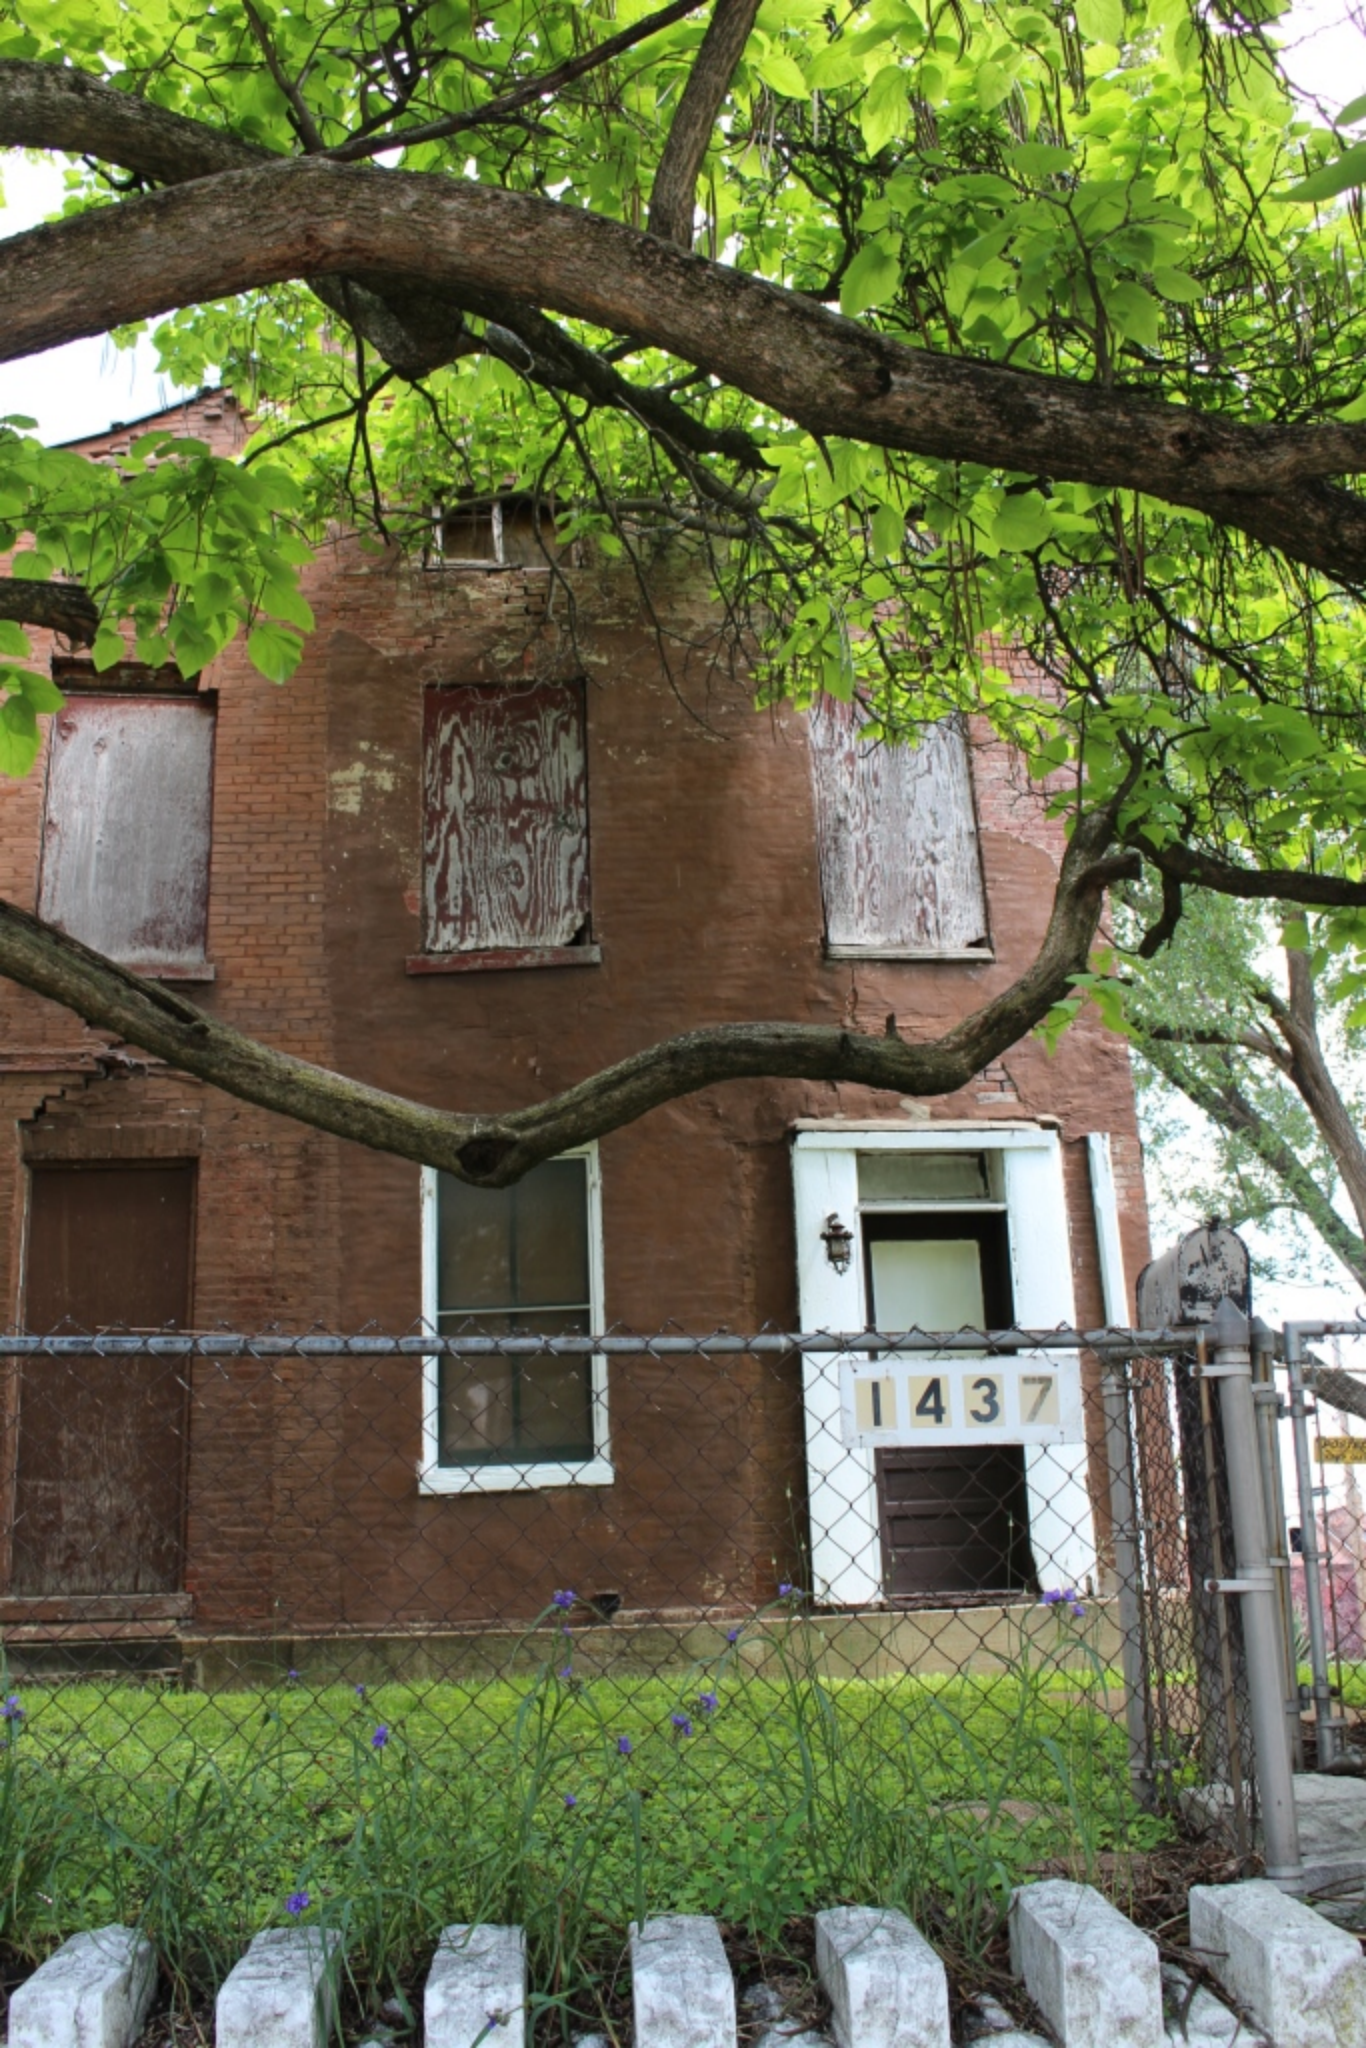
1437 and 1439 Dodier are a pair of nearly identical semi-detached flounders is set back a bit from the street. Both units are brick, now parged and painted brown. Both units are two bays wide, with entrances with stoops on the outer bays. Only ghost lines remain of the porch on 1439, as shown on the Sanborn map. Most of the façade windows, which have flat heads and wood sills, are boarded; one window has 2/2 doublehung wood sash. Windows on the east side have 1/1 replacement doublehung sash. The entrances in the façade are half-glazed doors set under transoms. 1437 has an entrance in the middle bay of the east side with a small gabled entrance porch. The inset gallery on that side has been enclosed above the ground-story porch. 1439 has a similar arrangement with a larger gabled entrance porch sheltering the entrance centered in the side wall; a porch also extends from the in-filled inset gallery.
