**ARCHITECTURAL/HISTORIC INVENTORY FORM - Cultural Resources Office**  
**St. Louis Planning and Urban Design**

1. Survey no. SLC-AS-053-0001	2. Survey name: Thematic Survey of Flounder Houses in St. Louis City	3. County: St. Louis [Independent City]
4. Address: (from City GEO database) <b>1812 S 8TH ST</b>		5. City/State: St. Louis, Missouri
Alternate address: 1812 S 8th		Property Zip Code: 63104
Latitude: 38.608949		6. UTM Easting: 743586.48
Longitude: -90.202538		UTM Northing: 4277095.00
8. Historic Name (if known): N/A	11a. Historic Use (if known): Domestic	City Block: 372 City Ward: 7
9. Present/other name (if known):	7. Township-Range-Section: N/A	10. Ownership: Private
11b. Current Use: Domestic		Neighborhood Number: 21

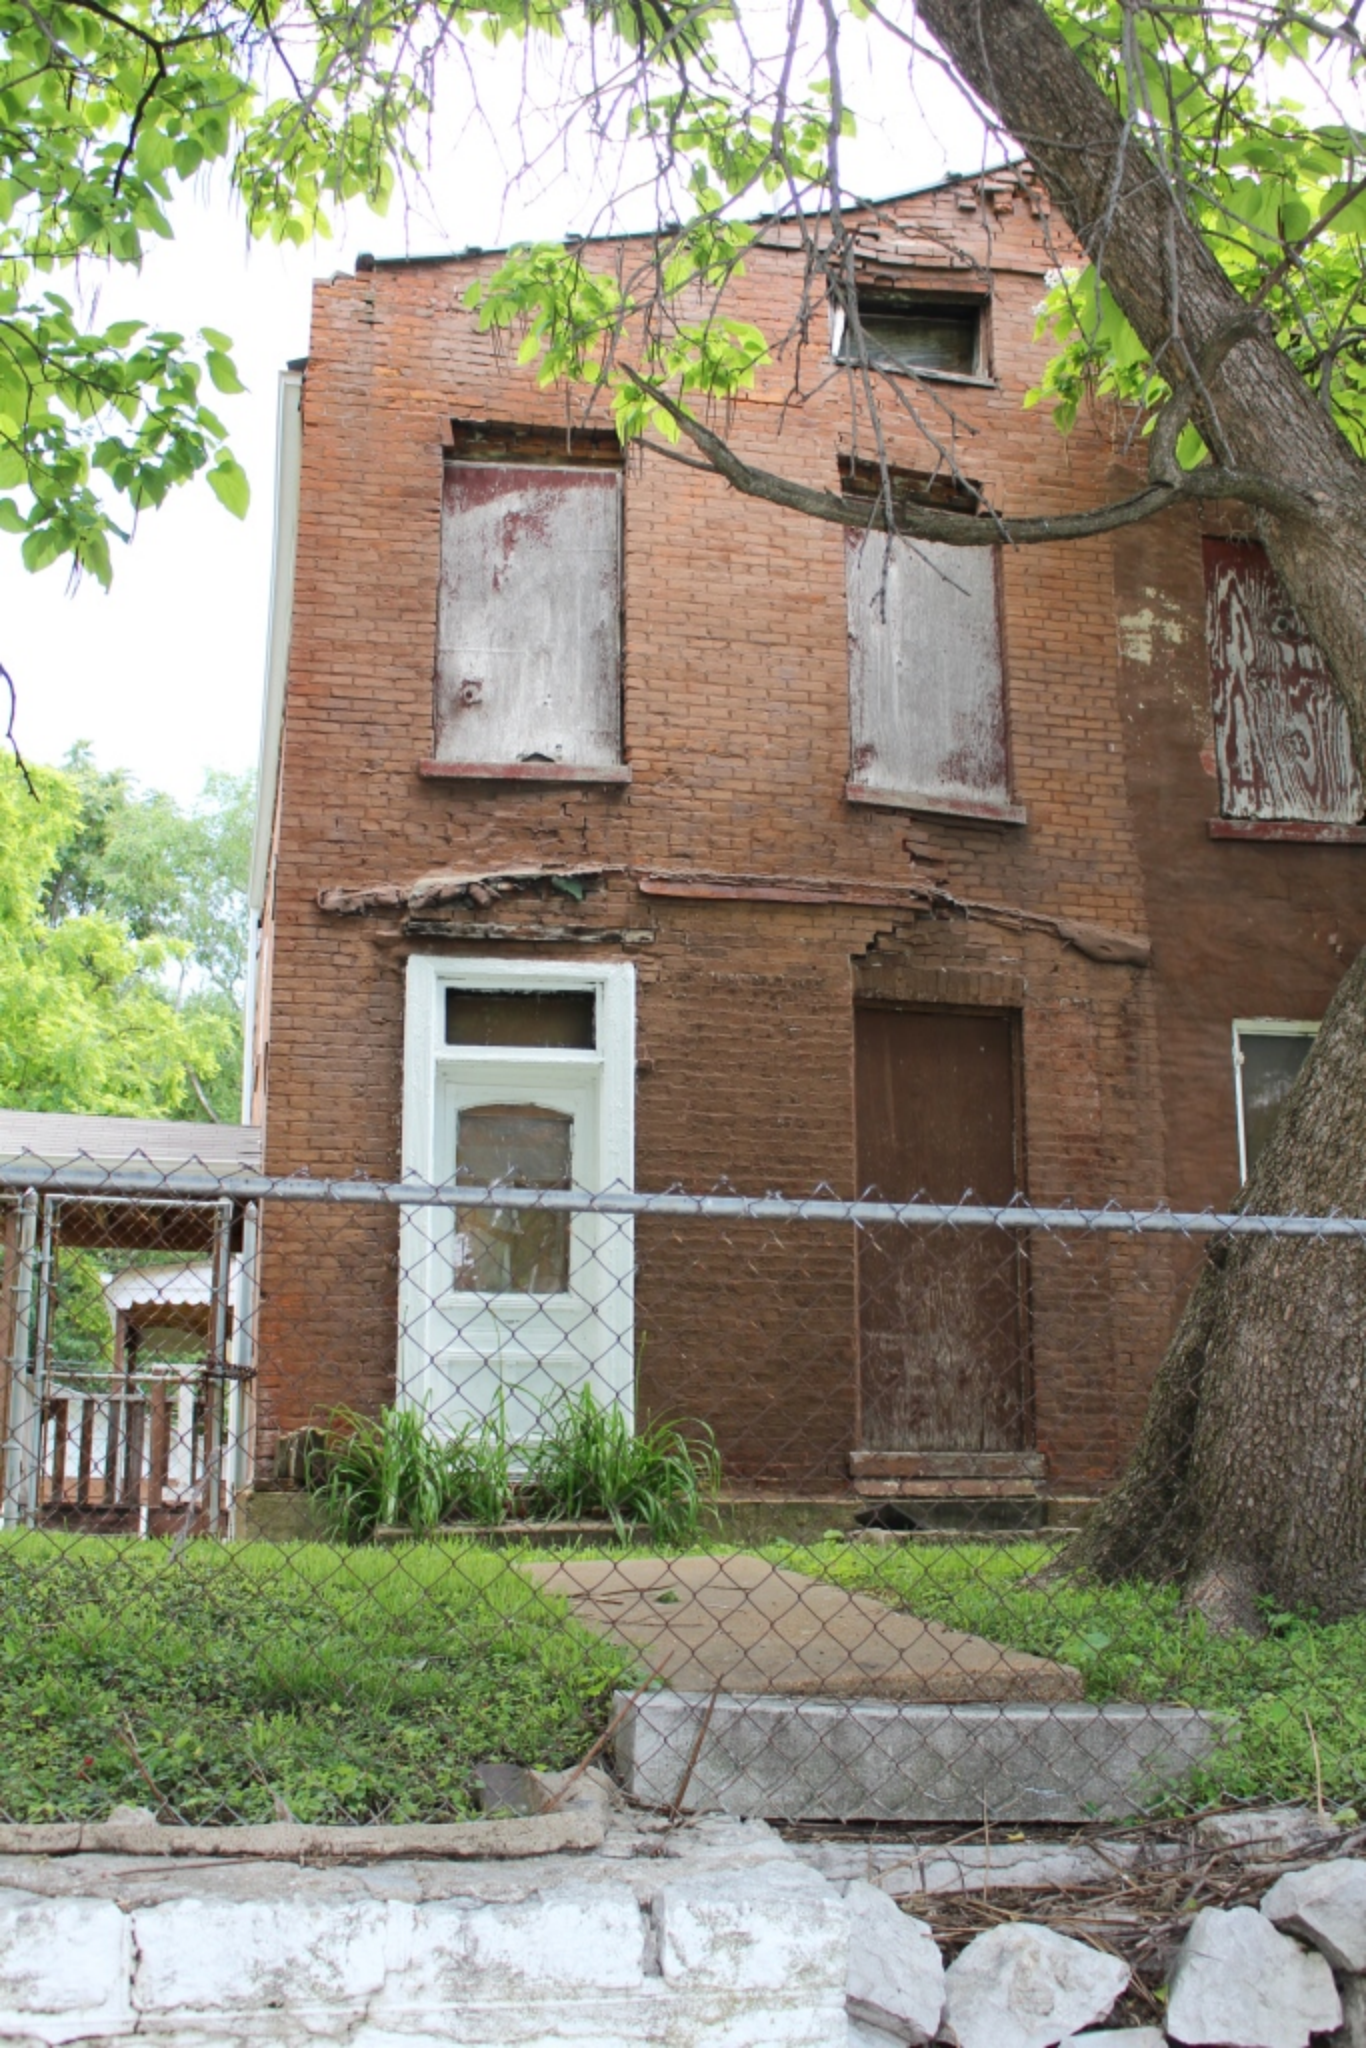
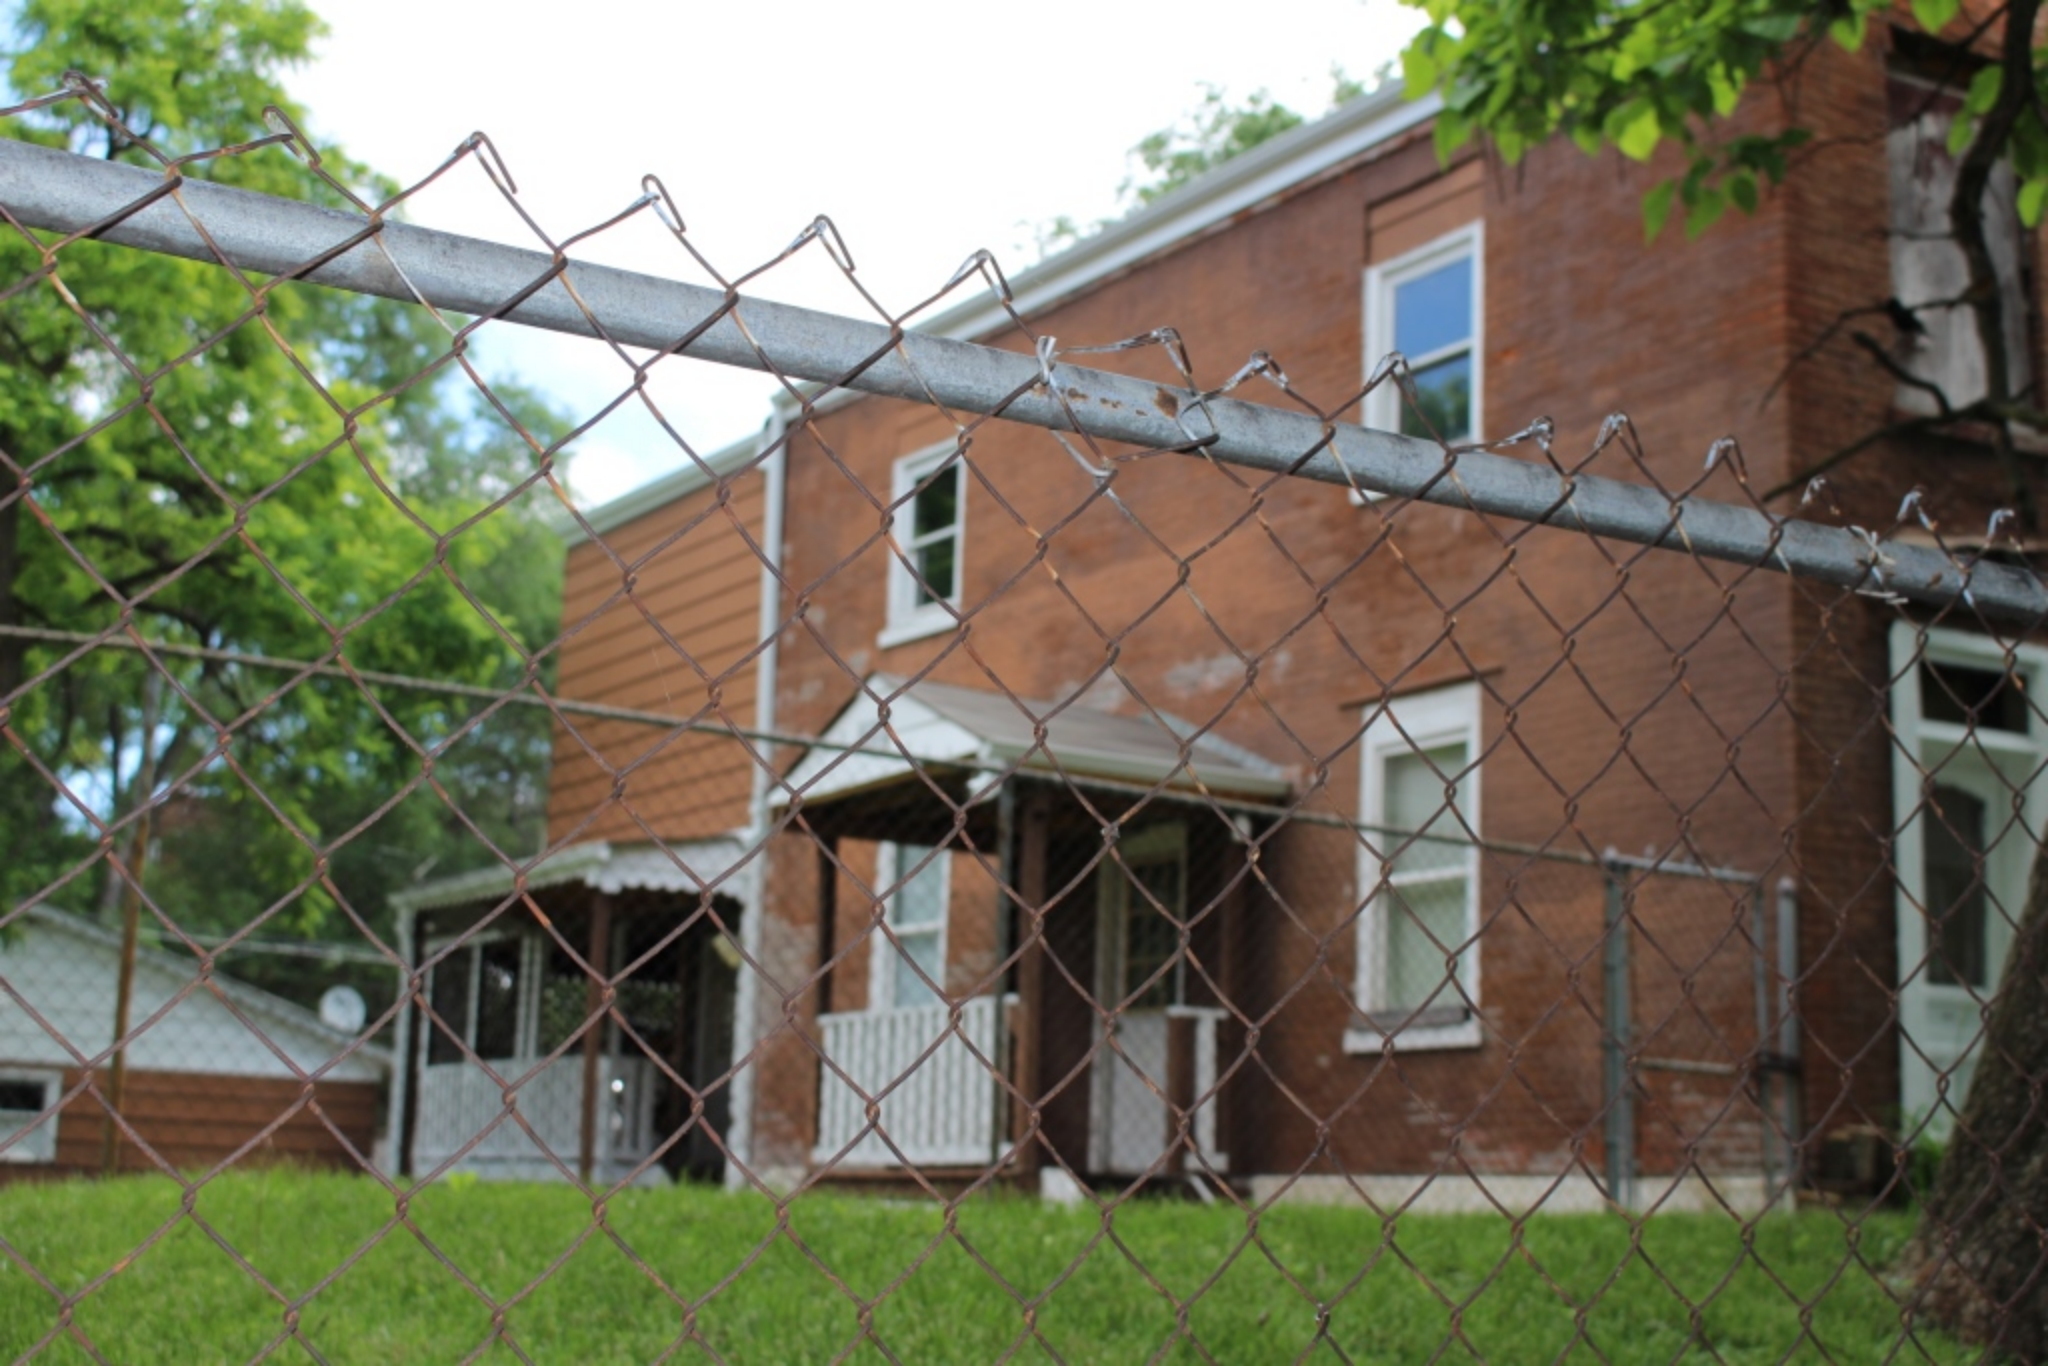
1437 and 1439 Dodier are pair of nearly identical semi-detached flounders set back a bit from the street. Both units are brick, now parged and painted brown. Both units are two bays wide, with entrances with stoops on the outer bays. Only ghost lines remain of the porch on 1439, as shown on the Sanborn map. Most of the façade windows, which have flat heads and wood sills, are boarded; one window has 2/2 doublehung wood sash. Windows on the east side have 1/1 replacement doublehung sash. The entrances in the façade are half-glazed doors set under transoms. 1437 has an entrance in the middle bay of the east side with a small gabled entrance porch. The inset gallery on that side has been enclosed above the ground-story porch. 1439 has a similar arrangement with a larger gabled entrance porch sheltering the entrance centered in the side wall; a porch also extends from the in-filled inset gallery.

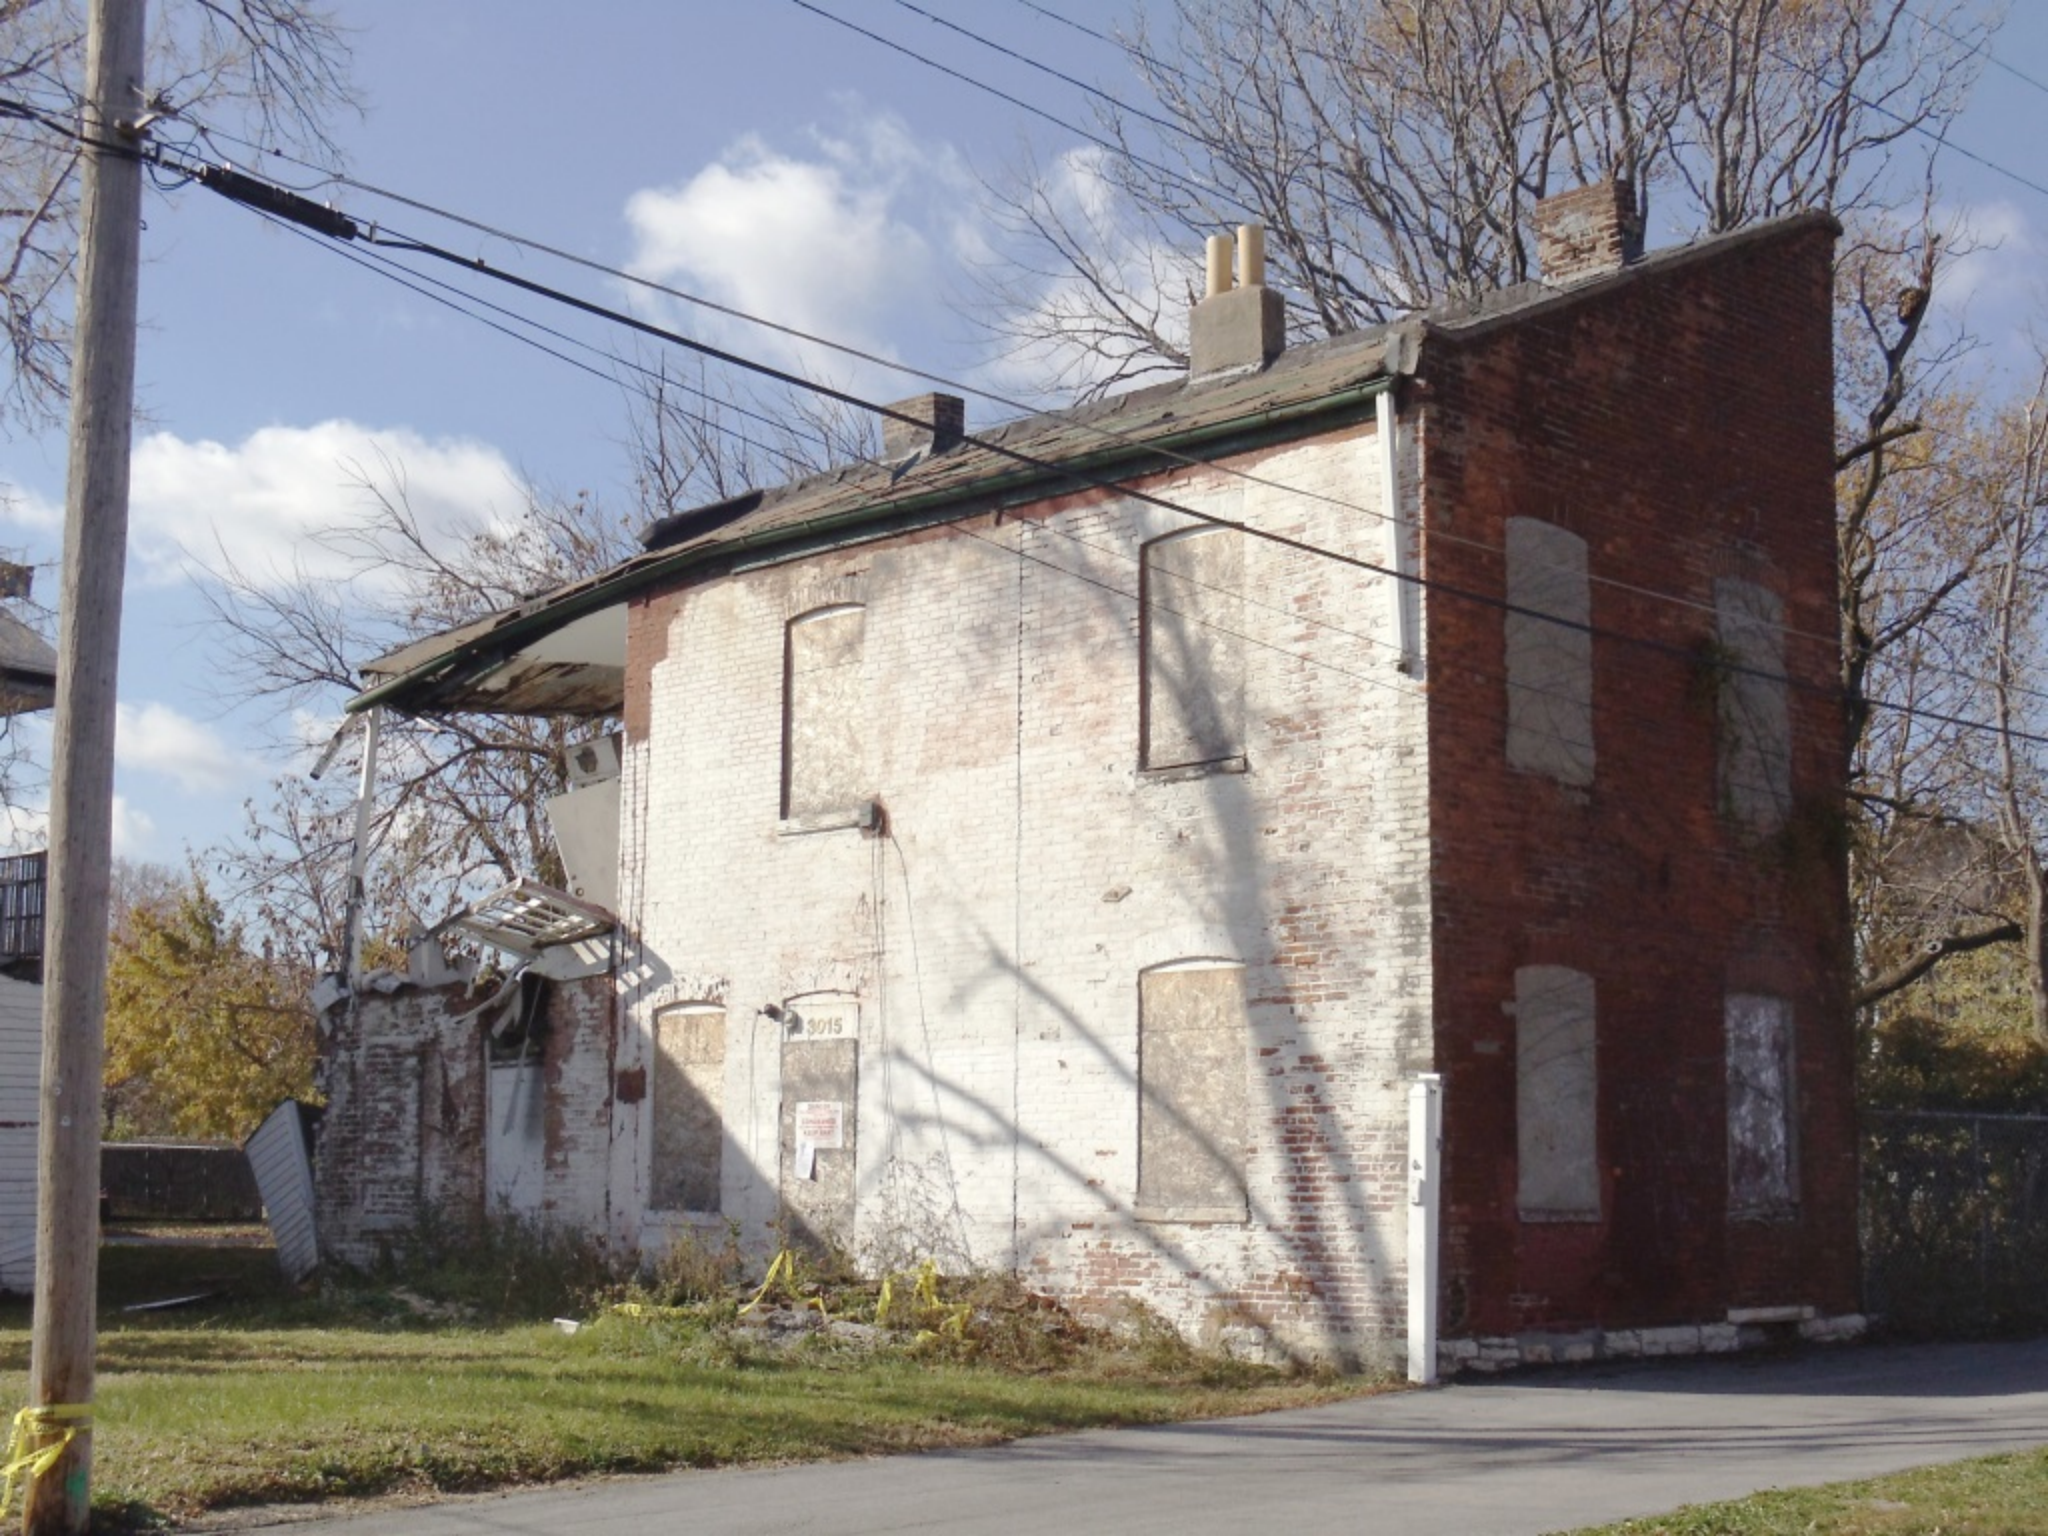
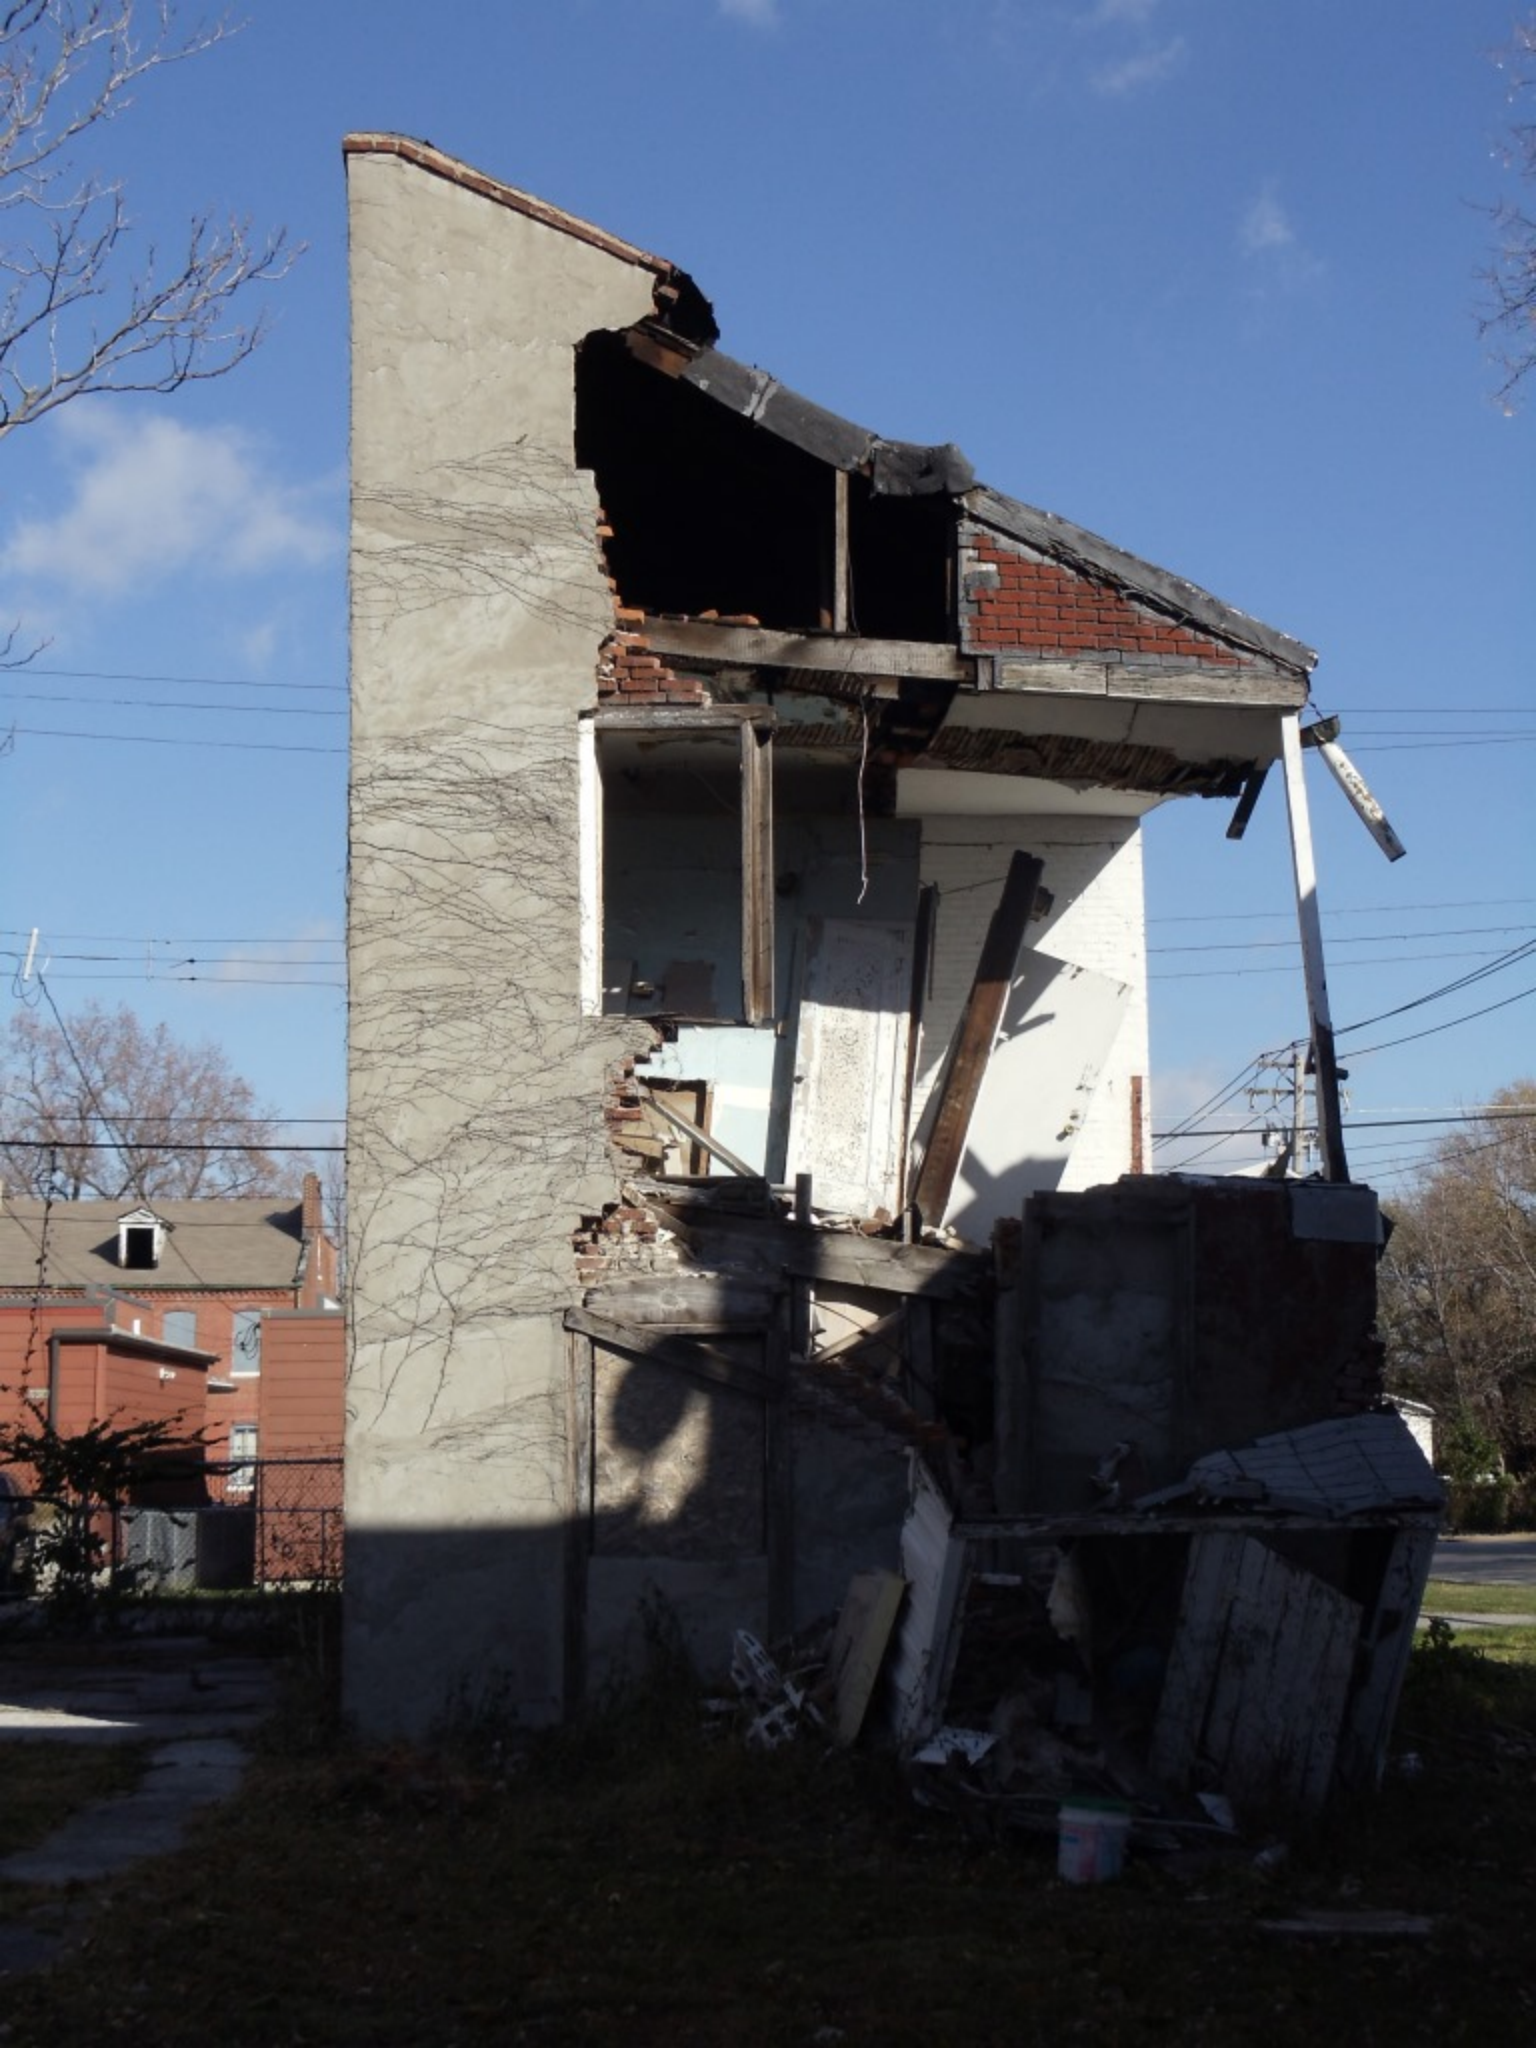
This is a 2-story flounder with loft, sited at the rear alley of 1914 Dodier Street. A common-bond brick building, openings have segmental arches of soldiers; window have wood lugsills. Approximately 1 foot of the rubble ashlar foundation is exposed above grade on all elevations. The taller blind wall is located at the west property line; it retains 3 brick stove chimneys at the roof ridge. The building appears to have been built in 3 equal sections, each with its own central chimney, the break between them being clearly visible in the masonry. The section at the alley is 1 room deep and presents a 2-bay alley façade, with two windows at each story: the window at the northern bay of the first story was once a door, indicating that this was the first section built: when the center section of the flounder constructed, this first door became unnecessary and the opening was blocked down. The center section of the flounder is also 1 room deep, with a singleleaf door under a transom at the first story flanked by a window; the second story has a single window above. The westernmost segment was narrower than the first two to accommodate a 2-story recessed porch; its south elevation was a single bay. The southeast corner of this section has partly collapsed, exposing the building interior. The first story of the recessed porch has been enclosed with brick.

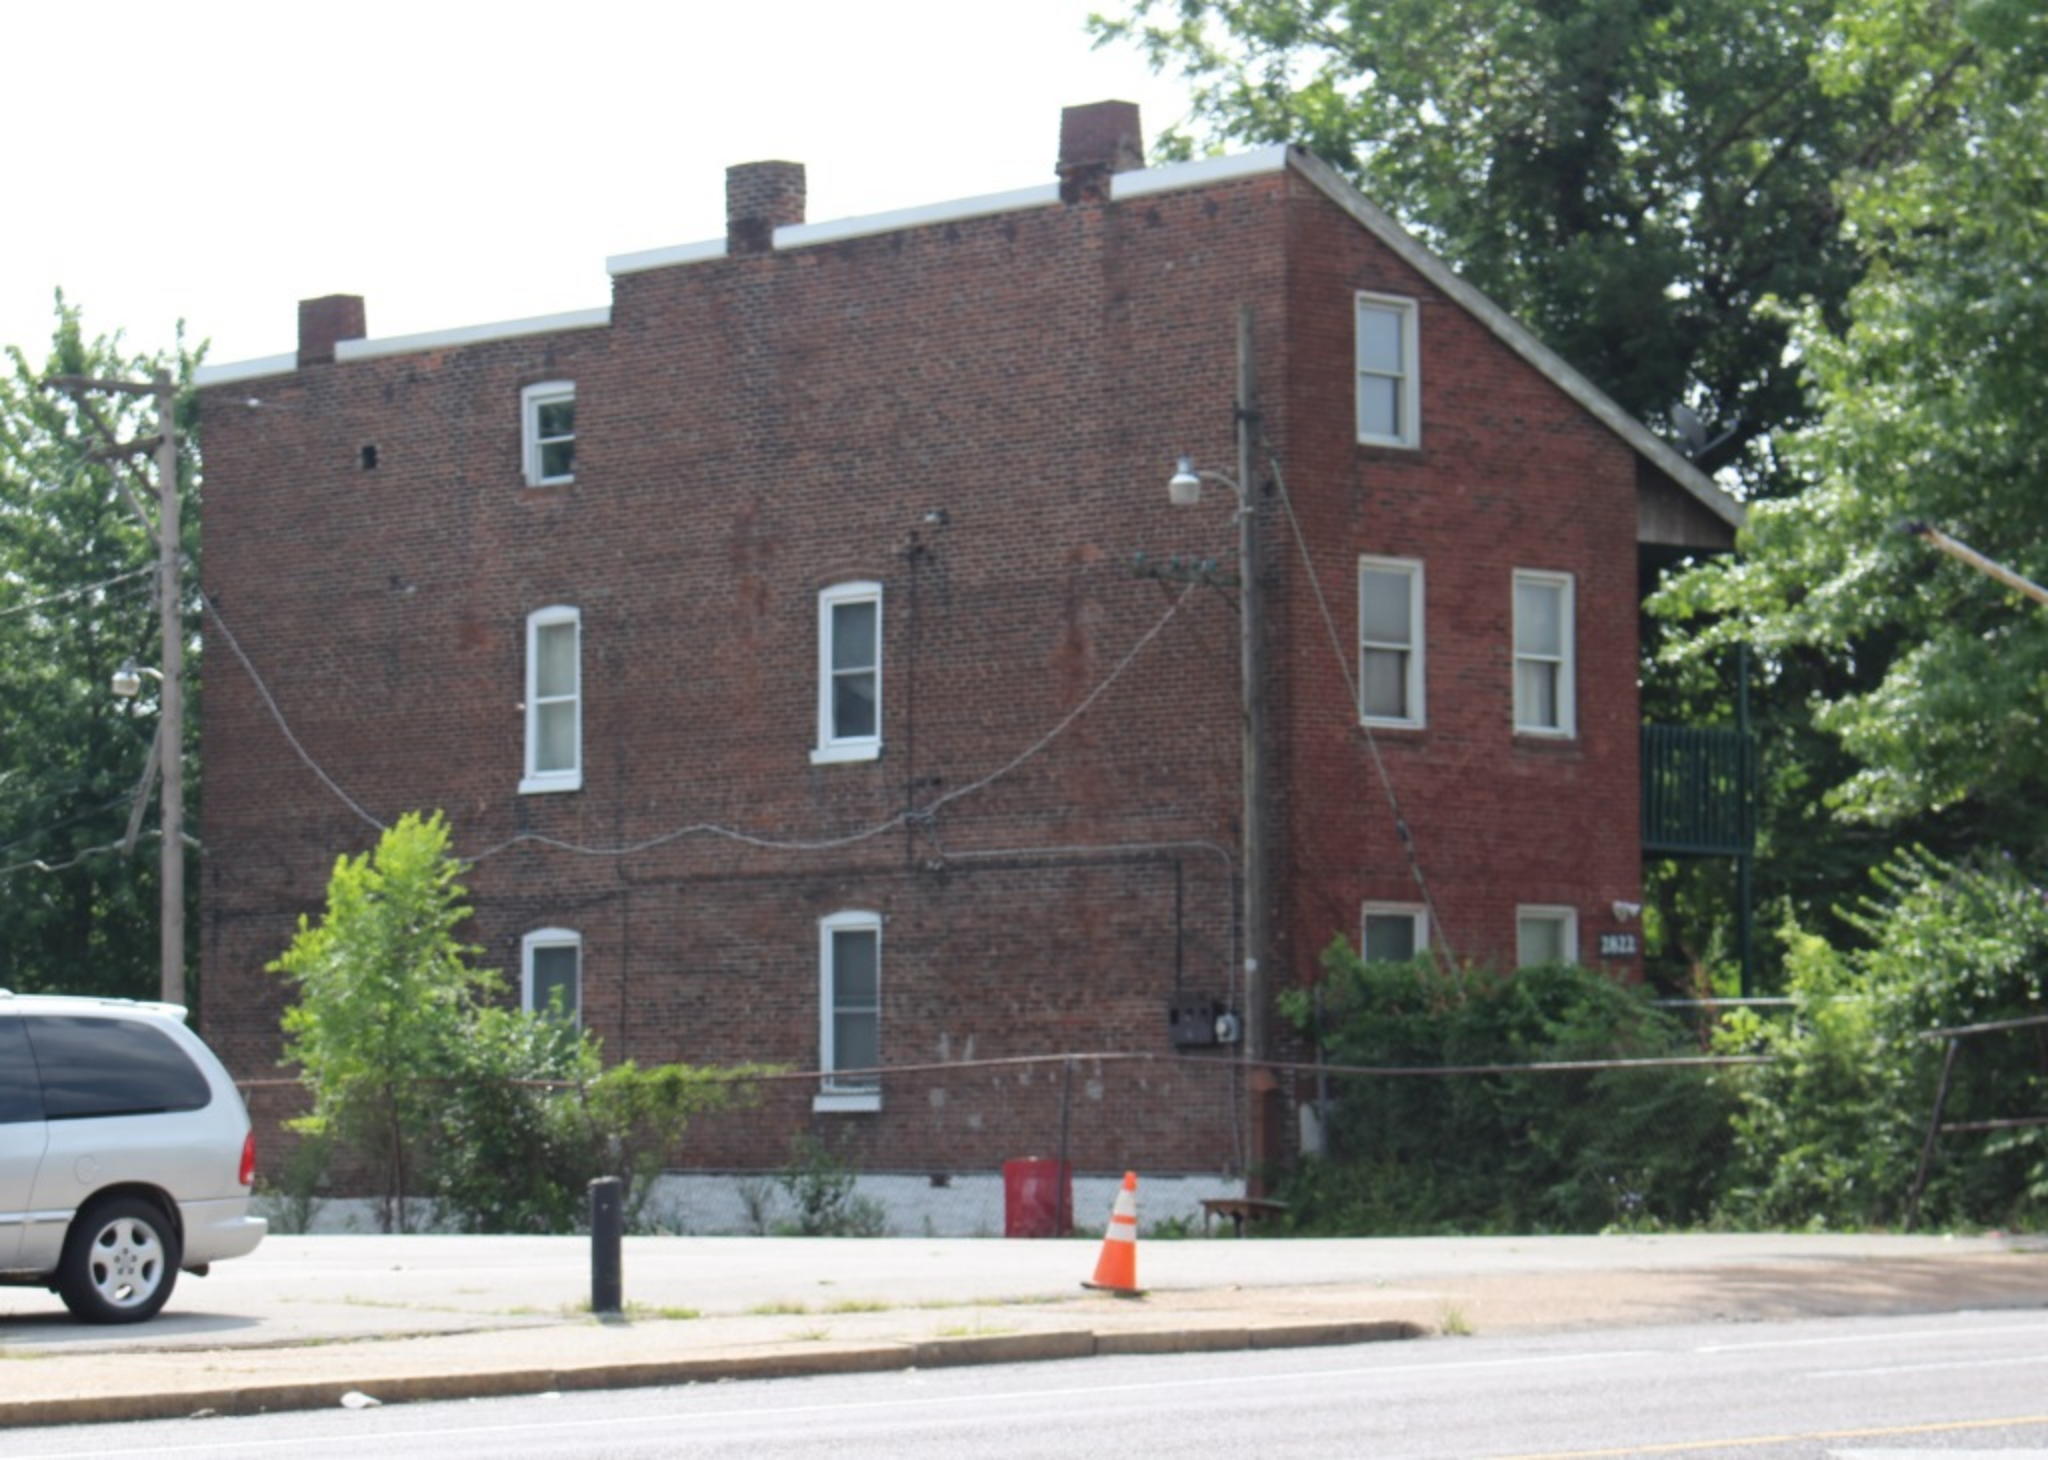
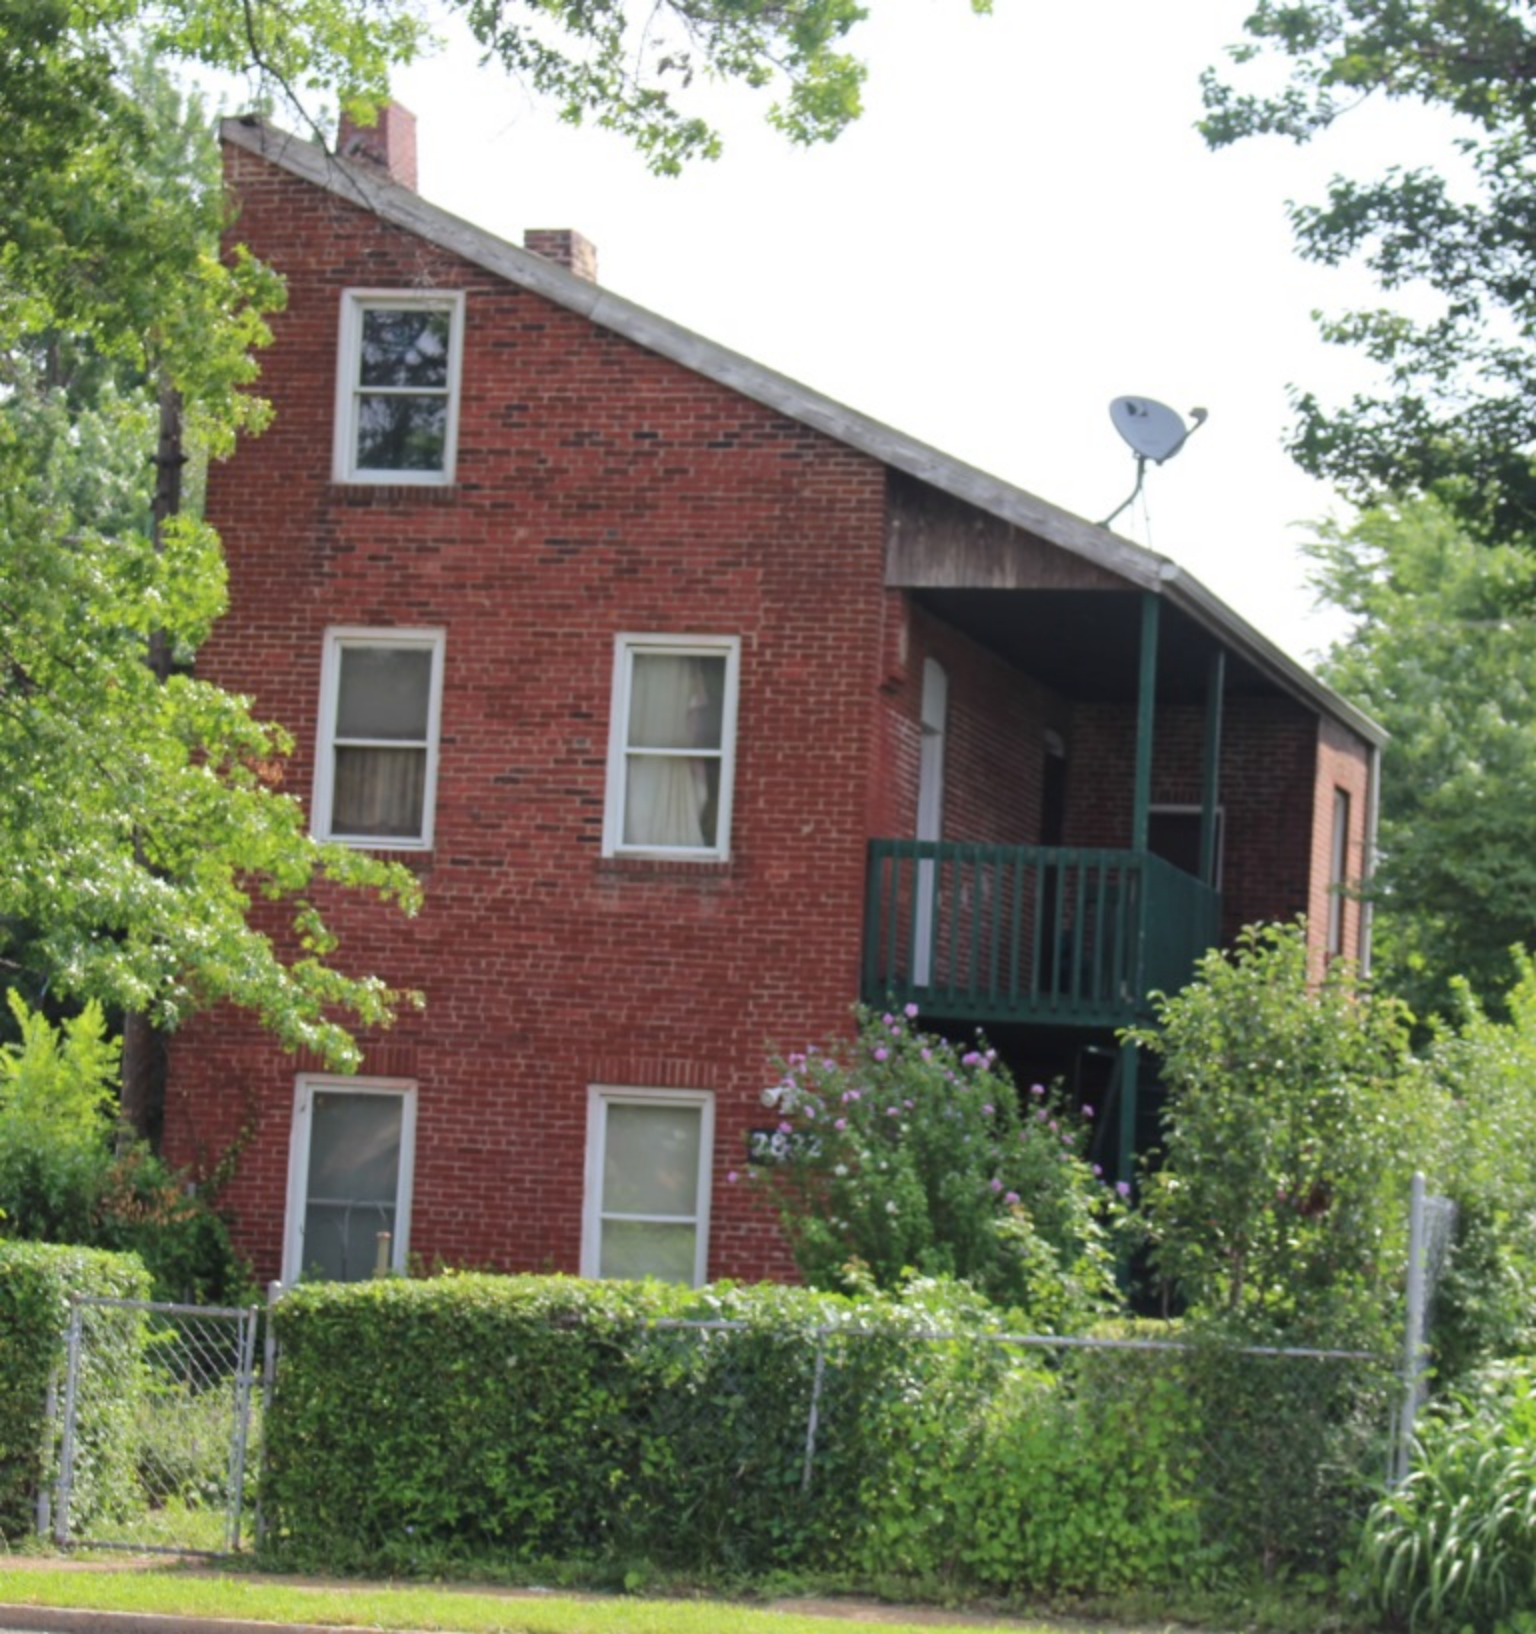
This 2-1/2 story brick flounder house has a 2-bay front façade with two doublehung windows at first and second stories and a single doublehung at the apex of the parapet. A portion at least of the front façade has been reconstructed: the windows of the first story are placed under flat soldier arches; those of the upper stories, under steel lintel. The 3-bay south façade displays a 2-story gallery with singleleaf doors with transoms in the first bay at both stories. These and the windows of the center bay have segmental arches. The eastern most bay of the façade has been enclosed with brick, likely at the same time as the reconstruction of the front, as the openings have similar steel lintels. On the taller, originally blind north wall, a window has been inserted into each story and in the rear ell. These appear to have been an early alteration: they are placed under segmental double-rowlock arches. Three brick stove chimneys protrude from the roof ridge on this elevation. The foundation of the building has been painted, and the parapets wrapped with aluminum.

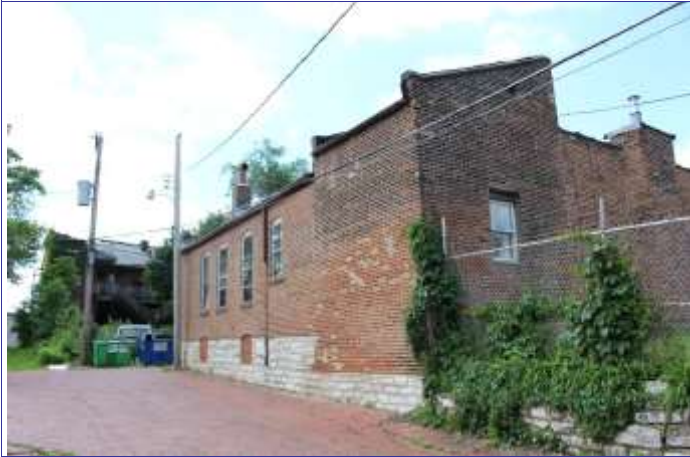
**3712-20 N FLORISSANT AV**

This nearly square flounder with a roof that is taller on the west is positioned at the alley and now connected to a building with a taller foundation to the south along the alley. It has one window in the north side that has a flat head and lintel ad may be an alteration. There may be small openings near the top of the west side, which can only be discerned in a bird's-eye view.

This small flounder form is not discernible on the Compton & Dry 1875 Pictorial and does not appear on the 1883 Hopkins Atlas. It seems to be the 2-story smoke house on the 1909 Sanborn Map that is now attached to a one-story brick building with a raised foundation.

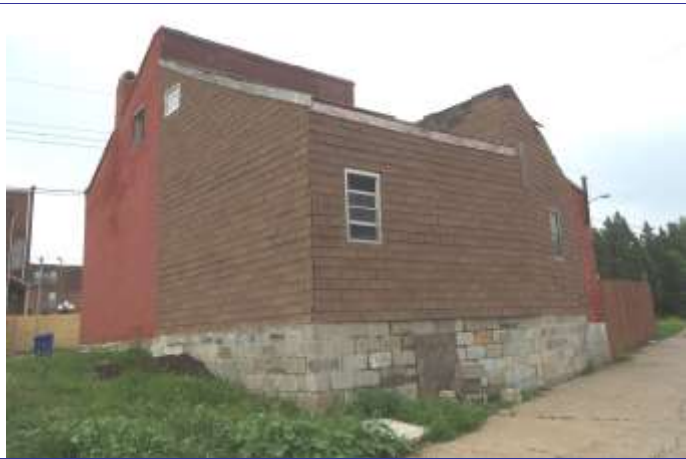
Rear (fachwerk) flounder

1-story fachwerk flounder with loft is set back-to-back with a 1-1/2 story brick flounder, with side entry. The fachwerk flounder originally had a gallery on its south façade; it has been enclosed and the entire exterior sheathed with asphalt brick-pattern siding. Entirely A corbelled cornice runs the length of the north façade of the original building. The building has three separate additions off of the south and east sides of the building. The entry to the house is within the frame addition on the east side of the house. The original building and brick addition off of the southeast corner of the house is painted red and grey. The foundation on the front façade has been parged over and painted white.

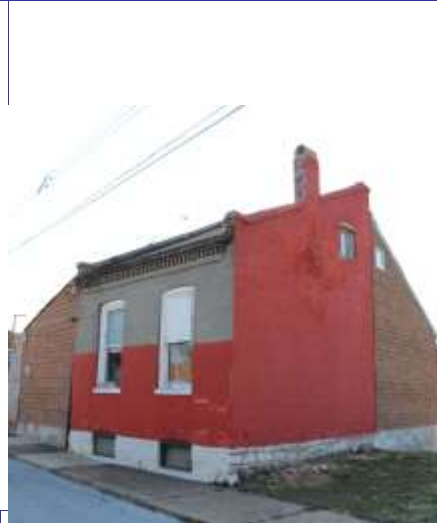
Front flounder

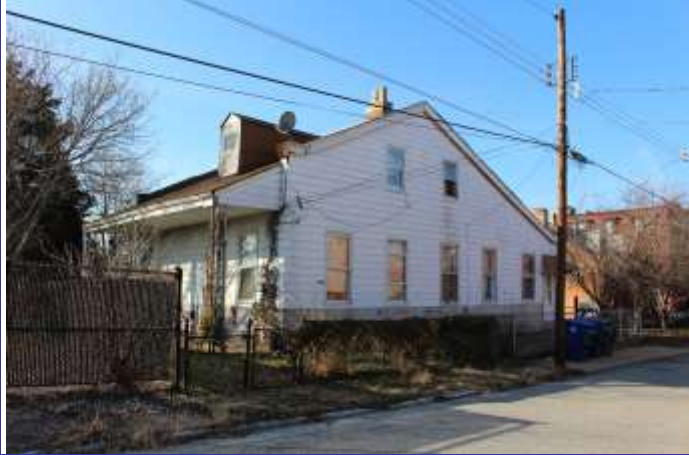
Front elevation - 2234 Gainé at left

These semi-detached flounders at 2236-2234 Gaine are not identical. Both buildings are indicated to be brick on the 1883 and 1909 maps although that material is concealed wide aluminum siding above a tall area clad with a thin material with a pattern of colored stone ashlar veneer. The windows were replaced in both units also, with metal or vinyl 1/1 double-hung sash.

The eastern house at 2234 Gaine presents two bays to the street. A wood-framed pent roof supported by moder posts shelters the east façade of the main block. An entrance is located in the second bay from the front. A dormer projects near the front of the roof. The lower rear wing with a flounder form with a shed roof is also clad with the wide siding.

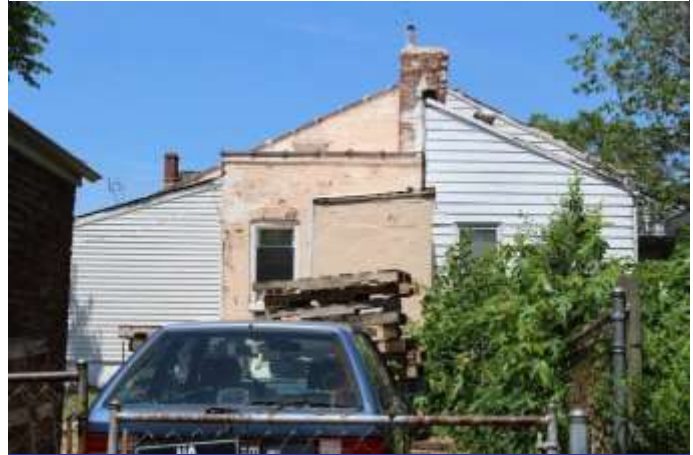
Rear elevation - 2234 Gainé at right

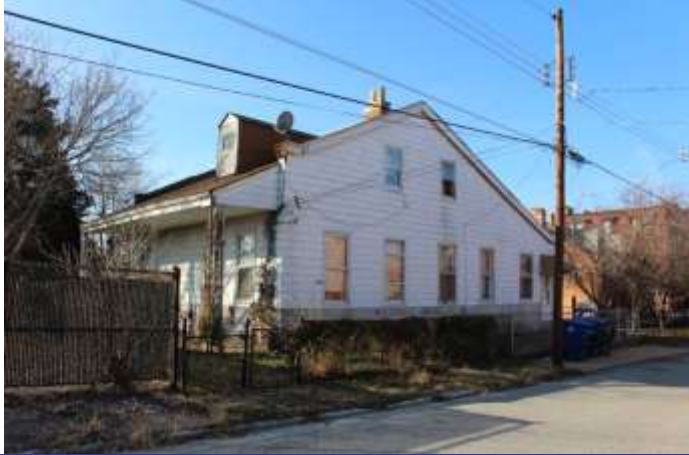
Front elevation - 2236 Gainé at right

These semi-detached frame flounders at 2236-2234 Gaines are not identical. Both buildings are indicated to be brick on the 1883 and 1909 maps although that material is concealed by wide aluminum siding above a tall area clad with a thin material with a pattern of colored stone ashlar veneer. The windows were replaced in both units also, with metal or vinyl 1/1 double-hung sash.

The western unit at 2236 Gaines presents four bays to the street, with an entrance occupying the western one. The exposed west brick wall with two bays of windows and the exposed brick rear wall confirm the original materials of the house. This unit has a flat-roofed brick rear wing to which a shed-roofed side addition is clad with narrow siding.

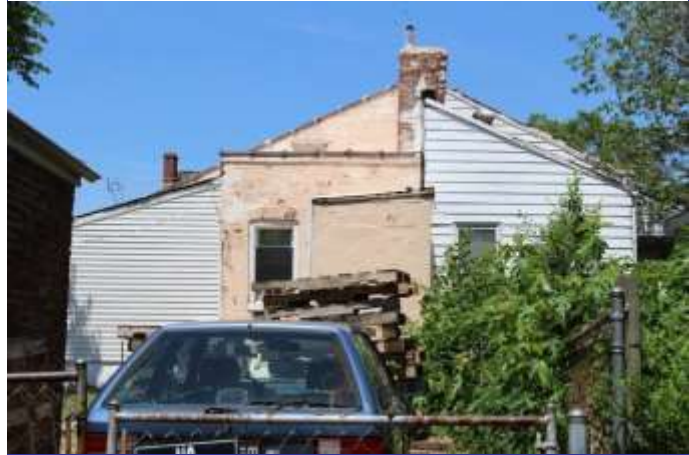
Rear elevation - 2236 Gainé at left
