**ARCHITECTURAL/HISTORIC INVENTORY FORM - Cultural Resources Office**  
**St. Louis Planning and Urban Design**

1. Survey no. SLC-AS-053-0001	2. Survey name: Thematic Survey of Flounder Houses in St. Louis City	3. County: St. Louis [Independent City]
4. Address: (from City GEO database) <b>1812 S 8TH ST</b>		5. City/State: St. Louis, Missouri
Alternate address: 1812 S 8th		Property Zip Code: 63104
Latitude: 38.608949		6. UTM Easting: 743586.48
Longitude: -90.202538		UTM Northing: 4277095.00
8. Historic Name (if known): N/A	11a. Historic Use (if known): Domestic	City Block: 372 City Ward: 7
9. Present/other name (if known):	7. Township-Range-Section: N/A	10. Ownership: Private
11b. Current Use: Domestic		Neighborhood Number: 21

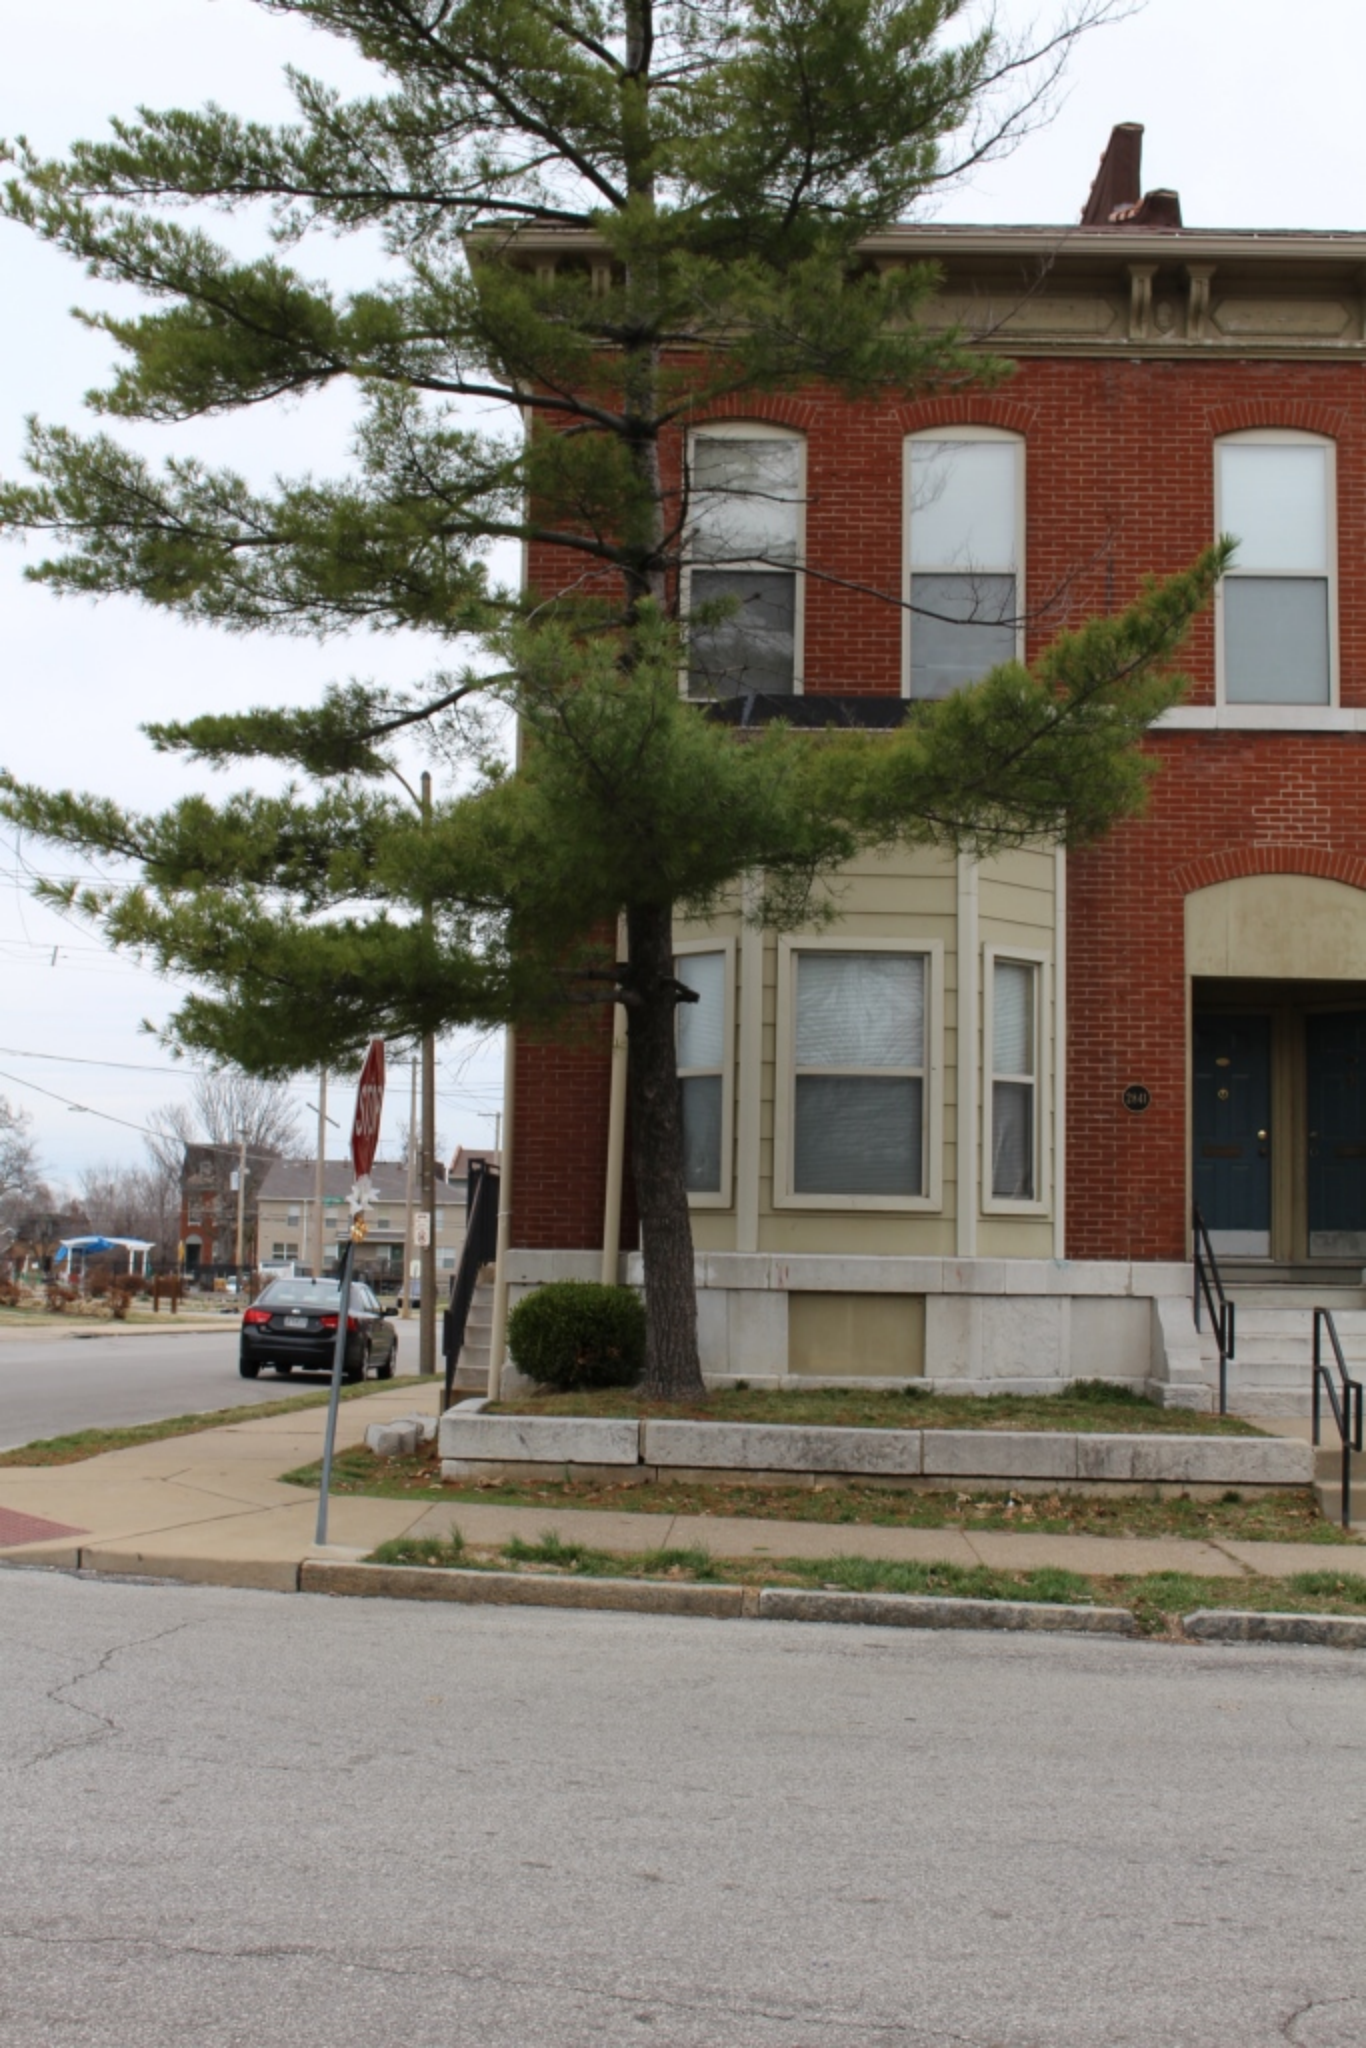
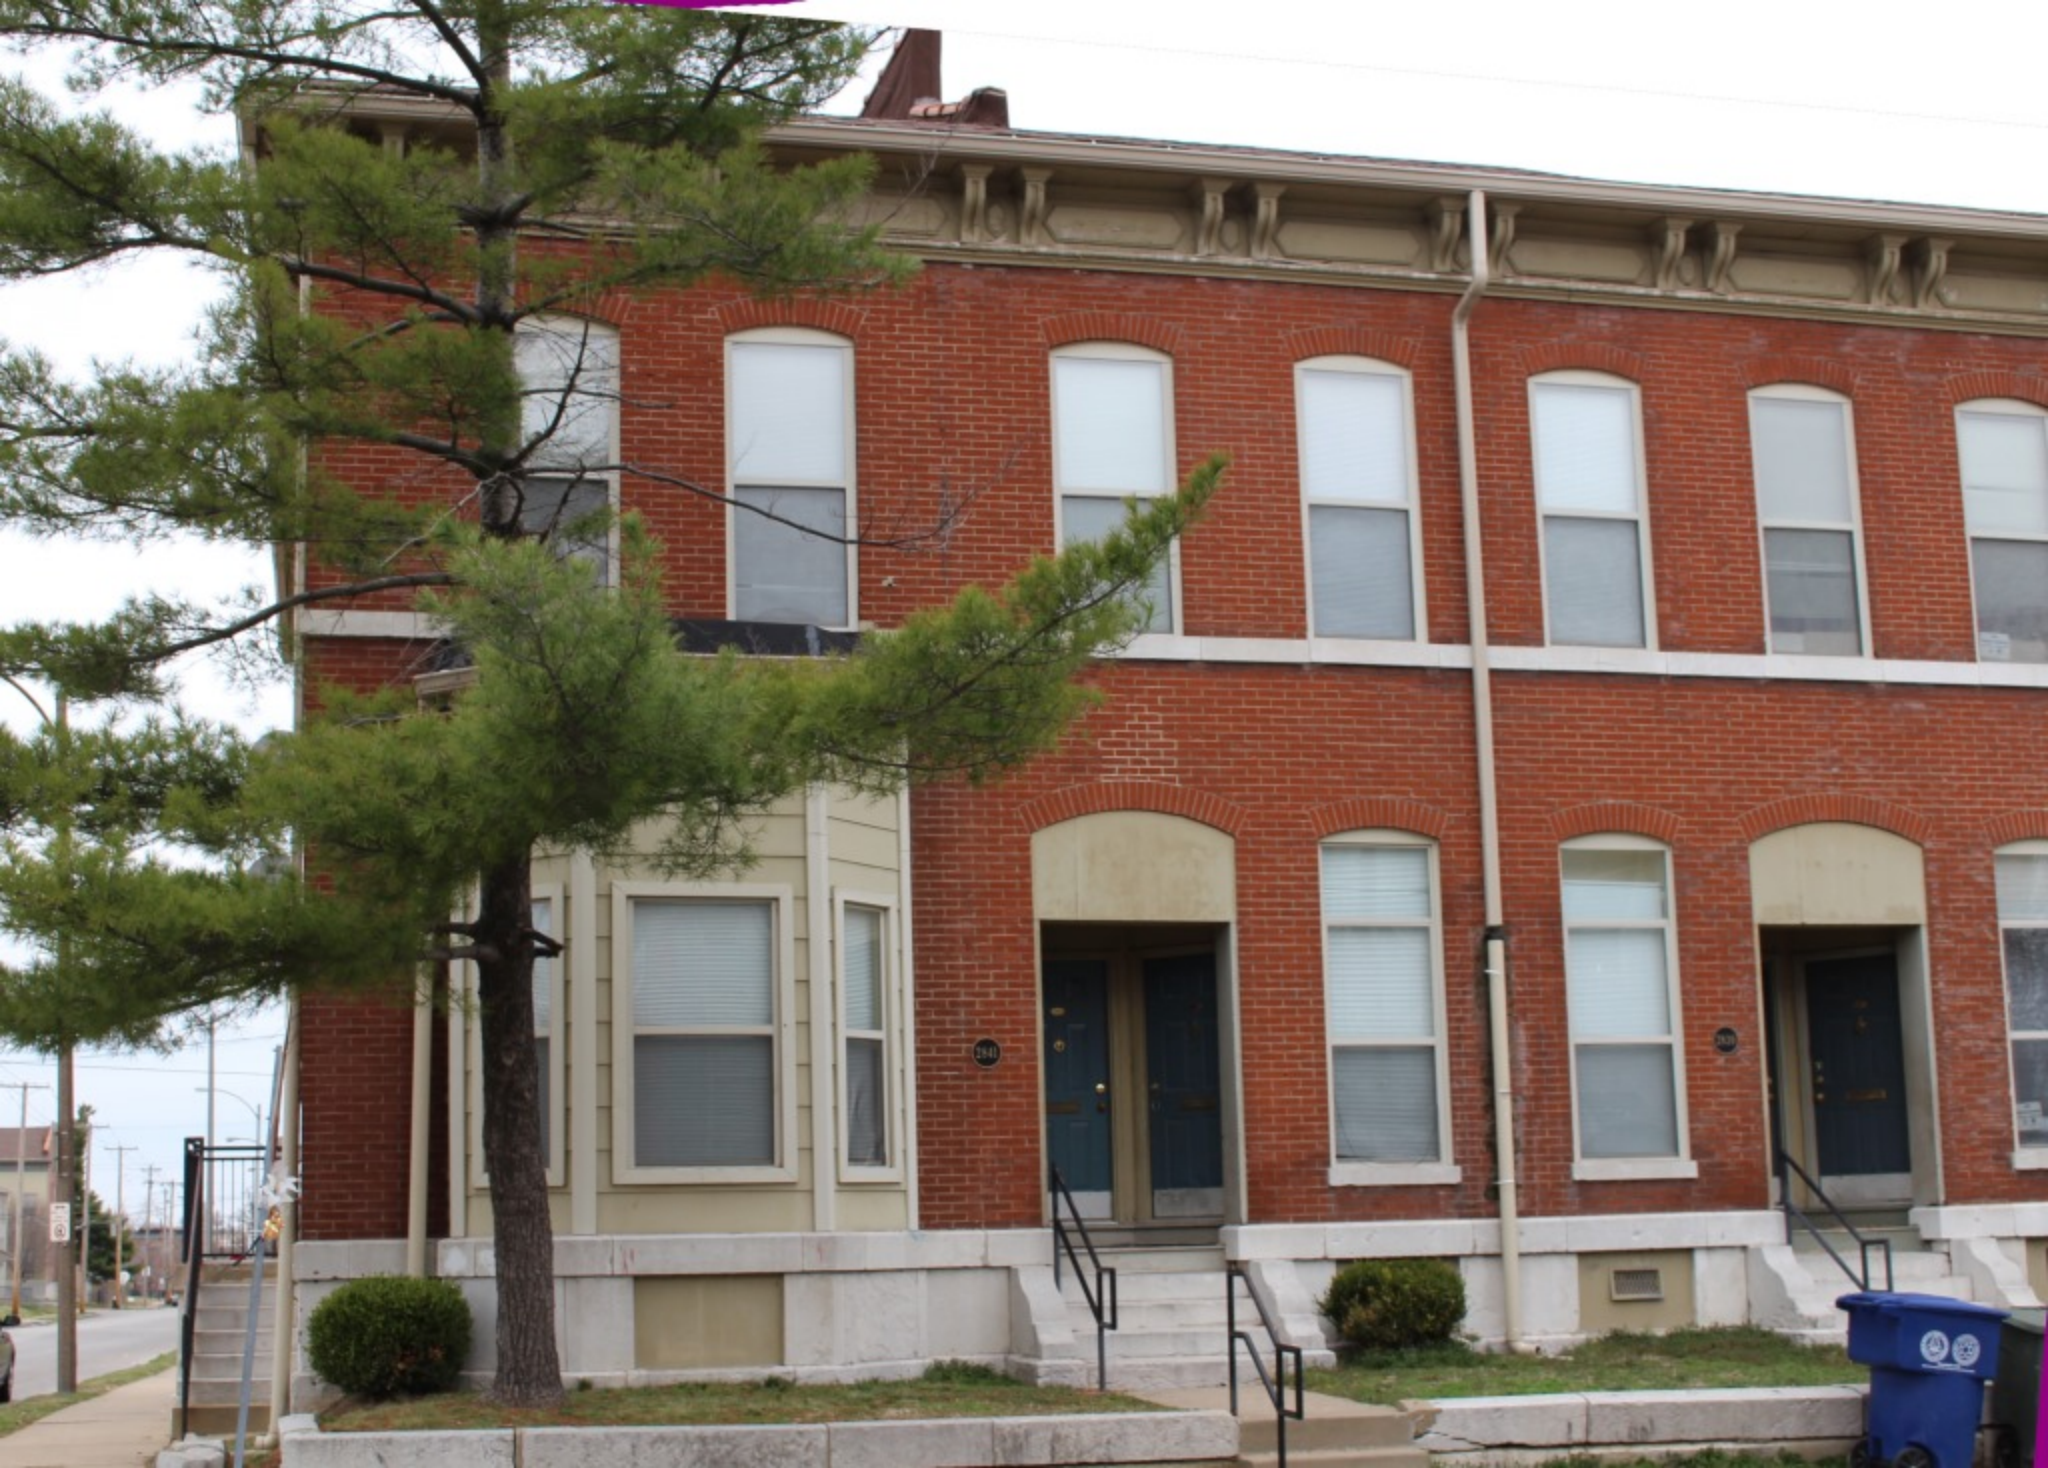
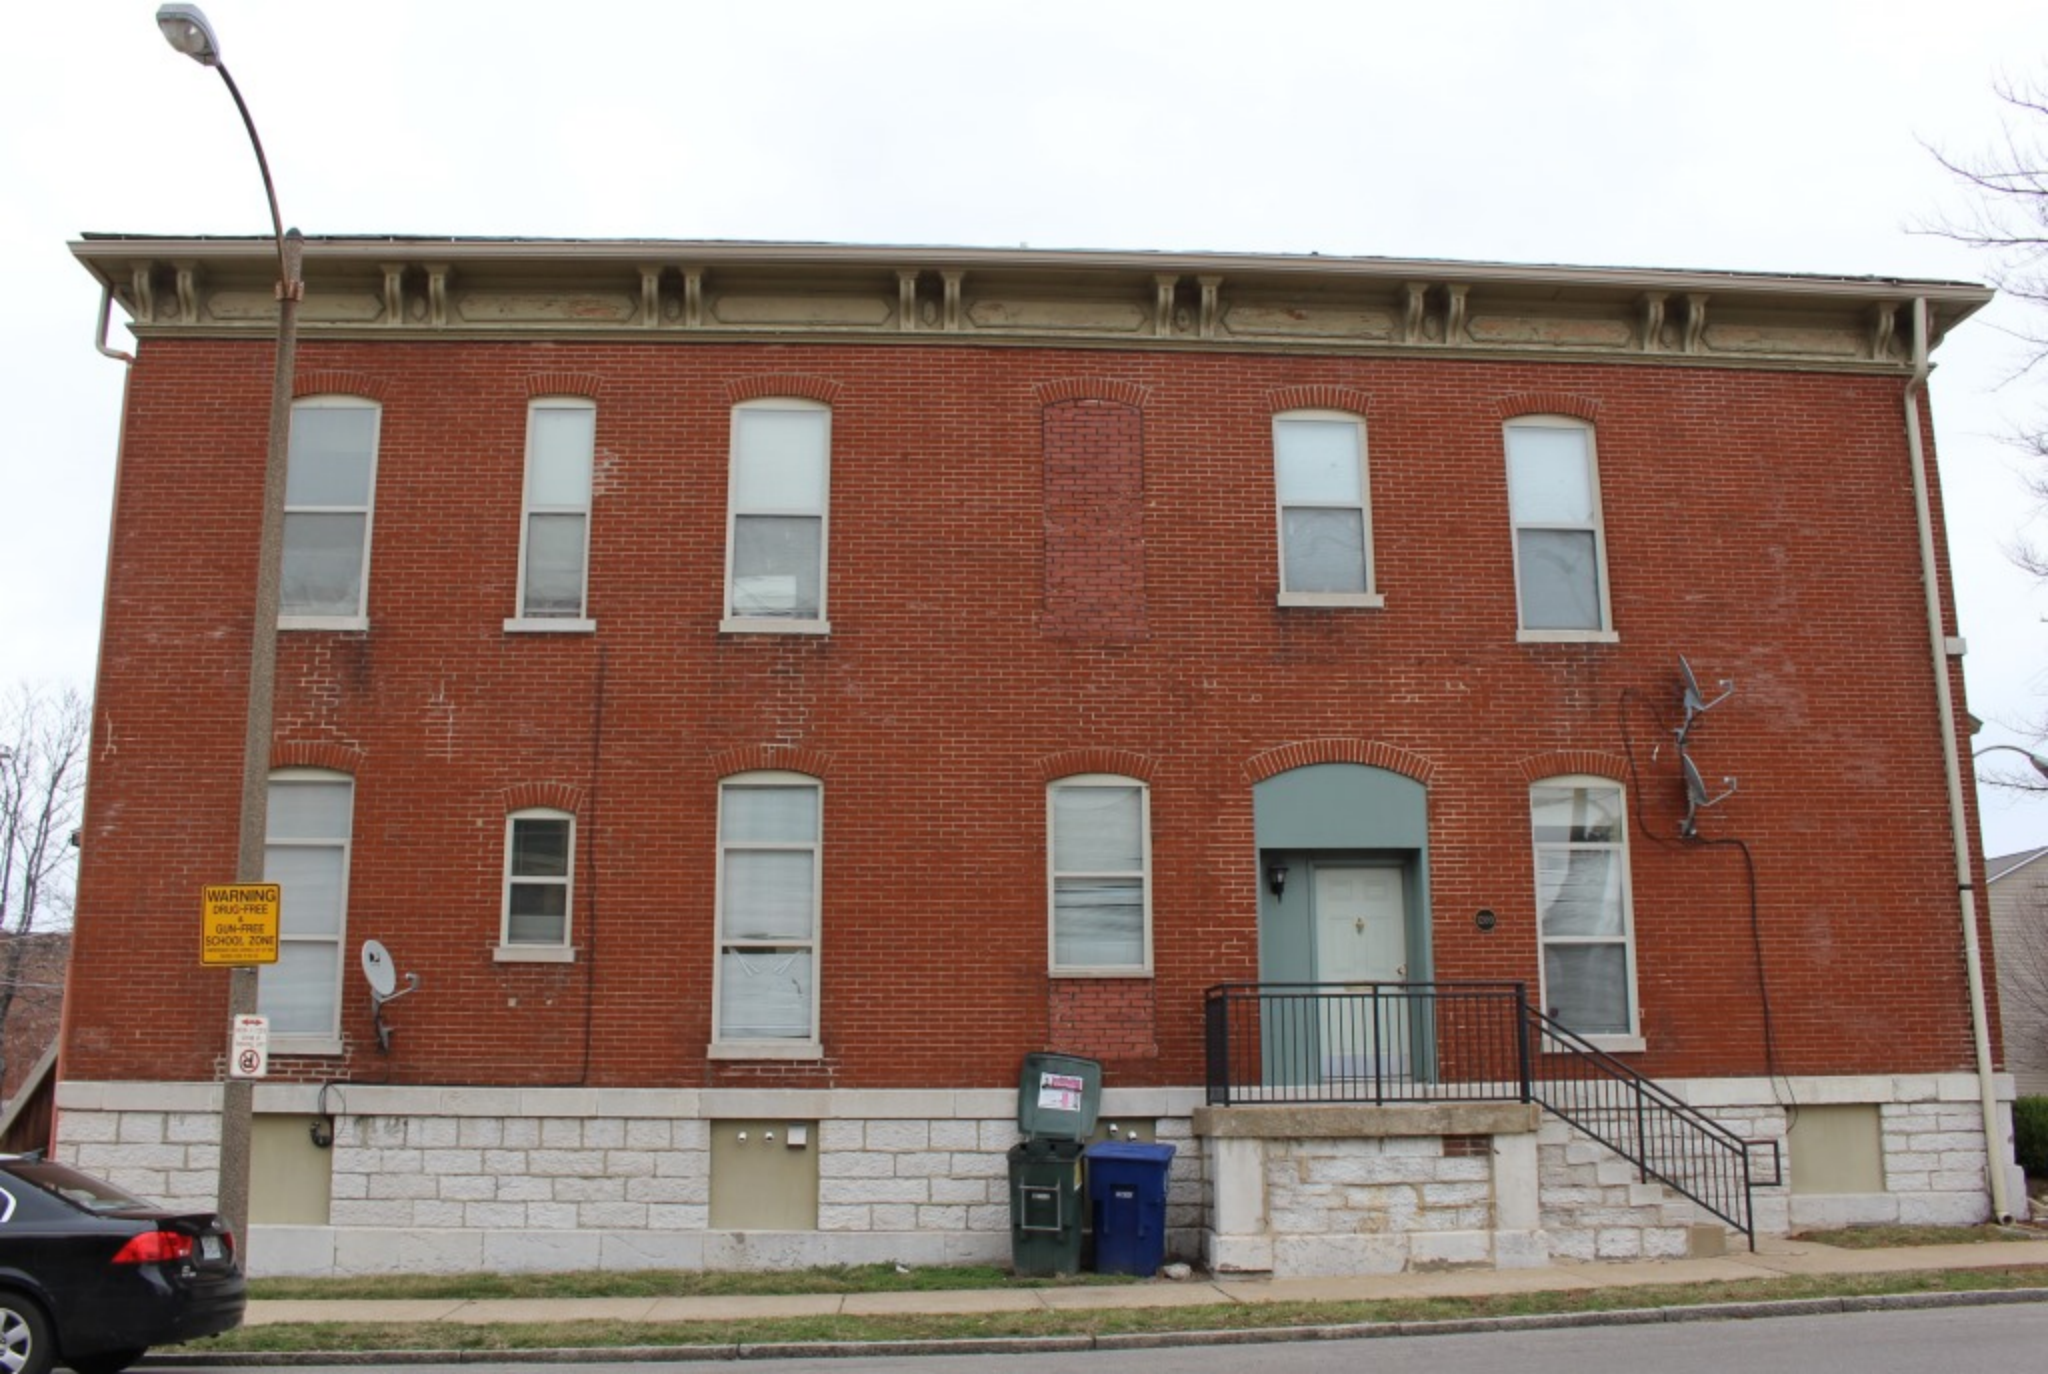
This end unit of a row house has a shed roof with front and rear hipped terminations in contrast to the side-gabled roof over the adjacent units. The two-story brick dwelling has an address on Gamble Street where the front façade presents an original bay window at the first story (resided with inappropriate wide-lap siding). Both the 2-bay front and 6-bay side façades have the dressed limestone ashlar watertable of the adjacent units as well as the paneled wood cornice with paired brackets. The front foundation is plastered; the side foundation displays coursed ashlar. At the side elevation facing Glasgow Avenue, the primary entrance is recessed below a wide segmentally-arched opening partly blocked down, and is a replacement door placed within infill material. All windows have segmentally-arched openings with soldier heads filled with replacement 1/1 double-hung sash, except for three exceptionally tall first-story openings at the side elevation, which have been filled with a fixed window below the doublehung unit and the second-story window of the center bay, which has been bricked in. The sill of the first story window below has been raised, and basement windows on this façade have been blocked. The one-bay rear (north) façade has a singleleaf entry at the first story, with a wood stair of contemporary construction, and a single window above that has been blocked down.

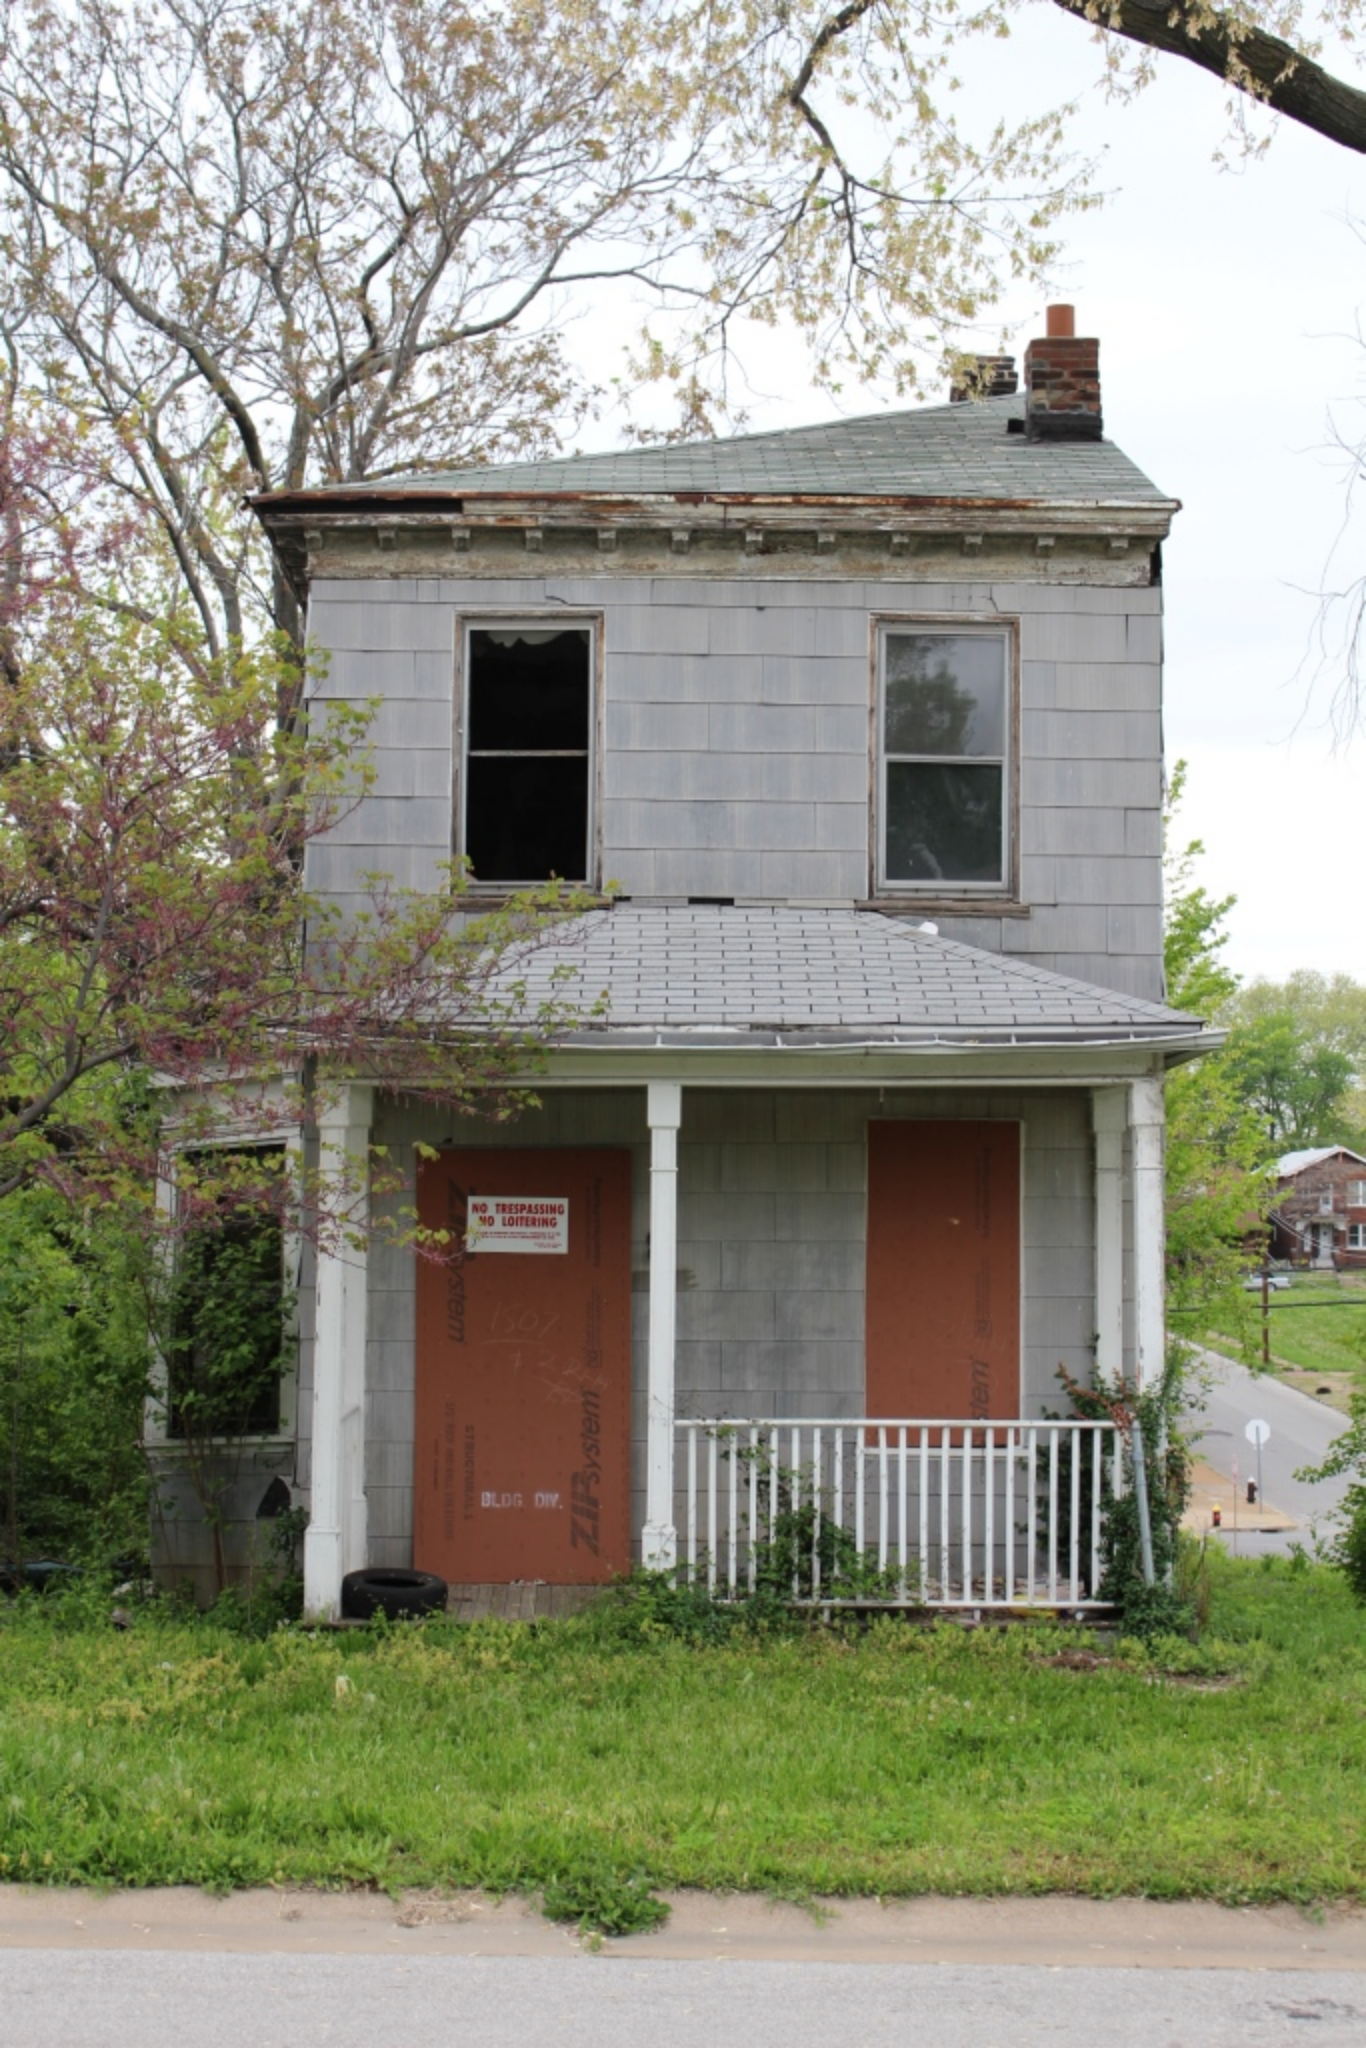
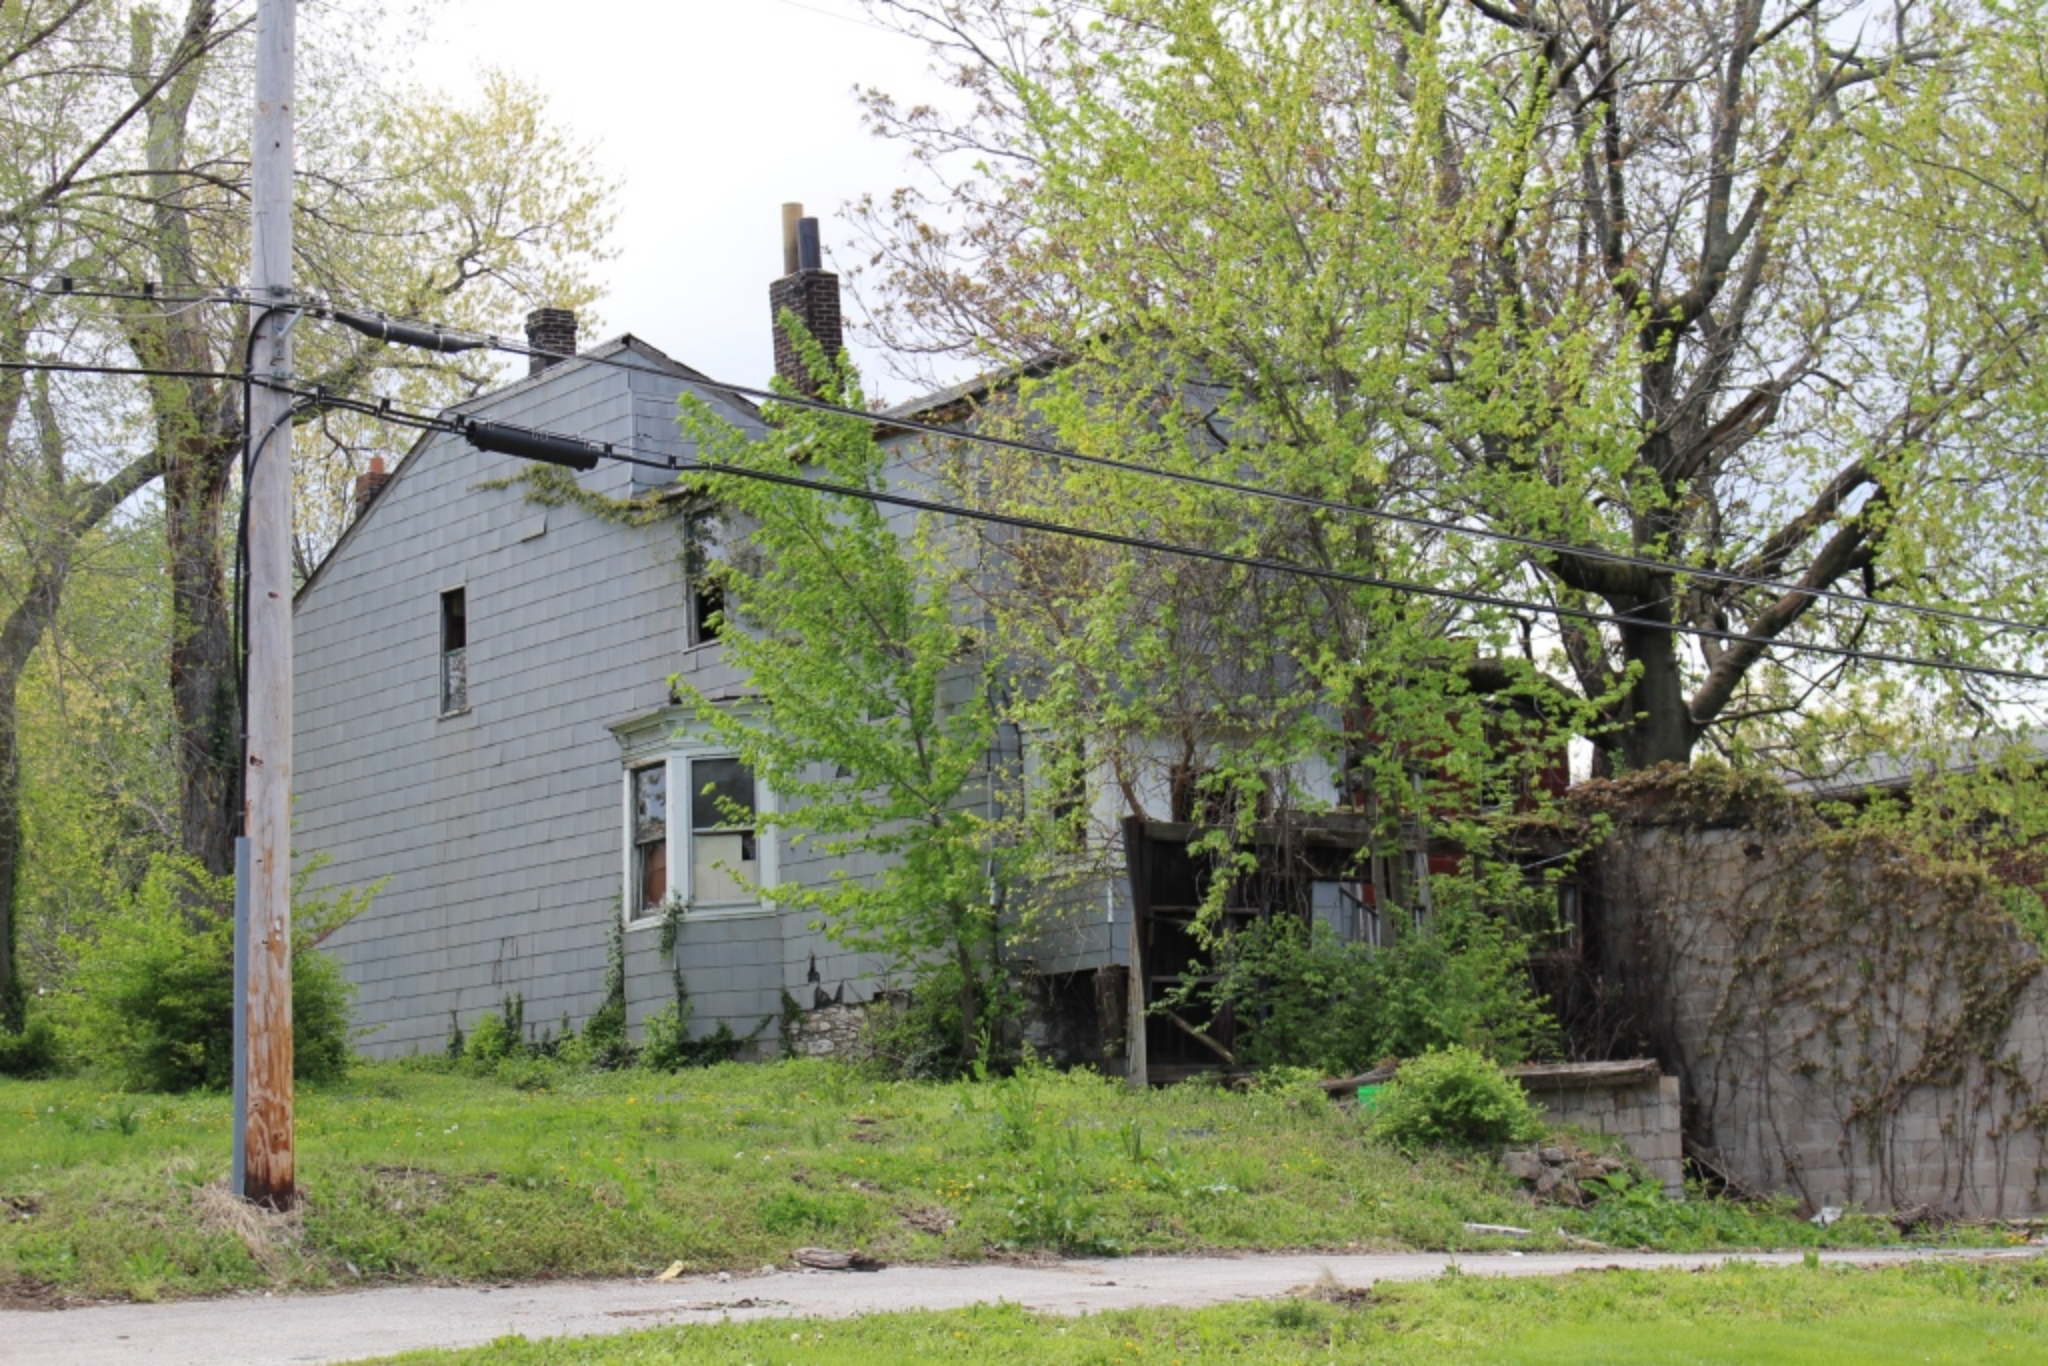
This two-story wood-framed flounder is a variant type of flounder. Its taller wall, on the east, has one window at the second story. A second window at that level and a projecting angled-bay window are in the rear wing with a gabled roof. There is a second angled bay window at the front of the west side of the building; both bays appear on the 1909 Sanborn map. The porch across the façade has a hipped roof supported by wood posts; the railing and the posts are replacements. Some of the openings are boarded; the sash that remains is one-over-one double-hung wood sash. The asbestos shingles conceal the foundation of the front wing.

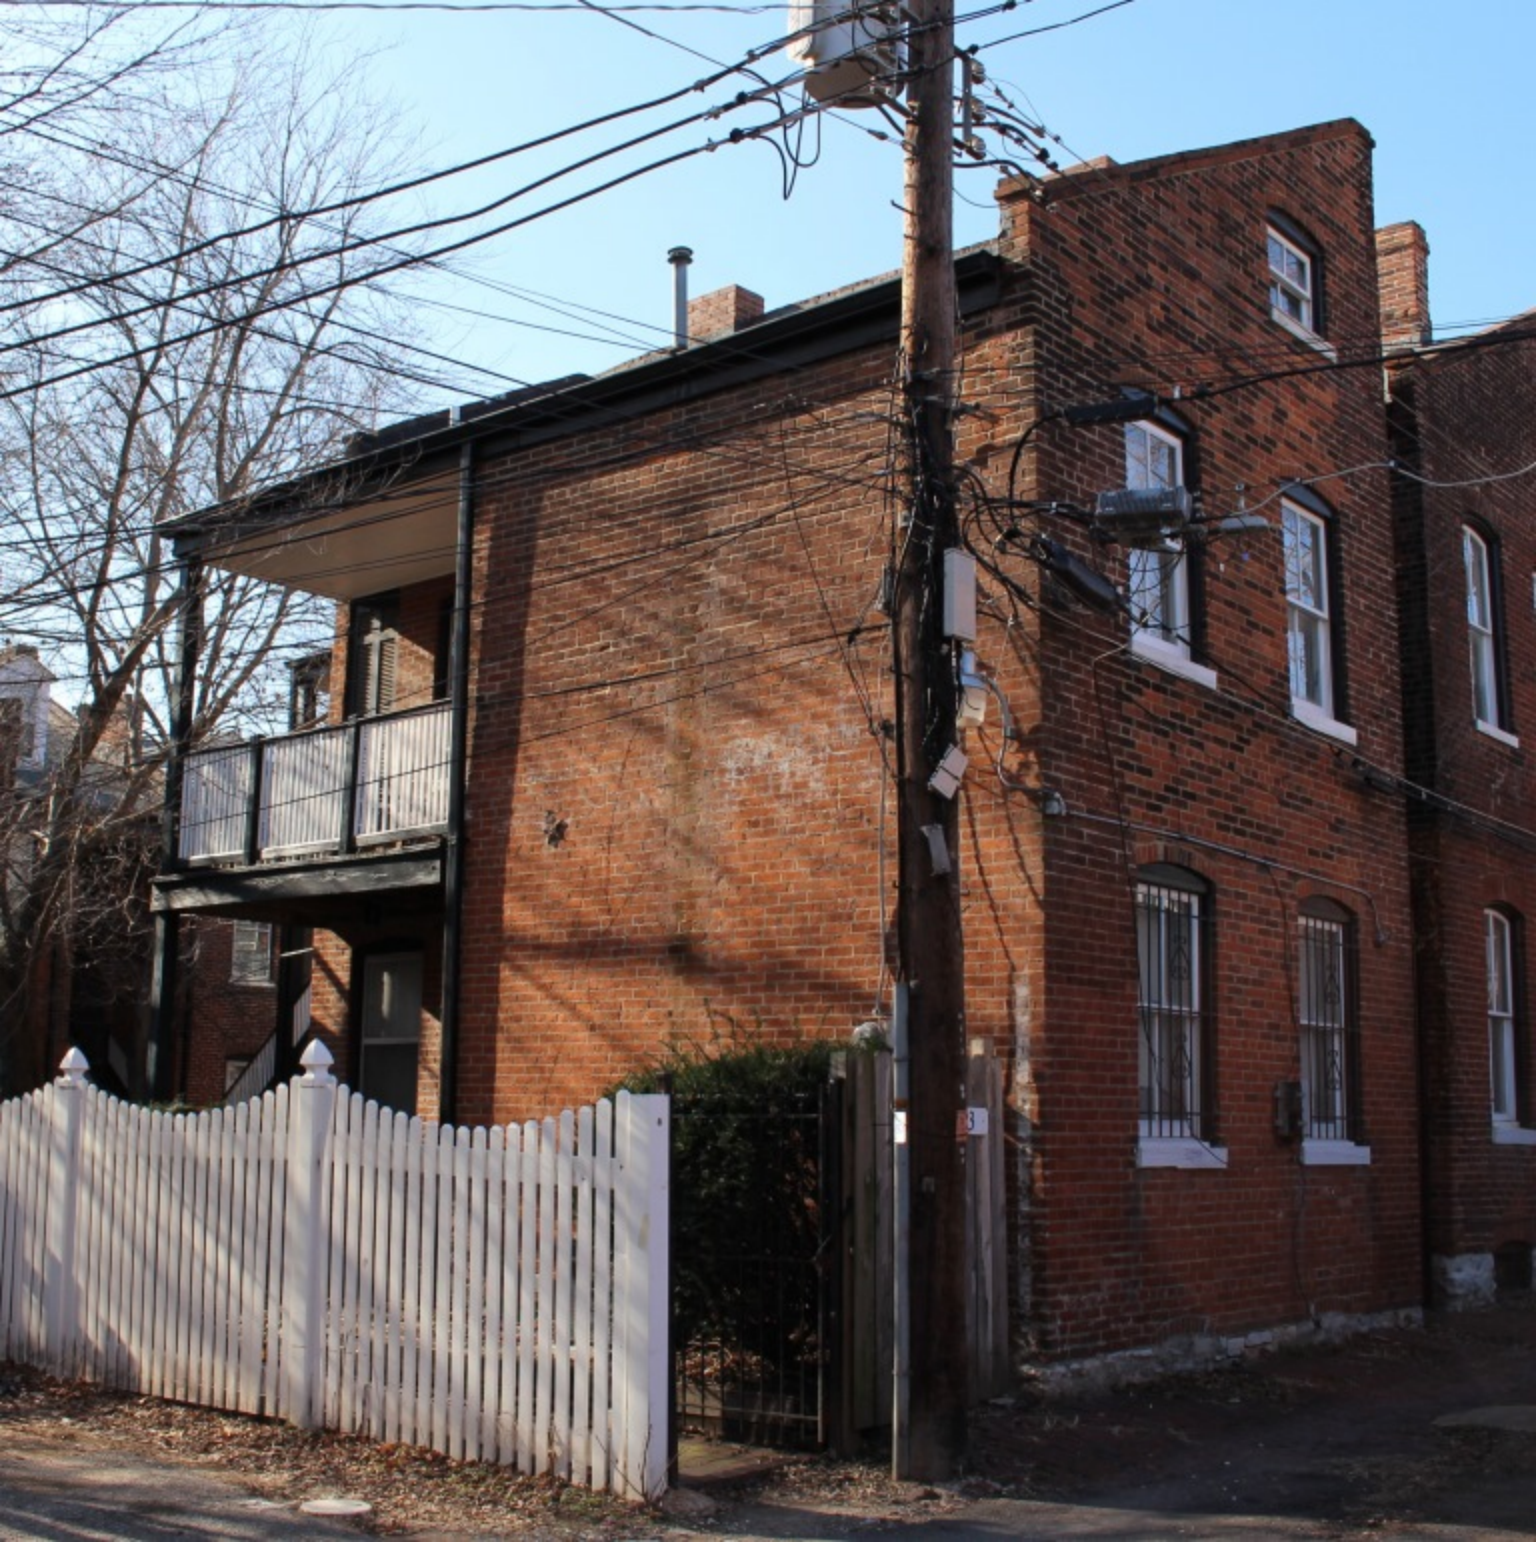
This 2 1/2 story brick alley house flounder is plainer than the flounder at the front of the lot. With only a shed roof, there is no corbelled cornice at the edge of horizontal end eaves. A wood fascia board edges the flat eaves of the east side. The alley façade is two bays with a smaller window in the attic level. The window openings are segmentally arched with header brick and have sills of stone; they all have replacement 2/2 doublehung wood sash. The inset gallery at the southeast corner has a second-story porch and wood steps lead to a projecting wood second-story porch facing Geyer.

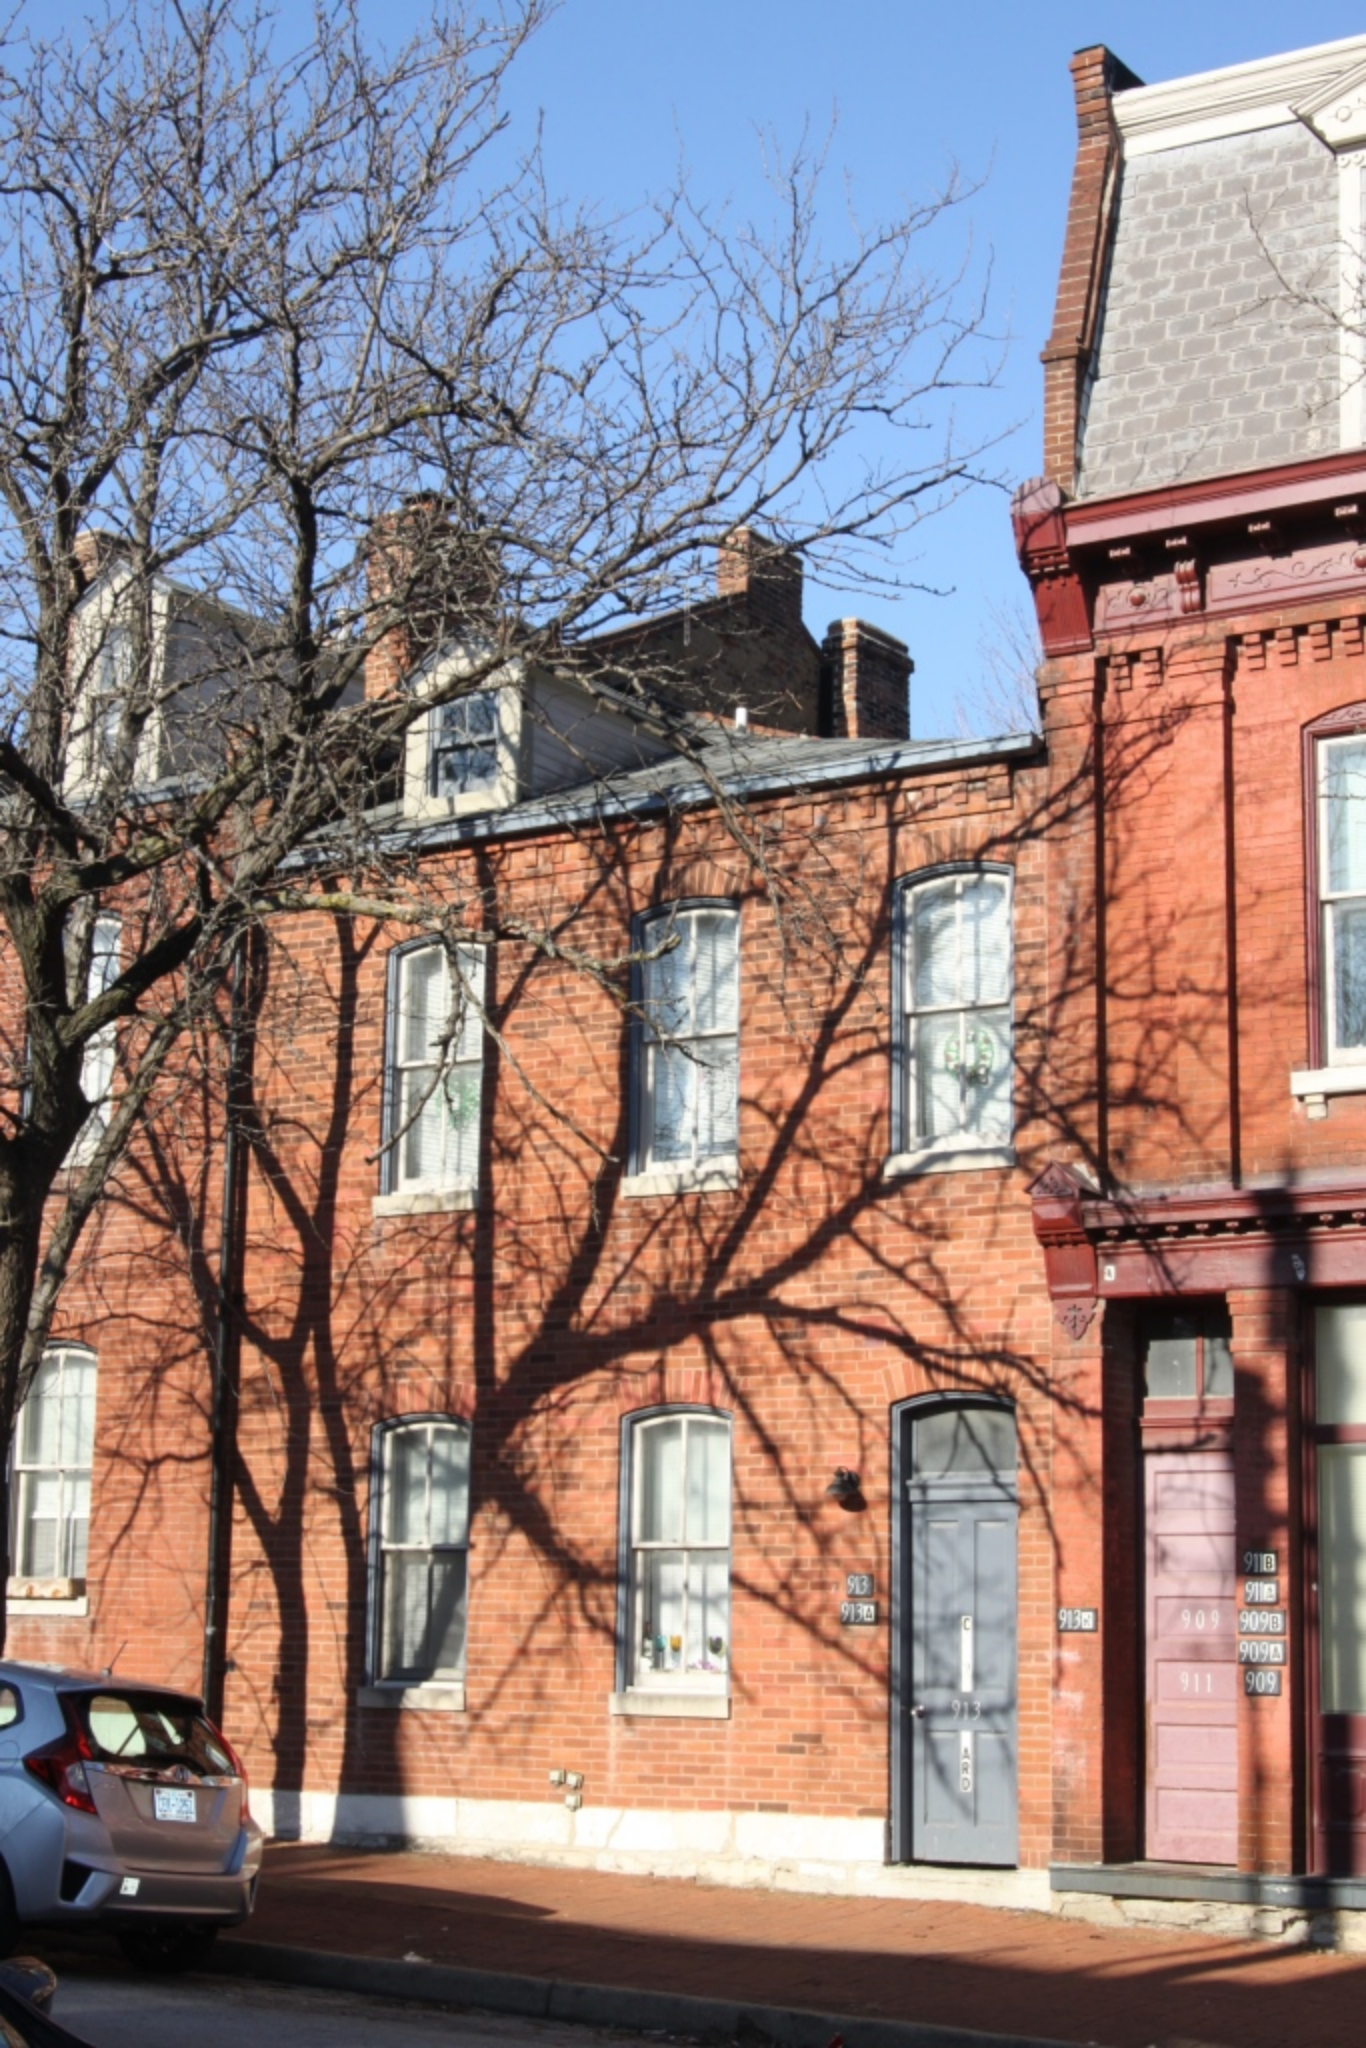
This 2-story brick flounder with hipped front roof presents three bays to the street. The entrance, in the east bay, was historically into a passageway that led to the rear yard and also the entrance into the building. The door, and all window, openings have segmentally-arched heads of soldier brick and the windows have stone sills. The sash is replacement arched head, 2/2 doublehung wood. A denticulated cornice edges the façade eaves. A small dormer above the west bay is filled with 2/2 wood sash. There is a shorter rear wing.
