**ARCHITECTURAL/HISTORIC INVENTORY FORM - Cultural Resources Office**  
**St. Louis Planning and Urban Design**

1. Survey no. SLC-AS-053-0001	2. Survey name: Thematic Survey of Flounder Houses in St. Louis City	3. County: St. Louis [Independent City]
4. Address: (from City GEO database) <b>1812 S 8TH ST</b>		5. City/State: St. Louis, Missouri
Alternate address: 1812 S 8th		Property Zip Code: 63104
Latitude: 38.608949		6. UTM Easting: 743586.48
Longitude: -90.202538		UTM Northing: 4277095.00
8. Historic Name (if known): N/A	11a. Historic Use (if known): Domestic	City Block: 372 City Ward: 7
9. Present/other name (if known):	7. Township-Range-Section: N/A	10. Ownership: Private
11b. Current Use: Domestic		Neighborhood Number: 21

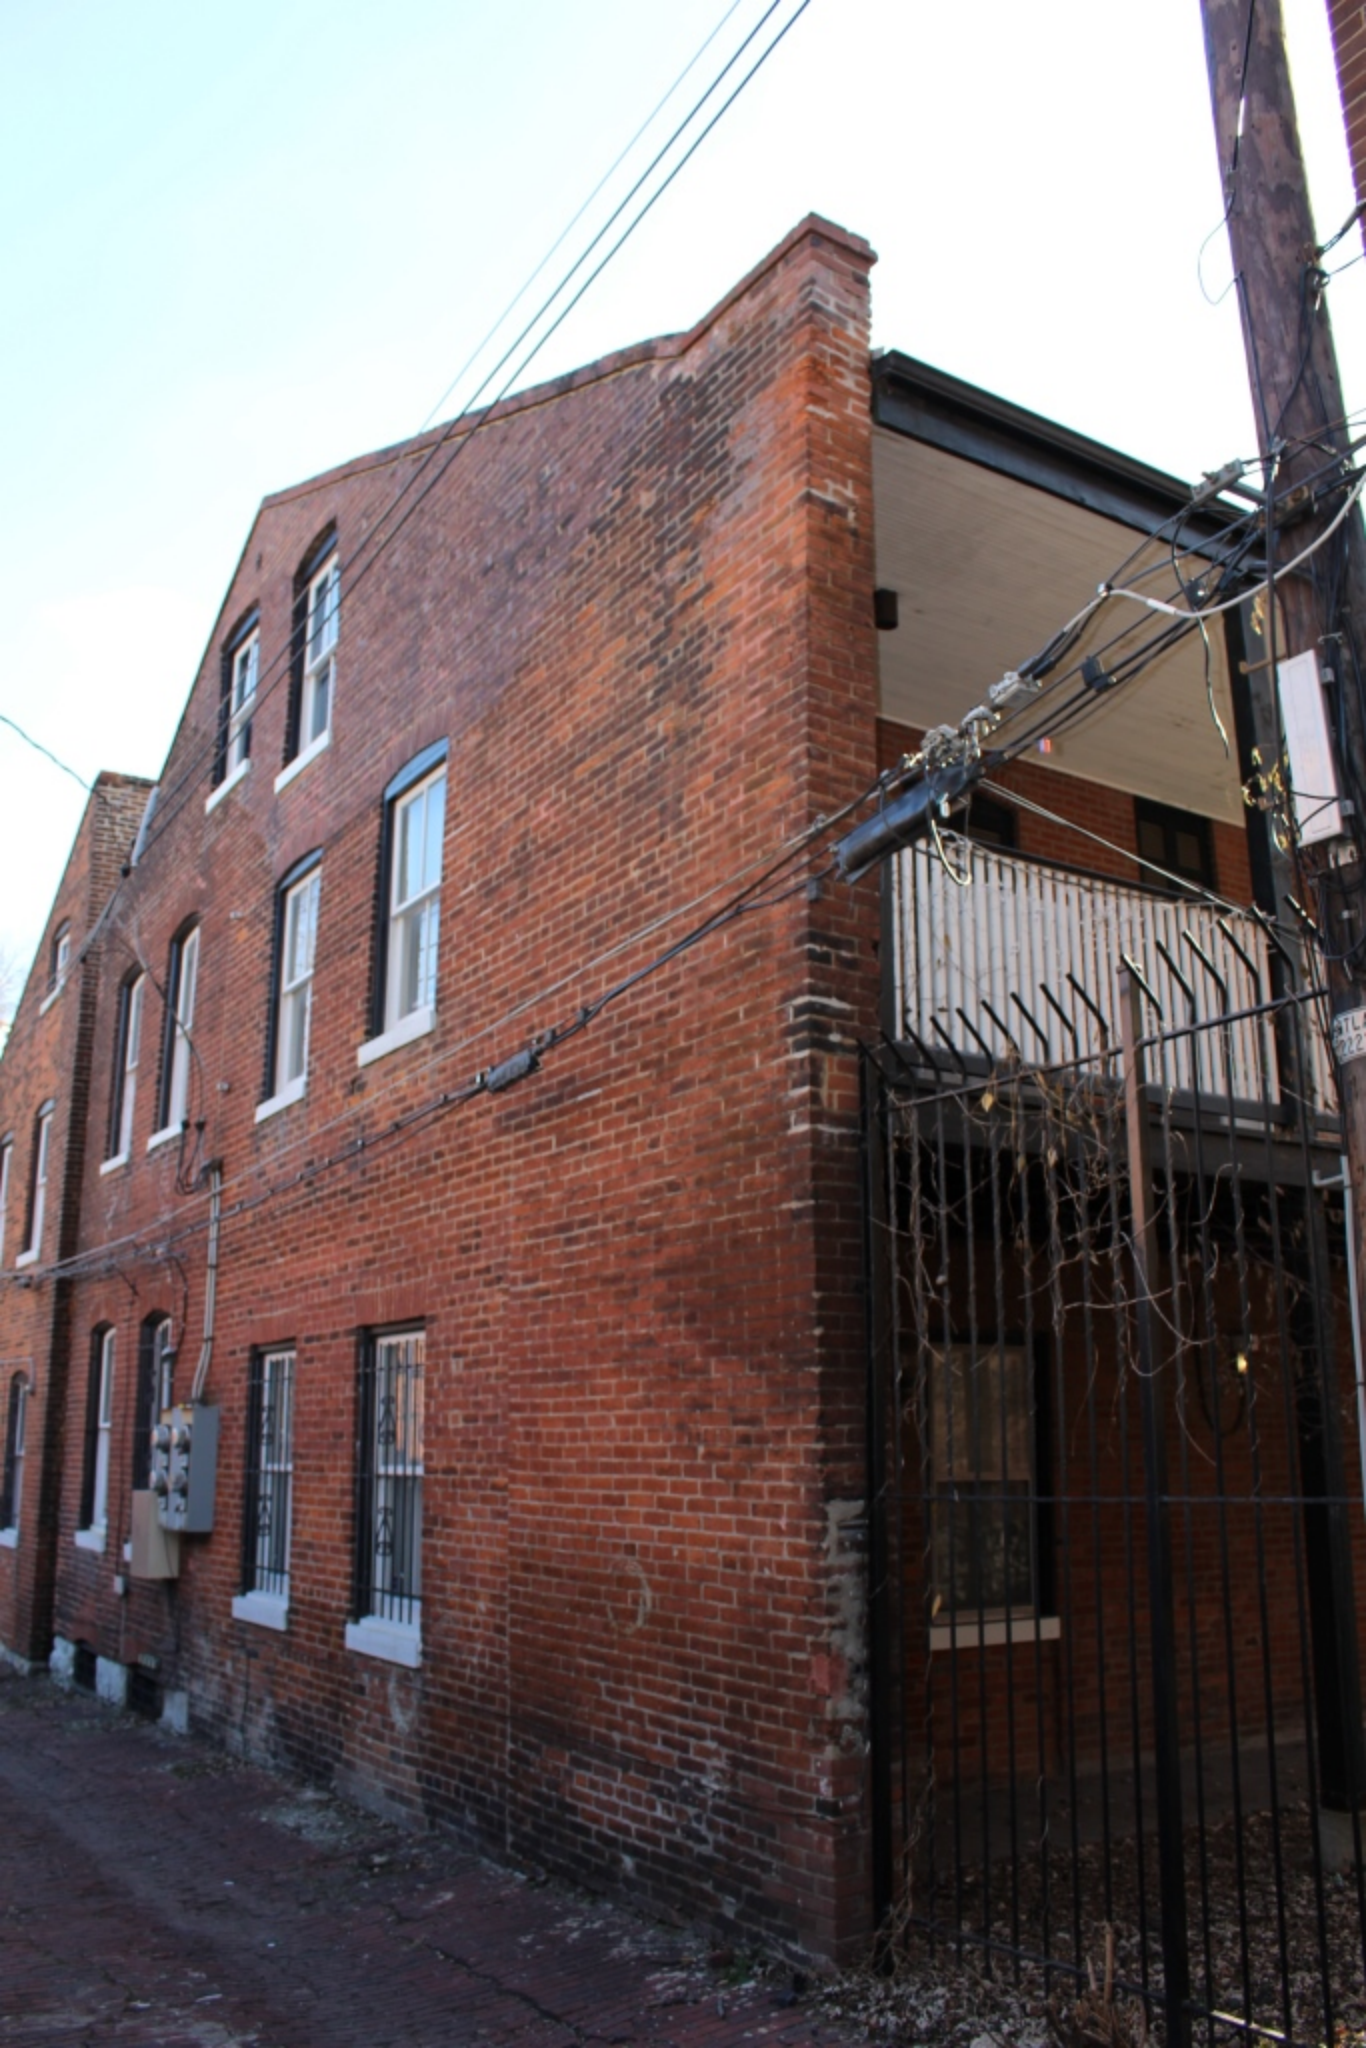
This 2 1/2-story brick flounder is positioned at the alley and has a side entrance through the gallery on the east side. The steeply-pitched shed roof flattens over the gallery as a brick wing wall. The window openings are different on each story. Those in the ground story are flat-arched with a soldier course. The openings in the second story have segmentally-arched heads formed of stretcher brick and the same shaped opening in the attic story are formed of header bricks. All have stone or wood sills. There is no stone foundation at the alley and it appears that the ground story of the gallery has been filled in with brick that matches the other brick. The two-story wood gallery is sheltered by the main roof and has stairs projecting into the yard at the south end. A narrower south ell also has a two-story gallery.

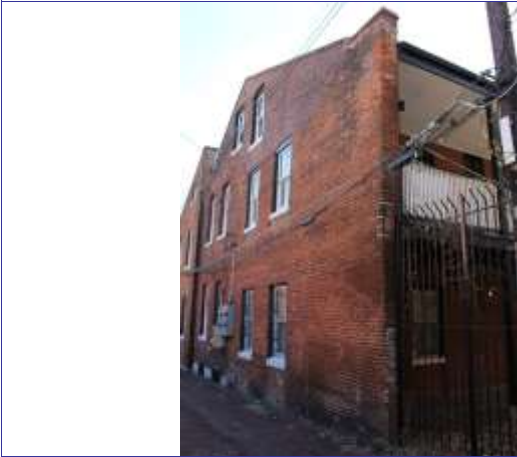
**915-9 GEYER AV**

Building is two semi-detached founders at the alley. The building is in good condition and is well-maintained. Building is difficult to photograph due to the narrow alley.

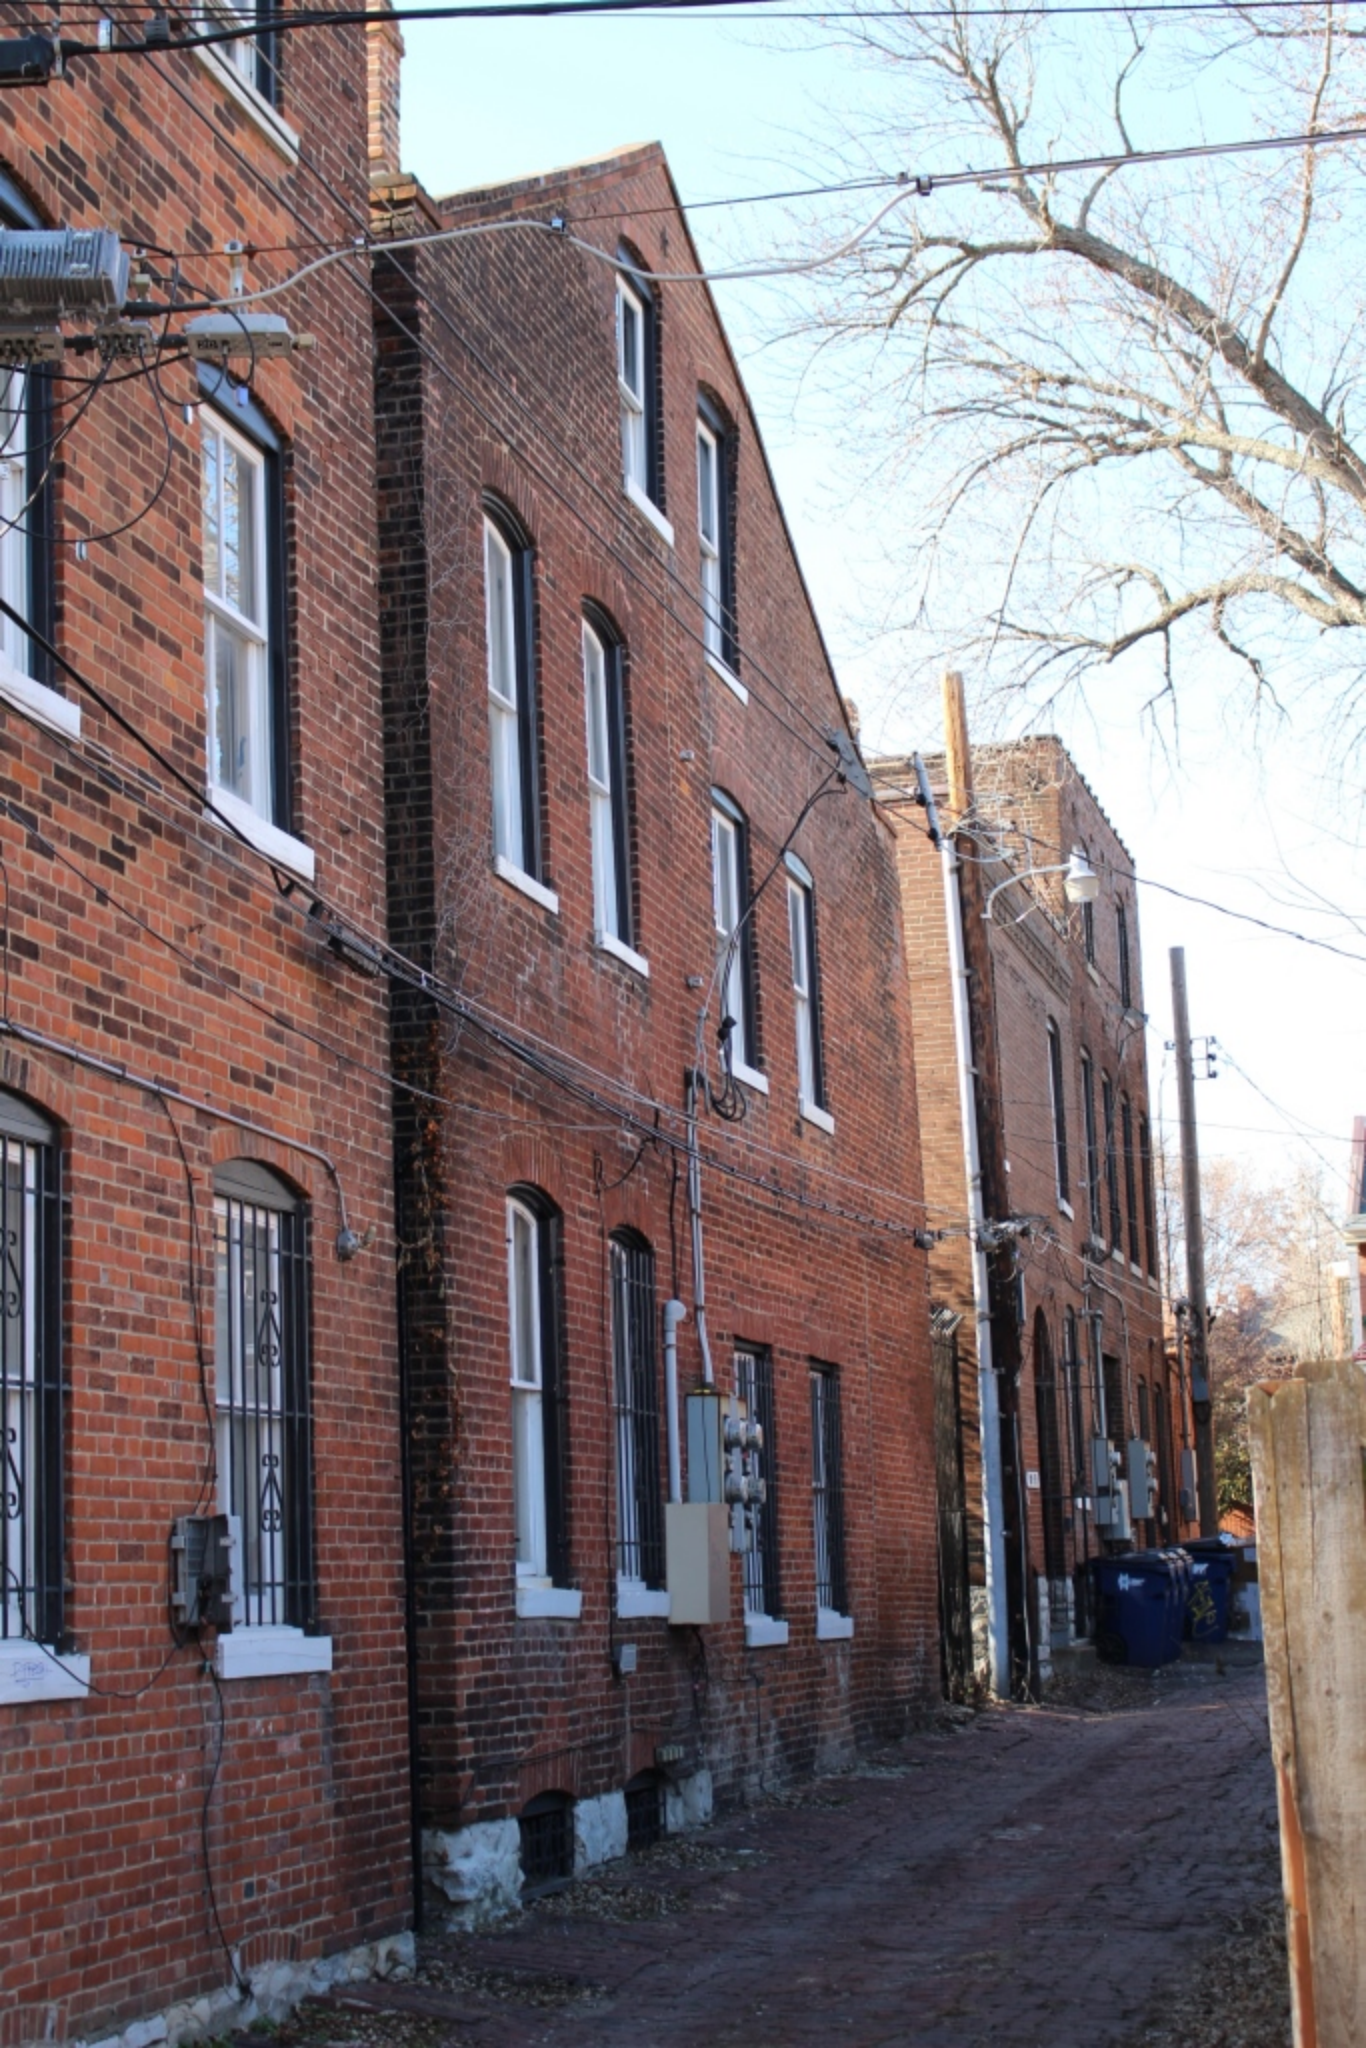
The building consists of two semi-detached brick flounders, both are 2-1/2 stories in height and are topped by brick copings. The flounder furthest east is a classical flounder. This side retains it's segmental arch sash two-over-two windows at the first two stories with soldier course lintels. The attic story window has an eyebrow in place of the arch. The window on the attic and 2nd story of the western flounder mimic the window at the eastern attic level although the western attic window is larger and the windows to not line up horizontally with those on the eastern flounder. The first story windows on this flounder have soldier course jack arch lintels and two-over-two sashes. All of the windows on the building have painted stone sills. A painted rubblestone foundation is evident on the eastern flounder with two small two-light awning windows behind decorative grates. The windows have segmental arch soldier brick lintels. The brick on the western flounder goes down to the alley level and there are no basement windows. The western flounder has a wing wall with no openings. Behind the wing wall is a two-story gallery porch. The flounder roof extends over this gallery porch.

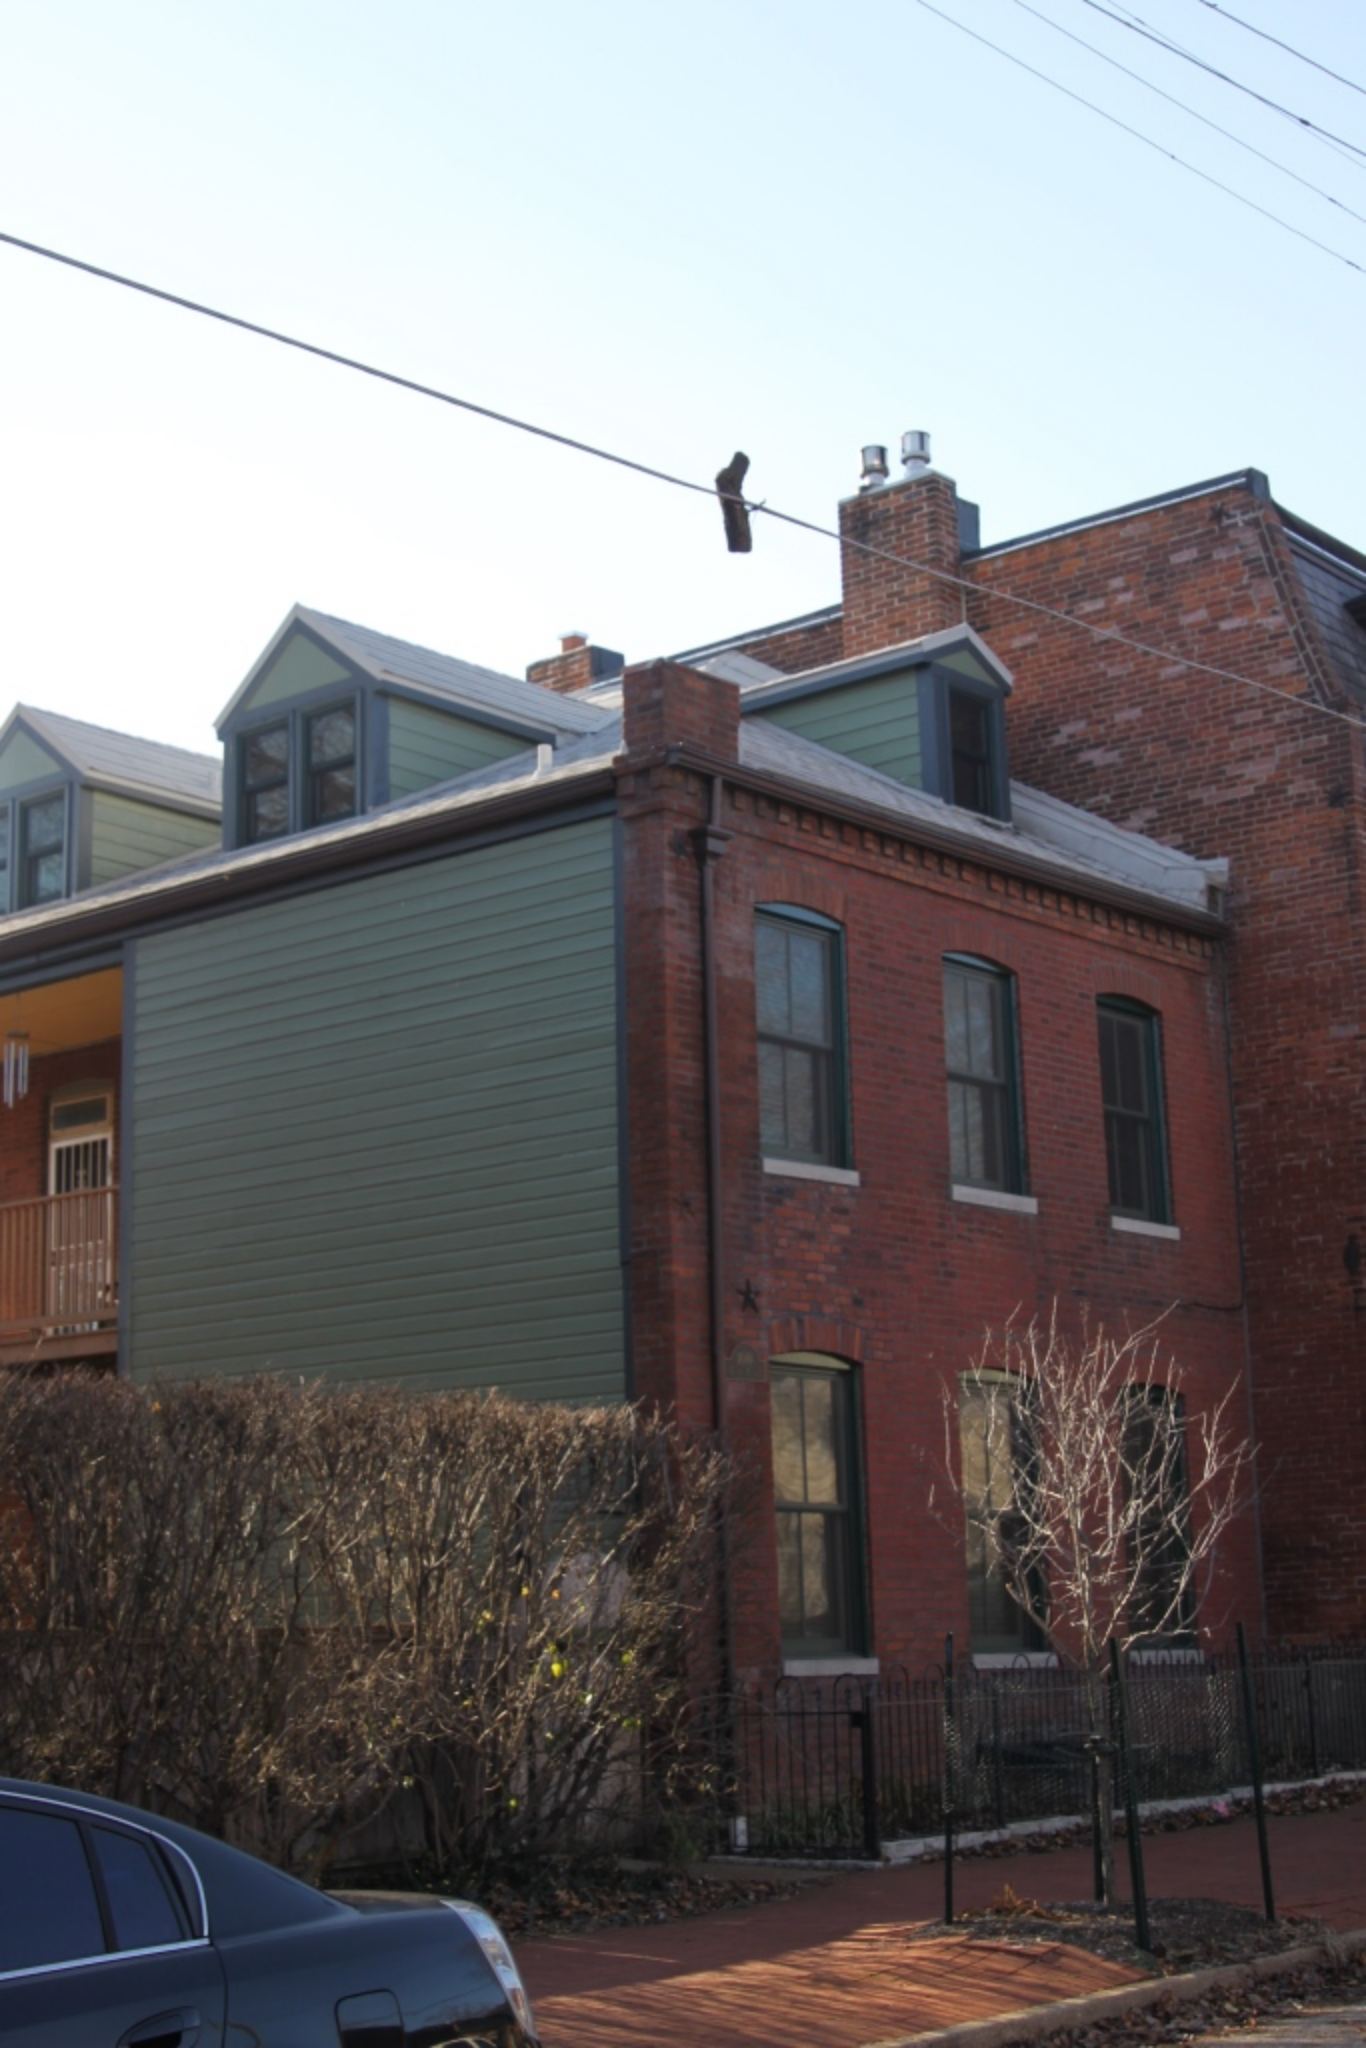
This 2 1/2-story brick flounder has a wood gallery with a brick wing wall along the east side. The three bays of the façade have window openings with segmentally-arched heads of soldier brick and stone sills; the dormer is above the west bay. The windows have replacement 2/2 doublehung wood sash. A denticulated brick cornice edges the façade eaves. Two larger dormers, additions, project from the east slope of the roof. ....siding encloses the front portion of the side gallery. The two-story open gallery along the rear portin of the building has a replacement balustrade. A door at the second story gives access to the gallery.

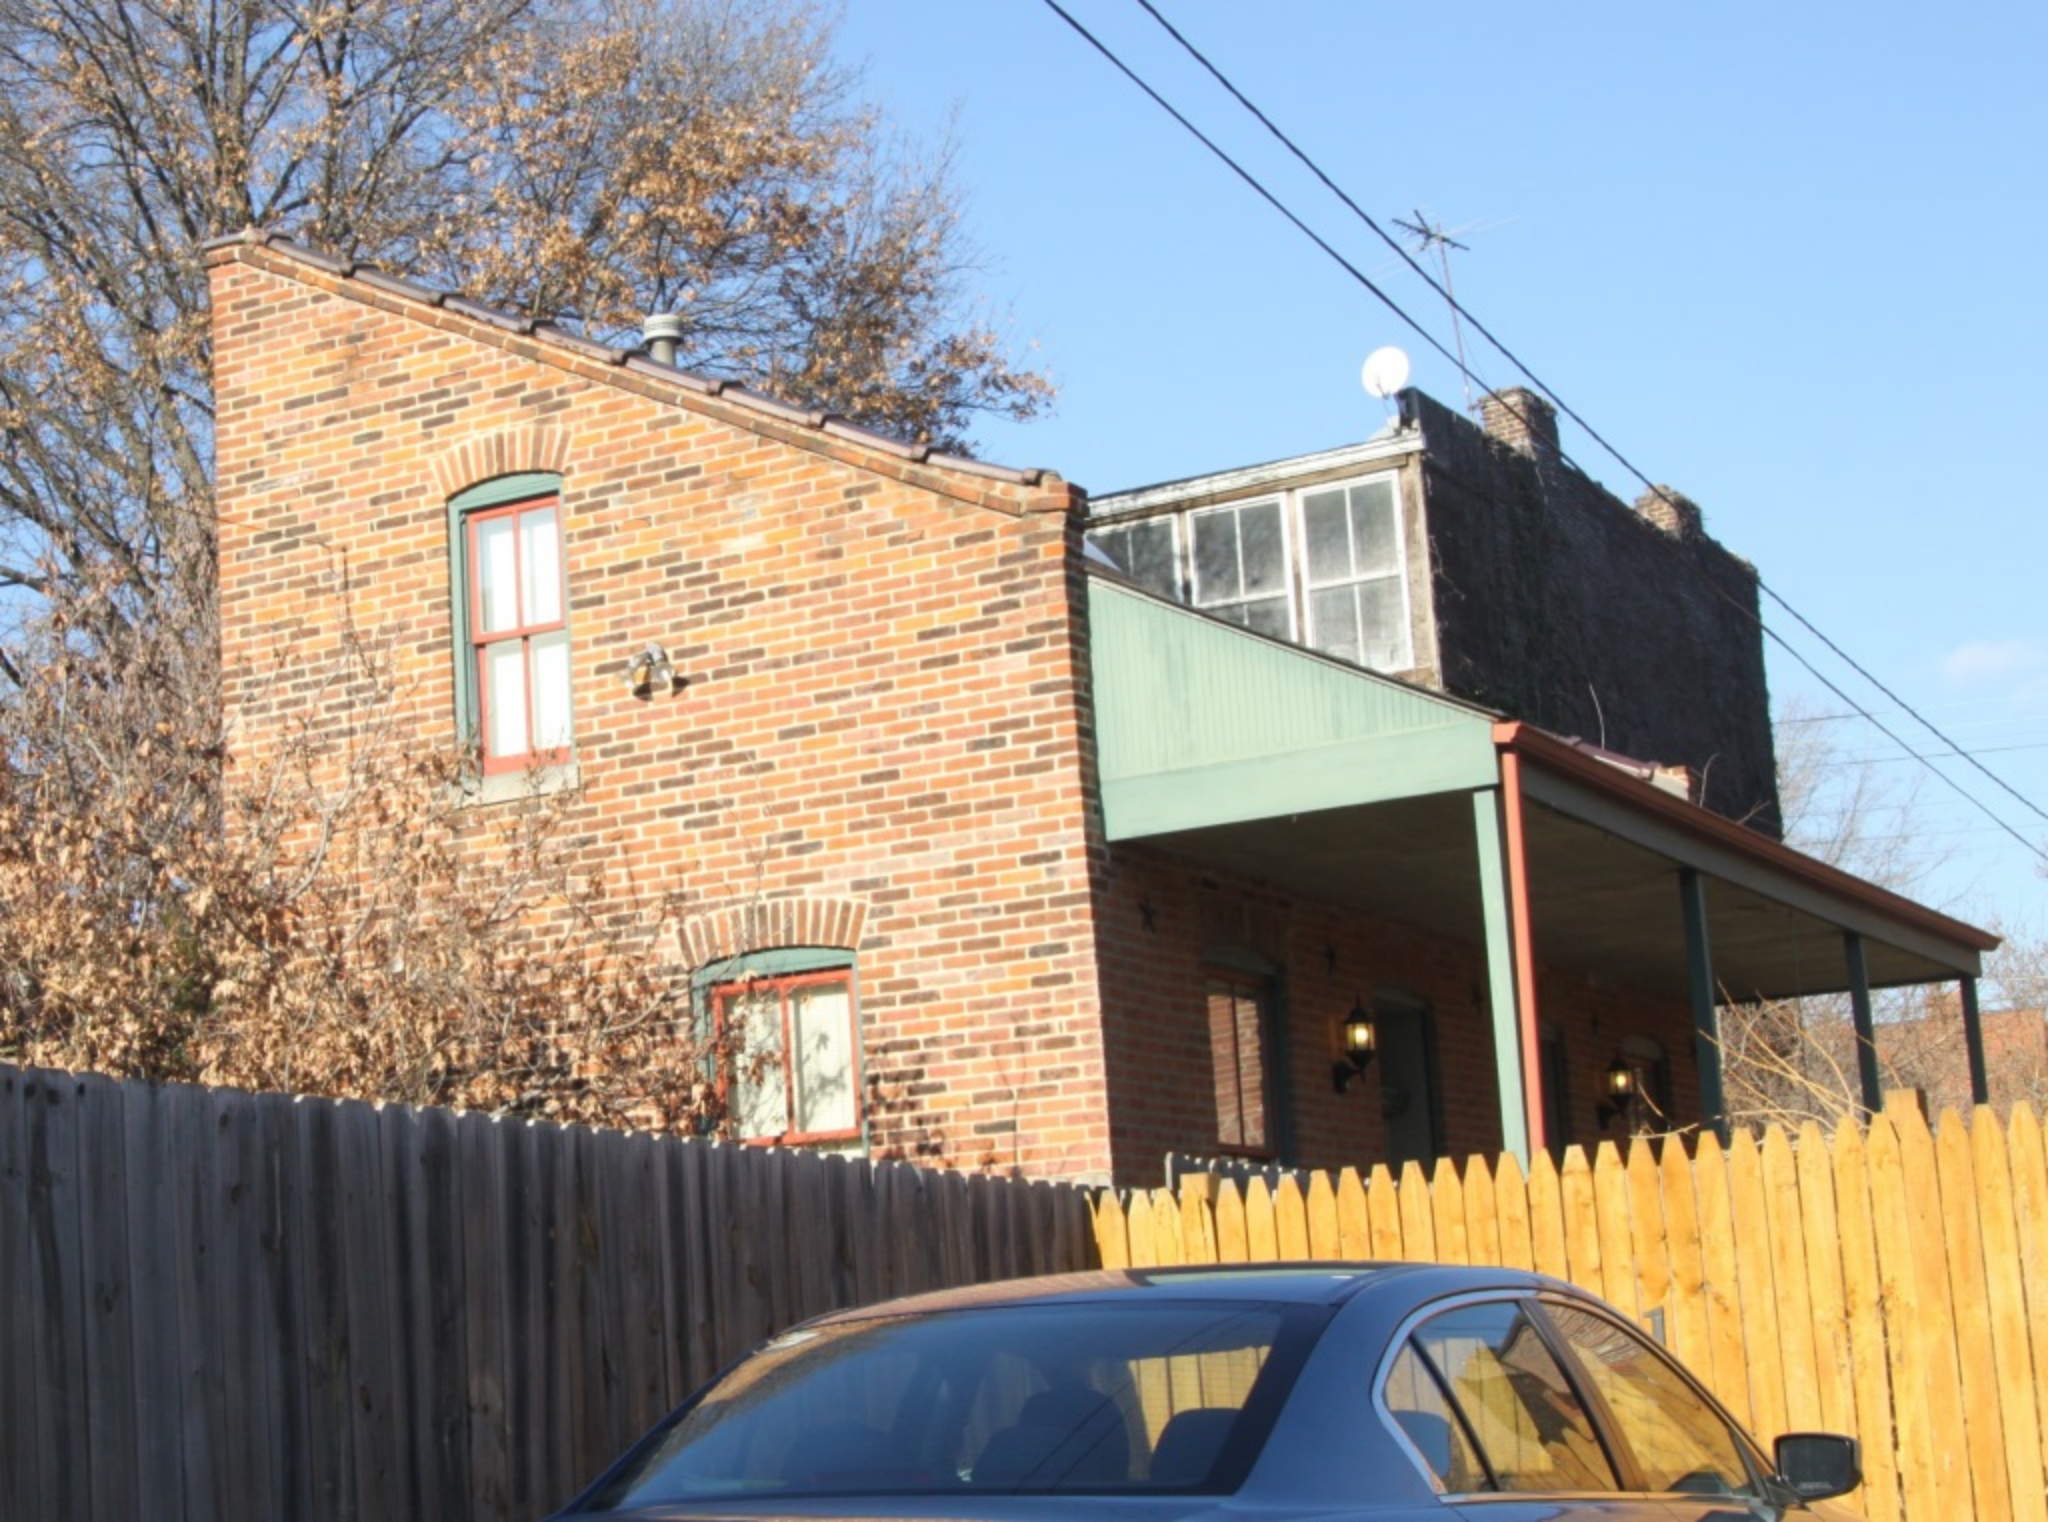
A steeply-pitched shed roof on this 1 1/2 story brick flounder provides for a tall attic space and room for large attic windows. The window openings have segmentally-arched heads of soldier brick and stone sills. A shed-roofed gallery extends along the east side wall where there are entrances and windows, one of which has slider sash. Square posts support the roof.

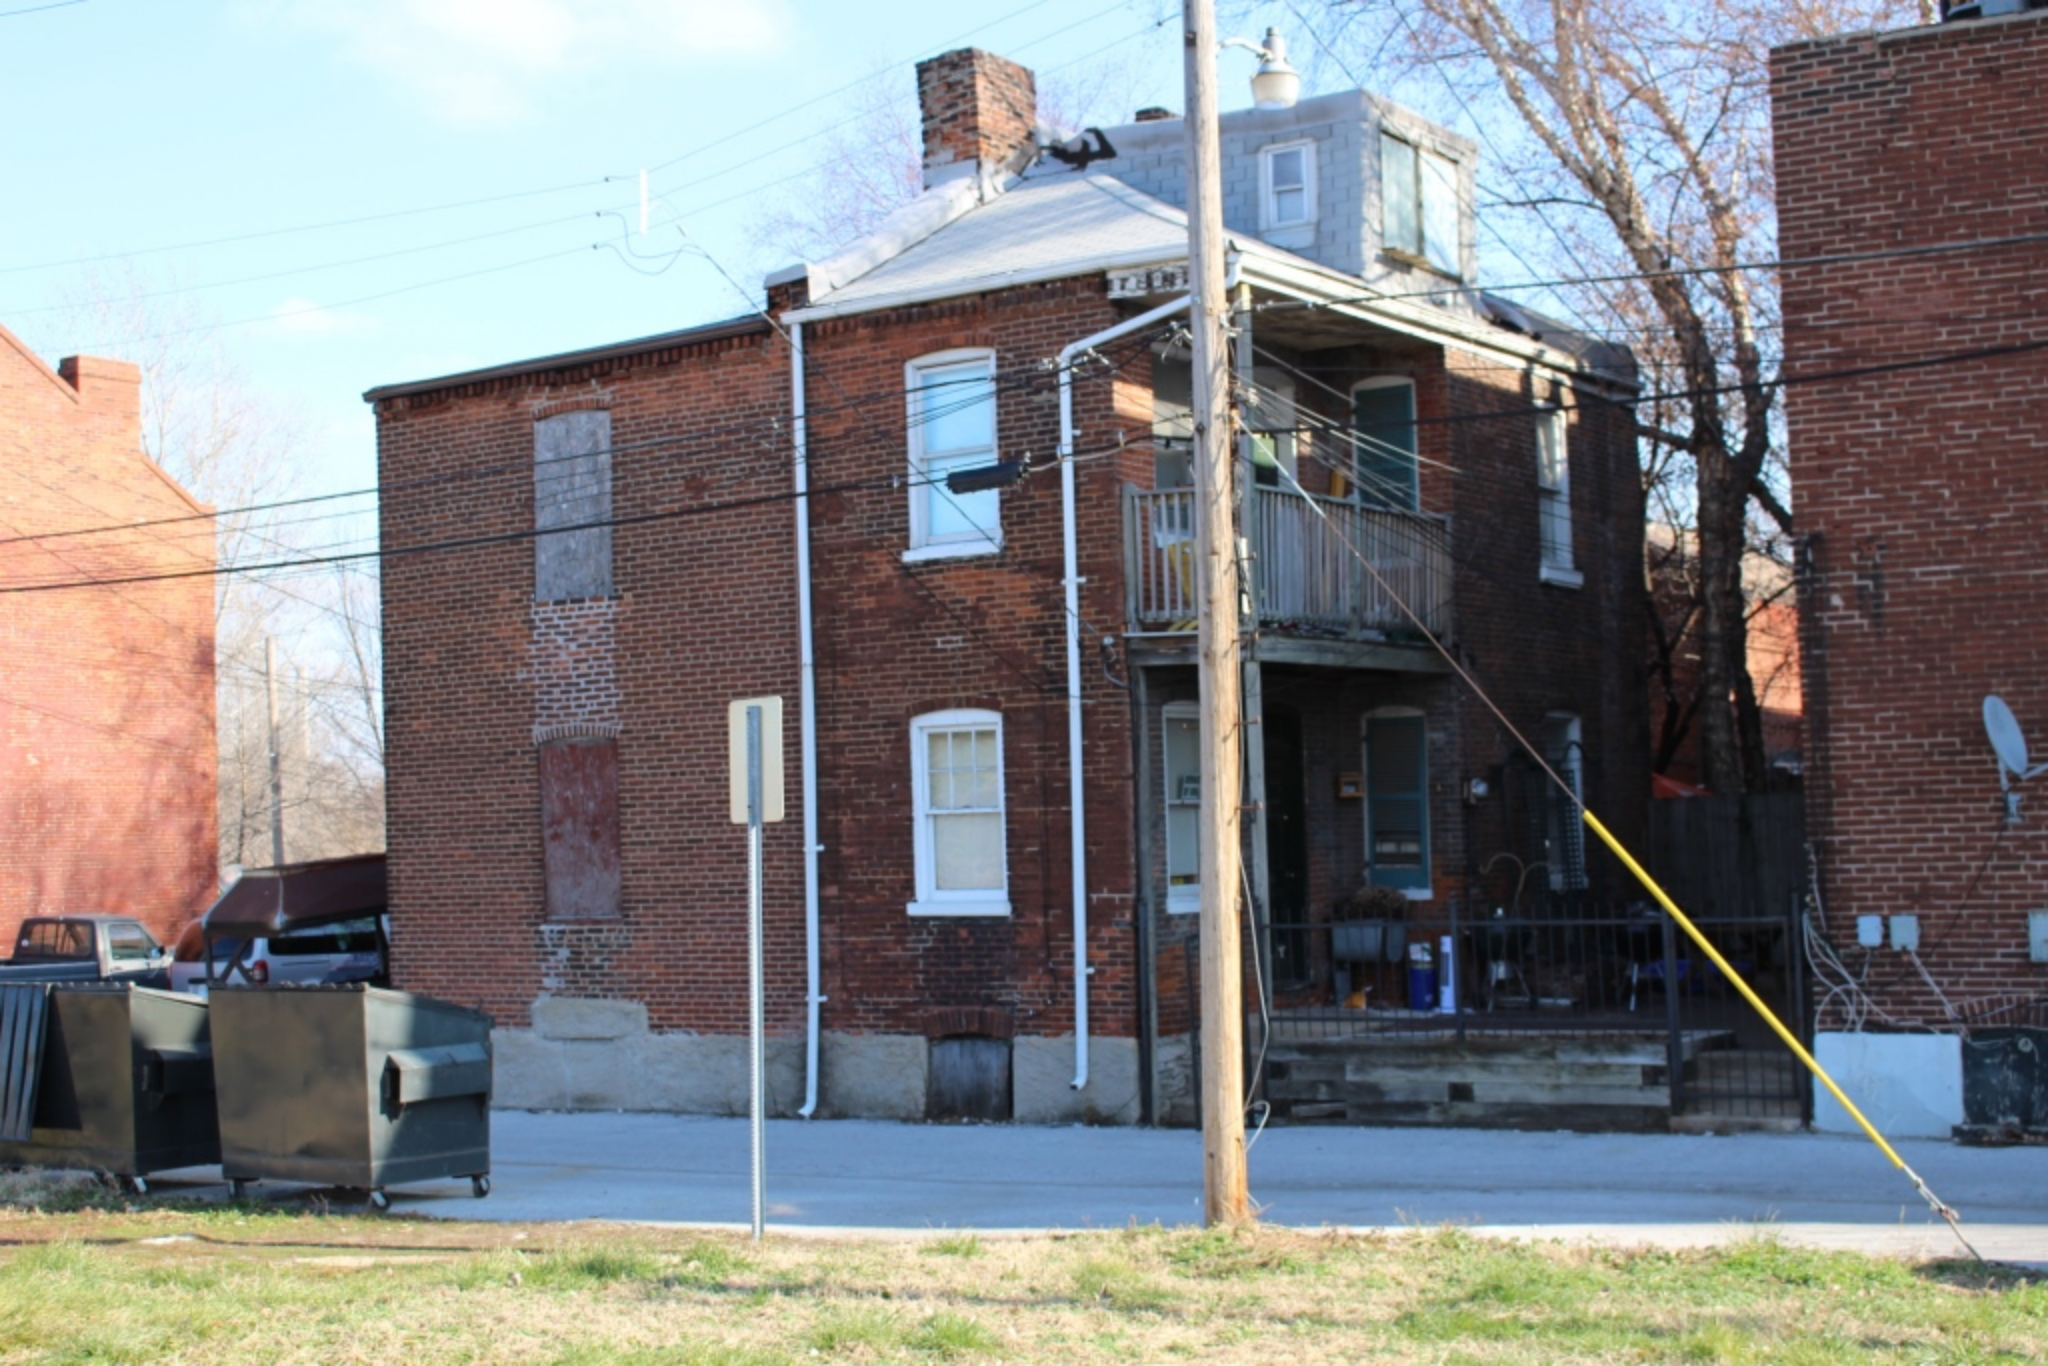
This 2 1/2 story brick flounder has a relatively small footprint, with only two bays facing the alley and an inset partial wood gallery. Its taller windowless wall is a party wall with the building to the north. The entrance is sheltered by the wood-framed gallery, which is a second-story porch as well. Window openings are segmentally-arched with brick headers forming the arches except at the basement windows where bricks placed as soldiers are used. A simple denticulated cornice edges the alley end wall eaves below the hipped portion of the roof. A large, non-historic dormer projects from the shed roof; it is set high on the roof plane and has a wide window openings in its face and a smaller side window facing the alley.

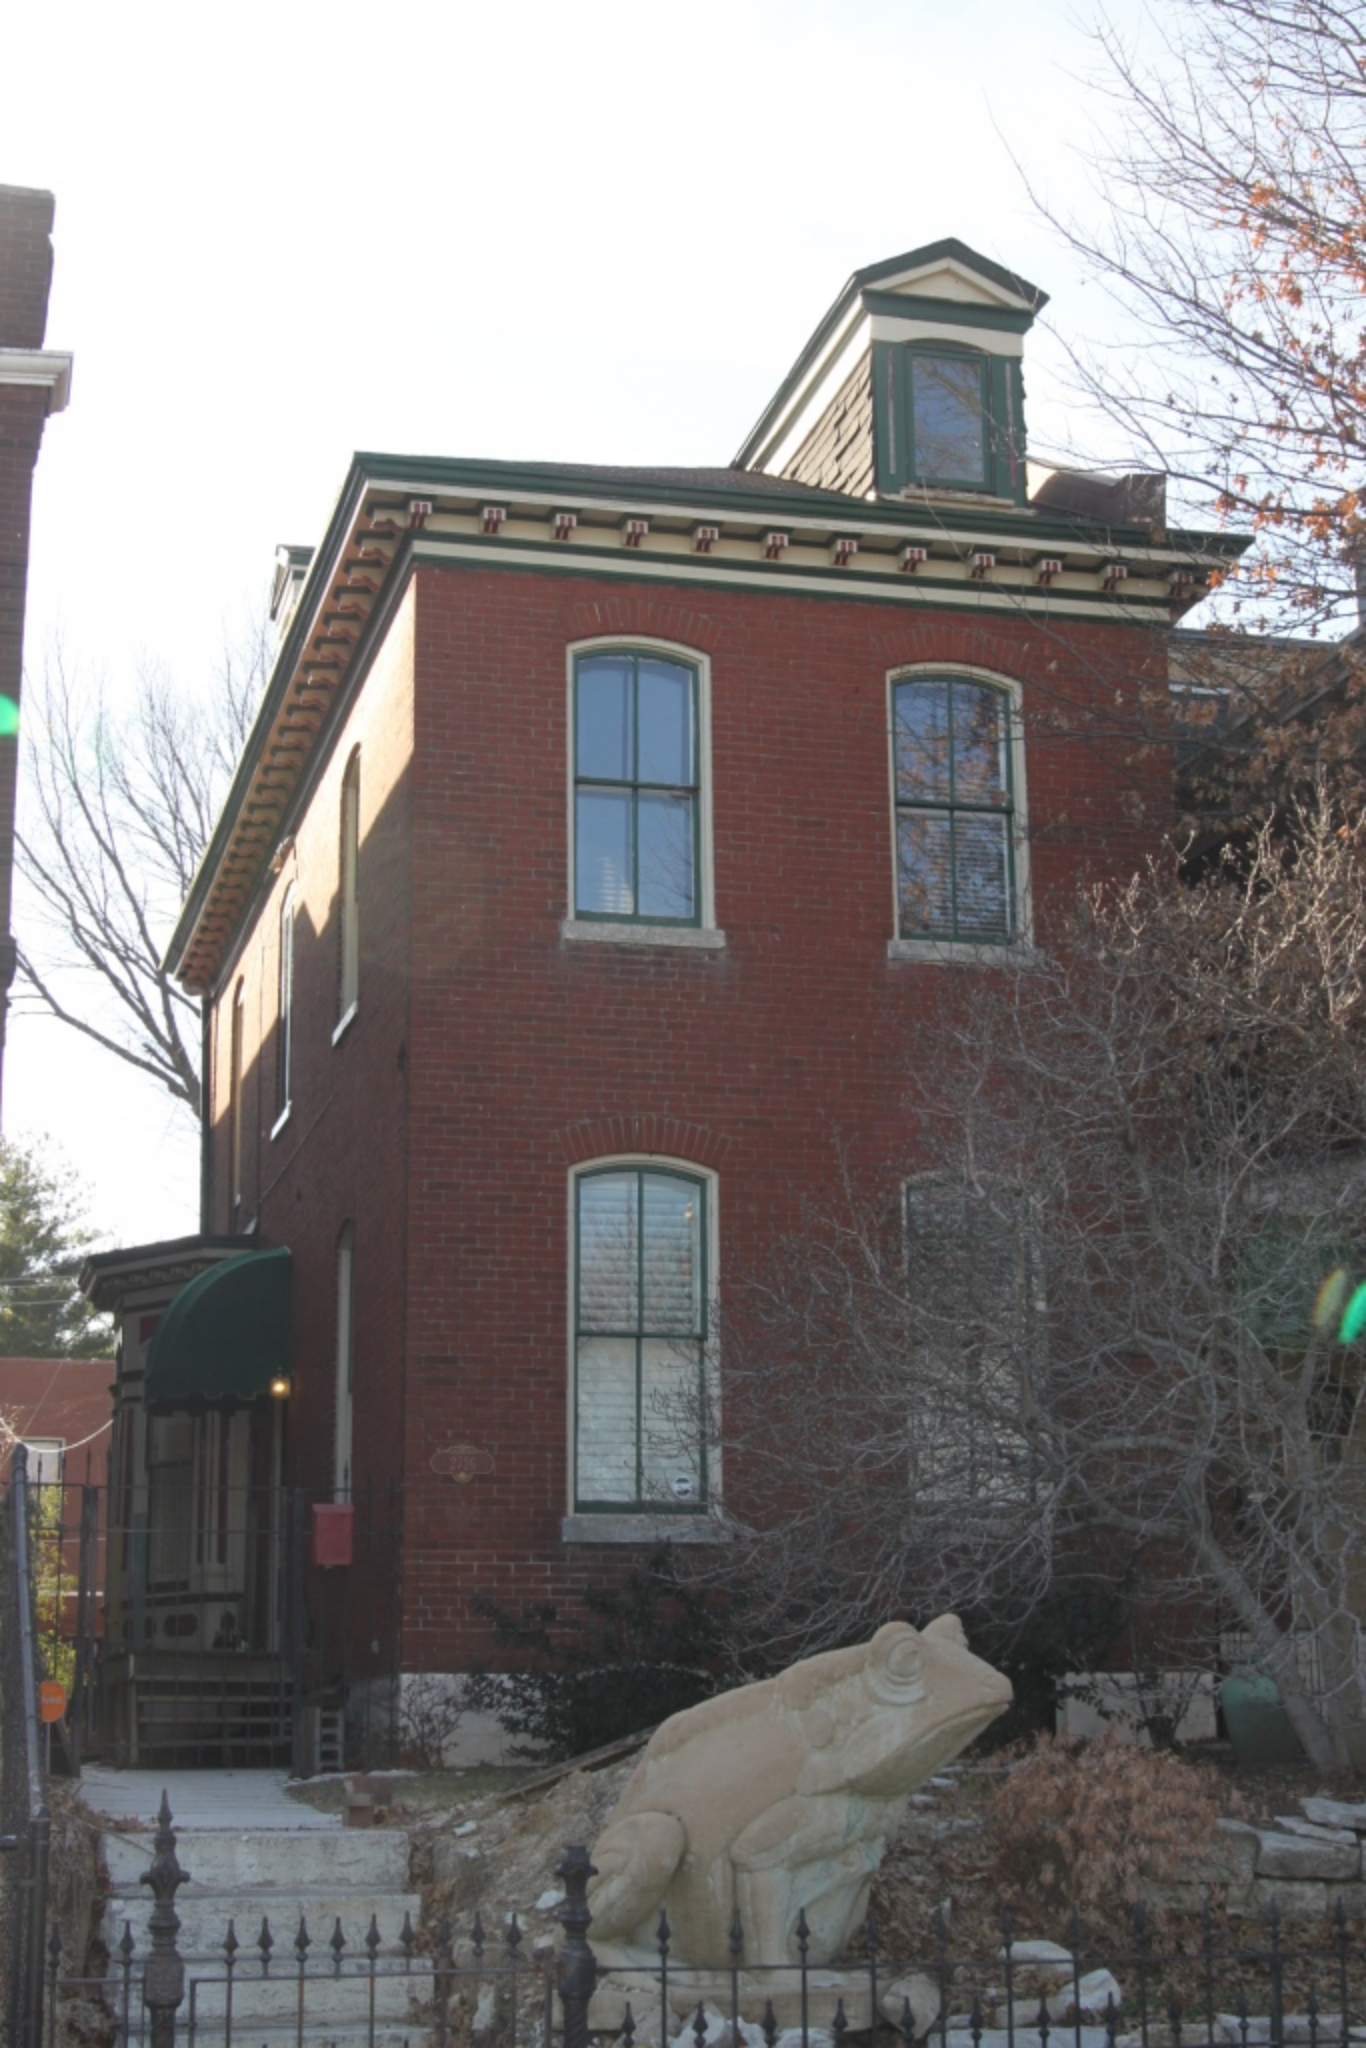
Sited at building line of block. Two-and-a-half story brick hipped flounder with side entry. Painted parged foundation with two segmental arch basement windows. Two 2-over-2 double-hung segmental arch windows with soldier brick lintels and limestone sills. Small pedimented dormer to right side of front with a single pane replacement window with a small eyebrow. Three chimneys along right side, not visible from street. Shallow cornice with small brackets/consols. Cornice extends along entire south side. Side entry at middle bay of south elevation with non-historic wood stoop. Ornate oriole window at back bay of south elevation at the 1st story. Oriole window has cornice similar to the main cornice. Two story historic rear flounder addition.

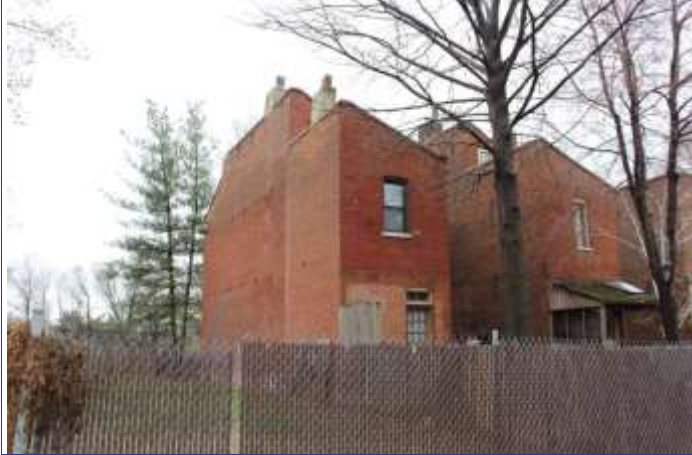
Rear façade looking southwest

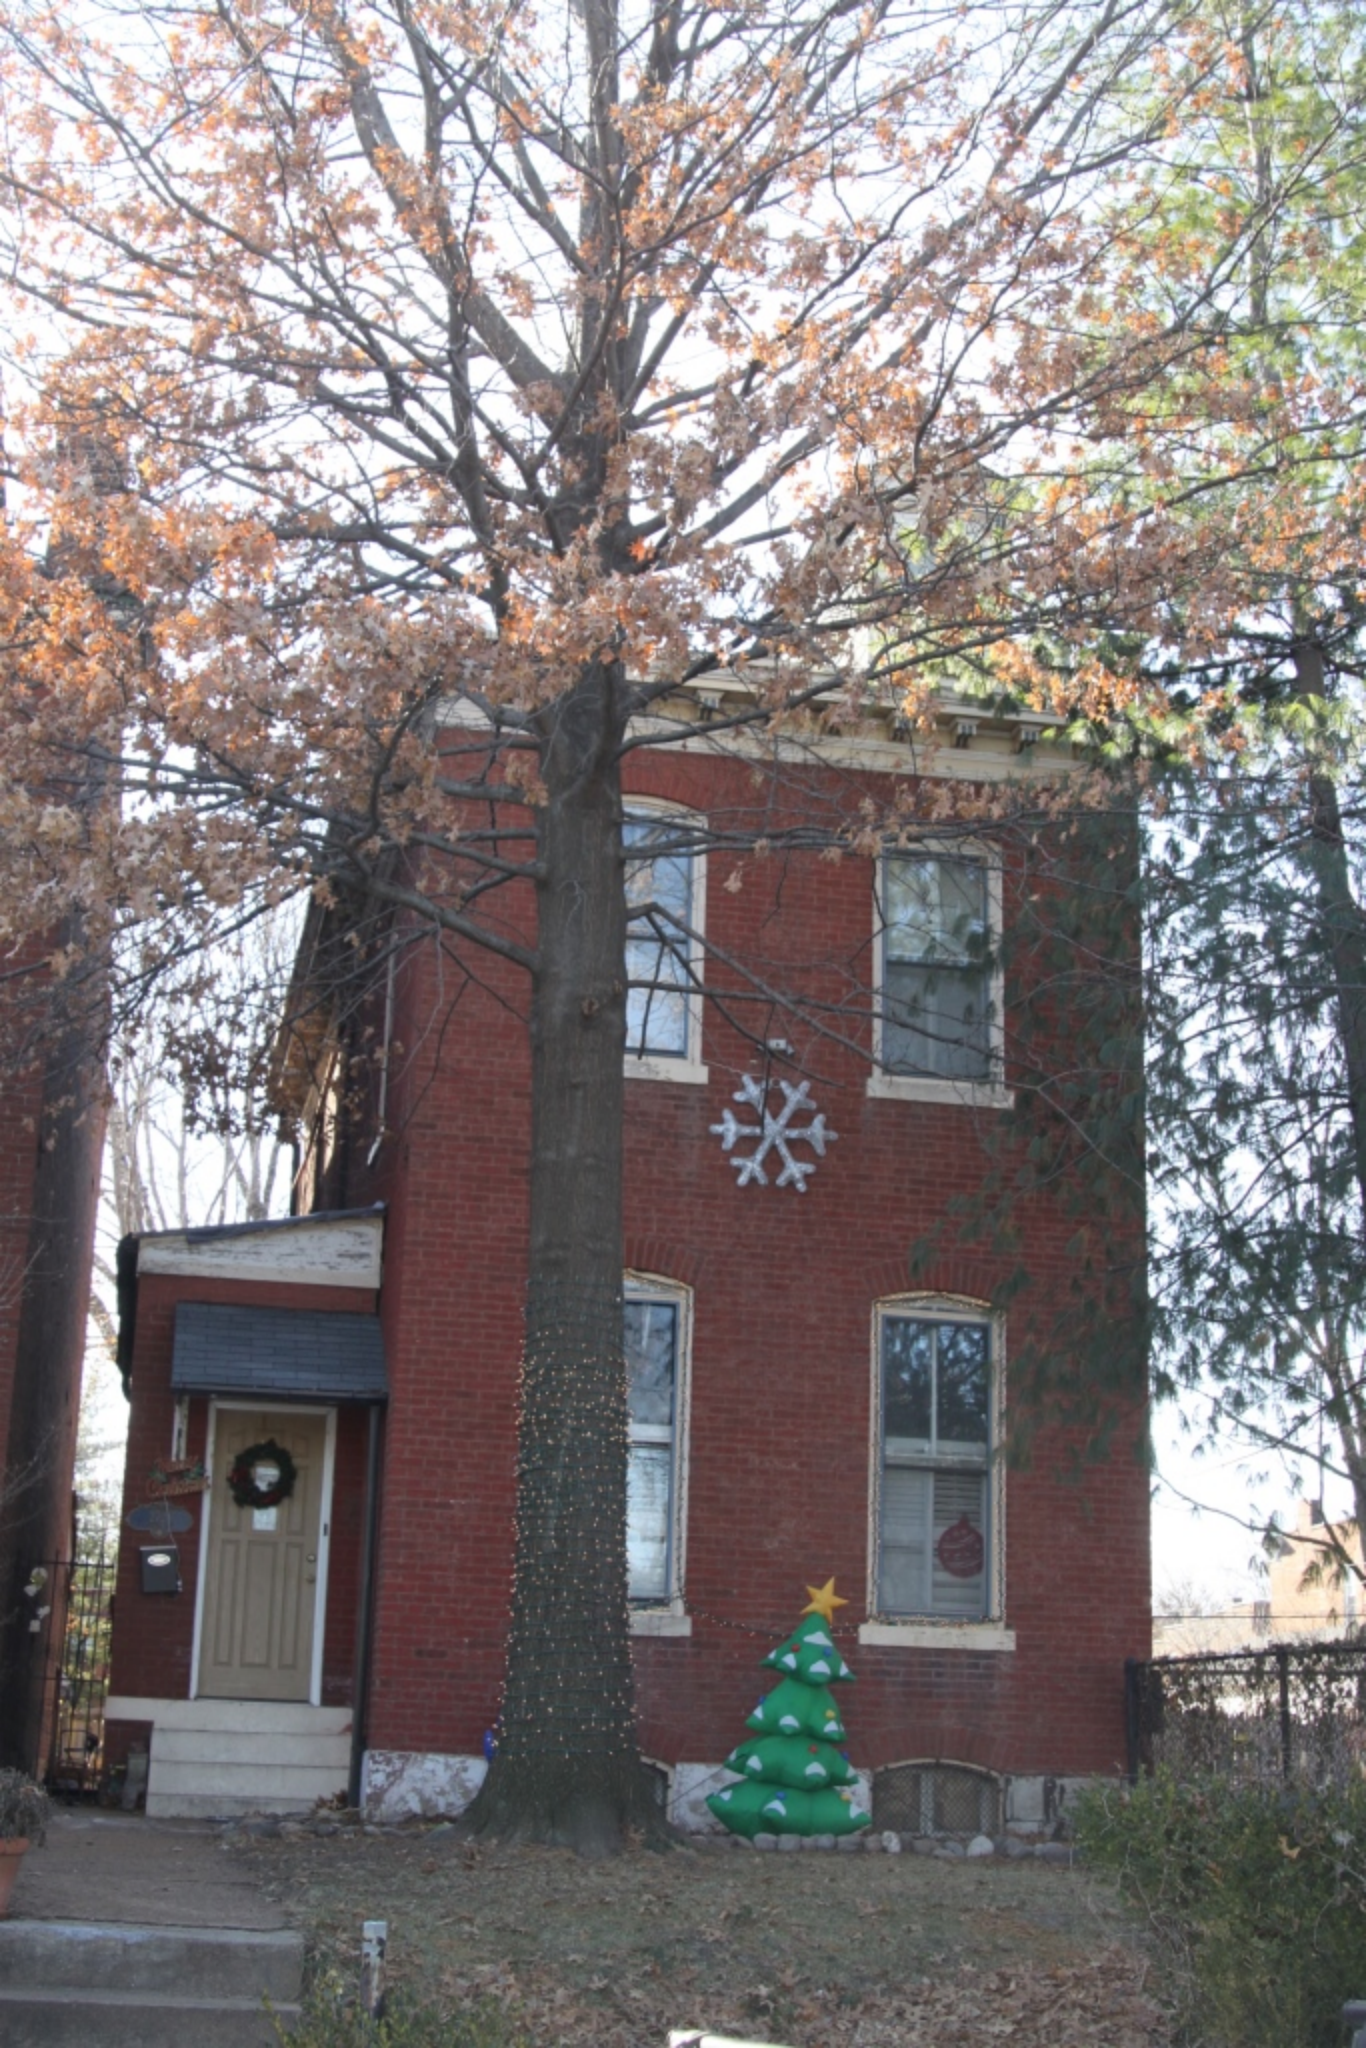
The two-bay front façade presents at each story two-over-two arched head windows placed under segmental arches of soldiers with stone lugsills. The coursed rubble limestone foundation has been parged at the front, an original condition. The basement windows are arched french casements also under segmental arches. A bracketed wood cornice extends the width of the front and returns the entire length of the east elevation. Above, an assymmetrically-placed narrow pedimented dormer, aligned near the west wall, has a segmentally-arched two-over-two sash. The original side entryin the northernmost bay of the east façade, is now hidden under a one-story frame addition, containing a new entry door and wood stoop. The 3-bay east elevation has a centered decorative oriel window; above is a narrow dormer ornamented similarly to the front dormer. An original 2-story brick flounder ell is extant at the rear. Alterations include painting of the front foundation and the installation of inappropriately-sized storm sash.
