**ARCHITECTURAL/HISTORIC INVENTORY FORM - Cultural Resources Office**  
**St. Louis Planning and Urban Design**

1. Survey no. SLC-AS-053-0001	2. Survey name: Thematic Survey of Flounder Houses in St. Louis City	3. County: St. Louis [Independent City]
4. Address: (from City GEO database) <b>1812 S 8TH ST</b>		5. City/State: St. Louis, Missouri
Alternate address: 1812 S 8th		Property Zip Code: 63104
Latitude: 38.608949		6. UTM Easting: 743586.48
Longitude: -90.202538		UTM Northing: 4277095.00
8. Historic Name (if known): N/A	11a. Historic Use (if known): Domestic	City Block: 372 City Ward: 7
9. Present/other name (if known):	7. Township-Range-Section: N/A	10. Ownership: Private
11b. Current Use: Domestic		Neighborhood Number: 21

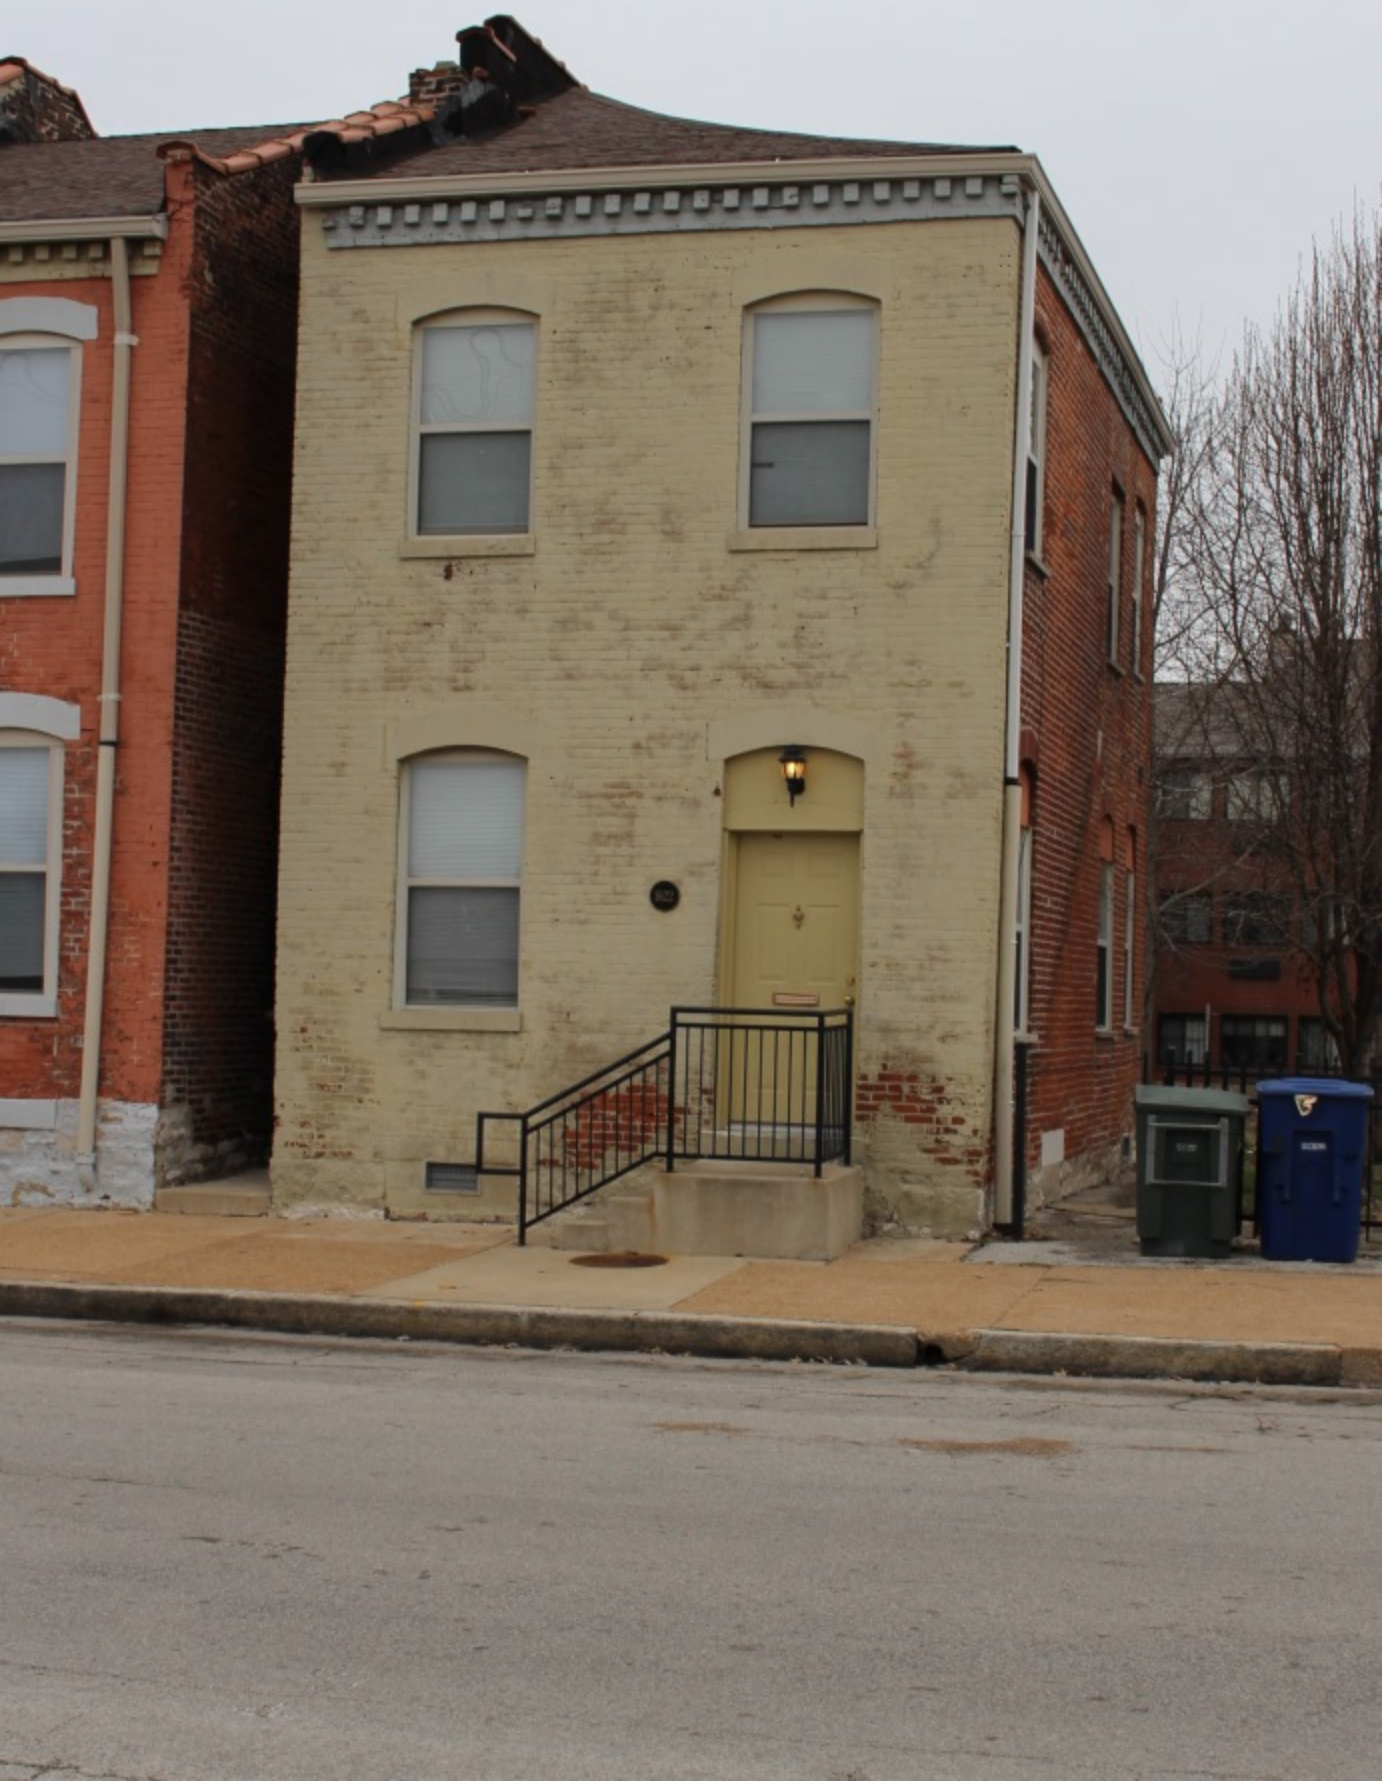
This two-story brick flounder with hipped front roof is separated by a narrow sidewalk from the adjacent building. The building has the stone headers and sills at façade window openings that the adjacent buildings have, as well as the same simple denticulated cornice, suggesting that it was built at the same time as the adjacent row. The entrance has a replacement concrete stoop and railing.

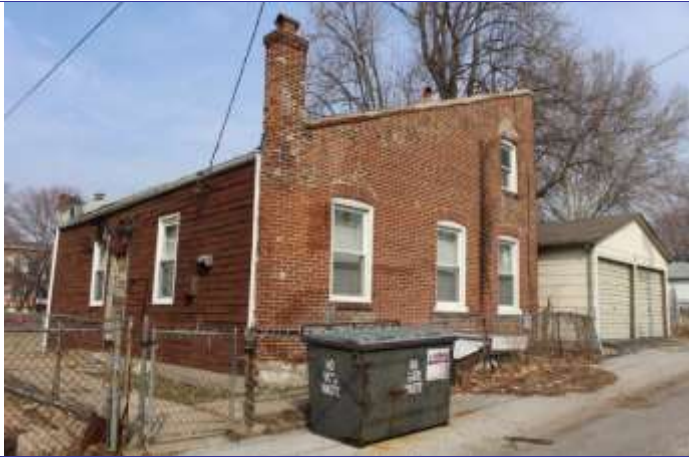
**3466 GRACE AV**

This one-and-one-half-story brick shed-roof flounder has a high, windowless wall on the north side and is positioned at the alley. No other building stands on the lot. The asphalt shingles on the south side wall, where a door is flanked by windows, seems to be the enclosure of a porch with brick wing walls. All windows have replacement 1/1 double-hung vinyl sash and the brickmold is wrapped. Window openings on the east side have arched soldier heads; those on the west side have flat heads. There is a window on both the east and west sides at the attic level. Chimneys rise from lower corners of the brick walls on east and west sides; additional chimneys at top roof edge.

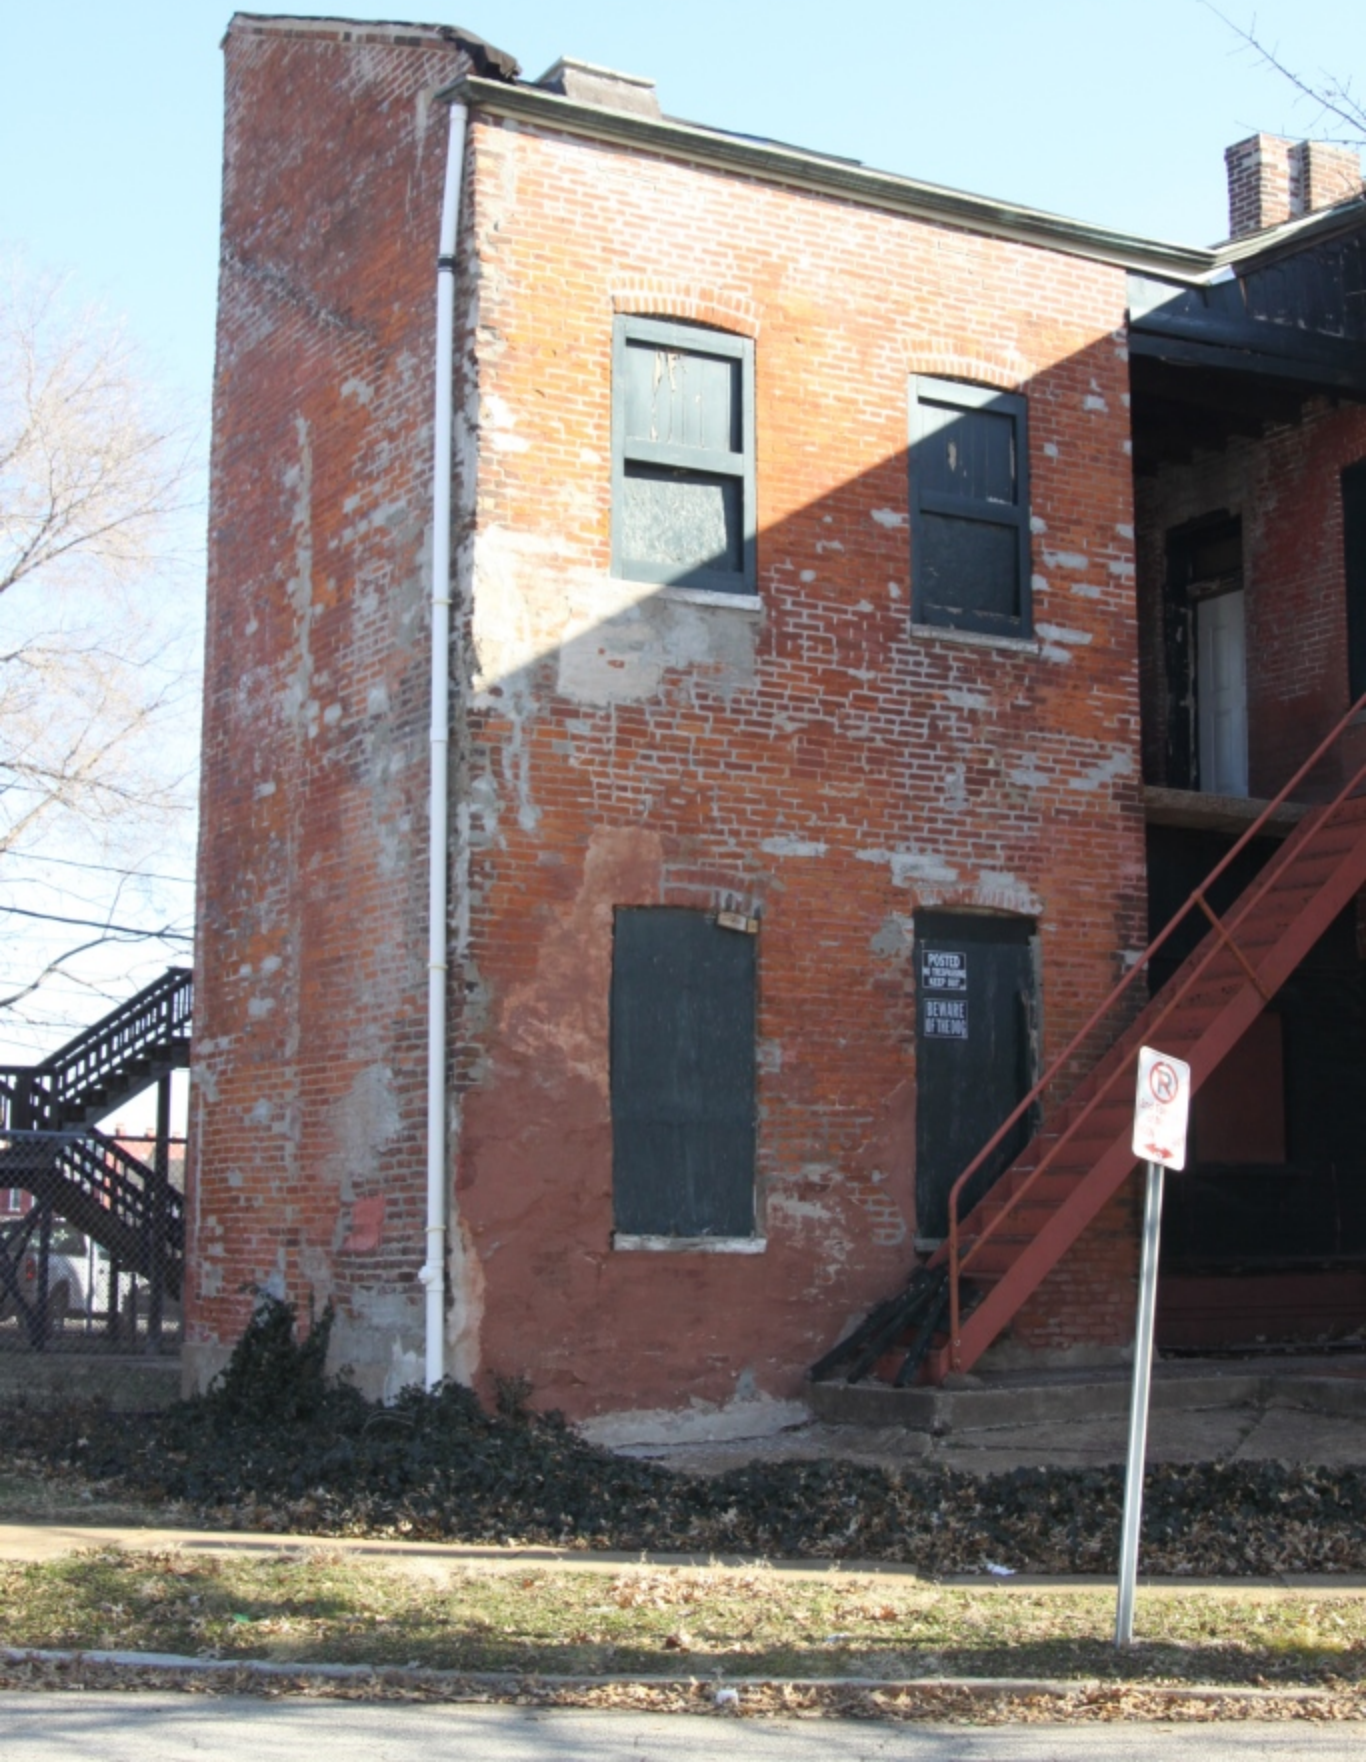
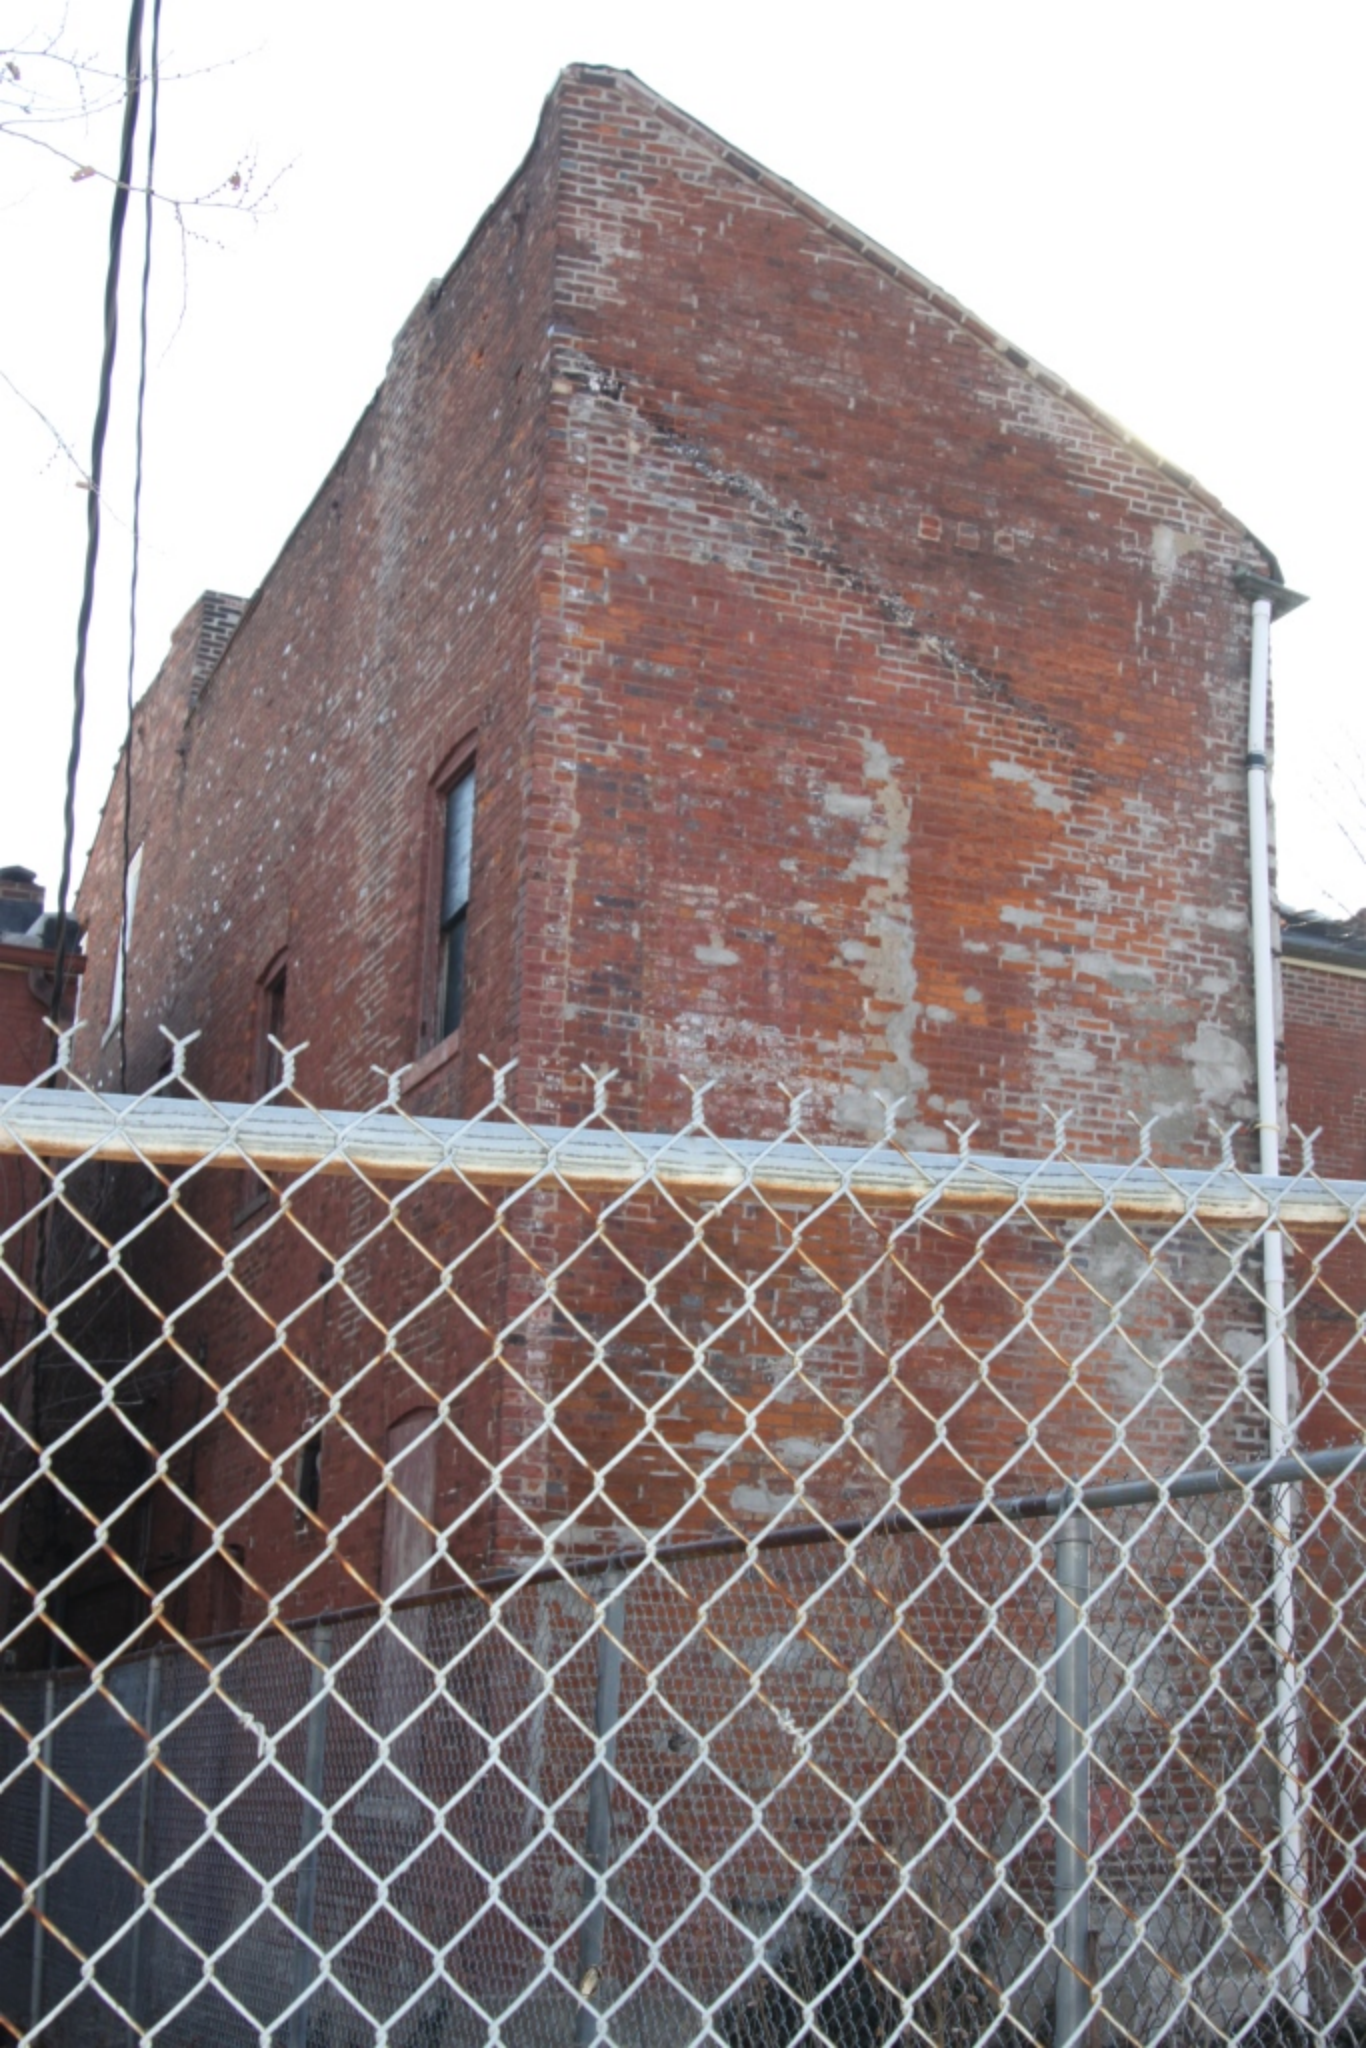
There are many places where the brick has been repointed and parged, indicating that has needed repair. Due to the widening of Gravois, the façade of this building, including the portion at the corner, have a replacement uniting façade.

Due to the angling of Gravois Avenue across the grid of streets the rear wing is close to and visible from California. Tthis mostly free-standing flounder is attached by a two-story gallery to the main block of the building and the brick east wall is continuous, uniting the front and flounder rear wing. The gallery, open on the California side, has a concrete floor at the second level and a metal staircase adjacent to gives access to the second story level; there are square window openings at both levels of the gallery. The wall facing California has two bays with segmentally-arched heads with two rows of brick headers. All of the openings are boarded. The rear wall parallel to Gravois has no windows. There is a door at grade in the taller, east-facing wall, and also several window openings. A narrow walkway separates this building and the one to the east.

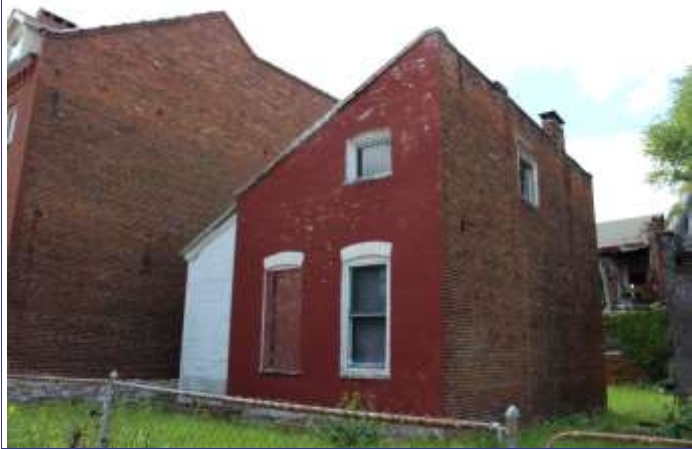
# 1420 HEBERT ST

This two-bay and gallery 1 1/2 story brick flounder has a steeply-pitched shed roof. The wall facing Hebert has two bays of windows on the main story and an attic window above the west bay adjacent to the taller, windowless wall. The windows have segmentally-arched heads formed of two rows of brick headers and wood sills. One window has 1/1 doublehung wood sash with storm sash; the other is blocked. The attic window is a single-pane fixed or awning sash. The gallery along the east side of the residence is enclosed with sheets of metal siding with a brick pattern, painted white. There is a door in the rear bay of the gallery and another in the rear wall. One window with a steel lintel has been added at the attic level in the otherwise windowless west wall.
