**ARCHITECTURAL/HISTORIC INVENTORY FORM - Cultural Resources Office**  
**St. Louis Planning and Urban Design**

1. Survey no. SLC-AS-053-0102	2. Survey name: Thematic Survey of Flounder Houses in St. Louis City	3. County: St. Louis [Independent City]
4. Address: (from City GEO database) <b>900 HICKORY ST</b>		5. City/State: St. Louis, Missouri
Alternate address: 900 Hickory Street		Property Zip Code: 63104
Latitude: 38.615737		6. UTM Easting: 743886.40
Longitude: -90.198830		UTM Northing: 4277858.27
8. Historic Name (if known): N/A	11a. Historic Use (if known): Commerce/Trade	City Block 467.03
9. Present/other name (if known):	11b. Current Use: Commerce/Trade	City Ward 7
7. Township-Range-Section: N/A		10. Ownership: Private
Neighborhood Number: 34

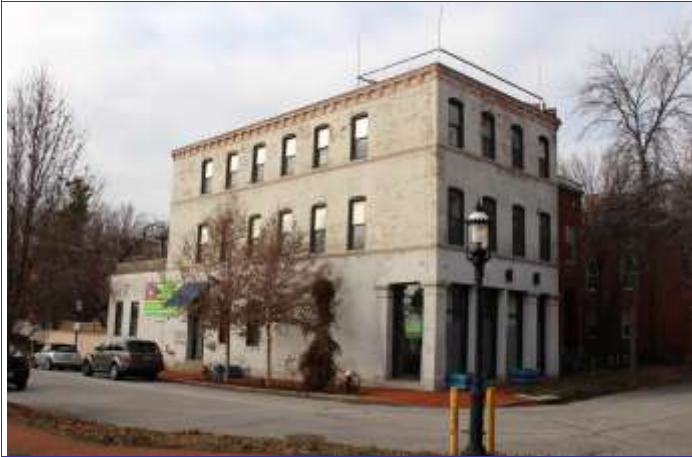
**900 HICKORY ST**

The original flounder hipped roof has been altered at the front of the building to incorporate a new rooftop deck. The storefront has been replaced.

The building is a three-story corner commerical. The front, or north, facing façade has four bays. The original storefront has been removed and replaced with a modern aluminum version which has a transome bar and the rest is comprised of glass. There are three brick columns with stone capitals and bases at the ends of the first floor. There are two cast iron columns flanking the entry door. The second and third floors feature four windows at each level each with segmentally arched lintels and stone sills that are integrated into belt courses that run the length of the north and east facades. The storefront wraps around to the first bay on the first floor of the east side of the building stopping at a brick pilaster that carries the same ornamentation as the three columns from the north side. The first floor on the east side has a single door accessed by a small stoop near the rear of the building. The door is a modern replacement. Two other small windows are situated between the door and the storefront. The second and third floors on the east side have six segmentally arched windows and stone sills that are integrated in belt courses that carried around from the front of the building. There is a small one-story brick addition off of the rear of the building.

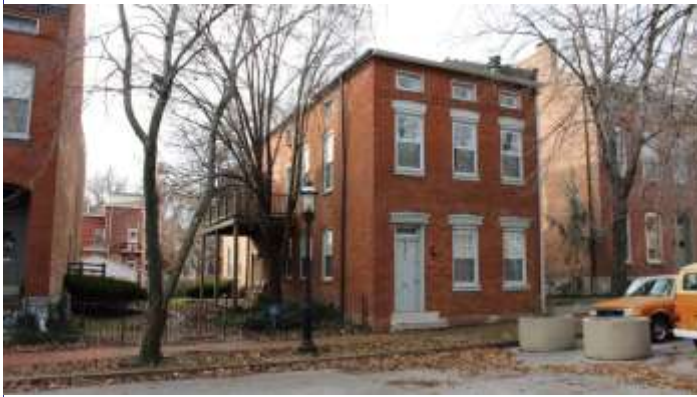
**908 HICKORY ST**

The front façade of the building has three bays. The first floor has an offset door on the left with two tripartite windows on to the right. The second floor features three windows and also has a clerestory row above the second floor. The first and second floor windows on the main façade feature decorative iron lintels and sills. The first floor lintels have decorative swag detail. The same element is also used over the front door. There is a soldier brick belt course running just above the first floor windows. There is a paired row of projecting stretcher courses between the second floor windows and the clerestory windows. A brick dentil cornice runs the length of the north and east façade. The east side of the building has three more clerestory windows situated above three of the four openings on the second floor. Two doors on the second floor enter out onto a large modern wooden deck. Two doors on the first floor on the side enter out onto a concrete patio. There are three windows on the first floor of the east side of the main block of the building. A two story flat roof addition projects off of the rear of the building. All windows and doors on the side and rear of the building feature segmented arched windows with brick sills.

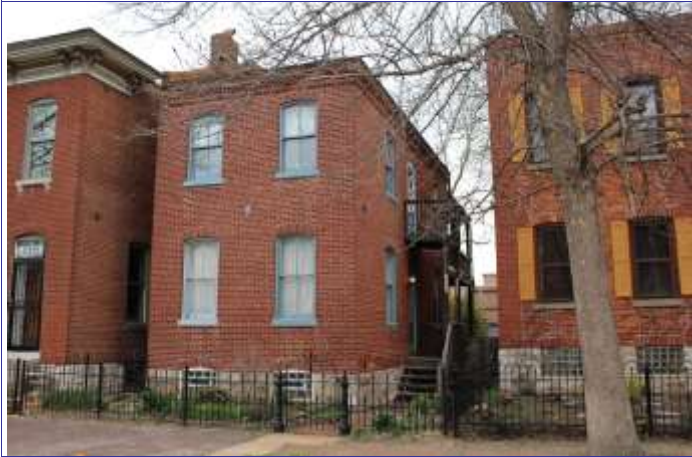
**2349 HICKORY ST**

The house is a two-story brick, side entry flounder with 2-story brick flounder ell. The windows on the front façade have segmental soldier arches and stone sills. The basement windows have been infilled with glass block. The first and second floors have wood 2/2 segmentally-arched doublehung sash. A dentilled brick cornice runs the length of the front façade and returns on the east. The singleleaf entry and transom is situated in the center of the 3-bay the east façade; the front door has been replaced. There is a door under a transom at the second story. Entries are flanked on each story with doublehung windows. The entry is covered by a contemporary wood porch and balcony, which connects to the two-story gallery that extends along the rear ell. Both the Whipple map of 1896 and the Sanborn of 1909 do not show a center porch at this location, only the rear gallery, so the original condition of this façade was most probably an entry accessed with steps and a balcony above.

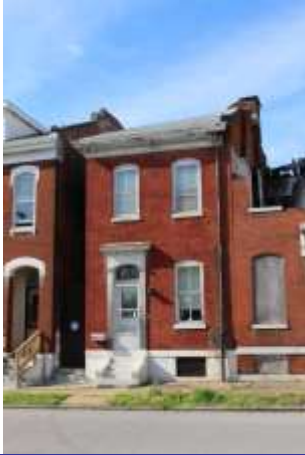
**1304 HOWARD ST**

This two-bay-wide brick flounder with a hipped front to the roof is one end unit of four townhouses; the unit at the other end also has a flounder form. The foundation of the façade is painted ashlar stone and the stoop has shaped cheekwalls. The entrance surround is ornate and identical to those of the reast of the row; wood pilasters support an arched surround for the transom window. A bracketed entablature terminates the surround, giving it very elongated proportions. All windows have segmentally-arched heads formed of soldier courses and stone sills. A bracketed and denticulated wood cornice edges the eaves at the façade and east side.

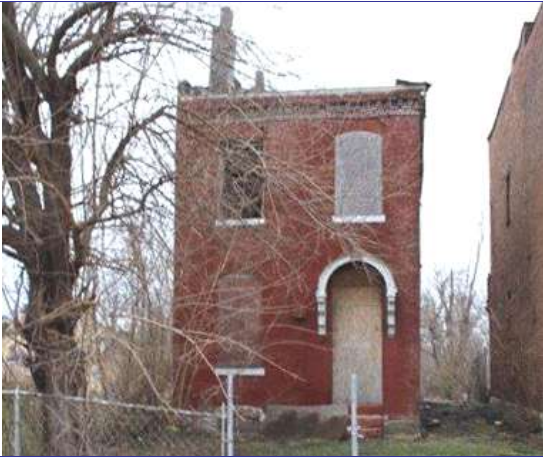
This 2-story, 2-bay hipped front brick flounder is set back from the street. The recessed singleleaf primary entry is in the eastern bay, below a curved wood entrance hood (a historic addition) and is approached by stone steps. The western bay contains a single window with small basement window below; there are 2 windows at the second story. All openings are placed below segmental soldier arches. Above, a corbelled brick cornice with brick-set gutter is in deteriorated condition and has started to fail above the eastern window head. The house shows a coursed rubble stone foundation on three sides; the front foundation has been parged. The taller windowless wall rises on west side.The east side of the building is 2 bays with a window at each story. At the rear, the remains of a 2-story wood gallery porch edges the rear flounder ell leaving exposed a single bay of the rear elevation, which contains a window at first and second stories. The rear of the ell has a window at each story and is experiencing some deterioration of its brick. The entire structure and foundation has been painted.

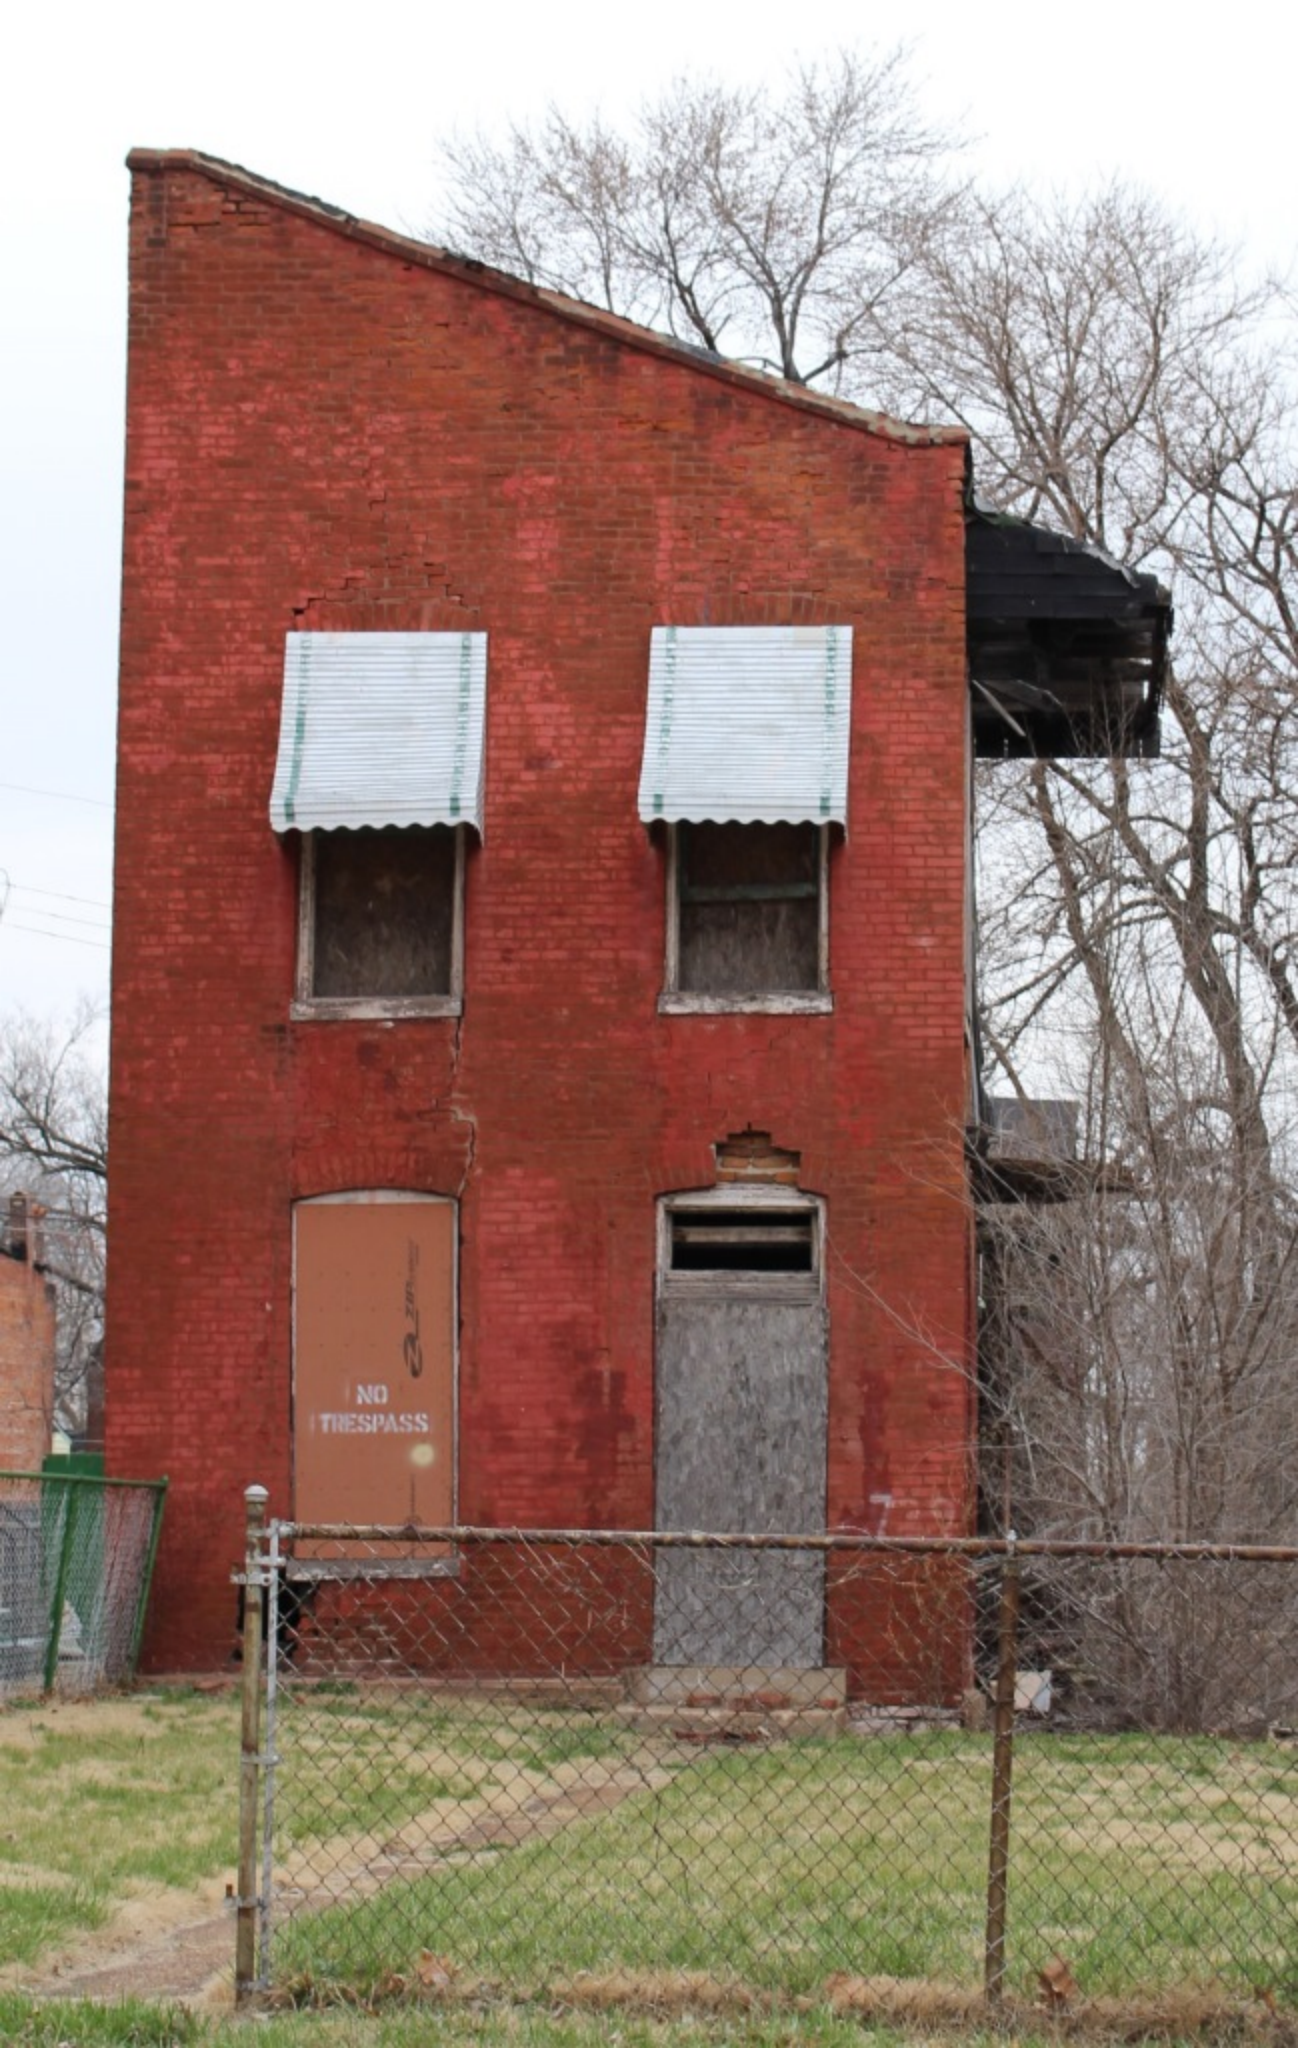
Building fire damaged at rear, no roof covering, boarded/no windows.

This small brick two-story, two-family flounder consists of a room above a room. Constructed of soft orange brick, the front and sides have been painted and part of the rear wall reconstructed. It once had an exterior staircase within a gallery porch on the east side to provide access to the upper level; remnants of the roof and floor framing remain. The two-bay front façade presents a singleleaf entry just above grade under a single-light transom in the eastern bay, flanked by a single window (boarded) on the west. Above each opening at the second story is placed a 1/1 window, current covered by aluminum awnings. Opening are set beneath segmental soldier arches and the parapet is capped with brick coping. The two-bay east elevation contains a single center window (boarded) at the first story; at the second is a singleleaf entry without transom flanked by a window (boarded). The rear façade shows remnants of a one-story addition with steeply sloped gable roof, plastered walls and a single door cut into the main block. Above at the second story, a small 4-light French casement window is set under a wood lintel with flat arch of headers.

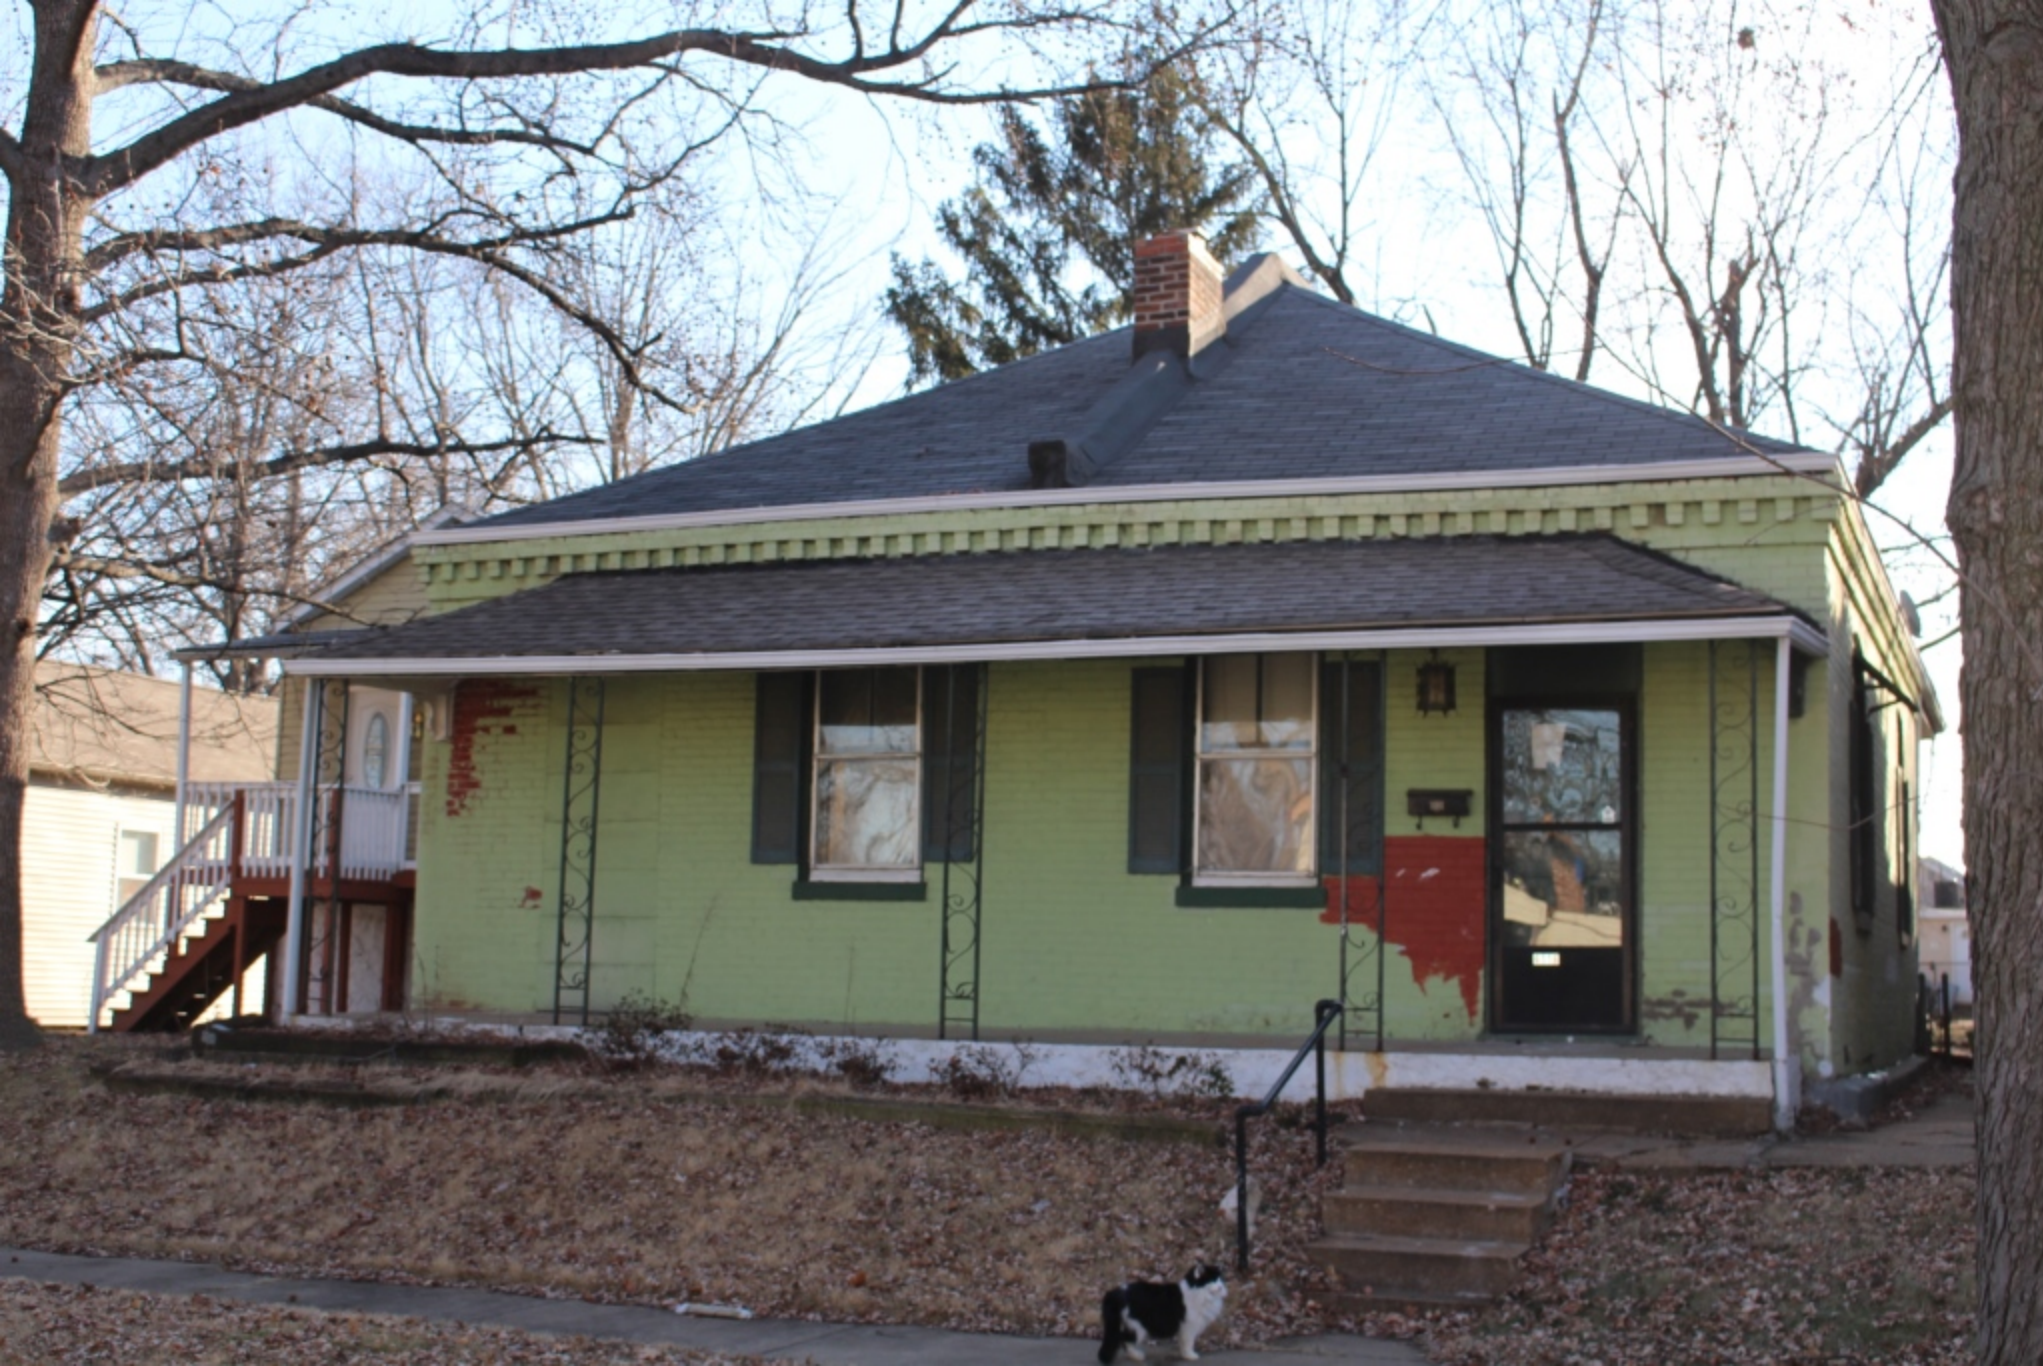
Two, one-story semi-detached flounders, now converted into a single house. Center projecting parapet with chimneys; doors are placed in outer bays at each unit and balanced with 2/2 doublehung window. Eastern entry has been boarded and sheathed with metal siding. Simple denticulated brick cornice at front façade continues on both east and west elevations. Galley porch at front façade is later addition. Building has been painted.

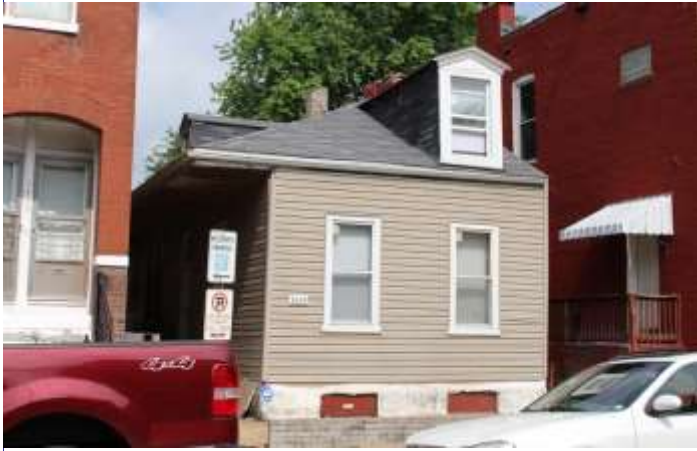
Front façade

Foundation is heavily parged on façade; house has been recently rehabilitated as Google maps shows windows as boarded.

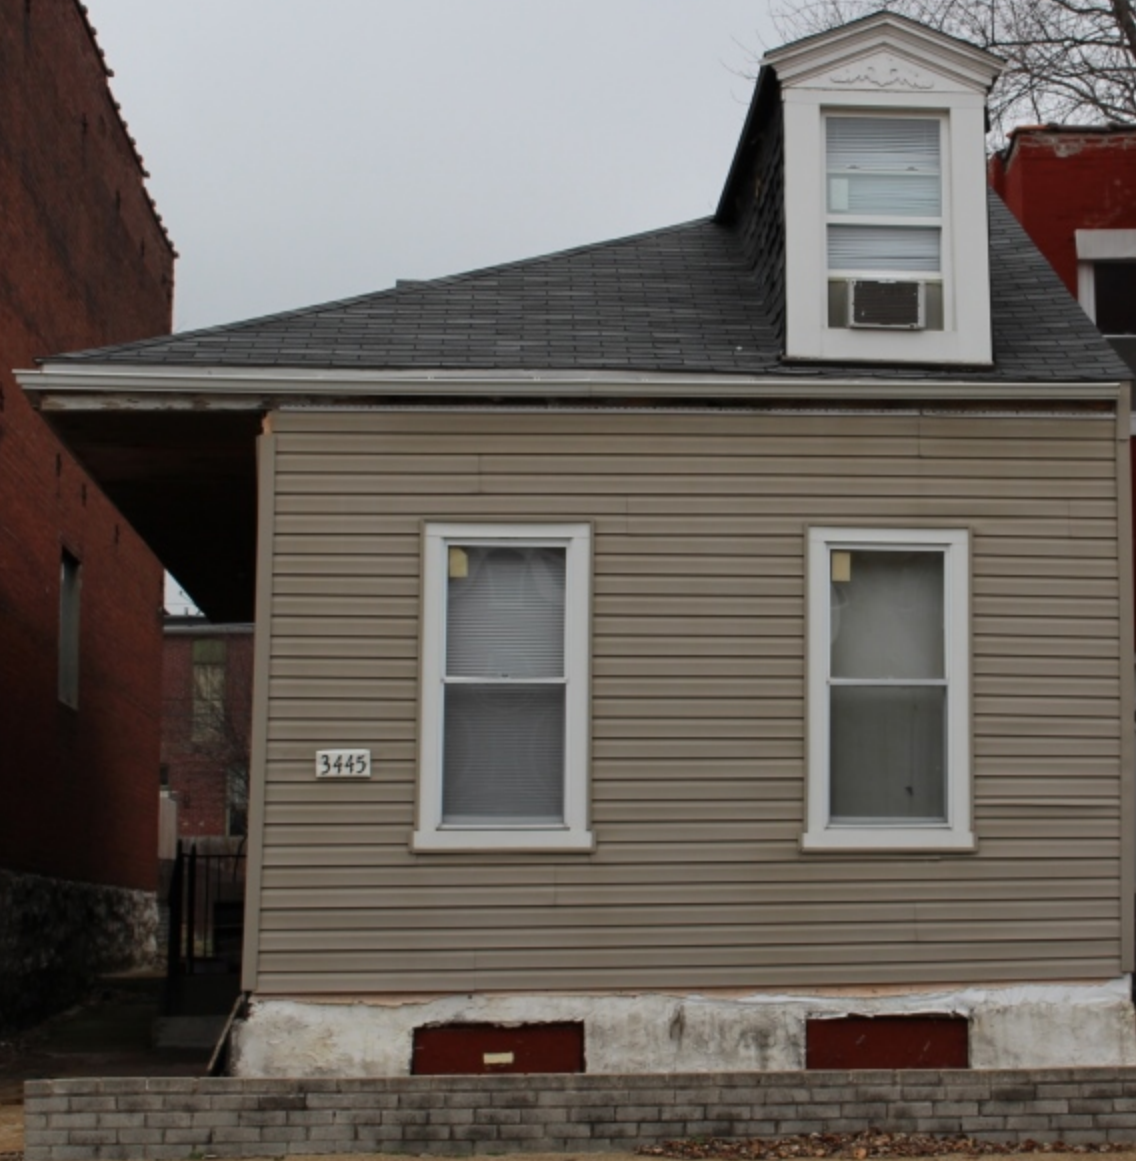
This 1-story frame flounder has an extending roof on the south side that indicates the historic presence of a gallery porch. In lieu of the gallery, there is a small stoop at the entrance. The windows on the ground story have been replaced; the gabled dormer projecting from the front roof plane has molding at the eaves and an applied ornament on th gable face; a second dormer projects from the side roof plane.

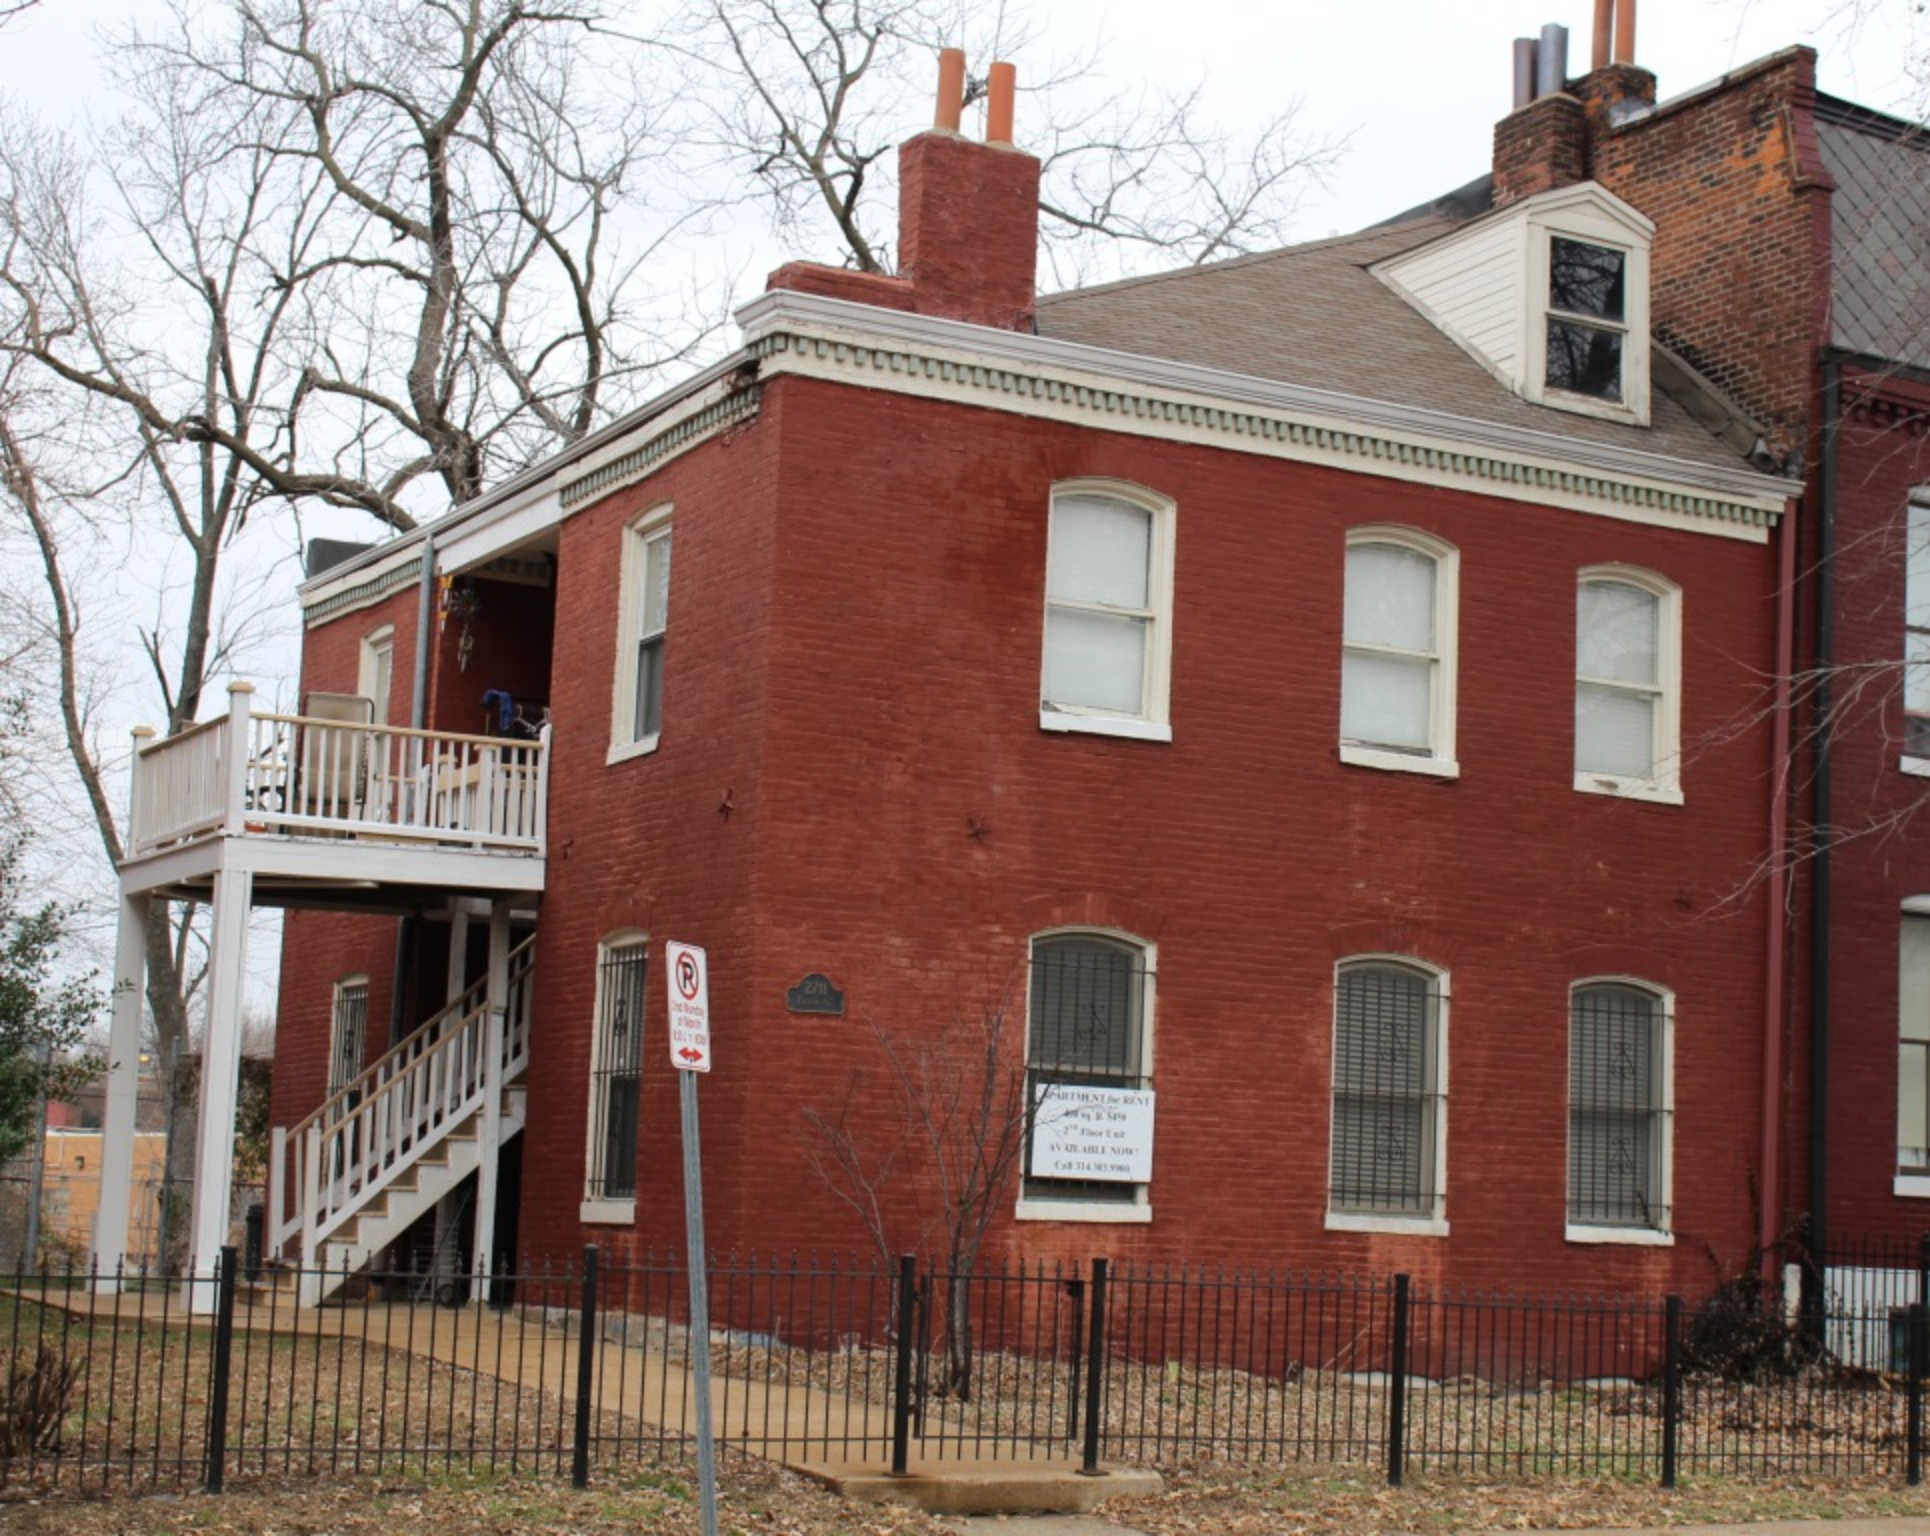
This 2 1/2-story brick flounder is set back from the sidewalk and has a sideyard on the south which the side gallery faces. The 3-bay façade has windows with segmentally-arched heads formed of brick and stone sills; its 1/1 doublehung wood sash has arched heads. The south side has a wood gallery flanked by enclosed brick bays; these bays each have a window opening at each story. The original recessed gallery occupied the center bay. The currrent wood gallery incorporates a staircase to the second story and upper level projecting porch. A denticulated brick cornice edges the façade and the brick bays flanking the gallery. A small gabled dormer projects from the front slope of the roof.

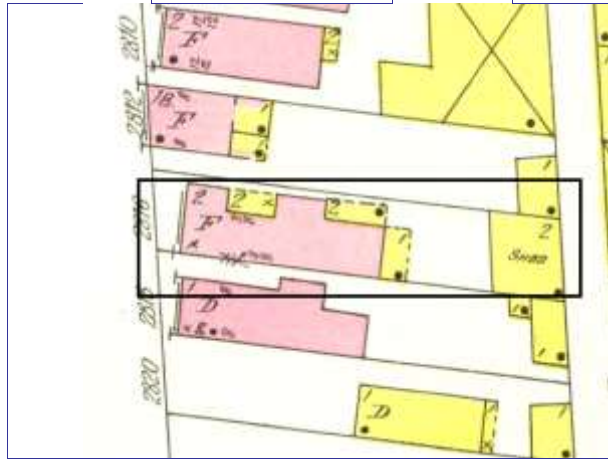
The foundation has been completely parged over. The building has been painted yellow

Front façade has three bays with three windows at the basement, first and second floors. The windows all have segmented arched lintels with cast stone sills. There is a street facing frame dormer projecting from the roof. The building has a raised basement appearance. The entire exposed foundation/watertable has been parged over. The north side houses the main entrance in a recessed portion of the building that is not visible from the street. A wooded deck is situated inside the second floor of the recess. The center portion of the main block is recessed on both floors. All windows on the north side of the buildings have segmented arched windows with stone sills. The south side of the building has two newer windows punched into the side of the building. There is a two story rear addition with a flat roof. The entire building has been painted yellow.

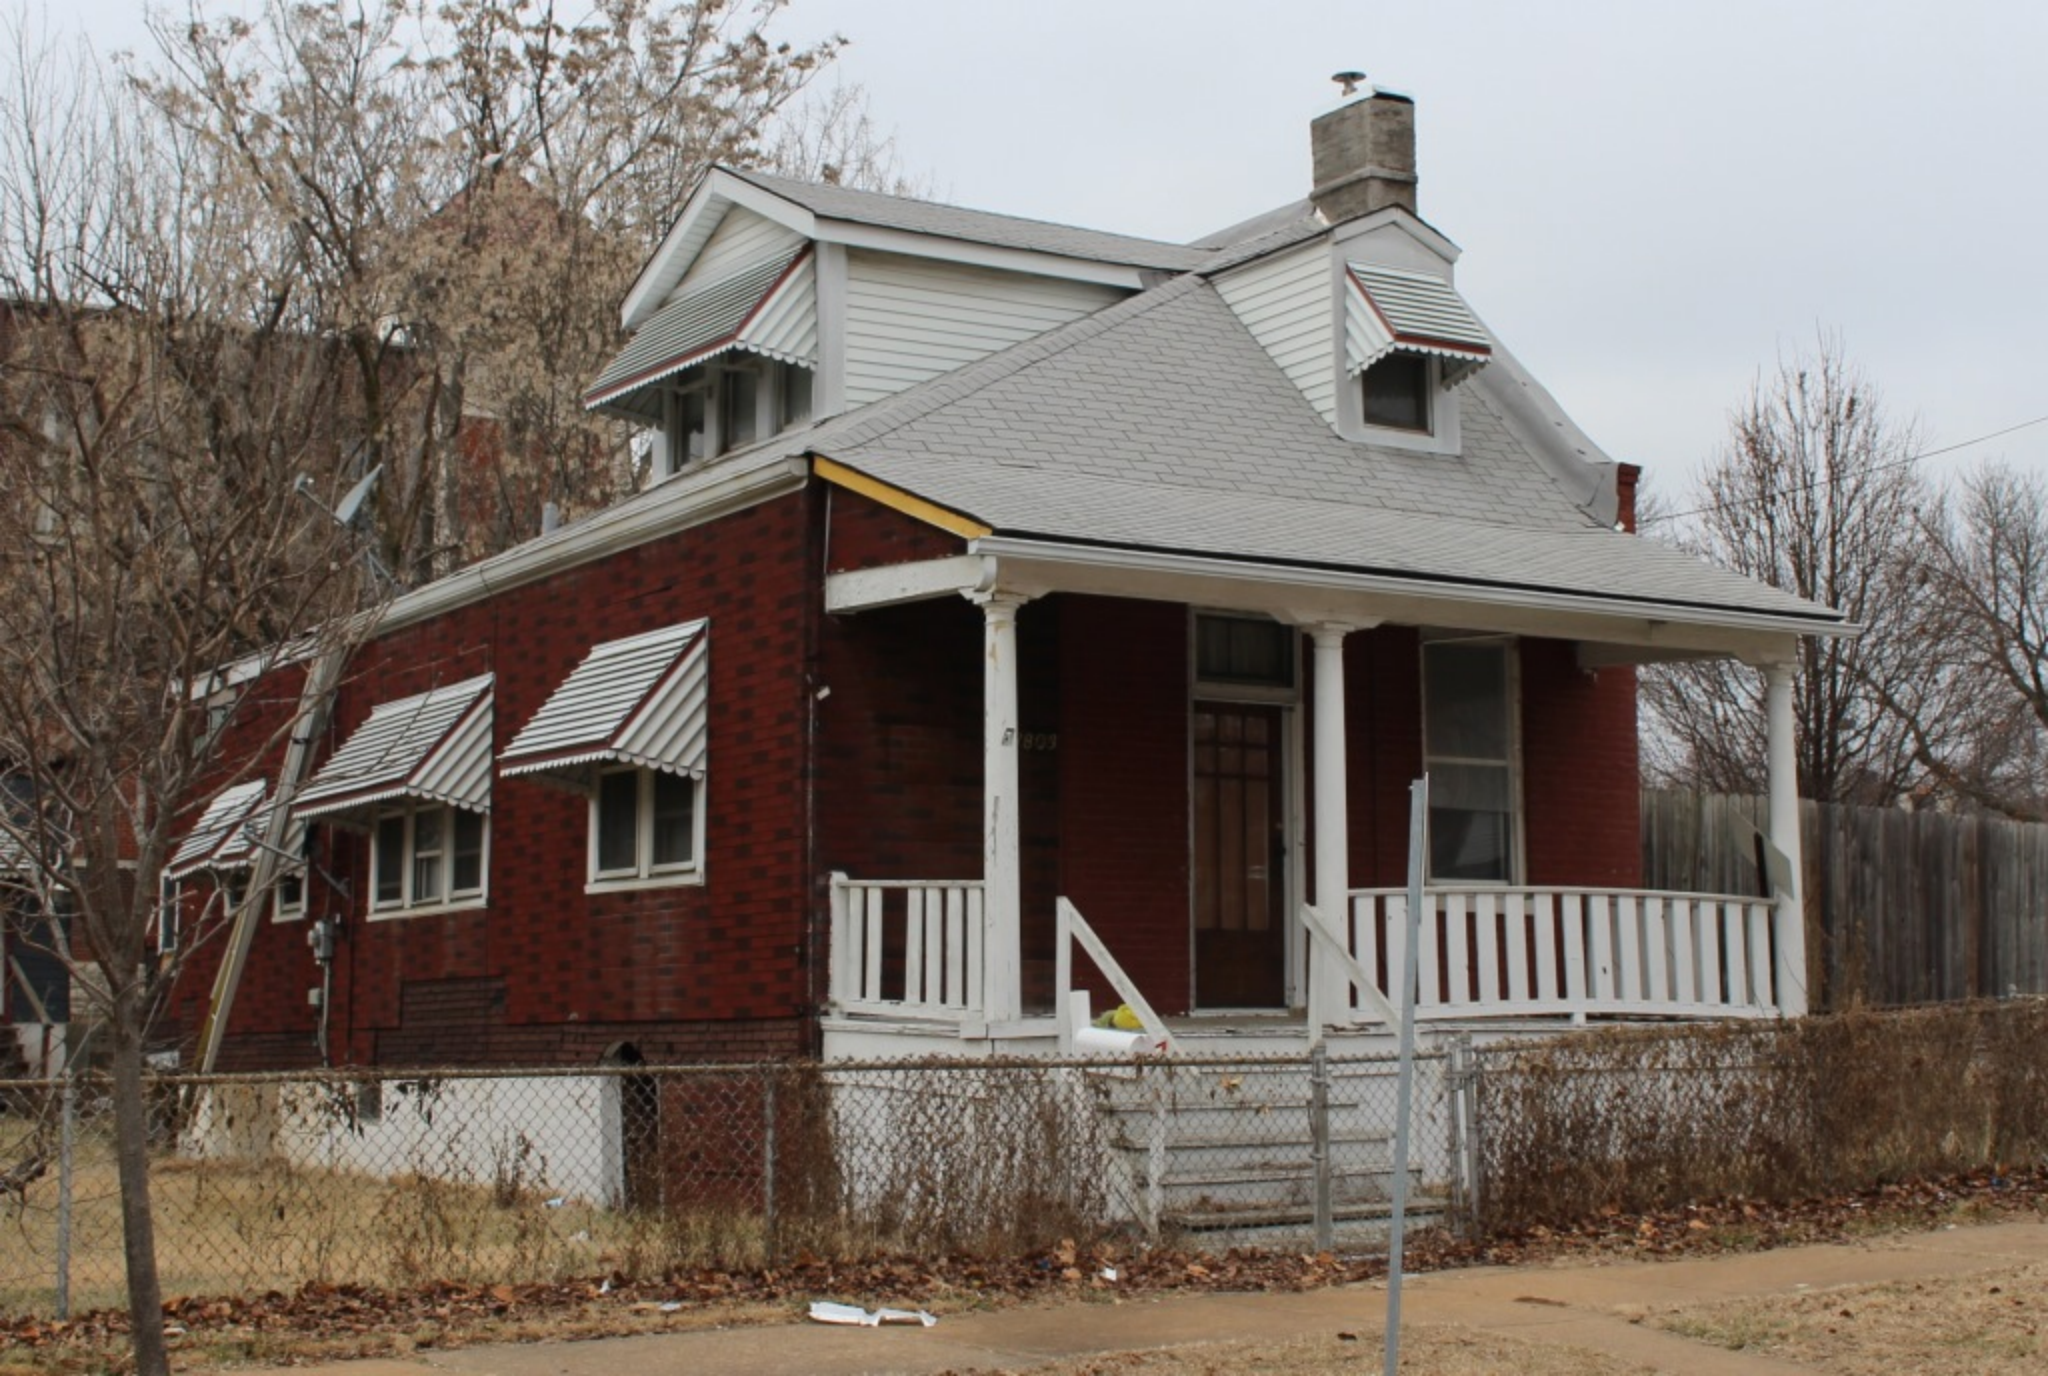
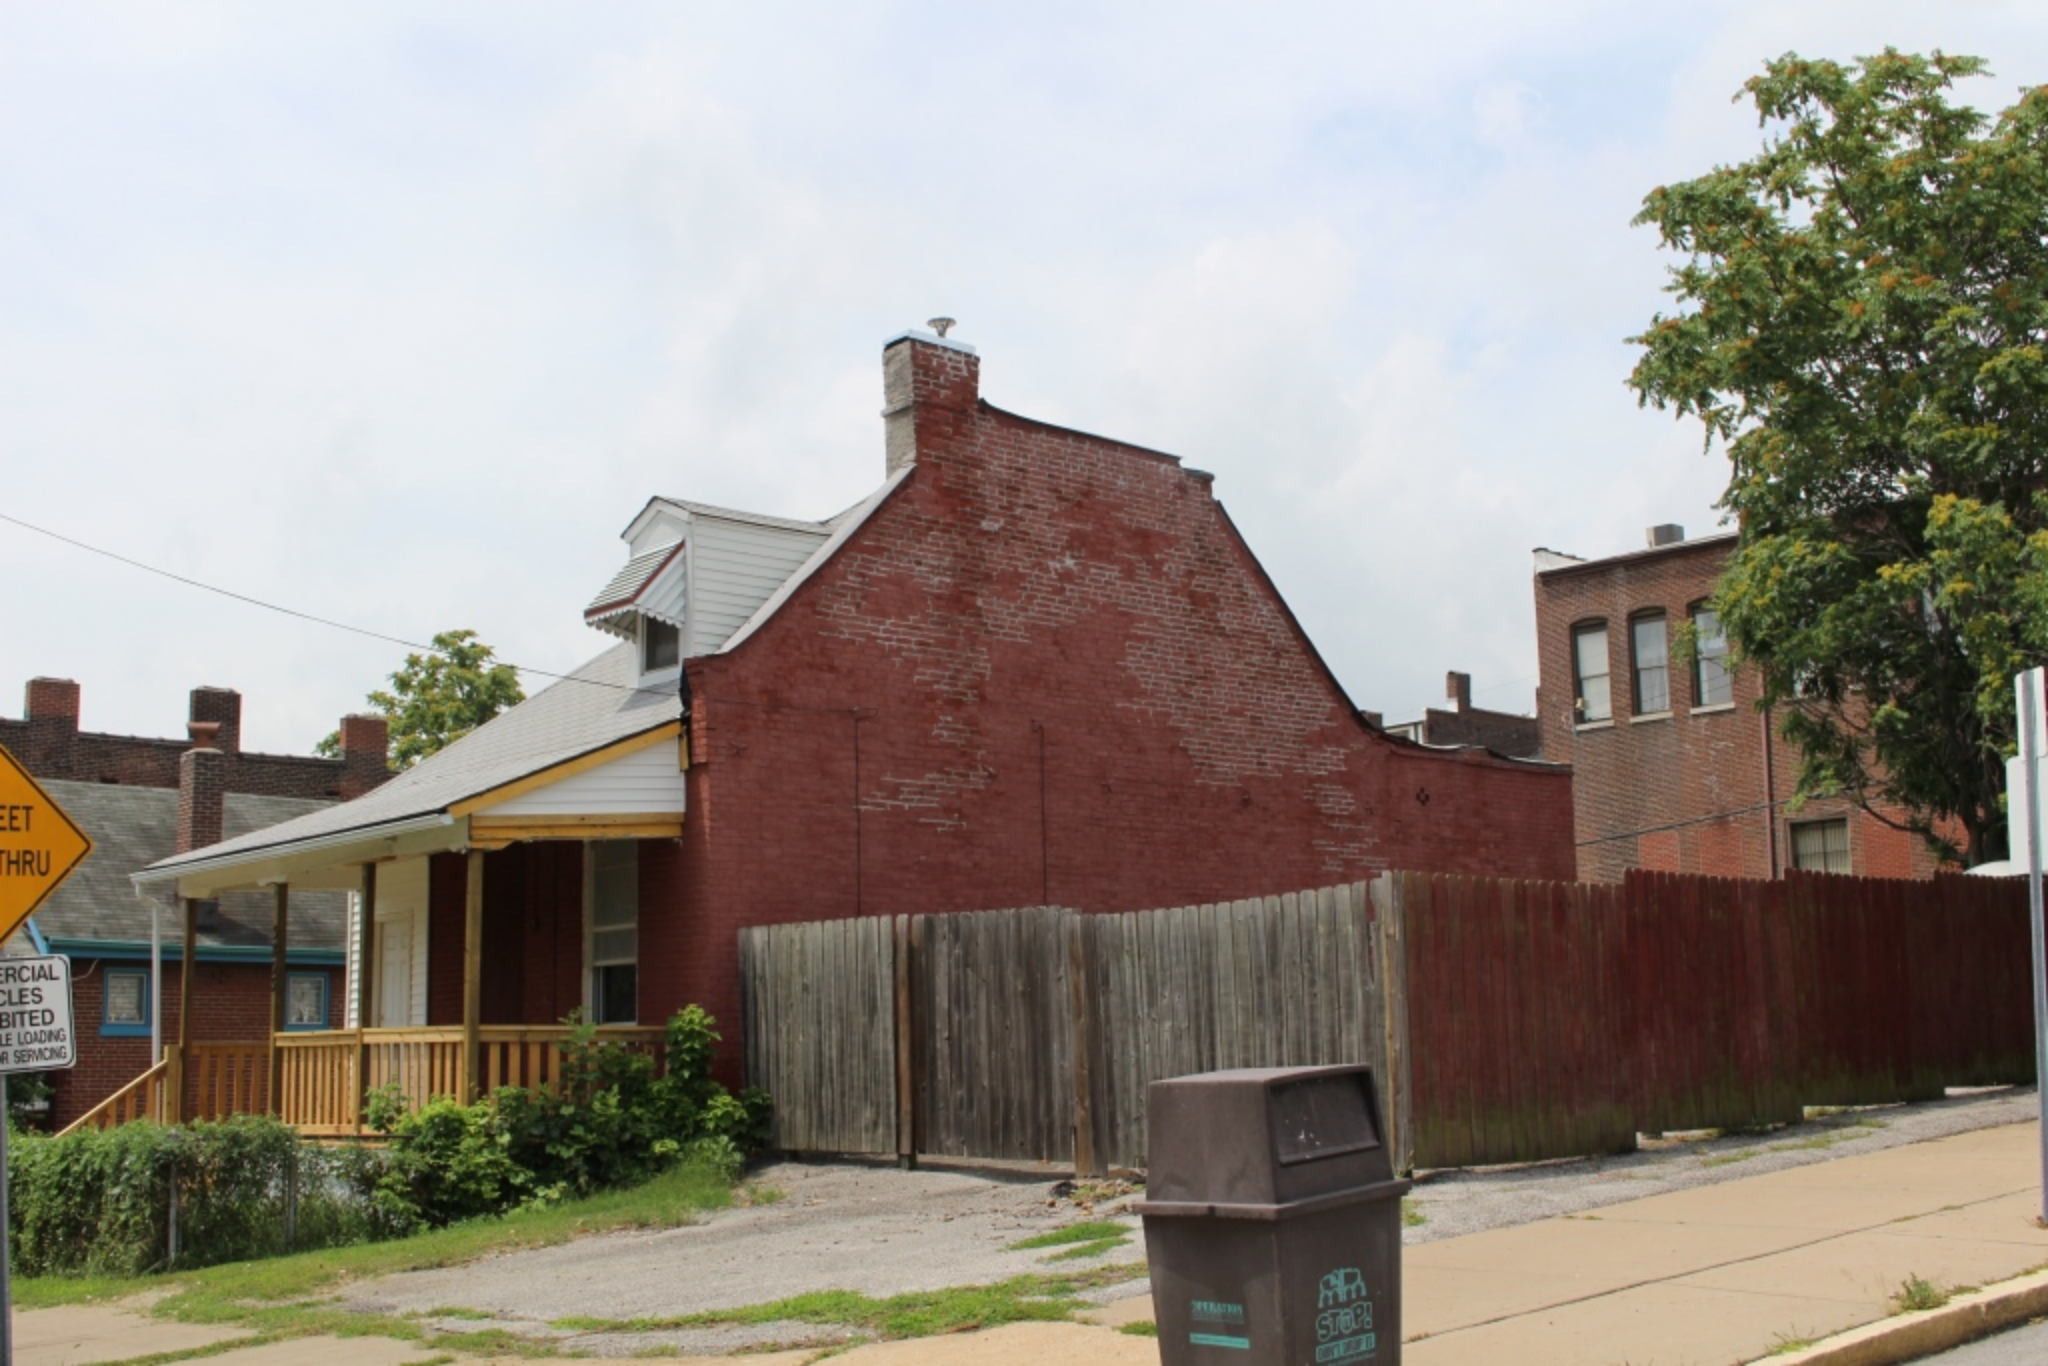
One and a half story brick flounder. First floor front façade has single segmented arched window with stone sill. Divided transomed front door has been replaced with Craftsman style door. The original side gallery has been enclosed for permanent interior space and has been sheathed with brick-pattern asphalt siding. The second floor front hipped roof retains the original front dormer, although somewhat altered and sheathed with metal siding; it has a replacement doublehung window. A full-width shed-roofed porch with columns has been added at the front façade c. 1920. The side gallery enclosure has eight windows. Also on this elevation a large central gabled dormer with three double-hung windows has been added. There is a small one-story brick addition off of the rear of the building.

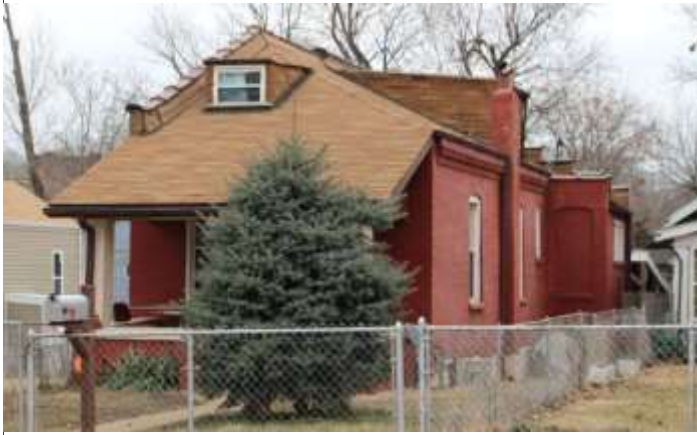
Front and south facades

Most of the building has been painted. Demolition of the adjacent building in 2010 has exposed the majority of the north elevation which has not been painted. See attached photos.

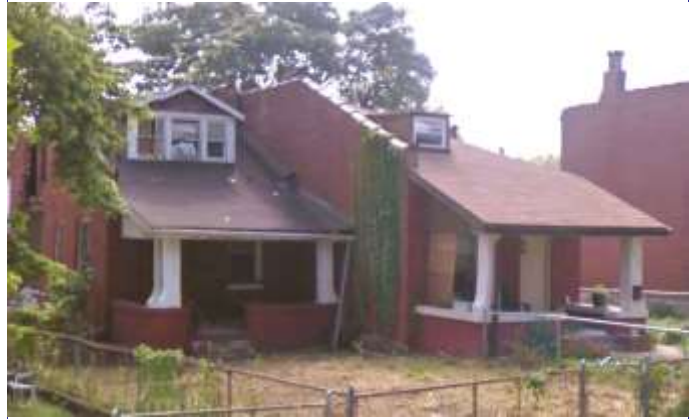
photo taken prior to demo of adjacent bldg.
