**ARCHITECTURAL/HISTORIC INVENTORY FORM - Cultural Resources Office**  
**St. Louis Planning and Urban Design**

1. Survey no. SLC-AS-053-0102	2. Survey name: Thematic Survey of Flounder Houses in St. Louis City	3. County: St. Louis [Independent City]
4. Address: (from City GEO database) <b>900 HICKORY ST</b>		5. City/State: St. Louis, Missouri
Alternate address: 900 Hickory Street		Property Zip Code: 63104
Latitude: 38.615737		6. UTM Easting: 743886.40
Longitude: -90.198830		UTM Northing: 4277858.27
8. Historic Name (if known): N/A	11a. Historic Use (if known): Commerce/Trade	City Block 467.03
9. Present/other name (if known):	11b. Current Use: Commerce/Trade	City Ward 7
7. Township-Range-Section: N/A		10. Ownership: Private
Neighborhood Number: 34

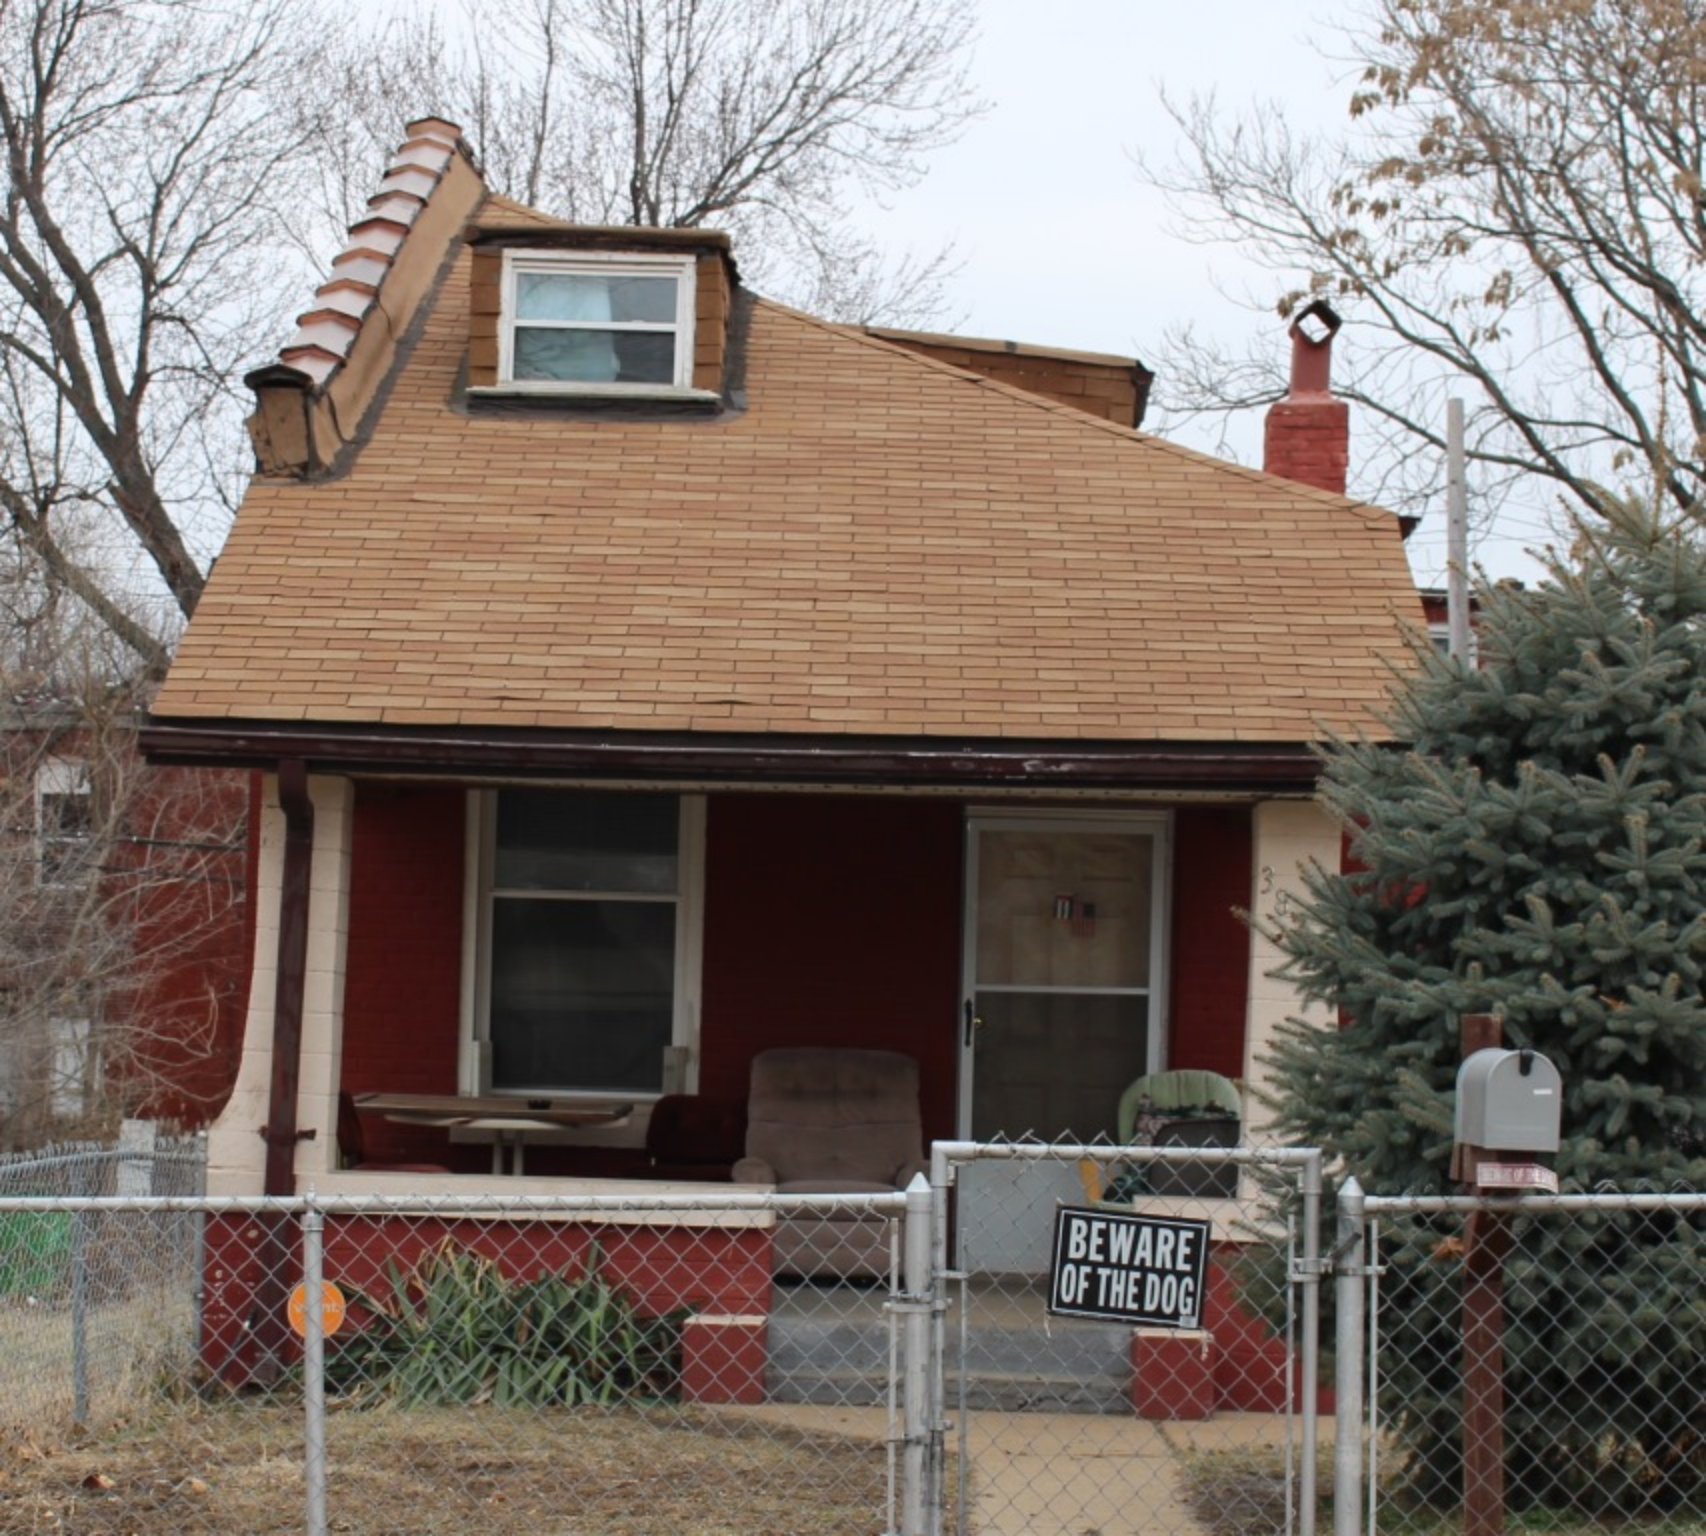
One and a half story flounder. Full length, concrete block front porch has Craftsman design and is not original. The existing front hip was extended to form the roof of the new porch. Windows and doors on the first floor have segmental soldier arches; original sills have been replaced. A small brick stove chimney projects from approximately the midpoint of the south elevation, interrupting a heavy, dentilled brick cornice that continues across this façade and likely the front as well, although obscured by the shed roof of the porch. A small window under a steel lintel has been cut into this façade at the junction of the rear addition. The roof, sheathed in brown composition shingles, has two dormers. The one at the front elevation, in a typical location for a hipped front flounder, may be original but modified, with a metal replacement window one on the west and one on the south. The south dormer is a later addition, likely added at the same time as the one-story brick ell at the rear. The ell's front-facing window has been blocked and a replacement casement window added on the south side.

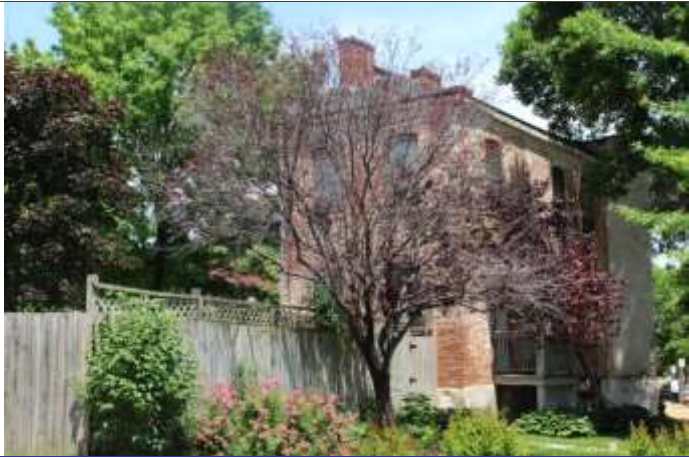
Foundation parged; porch fairly recent.

This 2-story brick flounder presents its long side to the street at an angle to the current street grid. The three-bay façade has an entrance in the south bay. A replacement wood porch and steps has a shed roof and shelters the basement entrance below the main entrance. Window openings have segmentally-arched heads formed of soldier brick and wood sills; storm sash makes it difficult to see the sash behind it. A corbelled brick cornice edges the façade and the south end façade where there are two bays of windows. The building abuts another on the north side. The taller rear wall has what appears to be a historic window at the attic level and two windows added at the second story level.

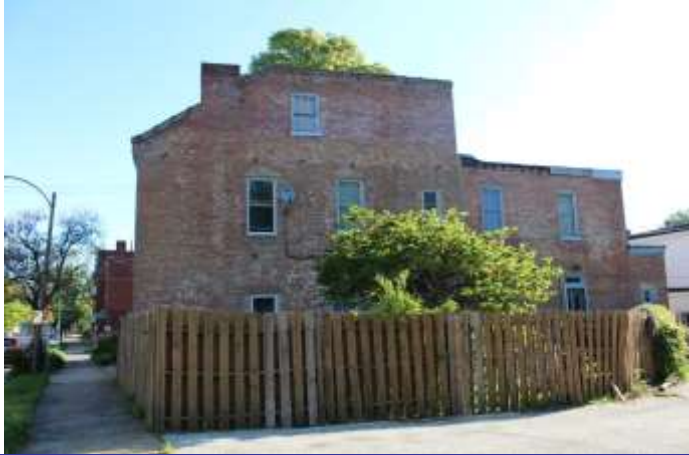
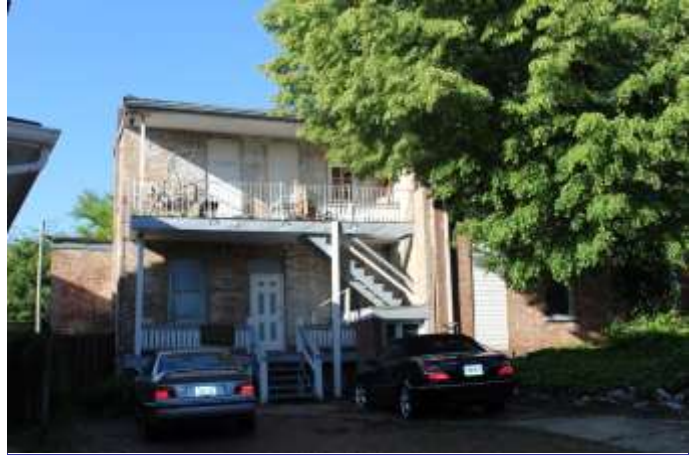
paint wearing off of brick; front of building at sidewalk on Iowa

This 2 1/2 story flounder is at the sidewalk; the original rectangular portion has 3 bays on the front and 3 on the side; an early two-story wing has a flat roof and a two-story gallery along the north side. The entrance in the façade is on the north side, approached by only a single step. A simple denticulated brick cornice edges only the façade wall at the eaves. The entrance and other openings on the ground story have segmentally-arched heads with soldier courses and painted wood or stone sills; second story windows have flat heads. The three bays in the north wall have have openings at both levels with segmentally-arched heads; they include a blocked door in the rear bay, and a blocked window on the first story. This flounder is unusual in that the taller wall on the south side has openings at each level with square heads; they have flat heads and include a window at the attic level with historic 6/6 doublehung wood sash. The attic window and one window at the first story are visible in the Compton & Dry depiction of the building. The rest of the window openings have 1/1 wood sash. Chimneys rise from both the north and south side walls near the façade. There is an entrance in the south side of the rear wing. The replacement wood gallery on the north side of the rear wing is approached by wood steps and has exterior wood steps to the second level, where there are two door openings, as well as windows. A brick extension houses the exterior access to the basement; there are basement window below the façade window bays but the extent of the bsement has not been determined.

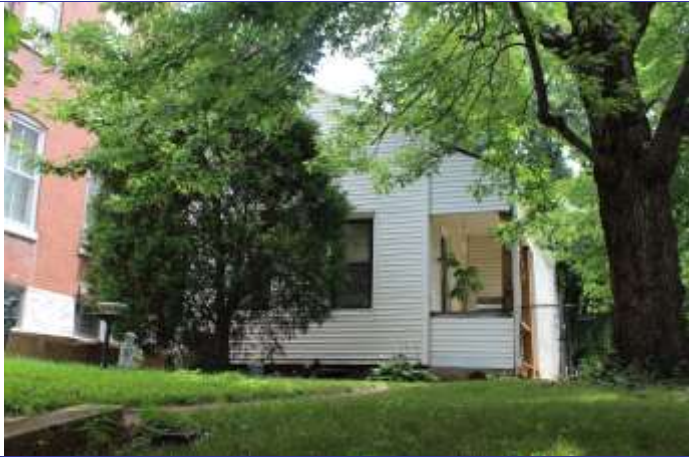
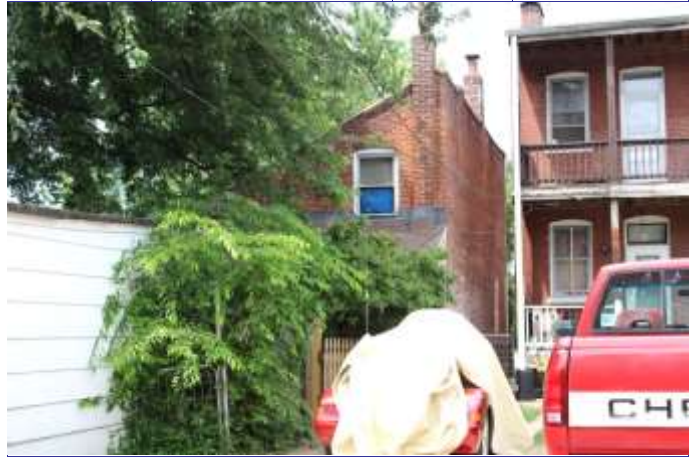
This one-and-one-half-story brick flounder has exposed brick on the taller windowless north wall. The façade is clad with vinyl siding, and the same material encloses the side gallery and a rear porch. The front bay of the gallery has been left open to serve as an entrance porch. The taller wall is windowless. A window in the rear wall lights the attic.

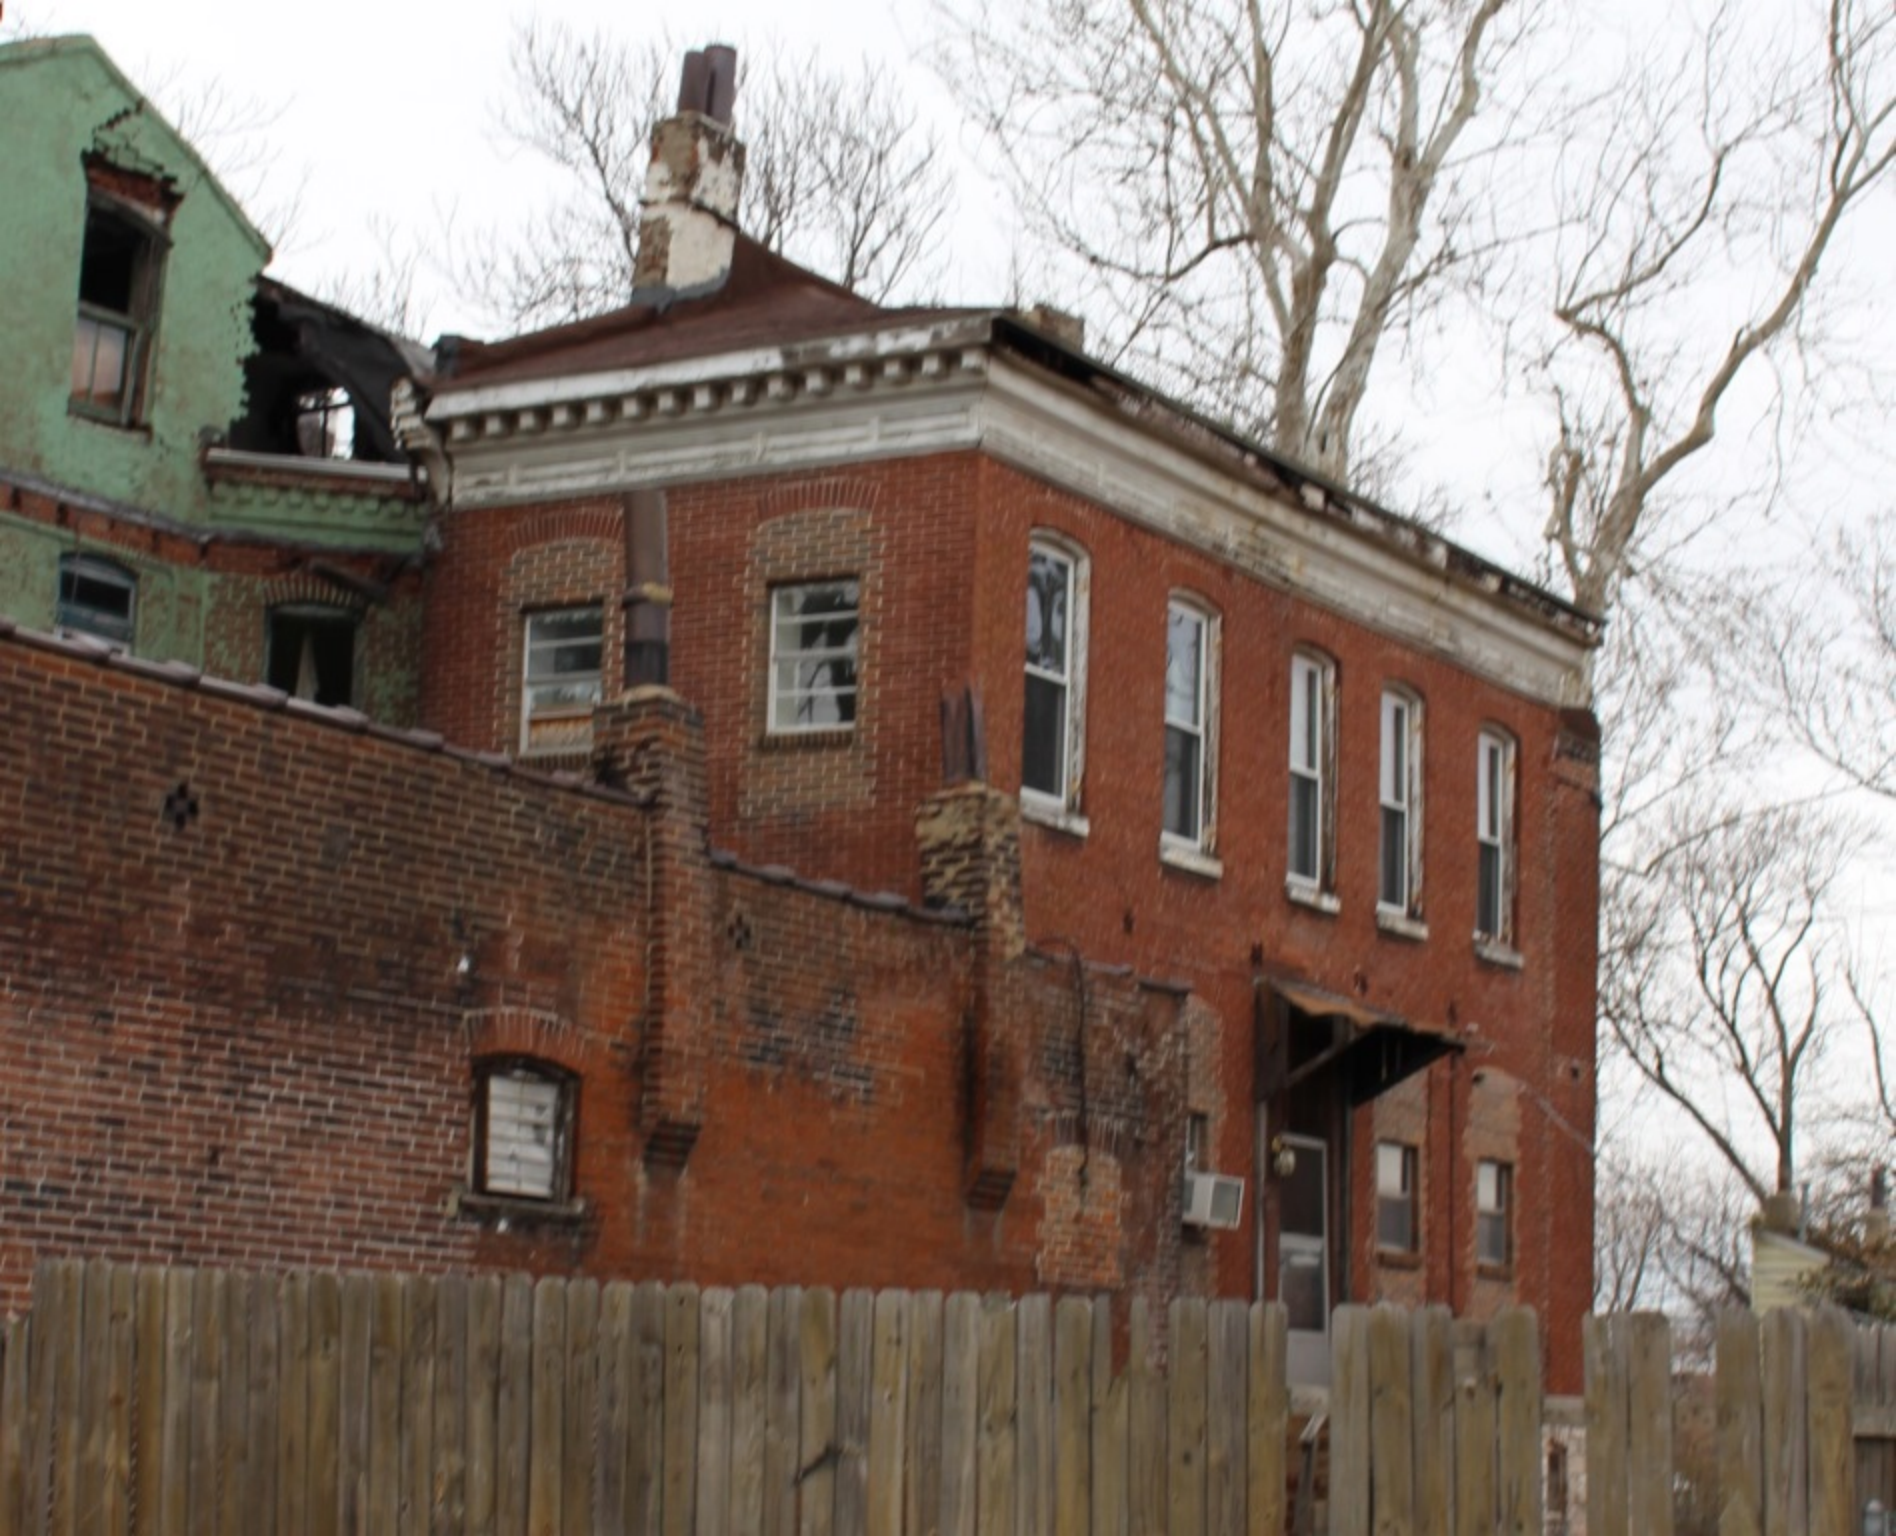
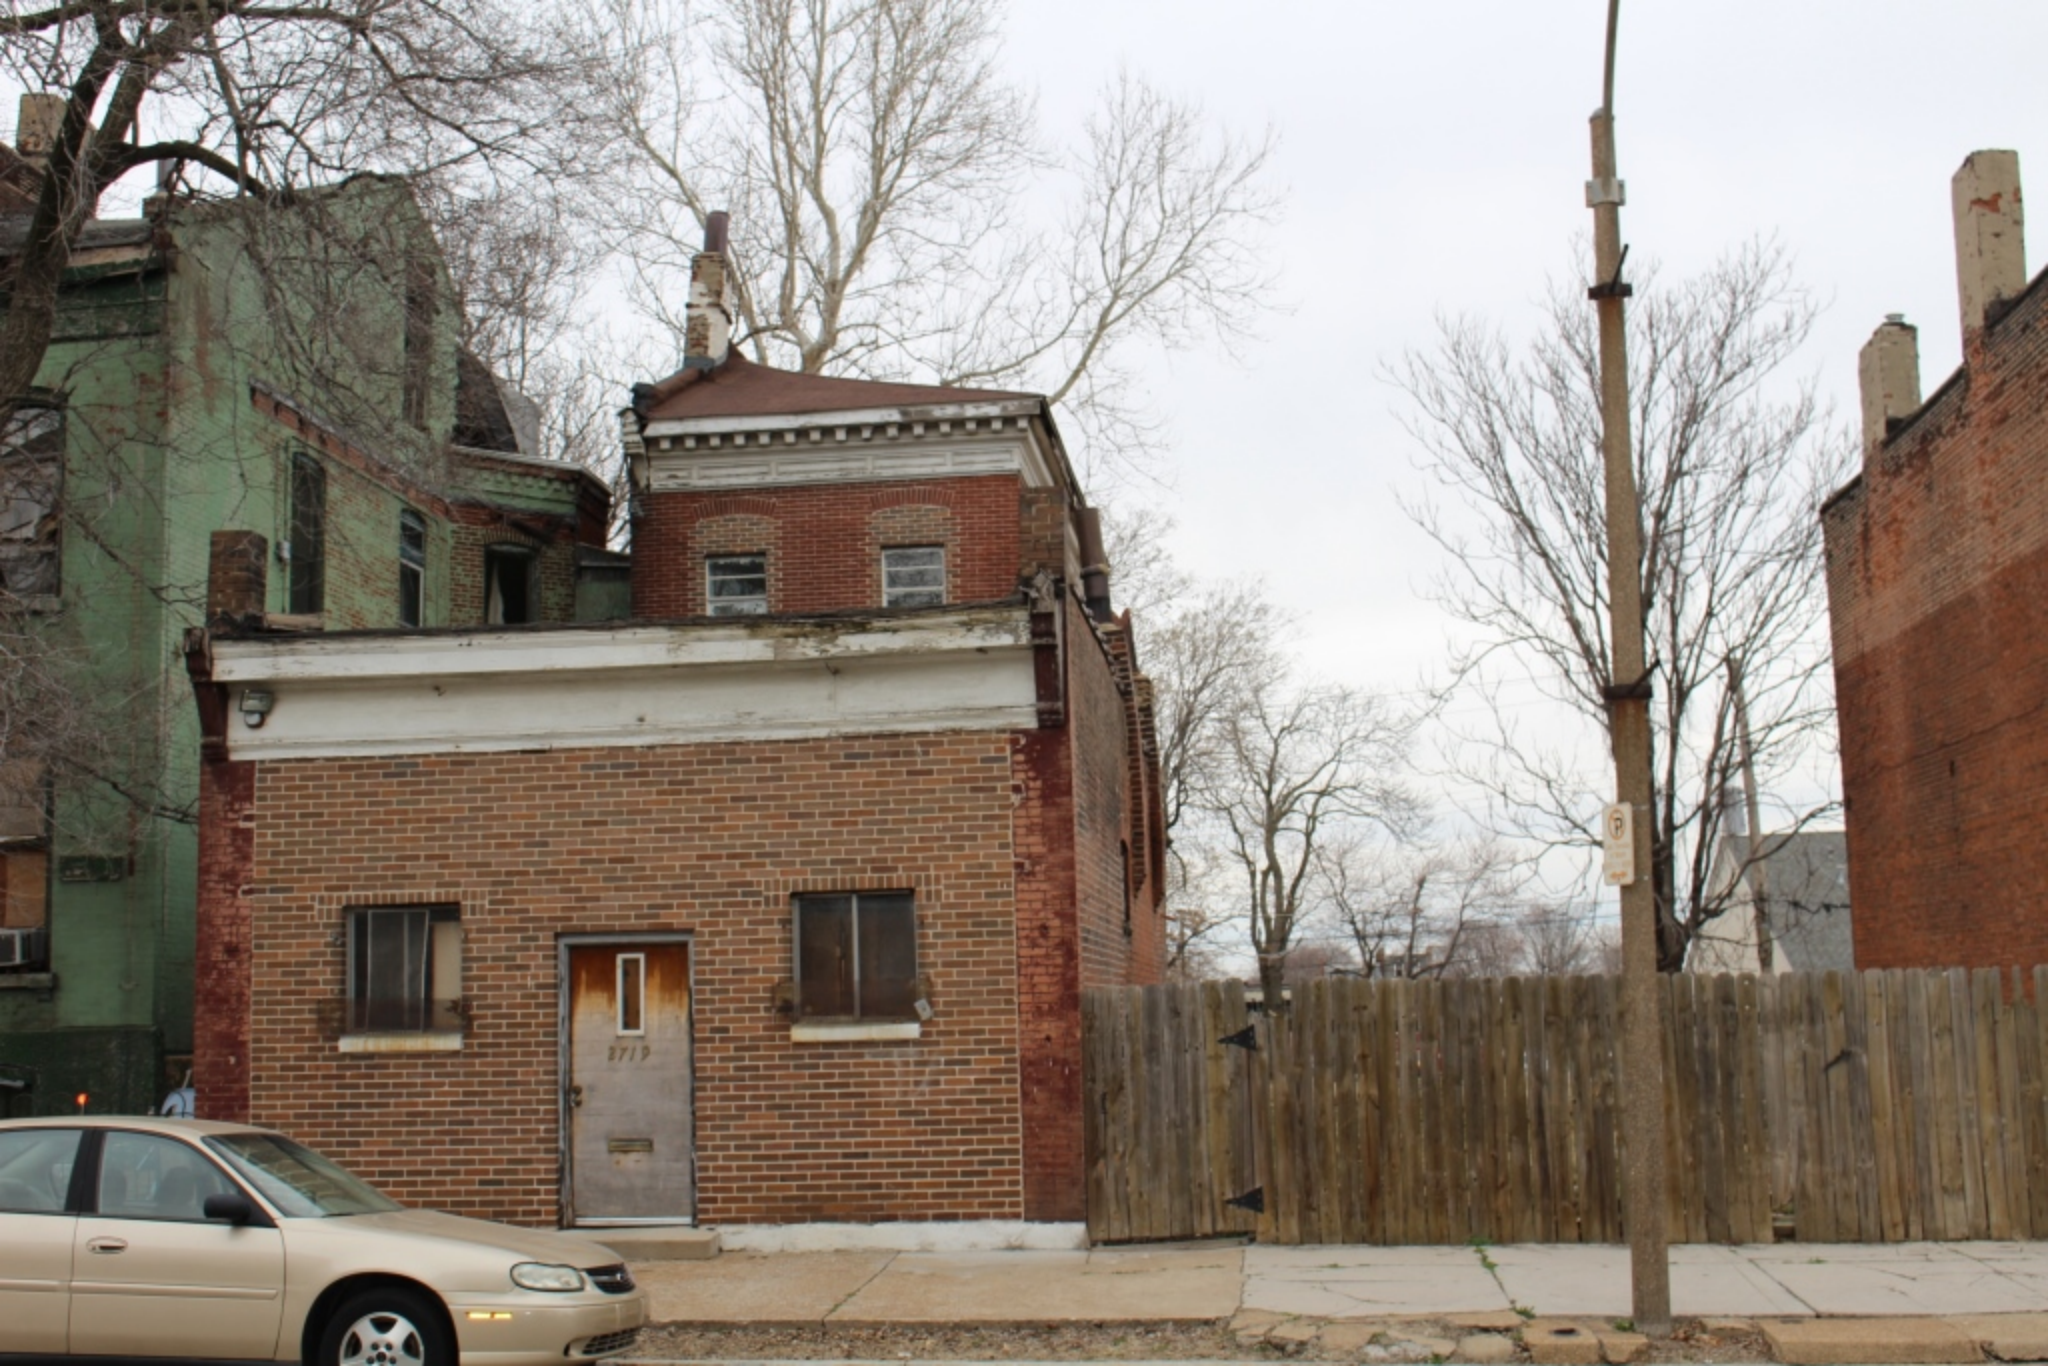
This two-story brick flounder with low-hipped roof terminations at the front and rear has a shed-roofed flounder ell. Situated at the middle of the lot (front to back) a one-story brick addition on the front is commercial space (the storefront area has been filled in with brick). A distinctive paneled wood cornice with dentils on the street end edges two sides of the roof and returns to the edge of the flounder rear ell. Window openings at most lower story, and the two bays facing the street have been reduced in height and width and have replacement sash; the second story windows in the east wall are intact. Chimneys rise at both ends of the parapet wall along the peak of the shed roof portion of the roof. The design of the entrance in the east side has been lost due to the replacement stoop and porch shed roof.

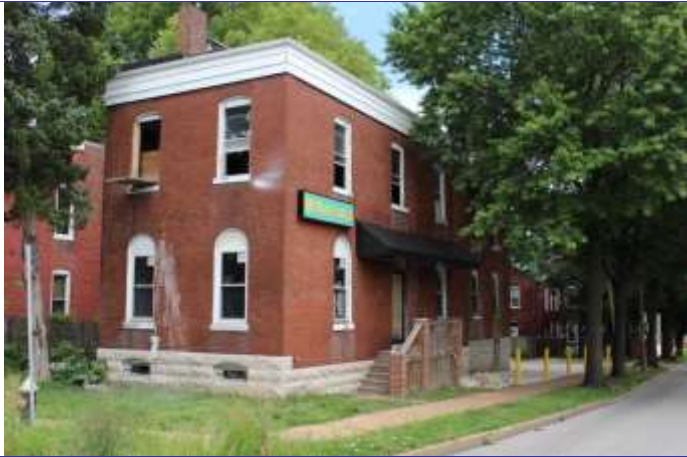
**1323 S JEFFERSON AV**

Metal coil stock covers cornice area; side porch a replacement combination brick post and wood. Yard recently covered with paving as conversion to business use.

This corner property consists of two flounder forms with a more high-style one at the corner and a plainer one to the north; the structure is either a large house with a large rear wing, or semi-detached dwellings as suggested by the labeling on the 1909 Sanborn Map. The corner block has round-arched windows on the main story and segmentally-arched ones above; the entrance is located in the second bay from the corner. The north block is one narrow-bay narrower than the front block. All of its window openings are segmentally-arched. The limestone foundation throughout is cut and coursed rock-faced limestone. A modest corbelled brick cornice remains exposed on the north block.

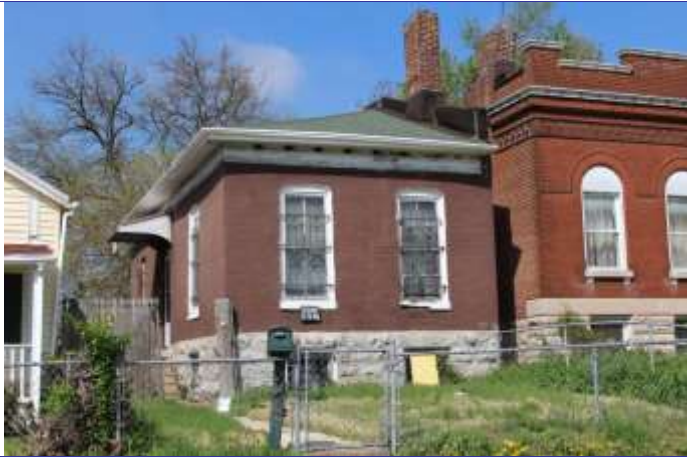
**1127 KENTUCKY AV**

wood vergeboard needs paint; one front wood sill has piece missing; fairly new roof with projecting eaves shelters vergeboard. It appears that a recessed wood porch on the side of the entrance has been enclosed with brick.

This one-story brick flounder has a raised rubblestone foundation with windows above grade. The shed roof with hipped front is a replacement one with eaves projecting enough to shelter the molded wood vergeboard along the front and side. Arched window openings, including the two on the front and one in front of the door on the side with the entrance have 2/2 wood sash. The entrance in the center bay on the side has a wood stoop and is sheltered by a modern aluminum awning. The windowless taller wall is at the property line. The house is positioned at the block's general set-back line.

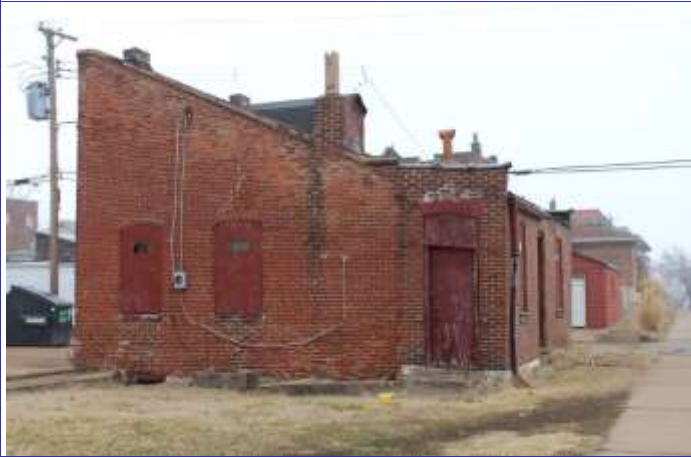
Looking north

Wood porch shown along Keokuk now brick addition.  
Condition rolled roofing; sagging rafters; brick stepped cracks and in movement

The one-story with loft brick flounder with higher blind north wall is located at the corner of Keokuk Street and an alley. All of the openings are boarded, including the dormer window in the shed roof and attic door and window. The bay facing Keokuk has a lower-pitched roof and joints in the brick indicate that it is an addition to the original flounder, obscuring what originally was likely a side gallery with brick wing walls. It presents three bays to Keokuk: a door flanked by windows in soldier headed segmentally-arched openings. This bay has a door in the west side and a window in the east. The openings in the other portion of the building have headers forming the arched openings. Two of the four chimneys are located at the high point of roof and the other two near front corners of original house. The gable-roofed dormer is offset slightly to the west and positioned low in the attic space.

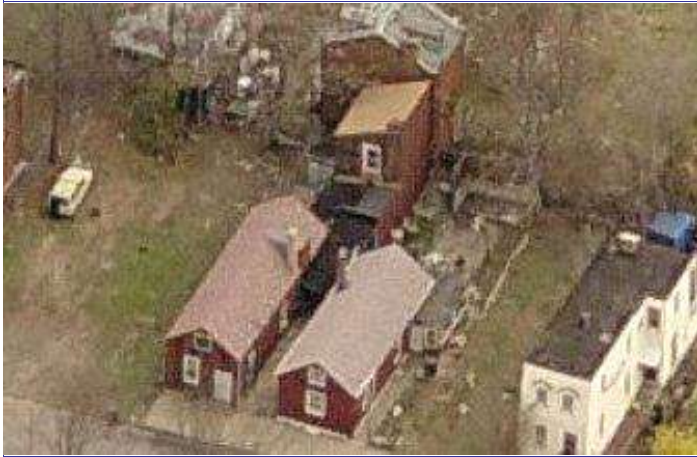
**3242 KNAPP ST**

Very difficult to see from the public right-of-way. Best view is down a narrow gangway between two street properties. It appears to be used currently for storage. The front house is occupied.

This is a 1-1/2 story frame flounder sited at the rear property line of 3242 Knapp; it has a square footprint. Its taller blind wall abuts the south property line and has a single brick stove chimney at the southeast corner. The front, west-facing façade has a 1-story frame addition, ca. 1925, projecting from its first story. Above in the apex below the roof, is a single doublehung window, now replaced with vinyl sash. The flounder's east façade is obscured by an adjacent two-story brick alley house at 3240 N. 20th Street. The north elevation has 2 doublehung windows at the second story; its first story is hidden by several small shed additions. The building has been sided with asphalt brick-pattern shingles.

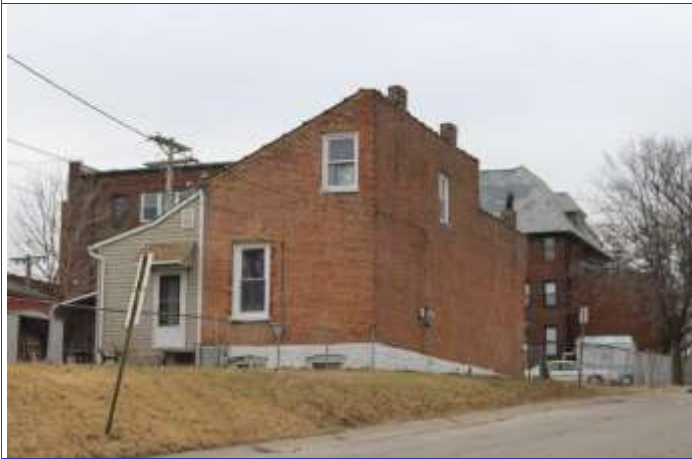
**3741 KOSCIUSKO ST**

One and a half story brick flounder with a one story frame addition that runs the length of the south façade. The original brick portion has two segmentally arched basement window facing the street. There is a single window on the first floor of the east side with a single window in the half story gable end. Both opening appear to have been altered at some poitn. The firsrt and secon d floor windows have stone sills. On the north side of the building that is usually devoid of fenestration, there is a singe trabiated doublehung window at the second floor. The entrance to the house accessed through the fram addition. The door has a craftsman appearance and is accompanied by a smal she awning. On the south side of the building there is a single dormer centered on the roof. Four windows punctuate the frame addition on the south side. There is a one-story brick and frame addition off of the west side of the building. A wing wall extends from the main block of the building and a frame portion accounts for the rest of the mass of the addition.

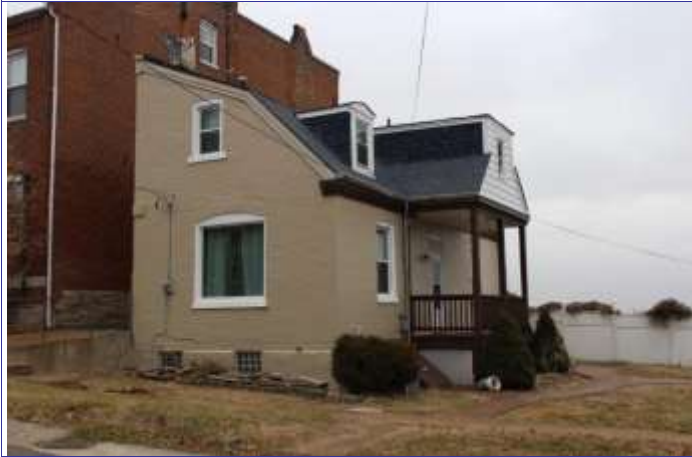
Street and south facades looking east

The 1-1/2 story building has a half-gambrel roof with a large central entry porch on the south side. The stone foundation has been parged and foundation and building painted a tan color. Original openings are placed under soldier segmental arches and have wood sills. The street-facing west façade has been altered with the insertion of a wide fixed window under a segmental arch of 2 rowlock rows. At the second story, a small doublehung window is centered under the gable; the brick parapet has been wrapped with aluminum. The south façade contains the main entry, a centered door with transom, flanked by two double-hung windows. Above, an original, pedimented dormer is above each window. An original center dormer has been increased in size and projects out over the front entry porch, also a later alteration. A prominent dentiled brick cornice runs the length of the south façade and returns approximately one foot at both east and west facades. The basement windows on all sides have been infilled with glass block.

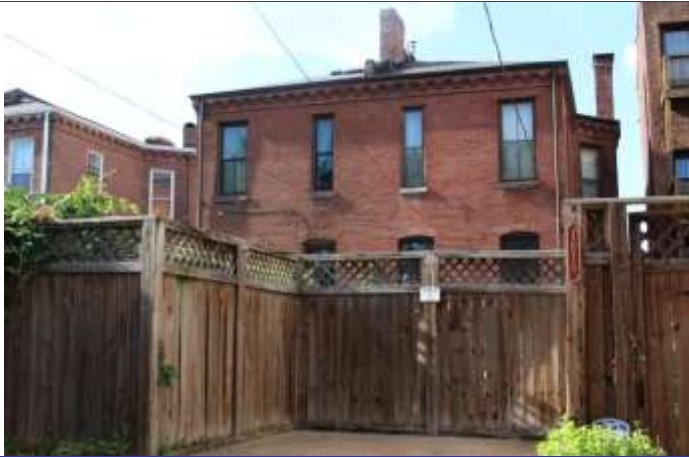
**1816 LAFAYETTE AV**

This is the eastern one of a pair of identical semi-detached brick flounders. The 2-story units present two bays to the street for a unified four-bay combined façade. A corbelled brick cornice edges the entire building at the horizontal eaves of the low-pitched shed roof with hipped front and rear. Each flounder has an entrance near the back half of the building, just in front of a brick bay window. The window openings on the ground story of the façade have segmentally-arched heads formed of soldier bricks and have arched sash. The heads of the second story windows have been altered and are now under steel lintels. Sills are painted stone. Corbelled chimneys rise at the parapet dividing the roof and from the bays. There is no porch; the entrance is "punched" in the wall. There is no rear wing.

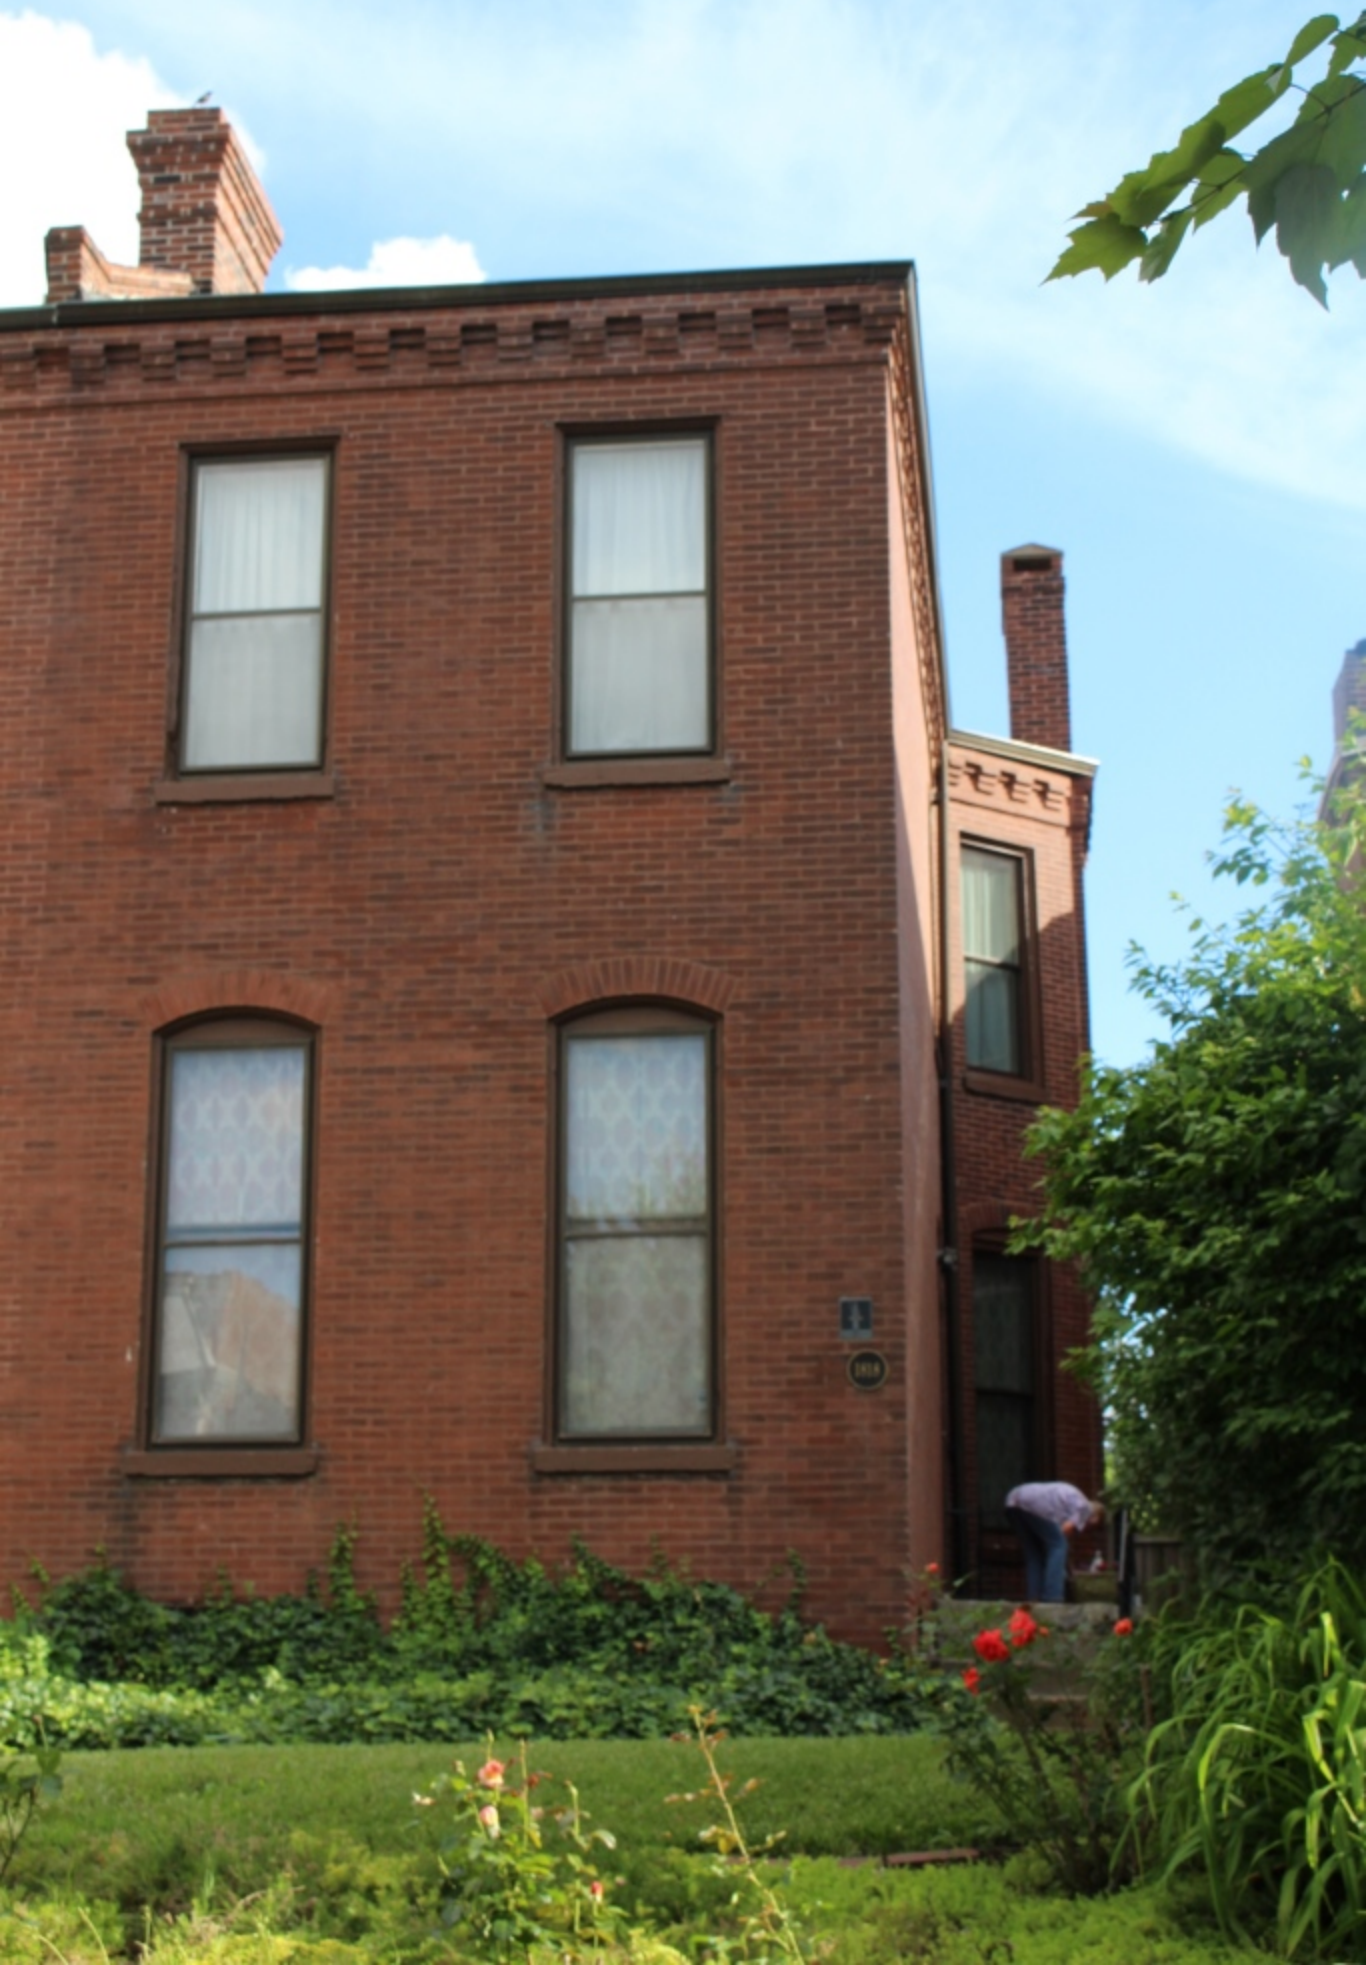
This is the western one of a pair of identical semi-detached brick flounders. The 2-story units present two bays to the street for a unified four-bay combined façade. A corbelled brick cornice edges the entire building at the horizontal eaves of the low-pitched shed roof with hipped front and rear. Each flounder has an entrance near the back half of the building, just in front of a brick bay window. The window openings on the ground story of the façade have segmentally-arched heads formed of soldier bricks and have arched sash. The heads of the second story windows have been altered and are now under steel lintels. The sills of these window openings and those of the second story with square-headed ones on the second story are painted stone. Corbelled chimneys rise at the parapet dividing the roof and from the bays. There is no porch; the entrance is "punched" in the wall. There is no rear wing.

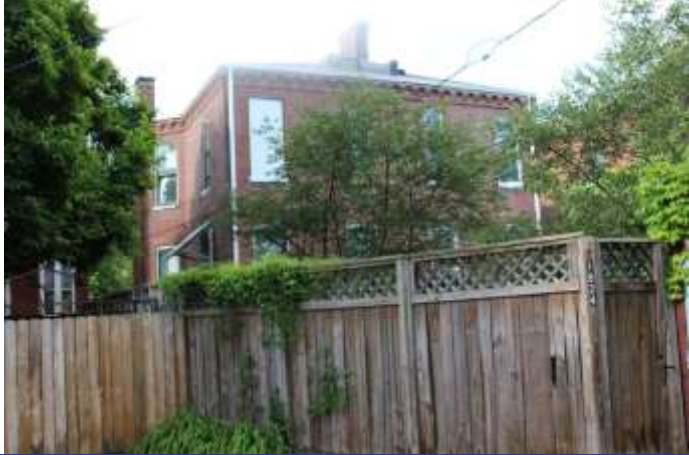
**1822 LAFAYETTE AV**

This is the eastern one of a pair of identical semi-detached brick flounders. The 2-story units present two bays to the street for a unified four-bay combined façade. A corbelled brick cornice edges the entire building at the horizontal eaves of the low-pitched shed roof with hipped front and rear. Each flounder has an entrance near the back half of the building, just in front of a brick bay window. The window openings on the ground story of the façade have segmentally-arched heads formed of soldier bricks and have arched sash. The heads of the second story windows have been altered and are now under steel lintels. Sills are painted stone. Corbelled chimneys rise at the parapet dividing the roof and from the bays. There is no porch; the entrance is "punched" in the wall. There is no rear wing.

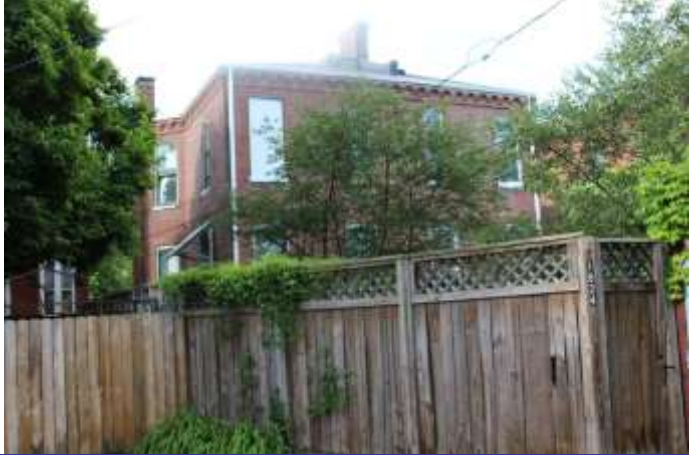
**1826 LAFAYETTE AV**

This is the eastern one of a pair of identical semi-detached brick flounders. The 2-story units present two bays to the street for a unified four-bay combined façade. A corbelled brick cornice edges the entire building at the horizontal eaves of the low-pitched shed roof with hipped front and rear. Each flounder has an entrance near the back half of the building, just in front of a brick bay window. The window openings on the ground story of the façade have segmentally-arched heads formed of soldier bricks and have arched sash. The heads of the second story windows have been altered and are now under steel lintels. Sills are painted stone. Corbelled chimneys rise at the parapet dividing the roof and from the bays. There is no porch; the entrance is "punched" in the wall. There is no rear wing.
