**ARCHITECTURAL/HISTORIC INVENTORY FORM - Cultural Resources Office**  
**St. Louis Planning and Urban Design**

1. Survey no. SLC-AS-053-0102	2. Survey name: Thematic Survey of Flounder Houses in St. Louis City	3. County: St. Louis [Independent City]
4. Address: (from City GEO database) <b>900 HICKORY ST</b>		5. City/State: St. Louis, Missouri
Alternate address: 900 Hickory Street		Property Zip Code: 63104
Latitude: 38.615737		6. UTM Easting: 743886.40
Longitude: -90.198830		UTM Northing: 4277858.27
8. Historic Name (if known): N/A	11a. Historic Use (if known): Commerce/Trade	City Block 467.03
9. Present/other name (if known):	11b. Current Use: Commerce/Trade	City Ward 7
7. Township-Range-Section: N/A		10. Ownership: Private
Neighborhood Number: 34

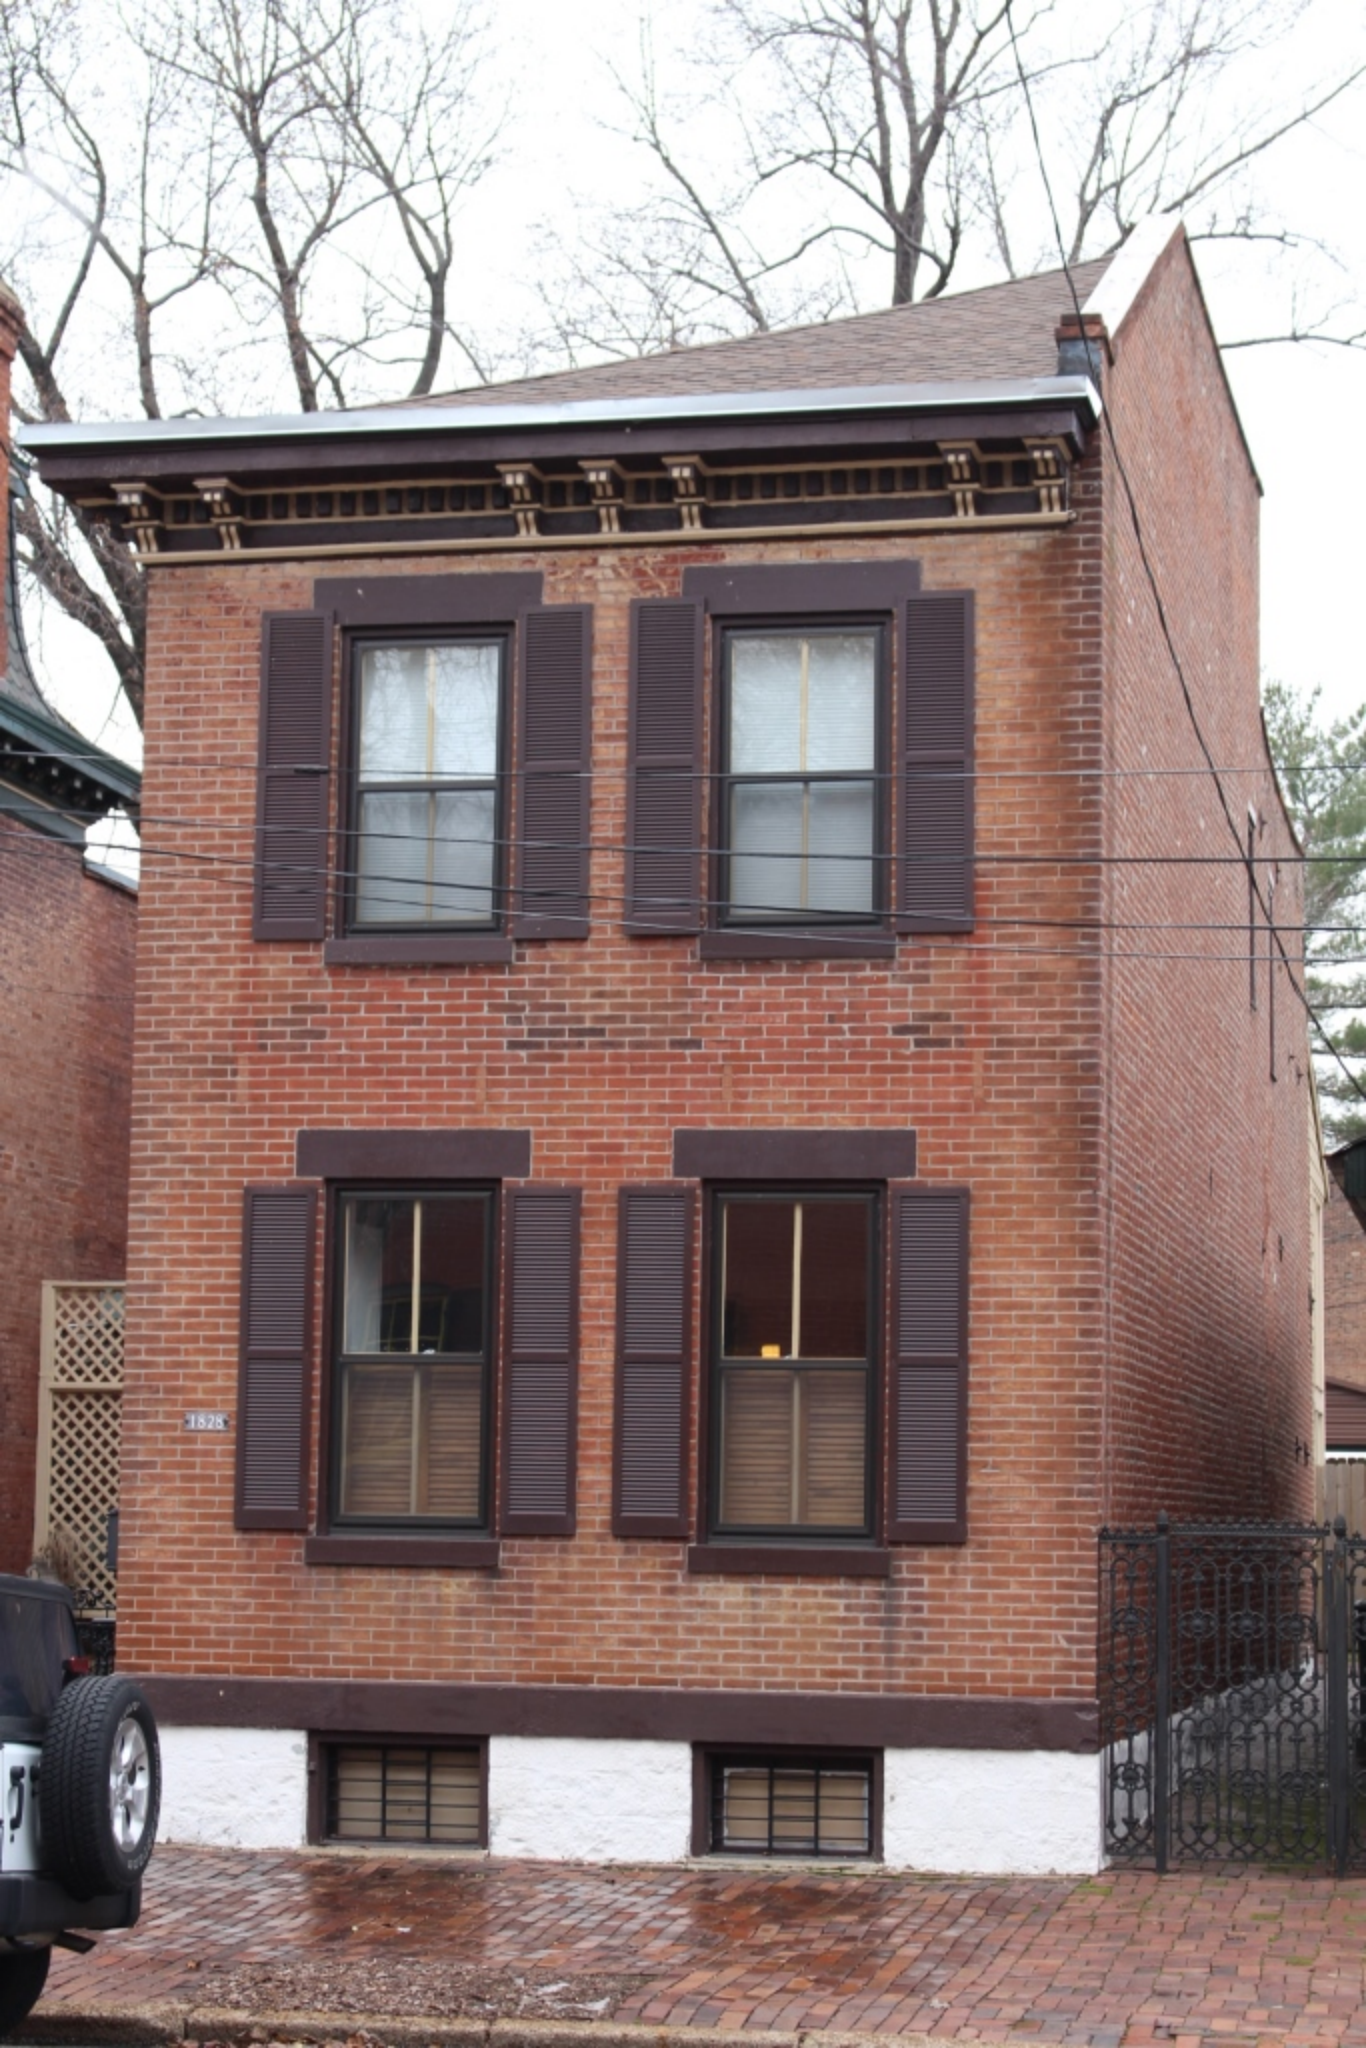
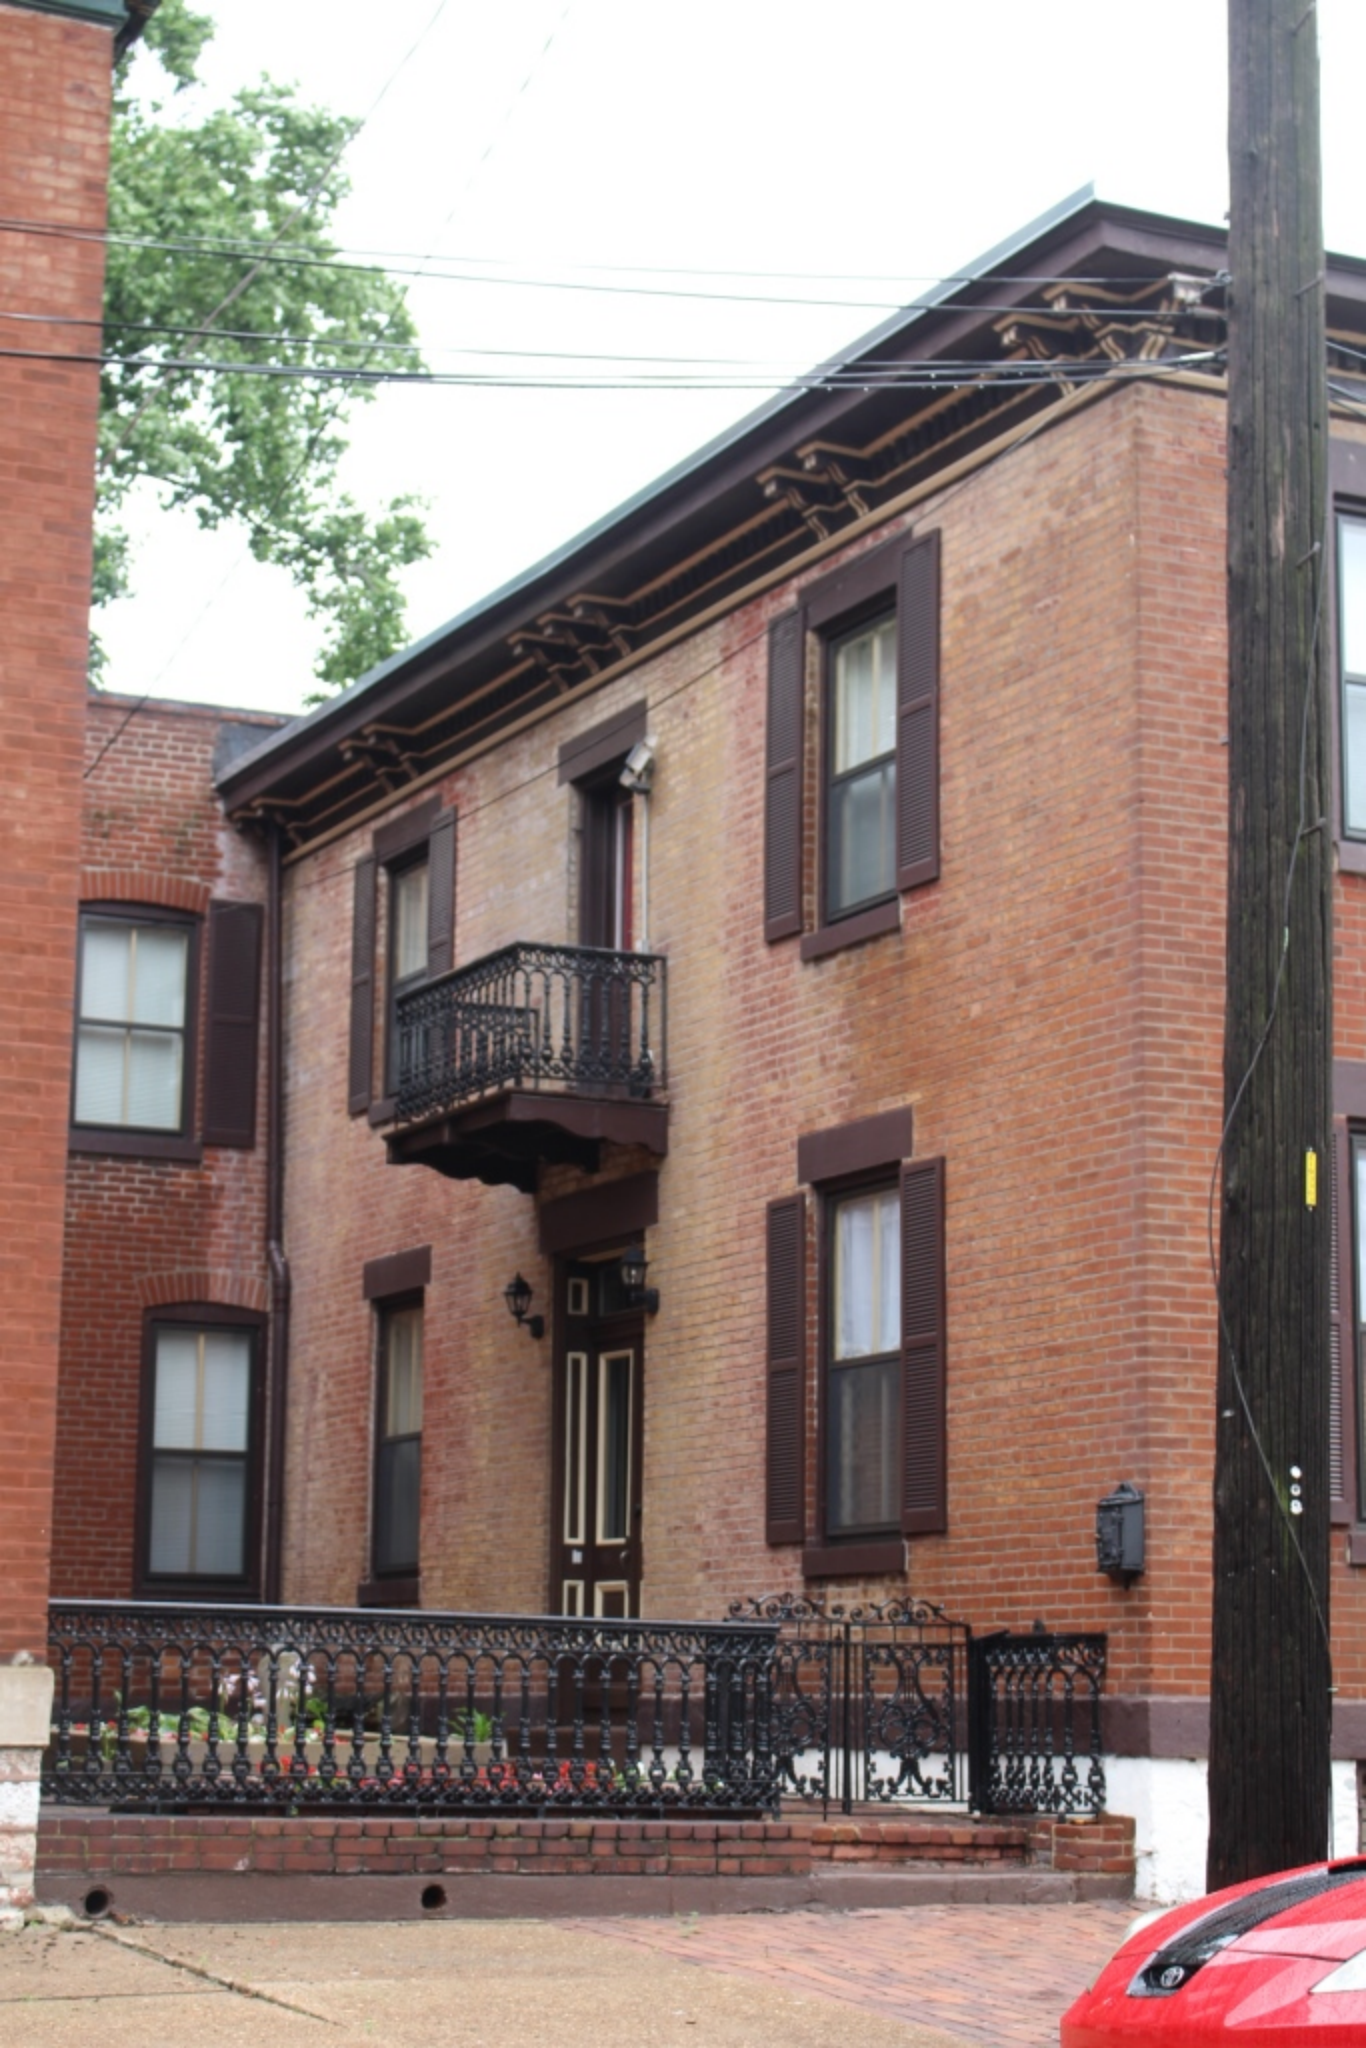
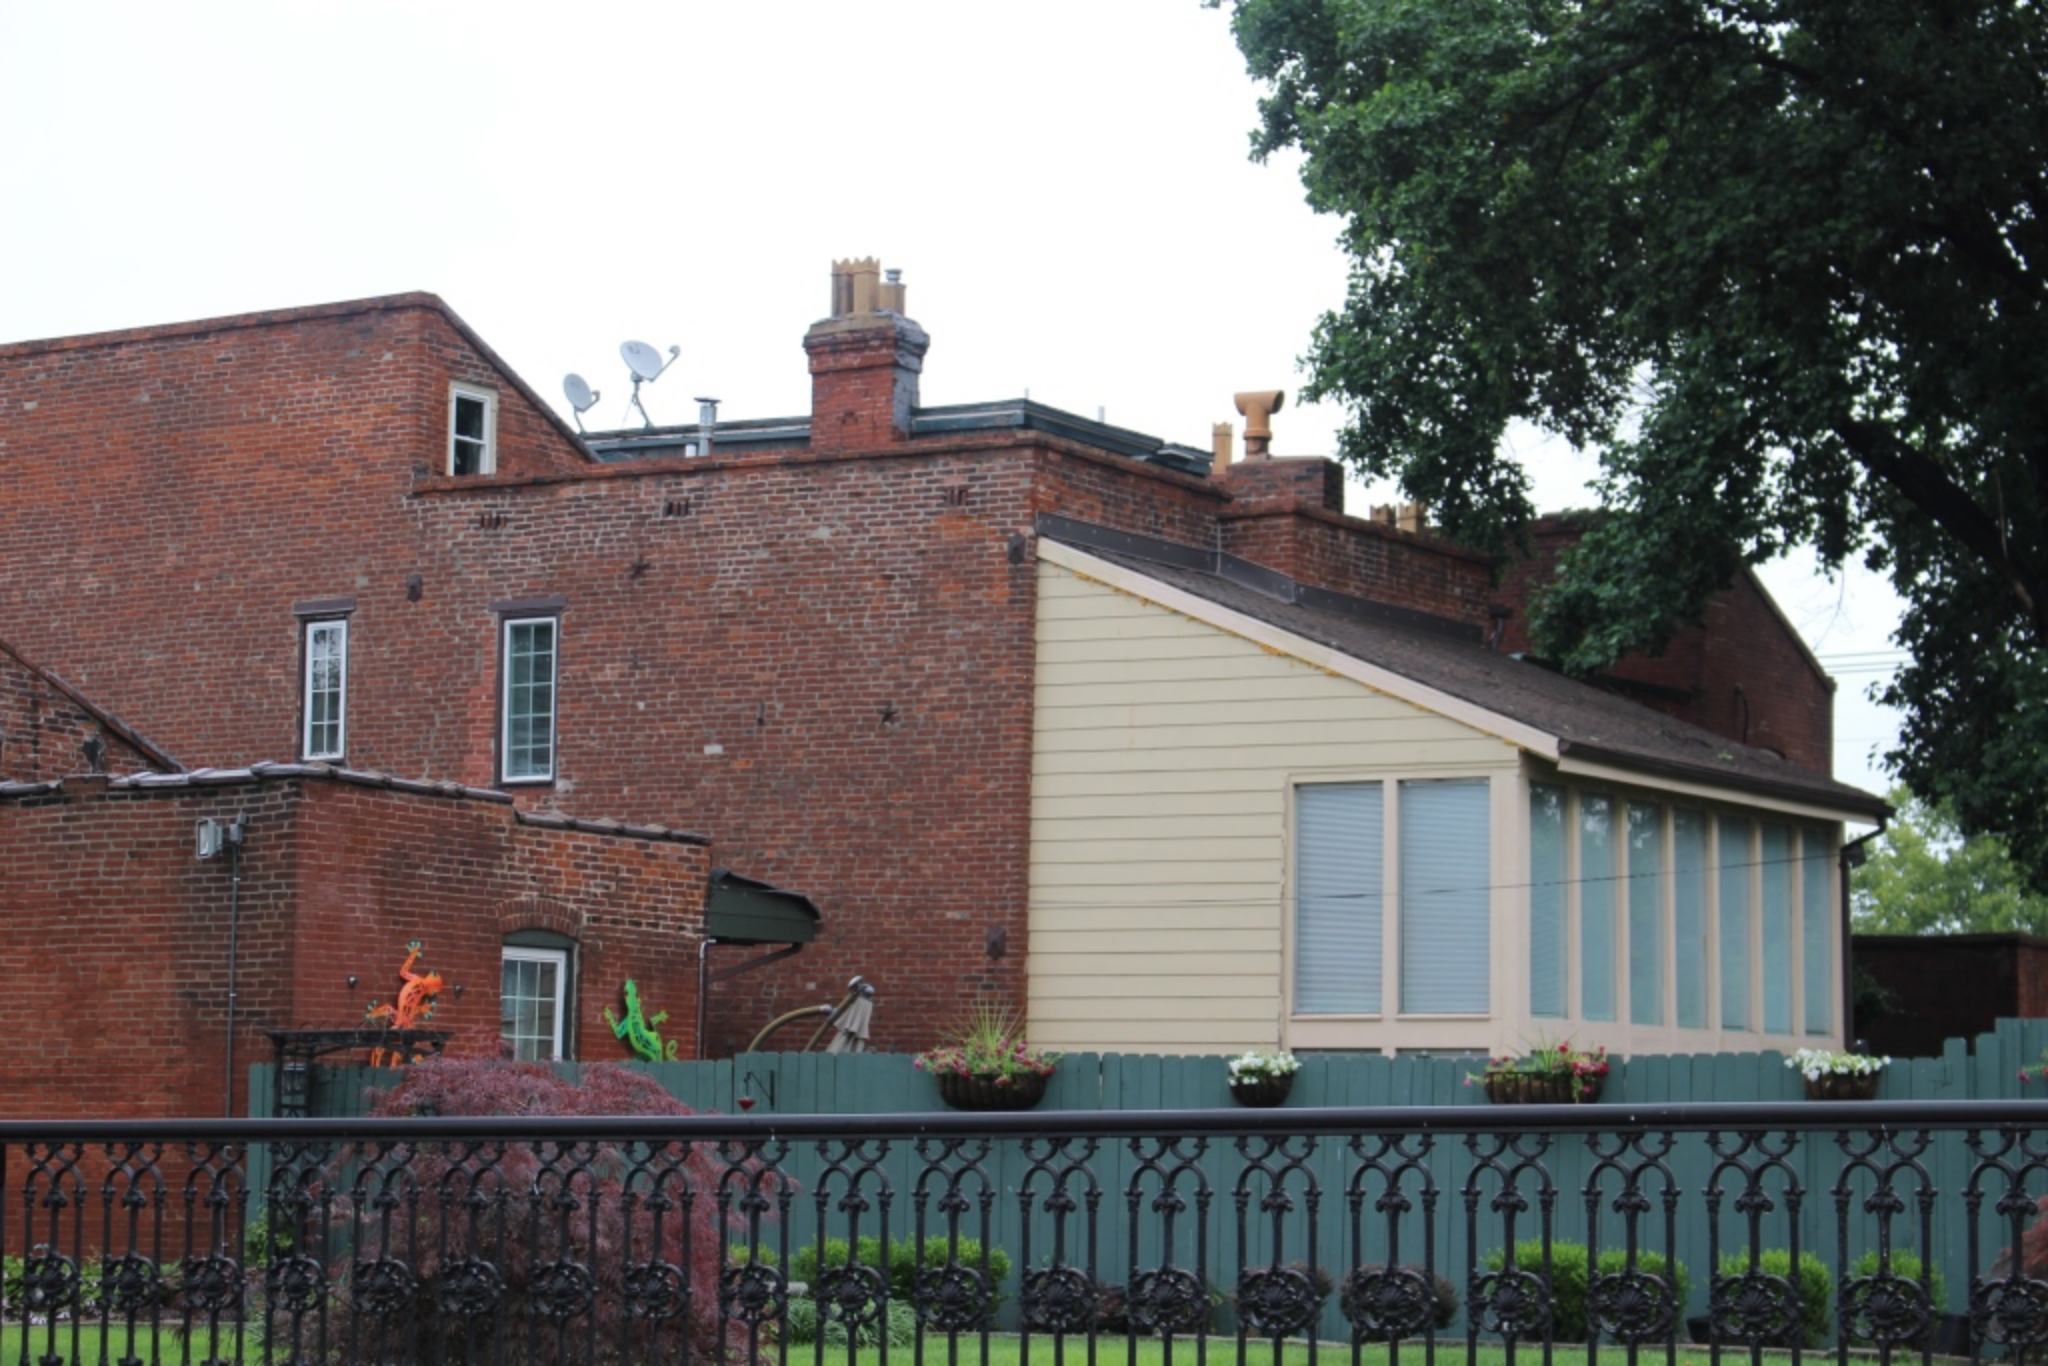
The 2-bay front façade has two 2/2 doublehung windows at each story, placed under heavy limestone lintels and sills. The front roof has a shallow pitched hip marked by a wide-eaved, bracketed wood cornice which returns the length of the east façade. This façade, originally 3 bays, has a recessed entry with panelled reveals and transom in the center bay, with a door above opening onto a wrought-iron balcony at the second story. The doors are flanked by windows identical to those of the front facade. The taller, blind wall is set at the west property line. A large 2-story brick addition was added c. 1900 at the rear of this elevation: it extends a single bay to the east, creating a L-shaped footprint.

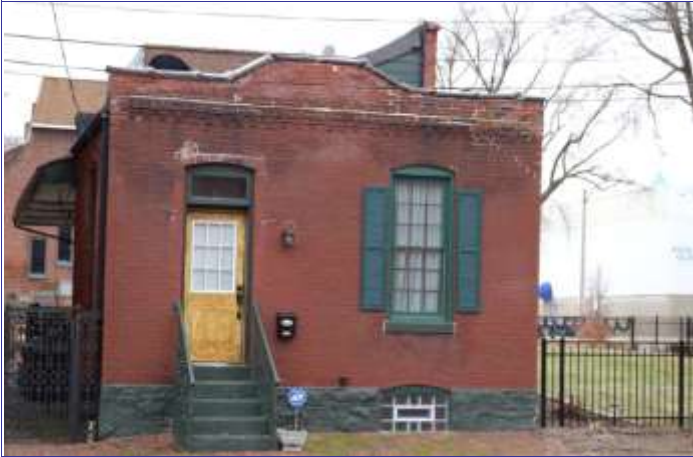
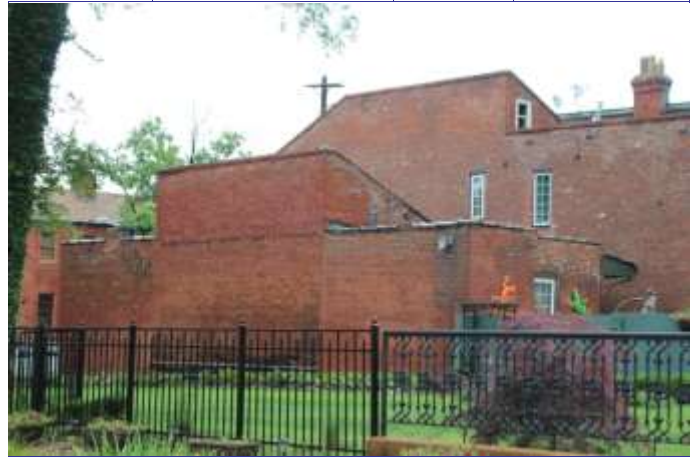
**1830 LAMI ST**

The original flounder house is set back from the street; its taller blind wall is sited at the western property line. It has a steeply-pitched shed roof and had originally a 2-bay front façade with a side gallery on the eastern façade; the gallery is extant and can be seen through the current gangway. Little of the flounder's front elevation remains, only a small portion near the apex of the roof, which is covered with asphalt siding: a fixed window has been added in the general location of the original loft opening. This area is partly visible above a 1-story, flat-roofed brick addition that was added to the front façade of the flounder sometime after 1909; it contains the new primary entry and is placed at the current building line of the block. The flounder's rear elevation has likewise been obscured with a 1-story brick addition.

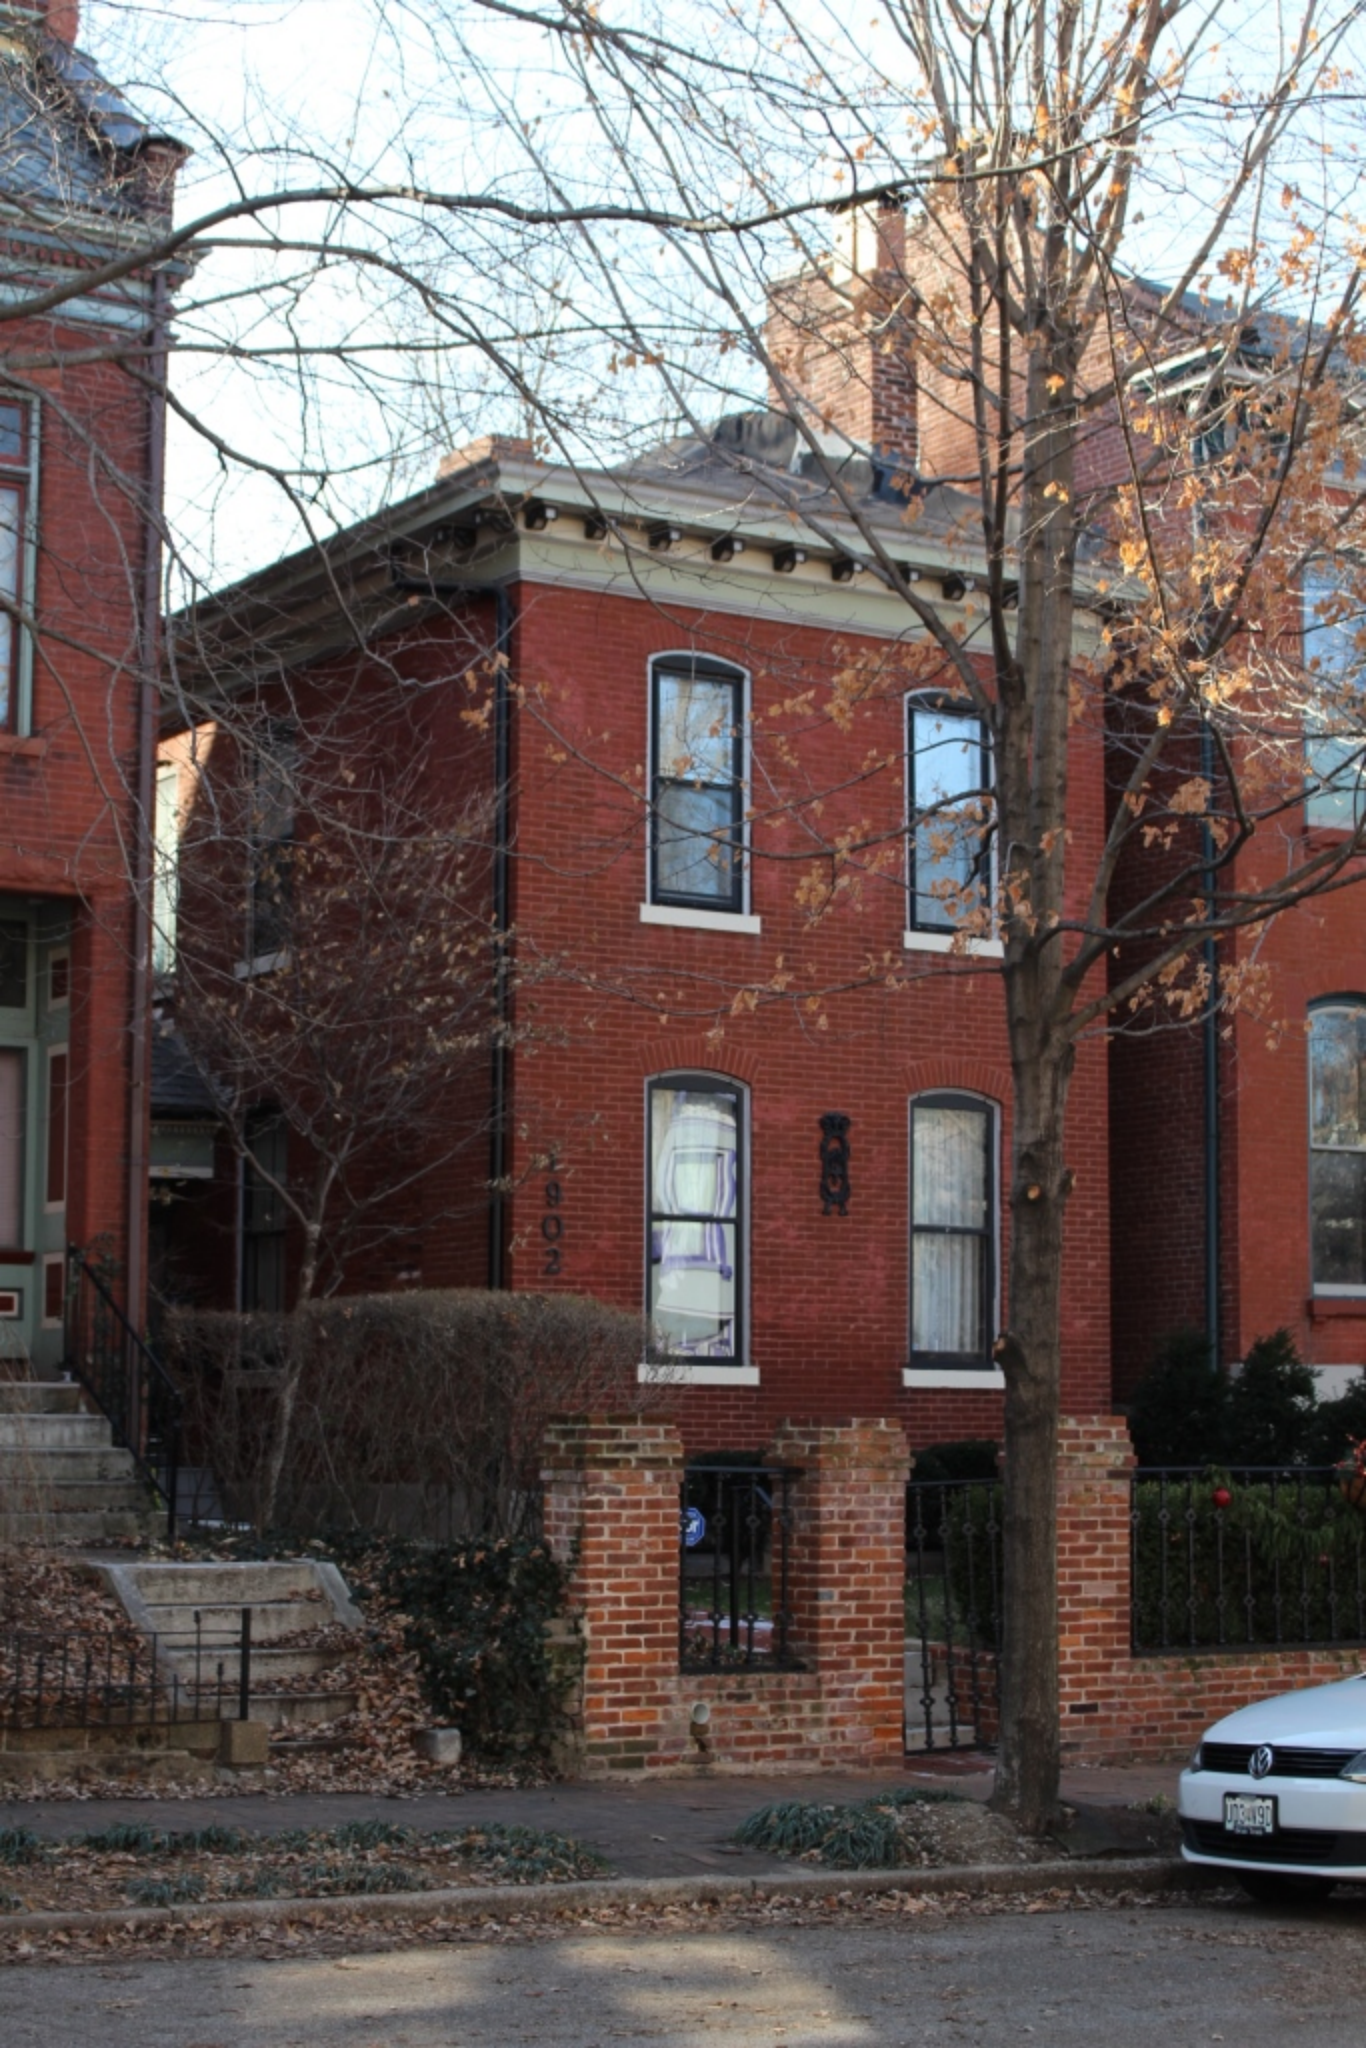
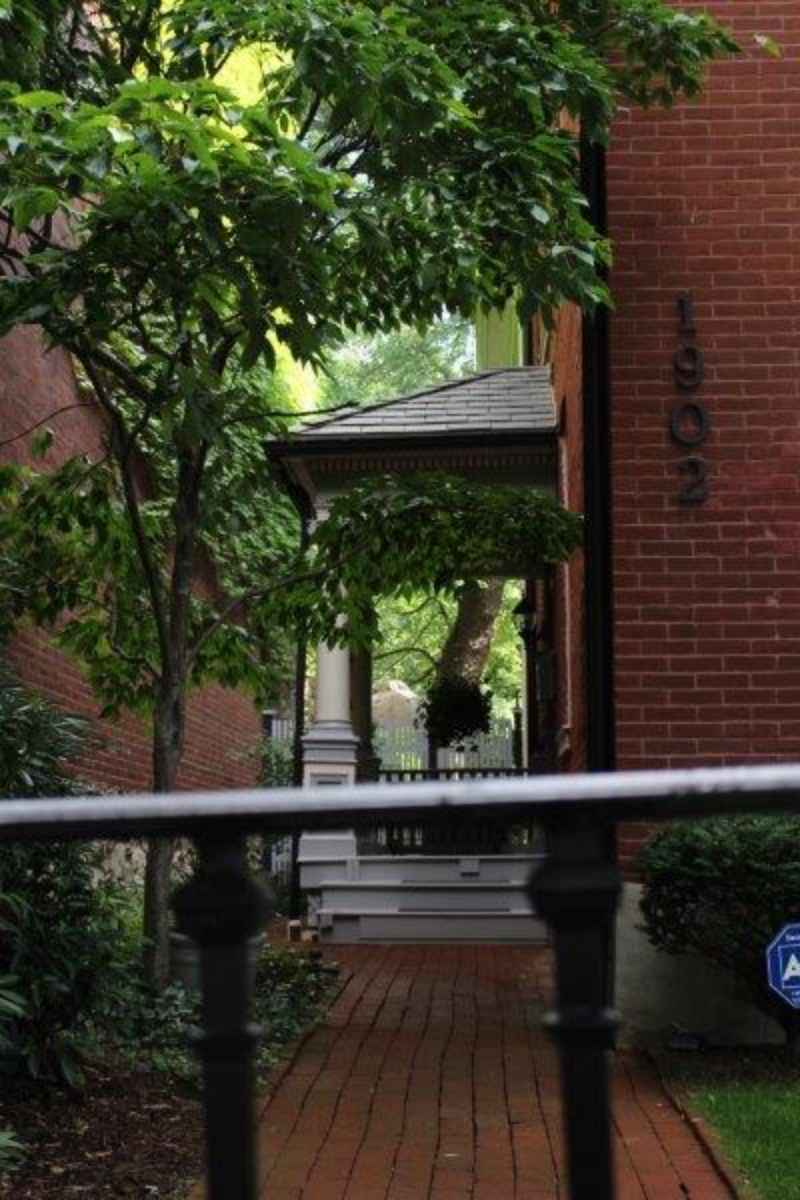
Building is in good condition and is well-maintained. Foundation is concealed in concrete parging.

This 2-story with loft brick flounder presents two bays to the street. Positioned at the building line, its side entrance is in the second bay from the façade on the east side. There a hipped roof porch wood porch shelters the entrance. Window openings have segmentally-arched heads formed of stretcher brick and flush stone sills. A prominent wood cornice with console brackets edges the façade and east side eaves.

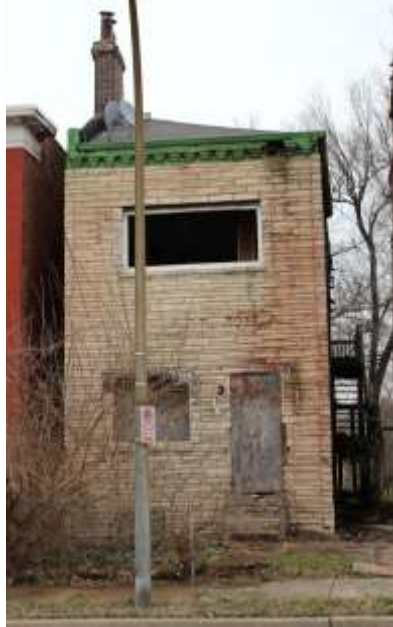
Front

Non-contributing building; boarded or no sash in windows.

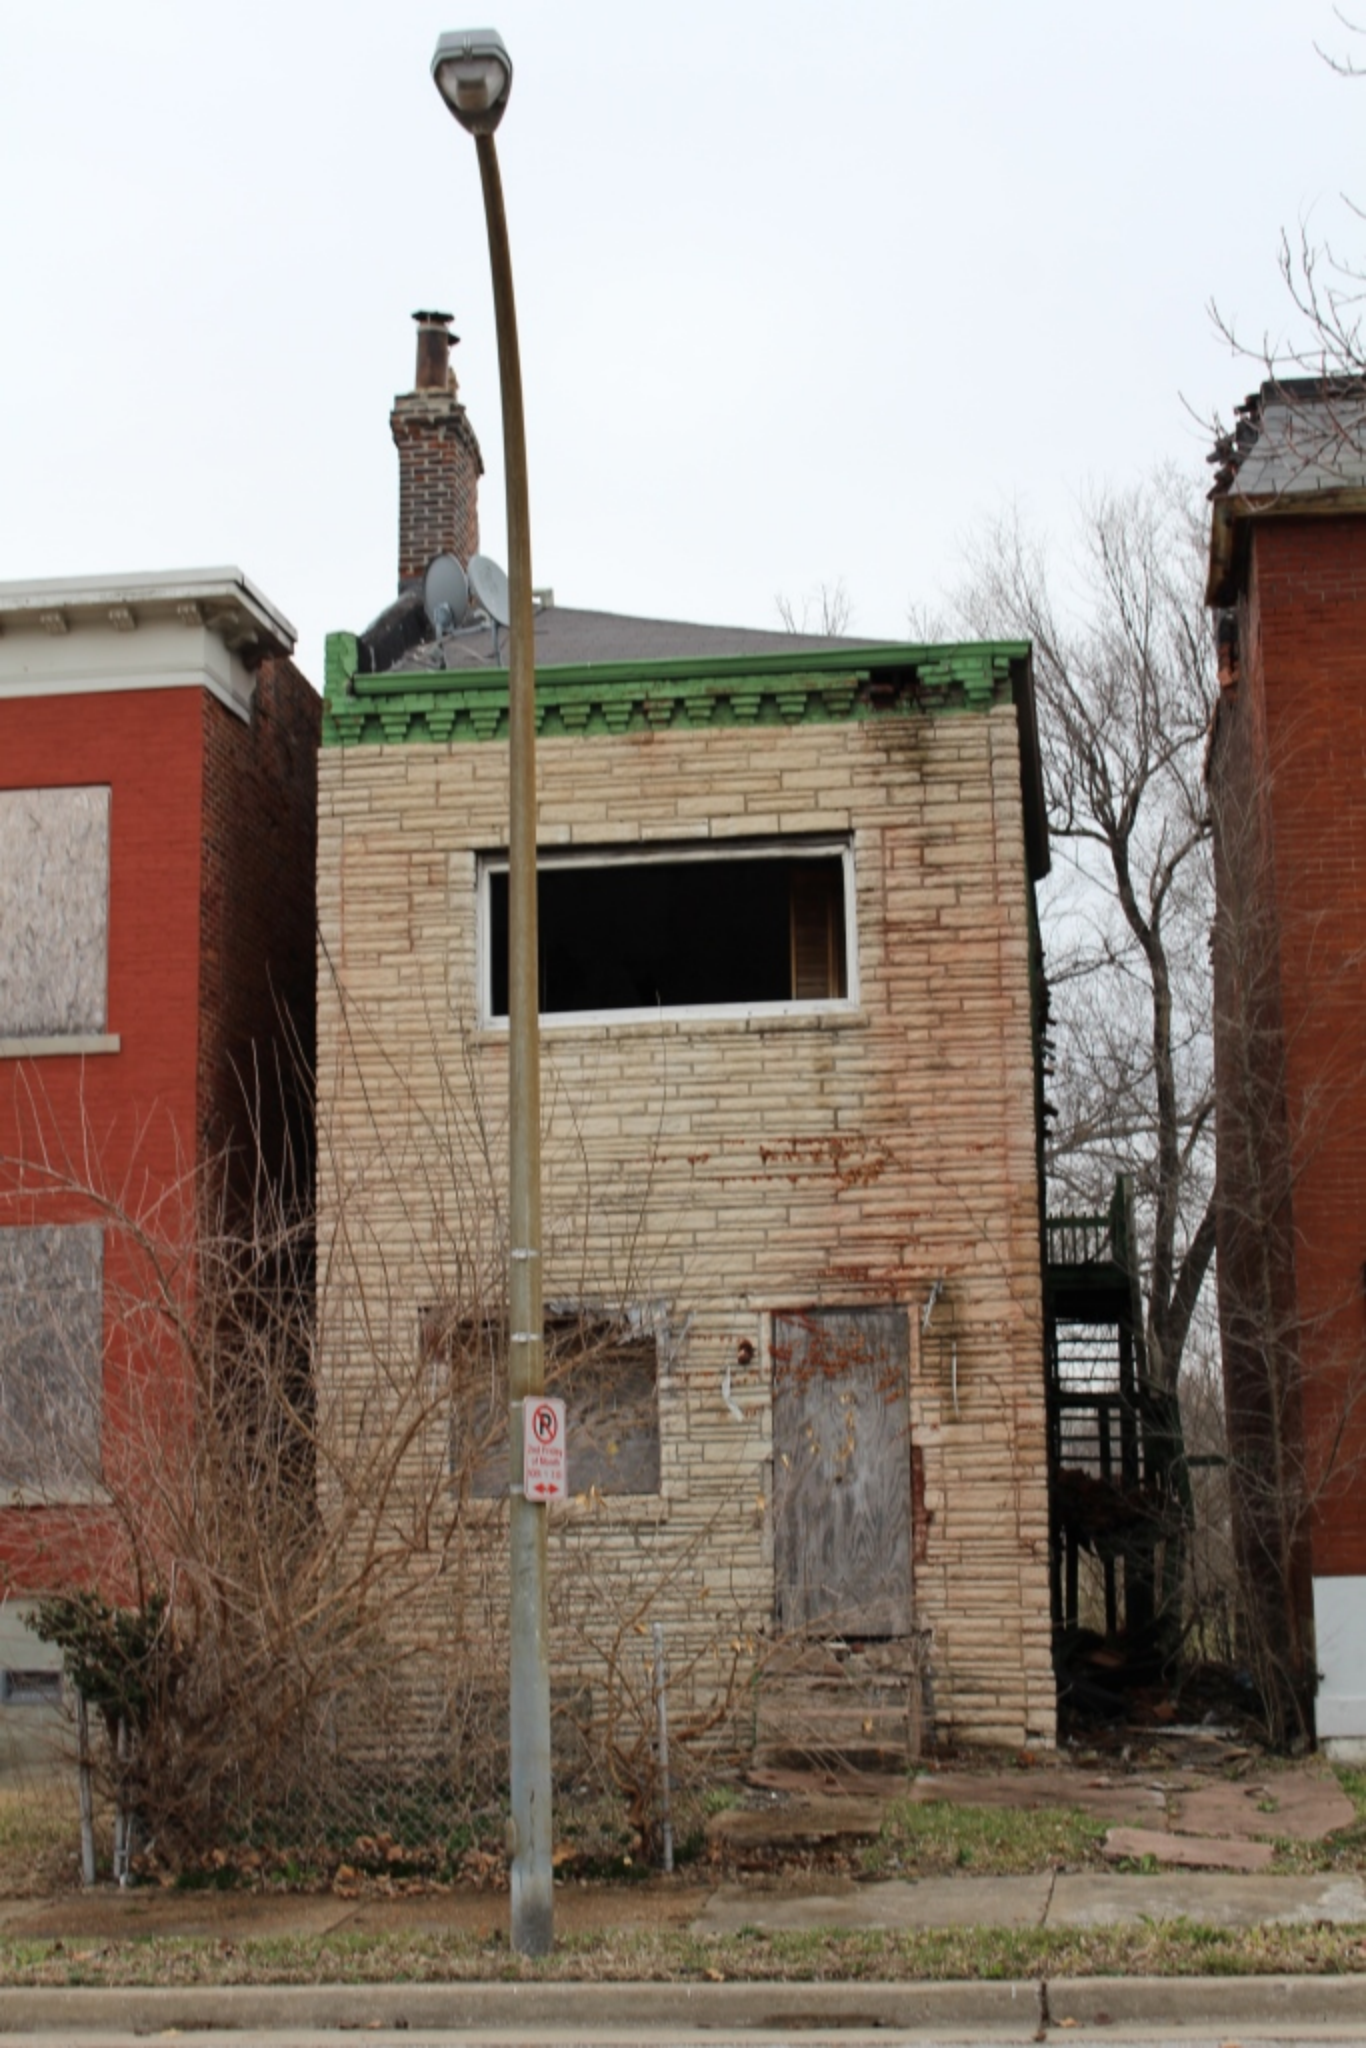
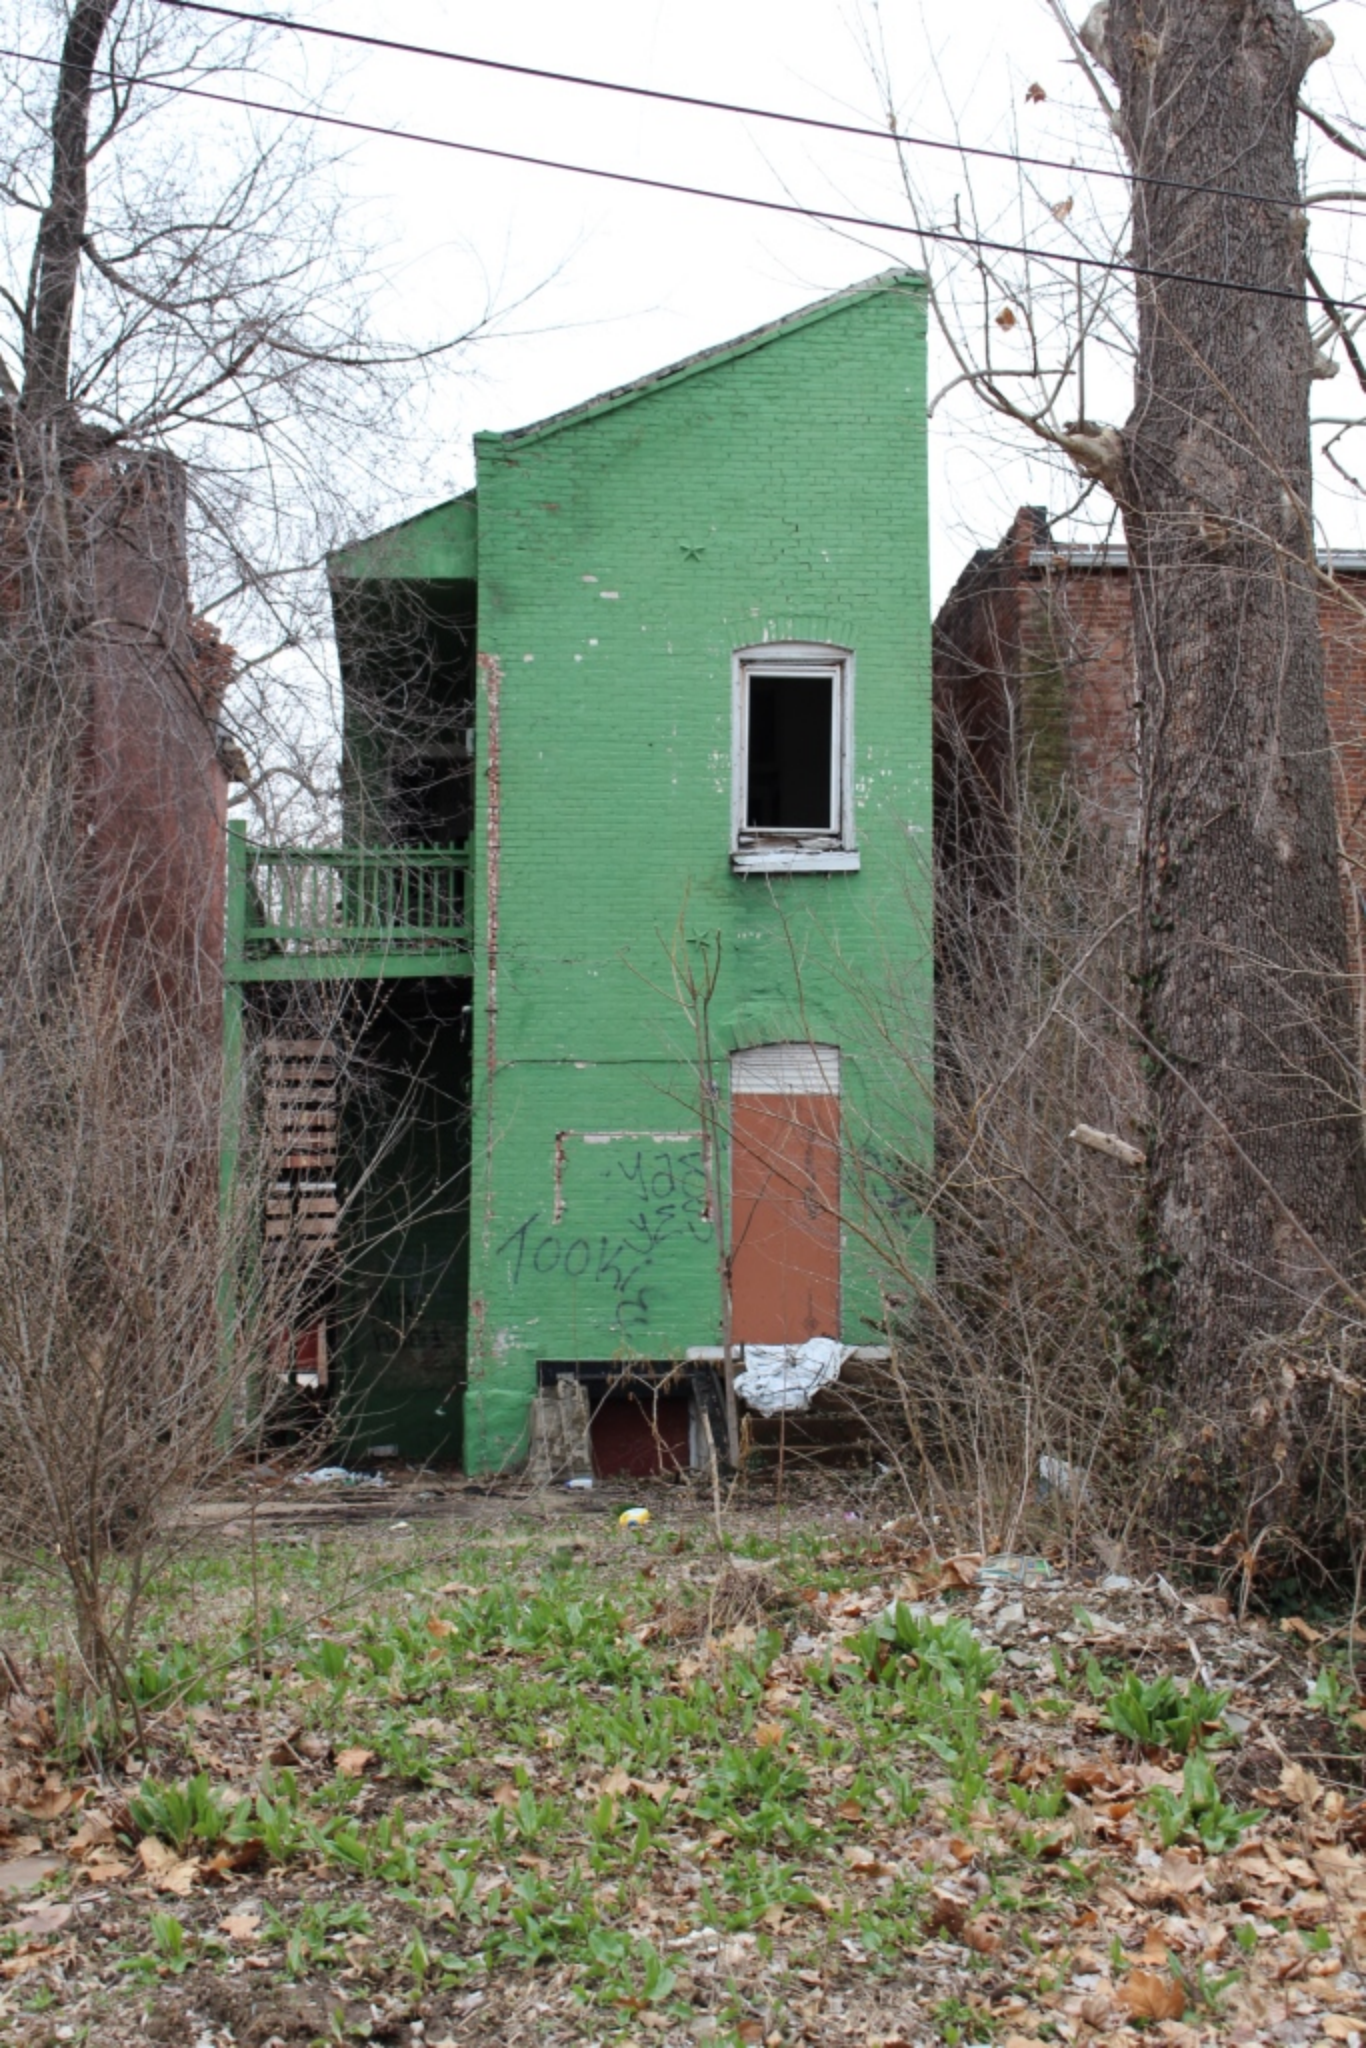
**1714 N LEFFINGWELL AV**

This two-story hip front brick flounder has had substantial alterations to its primary façade, retaining only its corbeled brick cornice which spans the front façade only. Synthetic stone added to the façade and window and door proportions altered. One wide window opening has been created in the second story. It has a shed roof flounder rear ell. Side and rear window openings have segmentally-arched heads. A two-story gallery porch spans the rear ell; the lower portion has been reconstructed and widened although the original cantilevered roof remains.

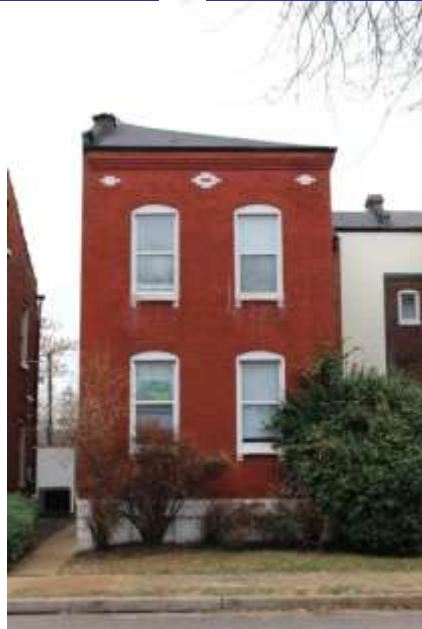
Front façade

The building is now attached to the the one to the south with an infill addition at the rear of the building that is visible from the street.

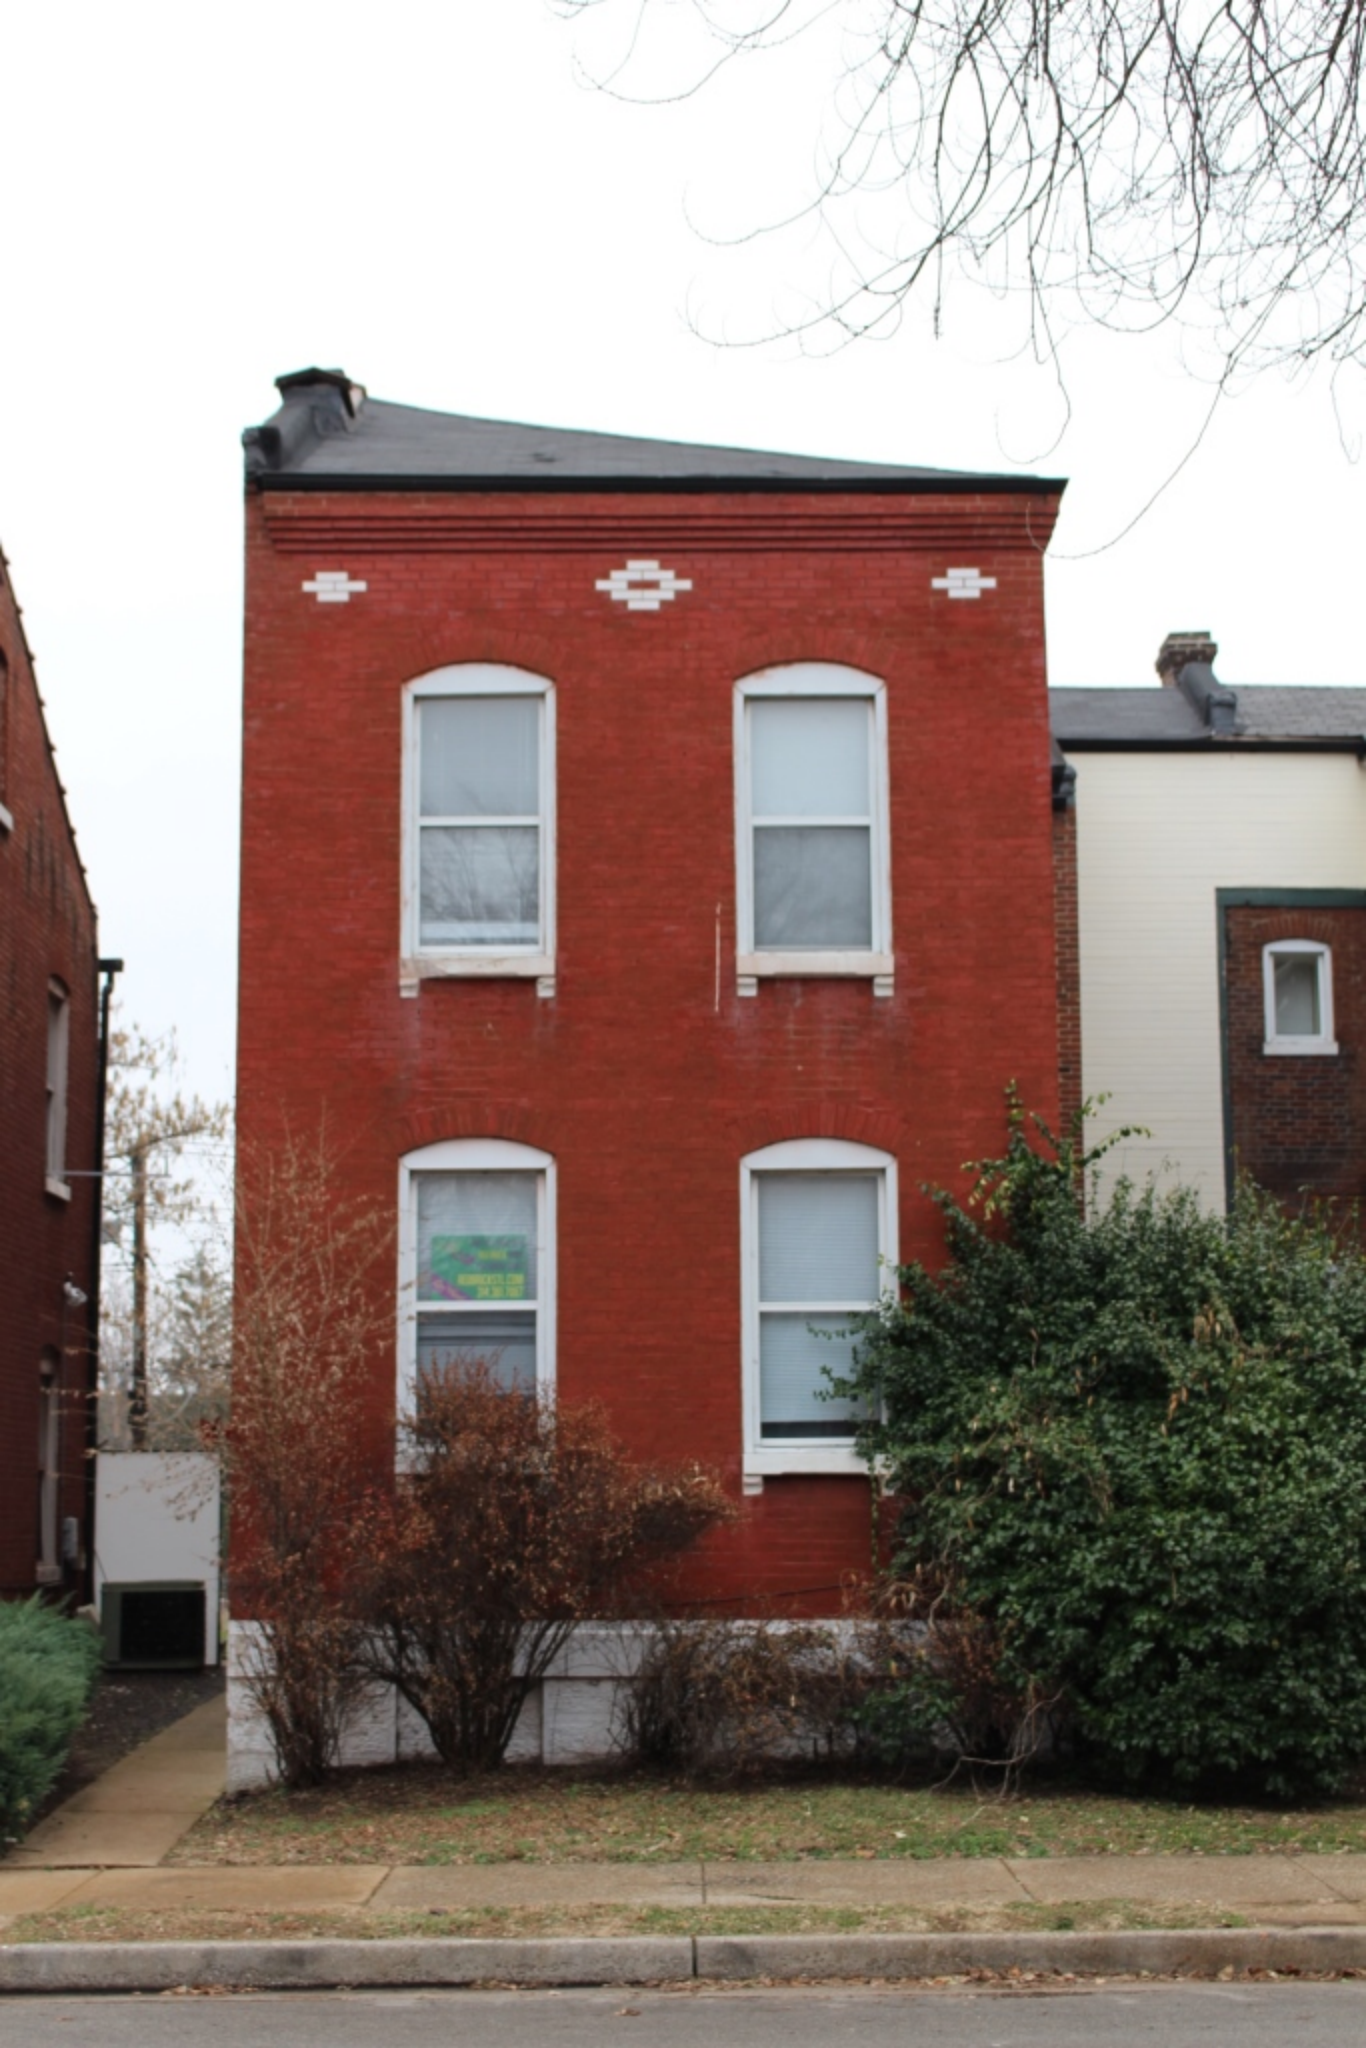
This 2-story flounder is nearly identical to a semi-detached pair of flounders adjacent on the south. A smooth ashlar watertable band edges the limestone foundation on the two-bay façade. The window openings have segmentally-arched heads formed of stretcher bricks; the limestone sills are lugged. Glazed white brick strether brick form three geometric patterns below the stepped brick cornice. The hipped front of the roof is low-pitched. The entrance is located in the front bay of the south side. The taller blind wall is on the north. The building's rear portion is a narrow bay wider to accommodate windows facing the street on both stories.
