**ARCHITECTURAL/HISTORIC INVENTORY FORM - Cultural Resources Office**  
**St. Louis Planning and Urban Design**

1. Survey no. SLC-AS-053-0102	2. Survey name: Thematic Survey of Flounder Houses in St. Louis City	3. County: St. Louis [Independent City]
4. Address: (from City GEO database) <b>900 HICKORY ST</b>		5. City/State: St. Louis, Missouri
Alternate address: 900 Hickory Street		Property Zip Code: 63104
Latitude: 38.615737		6. UTM Easting: 743886.40
Longitude: -90.198830		UTM Northing: 4277858.27
8. Historic Name (if known): N/A	11a. Historic Use (if known): Commerce/Trade	City Block 467.03
9. Present/other name (if known):	11b. Current Use: Commerce/Trade	City Ward 7
7. Township-Range-Section: N/A		10. Ownership: Private
Neighborhood Number: 34

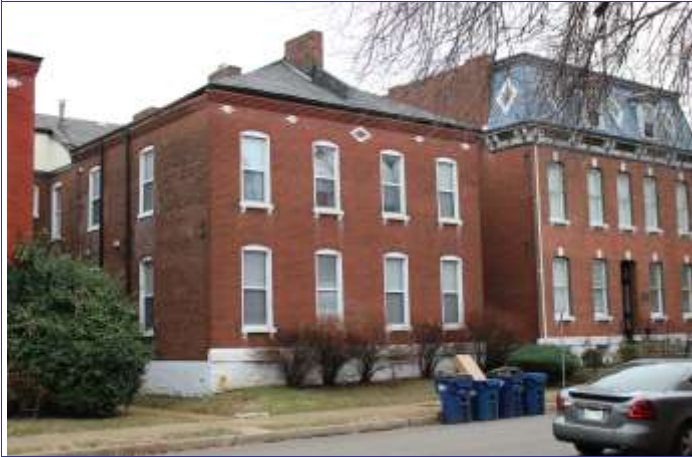
2630-32 Lemp

This 2-story flats flounder is nearly identical to its semi-detached partner to the southorth and the originally free-standing building to the north. A smooth ashlar watertable band edges the limestone foundation on the two-bay façade. The window openigns have segmentally-arched heads formed of stretcher bricks; the limestone sills are lugged. Glazed white brick strether brick form three geometric patterns below the stepped brick cornice. The hipped front of the roof is low-pitched; a parapet separates the roof from the one to the south and chimneys rise thorough this form. The taller blind wall is on the south. The building's rear portion is a narrow bay wider to accommodate windows facing the street on both stories.

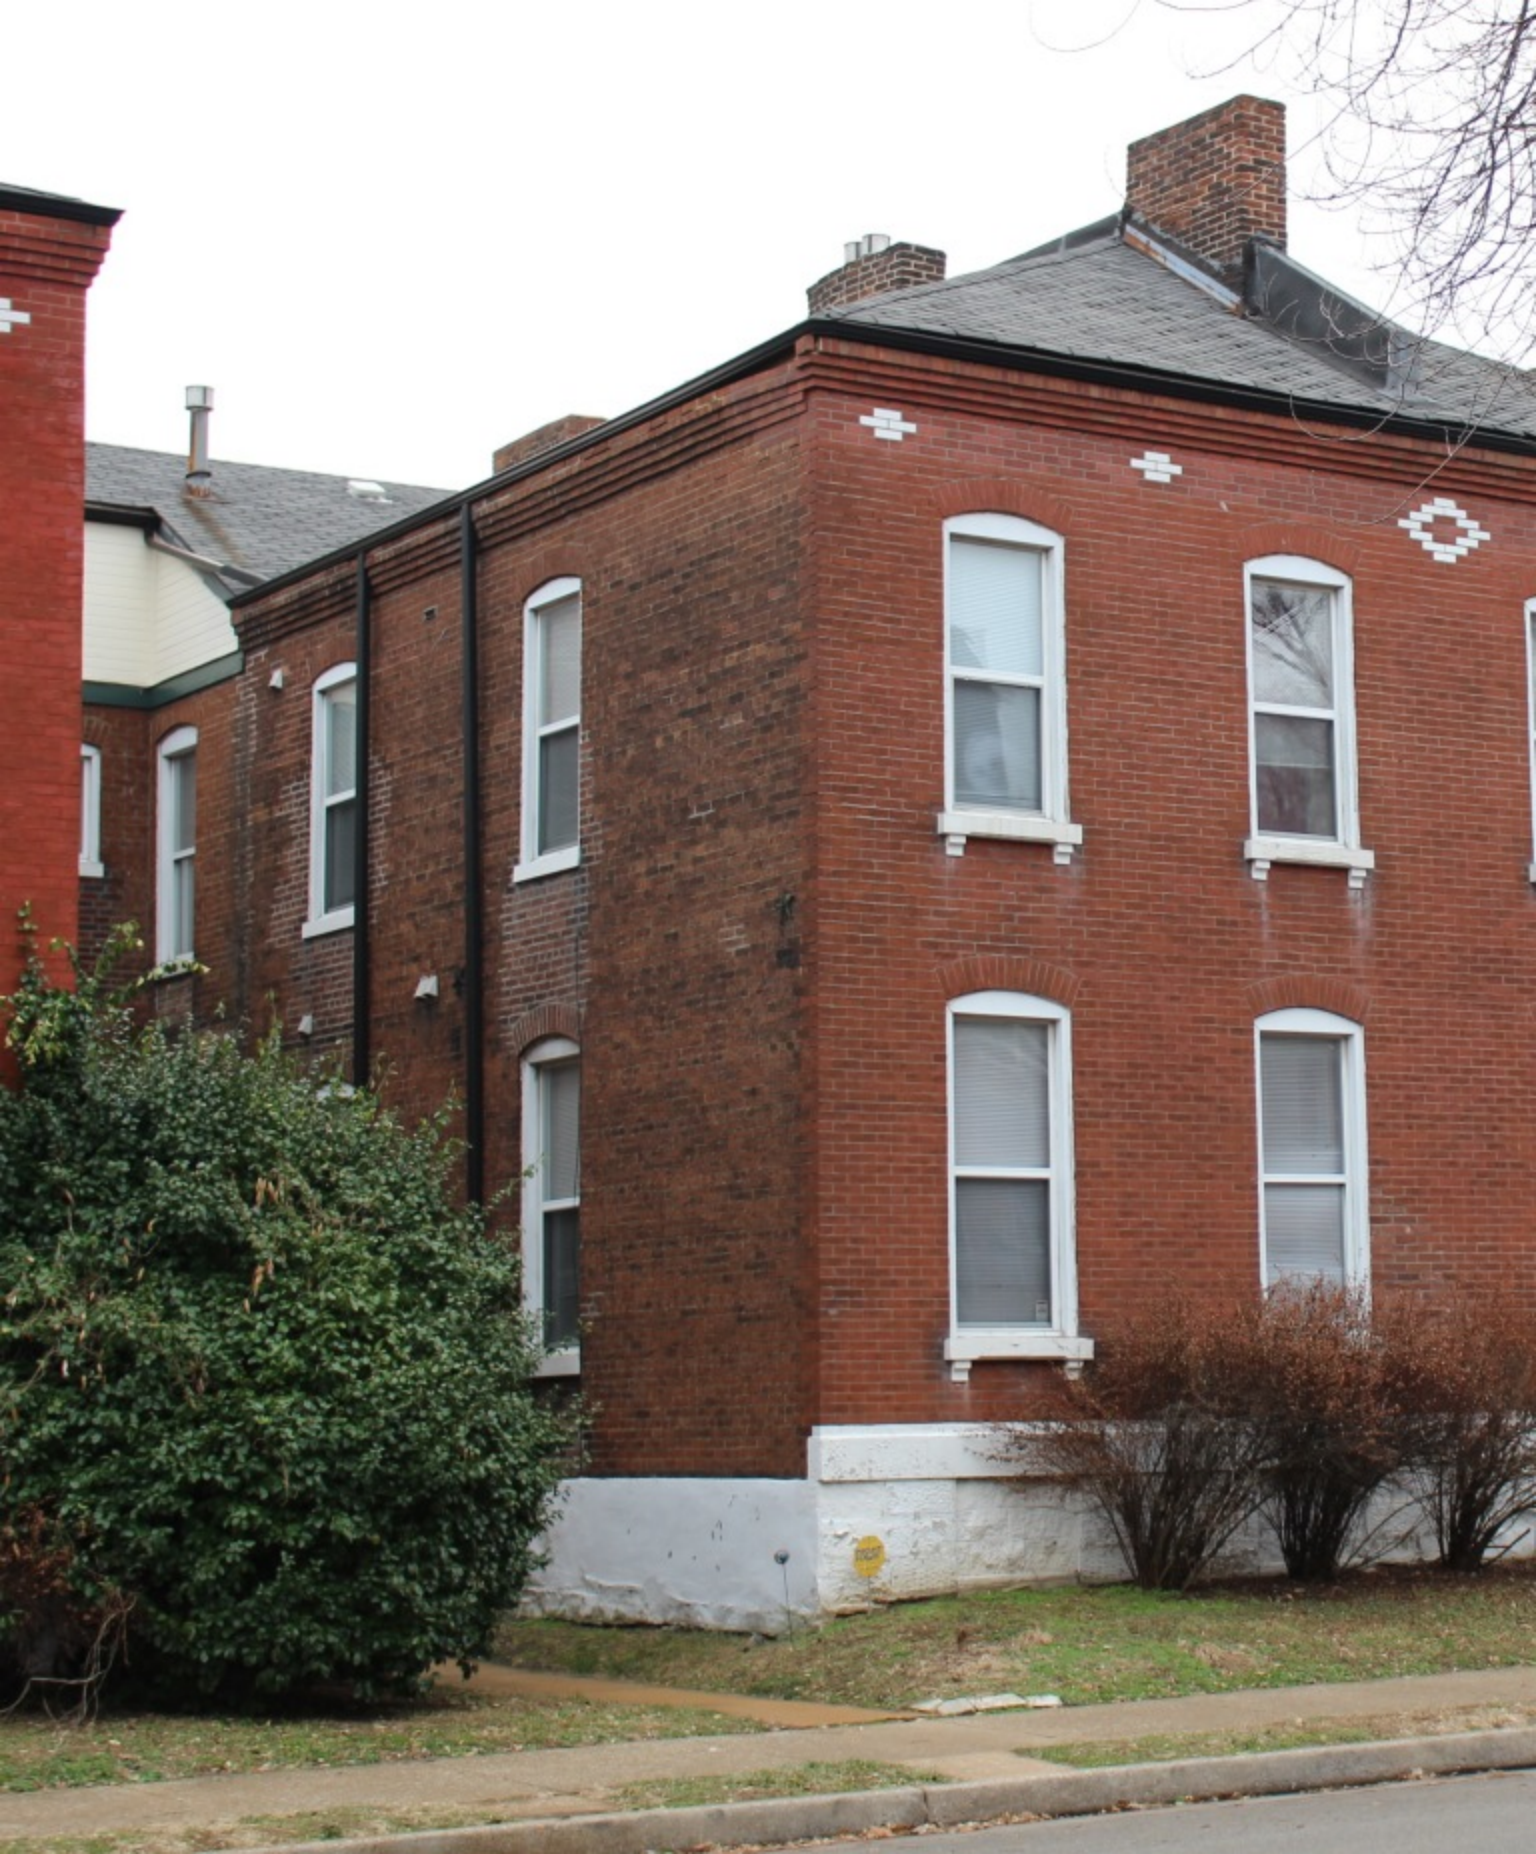
This 2-story flats flounder is nearly identical to its semi-detached partner to the south and the originally free-standing building to the north. A smooth ashlar watertable band edges the limestone foundation on the two-bay façade. The window openigns have segmentally-arched heads formed of stretcher bricks; the limestone sills are lugged. Glazed white brick strether brick form three geometric patterns below the stepped brick cornice. The hipped front of the roof is low-pitched; a parapet separates the roof from the one to the south and chimneys rise thorough this form. The taller blind wall is the party wall on the south. The building's rear portion is a narrow bay wider to accommodate windows facing the street on both stories. An addition fills in the space between that wider portion and 2628 to the north.

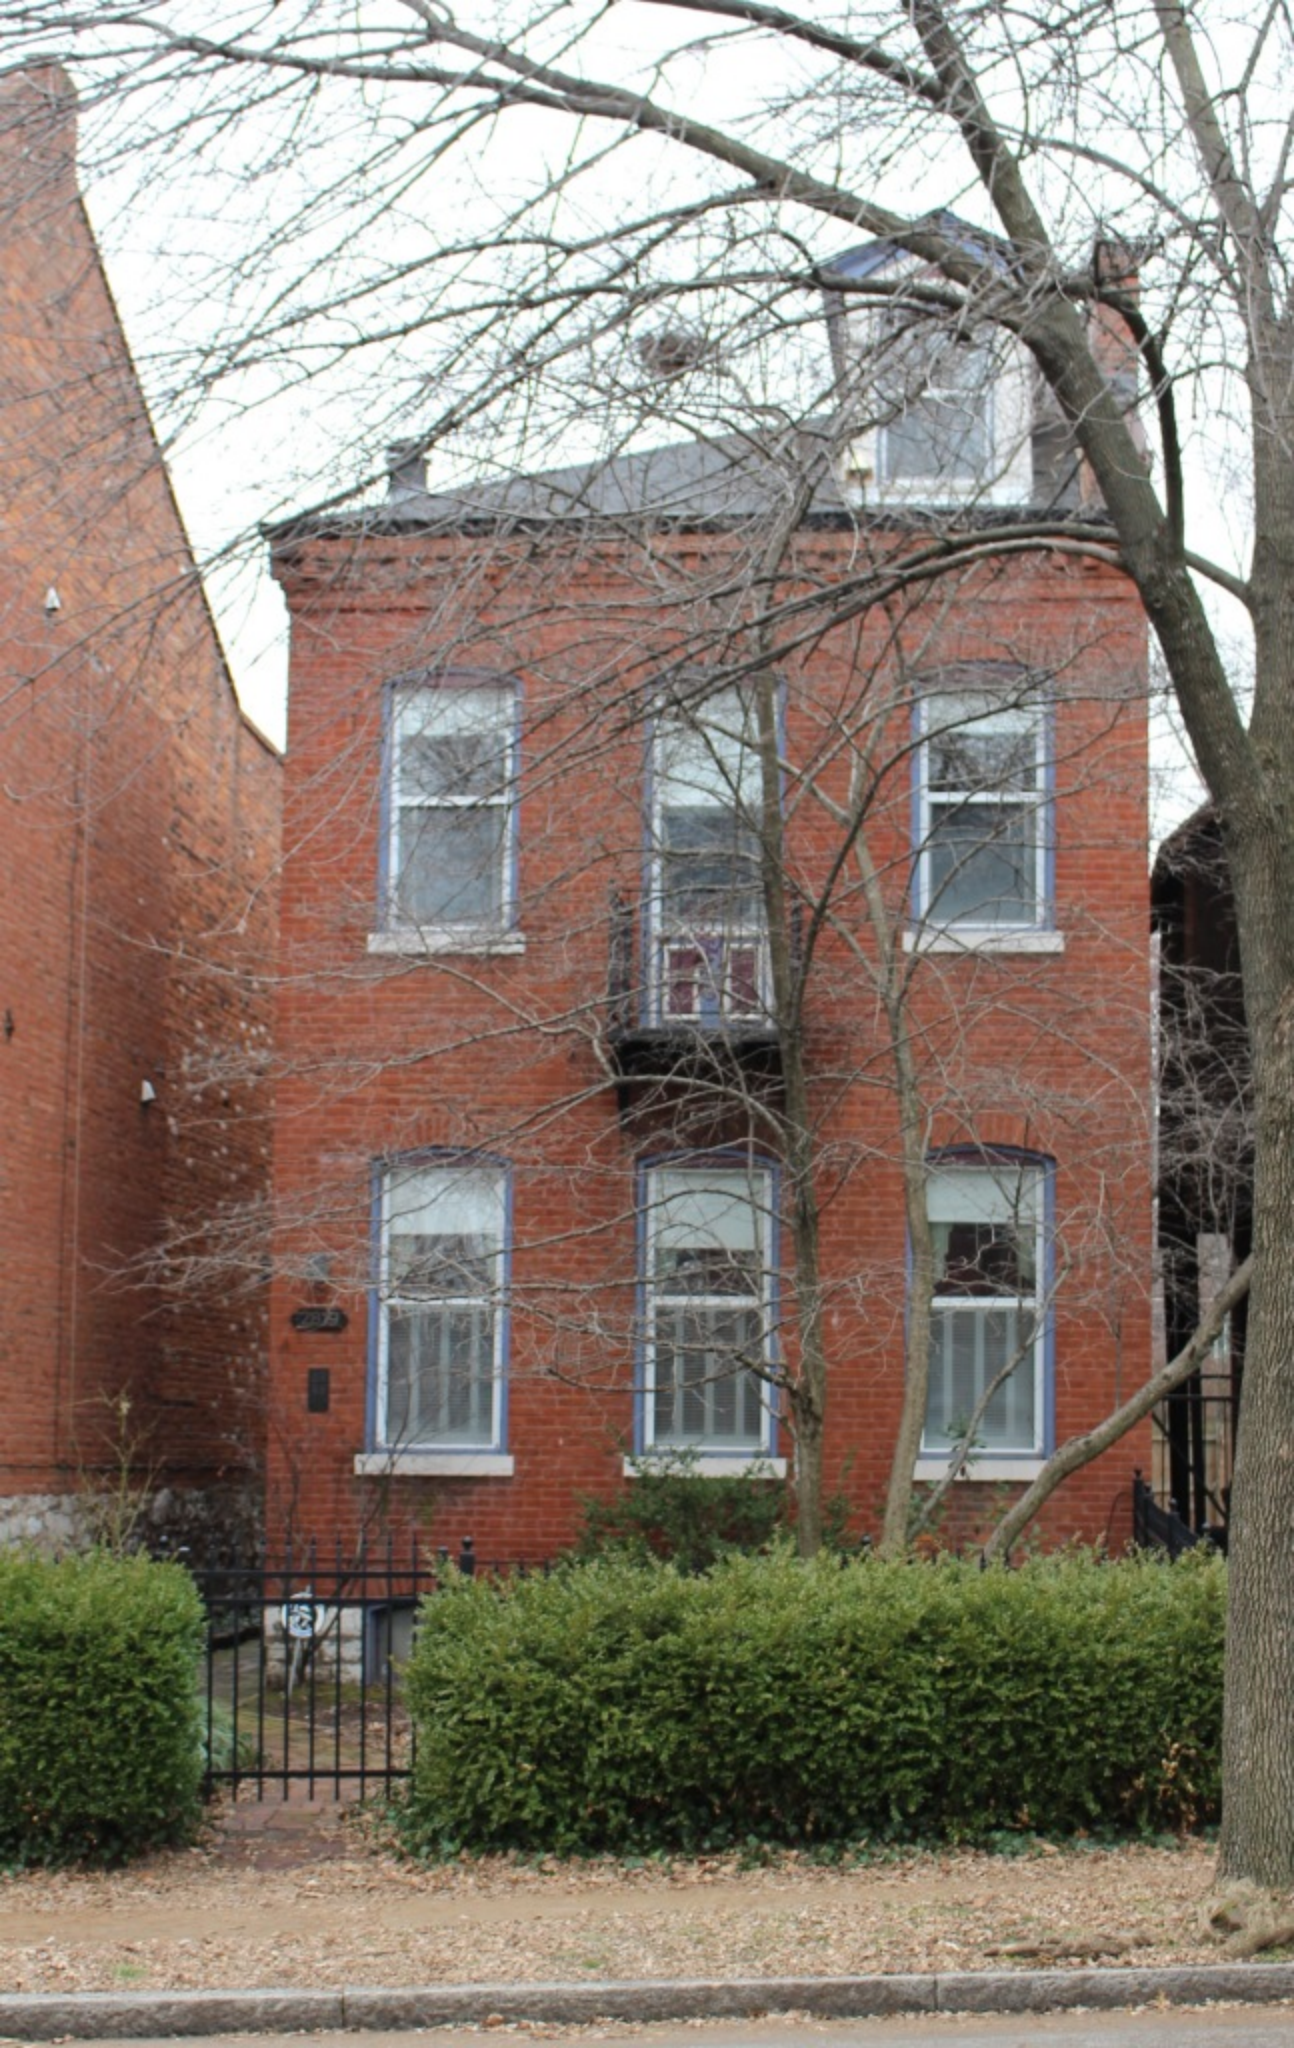
The building has three bays on the front façade. The basement and first floor have three windows each with segmented arched lintels. The windows are non original. The second floor features a a centered Jefferson window flanked by a window on either side. The Jefferson window has a lower panelled portion with two vertical recessed panels. The window opens out onto a metal balconette. A frame dormer faces the street. A brick dentil cornice runs the length of the front façade and the south side of the building. There is a dormer projecting on the west side of the building. Aerial maps show that the west side of the house has at least 5 bays but the configuration of the doors and windows cannot be ascertained. The rear of the building has a one bay brick addition with a flat root.

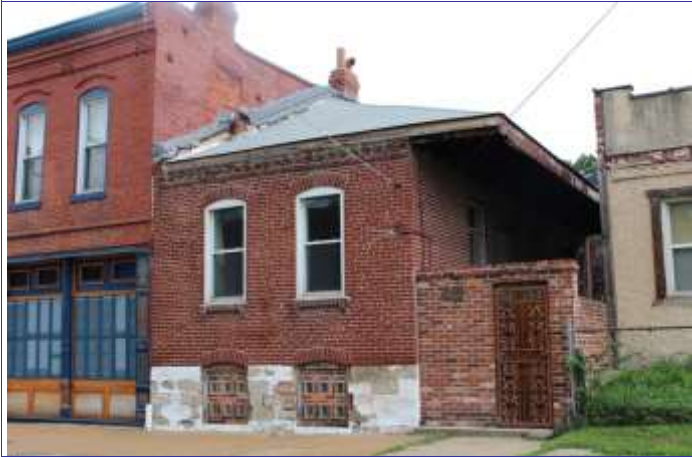
This 1-story brick flounder is positioned at the edge of the public sidewalk. A corbelled cornice edges the horizontal eaves of the hipped-front roof that extends to shelter what was a gallery along the east side. The two bays in the street façade are windows with segmentally-arched heads formed of stretcher bricks; sills are header bricks with brackets of brick. The windows have replacement 1/1 double-hung sash. A brick wall with a gate encloses the gallery at the street and extents to the property line. The entrance is in the second bay and is approached by steps.

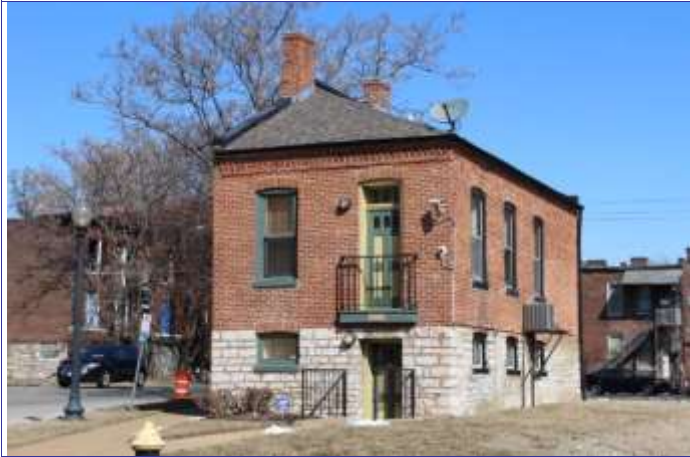
View from south.

This one-story with loft brick flounder with hip roof has unusually high cut and coursed limestone basement. There are exterior steps down to entrances in both front and rear walls. The basement stone is parged with concrete with exposed aggregate on the west wall and part of the north wall. The taller west wall is windowless. All window openings have soldier arched heads, including the blocked loft window in the rear wall. Storm sash over wood sash with historic brickmold on front the window, other windows have wrapped brickmold. The original entrance is intact with an iron railing across the front of it. A denticulated cornice terminates the façade wall only.

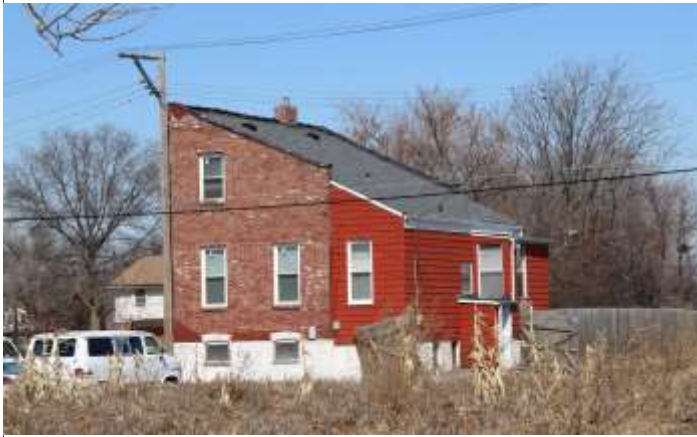
Looking northeast from alley

This one-and-one-half story brick house with a shed roof and taller windowless wall on the west side is positioned at the alley and west property line. The existing wood-framed addition along its east side, now clad with vinyl siding, appears as early as the 1916 Sanborn map and is likely the enclosure of an original side gallery. The two exposed sides of the house have segmentally-arched window openings with soldier heads; one 2/2 wood double-hung wood window remains in the north wall. The entrance in the east side wall is obscured. The raised basement foundation is parged and painted white. A second, smaller addition extends at the gallery's northeast corner.

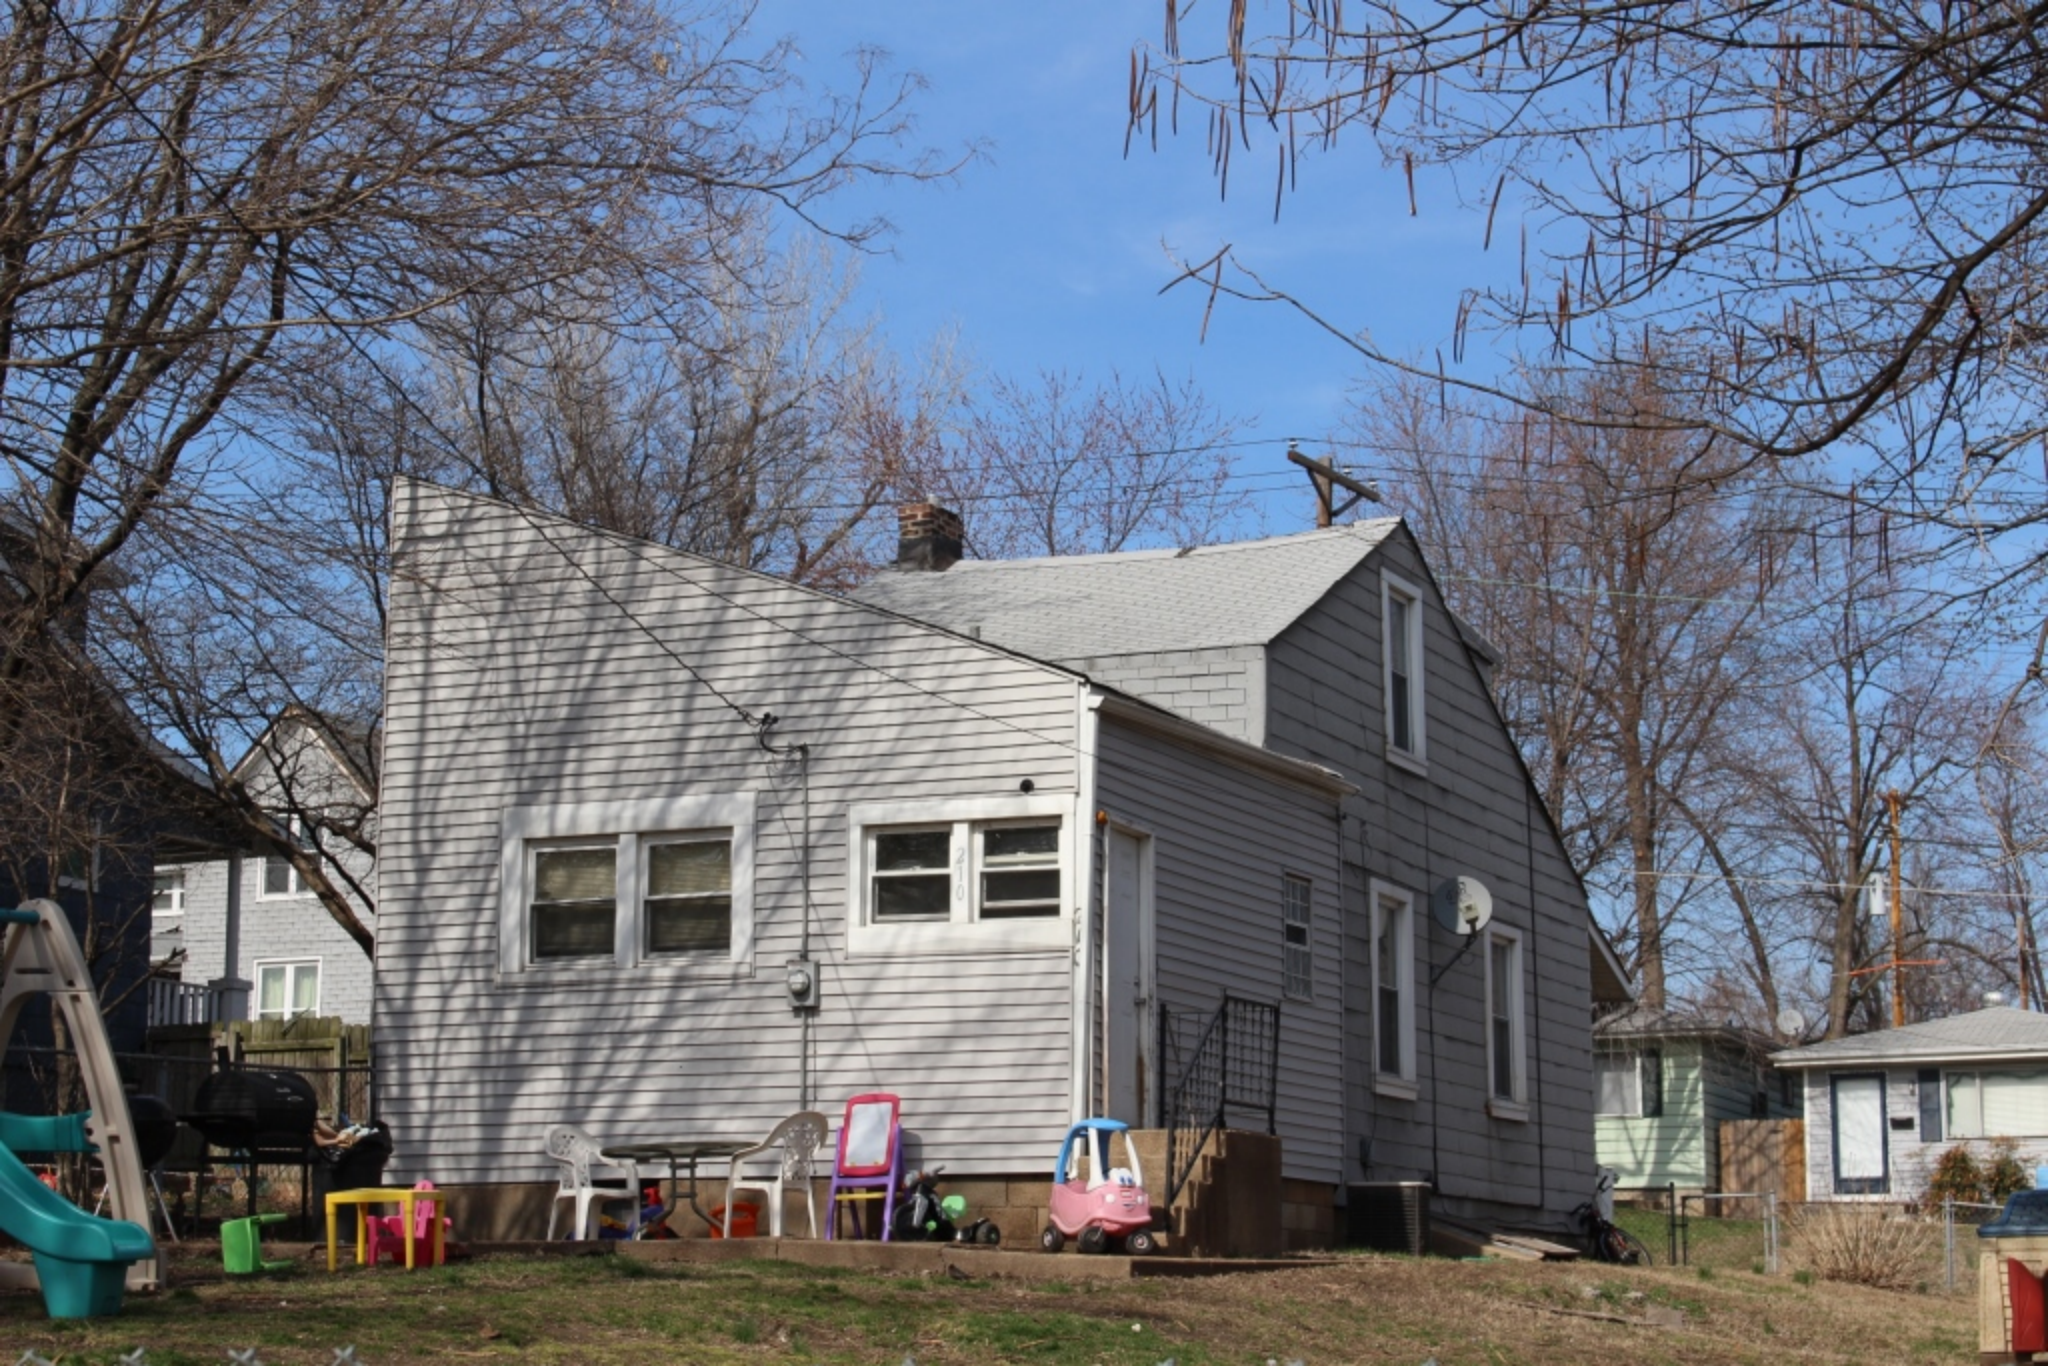
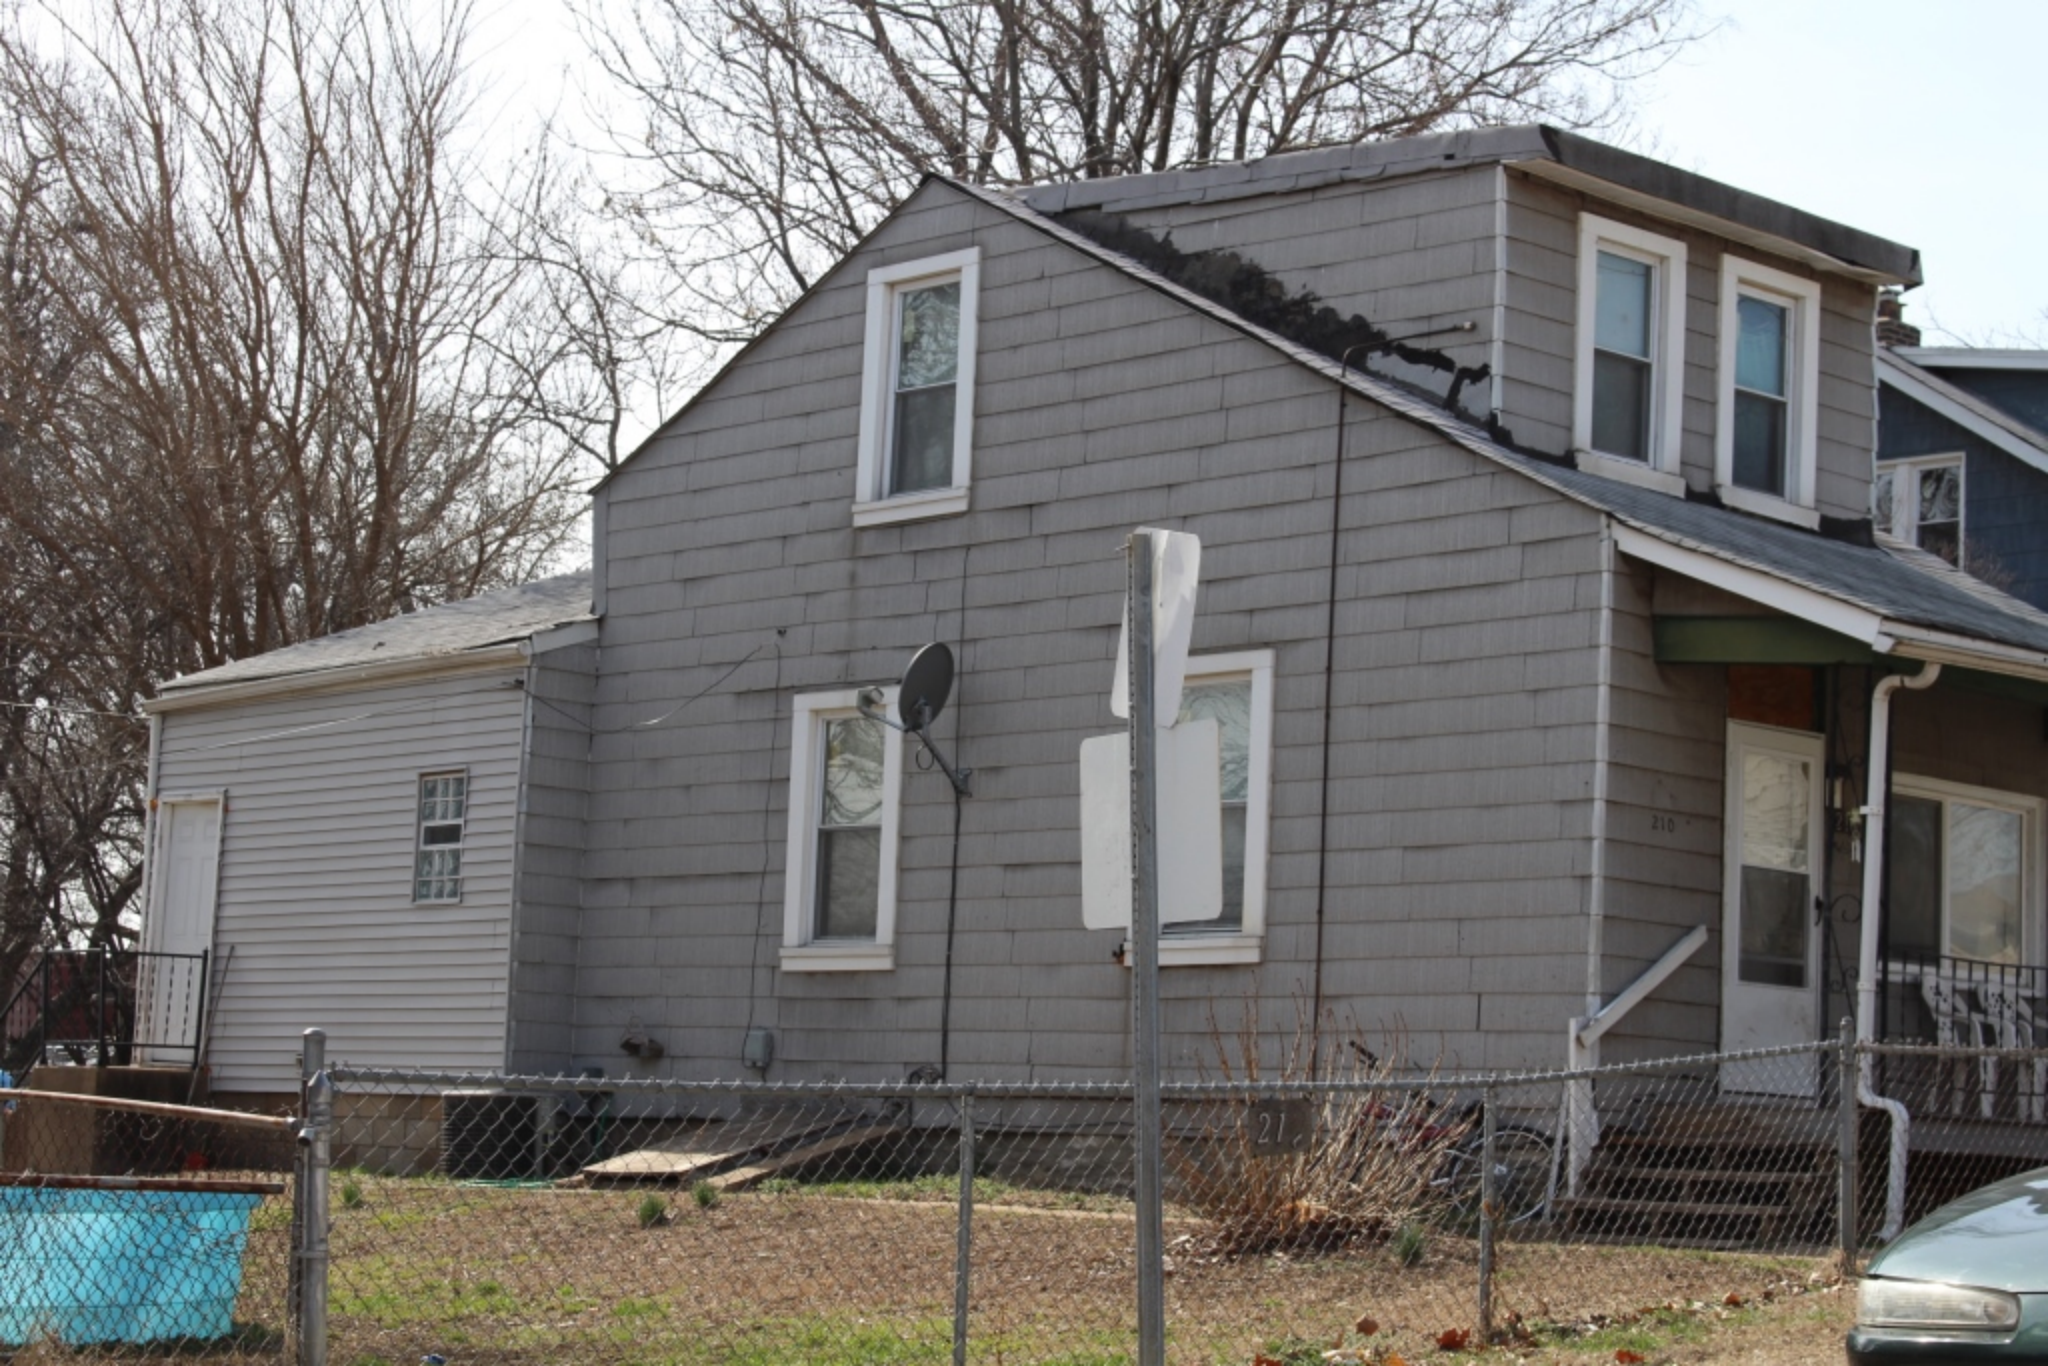
This is a 1-story frame flounder with loft area. Based on its connection with the front block, and its slightly greater width, the flounder appears to have been the first building on the site. The tall blind wall is sited close to the west property line in the center of the parcel. The flounder's foundation has been parged and its material is undetermined; its exterior walls are sheathed with aluminum siding. Window openings of the south façade have been altered in size and proportion and metal 1/1 sash installed. The east elevation once had a narrow side gallery that has been enclosed: a modern foundation of concrete block has been added, likely when the porch was first enclosed. The east façade currently presents a small single-leaf door at the south and a small rectangular window at the north of the façade; this opening has been filled with glass block. Attached at the north elevation is a frame, 1-1/2 story, side gable house dating from the turn of the 20th century.

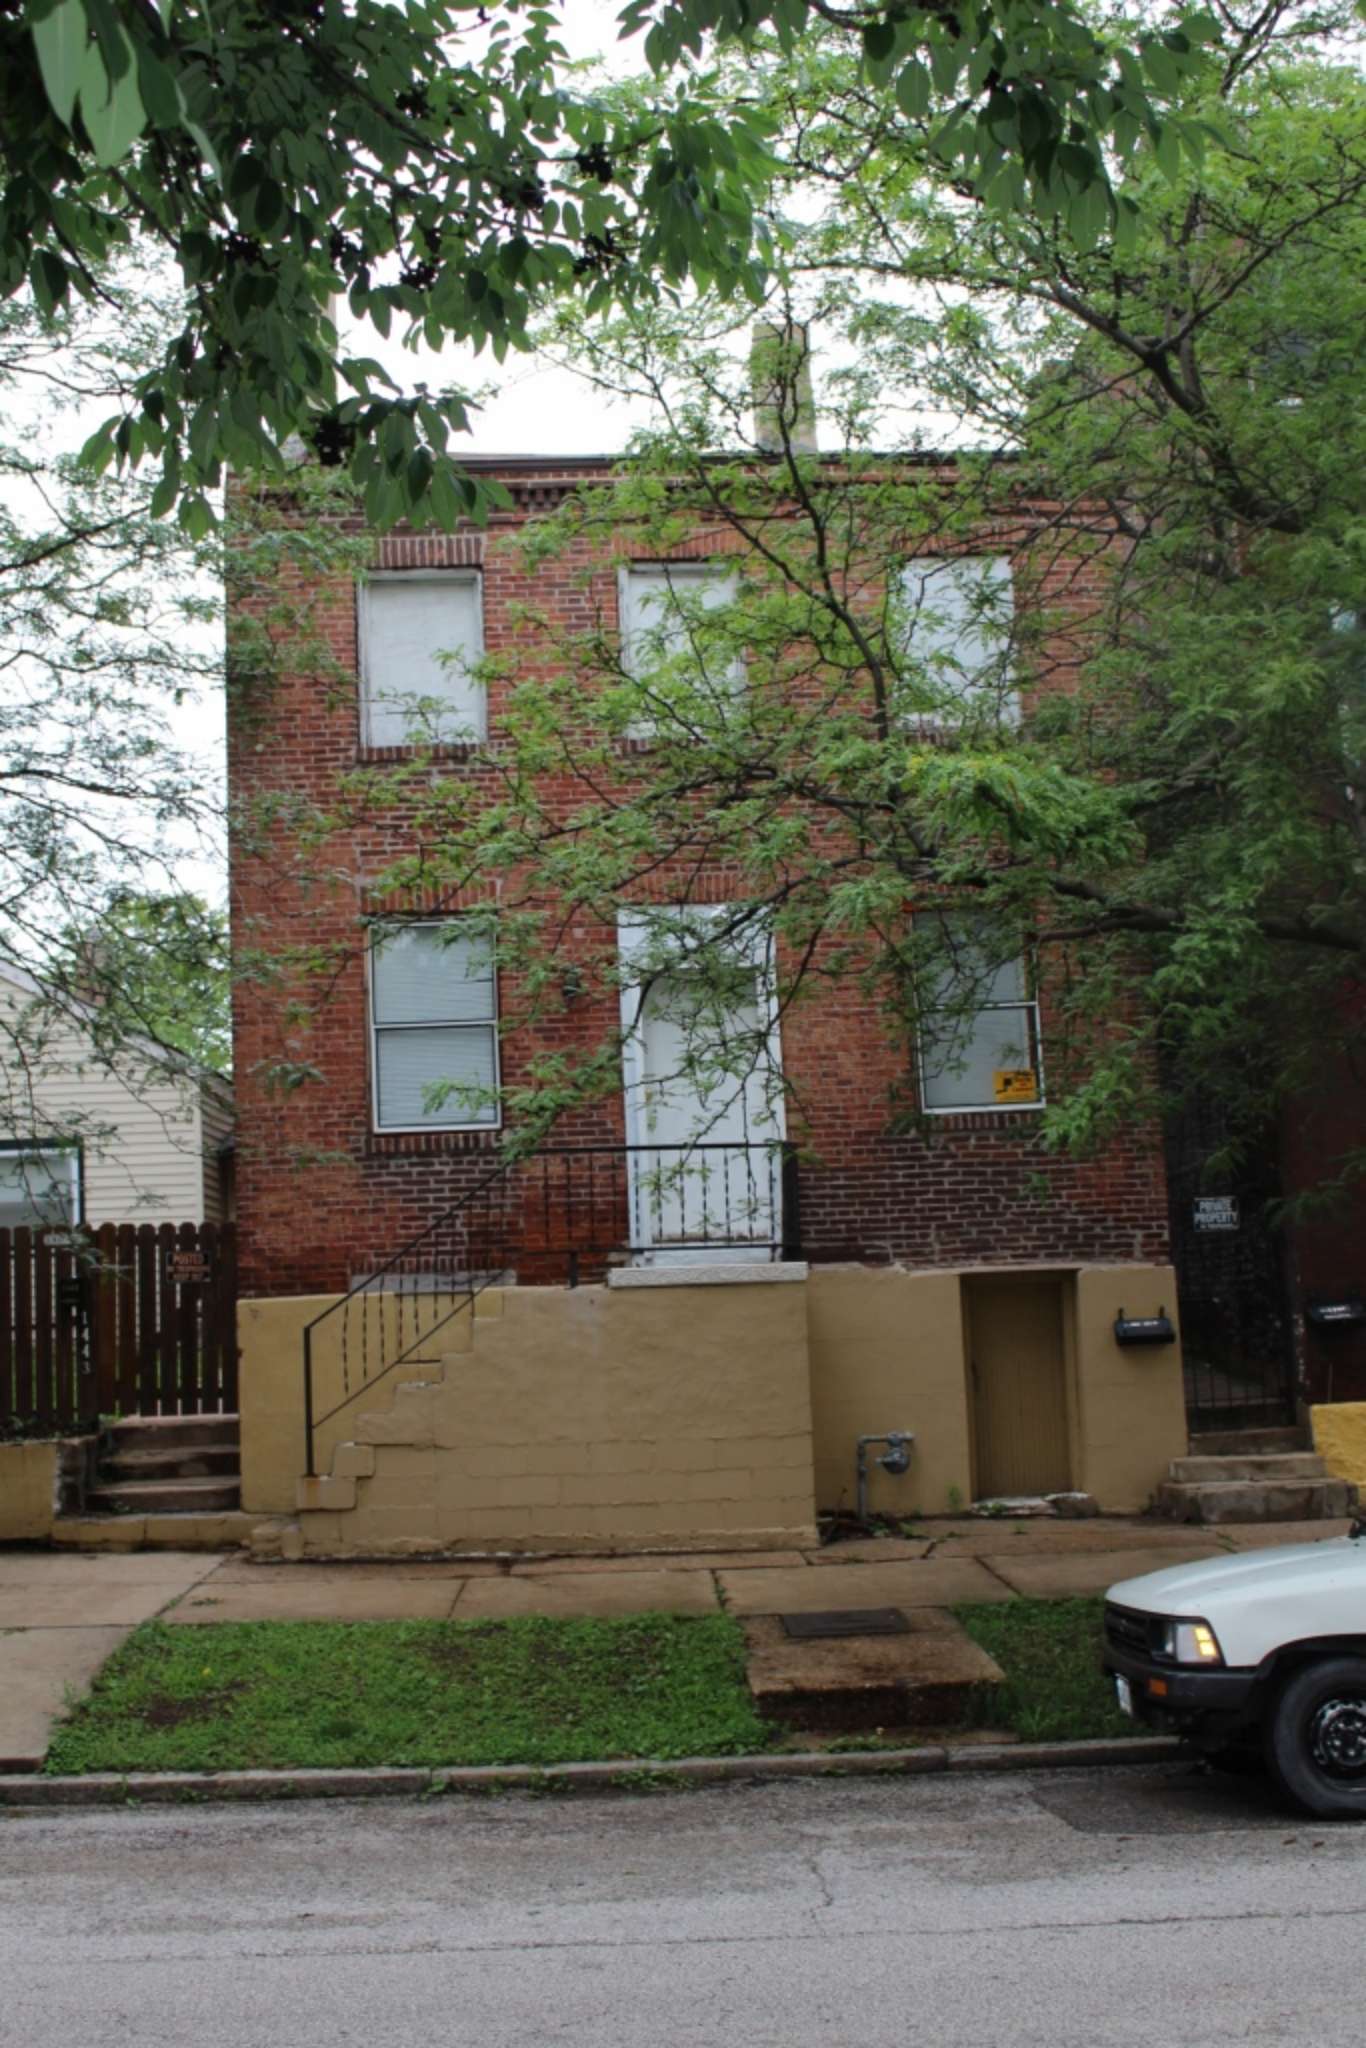
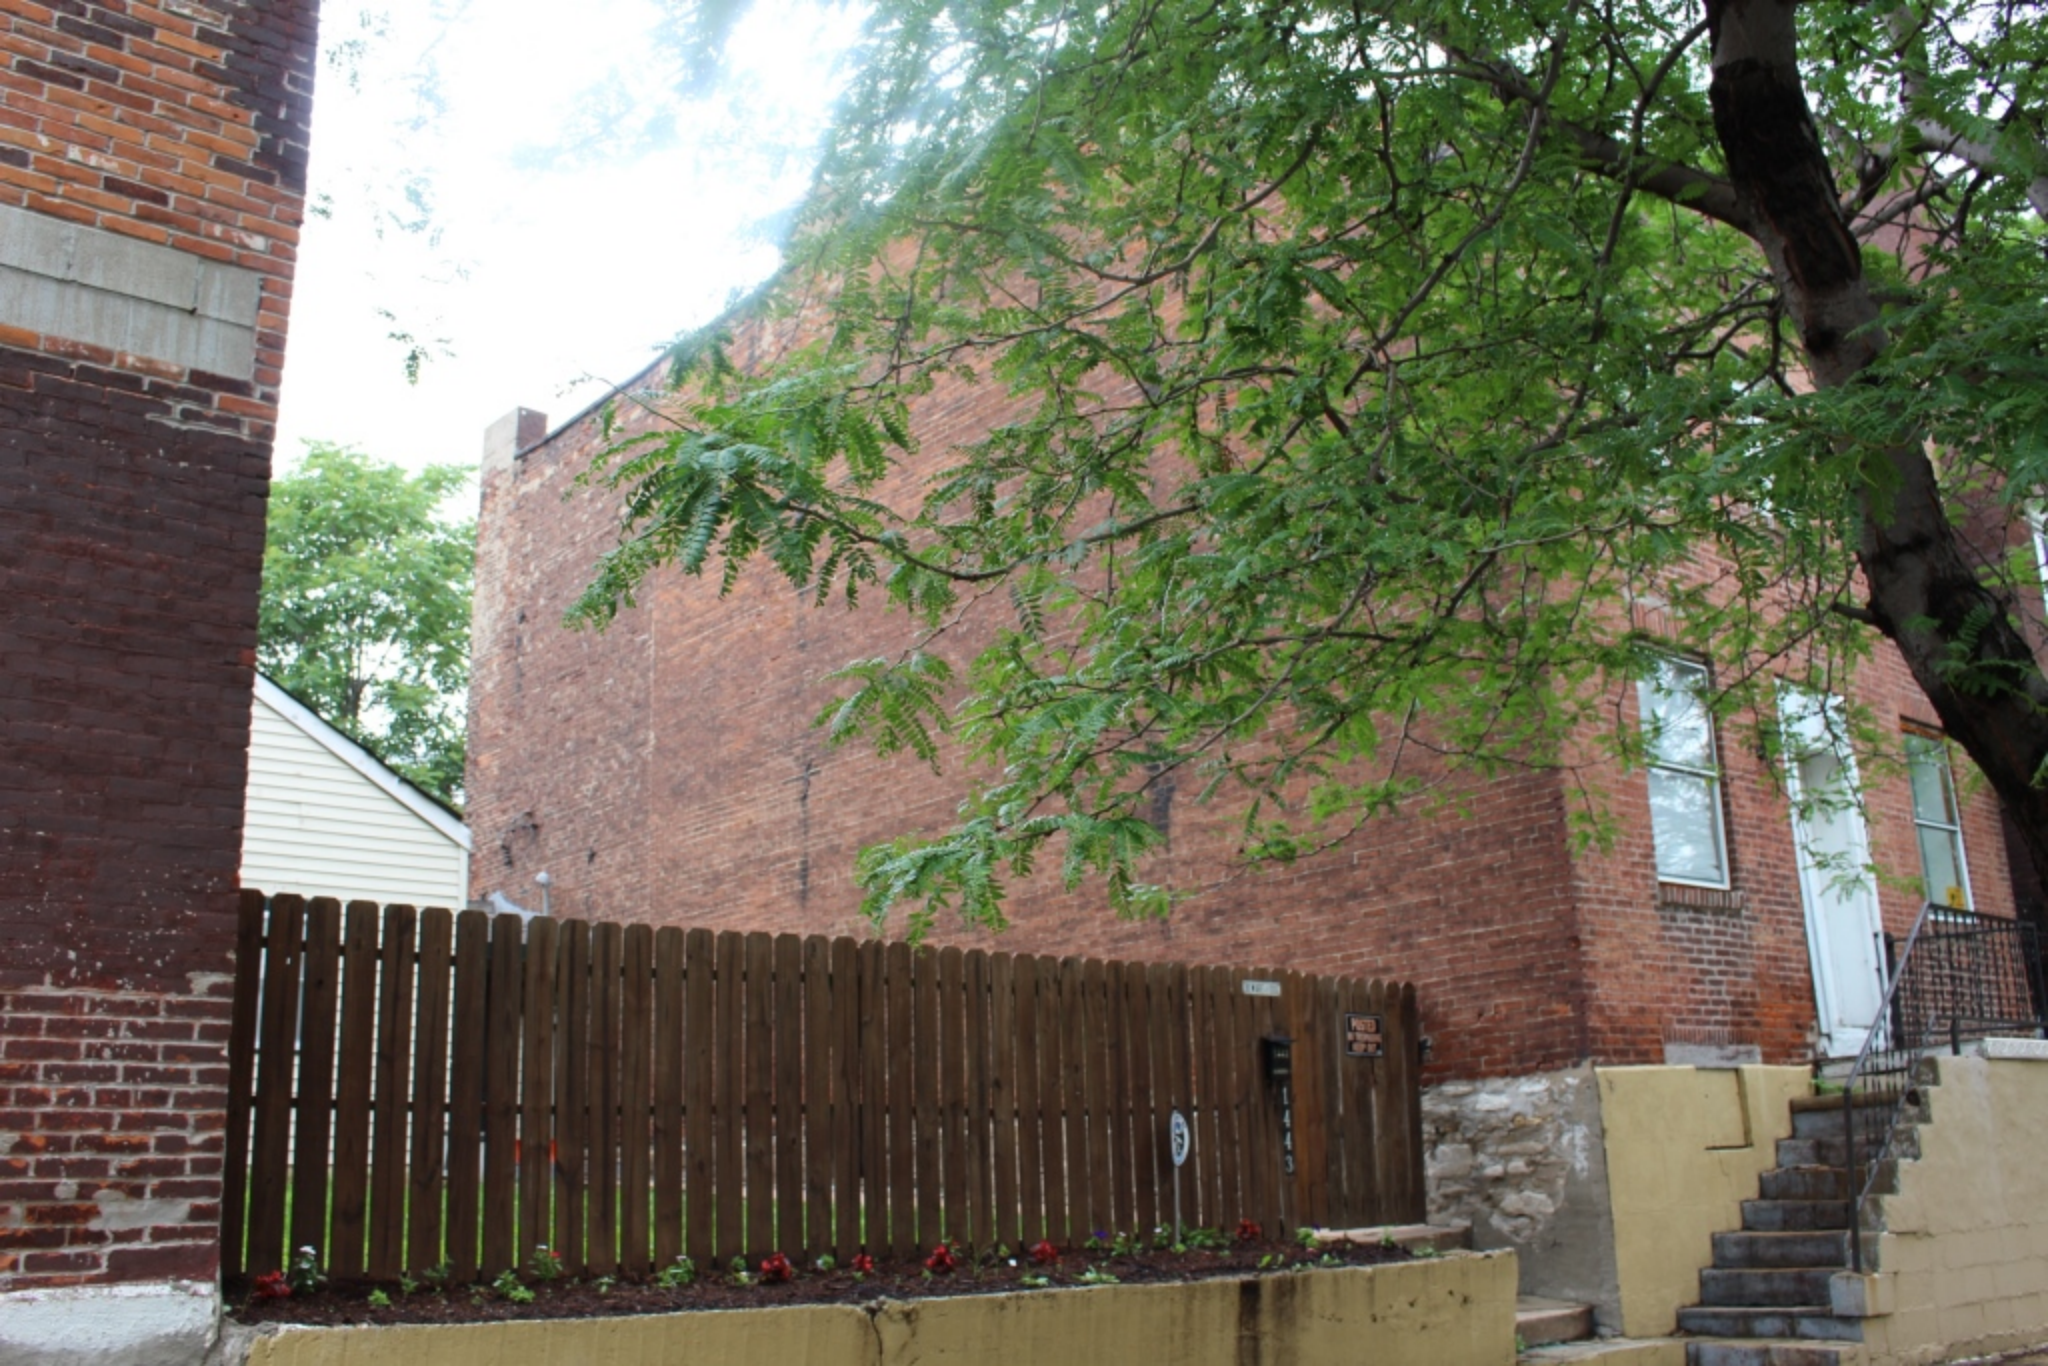
This 2 1/2-story brick flounder has a tall raised limestone foundation with a man-door facing the street. Its façade is symmetrical with a door centered in the three bays approached by a concrete block set of steps to a stoop. The door and window openings are square-headed with a jack arches of brick at the lintel and rowlock sills, later alterations: the front façade has been reconstructed. A corbelled brick cornice edges the façade. The taller blind wall rises on the west side, and is exposed. Openings in the north, rear, wall have been blocked yet there is a window at the attic level.

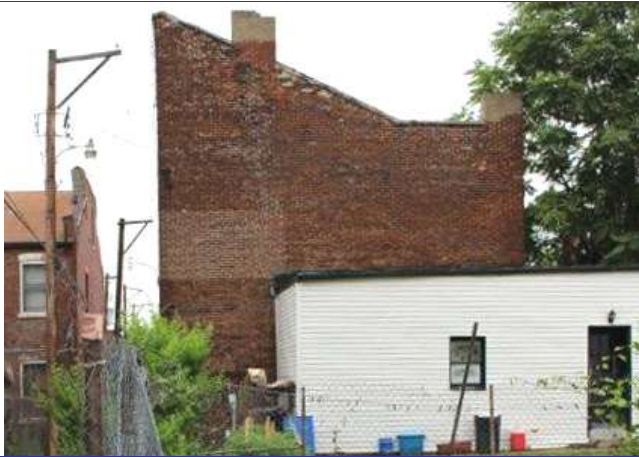
West elevation

This 2 1/2-story flounder is positioned at the rear of the lot at the alley. Its tall wall is adjacent to the alley and it has two windowless walls on the east and west sides, in contrast to the usual placement of windows. The shed roof flattens on the south end (facing the lot) in the manner that often indicates there are gallery wing walls; bird's-eye views indicate suggest that there was a center bay gallery, but this portion of the building is not visible from public areas. The alley wall has an entrance near the east corner and two bays of windows on the main and second floors. There is a single centered attic window.
