**ARCHITECTURAL/HISTORIC INVENTORY FORM - Cultural Resources Office**  
**St. Louis Planning and Urban Design**

1. Survey no. SLC-AS-053-0102	2. Survey name: Thematic Survey of Flounder Houses in St. Louis City	3. County: St. Louis [Independent City]
4. Address: (from City GEO database) <b>900 HICKORY ST</b>		5. City/State: St. Louis, Missouri
Alternate address: 900 Hickory Street		Property Zip Code: 63104
Latitude: 38.615737		6. UTM Easting: 743886.40
Longitude: -90.198830		UTM Northing: 4277858.27
8. Historic Name (if known): N/A	11a. Historic Use (if known): Commerce/Trade	City Block 467.03
9. Present/other name (if known):	11b. Current Use: Commerce/Trade	City Ward 7
7. Township-Range-Section: N/A		10. Ownership: Private
Neighborhood Number: 34

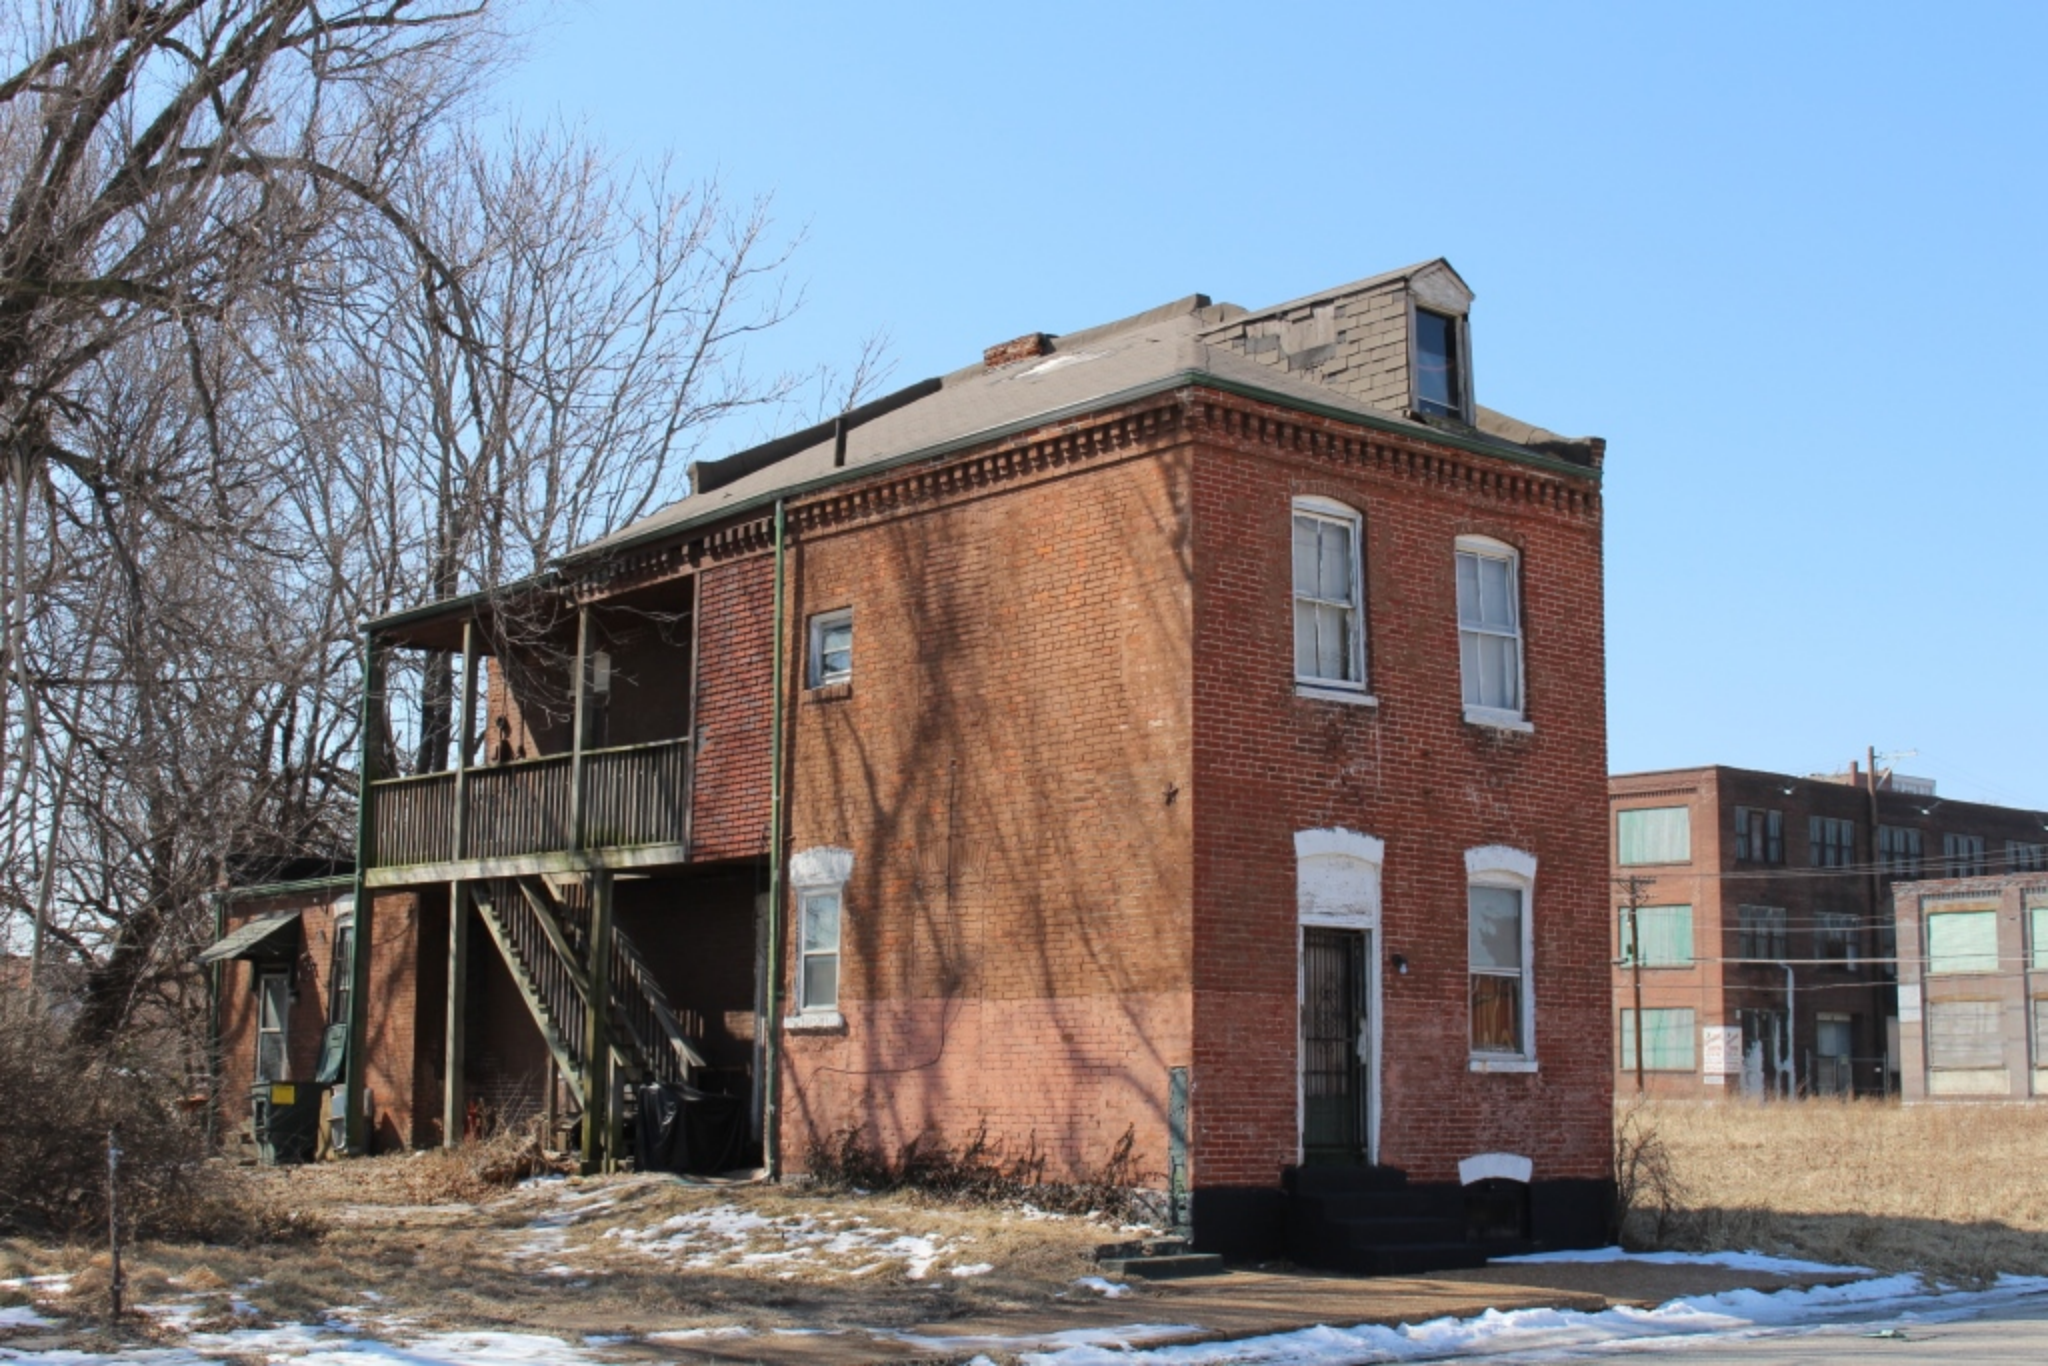
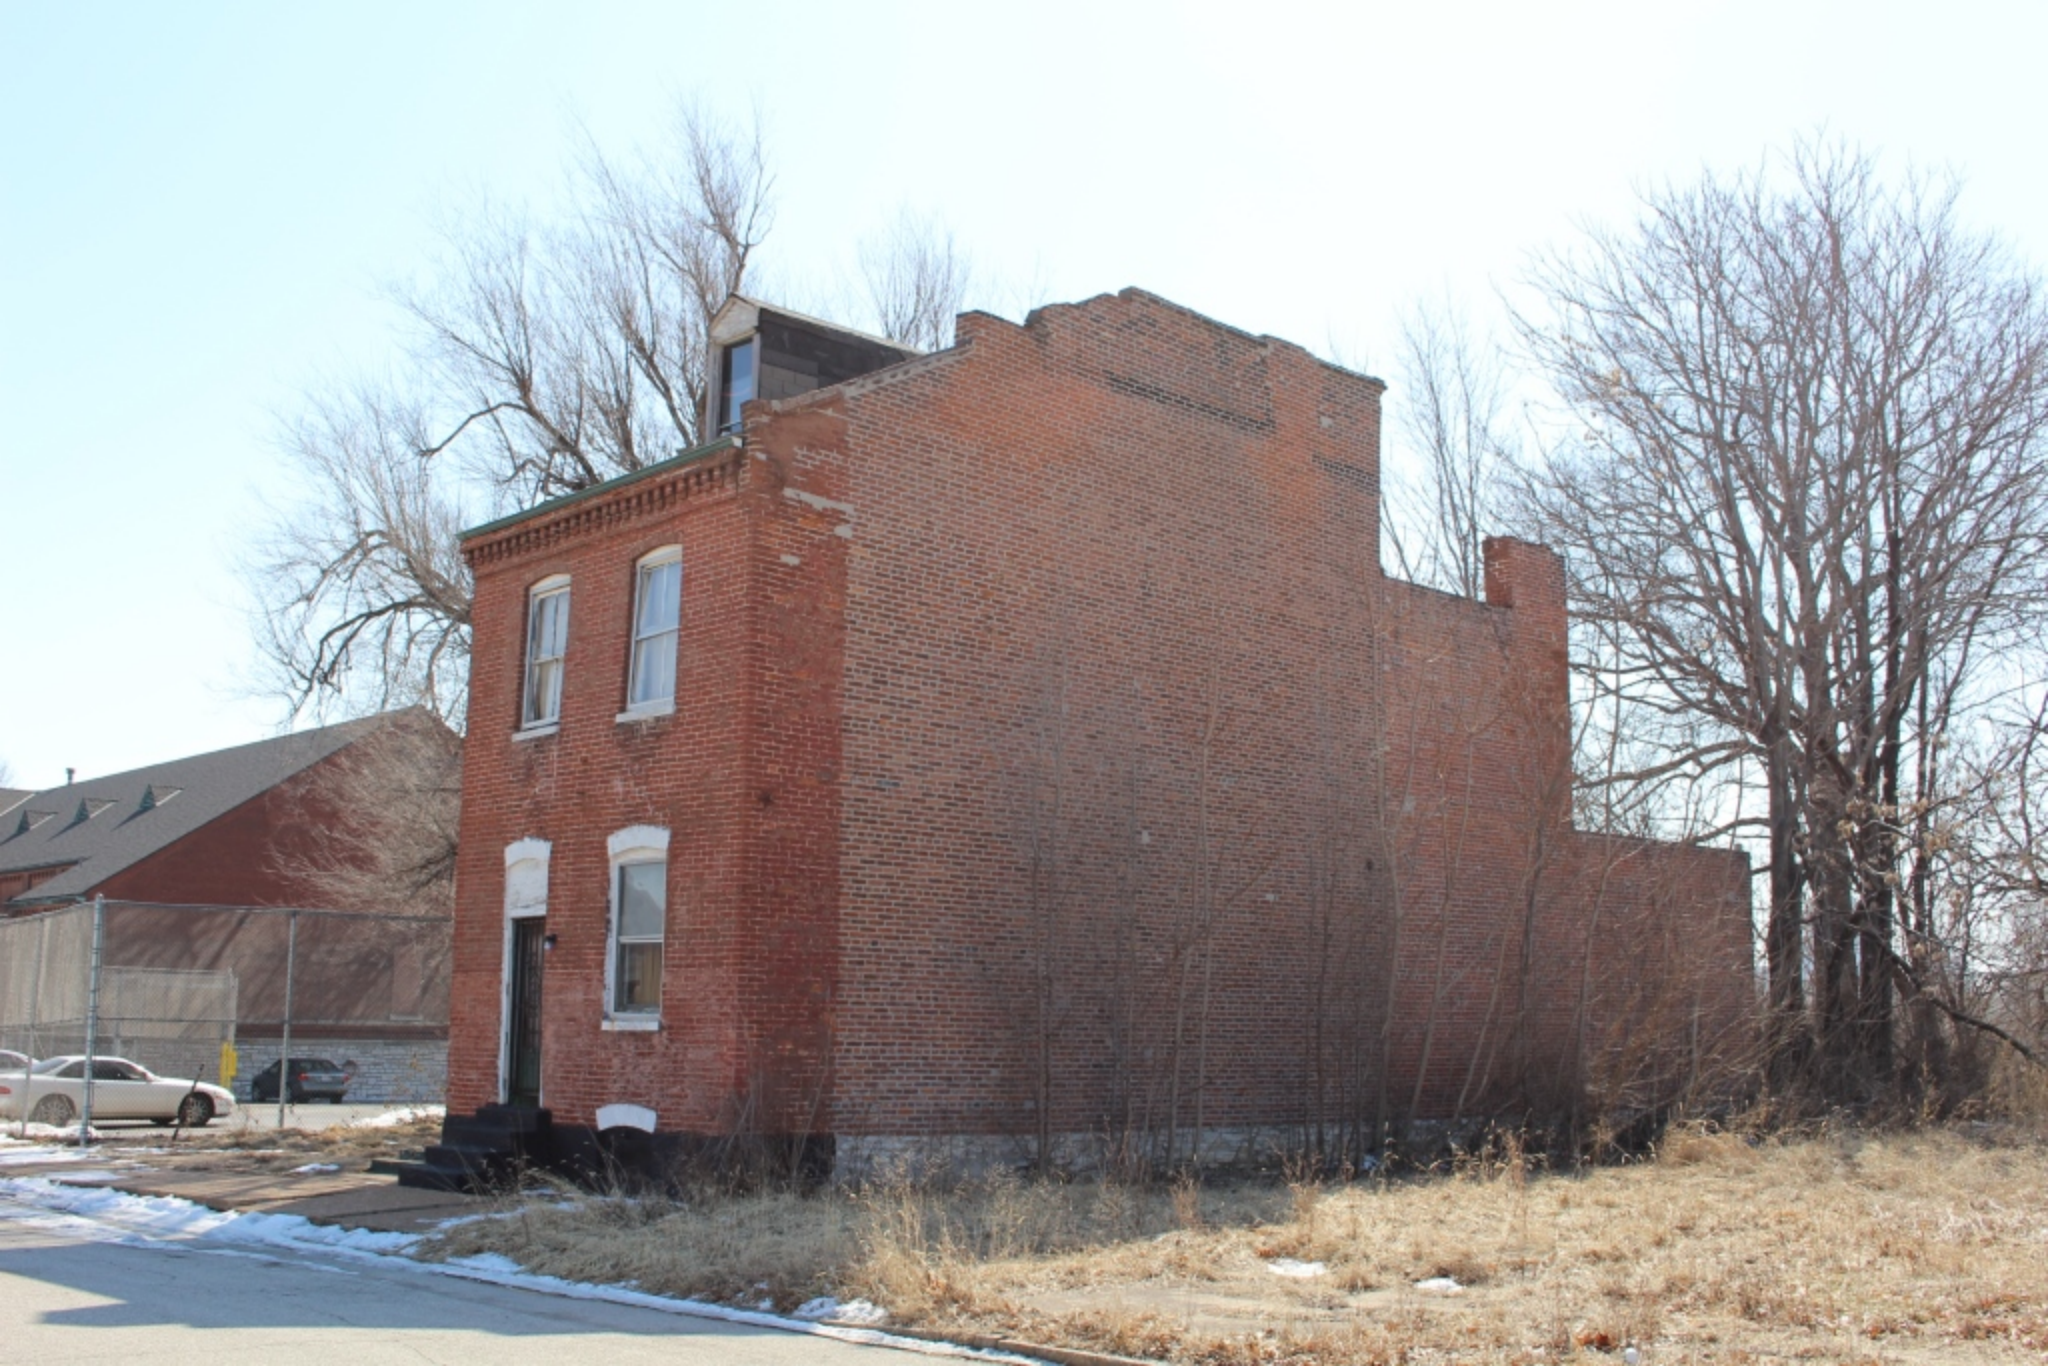
This two-bay by two-bay two-story brick flounder house is positioned at the sidewalk. A break in the brick visible on taller, windowless west side shows the extent of the addition to the rear; both portions of the building have a coursed rubble foundation although the front foundation is parged and painted black. The denticulated cornice extends across the street façade and east wall, including the addition. The segmentally-arched door and window openings on the ground floor of the North Market façade have soldier arches; the two windows above have arches of headers. A wood-framed gable-roofed dormer rises from the front slope of the hipped roof somewhat offset from the west bay. A two-story gallery porch on the east side of the addition has replacement wood components. The rear-most section of the house is one story with a flat roof.

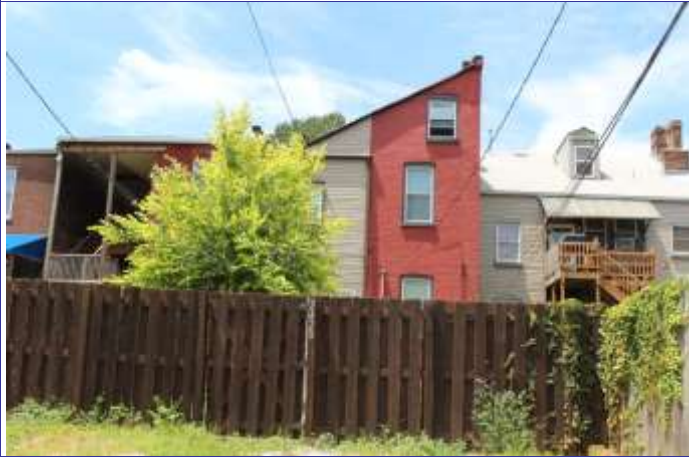
Façade and rear walls painted, side wall not painted.

This two-and-one-story brick flounder presents two bays to the street and the entrance is in one of them. The façade and other openings have segmentally-arched heads of soldier bricks. A simple denticulated brick cornice edges the eaves of the façade and south side wall. The taller north wall is a party wall in part. A wood-framed rear gallery wider than the house projects from the south side of the rear of the house ; it is enclosed with modern siding materials. The attic is lighted and ventilated by a window in the rear wall and a dormer projecting from the side roof slope.

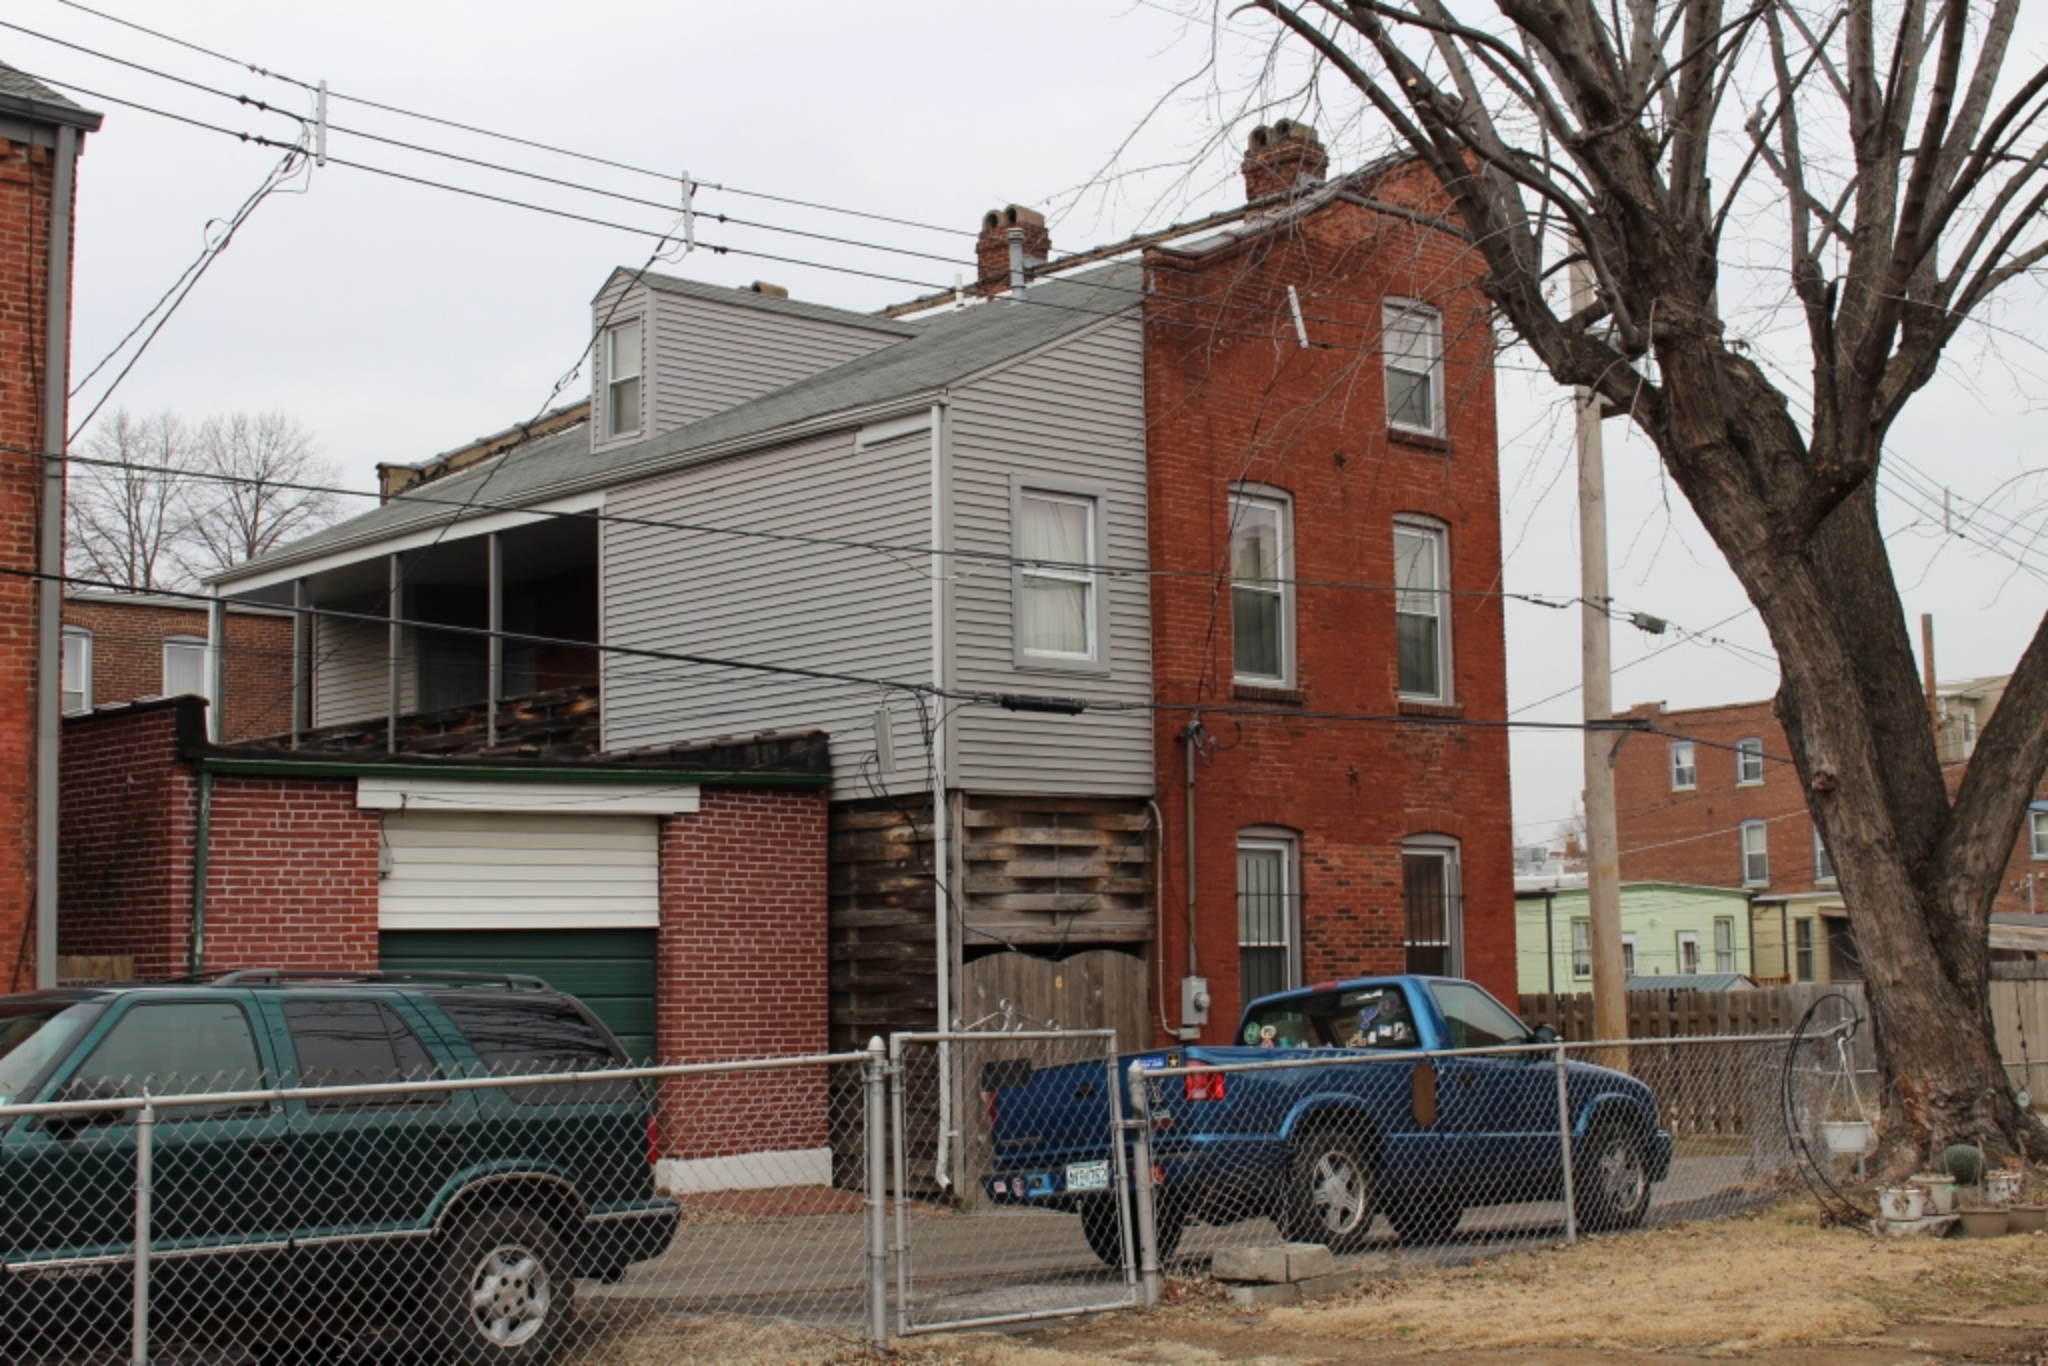
This 2 1/2 story brick flounder is positioned at the aley. Its taller, originally windowless wall rises on the north side; one flat-headed window has been inserted in each story. A two-story gallery extends the length of the south side; the portion near the alley is enclosed at the second story and clad in vinyl siding; the lower portion is fenced in. The gallery is open at the interior of the lot side. A small galed dormer extends from the roof; it is also clad in viny siding. Windows with segmental arch heads formed of solider brick have replacement 1/1 sash and wrapped brickmold.

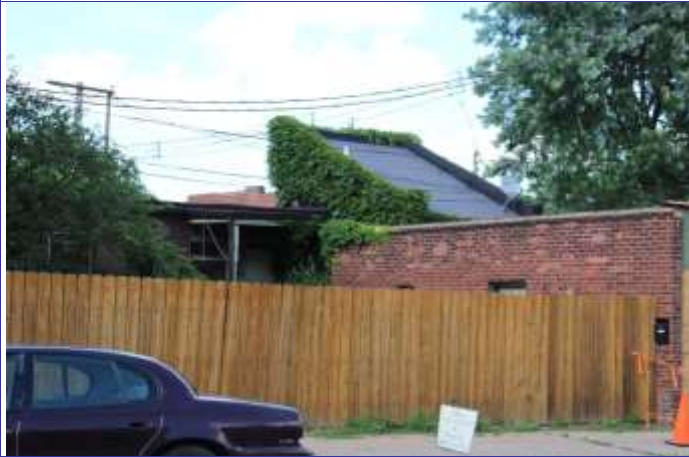
**2436 MCNAIR AV**

This one-room size 1 1/2-story flounder is positioned at the alley. Its alley façade has arched door and window openigns formed of two rowlocks of brick headers. A door and small window pierce the lower story; a larger window lights the attic level. Adjacent alley buildings have party walls with the taller windowless wall on the north side and the south wall.

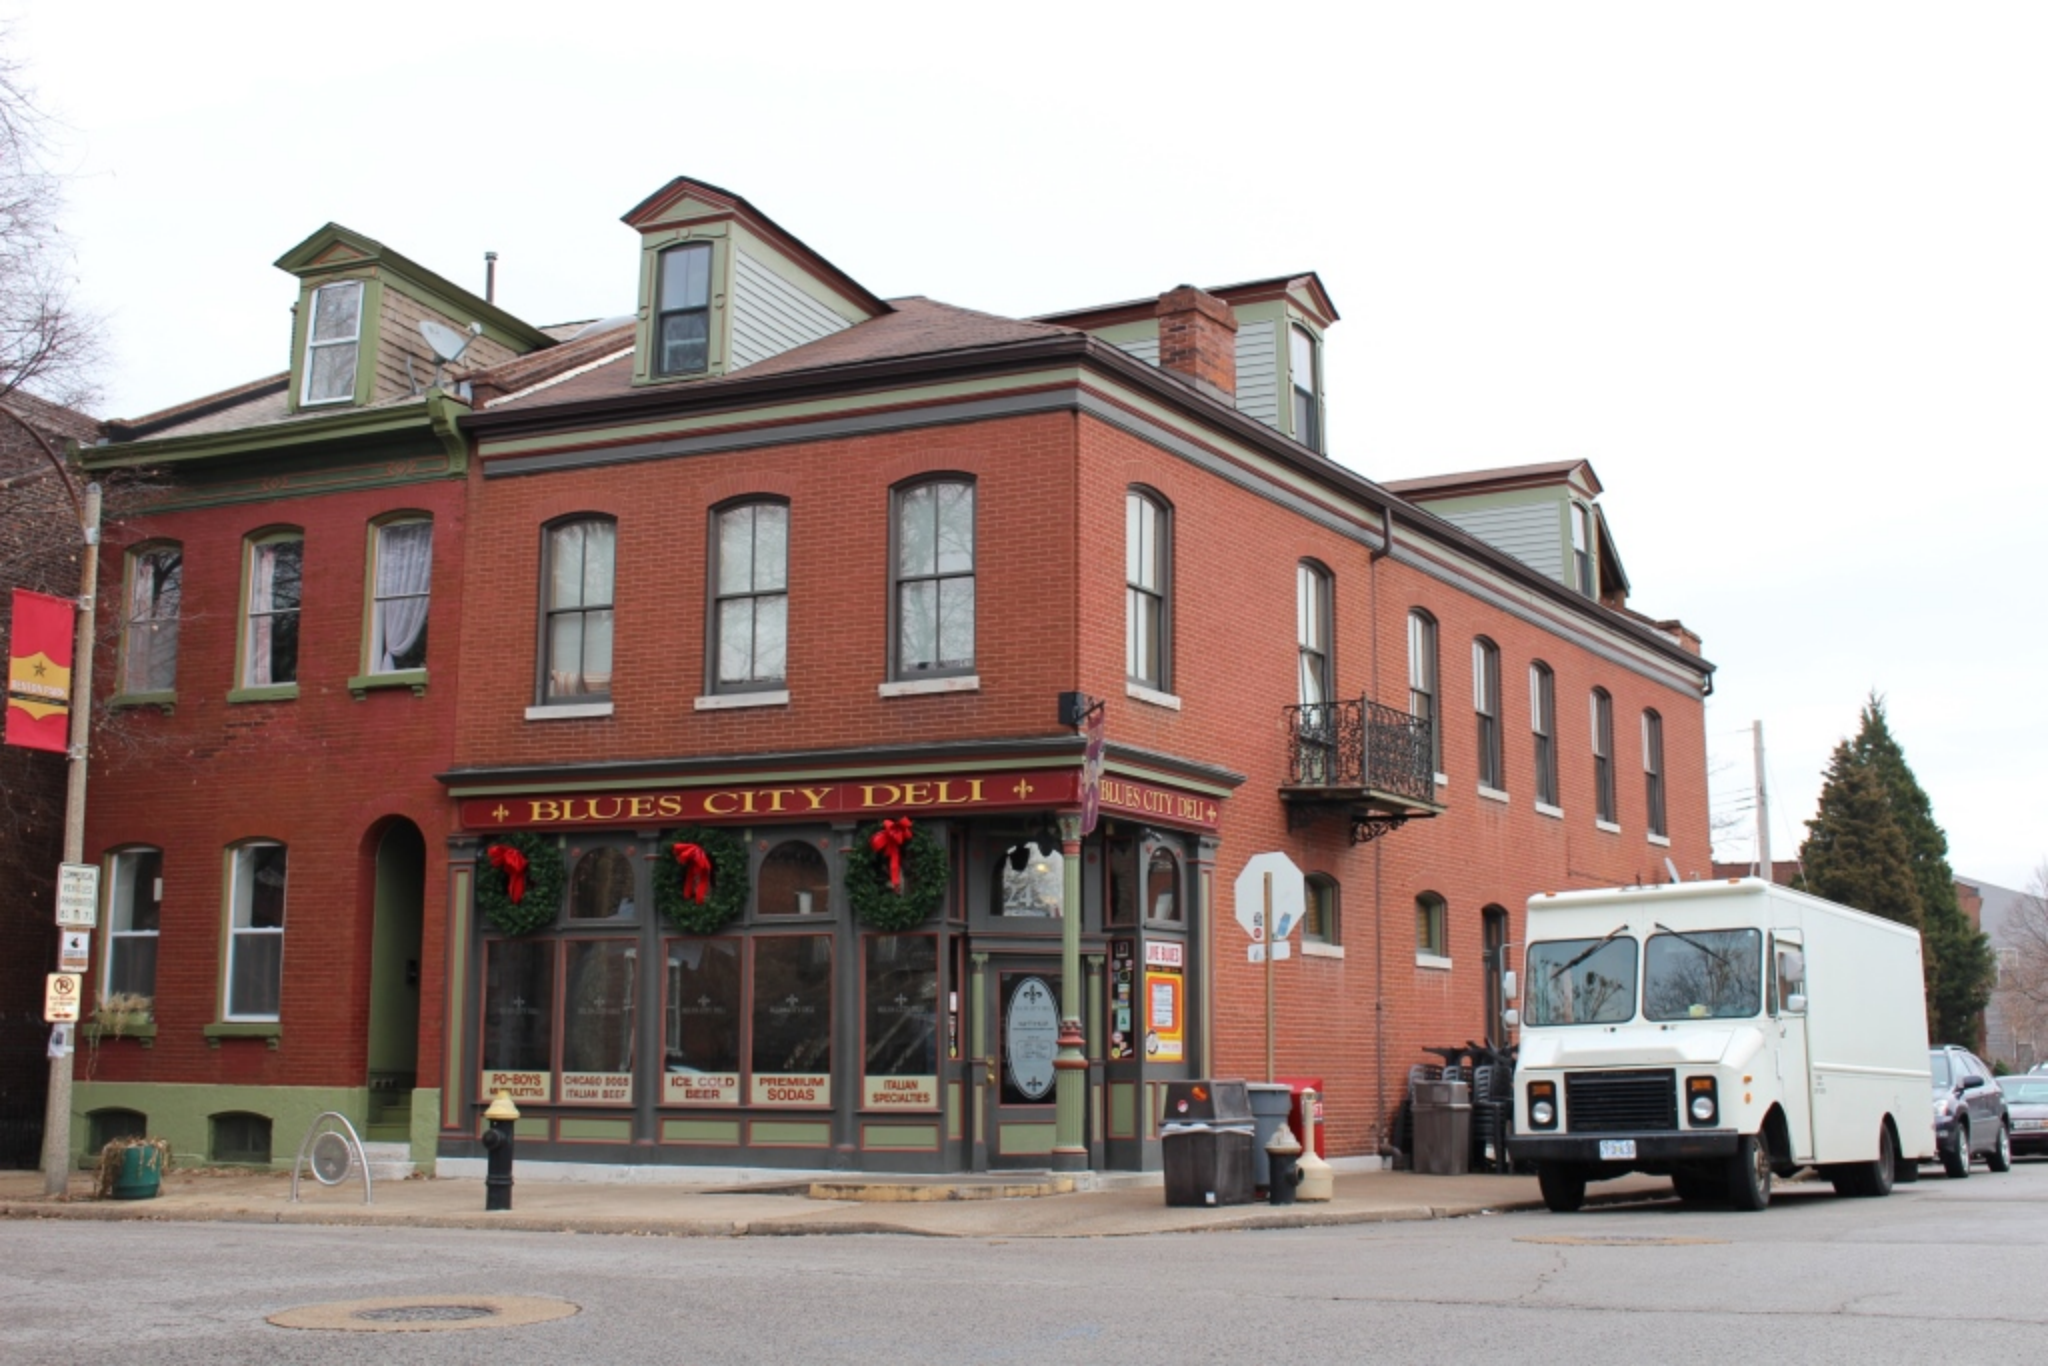
This 2 1/2 store and loft building at a corner location has a storefront in its McNair façade with a corner entrance. Two doors in the Victor façade are slightly recessed with paneled sides of the opening and have paneled doors set under transoms. All door and window openings on the two street facades, other than the storefront, have segmentall arched heads formed of soldier brick and stone sills; arched wood sash has a 2/2 configuration. A wood cornice edges the eaves on both street facades and two small gabled dormers project from the shed roof and another dormer projects from the hipped front portion of the roof facing McNair. The taller windowless wall is a party wall. The cast-iron storefront remains intact. A cast-iron balcony extends from a door at the second story near the McNair end of the Victor façade.

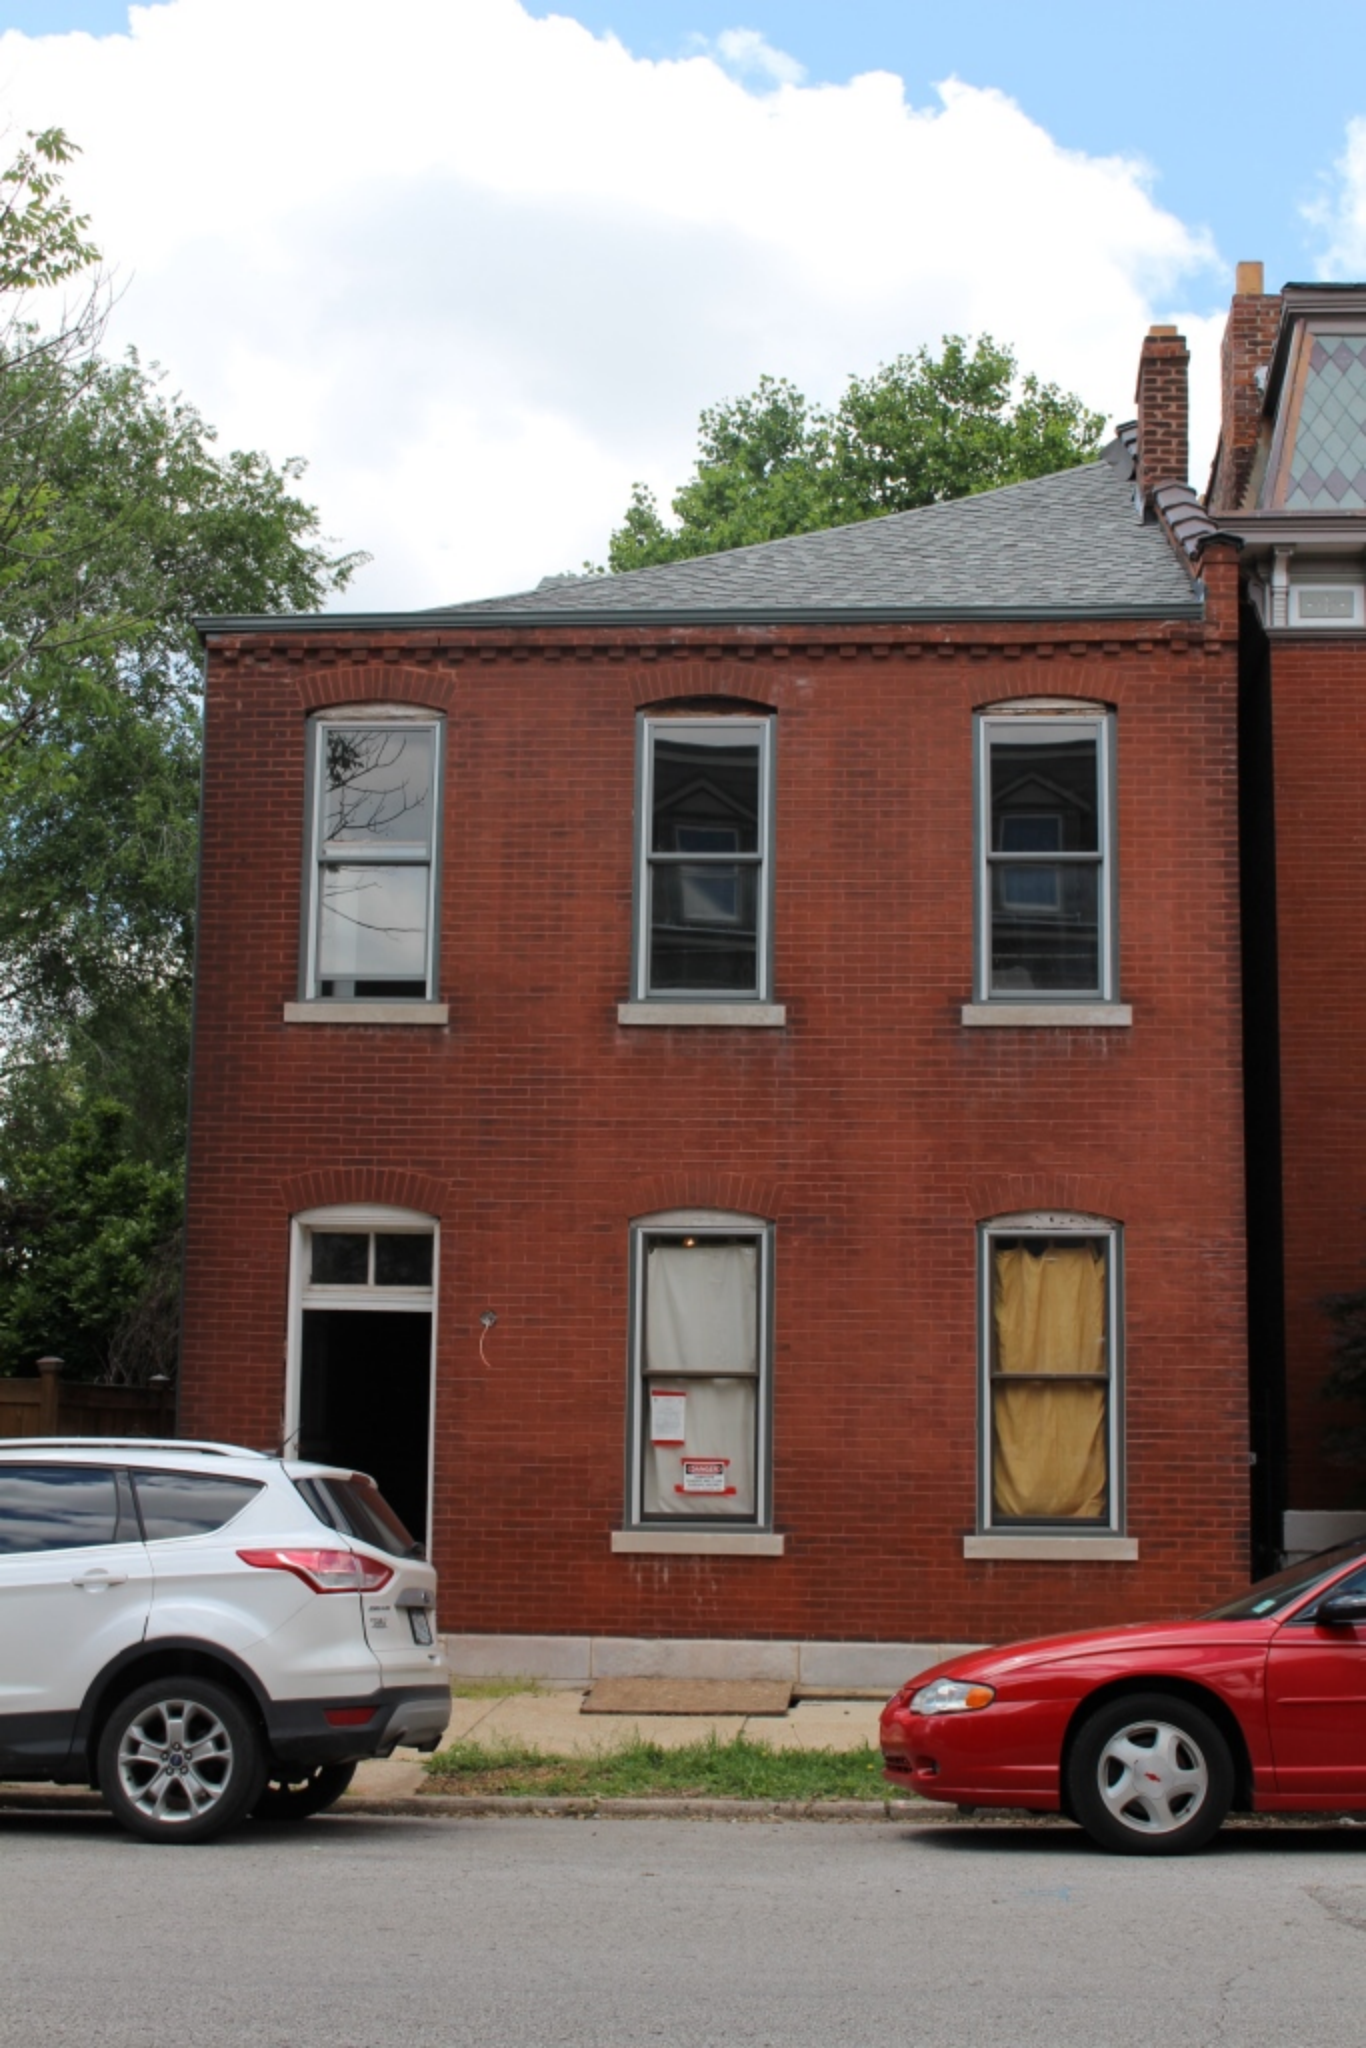
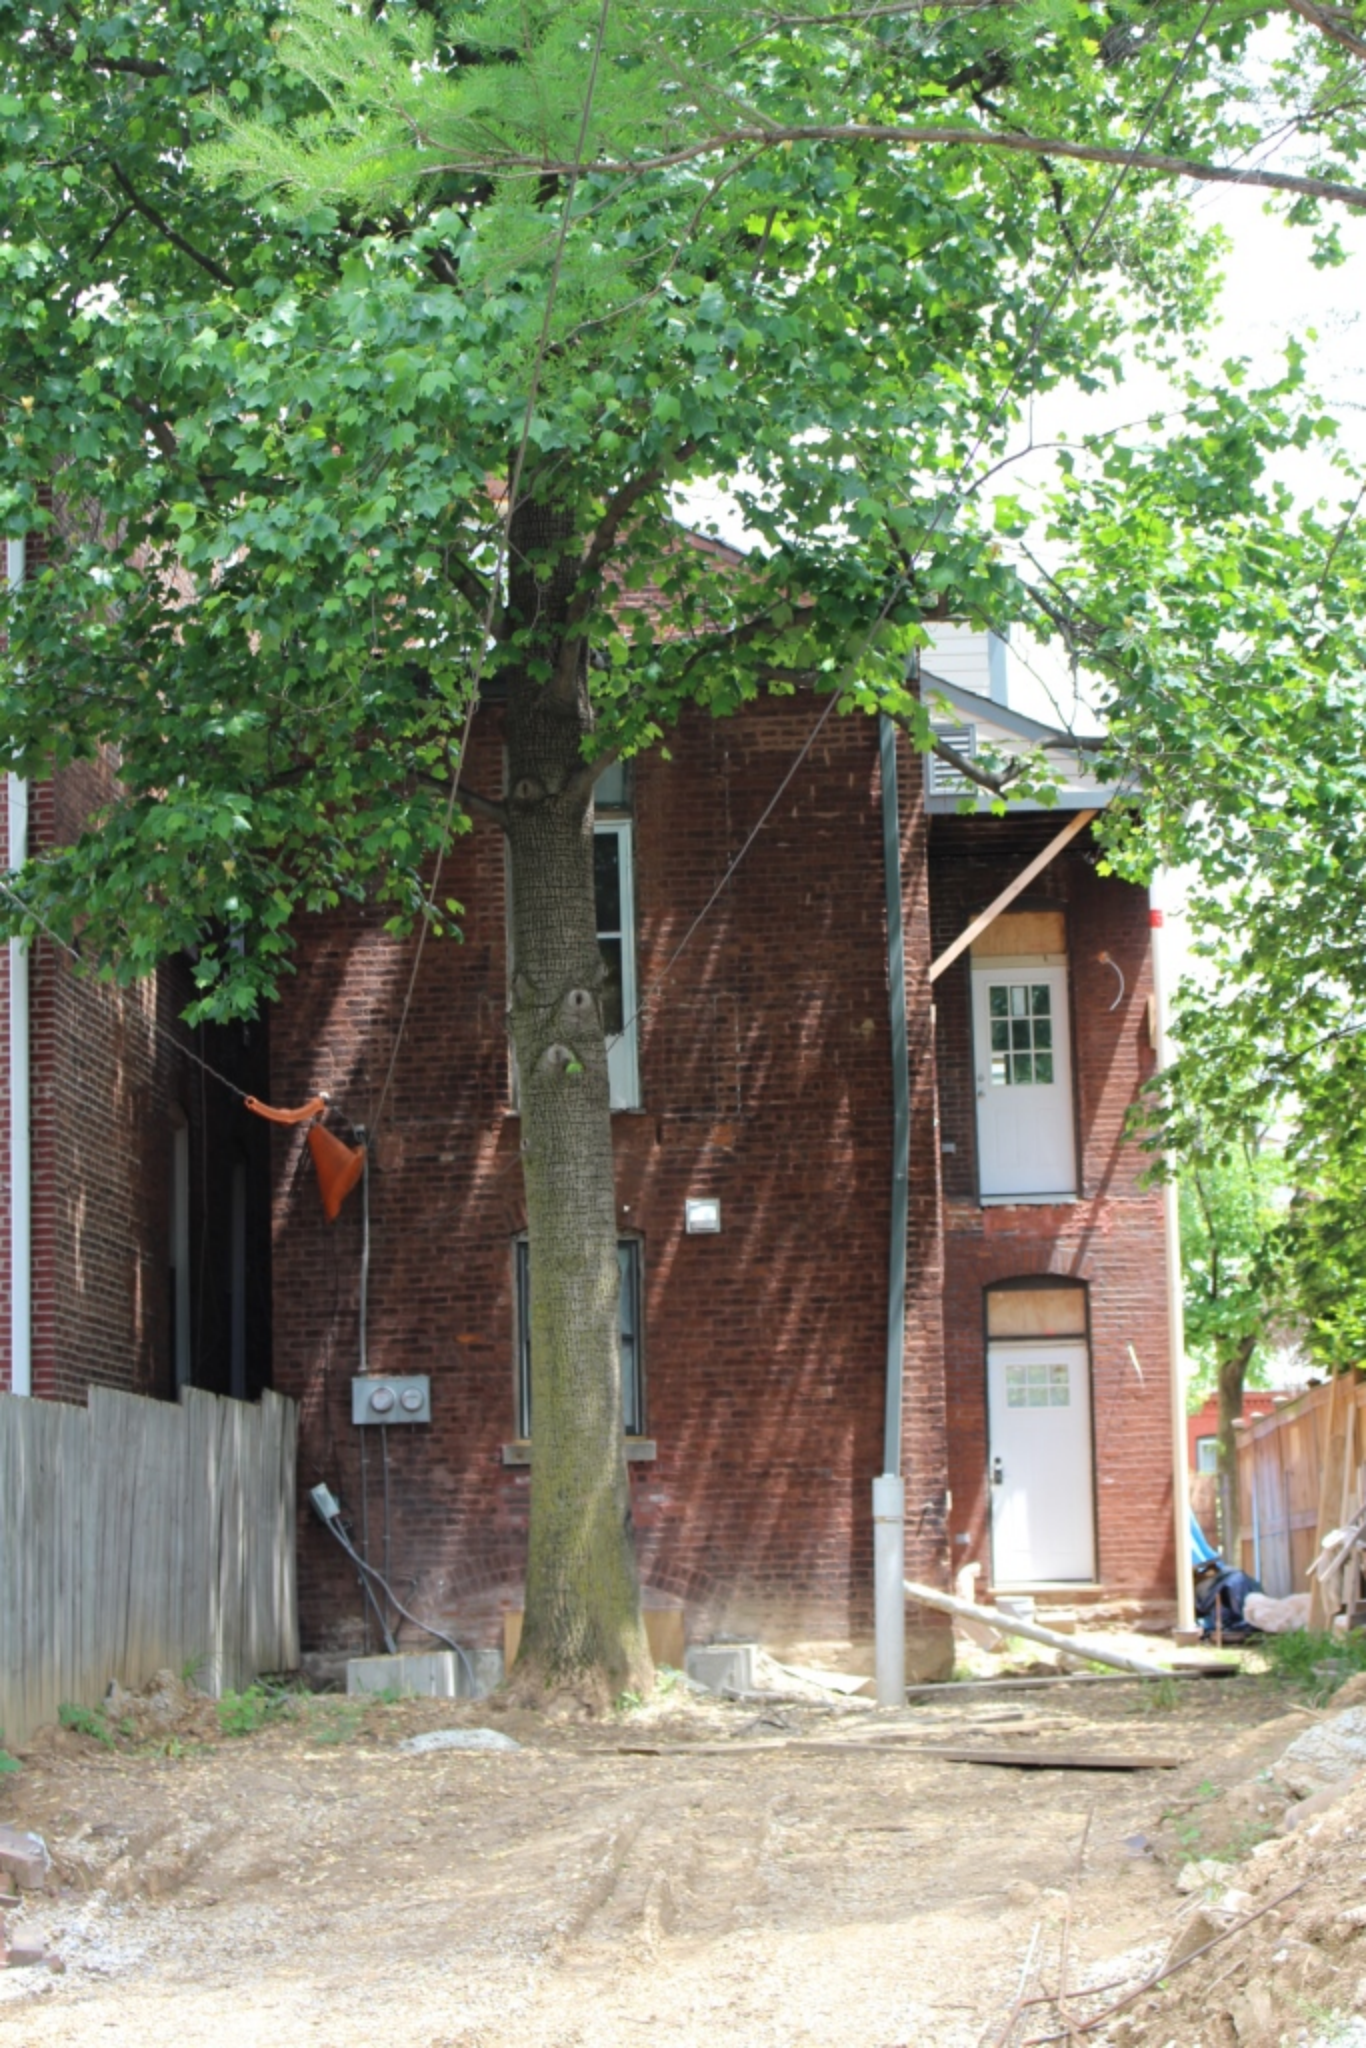
This two-story flounder has a realatively wide three-bay façade. Large ashlar blocks form the visible foundation on the façade. Ached window and door openigns have heads formed of soldier bricks and stone sills. Windows are square-headed replacement 1/1 doublehung sash set under eyebrows. A modest denticulated brick cornice edges the façade only. The taller windowless wall on the north side is only a narrow gangway-width away from the adjacent buiding. The exposed south wall has an entrance in the front bay. Doors at both levels at the rear of the front wing indicate that a two-story wood gallery filled the inset along the rear wing. A wide arch formed of rowlock header bricks accommodates an exterior entrance to the basement at the rear.

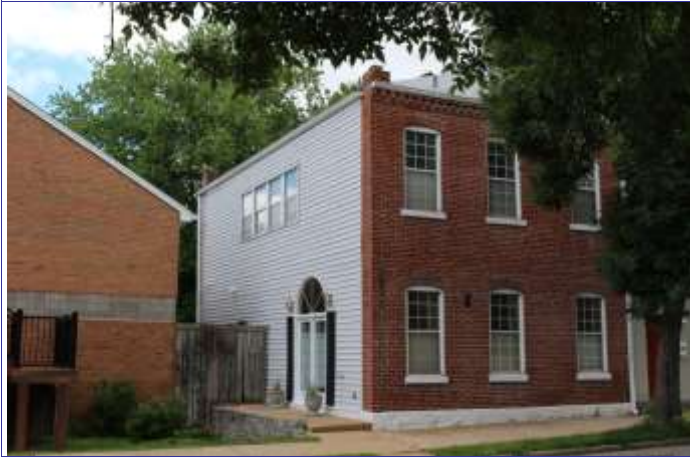
**2859 MCNAIR AV**

This three-bay wide 2 1/2 story brick flounder has brick wing walls at the two-story gallery that formed the south side wall. This wall is now enclosed with vinyl siding and has a modern entrance and a bank of windows. Th taller windowless wall rises on the north in a party wall condition. The six window openings on the façade have segmentally-arched heads formed of soldier bricks and stone sills. Replacement sash on the façade is vinyl with a 9/9 doublehung configuratin. This same sash is used on the rear, including the flat-headed window in the attic level. A two-story porch extends from the rear, serving a second story door.
