**ARCHITECTURAL/HISTORIC INVENTORY FORM - Cultural Resources Office**  
**St. Louis Planning and Urban Design**

1. Survey no. SLC-AS-053-0102	2. Survey name: Thematic Survey of Flounder Houses in St. Louis City	3. County: St. Louis [Independent City]
4. Address: (from City GEO database) <b>900 HICKORY ST</b>		5. City/State: St. Louis, Missouri
Alternate address: 900 Hickory Street		Property Zip Code: 63104
Latitude: 38.615737		6. UTM Easting: 743886.40
Longitude: -90.198830		UTM Northing: 4277858.27
8. Historic Name (if known): N/A	11a. Historic Use (if known): Commerce/Trade	City Block 467.03
9. Present/other name (if known):	11b. Current Use: Commerce/Trade	City Ward 7
7. Township-Range-Section: N/A		10. Ownership: Private
Neighborhood Number: 34

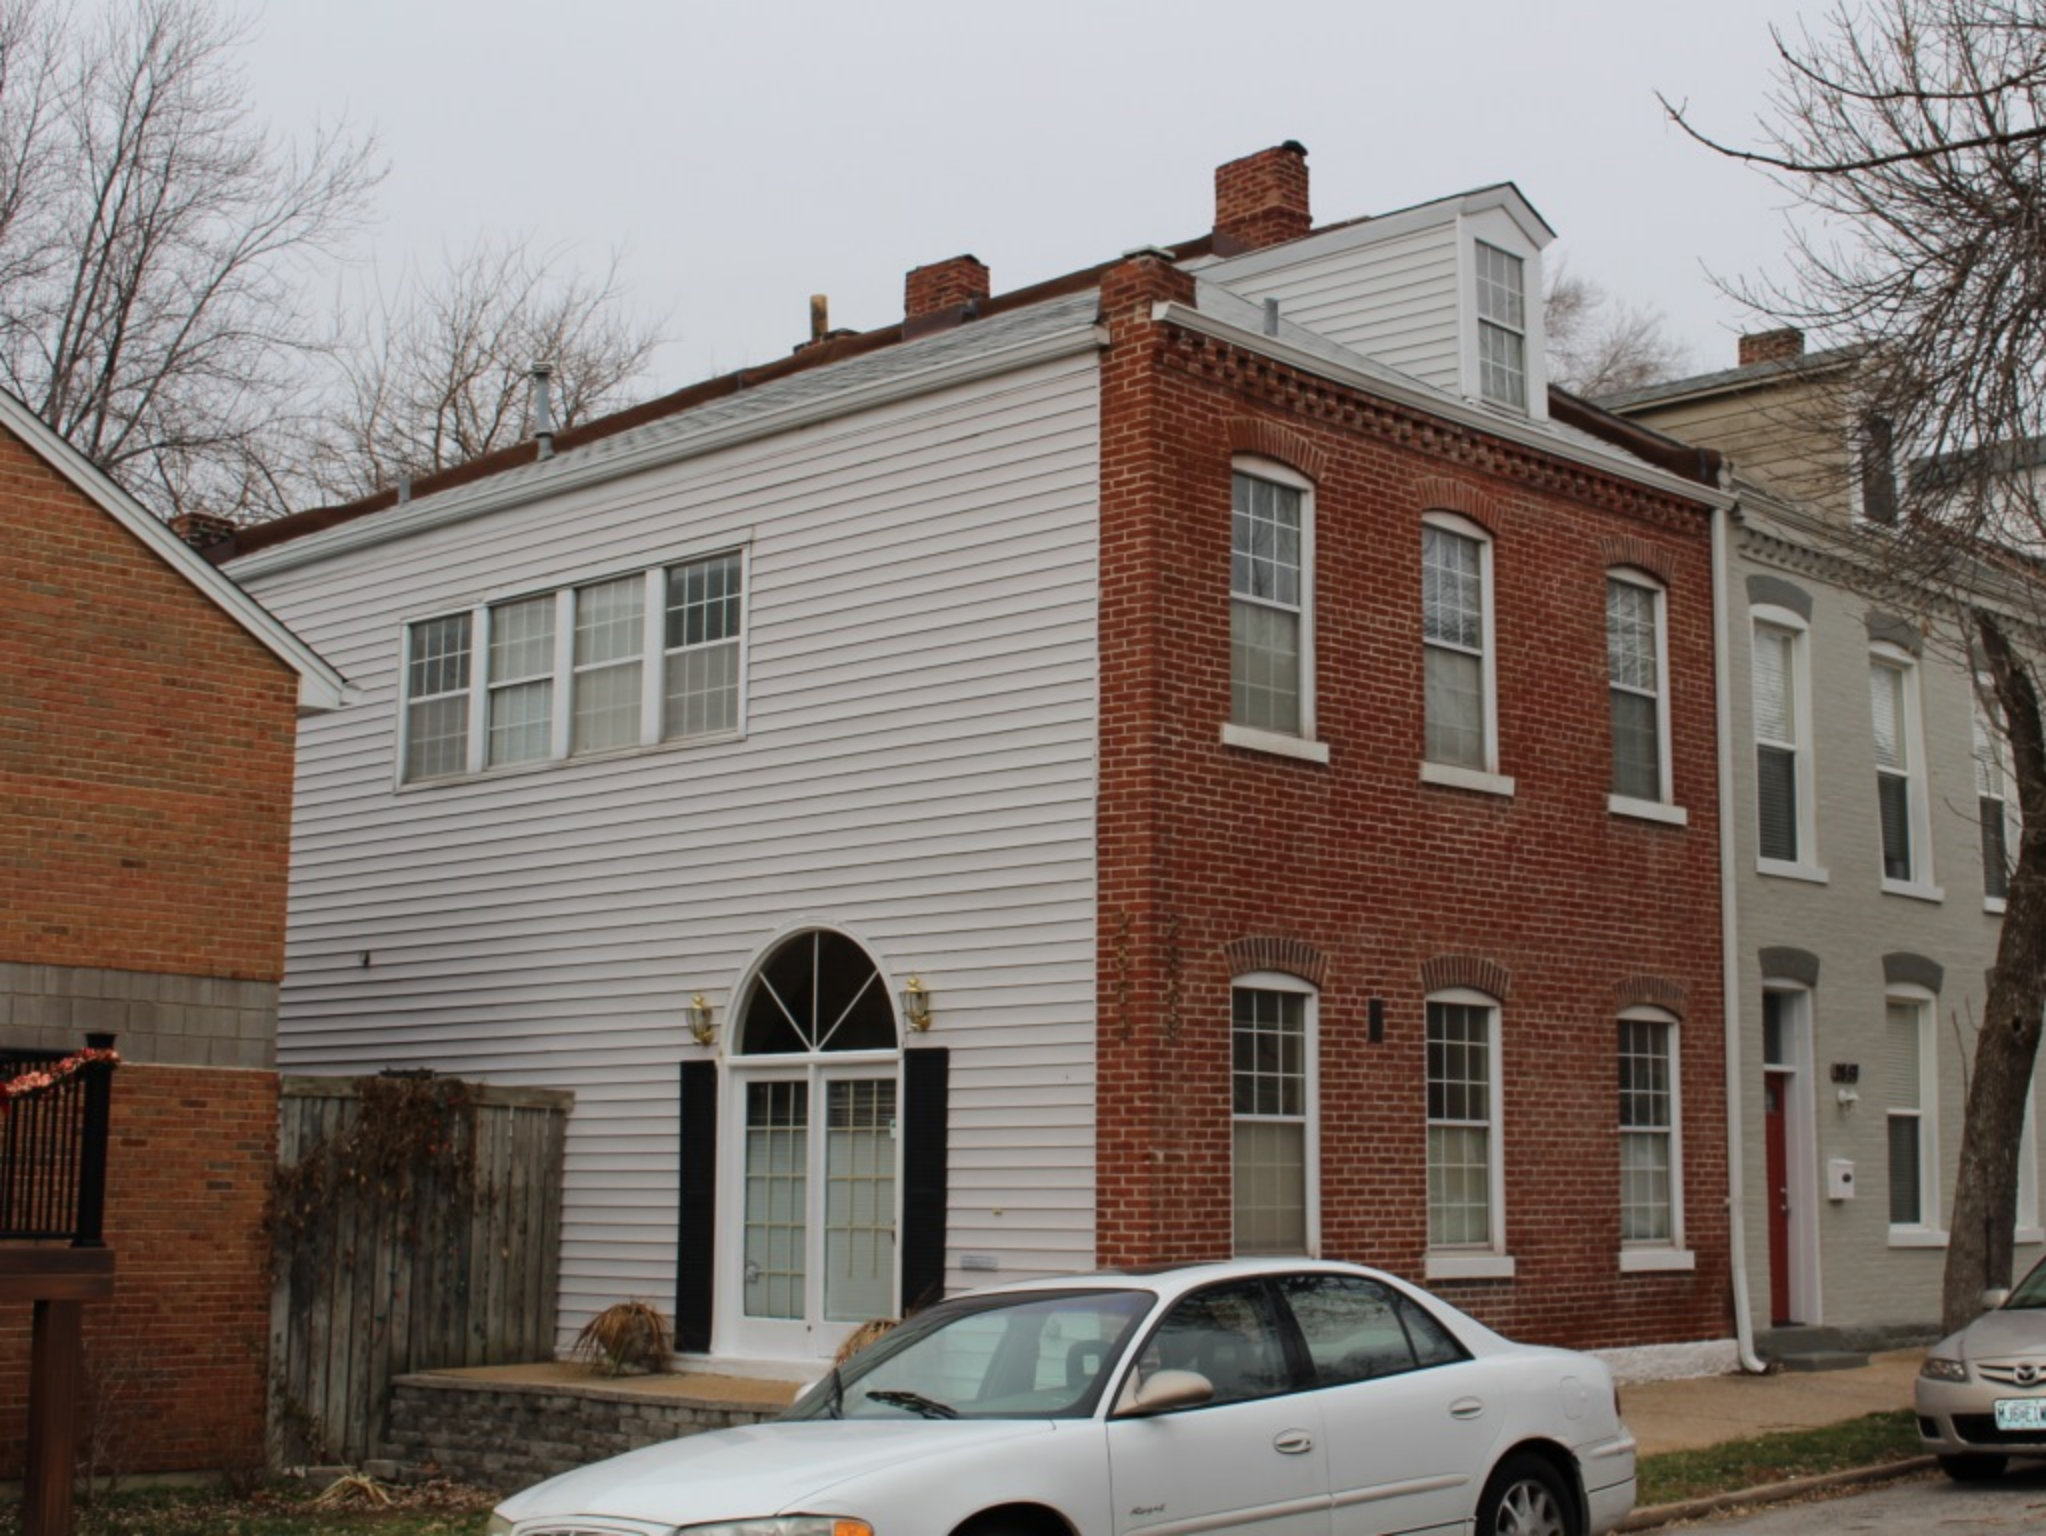
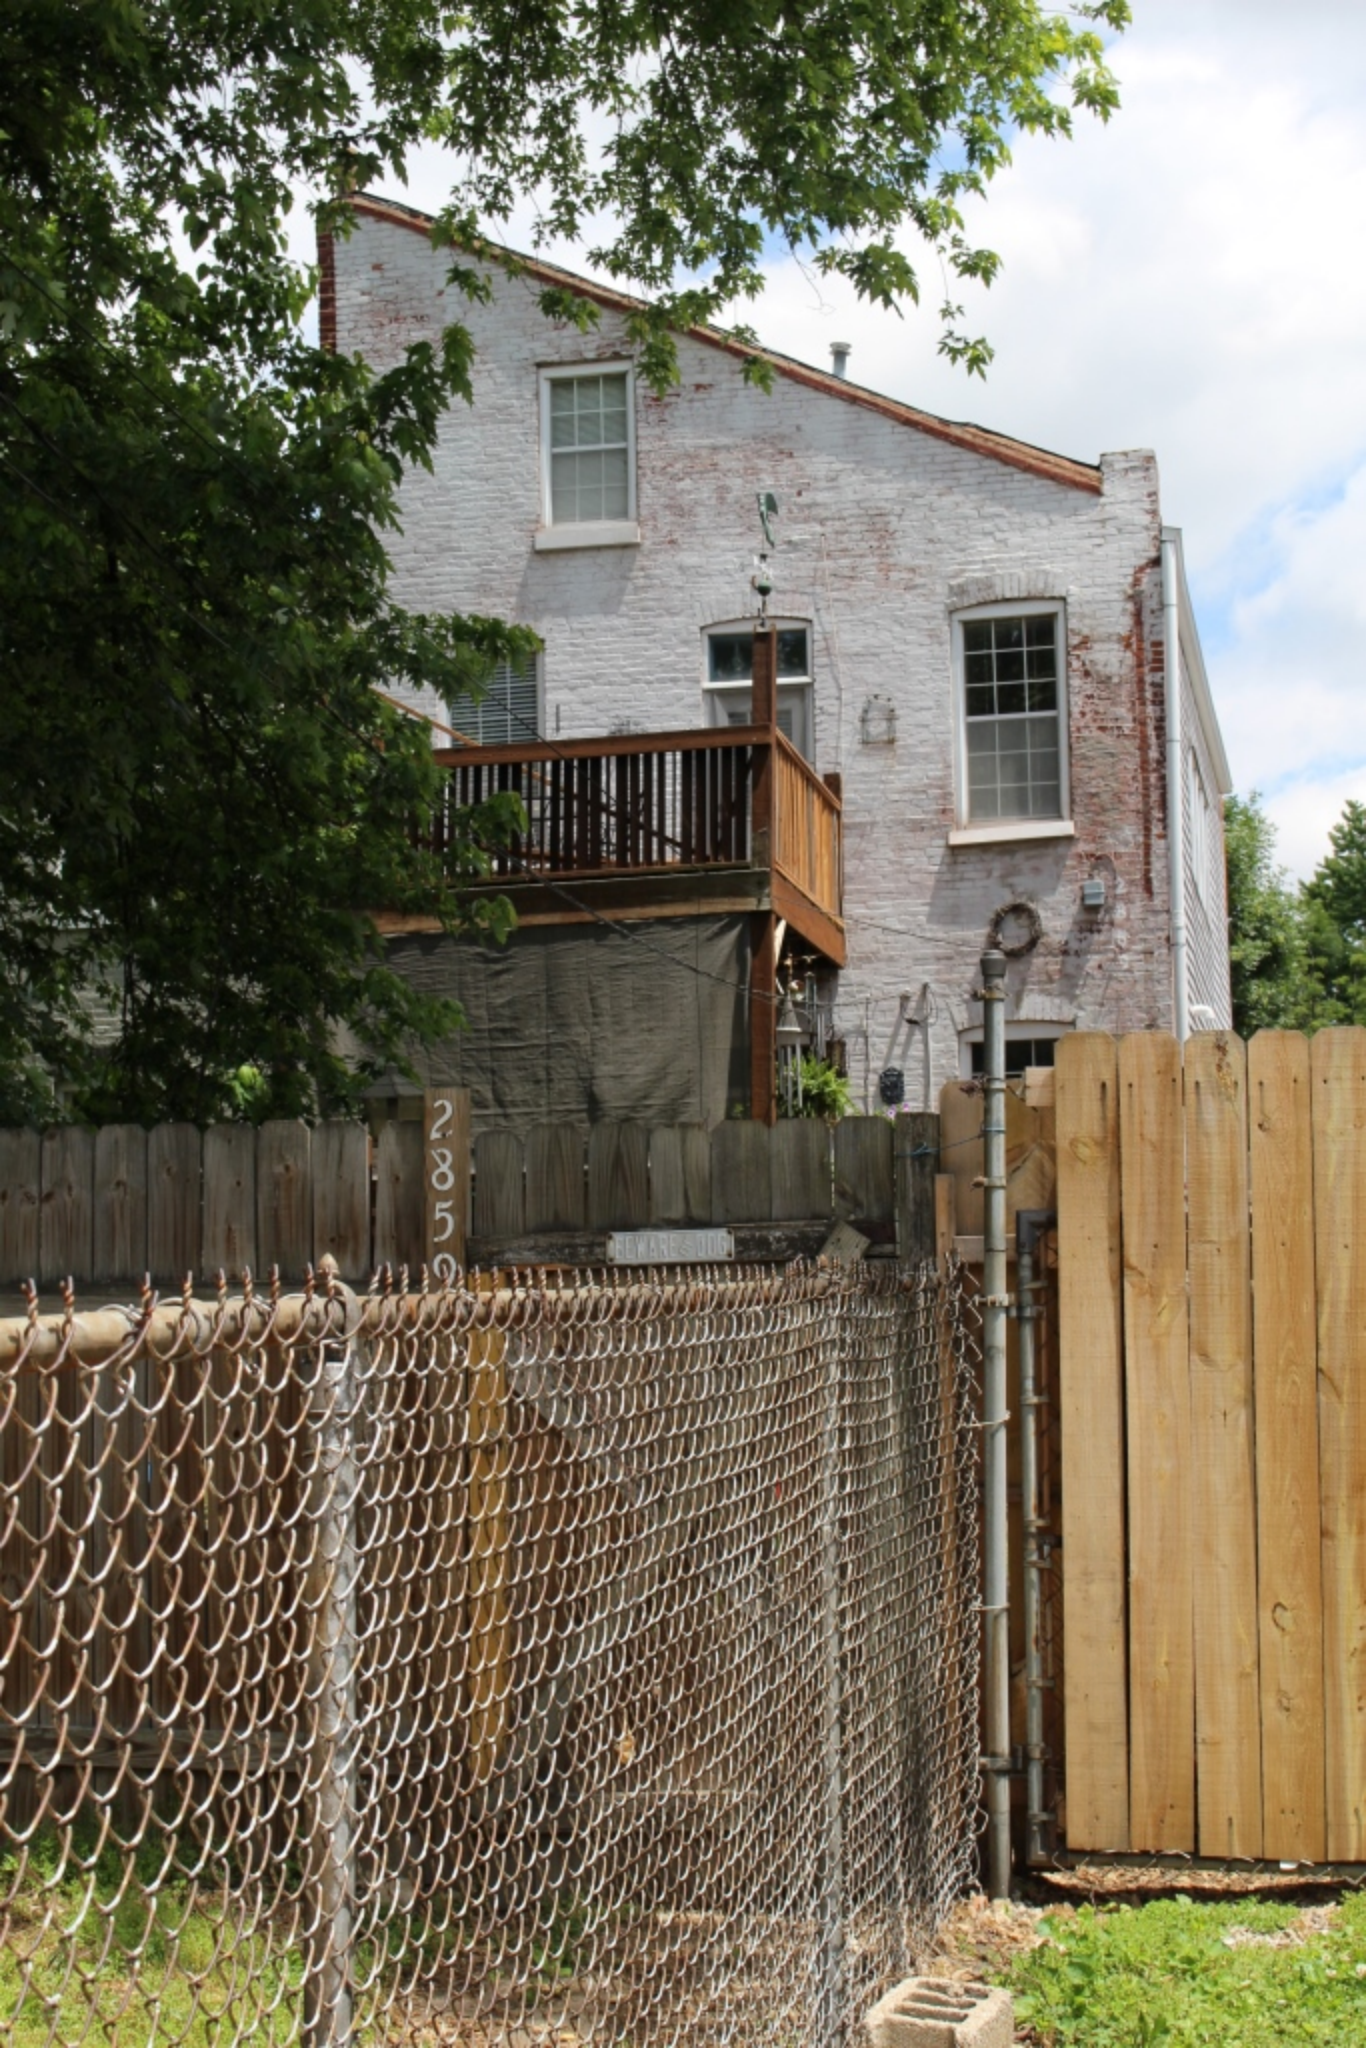
This three-bay wide 2 1/2 story brick flounder has brick wing walls at the two-story gallery that formed the south side wall. This wall is now enclosed with vinyl siding and has a modern entrance and a bank of windows. Th taller windowless wall rises on the north in a party wall condition. The six window openings on the façade have segmentally-arched heads formed of soldier bricks and stone sills. Replacement sash on the façade is vinyl with a 9/9 doublehung configuratin. This same sash is used on the rear, including the flat-headed window in the attic level. A two-story porch extends from the rear, serving a second story door.

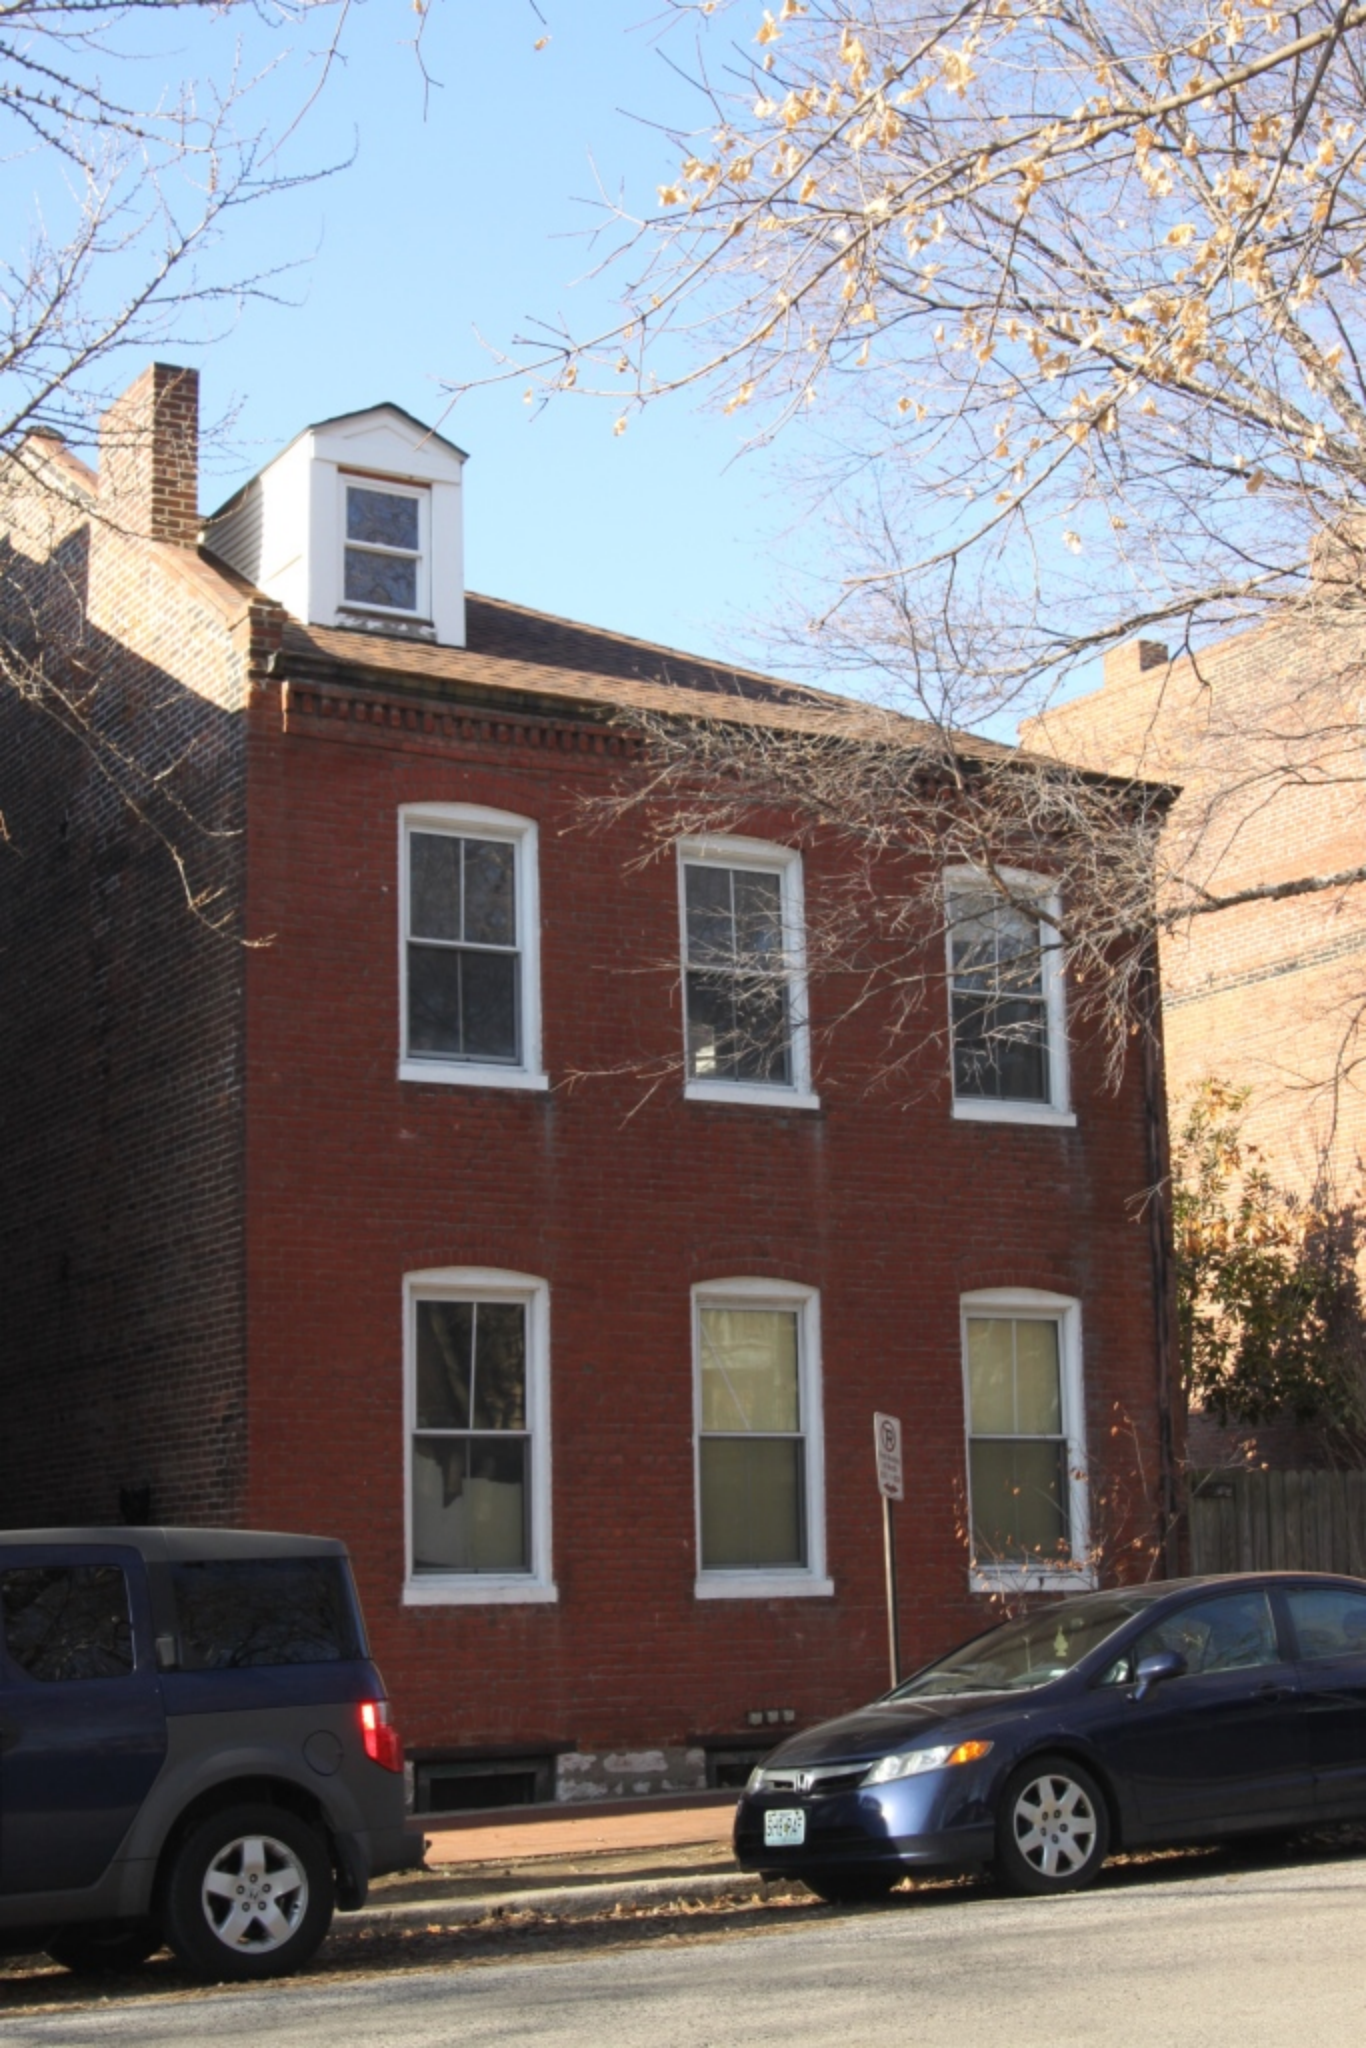
The two-and-a-half story brick hipped roof flounder has a corbelled cornice. There is a simple gabled dormer to the south side with a chimney positioned near the rear of the dormer. The dormer window is one-over-one. The front façade has three bays. The first and second story windows are two-over-two and have segmental arch soldier brick lintels with painted stone sills. There are small altered basement window openings at the two southernmost bays. Flat wood lintels extend across the windows beneath a segmental arch rowlock lintel which has been infilled below with brick. The foundation is coursed rubblestone. There is a recessed gallery porch at the north side of the building. The front section has been enclosed and sheathed in clapboard siding. There are entries on both stories from the gallery porch. A more narrow rear flounder with a steeper pitch to the roof extends out from the rear and has it's own gallery porch. The rear has look of a more classical flounder shape. It is difficult to photograph as there is an alley building behind it and a large tree which blocks the view.

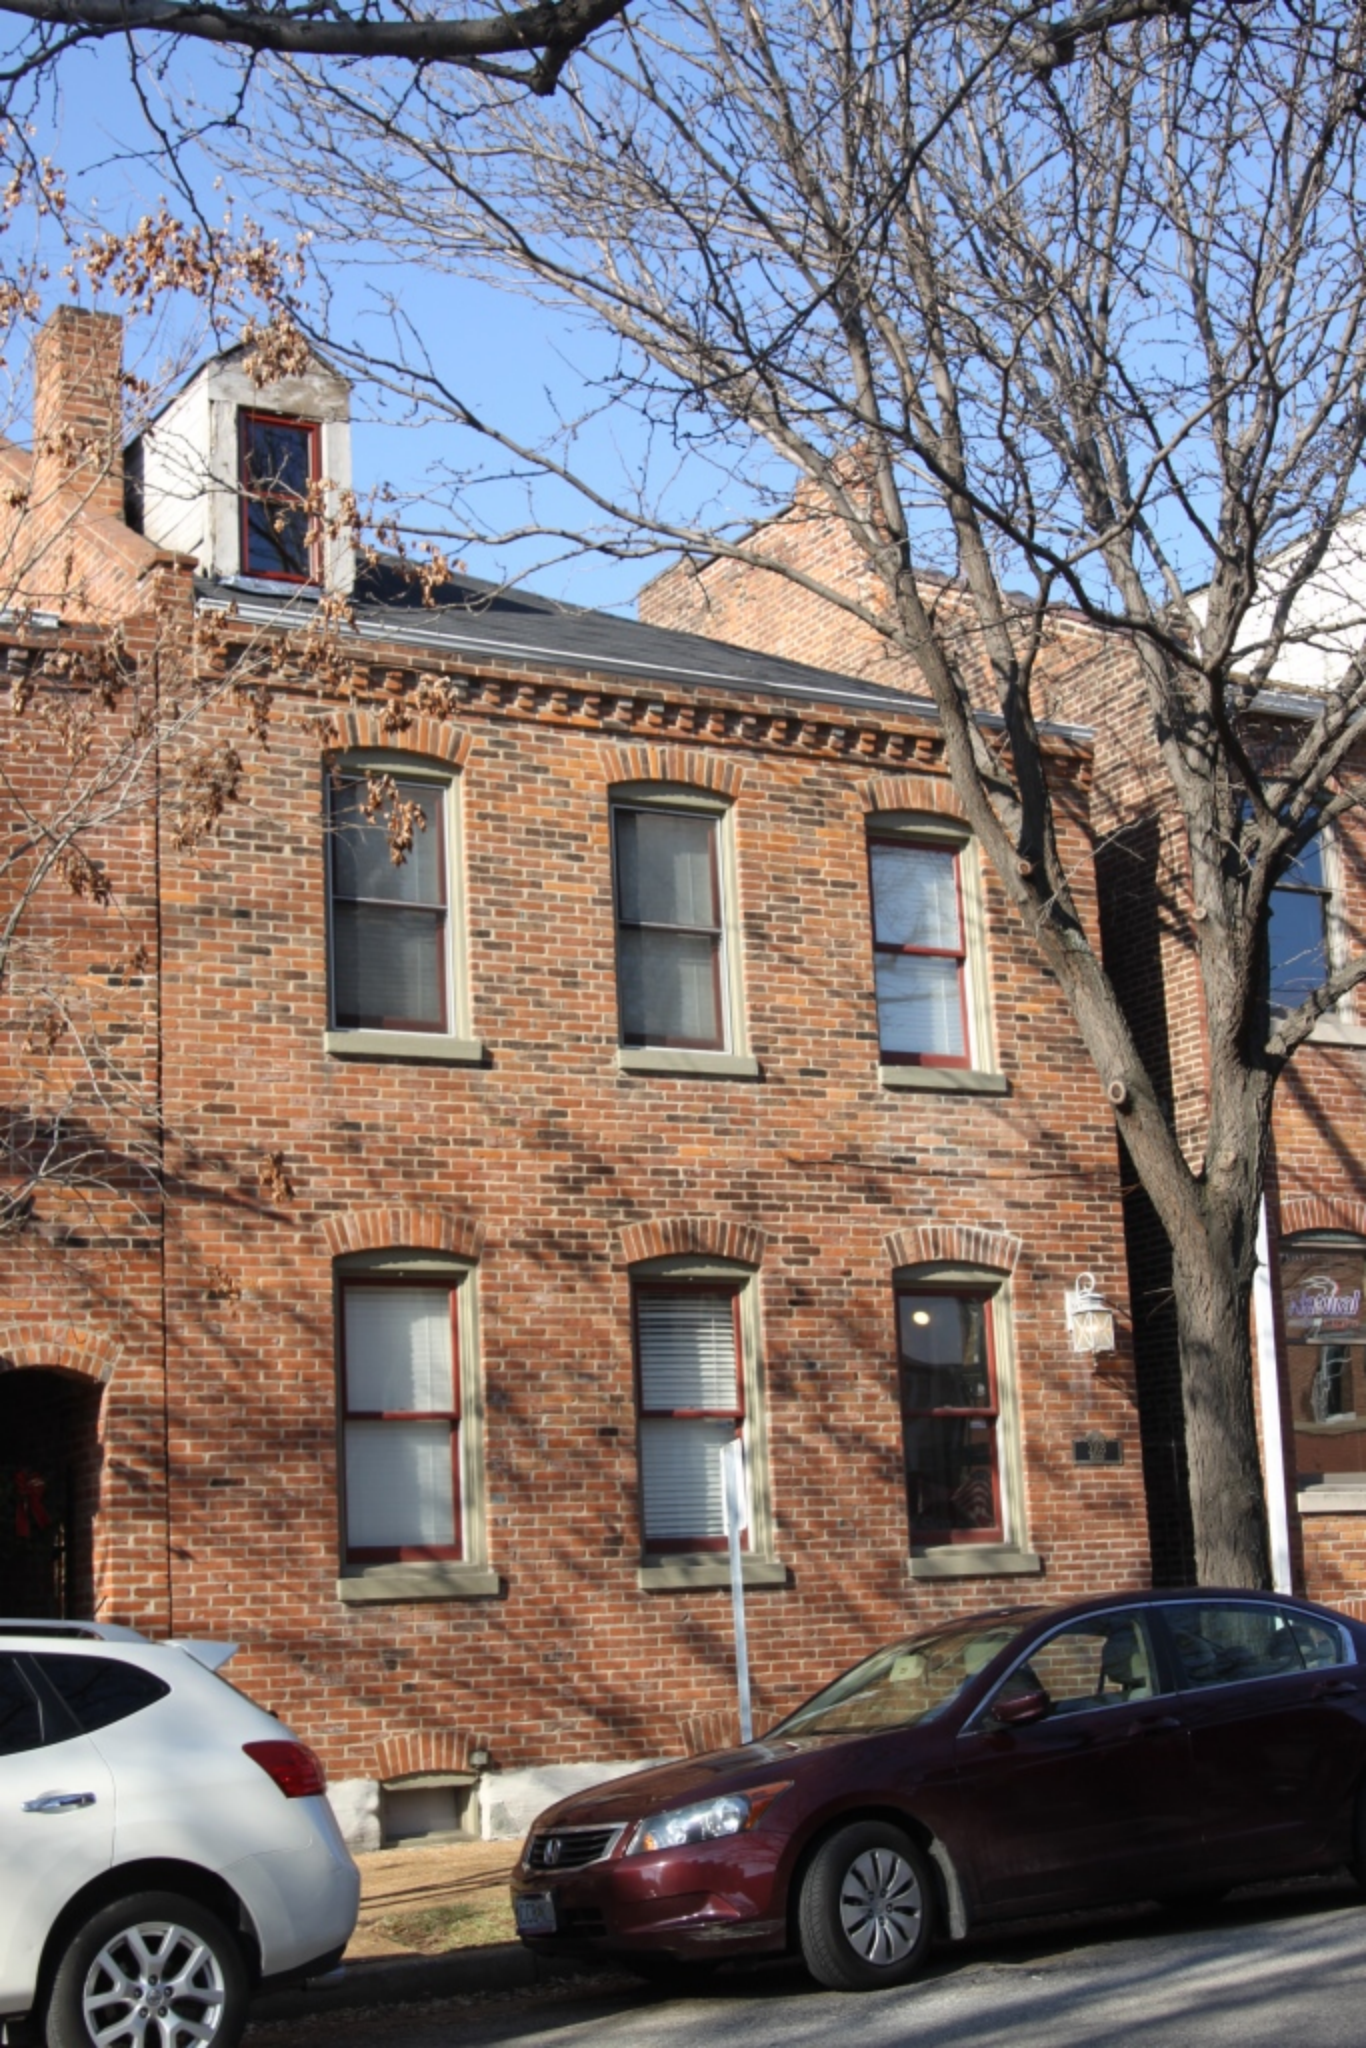
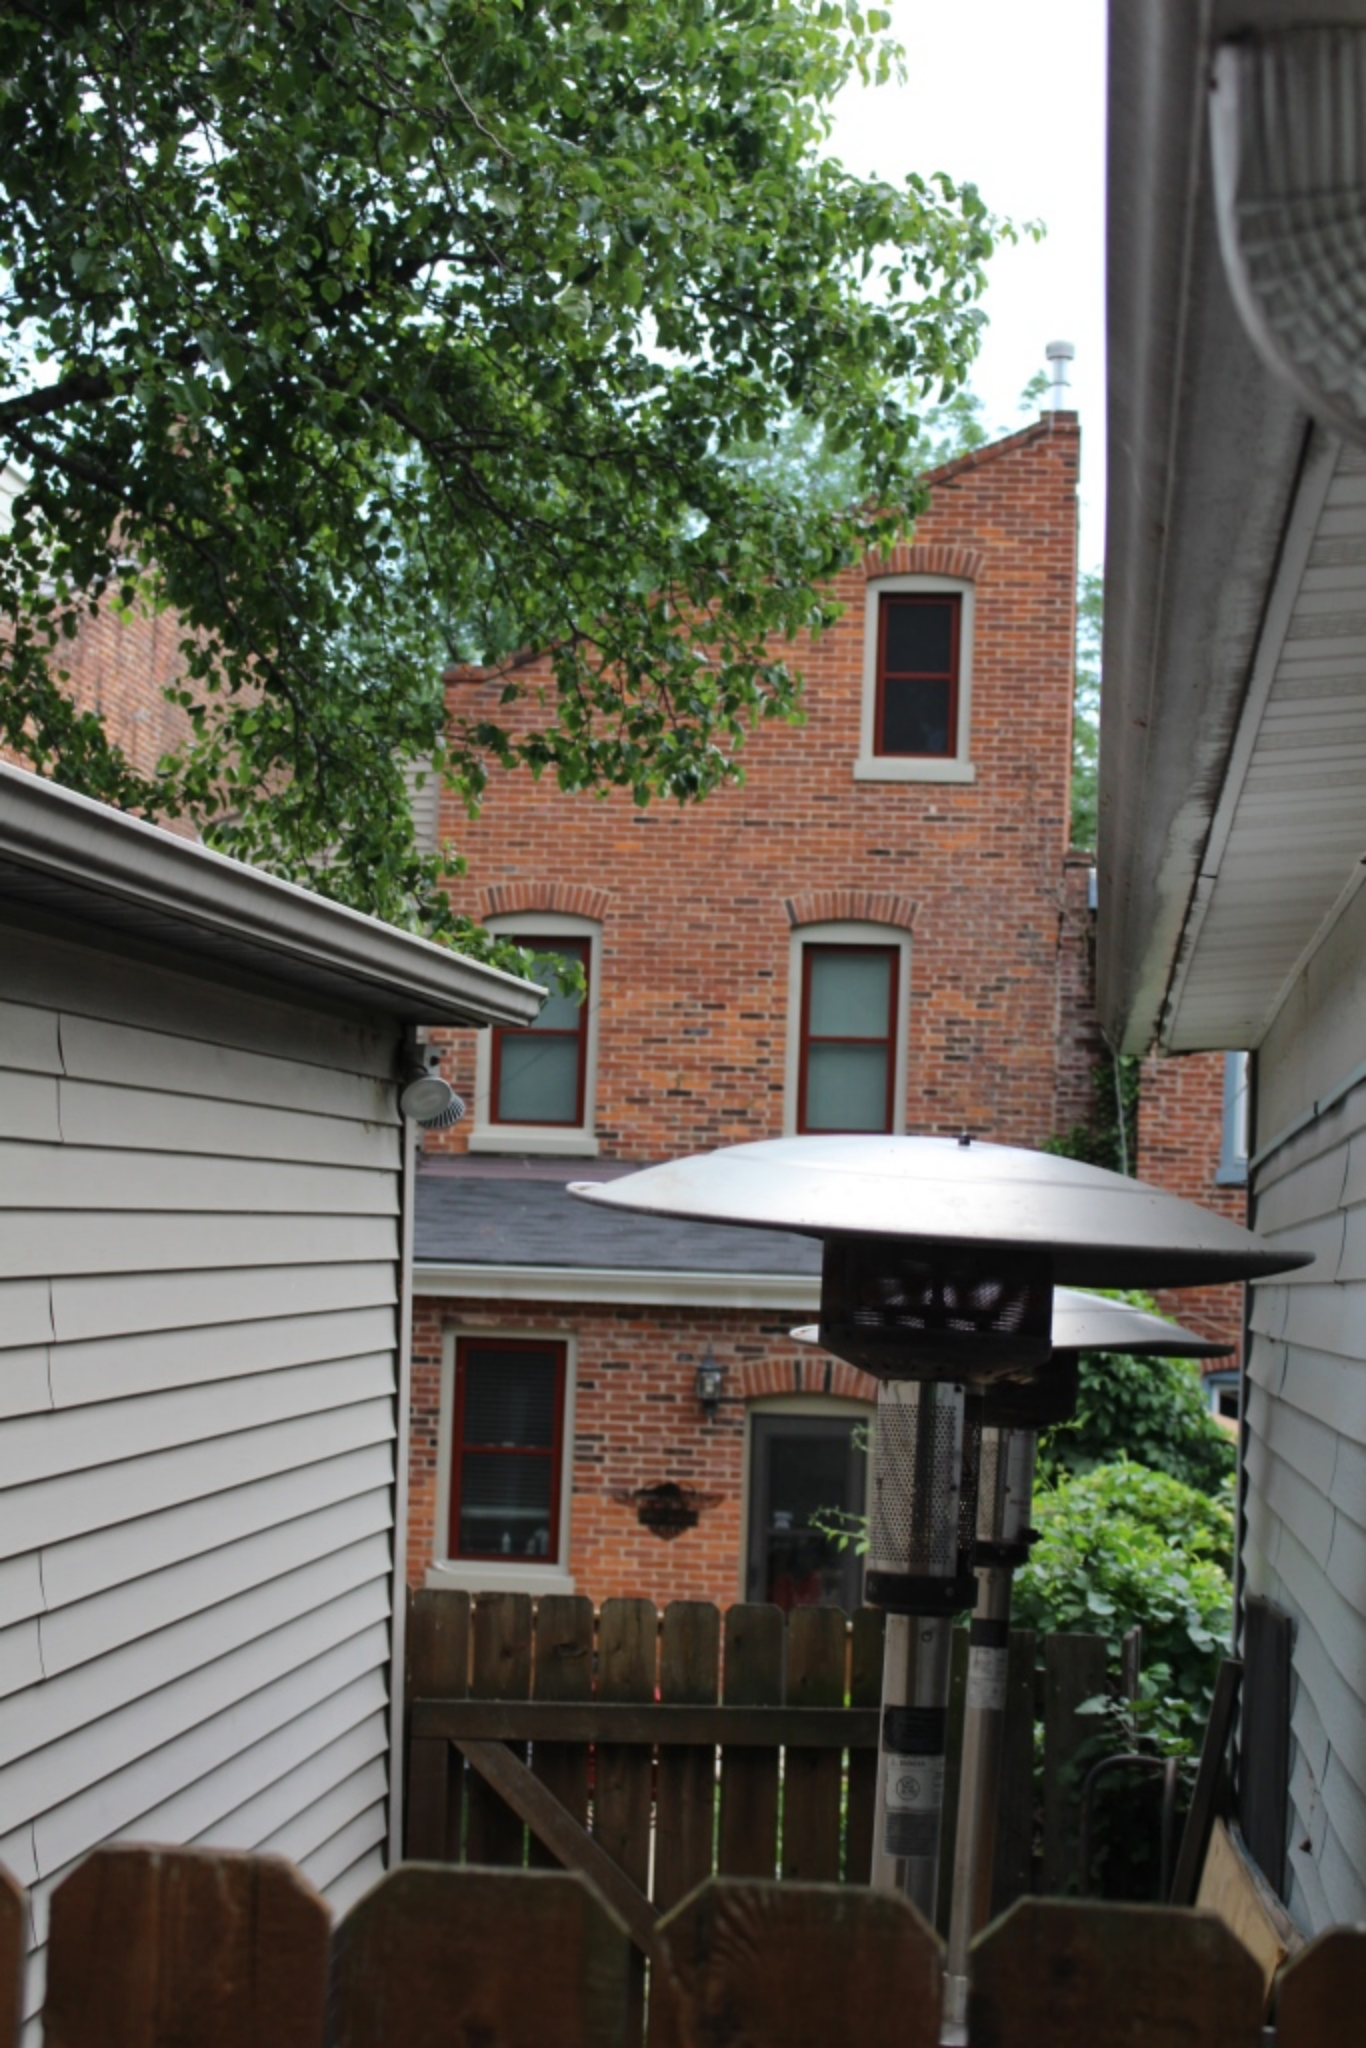
The two-and-a-half story brick hipped roof flounder has a corbelled cornice with large dentils. There is a simple gabled dormer to the south side with a chimney positioned near the rear of the dormer. The dormer has a small one-over-one window and is sheathed in wood and clapboards. The front façade has three bays. The first and second story windows are one-over-one and have segmental arch soldier brick lintels with painted stone sills. There are small single-light windows at the two southernmost bays of the basement level. The foundation rubblestone foundation has been parged. The recessed galleryat the north side of the building has been enclosed except for a small part of the front section of the first story which serves as a recessed porch and holds the entry. The remainder of the wall is sheathed in vinyl siding. The rear has look of a more classical flounder shape and has two bays in addition the enclosed gallery. There is a small one-story shed roof brick addition at the rear which holds the rear entry. The rear windows are one-over-one. It is difficult to photograph as there is a garage and fence behind the building.

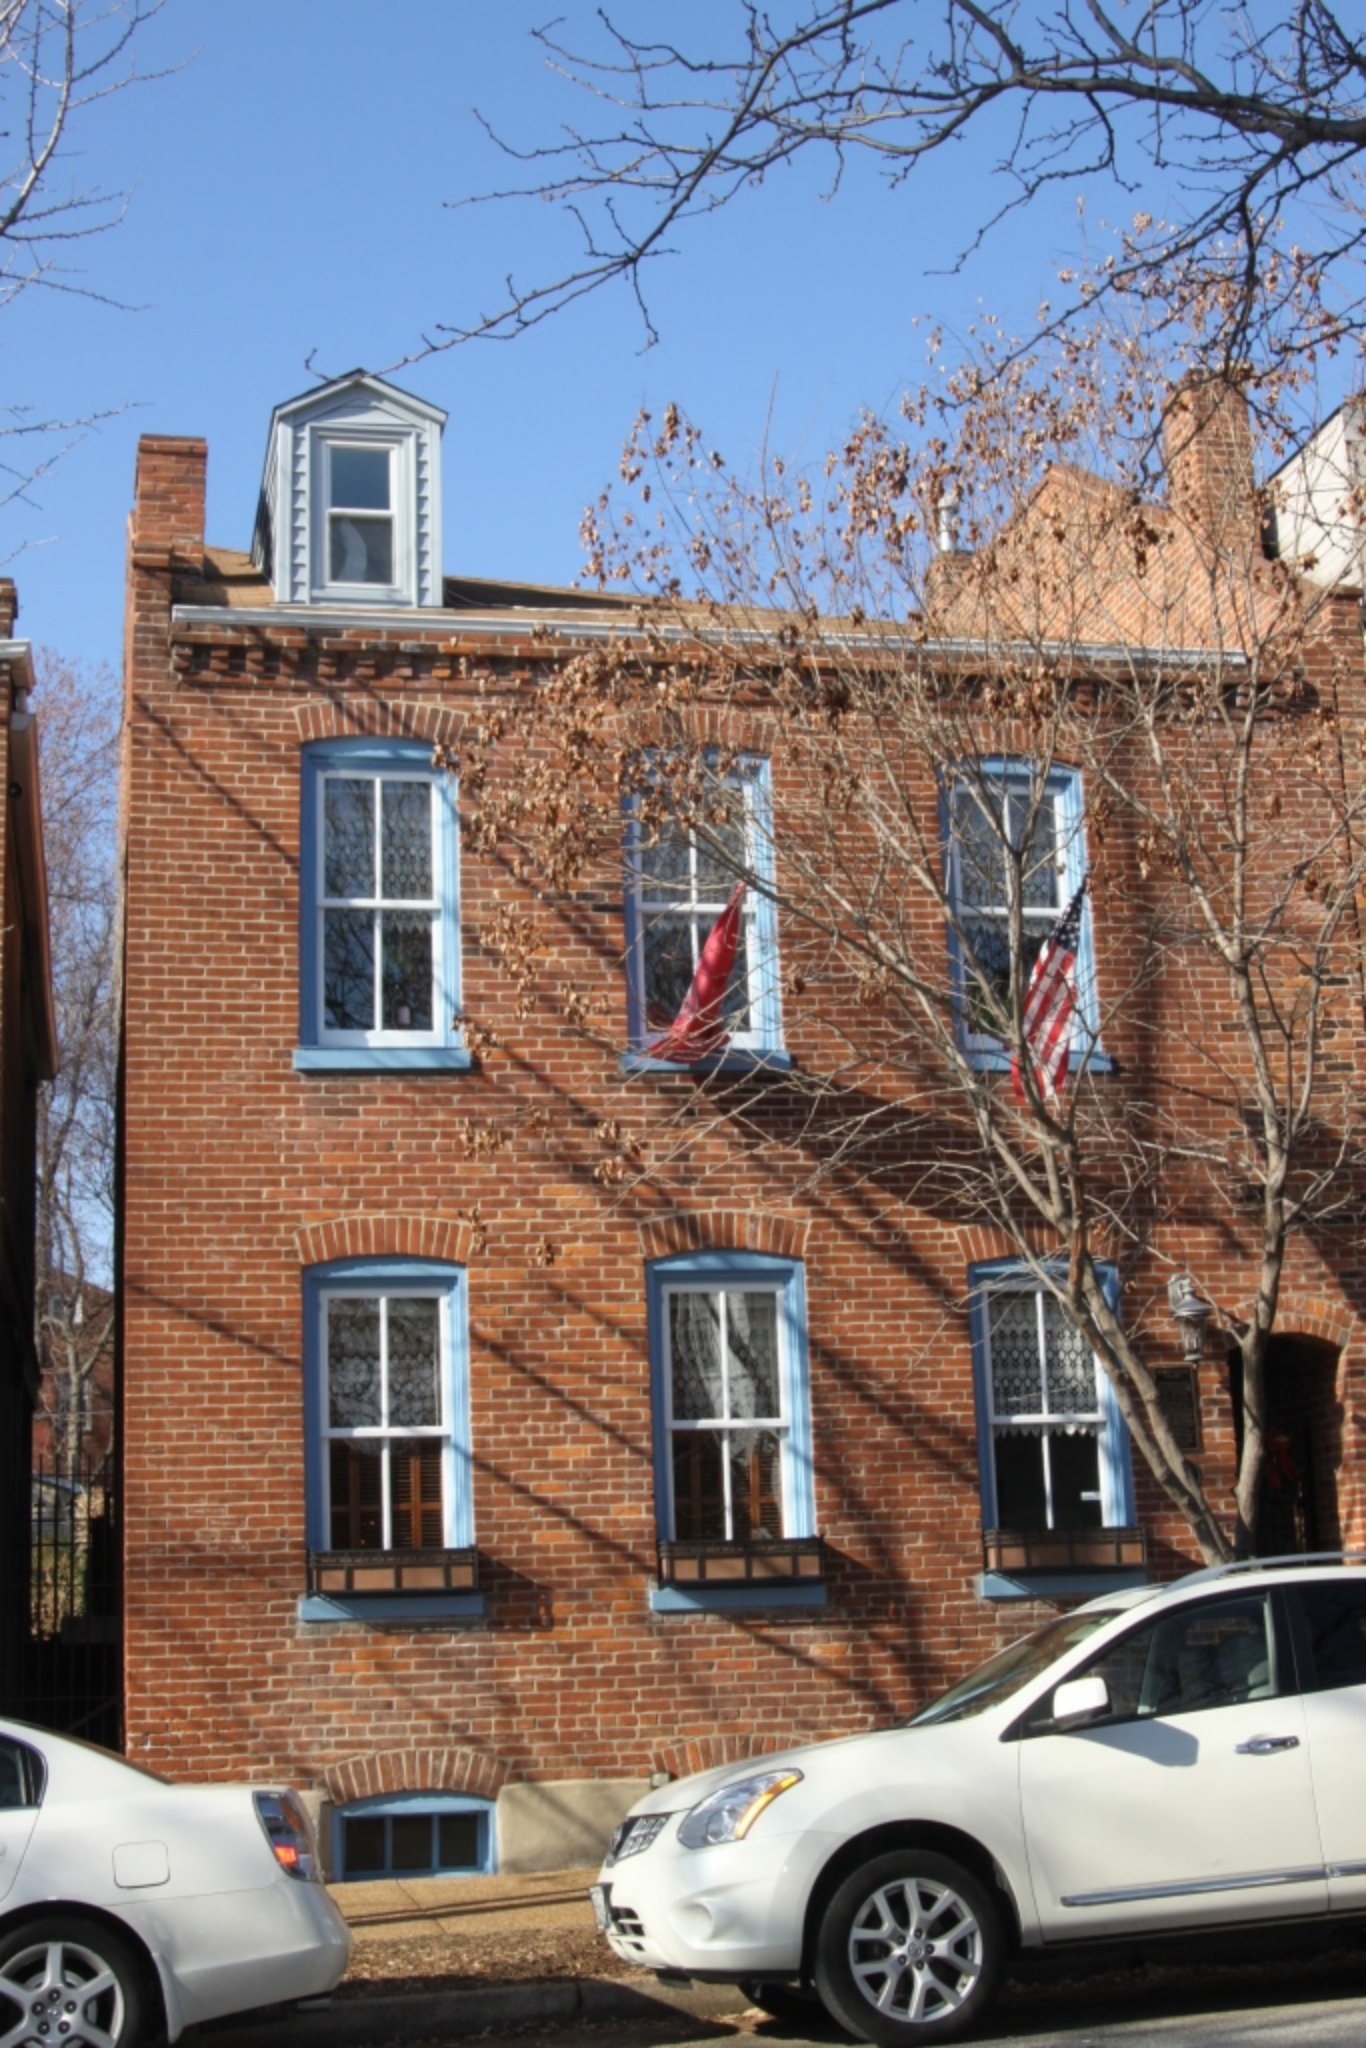
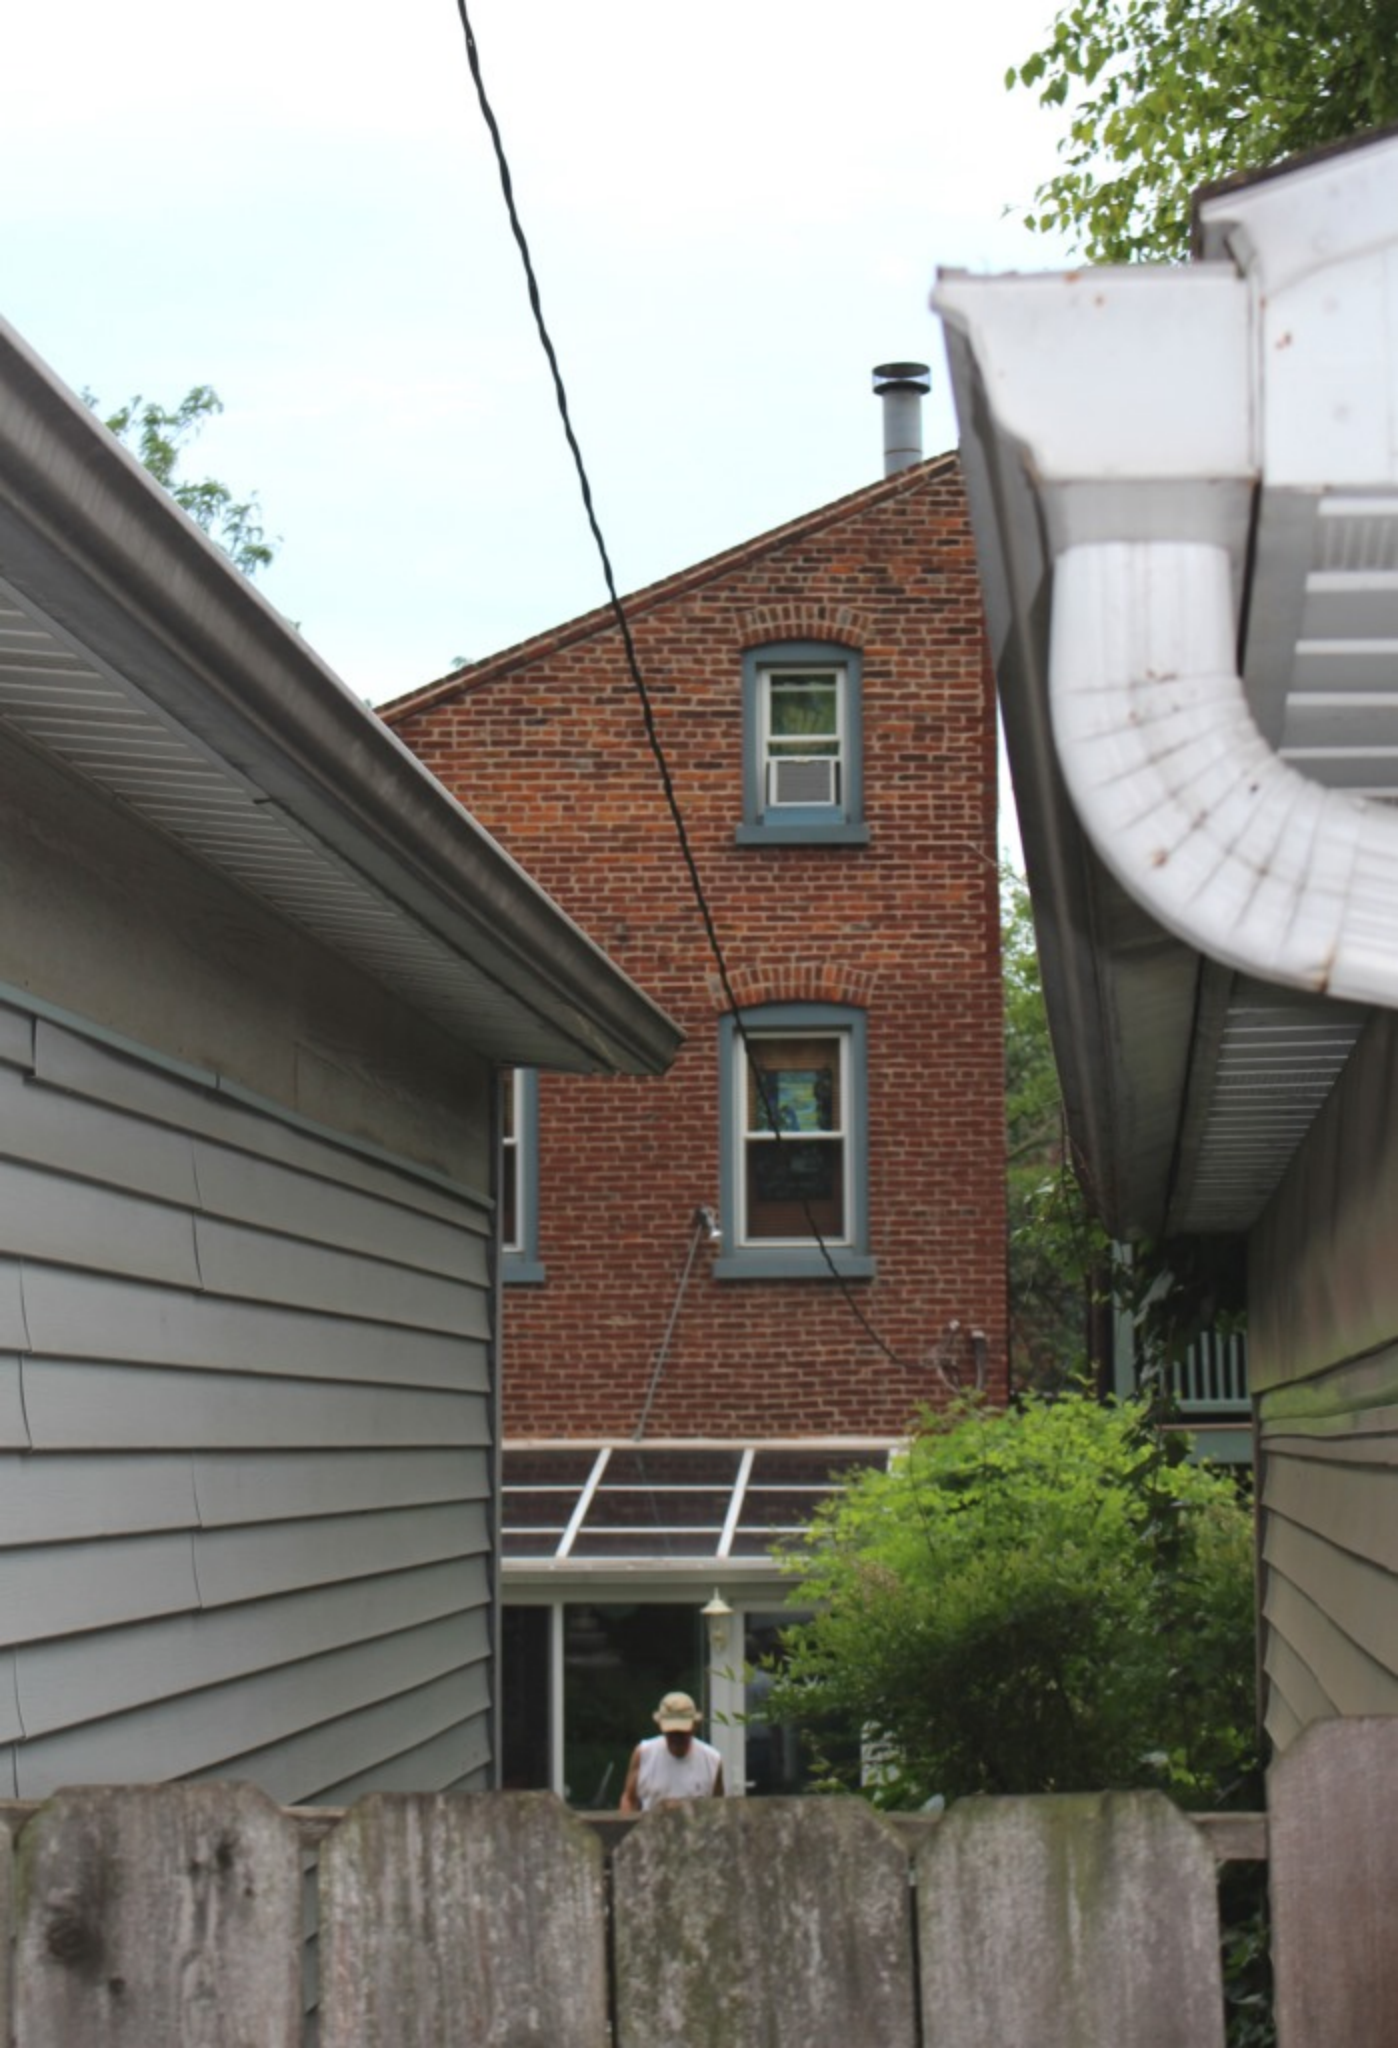
The two-and-a-half story brick hipped roof flounder has a corbelled cornice with large dentils. There is a simple gabled dormer to the south side with a chimney positioned near the rear of the dormer. The dormer has a small one-over-one window and is sheathed in vinyl siding. The front façade has three bays. The first and second story windows are two-over-two and have segmental arch soldier brick lintels with painted stone sills. There are small three-light windows at the two southernmost bays of the basement level. The foundation has a smooth stone finish. There is a narrow mousehole at the north side of the front façade. The recessed gallery at the north side of the building has been enclosed except for a small part of the front section of the first story which serves as a recessed porch and holds two entries. The mousehole leads to this recess. The recess is enclosed in clapboard siding. The enclosure butts up against the neighboring building. The rear has look of a more classical flounder shape and has three bays. There is a small one-story shed roof glass addition at the rear. The rear windows are one-over-one. It is difficult to photograph as there is a garage and fence behind the building.
