**ARCHITECTURAL/HISTORIC INVENTORY FORM - Cultural Resources Office**  
**St. Louis Planning and Urban Design**

1. Survey no. SLC-AS-053-0102	2. Survey name: Thematic Survey of Flounder Houses in St. Louis City	3. County: St. Louis [Independent City]
4. Address: (from City GEO database) <b>900 HICKORY ST</b>		5. City/State: St. Louis, Missouri
Alternate address: 900 Hickory Street		Property Zip Code: 63104
Latitude: 38.615737		6. UTM Easting: 743886.40
Longitude: -90.198830		UTM Northing: 4277858.27
8. Historic Name (if known): N/A	11a. Historic Use (if known): Commerce/Trade	City Block 467.03
9. Present/other name (if known):	11b. Current Use: Commerce/Trade	City Ward 7
7. Township-Range-Section: N/A		10. Ownership: Private
Neighborhood Number: 34

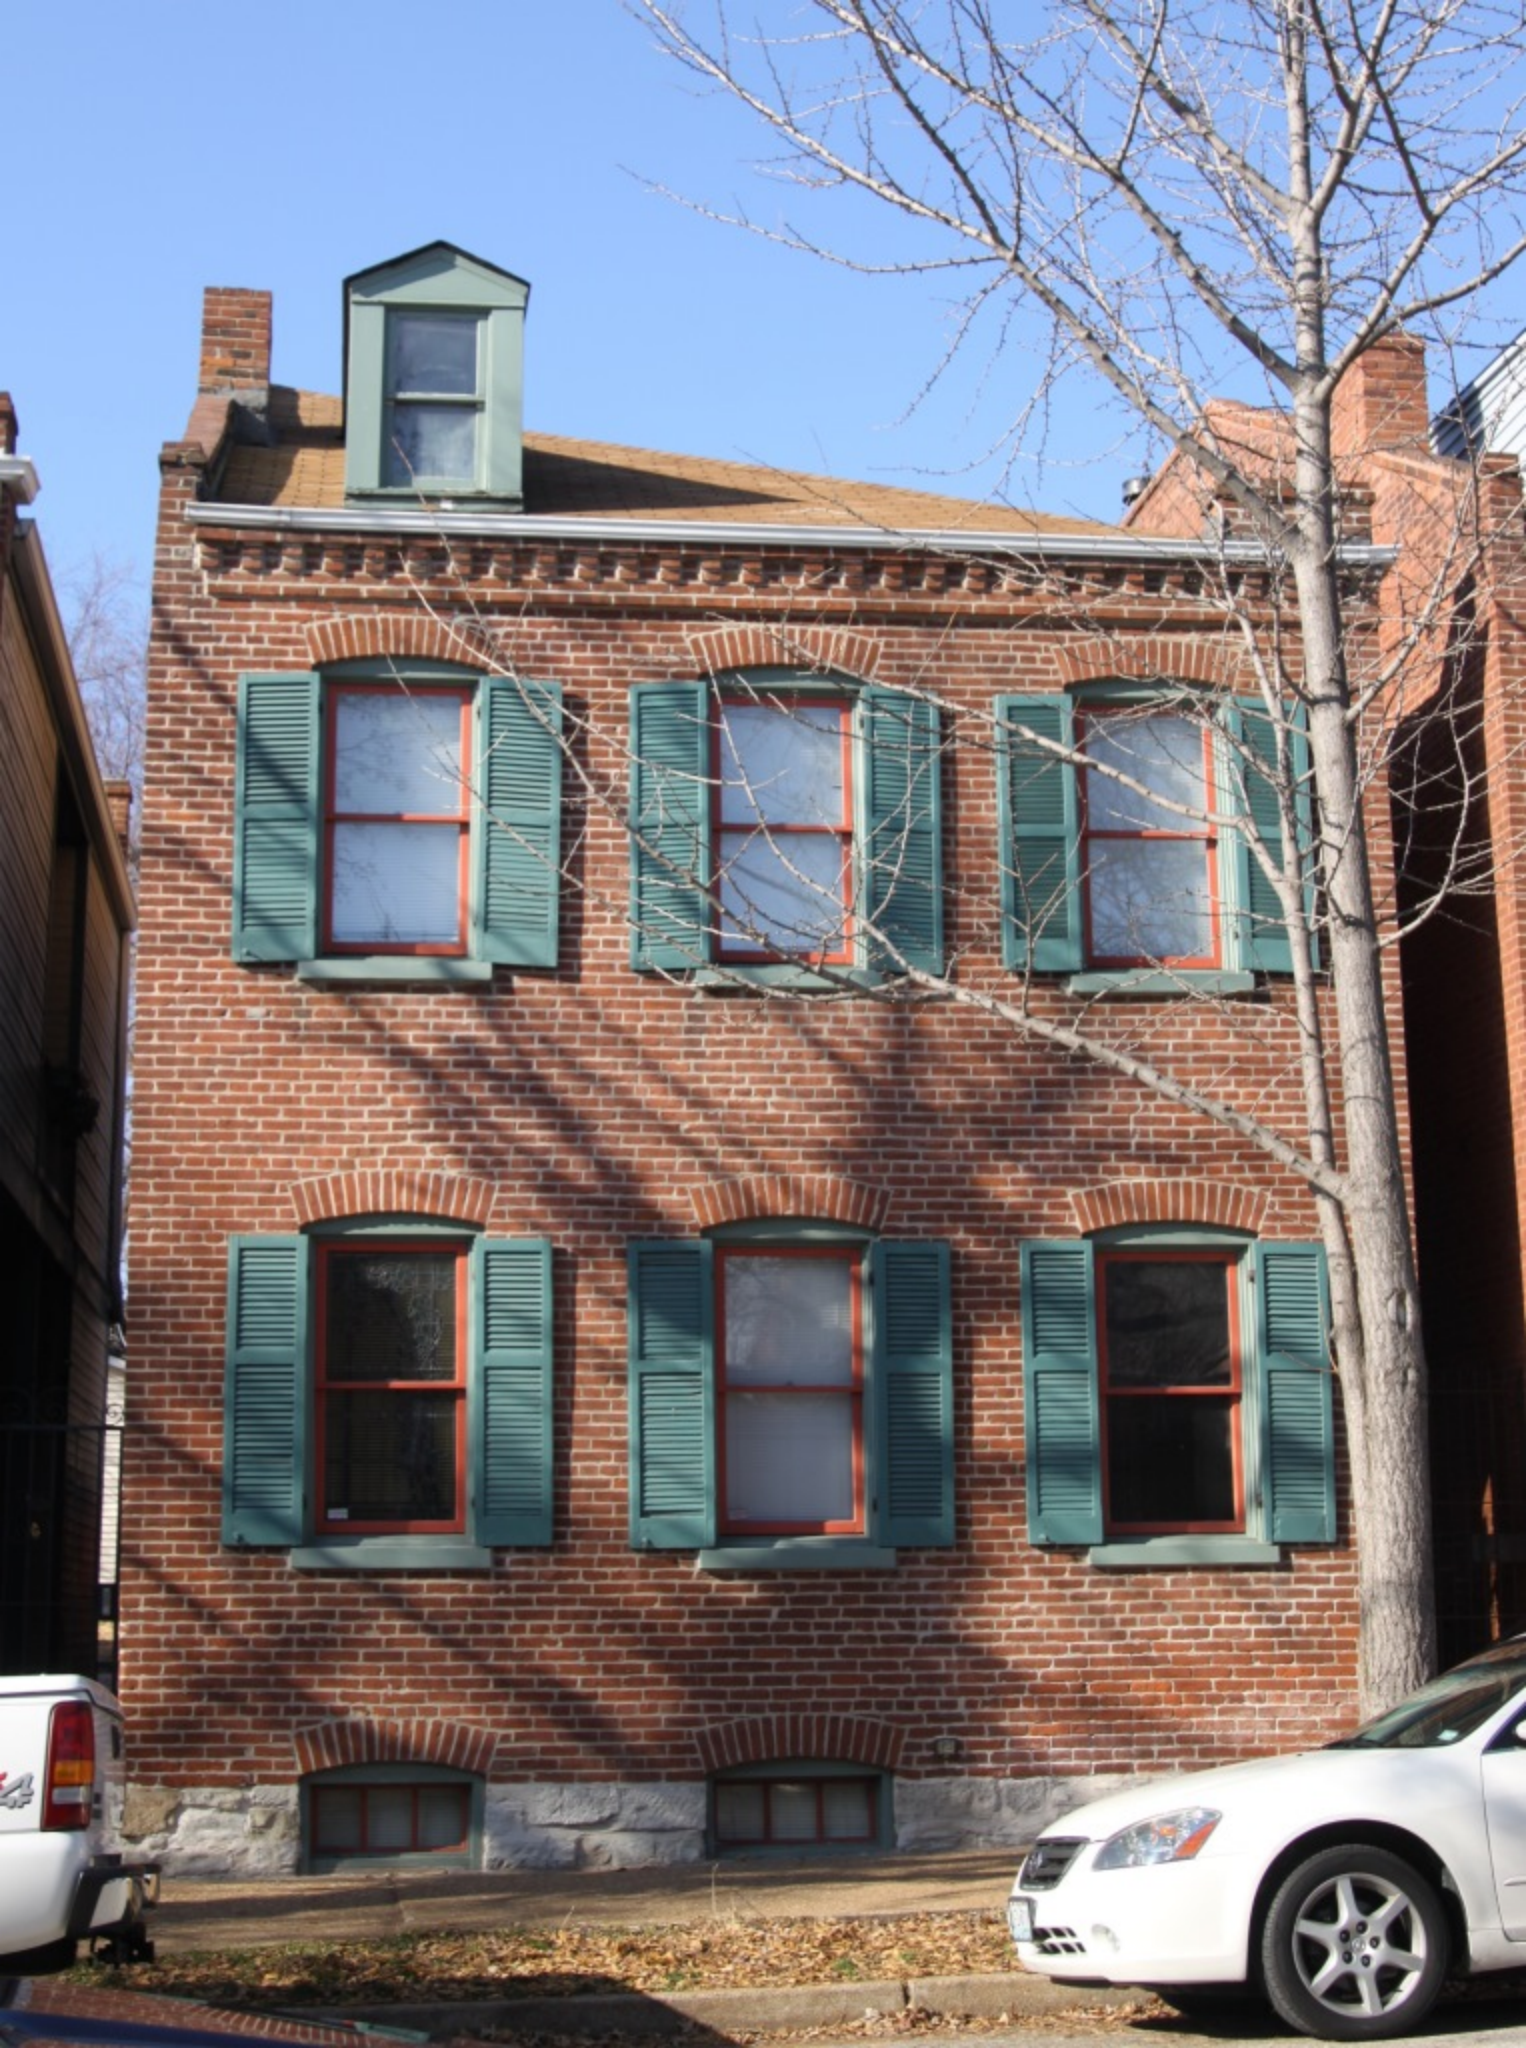
The two-and-a-half story brick hipped roof flounder has a corbelled cornice with large dentils. There is a simple gabled dormer to the south side with a chimney positioned near the rear of the dormer. The dormer has a small one-over-one window and is sheathed in wood and wood clapboards. The front façade has three bays. The first and second story windows are one-over-one and have segmental arch soldier brick lintels with painted stone sills. There are working shutters on the windows. There are small three-light windows at the two southernmost bays of the basement level. The coursed rubblestone foundation has been partially parged, but the shapes of the stones are visible beneath. There is a recessed gallery porch at the north side of the building. The gallery remains intact except for the front portion of the second story which has been enclosed and covered in clapboard siding. The wall behind the gallery is not visible from the street. The rear has look of a more classical flounder shape and has two bays in addition the gallery. The rear window are one-over-one. It is extremely difficult to photograph as there is a garage, fence and large tree behind the building.

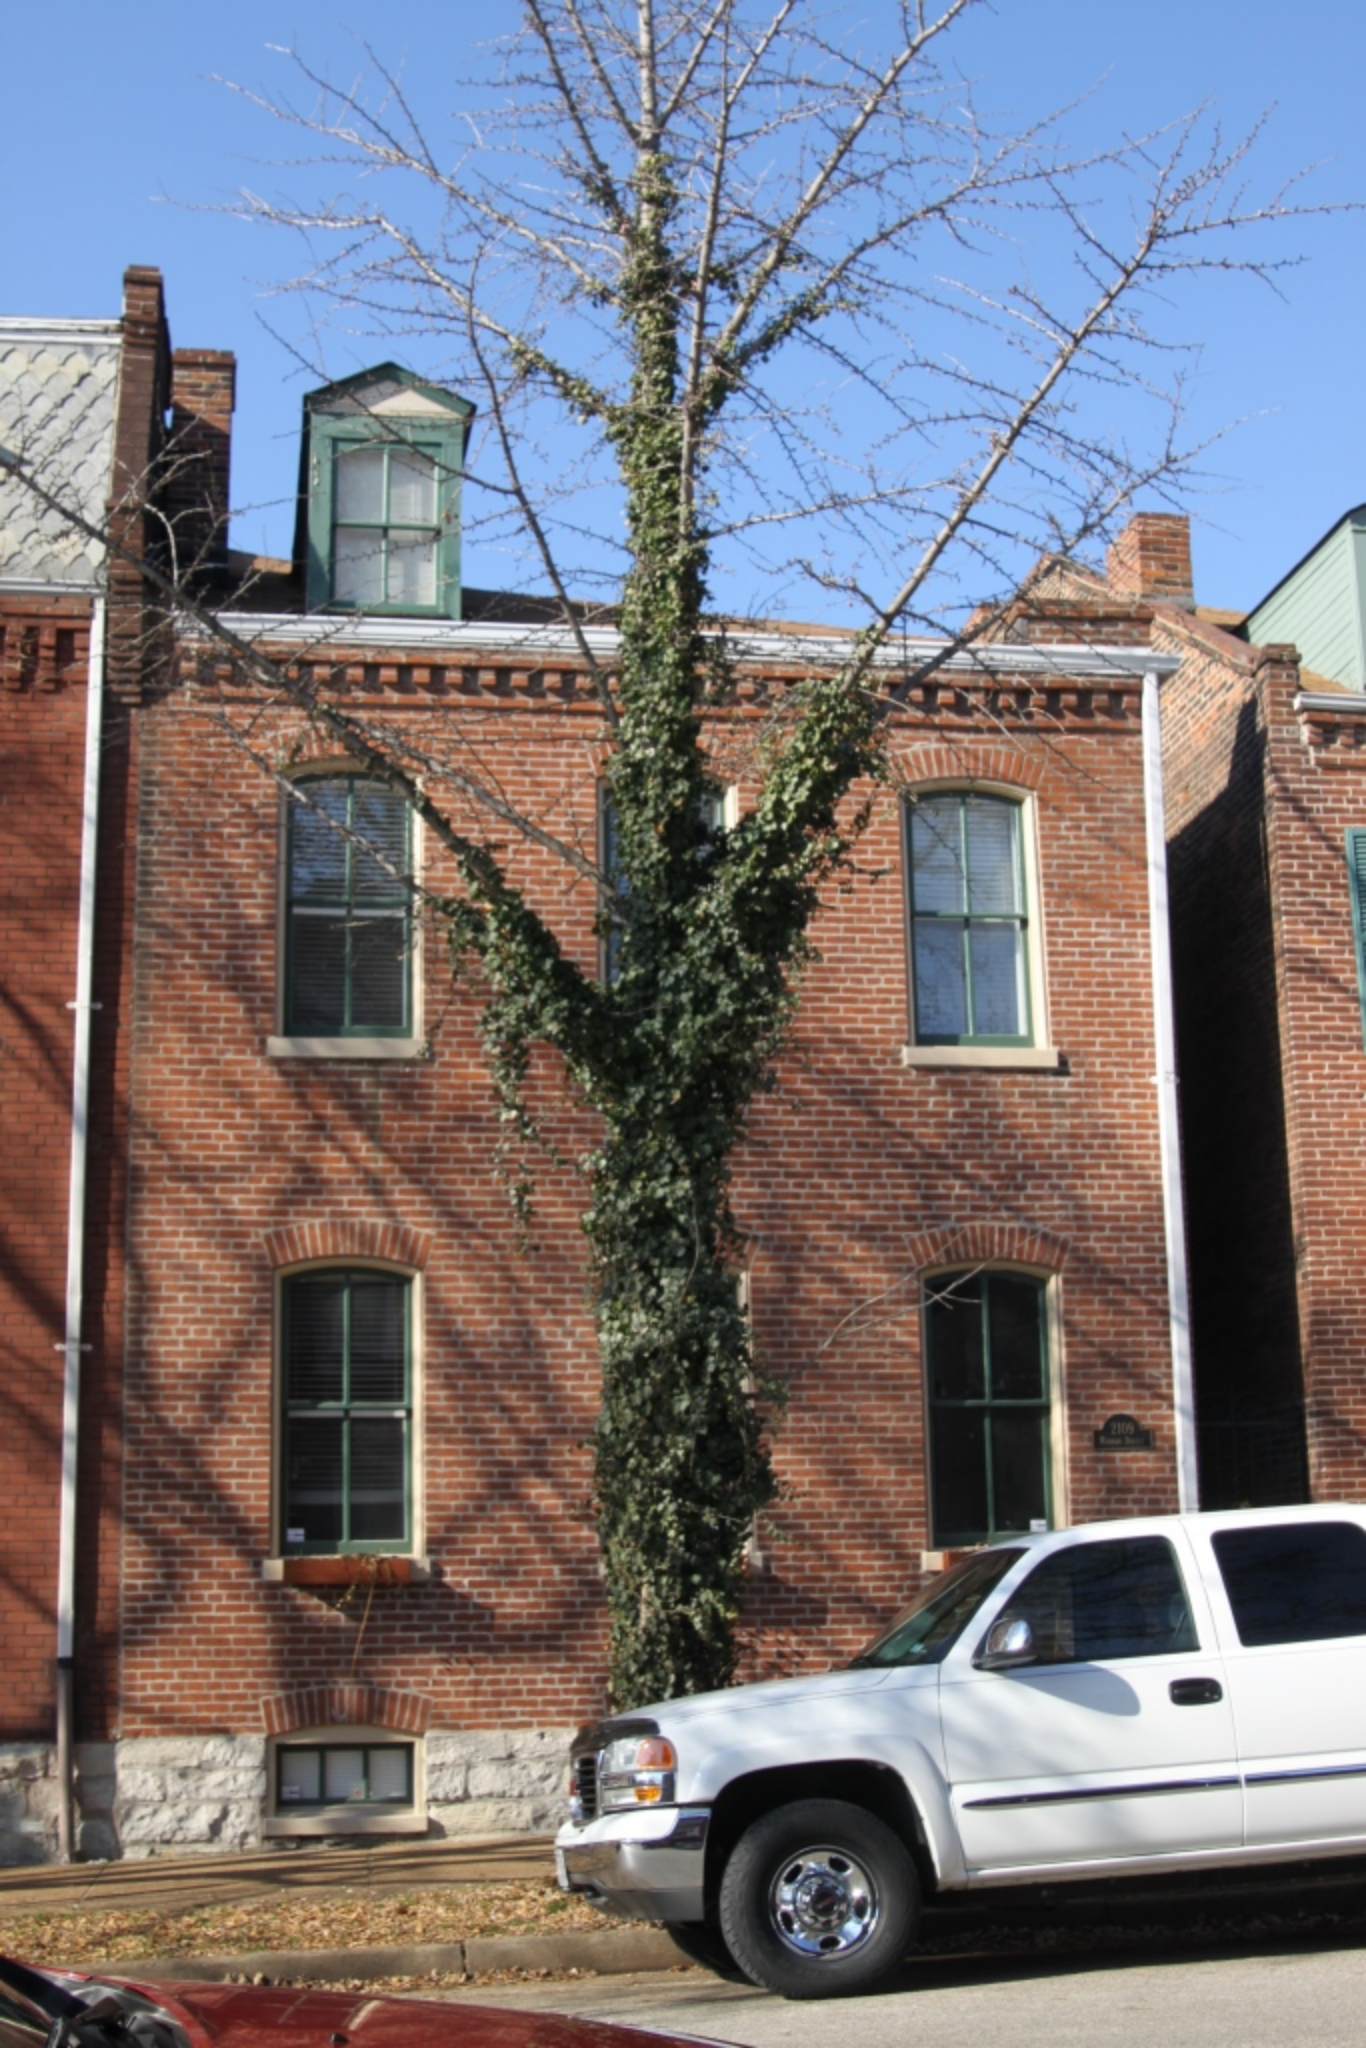
The two-and-a-half story brick hipped roof flounder has a corbelled cornice with large dentils. There is a simple gabled dormer to the south side with a chimney positioned near the rear of the dormer. The dormer has a small one-over-one window and is sheathed in wood and wood clapboards. The front façade has three bays. The first and second story have segmental arch one-over-one windows with soldier brick lintels and stone sills. There are small three-light windows at the two southernmost bays of the basement level. There is a coursed rubblestone foundation. The recessed gallery porch at the north side of the building has been partially enclosed. Only the middle section of the second story and the front half of the first story remain intact. The remainder has been enclosed and covered in clapboard siding. The wall behind the gallery is not visible from the street. The rear has look of a more classical flounder shape and has three bays. The rear window are one-over-one. It is extremely difficult to photograph as there is a garage, fence and large tree behind the building.

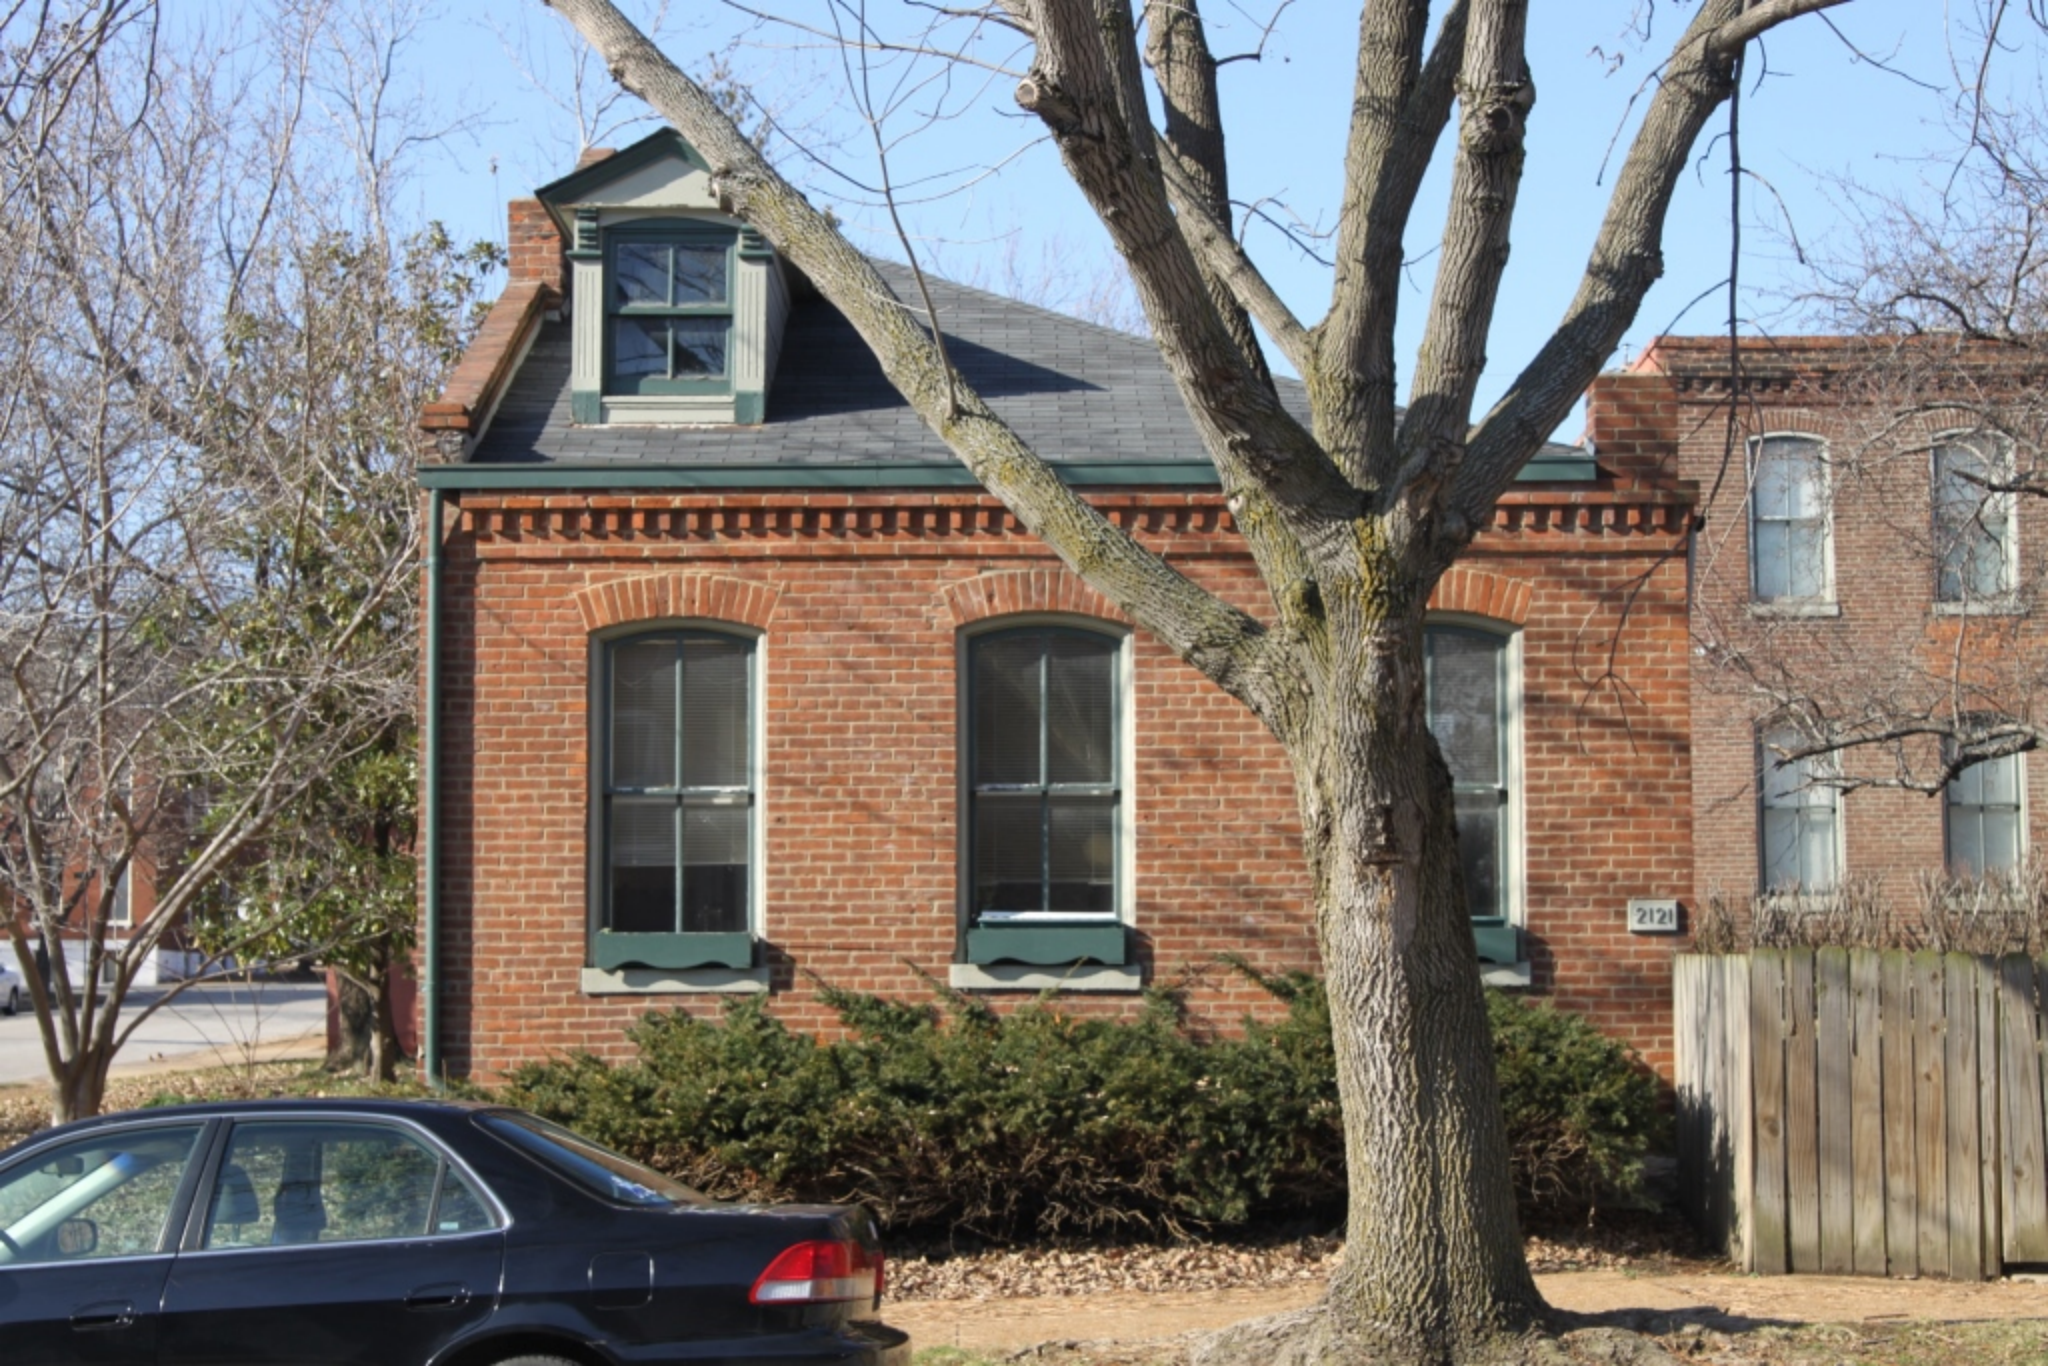
The one-and-a-half story brick hipped roof flounder has a corbelled cornice and a small chimney at the right end of the front façade. A decorative dormer with fluted molding and small brackets is located to the south side of the front with a larger chimney sitting towards the rear of the dormer on the south wall. All of the front windows are segmental arch sash, 2-over-2 double-hung windows. The first story windows have soldier brick lintels and limestone sills. Very little of the rubble limestone foundation is visible on any elevation. The northernmost bay on the front façade is only one room deep with a recessed 1-story porch behind. There are two entries off of this porch. There are 3 bays on this side with one additional bay on a slightly smaller one-and-a-half story flounder addition at the rear. The rear openings have been somewhat altered with window sizes altered and a door being changed to a window. The south side wall is blank except for a very small, more recently-cut slider window at the very top of the wall at the rear addition.

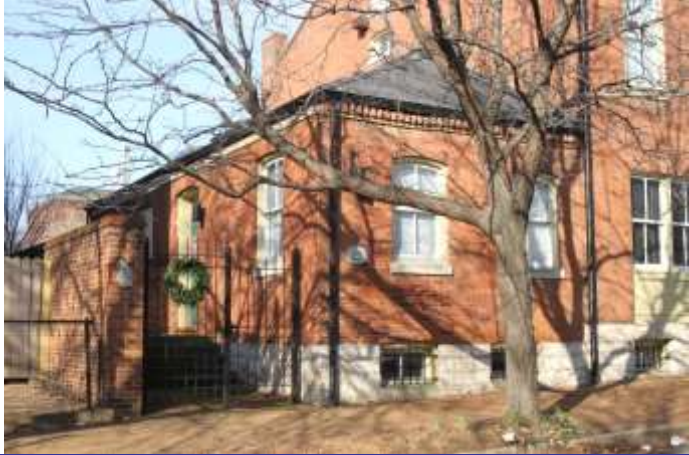
**2201-3 MENARD ST**

The building is in good condition and is well-maintained.

The one story brick hipped roof flounder has a corbelled cornice with brick dentils. The front windows are 2-over-2 double-hungs with segmental arch sashes. The windows have rowlock lintels and limestone sills. There is some evidence of flat rowlock lintels on the front façade but it is not clear when these were put in. There are two two-light basement windows one with a rowlock lintel and one with a soldier brick lintel set in the coursed limestone foundation. The forwardmost window opening on the south side of the building also has a 2-over-2 segmental arch sash double-hung window with a soldier brick lintel and limestone sill. The there are four openings on the south elevation including one entry with transom and one opening closed with shutters. A wide concrete stoop with a high brick wall surrounding it provides access to the entry. The rear of the building has a more classical flounder appearance and is two bays wide. The opening have been altered at some point as they have flat soldier brick lintels of contrasting brick. A square infilled opening is located at the attic level.

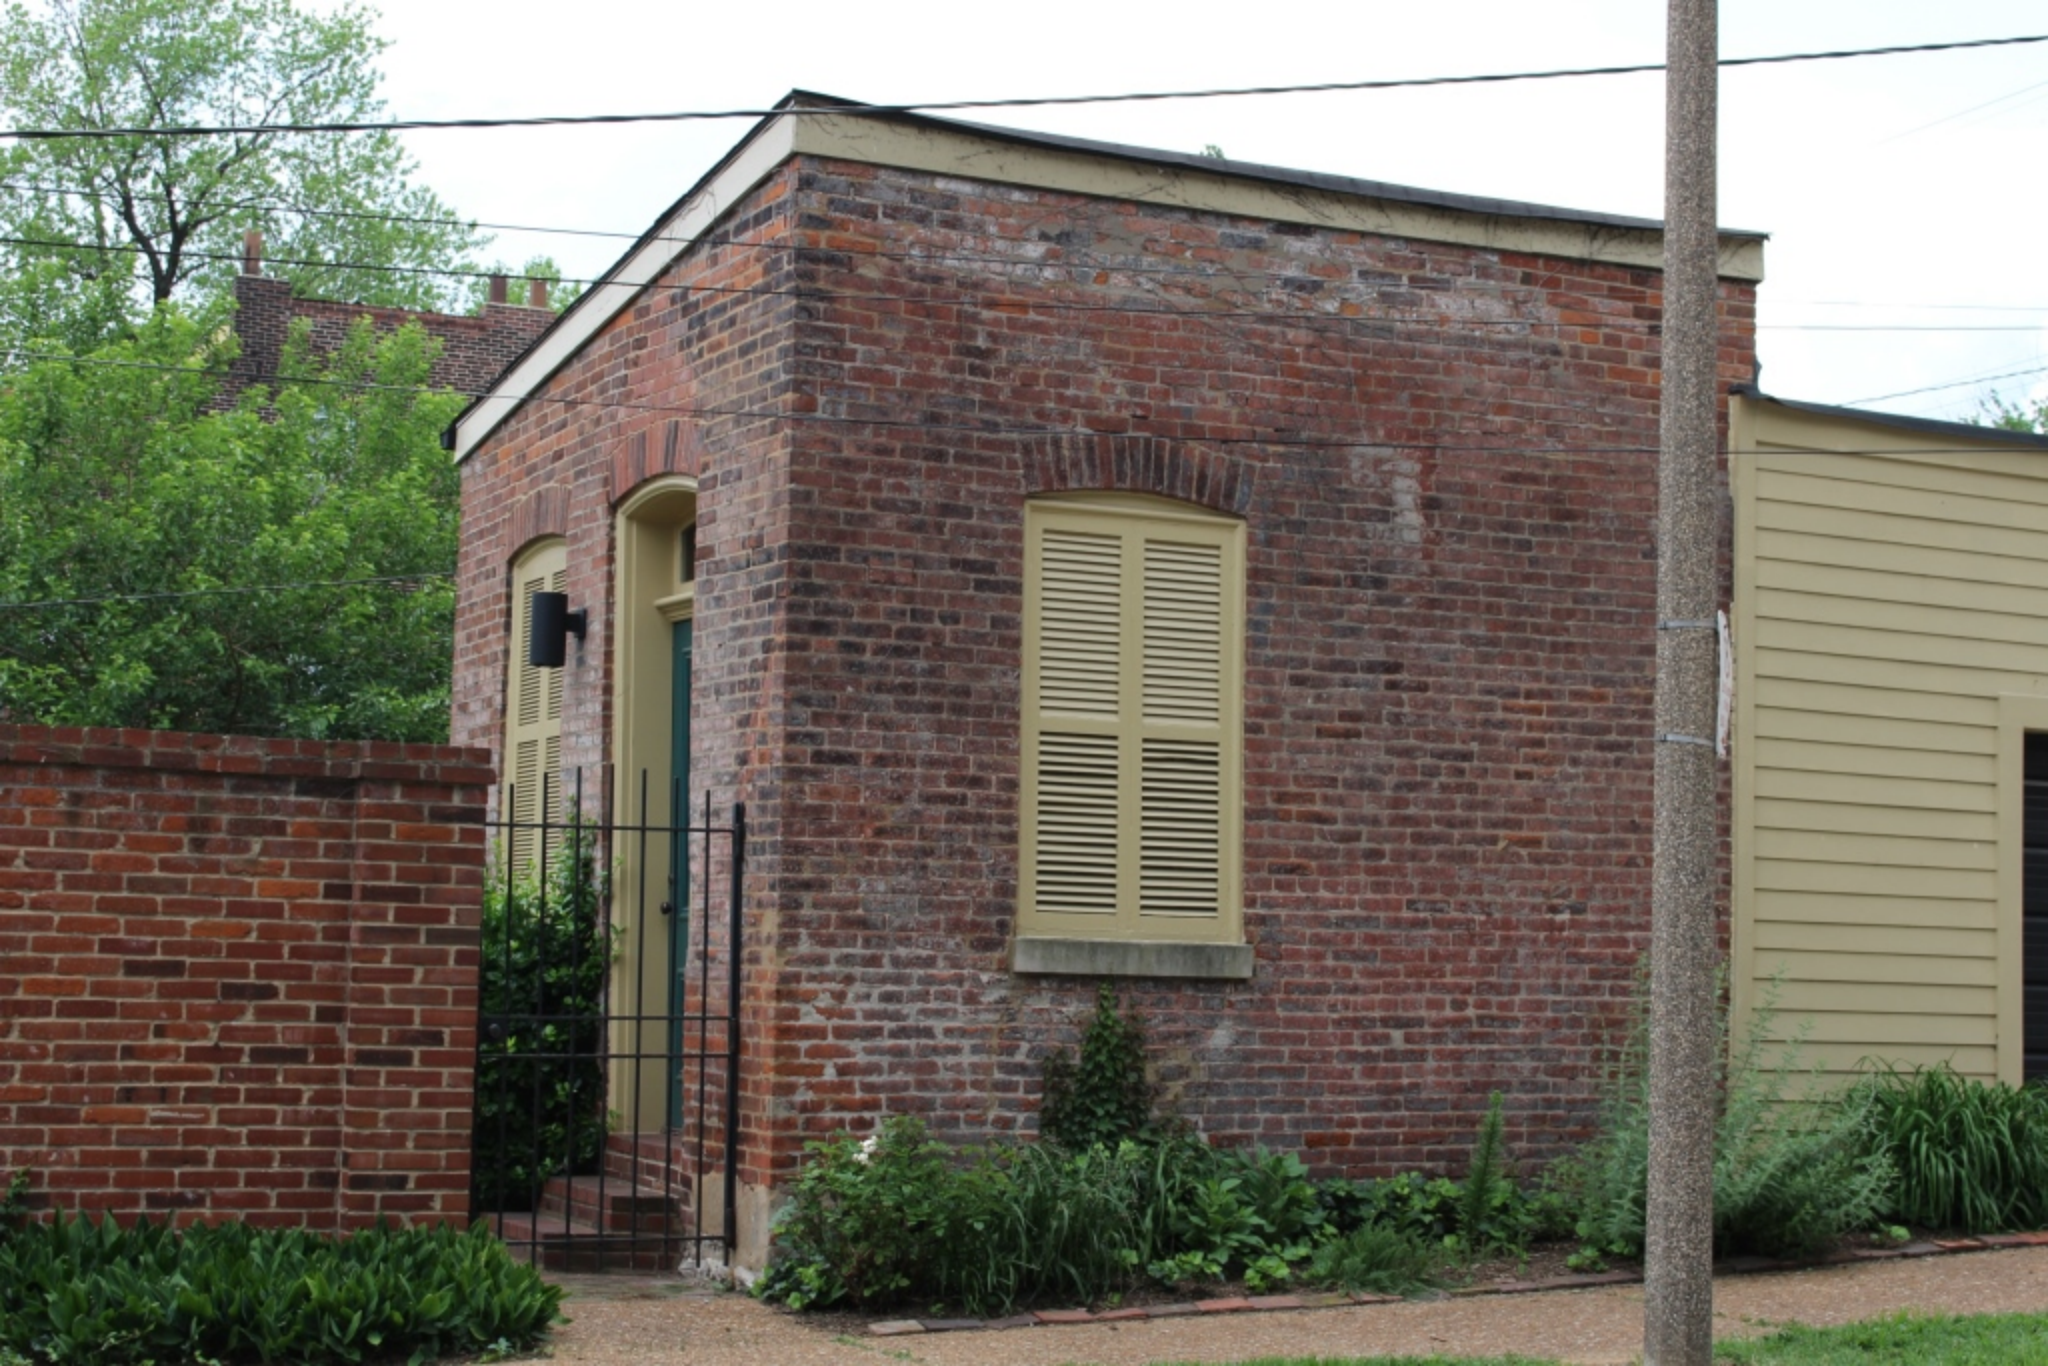
The outbuilding is in good condition and is well-maintained.

The one-story brick flounder outbuilding has two bays facing the rear of the front building (east elevation). One bay is a four-panel door with transom which has a soldier brick lintel. The window opening, also with a soldier brick lintel, has been closed with shutters. An opening on the north side of the building is similar to the window opening on the east side. The building is now attached to a frame garage and was historically attached to a building on that elevation.

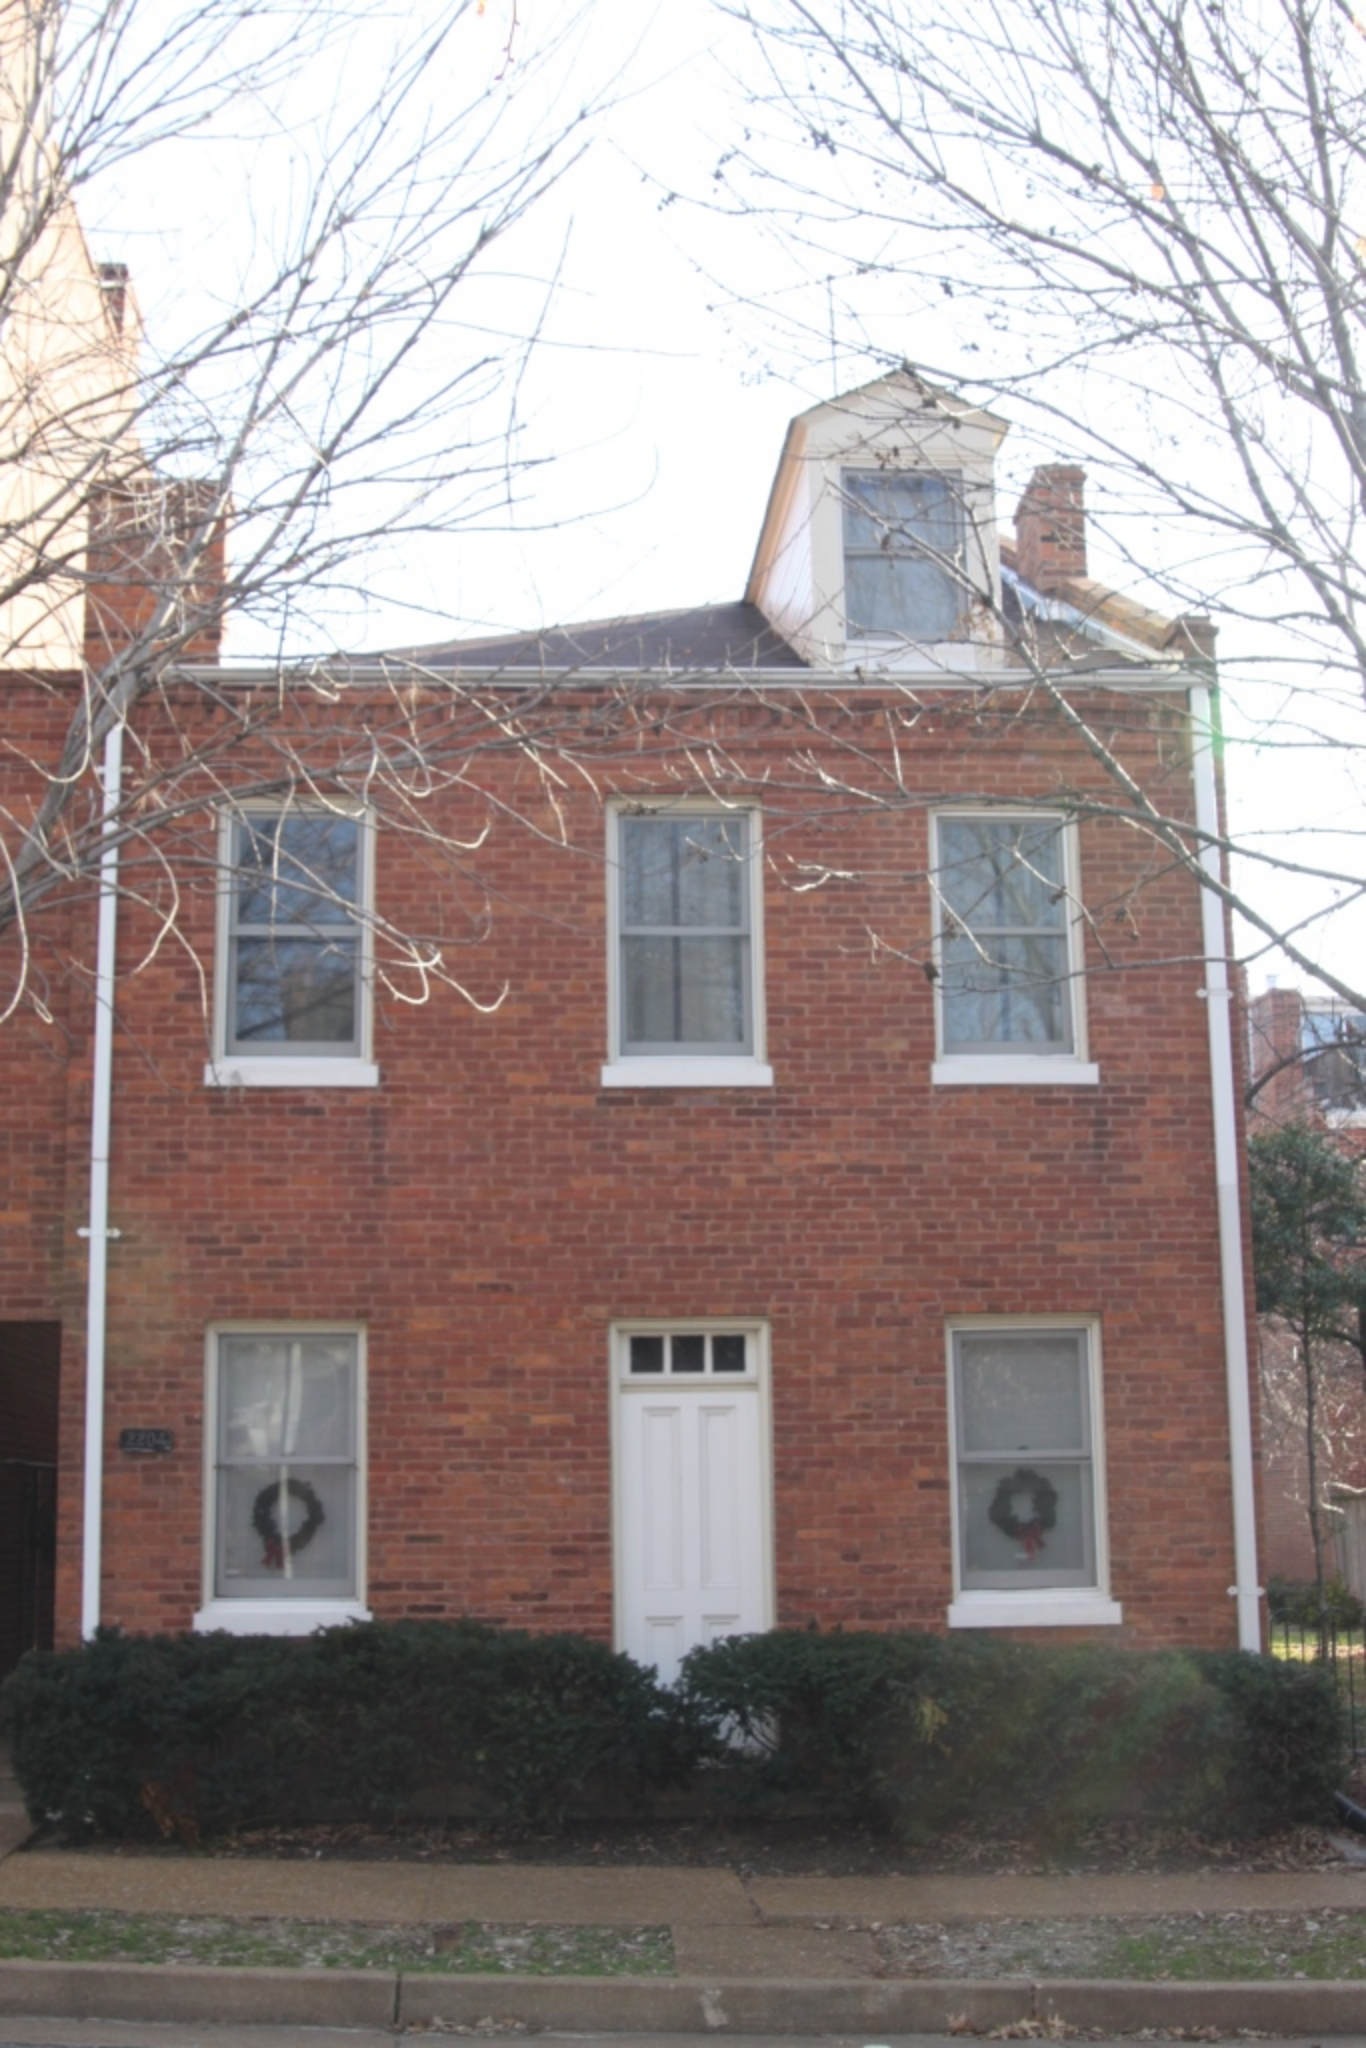
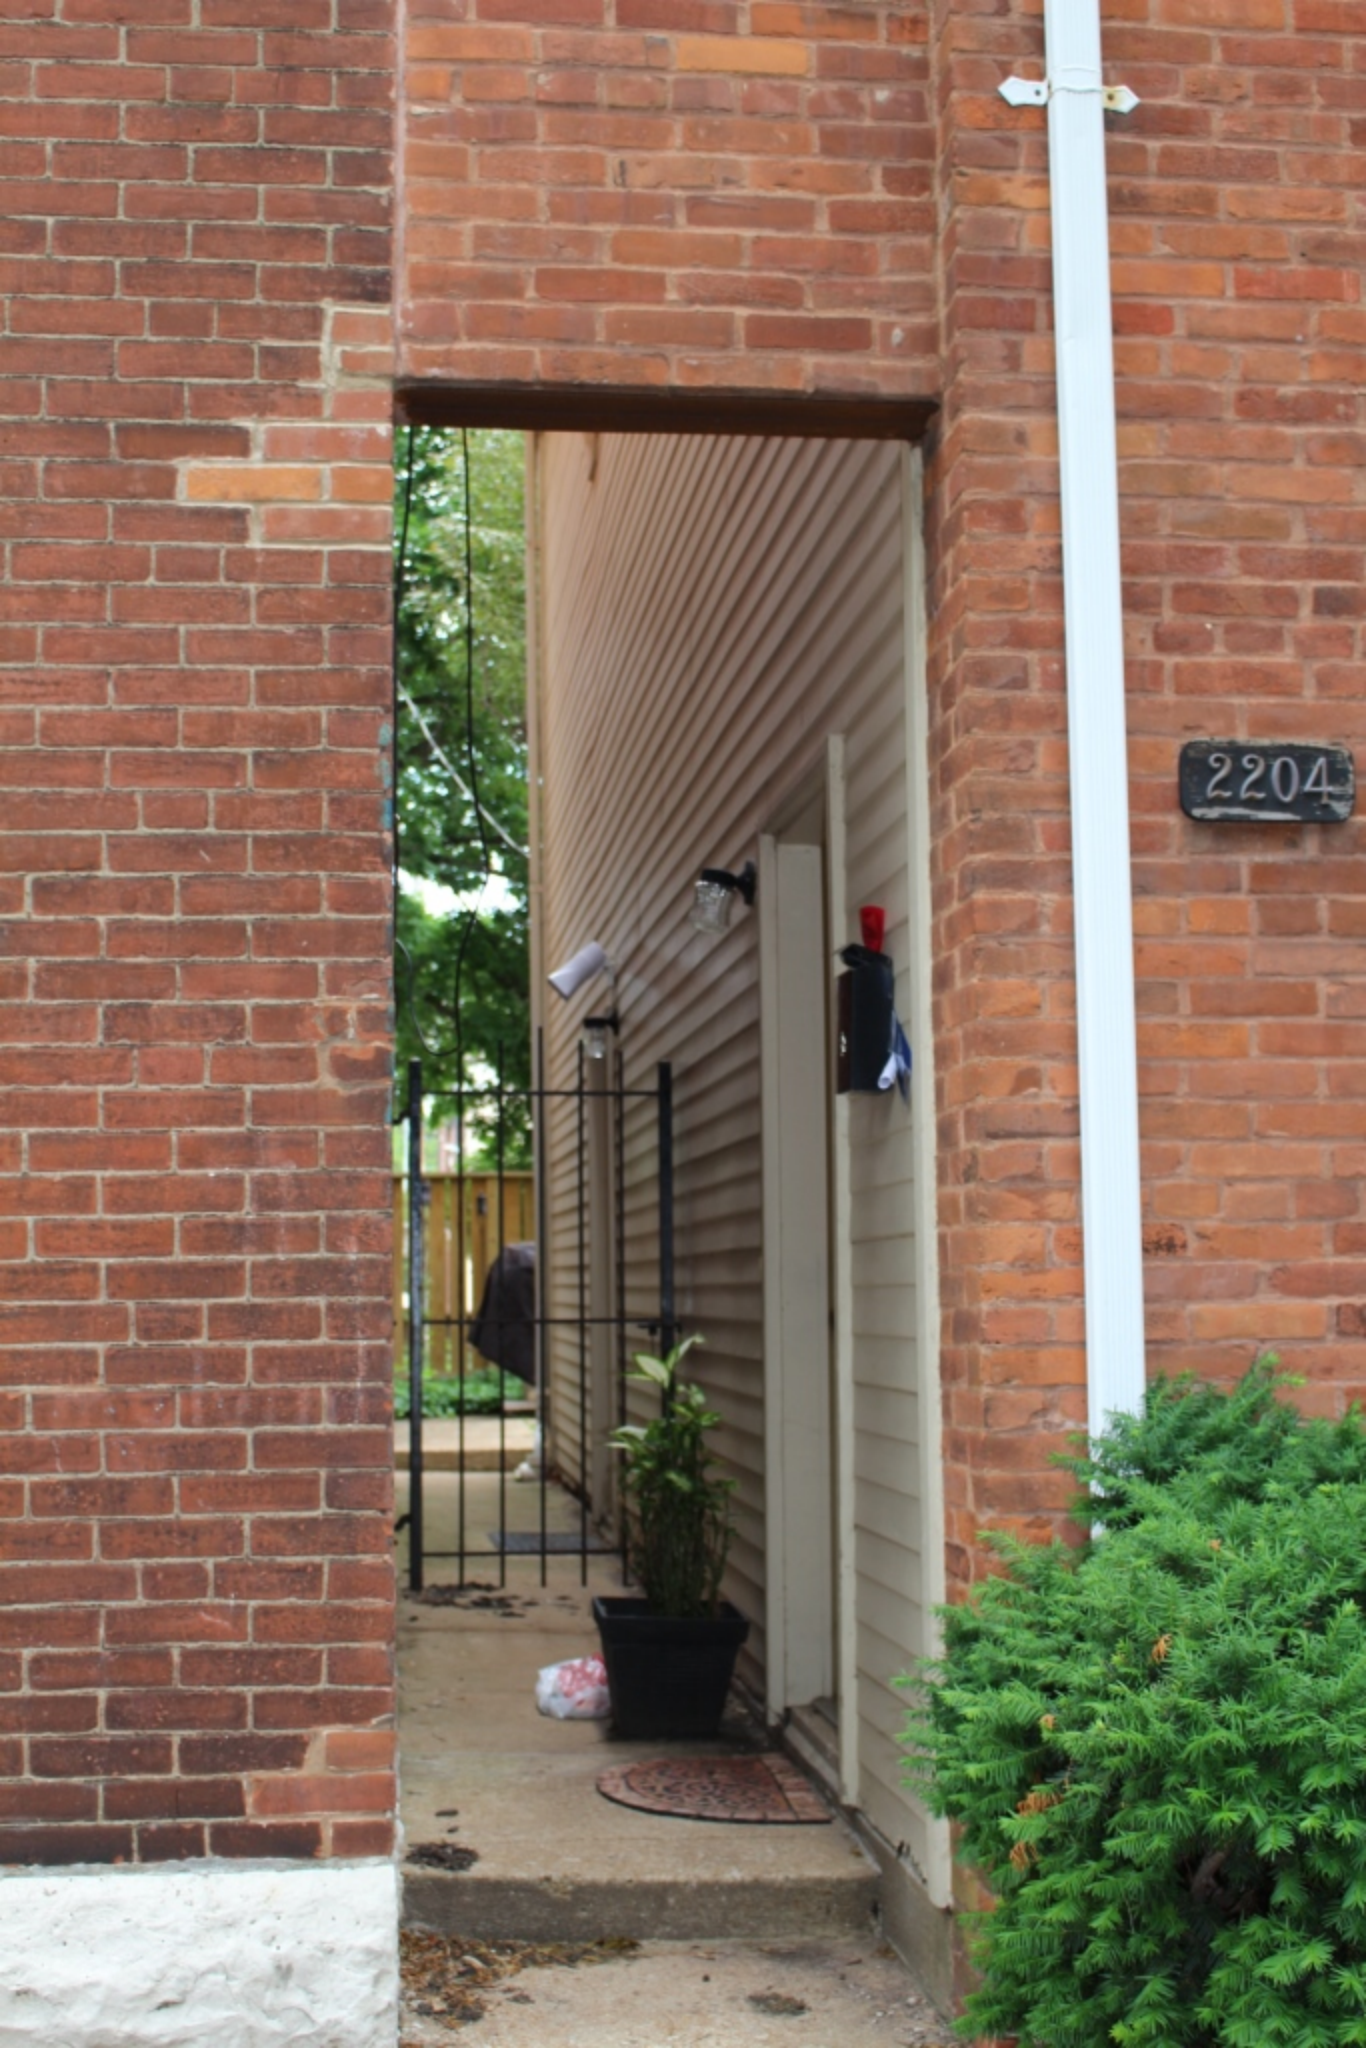
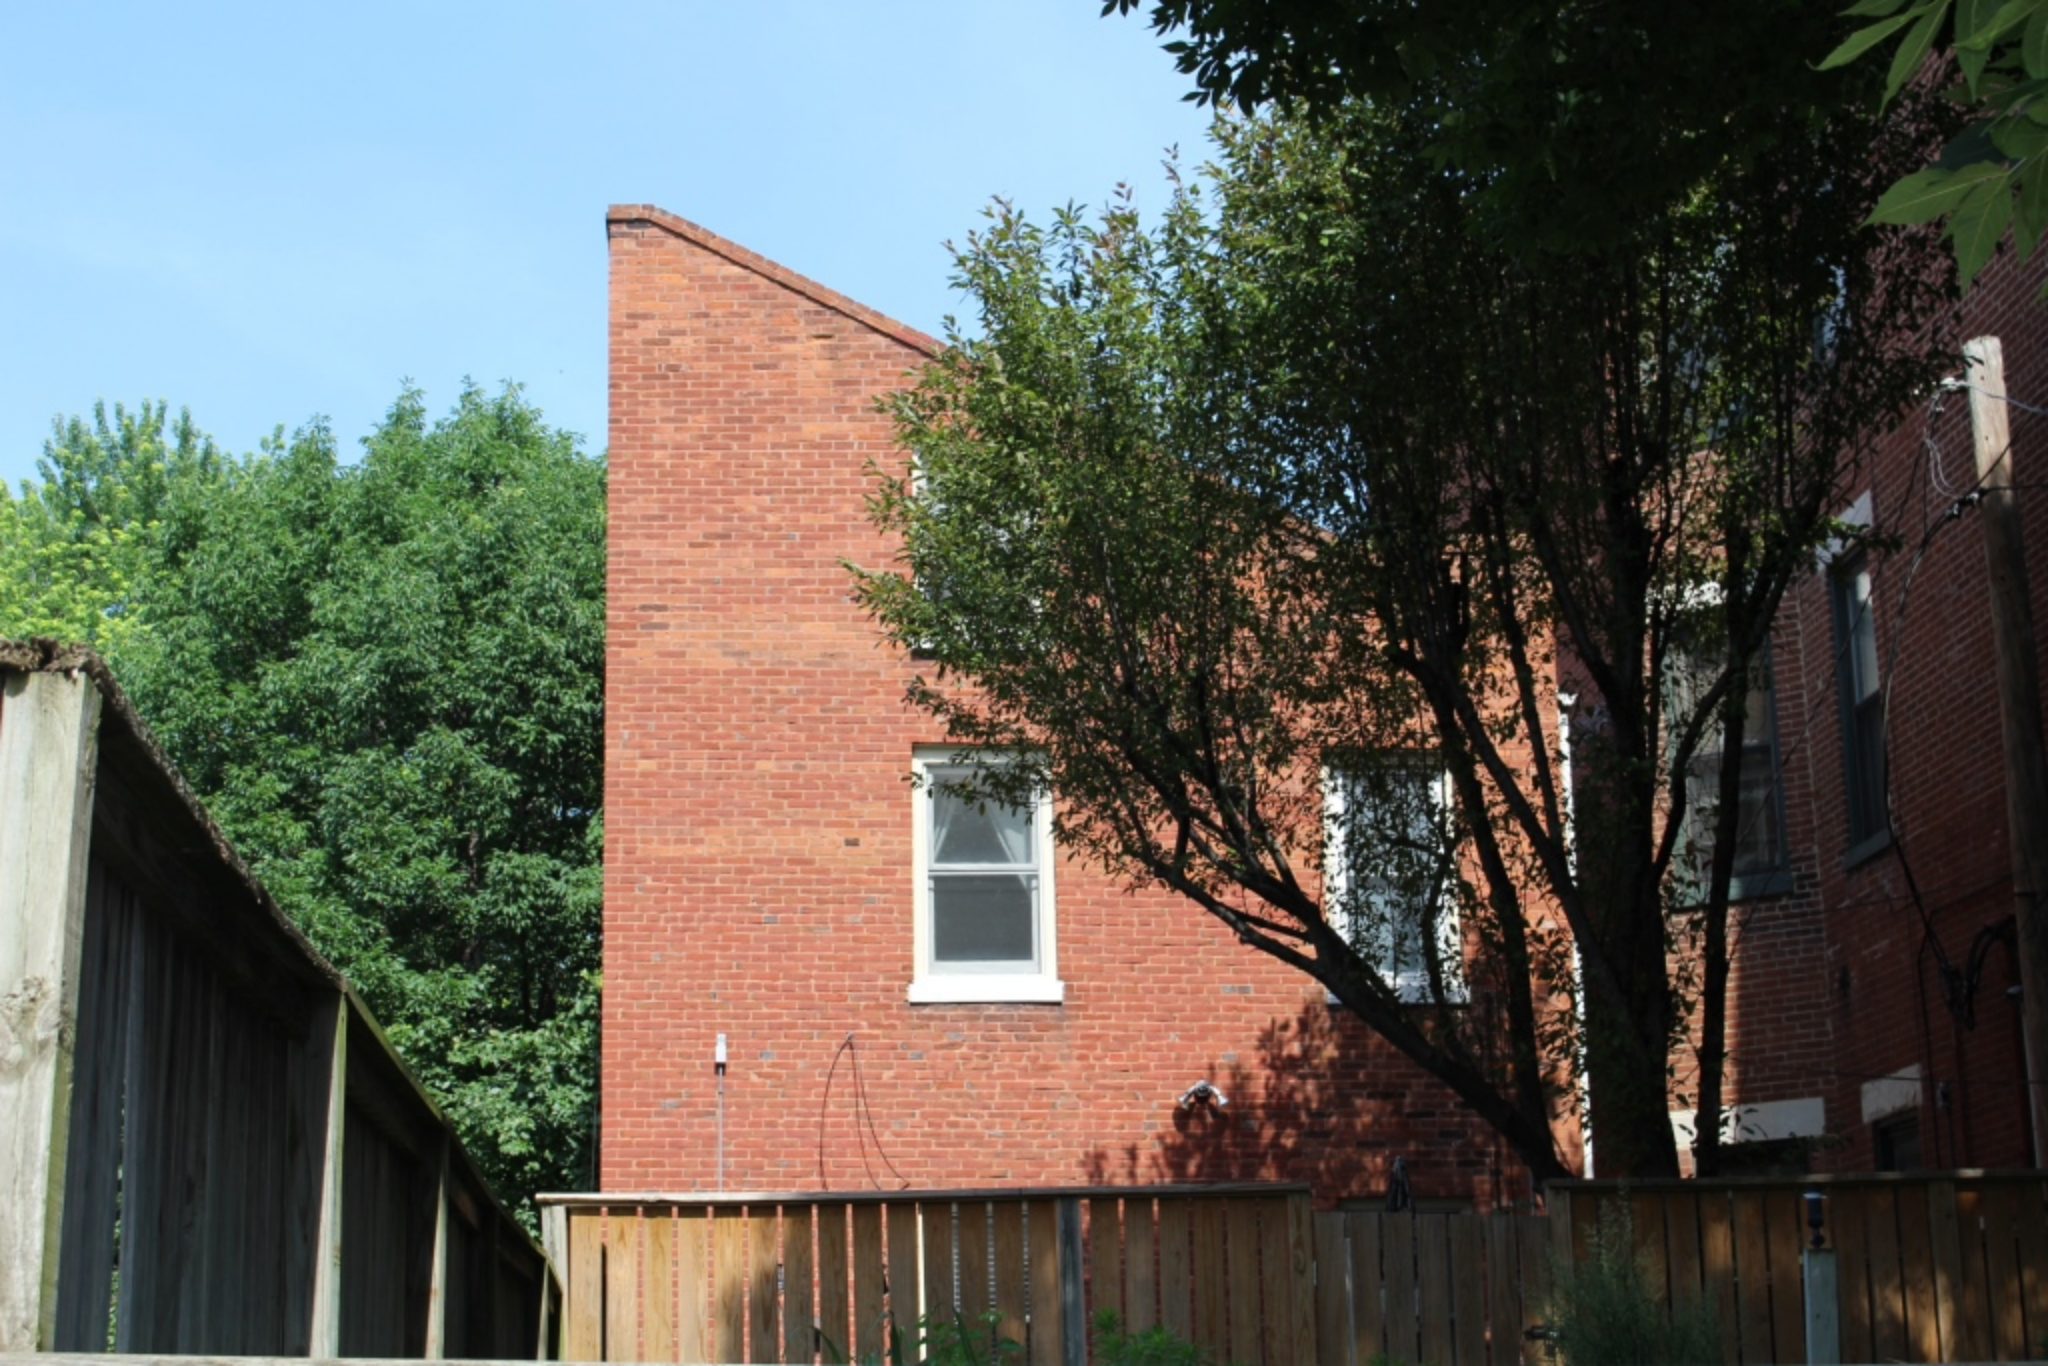
2204

The two-and-a-half story brick hipped roof flounder has a corbelled cornice with dentils and a chimney at the front of the north edge of the building. It has a simple dormer sheathed in wood and wood clapboard to the south side of the roof and a chimey set slightly to the rear of the dormer at the south wall. There is a brick attachment to the building to the north, forming a mousehole. There are three front bays with a center entry at the first story. The entry has a four-panel door with a three-light transom above. The front windows are one-over-one with flat-heads and painted stone sills. The recessed gallery on the north side has been enclosed and is sheathed in vinyl siding. There two entries on this elevation. The rear of the building has a classic flounder appearance and is two bays wide. The windows are one-over-one double-hungs with the half-story being a smaller window.

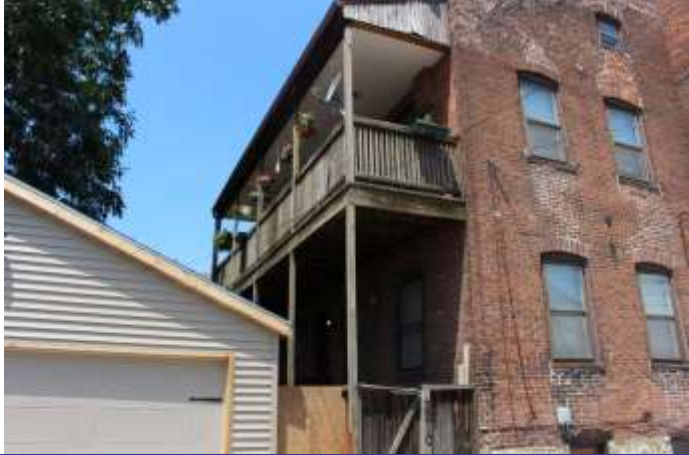
2210 MENARD ST

This two-and-one-story brick flounder is positioned at the edge of the alley. The two-bay alley end wall has basement windows above grade and a single window lighting the attic under the taller portion of the shed roof. There is a full-length two-story wood gallery with its own shed roof extending from the south side of the building. The taller north wall is windowless.
