**ARCHITECTURAL/HISTORIC INVENTORY FORM - Cultural Resources Office**  
**St. Louis Planning and Urban Design**

1. Survey no. SLC-AS-053-0102	2. Survey name: Thematic Survey of Flounder Houses in St. Louis City	3. County: St. Louis [Independent City]
4. Address: (from City GEO database) <b>900 HICKORY ST</b>		5. City/State: St. Louis, Missouri
Alternate address: 900 Hickory Street		Property Zip Code: 63104
Latitude: 38.615737		6. UTM Easting: 743886.40
Longitude: -90.198830		UTM Northing: 4277858.27
8. Historic Name (if known): N/A	11a. Historic Use (if known): Commerce/Trade	City Block 467.03
9. Present/other name (if known):	11b. Current Use: Commerce/Trade	City Ward 7
7. Township-Range-Section: N/A		10. Ownership: Private
Neighborhood Number: 34

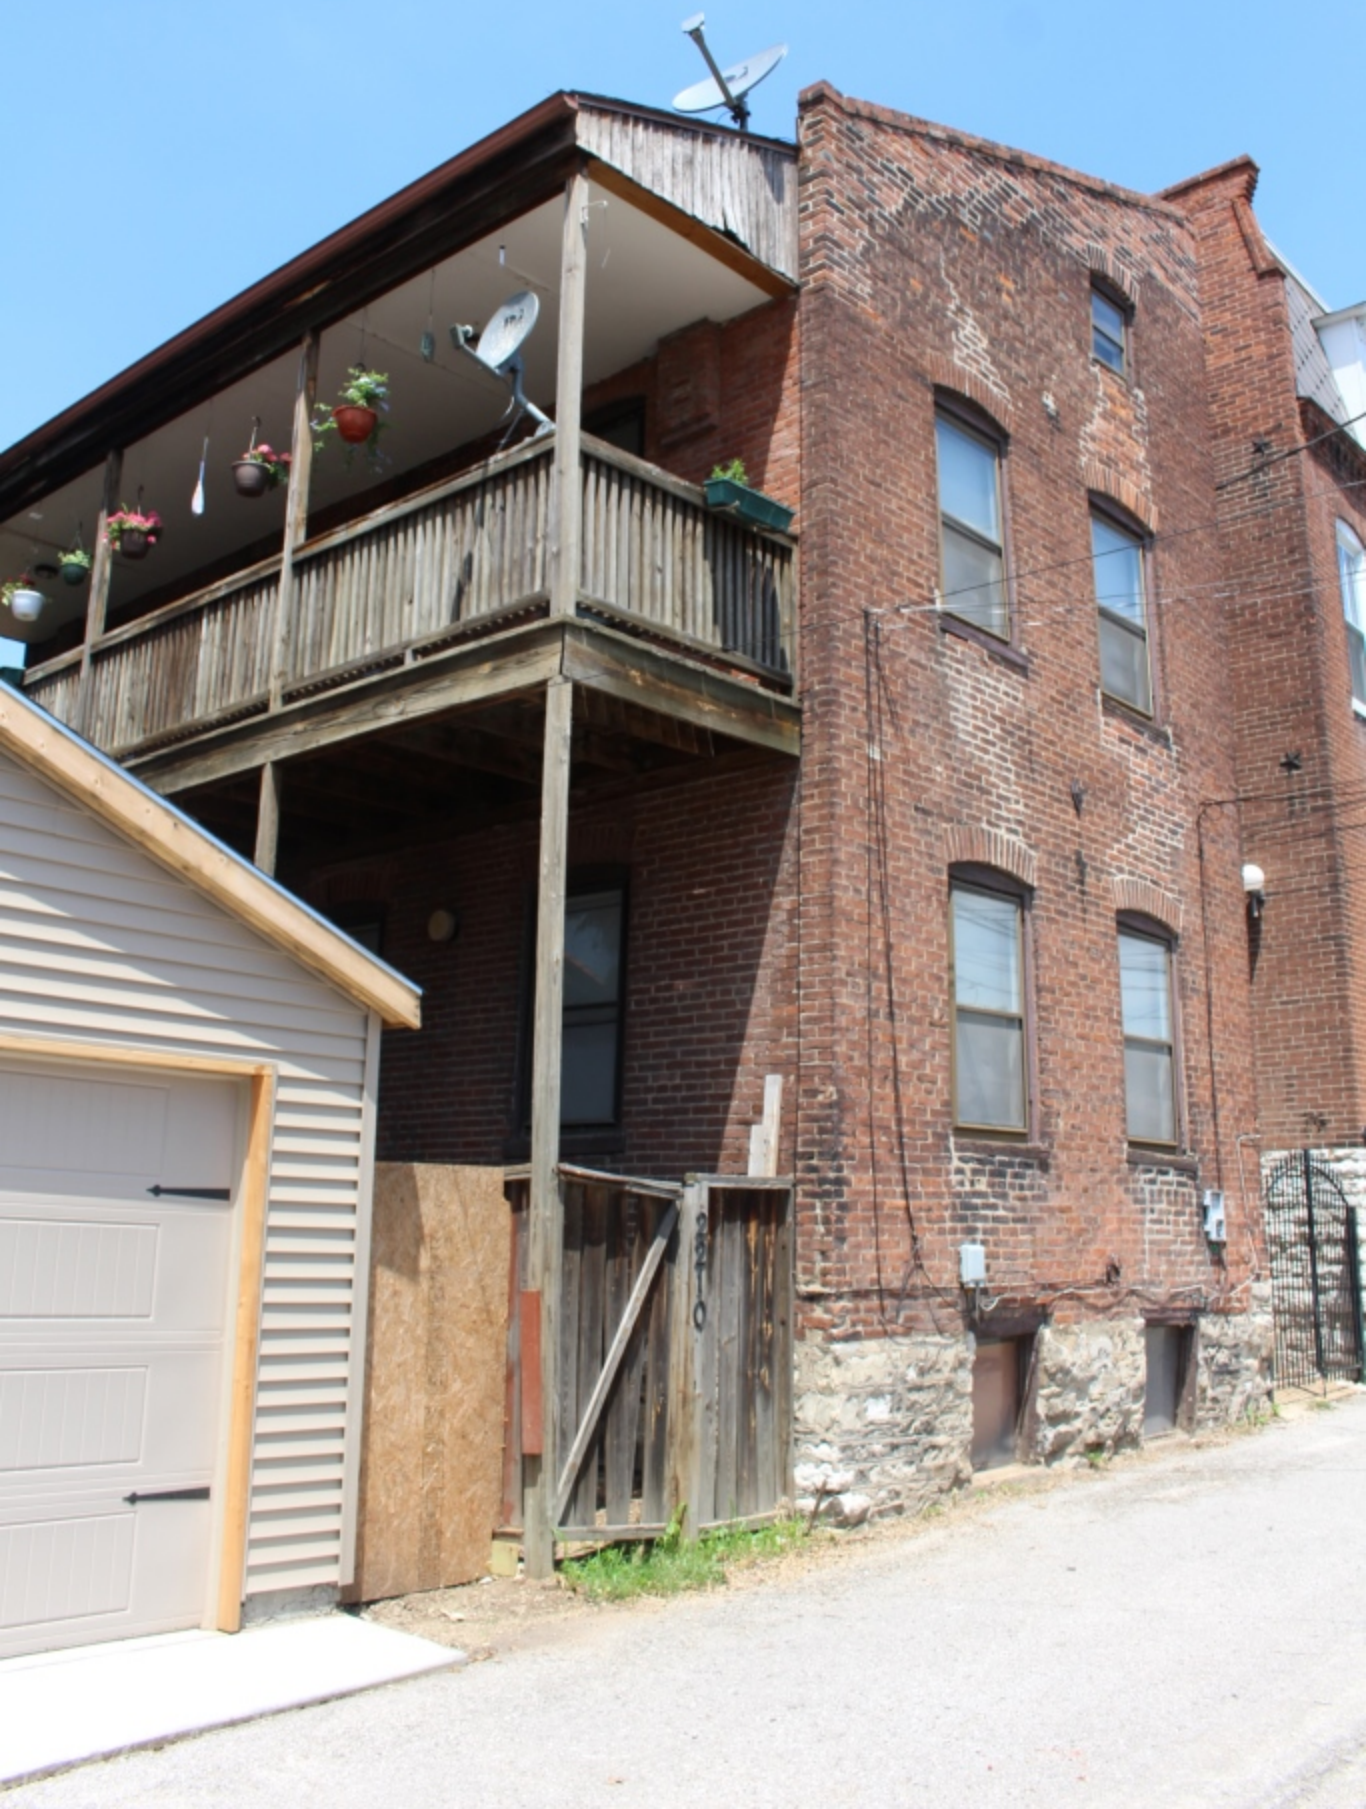
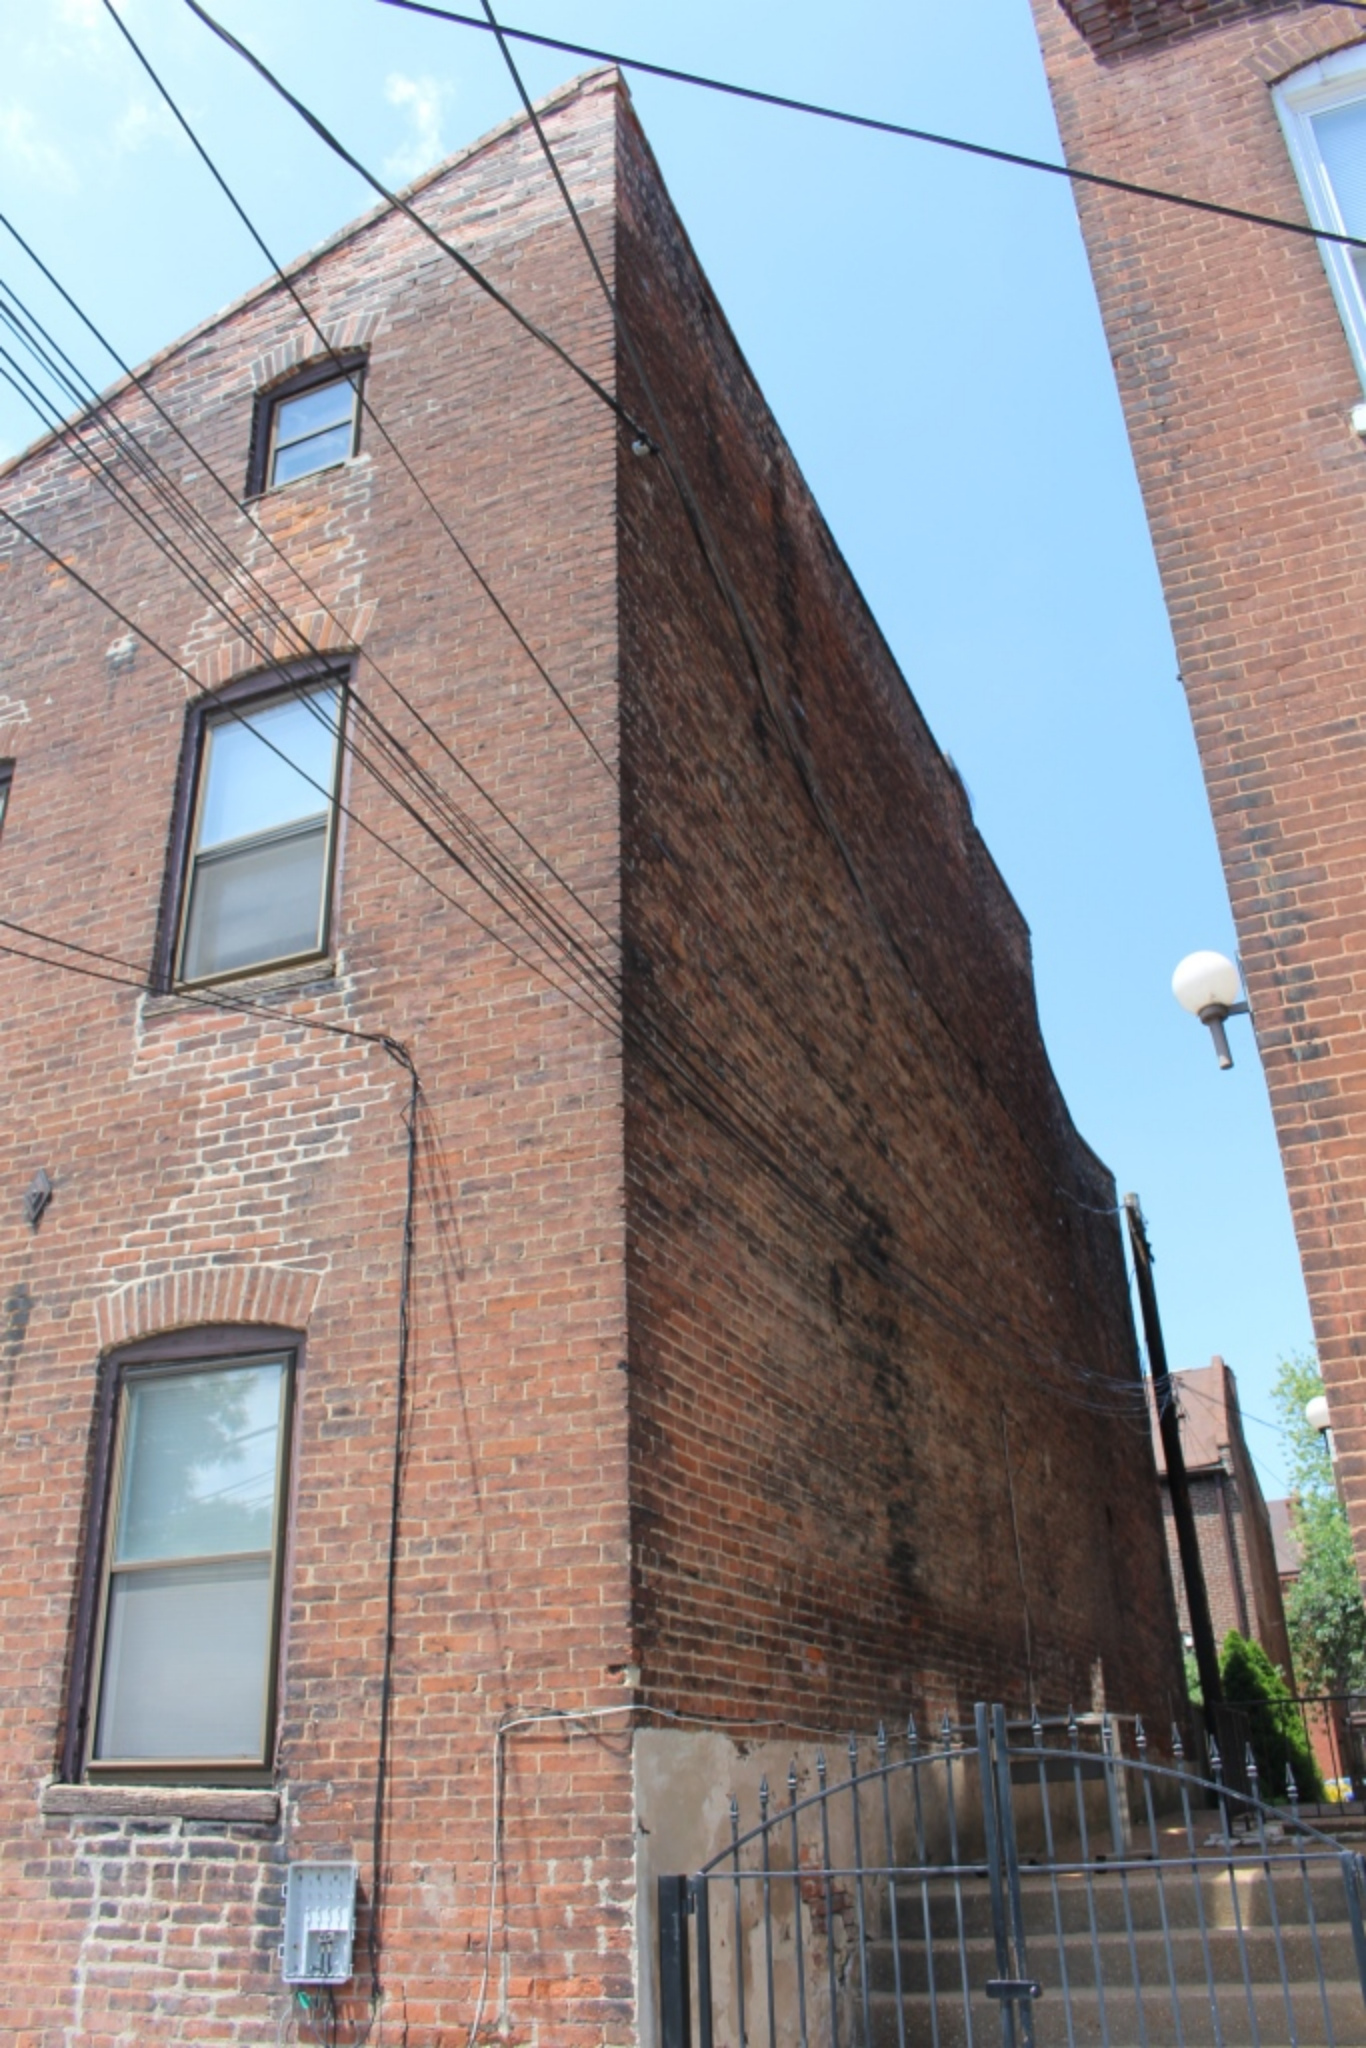
This two-and-one-story brick flounder is positioned at the edge of the alley. The two-bay alley end wall has basement windows above grade and a single window lighting the attic under the taller portion of the shed roof. There is a full-length two-story wood gallery with its own shed roof extending from the south side of the building. The taller north wall is windowless.

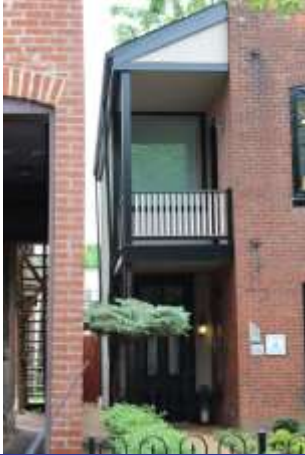
**2212 MENARD ST**

This two-and-one-half story brick flounder is set back from the building line. A smaller window lighting the attic is set in alignment with one of the two bays of windows facing the street. Much of the full-length wood gallery has been enclosed, leaving an open section one bay deep. The main entrance is now into the enclosed portion of th gallery, facing the street. The taller windowless wall abuts the adjacent building.

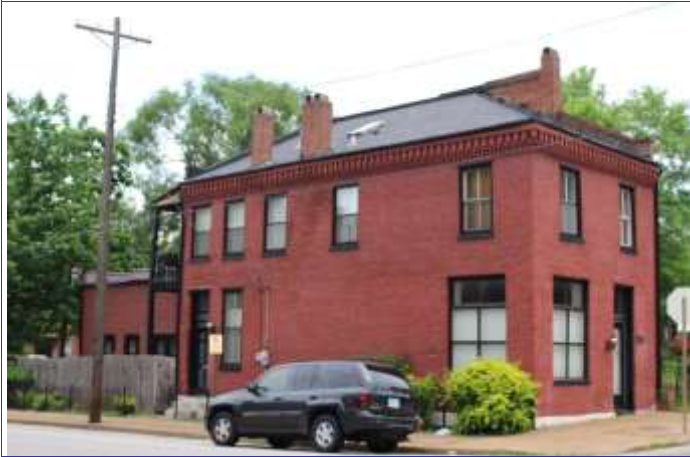
**2300 MENARD ST**

Building is in good condition and is well-maintained.

The two-story brick hipped-roof flounder has a corbelled cornice. There is a tall, narrow chimney at the south wall. A high parapet extends out behind this chimney to the roof ridge. The corbelled brick cornice has tiered dentils. The second story windows are 2-over-2 double-hung with painted stone sills. The front entry is a 3/4-light door with a two-light transom. The storefront window is a large four-light fixed window with a two-light transom and a painted stone sill. The north façade faces Shenandoah Av. and the corbelled cornice continues on this elevation. There are five second story windows like the ones on the front façade although they are asymmetrically placed. There is another large store front near the corner on this elevation matching the one on the front. At the other end of the first story is a large two-over-two double-hung window with a stone sill and an entry with a 6-panel door and two-light transom. Three stone steps lead up to the entry. There are two interior chimneys located on this side of the building. The rear of the building has a small loft window at the attic with a single-light sash with a segmental arch header lintel. There are two bays at the rear with one being a second-story entry. The other rear windows are one-over-one double-hungs. There is a small second-story porch with a shed roof which extends the width of the rear. The A one-story brick rear addition with a frame wall facing Shenandoah extends the length of the property. This may be part of an early addition which has been altered.

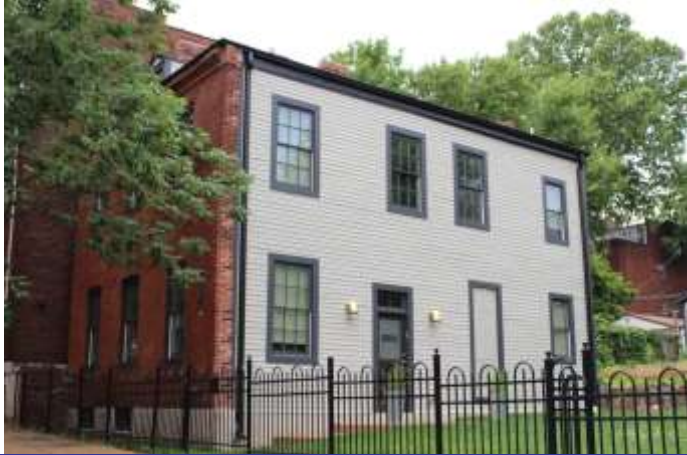
**2309 MENARD ST**

The building is in good condition and is well-maintained.

The two-and-a-half story brick flounder had a corbelled cornice with small brick brackets. There is a simple gabled dormer sheathed in wood and wood clapboards. A chimney sits at the south wall near the rear of the dormer. The front façade has three bays. The first and second story windows are four-over-four with segmental arch soldier brick lintels and painted stone sills. There are two small basement windows at the southernmost bays on the front façade. The windows are single-light, set in to a smooth, parged foundation. At the north elevation the gallery porch has been enclosed. There are four bays and it contains the entry. The entry is a three-panel, half-light door with two-light transom. Another large first-story opening has been closed with shutters. Three of the five windows are 6-over-6, with the two window toward the rear being one-over-one. The rear of the building has a more classical two-bay flounder appearance with an enclosed gallery. The windows on the first two stories are four-over-four, while the attice level is a one-over-one. There is a rear entry into the enclosed gallery porch.

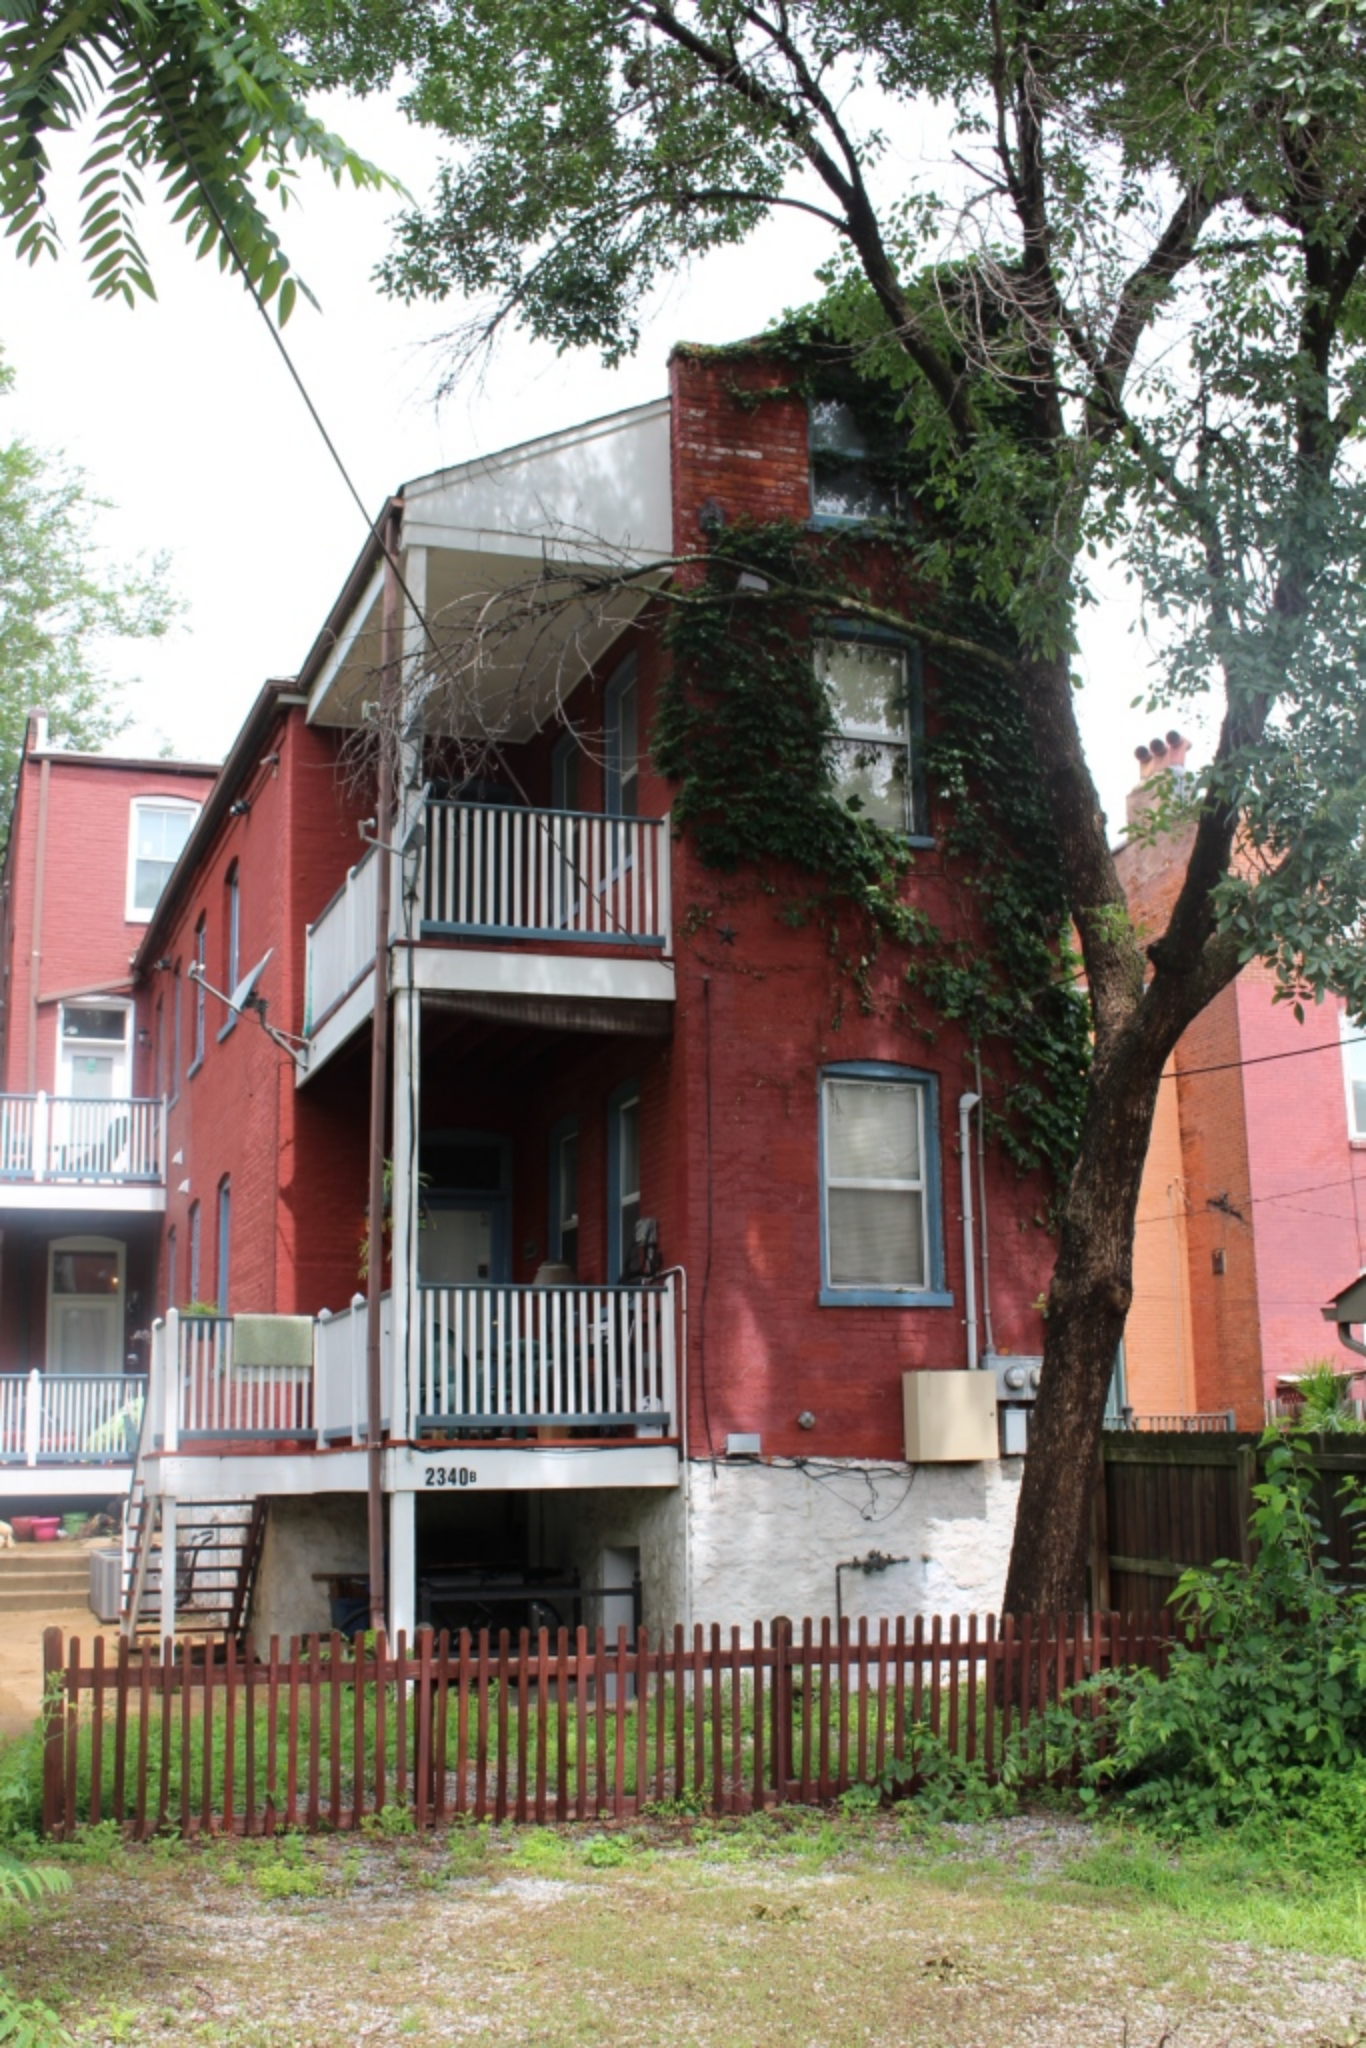
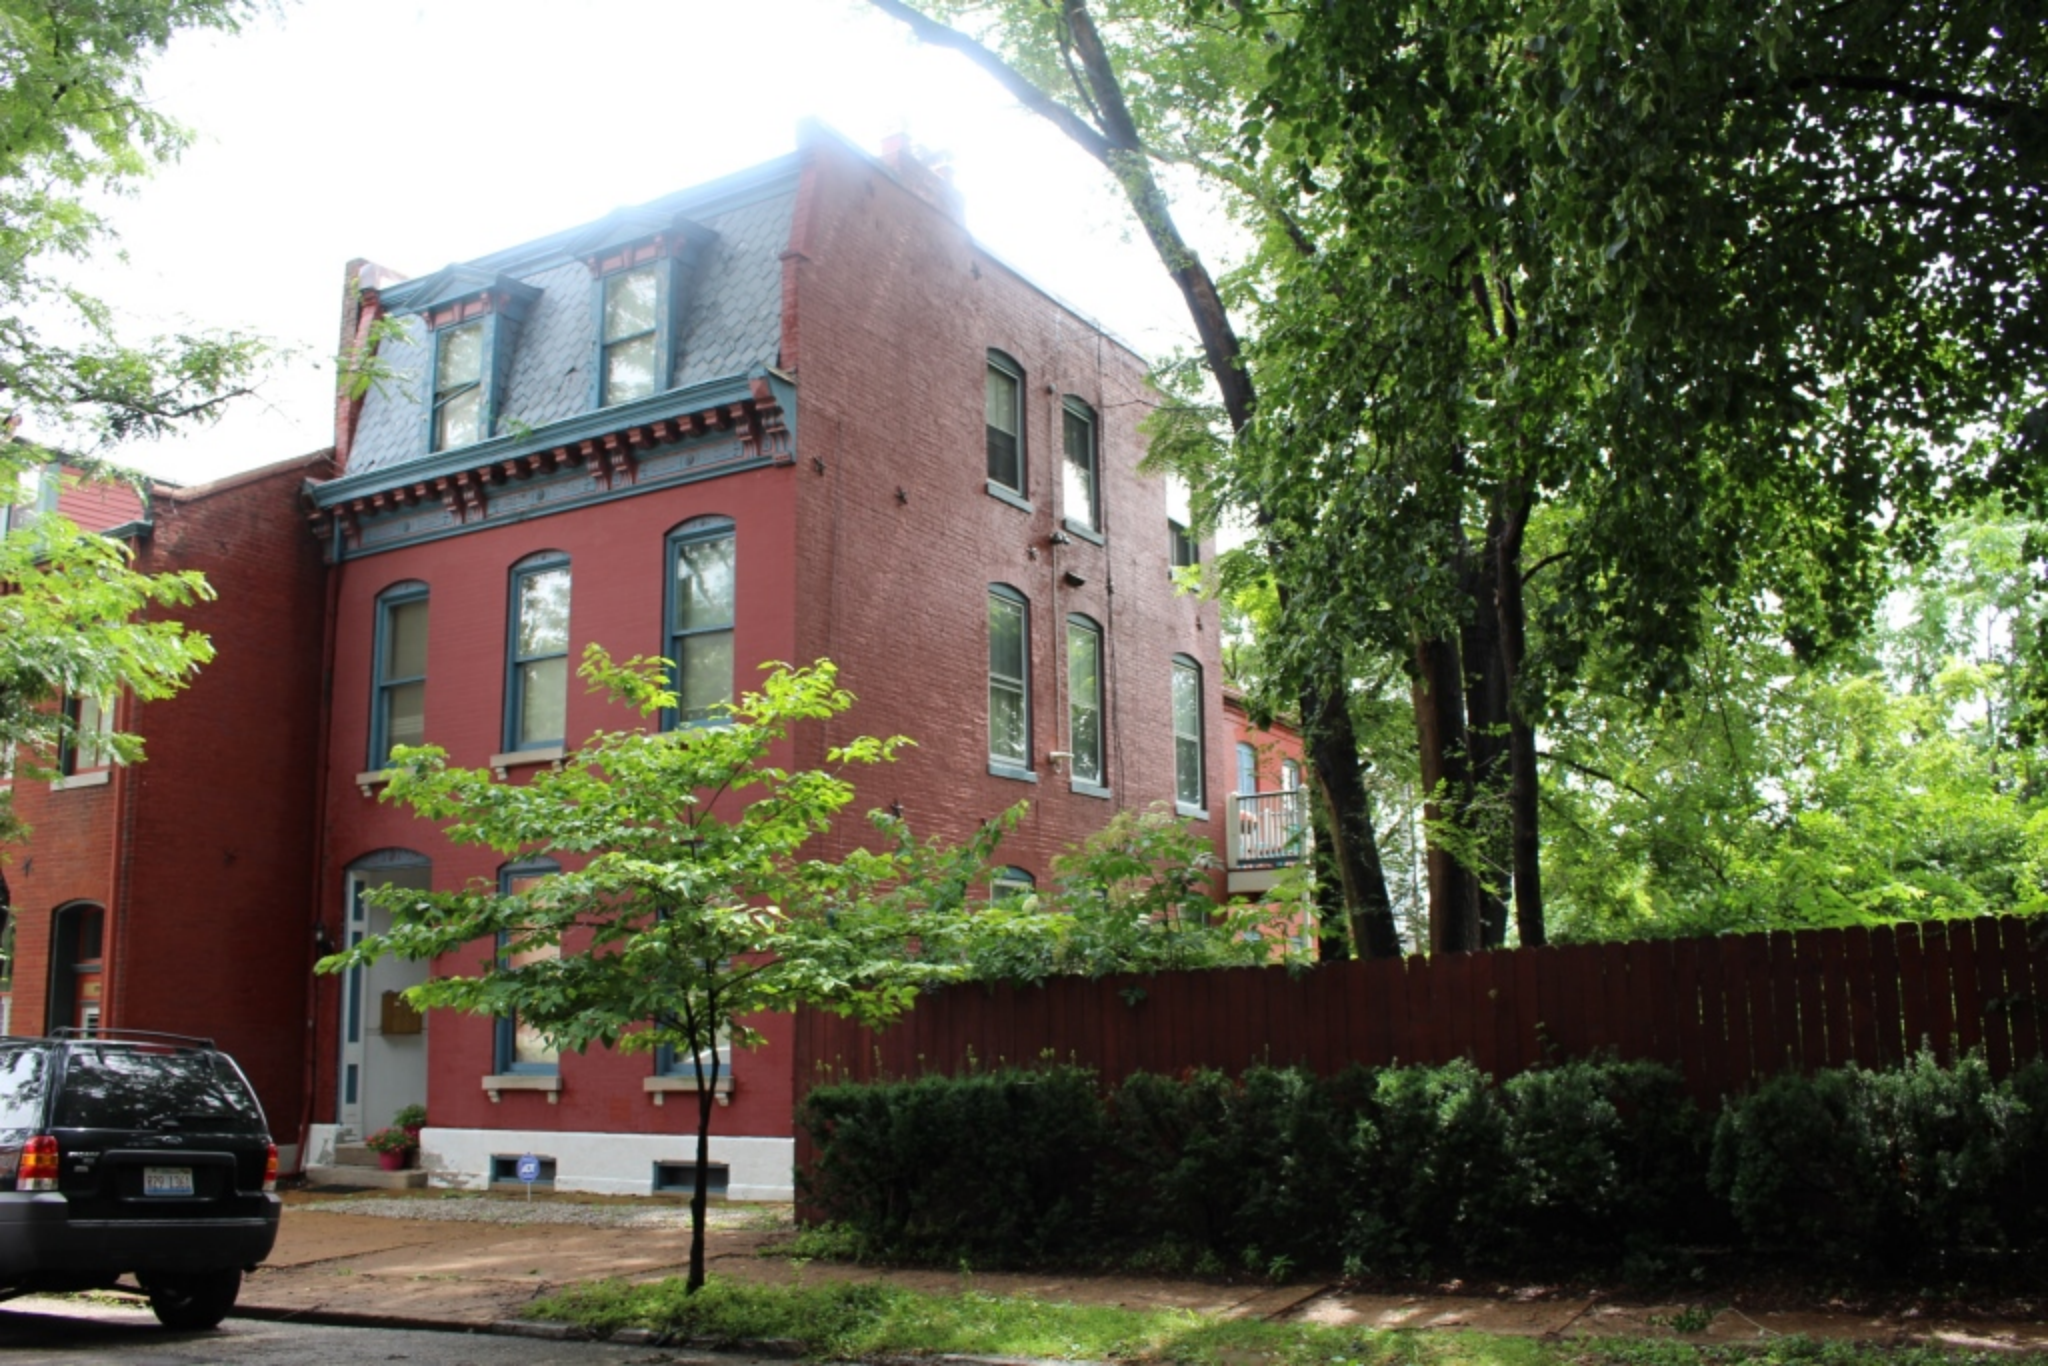
2340B

The two-story with a loft flounder is now attached to a Second Empire building that was constructed after 1883. The original front of the building has been obscured by the connection. There are three chimneys along the north wall of the building. The south elevation has four window openings at each floor. Two of the window openings have been boarded. There is one additional door opening at each story on the recessed section of the south side towards the rear. At the recessed section is a two story porch which extends out past the façade to allow stair access. The rear has one recessed bay and a one additional bay. At the rear, the foundation is raised as the grade is lower than at the front.

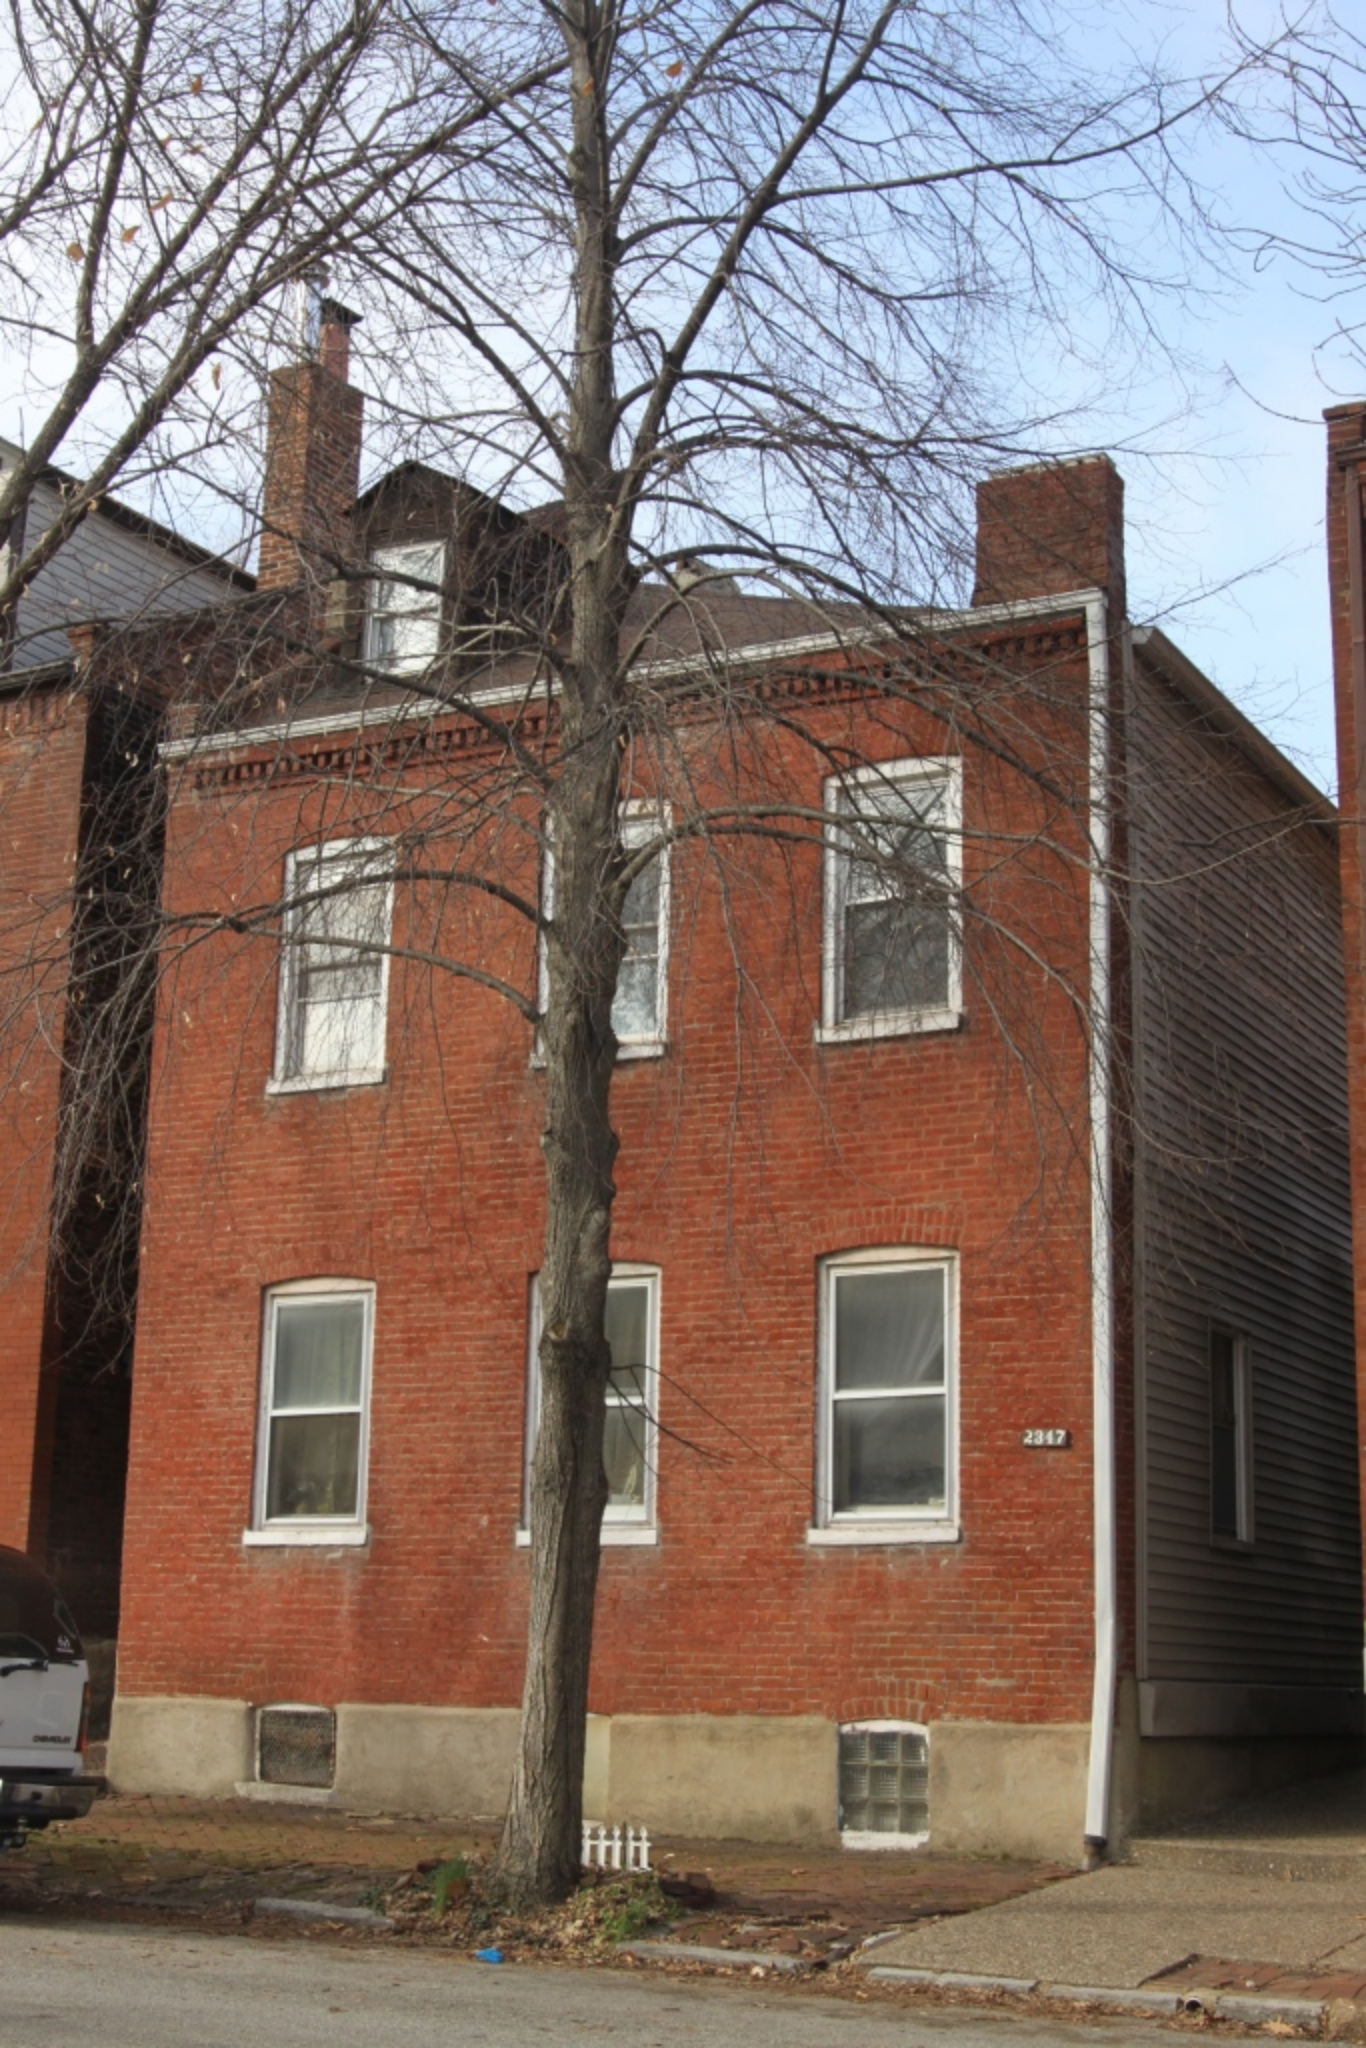
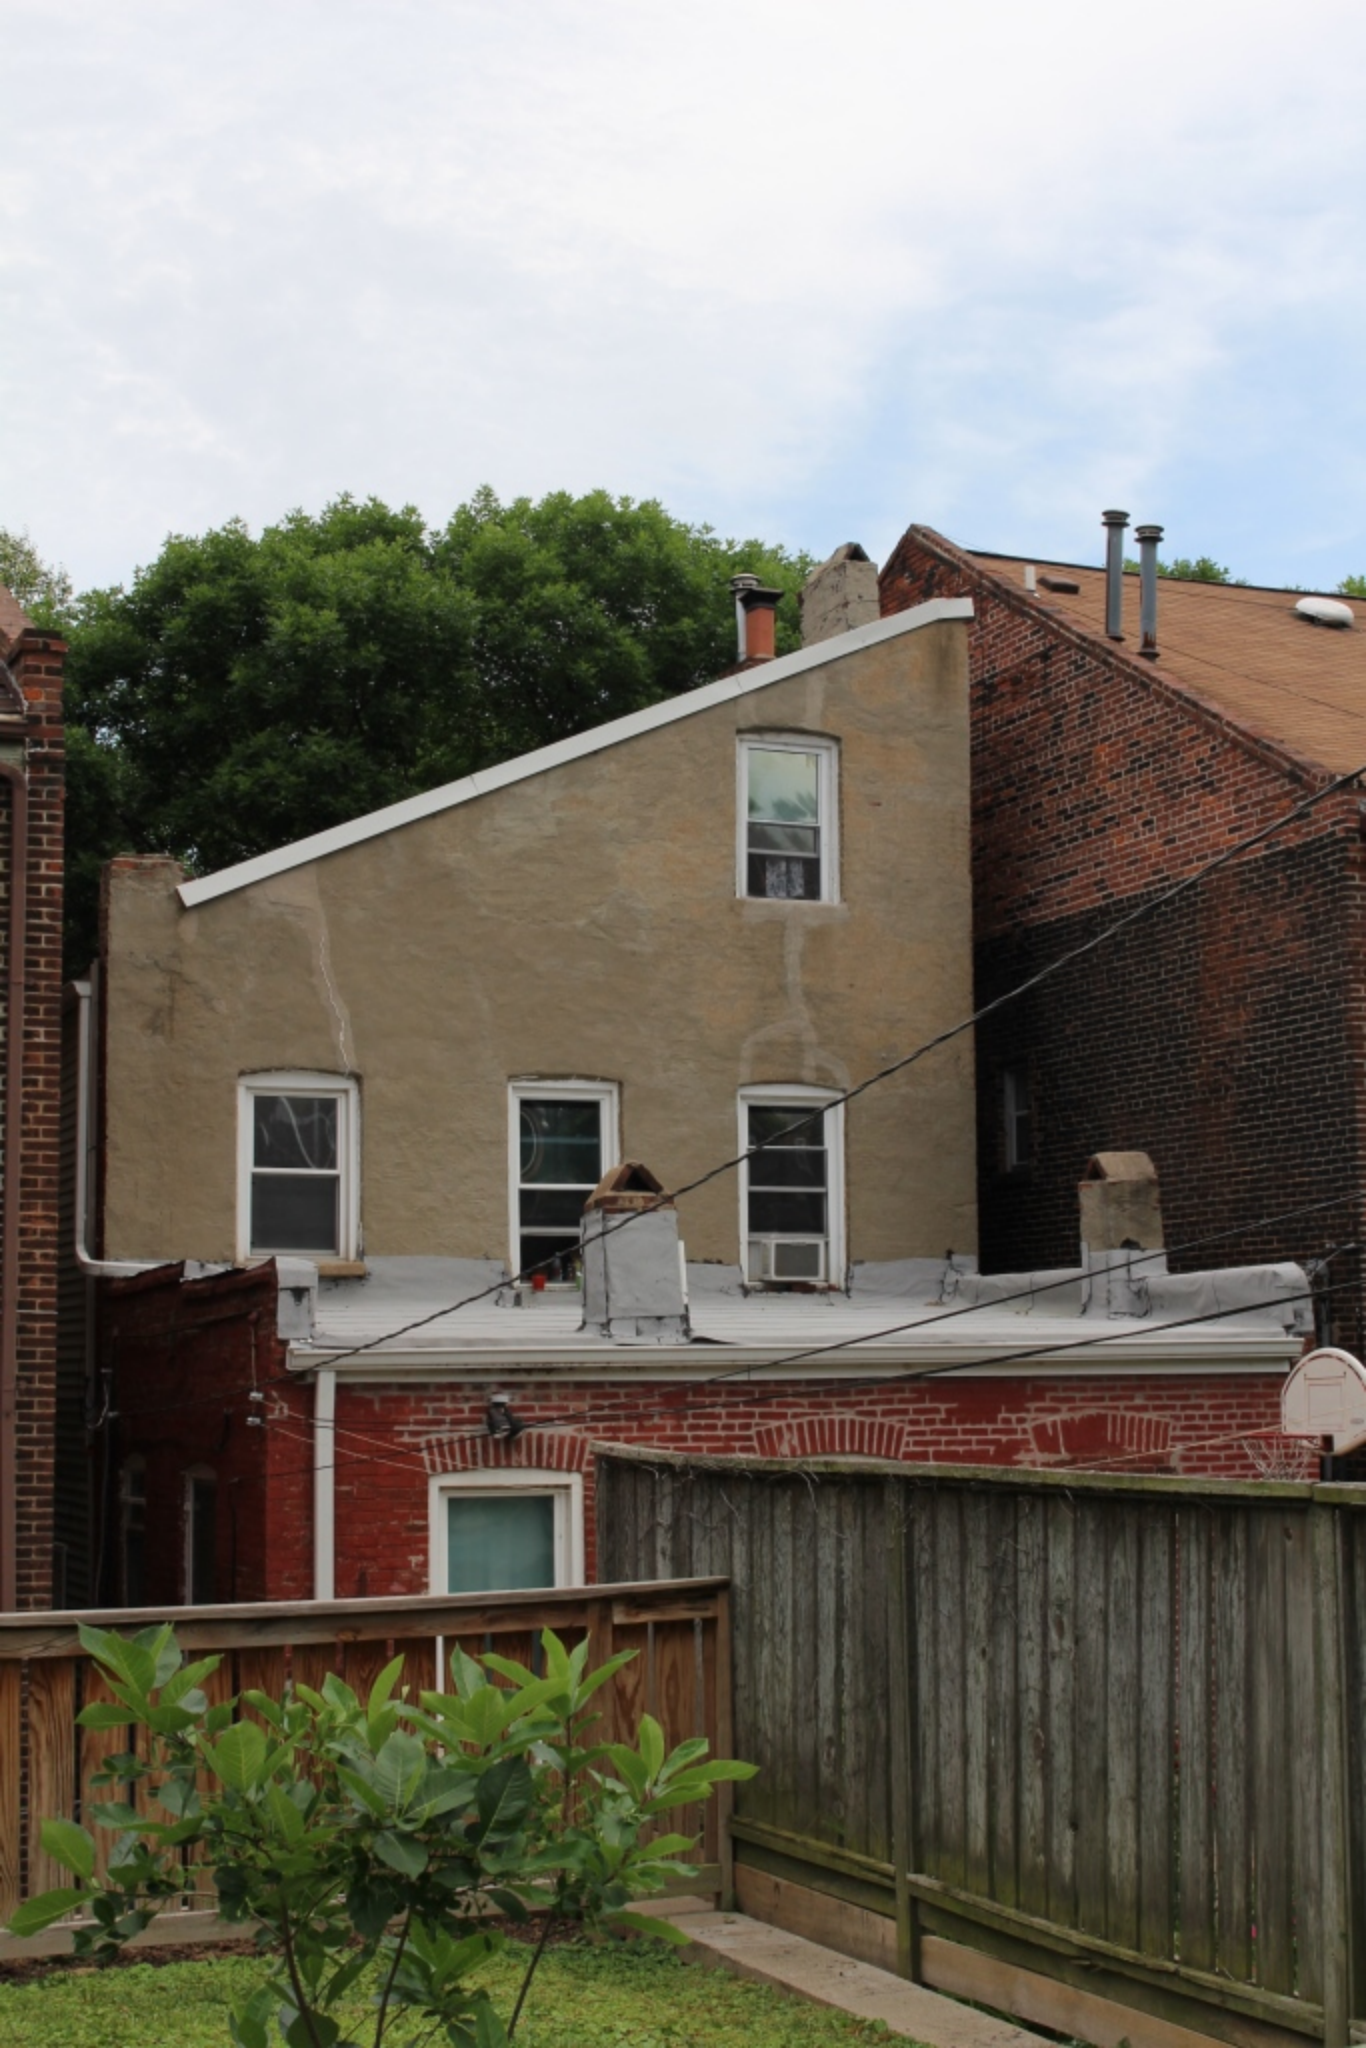
2347

The building is in fair-to-good condition. It could use some minor maintenance.

The two-and-a-half story brick flounder had a corbelled cornice with dentils and a chimney at the north corner of the façade. There is a simple gabled dormer sheathed asphalt shingles. A chimney sits at the south wall near the rear of the dormer. The front façade has three bays. The first and second story windows are one-over-four with segmental arch double-rowlock brick lintels and painted wood sills. There are three small basement openings on the front façade. The southernmost opening has wire mesh over the window. The center window has been boarded and the northernmost window has been infilled with glass block. The openings are set in to a smooth, parged foundation. At the north elevation the gallery porch has been enclosed. There are two bays and the entry is towards the rear. The rear of the building has a more classical two-bay flounder appearance with an enclosed gallery. The windows are one-over-one. The rear of the flounder has been parged. There is a one story flat-roof brick addition at the rear.

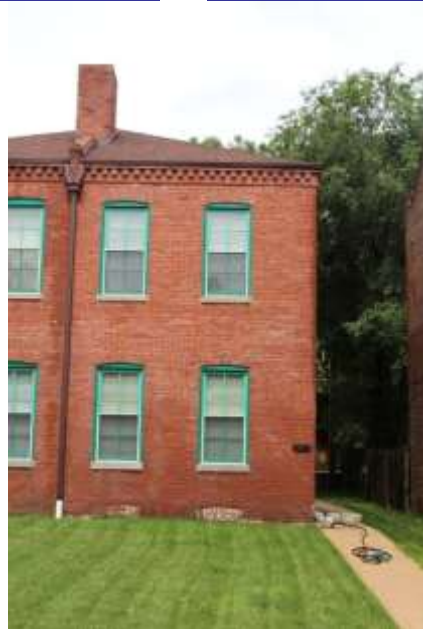
Front elevation

The building is in good condition and is well-maintained.
