**ARCHITECTURAL/HISTORIC INVENTORY FORM - Cultural Resources Office**  
**St. Louis Planning and Urban Design**

1. Survey no. SLC-AS-053-0102	2. Survey name: Thematic Survey of Flounder Houses in St. Louis City	3. County: St. Louis [Independent City]
4. Address: (from City GEO database) <b>900 HICKORY ST</b>		5. City/State: St. Louis, Missouri
Alternate address: 900 Hickory Street		Property Zip Code: 63104
Latitude: 38.615737		6. UTM Easting: 743886.40
Longitude: -90.198830		UTM Northing: 4277858.27
8. Historic Name (if known): N/A	11a. Historic Use (if known): Commerce/Trade	City Block 467.03
9. Present/other name (if known):	11b. Current Use: Commerce/Trade	City Ward 7
7. Township-Range-Section: N/A		10. Ownership: Private
Neighborhood Number: 34

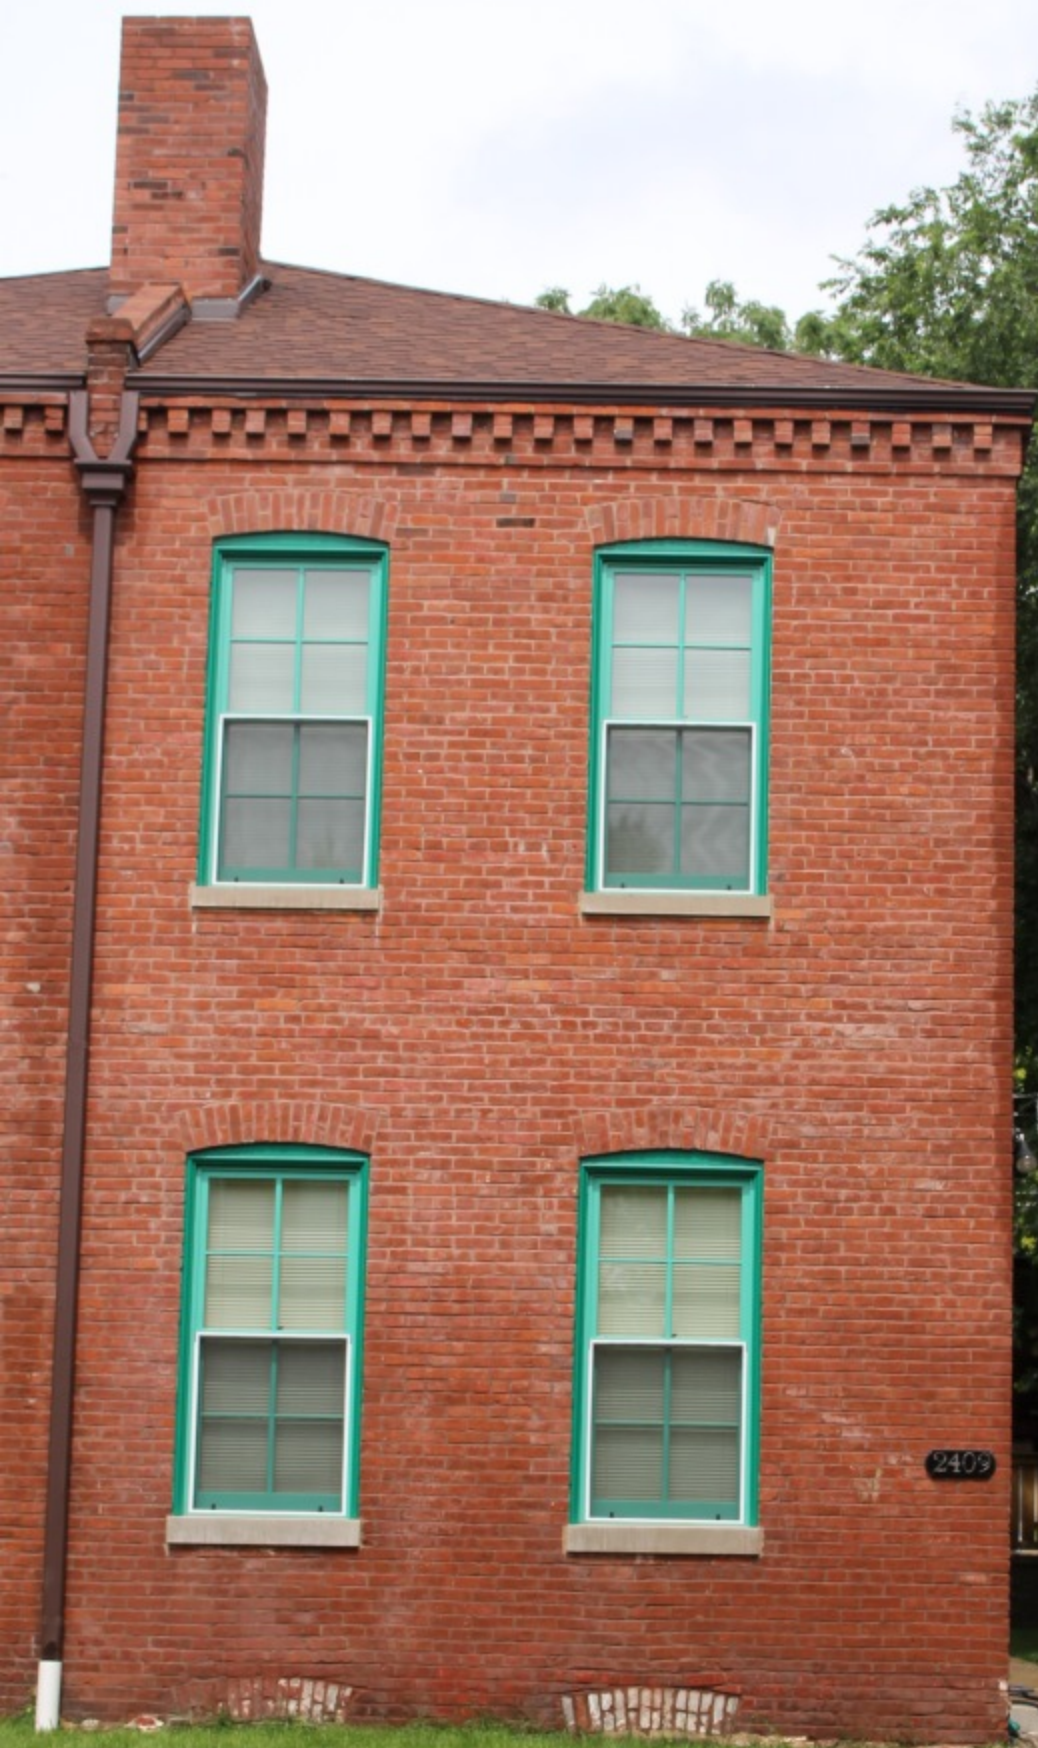
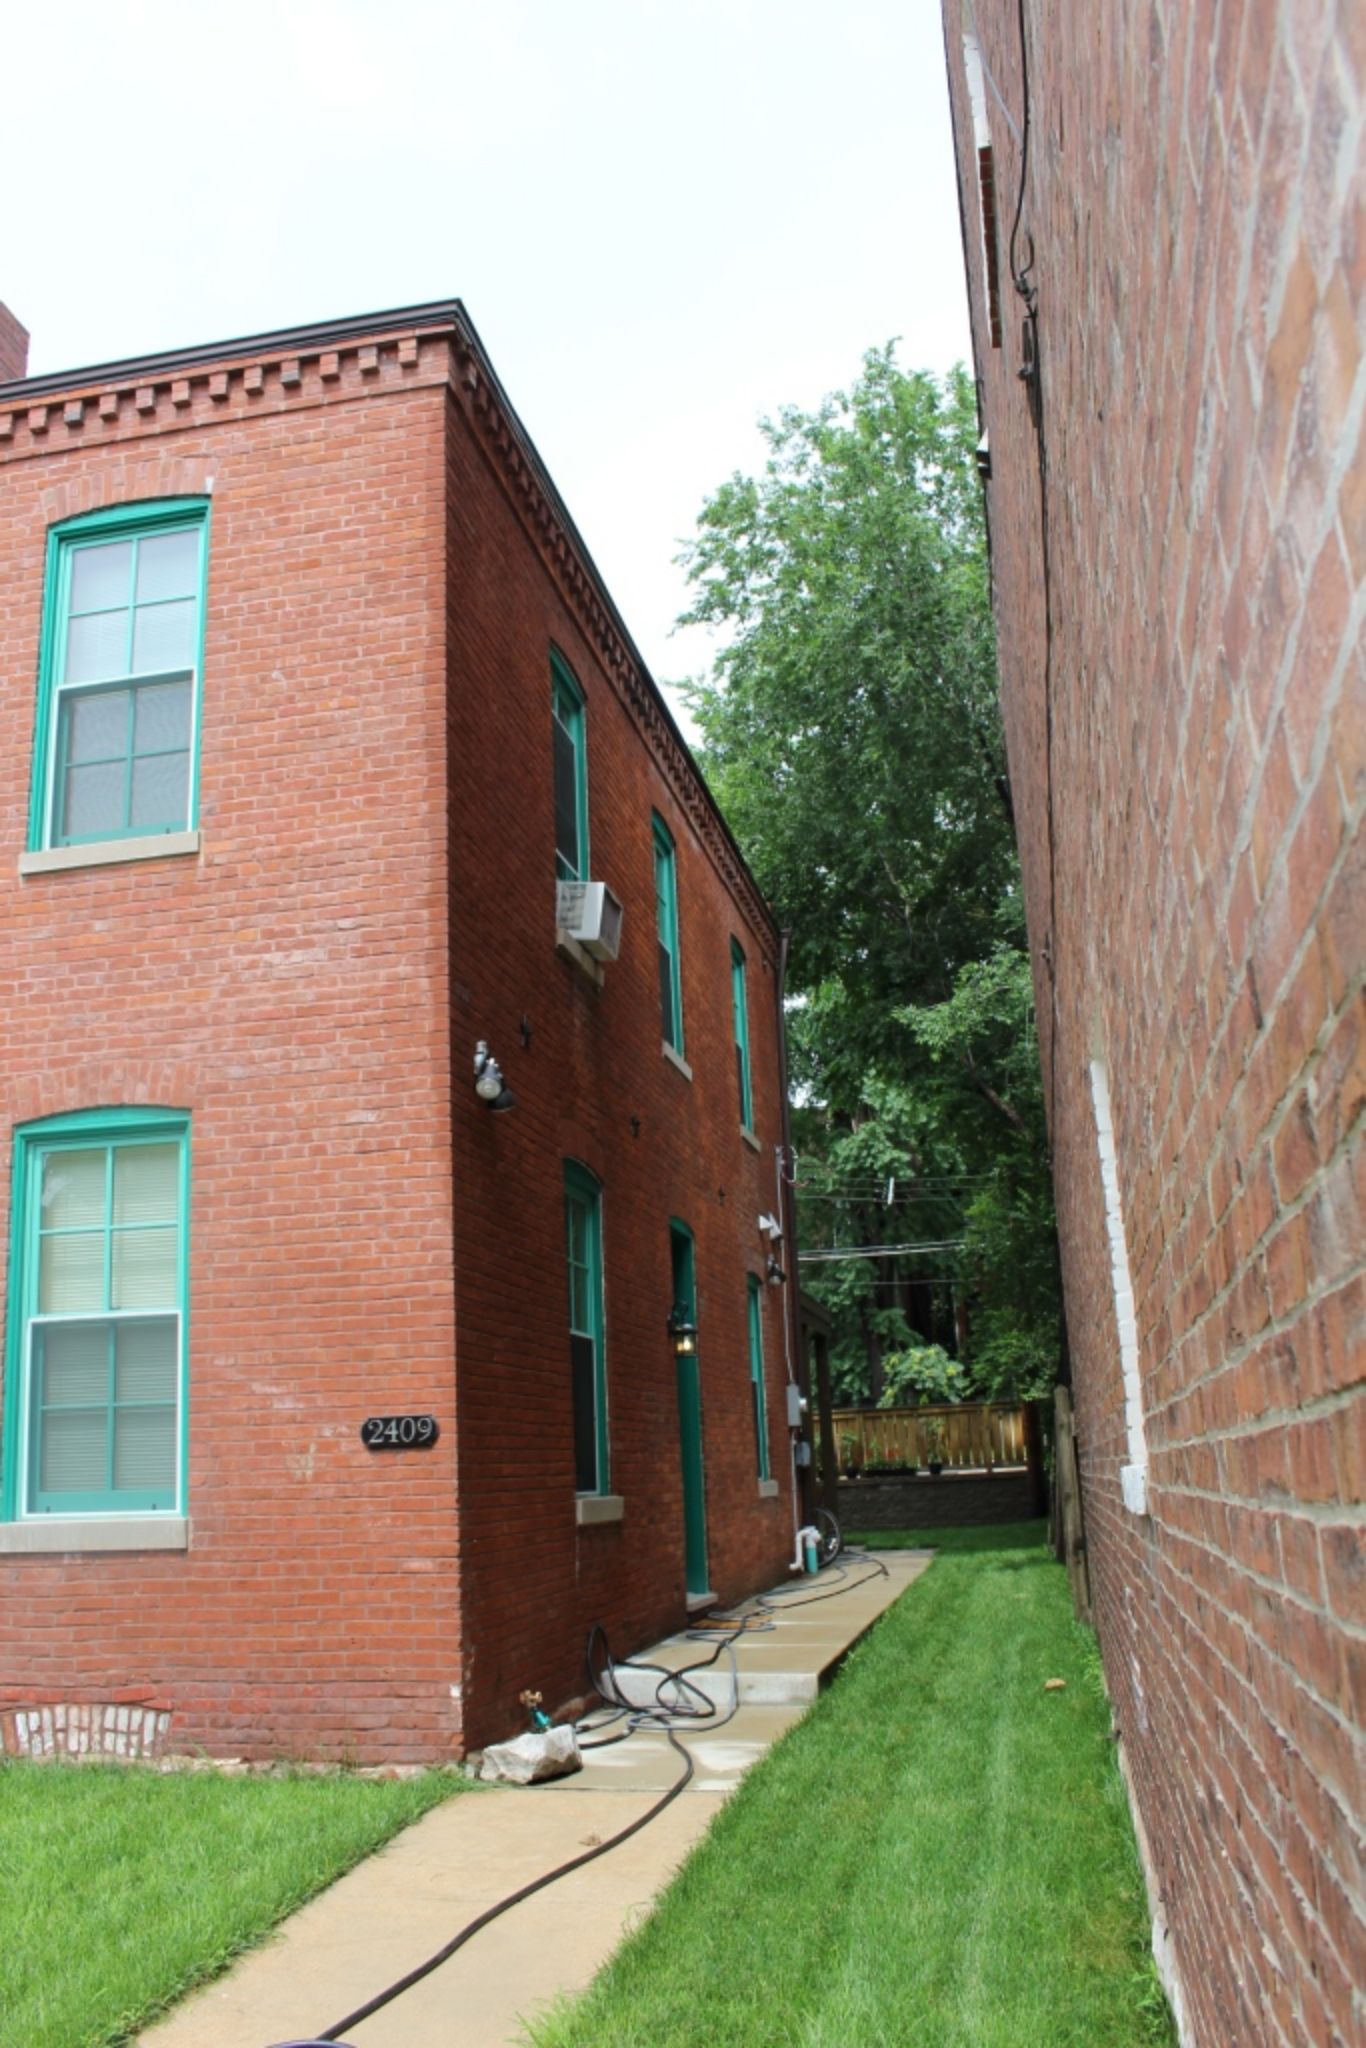
2409

The two-story brick hipped roof founder is semi-detached with an attached chimney on the left side and a denticulated brick cornice which extends along the north side of the building. The first and second story double-hung windows are four-over-four double-hungs with segmental arch soldier brick lintels and limestone sills. Only a rough-faced limestone sill is visible above grade. The north elevation has three bays on the main section and an additional bay on a smaller 2-story flat roof rear addition. The windows on both sections are 1-over-1. The entry is located at the center bay of the north elevation. There are door openings on both the first and second stories of the rear addition.

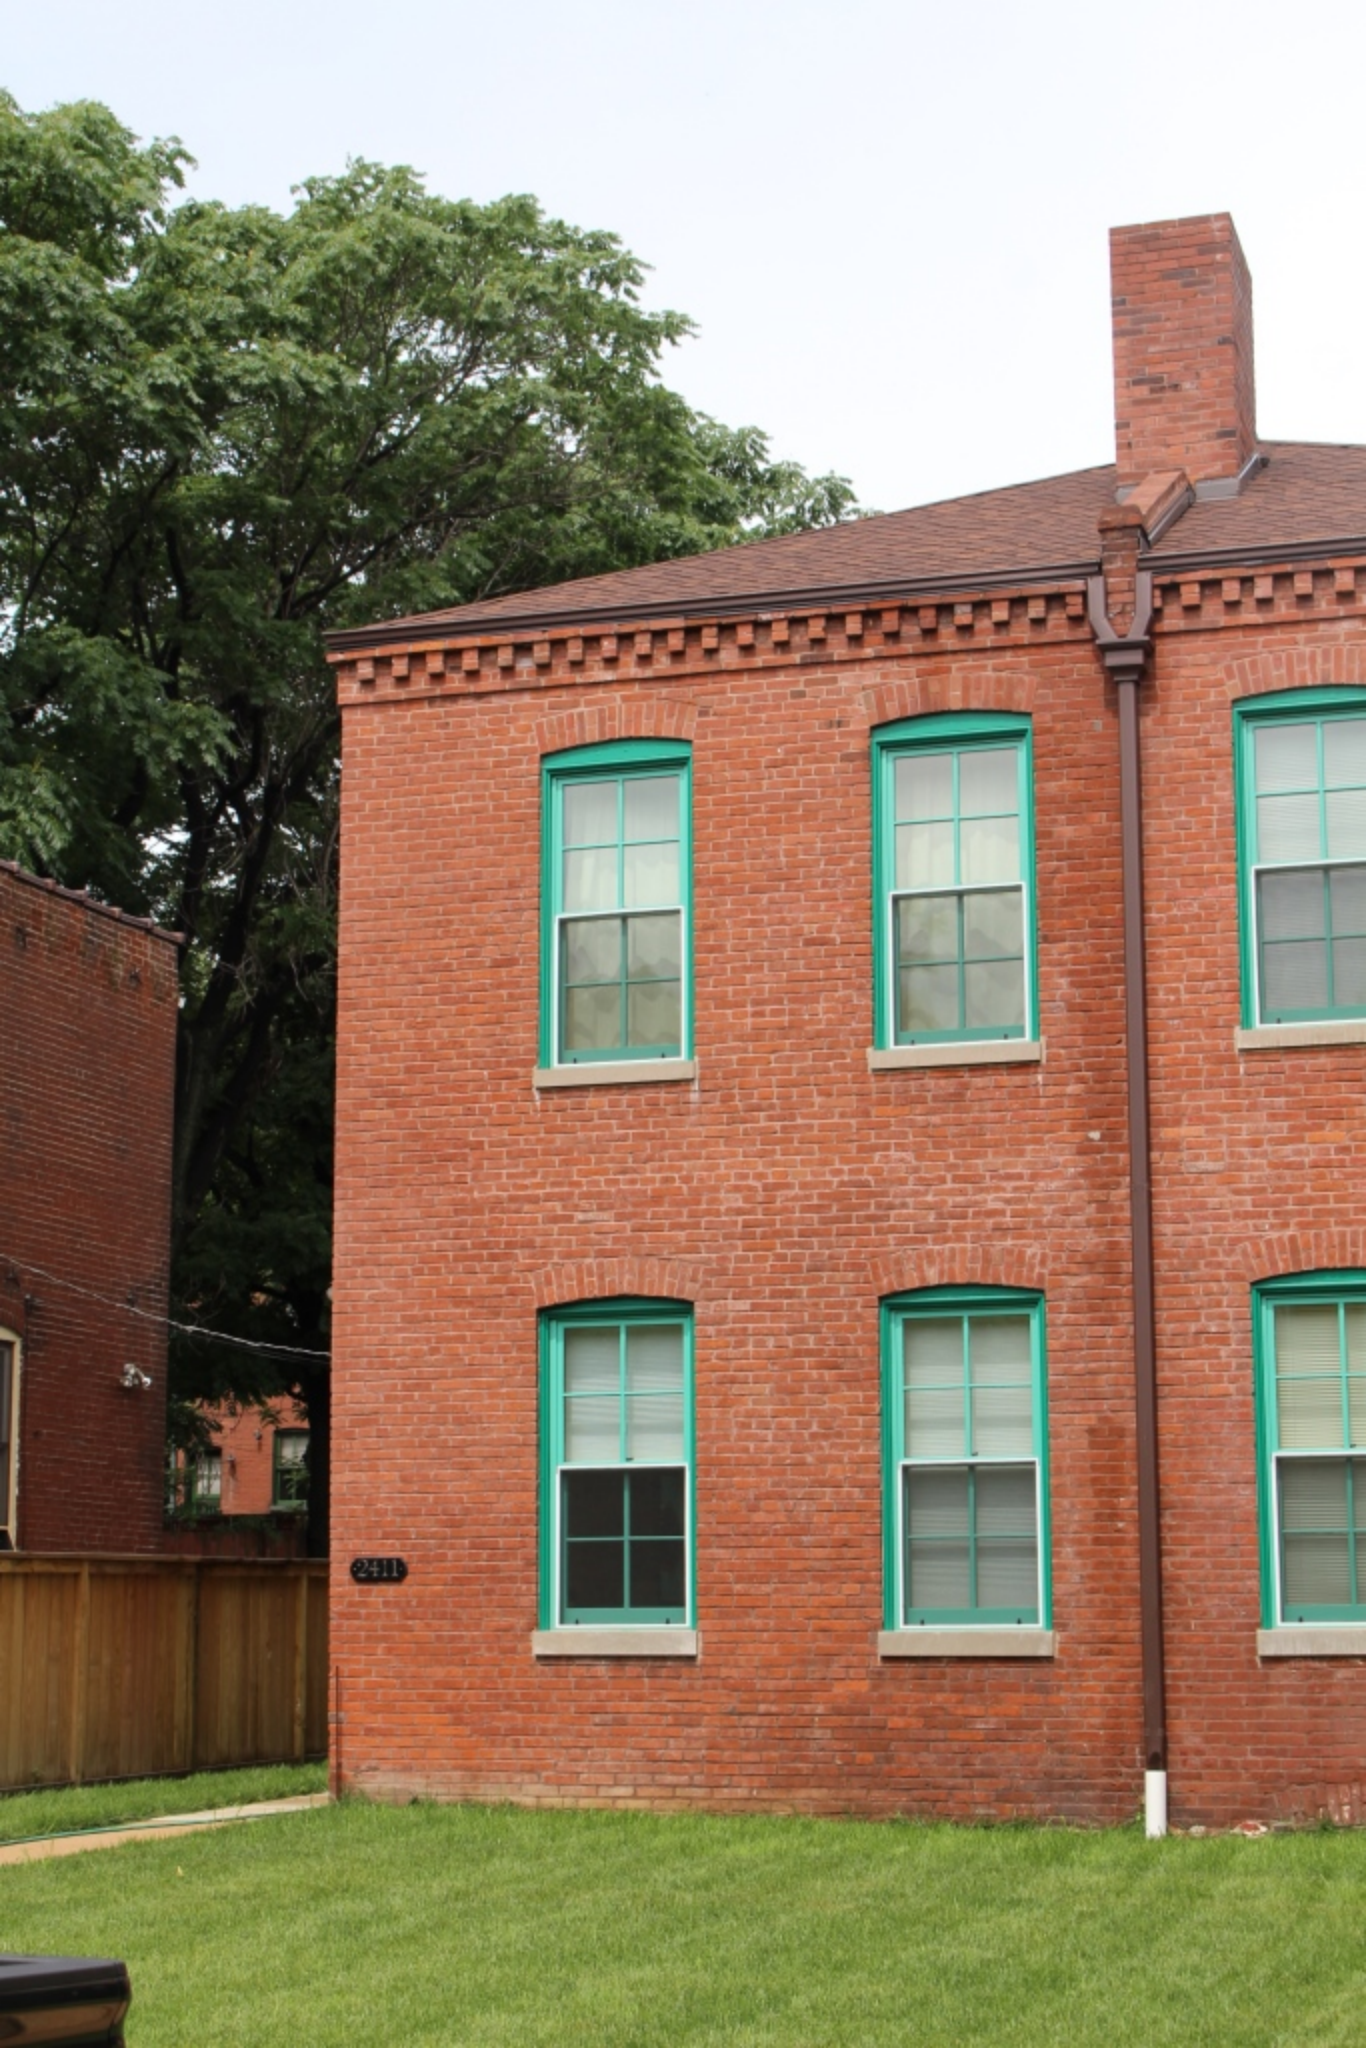
The two-story brick hipped roof founder is semi-detached with an attached chimney on the right side and a denticulated brick cornice which extends along the south side of the building. The first and second story double-hung windows are four-over-four double-hungs with segmental arch soldier brick lintels and limestone sills. Only a rough-faced limestone sill is visible above grade. The north elevation has three bays on the main section and an additional bay on a smaller 2-story flat roof rear addition. The windows on both sections are 1-over-1. The entry is located at the center bay of the south elevation. There are door openings on both the first and second stories of the rear addition.

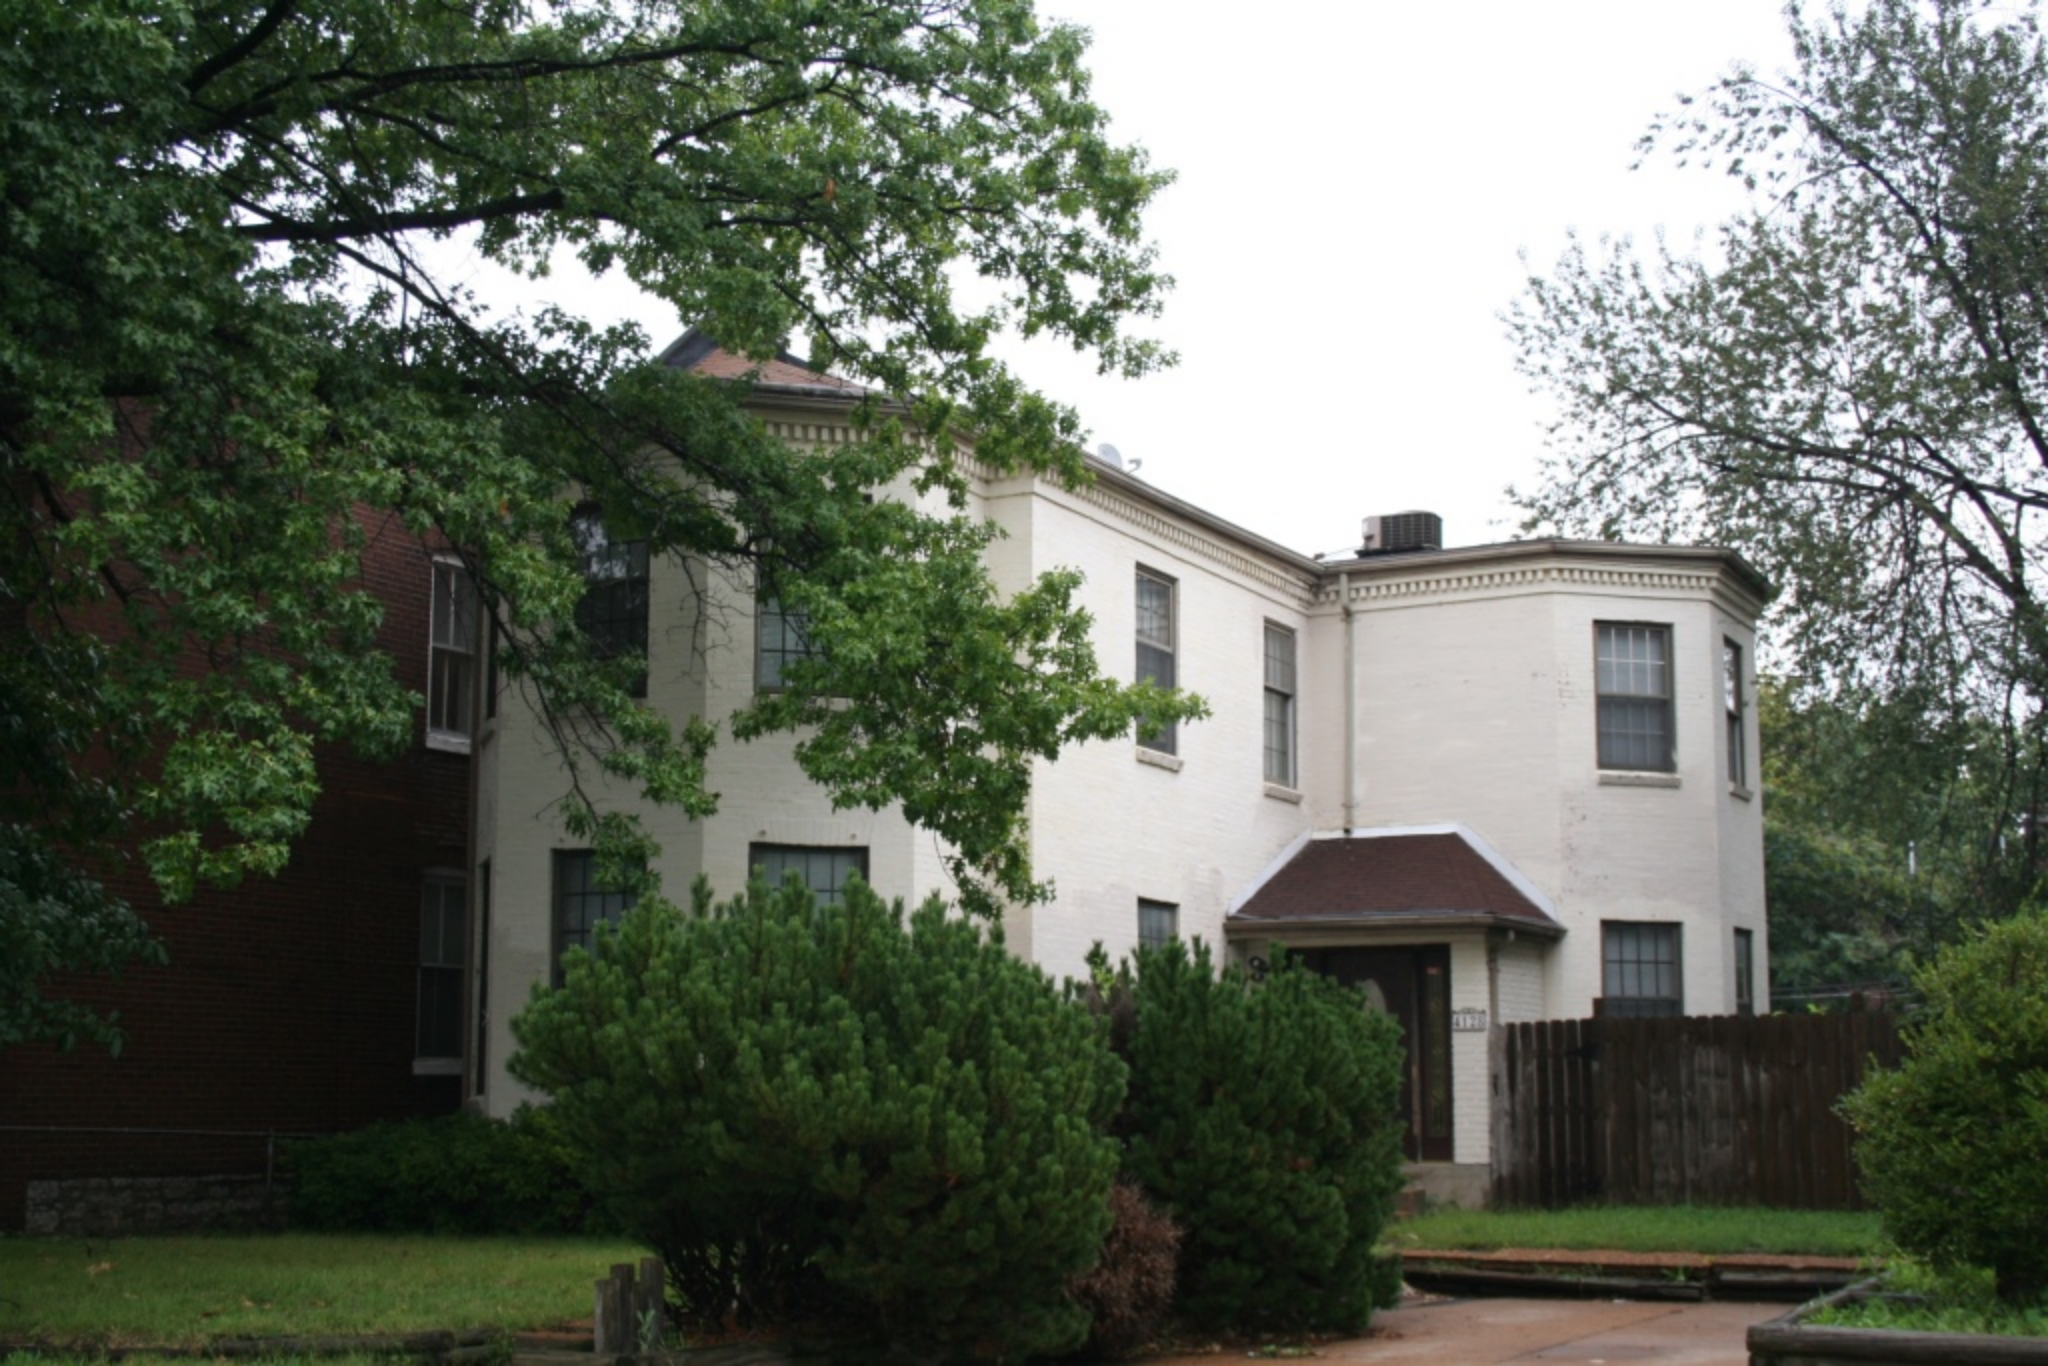
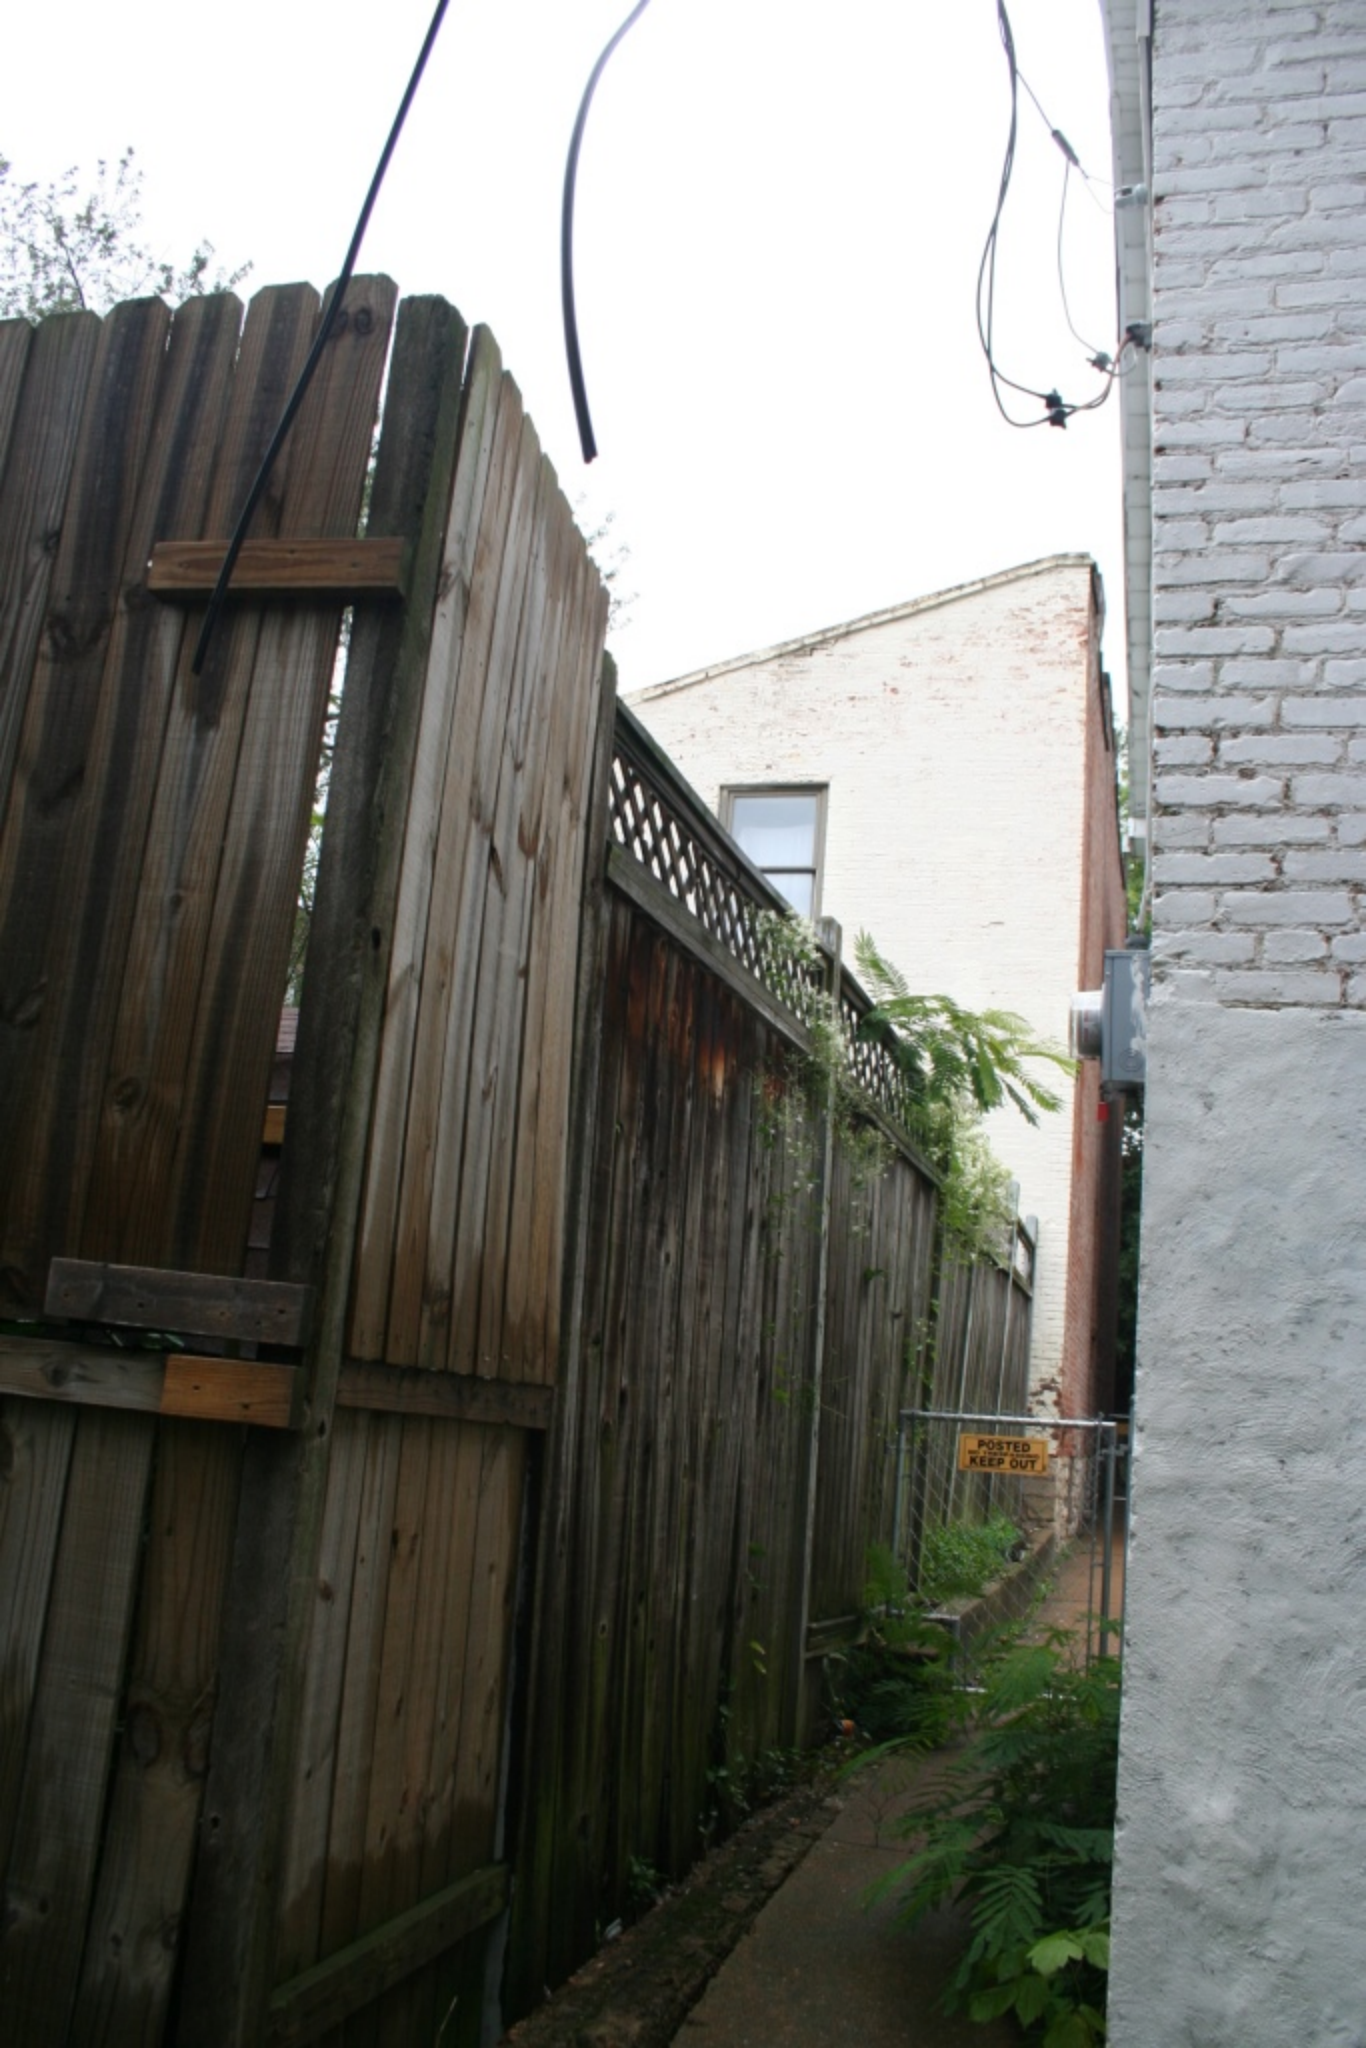
This two-story hipped front flounder has two, two-story brick bays extending from the main block that is rectangular in shape, as well as a slightly lower two-story brick rear wing that also has a flounder form. The front angled bay window projects from most of the steret façade; its own roof intersects the slope of the hipped front of the main roof. The second bar terminages a perpendicular rear wing, one room in size. A similar angled bay forms the entire south end of the ell. The eaves have dentils as part of a wood cornice that extends across the south side wall and both bay forms. Window openings are flat-arched; those on the two bays have soldier courses; stone stills project and are angled to shed water. All window sash is replacement multi-light sash. An enclosed entrance porch in the street side of the south-extending bay window room with a hipped roof is likely to be an alteration.

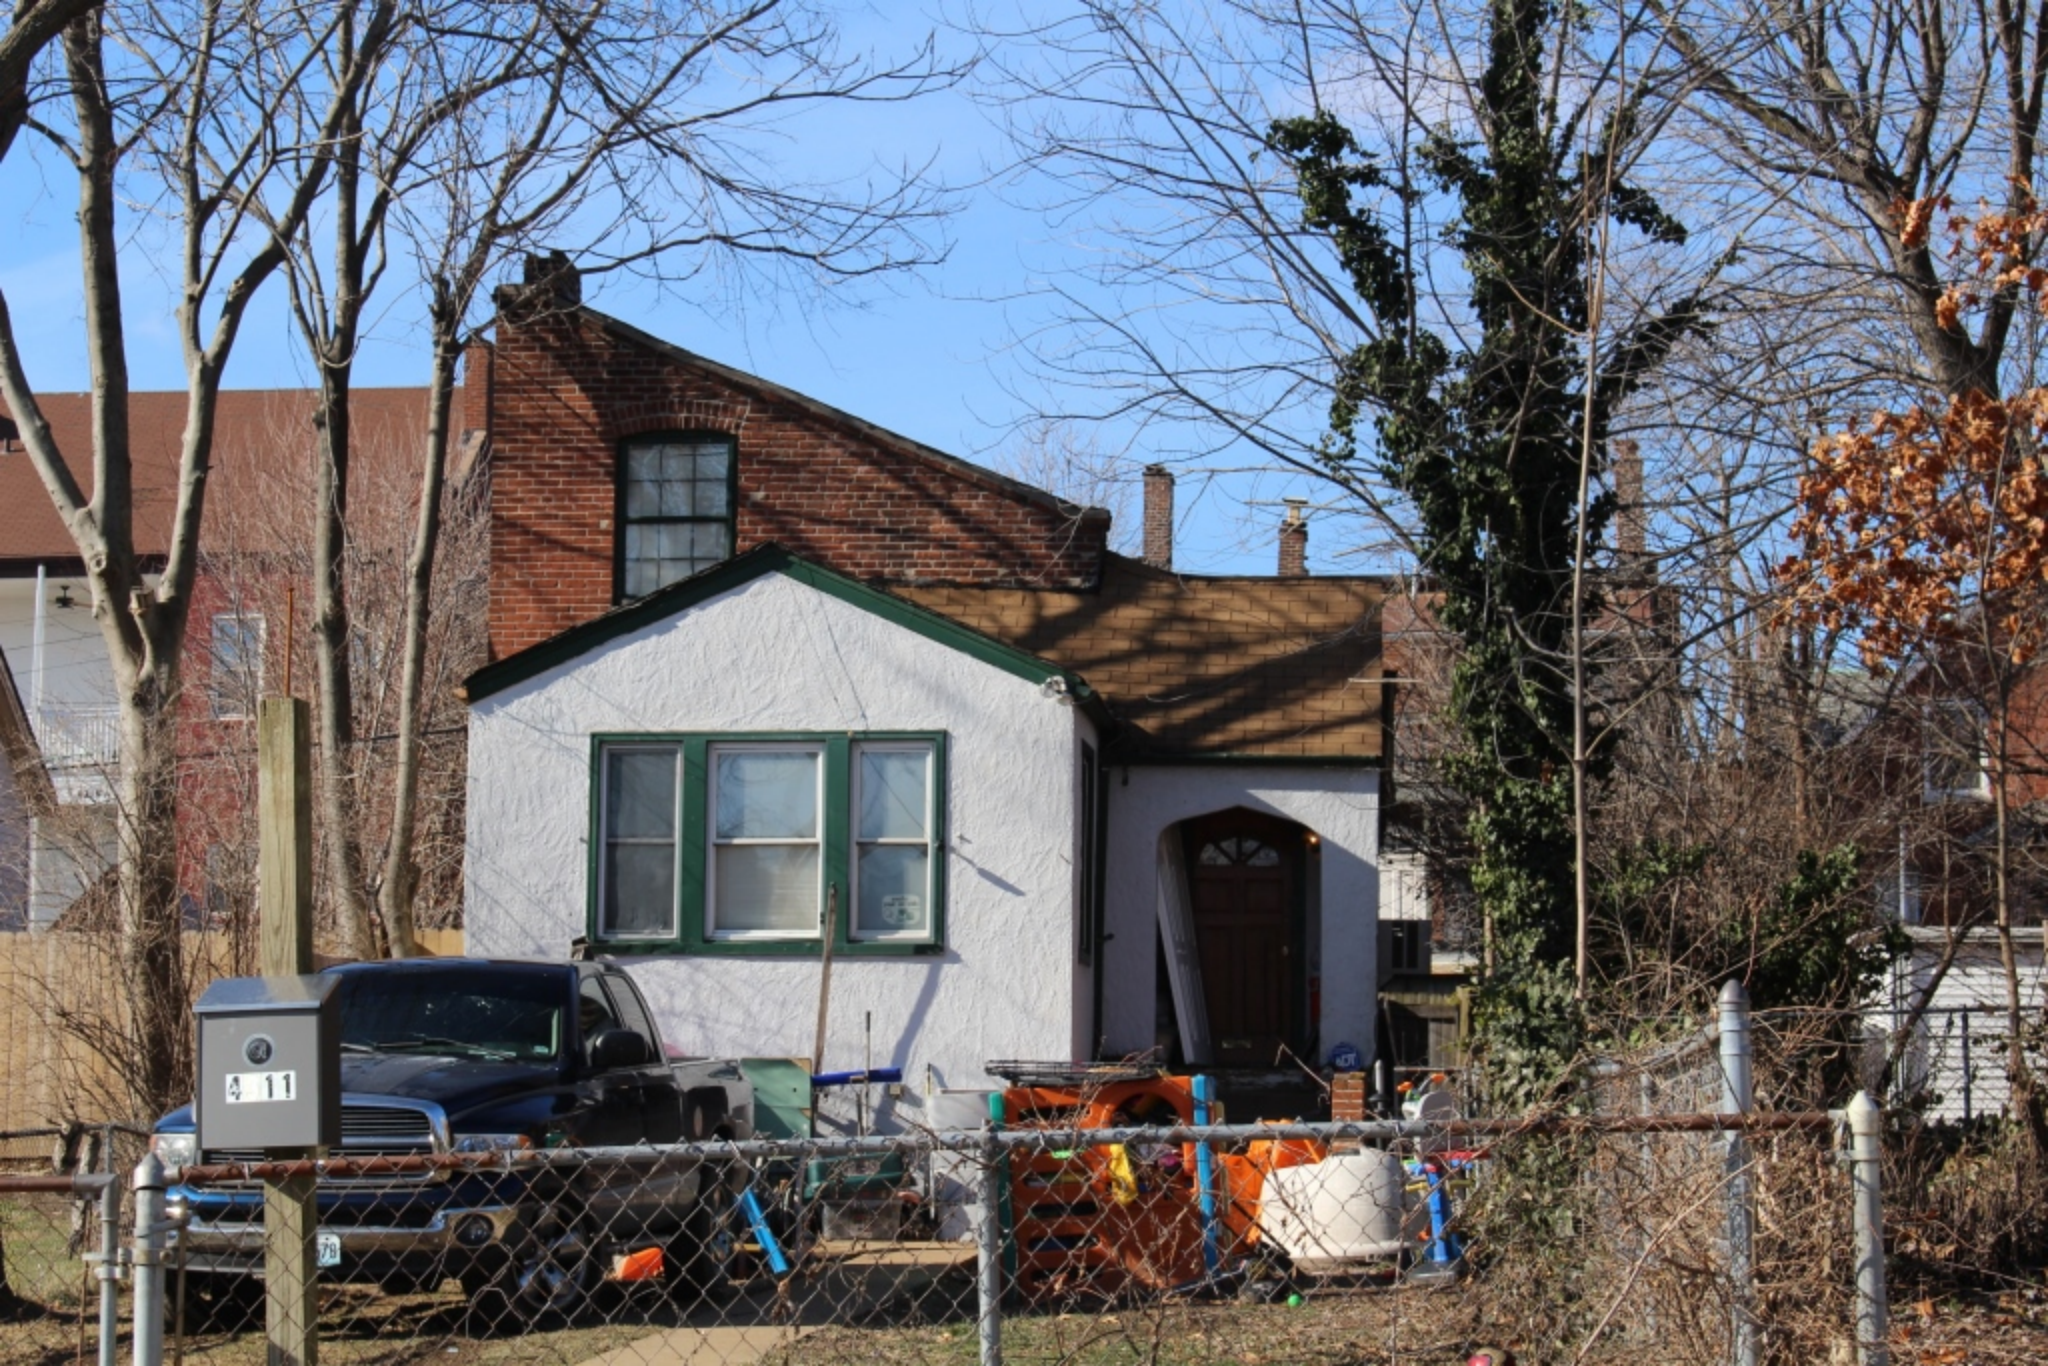
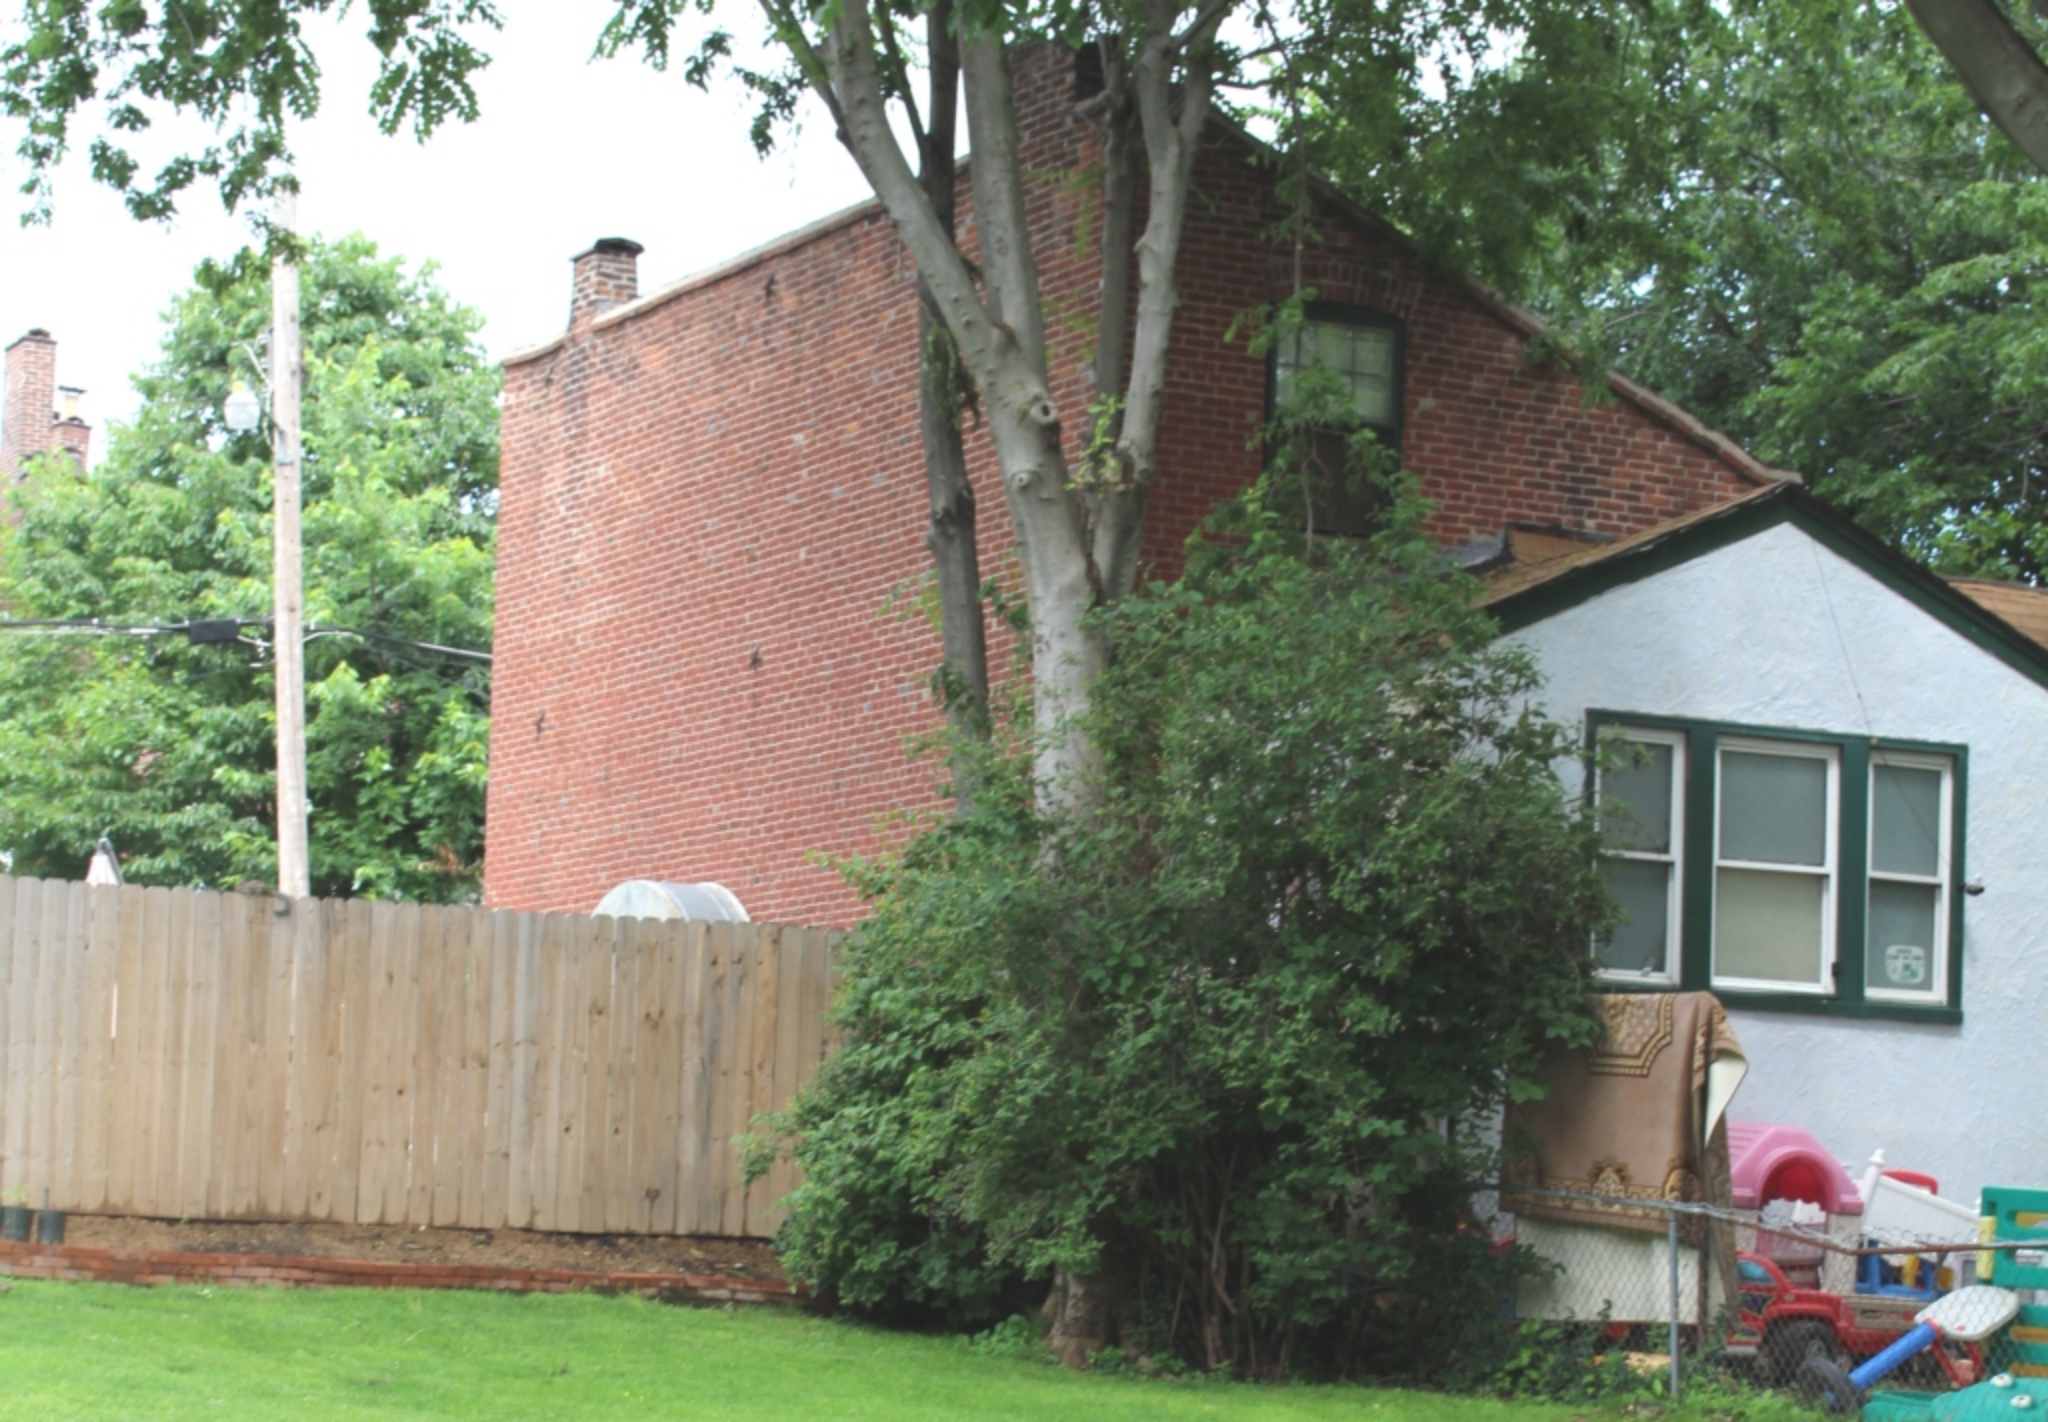
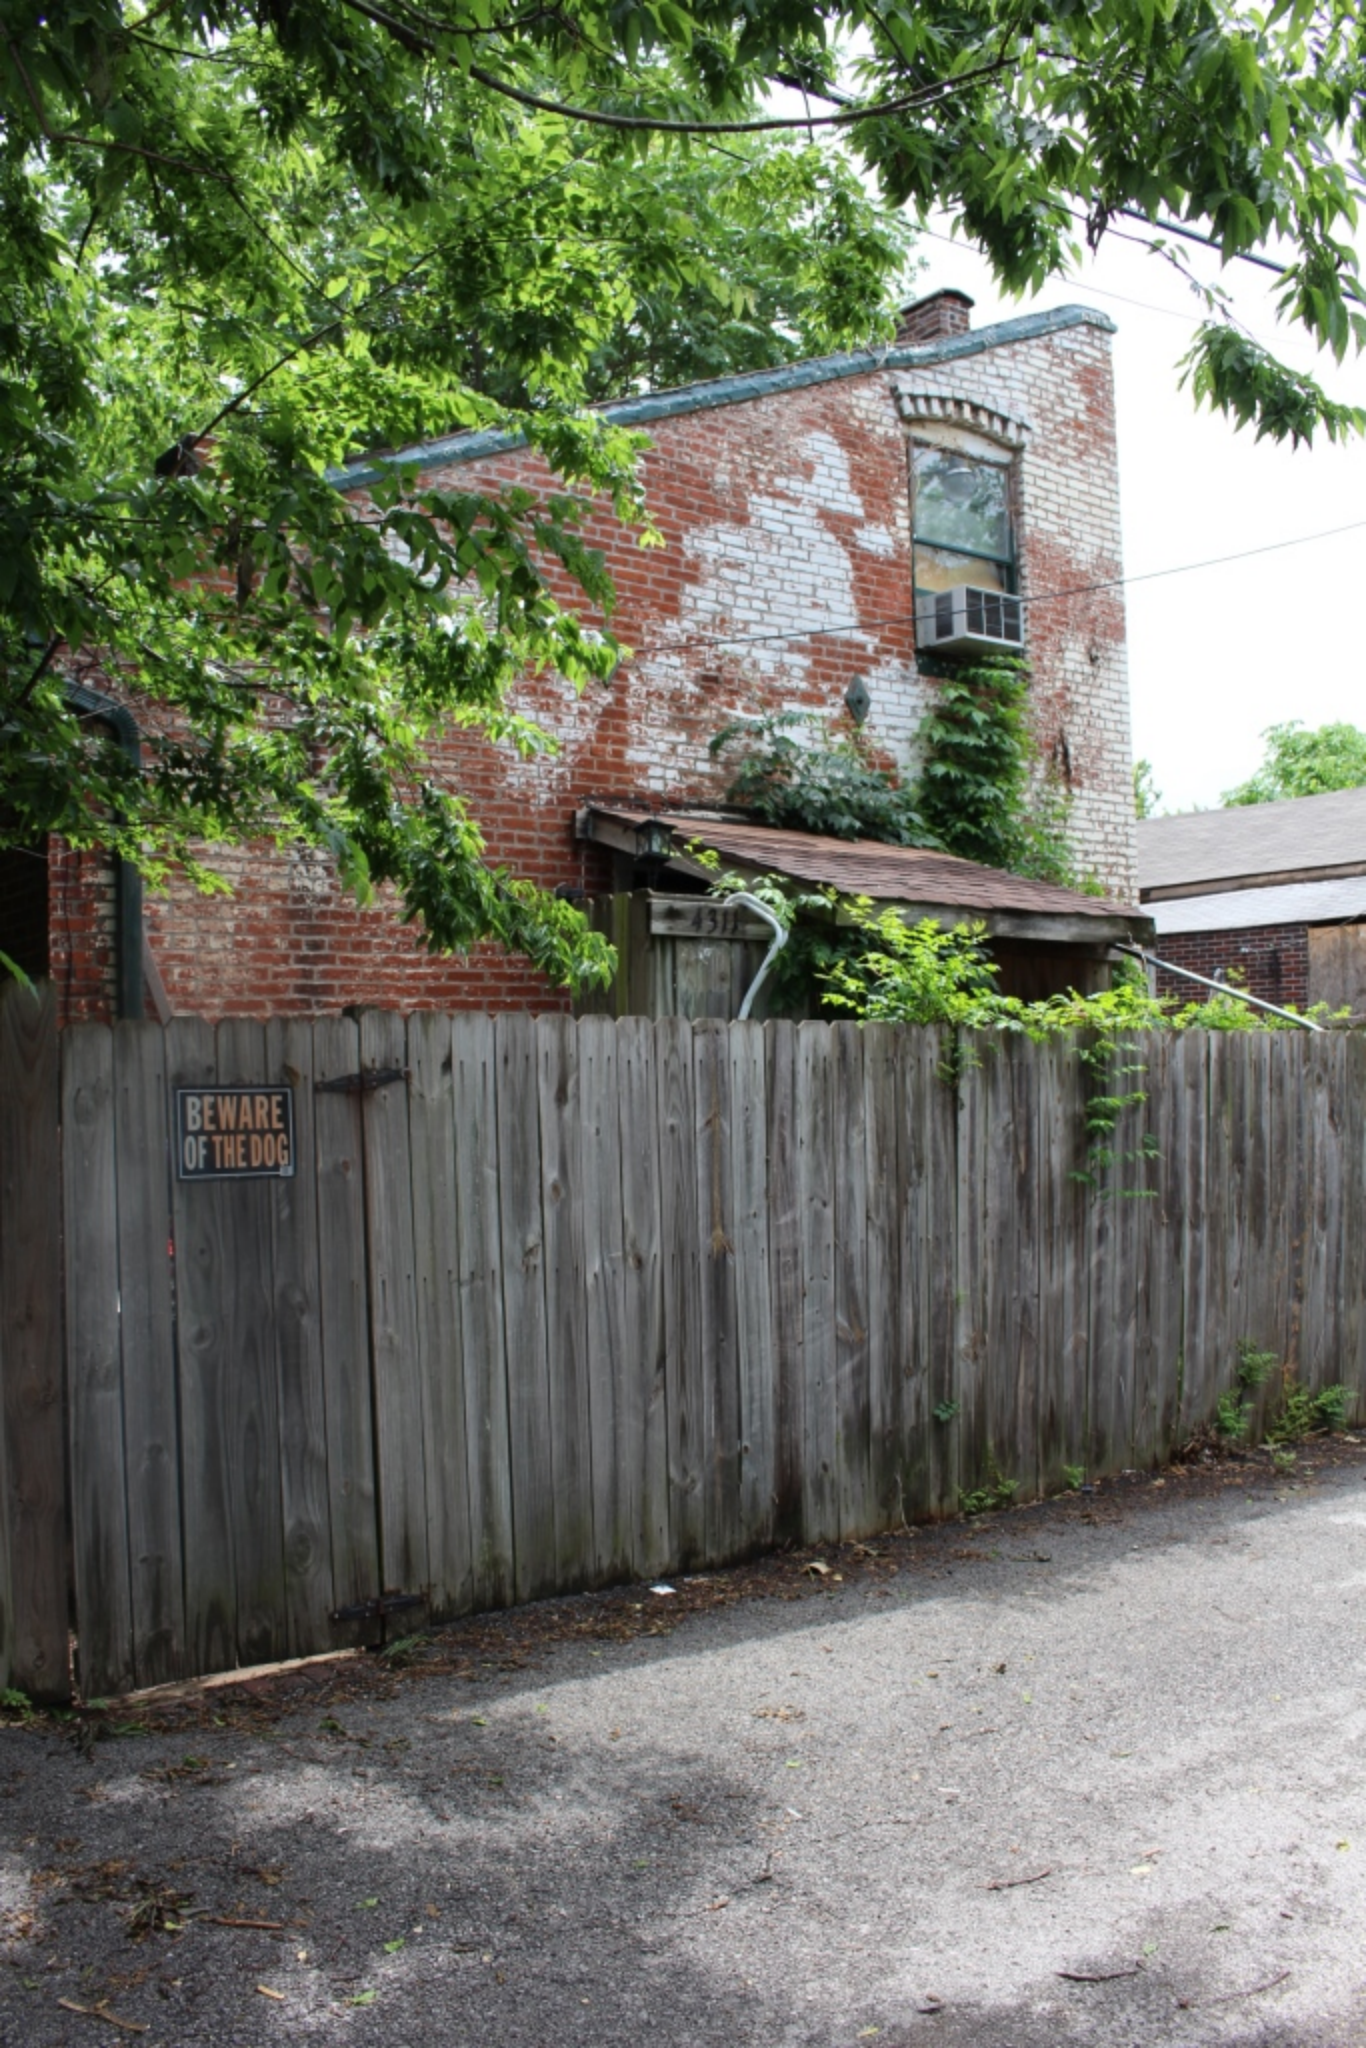
4311

This 1-1/2-story common bond brick flounder is set at the alley, with its taller blind wall at the south property line. It has two brick stove chimneys projecting from the roof ridge.The street-facing façade, originally 2 bays, has been obscured by a 1-story frame addition, containing a new entry vestibule on the north and a 1-roof addition projecting towards Michigan. The second story window is exposed: a single doublehung window under a double rowlock segmental arch. The original brick coping of the parapet is extant, but has been partly parged. On the north façade, the original side gallery extends behind the vestibule addition. The rear façade is has 2 bays, with a brick wing wall extending to the north to shield the side gallery porch. It is unusual to find such a wall at the rear of the building, and the unusual detail of the extant second story window, which displays a segmental arch of projecting headers above alternating flat and projecting soldiers, may indicate that this was intended as the original front façade. The rear door is obscured by a shed-roofed porch, and paint has been applied to the masonry.
