**ARCHITECTURAL/HISTORIC INVENTORY FORM - Cultural Resources Office**  
**St. Louis Planning and Urban Design**

1. Survey no. SLC-AS-053-0102	2. Survey name: Thematic Survey of Flounder Houses in St. Louis City	3. County: St. Louis [Independent City]
4. Address: (from City GEO database) <b>900 HICKORY ST</b>		5. City/State: St. Louis, Missouri
Alternate address: 900 Hickory Street		Property Zip Code: 63104
Latitude: 38.615737		6. UTM Easting: 743886.40
Longitude: -90.198830		UTM Northing: 4277858.27
8. Historic Name (if known): N/A	11a. Historic Use (if known): Commerce/Trade	City Block 467.03
9. Present/other name (if known):	11b. Current Use: Commerce/Trade	City Ward 7
7. Township-Range-Section: N/A		10. Ownership: Private
Neighborhood Number: 34

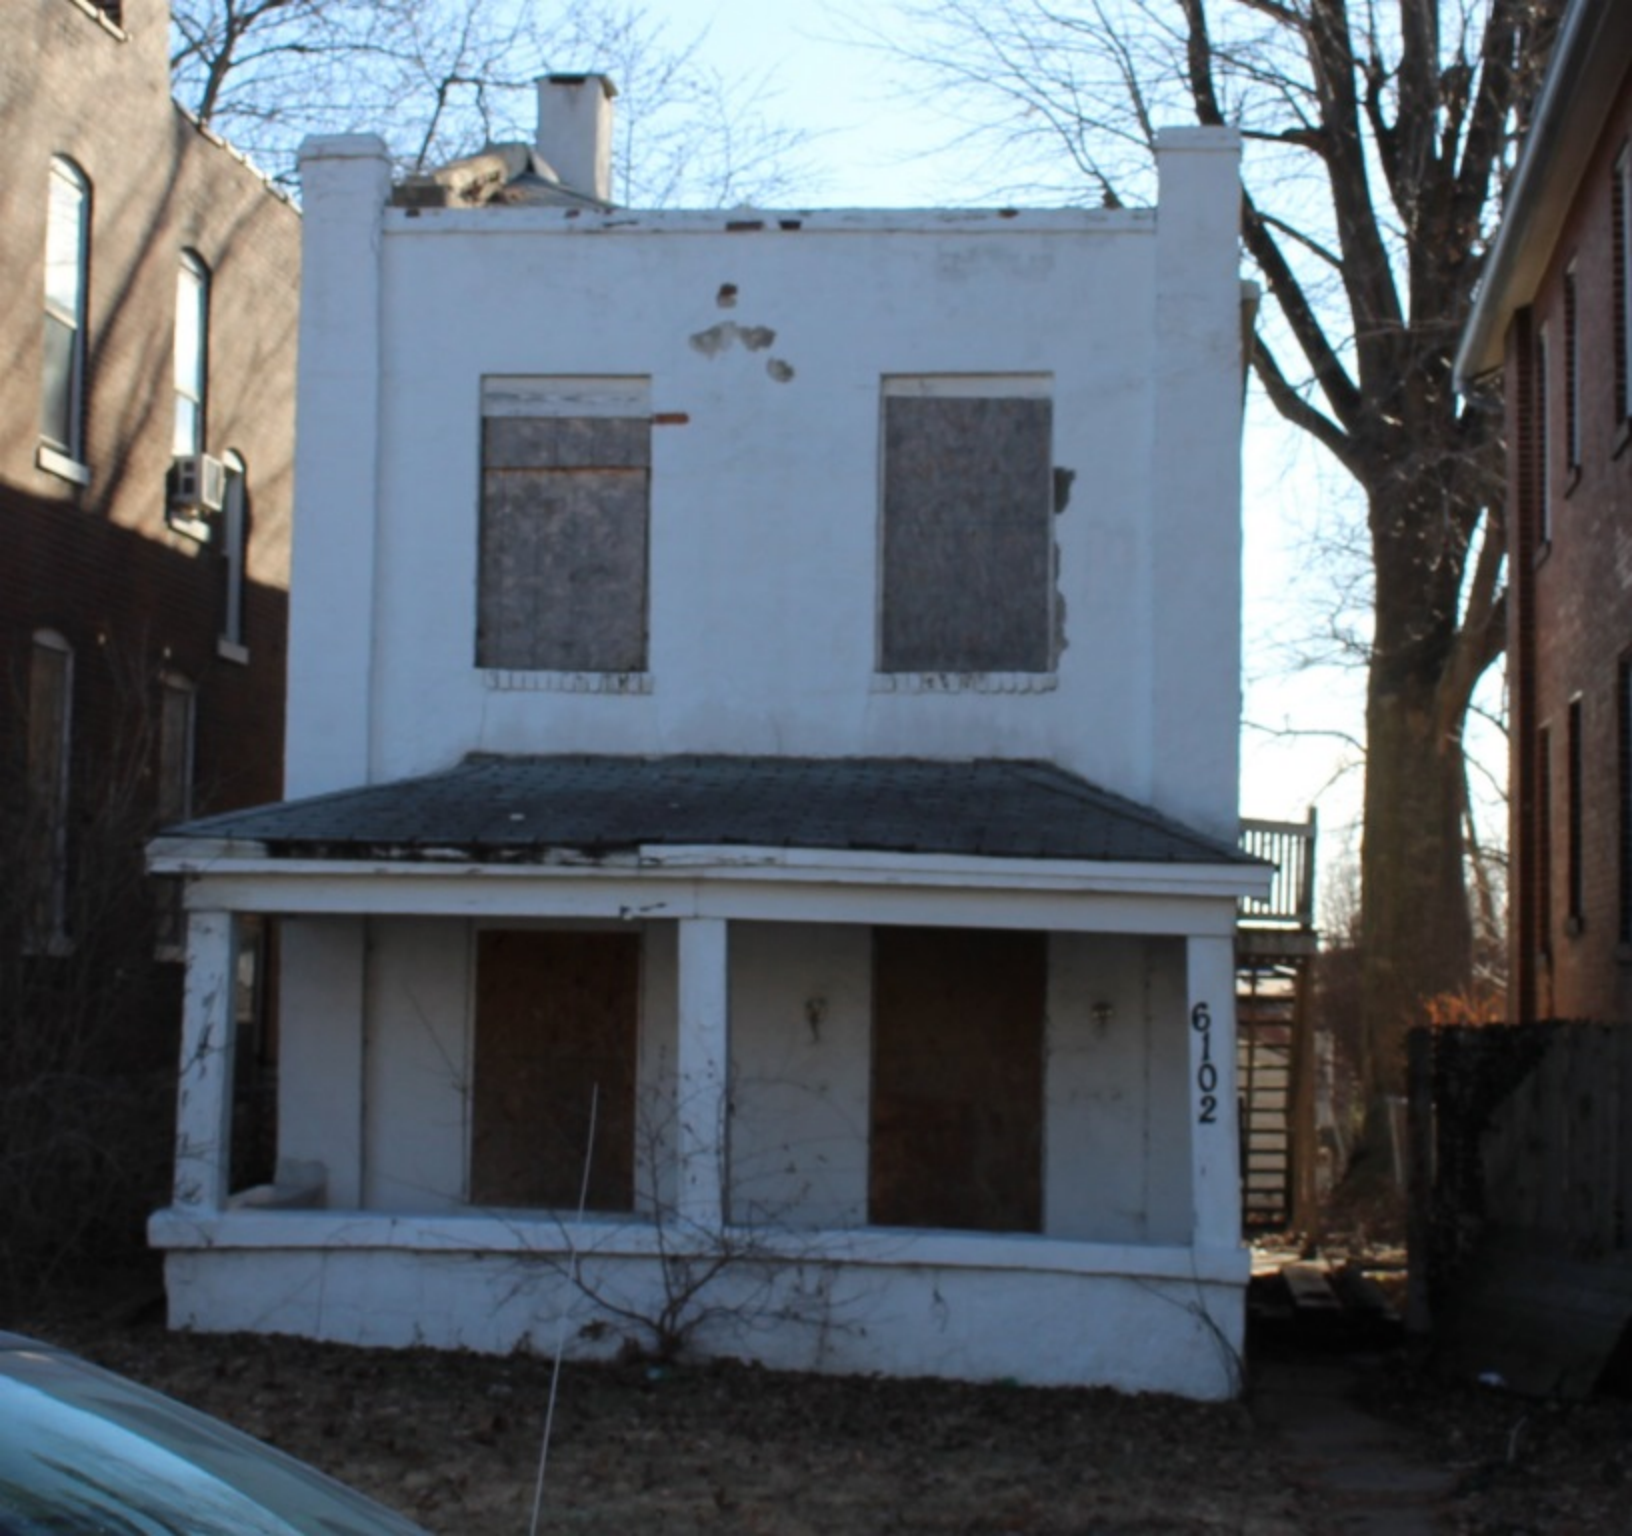
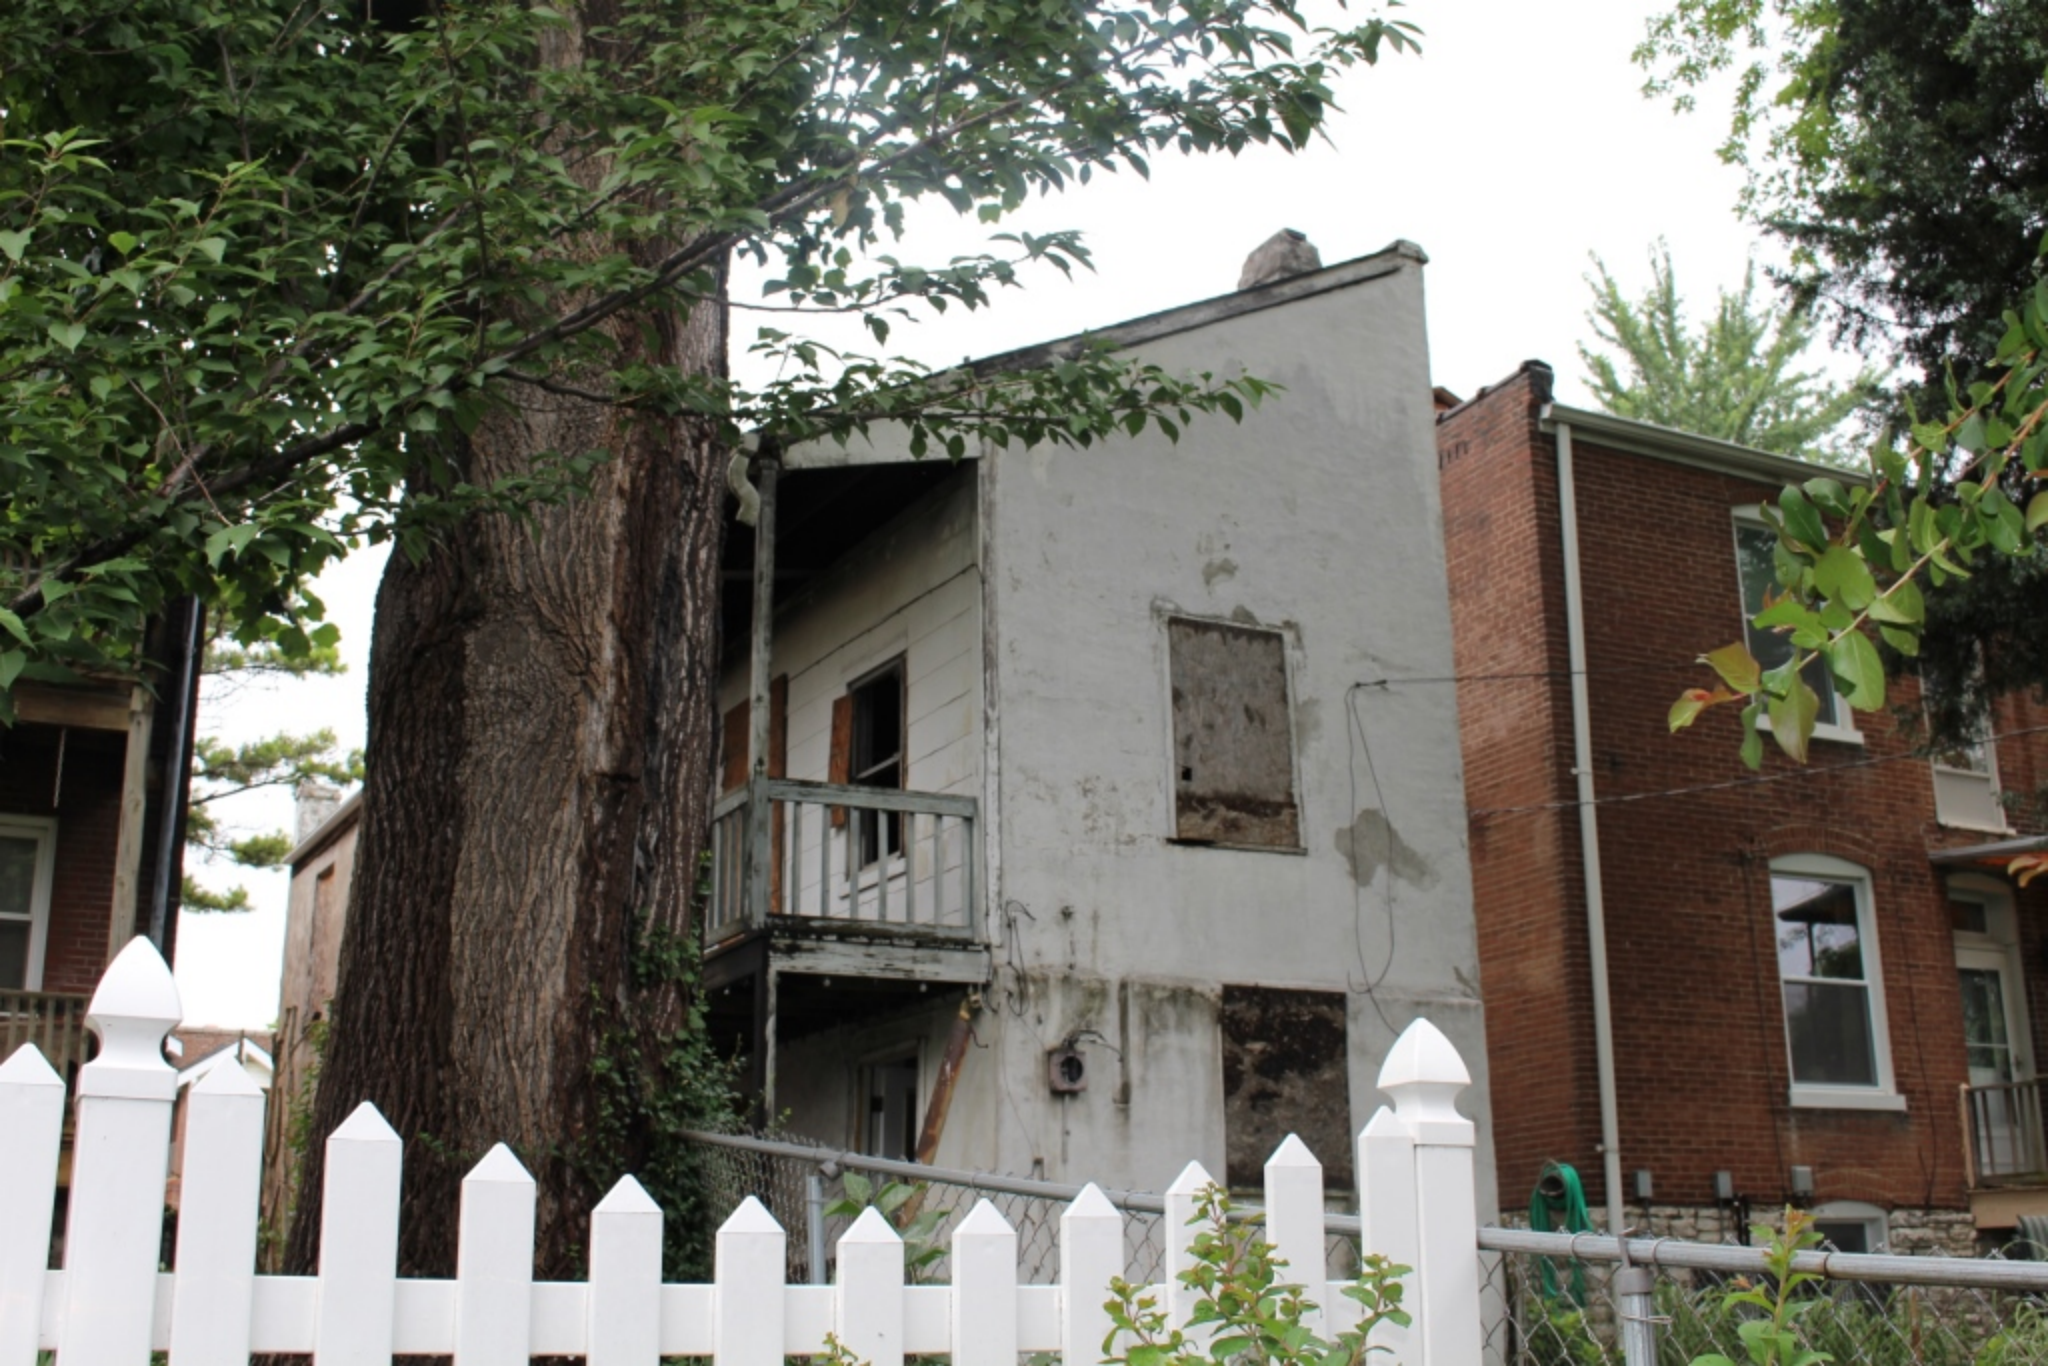
6102

This 2-story brick flounder has a façade indicated to be veneered in stone, and is a smooth, painted surface that terminates in a parapet with end piers that terminate shallow pilasters. A full masonry porch with a hipped roof shelters the ground story. The two bays have an entrance on the .... Side. The windows are blocked. The shallow hipped roof front rises a small amount above the parapet,

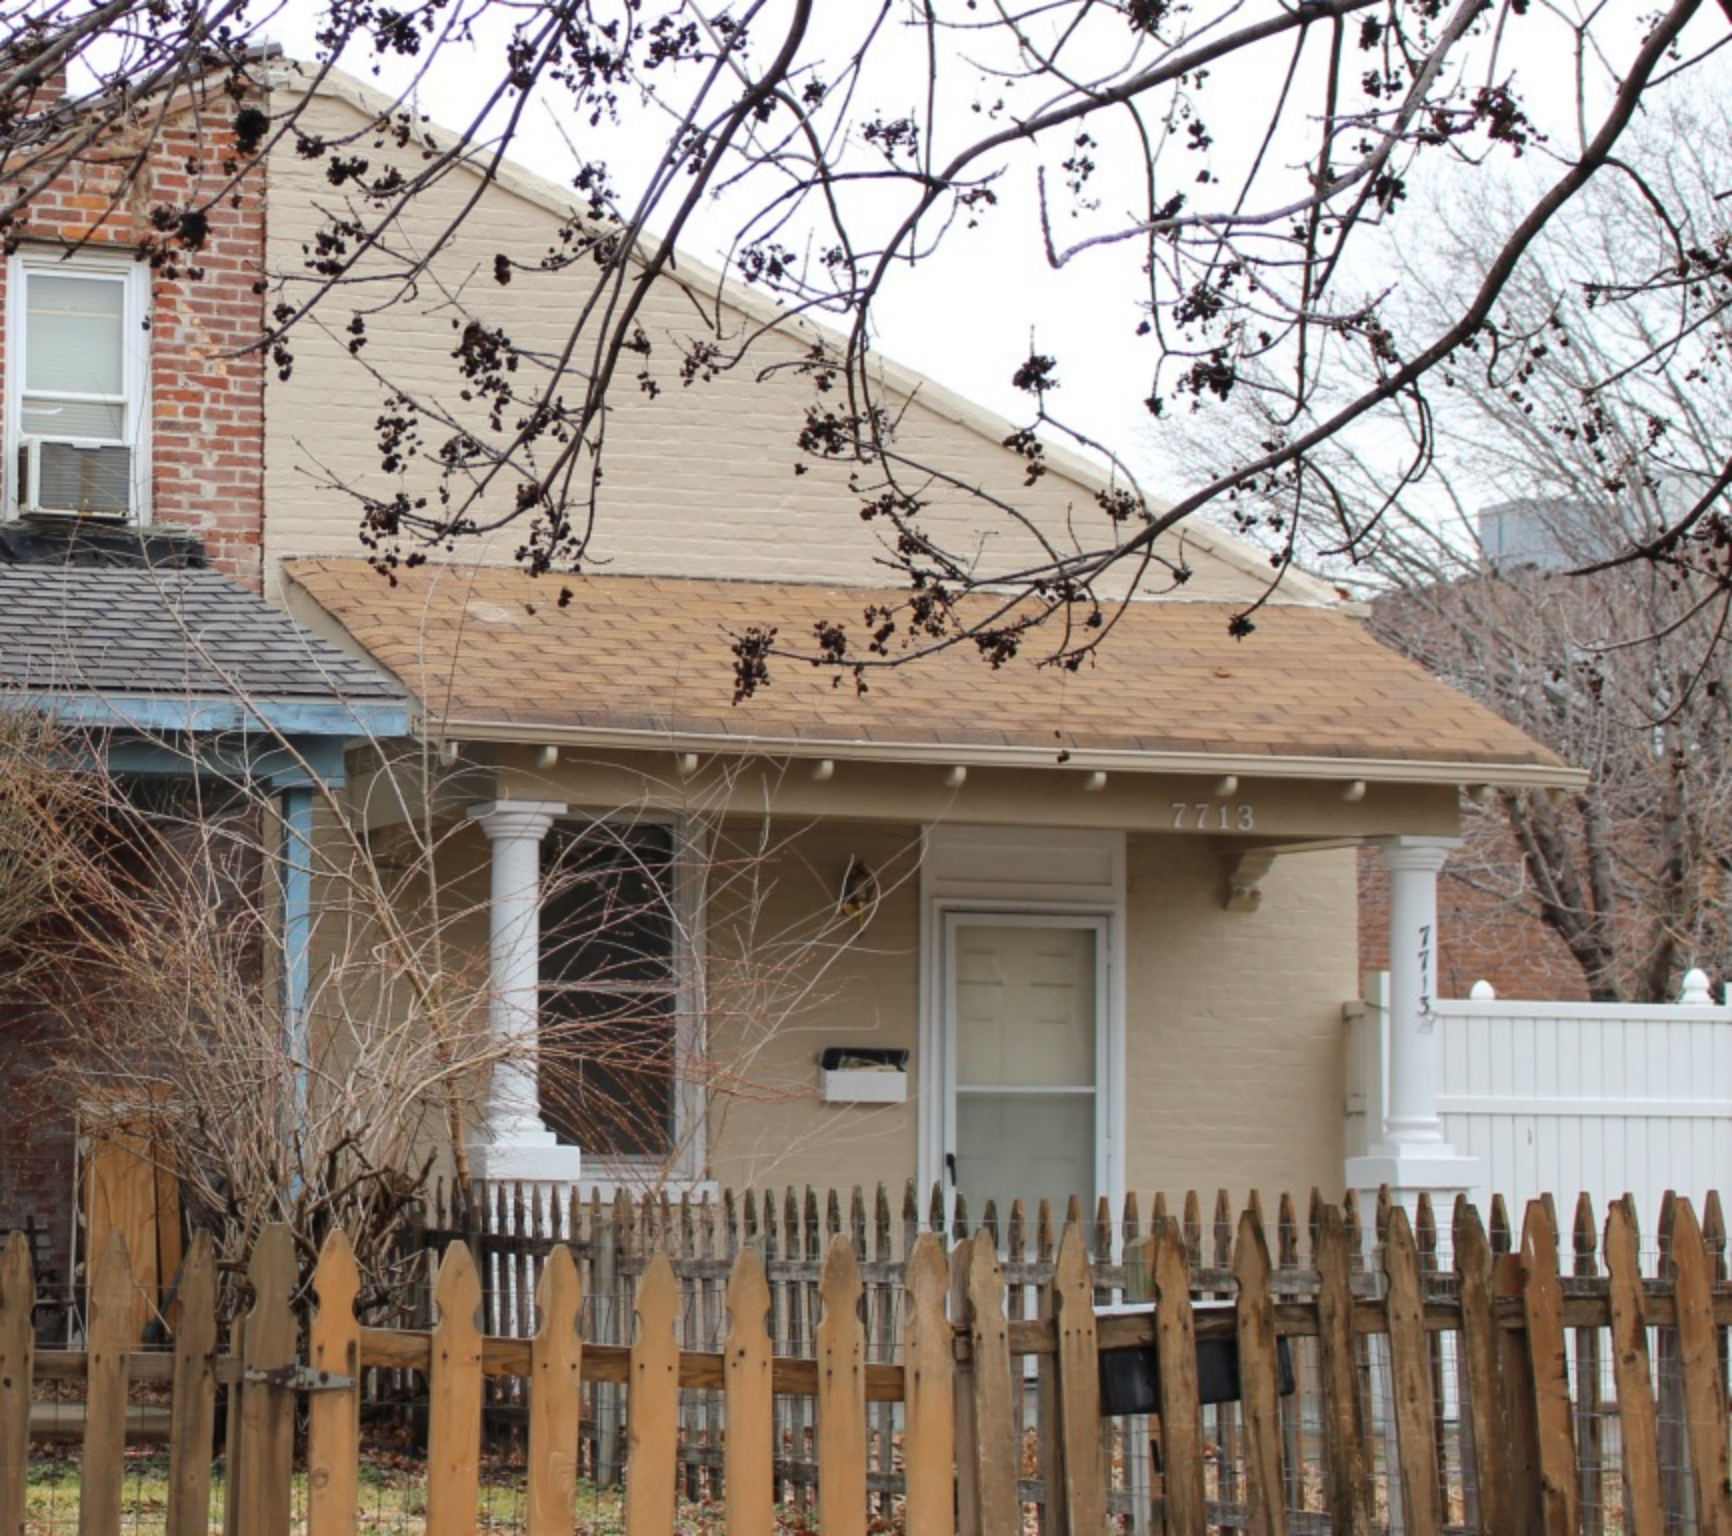
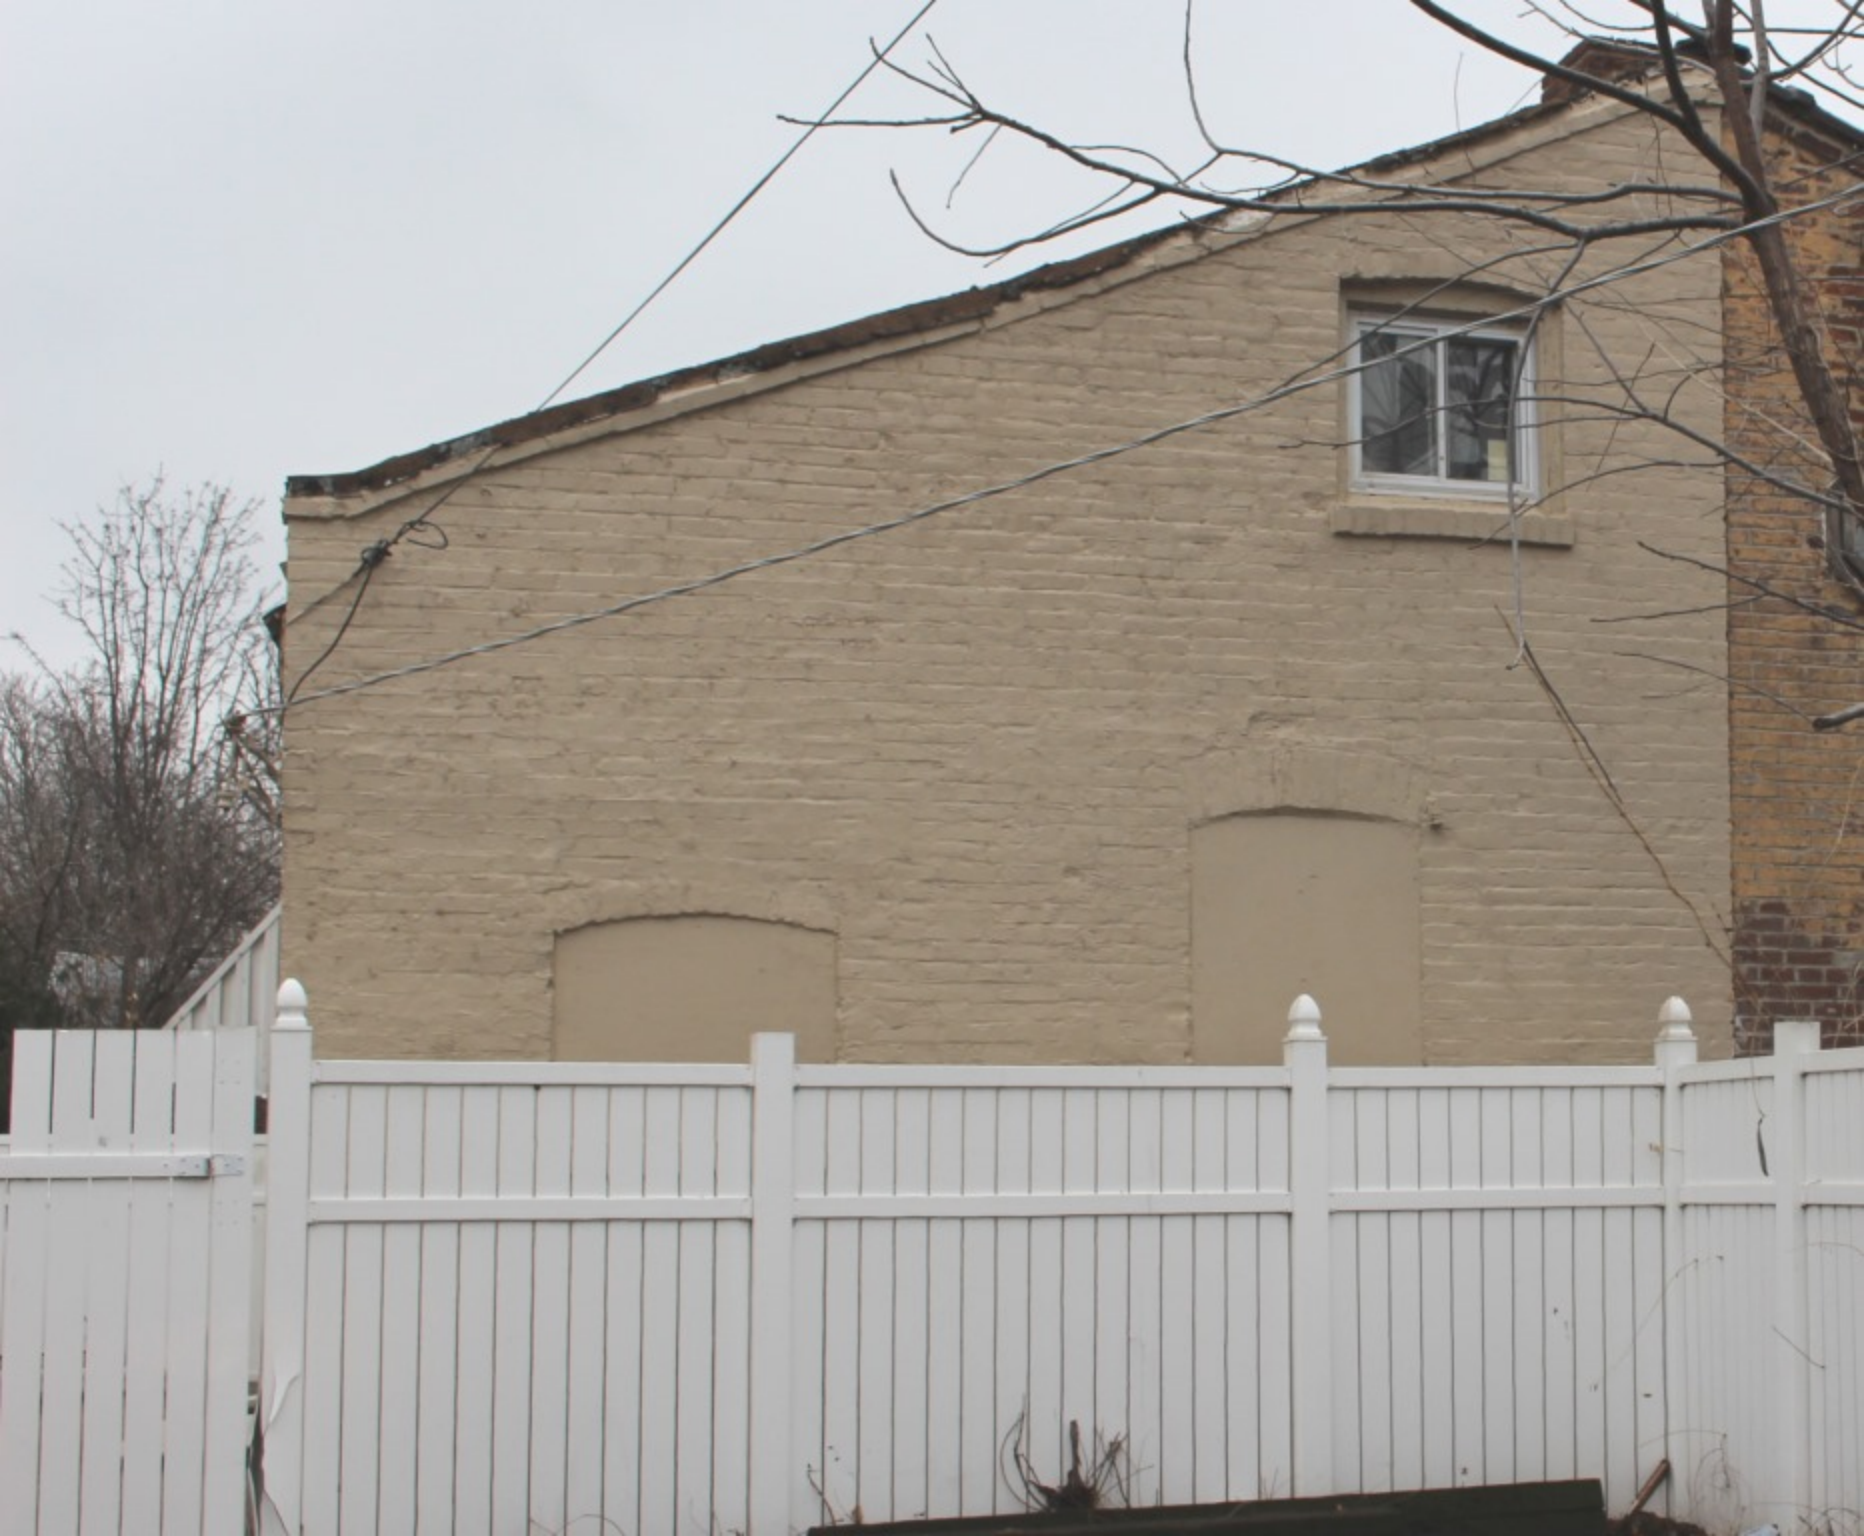
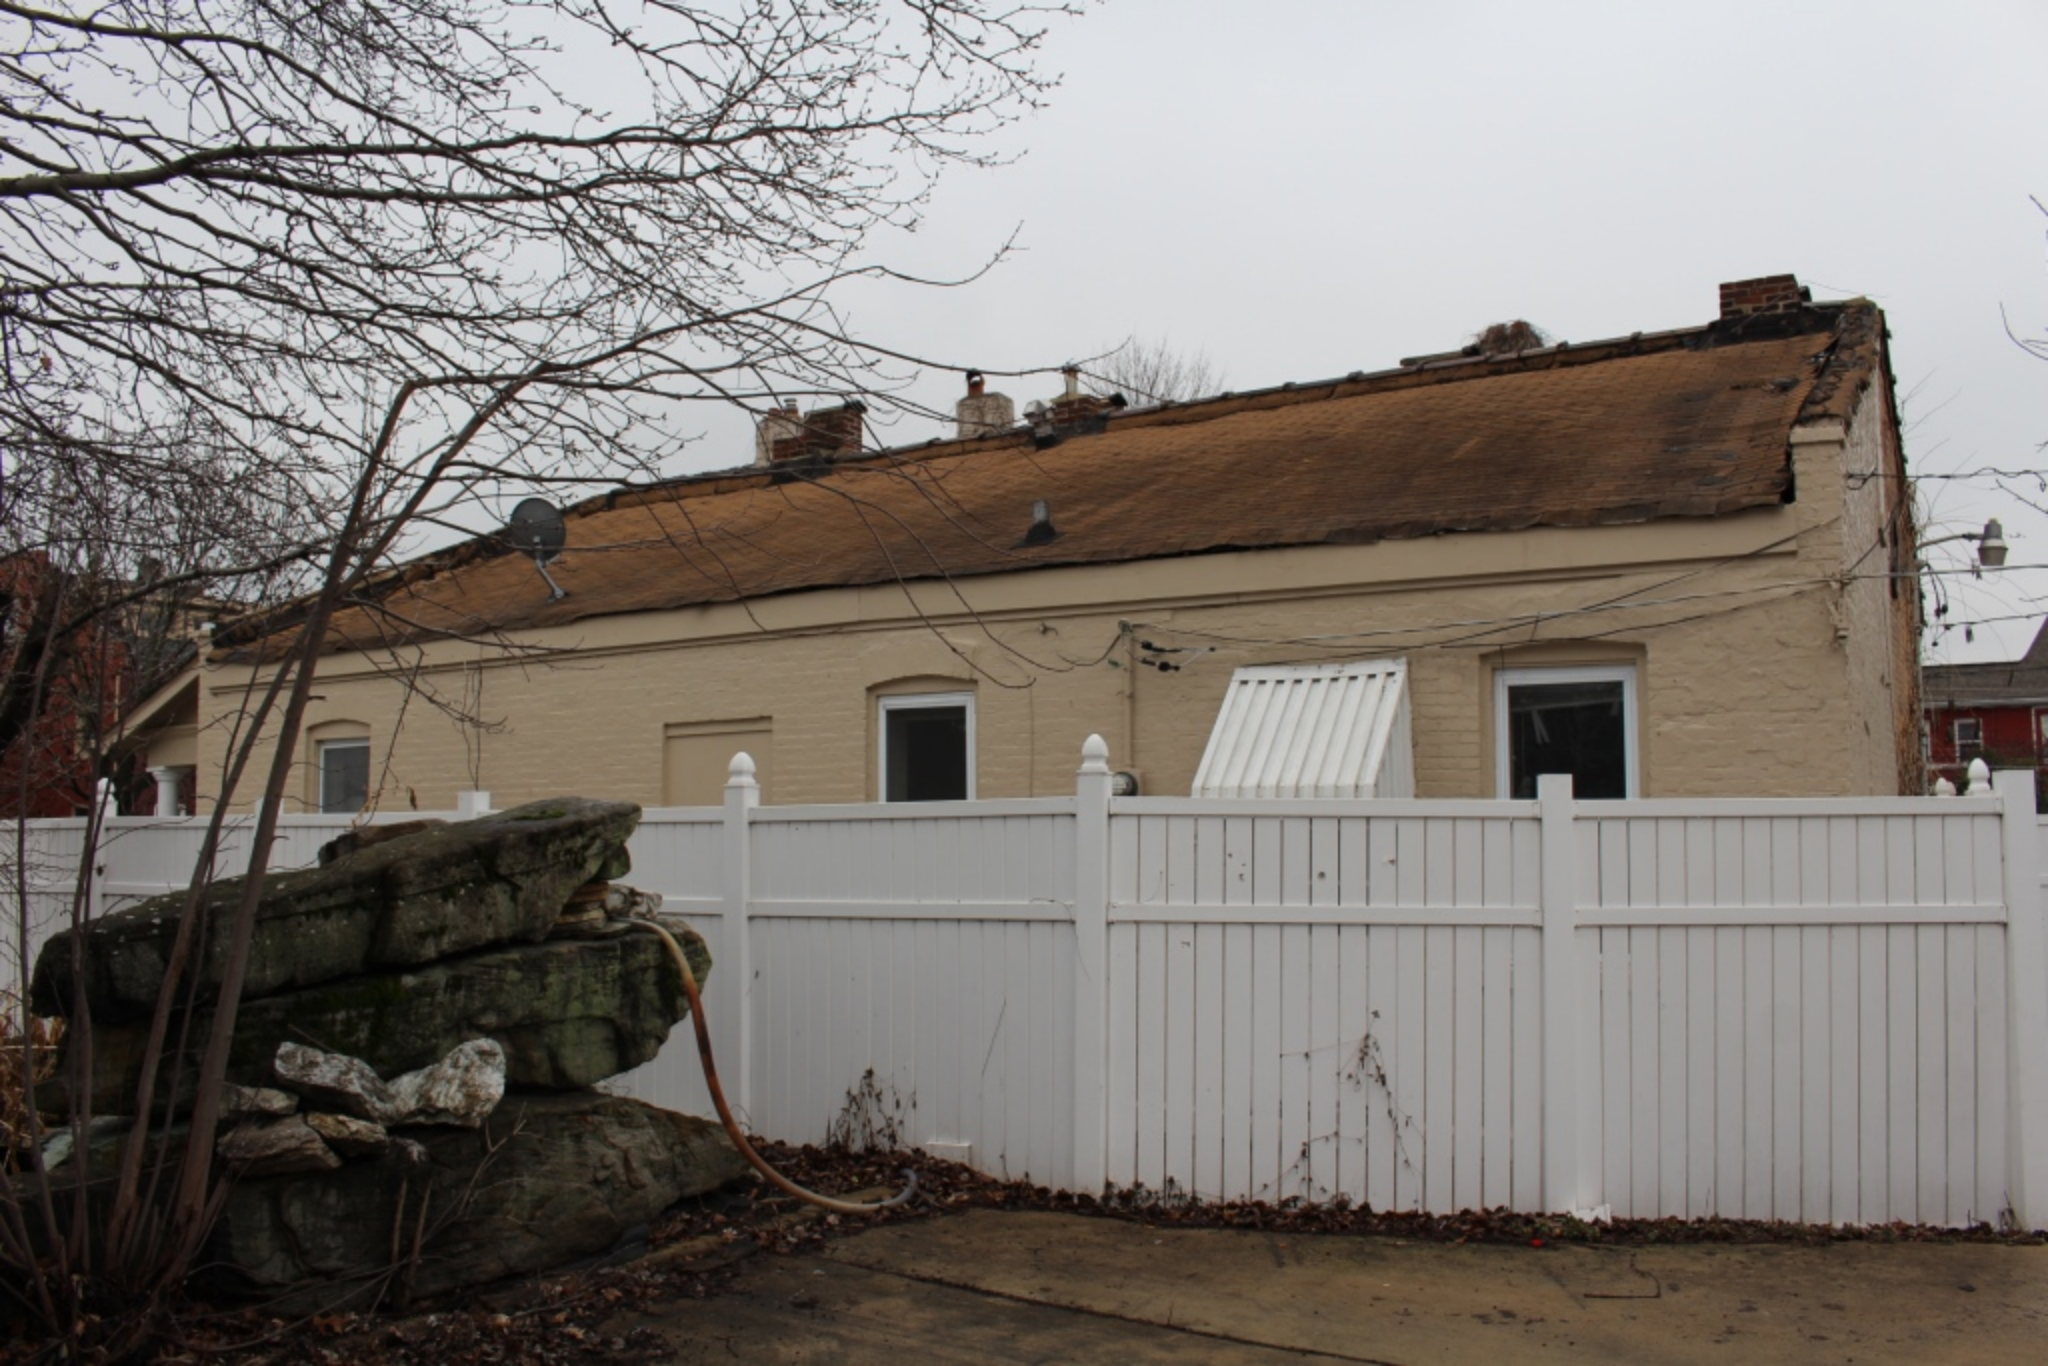
A 1-1/2 story brick semi-detached flounder house, with narrow façade facing the street. The east (front) façade has a projecting brick coping, and two bays, with single-leaf entry under a transom (closed) flanked by a single doublehung window. A full-width porch of new construction extends across the façade. All openings are placed under segmenal soldier arches; windows have wood sills. The 5-bay north elevation presents a window-door-window-door-window pattern. The rear elevation has 2 bays: a single tall transomed door on the south with a small casement window above at the apex of the roof. Another, wider opening is on the north: it appears to be a later alteration, as it is wider than the other windows and has a rowlock segmental arch. Both first story openings have been boarded. Remnants of 3 brick stove chimneys remain at the ridge. The building has been painted.

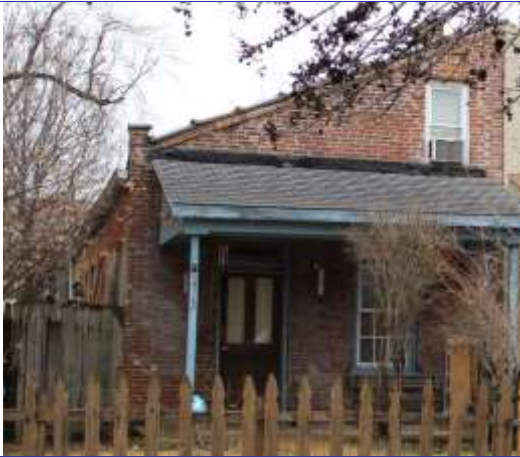
Front elevation

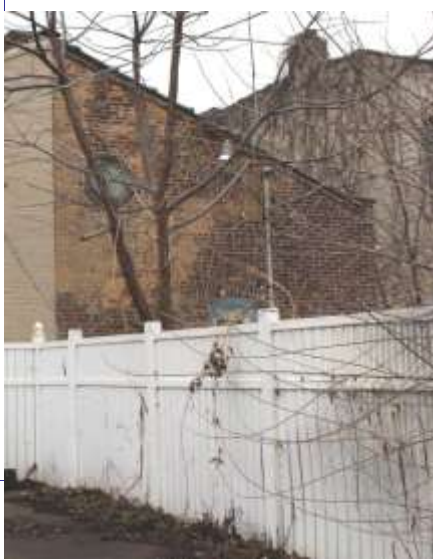
Rear elevation

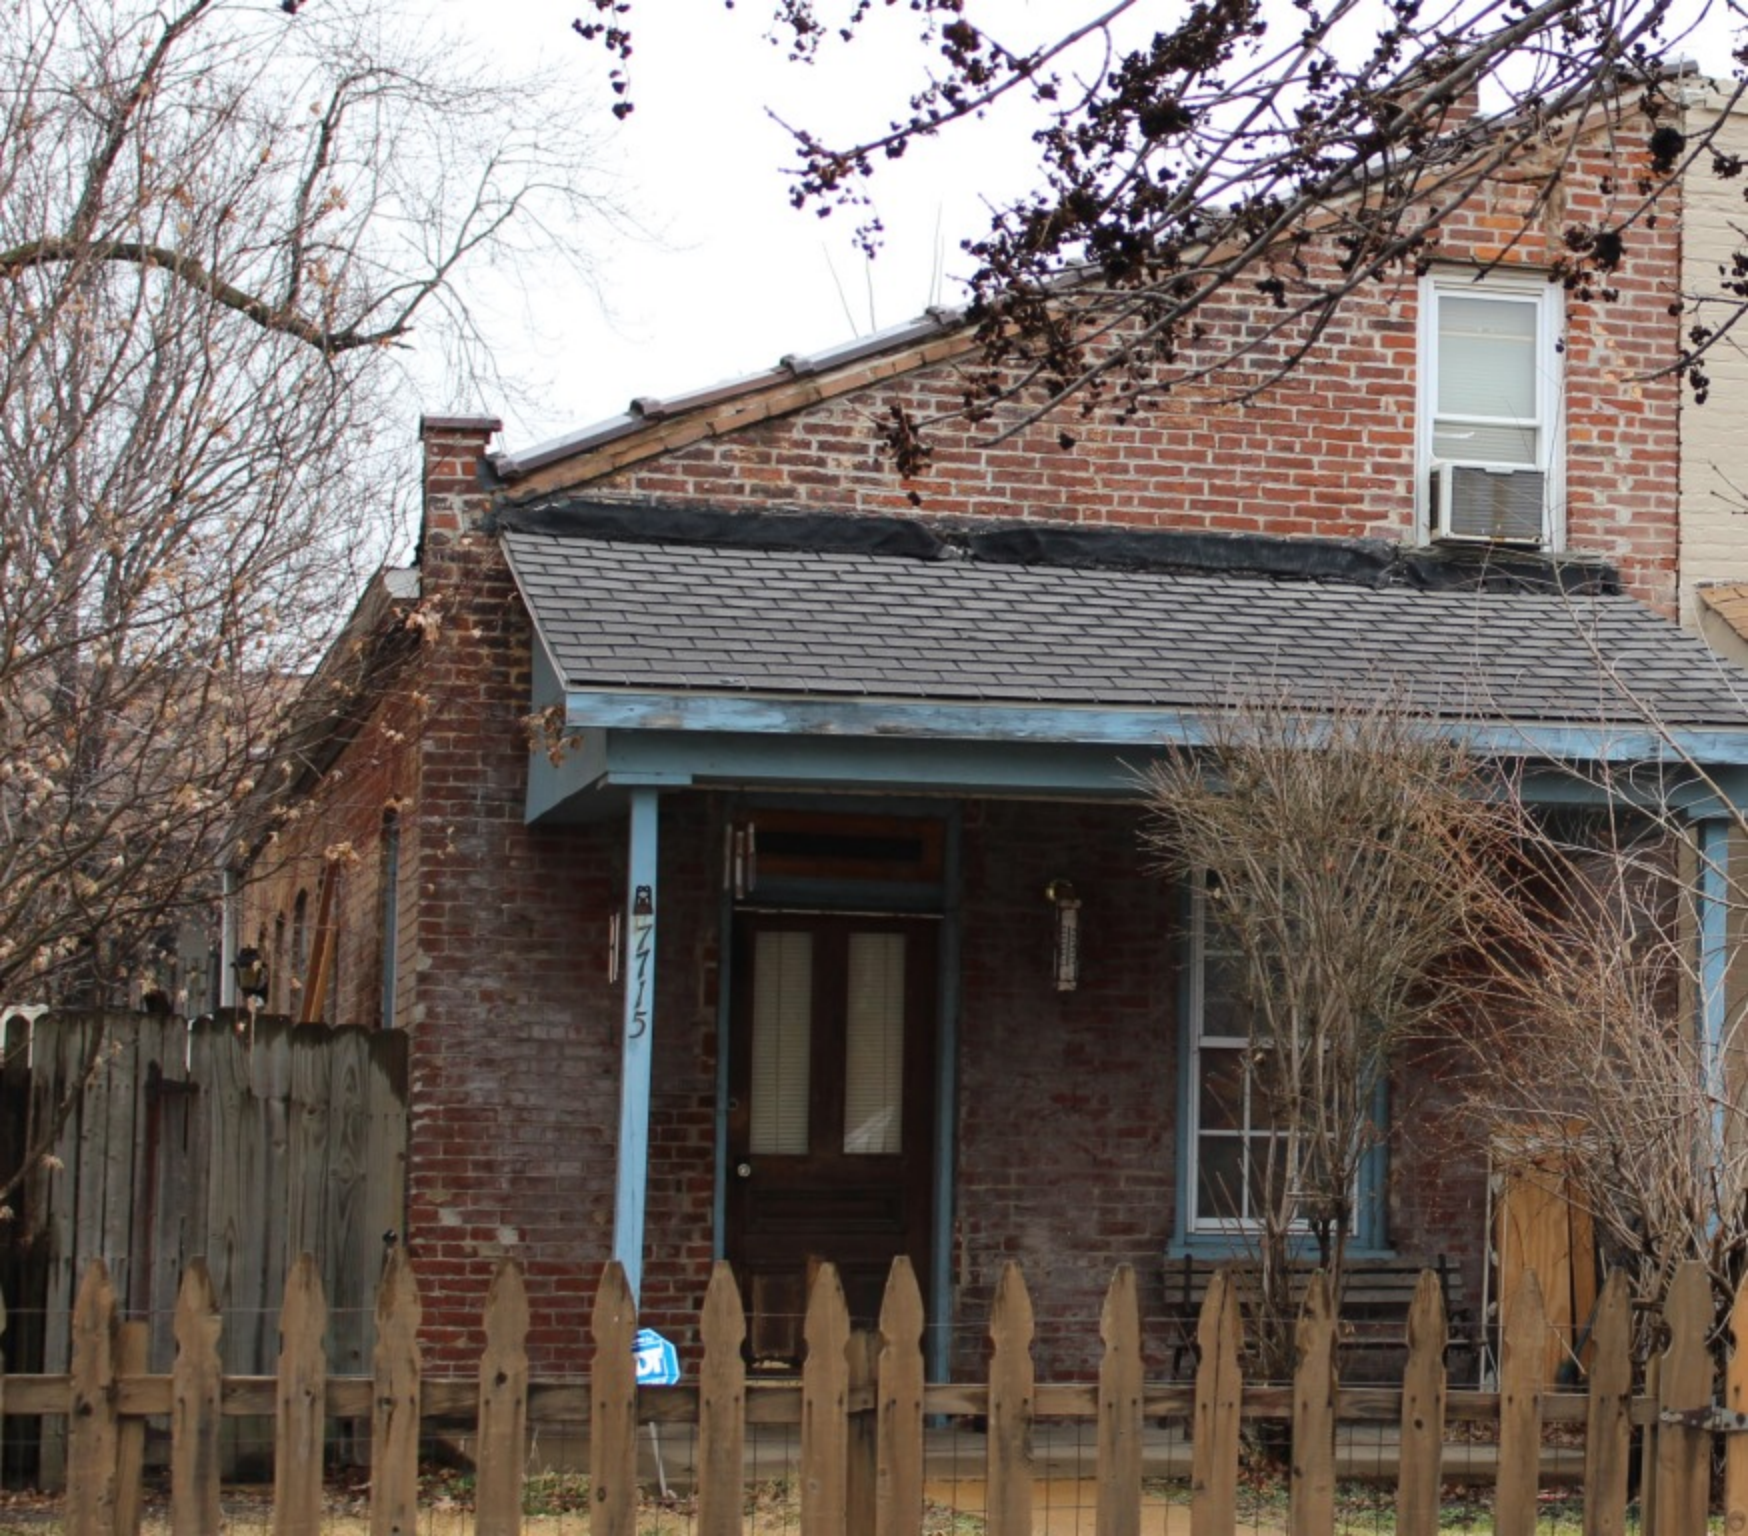
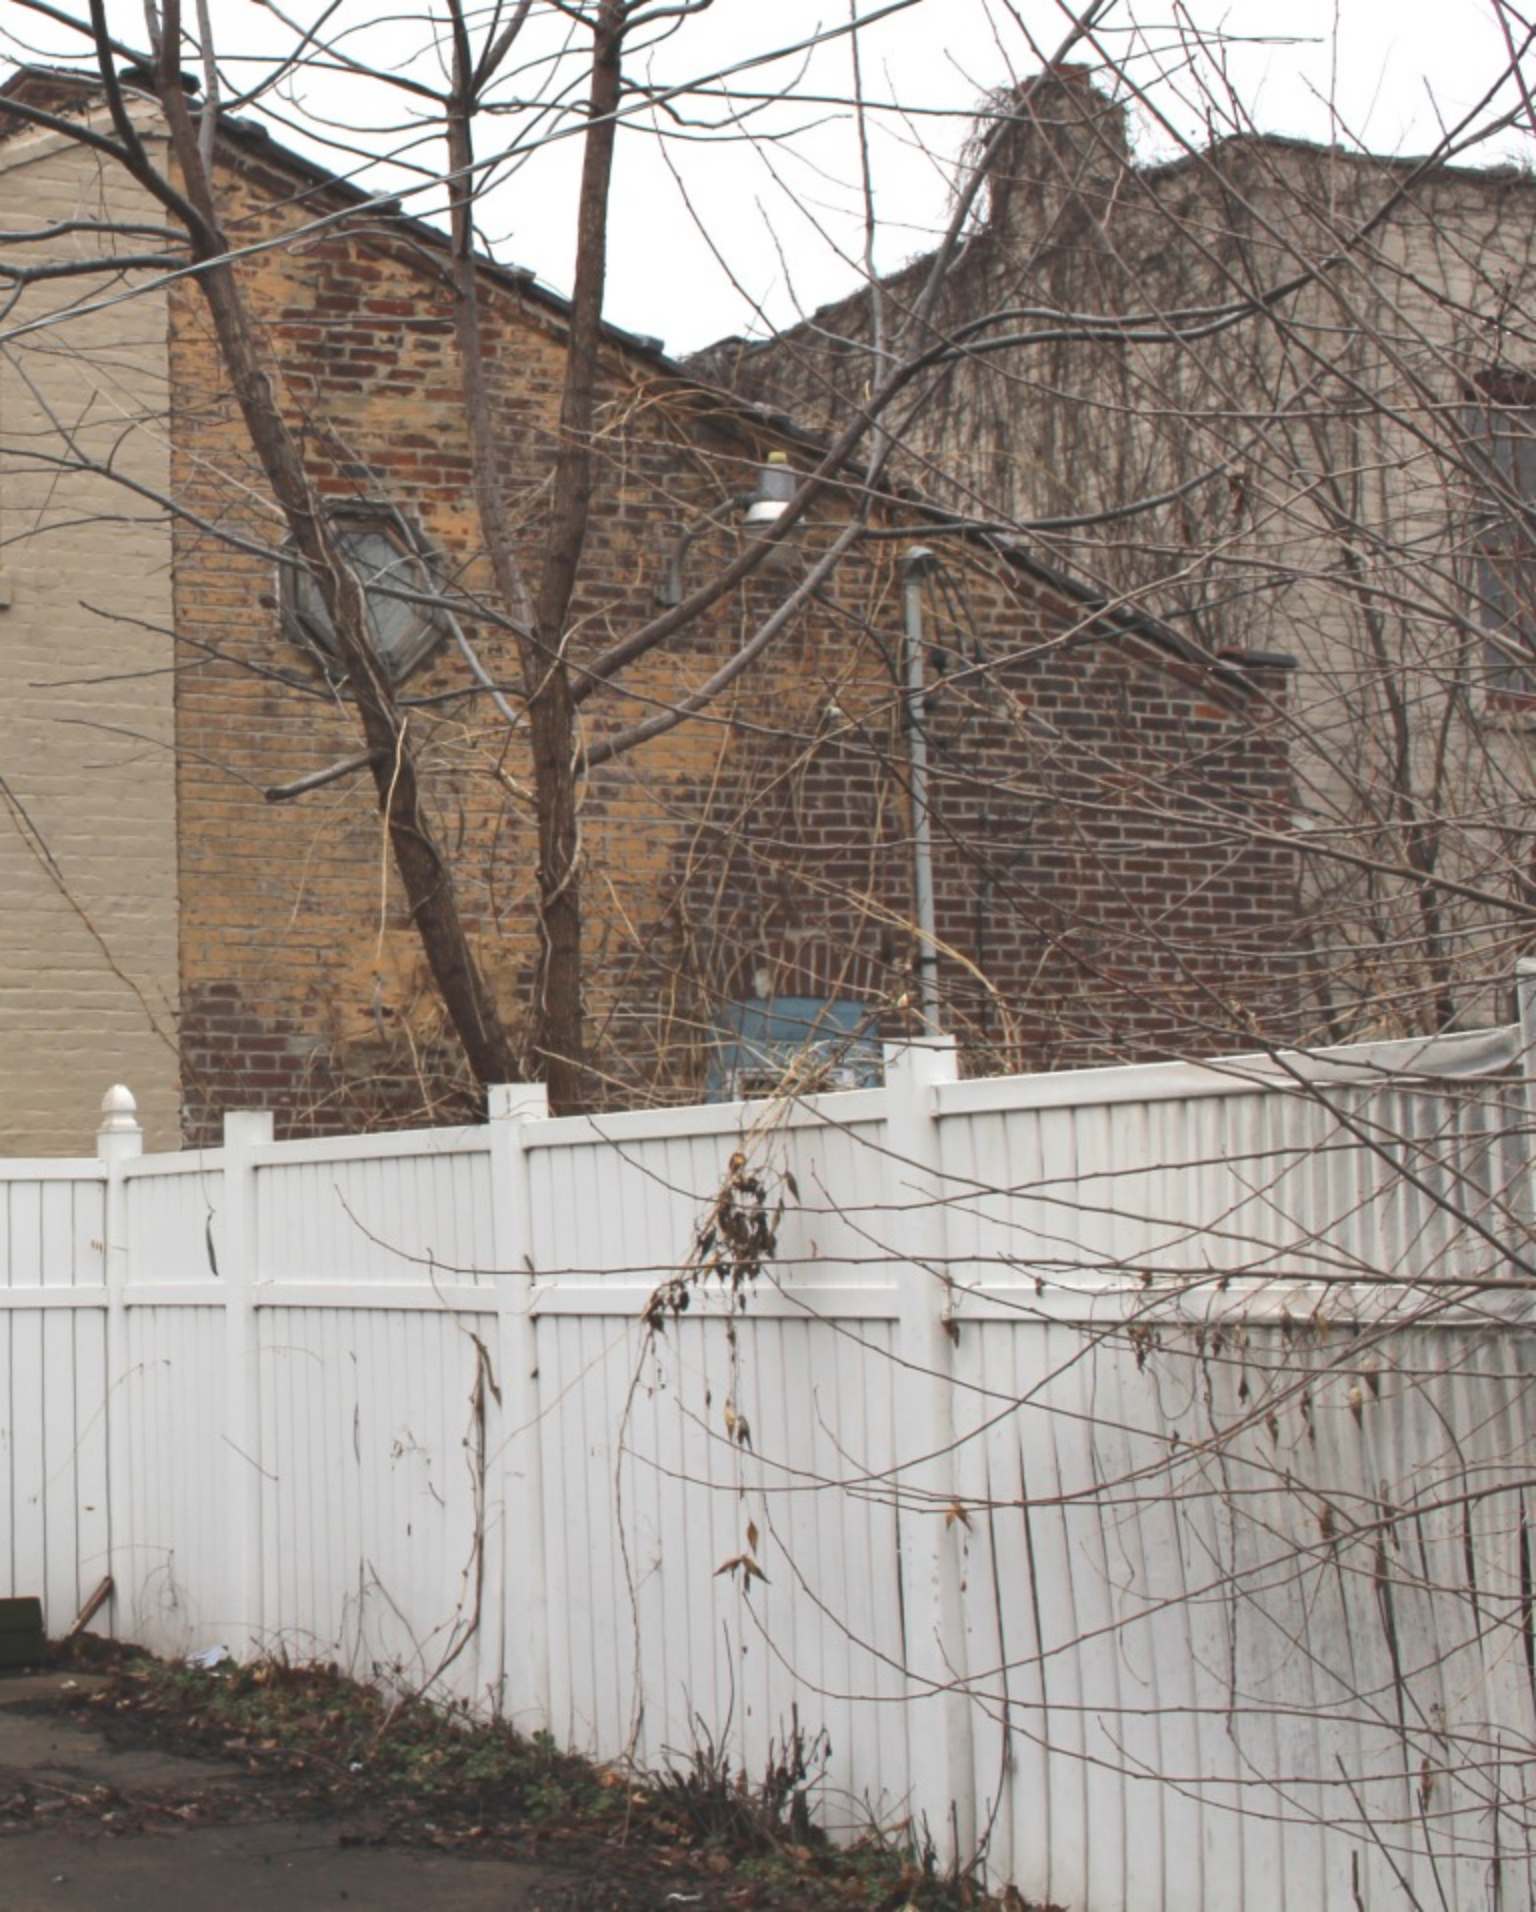
A 1-1/2 story brick semi-detached flounder house, with narrow façade facing the street. The east (front) 2-bay façade has a projecting brick coping currently capped with parapet tiles, a later alteration. The coping ends in a simple brick pinnacle at the corner. A single-leaf entry under a transom on the south is flanked by a single doublehung window on the north. A full-width porch of later construction extends across the façade. At the second story, a window has been inserted under a steel lintel, now filled with a vinyl doublehung window. All original openings are placed under segmental soldier arches; windows have wood sills. The 5-bay south elevation presents a window-window-window-door-window pattern. The rear elevation has 2 bays. In the southernmost bay is a single window opening. It has been partly blocked down to accommodate a small vinyl replacement window. The second story of the northern bay has been partly relaid and a modern hexagonal fixed window inserted at the second floor level. This area of the rear wall has been badly painted. Remnants of 3 brick stove chimneys remain at the ridge.
