**ARCHITECTURAL/HISTORIC INVENTORY FORM - Cultural Resources Office**  
**St. Louis Planning and Urban Design**

1. Survey no. SLC-AS-053-0102	2. Survey name: Thematic Survey of Flounder Houses in St. Louis City	3. County: St. Louis [Independent City]
4. Address: (from City GEO database) <b>900 HICKORY ST</b>		5. City/State: St. Louis, Missouri
Alternate address: 900 Hickory Street		Property Zip Code: 63104
Latitude: 38.615737		6. UTM Easting: 743886.40
Longitude: -90.198830		UTM Northing: 4277858.27
8. Historic Name (if known): N/A	11a. Historic Use (if known): Commerce/Trade	City Block 467.03
9. Present/other name (if known):	11b. Current Use: Commerce/Trade	City Ward 7
7. Township-Range-Section: N/A		10. Ownership: Private
Neighborhood Number: 34

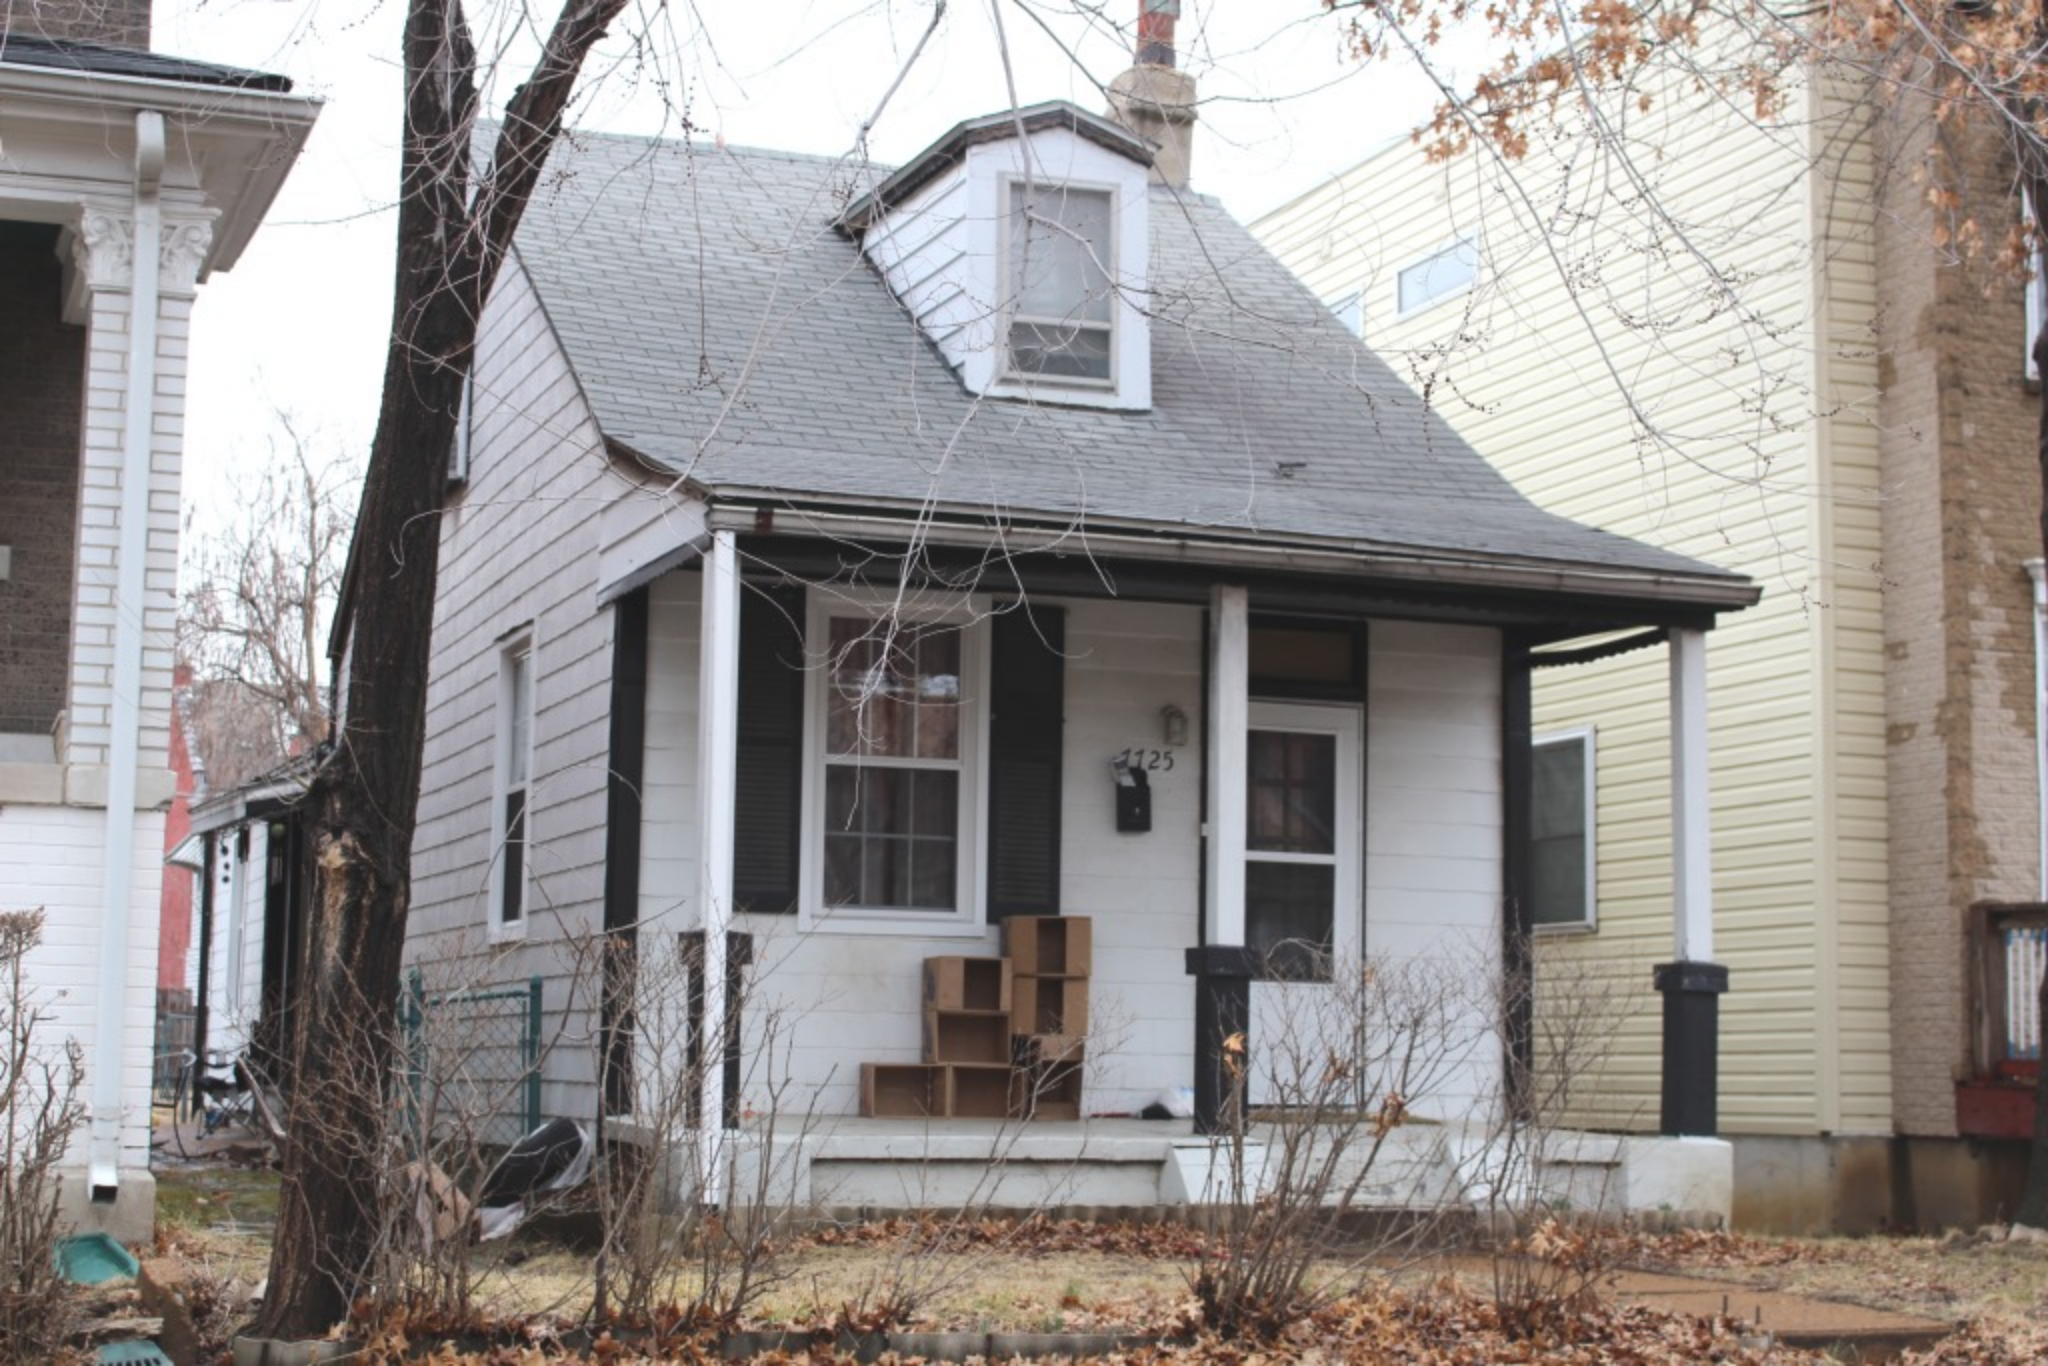
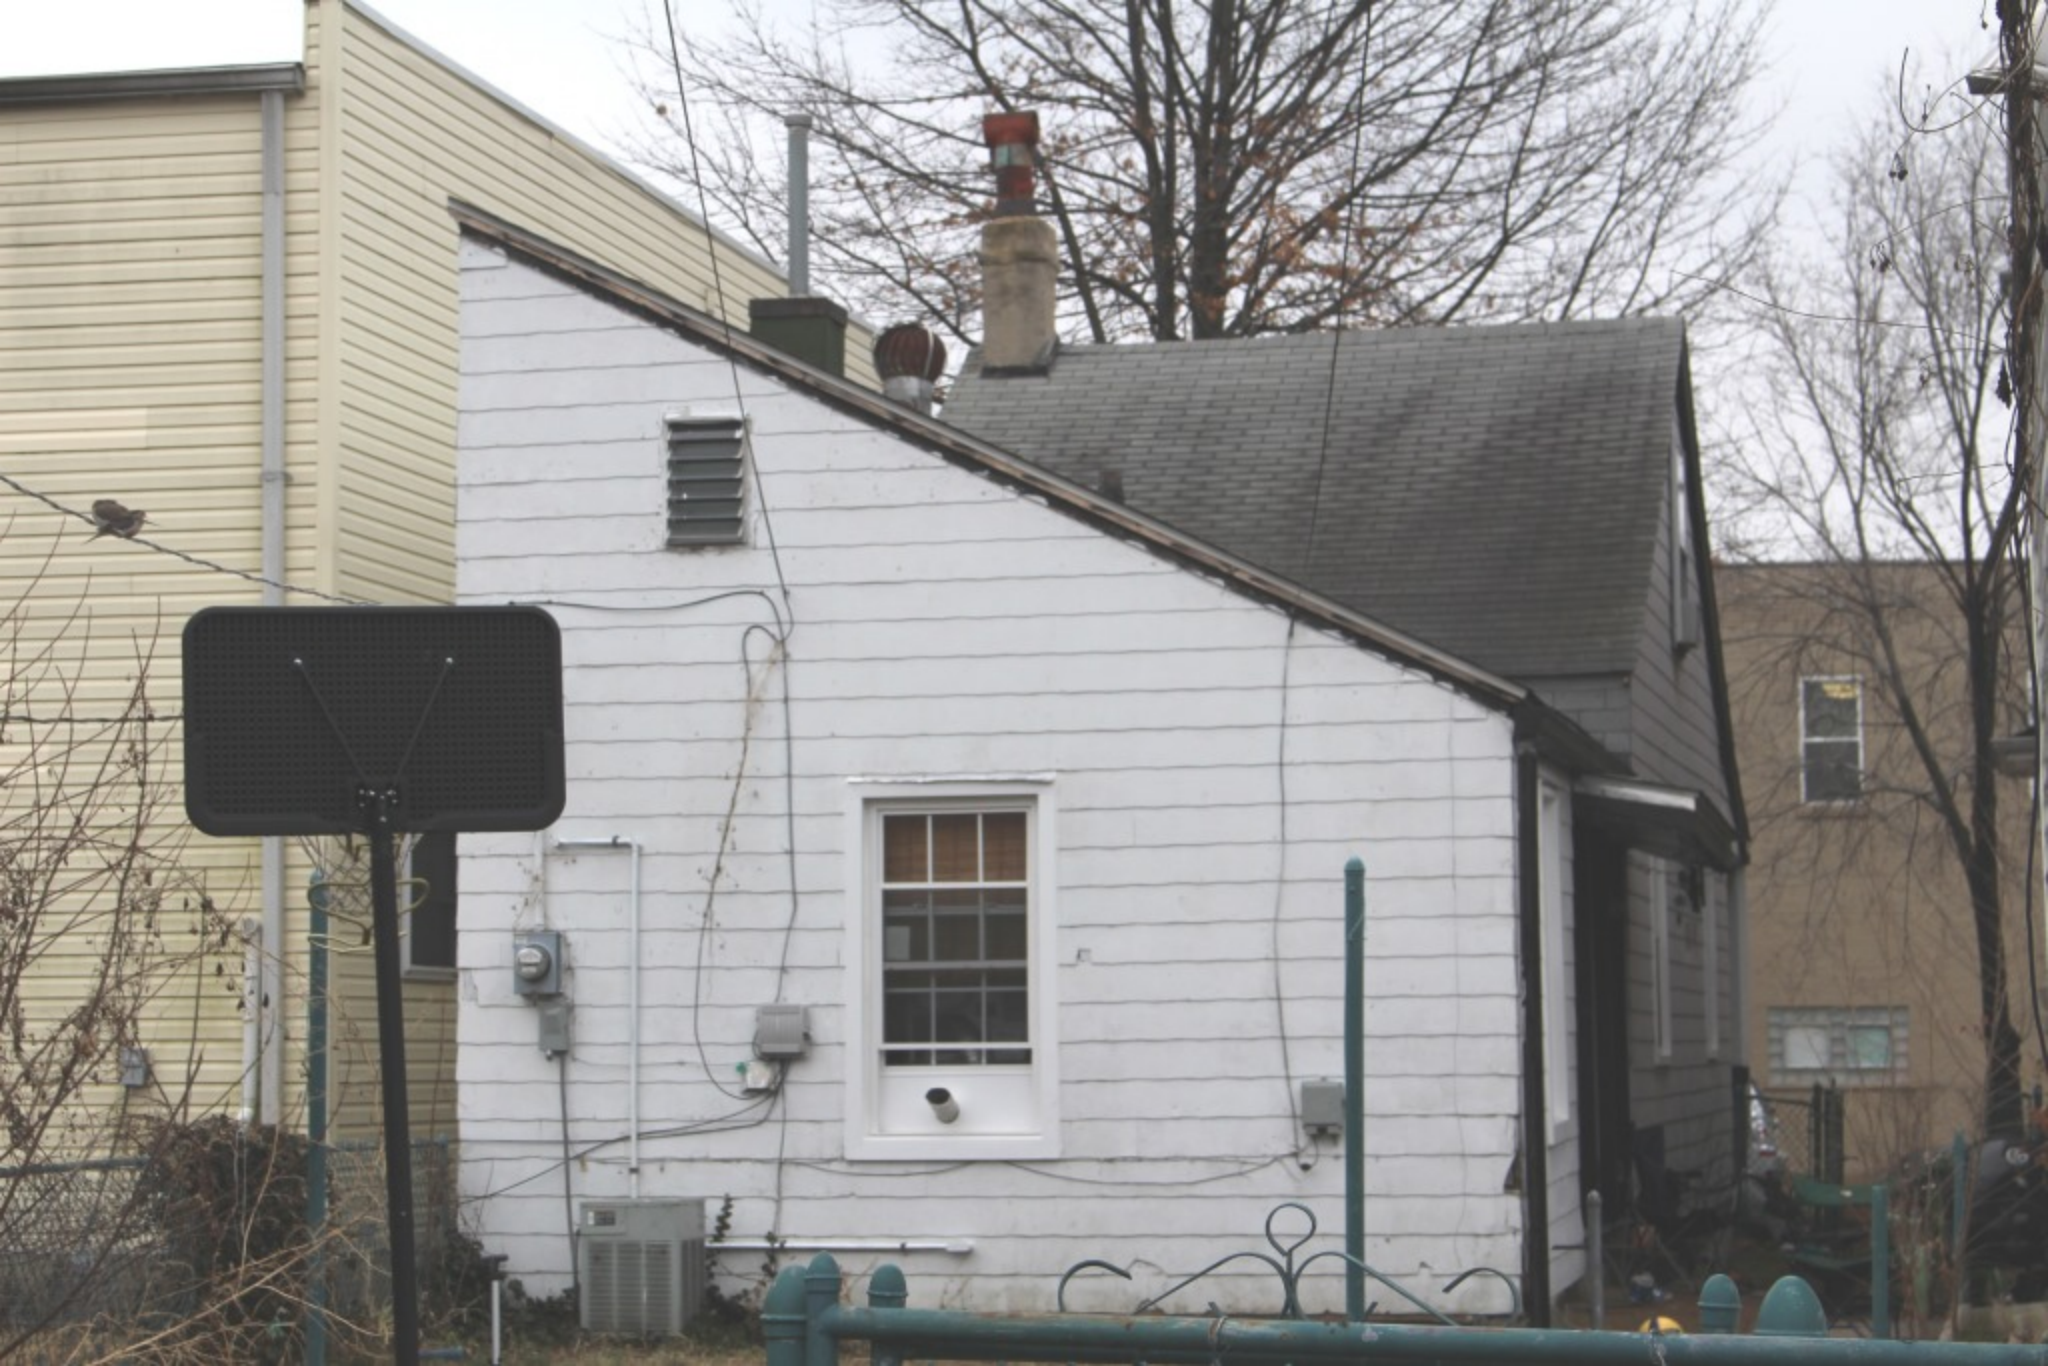
7725 Michigan is a 1-story frame flounder house with loft area, and appears as the original structure on the site. As early as 1883, the front block was constructed; a 1-1/2 story frame two-room house with full-width porch and dormer. The flounder's tall blind wall is sited on the northern property line; the western façade, originally the rear elevation, has a single bay with doublehung window. A small vent for an attic fan has been inserted just below the roof. The primary entry is located on the south elevation, which originally had a full gallery porch; the southwestern bay, however, has been framed in. This is an early alteration, as it appears in the 1909 Sanborn. The single-leaf entry with transom remains, as does a portion of the original porch roof. The house has been sheathed with aluminum siding, and exterior trim has been wrapped.

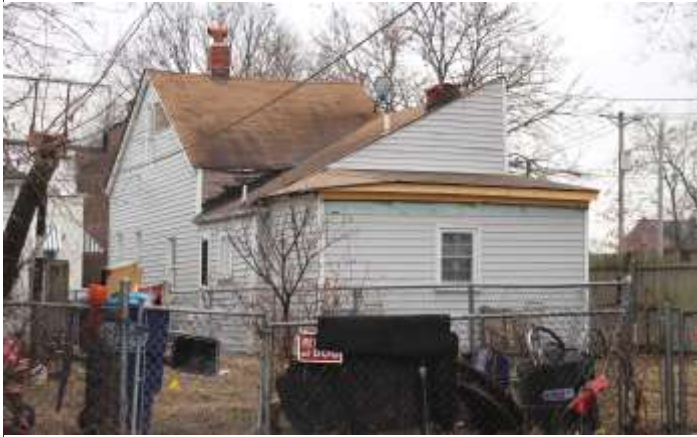
Looking southeast

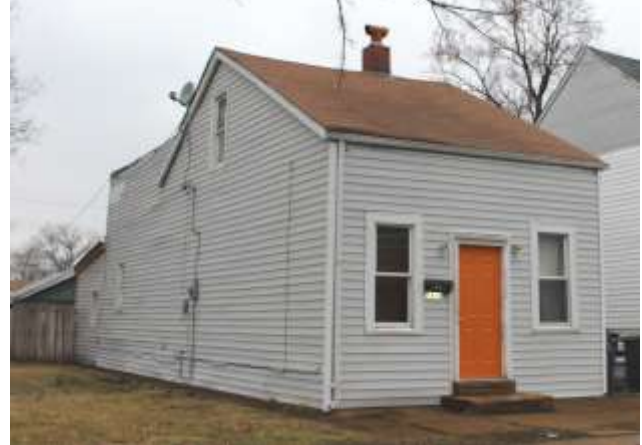
Front block looking northwest

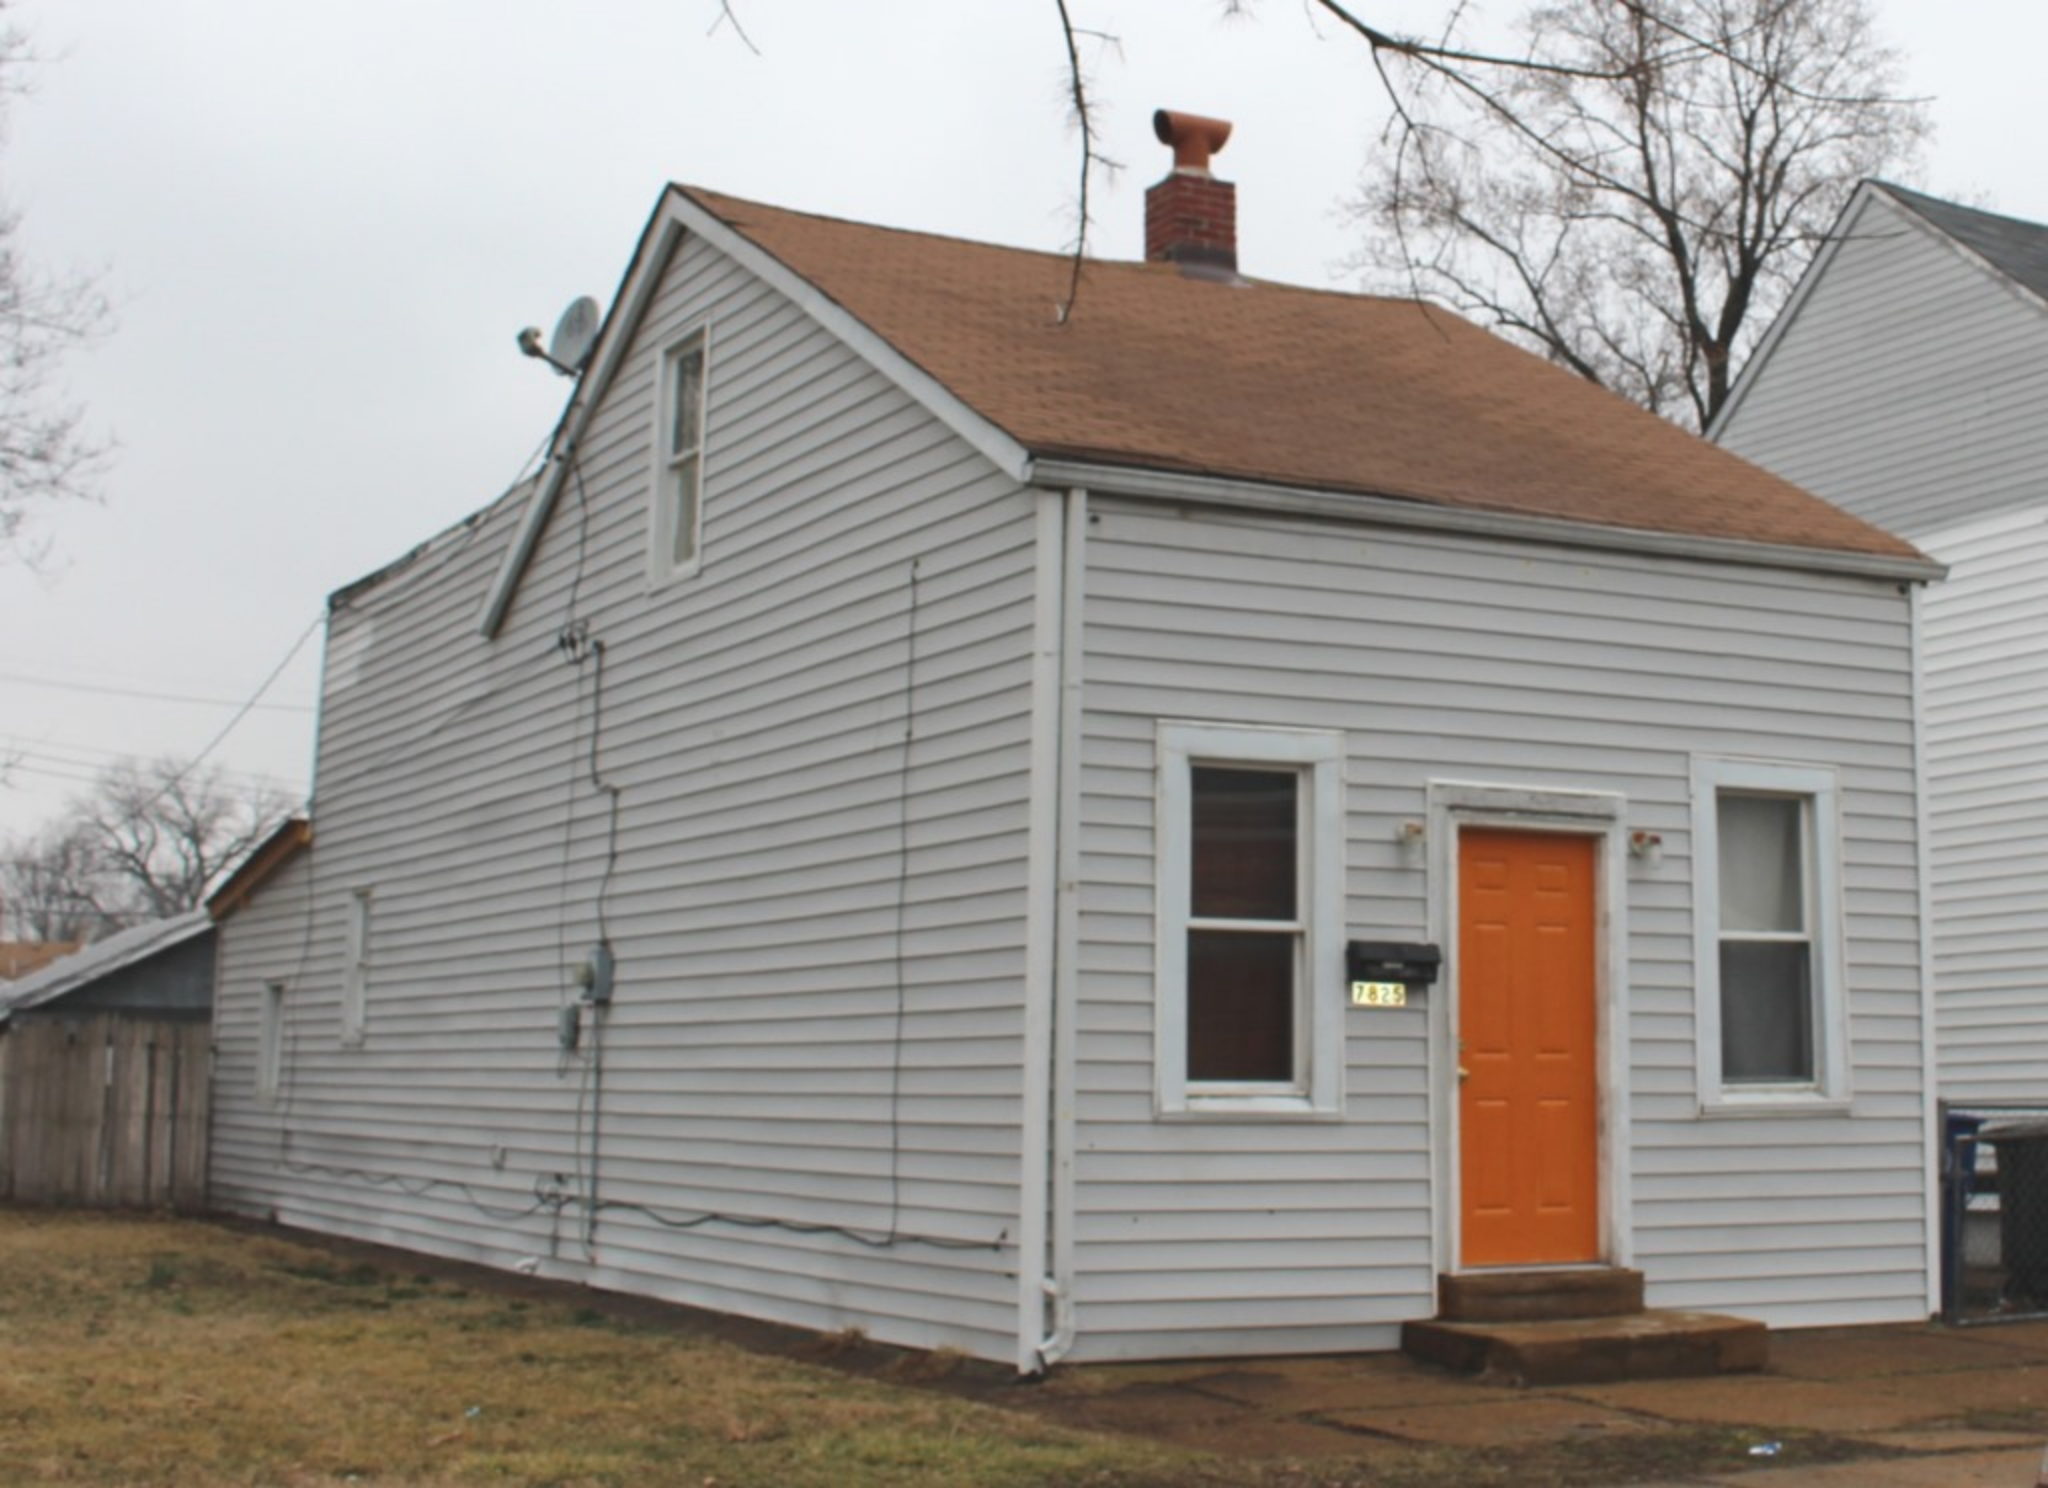
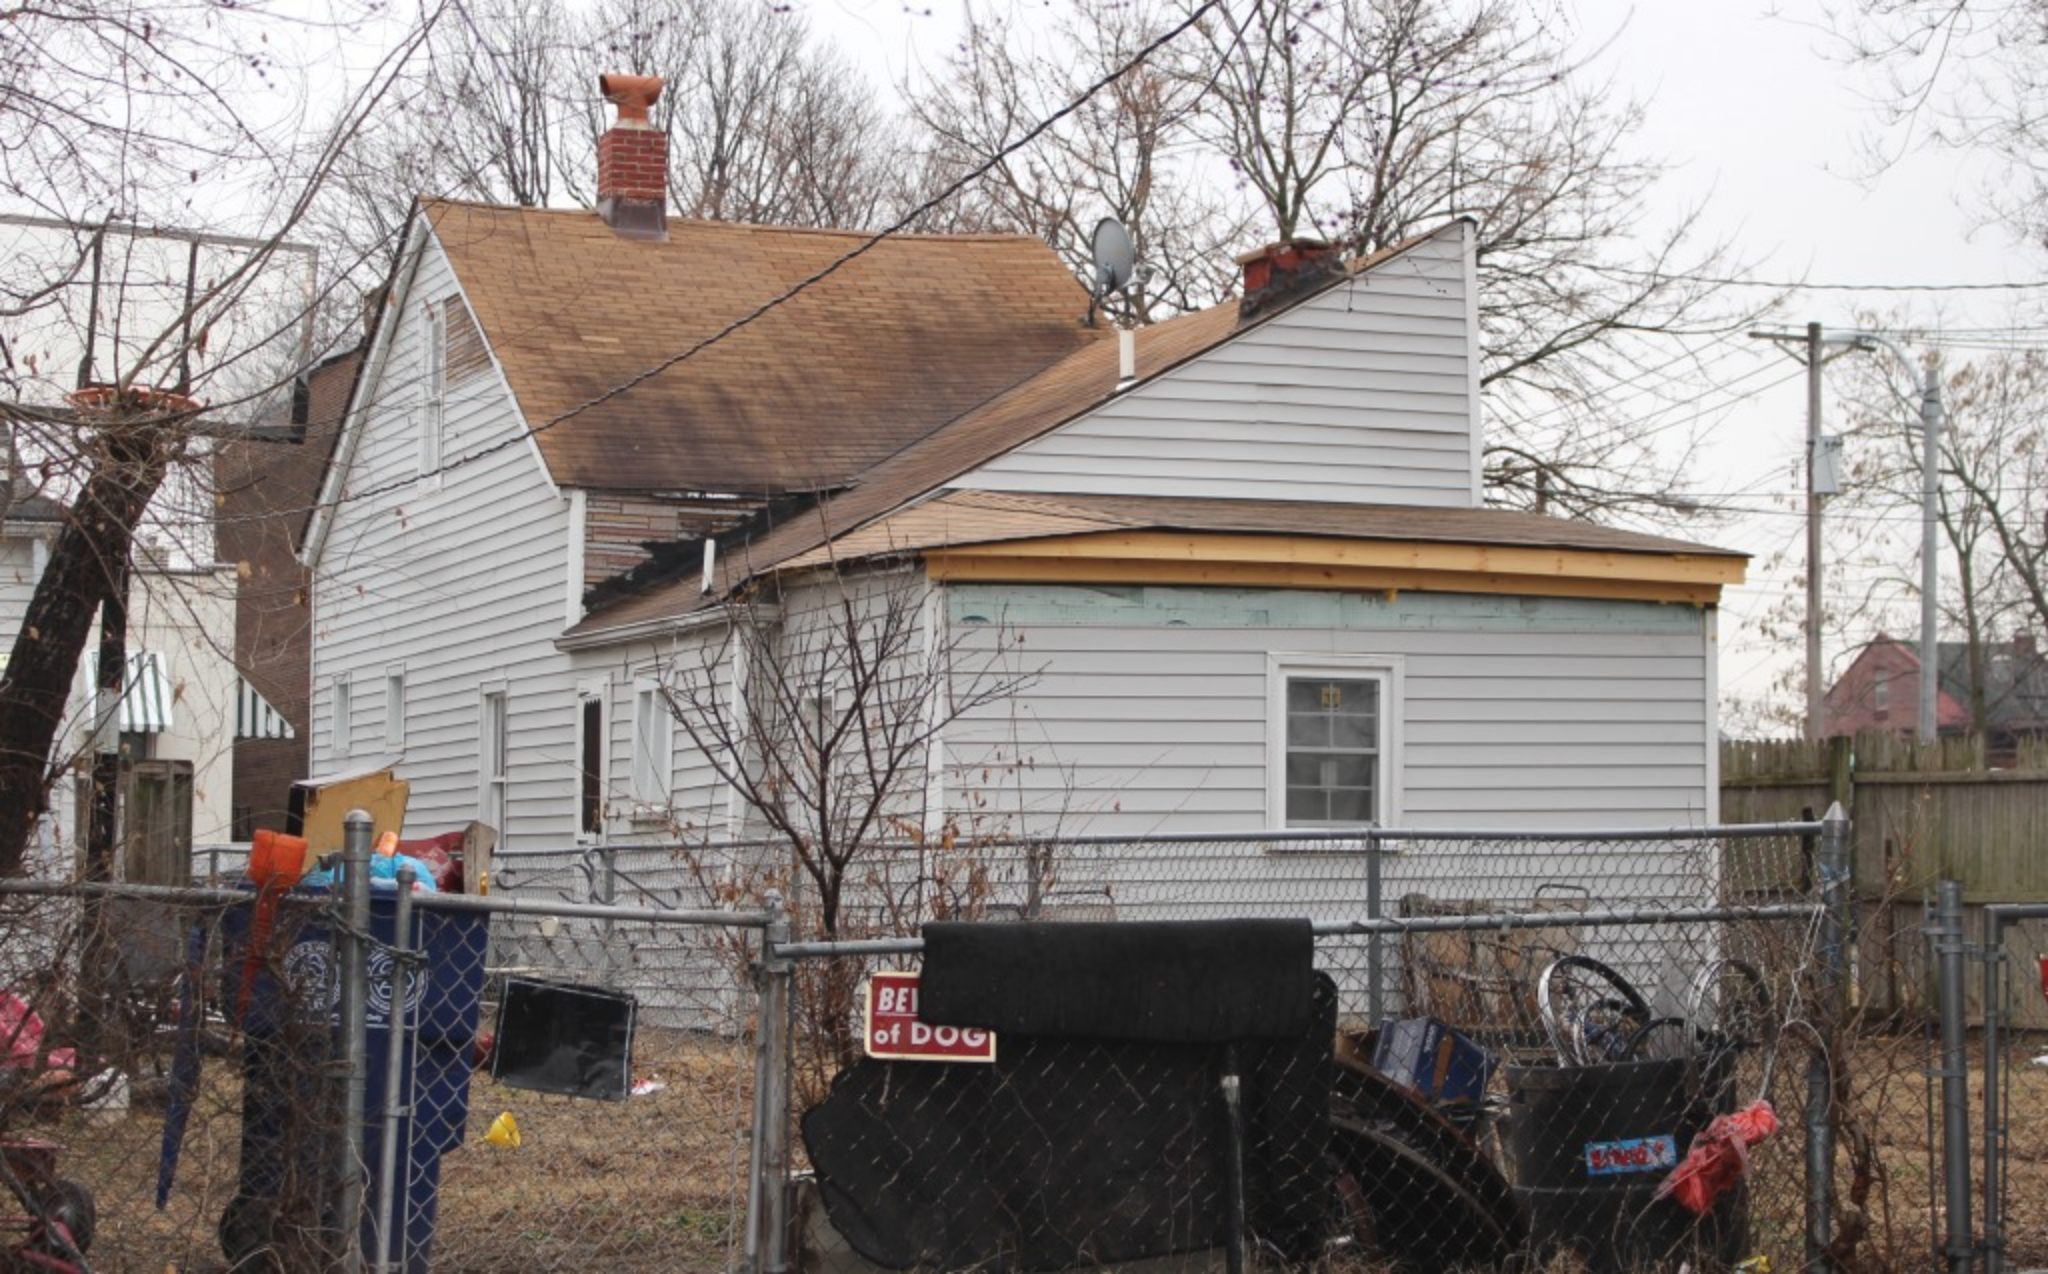
A frame one-story flounder house with high wall at south property line; north façade facing side yard displays a singleleaf entry door (replaced) flanked by a doublehung window to the east. Remnants of a brick stove chimney are located at southwestern corner slightly north of the roof ridge. The building is sheathed in vinyl lap siding. The east elevation is obscured by addition of a frame one-story, side gable 2-room house at the street building line. Another small one-story frame addition is attached at west façade.

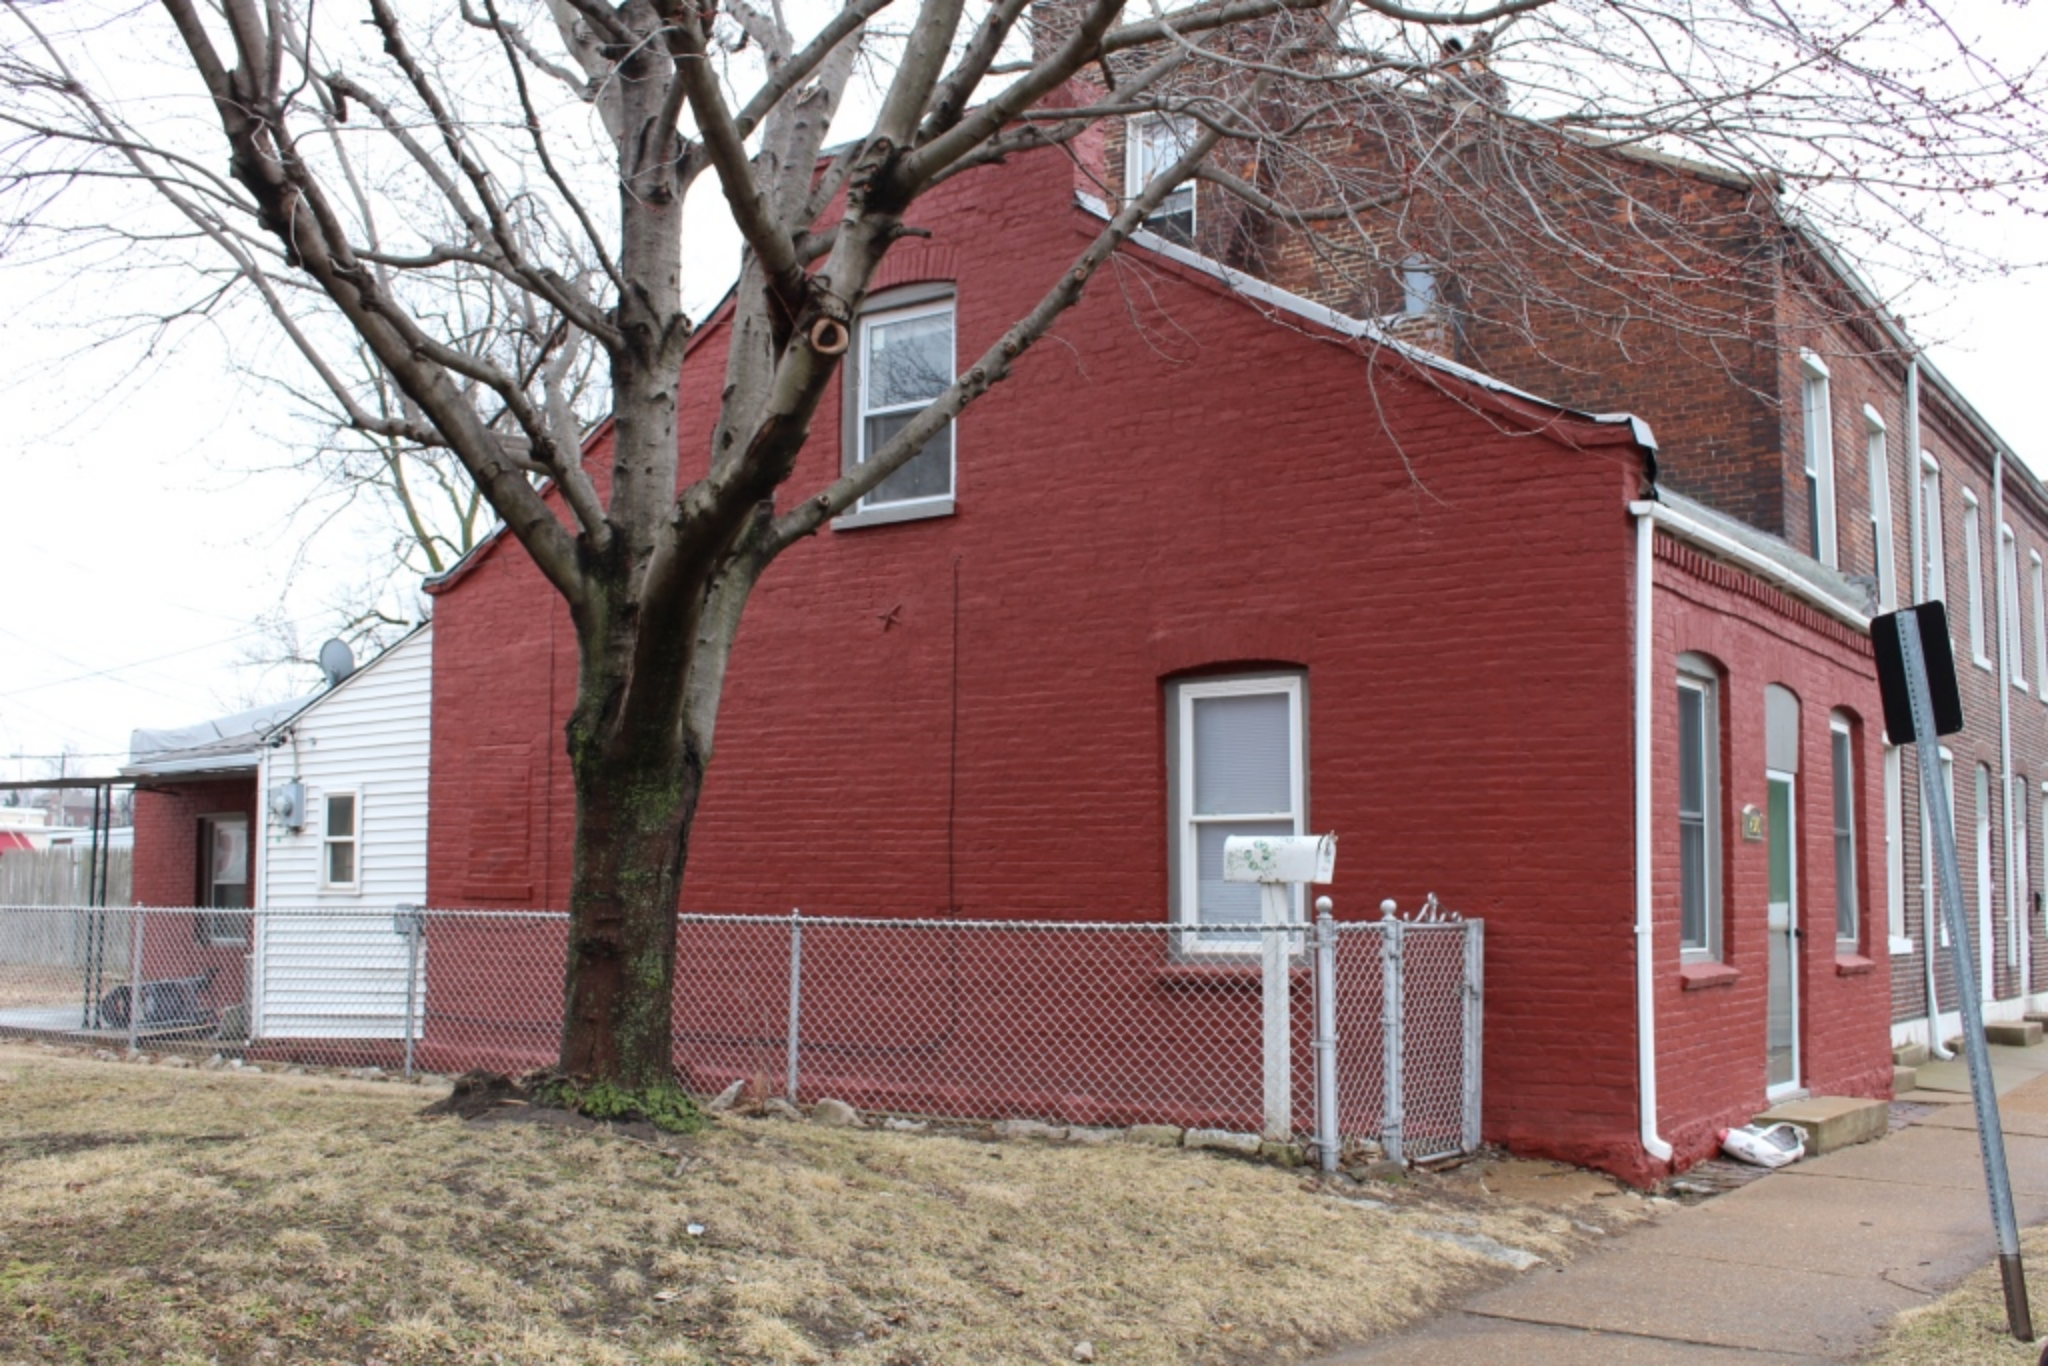
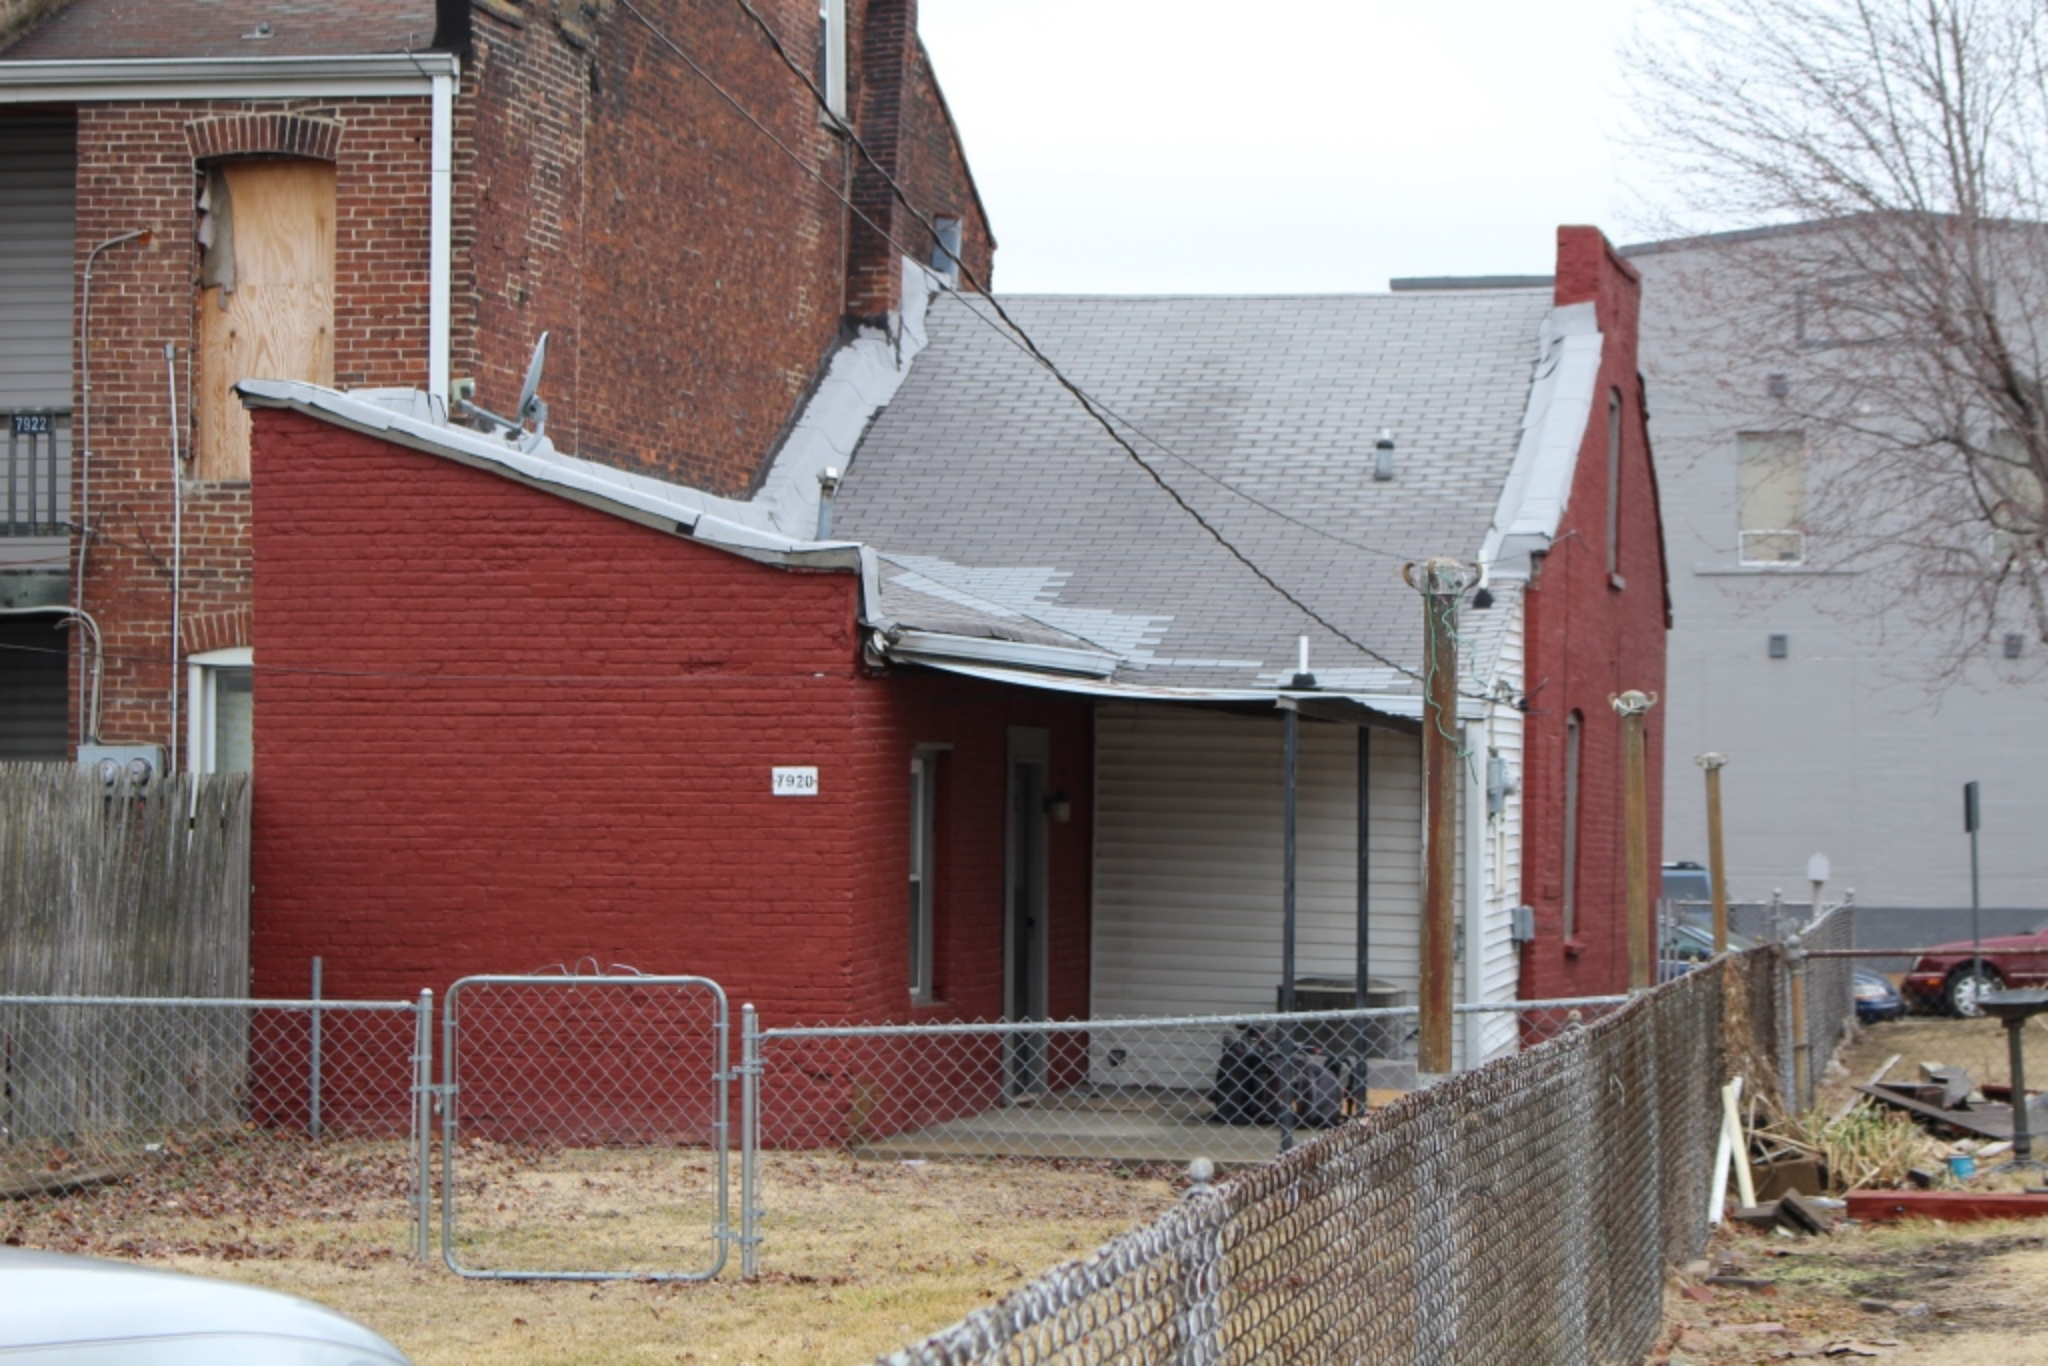
A 1-story common bond brick flounder with brick foundation, and the taller blind wall placed at the south property line. The eastern façade, original the rear elevation, has no openings. The northern façade has two bays: a single doublehung window on the east and a singleleaf door, with no transom, on the west. The flounder appears to be a very early example and primarily utilitarian. The south and east parapets have been wrapped with roll roofing, obscuring brick copings, and the building has been painted. On the west, a 1-1/2 story side gable block, also brick, has been added at the street. This appears to be a later addition, with a limestone foundation and more architectural detail.

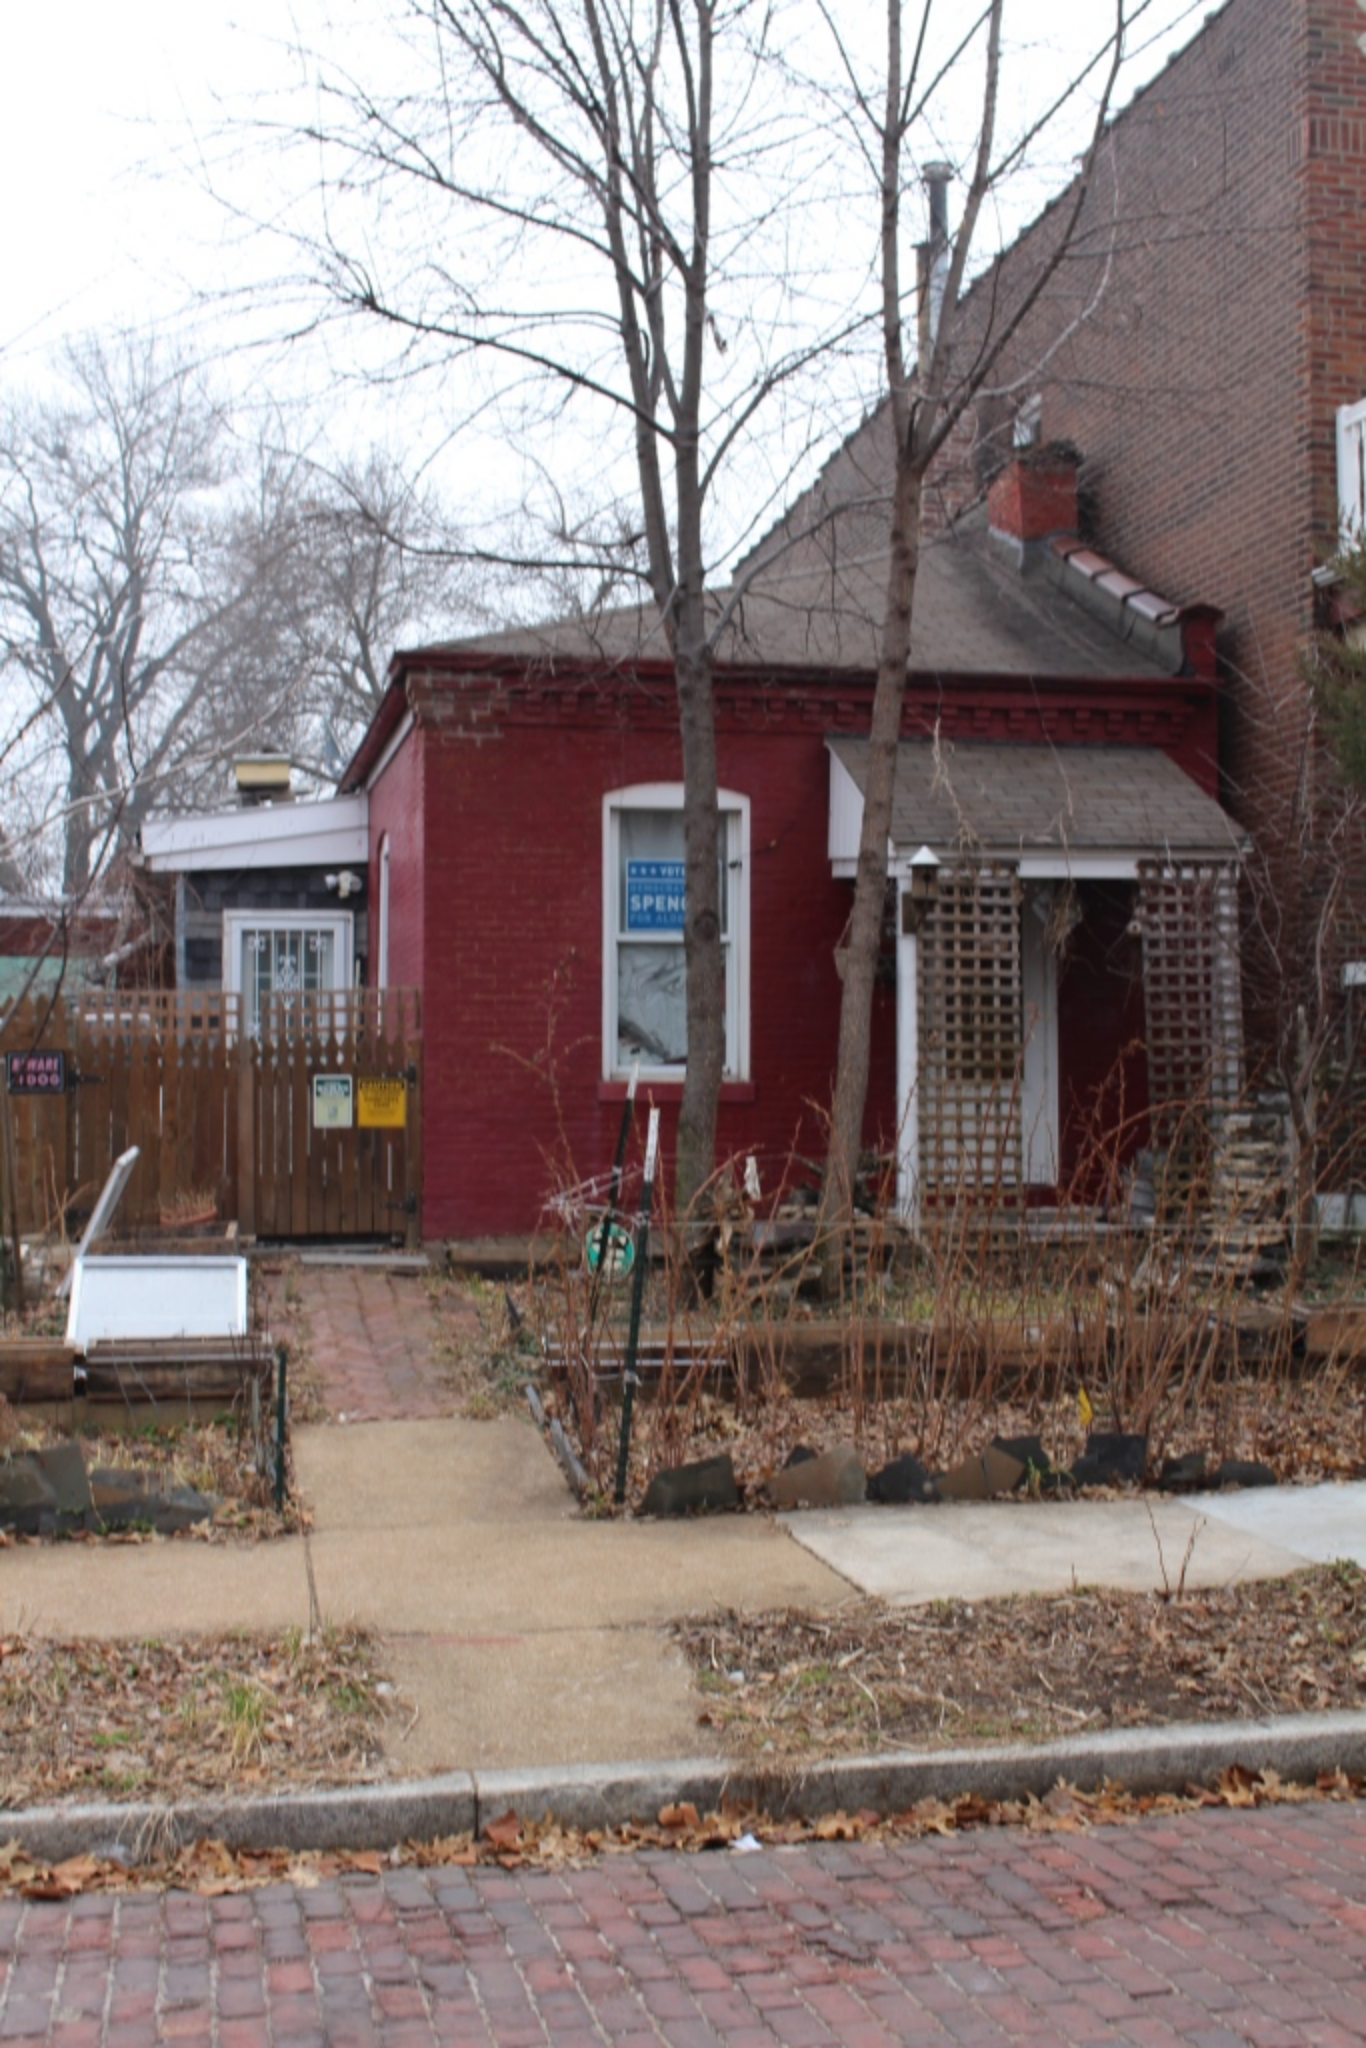
The front one-story with hipped roof brick flounder portion of this expanded house is quite small and nearly square in footprint. The painted brick walls are terminated with a denticulated cornice on the Minnesota façade only. The house, set back somewhat on the front of the lot, predates the one to the south built a few inches from it. A shed roof porch shelters the entrance; the window in the other façade bay and the one visible of likely a two-bay deep side façade are segmentally-arched openings with replacement 1/1 double-hung sash. There is a basement window in the façade with a segmentally-arched soldier header. An enclosed side porch addition conceals the original rear north bay of the house. A ramp to the front door in the south of two bays in the façade and gardening structures obscure the foundation. Two chimneys rise from the south parapet wall.
