**ARCHITECTURAL/HISTORIC INVENTORY FORM - Cultural Resources Office**  
**St. Louis Planning and Urban Design**

1. Survey no. SLC-AS-053-0102	2. Survey name: Thematic Survey of Flounder Houses in St. Louis City	3. County: St. Louis [Independent City]
4. Address: (from City GEO database) <b>900 HICKORY ST</b>		5. City/State: St. Louis, Missouri
Alternate address: 900 Hickory Street		Property Zip Code: 63104
Latitude: 38.615737		6. UTM Easting: 743886.40
Longitude: -90.198830		UTM Northing: 4277858.27
8. Historic Name (if known): N/A	11a. Historic Use (if known): Commerce/Trade	City Block 467.03
9. Present/other name (if known):	11b. Current Use: Commerce/Trade	City Ward 7
7. Township-Range-Section: N/A		10. Ownership: Private
Neighborhood Number: 34

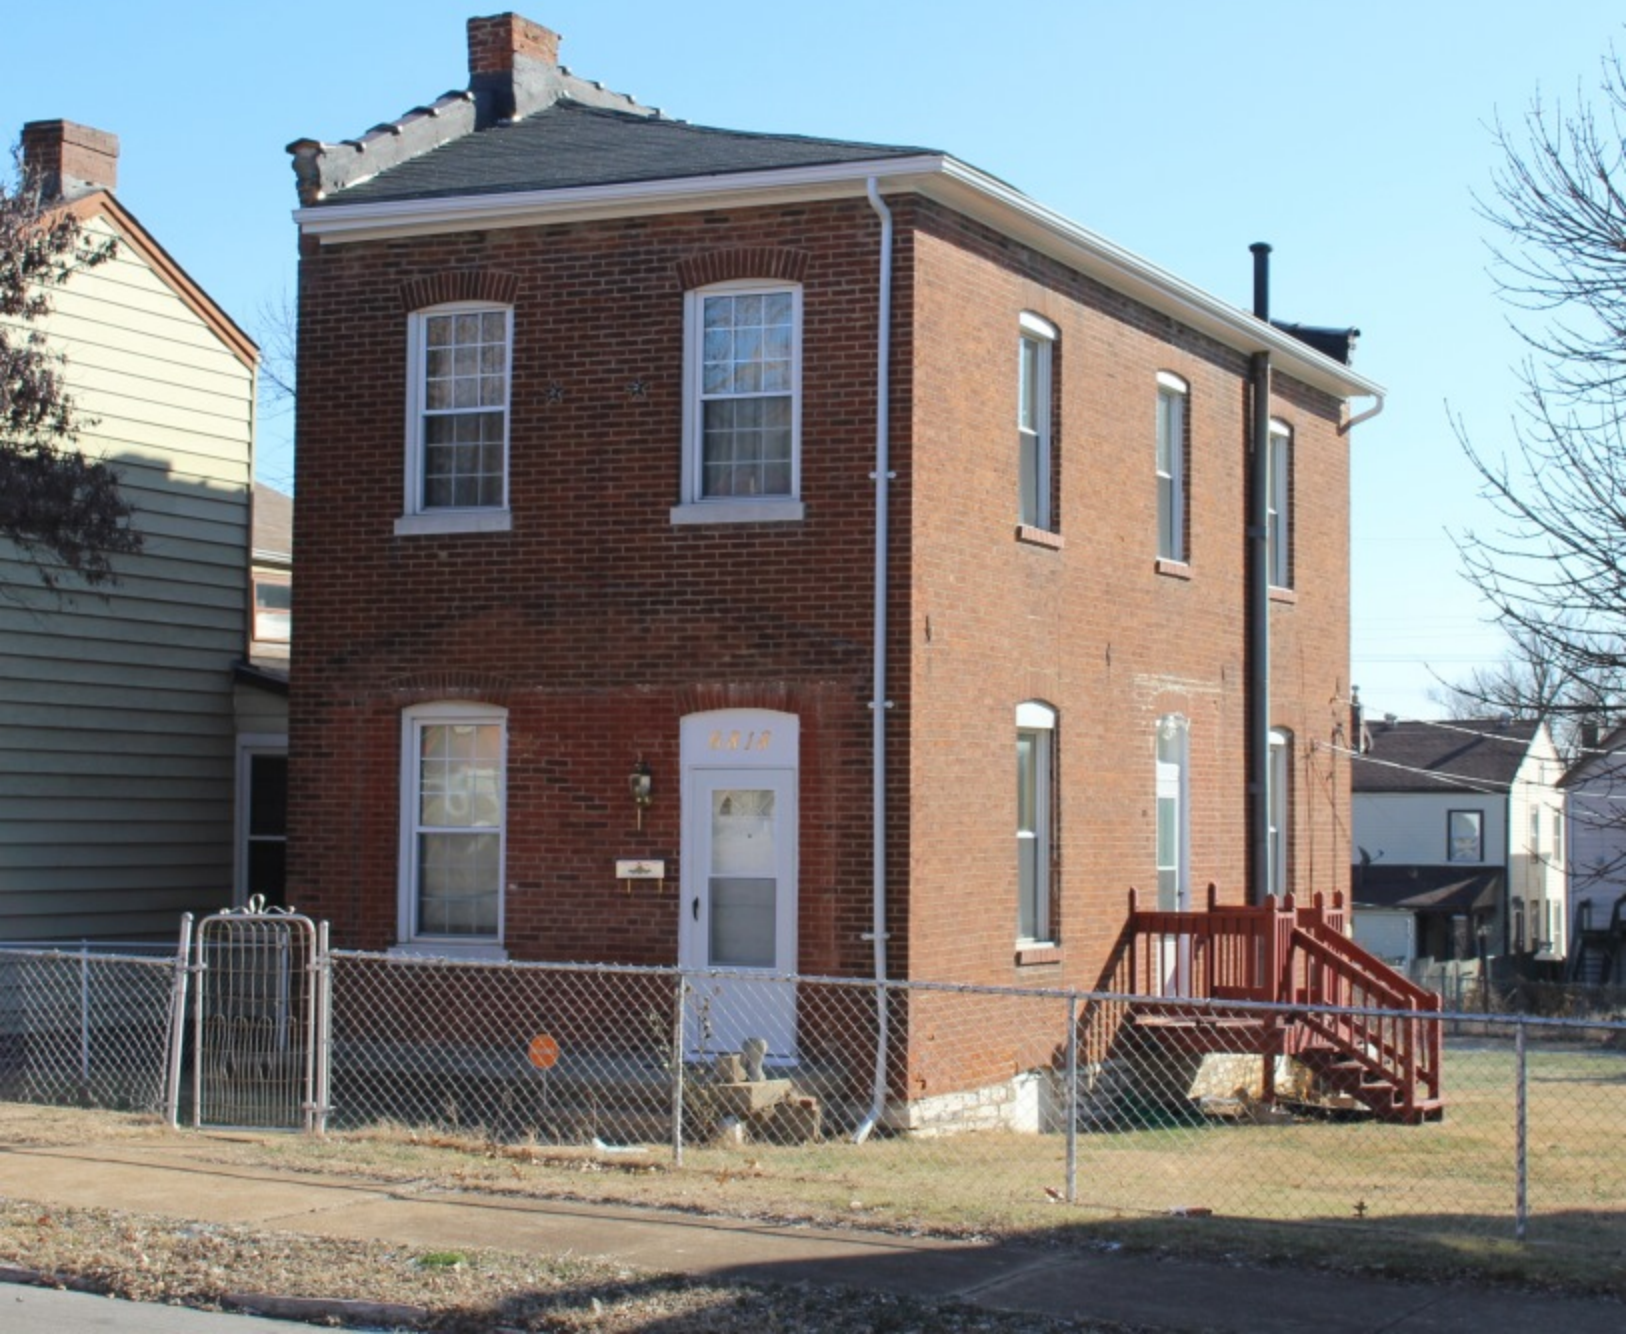
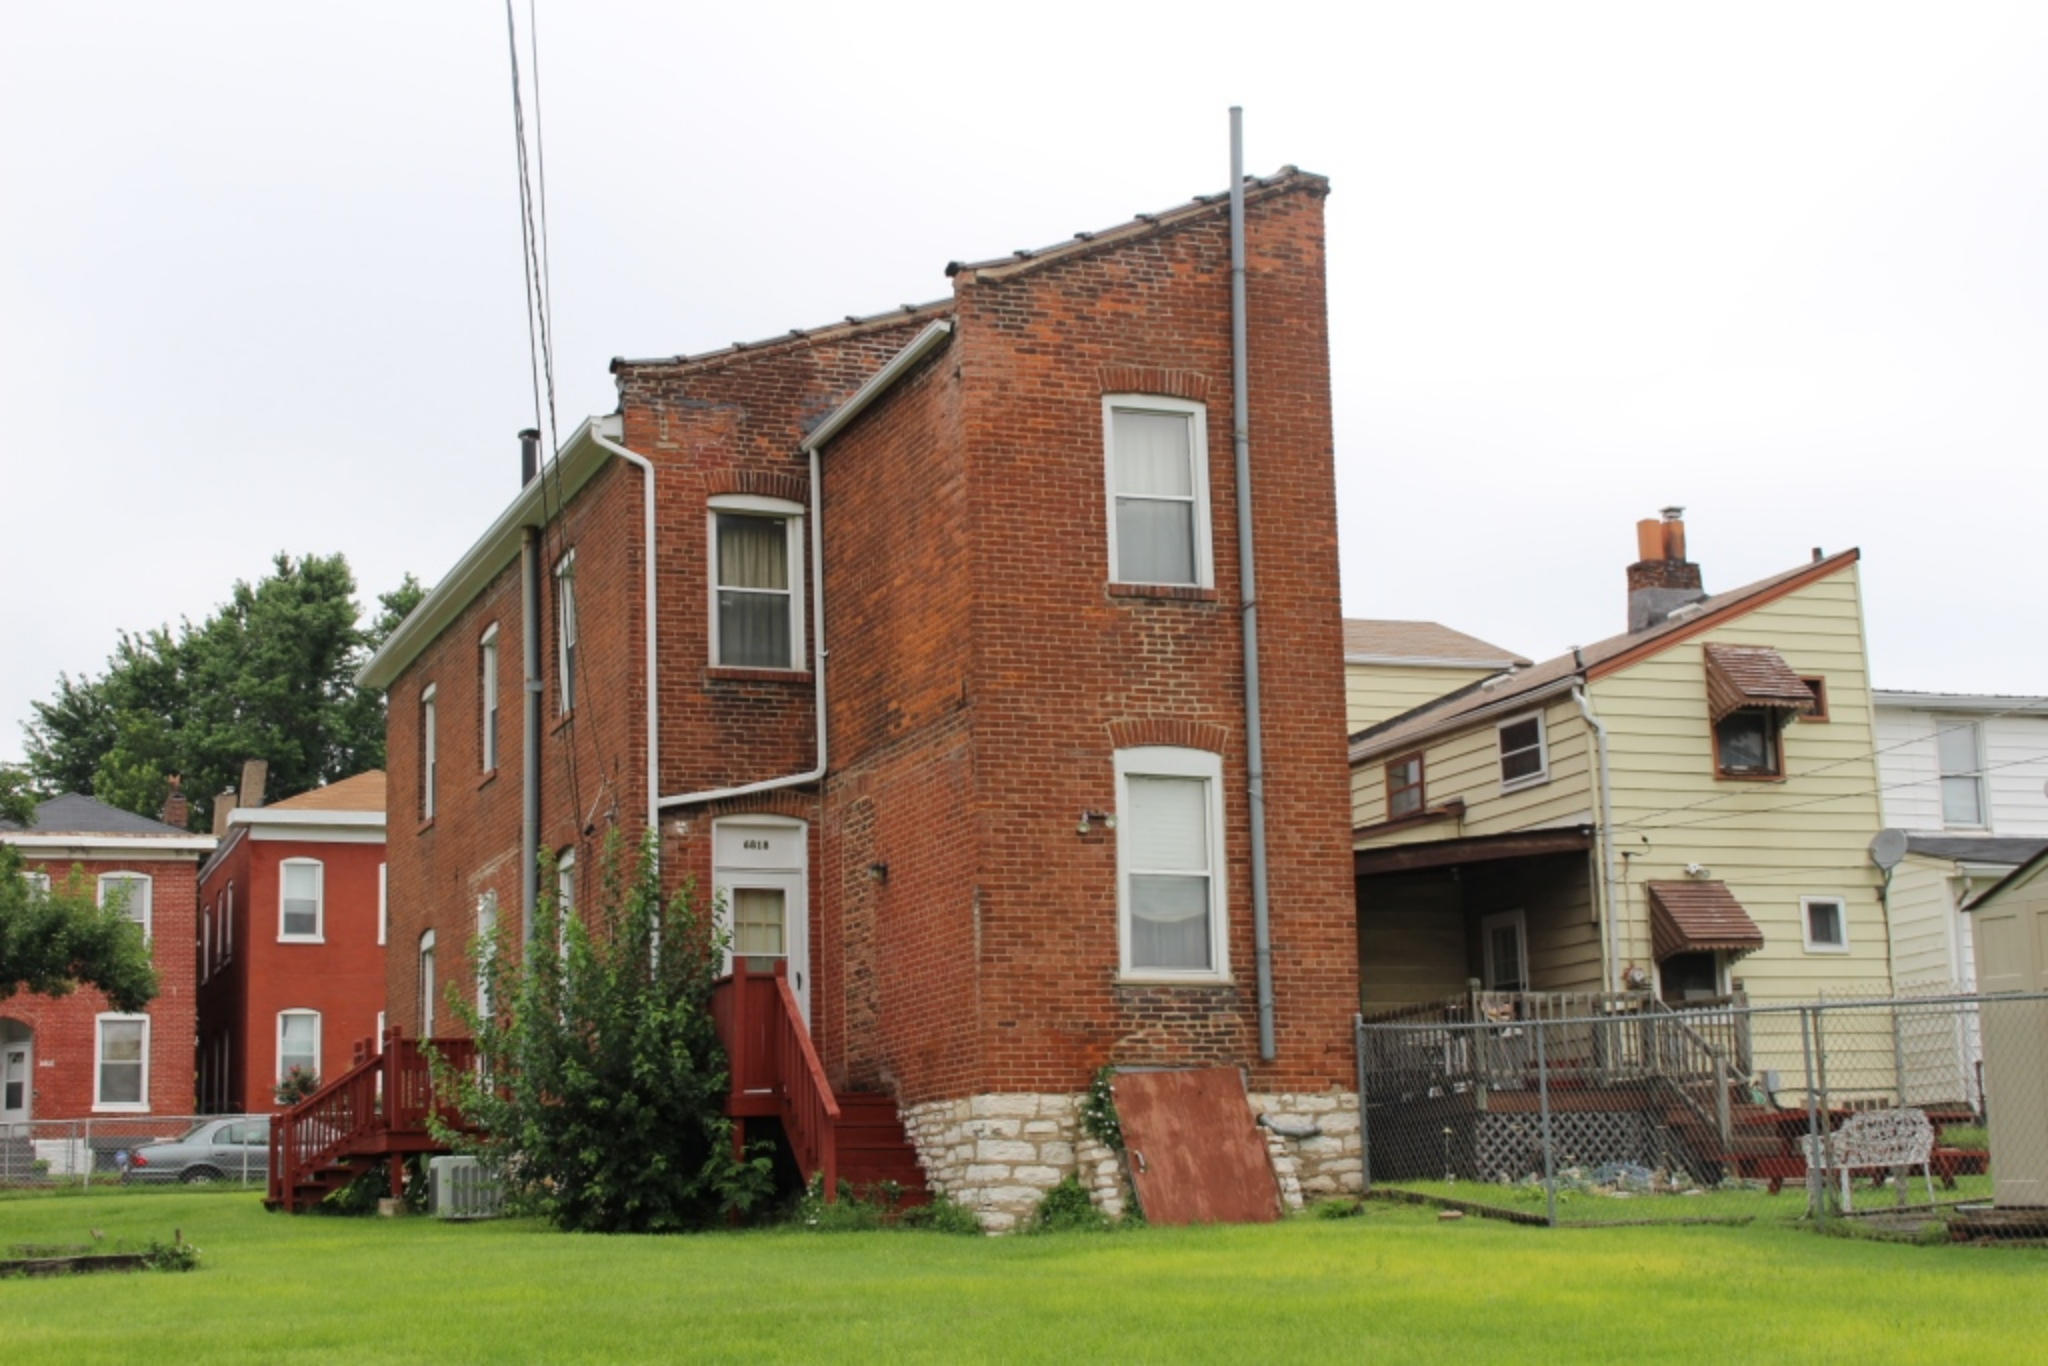
Two-story brick flounder with two entrances, one facing street and one on the long side facing south side yard. Front, or west façade, has two bays. The first floor has single heavily altered front door and transom with a poured concrete stoop. There is a single replacement window on the first floor. The second floor features two replacement windows. On the South side of the building there is a centered transomed entry door that has been heavily altered. The south door exits out onto a contemporary wooden deck. There are two flanking first floor windows and three second floor windows on the south façade. All windows and doors on the west and south façade have stone sills and soldier course brick lintels. The west and south side has an non-descript aluminum wrapped cornice that carries the guttering system. The rear of the house features a smaller subserviant flounder addition that has two windows on the east façade. The main block of the house as altered entry door that is serviced by a set of wooden stairs.

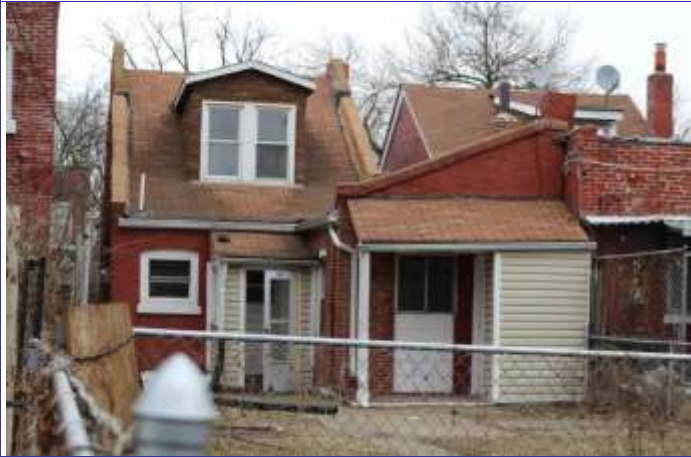
Rear elevation

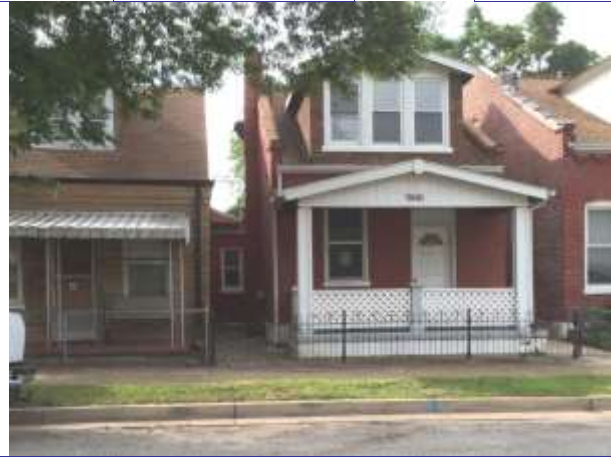
Front: note flounder wall exposed at left

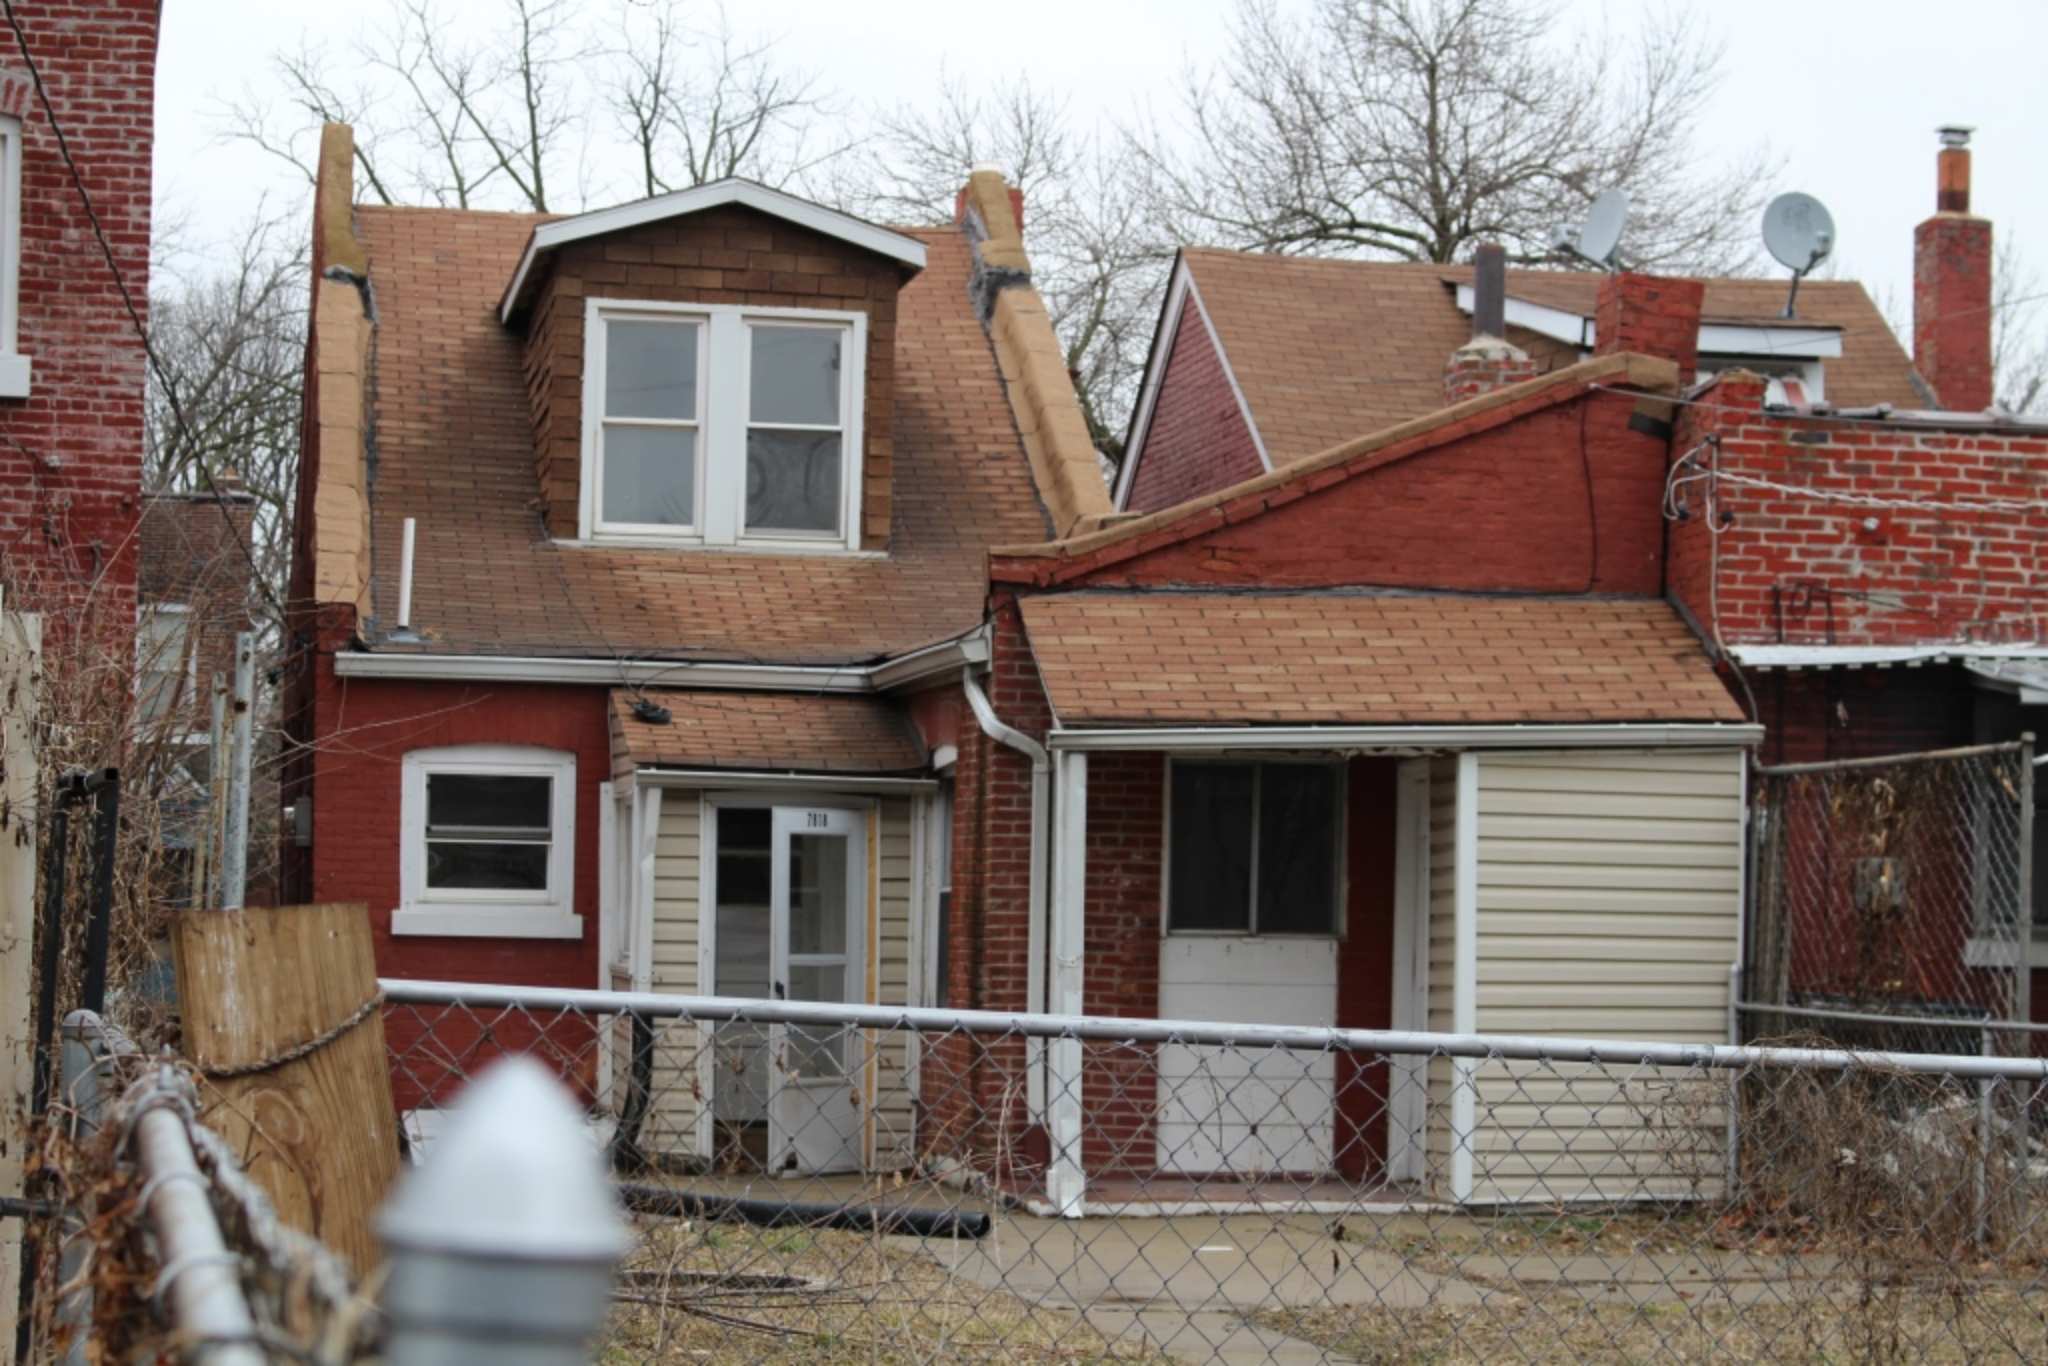
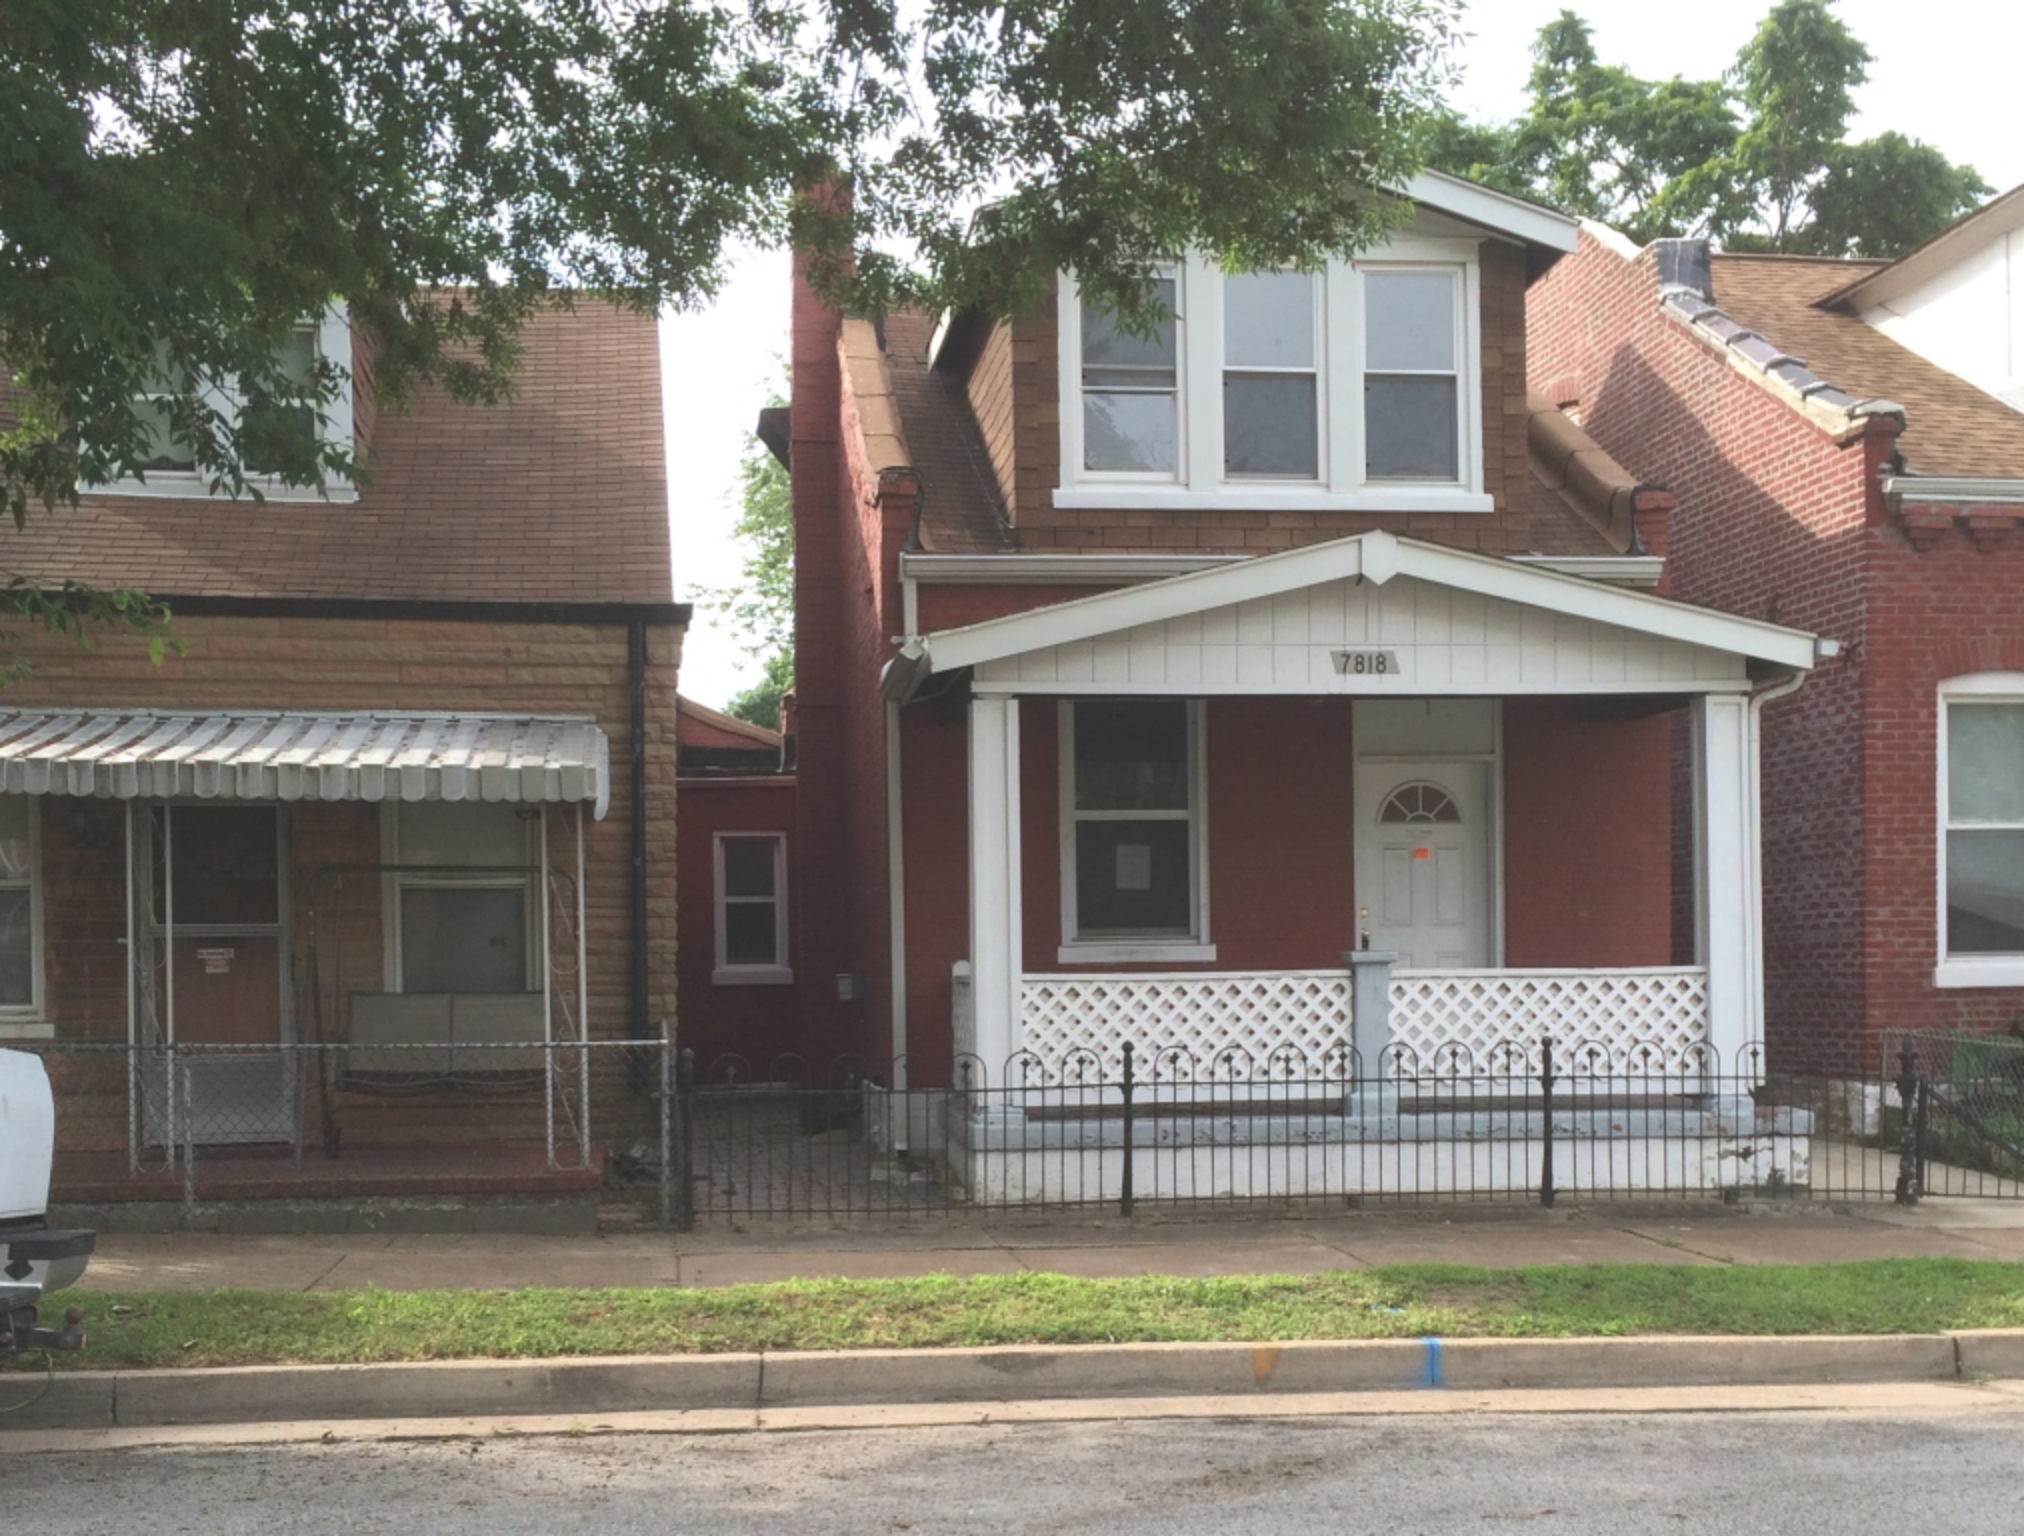
7818 Minnesota is a small, one-story brick flounder house, the first building constructed on the site. Its taller, blind wall is placed at the north property line abutting the rear addition of the adjacent property at 7716 Minnesota. The flounder's east (rear) elevation has a projecting brick coping and two bays. A square brick stove chimney is extant at the ridge of the roof on this elevation. Originally, a door was placed in the south bay but has been converted to a window with the area below framed in and sided. There is certainly a second opening in the northern bay, but it has been covered by a small frame vestibule addition with a door facing south. A contemporary shed-roofed porch extends the width of this elevation. Half of the south façade has been obscured by another frame vestibule; the remaining exposed bay on the east displays an original doublehung window opening. The front block of the property, a side-gable brick, is a later addition, and is offset from the flounder slightly to the east. A small portion of the flounder's original west (front) wall remains exposed and presents a single, doublehung window.

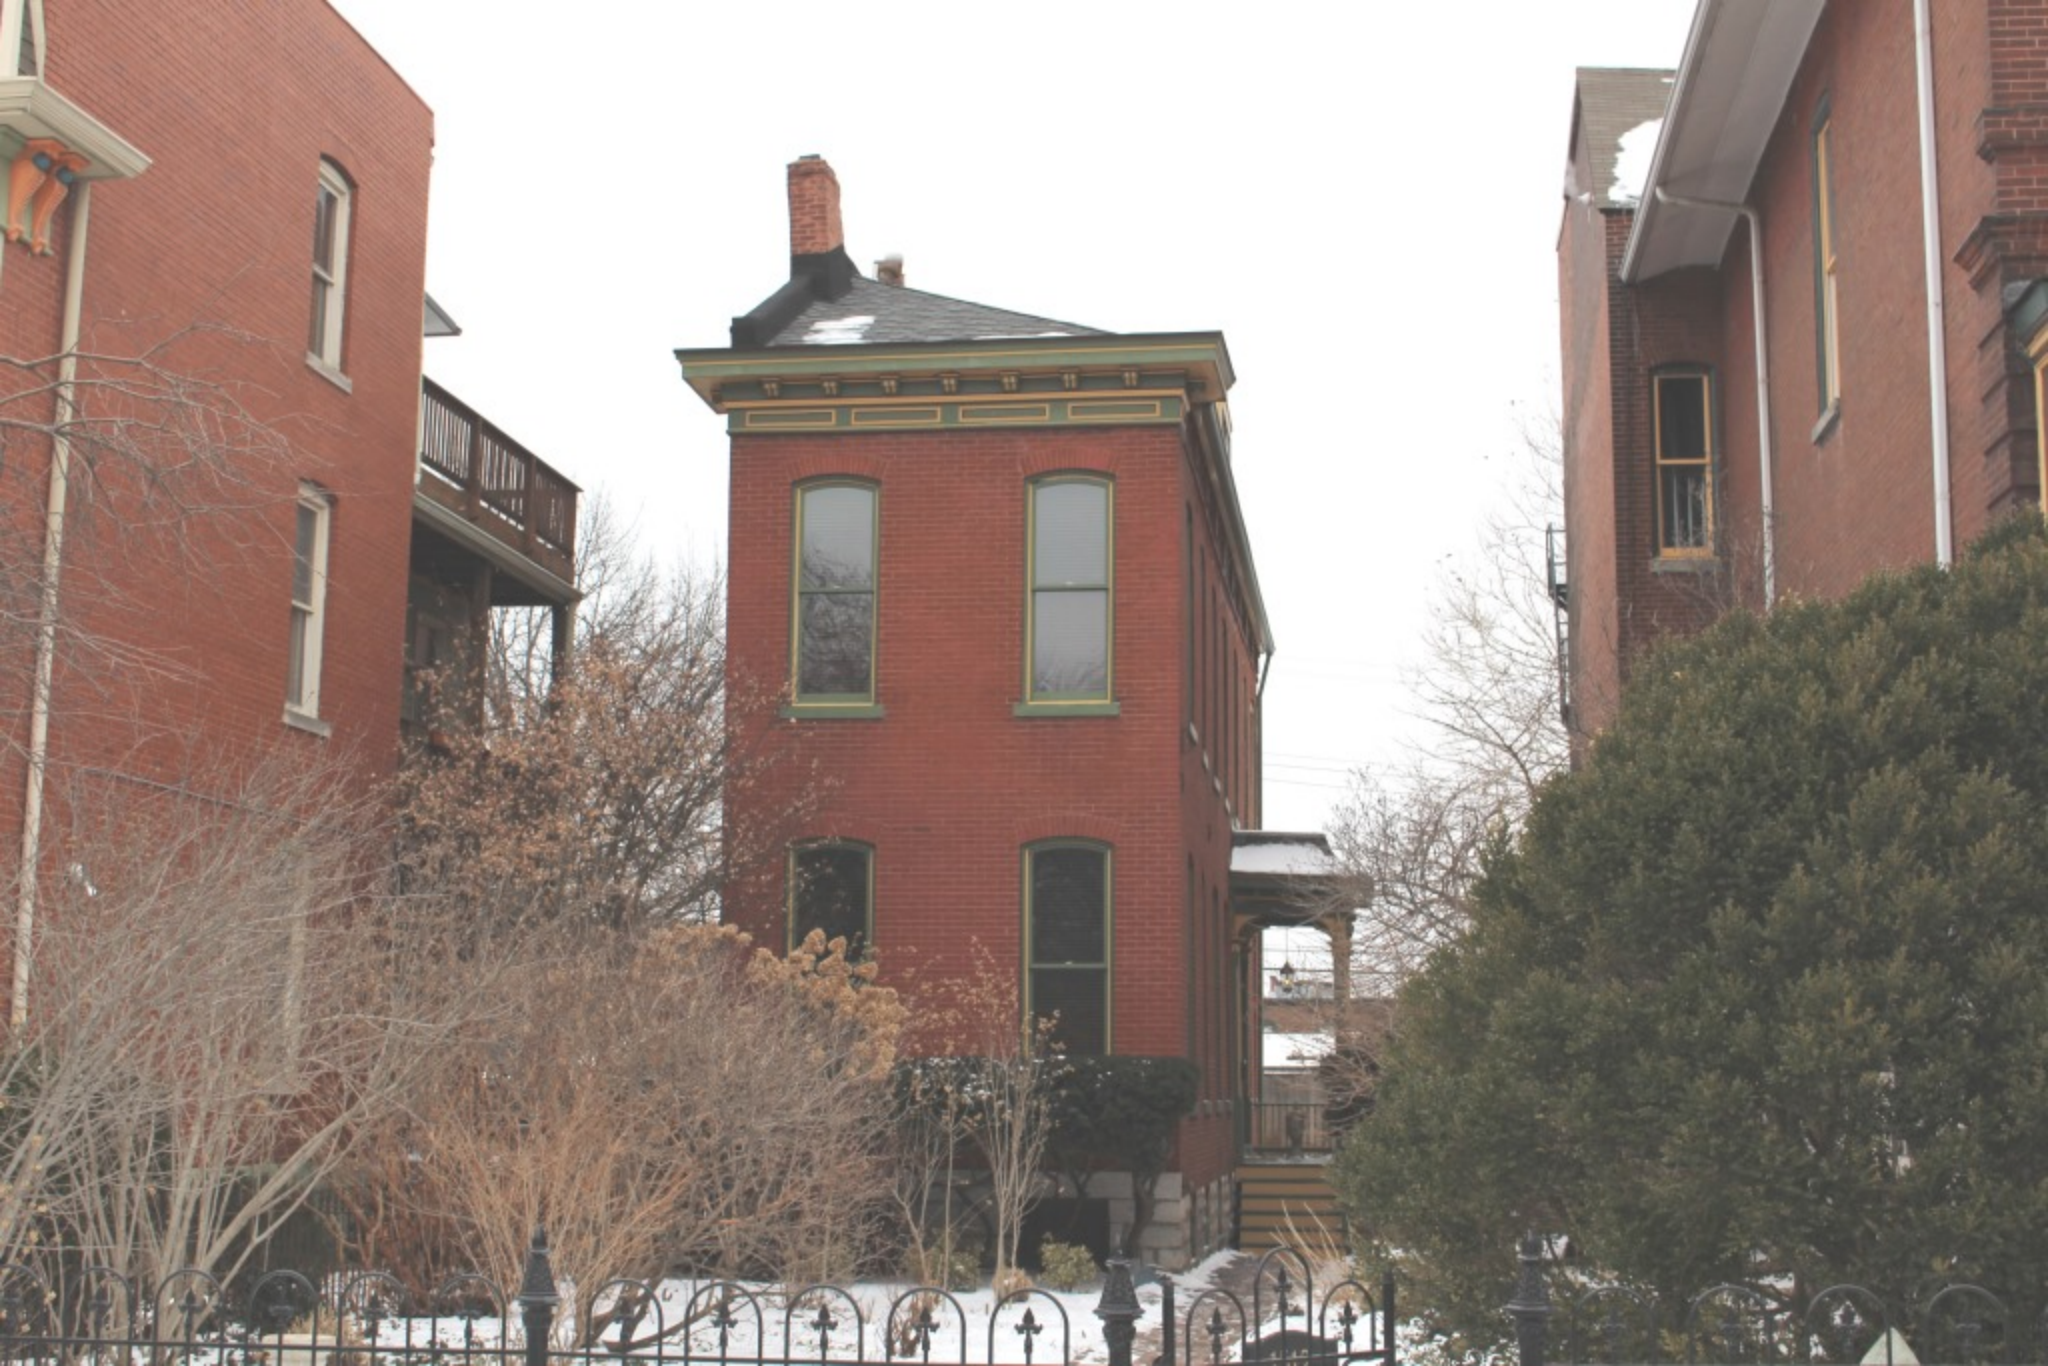
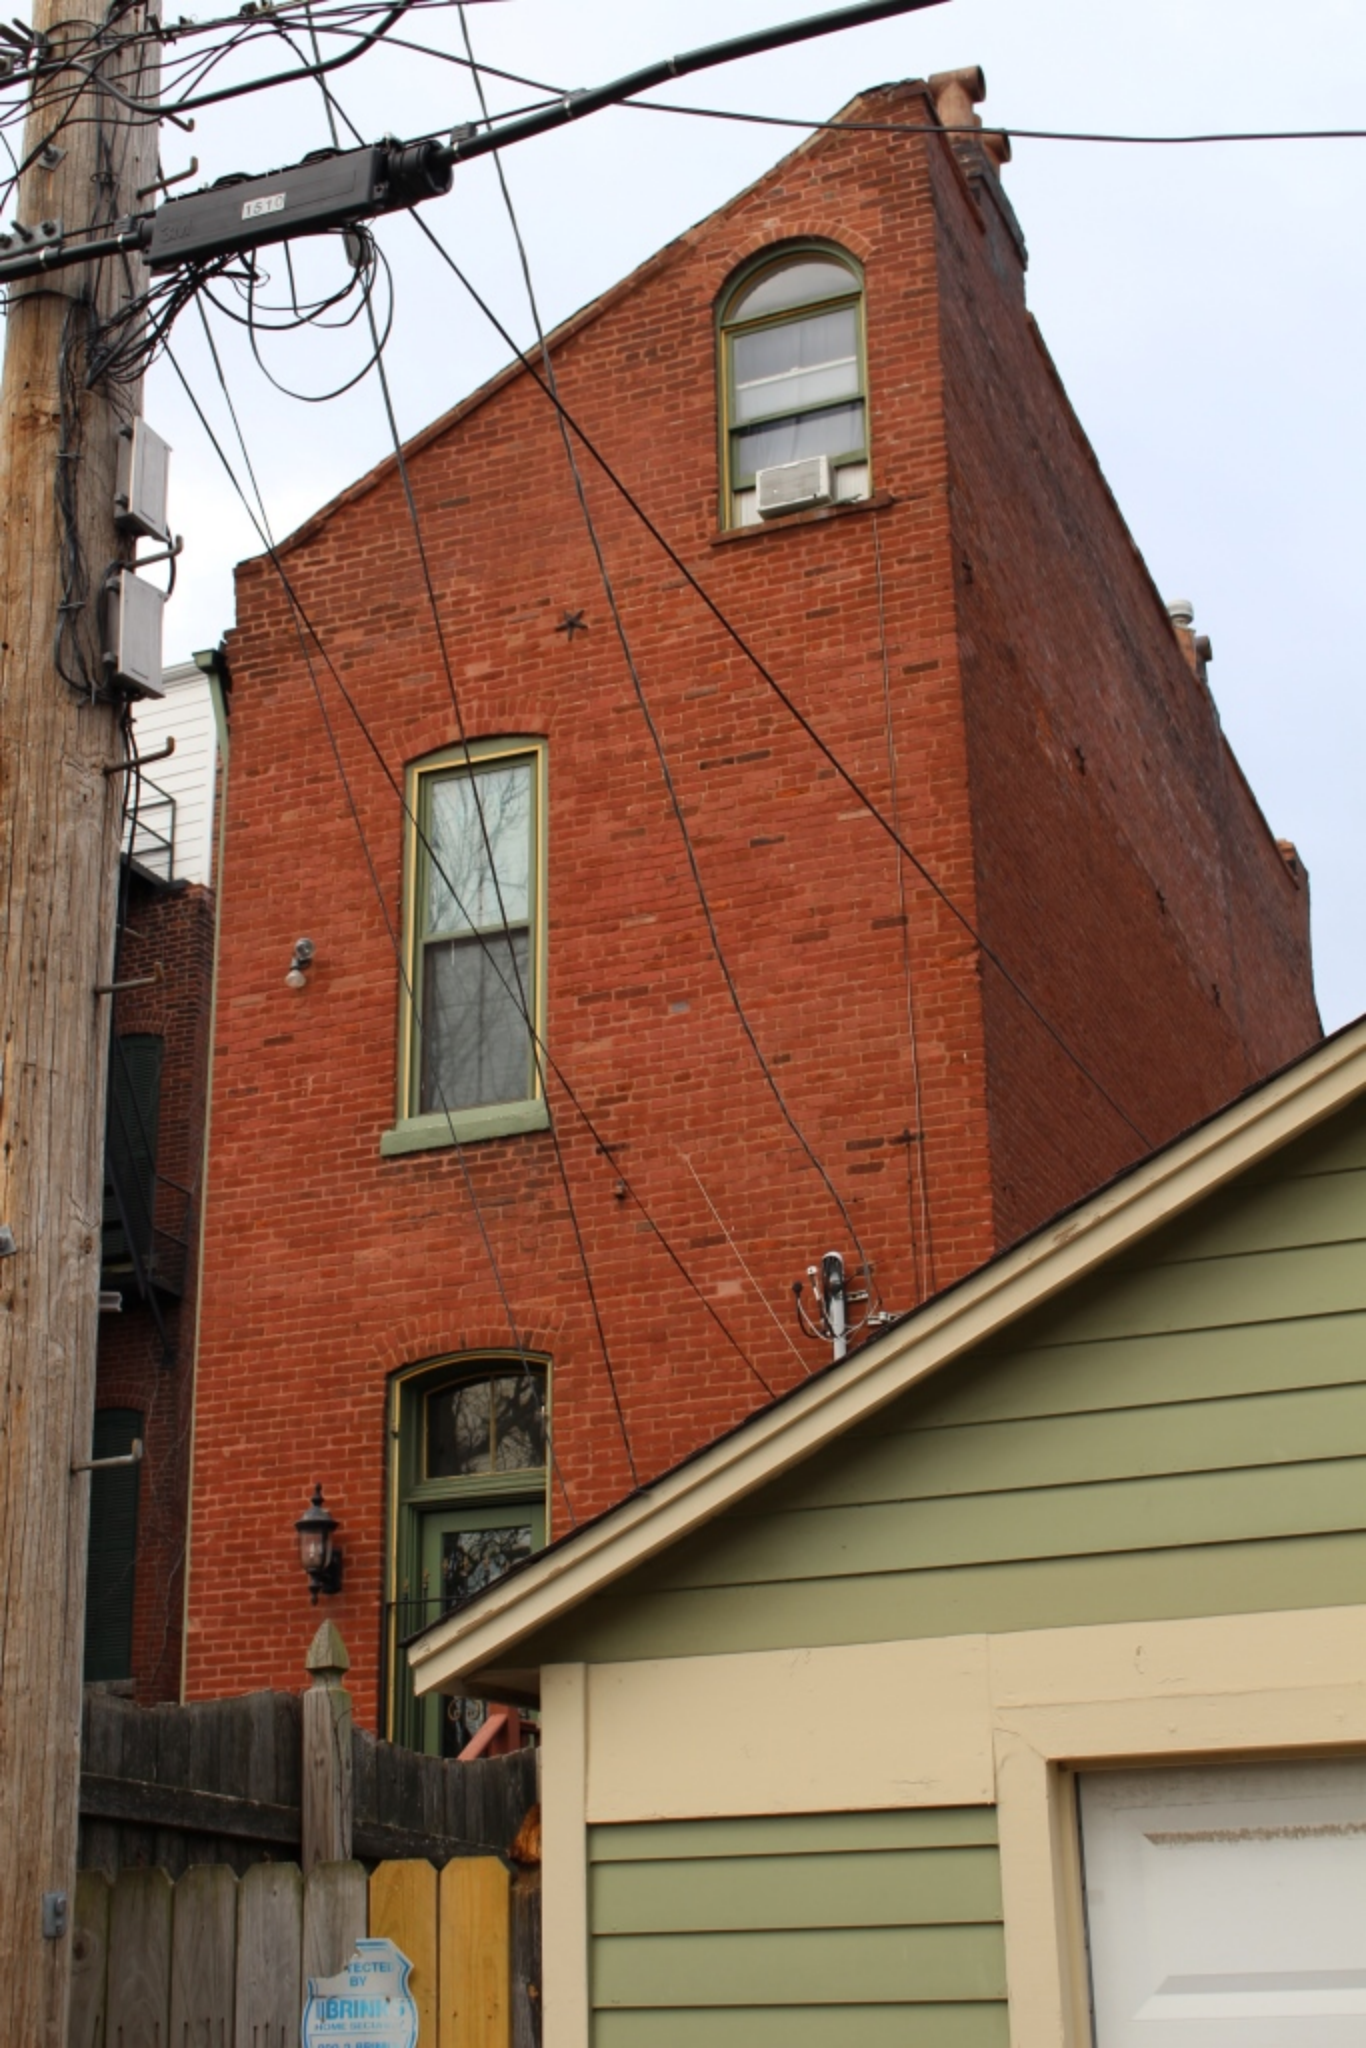
This 2 1/2-story brick flounder is set back near the alley. The house presents 2 bays to the street and has six or seven bays on the south side. The entrance sheltered by a small wood entrance porch is near the center of the wall, in the fifth bay from the front. The foundation is noticeable fine in its cut and coursed presence on the façade, complete with a watertable. Window openings have segmentally-arched heads formed of stretcher brick and sills are stone. Windows hold 1/1 double-hung wood sash. An ornate wood cornice with a paneled fascia and console brackets at the projecting upper portion extends across the façade. A dormer extends from the side roof slope. The taller blind wall has one small window at the second story. A round-headed window in the rear wall lights the attic level. There is a second entrance in the rear wall where the openings have segmentally-arched heads formed of two rowlocks of header brick.

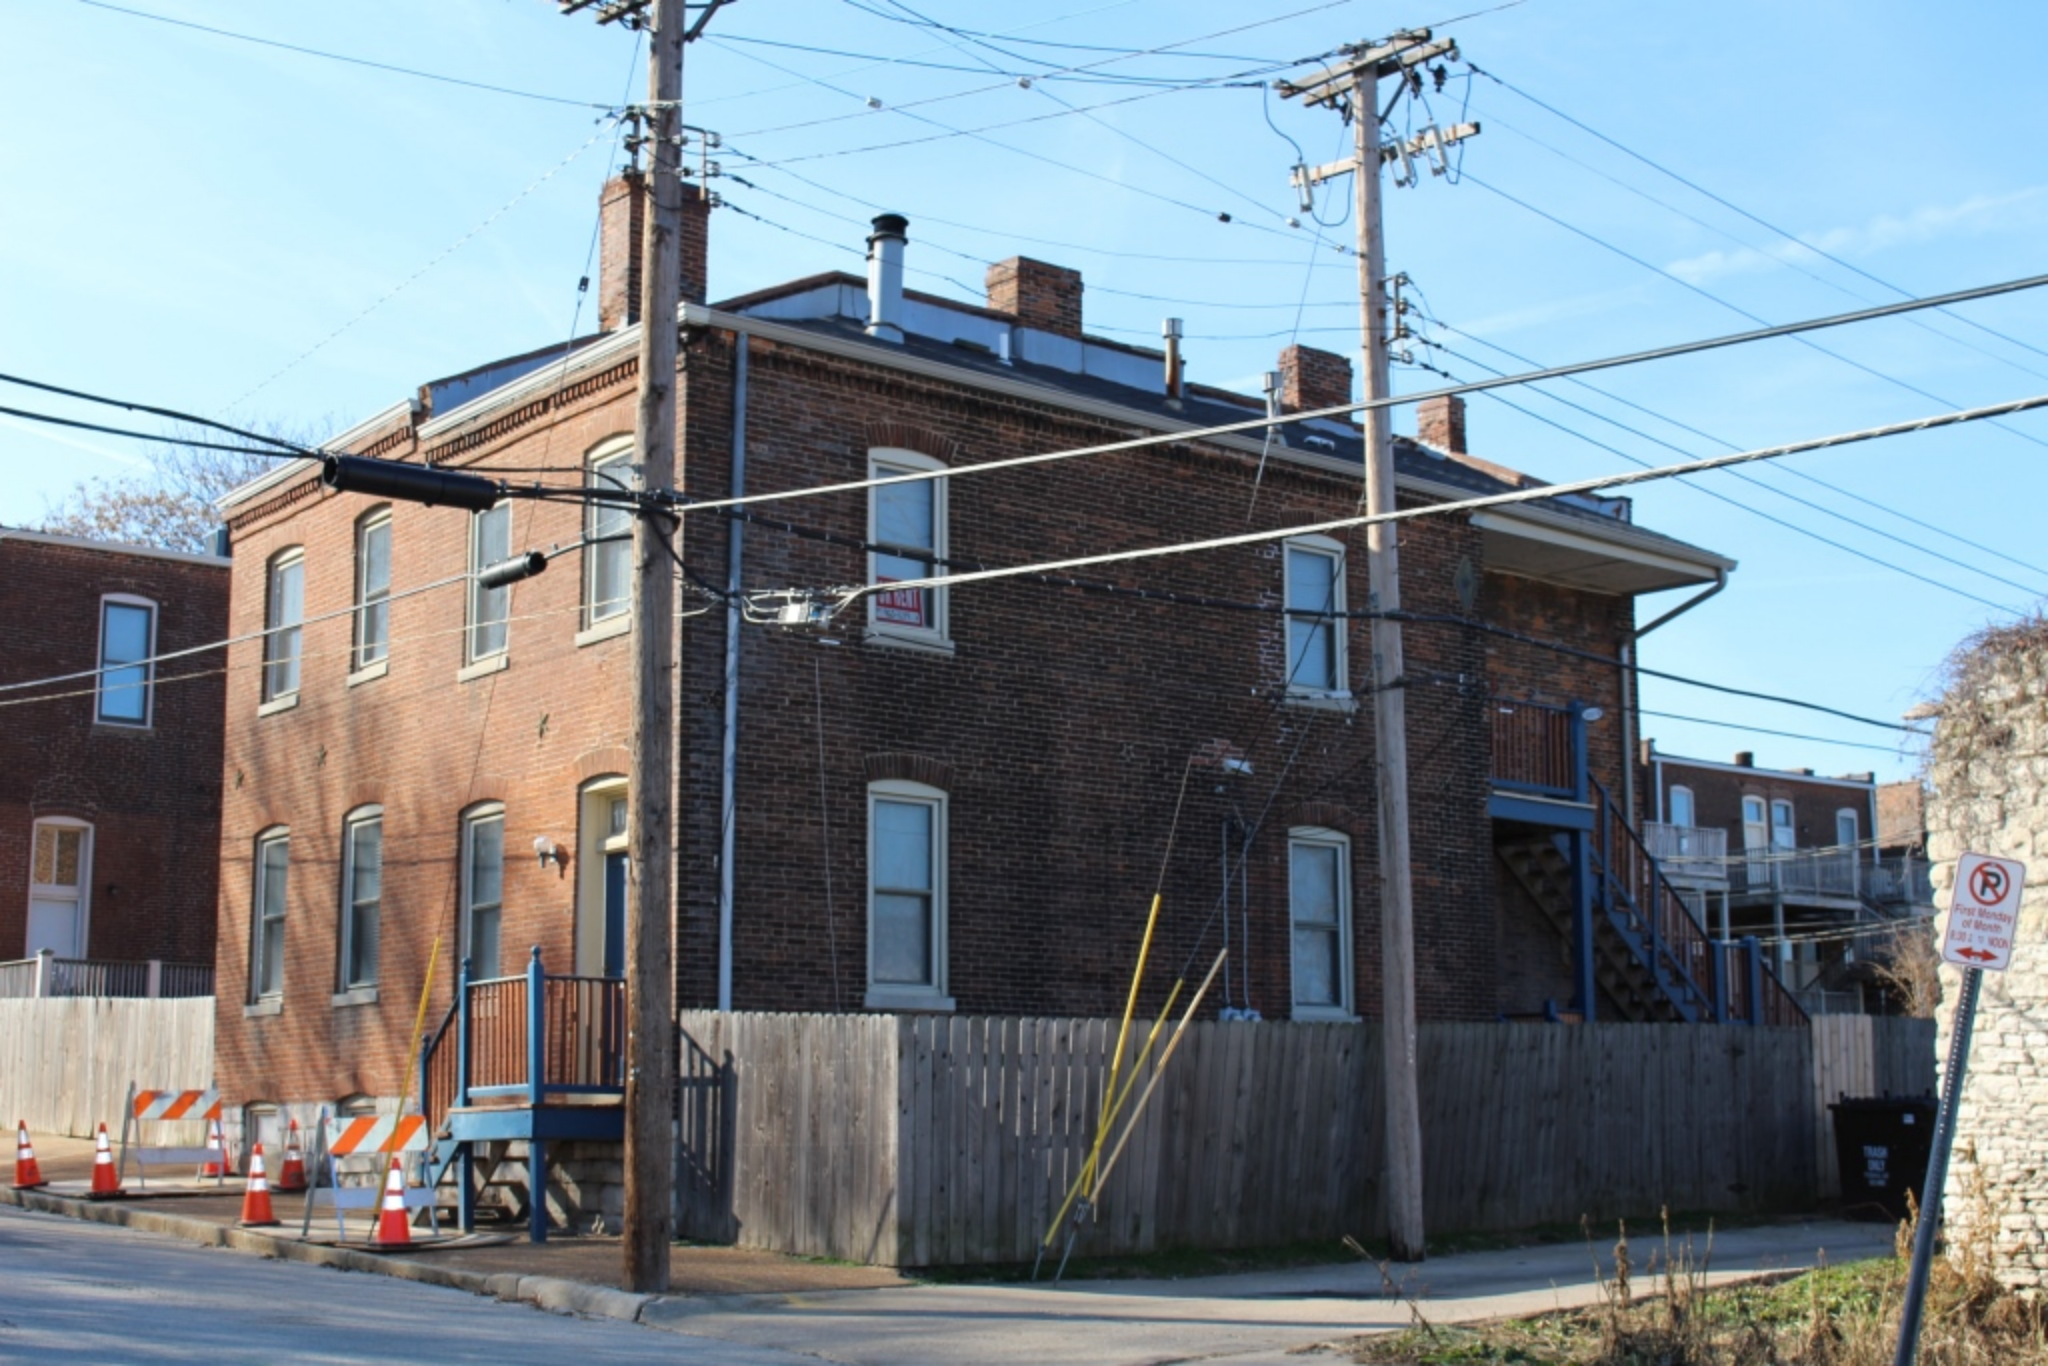
This is a semi-detached brick flounder 2 ½ stories in height and 2 bays wide. Built on a sloping street, it is slightly different in height from No. 1119. Both houses have hipped front roofs and a corbelled brick cornice edges two sides of each building. Both buildings have segmentally-arched window and door openings formed of soldier brick and stone sills. Windows in both buildings have 1/1 double-hung sash. This house has an entrance on Missouri approached by a replacement wood stoop. This building has a narrower rear wing flanked by a two-story gallery with a pent roof. Steps lead to an entrance at the second-story level.
