**ARCHITECTURAL/HISTORIC INVENTORY FORM - Cultural Resources Office**  
**St. Louis Planning and Urban Design**

1. Survey no. SLC-AS-053-0102	2. Survey name: Thematic Survey of Flounder Houses in St. Louis City	3. County: St. Louis [Independent City]
4. Address: (from City GEO database) <b>900 HICKORY ST</b>		5. City/State: St. Louis, Missouri
Alternate address: 900 Hickory Street		Property Zip Code: 63104
Latitude: 38.615737		6. UTM Easting: 743886.40
Longitude: -90.198830		UTM Northing: 4277858.27
8. Historic Name (if known): N/A	11a. Historic Use (if known): Commerce/Trade	City Block 467.03
9. Present/other name (if known):	11b. Current Use: Commerce/Trade	City Ward 7
7. Township-Range-Section: N/A		10. Ownership: Private
Neighborhood Number: 34

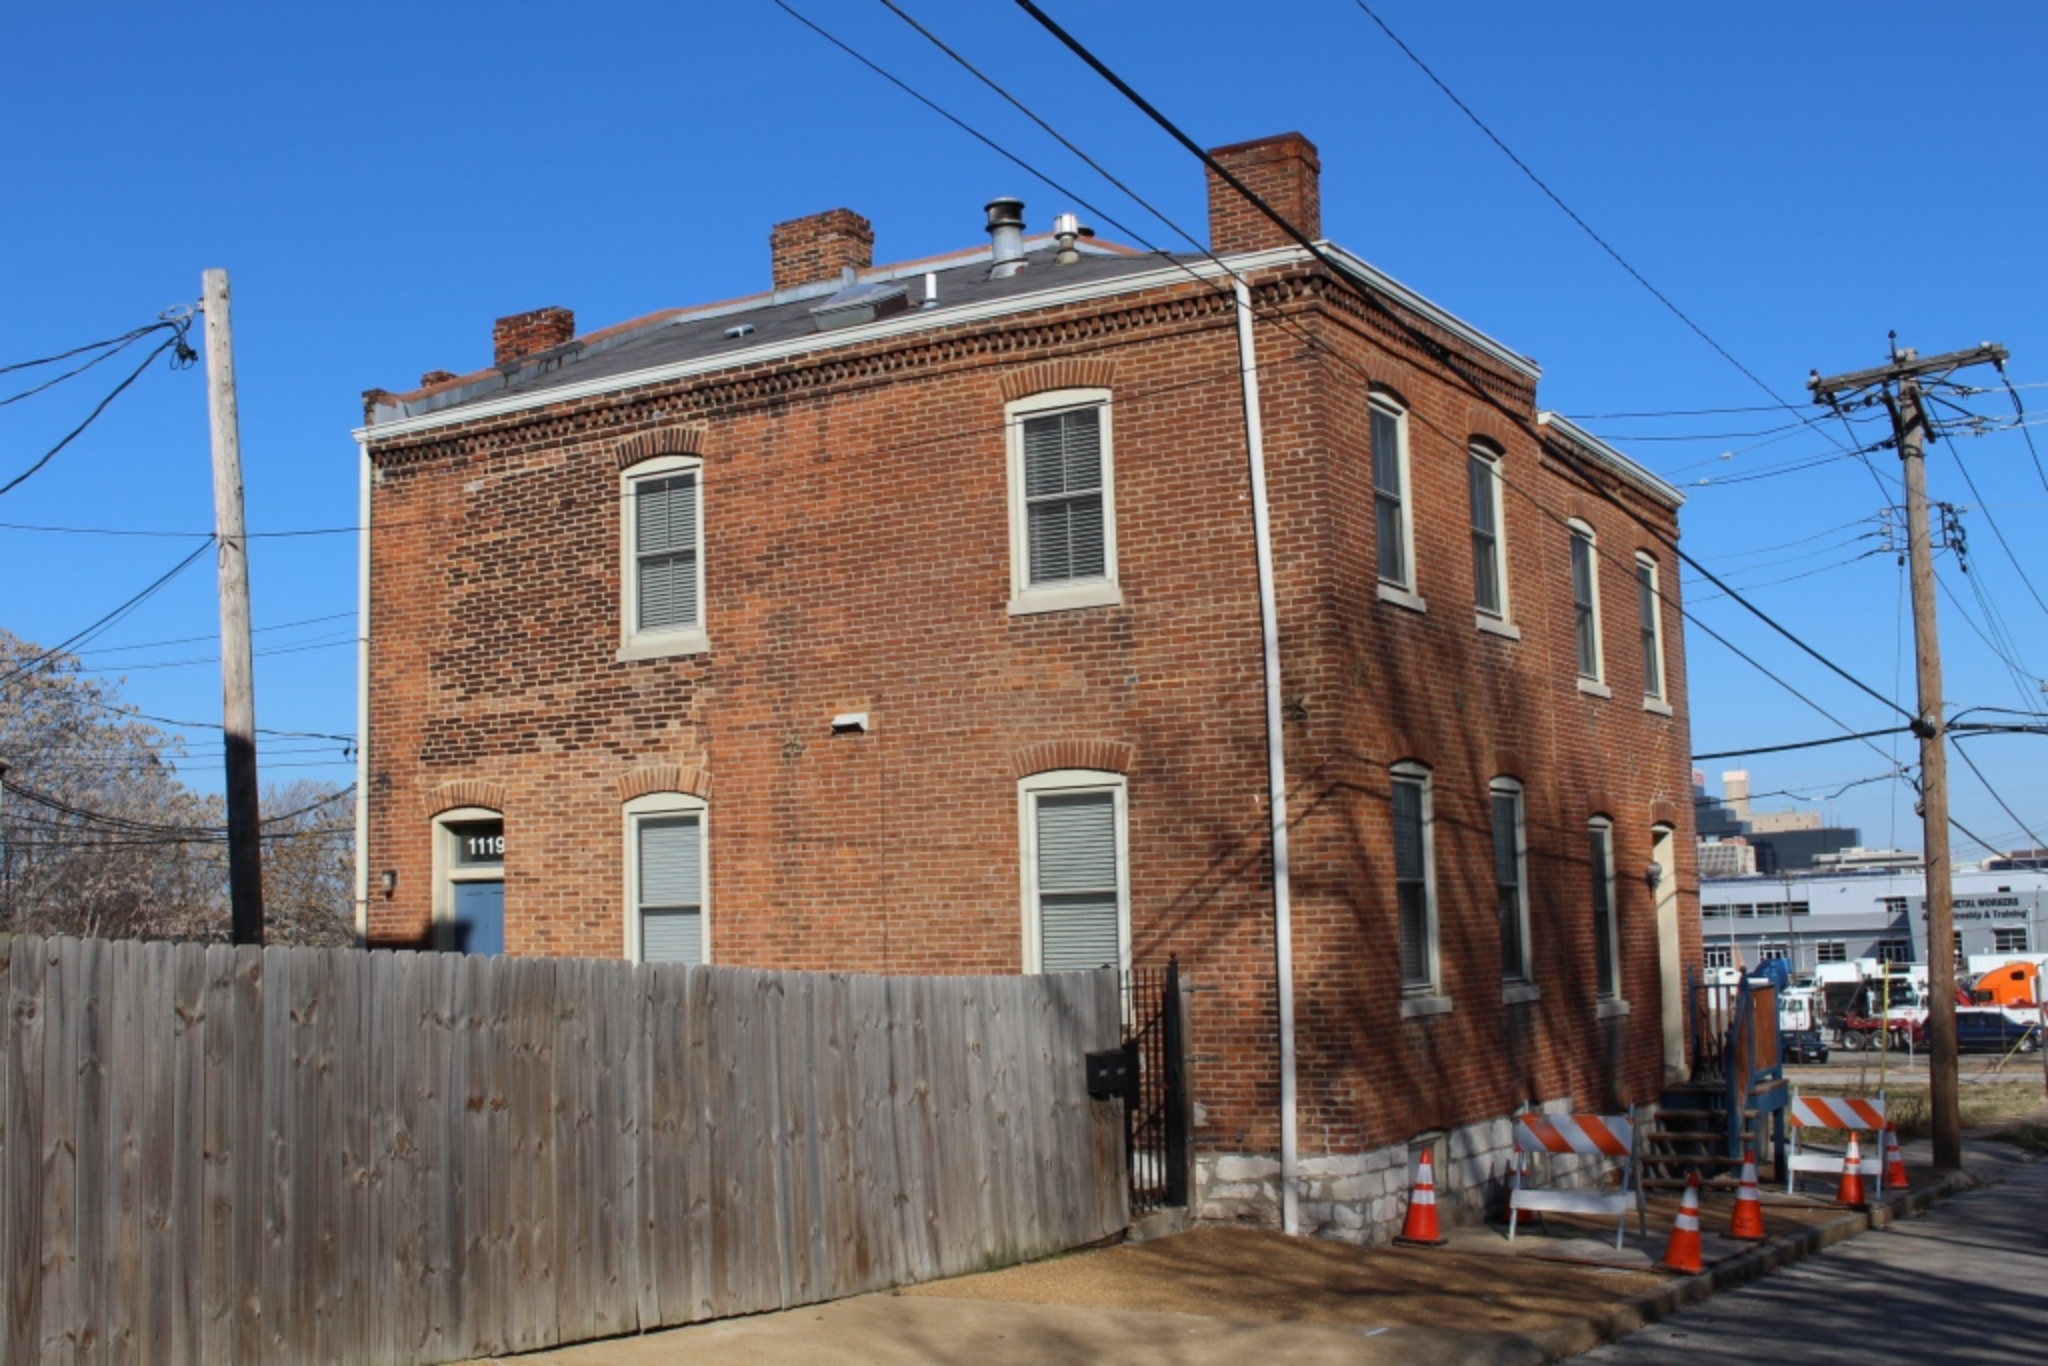
The building is in good condition and is well-maintained.

This is a semi-detached brick flounder 2 ½ stories in height and 2 bays wide. Built on a sloping street, it is slightly different in height from No. 1117. Both houses have hipped front roofs and a corbelled brick cornice edges two sides of each building. Both buildings have segmentally-arched window and door openings formed of soldier brick and stone sills. Windows in both buildings have 1/1 double-hung sash. This house has a two-story sinble-bay-wide gallery at the rear of the main block that incorporates entrances, as well as a door in the rear bay of the south side.

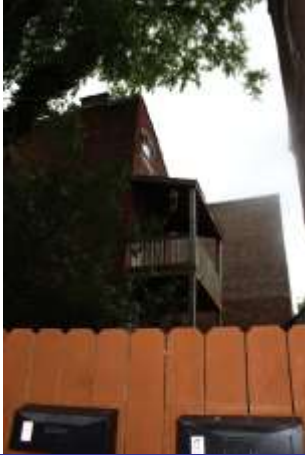
**1205 MISSOURI AV**

The building is in good condition and is well-maintained.

This two-story brick flounder presents two-bays to the street. The horizontal eaves of the hipped front shed roof are edged with a bracketed wood cornice on the façade and a corbelled brick cornice on the south side wall. Small gabled dormers project from both the front and side roof planes. The façade window openings have segmentally-arched heads formed of stretcher bricks and lugged stone sills. Window sash is arched-head 1/1 doublehung sash; the similar window openings on the exposed south side have plain stone sills and square-headed sash. The entrance in the center bay of the south wall; a wood entrance porch shelters the door and provides an exterior balcony at the door at the econd story. There is a two-story rear wing with a two-story gallery across its west end.

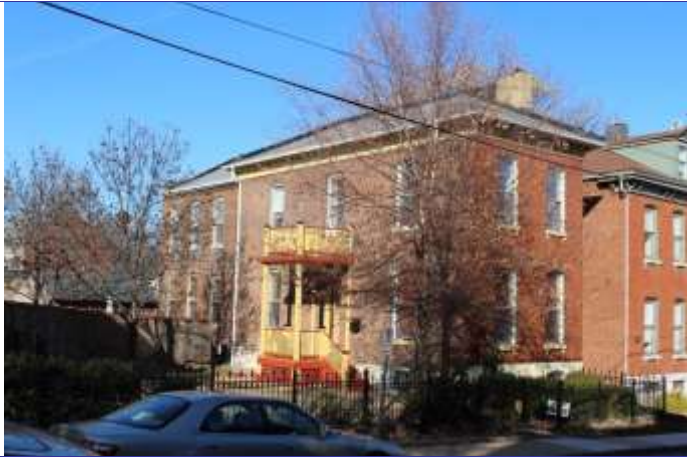
**1207 MISSOURI AV**

The building is in good condition and is well-maintained.

This two-story brick flounder presents two-bays to the street. The horizontal eaves of the hipped front shed roof are edged with a bracketed wood cornice. The façade window openings have segmentally-arched heads formed of stretcher bricks and lugged stone sills. Window sash is arched-head 1/1 doublehung sash; the similar window openings on the exposed south side have plain stone sills and square-headed sash. The entrance in the center bay of the south wall has a wood porch with a upper level; both levels have wood balustrades. A two-story rear wing has the typical flounder form with a shed roof.

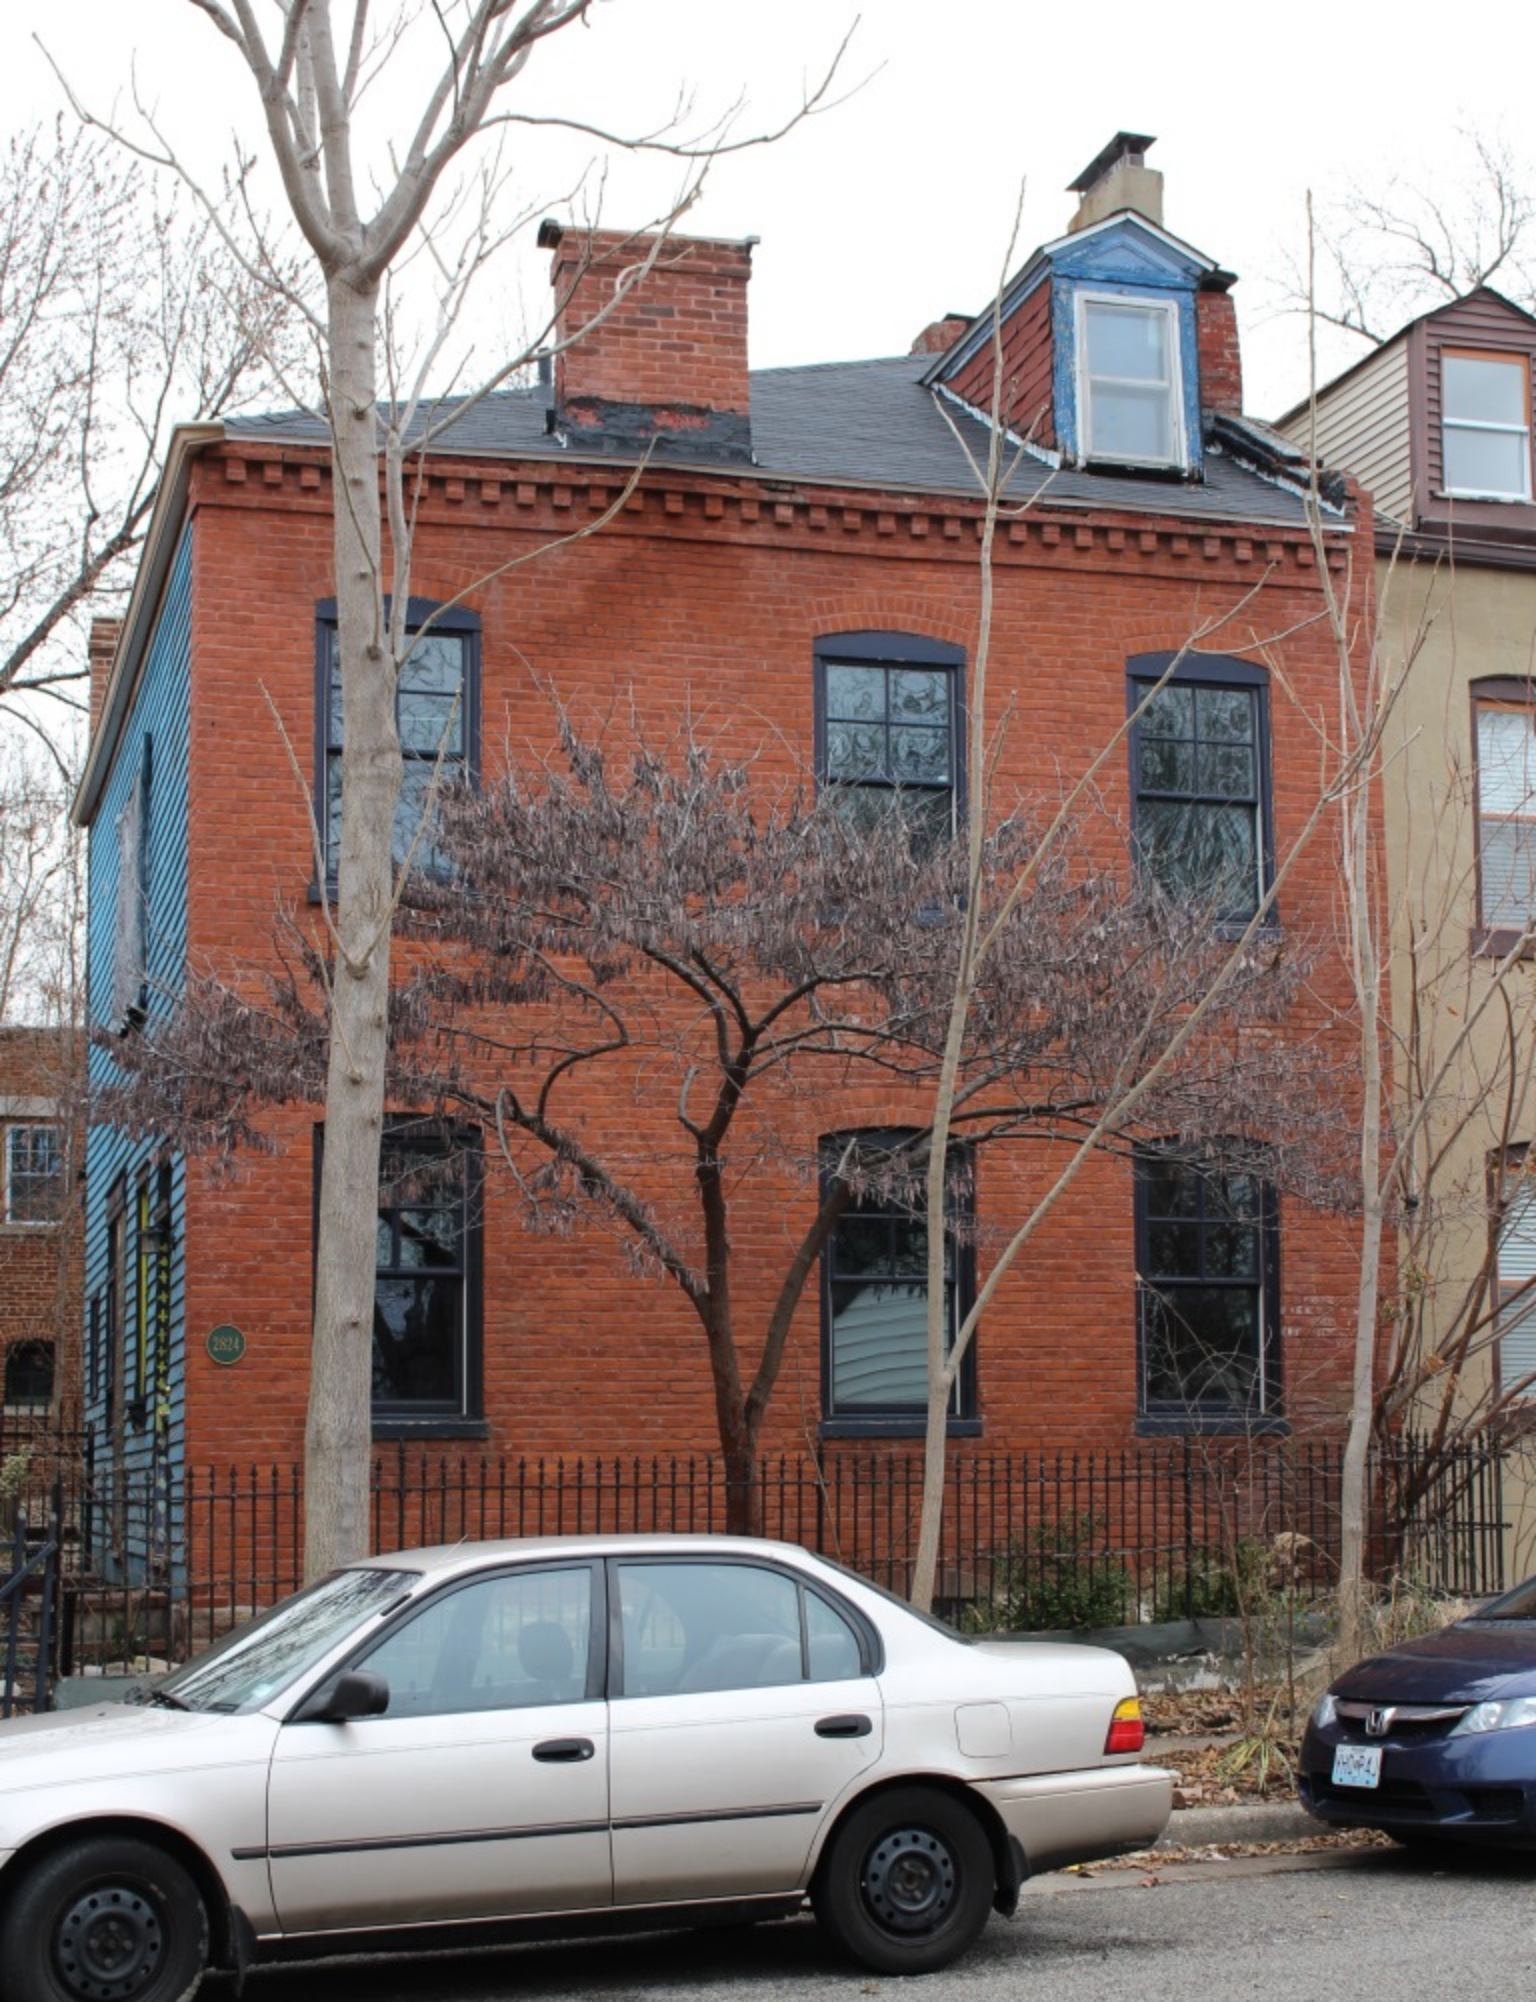
## 2824 MISSOURI AV

The building is a two-and-a-half story side entry Flounder with a wingwall and enclosed side porch. The front façade has three bays. The first and second floors have three windows each. The windows on the left, or first bay, are offset from the other two on the right as it originally served as the window for the open porch on the north side. The first and second floor windows have dual coarsed brick segmented arched lintels with case concrete sills. The basement windows have single brick segmental arch lintels. There is an ashlar watertable that runs the length of the front façade. A dentiled brick cornice runs the length west façade. A frame dormer projects from the roof on the west side of the house. The north side of the building was formerly a full length two-story exterior porch that has been enclosed. There are two doors on the north side. One serves as the primary entrance to the house and the other has been boarded over. There are two other windows on the first floor north side, one double-hung and one casement. There are two doublehung windows on the second floor on the north side. The rear of the building has a traditional flounder appearance. The hip roof is not evident in back. The first and second floor fenestration is the same as the front of the house. The third floor window is situated in the façade versus a dormer. The building has several chimneys coming from all four sides of the house. The front façade chimney projects from the front parapet at point where the wing-wall meets the main block of the building. There is another chimy along the ridge to the south where it connects with the adjacent building and also another chimney ar the rear along the northwesrt corner.

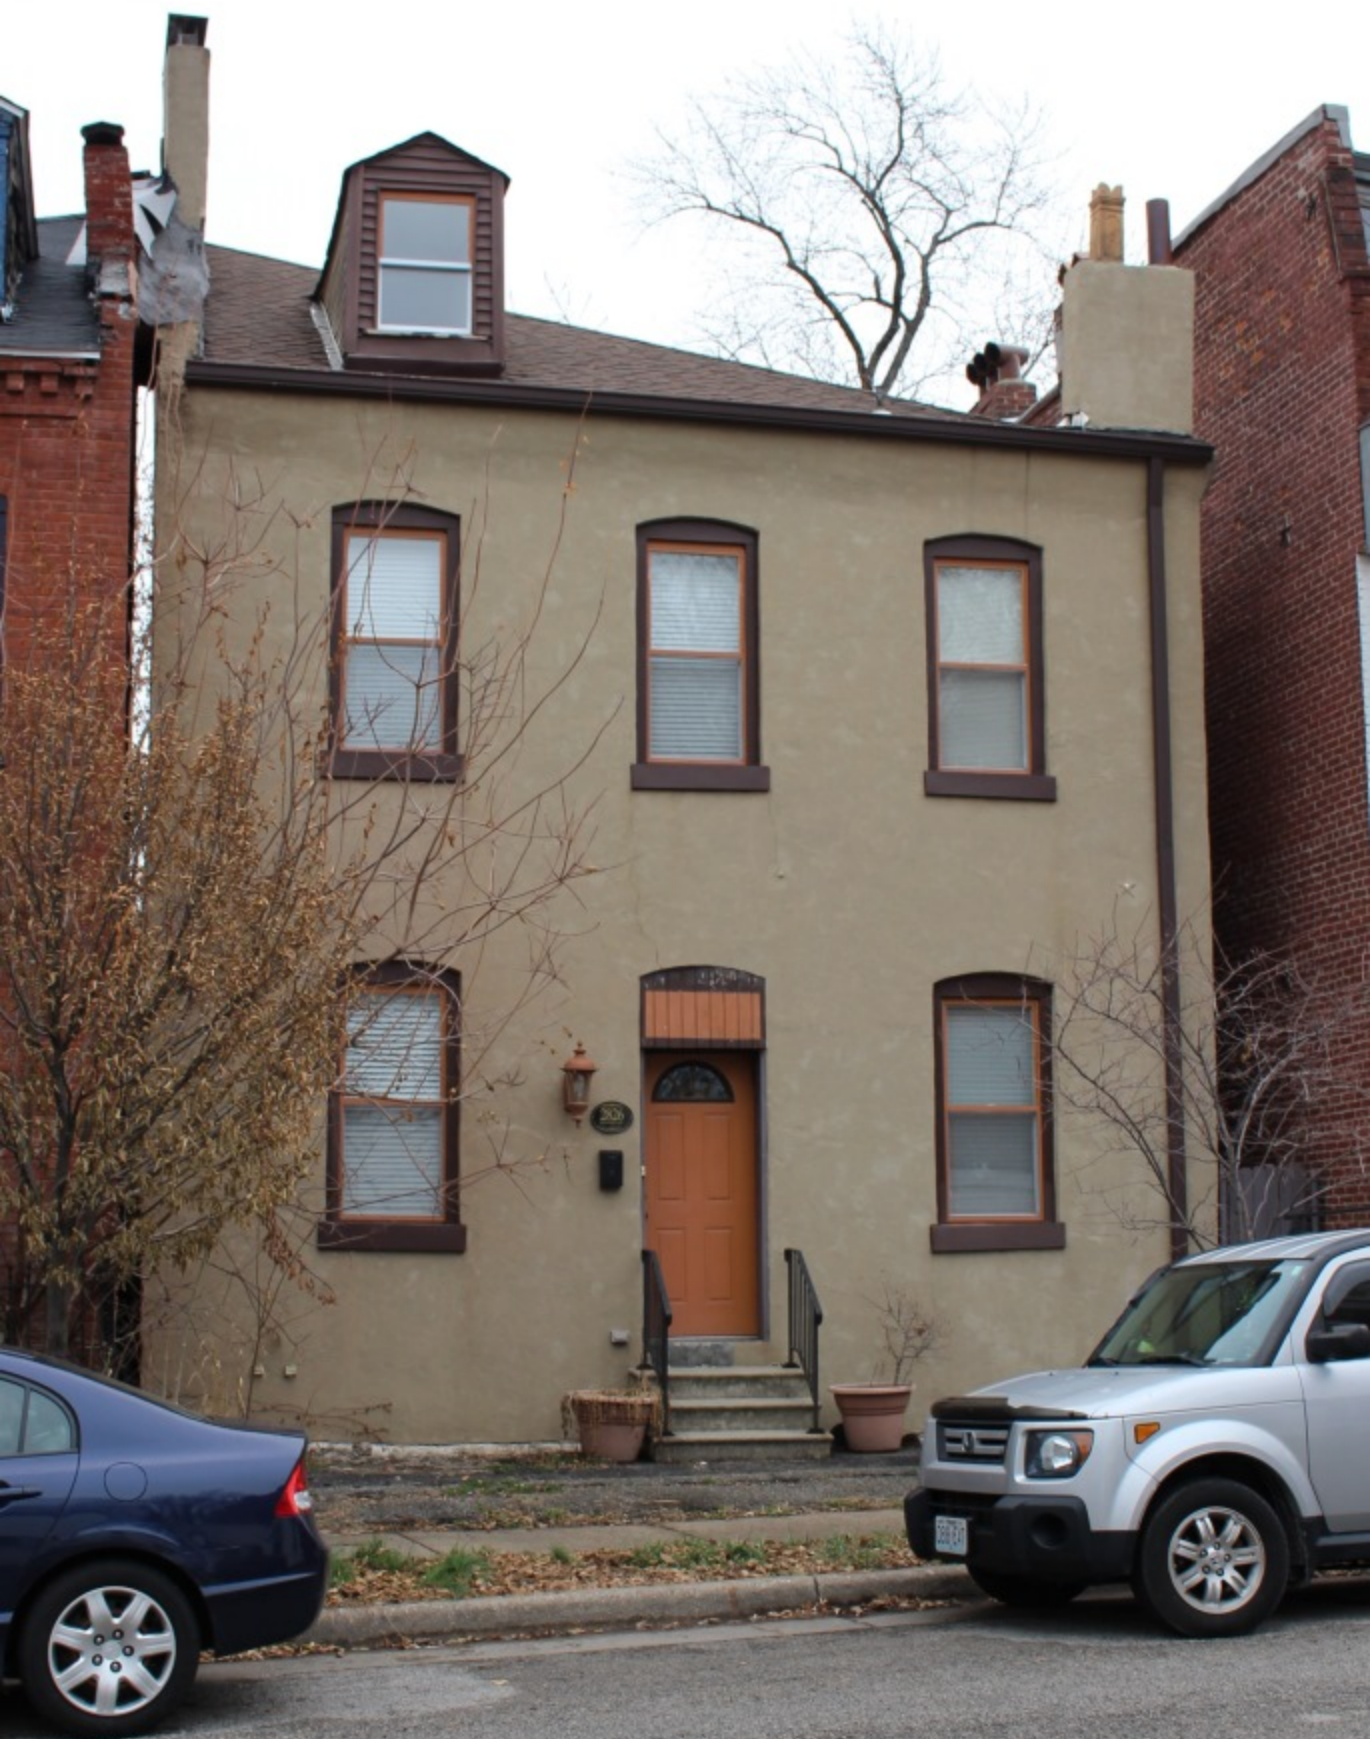
## 2826 MISSOURI AV

The front façade of the building has been covered over completely with stucco. There are three bays on the front with a centered front door on the first floor. All the windows and front door on the west façade have been replaced. The front door is a contemporary replacment and the transom has been boarded over. A small set of precast concrete steps accessed the front door. There are two flanking windows on the first floor and three windows on the second. All the windows are arched and have had their brickmolds and sill wrapped with aluminum. A frame domer with a small doublehung window projects form the roof on the west side. The dormer is clad with vinyl siding. The north and south facades are too close to the adjacent buildings and cannot be seen from the street. The rear of the house is not covered in stucco. There are three windows on the first and second floors. These windows have segmented arched lintels. There is a single window in the upper half section of the façade.

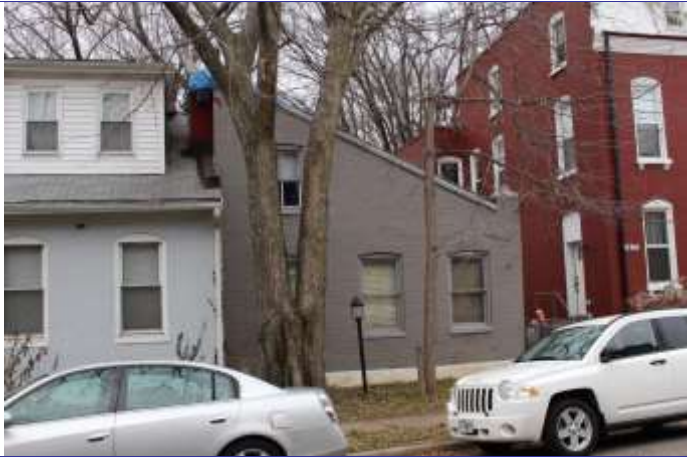
**2835 MISSOURI AV**

Roof in very poor condition. Blue tarp covering the entirety.

One and a half story traditional brick flounder. The first floor of the front façade has three segmentally arched linteled windows with cast concrete sills. There half story has the a similarly detailed window. The front foundation has been parged over. The parapet that runs along the front façade has a dual brick course covered by clay tile coping. The entrance to the house is on the north side. The door itself has been replaced with a modern model. No other openings are visibnle on the north side. The entire house has been painted grey.

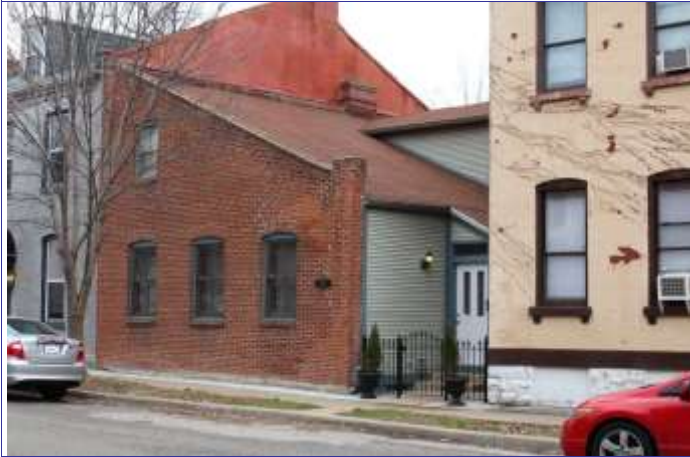
**2836 MISSOURI AV**

The main entrance has been altered to face street

The front facaded features three bays. The first floor has three windows that have header course brick sills and dual course segmented arched lintels. There is a smaller single window in the half story. That widow is shorter than the first fflow windows. The exposed foundation has been parged over. The parpet that faces the street has brick coping that has been covered over with mortar. The south side of the building is frame and covered with lap siding. The front entrance has been built out to accommodate a front facing modern door. A large frame dormer projects from the south facing roof like. The rear of the propert has the same fenestration pattern as the front of the house.

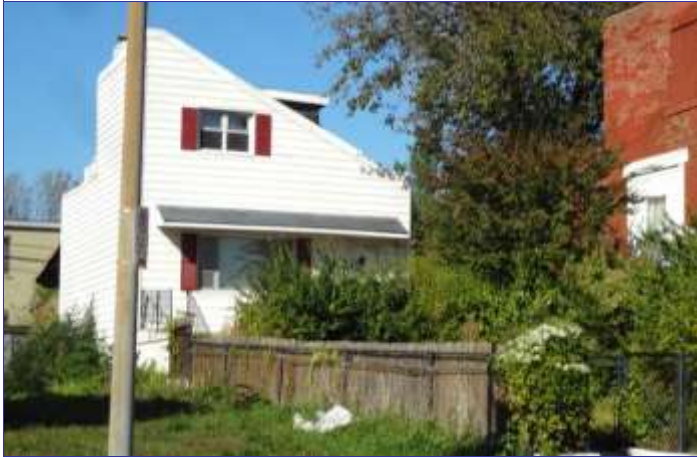
**3333 MISSOURI AV**

Two-and-a-half story brick flounder covered in wide lap aluminum siding. Appears to have originally had a side-gallery which has now been enclosed. Front window openings have been altered with a wide double-hung with shutters at the first story and small, paired double-hungs at the 1/2-story. The door has also been replaced. The brick front stoop with shed roof awning, a later addition, runs the width of the building. A shed roof dormer on the north side, also an addition, is visible from the street. There is a large, one-story frame addition at the rear of the building with a flat roof covered in the same aluminum siding. A pergola is attached at the rear of the addition.

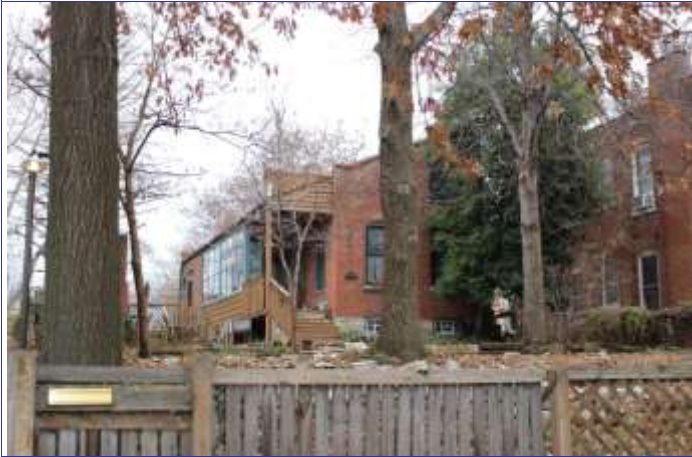
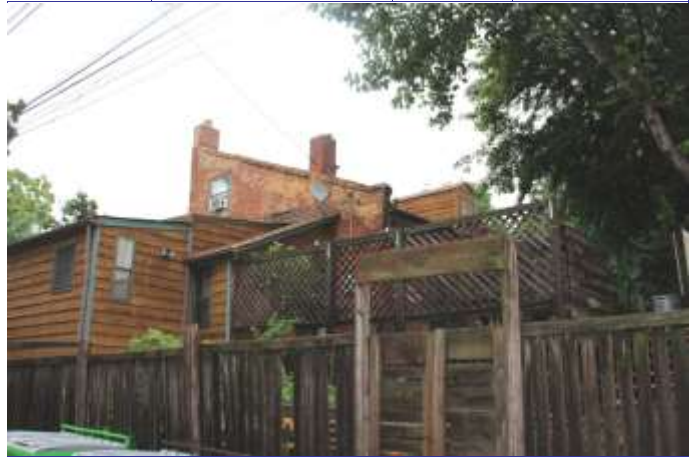
**3445 MISSOURI AV**

Additions, fencing and structures at alley obscure view of rear façade.

One and a half story Flounder. All windows and doors have segmental soldier arches and wooden sills. East, front, façade has two windows on the first floor with a single window at the half-story. The front facing basement windows have been closed with glass block. Entry is through the original side gallery, now partly enclosed, on south side of the building. The brick rear addition (c. 1900) has a singleleaf door and transom, and now accesses a wooden deck that wraps around the rear of the building. A small central dormer projects from the roof on the south side of the house.

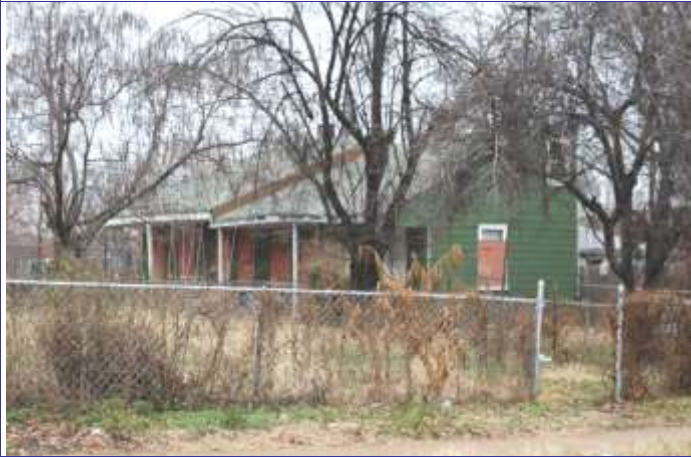
Looking northwest from Missouri Avenue

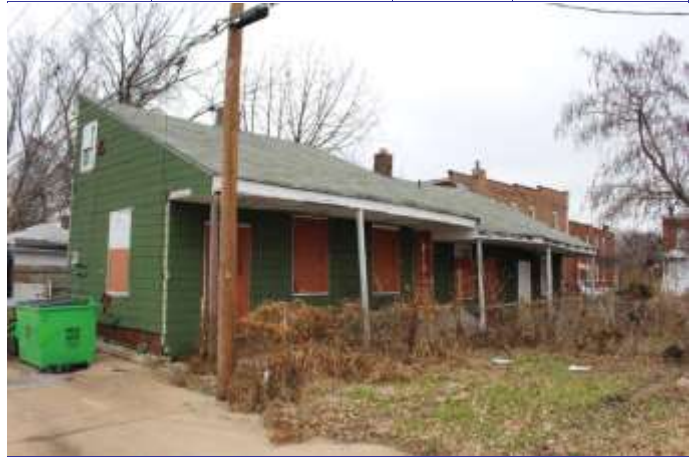
Looking southeast from alley

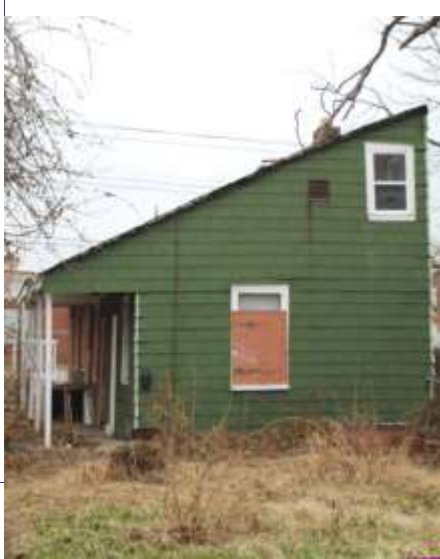
Front facing Missouri

Original 1-story flounder with loft was constructed in the center of the parcel at the north property line. It was constructed nearly at grade and does not appear to have a basement. Its narrow, 2-bay façade faces Missouri, and presents a single window (boarded) at the first story and a small doublehung window near the appex of the roof. A brick stove chimney is centered on the blind north wall. On the south façade, the roof extends to create a recessed galley porch. Paired doors (boarded) are centered on this elevation, flanked by single windows: that to the west of the entries is an original 2/2 wood window; the other has been replaced with wood 1/1 sash. Entry to the loft is from the exterior at the western façade; the original stair has been replaced with a cast concrete stoop. A larger but similar flounder addition was made to the west façade at an early date, with a full rubble limestone basement; access to the basement is down a very steep set of stairs adjacent to the attic stair. The foundation extends approximately 1 foot above grade, making the addition slightly taller than the original flounder. It also has a central brick stove chimney on its blind north wall and a side gallery on the south façade, which has 3 bays: an entry door on the west and two windows (all boarded) somewhat larger in size than those of the original structure. The west (alley) façade of the rear portion is similar to the front façade with a single window at the first story, and small window at the roof apex (replaced with a 4/4 vinyl window). The entire structure is clad in asbestos shake shingles, painted green, over brick-pattern asphalt siding atop the original wood clapboards. Porch posts have been replaced and the roof covered with asphalt shingles.

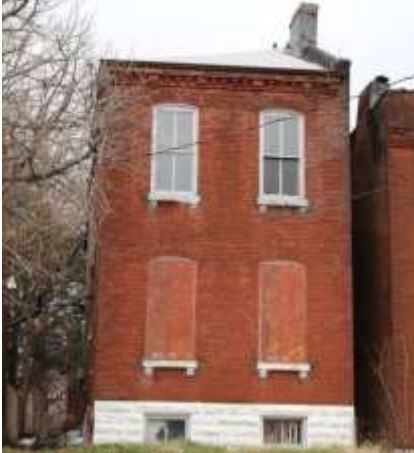
2-tory side entry flounder with corbelled brick cornice that wraps around the east and south sides of the building. Four first and second floor windows feature segmented arched windows with bracketed stone sills; original wood 2/2 sash remain in most openings. Eyebrows over each of the four front facing windows have incised decorattion. Original 2-light awning basement windows. Storm sash has been installed on all openings. The entry centered on the south elevation has been boarded, as have the first floor windows.

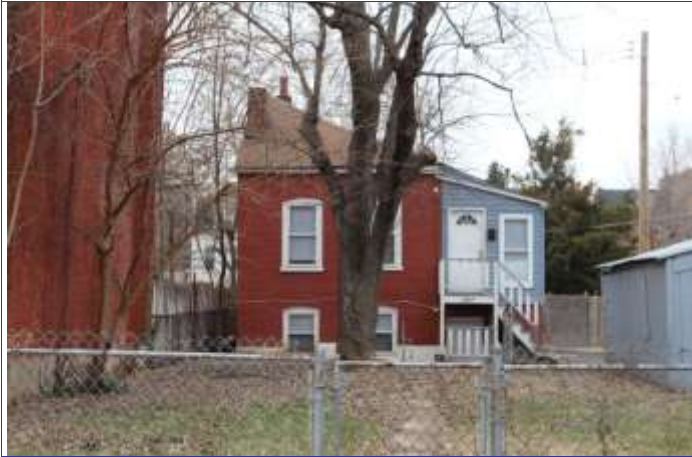
At the rear property line is a 1-story frame flounder, likely the first building on the property. The front block is a 1-1/2-story flounder with raised basement. Both flounders are sited with their tall blind walls at the lot's south property line. The rear flounder, which appears to have had a side gallery, has been altered with a brick foundation atop a limestone sill. A 1-story frame addition, shown by the time of the 1909 Sanborn, runs the length of the north wall of both flounders. The frame flounder and addition are sheathed in vinyl lap siding. The front flounder has a hipped front and similar brick and stone foundation; its 2-bay front elevation faces Missouri. A narrow brick corbelling runs below the exterior gutter. Windows have segmental arched soldier brick lintels. All sills and brickmolds have been wrapped on the building and vinyl replacement windows installed. Entries are now in the side addition: the main 1st-story singleleaf door is flanked by a doublehung window; directly below and half above grade is an entry into the raised basement. All masonry has been painted.

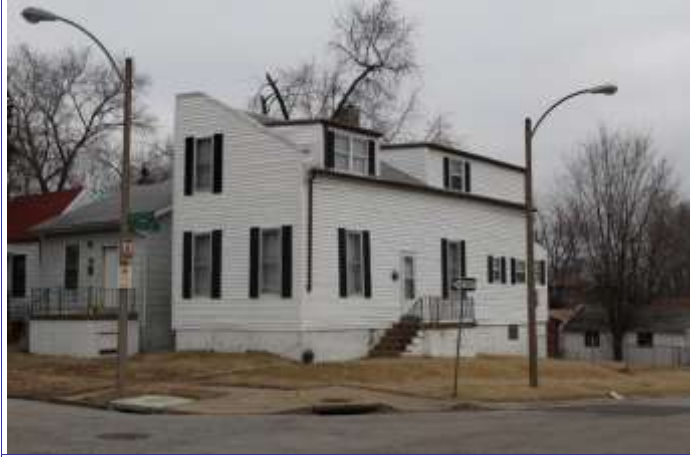
This 1 1/2-story wood framed flounder has a foundation of rubble limestone under the original portion of the house and concrete under the 3-bay addition on the east end. The 2-bay shorter wall facing Missouri has the same size of window in the attic level as at the main story. The entrance is the second bay in the long wall facing Osage; a concrete block stoop provides access to the door. Flanking windows, as well as those on the Missouri façade have 1/1 doublehung vinyl sash. Vinyl ship-lap style siding unifies the exterior walls. A shed-roofed dormer extends near the Missouri end of the shed roof and a much larger one extends to its east; the dormers are clad with the same siding. A one-story porch-size wing extends from the east end of the residence.

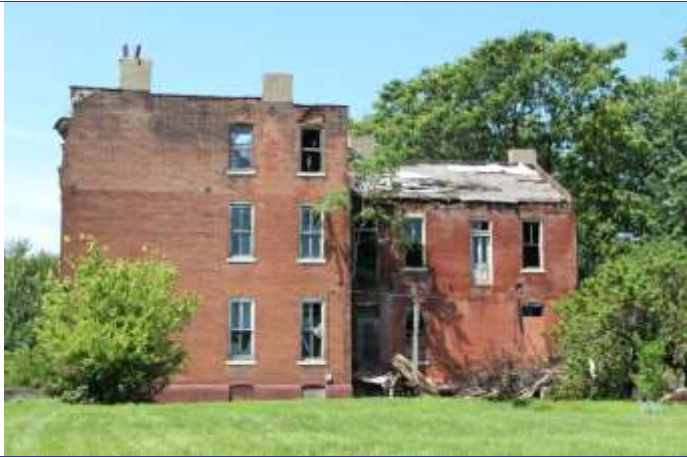
The two-and-one-half story brick flounder, now a rear wing but thought to have been free-standing initially, is perpendicular to the street and had a two-story wood gallery along its east side; only remnants of the gallery remain. Although some of the lower openings are blocked, it appears that two doors on each level opened onto the gallery. At the upper level, a four paneled wood door with glazing in the upper panels is set below a transom. The flounder has a rather high limestone foundation below brick with basement windows above grade. The narrow rear façade has only one bay of windows; the taller eastern wall is windowless.

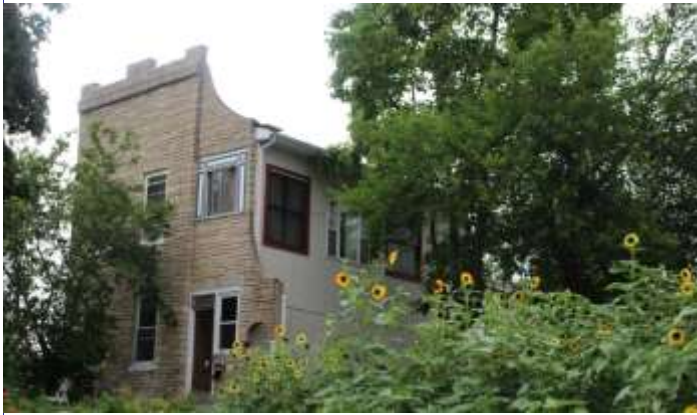
Front (south) elevation

Permastone front; gallery enclosed with T-111 siding. Variety of replacement windows.

This flounder is a 2-1/2 story common bond brick flounder. Its taller blind wall is situated on what was the site's original west property line and there is a 2-story brick flounder wing at the rear. The 2-bay front elevation has been sheathed in artificial stone, c. 1950, and received at the same time a high horizontal parapet with pinnacles; the originally open 2-story side gallery was faced on the front with a wing wall, of the same material, containing a new singleleaf door flanked by a single doublehung window. The side gallery has been enclosed with plywood vertical-scored siding, incorporating at the second story, three large window opening of different sizes. The same plywood covers the 2-story rear addition. Windows throughout are aluminum replacements. Despite the addition of artificial stone and the gallery enclosure, 1453 Monroe was determined to be a contributing resource to the Murphy-Blair National Register District.
