NATIONAL REGISTER OF HISTORIC PLACES REGISTRATION FORM
l. Name of Property
historic name: <u>Fulton Bag Company Buildings</u>
other name/site number: <u>John Milliken & Company Buildings</u>
2. Location
street & number: 612-18 South Seventh Street
not for publication: N/A
city/town: St. Louis vicinity: N/A
state: MO county: City of St. Louis code: 510 zip code: 63102
Ownership of Property: <u>private</u>
Category of Property: <u>Buildings</u>
Number of Resources within Property:
Contributing Noncontributing
2 buildings sites structures objects Total
Number of contributing resources previously listed in the National Register:0
Name of related multiple property listing: N/A

Section: 7 FULTON BAG COMPANY BUILDINGS

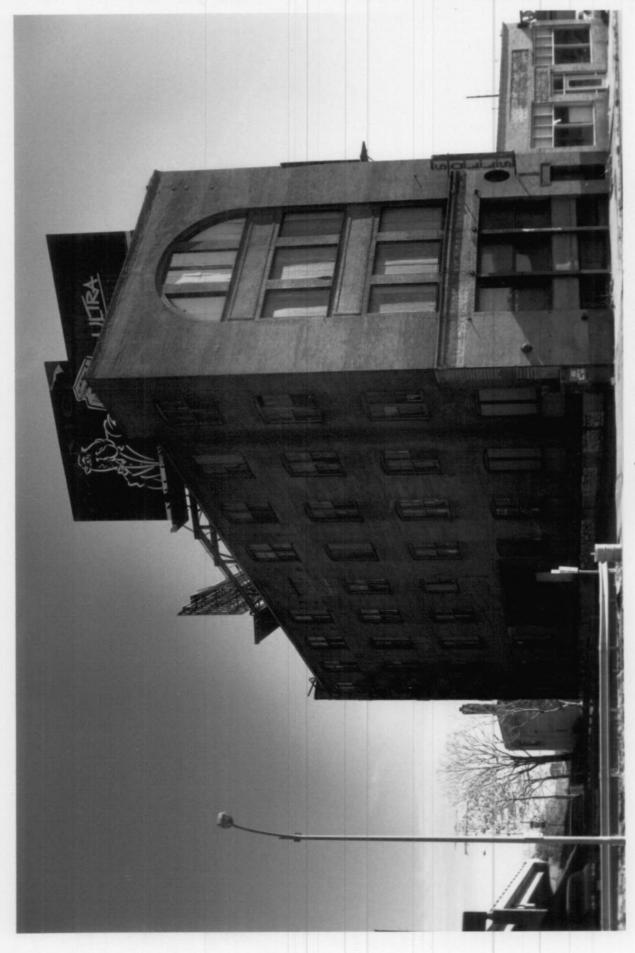
1#

PRIMARY & NORTH SIDE ELEVATIONS; FACING SOUTHEAST FEBRUARY 1991
PHOTOGRAPHER: CYNTHIA LONGWISCH
NEGATIVE: LANDMARKS ASSN. OF ST. LOWS, INC.

The Fulton Bag Company industrial buildings are located at 612-18 South Seventh Street in City Block 147, St. Louis, Missouri. The two attached buildings are located mid-block, directly on the sidewalk line (Photo #1). Northernmost is an 1899, four-story red brick building of Romanesque Revival design. It is one bay wide and nine bays deep; adjoining it is a one- and two-story, three-bay brick building of equal depth (see Site Plan and Photo #2). The two buildings have flat roofs; the single bay of the larger building prominently features a round arch at the fourth story. Adjoining it to the south, the shorter c. 1885 building has a c. 1925 facade of slip-glazed, variegated yellow brick. With the exception of the c. 1925 facade, the two buildings have been altered very little. Most of the windows of the larger building have been temporarily covered with corrugated fiberglas on the inside and some side and rear openings have been partially infilled with brick, none of which compromises the integrity of the building. The original brick cornice has been partially damaged and repaired; otherwise, the architectural integrity of the building remains intact and it is in good condition.

The four-story building at 612-14 South Seventh Street, designed by architects Eames & Young, features a handsome round-arched bay highlighted by triple rowlock brick banding and offsets. Rectangular spandrel panels are recessed and accented by the use of brick soldier courses around raised brick header trim. The basement and first story are separated from the upper stories on the primary elevation by the use of a molded-brick stringcourse/cornice. The cornice, found on all but the rear (east) elevation, is corbelled brick. A rectangular panel of raised brick headers and an oval window highlight the entrance to the building at the right (south) side of the facade. building features a raised first floor. North side elevation windows are paired, with double-hung wood sash; they feature triple rowlock segmental arches. Windows on the south side are single. A loading dock bay is located in the north side elevation: directly above it, openings for two bridges that formerly connected the building to its sister building to the north can be seen today as brick patches (visible in Photo #1). A second loading dock bay in the rear elevation has been infilled to form a window (Photo #3).

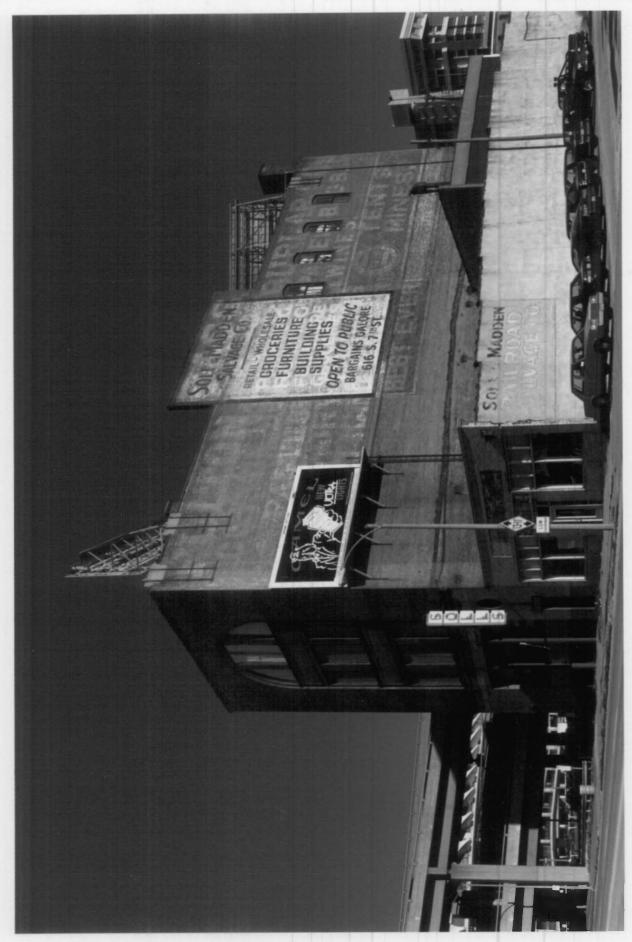
2 FULTON BAG COMPANY BUILDINGS # 2 612-14(L)-18(K) SOUTH SEVENTH 5T. LOUIS, MO

PRIMARY & SOUTH SIDE ELEVATIONS; FACING NORTHEAST FEBRUARY 1991
PHOTO GRAPHEE: CYNTHIA LONGWISCH
NEGATIVE: LANDMARKS ASSN. OF ST. LOUIS, INC.

The adjoining building at 618 South Seventh Street is a typical example of the small-scale commercial architecture in the area. Its simple, functional design was originally meant to accommodate a livery stable. The rear portion of the building includes a section two stories in height (Photo #2, right rear): inside, this section is not divided into two stories, the upper windows functioning as a clerestory. About 1925, a new facade was applied to this building, using slip-glazed yellow brick. basketweave-patterned brickwork crosses the building at the cornice. A recessed panel in the building's small parapet and another above the door probably held commercial signs. cotta coping is used on the parapet. A centered doorway is flanked by large display windows.

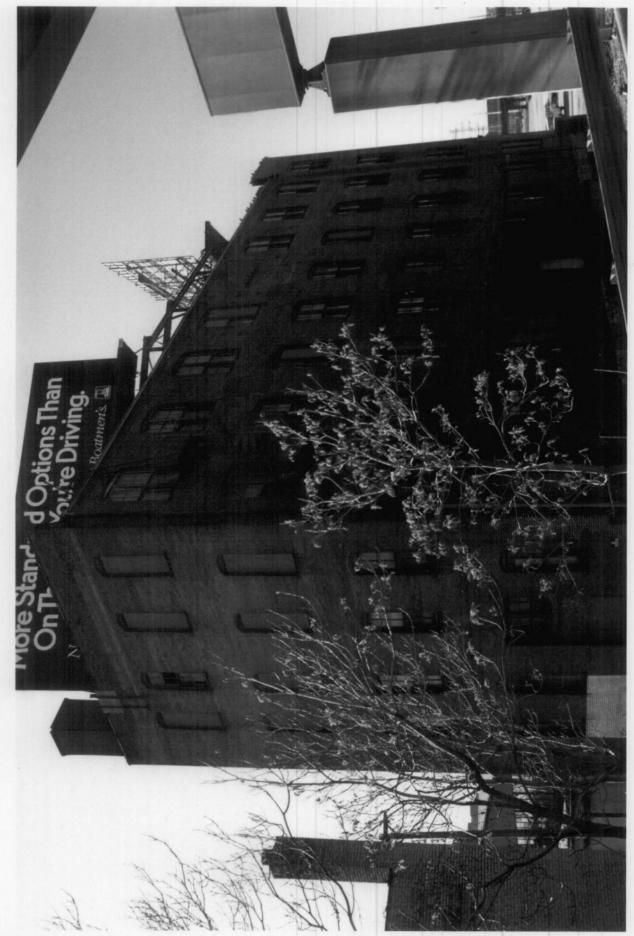
#3 FULTON BA 612-18 50 57. LOWS,

REAR & NORTH SIDE ELEVATIONS; FACING SOUTHWEST FEBRUARY 1991
PHOTOGRAPHER: CYNTHIA LONGWISCH
NEGATIVE: LANDMARKS ASSU. OF ST. LOUIS, INC.

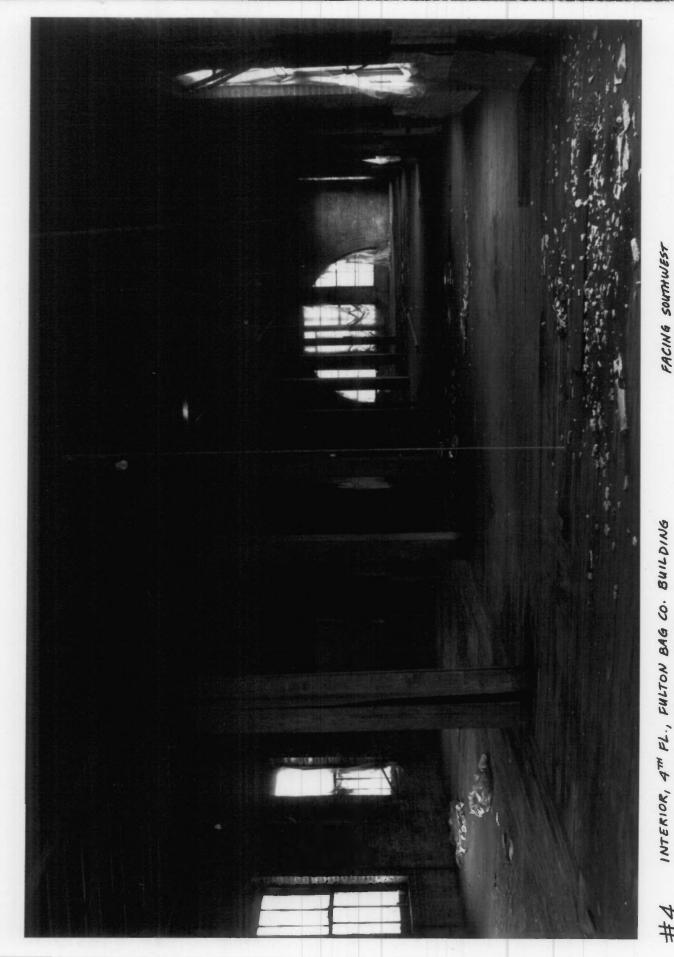
#4 INTERIOR, 4TH PL., FULTON BAG CO 612-14 SOUTH SEVENTH STREET ST. LOUIS, MO

FACING SOUTHWEST
FEBRUARY 1991
PHOTOGRAPHER: CYNTHIA LONGWISCH
NEGATIVE: LANDMARKS ASSIN. OF ST. LOUIS, INC.

The interior of the larger building is of post and beam construction (Photo #4 shows the fourth floor). Eight wooden posts are evenly spaced down the center of each floor, supporting a heavy center wood beam (see Floor Plan). Joists run northsouth, at right angles to the beam. Walls are bare brick, coated with a thin layer of plaster in stairwells. Tongue and groove wood flooring is used throughout. The [freight] elevator is still operational. The interior has suffered some water damage but remains largely intact.

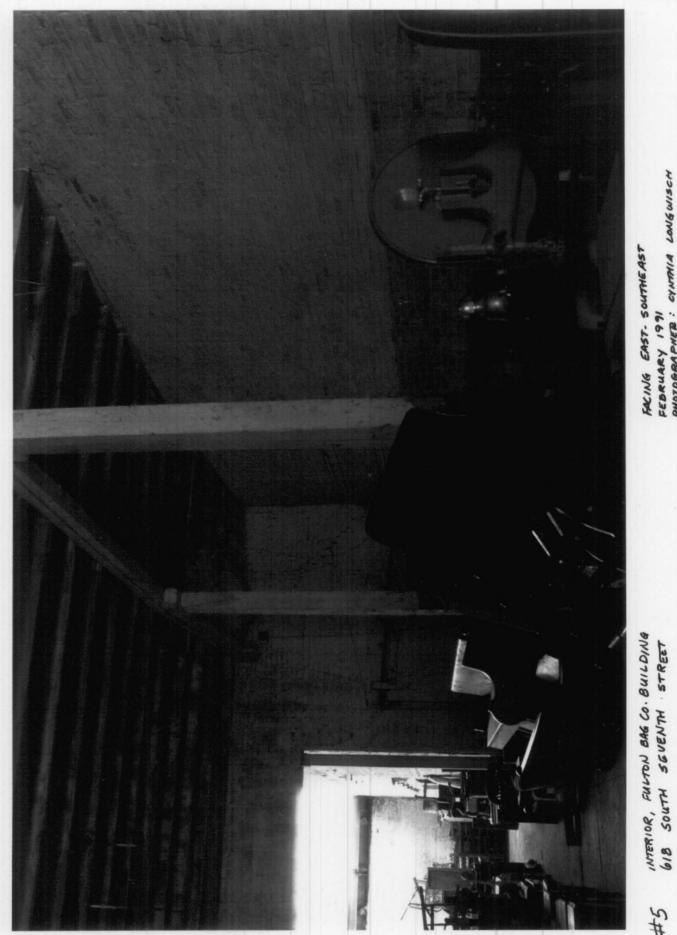
> ST. LOUIS, MO #5

NEBATIVE : LANDMARKS ASSN. OF ST. LOWIS, INC. FEBRUARY 1991 PHOTOGRAPHED: CYNTHIA LONGWISCH FACING EAST. SOUTHEAST

The interior of 618 South Seventh is also of post and beam construction (Photo #5), somewhat less substantial in nature than that of the larger building. Very little appears to have been altered in the interior.
