Title: Historic and Architectural Survey of Higginsville,

Missouri

Abstract: This study consists of two parts: Part I, Historic and

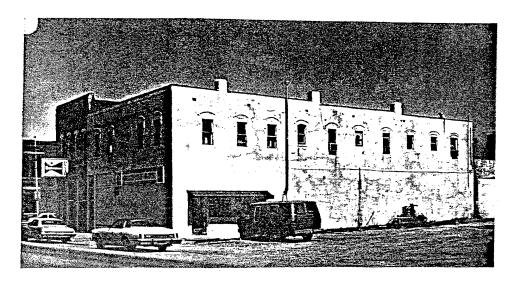
Only two buildings remain in the 2100 block on the east side, the bowling alley and Red Mann Saloon (closed). These are older original buildings which could be included in a "founding fathers" district as described in the next chapter, Preservation Potential.

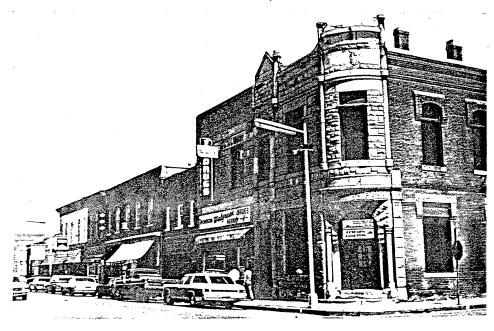
The east side of the 2000 block includes the American Bank building with its facade of Warrensburg sandstone. The adjacent building to the north is of the same vintage and blends well with the bank. Proceeding north, lower-story modifications would make restoration relatively expensive. At the end of the block is the post office, built in 1930.

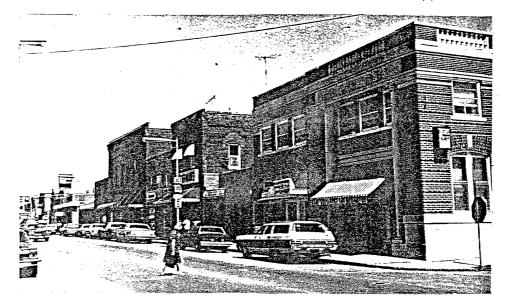
The 1900 block commences with the Zeikle Building, followed by an intrusion of a one-story building housing Gaslight Real Estate and the Green & Green law office. Next is Lefman's Appliance, modified in 1946, followed by Kramer Mens and Boys Clothing, another intrusion. The north end of the block contains the modern American Bank of Higginsville.

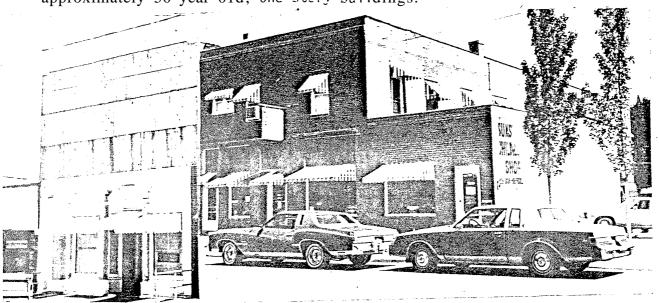
A bank parking lot, site of the old Merchants Hotel, occupies the beginning of the 1800 block. The first building is a realty office constructed in the 1930s, followed by Smith's Book Store and the Wilson Building of hand-cut sandstone. Most of the sandstone is covered with wood to slow its deterioration. The remainder of the block consists of approximately 50-year-01d, one-story buildings.

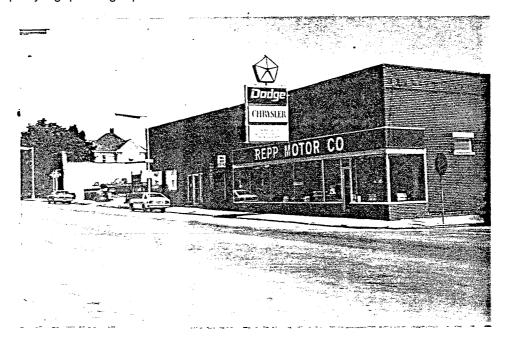
The 1700 block contains the old mule livery stable/Dr. Blackmon building which has modified windows; a vacant lot; a garage; and the very significant Wiegers Funeral Home which is barely visible in the accompanying photograph.

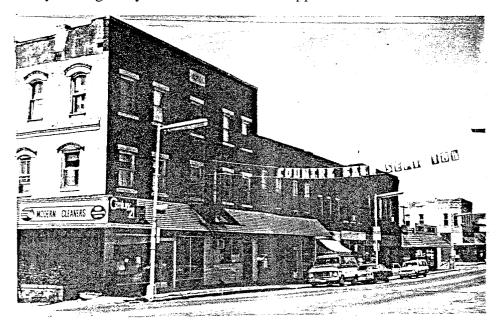
The Arcade Hotel with its modified facade begins the west side of the 2100 block. The next three buildings, all with modified first floor facades, are occupied by the E Z Manufacturing Co., a doughnut shop/print shop, and Kracker's Bar. Next is an intrusion of a one-story building occupied by Montgomery Ward and Office Suppliers.

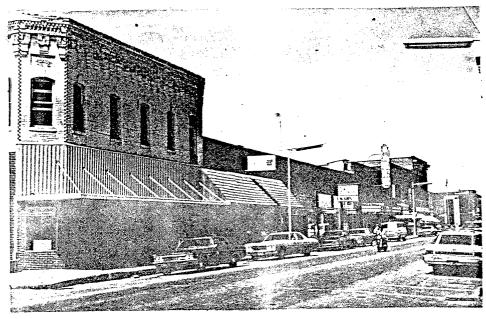
The 2000 block starts with the very significant Thaller Electric and Crafts Shop, which is followed by several one-story modified buildings. At the end of the block is the Western Store and the Dollar Store, which occupies the old T. M. Lake Building.

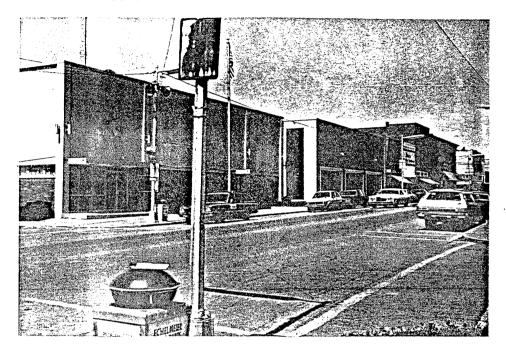
The 1900 block contains the new City Hall, the recently modified facade of Hoefer Furniture, and modified first floor shops extending to the end of the block.

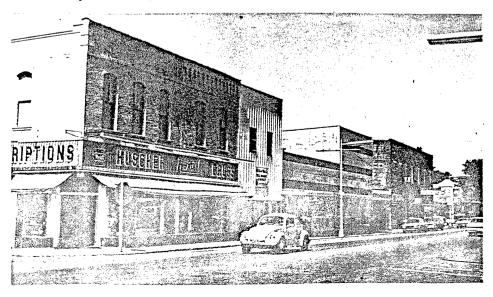
Of buildings in the 1800 block, the Huscher Drug Store has a modified first floor but has an original second floor and is a significant landmark. Other buildings in the 1800 block have modernized facades with the exception of those at 1800 and 1802 Main (the old Hader's Furniture and McCord's Grocery stores), now Hoefer Furniture.
