# National Register of Historic Places Registration Form

historic name Hillview Cooperative Dairy Farm Historic District  
other names/site number \_\_\_\_\_

street & number Missouri Highway T and Hillview Road  N/A not for publication  
city, town Hughesville  vicinity  
state Missouri code MO county Pettis code 159 zip code 65334

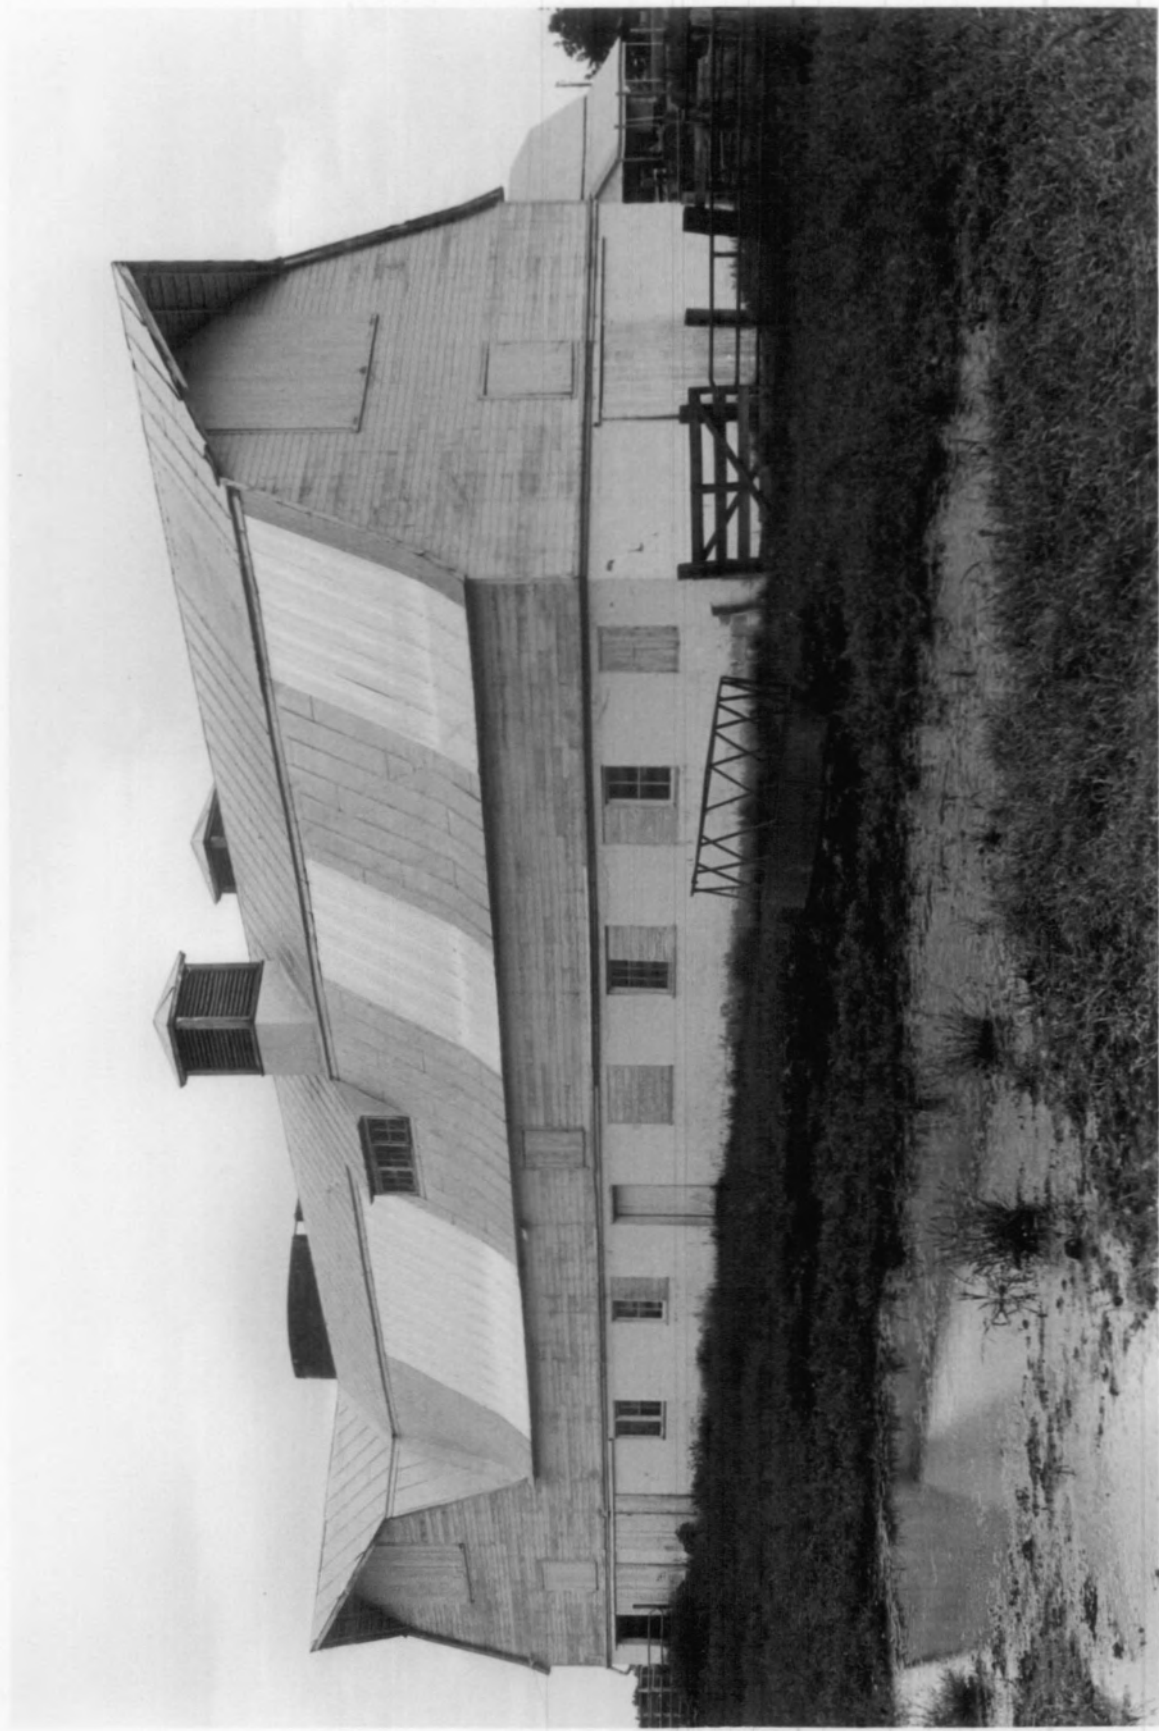
# 4

W & S FACADES OF SMALLER WING, FORMER DAIRY BARN  
(FACING NE)

F. Type 411:2 Government Dairy Barn. The largest of the Osage Farms properties, the Type 411:2 government dairy barn (shaped like the letter Z with the center stroke straightened) is relatively unaltered. The lower barns are for beef cattle rather than for dairy cattle today, however, and the milking wing serves as a workshop. The old sterilization and chill rooms are used for storage. The loft is still used for hay storage. The feed bunk along a central row of posts is original but a hay manger along the south wall is recent. Cattle stalls have been added at the south end of the milking wing. Several original windows have been replaced with four-light units and some window openings have been covered. A few sections of the flat metal roof with standing seams have been replaced with corrugated steel. Within the old milking wing, a trough in the concrete floor for cattle droppings is a reminder of the past. Contributing. (See Photos #3, 4, 5, 7, 17, 19, 20, 22, 23, 24, 25, 26, 27 and 28.)

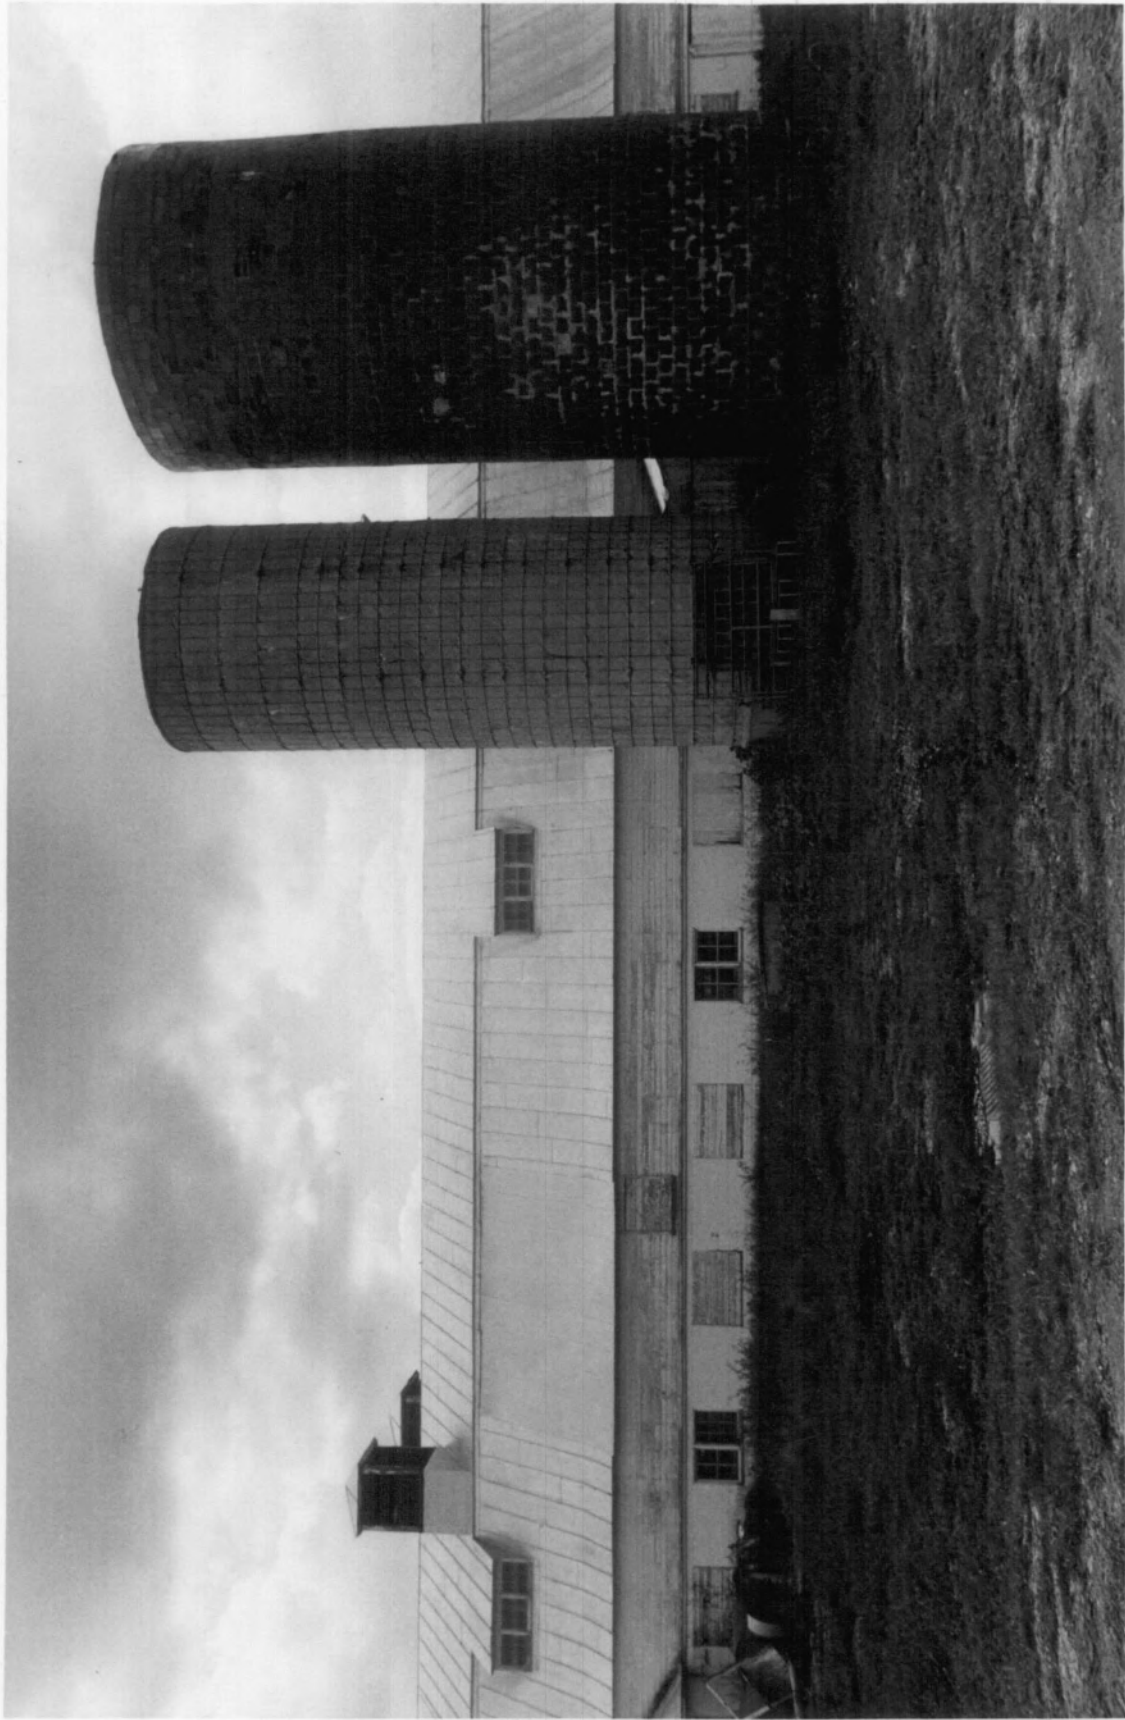
#5

NORTH SIDE OF DAIRY BARN (FACING S)

D. Reconditioned Silo. This ca. 1920s tile block silo is a good example of a structure that was reconditioned by the RA/FSA and used on the project. According to a 1937 project map, this was the only reconditioned silo at Osage Farms. The cap has been removed and it is no longer used. Constructed before the ca. 1937 Type 411:2 barn, to which it is only semi-attached, it is counted as a contributing structure. (See Photos #3 and 5.)

E. Government Silo. At least four cement silos are believed to have been constructed at Osage Farms, but this is the only one standing. The cap is missing and it is no longer used. Because it is only semi-attached to the barn and because it is the only extant example of a government constructed silo, it is counted as a contributing structure. (See Photos #3 and 5.)

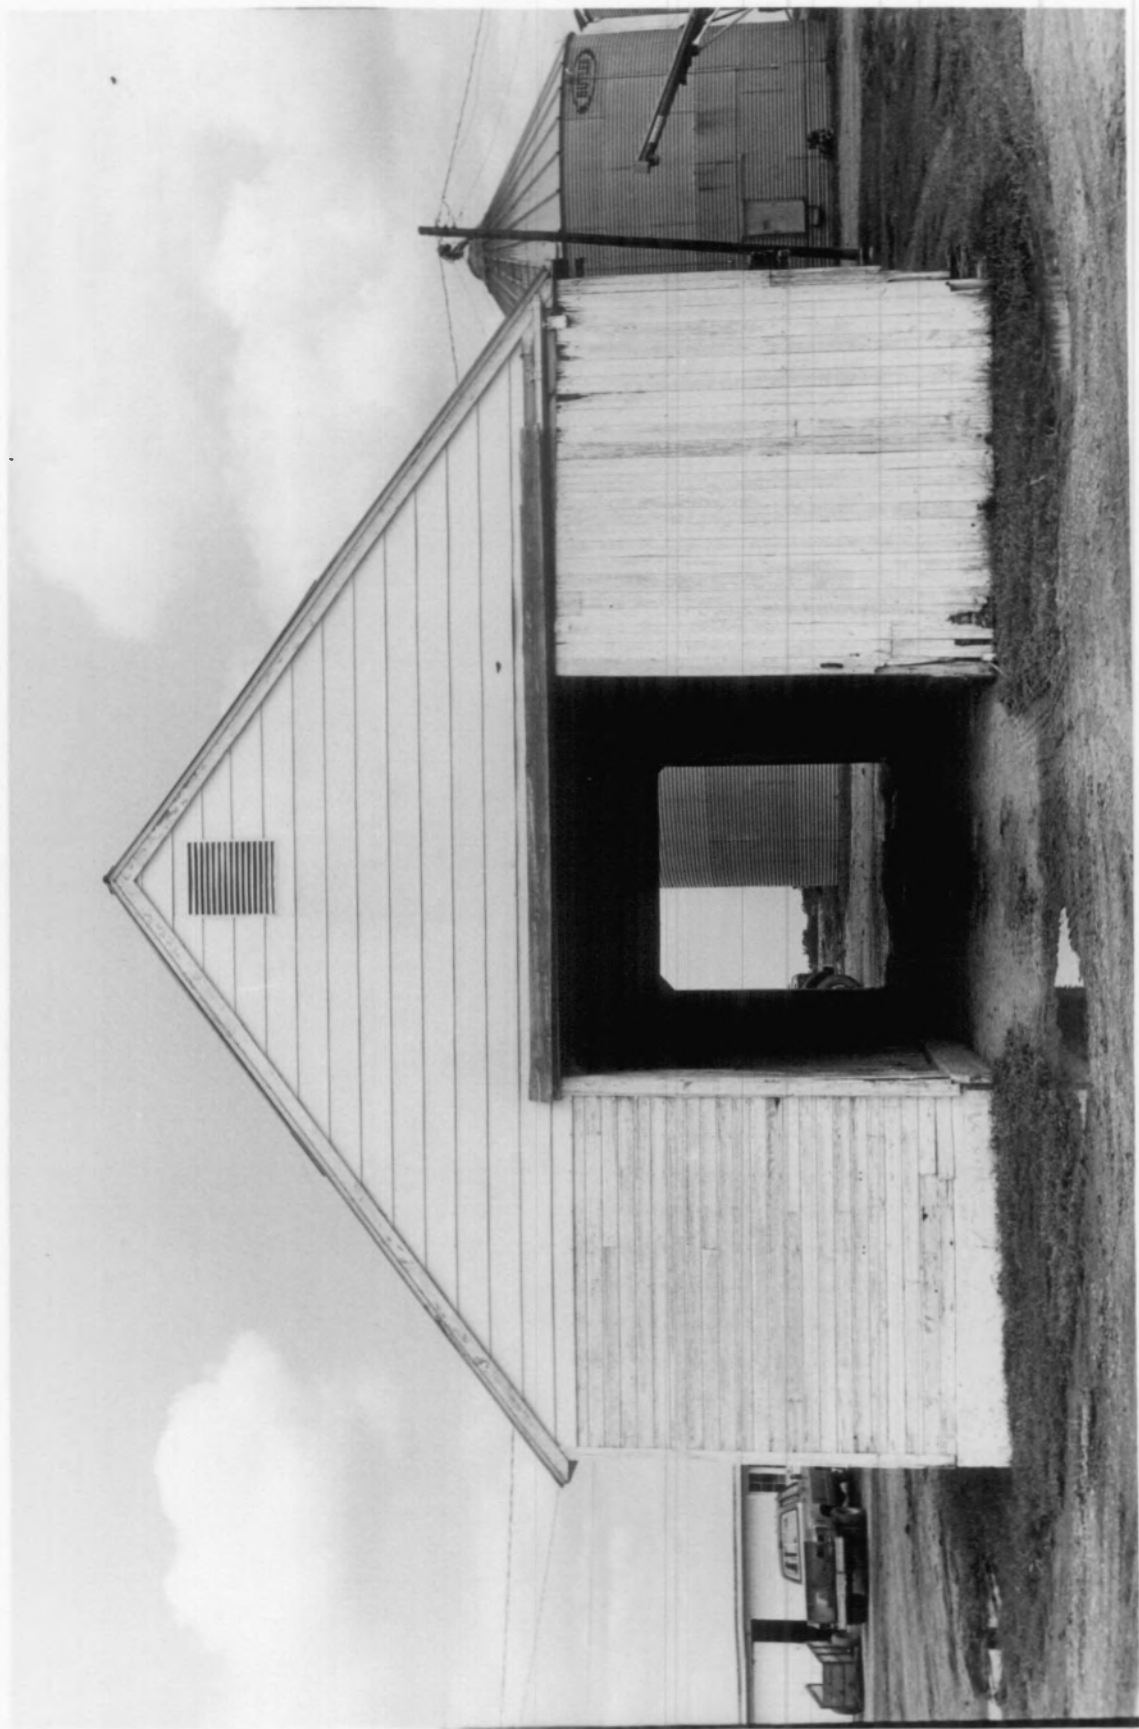
#10

SHOW-ME RPC  
S. FACADE OF GRANARY

G. Grain Bins. Three steel grain bins were erected in the 1970s-80s. While these structures are not out of place in an agricultural context, they are noncontributing. (See Photos #6 and 10.)

H. Granary. Composition siding was used to repair the deteriorated shiplap siding in both gables in the early 1980s. The corrugated metal roof may or may not be original. The building is used as a granary today and is counted as a contributing structure. (See photos #6, 10, 29 and 30.)

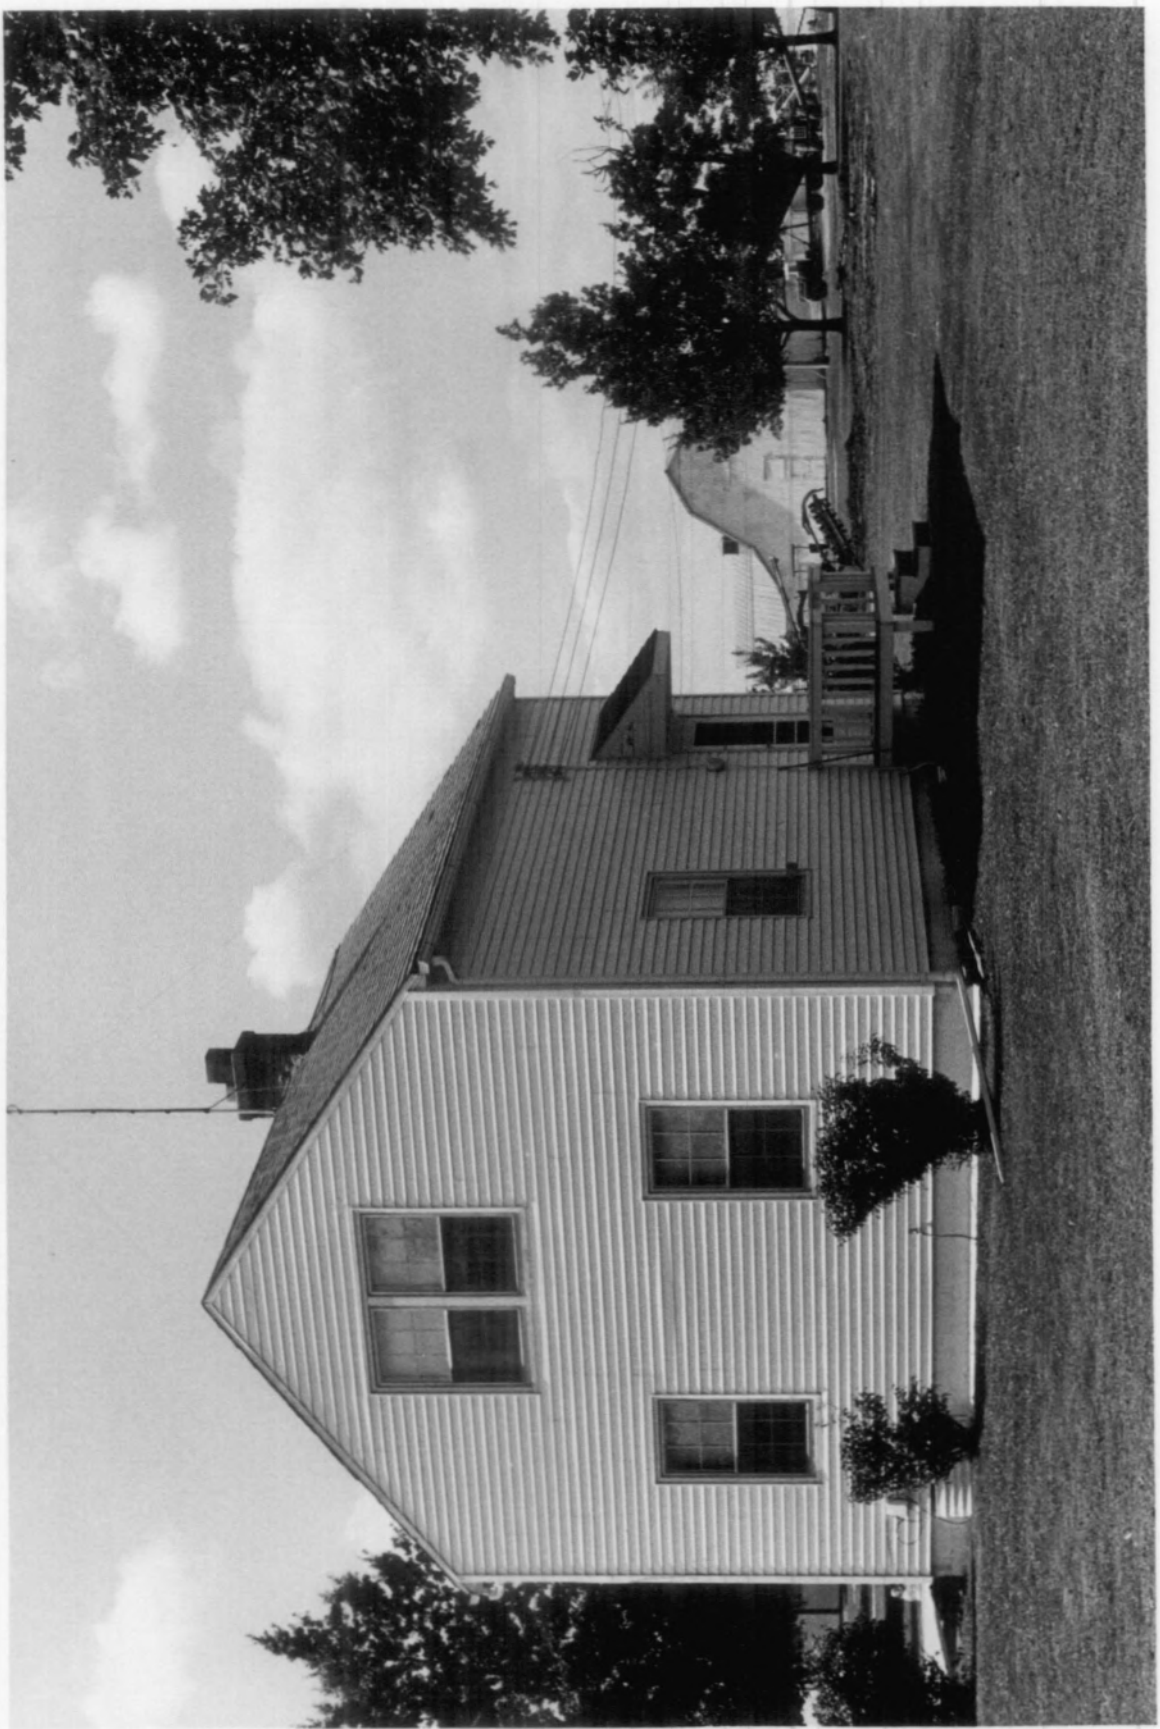
#11

E & N FACADES, TYPE 3/5.11 TENANT HOUSE (FACING SW)

K. Type 315:11 Government Farmhouse. This is a good example of the most common type of government farmhouse, although close inspection will reveal that vinyl siding covers the original clapboard. Since the significant form, features and detailing can be seen, this application of non-historic siding, as noted in the cover document, does not preclude listing. The concrete slab porch and a small wooden porch are not original. Only the Type 315:11 government farmhouse had a basement. Contributing. (See Photos #11, 12, 13, 15 and 19.)

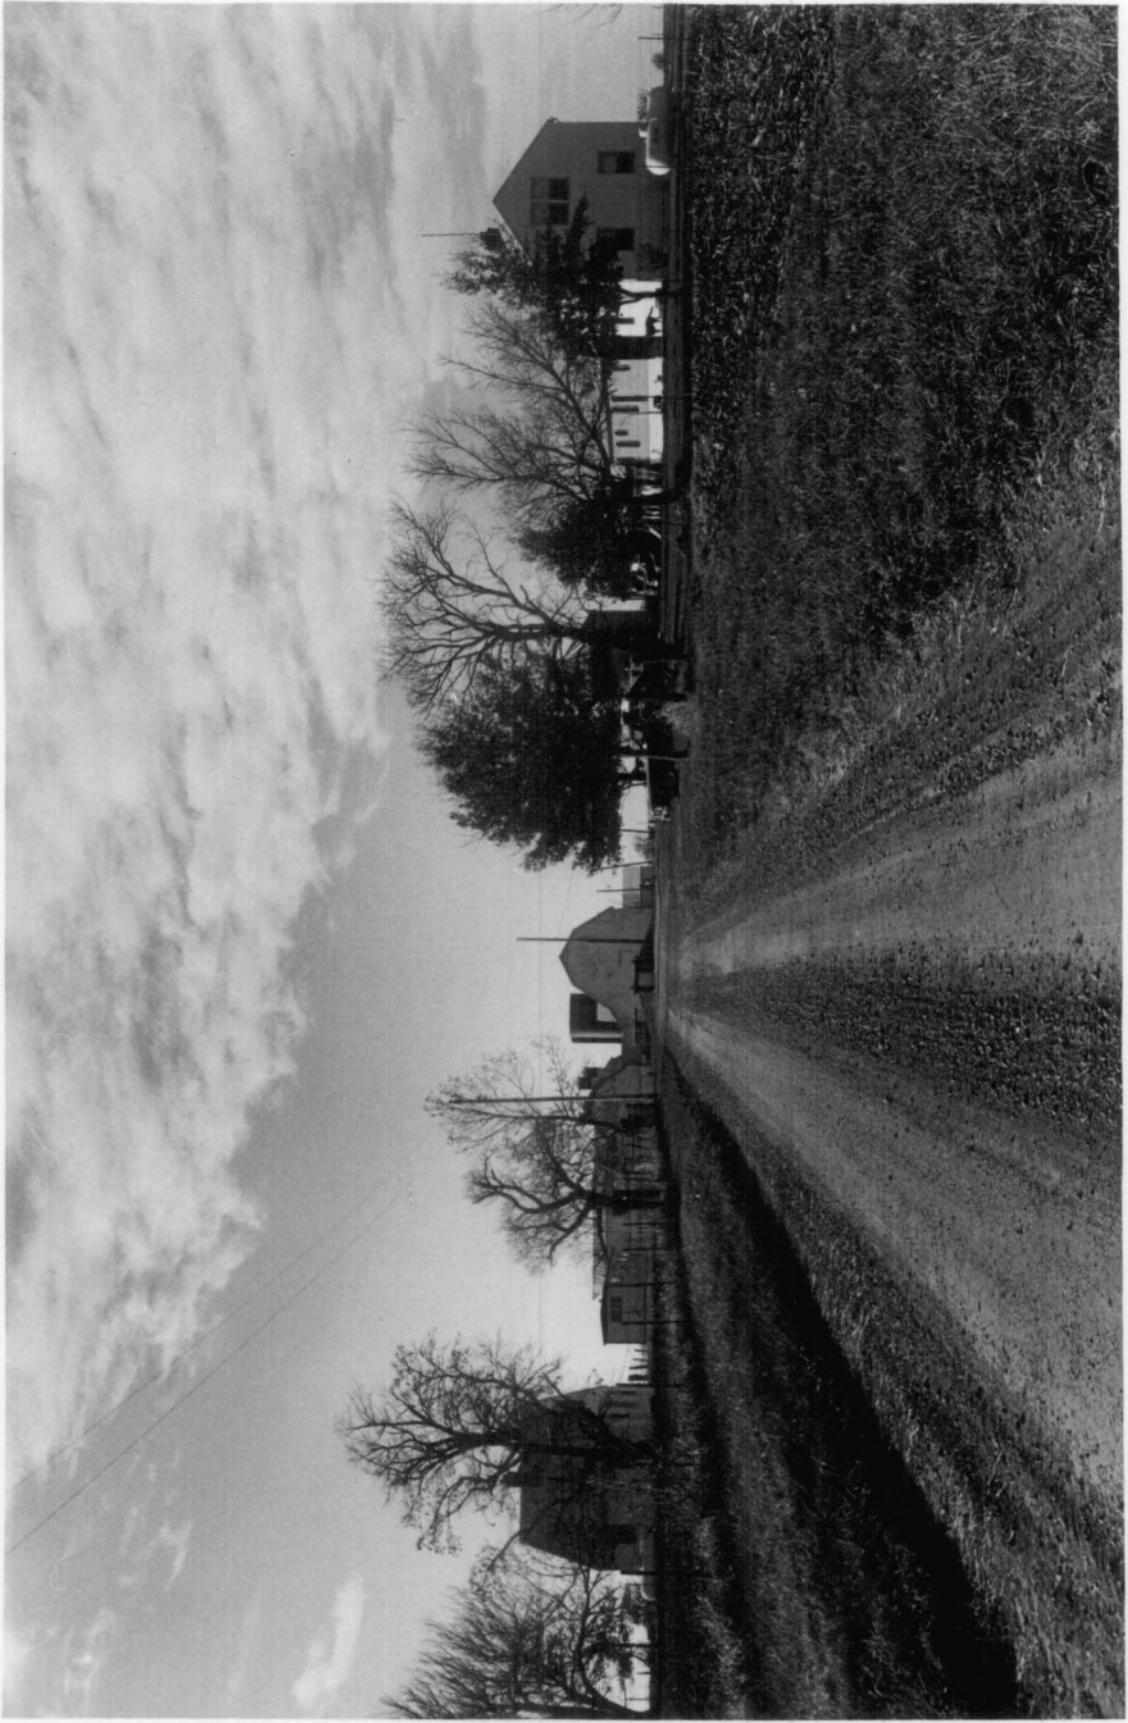
SHOW-ME RPC  
FACING WEST INTO COMPLEX

J. Mobile Home. Modern, noncontributing. (See Photos #13 and 19.)

L. Well House. This 7' x 9' cinder block well house enclosed a well with a pressure system that provided water for barns and dwellings at Hillview. The well and pressure system are new but the building is probably unaltered, unless the roof has been changed. Its dimensions are similar to those of the government food storage building but it has a concrete slab topping instead of a gable roof. Contributing. (See Photos #13 and 14.)

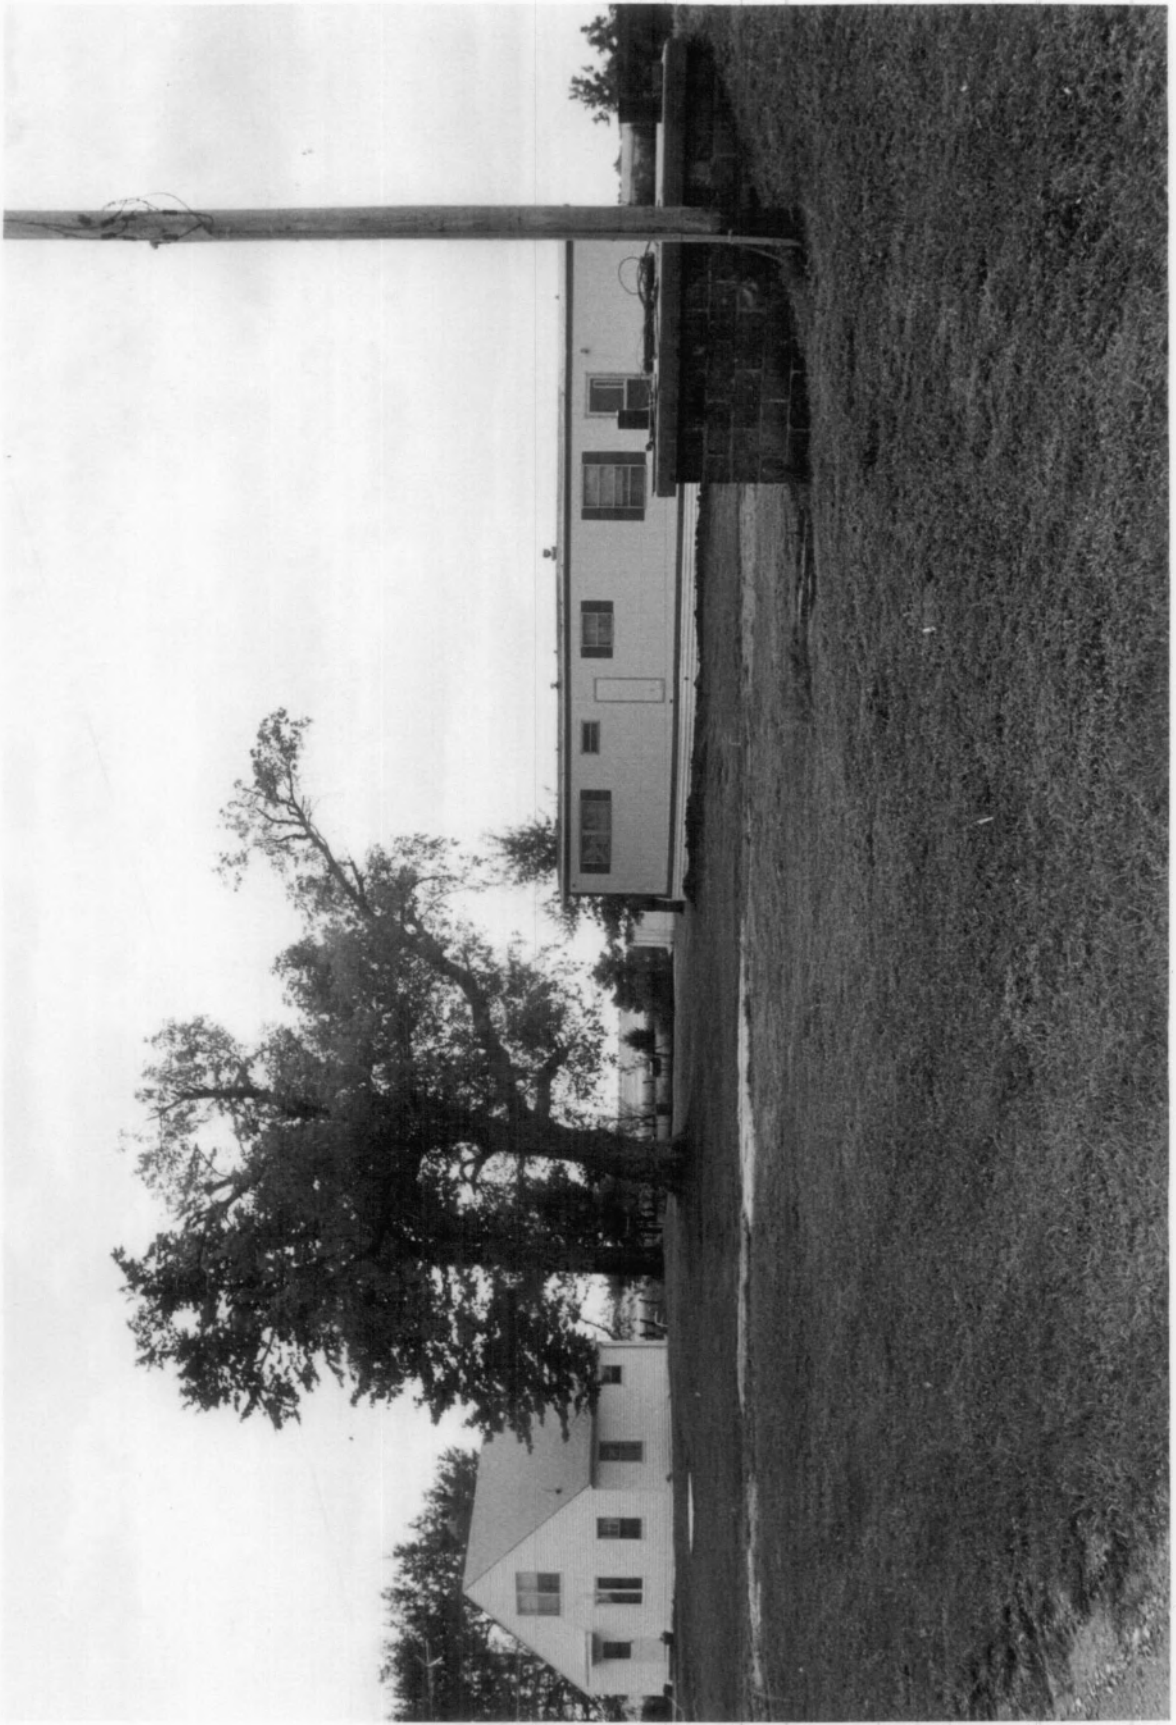
#14

FORMER TENANT HOUSE, MOBILE HOME AND  
WELL HOUSE, FACING S

M. Mobile Home. Modern, noncontributing. (See Photos #13 and 14.)

N. Type 315:12 Government Farmhouse. Vinyl siding has been installed, but this is an otherwise impressive Type 315:12 farmhouse. Properties with non-historic siding may be listed when, as in this case, the original form, features and detailing are intact. Both entrances are in gable ends. One 6/6 window has been replaced with a modern window in the main facade. This very postwar-looking house is contributing. (See Photos #13, 14, 15, 16 and 18.)

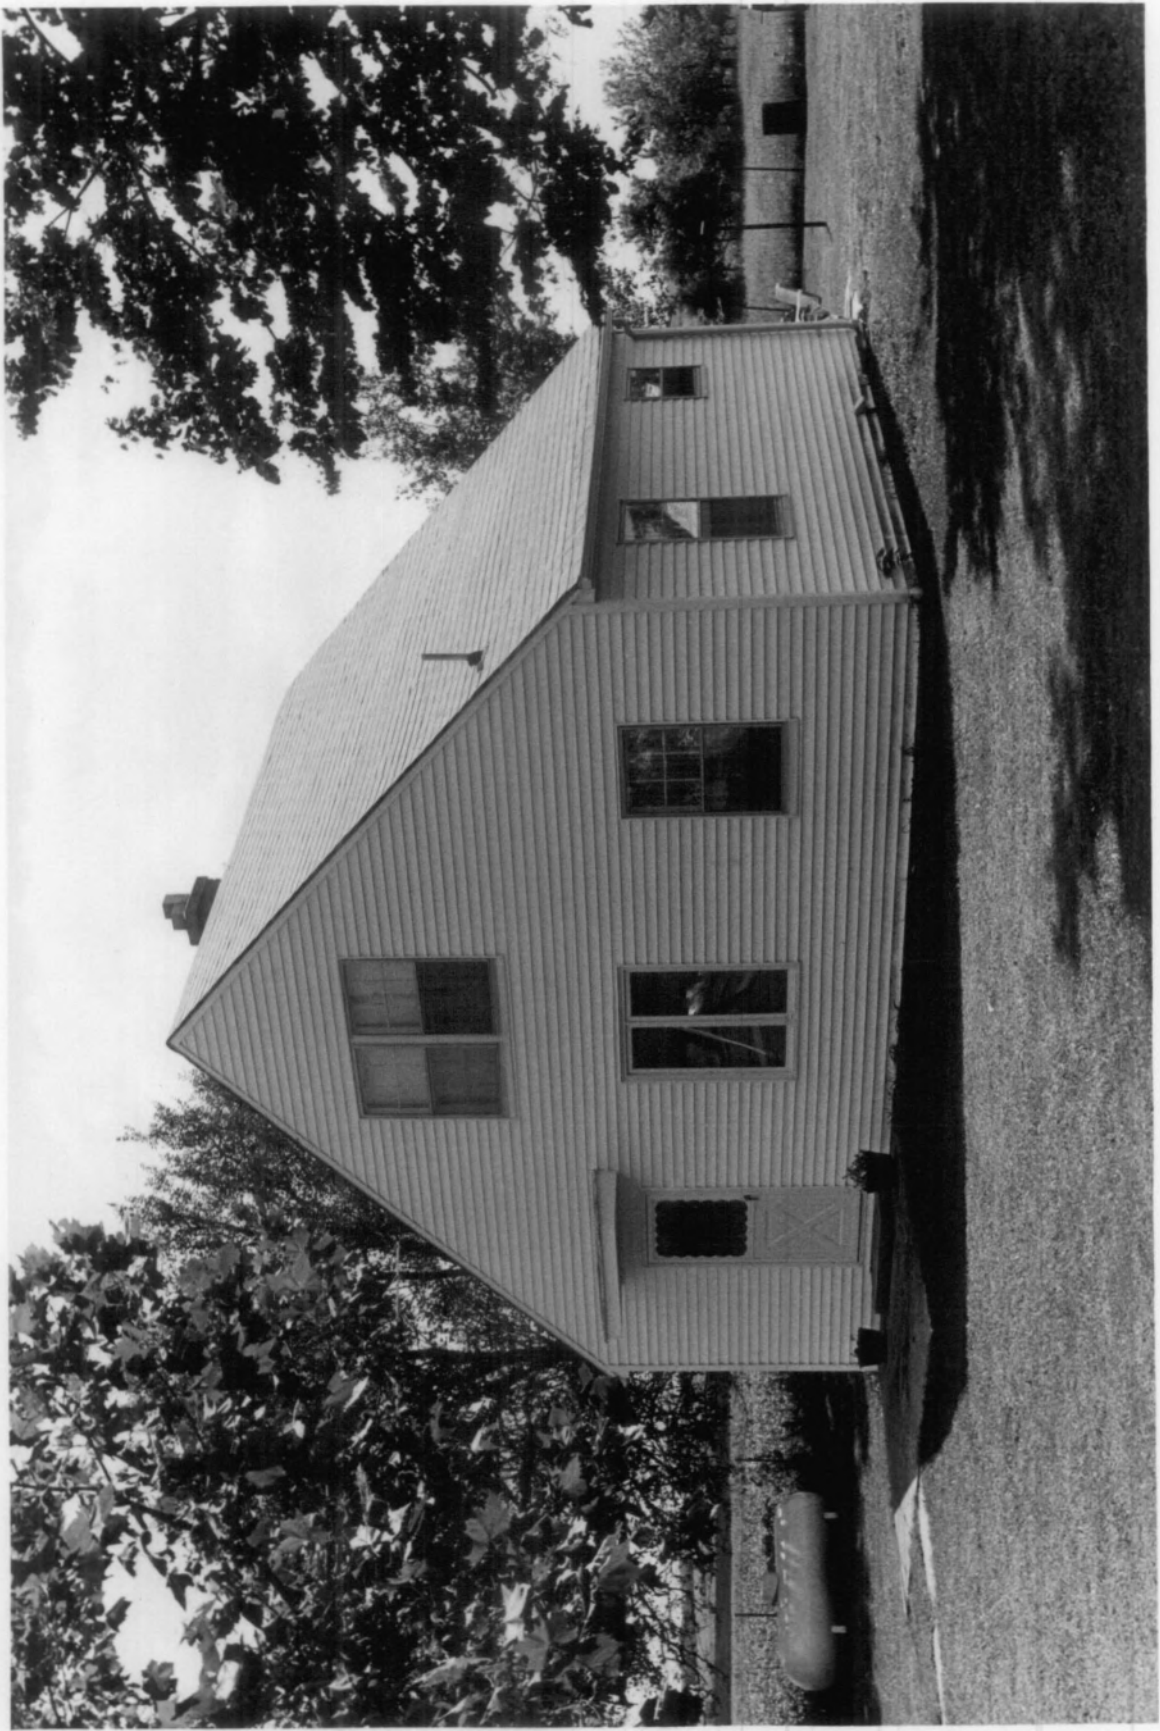
#16

N + W FACADES, TYPE 315:12 HOUSE

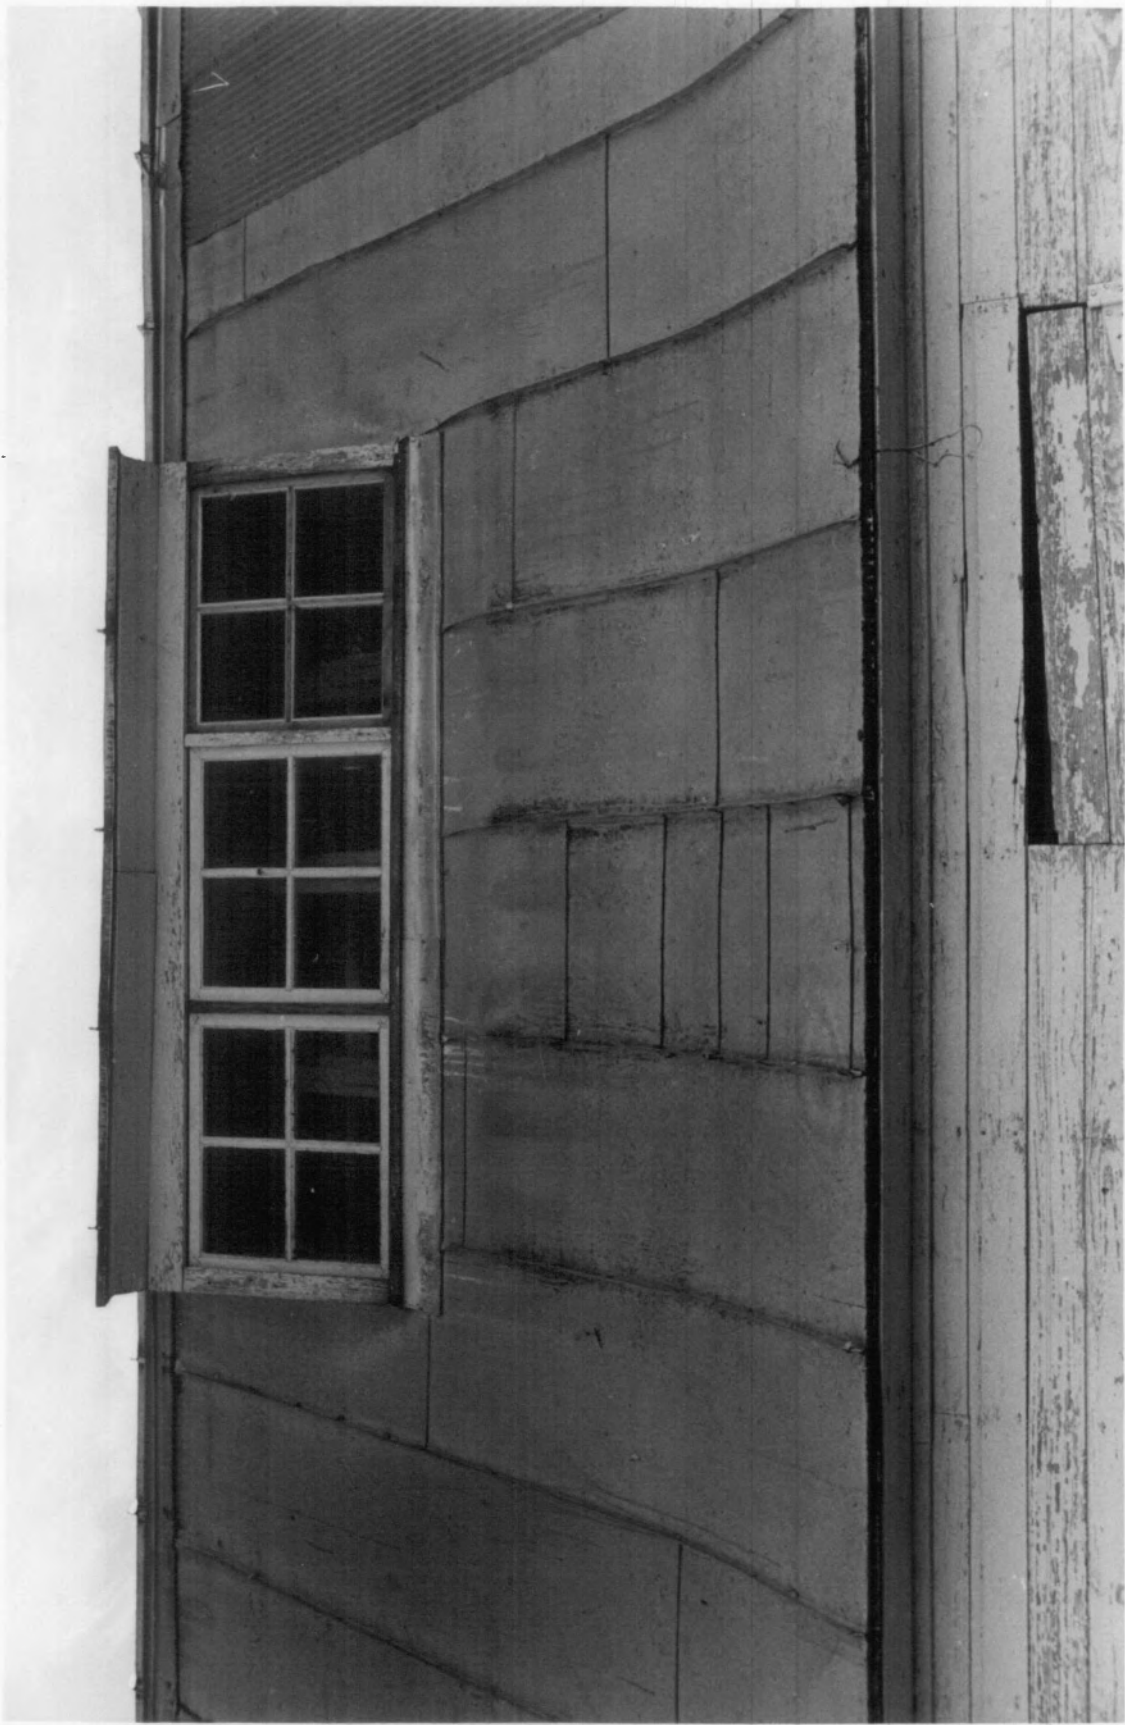
#20

ROOF DETAIL WITH DORMER WINDOW ON FORMER DAIRY BARN

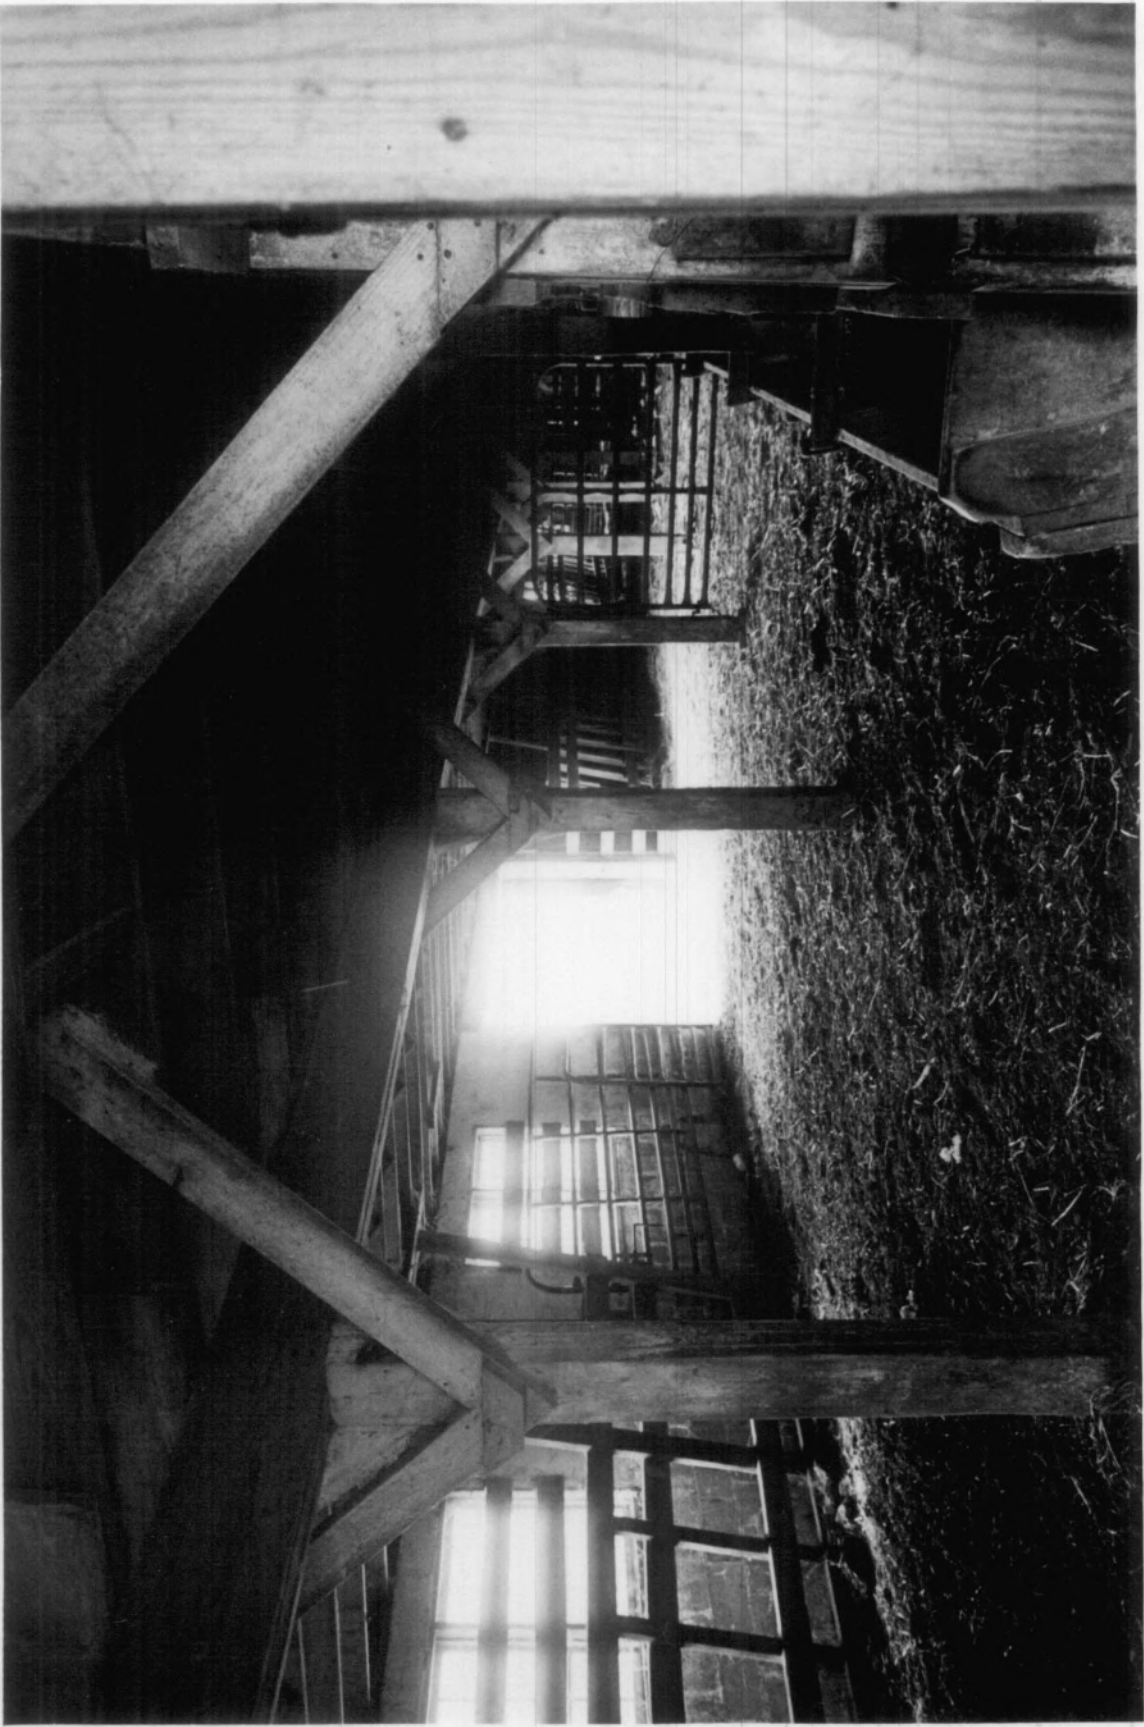
# 23

SHOW-ME RPC  
INTERIOR, SHOWING TWO OF THREE  
AISLES, FACING SW
